John Gordon House

Interior Finishes Analysis

Natchez Trace Parkway, Tennessee

April 2011

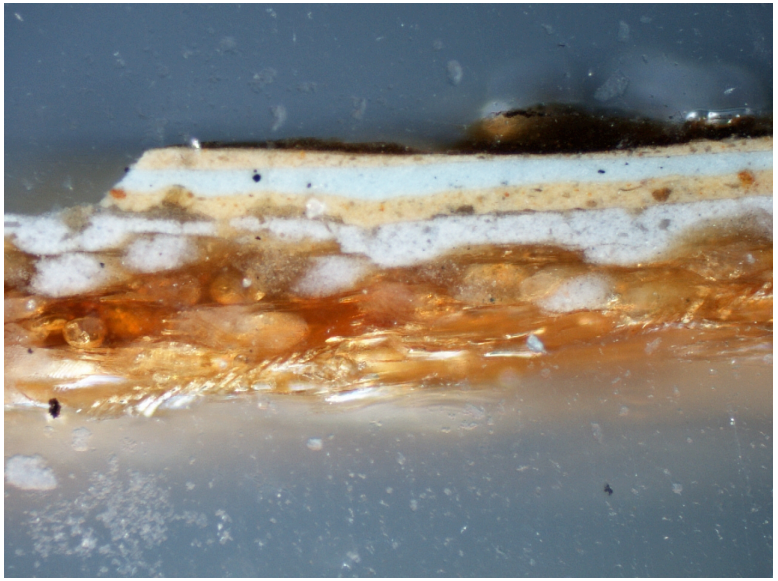
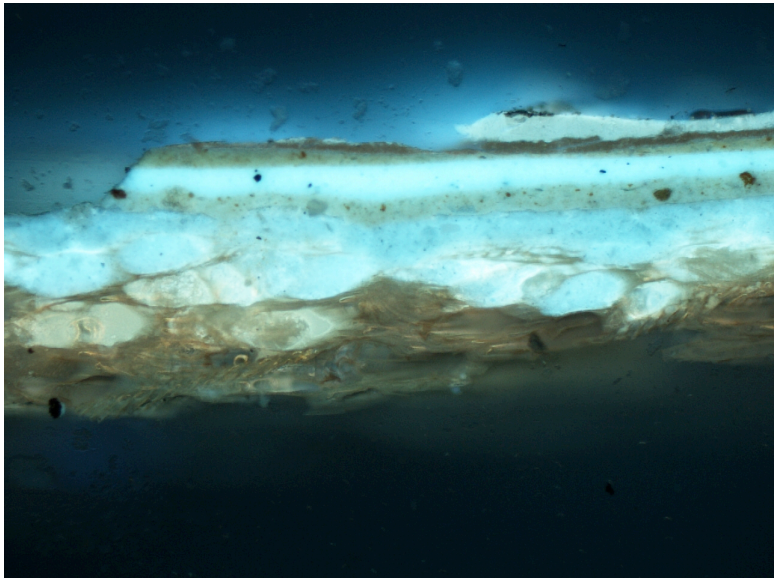
SAMPLE NO:	JGH.102.10
LOCATION:	Exterior door, interior side

LAYER	***COLOR***	***NOTES***
Substrate	Wood	Missing early paint
1	Blue-gray	
2	Yellow Peach	
3	White/Light aqua	
4	Light peach	
5	Brown	
6	Brown/Varnish

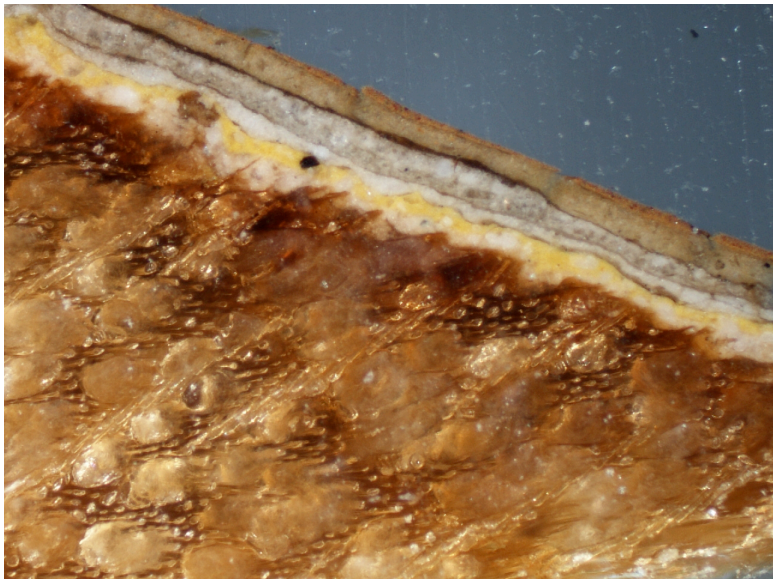
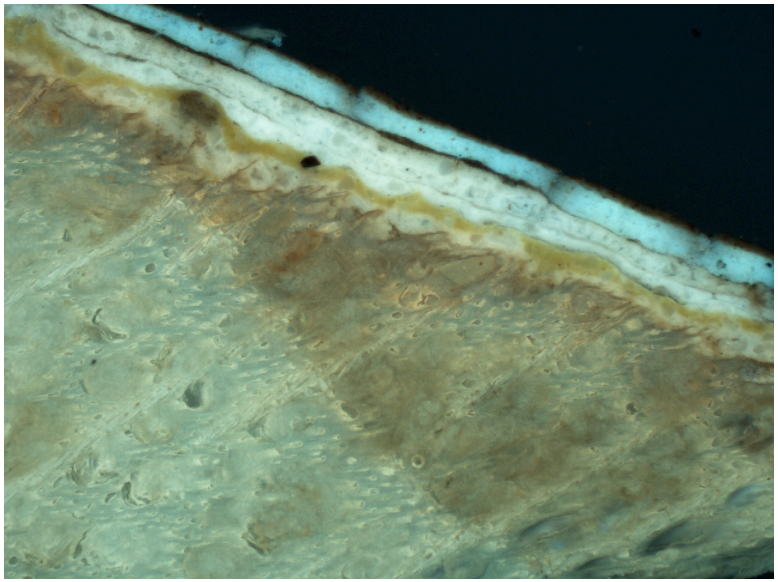
SAMPLE NO:	JGH.201.1
LOCATION:	baluster

LAYER	***COLOR***	***NOTES***
Substrate	Wood	Something reddish and autofl. saturated into surface
1	Cream	Thin, traces
2	Yellow	Coarsely ground
Dirt		Or thin, uneven brown
3	White	
Dirt		
4	Whitish	
5	Whitish	
	Brown	Thin
6	Tan/cream	
7	Orange-brown

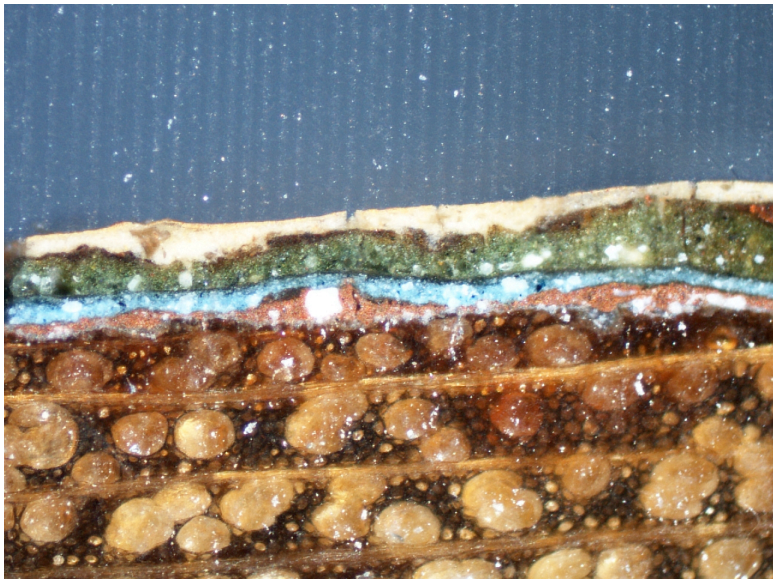
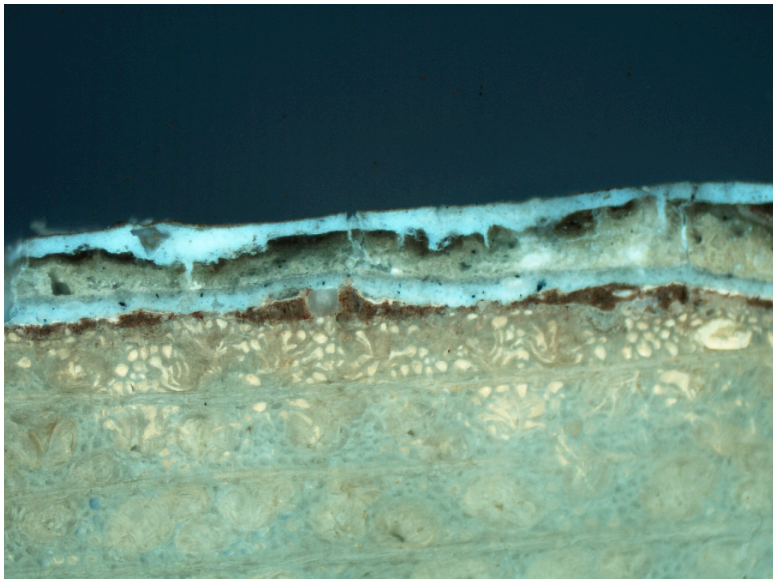
SAMPLE NO:	JGH.201.2
LOCATION:	Stair string

LAYER	***COLOR***	***NOTES***
Substrate	Wood	Reddish saturation in surface; autofl.
1	Gray	Very thin
2	Red-brown	
3	Brown	Thin, varnish?
4	Blue	
Dirt		
5	Yellow Green	Damaged
6	Brown	Damaged
7	Cream	
8	Orange-brown

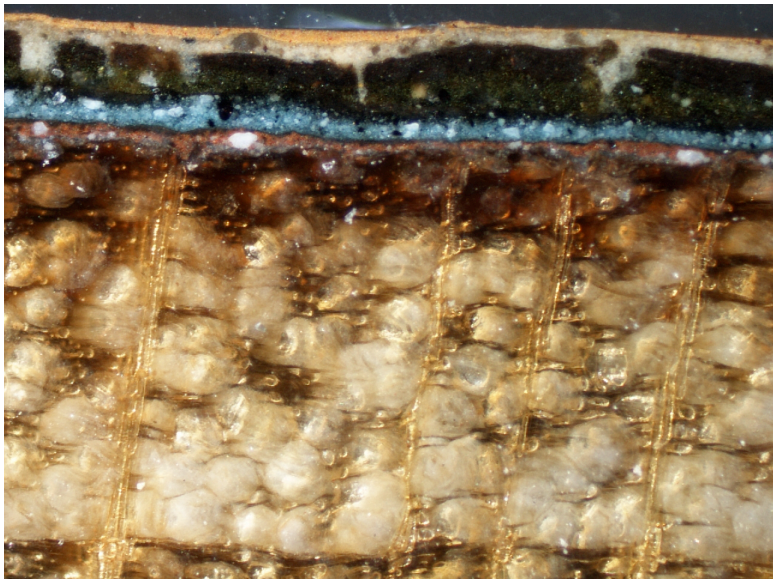
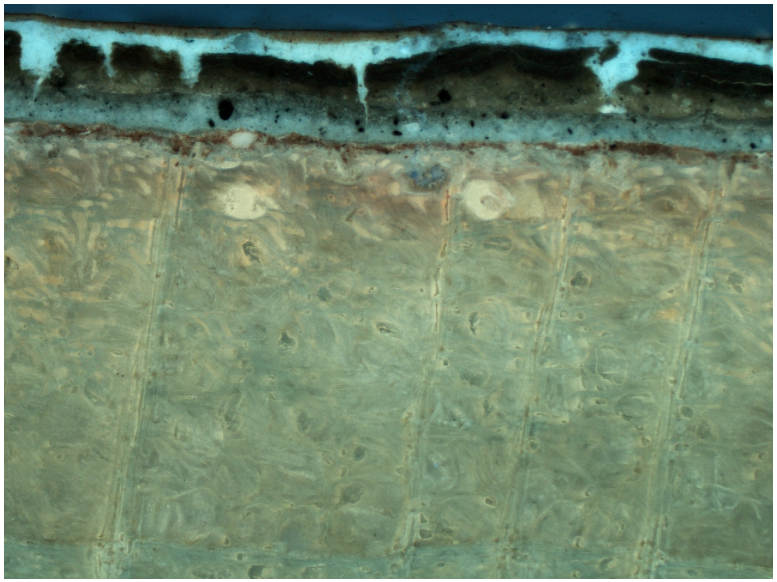
SAMPLE NO:	JGH.201.3
LOCATION:	Floor nosing

LAYER	***COLOR***	***NOTES***
Substrate	Wood	Dark reddish saturation in surface; autofl. orange
1	Gray	Thin
2	Red-brown	
Dirt		
3	Blue	
Dirt		Or discolored previous surface
4	Yellow-green	Damaged
5	Brown	Damaged
6	Cream	Thin
7	Orange-brown

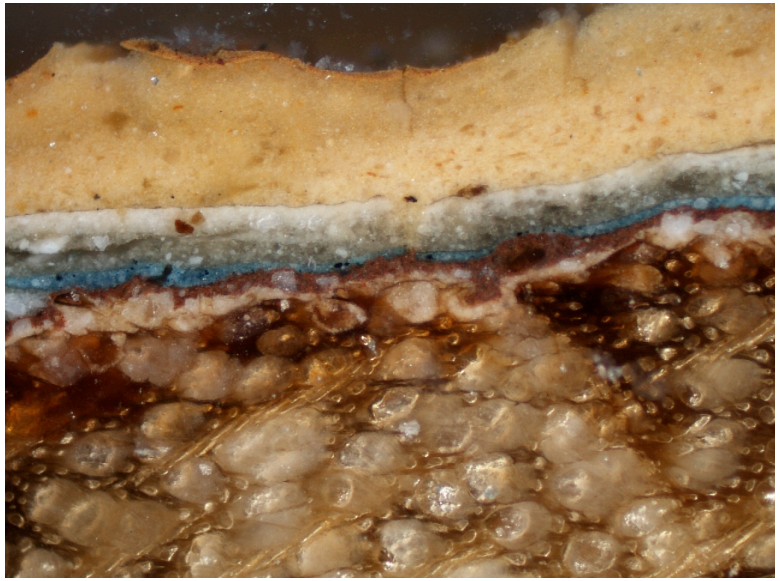
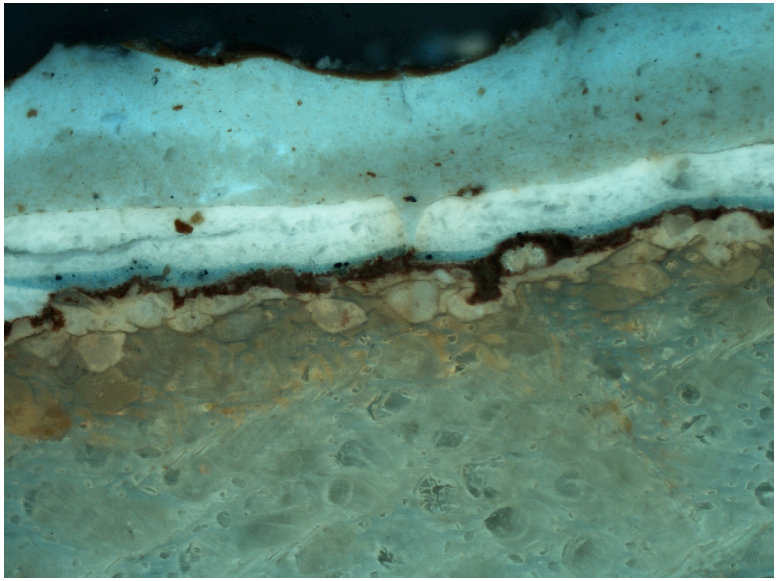
SAMPLE NO:	JGH.201.4
LOCATION:	Hand rail

LAYER	***COLOR***	***NOTES***
Substrate	Wood	Saturation in surface; autofl. orange
1	Cream	Thin, uneven
2	Red-brown	
Dirt		
3	Blue	Thin
4	Gray	
5	Whitish	
Dirt		
6	Peach	Thick
7	Orange-brown	Thin

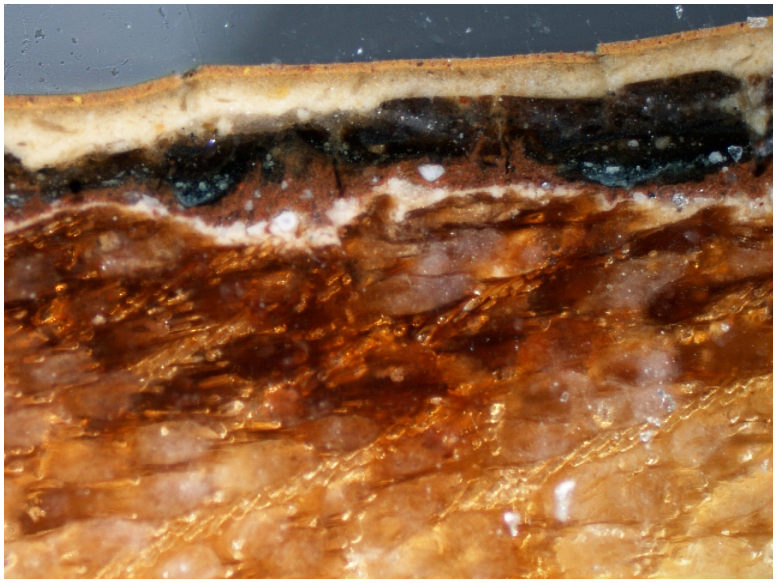
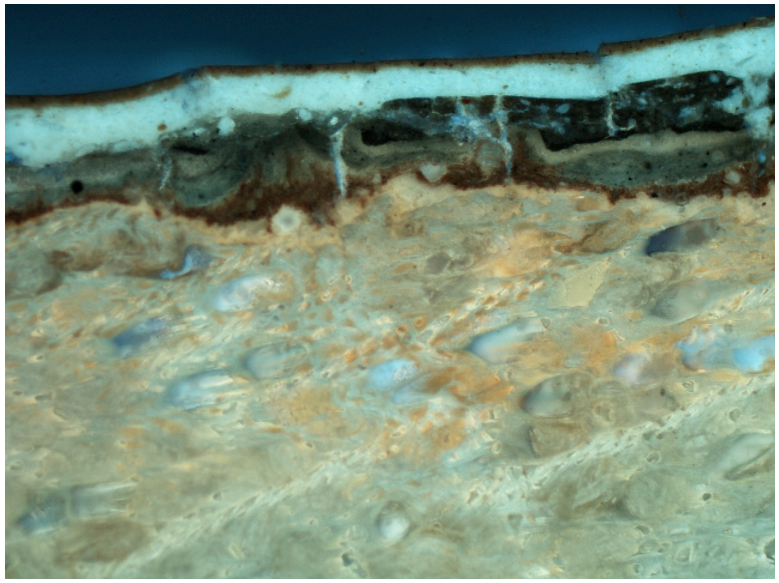
SAMPLE NO:	JGH.201.5
LOCATION:	handrail

LAYER	***COLOR***	***NOTES***
Substrate	Wood	Red saturation in surface
1	Cream	Thin, uneven
2	Red-brown	
3	Blue	
4	Gray	
5	Brown	Varnish; damaged
6	Brown	Damaged
7	Cream	
Dirt		
8	Orange-brown

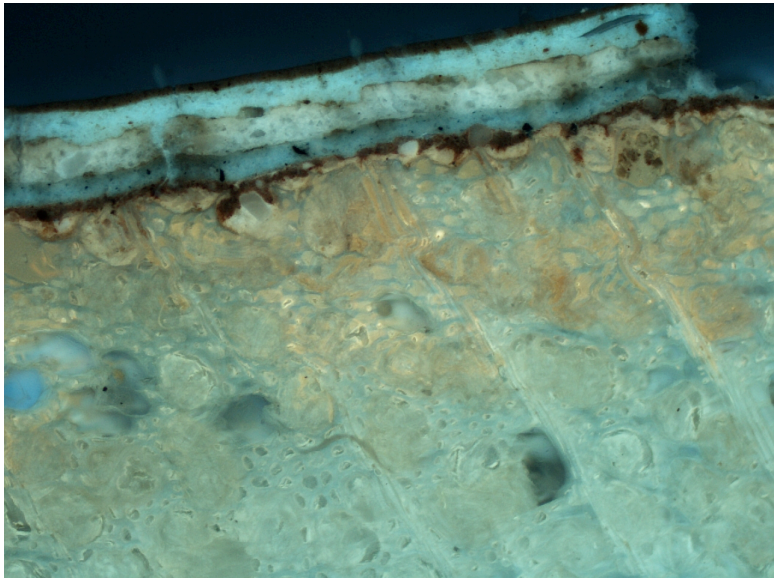
SAMPLE NO:	JGH.201.6
LOCATION:	Newel post

LAYER	***COLOR***	***NOTES***
Substrate	Wood	Red saturated in surface
1	Cream	Partial, thin
2	Red-brown	
Dirt		
3	Blue	
Dirt		
4	Gray	
Dirt		
5	Cream	
Dirt		
6	Orange-brown

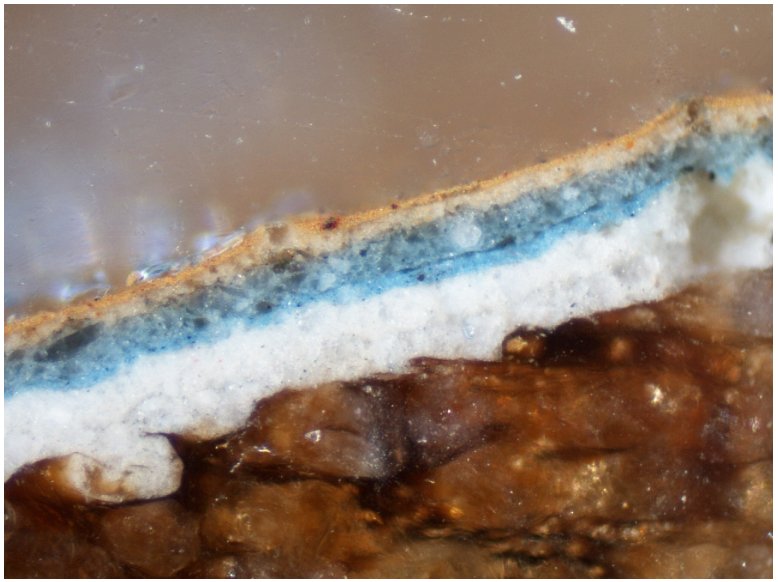
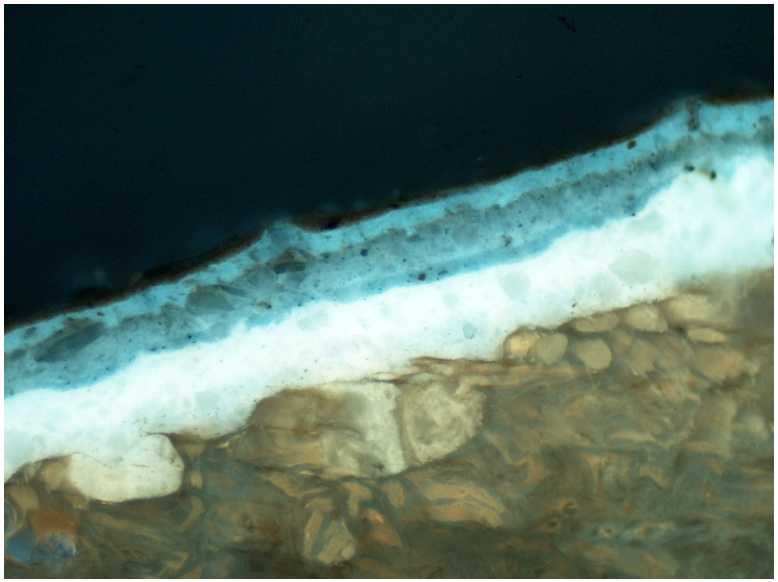
SAMPLE NO:	JGH.201.9
LOCATION:	Chair rail

LAYER	***COLOR***	***NOTES***
Substrate	Wood	
1	Light gray	
2	Whitish	
3	Bright blue	
4	Gray-blue	
5	Peachy cream	
6	Orange-brown

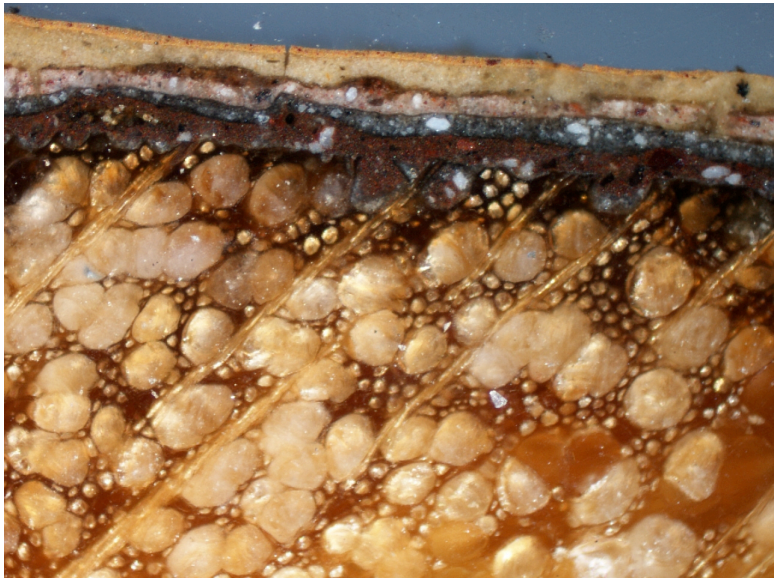
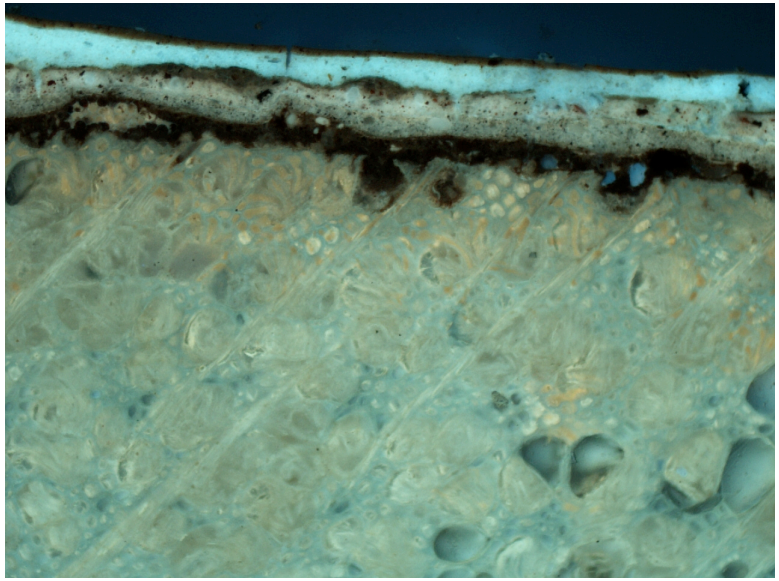
SAMPLE NO:	JGH.201.12
LOCATION:	baseboard

LAYER	***COLOR***	***NOTES***
Substrate	Wood	Saturation in surface; autofl. orange
1	Gray	Thin, uneven
2	Red-brown	Coarse
Dirt		
3	Gray	Coarse
4	Pink	Coarse
5	Brown	Partial
6	Yellow-peach	
7	Orange-brown

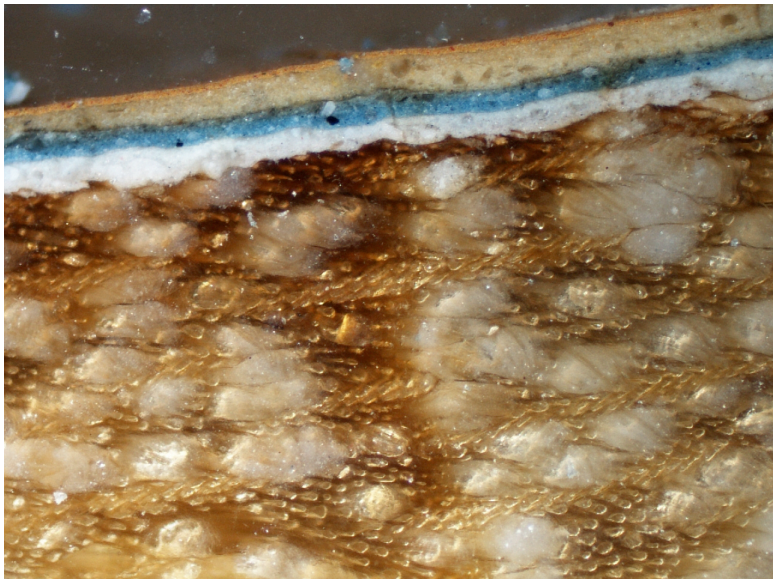
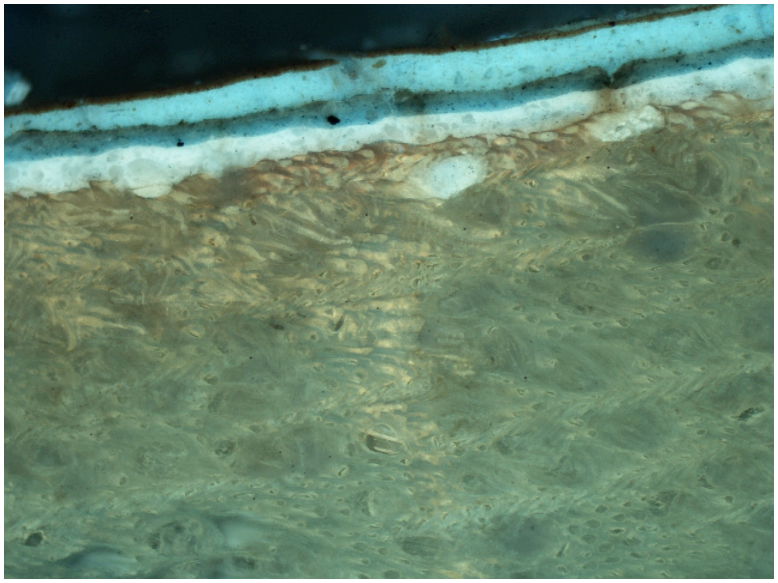
SAMPLE NO:	JGH.201.13
LOCATION:	Window casing - top

LAYER	***COLOR***	***NOTES***
Substrate	Wood	Saturated surface; autofl. slightly orange
1	Whitish	
2	White	Thin
3	Blue	
4	Gray-blue	
Dirt		
5	Peachy cream	
6	Orange-brown

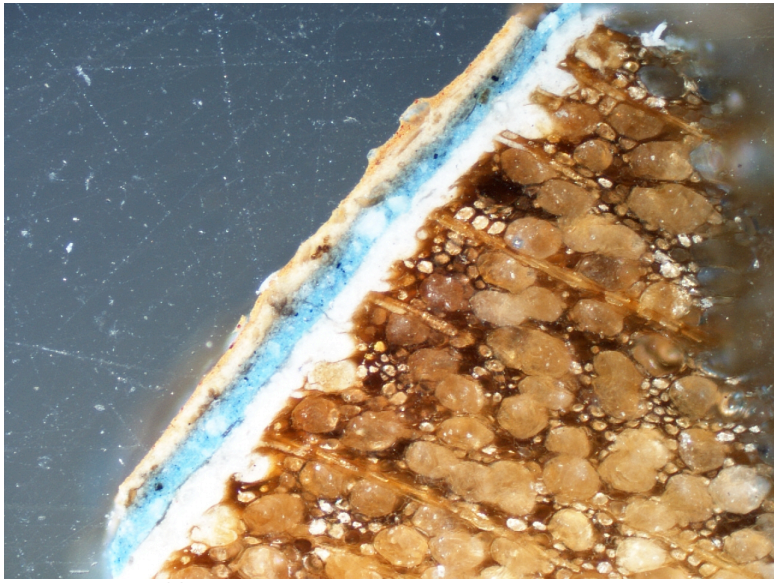
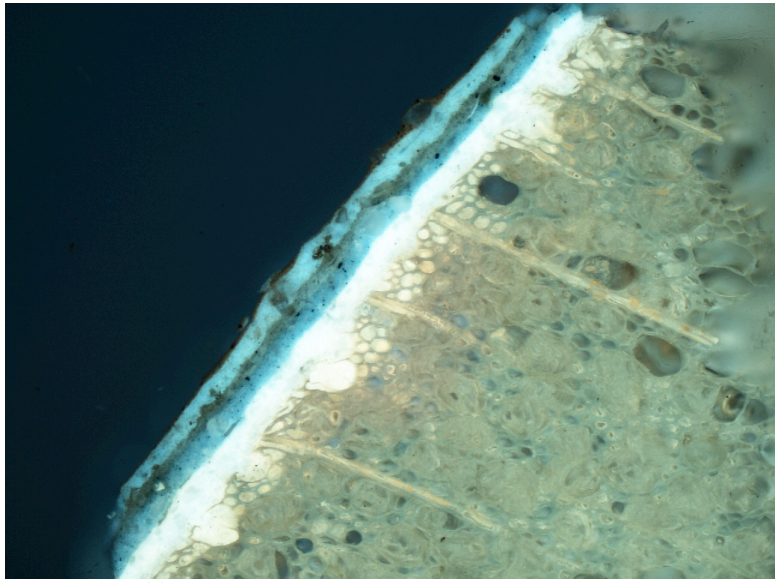
SAMPLE NO:	JGH.201.14
LOCATION:	Door jamb

LAYER	***COLOR***	***NOTES***
Substrate	Wood	Saturated at surface; autofl. bright white
1	Whitish	
2	Whitish	
Dirt		
3	Blue	Coarse
4	Blue-gray	
5	Peachy cream	
6	Orange-brown

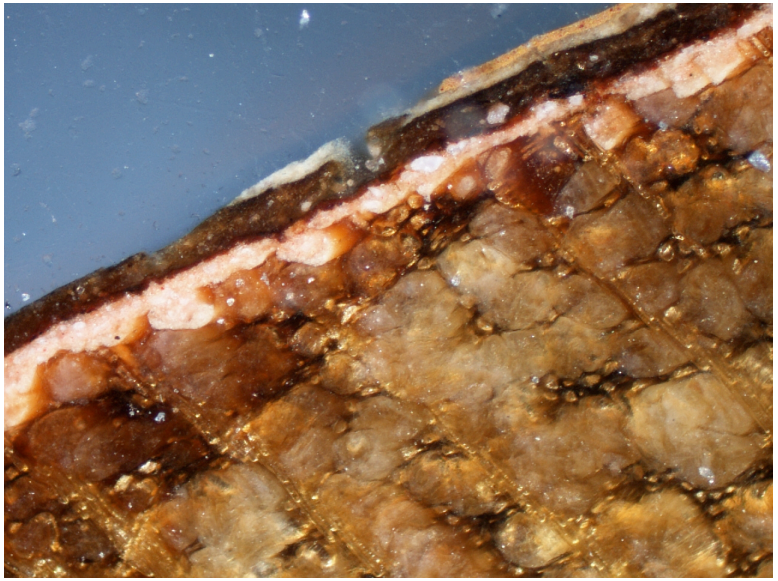
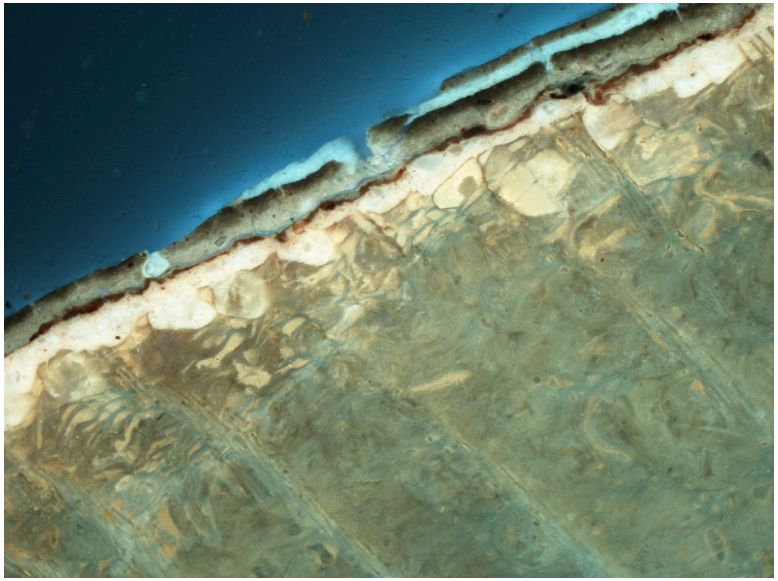
SAMPLE NO:	JGH.201.15
LOCATION:	Door, hinge stile

LAYER	***COLOR***	***NOTES***
Substrate	Wood	Reddish saturation in surface; autofl. bright orange
1	Cream	5Y 9/2
2	Peachy-pink	
3	Red	Thin, uneven; possible decorative finish
4	Brown	
5	Brown	
6	Brown	
7	Peachy cream	
8	Orange-brown

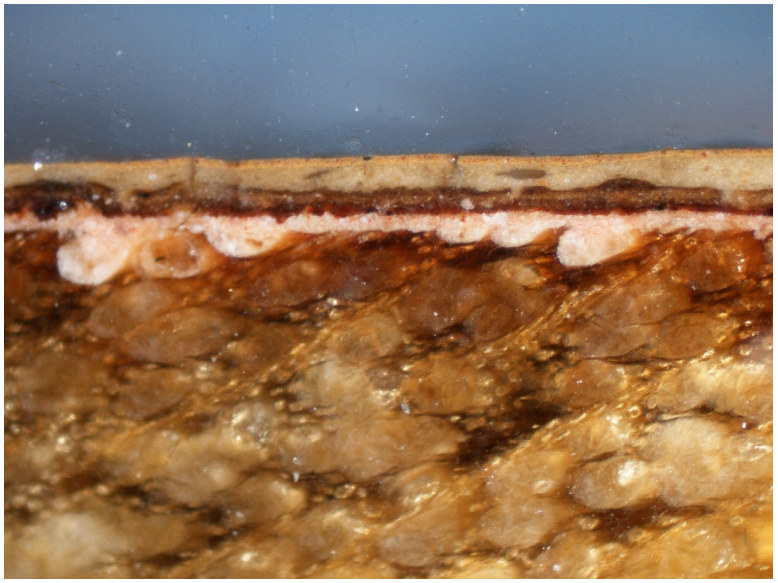
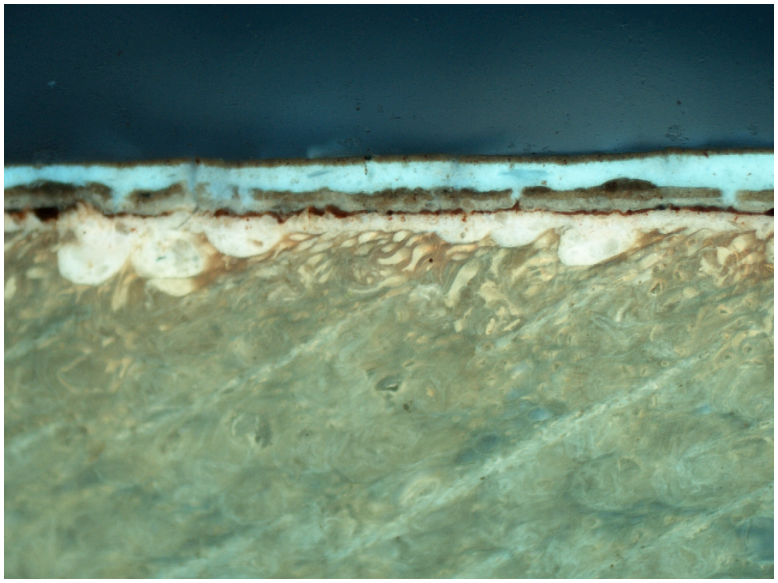
SAMPLE NO:	JGH.201.16
LOCATION:	door

The sample from the door itself is similar to the door in Hall (Room 101), which had evidence of a possible decorative graining finish. The same peachy pink ground coat and red glaze are present on this door. Like the door in the Hall, the evidence found here is not conclusive.

LAYER	***COLOR***	***NOTES***
Substrate	Wood	Reddish saturation in surface; autofl. bright orange
1	Peachy-pink	
2	Red-brown	Very thin and uneven; possible decorative finish
3	Brown	
4	Brown	
5	Brown	
6	Yellow-peachy cream	
7	Orange-brown

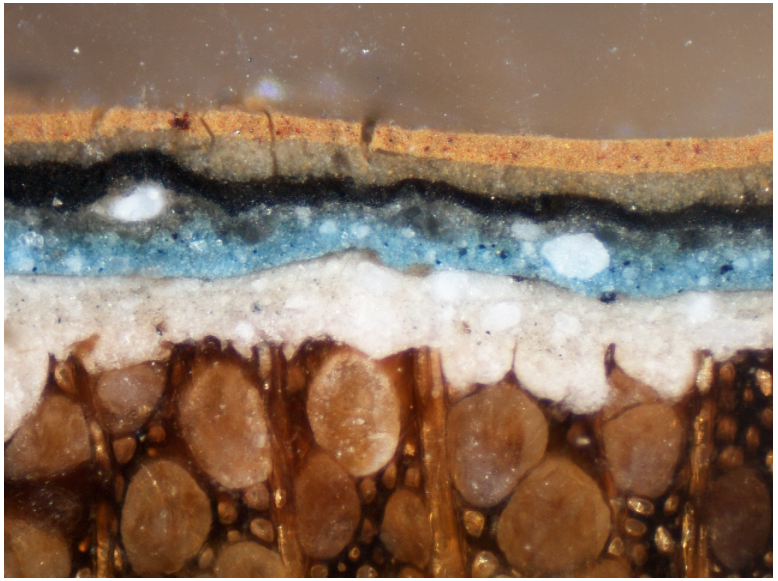
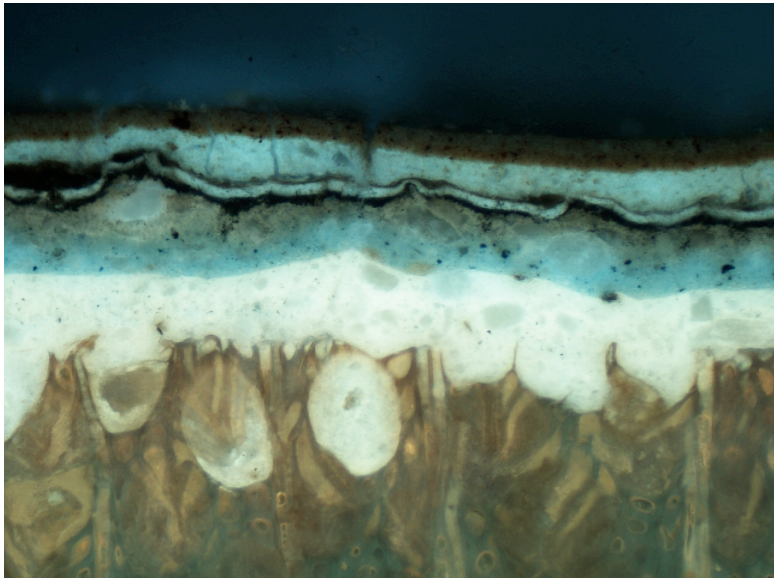
SAMPLE NO:	JGH.201.18
LOCATION:	Mantel, flat piece above firebox opening

Figure 20: Sample 201.18 (mantel, flat header above firebox opening, 200x magnification - visible light, left, and UV light, right). The first campaign has a white finish. A blue, also found on other samples, is then followed by a varnish.

LAYER	***COLOR***	***NOTES***
Substrate	Wood	Red saturated in surface
1	Cream/Off-white	
2	Cream/Off-white	
Dirt		
3	Blue	Coarse
4	Gray	
5	Brown	
6	Brown	Varnish – autofl. bright blue
7	Brown	
8	Tannish-cream	
9	Orange-brown

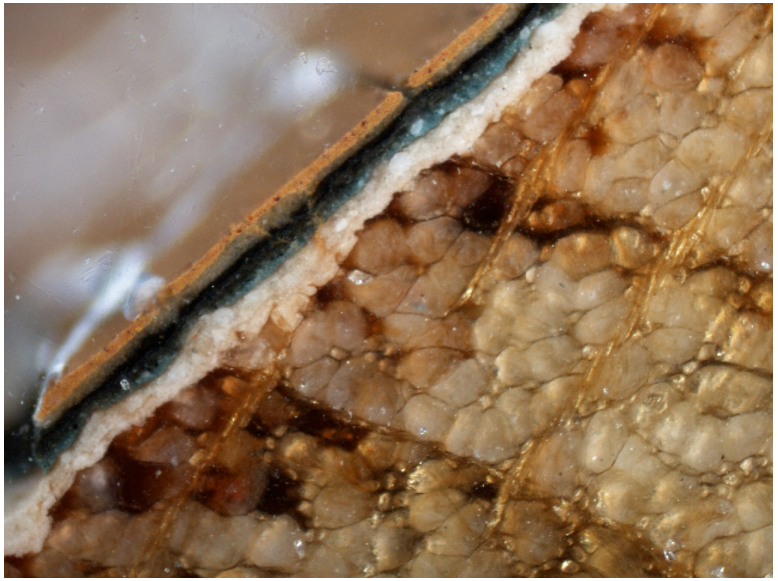
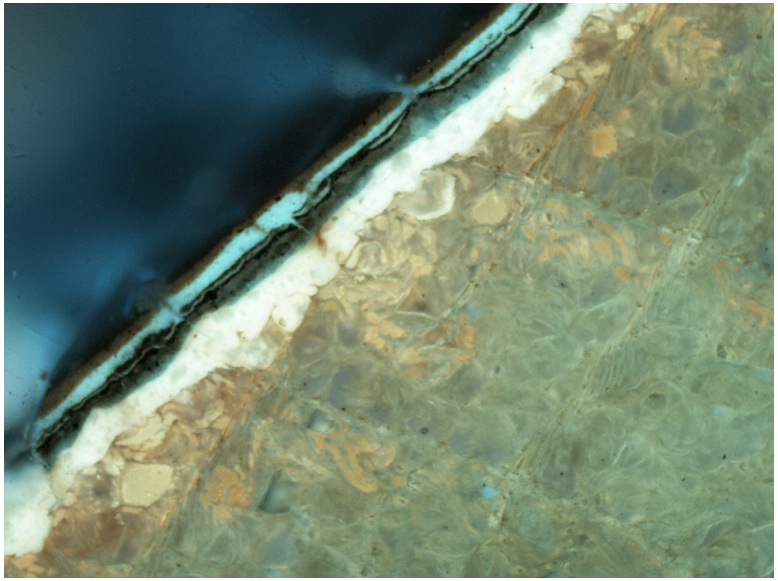
SAMPLE NO:	JGH.201.21
LOCATION:	Mantel, vertical middle piece (same as 201.18)

LAYER	***COLOR***	***NOTES***
Substrate	Wood	Red saturation in surface; autofl. orange
1	Whitish/Cream	
2	Whitish/Cream	
3	Blue	Thin; coarse
4	Gray	Thin
5	Brown	
6	Brown	Varnish – autofl. bright blue
7	Brown	
8	Gray-tan	
9	Orange-brown

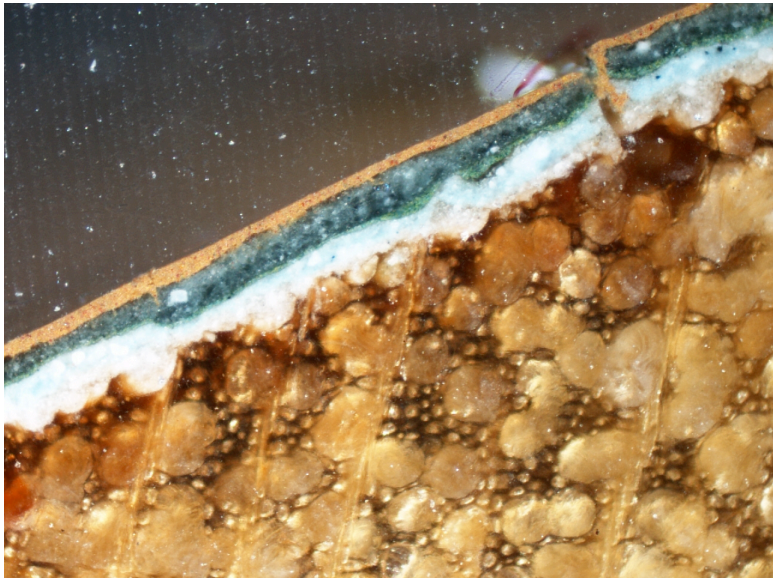
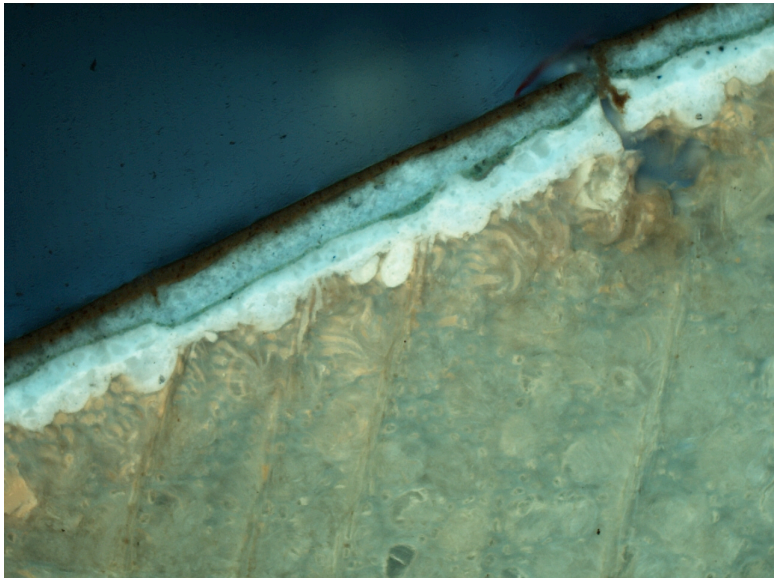
SAMPLE NO:	JGH.202.1
LOCATION:	Window casing

LAYER	***COLOR***	***NOTES***
Substrate	Wood	Reddish saturation in surface; autofl. orange
1	Cream/Whitish	In pores only
2	Light blue	Coarse
3	Green	Thin
4	Blue	Coarse
Dirt		
5	Grayish blue	Coarse
6	Orange-brown	
7

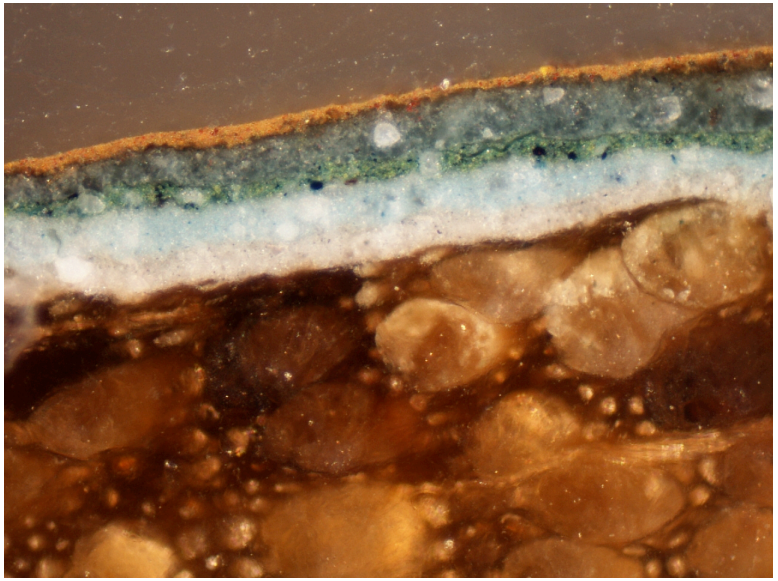
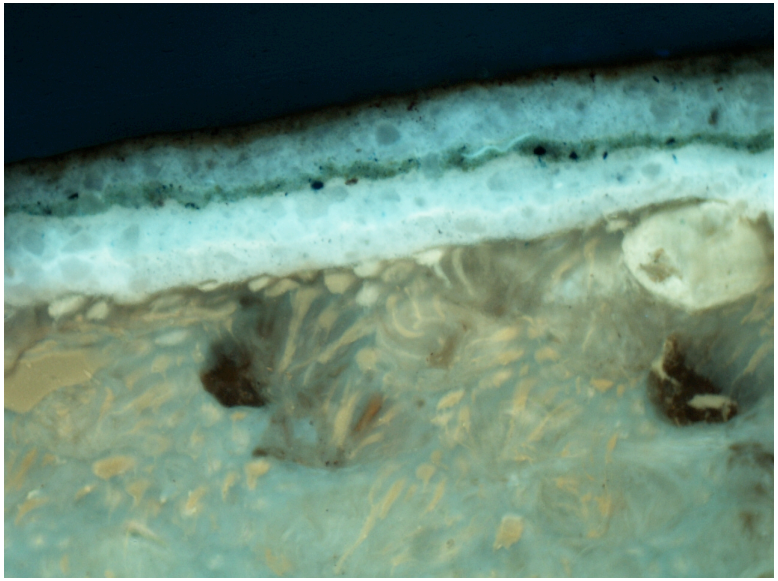
SAMPLE NO:	JGH.202.3
LOCATION:	Chair rail

LAYER	***COLOR***	***NOTES***
Substrate	Wood	Saturation at surface; autofl. orange
1	Whitish	
2	Light blue	Coarse
3	Green	
Dirt/sep.		
4	Gray-blue	Coarse
Dirt		
5	Orange-brown	
6

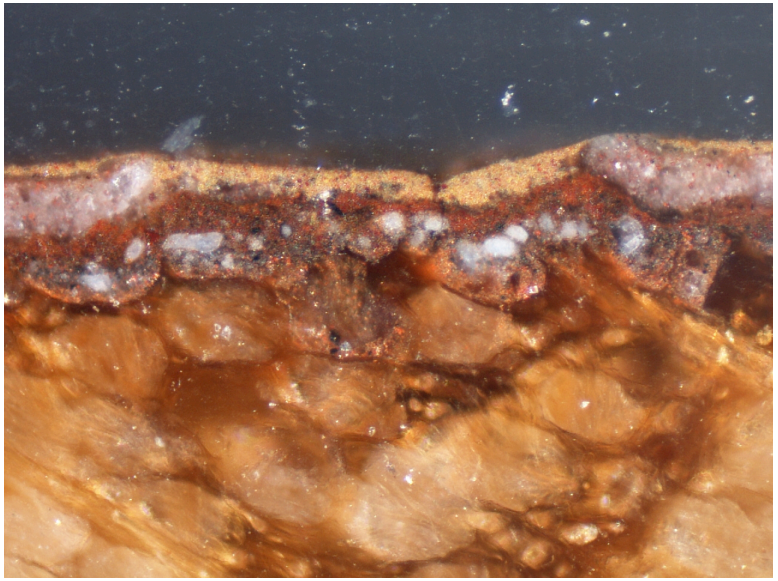
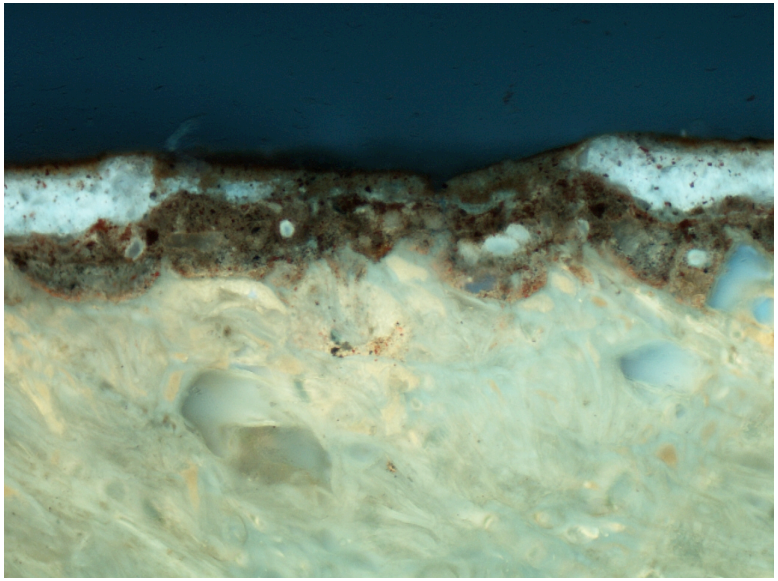
SAMPLE NO:	JGH.202.5
LOCATION:	baseboard

LAYER	***COLOR***	***NOTES***
Substrate	Wood	
1	Brown	Damaged
2	Red-brown	Damaged
3	Pinkish	Damaged
4	Orange-brown

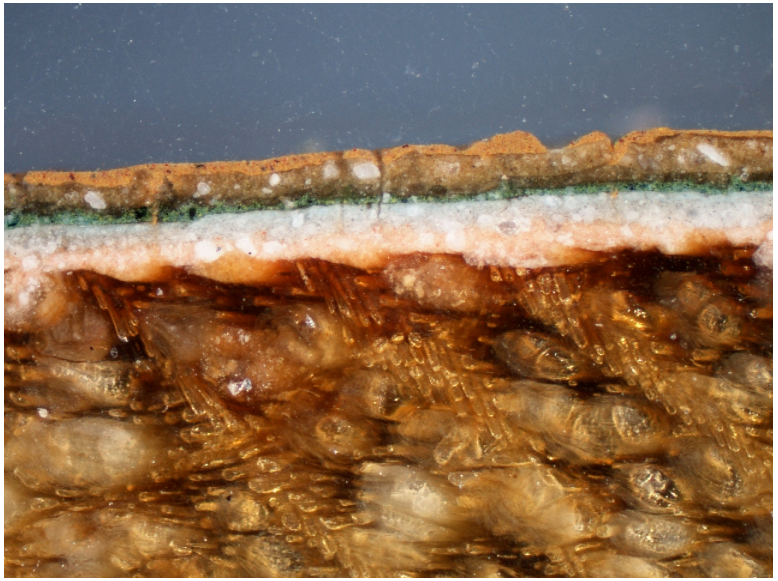
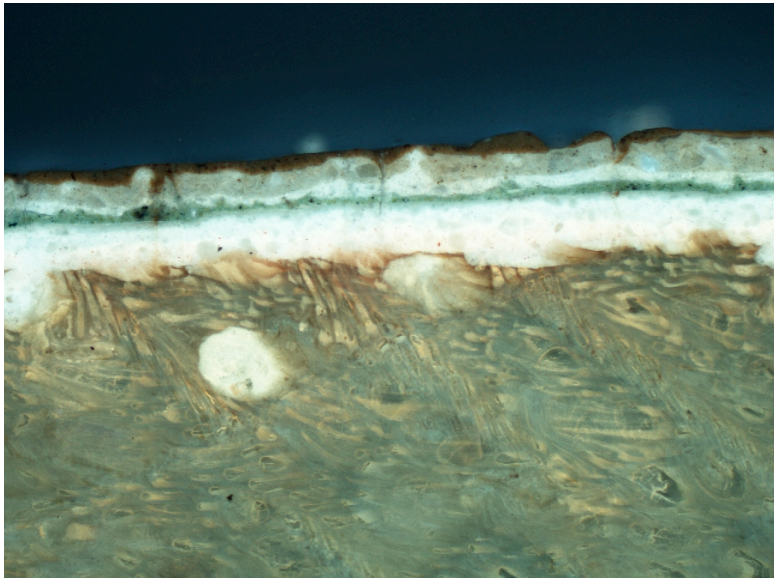
SAMPLE NO:	JGH.202.6
LOCATION:	door

LAYER	***COLOR***	***NOTES***
Substrate	Wood	
	Cream	Coarse
	Cream/Pink	in crevices; coarse
	Light blue	
Dirt		
	Green	Coarse
	Light brown	
	Light brown	Coarse
Dirt		
	Orange-brown

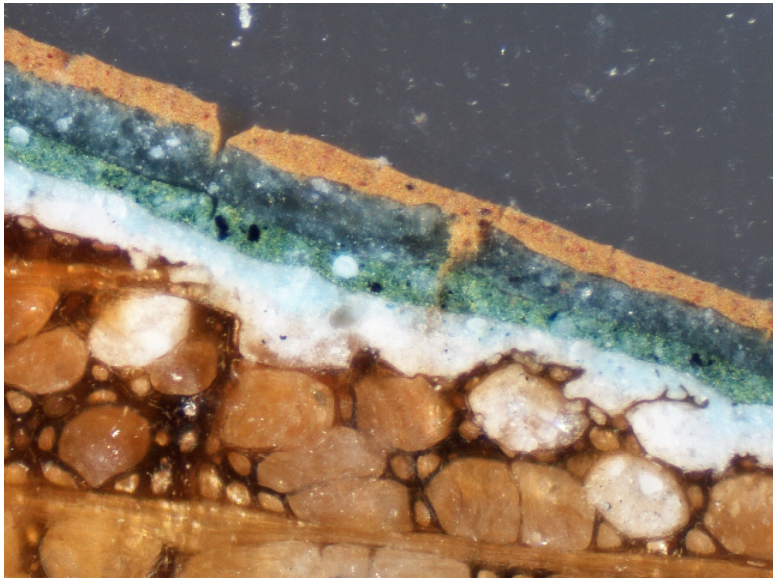
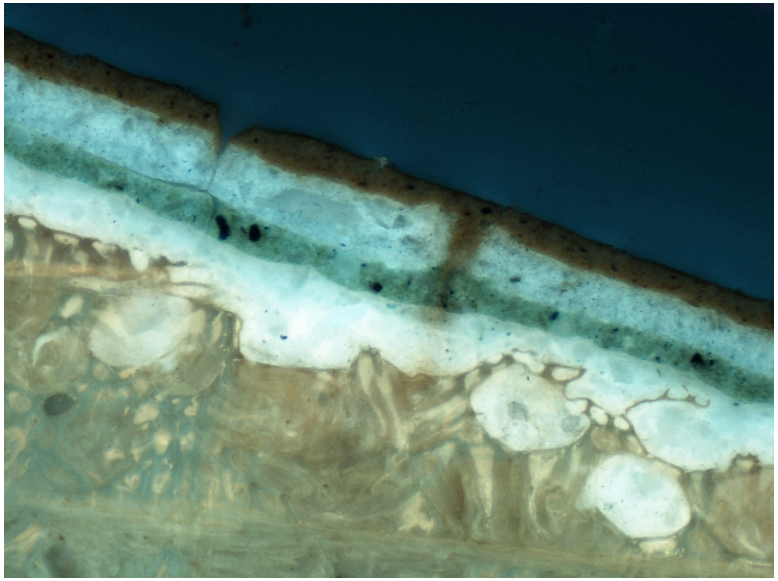
SAMPLE NO:	JGH.202.7
LOCATION:	Door surround

LAYER	***COLOR***	***NOTES***
Substrate	Wood	Reddish saturation in surface
1	Whitish	
2	Light blue	Coarse
3	Green	Coarse
Dirt/Sep.		
4	Blue-gray	Coarse
5	Orange-brown

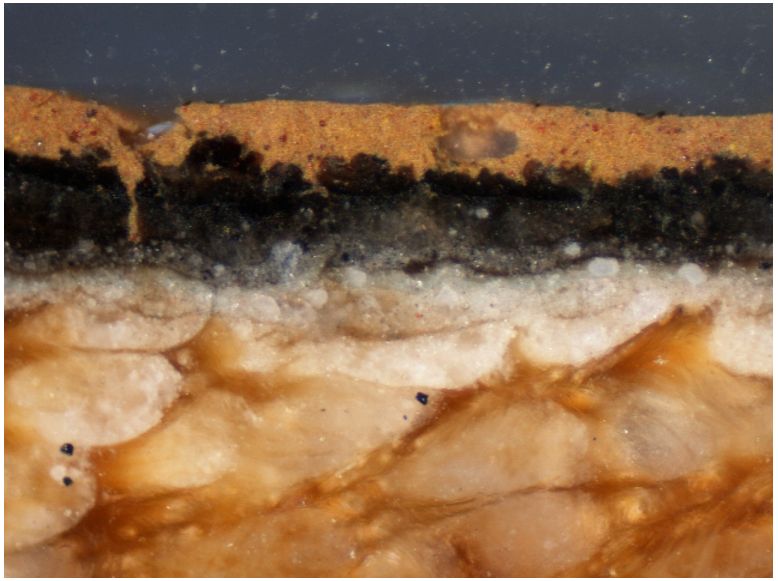
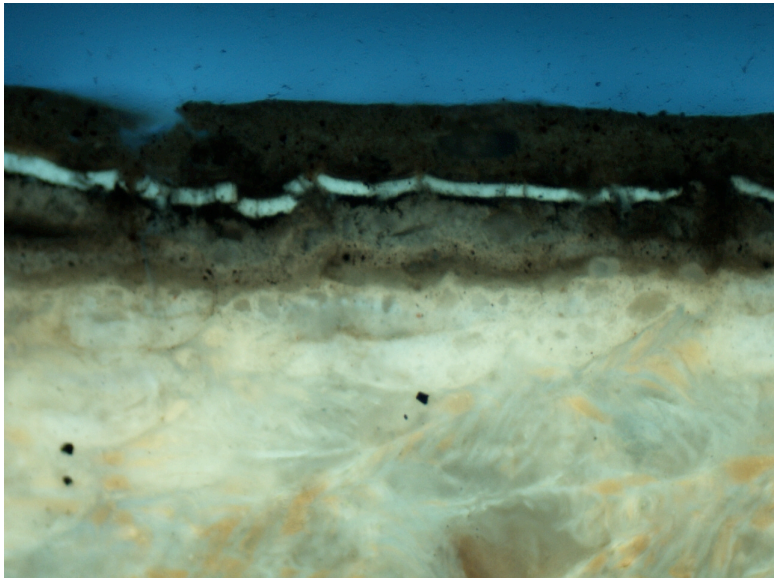
SAMPLE NO:	JGH.202.11
LOCATION:	Mantel, flat molding under mantelshelf

LAYER	***COLOR***	***NOTES***
Substrate	Wood	
1	Cream	
2	Cream	
3	Grayish green	Worn/damaged
4	Brown	Thin, worn, damaged
5	Brown	Varnish; damaged
6	Brown	Very worn
7	Orange-brown

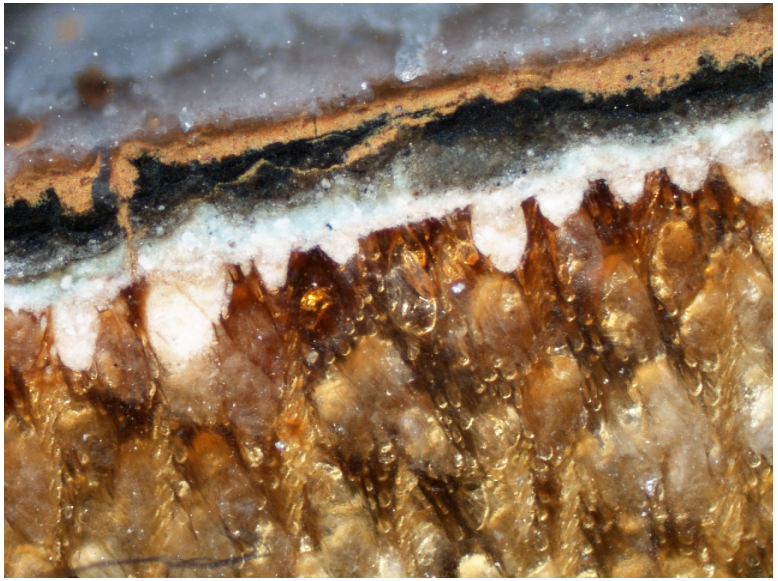
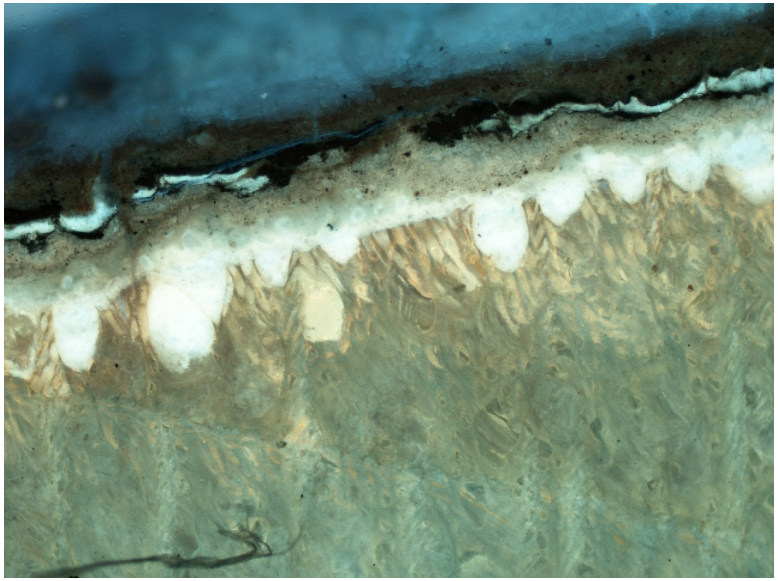
SAMPLE NO:	JGH.202.13
LOCATION:	Mantel, molding above firebox opening

Two samples from the mantel were also examined in cross section. The layers in both samples are somewhat rough and damaged. One sample (JGH.202.13, *Figure 22*) contains similar early layers as the rest of the room, including traces of the blue paint. Later layers in both samples include dark browns and a varnish, similar to the mantel samples from Room 201.

LAYER	***COLOR***	***NOTES***
Substrate	Wood	Reddish saturation in surface; autofl. orange
1	Cream	in crevices
2	Blue-green	Partial only
Dirt		
3	Blue-gray	Uneven
4	Brown	Thin, damaged
5	Brown	Varnish; damaged
6	Brown	Worn, uneven
7	Orange-brown
