NPS Wildfire Risk Assessments
Assessment Locations

NPS Wildfire Risk Assessment Project

MACA - Administration - Overview

MACA - Mammoth Cave National Park

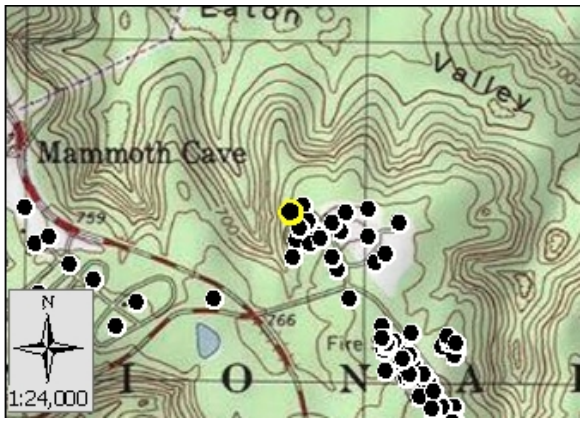
Facility: Q-000000034 Bldg 034, Residence #34

Unit - Location: MACA - MACA - Administration
FMSS ID: 5860
Structure Type: Building
Structure Use: Residence
Owner: NPS
Field Crew: castillo/szturm
Last Site Visit Date: 3/10/2022

Primary Access: Road
Ingress/Egress: One roads in/out
Access Width: 1.5 lanes (>18ft)
Access Condition: Surfaced-paved, grade<5%
Bridge Condition: None/nonflammable,load limit will not limit response
Access & Turnarounds: Access is <300 ft from facility w/turnaround
Facility Number/Sign: Marked and clearly visible
Defensible Space: No defensible space
Fuel Load (w/in 300 ft): Moderate
Fuel Type (w/in 300ft): Grass,shrub,hardwood litter
Topography (w/in 300ft): Slope 31% to 40%
Roof Material: Fire resistant- tar,rubberized
Siding Material: Wood or open sided
Foundation: Closed, < 6in masonry exposed
Fences/Decks: None or noncombustible
Firewood: Adjacent to/under deck of facility
Propane Tanks: Present and little to no fuels clearance
Water Supply: Pressurized hydrant(s) or fixed sprinkler system
Overhead Hazards: No overhead hazards
Safety Zones: Potential saftey zone(s) in area
Additional Obstacles: Hazmat, UXO,etc. , PLEASE COMMENT

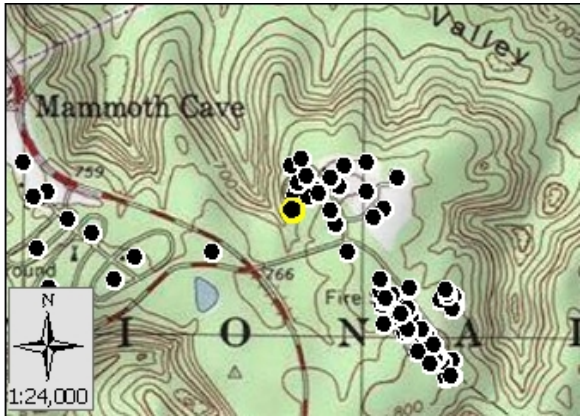
Facility: Bldg 413, Lift Station - Permament Housing Area

Unit - Location: MACA - MACA - Administration
FMSS ID: 49139
Structure Type: Building
Structure Use: Admin
Owner: NPS
Field Crew: castillo/szturm
Last Site Visit Date: 3/10/2022

Primary Access: Road
Ingress/Egress: One roads in/out
Access Width: 1.5 lanes (>18ft)
Access Condition: Surfaced-paved, grade<5%
Bridge Condition: None/nonflammable,load limit will not limit response
Access & Turnarounds: Access is <300 ft from facility w/turnaround
Facility Number/Sign: Marked and clearly visible
Defensible Space: <30 ft treated
Fuel Load (w/in 300 ft): Moderate
Fuel Type (w/in 300ft): Grass,shrub,hardwood litter
Topography (w/in 300ft): Slope >40%
Roof Material: Fire resistant- tar,rubberized
Siding Material: Wood or open sided
Foundation: Closed, >30in masonry exposed or N/A
Fences/Decks: None or noncombustible
Firewood: None
Propane Tanks: None
Water Supply: Pressurized hydrant(s) or fixed sprinkler system
Overhead Hazards: No overhead hazards
Safety Zones: Potential saftey zone(s) in area
Additional Obstacles: Hazmat, UXO,etc. , PLEASE COMMENT
Triage Category:
Hazmat: None visible
Assessment Comments: From FMSS_Export - FRPP_PREDUSE: Bldg. Pump / House (GSF)

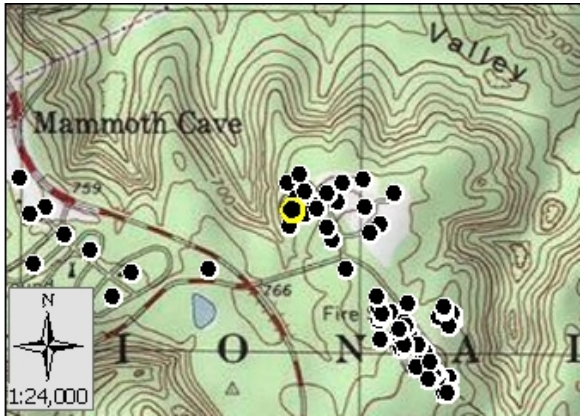
Facility: Bldg 032, CCC Constructed Housing Unit

Unit - Location: MACA - MACA - Administration
FMSS ID: 5951
Structure Type: Building
Structure Use: Admin
Owner: NPS
Field Crew: castillo/szturm
Last Site Visit Date: 3/10/2022

Primary Access: Road
Ingress/Egress: One roads in/out
Access Width: 1.5 lanes (>18ft)
Access Condition: Surfaced-paved, grade<5%
Bridge Condition: None/nonflammable,load limit will not limit response
Access & Turnarounds: Access is <300 ft from facility w/turnaround
Facility Number/Sign: Marked and clearly visible
Defensible Space: No defensible space
Fuel Load (w/in 300 ft): Light
Fuel Type (w/in 300ft): Grass,shrub,hardwood litter
Topography (w/in 300ft): Slope 21% to 30%
Roof Material: Fire resistant- tar,rubberized
Siding Material: Wood or open sided
Foundation: Closed, < 6in masonry exposed
Fences/Decks: None or noncombustible
Firewood: None
Propane Tanks: Present and fuels clearance
Water Supply: Pressurized hydrant(s) or fixed sprinkler system
Overhead Hazards: No overhead hazards
Safety Zones: Potential saftey zone(s) in area
Additional Obstacles: Hazmat, UXO,etc. , PLEASE COMMENT
Triage Category:
Hazmat: Propane

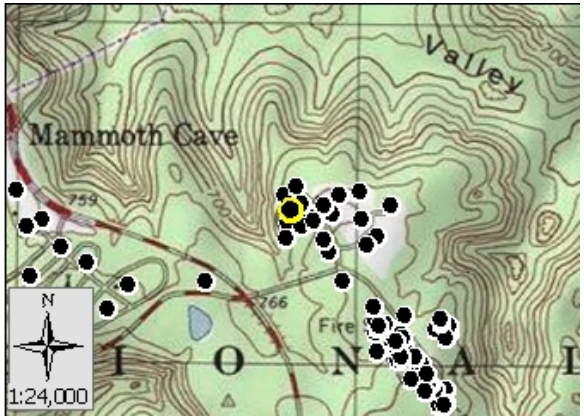
Facility: Bldg 031, CCC Constructed Housing Unit

Unit - Location: MACA - MACA - Administration
FMSS ID: 5949
Structure Type: Building
Structure Use: Admin
Owner: NPS
Field Crew: castillo/szturm
Last Site Visit Date: 3/10/2022

Primary Access: Road
Ingress/Egress: One roads in/out
Access Width: 1.5 lanes (>18ft)
Access Condition: Surfaced-paved, grade<5%
Bridge Condition: None/nonflammable,load limit will not limit response
Access & Turnarounds: Access is <300 ft from facility w/turnaround
Facility Number/Sign: Marked and clearly visible
Defensible Space: No defensible space
Fuel Load (w/in 300 ft): Light
Fuel Type (w/in 300ft): Grass,shrub,hardwood litter
Topography (w/in 300ft): Slope 5% to 20%
Roof Material: Fire resistant- tar,rubberized
Siding Material: Wood or open sided
Foundation: Closed, < 6in masonry exposed
Fences/Decks: None or noncombustible
Firewood: None
Propane Tanks: Present and fuels clearance
Water Supply: Pressurized hydrant(s) or fixed sprinkler system
Overhead Hazards: No overhead hazards
Safety Zones: Potential saftey zone(s) in area
Additional Obstacles: Hazmat, UXO,etc. , PLEASE COMMENT
Triage Category:
Hazmat: Propane

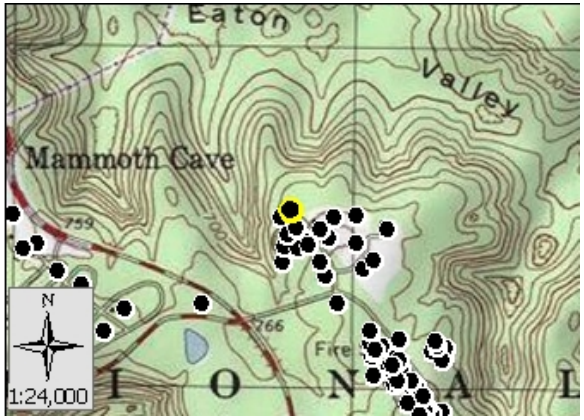
Facility: Bldg 035, Administrative Annex

Unit - Location: MACA - MACA - Administration
FMSS ID: 47317
Structure Type: Building
Structure Use: Admin
Owner: NPS
Field Crew: castillo/szturm
Last Site Visit Date: 3/10/2022

Primary Access: Road
Ingress/Egress: One roads in/out
Access Width: 1.5 lanes (>18ft)
Access Condition: Surfaced-paved, grade<5%
Bridge Condition: None/nonflammable,load limit will not limit response
Access & Turnarounds: Access is <300 ft from facility w/turnaround
Facility Number/Sign: Marked and clearly visible
Defensible Space: No defensible space
Fuel Load (w/in 300 ft): Moderate
Fuel Type (w/in 300ft): Grass,shrub,hardwood litter
Topography (w/in 300ft): Slope 5% to 20%
Roof Material: Fire resistant- tar,rubberized
Siding Material: Wood or open sided
Foundation: Closed, < 6in masonry exposed
Fences/Decks: None or noncombustible
Firewood: None
Propane Tanks: Present and little to no fuels clearance
Water Supply: Pressurized hydrant(s) or fixed sprinkler system
Overhead Hazards: No overhead hazards
Safety Zones: Potential saftey zone(s) in area
Additional Obstacles: Hazmat, UXO,etc. , PLEASE COMMENT
Triage Category:

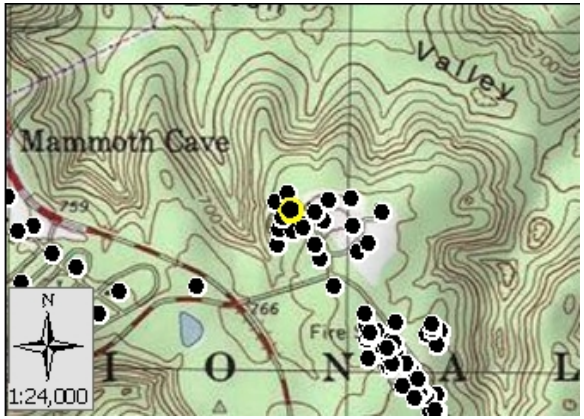
Facility: Bldg 030, CCC Constructed Housing Unit

Unit - Location: MACA - MACA - Administration
FMSS ID: 5952
Structure Type: Building
Structure Use: Admin
Owner: NPS
Field Crew: castillo/szturm
Last Site Visit Date: 3/10/2022

Primary Access: Road
Ingress/Egress: One roads in/out
Access Width: 1.5 lanes (>18ft)
Access Condition: Surfaced-paved, grade<5%
Bridge Condition: None/nonflammable,load limit will not limit response
Access & Turnarounds: Access is <300 ft from facility w/turnaround
Facility Number/Sign: Marked and clearly visible
Defensible Space: 100 ft treated
Fuel Load (w/in 300 ft): Light
Fuel Type (w/in 300ft): Grass,shrub,hardwood litter
Topography (w/in 300ft): Slope <5%
Roof Material: Fire resistant- tar,rubberized
Siding Material: Wood or open sided
Foundation: Closed, < 6in masonry exposed
Fences/Decks: None or noncombustible
Firewood: None
Propane Tanks: Present and little to no fuels clearance
Water Supply: Pressurized hydrant(s) or fixed sprinkler system
Overhead Hazards: No overhead hazards
Safety Zones: Potential saftey zone(s) in area
Additional Obstacles: Hazmat, UXO,etc. , PLEASE COMMENT
Triage Category:
Hazmat: Propane

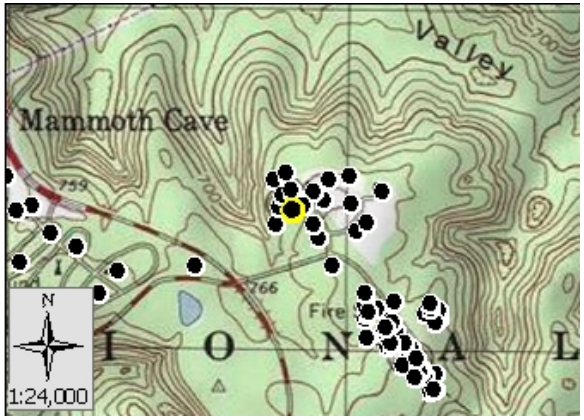
Facility: Bldg 033, CCC Constructed Housing Unit

Unit - Location: MACA - MACA - Administration
FMSS ID: 5861
Structure Type: Building
Structure Use: Admin
Owner: NPS
Field Crew: castillo/szturm
Last Site Visit Date: 3/10/2022

Primary Access: Road
Ingress/Egress: One roads in/out
Access Width: 1.5 lanes (>18ft)
Access Condition: Surfaced-paved, grade<5%
Bridge Condition: None/nonflammable,load limit will not limit response
Access & Turnarounds: Access is <300 ft from facility w/turnaround
Facility Number/Sign: Marked and clearly visible
Defensible Space: 30 ft treated
Fuel Load (w/in 300 ft): Moderate
Fuel Type (w/in 300ft): Grass,shrub,hardwood litter
Topography (w/in 300ft): Slope 5% to 20%
Roof Material: Fire resistant- tar,rubberized
Siding Material: Wood or open sided
Foundation: Closed, < 6in masonry exposed
Fences/Decks: None or noncombustible
Firewood: None
Propane Tanks: Present and fuels clearance
Water Supply: Pressurized hydrant(s) or fixed sprinkler system
Overhead Hazards: No overhead hazards
Safety Zones: Potential saftey zone(s) in area
Additional Obstacles: Hazmat, UXO,etc. , PLEASE COMMENT
Triage Category:
Hazmat: Propane

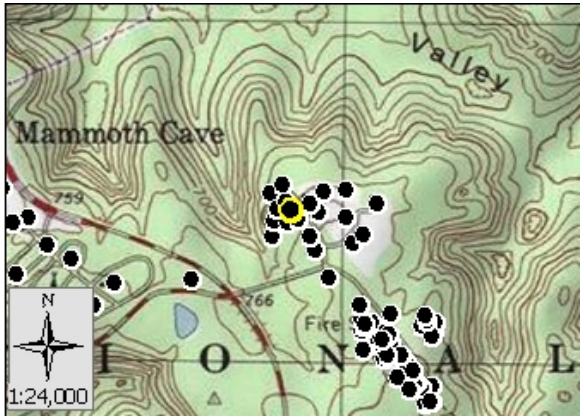
Facility: Bldg 029, CCC Constructed Housing Unit

Unit - Location: MACA - MACA - Administration
FMSS ID: 5858
Structure Type: Building
Structure Use: Admin
Owner: NPS
Field Crew: castillo/szturm
Last Site Visit Date: 3/10/2022

Primary Access: Road
Ingress/Egress: One roads in/out
Access Width: 1.5 lanes (>18ft)
Access Condition: Surfaced-paved, grade<5%
Bridge Condition: None/nonflammable,load limit will not limit response
Access & Turnarounds: Access is <300 ft from facility w/turnaround
Facility Number/Sign: Marked and clearly visible
Defensible Space: No defensible space
Fuel Load (w/in 300 ft): Light
Fuel Type (w/in 300ft): Grass,shrub,hardwood litter
Topography (w/in 300ft): Slope <5%
Roof Material: Fire resistant- tar,rubberized
Siding Material: Wood or open sided
Foundation: Closed, < 6in masonry exposed
Fences/Decks: None or noncombustible
Firewood: None
Propane Tanks: Present and little to no fuels clearance
Water Supply: Pressurized hydrant(s) or fixed sprinkler system
Overhead Hazards: No overhead hazards
Safety Zones: Potential saftey zone(s) in area
Additional Obstacles: Hazmat, UXO,etc. , PLEASE COMMENT
Triage Category:

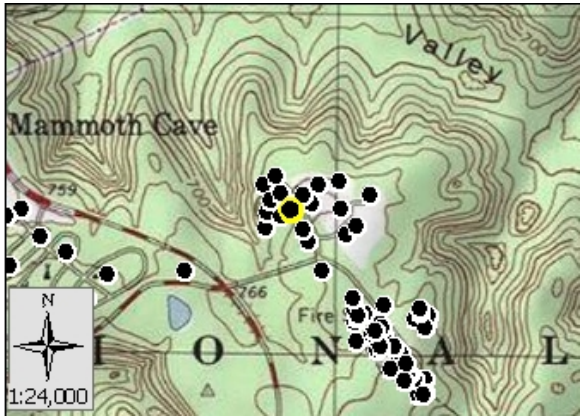
Facility: Bldg 028, CCC Constructed Housing Unit

Unit - Location: MACA - MACA - Administration
FMSS ID: 5948
Structure Type: Building
Structure Use: Admin
Owner: NPS
Field Crew: castillo/szturm
Last Site Visit Date: 3/10/2022

Primary Access: Road
Ingress/Egress: One roads in/out
Access Width: 1.5 lanes (>18ft)
Access Condition: Surfaced-paved, grade<5%
Bridge Condition: None/nonflammable,load limit will not limit response
Access & Turnarounds: Access is <300 ft from facility w/turnaround
Facility Number/Sign: Marked and clearly visible
Defensible Space: 30 ft treated
Fuel Load (w/in 300 ft): Light
Fuel Type (w/in 300ft): Grass,shrub,hardwood litter
Topography (w/in 300ft): Slope <5%
Roof Material: Fire resistant- tar,rubberized
Siding Material: Wood or open sided
Foundation: Closed, < 6in masonry exposed
Fences/Decks: None or noncombustible
Firewood: None
Propane Tanks: Present and fuels clearance
Water Supply: Pressurized hydrant(s) or fixed sprinkler system
Overhead Hazards: No overhead hazards
Safety Zones: Potential saftey zone(s) in area
Additional Obstacles: Hazmat, UXO,etc. , PLEASE COMMENT
Triage Category:
Hazmat: Propane
Assessment Comments: From FMSS_Export - FRPP_PREDUSE: Bldg. Office (GSF)

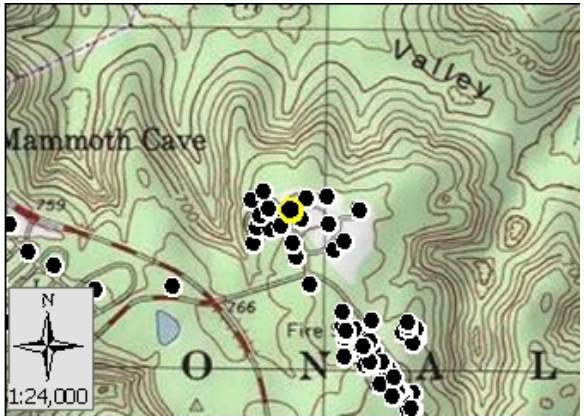
Facility: Bldg 037, Interpretation & Fee Program Offices

Unit - Location: MACA - MACA - Administration
FMSS ID: 5849
Structure Type: Building
Structure Use: Admin
Owner: NPS
Field Crew: castillo/szturm
Last Site Visit Date: 3/10/2022

Primary Access: Road
Ingress/Egress: One roads in/out
Access Width: 1.5 lanes (>18ft)
Access Condition: Surfaced-paved, grade<5%
Bridge Condition: None/nonflammable,load limit will not limit response
Access & Turnarounds: Access is <300 ft from facility w/turnaround
Facility Number/Sign: Marked and clearly visible
Defensible Space: 100 ft treated
Fuel Load (w/in 300 ft): Light
Fuel Type (w/in 300ft): Grass,shrub,hardwood litter
Topography (w/in 300ft): Slope <5%
Roof Material: Fire resistant- tar,rubberized
Siding Material: Vinyl
Foundation: Closed, < 6in masonry exposed
Fences/Decks: None or noncombustible
Firewood: None
Propane Tanks: Present and little to no fuels clearance
Water Supply: Pressurized hydrant(s) or fixed sprinkler system
Overhead Hazards: No overhead hazards
Safety Zones: Potential saftey zone(s) in area
Additional Obstacles: Hazmat, UXO,etc. , PLEASE COMMENT
Triage Category:
Hazmat: Propane
Assessment Comments: From FMSS_Export - FRPP_PREDUSE: Bldg. Office (GSF)

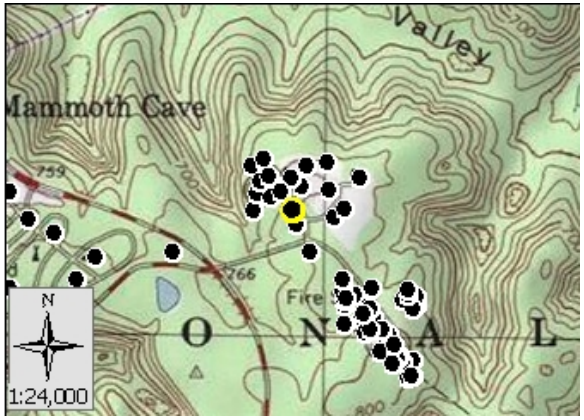
Facility: Bldg 044, Residence #44 (VIP House)

Unit - Location: MACA - MACA - Administration
FMSS ID: 5852
Structure Type: Building
Structure Use: Residence
Owner: NPS
Field Crew: castillo/szturm
Last Site Visit Date: 3/10/2022

Primary Access: Road
Ingress/Egress: One roads in/out
Access Width: 1.5 lanes (>18ft)
Access Condition: Surfaced-paved, grade<5%
Bridge Condition: None/nonflammable,load limit will not limit response
Access & Turnarounds: Access is <300 ft from facility w/turnaround
Facility Number/Sign: Marked and clearly visible
Defensible Space: <30 ft treated
Fuel Load (w/in 300 ft): Moderate
Fuel Type (w/in 300ft): Grass,shrub,hardwood litter
Topography (w/in 300ft): Slope 5% to 20%
Roof Material: Fire resistant- tar,rubberized
Siding Material: Wood or open sided
Foundation: Closed, < 6in masonry exposed
Fences/Decks: None or noncombustible
Firewood: None
Propane Tanks: Present and little to no fuels clearance
Water Supply: Pressurized hydrant(s) or fixed sprinkler system
Overhead Hazards: No overhead hazards
Safety Zones: Potential saftey zone(s) in area
Additional Obstacles: Hazmat, UXO,etc. , PLEASE COMMENT
Triage Category:

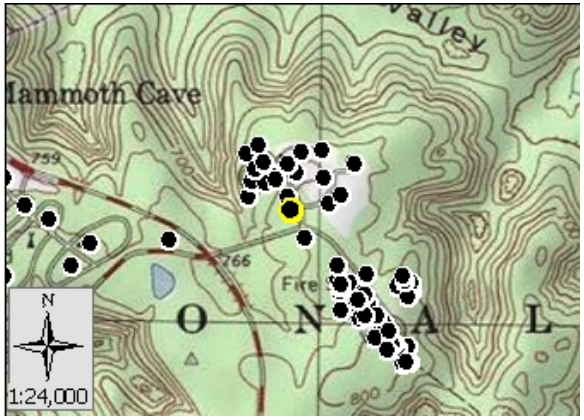
Facility: Bldg 043, Eastern National Office

Unit - Location: MACA - MACA - Administration
FMSS ID: 5853
Structure Type: Building
Structure Use: Admin
Owner: NPS
Field Crew: castillo/szturm
Last Site Visit Date: 3/10/2022

Primary Access: Road
Ingress/Egress: One roads in/out
Access Width: 1.5 lanes (>18ft)
Access Condition: Surfaced-paved, grade<5%
Bridge Condition: None/nonflammable,load limit will not limit response
Access & Turnarounds: Access is <300 ft from facility w/turnaround
Facility Number/Sign: Marked and clearly visible
Defensible Space: <30 ft treated
Fuel Load (w/in 300 ft): Moderate
Fuel Type (w/in 300ft): Grass,shrub,hardwood litter
Topography (w/in 300ft): Slope <5%
Roof Material: Fire resistant- tar,rubberized
Siding Material: Wood or open sided
Foundation: Closed, < 6in masonry exposed
Fences/Decks: None or noncombustible
Firewood: None
Propane Tanks: Present and little to no fuels clearance
Water Supply: Pressurized hydrant(s) or fixed sprinkler system
Overhead Hazards: No overhead hazards
Safety Zones: Potential saftey zone(s) in area
Additional Obstacles: Hazmat, UXO,etc. , PLEASE COMMENT
Triage Category:

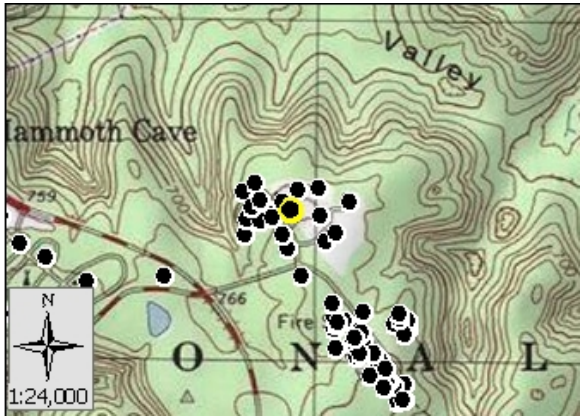
Facility: Bldg 039, External Programs Office

Unit - Location: MACA - MACA - Administration
FMSS ID: 5857
Structure Type: Building
Structure Use: Admin
Owner: NPS
Field Crew: castillo/szturm
Last Site Visit Date: 3/10/2022

Primary Access: Road
Ingress/Egress: One roads in/out
Access Width: 1.5 lanes (>18ft)
Access Condition: Surfaced-paved, grade<5%
Bridge Condition: None/nonflammable,load limit will not limit response
Access & Turnarounds: Access is <300 ft from facility w/turnaround
Facility Number/Sign: Marked and clearly visible
Defensible Space: 100 ft treated
Fuel Load (w/in 300 ft): Light
Fuel Type (w/in 300ft): Grass,shrub,hardwood litter
Topography (w/in 300ft): Slope <5%
Roof Material: Fire resistant- tar,rubberized
Siding Material: Wood or open sided
Foundation: Closed, < 6in masonry exposed
Fences/Decks: None or noncombustible
Firewood: None
Propane Tanks: Present and little to no fuels clearance
Water Supply: Pressurized hydrant(s) or fixed sprinkler system
Overhead Hazards: No overhead hazards
Safety Zones: Potential saftey zone(s) in area
Additional Obstacles: Hazmat, UXO,etc. , PLEASE COMMENT
Triage Category:
Hazmat: Propane

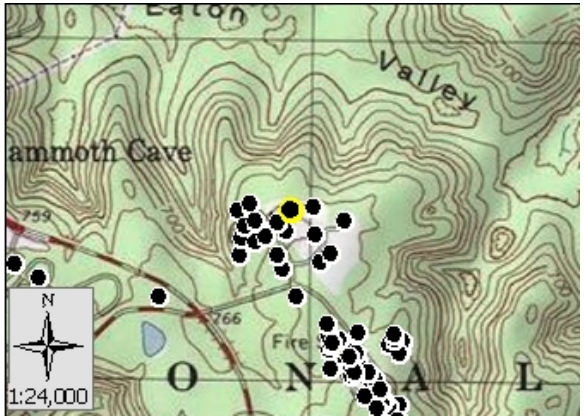
Facility: Raptor Enclosure

Unit - Location: MACA - MACA - Administration
FMSS ID: NA
Structure Type: Building
Structure Use: Admin
Owner: NPS
Field Crew: castillo/szturm
Last Site Visit Date: 3/10/2022

Primary Access: Road
Ingress/Egress: One roads in/out
Access Width: 1.5 lanes (>18ft)
Access Condition: Surfaced-paved, grade<5%
Bridge Condition: None/nonflammable,load limit will not limit response
Access & Turnarounds: Access is <300 ft from facility w/turnaround
Facility Number/Sign: Marked and clearly visible
Defensible Space: <30 ft treated
Fuel Load (w/in 300 ft): Moderate
Fuel Type (w/in 300ft): Grass,shrub,hardwood litter
Topography (w/in 300ft): Slope <5%
Roof Material: Fire resistant- tar,rubberized
Siding Material: Wood or open sided
Foundation: Open or deck
Fences/Decks: None or noncombustible
Firewood: None
Propane Tanks: None
Water Supply: Pressurized hydrant(s) or fixed sprinkler system
Overhead Hazards: No overhead hazards
Safety Zones: Potential saftey zone(s) in area
Additional Obstacles: Hazmat, UXO,etc. , PLEASE COMMENT
Triage Category:
Hazmat: Propane
Assessment Comments:

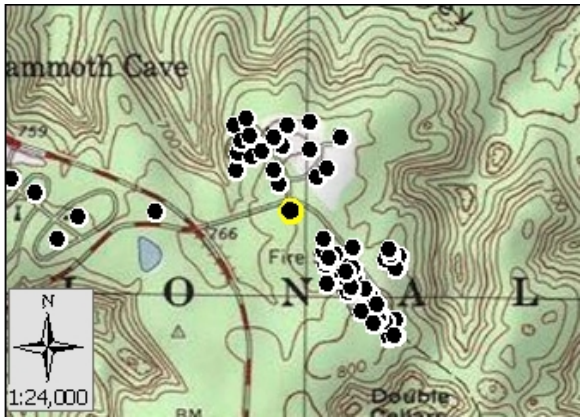
Facility: Bldg 448, Pressure Tank Building

Unit - Location: MACA - MACA - Administration
FMSS ID: 112706
Structure Type: Building
Structure Use: Admin
Owner: NPS
Field Crew: castillo/szturm
Last Site Visit Date: 3/10/2022

Primary Access: Road
Ingress/Egress: One roads in/out
Access Width: 1.5 lanes (>18ft)
Access Condition: Surfaced-paved, grade<5%
Bridge Condition: None/nonflammable,load limit will not limit response
Access & Turnarounds: Access is <300 ft from facility w/turnaround
Facility Number/Sign: Marked and clearly visible
Defensible Space: No defensible space
Fuel Load (w/in 300 ft): Moderate
Fuel Type (w/in 300ft): Grass,shrub,hardwood litter
Topography (w/in 300ft): Slope <5%
Roof Material: Fire resistant- tar,rubberized
Siding Material: Wood or open sided
Foundation: Closed, 6in to 30in masonry exposed
Fences/Decks: None or noncombustible
Firewood: None
Propane Tanks: None
Water Supply: Pressurized hydrant(s) or fixed sprinkler system
Overhead Hazards: No overhead hazards
Safety Zones: Potential saftey zone(s) in area
Additional Obstacles: Hazmat, UXO,etc. , PLEASE COMMENT
Triage Category:
Hazmat: None visible
Assessment Comments: From FMSS_Export - FRPP_PREDUSE: Not Applicable

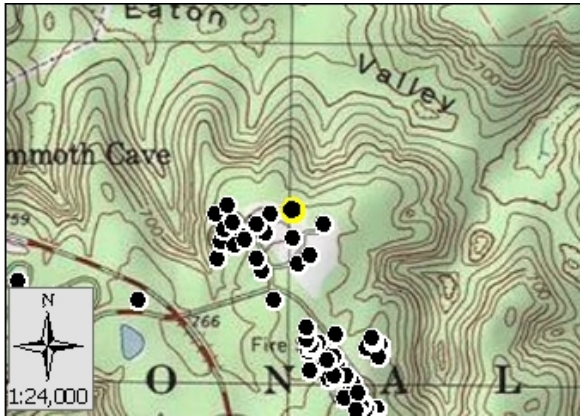
Facility: Bldg 404, Garage in Residence Area

Unit - Location: MACA - MACA - Administration
FMSS ID: 49133
Structure Type: Building
Structure Use: Admin
Owner: NPS
Field Crew: castillo/szturm
Last Site Visit Date: 3/10/2022

Primary Access: Road
Ingress/Egress: One roads in/out
Access Width: 1.5 lanes (>18ft)
Access Condition: Surfaced-paved, grade<5%
Bridge Condition: None/nonflammable,load limit will not limit response
Access & Turnarounds: Access is <300 ft from facility w/turnaround
Facility Number/Sign: Marked and clearly visible
Defensible Space: No defensible space
Fuel Load (w/in 300 ft): Moderate
Fuel Type (w/in 300ft): Grass,shrub,hardwood litter
Topography (w/in 300ft): Slope <5%
Roof Material: Fire resistant- tar,rubberized
Siding Material: Wood or open sided
Foundation: Closed, < 6in masonry exposed
Fences/Decks: None or noncombustible
Firewood: None
Propane Tanks: None
Water Supply: Pressurized hydrant(s) or fixed sprinkler system
Overhead Hazards: No overhead hazards
Safety Zones: Potential saftey zone(s) in area
Additional Obstacles: Hazmat, UXO,etc. , PLEASE COMMENT
Triage Category:
Hazmat: Propane
Assessment Comments: From FMSS_Export - FRPP_PREDUSE: Bldg. Housing Garage (GSF)

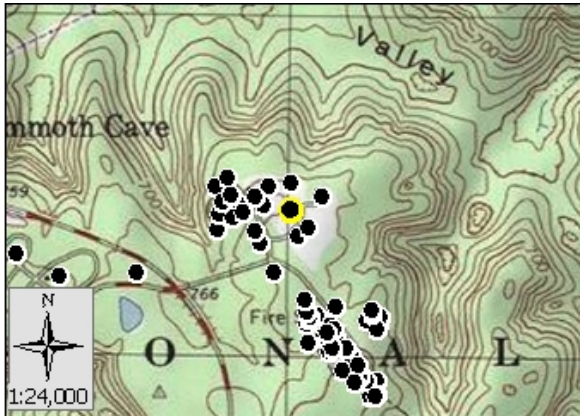
Facility: Bldg 040, Administration & Human Resource Office

Unit - Location: MACA - MACA - Administration
FMSS ID: 5855
Structure Type: Building
Structure Use: Admin
Owner: NPS
Field Crew: castillo/szturm
Last Site Visit Date: 3/10/2022

Primary Access: Road
Ingress/Egress: One roads in/out
Access Width: 1.5 lanes (>18ft)
Access Condition: Surfaced-paved, grade<5%
Bridge Condition: None/nonflammable,load limit will not limit response
Access & Turnarounds: Access is <300 ft from facility w/turnaround
Facility Number/Sign: Marked and clearly visible
Defensible Space: 100 ft treated
Fuel Load (w/in 300 ft): Light
Fuel Type (w/in 300ft): Grass,shrub,hardwood litter
Topography (w/in 300ft): Slope <5%
Roof Material: Fire resistant- tar,rubberized
Siding Material: Wood or open sided
Foundation: Closed, < 6in masonry exposed
Fences/Decks: Combustible, adjacent, clear of veg/debris
Firewood: None
Propane Tanks: Present and fuels clearance
Water Supply: Pressurized hydrant(s) or fixed sprinkler system
Overhead Hazards: No overhead hazards
Safety Zones: Potential saftey zone(s) in area
Additional Obstacles: Hazmat, UXO,etc. , PLEASE COMMENT
Triage Category:

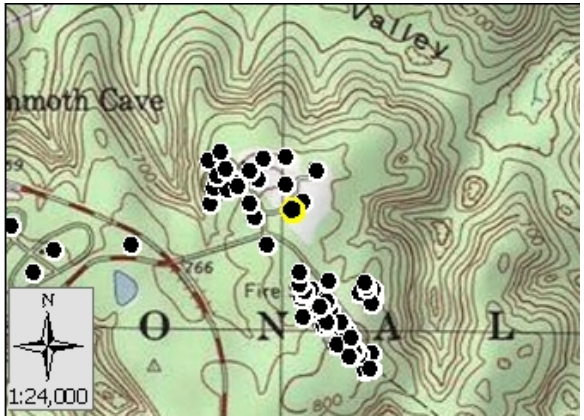
Facility: Q-00000042 Bldg 042, Residence #42

Unit - Location: MACA - MACA - Administration
FMSS ID: 5854
Structure Type: Building
Structure Use: Admin
Owner: NPS
Field Crew: castillo/szturm
Last Site Visit Date: 3/10/2022

Primary Access: Road
Ingress/Egress: One roads in/out
Access Width: 1.5 lanes (>18ft)
Access Condition: Surfaced-paved, grade<5%
Bridge Condition: None/nonflammable,load limit will not limit response
Access & Turnarounds: Access is <300 ft from facility w/turnaround
Facility Number/Sign: Marked and clearly visible
Defensible Space: 100 ft treated
Fuel Load (w/in 300 ft): Light
Fuel Type (w/in 300ft): Grass,shrub,hardwood litter
Topography (w/in 300ft): Slope <5%
Roof Material: Fire resistant- tar,rubberized
Siding Material: Vinyl
Foundation: Closed, < 6in masonry exposed
Fences/Decks: Combustible, adjacent, clear of veg/debris
Firewood: >30 ft from facility
Propane Tanks: Present and little to no fuels clearance
Water Supply: Pressurized hydrant(s) or fixed sprinkler system
Overhead Hazards: No overhead hazards
Safety Zones: Potential saftey zone(s) in area
Additional Obstacles: Hazmat, UXO,etc. , PLEASE COMMENT

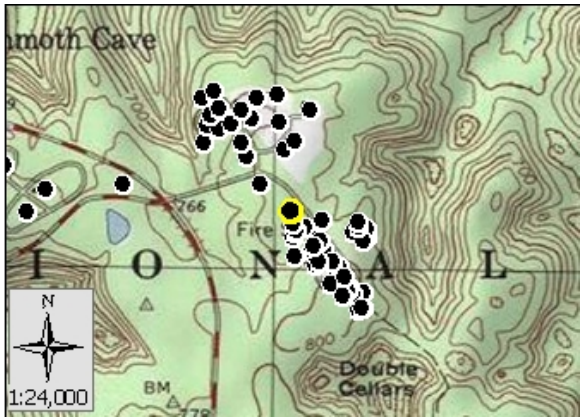
Facility: Q-00000099 Bldg 099, Seasonal Apartment #99

Unit - Location: MACA - MACA - Administration
FMSS ID: 5975
Structure Type: Building
Structure Use: Residence
Owner: NPS
Field Crew: castillo/szturm
Last Site Visit Date: 3/10/2022

Primary Access: Road
Ingress/Egress: One roads in/out
Access Width: 1.5 lanes (>18ft)
Access Condition: Surfaced-paved, grade<5%
Bridge Condition: None/nonflammable,load limit will not limit response
Access & Turnarounds: Access is <300 ft from facility w/turnaround
Facility Number/Sign: Marked and clearly visible
Defensible Space: 30 ft treated
Fuel Load (w/in 300 ft): Moderate
Fuel Type (w/in 300ft): Grass,shrub,hardwood litter
Topography (w/in 300ft): Slope <5%
Roof Material: Fire resistant- tar,rubberized
Siding Material: Wood or open sided
Foundation: Closed, 6in to 30in masonry exposed
Fences/Decks: None or noncombustible
Firewood: None
Propane Tanks: Present and fuels clearance
Water Supply: Pressurized hydrant(s) or fixed sprinkler system
Overhead Hazards: No overhead hazards
Safety Zones: Potential saftey zone(s) in area
Additional Obstacles: Hazmat, UXO,etc. , PLEASE COMMENT
Triage Category:
Hazmat: Propane

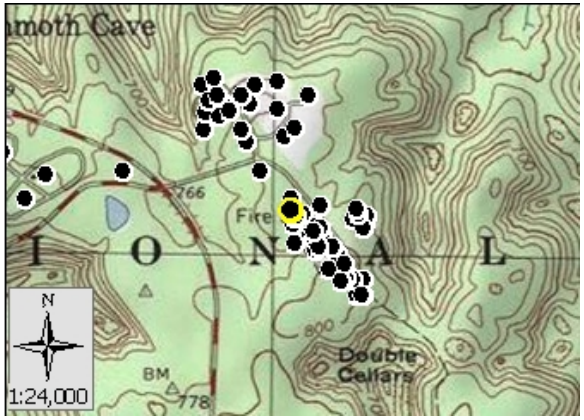
Facility: Seasonal Apartment #98

Unit - Location: MACA - MACA - Administration
FMSS ID: 5965
Structure Type: Building
Structure Use: Residence
Owner: NPS
Field Crew: castillo/szturm
Last Site Visit Date: 3/10/2022

Primary Access: Road
Ingress/Egress: One roads in/out
Access Width: 1.5 lanes (>18ft)
Access Condition: Surfaced-paved, grade<5%
Bridge Condition: None/nonflammable,load limit will not limit response
Access & Turnarounds: Access is <300 ft from facility w/turnaround
Facility Number/Sign: Marked and clearly visible
Defensible Space: <30 ft treated
Fuel Load (w/in 300 ft): Moderate
Fuel Type (w/in 300ft): Grass,shrub,hardwood litter
Topography (w/in 300ft): Slope <5%
Roof Material: Fire resistant- tar,rubberized
Siding Material: Wood or open sided
Foundation: Closed, 6in to 30in masonry exposed
Fences/Decks: None or noncombustible
Firewood: None
Propane Tanks: Present and fuels clearance
Water Supply: Pressurized hydrant(s) or fixed sprinkler system
Overhead Hazards: No overhead hazards
Safety Zones: Potential saftey zone(s) in area
Additional Obstacles: Hazmat, UXO,etc. , PLEASE COMMENT
Triage Category:
Hazmat: Diesel

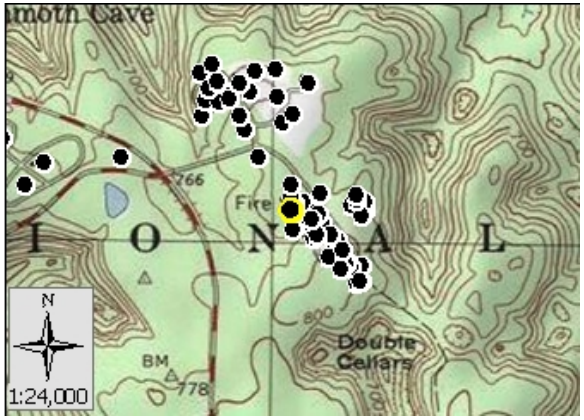
Facility: Bldg 096, Rangers Office and Training Center

Unit - Location: MACA - MACA - Administration
FMSS ID: 5848
Structure Type: Building
Structure Use: Admin
Owner: NPS
Field Crew: castillo/szturm
Last Site Visit Date: 3/10/2022

Primary Access: Road
Ingress/Egress: One roads in/out
Access Width: 1.5 lanes (>18ft)
Access Condition: Surfaced-paved, grade<5%
Bridge Condition: None/nonflammable,load limit will not limit response
Access & Turnarounds: Access is <300 ft from facility w/turnaround
Facility Number/Sign: Marked and clearly visible
Defensible Space: 30 ft treated
Fuel Load (w/in 300 ft): Light
Fuel Type (w/in 300ft): Grass,shrub,hardwood litter
Topography (w/in 300ft): Slope <5%
Roof Material: Fire resistant- tar,rubberized
Siding Material: Rock, concrete, metal
Foundation: Closed, >30in masonry exposed or N/A
Fences/Decks: Combustible but separated from facility
Firewood: 5ft to 30ft from facility
Propane Tanks: Present and fuels clearance
Water Supply: Pressurized hydrant(s) or fixed sprinkler system
Overhead Hazards: No overhead hazards
Safety Zones: Potential saftey zone(s) in area
Additional Obstacles: Hazmat, UXO,etc. , PLEASE COMMENT

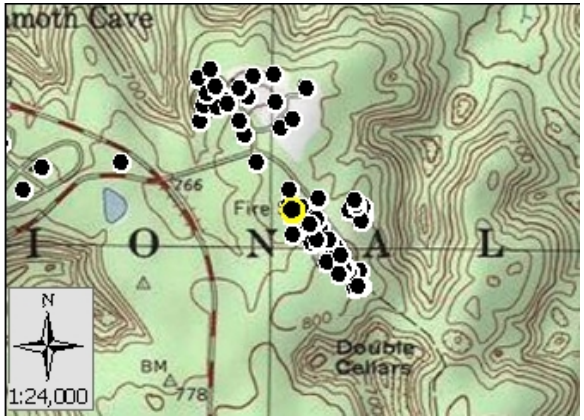
Facility: Generator

Unit - Location: MACA - MACA - Administration
FMSS ID: 49134
Structure Type: Utility
Structure Use: Unknown
Owner: NPS
Field Crew: castillo/szturm
Last Site Visit Date: 3/10/2022

Primary Access: Road
Ingress/Egress: One roads in/out
Access Width: 1.5 lanes (>18ft)
Access Condition: Surfaced-paved, grade<5%
Bridge Condition: None/nonflammable,load limit will not limit response
Access & Turnarounds: Access is <300 ft from facility w/turnaround
Facility Number/Sign: Marked and clearly visible
Defensible Space: <30 ft treated
Fuel Load (w/in 300 ft): Moderate
Fuel Type (w/in 300ft): Grass,shrub,hardwood litter
Topography (w/in 300ft): Slope <5%
Roof Material: Noncombustible or not applicable
Siding Material: Rock, concrete, metal
Foundation: Closed, >30in masonry exposed or N/A
Fences/Decks: None or noncombustible
Firewood: >30 ft from facility
Propane Tanks: None
Water Supply: Pressurized hydrant(s) or fixed sprinkler system
Overhead Hazards: No overhead hazards
Safety Zones: Potential saftey zone(s) in area
Additional Obstacles: Hazmat, UXO,etc. , PLEASE COMMENT
Triage Category:
Hazmat: Diesel

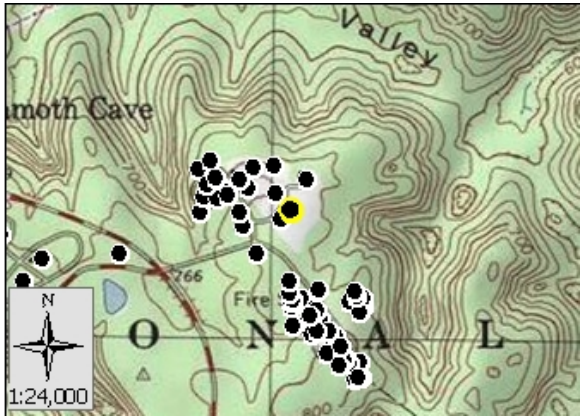
Facility: Bldg 041, Superintendents Office

Unit - Location: MACA - MACA - Administration
FMSS ID: 5856
Structure Type: Building
Structure Use: Admin
Owner: NPS
Field Crew: castillo/szturm
Last Site Visit Date: 3/10/2022

Primary Access: Road
Ingress/Egress: One roads in/out
Access Width: 1.5 lanes (>18ft)
Access Condition: Surfaced-paved, grade<5%
Bridge Condition: None/nonflammable,load limit will not limit response
Access & Turnarounds: Access is <300 ft from facility w/turnaround
Facility Number/Sign: Marked and clearly visible
Defensible Space: 100 ft treated
Fuel Load (w/in 300 ft): Light
Fuel Type (w/in 300ft): Grass,shrub,hardwood litter
Topography (w/in 300ft): Slope <5%
Roof Material: Fire resistant- tar,rubberized
Siding Material: Wood or open sided
Foundation: Closed, < 6in masonry exposed
Fences/Decks: Combustible, adjacent, clear of veg/debris
Firewood: None
Propane Tanks: Present and fuels clearance
Water Supply: Pressurized hydrant(s) or fixed sprinkler system
Overhead Hazards: No overhead hazards
Safety Zones: Potential saftey zone(s) in area
Additional Obstacles: Hazmat, UXO,etc. , PLEASE COMMENT
Triage Category:

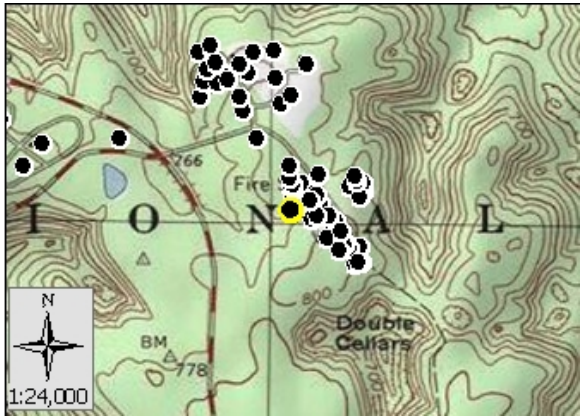
Facility: Bldg 445, Repeater House

Unit - Location: MACA - MACA - Administration
FMSS ID: 91959
Structure Type: CommSite
Structure Use: Admin
Owner: NPS
Field Crew: castillo/szturm
Last Site Visit Date: 3/10/2022

Primary Access: Road
Ingress/Egress: One roads in/out
Access Width: 1.5 lanes (>18ft)
Access Condition: Surfaced-paved, grade<5%
Bridge Condition: None/nonflammable,load limit will not limit response
Access & Turnarounds: Access is <300 ft from facility w/turnaround
Facility Number/Sign: Marked and clearly visible
Defensible Space: <30 ft treated
Fuel Load (w/in 300 ft): Moderate
Fuel Type (w/in 300ft): Grass,shrub,hardwood litter
Topography (w/in 300ft): Slope <5%
Roof Material: Fire resistant- tar,rubberized
Siding Material: Wood or open sided
Foundation: Closed, >30in masonry exposed or N/A
Fences/Decks: None or noncombustible
Firewood: None
Propane Tanks: None
Water Supply: Pressurized hydrant(s) or fixed sprinkler system
Overhead Hazards: No overhead hazards
Safety Zones: Potential saftey zone(s) in area
Additional Obstacles: Hazmat, UXO,etc. , PLEASE COMMENT
Triage Category:
Hazmat: Propane
Assessment Comments: From FMSS_Export - FRPP_PREDUSE: Bldg. Communications Sys (GSF)

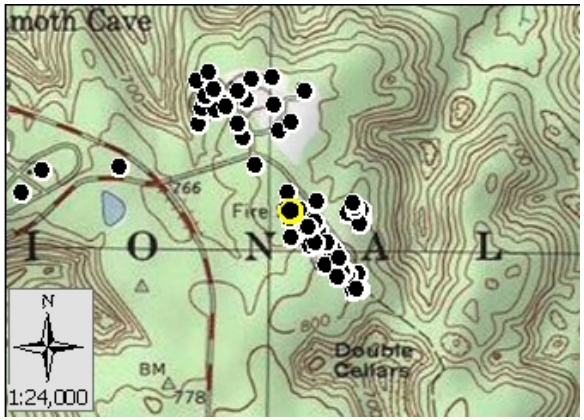
Facility: Bldg 407, Phone Building at Seasonal Quarters

Unit - Location: MACA - MACA - Administration
FMSS ID: 49136
Structure Type: Building
Structure Use: Admin
Owner: NPS
Field Crew: castillo/szturm
Last Site Visit Date: 3/10/2022

Primary Access: Road
Ingress/Egress: One roads in/out
Access Width: 1.5 lanes (>18ft)
Access Condition: Surfaced-paved, grade<5%
Bridge Condition: None/nonflammable,load limit will not limit response
Access & Turnarounds: Access is <300 ft from facility w/turnaround
Facility Number/Sign: Marked and clearly visible
Defensible Space: 30 ft treated
Fuel Load (w/in 300 ft): Moderate
Fuel Type (w/in 300ft): Grass,shrub,hardwood litter
Topography (w/in 300ft): Slope <5%
Roof Material: Fire resistant- tar,rubberized
Siding Material: Wood or open sided
Foundation: Open or deck
Fences/Decks: None or noncombustible
Firewood: Adjacent to/under deck of facility
Propane Tanks: Present and fuels clearance
Water Supply: Pressurized hydrant(s) or fixed sprinkler system
Overhead Hazards: No overhead hazards
Safety Zones: Potential saftey zone(s) in area
Additional Obstacles: Hazmat, UXO,etc. , PLEASE COMMENT
Triage Category:
Hazmat: Diesel

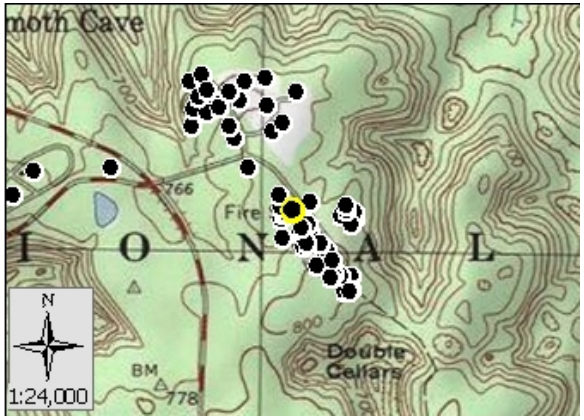
Facility: Q-00000097 Bldg 097, Seasonal Apartment #97

Unit - Location: MACA - MACA - Administration
FMSS ID: 5966
Structure Type: Building
Structure Use: Residence
Owner: NPS
Field Crew: castillo/szturm
Last Site Visit Date: 3/10/2022

Primary Access: Road
Ingress/Egress: One roads in/out
Access Width: 1.5 lanes (>18ft)
Access Condition: Surfaced-paved, grade<5%
Bridge Condition: None/nonflammable,load limit will not limit response
Access & Turnarounds: Access is <300 ft from facility w/turnaround
Facility Number/Sign: Marked and clearly visible
Defensible Space: 100 ft treated
Fuel Load (w/in 300 ft): Light
Fuel Type (w/in 300ft): Grass,shrub,hardwood litter
Topography (w/in 300ft): Slope <5%
Roof Material: Fire resistant- tar,rubberized
Siding Material: Wood or open sided
Foundation: Closed, 6in to 30in masonry exposed
Fences/Decks: None or noncombustible
Firewood: >30 ft from facility
Propane Tanks: Present and fuels clearance
Water Supply: Pressurized hydrant(s) or fixed sprinkler system
Overhead Hazards: No overhead hazards
Safety Zones: Potential saftey zone(s) in area
Additional Obstacles: Hazmat, UXO,etc. , PLEASE COMMENT
Triage Category:

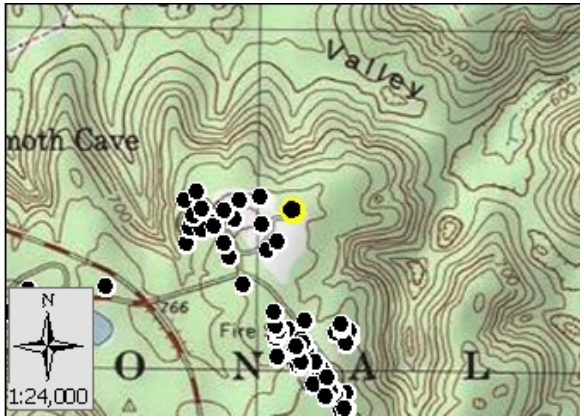
Facility: Bldg 038, Piedmont Network Office

Unit - Location: MACA - MACA - Administration
FMSS ID: 5850
Structure Type: Building
Structure Use: Admin
Owner: NPS
Field Crew: castillo/szturm
Last Site Visit Date: 3/10/2022

Primary Access: Road
Ingress/Egress: One roads in/out
Access Width: 1.5 lanes (>18ft)
Access Condition: Surfaced-paved, grade<5%
Bridge Condition: None/nonflammable,load limit will not limit response
Access & Turnarounds: Access is <300 ft from facility w/turnaround
Facility Number/Sign: Marked and clearly visible
Defensible Space: 30 ft treated
Fuel Load (w/in 300 ft): Light
Fuel Type (w/in 300ft): Grass,shrub,hardwood litter
Topography (w/in 300ft): Slope <5%
Roof Material: Noncombustible or not applicable
Siding Material: Wood or open sided
Foundation: Closed, < 6in masonry exposed
Fences/Decks: None or noncombustible
Firewood: None
Propane Tanks: Present and fuels clearance
Water Supply: Pressurized hydrant(s) or fixed sprinkler system
Overhead Hazards: No overhead hazards
Safety Zones: Potential saftey zone(s) in area
Additional Obstacles: Hazmat, UXO,etc. , PLEASE COMMENT
Triage Category:
Hazmat: Propane

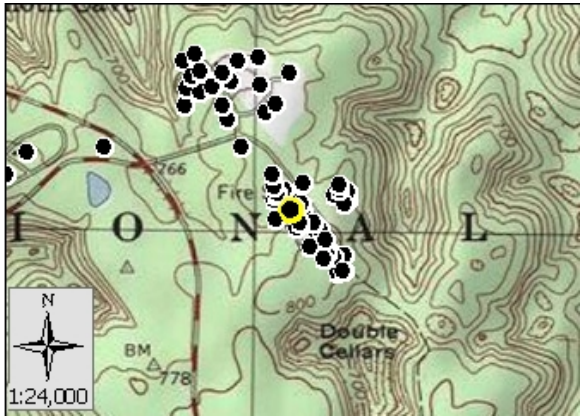
Facility: Bldg 060, Paint Shop

Unit - Location: MACA - MACA - Administration
FMSS ID: 5826
Structure Type: Building
Structure Use: Admin
Owner: NPS
Field Crew: castillo/szturm
Last Site Visit Date: 3/10/2022

Primary Access: Road
Ingress/Egress: One roads in/out
Access Width: 1.5 lanes (>18ft)
Access Condition: Surfaced-paved, grade<5%
Bridge Condition: None/nonflammable,load limit will not limit response
Access & Turnarounds: Access is <300 ft from facility w/turnaround
Facility Number/Sign: Marked and clearly visible
Defensible Space: 30 ft treated
Fuel Load (w/in 300 ft): Light
Fuel Type (w/in 300ft): Grass,shrub,hardwood litter
Topography (w/in 300ft): Slope <5%
Roof Material: Fire resistant- tar,rubberized
Siding Material: Rock, concrete, metal
Foundation: Closed, >30in masonry exposed or N/A
Fences/Decks: None or noncombustible
Firewood: None
Propane Tanks: Present and fuels clearance
Water Supply: Pressurized hydrant(s) or fixed sprinkler system
Overhead Hazards: No overhead hazards
Safety Zones: Potential saftey zone(s) in area
Additional Obstacles: Hazmat, UXO,etc. , PLEASE COMMENT
Triage Category:
Hazmat: Propane

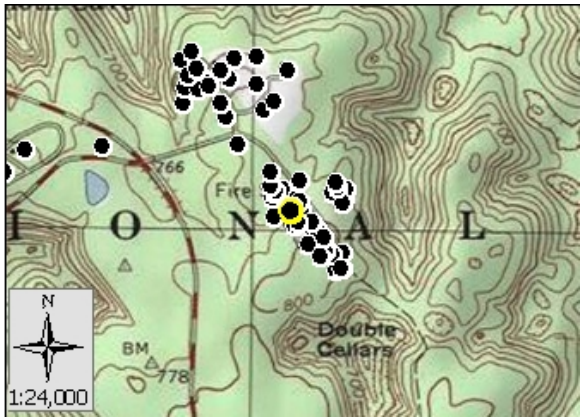
Facility: Bldg 318, Rangers Storage Shed (Veh Wash House)

Rating: Low
Protection Level : Not Designated
Resources of Concern Present? Unknown
Occupied? No
Local ID: [Local_ID]
In a Community? Yes - Admin Buildings
Lat(WGS84): 37° 10.8163' **Long(WGS84):** -86° 5.17178'

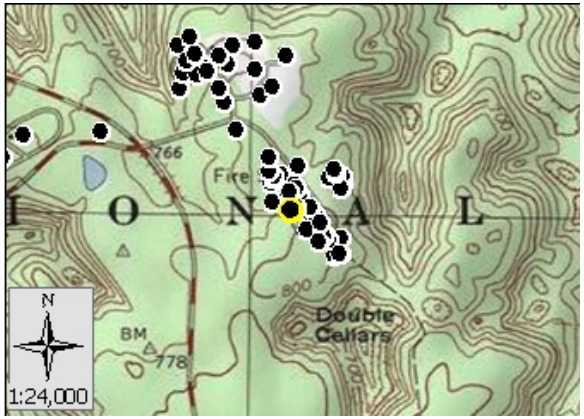
Facility: Bldg 061, Storage Shed North End of Utility Area

Rating: Moderate
Protection Level : Not Designated
Resources of Concern Present? Unknown
Occupied? Yes
Local ID: [Local_ID]
In a Community? Yes - Admin Buildings
Lat(WGS84): 37° 10.7947' **Long(WGS84):** -86° 5.16799'

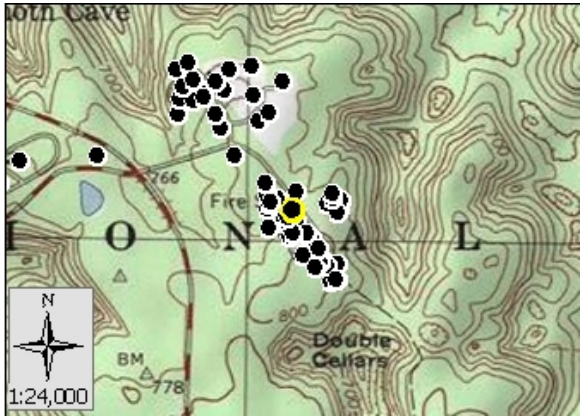
Facility: Bldg 064, Fitness Center/Evidence Locker

Rating: Low
Protection Level : Not Designated
Resources of Concern Present? Unknown
Occupied? Yes
Local ID: [Local_ID]
In a Community? Yes - Admin Buildings
Lat(WGS84): 37° 10.8348' **Long(WGS84):** -86° 5.16184'

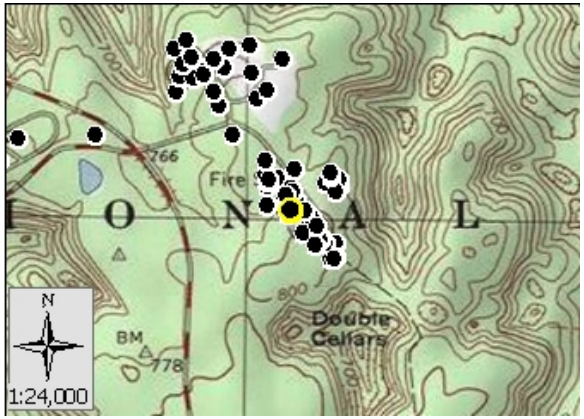
Facility: Bldg 312, Oil and Gas Storage

Rating: Low
Protection Level : Not Designated
Resources of Concern Present? Unknown
Occupied? No
Local ID: [Local_ID]
In a Community? Yes - Admin Buildings
Lat(WGS84): 37° 10.8005' **Long(WGS84):** -86° 5.15989'

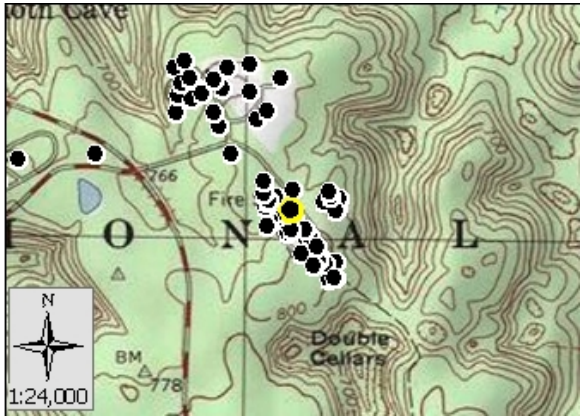
Facility: Bldg 406, Raptor Aviary

Rating: Low
Protection Level : Not Designated
Resources of Concern Present? Unknown
Occupied? No
Local ID: [Local_ID]
In a Community? Yes - Admin Buildings
Lat(WGS84): 37° 10.8316' **Long(WGS84):** -86° 5.15804'

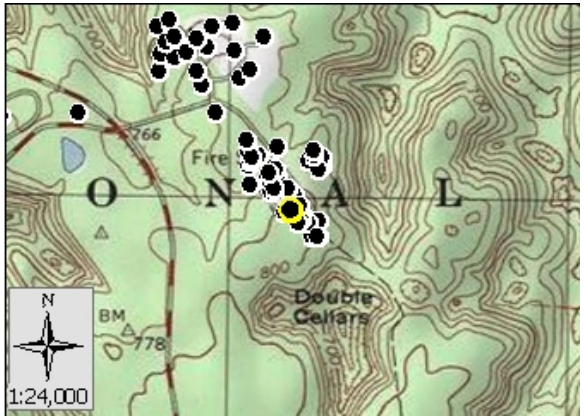
Facility: Bldg 319, Lumber Storage

Rating: Low
Protection Level : Not Designated
Resources of Concern Present? Unknown
Occupied? No
Local ID: [Local_ID]
In a Community? Yes - Admin Buildings
Lat(WGS84): 37° 10.7658' **Long(WGS84):** -86° 5.1248'

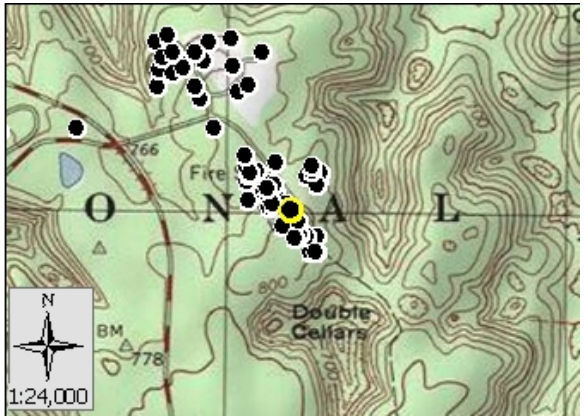
Facility: Bldg 333, Curatorial Storage

Rating: Low
Protection Level : Not Designated
Resources of Concern Present? Unknown
Occupied? Yes
Local ID: [Local_ID]
In a Community? Yes - Admin Buildings
Lat(WGS84): 37° 10.7901' **Long(WGS84):** -86° 5.12075'

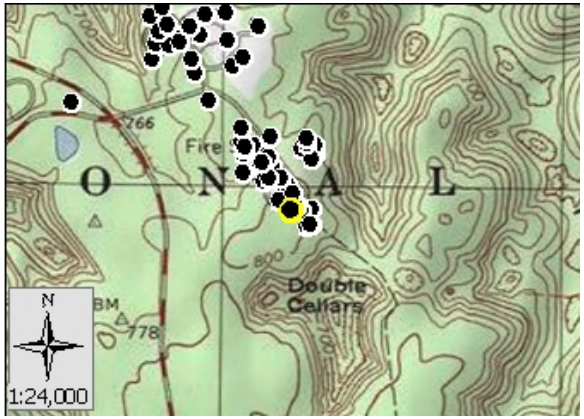
Facility: Boat Storage

Rating: Moderate
Protection Level : Not Designated
Resources of Concern Present? Unknown
Occupied? No
Local ID: [Local_ID]
In a Community? Yes - Admin Buildings
Lat(WGS84): 37° 10.7479' **Long(WGS84):** -86° 5.11204'

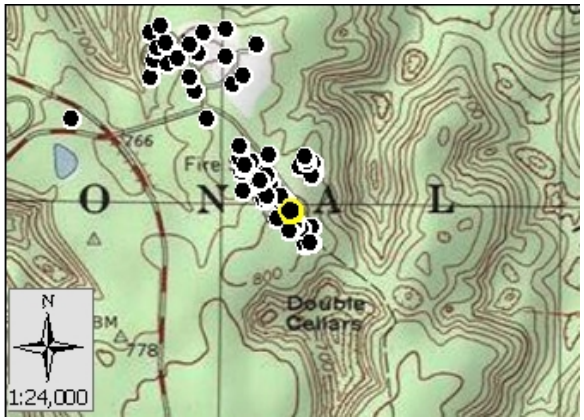
Facility: Bldg 065, Craft Shop

Rating: Low
Protection Level : Not Designated
Resources of Concern Present? Unknown
Occupied? Yes
Local ID: [Local_ID]
In a Community? Yes - Admin Buildings
Lat(WGS84): 37° 10.7745' **Long(WGS84):** -86° 5.10992'

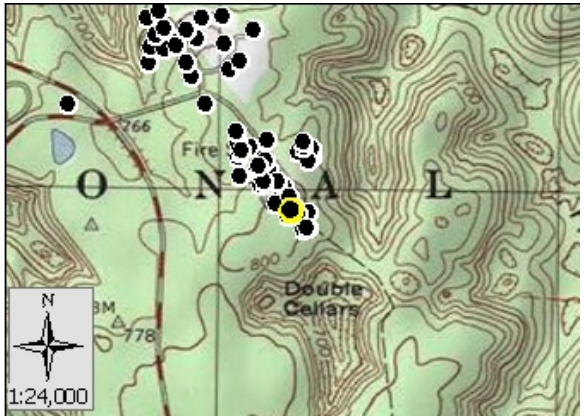
Facility: Storage Garage

Rating: Moderate
Protection Level : Not Designated
Resources of Concern Present? Unknown
Occupied? No
Local ID: [Local_ID]
In a Community? Yes - Admin Buildings
Lat(WGS84): 37° 10.7529' **Long(WGS84):** -86° 5.10493'

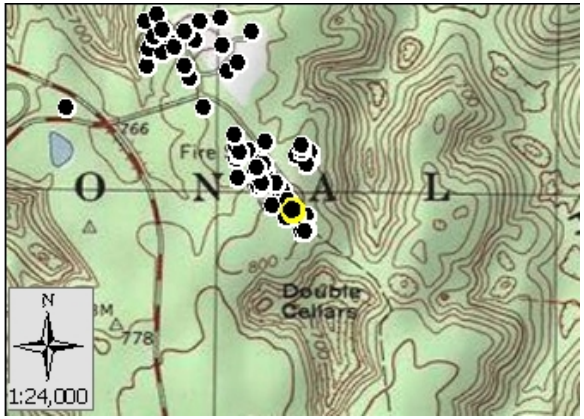
Facility: Bldg 328, YCC Building

Rating: Moderate
Protection Level : Not Designated
Resources of Concern Present? Unknown
Occupied? No
Local ID: [Local_ID]
In a Community? Yes - Admin Buildings
Lat(WGS84): 37° 10.757' **Long(WGS84):** -86° 5.10099'

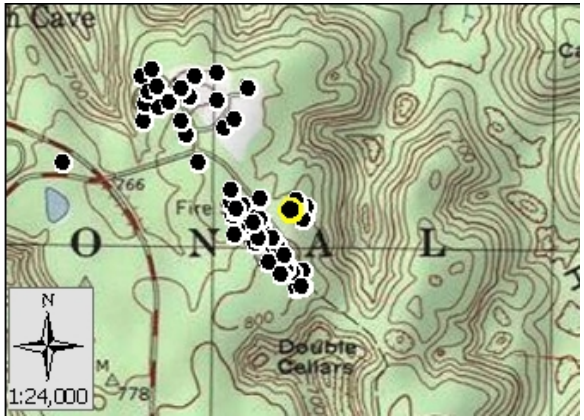
Facility: Bldg 052, Concession Workshop

Rating: Moderate
Protection Level : Not Designated
Resources of Concern Present? Unknown
Occupied? No
Local ID: [Local_ID]
In a Community? Yes - Admin Buildings
Lat(WGS84): 37° 10.8454' **Long(WGS84):** -86° 5.09288'

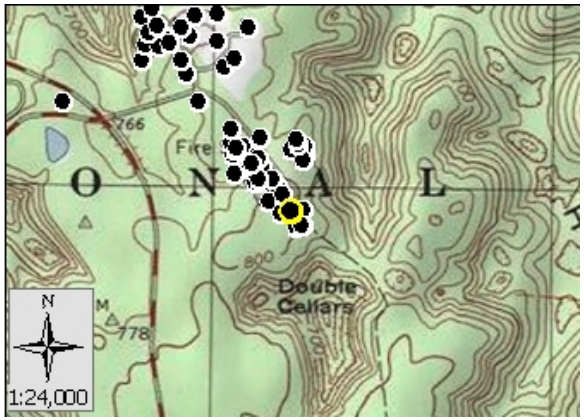
Facility: Bldg 102, Equipment Storage Building- Salvage Yard

Rating: Low
Protection Level : Not Designated
Resources of Concern Present? Unknown
Occupied? No
Local ID: [Local_ID]
In a Community? Yes - Admin Buildings
Lat(WGS84): 37° 10.7479' **Long(WGS84):** -86° 5.09274'

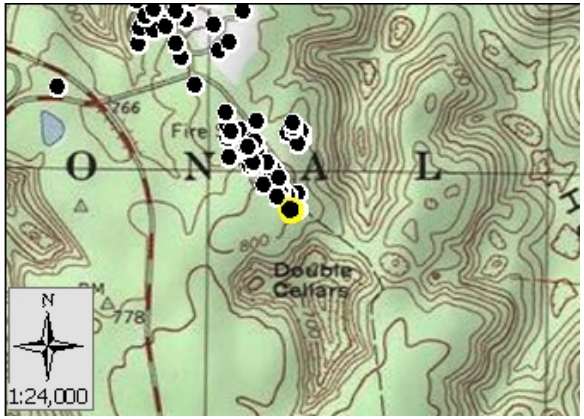
Facility: Carport 3

Rating: Moderate
Protection Level : Not Designated
Resources of Concern Present? Unknown
Occupied? No
Local ID: [Local_ID]
In a Community? Yes - Admin Buildings
Lat(WGS84): 37° 10.7235' **Long(WGS84):** -86° 5.08369'

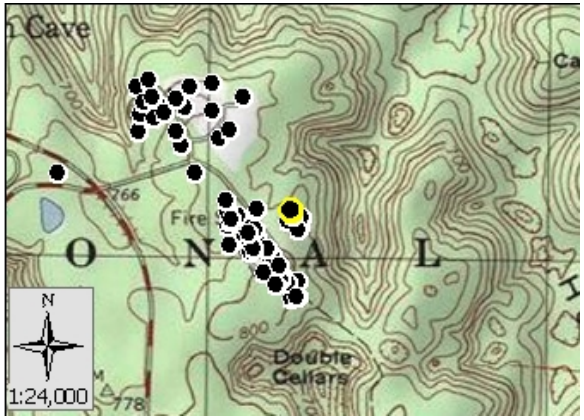
Facility: Old Chicken Coop

Rating: High
Protection Level : Not Designated
Resources of Concern Present? Unknown
Occupied? No
Local ID: [Local_ID]
In a Community? Yes - Admin Buildings
Lat(WGS84): 37° 10.8616' **Long(WGS84):** -86° 5.08279'

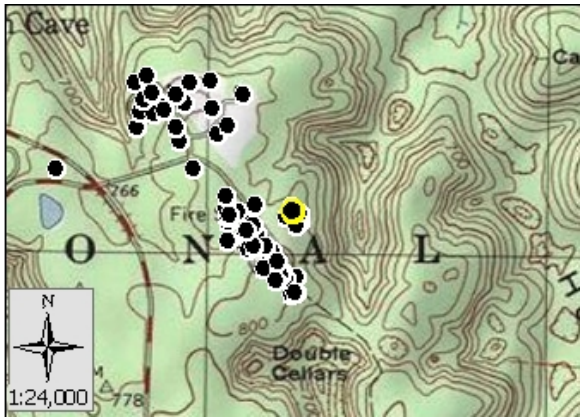
Facility: Bldg 301, Concession Storage Building

Rating: Moderate
Protection Level : Not Designated
Resources of Concern Present? Unknown
Occupied? No
Local ID: [Local_ID]
In a Community? Yes - Admin Buildings
Lat(WGS84): 37° 10.854' **Long(WGS84):** -86° 5.08128'

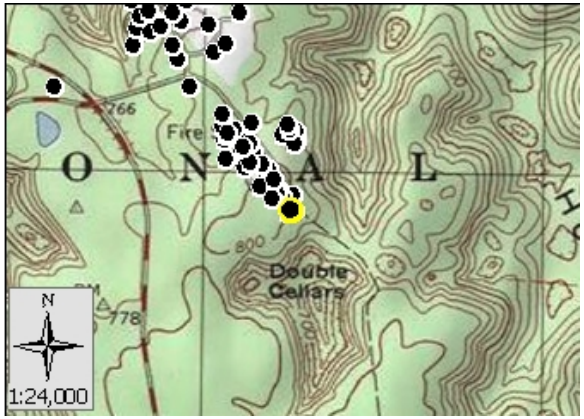
Facility: Carport 2

Rating: Moderate
Protection Level : Not Designated
Resources of Concern Present? Unknown
Occupied? No
Local ID: [Local_ID]
In a Community? Yes - Admin Buildings
Lat(WGS84): 37° 10.7252' **Long(WGS84):** -86° 5.07506'

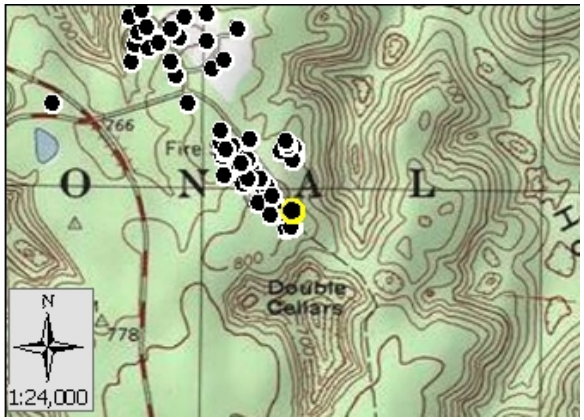
Facility: Bldg 310, Haz-Mat Collection Building

Rating: Moderate
Protection Level : Not Designated
Resources of Concern Present? Unknown
Occupied? No
Local ID: [Local_ID]
In a Community? Yes - Admin Buildings
Lat(WGS84): 37° 10.7496' **Long(WGS84):** -86° 5.07183'

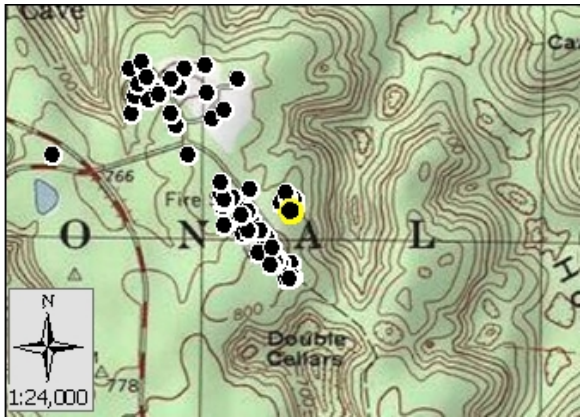
Facility: Bldg 055, Concession Warehouse

Rating: High
Protection Level : Not Designated
Resources of Concern Present? Unknown
Occupied? No
Local ID: [Local_ID]
In a Community? Yes - Admin Buildings
Lat(WGS84): 37° 10.8308' **Long(WGS84):** -86° 5.07134'
