NPS Wildfire Risk Assessments
Assessment Locations

NPS Wildfire Risk Assessment Project

MACA - Administration - Overview

MACA - Mammoth Cave National Park

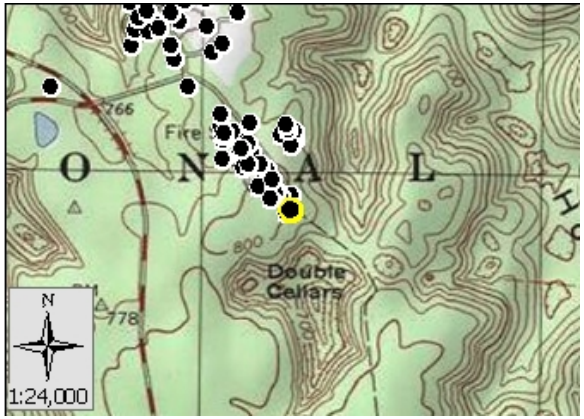
Facility: Carport 1

Rating: Moderate
Protection Level : Not Designated
Resources of Concern Present? Unknown
Occupied? No
Local ID: [Local_ID]
In a Community? Yes - Admin Buildings
Lat(WGS84): 37° 10.7258' **Long(WGS84):** -86° 5.07107'

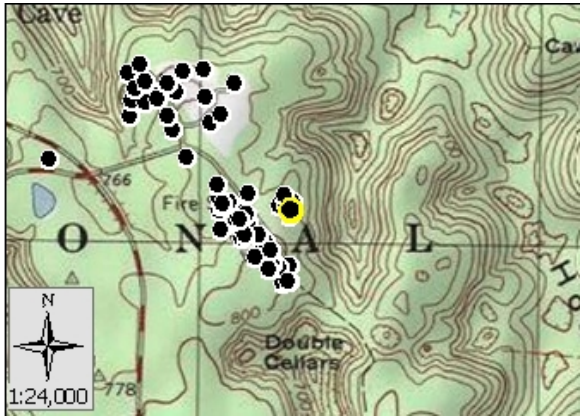
Facility: Recycling shelter

Rating: Moderate
Protection Level : Not Designated
Resources of Concern Present? Unknown
Occupied? No
Local ID: [Local_ID]
In a Community? Yes - Admin Buildings
Lat(WGS84): 37° 10.8382' **Long(WGS84):** -86° 5.0661'

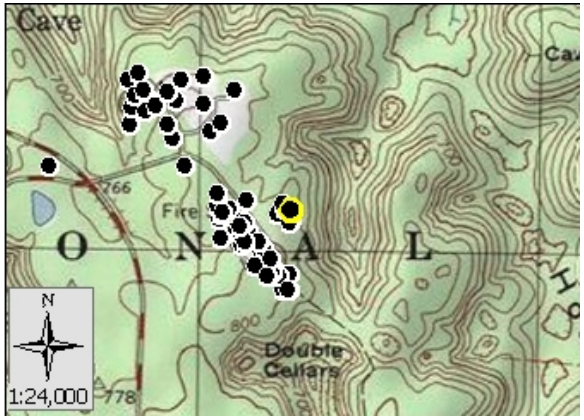
Facility: Bldg 300, Concessions Warehouse in Utility Area

Unit - Location: MACA - MACA - Administration
FMSS ID: 49096
Structure Type: Building
Structure Use: Concession
Owner: NPS
Field Crew: castillo/szturm
Last Site Visit Date: 3/10/2022

Rating: Moderate
Protection Level : Not Designated
Resources of Concern Present? Unknown
Occupied? No
Local ID: [Local_ID]
In a Community? Yes - Admin Buildings
Lat(WGS84): 37° 10.8506' **Long(WGS84):** -86° 5.0654'

Primary Access: Road
Ingress/Egress: One roads in/out
Access Width: 1.5 lanes (>18ft)
Access Condition: Surfaced-paved, grade<5%
Bridge Condition: None/nonflammable,load limit will not limit response
Access & Turnarounds: Access is <300 ft from facility w/turnaround
Facility Number/Sign: Marked and clearly visible
Defensible Space: No defensible space
Fuel Load (w/in 300 ft): Heavy
Fuel Type (w/in 300ft): Grass,shrub,hardwood litter
Topography (w/in 300ft): Slope 5% to 20%
Roof Material: Fire resistant- tar,rubberized
Siding Material: Rock, concrete, metal
Foundation: Closed, >30in masonry exposed or N/A
Fences/Decks: None or noncombustible
Firewood: None
Propane Tanks: None
Water Supply: Pressurized hydrant(s) or fixed sprinkler system
Overhead Hazards: No overhead hazards
Safety Zones: Potential saftey zone(s) in area
Additional Obstacles: Hazmat, UXO,etc. , PLEASE COMMENT
Triage Category:
Hazmat: Fuel depot
