NPS Wildfire Risk Assessments
Assessment Locations

Antietam National Battlefield - Overview

National Park Service
U.S. Department of the Interior

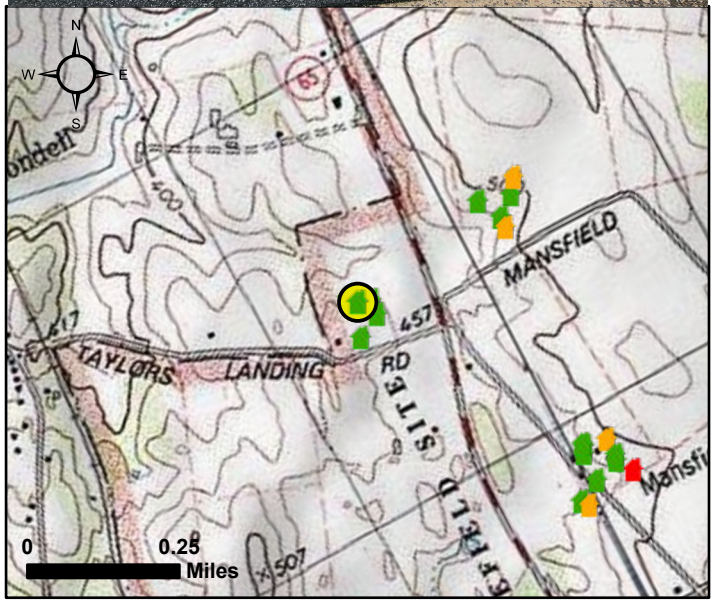
Rating: Low
ProtectionLevel: Not Designated,
Resources of Concern: Unknown
Occupied: Yes
In Community: Yes,
Revisit Interval: 5 yrs
Map Label: 103

Primary Access: Road
Ingress Egress: 2 or more roads in/out
Access Width: 2 lanes (Greater than 24')
Access Condition: Surfaced-paved, gradeLess than 5%
Bridge Condition: Greater than 300 ft with turnaround
Access and Turnarounds: Greater than 300 ft with turnaround
Facility Number or Sign: Marked and clearly visible
Fuel Type: Grass/tundra,northern hardwood litter
Fuel Load: Light or no wildland fuels
Defensible Space: Greater than 100ft treated
Topography: Slope Less than 5%
Roof Material: Noncombustible or not applicable
Siding Material: Rock, concrete, metal
Foundation: Closed, Less than 6in masonry exposed
Firewood: Adjacent to/under deck of facility
Water Supply: Pressurized hydrant(s) or fixed sprinkler system
Propane: Present and fuels clearance
Overhead Hazards: No overhead hazards

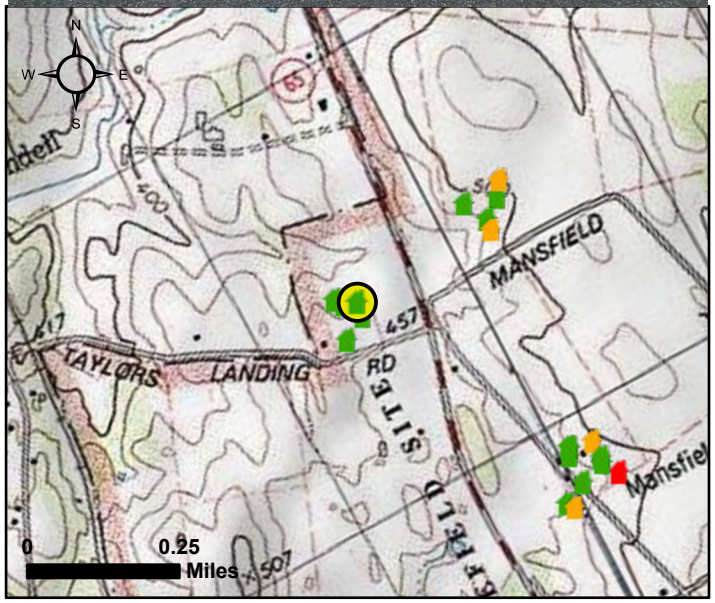
Rating: Low
ProtectionLevel: Not Designated,
Resources of Concern: Unknown
Occupied: Yes
In Community: No,
Revisit Interval: 5 yrs
Map Label: 2

Primary Access: Road
Ingress Egress: 2 or more roads in/out
Access Width: 2 lanes (Greater than 24')
Access Condition: Surfaced-paved, gradeLess than 5%
Bridge Condition: Less than 300 ft with turnaround
Access and Turnarounds: Less than 300 ft with turnaround
Facility Number or Sign: Marked and clearly visible
Fuel Type: Grass/tundra,northern hardwood litter
Fuel Load: Light or no wildland fuels
Defensible Space: Less than 30 ft treated
Topography: Slope Less than 5%
Roof Material: Noncombustible or not applicable
Siding Material: Rock, concrete, metal
Foundation: Open or deck
Firewood: None
Water Supply: Pressurized hydrant(s) or fixed sprinkler system
Propane: Present and fuels clearance
Overhead Hazards: No overhead hazards

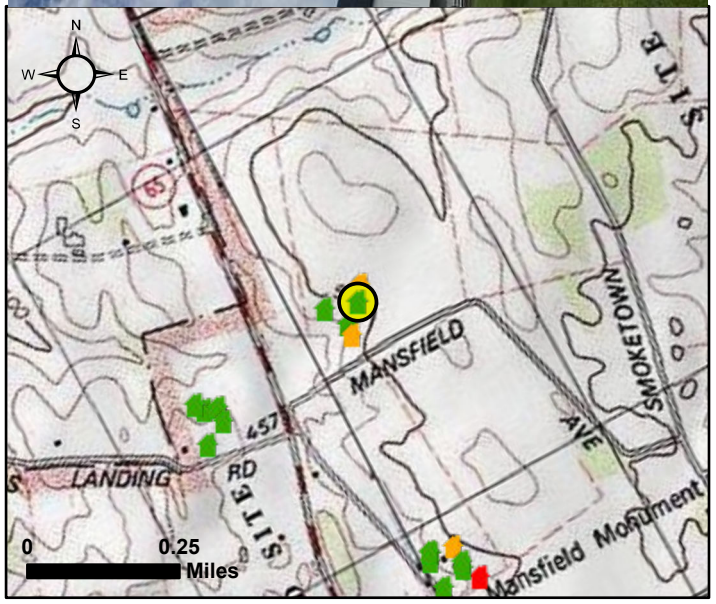
Rating: Low
ProtectionLevel: Undesignated,
Resources of Concern: Unknown
Occupied: No
In Community: Yes,
Revisit Interval: 5 yrs
Map Label: 80

Primary Access: Road
Ingress Egress: 1 road in/out
Access Width: 2 lanes (Greater than 24')
Access Condition: Surfaced-paved, gradeLess than 5%
Bridge Condition: Less than 300 ft with turnaround
Access and Turnarounds: Less than 300 ft with turnaround
Facility Number or Sign: None or not clearly visible
Fuel Type: Grass/tundra,northern hardwood litter
Fuel Load: Light or no wildland fuels
Defensible Space: 100 ft treated
Topography: Slope Less than 5%
Roof Material: Noncombustible or not applicable
Siding Material: Wood or open sided
Foundation: Open or deck
Firewood: None
Water Supply: No reliable water source nearby
Propane: None
Overhead Hazards: No overhead hazards

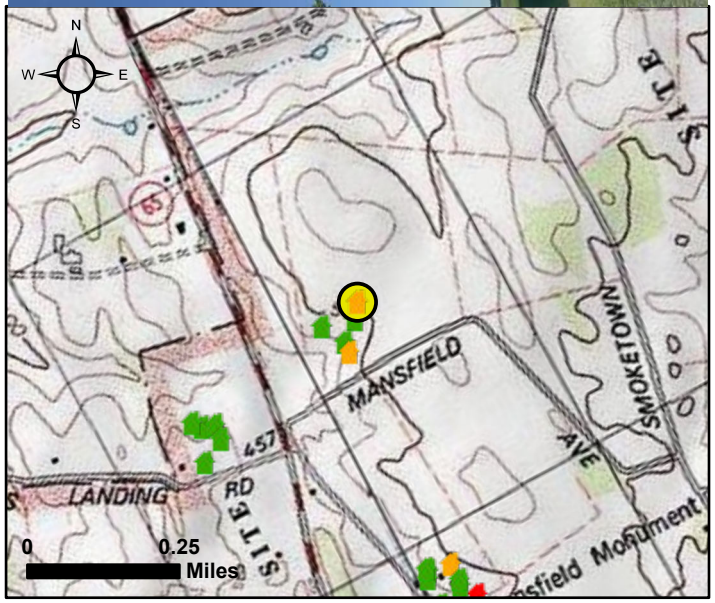
Rating: Moderate
ProtectionLevel: Not Designated,
Resources of Concern: Unknown
Occupied: No
In Community: Yes,
Revisit Interval: 5 yrs
Map Label: 81

Primary Access: Road
Ingress Egress: 1 road in/out
Access Width: 2 lanes (Greater than 24')
Access Condition: Surfaced-paved, gradeLess than 5%
Bridge Condition: Less than 300 ft with turnaround
Access and Turnarounds: Less than 300 ft with turnaround
Facility Number or Sign: None or not clearly visible
Fuel Type: Grass and shrub, hardwood litter
Fuel Load: Light or no wildland fuels
Defensible Space: 100 ft treated
Topography: Slope Less than 5%
Roof Material: Combustible or no roof
Siding Material: Wood or open sided
Foundation: Closed, Greater than 30in masonry exposed or N/A
Firewood: None
Water Supply: No reliable water source nearby
Propane: None
Overhead Hazards: No overhead hazards

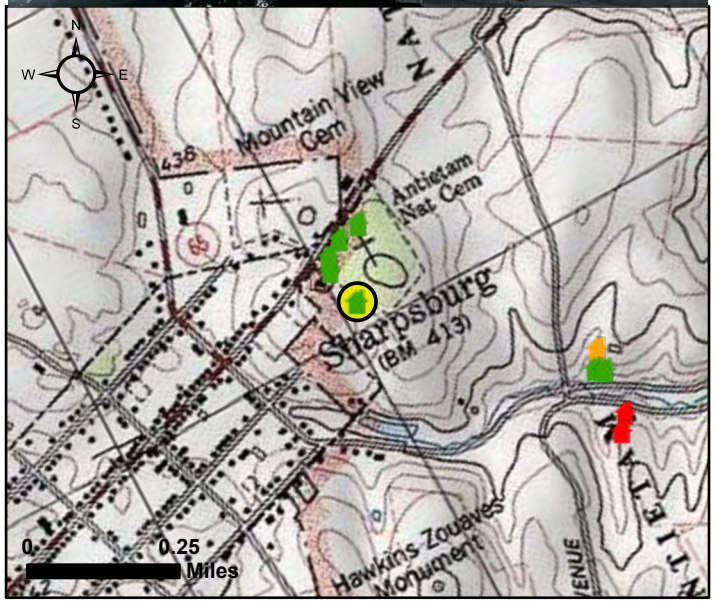
Rating: Low
ProtectionLevel: Undesignated,
Resources of Concern: Unknown
Occupied: Yes
In Community: Yes,
Revisit Interval: 5 yrs
Map Label: 151

Primary Access: Road
Ingress Egress: 2 or more roads in/out
Access Width: 2 lanes (Greater than 24')
Access Condition: Surfaced-paved, gradeLess than 5%
Bridge Condition: Less than 300 ft with turnaround
Access and Turnarounds: Less than 300 ft with turnaround
Facility Number or Sign: Marked and clearly visible
Fuel Type: Grass and shrub, hardwood litter
Fuel Load: Light or no wildland fuels
Defensible Space: Less than 30 ft treated
Topography: Slope 5% to 20%
Roof Material: Fire resistant- tar,rubberized
Siding Material: Rock, concrete, metal
Foundation: Closed, Greater than 30in masonry exposed or N/A
Firewood: None
Water Supply: Pressurized hydrant(s) or fixed sprinkler system
Propane: None
Overhead Hazards: No overhead hazards

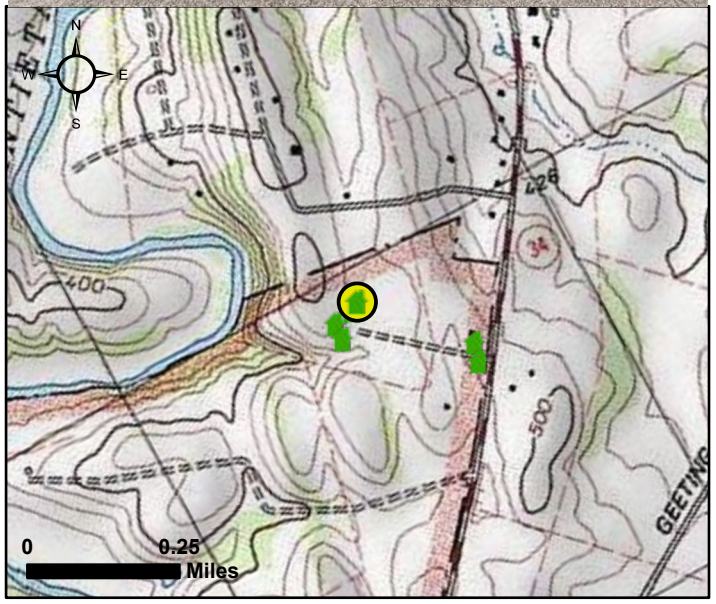
Facility Name: Pry Barn
Unit - Location: ANTI - Antietam National Battlefield
FMSS ID: 40542, ***Local ID:***
Structure Type, Use: Building, Public
Owner: National Park Service
Field Crew, Visit Date: Ncr fire guys, June 14, 2022
Coordinates (DDM): 39° 28.57337256' N 077° 42.80205252' W

Rating: Low
ProtectionLevel: Not Designated,
Resources of Concern: Unknown
Occupied: No
In Community: No,
Revisit Interval: 5 yrs
Map Label: 39

Primary Access: Road
Ingress Egress: 1 road in/out
Access Width: 1 lane (Less than 18')
Access Condition: Surfaced-paved, gradeLess than 5%
Bridge Condition: Greater than 300 ft with turnaround
Access and Turnarounds: Greater than 300 ft with turnaround
Facility Number or Sign: None or not clearly visible
Fuel Type: Grass/tundra,northern hardwood litter
Fuel Load: Light or no wildland fuels
Defensible Space: Greater than 100ft treated
Topography: Slope 5% to 20%
Roof Material: Noncombustible or not applicable
Siding Material: Wood or open sided
Foundation: Open or deck
Firewood: None
Water Supply: Reliable water source nearby
Propane: None
Overhead Hazards: No overhead hazards

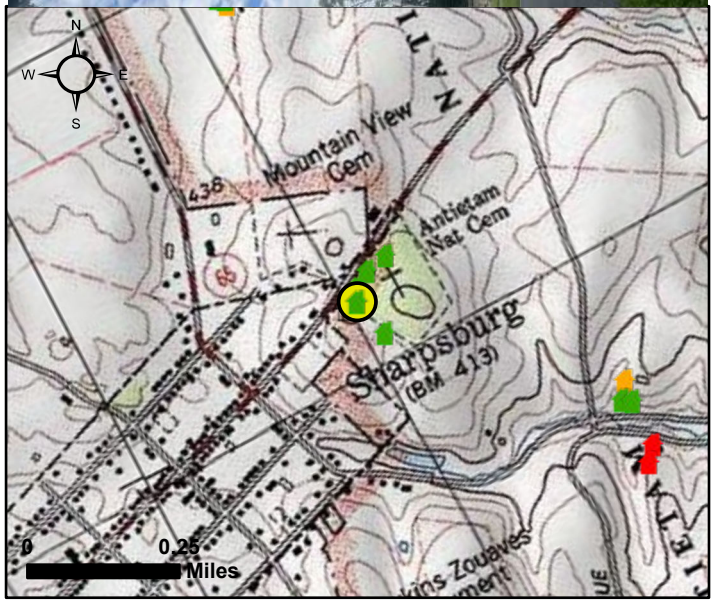
Rating: Low
ProtectionLevel: Undesignated,
Resources of Concern: Unknown
Occupied: Yes
In Community: Yes,
Revisit Interval: 5 yrs
Map Label: 149

Primary Access: Road
Ingress Egress: 2 or more roads in/out
Access Width: 2 lanes (Greater than 24')
Access Condition: Surfaced-paved, gradeLess than 5%
Bridge Condition: Less than 300 ft with turnaround
Access and Turnarounds: Less than 300 ft with turnaround
Facility Number or Sign: Marked and clearly visible
Fuel Type: Grass and shrub, hardwood litter
Fuel Load: Light or no wildland fuels
Defensible Space: Greater than 100ft treated
Topography: Slope Less than 5%
Roof Material: Noncombustible or not applicable
Siding Material: Rock, concrete, metal
Foundation: Closed, Greater than 30in masonry exposed or N/A
Firewood: None
Water Supply: Pressurized hydrant(s) or fixed sprinkler system
Propane: None
Overhead Hazards: No overhead hazards

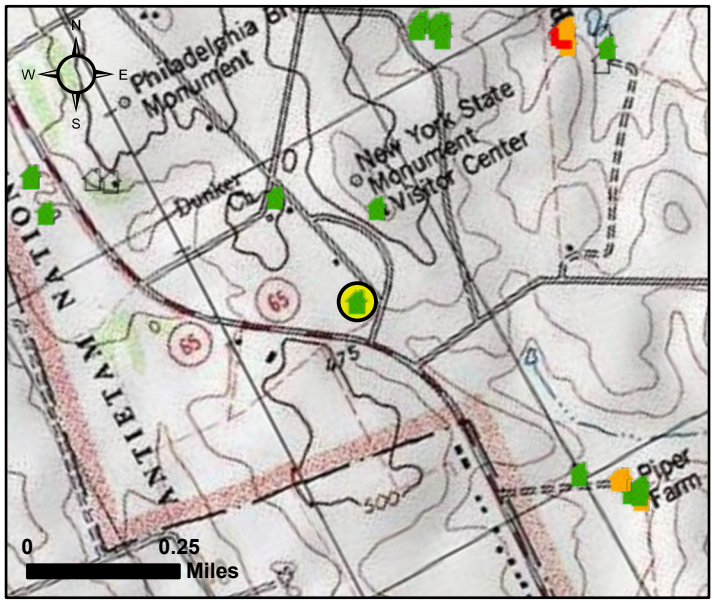
Rating: Low
ProtectionLevel: Not Designated,
Resources of Concern: Unknown
Occupied: No
In Community: Yes,
Revisit Interval: 5 yrs
Map Label: 175

Primary Access: Road
Ingress Egress: 1 road in/out
Access Width: 1 lane (Less than 18')
Access Condition: Surfaced-paved, gradeGreater than 5%
Bridge Condition: Greater than 300 ft with turnaround
Access and Turnarounds: Greater than 300 ft with turnaround
Facility Number or Sign: Marked and clearly visible
Fuel Type: Grass/tundra,northern hardwood litter
Fuel Load: Light or no wildland fuels
Defensible Space: 30 ft treated
Topography: Slope 5% to 20%
Roof Material: Fire resistant- tar,rubberized
Siding Material: Rock, concrete, metal
Foundation: Closed, Less than 6in masonry exposed
Firewood: None
Water Supply: Pressurized hydrant(s) or fixed sprinkler system
Propane: None
Overhead Hazards: No overhead hazards

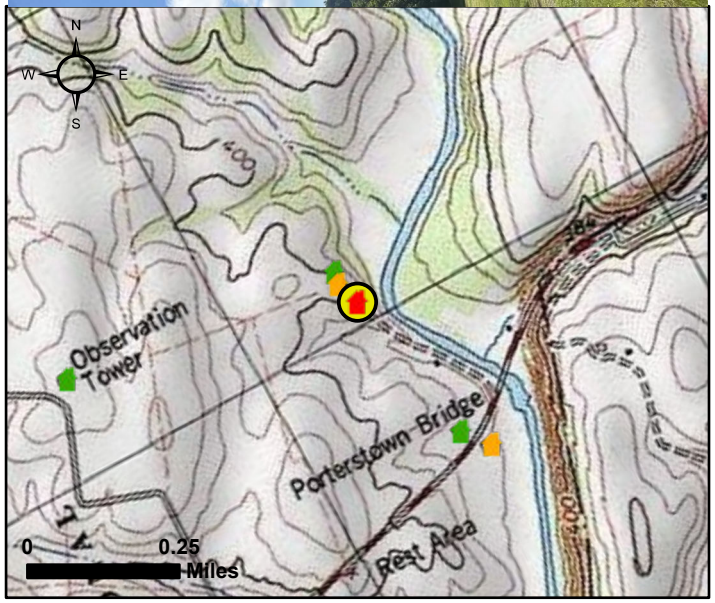
Rating: High
ProtectionLevel: Undesignated,
Resources of Concern: Unknown
Occupied: No
In Community: Yes,
Revisit Interval: 5 yrs
Map Label: 123

Primary Access: Road
Ingress Egress: 1 road in/out
Access Width: 1 lane (Less than 18')
Access Condition: Non-surfaced- gravel,dirt,gradeLess than 5%
Bridge Condition: Greater than 300 ft with turnaround
Access and Turnarounds: Greater than 300 ft with turnaround
Facility Number or Sign: None or not clearly visible
Fuel Type: Grass and shrub, hardwood litter
Fuel Load: Light or no wildland fuels
Defensible Space: 100 ft treated
Topography: Slope 5% to 20%
Roof Material: Combustible or no roof
Siding Material: Wood or open sided
Foundation: Closed, Less than 6in masonry exposed
Firewood: None
Water Supply: Reliable water source nearby
Propane: None
Overhead Hazards: No overhead hazards

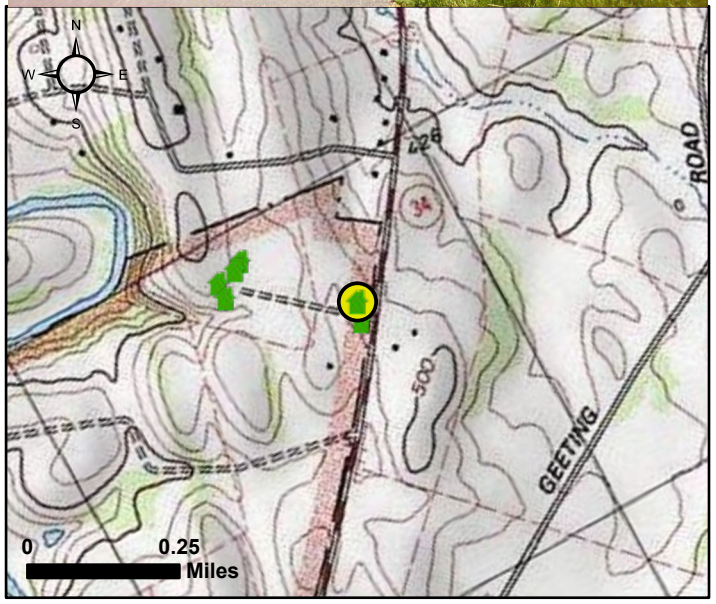
Facility Name: Wyand House
Unit - Location: ANTI - Antietam National Battlefield
FMSS ID: 48708, ***Local ID:***
Structure Type, Use: Building, Administrative
Owner: National Park Service
Field Crew, Visit Date: NCR fire, June 14, 2022
Coordinates (DDM): 39° 28.46123280' N 077° 42.66538656' W

Rating: Low
ProtectionLevel: Not Designated,
Resources of Concern: Unknown
Occupied: Yes
In Community: Yes,
Revisit Interval: 5 yrs
Map Label: 182

Primary Access: Road
Ingress Egress: 1 road in/out
Access Width: 1.5 lanes (Greater than 18')
Access Condition: Surfaced-paved, gradeLess than 5%
Bridge Condition: Less than 300 ft with turnaround
Access and Turnarounds: Less than 300 ft with turnaround
Facility Number or Sign: Marked and clearly visible
Fuel Type: Grass/tundra,northern hardwood litter
Fuel Load: Light or no wildland fuels
Defensible Space: Greater than 100ft treated
Topography: Slope Less than 5%
Roof Material: Fire resistant- tar,rubberized
Siding Material: Rock, concrete, metal
Foundation: Closed, Less than 6in masonry exposed
Firewood: None
Water Supply: Reliable water source nearby
Propane: None
Overhead Hazards: Overhead hazards will limit aircraft
Comments: From FMSS_Export - FRPP_PREDUSE: Bldg. Library (GSF)

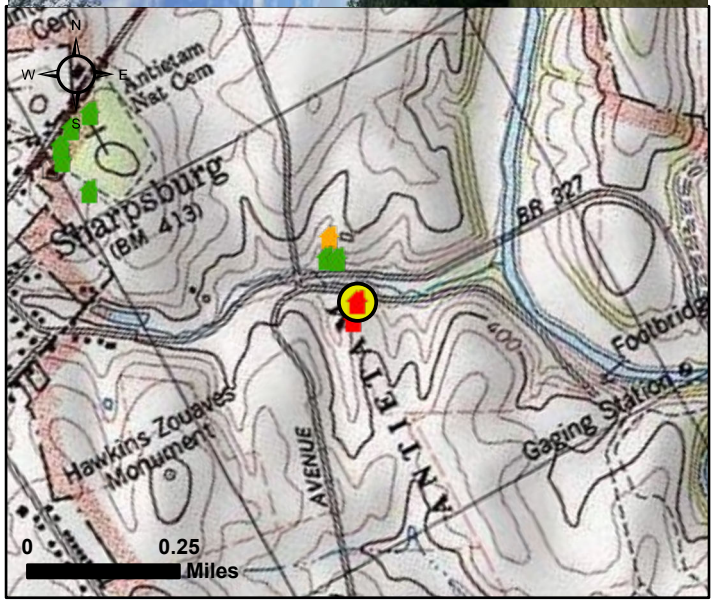
Rating: High
ProtectionLevel: Undesignated,
Resources of Concern: Unknown
Occupied: No
In Community: Yes,
Revisit Interval: 5 yrs
Map Label: 186

Primary Access: Road
Ingress Egress: 2 or more roads in/out
Access Width: 2 lanes (Greater than 24')
Access Condition: Surfaced-paved, gradeLess than 5%
Bridge Condition: Greater than 300 ft with turnaround
Access and Turnarounds: Greater than 300 ft with turnaround
Facility Number or Sign: Marked and clearly visible
Fuel Type: Grass and shrub, hardwood litter
Fuel Load: Light or no wildland fuels
Defensible Space: Less than 30 ft treated
Topography: Slope 5% to 20%
Roof Material: Combustible or no roof
Siding Material: Wood or open sided
Foundation: Open or deck
Firewood: None
Water Supply: Reliable water source nearby
Propane: None
Overhead Hazards: No overhead hazards

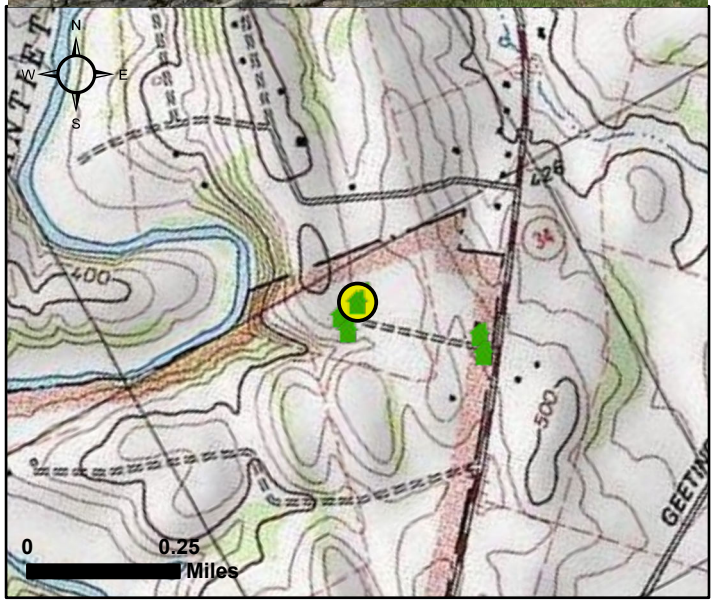
Rating: Low
ProtectionLevel: Not Designated,
Resources of Concern: Unknown
Occupied: No
In Community: No,
Revisit Interval: 5 yrs
Map Label: 38

Primary Access: Road
Ingress Egress: 1 road in/out
Access Width: 1 lane (Less than 18')
Access Condition: Surfaced-paved, gradeLess than 5%
Bridge Condition: Greater than 300 ft with turnaround
Access and Turnarounds: Greater than 300 ft with turnaround
Facility Number or Sign: None or not clearly visible
Fuel Type: Grass/tundra,northern hardwood litter
Fuel Load: Light or no wildland fuels
Defensible Space: Greater than 100ft treated
Topography: Slope 5% to 20%
Roof Material: Noncombustible or not applicable
Siding Material: Not applicable
Foundation: Closed, Greater than 30in masonry exposed or N/A
Firewood: None
Water Supply: Reliable water source nearby
Propane: None
Overhead Hazards: No overhead hazards

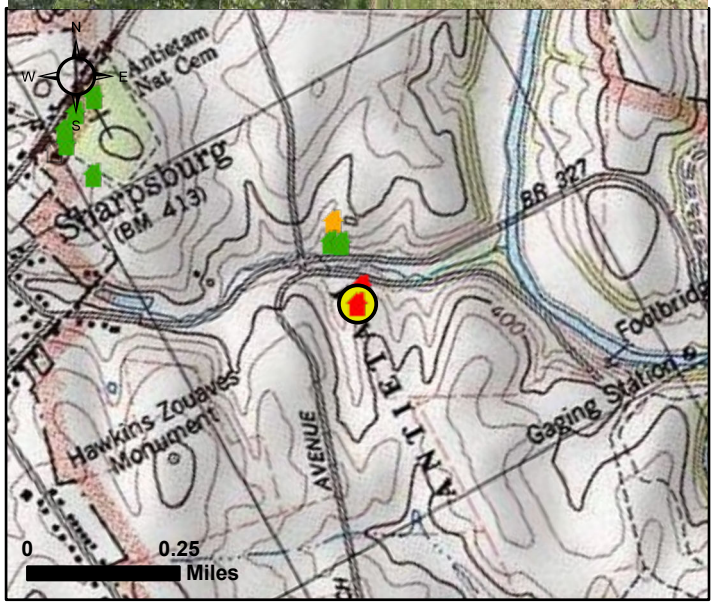
Rating: High
ProtectionLevel: Undesignated,
Resources of Concern: Unknown
Occupied: No
In Community: Yes,
Revisit Interval: 5 yrs
Map Label: 184

Primary Access: Road
Ingress Egress: 2 or more roads in/out
Access Width: 2 lanes (Greater than 24')
Access Condition: Surfaced-paved, gradeLess than 5%
Bridge Condition: Greater than 300 ft with turnaround
Access and Turnarounds: Greater than 300 ft with turnaround
Facility Number or Sign: Marked and clearly visible
Fuel Type: Grass/tundra,northern hardwood litter
Fuel Load: Moderate
Defensible Space: Less than 30 ft treated
Topography: Slope 5% to 20%
Roof Material: Combustible or no roof
Siding Material: Wood or open sided
Foundation: Closed, Less than 6in masonry exposed
Firewood: None
Water Supply: Reliable water source nearby
Propane: None
Overhead Hazards: No overhead hazards

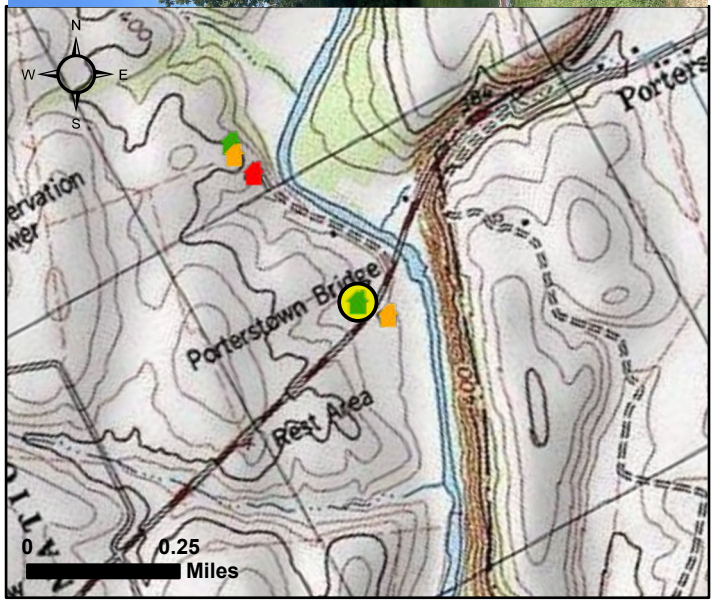
Rating: Low
ProtectionLevel: Undesignated,
Resources of Concern: Unknown
Occupied: Yes
In Community: No,
Revisit Interval: 5 yrs
Map Label: 29

Primary Access: Road
Ingress Egress: 2 or more roads in/out
Access Width: 2 lanes (Greater than 24')
Access Condition: Surfaced-paved, gradeLess than 5%
Bridge Condition: Less than 300 ft with turnaround
Access and Turnarounds: Less than 300 ft with turnaround
Facility Number or Sign: Marked and clearly visible
Fuel Type: Grass and shrub, hardwood litter
Fuel Load: Light or no wildland fuels
Defensible Space: 30 ft treated
Topography: Slope 5% to 20%
Roof Material: Noncombustible or not applicable
Siding Material: Wood or open sided
Foundation: Closed, 6in to 30in masonry exposed
Firewood: None
Water Supply: Reliable water source nearby
Propane: None
Overhead Hazards: No overhead hazards

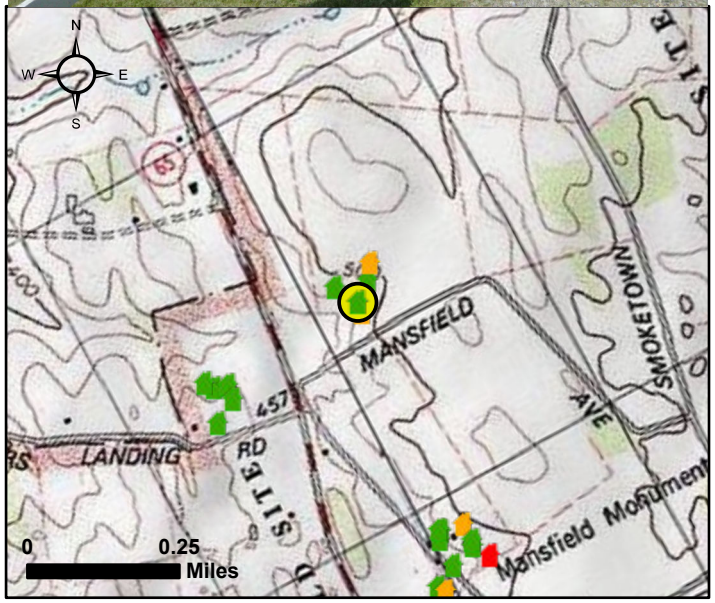
Facility Name: Poffenberger Stone Building
Unit - Location: ANTI - Antietam National Battlefield
FMSS ID: 43566, ***Local ID:***
Structure Type, Use: Building, Public
Owner: National Park Service
Field Crew, Visit Date: NCR Wildland Fire , August 9, 2022
Coordinates (DDM): 39° 29.37214140' N 077° 44.90625324' W

Rating: Low
ProtectionLevel: Not Designated,
Resources of Concern: Unknown
Occupied: No
In Community: Yes,
Revisit Interval: 5 yrs
Map Label: 79

Primary Access: Road
Ingress Egress: 1 road in/out
Access Width: 2 lanes (Greater than 24')
Access Condition: Surfaced-paved, gradeLess than 5%
Bridge Condition: Less than 300 ft with turnaround
Access and Turnarounds: Less than 300 ft with turnaround
Facility Number or Sign: None or not clearly visible
Fuel Type: Grass and shrub, hardwood litter
Fuel Load: Light or no wildland fuels
Defensible Space: 100 ft treated
Topography: Slope Less than 5%
Roof Material: Noncombustible or not applicable
Siding Material: Wood or open sided
Foundation: Closed, Less than 6in masonry exposed
Firewood: None
Water Supply: No reliable water source nearby
Propane: None
Overhead Hazards: No overhead hazards

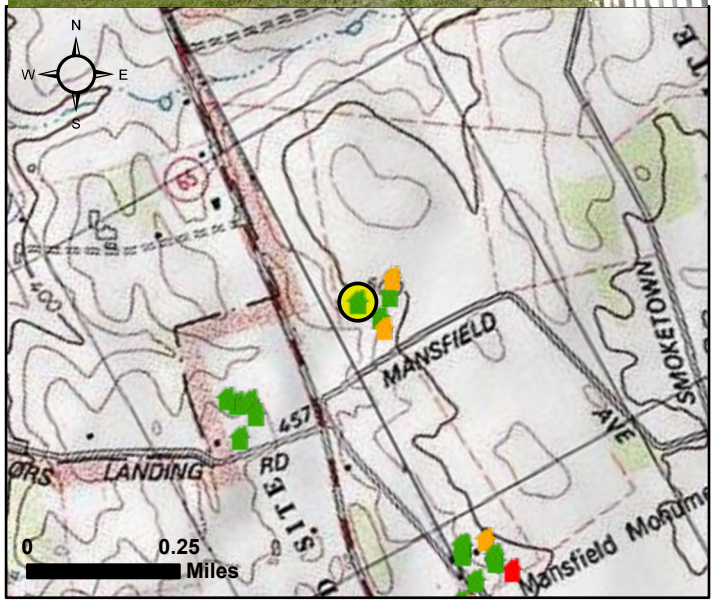
Facility Name: Poffenberger House
Unit - Location: ANTI - Antietam National Battlefield
FMSS ID: 43563, ***Local ID:***
Structure Type, Use: Building, Public
Owner: National Park Service
Field Crew, Visit Date: NCR Wildland Fire , August 9, 2022
Coordinates (DDM): 39° 29.40214446' N 077° 44.92695324' W

Rating: Low
ProtectionLevel: Not Designated,
Resources of Concern: Unknown
Occupied: No
In Community: Yes,
Revisit Interval: 5 yrs
Map Label: 77

Primary Access: Road
Ingress Egress: 1 road in/out
Access Width: 2 lanes (Greater than 24')
Access Condition: Surfaced-paved, gradeLess than 5%
Bridge Condition: Less than 300 ft with turnaround
Access and Turnarounds: Less than 300 ft with turnaround
Facility Number or Sign: None or not clearly visible
Fuel Type: Grass and shrub, hardwood litter
Fuel Load: Light or no wildland fuels
Defensible Space: 100 ft treated
Topography: Slope Less than 5%
Roof Material: Noncombustible or not applicable
Siding Material: Wood or open sided
Foundation: Closed, Less than 6in masonry exposed
Firewood: None
Water Supply: No reliable water source nearby
Propane: None
Overhead Hazards: No overhead hazards

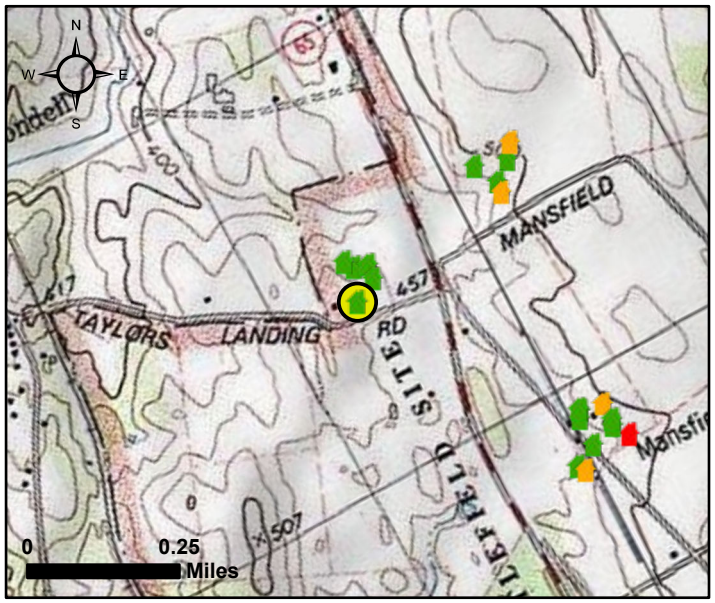
Facility Name: Shull House
Unit - Location: ANTI - Antietam National Battlefield
FMSS ID: 48712, ***Local ID:***
Structure Type, Use: Building, Administrative
Owner: National Park Service
Field Crew, Visit Date: NCR, April 17, 2023
Coordinates (DDM): 39° 29.319' N 77° 45.195' W

Rating: Low
ProtectionLevel: Not Designated,
Resources of Concern: Unknown
Occupied: Yes
In Community: Yes,
Revisit Interval: 5 yrs
Map Label: 102

Primary Access: Road
Ingress Egress: 2 or more roads in/out
Access Width: 2 lanes (Greater than 24')
Access Condition: Surfaced-paved, gradeLess than 5%
Bridge Condition: Greater than 300 ft with turnaround
Access and Turnarounds: Greater than 300 ft with turnaround
Facility Number or Sign: Marked and clearly visible
Fuel Type: Shrub or timber
Fuel Load: Light or no wildland fuels
Defensible Space: 100 ft treated
Topography: Slope Less than 5%
Roof Material: Fire resistant- tar,rubberized
Siding Material: Rock, concrete, metal
Foundation: Closed, Greater than 30in masonry exposed or N/A
Firewood: None
Water Supply: Pressurized hydrant(s) or fixed sprinkler system
Propane: None
Overhead Hazards: No overhead hazards
Comments: From FMSS_Export - FRPP_PREDUSE: Bldg. Office (GSF)

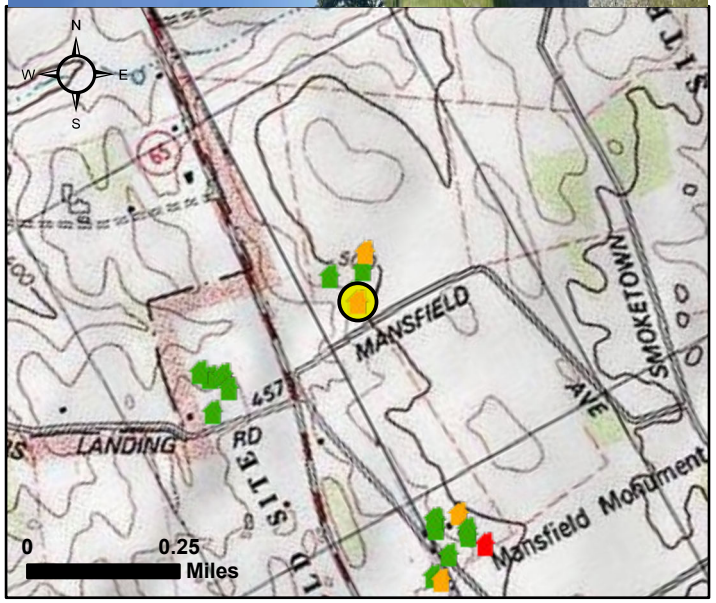
Rating: Moderate
ProtectionLevel: Not Designated,
Resources of Concern: Unknown
Occupied: No
In Community: Yes,
Revisit Interval: 5 yrs
Map Label: 78

Primary Access: Road
Ingress Egress: 1 road in/out
Access Width: 2 lanes (Greater than 24')
Access Condition: Surfaced-paved, gradeLess than 5%
Bridge Condition: Less than 300 ft with turnaround
Access and Turnarounds: Less than 300 ft with turnaround
Facility Number or Sign: None or not clearly visible
Fuel Type: Grass and shrub, hardwood litter
Fuel Load: Light or no wildland fuels
Defensible Space: 30 ft treated
Topography: Slope Less than 5%
Roof Material: Noncombustible or not applicable
Siding Material: Wood or open sided
Foundation: Closed, Less than 6in masonry exposed
Firewood: None
Water Supply: No reliable water source nearby
Propane: None
Overhead Hazards: No overhead hazards

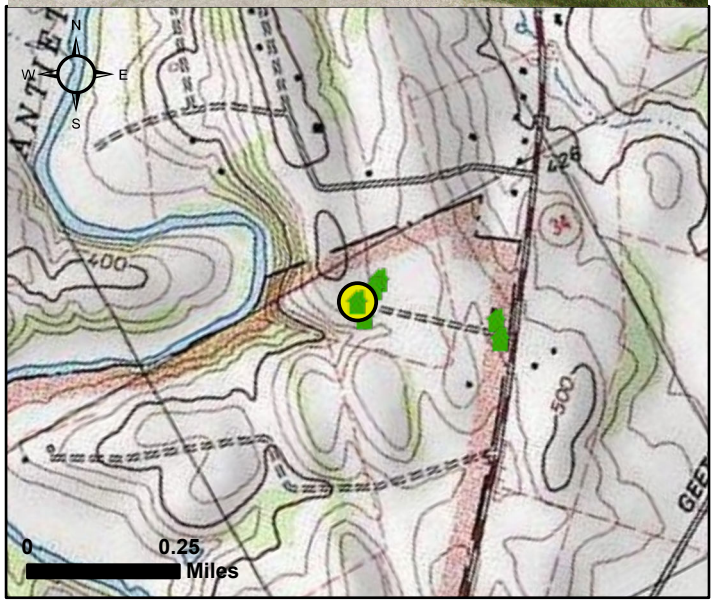
Facility Name: Pry House
Unit - Location: ANTI - Antietam National Battlefield
FMSS ID: 40540, ***Local ID:***
Structure Type, Use: Building, Public
Owner: National Park Service
Field Crew, Visit Date: NCR fire, June 14, 2022
Coordinates (DDM): 39° 28.56165810' N 077° 42.85005252' W

Rating: Low
ProtectionLevel: Not Designated,
Resources of Concern: Unknown
Occupied: No
In Community: No,
Revisit Interval: 5 yrs
Map Label: 37

Primary Access: Road
Ingress Egress: 2 or more roads in/out
Access Width: 1 lane (Less than 18')
Access Condition: Surfaced-paved, gradeLess than 5%
Bridge Condition: Less than 300 ft with turnaround
Access and Turnarounds: Less than 300 ft with turnaround
Facility Number or Sign: Marked and clearly visible
Fuel Type: Grass/tundra,northern hardwood litter
Fuel Load: Light or no wildland fuels
Defensible Space: Greater than 100ft treated
Topography: Slope Less than 5%
Roof Material: Combustible or no roof
Siding Material: Rock, concrete, metal
Foundation: Closed, Greater than 30in masonry exposed or N/A
Firewood: None
Water Supply: Reliable water source nearby
Propane: None
Overhead Hazards: No overhead hazards

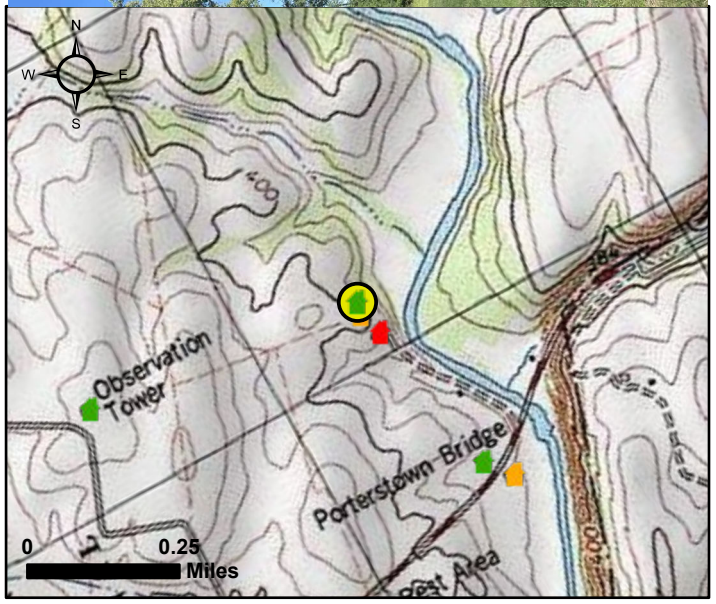
Facility Name: Cunningham (Park) Log Dependency House (Ktichen)
Unit - Location: ANTI - Antietam National Battlefield
FMSS ID: 44049, ***Local ID:***
Structure Type, Use: Building, Public
Owner: National Park Service
Field Crew, Visit Date: NCR Wildland Fire , August 18, 2022
Coordinates (DDM): 39° 28.12997244' N 077° 43.69935276' W

Rating: Low
ProtectionLevel: Undesignated,
Resources of Concern: Unknown
Occupied: No
In Community: Yes,
Revisit Interval: 5 yrs
Map Label: 122

Primary Access: Road
Ingress Egress: 1 road in/out
Access Width: 1 lane (Less than 18')
Access Condition: Non-surfaced- gravel,dirt,gradeLess than 5%
Bridge Condition: Greater than 300 ft with turnaround
Access and Turnarounds: Greater than 300 ft with turnaround
Facility Number or Sign: None or not clearly visible
Fuel Type: Grass and shrub, hardwood litter
Fuel Load: Light or no wildland fuels
Defensible Space: 30 ft treated
Topography: Slope Less than 5%
Roof Material: Noncombustible or not applicable
Siding Material: Wood or open sided
Foundation: Closed, Less than 6in masonry exposed
Firewood: None
Water Supply: Reliable water source nearby
Propane: None
Overhead Hazards: No overhead hazards

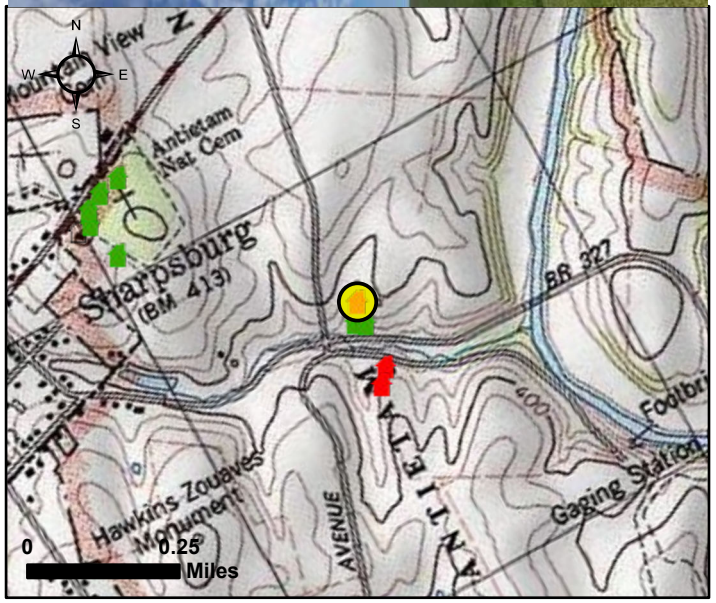
Rating: Moderate
ProtectionLevel: Undesignated,
Resources of Concern: Unknown
Occupied: No
In Community: Yes,
Revisit Interval: 5 yrs
Map Label: 188

Primary Access: Road
Ingress Egress: 2 or more roads in/out
Access Width: 2 lanes (Greater than 24')
Access Condition: Surfaced-paved, gradeLess than 5%
Bridge Condition: Greater than 300 ft with turnaround
Access and Turnarounds: Greater than 300 ft with turnaround
Facility Number or Sign: Marked and clearly visible
Fuel Type: Grass and shrub, hardwood litter
Fuel Load: Light or no wildland fuels
Defensible Space: 30 ft treated
Topography: Slope 5% to 20%
Roof Material: Combustible or no roof
Siding Material: Wood or open sided
Foundation: Open or deck
Firewood: None
Water Supply: Reliable water source nearby
Propane: None
Overhead Hazards: No overhead hazards

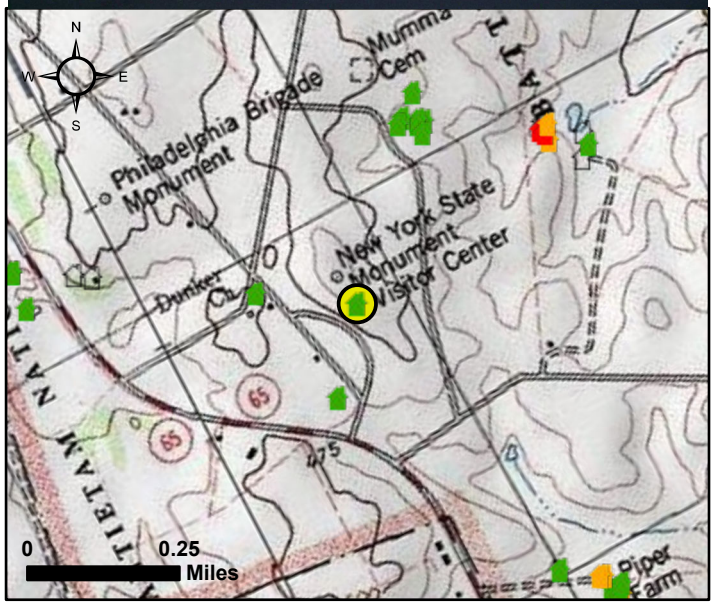
Facility Name: Visitor Center
Unit - Location: ANTI - Antietam National Battlefield
FMSS ID: 48706, ***Local ID:***
Structure Type, Use: Building, Public
Owner: National Park Service
Field Crew, Visit Date: NCR Fire, January 30, 2024
Coordinates (DDM): 39° 28.453' N 77° 44.672' W

Rating: Low
ProtectionLevel: Not Designated,
Resources of Concern: Unknown
Occupied: Yes
In Community: Yes, Mary Locher
Revisit Interval: 5 yrs
Map Label: 176

Primary Access: Road
Ingress Egress: 2 or more roads in/out
Access Width: 2 lanes (Greater than 24')
Access Condition: Surfaced-paved, gradeLess than 5%
Bridge Condition: Less than 300 ft with turnaround
Access and Turnarounds: Less than 300 ft with turnaround
Facility Number or Sign: Marked and clearly visible
Fuel Type: Grass and shrub, hardwood litter
Fuel Load: Light or no wildland fuels
Defensible Space: Greater than 100ft treated
Topography: Slope Less than 5%
Roof Material: Fire resistant- tar,rubberized
Siding Material: Rock, concrete, metal
Foundation: Closed, Greater than 30in masonry exposed or N/A
Firewood: None
Water Supply: Pressurized hydrant(s) or fixed sprinkler system
Propane: None
Overhead Hazards: No overhead hazards

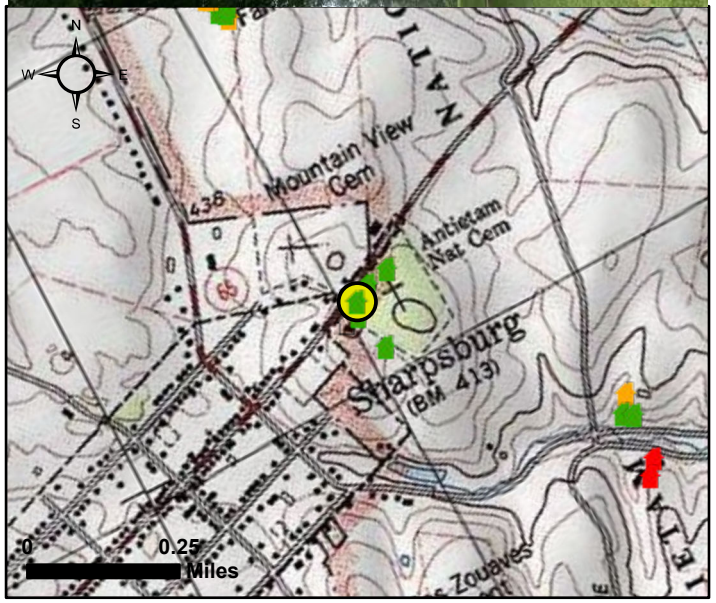
Facility Name: Admininstration Building
Unit - Location: ANTI - Antietam National Battlefield
FMSS ID: 40965, ***Local ID:***
Structure Type, Use: Building, Administrative
Owner: National Park Service
Field Crew, Visit Date: NCR Wildland Fire , August 17, 2022
Coordinates (DDM): 39° 27.59049960' N 077° 44.53695300' W

Rating: Low
ProtectionLevel: Not Designated,
Resources of Concern: Unknown
Occupied: Yes
In Community: Yes,
Revisit Interval: 5 yrs
Map Label: 150

Primary Access: Road
Ingress Egress: 2 or more roads in/out
Access Width: 2 lanes (Greater than 24')
Access Condition: Surfaced-paved, gradeLess than 5%
Bridge Condition: Less than 300 ft with turnaround
Access and Turnarounds: Less than 300 ft with turnaround
Facility Number or Sign: Marked and clearly visible
Fuel Type: Grass/tundra,northern hardwood litter
Fuel Load: Light or no wildland fuels
Defensible Space: Greater than 100ft treated
Topography: Slope Less than 5%
Roof Material: Fire resistant- tar,rubberized
Siding Material: Rock, concrete, metal
Foundation: Closed, 6in to 30in masonry exposed
Firewood: None
Water Supply: Pressurized hydrant(s) or fixed sprinkler system
Propane: None
Overhead Hazards: No overhead hazards

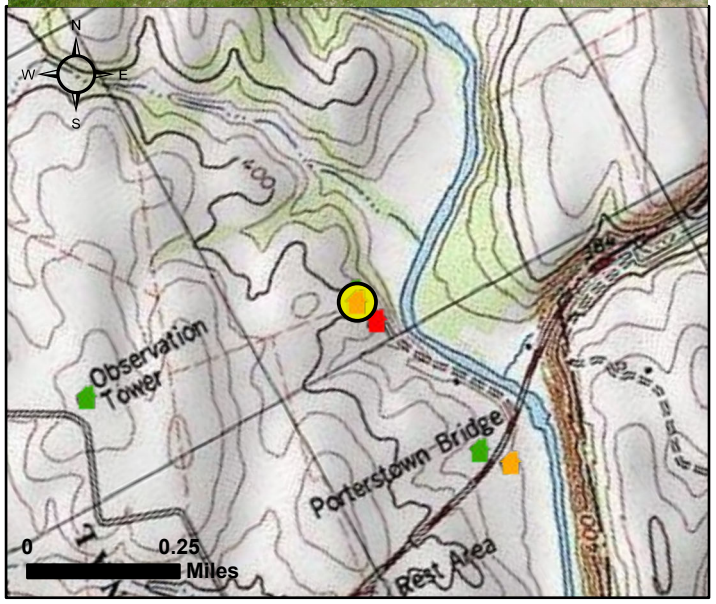
Rating: Moderate
ProtectionLevel: Undesignated,
Resources of Concern: Unknown
Occupied: No
In Community: Yes,
Revisit Interval: 5 yrs
Map Label: 121

Primary Access: Road
Ingress Egress: 1 road in/out
Access Width: 1 lane (Less than 18')
Access Condition: Non-surfaced- gravel,dirt,gradeLess than 5%
Bridge Condition: Greater than 300 ft with turnaround
Access and Turnarounds: Greater than 300 ft with turnaround
Facility Number or Sign: None or not clearly visible
Fuel Type: Grass and shrub, hardwood litter
Fuel Load: Light or no wildland fuels
Defensible Space: 30 ft treated
Topography: Slope Less than 5%
Roof Material: Fire resistant- tar,rubberized
Siding Material: Vinyl
Foundation: Closed, Less than 6in masonry exposed
Firewood: None
Water Supply: Reliable water source nearby
Propane: None
Overhead Hazards: No overhead hazards

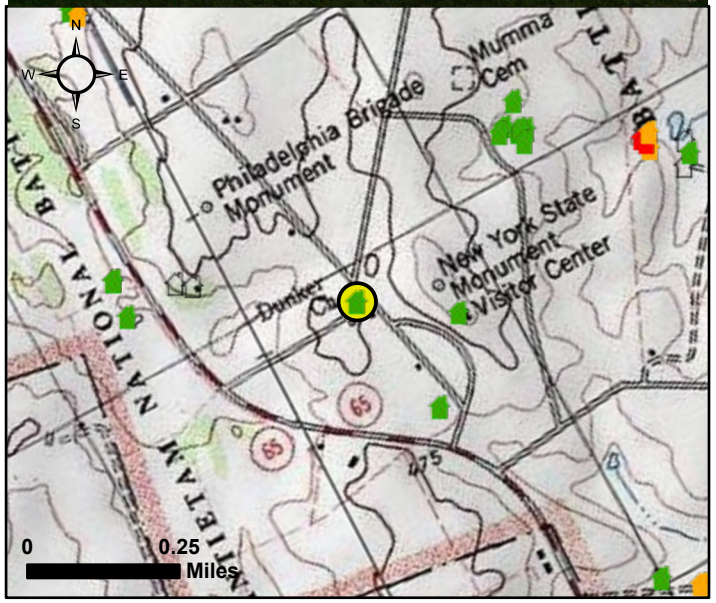
Facility Name: Dunker Church
Unit - Location: ANTI - Antietam National Battlefield
FMSS ID: 43586, ***Local ID:***
Structure Type, Use: Building, Public
Owner: National Park Service
Field Crew, Visit Date: NCR Wildland Fire , August 16, 2022
Coordinates (DDM): 39° 28.52297250' N 077° 44.80875312' W

Rating: Low
ProtectionLevel: Undesignated,
Resources of Concern: Unknown
Occupied: No
In Community: No, Mary Locher
Revisit Interval: 5 yrs
Map Label: 7

Primary Access: Road
Ingress Egress: 2 or more roads in/out
Access Width: 2 lanes (Greater than 24')
Access Condition: Surfaced-paved, gradeLess than 5%
Bridge Condition: Less than 300 ft with turnaround
Access and Turnarounds: Less than 300 ft with turnaround
Facility Number or Sign: Marked and clearly visible
Fuel Type: Grass/tundra,northern hardwood litter
Fuel Load: Light or no wildland fuels
Defensible Space: Greater than 100ft treated
Topography: Slope Less than 5%
Roof Material: Combustible or no roof
Siding Material: Rock, concrete, metal
Foundation: Closed, Greater than 30in masonry exposed or N/A
Firewood: None
Water Supply: No reliable water source nearby
Propane: None
Overhead Hazards: Overhead hazards will limit aircraft
Comments: From FMSS_Export - FRPP_PREDUSE: Bldg. Museum Repository (GSF)

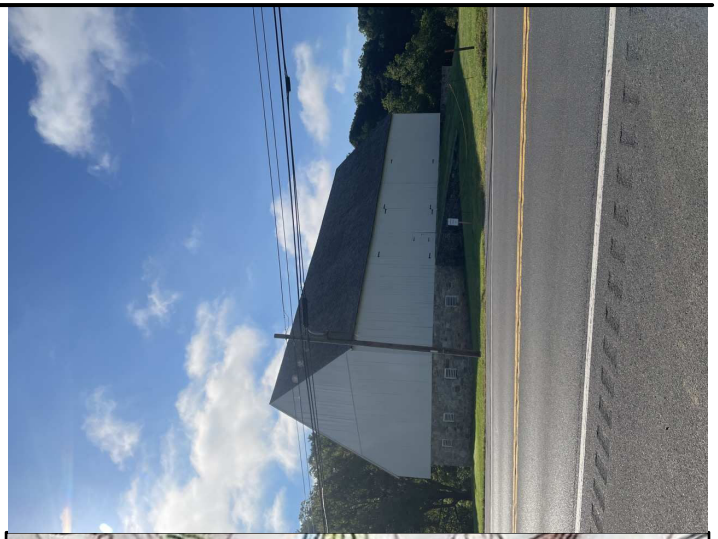
Facility Name: Newcomer Barn
Unit - Location: ANTI - Antietam National Battlefield
FMSS ID: 44055, ***Local ID:***
Structure Type, Use: Building, Public
Owner: National Park Service
Field Crew, Visit Date: NCR Wildland Fire , August 18, 2022
Coordinates (DDM): 39° 27.84917238' N 077° 43.60305270' W

Rating: Moderate
ProtectionLevel: Undesignated,
Resources of Concern: Unknown
Occupied: No
In Community: No,
Revisit Interval: 5 yrs
Map Label: 31

Primary Access: Road
Ingress Egress: 2 or more roads in/out
Access Width: 2 lanes (Greater than 24')
Access Condition: Surfaced-paved, gradeLess than 5%
Bridge Condition: Greater than 300 ft with turnaround
Access and Turnarounds: Greater than 300 ft with turnaround
Facility Number or Sign: None or not clearly visible
Fuel Type: Grass and shrub, hardwood litter
Fuel Load: Light or no wildland fuels
Defensible Space: 30 ft treated
Topography: Slope Less than 5%
Roof Material: Combustible or no roof
Siding Material: Wood or open sided
Foundation: Closed, Greater than 30in masonry exposed or N/A
Firewood: None
Water Supply: Reliable water source nearby
Propane: None
Overhead Hazards: No overhead hazards

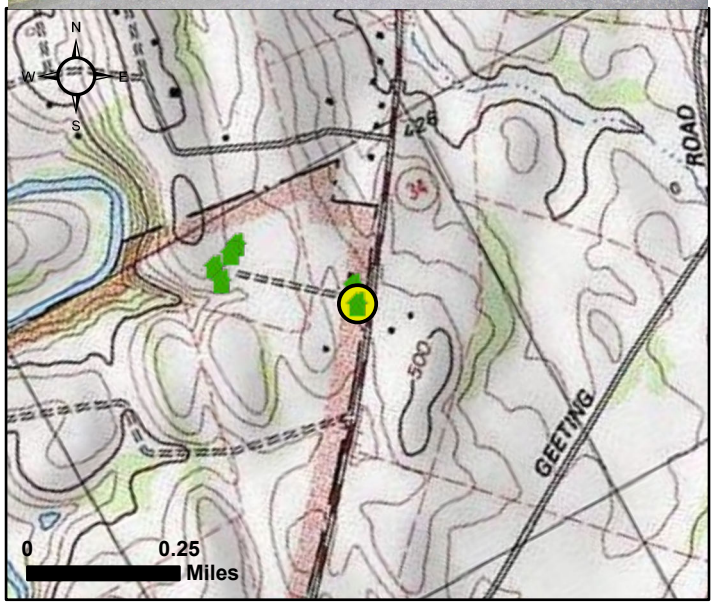
Facility Name: Fulk House
Unit - Location: ANTI - Antietam National Battlefield
FMSS ID: 48711, ***Local ID:***
Structure Type, Use: Building, Residence
Owner: National Park Service
Field Crew, Visit Date: NCR fire, June 14, 2022
Coordinates (DDM): 39° 28.43783250' N 077° 42.67395246' W

Rating: Low
ProtectionLevel: Not Designated,
Resources of Concern: Unknown
Occupied: Yes
In Community: Yes,
Revisit Interval: 5 yrs
Map Label: 180

Primary Access: Road
Ingress Egress: 1 road in/out
Access Width: 1.5 lanes (Greater than 18')
Access Condition: Surfaced-paved, gradeLess than 5%
Bridge Condition: Less than 300 ft with turnaround
Access and Turnarounds: Less than 300 ft with turnaround
Facility Number or Sign: Marked and clearly visible
Fuel Type: Shrub or timber
Fuel Load: Light or no wildland fuels
Defensible Space: Greater than 100ft treated
Topography: Slope Less than 5%
Roof Material: Fire resistant- tar,rubberized
Siding Material: Vinyl
Foundation: Closed, Greater than 30in masonry exposed or N/A
Firewood: None
Water Supply: Pressurized hydrant(s) or fixed sprinkler system
Propane: None
Overhead Hazards: No overhead hazards

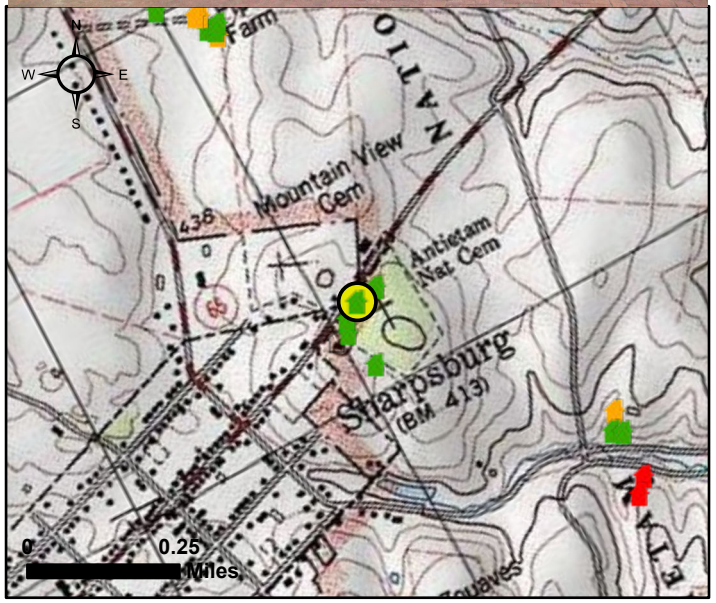
Facility Name: Lodge Building
Unit - Location: ANTI - Antietam National Battlefield
FMSS ID: 40956, ***Local ID:***
Structure Type, Use: Building, Public
Owner: National Park Service
Field Crew, Visit Date: NCR Wildland Fire , August 17, 2022
Coordinates (DDM): 39° 27.60377910' N 077° 44.50905300' W

Rating: Low
ProtectionLevel: Not Designated,
Resources of Concern: Unknown
Occupied: No
In Community: Yes,
Revisit Interval: 5 yrs
Map Label: 152

Primary Access: Road
Ingress Egress: 2 or more roads in/out
Access Width: 2 lanes (Greater than 24')
Access Condition: Surfaced-paved, gradeLess than 5%
Bridge Condition: Less than 300 ft with turnaround
Access and Turnarounds: Less than 300 ft with turnaround
Facility Number or Sign: Marked and clearly visible
Fuel Type: Grass/tundra,northern hardwood litter
Fuel Load: Light or no wildland fuels
Defensible Space: Greater than 100ft treated
Topography: Slope Less than 5%
Roof Material: Noncombustible or not applicable
Siding Material: Rock, concrete, metal
Foundation: Closed, 6in to 30in masonry exposed
Firewood: None
Water Supply: Pressurized hydrant(s) or fixed sprinkler system
Propane: None
Overhead Hazards: No overhead hazards

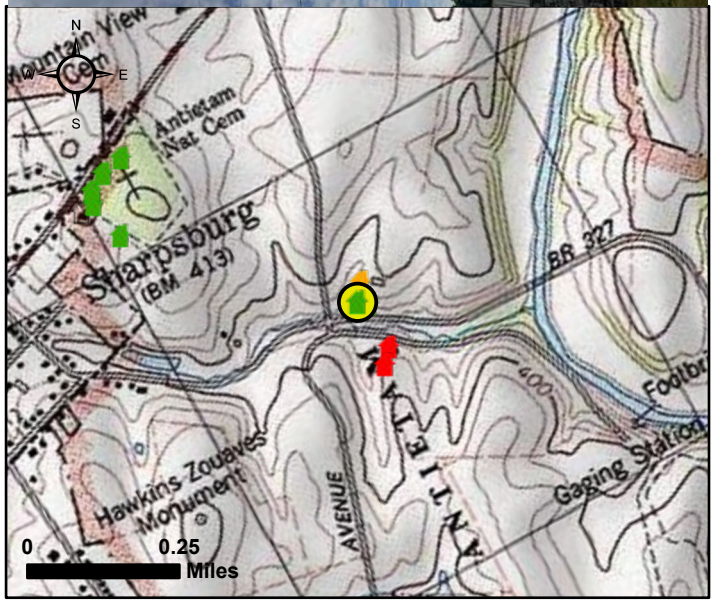
Facility Name: Sherrick House
Unit - Location: ANTI - Antietam National Battlefield
FMSS ID: 43573, ***Local ID:***
Structure Type, Use: Building, Administrative
Owner: National Park Service
Field Crew, Visit Date: NCR Wildland Fire , August 17, 2022
Coordinates (DDM): 39° 27.31389042' N 077° 44.24115288' W

Rating: Low
ProtectionLevel: Not Designated,
Resources of Concern: Unknown
Occupied: No
In Community: Yes,
Revisit Interval: 5 yrs
Map Label: 185

Primary Access: Road
Ingress Egress: 2 or more roads in/out
Access Width: 2 lanes (Greater than 24')
Access Condition: Surfaced-paved, gradeLess than 5%
Bridge Condition: Greater than 300 ft with turnaround
Access and Turnarounds: Greater than 300 ft with turnaround
Facility Number or Sign: Marked and clearly visible
Fuel Type: Grass and shrub, hardwood litter
Fuel Load: Light or no wildland fuels
Defensible Space: Greater than 100ft treated
Topography: Slope 5% to 20%
Roof Material: Combustible or no roof
Siding Material: Rock, concrete, metal
Foundation: Closed, Greater than 30in masonry exposed or N/A
Firewood: None
Water Supply: Reliable water source nearby
Propane: None
Overhead Hazards: No overhead hazards
Comments: From FMSS_Export - FRPP_PREDUSE: Bldg. Museum Repository (GSF)

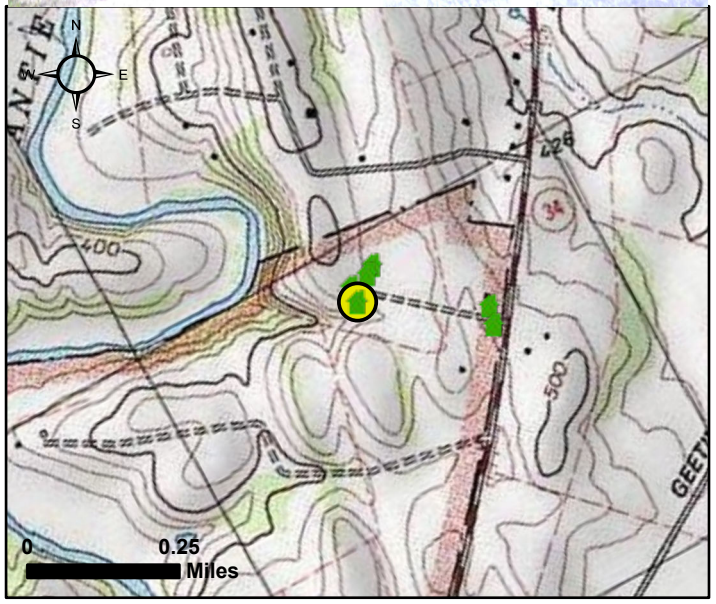
Facility Name: Pry Springhouse
Unit - Location: ANTI - Antietam National Battlefield
FMSS ID: 40545, ***Local ID:***
Structure Type, Use: Building, Public
Owner: National Park Service
Field Crew, Visit Date: NCR fire, June 14, 2022
Coordinates (DDM): 39° 28.54127256' N 077° 42.85125252' W

Rating: Low
ProtectionLevel: Not Designated,
Resources of Concern: Unknown
Occupied: No
In Community: No,
Revisit Interval: 5 yrs
Map Label: 36

Primary Access: Road
Ingress Egress: 2 or more roads in/out
Access Width: 1 lane (Less than 18')
Access Condition: Surfaced-paved, gradeLess than 5%
Bridge Condition: Less than 300 ft with turnaround
Access and Turnarounds: Less than 300 ft with turnaround
Facility Number or Sign: None or not clearly visible
Fuel Type: Grass/tundra,northern hardwood litter
Fuel Load: Light or no wildland fuels
Defensible Space: 30 ft treated
Topography: Slope Less than 5%
Roof Material: Noncombustible or not applicable
Siding Material: Rock, concrete, metal
Foundation: Closed, Greater than 30in masonry exposed or N/A
Firewood: None
Water Supply: Reliable water source nearby
Propane: None
Overhead Hazards: No overhead hazards

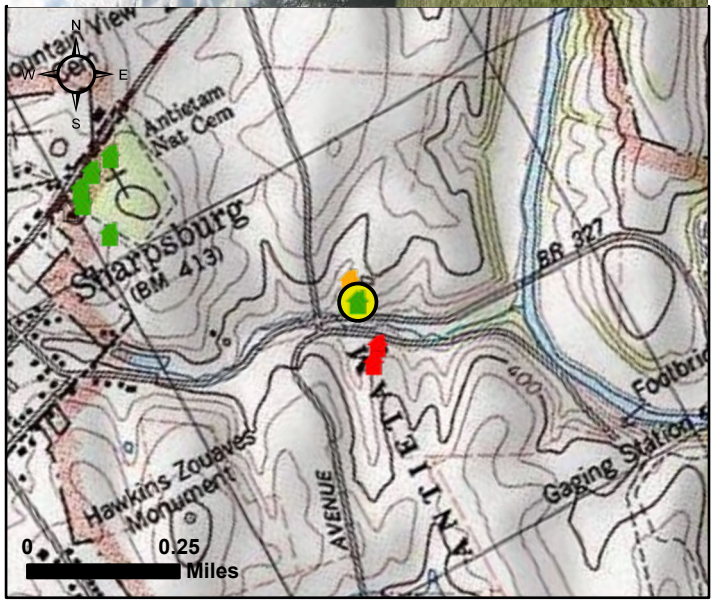
Facility Name: Sherrick Smokehouse
Unit - Location: ANTI - Antietam National Battlefield
FMSS ID: 43574, ***Local ID:***
Structure Type, Use: Building, Administrative
Owner: National Park Service
Field Crew, Visit Date: NCR Wildland Fire , August 17, 2022
Coordinates (DDM): 39° 27.30635232' N 077° 44.22675288' W

Rating: Low
ProtectionLevel: Undesignated,
Resources of Concern: Unknown
Occupied: No
In Community: Yes,
Revisit Interval: 5 yrs
Map Label: 187

Primary Access: Road
Ingress Egress: 2 or more roads in/out
Access Width: 2 lanes (Greater than 24')
Access Condition: Surfaced-paved, gradeLess than 5%
Bridge Condition: Greater than 300 ft with turnaround
Access and Turnarounds: Greater than 300 ft with turnaround
Facility Number or Sign: Marked and clearly visible
Fuel Type: Grass and shrub, hardwood litter
Fuel Load: Light or no wildland fuels
Defensible Space: Greater than 100ft treated
Topography: Slope 5% to 20%
Roof Material: Combustible or no roof
Siding Material: Rock, concrete, metal
Foundation: Closed, Greater than 30in masonry exposed or N/A
Firewood: None
Water Supply: Reliable water source nearby
Propane: None
Overhead Hazards: No overhead hazards
