NPS Wildfire Risk Assessments
Assessment Locations

Antietam National Battlefield - Overview

National Park Service
U.S. Department of the Interior

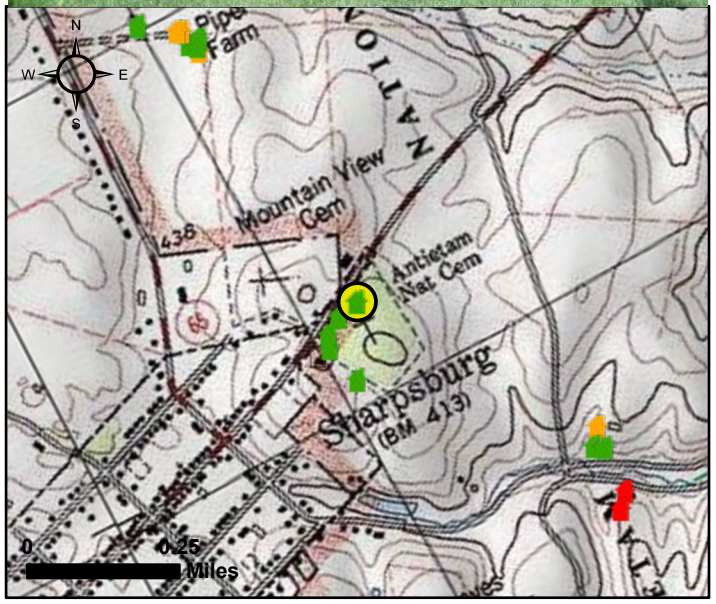
Facility Name: Rostrum
Unit - Location: ANTI - Antietam National Battlefield
FMSS ID: 40957, ***Local ID:***
Structure Type, Use: Building, Public
Owner: National Park Service
Field Crew, Visit Date: NCR Wildland Fire , August 17, 2022
Coordinates (DDM): 39° 27.61007232' N 077° 44.47125300' W

Rating: Low
ProtectionLevel: Undesignated,
Resources of Concern: Unknown
Occupied: No
In Community: Yes,
Revisit Interval: 5 yrs
Map Label: 153

Primary Access: Road
Ingress Egress: 2 or more roads in/out
Access Width: 2 lanes (Greater than 24')
Access Condition: Surfaced-paved, gradeLess than 5%
Bridge Condition: Less than 300 ft with turnaround
Access and Turnarounds: Less than 300 ft with turnaround
Facility Number or Sign: Marked and clearly visible
Fuel Type: Grass and shrub, hardwood litter
Fuel Load: Light or no wildland fuels
Defensible Space: Greater than 100ft treated
Topography: Slope Less than 5%
Roof Material: Noncombustible or not applicable
Siding Material: Rock, concrete, metal
Foundation: Closed, Greater than 30in masonry exposed or N/A
Firewood: None
Water Supply: Pressurized hydrant(s) or fixed sprinkler system
Propane: None
Overhead Hazards: No overhead hazards

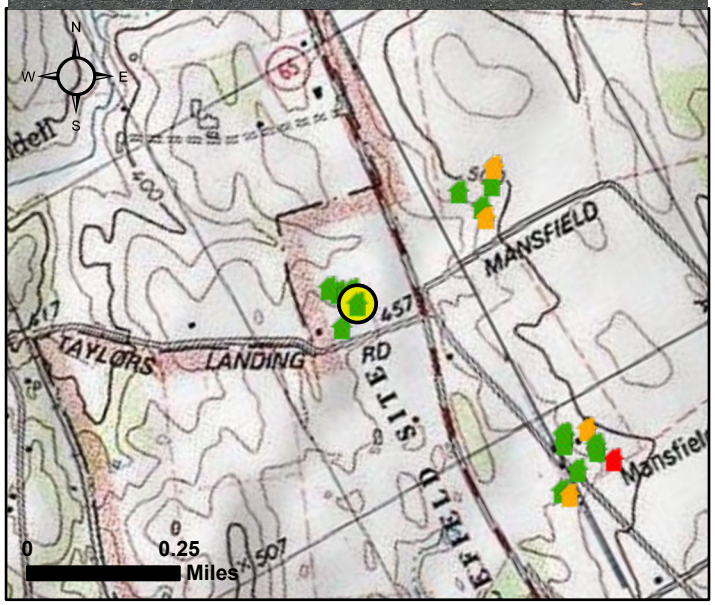
Facility Name: Fire Cache
Unit - Location: ANTI - Antietam National Battlefield
FMSS ID: 101144, ***Local ID:***
Structure Type, Use: Building, Administrative
Owner: National Park Service
Field Crew, Visit Date: NCR, April 17, 2023
Coordinates (DDM): 39° 29.336' N 77° 45.156' W

Rating: Low
ProtectionLevel: Not Designated,
Resources of Concern: Unknown
Occupied: Yes
In Community: Yes,
Revisit Interval: 5 yrs
Map Label: 104

Primary Access: Road
Ingress Egress: 2 or more roads in/out
Access Width: 2 lanes (Greater than 24')
Access Condition: Surfaced-paved, gradeLess than 5%
Bridge Condition: Less than 300 ft with turnaround
Access and Turnarounds: Less than 300 ft with turnaround
Facility Number or Sign: Marked and clearly visible
Fuel Type: Shrub or timber
Fuel Load: Light or no wildland fuels
Defensible Space: 100 ft treated
Topography: Slope Less than 5%
Roof Material: Noncombustible or not applicable
Siding Material: Rock, concrete, metal
Foundation: Open or deck
Firewood: None
Water Supply: Pressurized hydrant(s) or fixed sprinkler system
Propane: Present and fuels clearance
Overhead Hazards: No overhead hazards

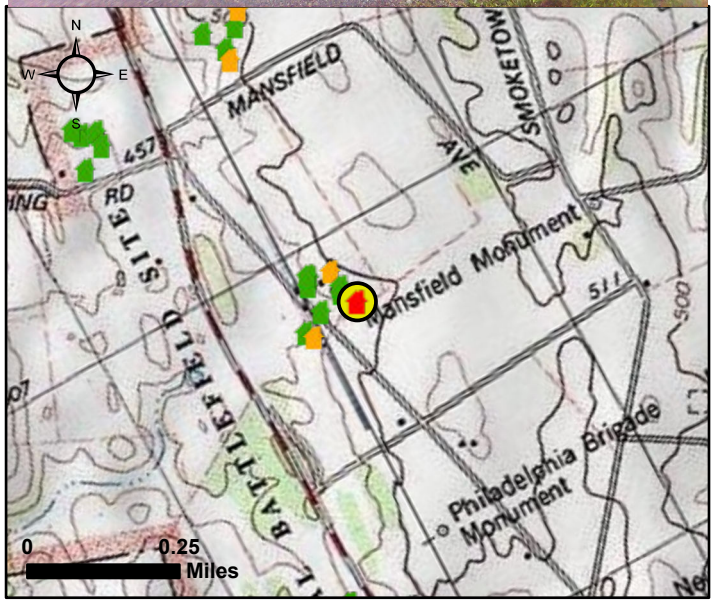
Rating: High
ProtectionLevel: Undesignated,
Resources of Concern: Unknown
Occupied: No
In Community: Yes, Mary Locher
Revisit Interval: 5 yrs
Map Label: 62

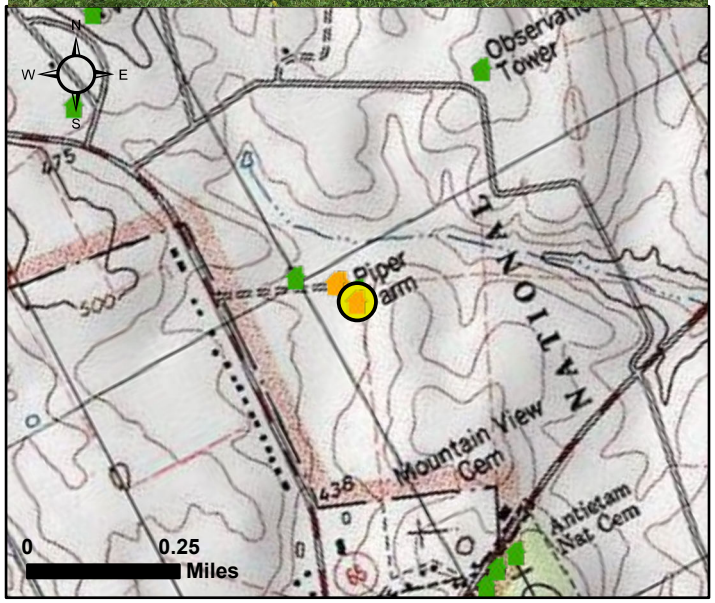
Facility Name: Piper Ice House
Unit - Location: ANTI - Antietam National Battlefield
FMSS ID: 41402, ***Local ID:***
Structure Type, Use: Building, Public
Owner: National Park Service
Field Crew, Visit Date: NCR, April 17, 2023
Coordinates (DDM): 39° 27.979' N 77° 44.510' W

Rating: Moderate
ProtectionLevel: Not Designated,
Resources of Concern: Unknown
Occupied: No
In Community: Yes,
Revisit Interval: 5 yrs
Map Label: 67

Primary Access: Road
Ingress Egress: 1 road in/out
Access Width: 1 lane (Less than 18')
Access Condition: Surfaced-paved, gradeLess than 5%
Bridge Condition: Less than 300 ft with turnaround
Access and Turnarounds: Less than 300 ft with turnaround
Facility Number or Sign: Marked and clearly visible
Fuel Type: Grass/tundra,northern hardwood litter
Fuel Load: Light or no wildland fuels
Defensible Space: Greater than 100ft treated
Topography: Slope 5% to 20%
Roof Material: Combustible or no roof
Siding Material: Rock, concrete, metal
Foundation: Closed, Greater than 30in masonry exposed or N/A
Firewood: None
Water Supply: Pressurized hydrant(s) or fixed sprinkler system
Propane: None
Overhead Hazards: No overhead hazards
Comments: From FMSS_Export - FRPP_PREDUSE: Bldg. Museum Repository (GSF)

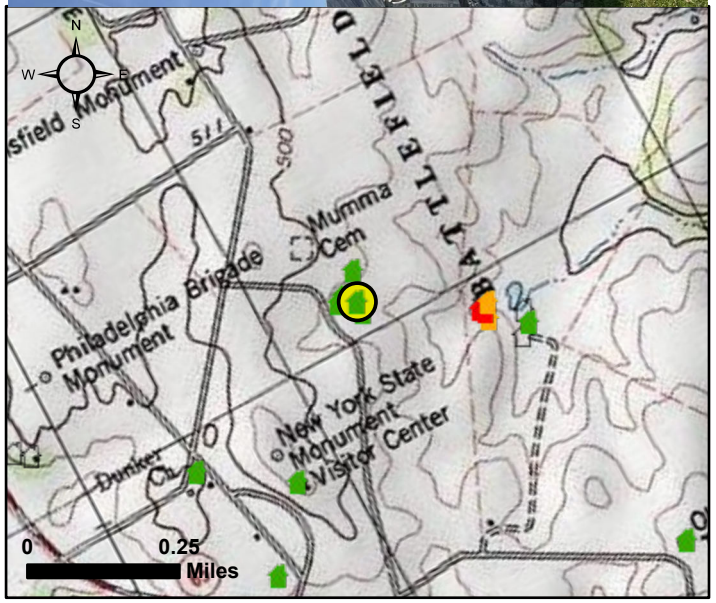
Facility Name: Mumma Springhouse
Unit - Location: ANTI - Antietam National Battlefield
FMSS ID: 44037, ***Local ID:***
Structure Type, Use: Building, Public
Owner: National Park Service
Field Crew, Visit Date: NCR Wildland Fire , November 2, 2022
Coordinates (DDM): 39° 28.61813676' N 077° 44.45265306' W

Rating: Low
ProtectionLevel: Undesignated,
Resources of Concern: Unknown
Occupied: No
In Community: Yes, Mary Locher
Revisit Interval: 5 yrs
Map Label: 72

Primary Access: Road
Ingress Egress: 1 road in/out
Access Width: 1.5 lanes (Greater than 18')
Access Condition: Surfaced-paved, gradeLess than 5%
Bridge Condition: Less than 300 ft with turnaround
Access and Turnarounds: Less than 300 ft with turnaround
Facility Number or Sign: Marked and clearly visible
Fuel Type: Grass and shrub, hardwood litter
Fuel Load: Light or no wildland fuels
Defensible Space: 100 ft treated
Topography: Slope Less than 5%
Roof Material: Combustible or no roof
Siding Material: Rock, concrete, metal
Foundation: Closed, Greater than 30in masonry exposed or N/A
Firewood: None
Water Supply: Pressurized hydrant(s) or fixed sprinkler system
Propane: None
Overhead Hazards: No overhead hazards

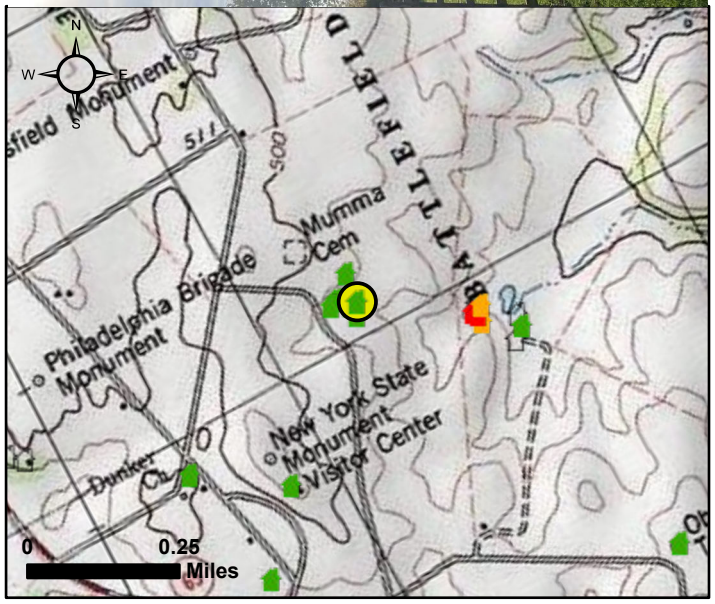
Facility Name: Mumma Hog Pen
Unit - Location: ANTI - Antietam National Battlefield
FMSS ID: 44040, ***Local ID:***
Structure Type, Use: Building, Public
Owner: National Park Service
Field Crew, Visit Date: NCR Wildland Fire , November 2, 2022
Coordinates (DDM): 39° 28.61807250' N 077° 44.44035300' W

Rating: Low
ProtectionLevel: Undesignated,
Resources of Concern: Unknown
Occupied: No
In Community: Yes, Mary Locher
Revisit Interval: 5 yrs
Map Label: 75

Primary Access: Road
Ingress Egress: 1 road in/out
Access Width: 1.5 lanes (Greater than 18')
Access Condition: Surfaced-paved, gradeLess than 5%
Bridge Condition: Less than 300 ft with turnaround
Access and Turnarounds: Less than 300 ft with turnaround
Facility Number or Sign: Marked and clearly visible
Fuel Type: Grass and shrub, hardwood litter
Fuel Load: Light or no wildland fuels
Defensible Space: Less than 30 ft treated
Topography: Slope Less than 5%
Roof Material: Noncombustible or not applicable
Siding Material: Wood or open sided
Foundation: Open or deck
Firewood: None
Water Supply: Pressurized hydrant(s) or fixed sprinkler system
Propane: None
Overhead Hazards: No overhead hazards

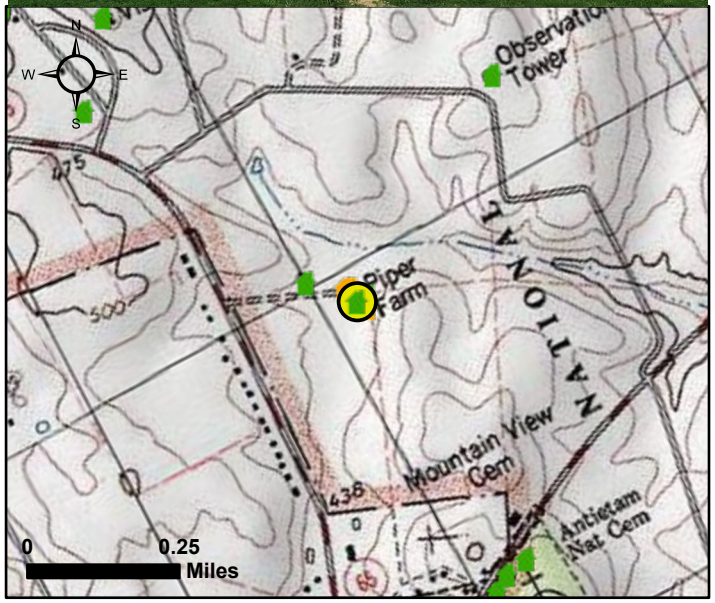
Facility Name: Piper Slave House
Unit - Location: ANTI - Antietam National Battlefield
FMSS ID: 41400, ***Local ID:***
Structure Type, Use: Building, Public
Owner: National Park Service
Field Crew, Visit Date: NCR, April 17, 2023
Coordinates (DDM): 39° 27.992' N 77° 44.520' W

Rating: Low
ProtectionLevel: Not Designated,
Resources of Concern: Unknown
Occupied: No
In Community: Yes,
Revisit Interval: 5 yrs
Map Label: 66

Primary Access: Road
Ingress Egress: 1 road in/out
Access Width: 1 lane (Less than 18')
Access Condition: Surfaced-paved, gradeLess than 5%
Bridge Condition: Less than 300 ft with turnaround
Access and Turnarounds: Less than 300 ft with turnaround
Facility Number or Sign: Marked and clearly visible
Fuel Type: Grass/tundra,northern hardwood litter
Fuel Load: Light or no wildland fuels
Defensible Space: Greater than 100ft treated
Topography: Slope Less than 5%
Roof Material: Combustible or no roof
Siding Material: Wood or open sided
Foundation: Closed, Greater than 30in masonry exposed or N/A
Firewood: None
Water Supply: Pressurized hydrant(s) or fixed sprinkler system
Propane: None
Overhead Hazards: No overhead hazards

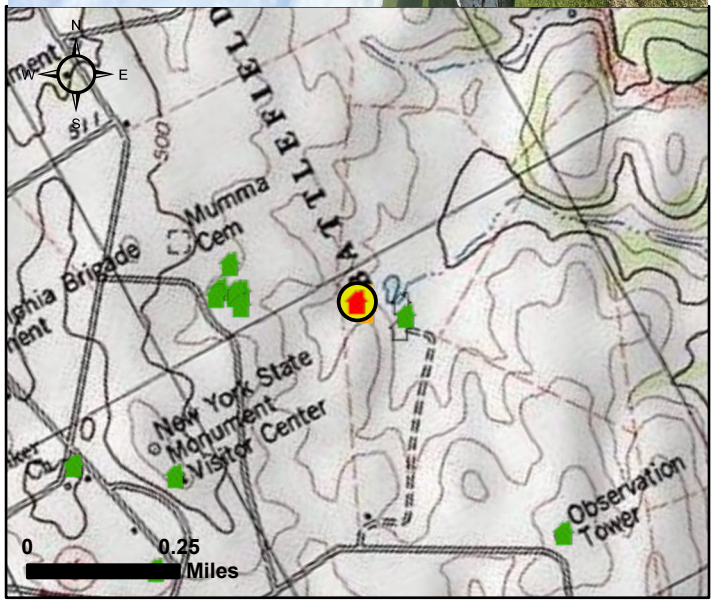
Rating: High
ProtectionLevel: Undesignated,
Resources of Concern: Unknown
Occupied: No
In Community: Yes,
Revisit Interval: 5 yrs
Map Label: 46

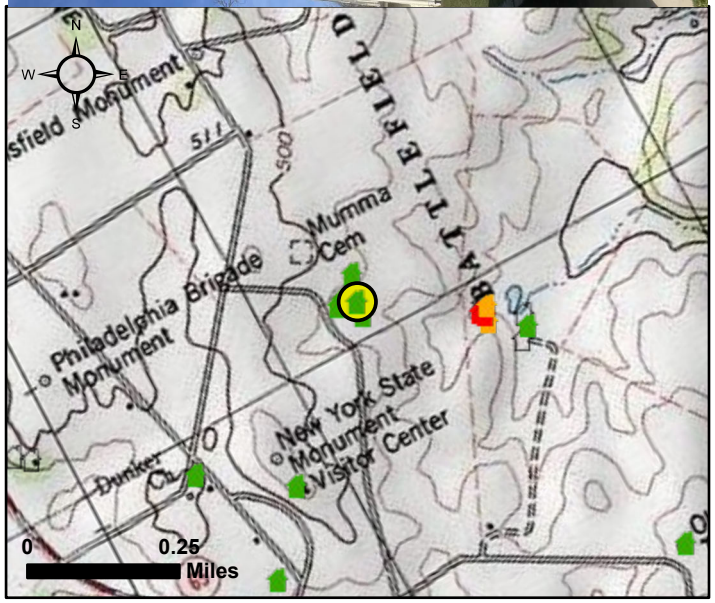
Rating: Low
ProtectionLevel: Undesignated,
Resources of Concern: Unknown
Occupied: No
In Community: Yes, Mary Locher
Revisit Interval: 5 yrs
Map Label: 74

Primary Access: Road
Ingress Egress: 1 road in/out
Access Width: 1.5 lanes (Greater than 18')
Access Condition: Surfaced-paved, gradeLess than 5%
Bridge Condition: Less than 300 ft with turnaround
Access and Turnarounds: Less than 300 ft with turnaround
Facility Number or Sign: Marked and clearly visible
Fuel Type: Grass and shrub, hardwood litter
Fuel Load: Light or no wildland fuels
Defensible Space: 100 ft treated
Topography: Slope Less than 5%
Roof Material: Noncombustible or not applicable
Siding Material: Wood or open sided
Foundation: Closed, Less than 6in masonry exposed
Firewood: None
Water Supply: Pressurized hydrant(s) or fixed sprinkler system
Propane: None
Overhead Hazards: No overhead hazards

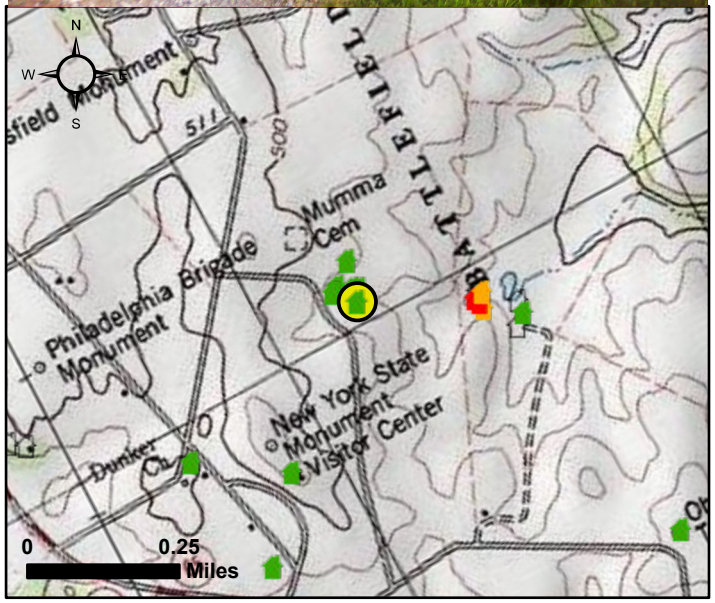
Rating: Low
ProtectionLevel: Undesignated,
Resources of Concern: Unknown
Occupied: No
In Community: Yes, Mary Locher
Revisit Interval: 5 yrs
Map Label: 73

Primary Access: Road
Ingress Egress: 1 road in/out
Access Width: 1.5 lanes (Greater than 18')
Access Condition: Surfaced-paved, gradeLess than 5%
Bridge Condition: Less than 300 ft with turnaround
Access and Turnarounds: Less than 300 ft with turnaround
Facility Number or Sign: Marked and clearly visible
Fuel Type: Grass and shrub, hardwood litter
Fuel Load: Light or no wildland fuels
Defensible Space: 30 ft treated
Topography: Slope Less than 5%
Roof Material: Noncombustible or not applicable
Siding Material: Wood or open sided
Foundation: Open or deck
Firewood: None
Water Supply: Pressurized hydrant(s) or fixed sprinkler system
Propane: None
Overhead Hazards: No overhead hazards

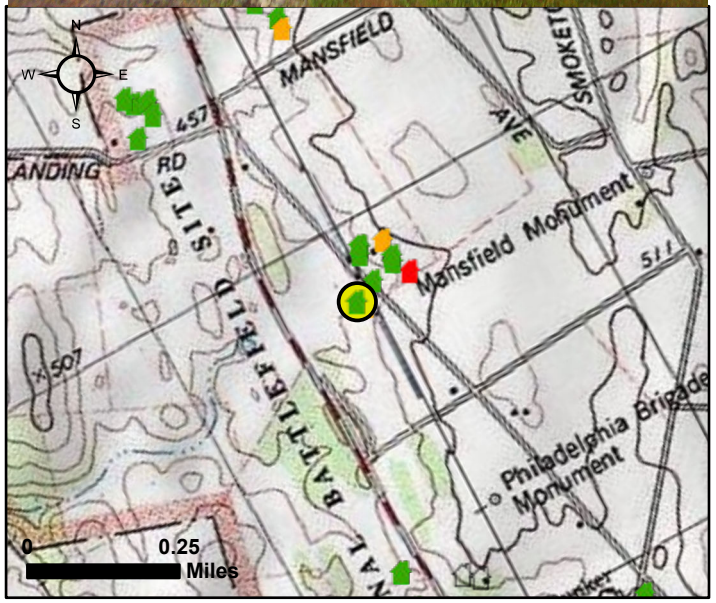
Rating: Low
ProtectionLevel: Not Designated,
Resources of Concern: Unknown
Occupied: No
In Community: Yes, Mary Locher
Revisit Interval: 5 yrs
Map Label: 54

Primary Access: Road
Ingress Egress: 1 road in/out
Access Width: 2 lanes (Greater than 24')
Access Condition: Surfaced-paved, gradeLess than 5%
Bridge Condition: Less than 300 ft with turnaround
Access and Turnarounds: Less than 300 ft with turnaround
Facility Number or Sign: Marked and clearly visible
Fuel Type: Grass and shrub, hardwood litter
Fuel Load: Light or no wildland fuels
Defensible Space: 30 ft treated
Topography: Slope Less than 5%
Roof Material: Noncombustible or not applicable
Siding Material: Wood or open sided
Foundation: Open or deck
Firewood: None
Water Supply: No reliable water source nearby
Propane: None
Overhead Hazards: No overhead hazards

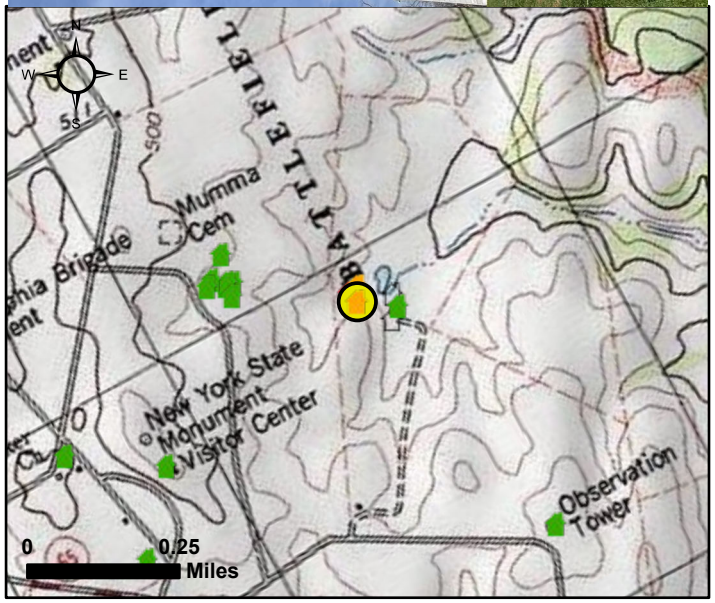
Rating: Moderate
ProtectionLevel: Undesignated,
Resources of Concern: Unknown
Occupied: Yes
In Community: Yes,
Revisit Interval: 5 yrs
Map Label: 48

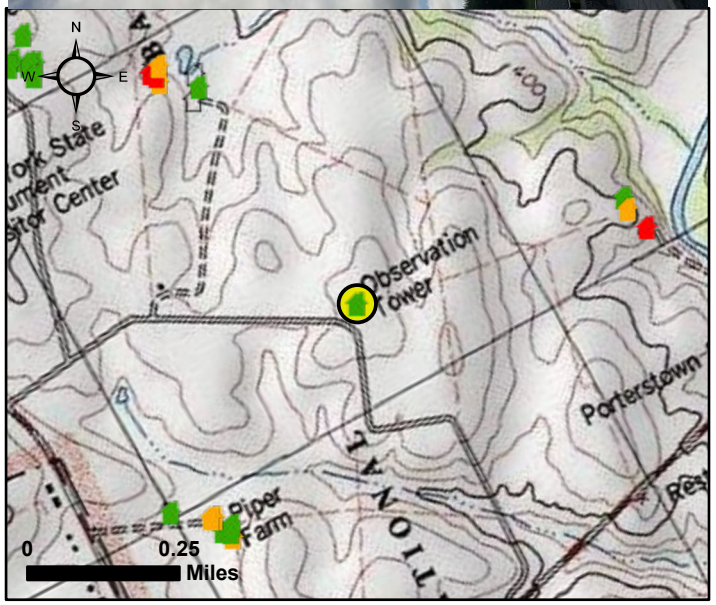
Rating: Low
ProtectionLevel: Undesignated,
Resources of Concern: Unknown
Occupied: Yes
In Community: No,
Revisit Interval: 5 yrs
Map Label: 21

Primary Access: Road
Ingress Egress: 2 or more roads in/out
Access Width: 2 lanes (Greater than 24')
Access Condition: Surfaced-paved, gradeLess than 5%
Bridge Condition: Less than 300 ft with turnaround
Access and Turnarounds: Less than 300 ft with turnaround
Facility Number or Sign: Marked and clearly visible
Fuel Type: Grass and shrub, hardwood litter
Fuel Load: Light or no wildland fuels
Defensible Space: Greater than 100ft treated
Topography: Slope Less than 5%
Roof Material: Noncombustible or not applicable
Siding Material: Rock, concrete, metal
Foundation: Closed, Greater than 30in masonry exposed or N/A
Firewood: None
Water Supply: Reliable water source nearby
Propane: None
Overhead Hazards: No overhead hazards

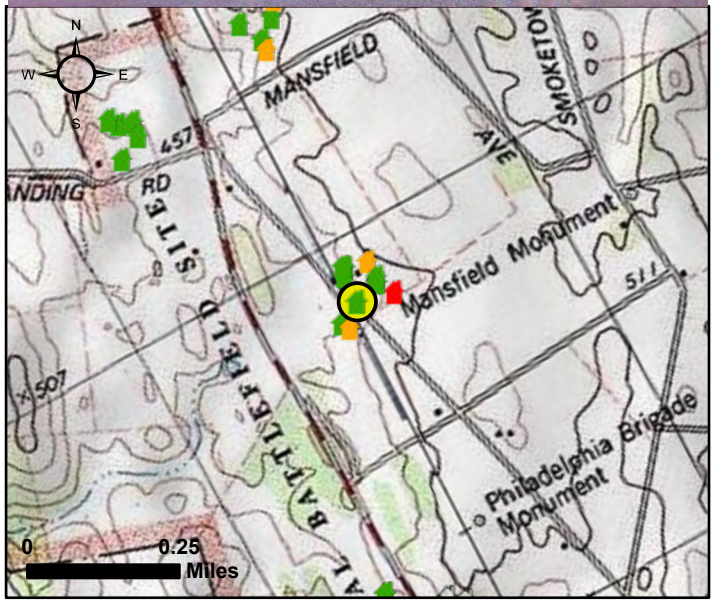
Rating: Low
ProtectionLevel: Undesignated,
Resources of Concern: Unknown
Occupied: No
In Community: Yes, Mary Locher
Revisit Interval: 5 yrs
Map Label: 56

Primary Access: Road
Ingress Egress: 1 road in/out
Access Width: 2 lanes (Greater than 24')
Access Condition: Surfaced-paved, gradeLess than 5%
Bridge Condition: Less than 300 ft with turnaround
Access and Turnarounds: Less than 300 ft with turnaround
Facility Number or Sign: Marked and clearly visible
Fuel Type: Grass and shrub, hardwood litter
Fuel Load: Light or no wildland fuels
Defensible Space: Greater than 100ft treated
Topography: Slope Less than 5%
Roof Material: Noncombustible or not applicable
Siding Material: Rock, concrete, metal
Foundation: Closed, Greater than 30in masonry exposed or N/A
Firewood: None
Water Supply: No reliable water source nearby
Propane: None
Overhead Hazards: No overhead hazards

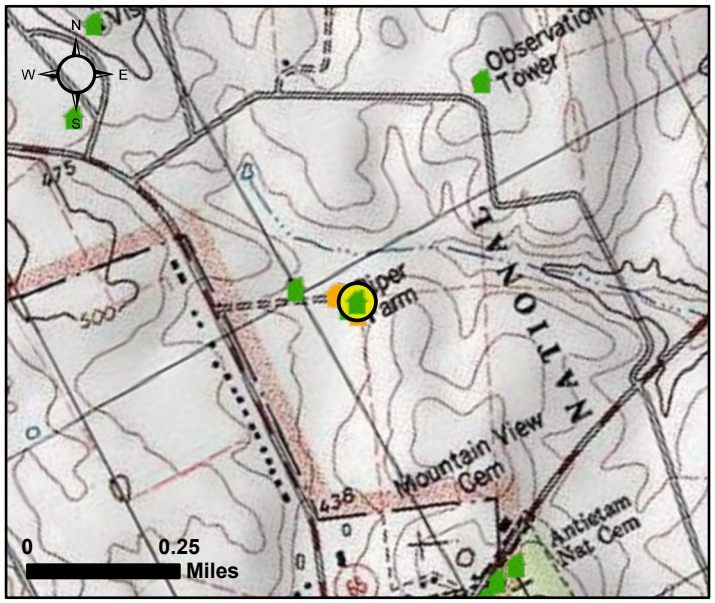
Facility Name: Piper Smoke House
Unit - Location: ANTI - Antietam National Battlefield
FMSS ID: 41401, ***Local ID:***
Structure Type, Use: Building, Public
Owner: National Park Service
Field Crew, Visit Date: NCR, May 19, 2015
Coordinates (DDM): 39° 27.993' N 77° 44.502' W

Rating: Low
ProtectionLevel: Not Designated,
Resources of Concern: Unknown
Occupied: No
In Community: Yes, Piper Farm Area
Revisit Interval: 5 yrs
Map Label: 69

Primary Access: Road
Ingress Egress: 1 road in/out
Access Width: 1 lane (Less than 18')
Access Condition: Surfaced-paved, gradeLess than 5%
Bridge Condition: Less than 300 ft with turnaround
Access and Turnarounds: Less than 300 ft with turnaround
Facility Number or Sign: Marked and clearly visible
Fuel Type: Grass/tundra,northern hardwood litter
Fuel Load: Light or no wildland fuels
Defensible Space: Greater than 100ft treated
Topography: Slope 5% to 20%
Roof Material: Noncombustible or not applicable
Siding Material: Wood or open sided
Foundation: Closed, 6in to 30in masonry exposed
Firewood: None
Water Supply: Pressurized hydrant(s) or fixed sprinkler system
Propane: None
Overhead Hazards: No overhead hazards
Comments: From FMSS_Export - FRPP_PREDUSE: Bldg. Museum Repository (GSF)

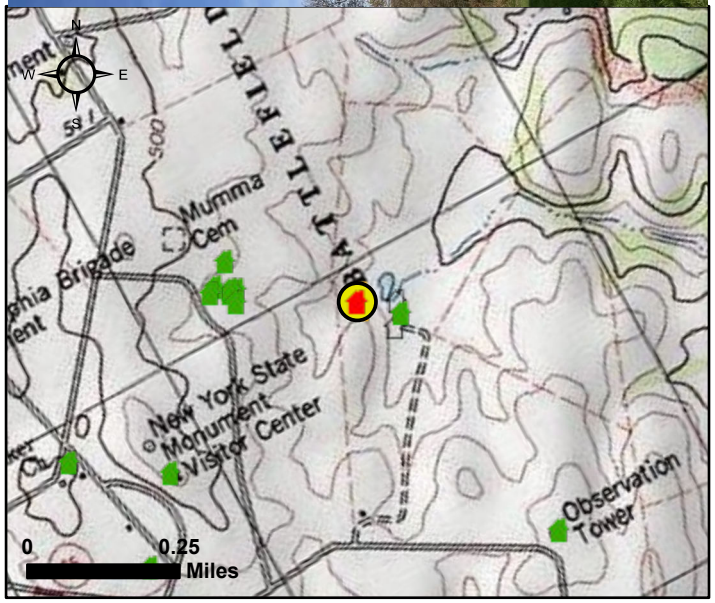
Rating: High
ProtectionLevel: Undesignated,
Resources of Concern: Unknown
Occupied: No
In Community: Yes,
Revisit Interval: 5 yrs
Map Label: 47

Primary Access: Road
Ingress Egress: 1 road in/out
Access Width: 1 lane (Less than 18')
Access Condition: Non-surfaced- gravel,dirt,gradeLess than 5%
Bridge Condition: Greater than 300 ft with turnaround
Access and Turnarounds: Greater than 300 ft with turnaround
Facility Number or Sign: Marked and clearly visible
Fuel Type: Grass and shrub, hardwood litter
Fuel Load: Light or no wildland fuels
Defensible Space: 100 ft treated
Topography: Slope 5% to 20%
Roof Material: Combustible or no roof
Siding Material: Wood or open sided
Foundation: Closed, 6in to 30in masonry exposed
Firewood: None
Water Supply: No reliable water source nearby
Propane: None
Overhead Hazards: No overhead hazards
Comments: From FMSS_Export - FRPP_PREDUSE: Bldg. Museum Repository (GSF)

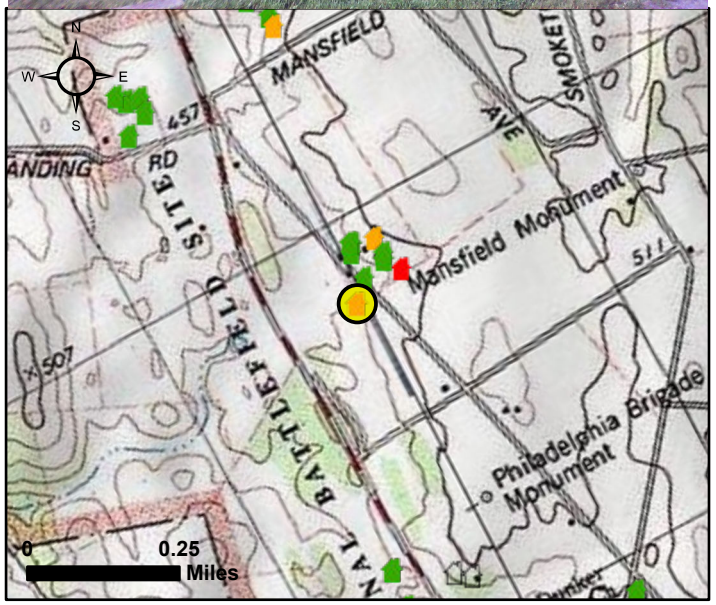
Rating: Moderate
ProtectionLevel: Not Designated,
Resources of Concern: Unknown
Occupied: No
In Community: Yes, Mary Locher
Revisit Interval: 5 yrs
Map Label: 55

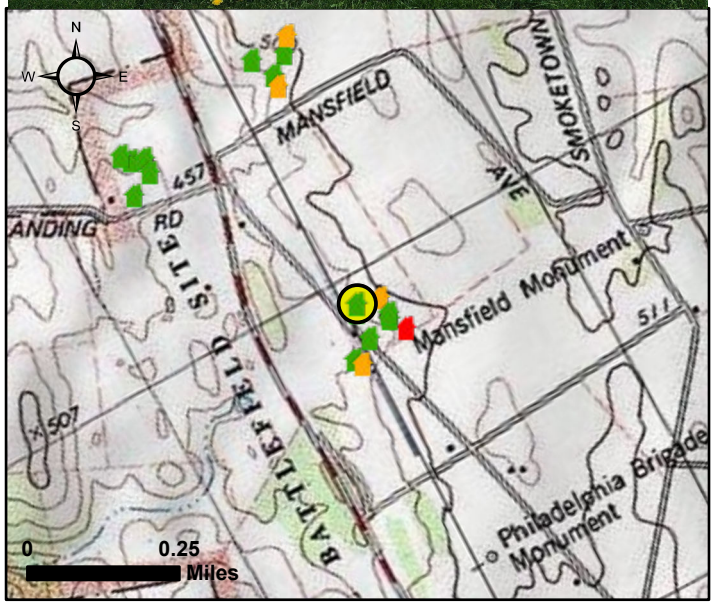
Facility Name: D.R. Miller Wash House
Unit - Location: ANTI - Antietam National Battlefield
FMSS ID: 40425, ***Local ID:***
Structure Type, Use: Building, Public
Owner: National Park Service
Field Crew, Visit Date: NCR, April 17, 2023
Coordinates (DDM): 39° 29.071' N 77° 44.958' W

Rating: Low
ProtectionLevel: Not Designated,
Resources of Concern: Unknown
Occupied: No
In Community: Yes,
Revisit Interval: 5 yrs
Map Label: 59

Primary Access: Road
Ingress Egress: 2 or more roads in/out
Access Width: 2 lanes (Greater than 24')
Access Condition: Surfaced-paved, gradeLess than 5%
Bridge Condition: Less than 300 ft with turnaround
Access and Turnarounds: Less than 300 ft with turnaround
Facility Number or Sign: Marked and clearly visible
Fuel Type: Grass/tundra,northern hardwood litter
Fuel Load: Light or no wildland fuels
Defensible Space: 100 ft treated
Topography: Slope Less than 5%
Roof Material: Noncombustible or not applicable
Siding Material: Rock, concrete, metal
Foundation: Closed, Greater than 30in masonry exposed or N/A
Firewood: None
Water Supply: Reliable water source nearby
Propane: None
Overhead Hazards: No overhead hazards

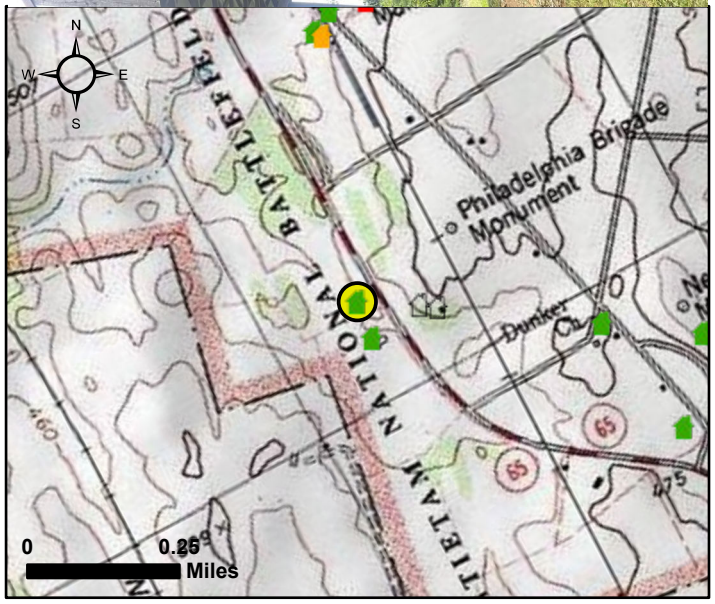
Rating: Low
ProtectionLevel: Not Designated,
Resources of Concern: Unknown
Occupied: No
In Community: Yes, Mary Locher
Revisit Interval: 5 yrs
Map Label: 145

Primary Access: Road
Ingress Egress: 2 or more roads in/out
Access Width: 2 lanes (Greater than 24')
Access Condition: Surfaced-paved, gradeLess than 5%
Bridge Condition: Less than 300 ft with turnaround
Access and Turnarounds: Less than 300 ft with turnaround
Facility Number or Sign: None or not clearly visible
Fuel Type: Grass and shrub, hardwood litter
Fuel Load: Light or no wildland fuels
Defensible Space: 30 ft treated
Topography: Slope Less than 5%
Roof Material: Noncombustible or not applicable
Siding Material: Wood or open sided
Foundation: Closed, 6in to 30in masonry exposed
Firewood: None
Water Supply: No reliable water source nearby
Propane: None
Overhead Hazards: No overhead hazards

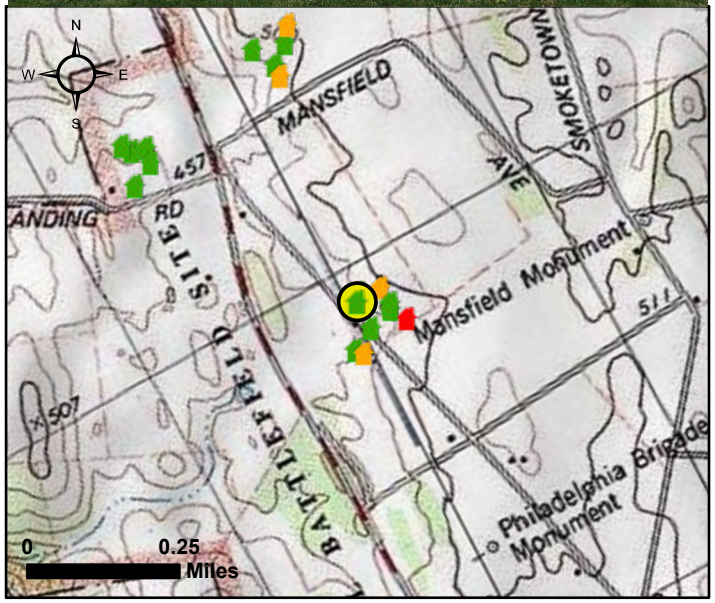
Facility Name: D.R. Miller House
Unit - Location: ANTI - Antietam National Battlefield
FMSS ID: 40423, ***Local ID:***
Structure Type, Use: Building, Public
Owner: National Park Service
Field Crew, Visit Date: NCR, April 17, 2023
Coordinates (DDM): 39° 29.063' N 77° 44.964' W

Rating: Low
ProtectionLevel: Not Designated,
Resources of Concern: Unknown
Occupied: No
In Community: Yes,
Revisit Interval: 5 yrs
Map Label: 57

Primary Access: Road
Ingress Egress: 2 or more roads in/out
Access Width: 2 lanes (Greater than 24')
Access Condition: Surfaced-paved, gradeLess than 5%
Bridge Condition: Less than 300 ft with turnaround
Access and Turnarounds: Less than 300 ft with turnaround
Facility Number or Sign: Marked and clearly visible
Fuel Type: Grass/tundra,northern hardwood litter
Fuel Load: Light or no wildland fuels
Defensible Space: 100 ft treated
Topography: Slope Less than 5%
Roof Material: Fire resistant- tar,rubberized
Siding Material: Rock, concrete, metal
Foundation: Closed, Greater than 30in masonry exposed or N/A
Firewood: None
Water Supply: Reliable water source nearby
Propane: None
Overhead Hazards: No overhead hazards

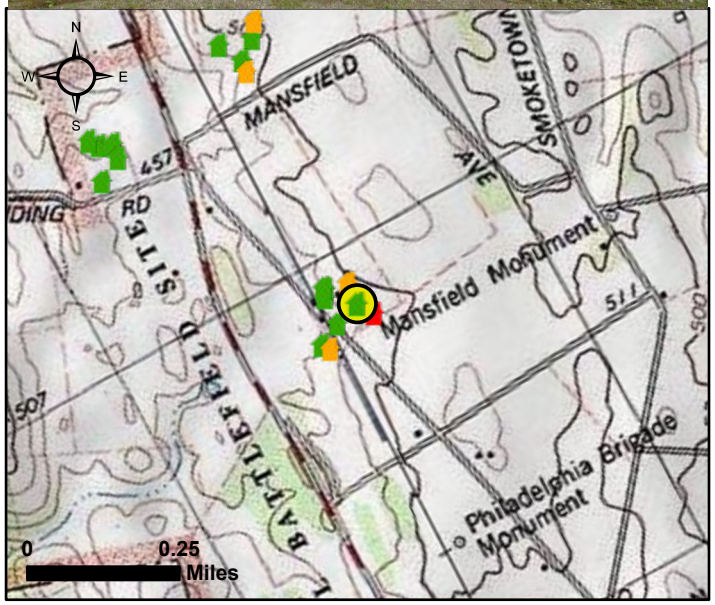
Rating: Low
ProtectionLevel: Undesignated,
Resources of Concern: Unknown
Occupied: No
In Community: Yes, Mary Locher
Revisit Interval: 5 yrs
Map Label: 60

Primary Access: Road
Ingress Egress: 1 road in/out
Access Width: 2 lanes (Greater than 24')
Access Condition: Surfaced-paved, gradeLess than 5%
Bridge Condition: Less than 300 ft with turnaround
Access and Turnarounds: Less than 300 ft with turnaround
Facility Number or Sign: Marked and clearly visible
Fuel Type: Grass and shrub, hardwood litter
Fuel Load: Light or no wildland fuels
Defensible Space: 100 ft treated
Topography: Slope Less than 5%
Roof Material: Noncombustible or not applicable
Siding Material: Wood or open sided
Foundation: Closed, 6in to 30in masonry exposed
Firewood: None
Water Supply: No reliable water source nearby
Propane: None
Overhead Hazards: No overhead hazards

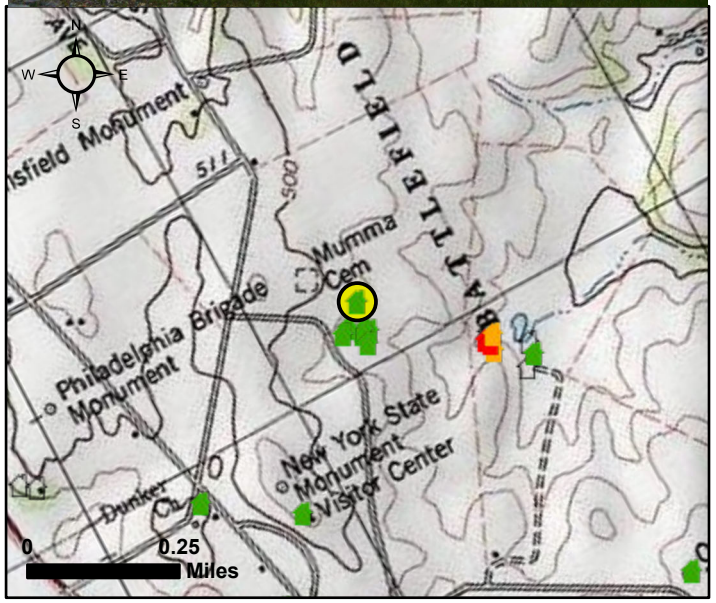
Facility Name: Mumma Barn
Unit - Location: ANTI - Antietam National Battlefield
FMSS ID: 44031, ***Local ID:***
Structure Type, Use: Building, Public
Owner: National Park Service
Field Crew, Visit Date: NCR Wildland Fire , November 2, 2022
Coordinates (DDM): 39° 28.65600504' N 077° 44.43615300' W

Rating: Low
ProtectionLevel: Undesignated,
Resources of Concern: Unknown
Occupied: No
In Community: Yes, Mary Locher
Revisit Interval: 5 yrs
Map Label: 76

Primary Access: Road
Ingress Egress: 1 road in/out
Access Width: 1.5 lanes (Greater than 18')
Access Condition: Surfaced-paved, gradeLess than 5%
Bridge Condition: Less than 300 ft with turnaround
Access and Turnarounds: Less than 300 ft with turnaround
Facility Number or Sign: Marked and clearly visible
Fuel Type: Grass and shrub, hardwood litter
Fuel Load: Light or no wildland fuels
Defensible Space: 30 ft treated
Topography: Slope Less than 5%
Roof Material: Noncombustible or not applicable
Siding Material: Wood or open sided
Foundation: Closed, 6in to 30in masonry exposed
Firewood: None
Water Supply: Pressurized hydrant(s) or fixed sprinkler system
Propane: None
Overhead Hazards: No overhead hazards

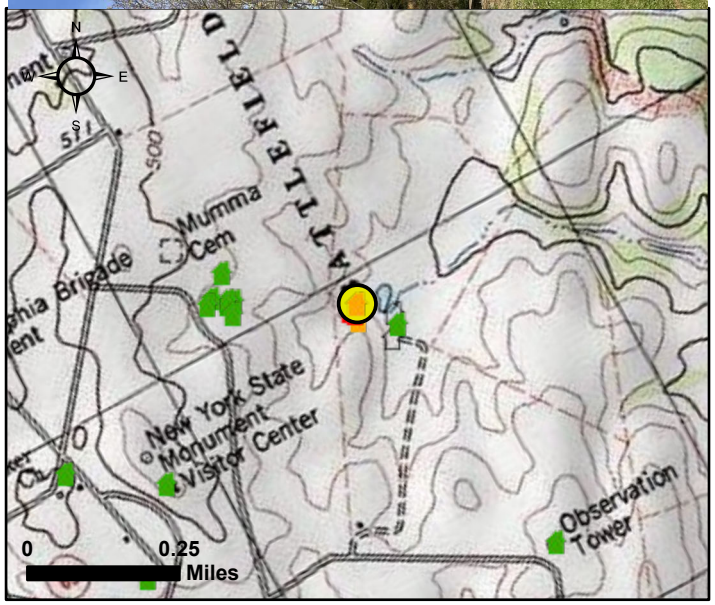
Rating: Moderate
ProtectionLevel: Undesignated,
Resources of Concern: Unknown
Occupied: No
In Community: Yes,
Revisit Interval: 5 yrs
Map Label: 50

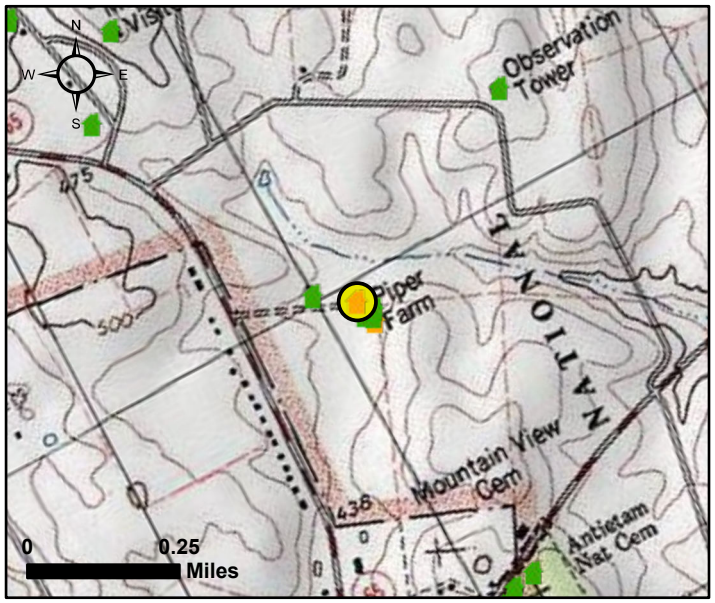
Rating: Moderate
ProtectionLevel: Not Designated,
Resources of Concern: Unknown
Occupied: No
In Community: Yes, Piper Farm Area
Revisit Interval: 5 yrs
Map Label: 65

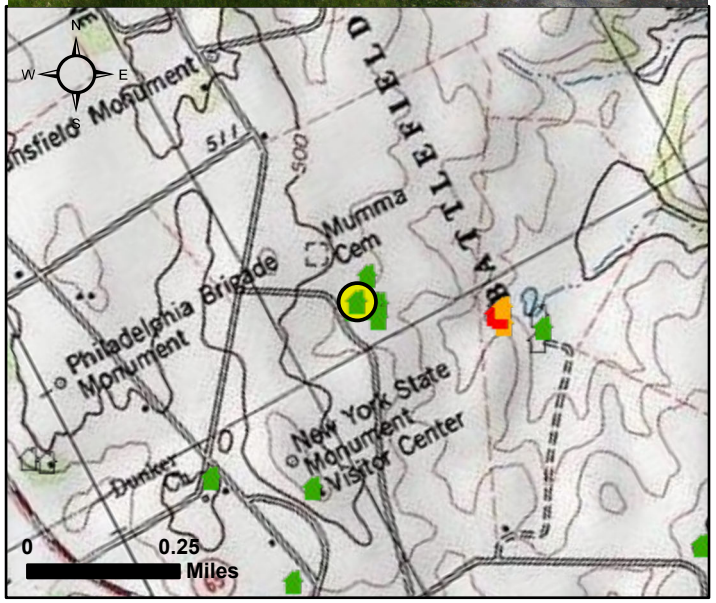
Facility Name: Mumma House
Unit - Location: ANTI - Antietam National Battlefield
FMSS ID: 44033, ***Local ID:***
Structure Type, Use: Building, Public
Owner: National Park Service
Field Crew, Visit Date: NCR Wildland Fire , November 2, 2022
Coordinates (DDM): 39° 28.63318920' N 077° 44.46975306' W

Rating: Low
ProtectionLevel: Undesignated,
Resources of Concern: Unknown
Occupied: Yes
In Community: Yes, Mary Locher
Revisit Interval: 5 yrs
Map Label: 71

Primary Access: Road
Ingress Egress: 1 road in/out
Access Width: 1.5 lanes (Greater than 18')
Access Condition: Surfaced-paved, gradeLess than 5%
Bridge Condition: Less than 300 ft with turnaround
Access and Turnarounds: Less than 300 ft with turnaround
Facility Number or Sign: Marked and clearly visible
Fuel Type: Grass and shrub, hardwood litter
Fuel Load: Light or no wildland fuels
Defensible Space: Greater than 100ft treated
Topography: Slope Less than 5%
Roof Material: Noncombustible or not applicable
Siding Material: Wood or open sided
Foundation: Closed, Less than 6in masonry exposed
Firewood: None
Water Supply: Pressurized hydrant(s) or fixed sprinkler system
Propane: None
Overhead Hazards: No overhead hazards

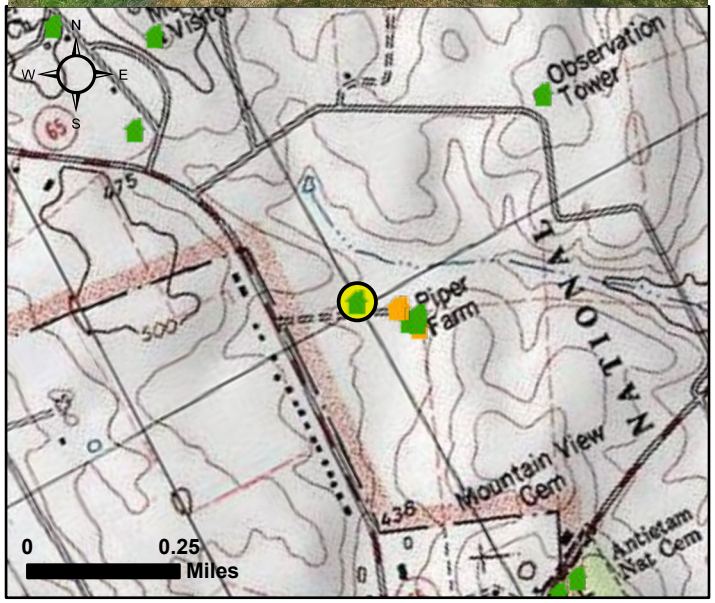
Facility Name: Piper Barn
Unit - Location: ANTI - Antietam National Battlefield
FMSS ID: 41399, ***Local ID:***
Structure Type, Use: Building, Public
Owner: National Park Service
Field Crew, Visit Date: CUGA WFM, April 17, 2023
Coordinates (DDM): 39° 28.042' N 77° 44.580' W

Rating: Low
ProtectionLevel: Not Designated,
Resources of Concern: Unknown
Occupied: No
In Community: Yes,
Revisit Interval: 5 yrs
Map Label: 63

Primary Access: Road
Ingress Egress: 1 road in/out
Access Width: 1 lane (Less than 18')
Access Condition: Surfaced-paved, gradeLess than 5%
Bridge Condition: Less than 300 ft with turnaround
Access and Turnarounds: Less than 300 ft with turnaround
Facility Number or Sign: Marked and clearly visible
Fuel Type: Grass/tundra,northern hardwood litter
Fuel Load: Light or no wildland fuels
Defensible Space: Greater than 100ft treated
Topography: Slope Less than 5%
Roof Material: Noncombustible or not applicable
Siding Material: Wood or open sided
Foundation: Open or deck
Firewood: Adjacent to/under deck of facility
Water Supply: Pressurized hydrant(s) or fixed sprinkler system
Propane: None
Overhead Hazards: No overhead hazards

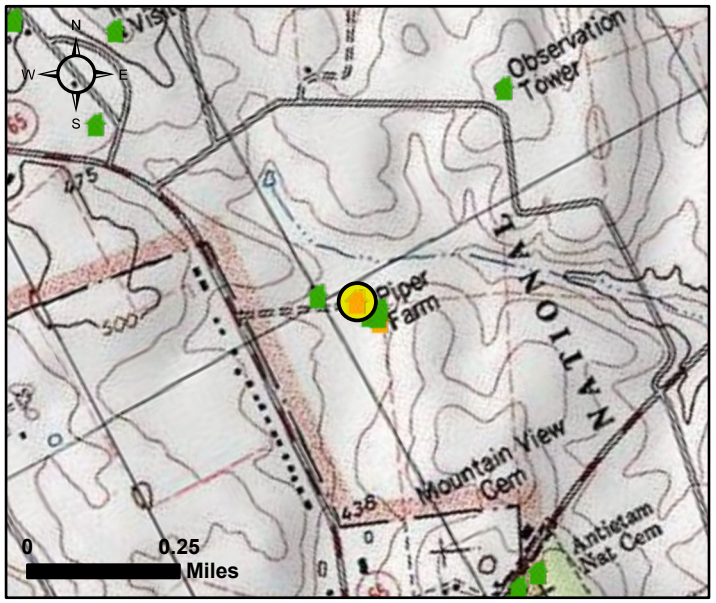
Rating: Moderate
ProtectionLevel: Not Designated,
Resources of Concern: Unknown
Occupied: No
In Community: Yes, Piper Farm Area
Revisit Interval: 5 yrs
Map Label: 64

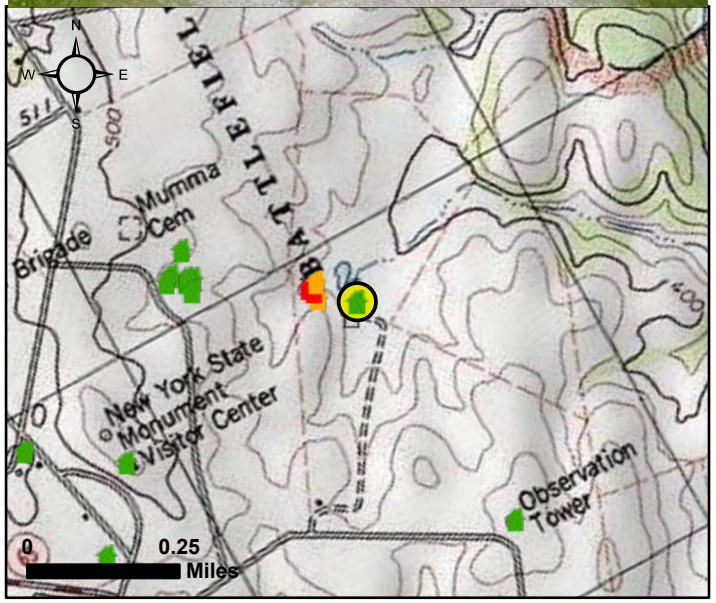
Facility Name: Roulette Barn
Unit - Location: ANTI - Antietam National Battlefield
FMSS ID: 41438, ***Local ID:***
Structure Type, Use: Building, Public
Owner: National Park Service
Field Crew, Visit Date: NCR Wildland Fire , November 2, 2022
Coordinates (DDM): 39° 28.49727510' N 077° 44.22315294' W

Rating: Low
ProtectionLevel: Undesignated,
Resources of Concern: Unknown
Occupied: No
In Community: Yes,
Revisit Interval: 5 yrs
Map Label: 52

Primary Access: Road
Ingress Egress: 1 road in/out
Access Width: 1 lane (Less than 18')
Access Condition: Non-surfaced- gravel,dirt,gradeLess than 5%
Bridge Condition: Greater than 300 ft with turnaround
Access and Turnarounds: Greater than 300 ft with turnaround
Facility Number or Sign: Marked and clearly visible
Fuel Type: Grass and shrub, hardwood litter
Fuel Load: Light or no wildland fuels
Defensible Space: 100 ft treated
Topography: Slope Less than 5%
Roof Material: Noncombustible or not applicable
Siding Material: Wood or open sided
Foundation: Closed, 6in to 30in masonry exposed
Firewood: None
Water Supply: No reliable water source nearby
Propane: None
Overhead Hazards: No overhead hazards

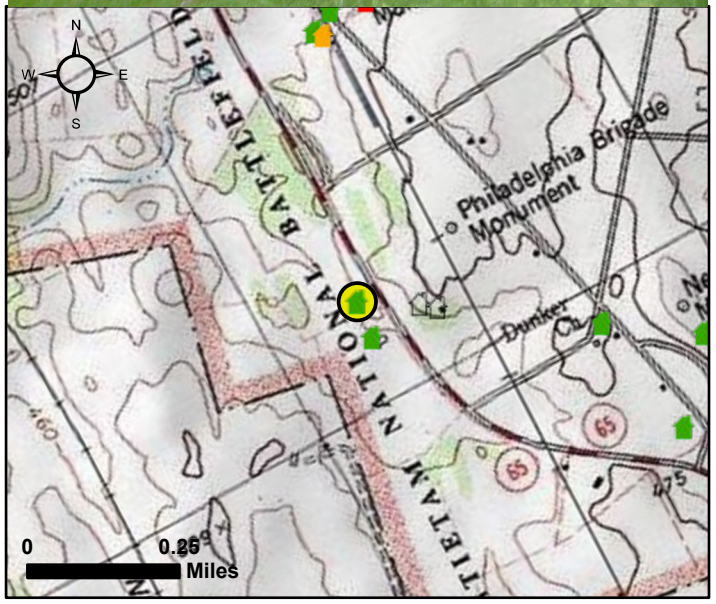
Rating: Low
ProtectionLevel: Undesignated,
Resources of Concern: Unknown
Occupied: No
In Community: Yes, Mary Locher
Revisit Interval: 5 yrs
Map Label: 144

Primary Access: Road
Ingress Egress: 2 or more roads in/out
Access Width: 2 lanes (Greater than 24')
Access Condition: Surfaced-paved, gradeLess than 5%
Bridge Condition: Less than 300 ft with turnaround
Access and Turnarounds: Less than 300 ft with turnaround
Facility Number or Sign: None or not clearly visible
Fuel Type: Grass/tundra,northern hardwood litter
Fuel Load: Light or no wildland fuels
Defensible Space: 30 ft treated
Topography: Slope Less than 5%
Roof Material: Noncombustible or not applicable
Siding Material: Wood or open sided
Foundation: Closed, Less than 6in masonry exposed
Firewood: None
Water Supply: No reliable water source nearby
Propane: None
Overhead Hazards: No overhead hazards

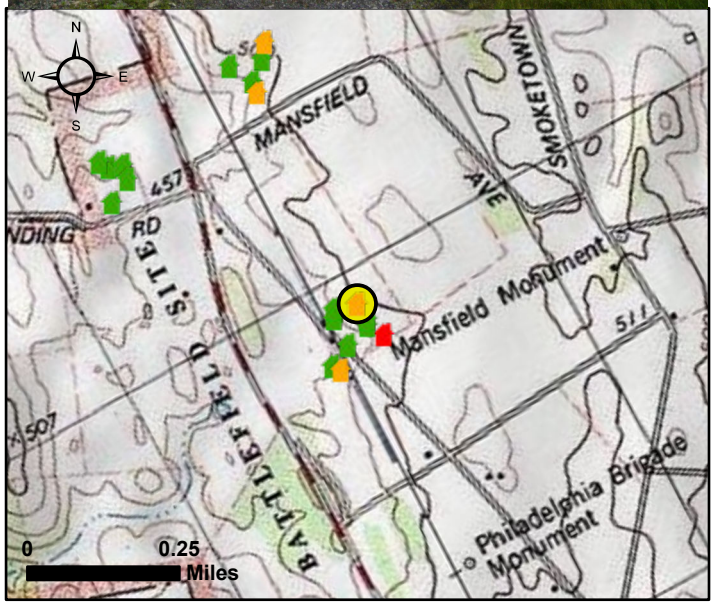
Rating: Moderate
ProtectionLevel: Not Designated,
Resources of Concern: Unknown
Occupied: No
In Community: Yes,
Revisit Interval: 5 yrs
Map Label: 61

Primary Access: Road
Ingress Egress: 1 road in/out
Access Width: 2 lanes (Greater than 24')
Access Condition: Surfaced-paved, gradeLess than 5%
Bridge Condition: Less than 300 ft with turnaround
Access and Turnarounds: Less than 300 ft with turnaround
Facility Number or Sign: Marked and clearly visible
Fuel Type: Grass and shrub, hardwood litter
Fuel Load: Light or no wildland fuels
Defensible Space: No defensible space
Topography: Slope Less than 5%
Roof Material: Noncombustible or not applicable
Siding Material: Rock, concrete, metal
Foundation: Closed, Greater than 30in masonry exposed or N/A
Firewood: None
Water Supply: No reliable water source nearby
Propane: None
Overhead Hazards: Overhead hazards will limit aircraft
Comments: From FMSS_Export - FRPP_PREDUSE: Bldg. Shed/Outbuilding (GSF)

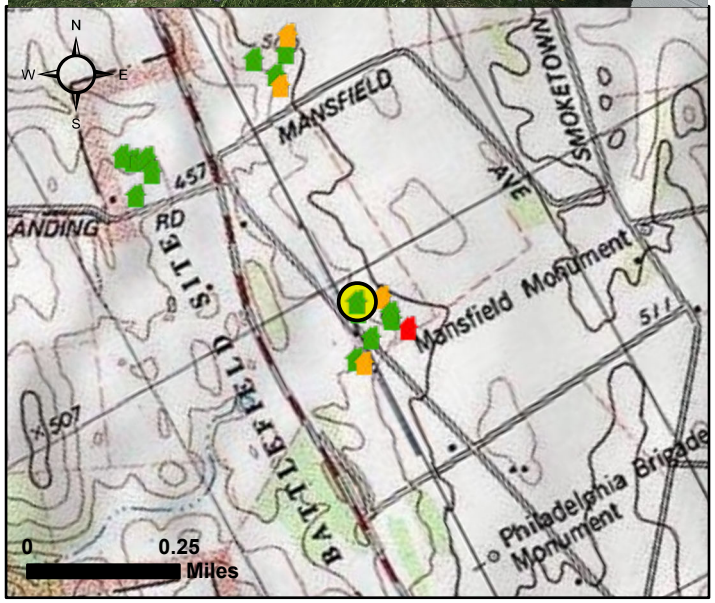
Facility Name: D.R. Miller Smoke House
Unit - Location: ANTI - Antietam National Battlefield
FMSS ID: 40426, ***Local ID:***
Structure Type, Use: Building, Public
Owner: National Park Service
Field Crew, Visit Date: NCR, April 17, 2023
Coordinates (DDM): 39° 29.073' N 77° 44.959' W

Rating: Low
ProtectionLevel: Not Designated,
Resources of Concern: Unknown
Occupied: No
In Community: Yes,
Revisit Interval: 5 yrs
Map Label: 58

Primary Access: Road
Ingress Egress: 2 or more roads in/out
Access Width: 2 lanes (Greater than 24')
Access Condition: Surfaced-paved, gradeLess than 5%
Bridge Condition: Less than 300 ft with turnaround
Access and Turnarounds: Less than 300 ft with turnaround
Facility Number or Sign: Marked and clearly visible
Fuel Type: Grass/tundra,northern hardwood litter
Fuel Load: Light or no wildland fuels
Defensible Space: 100 ft treated
Topography: Slope Less than 5%
Roof Material: Fire resistant- tar,rubberized
Siding Material: Rock, concrete, metal
Foundation: Closed, Greater than 30in masonry exposed or N/A
Firewood: None
Water Supply: Reliable water source nearby
Propane: None
Overhead Hazards: No overhead hazards

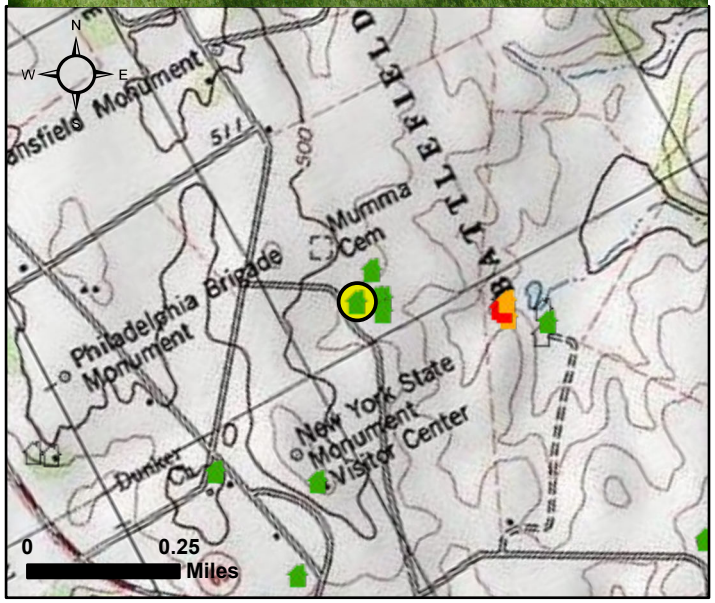
Rating: Low
ProtectionLevel: Undesignated,
Resources of Concern: Unknown
Occupied: No
In Community: Yes, Mary Locher
Revisit Interval: 5 yrs
Map Label: 70

Primary Access: Road
Ingress Egress: 1 road in/out
Access Width: 1.5 lanes (Greater than 18')
Access Condition: Surfaced-paved, gradeLess than 5%
Bridge Condition: Less than 300 ft with turnaround
Access and Turnarounds: Less than 300 ft with turnaround
Facility Number or Sign: Marked and clearly visible
Fuel Type: Grass and shrub, hardwood litter
Fuel Load: Light or no wildland fuels
Defensible Space: Greater than 100ft treated
Topography: Slope Less than 5%
Roof Material: Noncombustible or not applicable
Siding Material: Wood or open sided
Foundation: Closed, Less than 6in masonry exposed
Firewood: None
Water Supply: Pressurized hydrant(s) or fixed sprinkler system
Propane: None
Overhead Hazards: No overhead hazards

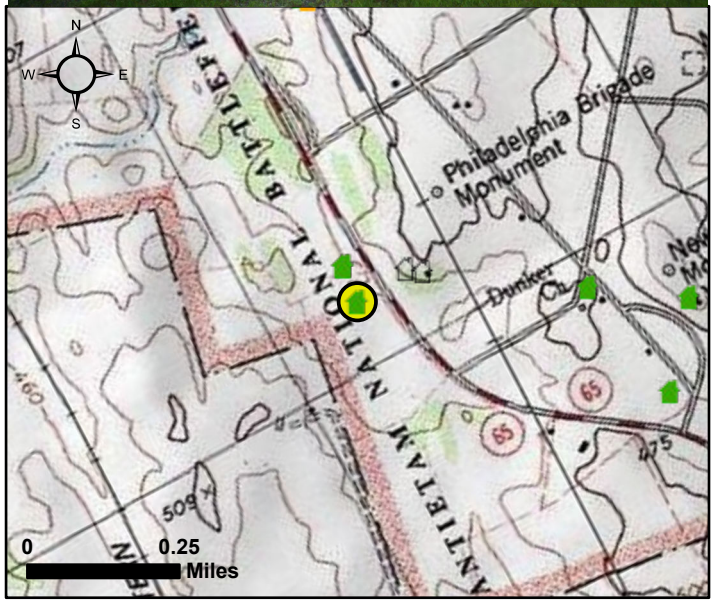
Rating: Low
ProtectionLevel: Undesignated,
Resources of Concern: Unknown
Occupied: No
In Community: Yes, Mary Locher
Revisit Interval: 5 yrs
Map Label: 143

Primary Access: Road
Ingress Egress: 2 or more roads in/out
Access Width: 2 lanes (Greater than 24')
Access Condition: Surfaced-paved, gradeLess than 5%
Bridge Condition: Less than 300 ft with turnaround
Access and Turnarounds: Less than 300 ft with turnaround
Facility Number or Sign: None or not clearly visible
Fuel Type: Grass/tundra,northern hardwood litter
Fuel Load: Light or no wildland fuels
Defensible Space: Greater than 100ft treated
Topography: Slope Less than 5%
Roof Material: Noncombustible or not applicable
Siding Material: Rock, concrete, metal
Foundation: Closed, Greater than 30in masonry exposed or N/A
Firewood: None
Water Supply: No reliable water source nearby
Propane: None
Overhead Hazards: No overhead hazards
Comments: From FMSS_Export - FRPP_PREDUSE:
