NPS Wildfire Risk Assessments
Assessment Locations

Harpers Ferry National Historical Park - Overview

NPS Wildfire Risk Assessment Project

HAFE - Harpers Ferry National Historical Park

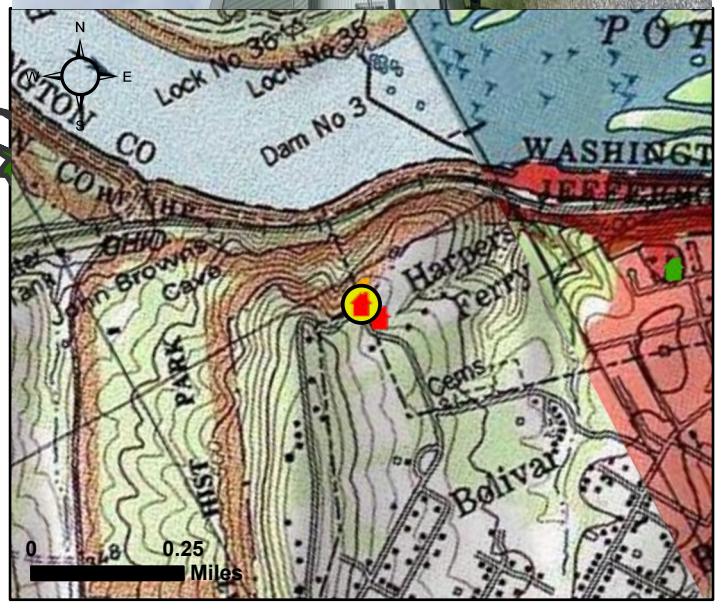
Facility Name: Nash Little House
Unit - Location: HAFE - Harper's Ferry NHP
FMSS ID: 87849, ***Local ID:***
Structure Type, Use: Building, Unknown
Owner: National Park Service
Field Crew, Visit Date: NCR Wildland Fire , June 14, 2022
Coordinates (DDM): 39° 19.87048830' N 077° 45.26826420' W

Rating: High
ProtectionLevel: Undesignated,
Resources of Concern: Unknown
Occupied: No
In Community: Yes,
Revisit Interval: 5 yrs
Map Label: 23

Primary Access: Road
Ingress Egress: 1 road in/out
Access Width: 1 lane (Less than 18')
Access Condition: Surfaced-paved, gradeGreater than 5%
Bridge Condition: Less than 300 ft with turnaround
Access and Turnarounds: Less than 300 ft with turnaround
Facility Number or Sign: None or not clearly visible
Fuel Type: Grass and shrub, hardwood litter
Fuel Load: Moderate
Defensible Space: No defensible space
Topography: Slope 31% to 40%
Roof Material: Noncombustible or not applicable
Siding Material: Wood or open sided
Foundation: Open or deck
Firewood: None
Water Supply: Pressurized hydrant(s) or fixed sprinkler system
Propane: None
Overhead Hazards: No overhead hazards

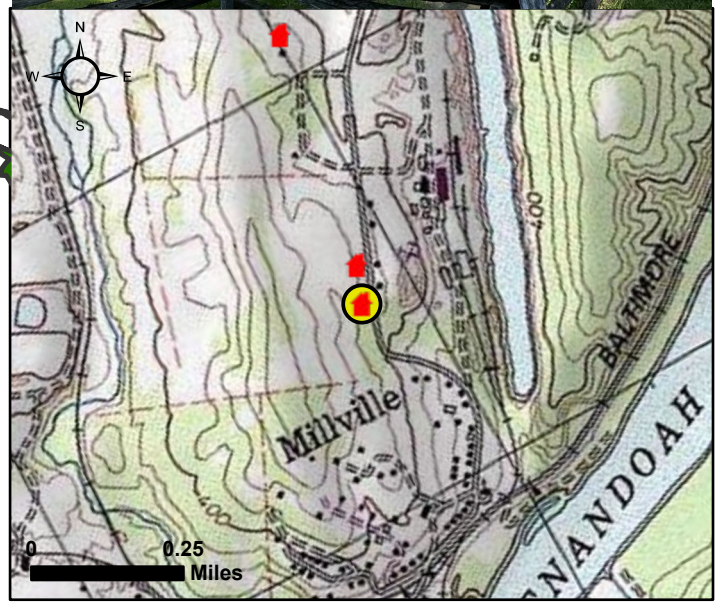
Facility Name: Shack (Quarry Workers)
Unit - Location: HAFE - Harper's Ferry NHP
FMSS ID: N/A, ***Local ID:***
Structure Type, Use: Building, Unknown
Owner: National Park Service
Field Crew, Visit Date: NCR Fire, June 2, 2022
Coordinates (DDM): 39° 17.95324734' N 077° 47.05620870' W

Rating: High
ProtectionLevel: Undesignated,
Resources of Concern: Unknown
Occupied: No
In Community: No,
Revisit Interval: 5 yrs
Map Label: 5

Primary Access: Road
Ingress Egress: 1 road in/out
Access Width: 2 lanes (Greater than 24')
Access Condition: Surfaced-paved, gradeLess than 5%
Bridge Condition: Less than 300 ft with turnaround
Access and Turnarounds: Less than 300 ft with turnaround
Facility Number or Sign: None or not clearly visible
Fuel Type: Shrub or timber
Fuel Load: Moderate
Defensible Space: No defensible space
Topography: Slope Less than 5%
Roof Material: Noncombustible or not applicable
Siding Material: Rock, concrete, metal
Foundation: Closed, Greater than 30in masonry exposed or N/A
Firewood: None
Water Supply: No reliable water source nearby
Propane: None
Overhead Hazards: Overhead hazards will limit aircraft
Comments: From FMSS_Export - FRPP_PREDUSE:

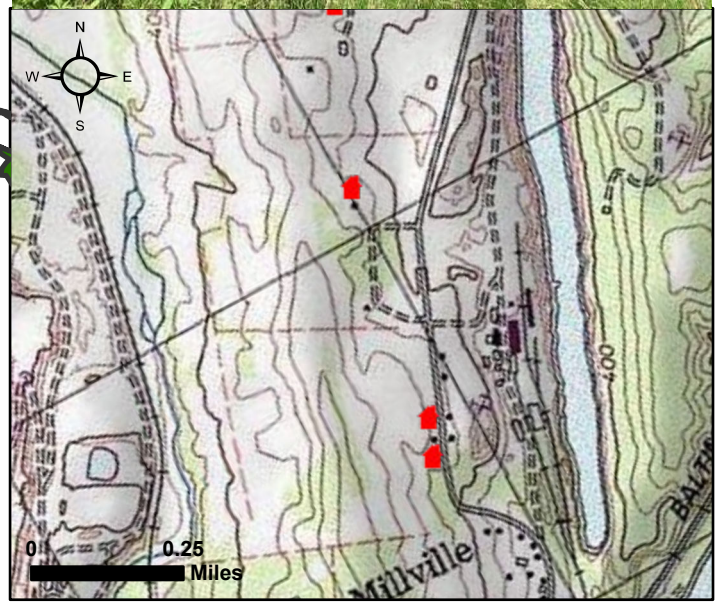
Facility Name:
Unit - Location:
FMSS ID: 105862, ***Local ID:***
Structure Type, Use: Destroyed, Not a building
Owner: National Park Service
Field Crew, Visit Date: Ncr fire crew,
Coordinates (DDM): 39° 18.16300224' N 077° 47.04639126' W

Rating: Destroyed
ProtectionLevel: Not Designated,
Resources of Concern: Unknown
Occupied: No
In Community: No,
Revisit Interval: 5 yrs
Map Label: 6

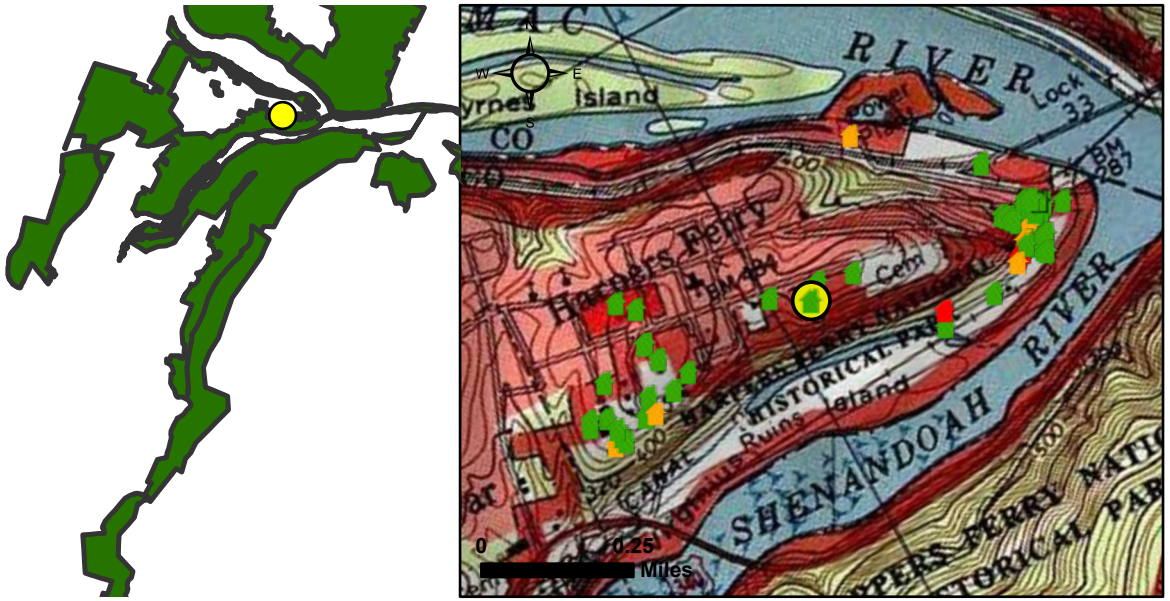
Facility Name: B82 - Office (The Jackson House)
Unit - Location: HAFE - Harper's Ferry NHP
FMSS ID: 3798, ***Local ID:***
Structure Type, Use: Building, Administrative
Owner: National Park Service
Field Crew, Visit Date: NCR FIRE, February 12, 2024
Coordinates (DDM): 39° 19.416' N 77° 44.205' W

Rating: Low
ProtectionLevel: Not Designated,
Resources of Concern: Unknown
Occupied: Yes
In Community: Yes, John Brownandapos;s Fort
Revisit Interval: 10 yrs
Map Label: 85

Primary Access: Road
Ingress Egress: 2 or more roads in/out
Access Width: 2 lanes (Greater than 24')
Access Condition: Surfaced-paved, gradeLess than 5%
Bridge Condition: Less than 300 ft with turnaround
Access and Turnarounds: Less than 300 ft with turnaround
Facility Number or Sign: Marked and clearly visible
Fuel Type: Grass/tundra,northern hardwood litter
Fuel Load: Light or no wildland fuels
Defensible Space: 100 ft treated
Topography: Slope Greater than 40%
Roof Material: Fire resistant- tar,rubberized
Siding Material: Vinyl
Foundation: Closed, Greater than 30in masonry exposed or N/A
Firewood: None
Water Supply: Pressurized hydrant(s) or fixed sprinkler system
Propane: None
Overhead Hazards: No overhead hazards

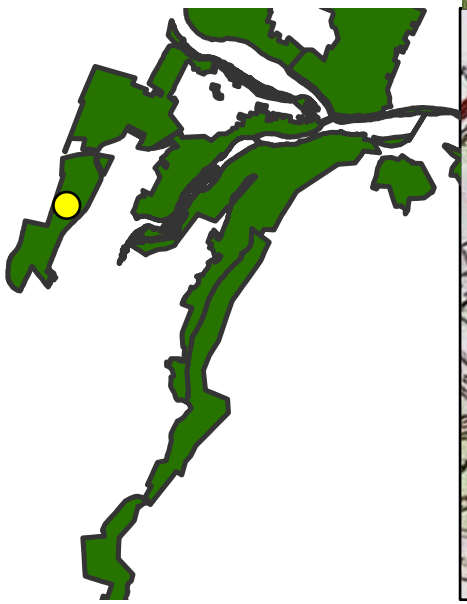
Facility Name: Farm House
Unit - Location: HAFE - Harper's Ferry NHP
FMSS ID: 105864, ***Local ID:***
Structure Type, Use: Cultural Resource, Unknown
Owner: National Park Service
Field Crew, Visit Date: NCR FIRE CREW, June 2, 2022
Coordinates (DDM): 39° 18.51152550' N 077° 46.86247146' W

Primary Access: Road
Ingress Egress: 1 road in/out
Access Width: 1 lane (Less than 18')
Access Condition: Non-surfaced- gravel,dirt,gradeLess than 5%
Bridge Condition: Less than 300 ft with turnaround
Access and Turnarounds: Less than 300 ft with turnaround
Facility Number or Sign: None or not clearly visible
Fuel Type: Grass and shrub, hardwood litter
Fuel Load: Moderate
Defensible Space: No defensible space
Topography: Slope Less than 5%
Roof Material: Noncombustible or not applicable
Siding Material: Not applicable
Foundation: Open or deck
Firewood: None
Water Supply: No reliable water source nearby
Propane: None
Overhead Hazards: No overhead hazards

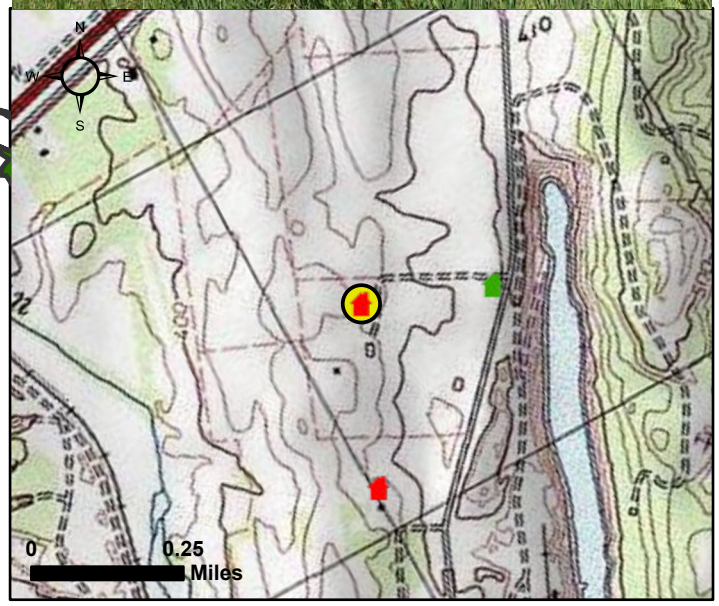
Rating: High
ProtectionLevel: Not Applicable,
Resources of Concern: Unknown
Occupied: No
In Community: No,
Revisit Interval: 5 yrs
Map Label: 9

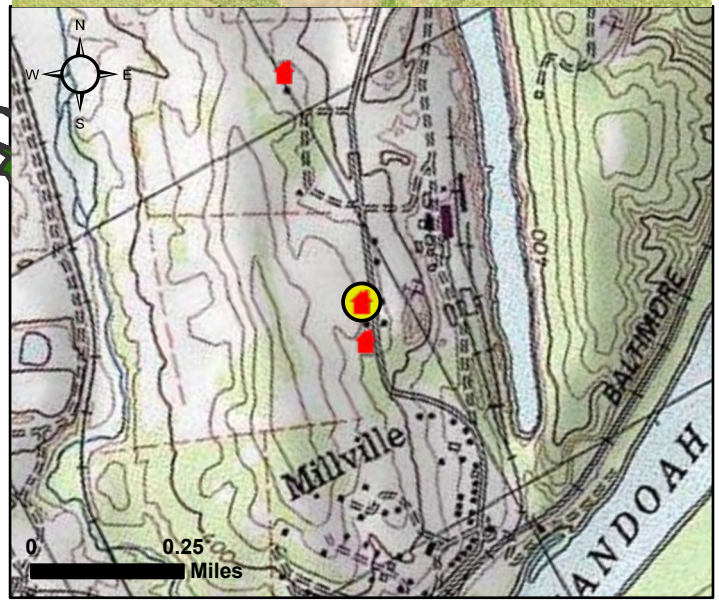
Facility Name: Shack (Quarry Workers)
Unit - Location: HAFE - Harper's Ferry NHP
FMSS ID: 105863, ***Local ID:***
Structure Type, Use: Building, No known use
Owner: National Park Service
Field Crew, Visit Date: NCR fire management , June 2, 2022
Coordinates (DDM): 39° 17.99931042' N 077° 47.03361276' W

Rating: High
ProtectionLevel: Not Designated,
Resources of Concern: Unknown
Occupied: No
In Community: No,
Revisit Interval: 5 yrs
Map Label: 7

Primary Access: Road
Ingress Egress: 1 road in/out
Access Width: 2 lanes (Greater than 24')
Access Condition: Surfaced-paved, gradeLess than 5%
Bridge Condition: Less than 300 ft with no turnaround
Access and Turnarounds: Less than 300 ft with no turnaround
Facility Number or Sign: None or not clearly visible
Fuel Type: Shrub or timber
Fuel Load: Heavy
Defensible Space: No defensible space
Topography: Slope Less than 5%
Roof Material: Combination of fire resisitant and combustible
Siding Material: Rock, concrete, metal
Foundation: Closed, Greater than 30in masonry exposed or N/A
Firewood: None
Water Supply: No reliable water source nearby
Propane: None
Overhead Hazards: No overhead hazards
Comments:

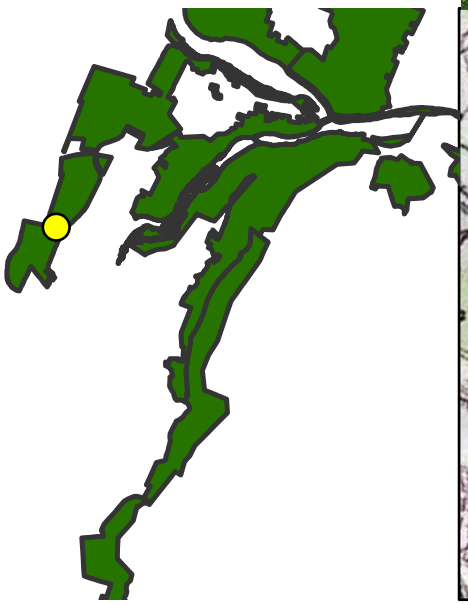
Facility Name: Shack (Quarry Workers)
Unit - Location: HAFE - Harper's Ferry NHP
FMSS ID: 105861, ***Local ID:***
Structure Type, Use: Building, Unknown
Owner: National Park Service
Field Crew, Visit Date: NCR Fire, June 2, 2022
Coordinates (DDM): 39° 18.29817780' N 077° 46.97354364' W

Primary Access: Road
Ingress Egress: 1 road in/out
Access Width: 1 lane (Less than 18')
Access Condition: Non-surfaced- gravel,dirt,gradeLess than 5%
Bridge Condition: Less than 300 ft with no turnaround
Access and Turnarounds: Less than 300 ft with no turnaround
Facility Number or Sign: None or not clearly visible
Fuel Type: Shrub or timber
Fuel Load: Heavy
Defensible Space: No defensible space
Topography: Slope Less than 5%
Roof Material: Combustible or no roof
Siding Material: Wood or open sided
Foundation: Closed, Greater than 30in masonry exposed or N/A
Firewood: None
Water Supply: No reliable water source nearby
Propane: None
Overhead Hazards: No overhead hazards

Comments: Four additional standing outbuildings in poor condition.

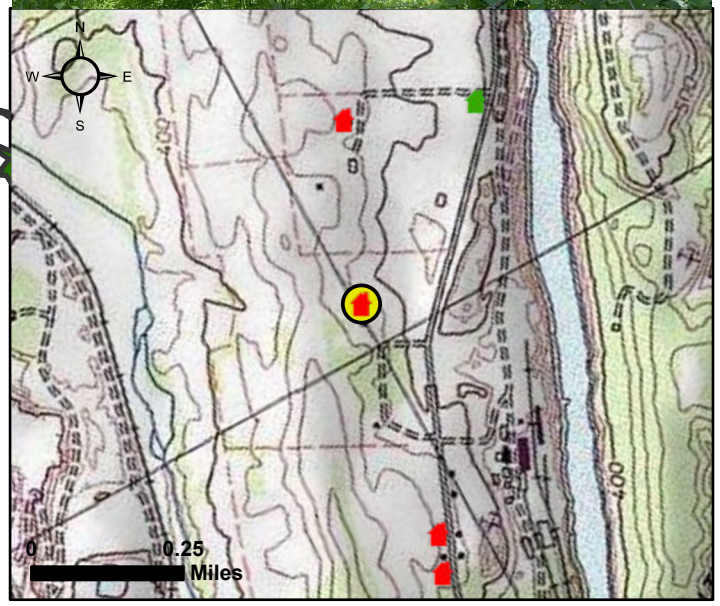
Rating: High
ProtectionLevel: Undesignated,
Resources of Concern: Unknown
Occupied: No
In Community: No,
Revisit Interval: 5 yrs
Map Label: 8

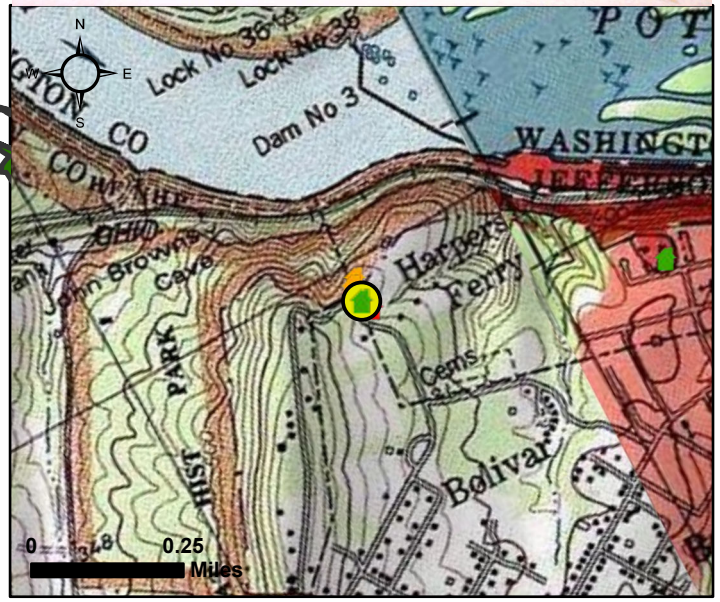
Facility Name: Nash Main House
Unit - Location: HAFE - Harper's Ferry NHP
FMSS ID: 87850, ***Local ID:***
Structure Type, Use: Building, Residence
Owner: National Park Service
Field Crew, Visit Date: NCR Wildland Fire , June 14, 2022
Coordinates (DDM): 39° 19.85815884' N 077° 45.26248314' W

Rating: Low
ProtectionLevel: Undesignated,
Resources of Concern: Unknown
Occupied: No
In Community: Yes,
Revisit Interval: 5 yrs
Map Label: 25

Primary Access: Road
Ingress Egress: 1 road in/out
Access Width: 1 lane (Less than 18')
Access Condition: Surfaced-paved, gradeGreater than 5%
Bridge Condition: Less than 300 ft with turnaround
Access and Turnarounds: Less than 300 ft with turnaround
Facility Number or Sign: None or not clearly visible
Fuel Type: Grass and shrub, hardwood litter
Fuel Load: Light or no wildland fuels
Defensible Space: 100 ft treated
Topography: Slope 5% to 20%
Roof Material: Noncombustible or not applicable
Siding Material: Wood or open sided
Foundation: Closed, Greater than 30in masonry exposed or N/A
Firewood: None
Water Supply: Pressurized hydrant(s) or fixed sprinkler system
Propane: None
Overhead Hazards: No overhead hazards

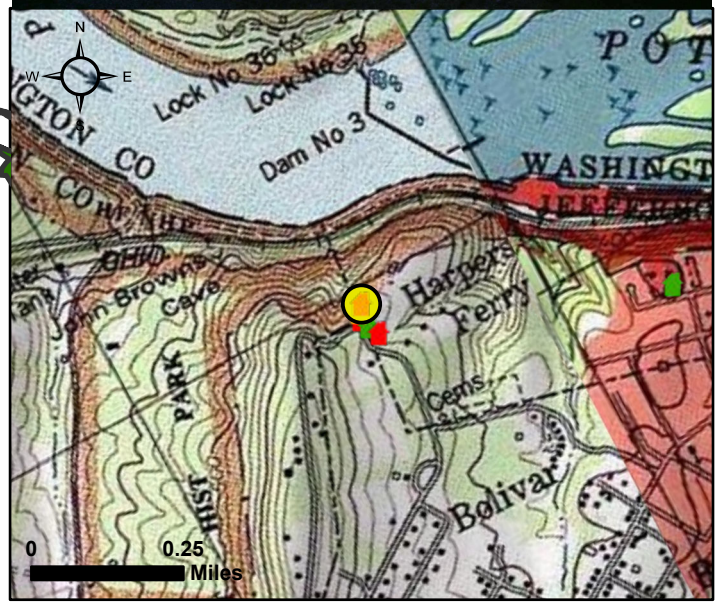
Facility Name: Nash Randolph Cottage
Unit - Location: HAFE - Harper's Ferry NHP
FMSS ID: 105526, ***Local ID:***
Structure Type, Use: Building, Administrative
Owner: National Park Service
Field Crew, Visit Date: NCR Wildland Fire, June 14, 2022
Coordinates (DDM): 39° 19.88678724' N 077° 45.25556862' W

Rating: Moderate
ProtectionLevel: Undesignated,
Resources of Concern: Unknown
Occupied: No
In Community: Yes,
Revisit Interval: 5 yrs
Map Label: 26

Primary Access: Road
Ingress Egress: 1 road in/out
Access Width: 1 lane (Less than 18')
Access Condition: Surfaced-paved, gradeGreater than 5%
Bridge Condition: Less than 300 ft with turnaround
Access and Turnarounds: Less than 300 ft with turnaround
Facility Number or Sign: None or not clearly visible
Fuel Type: Grass and shrub, hardwood litter
Fuel Load: Moderate
Defensible Space: 30 ft treated
Topography: Slope 31% to 40%
Roof Material: Noncombustible or not applicable
Siding Material: Wood or open sided
Foundation: Closed, 6in to 30in masonry exposed
Firewood: Adjacent to/under deck of facility
Water Supply: Pressurized hydrant(s) or fixed sprinkler system
Propane: None
Overhead Hazards: No overhead hazards

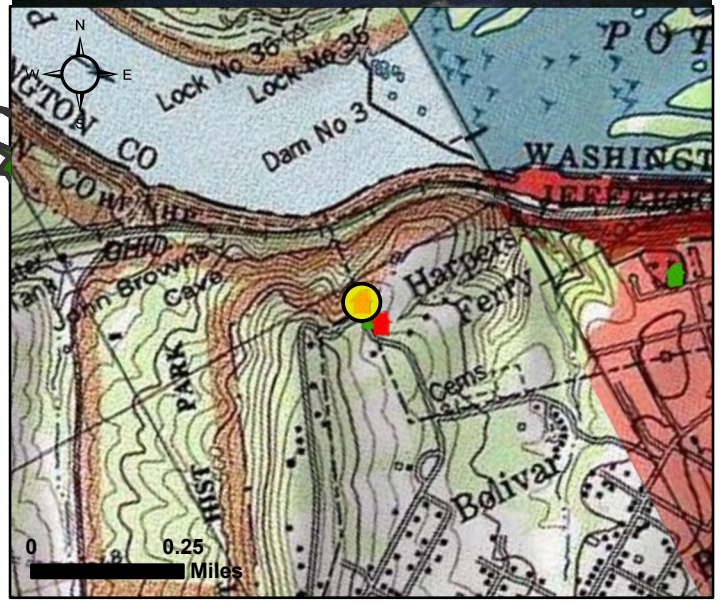
Facility Name: Nash Barn
Unit - Location: HAFE - Harper's Ferry NHP
FMSS ID: 87848, ***Local ID:***
Structure Type, Use: Building, Administrative
Owner: National Park Service
Field Crew, Visit Date: NCR Wildland Fire, June 14, 2022
Coordinates (DDM): 39° 19.87964832' N 077° 45.26486478' W

Rating: Moderate
ProtectionLevel: Undesignated,
Resources of Concern: Unknown
Occupied: No
In Community: Yes,
Revisit Interval: 5 yrs
Map Label: 24

Primary Access: Road
Ingress Egress: 1 road in/out
Access Width: 1 lane (Less than 18')
Access Condition: Surfaced-paved, gradeGreater than 5%
Bridge Condition: Less than 300 ft with turnaround
Access and Turnarounds: Less than 300 ft with turnaround
Facility Number or Sign: None or not clearly visible
Fuel Type: Grass and shrub, hardwood litter
Fuel Load: Moderate
Defensible Space: 30 ft treated
Topography: Slope 31% to 40%
Roof Material: Noncombustible or not applicable
Siding Material: Wood or open sided
Foundation: Closed, 6in to 30in masonry exposed
Firewood: None
Water Supply: Pressurized hydrant(s) or fixed sprinkler system
Propane: None
Overhead Hazards: No overhead hazards

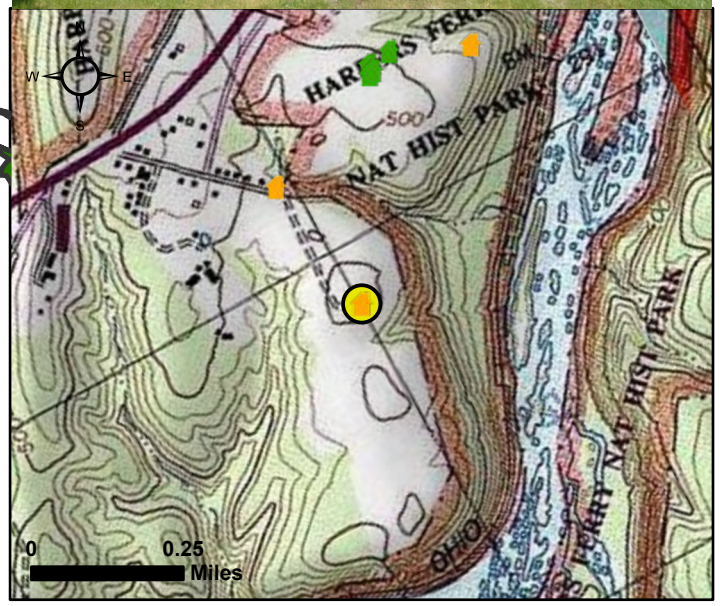
Facility Name: Murphy Farm House
Unit - Location: HAFE - Harper's Ferry NHP
FMSS ID: 3794, ***Local ID:***
Structure Type, Use: Building, Administrative
Owner: National Park Service
Field Crew, Visit Date: Awesome NCR Fire Crew , May 31, 2022
Coordinates (DDM): 39° 18.74254632' N 077° 45.60592182' W

Rating: Moderate
ProtectionLevel: Not Designated,
Resources of Concern: Unknown
Occupied: Yes
In Community: No,
Revisit Interval: 5 yrs
Map Label: 13

Primary Access: Road
Ingress Egress: 1 road in/out
Access Width: 1 lane (Less than 18')
Access Condition: Non-surfaced- gravel,dirt,gradeLess than 5%
Bridge Condition: Greater than 300 ft with turnaround
Access and Turnarounds: Greater than 300 ft with turnaround
Facility Number or Sign: Marked and clearly visible
Fuel Type: Grass/tundra,northern hardwood litter
Fuel Load: Light or no wildland fuels
Defensible Space: Less than 30 ft treated
Topography: Slope 5% to 20%
Roof Material: Fire resistant- tar,rubberized
Siding Material: Wood or open sided
Foundation: Closed, Less than 6in masonry exposed
Firewood: None
Water Supply: Reliable water source nearby
Propane: None
Overhead Hazards: No overhead hazards
Comments: 1500' to fire hydrant at KOA on Murphy Road

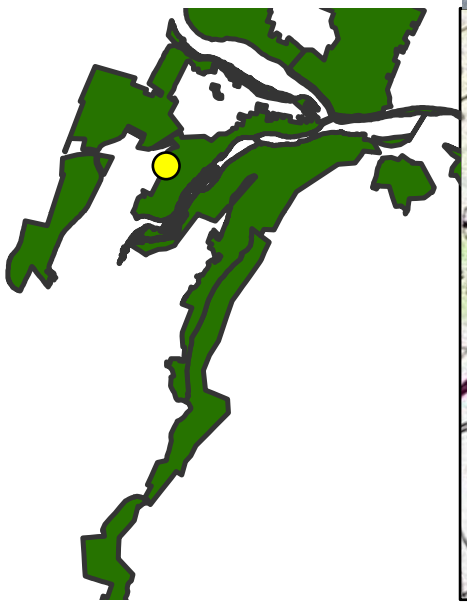
Facility Name: Q-00000091 H91 Quarters
Unit - Location: HAFE - Harper's Ferry NHP
FMSS ID: 3799, ***Local ID:***
Structure Type, Use: Building, Other
Owner: National Park Service
Field Crew, Visit Date: Ncr fire, June 3, 2022
Coordinates (DDM): 39° 18.92136336' N 077° 45.64021818' W

Primary Access: Road
Ingress Egress: 1 road in/out
Access Width: 1.5 lanes (Greater than 18')
Access Condition: Surfaced-paved, gradeLess than 5%
Bridge Condition: Less than 300 ft with turnaround
Access and Turnarounds: Less than 300 ft with turnaround
Facility Number or Sign: None or not clearly visible
Fuel Type: Grass and shrub, hardwood litter
Fuel Load: Moderate
Defensible Space: 30 ft treated
Topography: Slope Greater than 40%
Roof Material: Fire resistant- tar,rubberized
Siding Material: Vinyl
Foundation: Closed, Greater than 30in masonry exposed or N/A
Firewood: None
Water Supply: Reliable water source nearby
Propane: None
Overhead Hazards: No overhead hazards

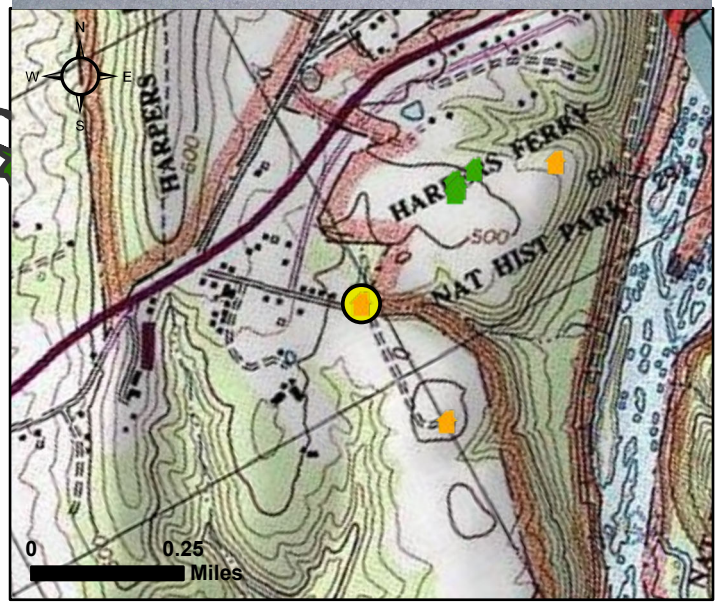
Rating: Moderate
ProtectionLevel: Not Designated,
Resources of Concern: Unknown
Occupied: Yes
In Community: No,
Revisit Interval: 5 yrs
Map Label: 12

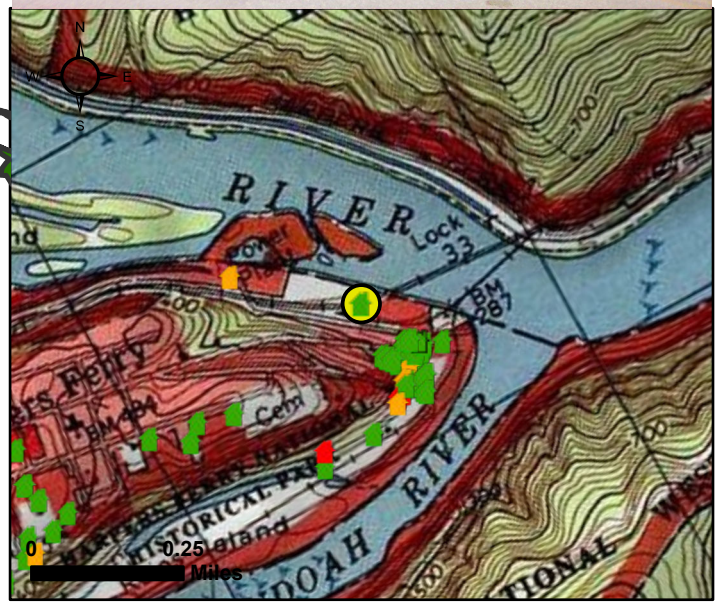
Facility Name: BandO Railroad Train Station
Unit - Location: HAFE - Harper's Ferry NHP
FMSS ID: 33295, ***Local ID:***
Structure Type, Use: Building, Public
Owner: National Park Service
Field Crew, Visit Date: CUGA WFM, May 20, 2015
Coordinates (DDM): 39° 19.47120678' N 077° 43.86108390' W

Rating: Low
ProtectionLevel: Not Designated,
Resources of Concern: Unknown
Occupied: Yes
In Community: Yes, John Brownandapos;s Fort
Revisit Interval: yrs
Map Label: 31

Primary Access: Road
Ingress Egress: 1 road in/out
Access Width: 1.5 lanes (Greater than 18')
Access Condition: Surfaced-paved, gradeGreater than 5%
Bridge Condition: Less than 300 ft with turnaround
Access and Turnarounds: Less than 300 ft with turnaround
Facility Number or Sign: Marked and clearly visible
Fuel Type: Grass and shrub, hardwood litter
Fuel Load: Light or no wildland fuels
Defensible Space: 30 ft treated
Topography: Slope Less than 5%
Roof Material: Noncombustible or not applicable
Siding Material: Wood or open sided
Foundation: Closed, Less than 6in masonry exposed
Firewood: None
Water Supply: Pressurized hydrant(s) or fixed sprinkler system
Propane: None
Overhead Hazards: No overhead hazards

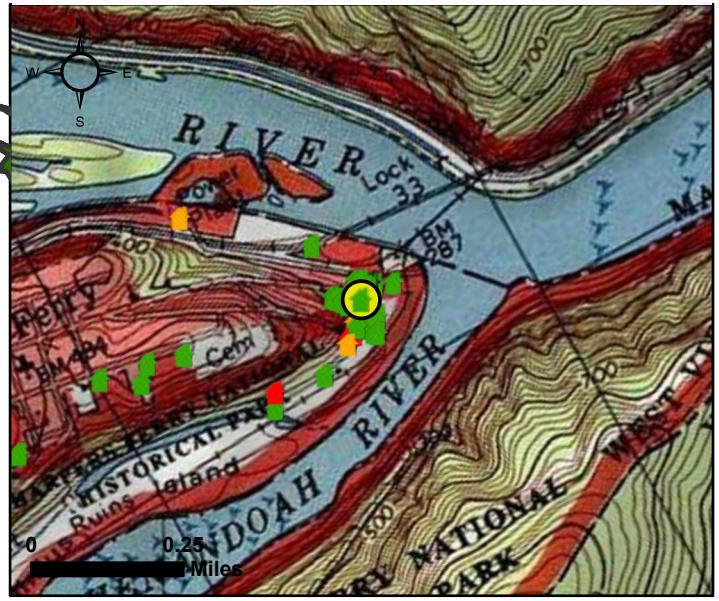
Facility Name: B37 - Black History Exhibit (or John T. Reily)
Unit - Location: HAFE - Harper's Ferry NHP
FMSS ID: 3734, ***Local ID:***
Structure Type, Use: Building, Public
Owner: National Park Service
Field Crew, Visit Date: CUGA WFM, May 20, 2015
Coordinates (DDM): 39° 19.38213378' N 077° 43.83110832' W

Rating: Low
ProtectionLevel: Not Designated,
Resources of Concern: Unknown
Occupied: Yes
In Community: Yes, John Brownandapos;s Fort
Revisit Interval: yrs
Map Label: 50

Primary Access: Road
Ingress Egress: 1 road in/out
Access Width: 1.5 lanes (Greater than 18')
Access Condition: Surfaced-paved, gradeGreater than 5%
Bridge Condition: Less than 300 ft with turnaround
Access and Turnarounds: Less than 300 ft with turnaround
Facility Number or Sign: Marked and clearly visible
Fuel Type: Grass/tundra,northern hardwood litter
Fuel Load: Light or no wildland fuels
Defensible Space: 30 ft treated
Topography: Slope Greater than 40%
Roof Material: Noncombustible or not applicable
Siding Material: Rock, concrete, metal
Foundation: Closed, Less than 6in masonry exposed
Firewood: None
Water Supply: Pressurized hydrant(s) or fixed sprinkler system
Propane: None
Overhead Hazards: No overhead hazards

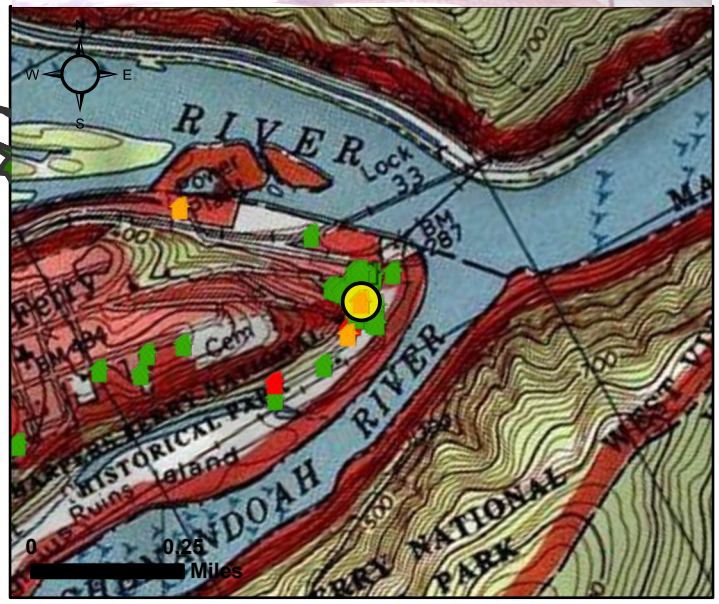
Facility Name: B40 - Frankel Brother Store (or William Richards)
Unit - Location: HAFE - Harper's Ferry NHP
FMSS ID: 3736, ***Local ID:***
Structure Type, Use: Building, Public
Owner: National Park Service
Field Crew, Visit Date: J shedd , October 12, 2022
Coordinates (DDM): 39° 19.36850988' N 077° 43.83936450' W

Rating: Moderate
ProtectionLevel: Not Designated,
Resources of Concern: Unknown
Occupied: Yes
In Community: Yes, John Brownandapos;s Fort
Revisit Interval: 5 yrs
Map Label: 39

Primary Access: Road
Ingress Egress: 2 or more roads in/out
Access Width: 1.5 lanes (Greater than 18')
Access Condition: Surfaced-paved, gradeGreater than 5%
Bridge Condition: Less than 300 ft with turnaround
Access and Turnarounds: Less than 300 ft with turnaround
Facility Number or Sign: Marked and clearly visible
Fuel Type: Grass and shrub, hardwood litter
Fuel Load: Light or no wildland fuels
Defensible Space: 30 ft treated
Topography: Slope Greater than 40%
Roof Material: Combination of fire resisitant and combustible
Siding Material: Rock, concrete, metal
Foundation: Closed, Greater than 30in masonry exposed or N/A
Firewood: None
Water Supply: Pressurized hydrant(s) or fixed sprinkler system
Propane: None
Overhead Hazards: No overhead hazards

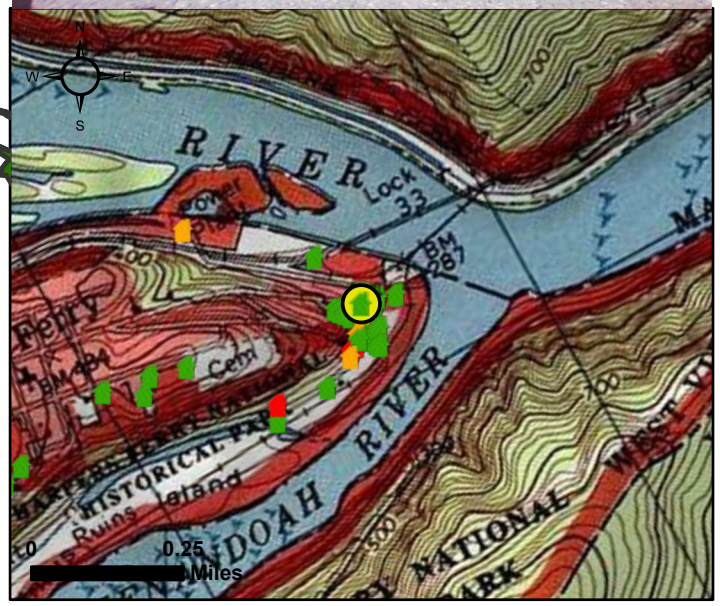
Facility Name: B14 - Alfred Burton Jewelry Shop
Unit - Location: HAFE - Harper's Ferry NHP
FMSS ID: 34253, ***Local ID:***
Structure Type, Use: Building, Public
Owner: National Park Service
Field Crew, Visit Date: CUGA WFM, May 20, 2015
Coordinates (DDM): 39° 19.39245816' N 077° 43.82860296' W

Rating: Low
ProtectionLevel: Not Designated,
Resources of Concern: Unknown
Occupied: Yes
In Community: Yes, John Brownandapos;s Fort
Revisit Interval: yrs
Map Label: 52

Primary Access: Road
Ingress Egress: 1 road in/out
Access Width: 1.5 lanes (Greater than 18')
Access Condition: Surfaced-paved, gradeGreater than 5%
Bridge Condition: Less than 300 ft with turnaround
Access and Turnarounds: Less than 300 ft with turnaround
Facility Number or Sign: Marked and clearly visible
Fuel Type: Grass/tundra,northern hardwood litter
Fuel Load: Light or no wildland fuels
Defensible Space: 30 ft treated
Topography: Slope Greater than 40%
Roof Material: Noncombustible or not applicable
Siding Material: Wood or open sided
Foundation: Closed, Greater than 30in masonry exposed or N/A
Firewood: None
Water Supply: Pressurized hydrant(s) or fixed sprinkler system
Propane: None
Overhead Hazards: No overhead hazards

Comments: From FMSS_Export - FRPP_PREDUSE: Bldg. Museum Repository (GSF)

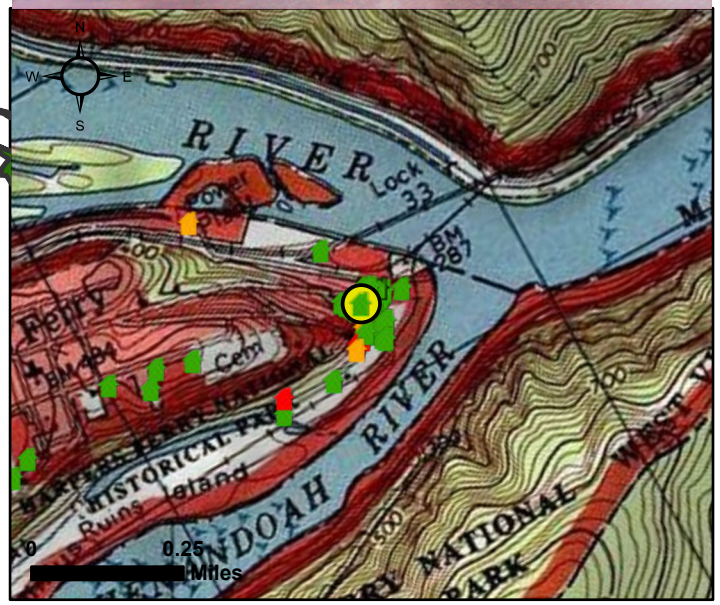
Facility Name: B3 - Civil War Story EXH
Unit - Location: HAFE - Harper's Ferry NHP
FMSS ID: 3765, ***Local ID:***
Structure Type, Use: Building, Public
Owner: National Park Service
Field Crew, Visit Date: CUGA WFM, May 20, 2015
Coordinates (DDM): 39° 19.38907314' N 077° 43.84268106' W

Rating: Low
ProtectionLevel: Not Designated,
Resources of Concern: Unknown
Occupied: Yes
In Community: Yes, John Brownandapos;s Fort
Revisit Interval: yrs
Map Label: 37

Primary Access: Road
Ingress Egress: 1 road in/out
Access Width: 1.5 lanes (Greater than 18')
Access Condition: Surfaced-paved, gradeGreater than 5%
Bridge Condition: Less than 300 ft with turnaround
Access and Turnarounds: Less than 300 ft with turnaround
Facility Number or Sign: Marked and clearly visible
Fuel Type: Grass/tundra,northern hardwood litter
Fuel Load: Light or no wildland fuels
Defensible Space: 30 ft treated
Topography: Slope Greater than 40%
Roof Material: Noncombustible or not applicable
Siding Material: Rock, concrete, metal
Foundation: Closed, 6in to 30in masonry exposed
Firewood: None
Water Supply: Pressurized hydrant(s) or fixed sprinkler system
Propane: None
Overhead Hazards: No overhead hazards

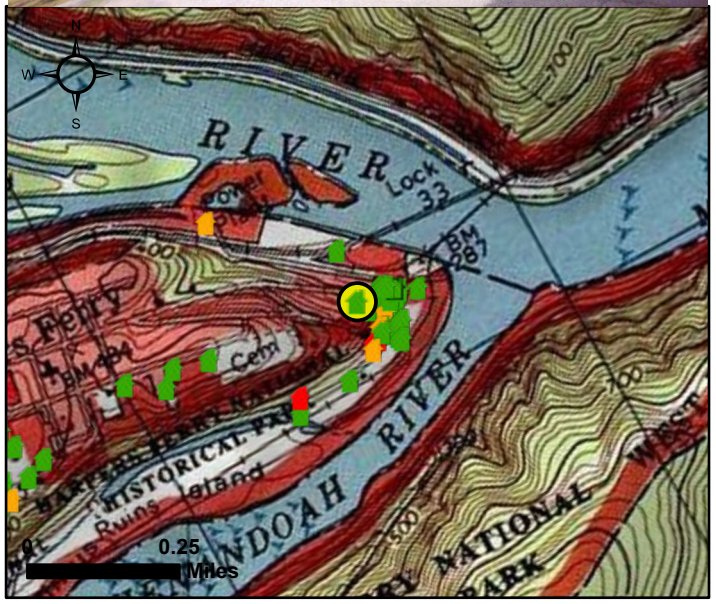
Facility Name: Q-0000001D H1D - Quarters
Unit - Location: HAFE - Harper's Ferry NHP
FMSS ID: 3802, ***Local ID:***
Structure Type, Use: Building, Residence
Owner: National Park Service
Field Crew, Visit Date: CUGA WFM, May 20, 2015
Coordinates (DDM): 39° 19.40216718' N 077° 43.86995364' W

Rating: Low
ProtectionLevel: Not Designated,
Resources of Concern: Unknown
Occupied: Yes
In Community: Yes, John Brownandapos;s Fort
Revisit Interval: yrs
Map Label: 28

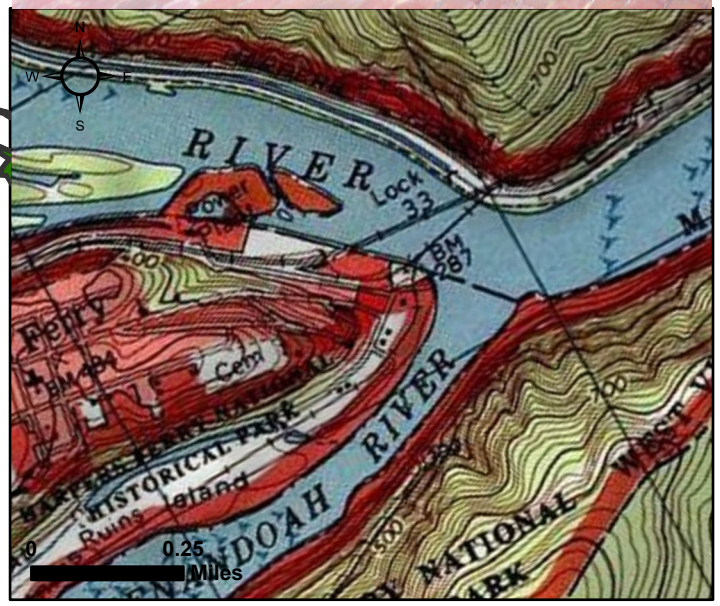
Facility Name:
Unit - Location:
FMSS ID: 3727, ***Local ID:***
Structure Type, Use: Building, Public
Owner: National Park Service
Field Crew, Visit Date: CUGA WFM, May 20, 2015
Coordinates (DDM): 39° 19.39903728' N 077° 43.83668940' W

Rating: Low
ProtectionLevel: Not Designated,
Resources of Concern: Unknown
Occupied: Yes
In Community: Yes, John Brownandapos;s Fort
Revisit Interval: yrs
Map Label: 43

Primary Access: Road
Ingress Egress: 1 road in/out
Access Width: 1.5 lanes (Greater than 18')
Access Condition: Surfaced-paved, gradeGreater than 5%
Bridge Condition: Less than 300 ft with turnaround
Access and Turnarounds: Less than 300 ft with turnaround
Facility Number or Sign: Marked and clearly visible
Fuel Type: Grass/tundra,northern hardwood litter
Fuel Load: Light or no wildland fuels
Defensible Space: 30 ft treated
Topography: Slope Greater than 40%
Roof Material: Noncombustible or not applicable
Siding Material: Rock, concrete, metal
Foundation: Open or deck
Firewood: Adjacent to/under deck of facility
Water Supply: Pressurized hydrant(s) or fixed sprinkler system
Propane: None
Overhead Hazards: No overhead hazards

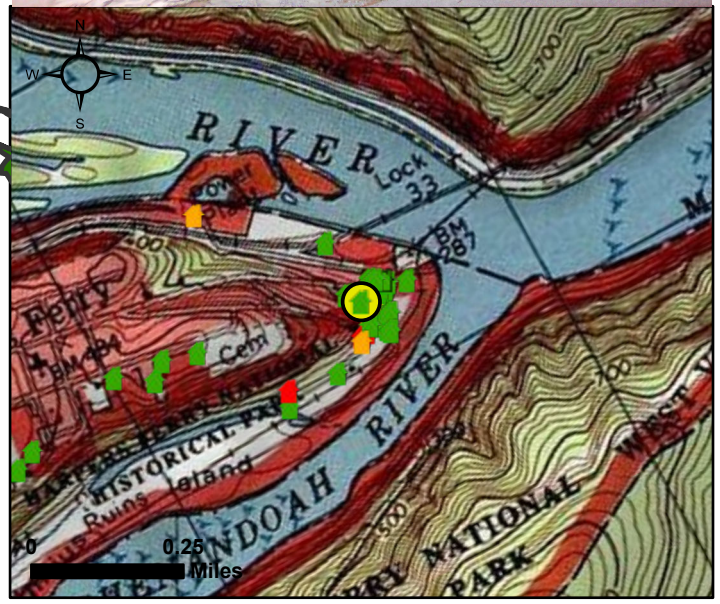
Facility Name: B1A - Harper House
Unit - Location: HAFE - Harper's Ferry NHP
FMSS ID: 3728, ***Local ID:***
Structure Type, Use: Building, Administrative
Owner: National Park Service
Field Crew, Visit Date: CUGA WFM, May 20, 2015
Coordinates (DDM): 39° 19.38526428' N 077° 43.85339034' W

Rating: Low
ProtectionLevel: Not Designated,
Resources of Concern: Unknown
Occupied: Yes
In Community: Yes, John Brownandapos;s Fort
Revisit Interval: yrs
Map Label: 35

Primary Access: Road
Ingress Egress: 1 road in/out
Access Width: 1.5 lanes (Greater than 18')
Access Condition: Surfaced-paved, gradeGreater than 5%
Bridge Condition: Less than 300 ft with turnaround
Access and Turnarounds: Less than 300 ft with turnaround
Facility Number or Sign: Marked and clearly visible
Fuel Type: Grass/tundra,northern hardwood litter
Fuel Load: Light or no wildland fuels
Defensible Space: 30 ft treated
Topography: Slope 31% to 40%
Roof Material: Noncombustible or not applicable
Siding Material: Rock, concrete, metal
Foundation: Open or deck
Firewood: None
Water Supply: Pressurized hydrant(s) or fixed sprinkler system
Propane: None
Overhead Hazards: No overhead hazards

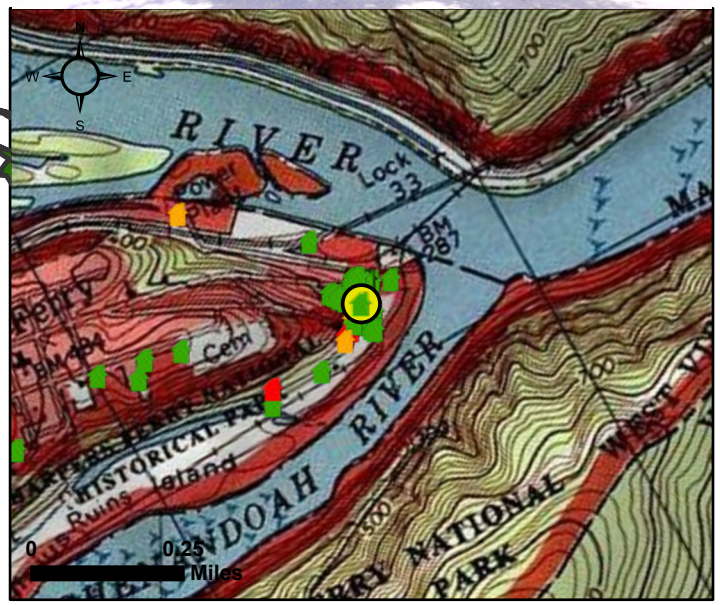
Rating: Low
ProtectionLevel: Not Designated,
Resources of Concern: Unknown
Occupied: No
In Community: Yes, John Brownandapos;s Fort
Revisit Interval: 5 yrs
Map Label: 47

Primary Access: Road
Ingress Egress: 2 or more roads in/out
Access Width: 1.5 lanes (Greater than 18')
Access Condition: Surfaced-paved, gradeGreater than 5%
Bridge Condition: Less than 300 ft with turnaround
Access and Turnarounds: Less than 300 ft with turnaround
Facility Number or Sign: Marked and clearly visible
Fuel Type: Grass/tundra,northern hardwood litter
Fuel Load: Light or no wildland fuels
Defensible Space: 30 ft treated
Topography: Slope 21% to 30%
Roof Material: Combination of fire resisitant and combustible
Siding Material: Rock, concrete, metal
Foundation: Closed, Greater than 30in masonry exposed or N/A
Firewood: None
Water Supply: Pressurized hydrant(s) or fixed sprinkler system
Propane: None
Overhead Hazards: No overhead hazards

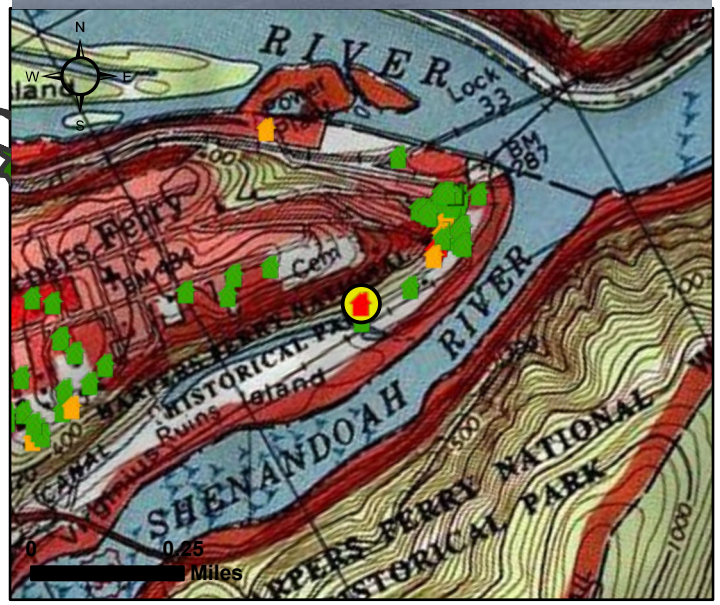
Rating: High
ProtectionLevel: Not Designated,
Resources of Concern: Unknown
Occupied: Yes
In Community: No, John Brownandapos;s Fort
Revisit Interval: 5 yrs
Map Label: 22

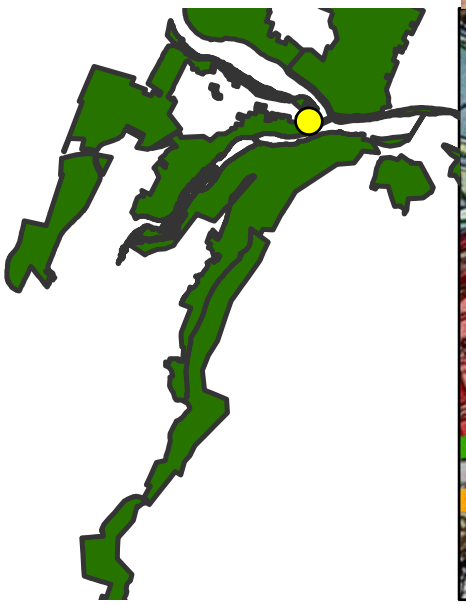
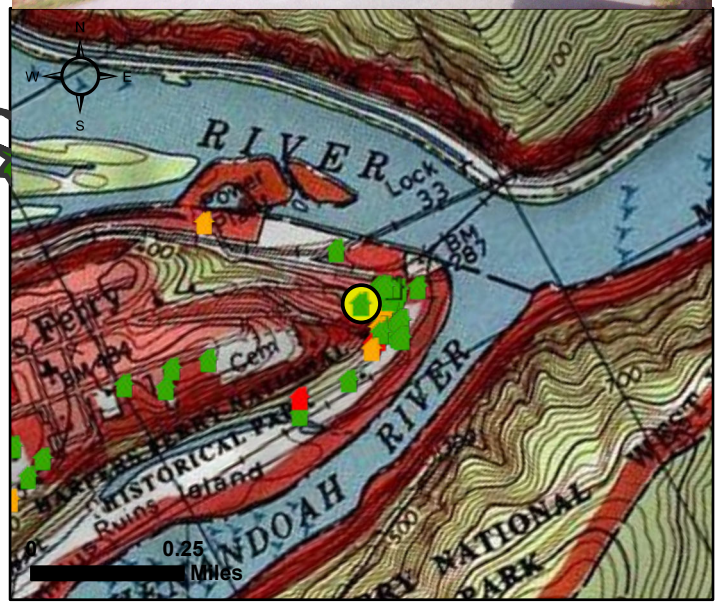
Facility Name: Q-0000001C H1C - Quarters
Unit - Location: HAFE - Harper's Ferry NHP
FMSS ID: 3801, ***Local ID:***
Structure Type, Use: Building, Residence
Owner: National Park Service
Field Crew, Visit Date: CUGA WFM, May 20, 2015
Coordinates (DDM): 39° 19.39713696' N 077° 43.86491022' W

Rating: Low
ProtectionLevel: Not Designated,
Resources of Concern: Unknown
Occupied: Yes
In Community: Yes, John Brownandapos;s Fort
Revisit Interval: yrs
Map Label: 30

Primary Access: Road
Ingress Egress: 1 road in/out
Access Width: 1.5 lanes (Greater than 18')
Access Condition: Surfaced-paved, gradeGreater than 5%
Bridge Condition: Less than 300 ft with turnaround
Access and Turnarounds: Less than 300 ft with turnaround
Facility Number or Sign: Marked and clearly visible
Fuel Type: Grass/tundra,northern hardwood litter
Fuel Load: Light or no wildland fuels
Defensible Space: 30 ft treated
Topography: Slope 31% to 40%
Roof Material: Noncombustible or not applicable
Siding Material: Rock, concrete, metal
Foundation: Closed, Less than 6in masonry exposed
Firewood: None
Water Supply: Pressurized hydrant(s) or fixed sprinkler system
Propane: None
Overhead Hazards: No overhead hazards

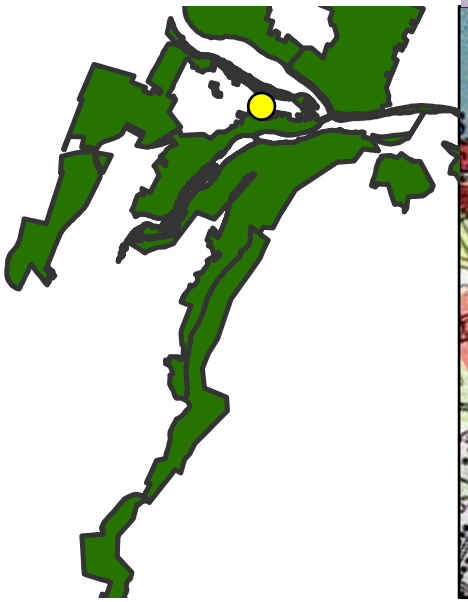
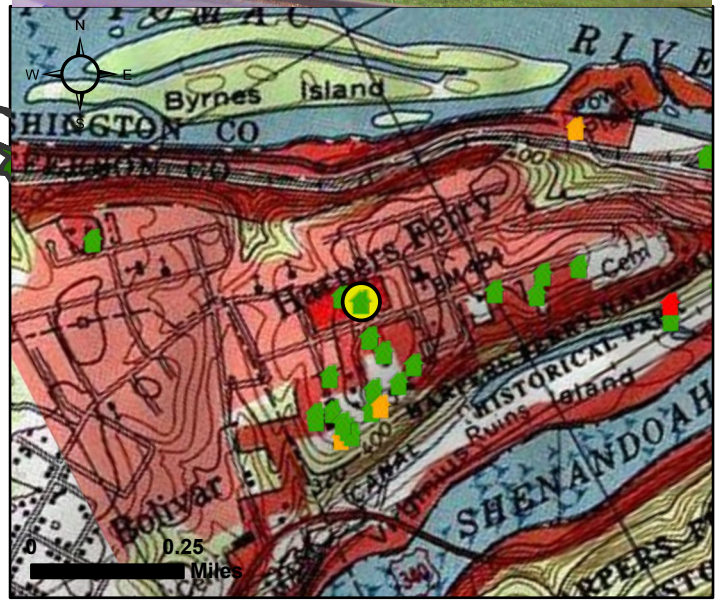
Facility Name: B75 - Freewill Baptist Church
Unit - Location: HAFE - Harper's Ferry NHP
FMSS ID: 28547, ***Local ID:***
Structure Type, Use: Building, Administrative
Owner: National Park Service
Field Crew, Visit Date: CUGA WFM, May 20, 2015
Coordinates (DDM): 39° 19.50801468' N 077° 44.46096696' W

Rating: Low
ProtectionLevel: Not Designated,
Resources of Concern: Unknown
Occupied: Yes
In Community: Yes,
Revisit Interval: yrs
Map Label: 77

Primary Access: Road
Ingress Egress: 2 or more roads in/out
Access Width: 2 lanes (Greater than 24')
Access Condition: Surfaced-paved, gradeLess than 5%
Bridge Condition: Less than 300 ft with turnaround
Access and Turnarounds: Less than 300 ft with turnaround
Facility Number or Sign: Marked and clearly visible
Fuel Type: Grass/tundra,northern hardwood litter
Fuel Load: Light or no wildland fuels
Defensible Space: 100 ft treated
Topography: Slope 5% to 20%
Roof Material: Noncombustible or not applicable
Siding Material: Rock, concrete, metal
Foundation: Closed, Greater than 30in masonry exposed or N/A
Firewood: None
Water Supply: Pressurized hydrant(s) or fixed sprinkler system
Propane: None
Overhead Hazards: No overhead hazards

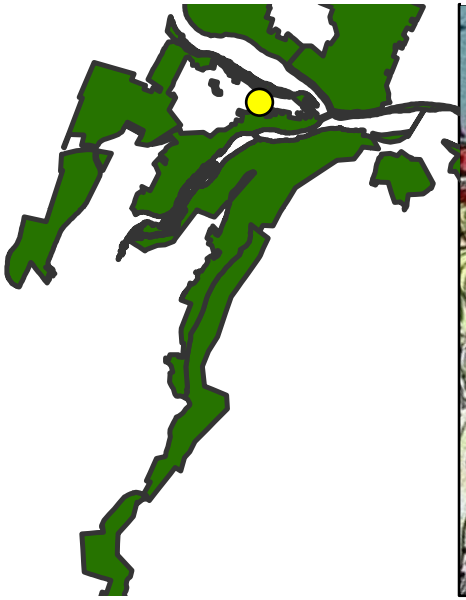
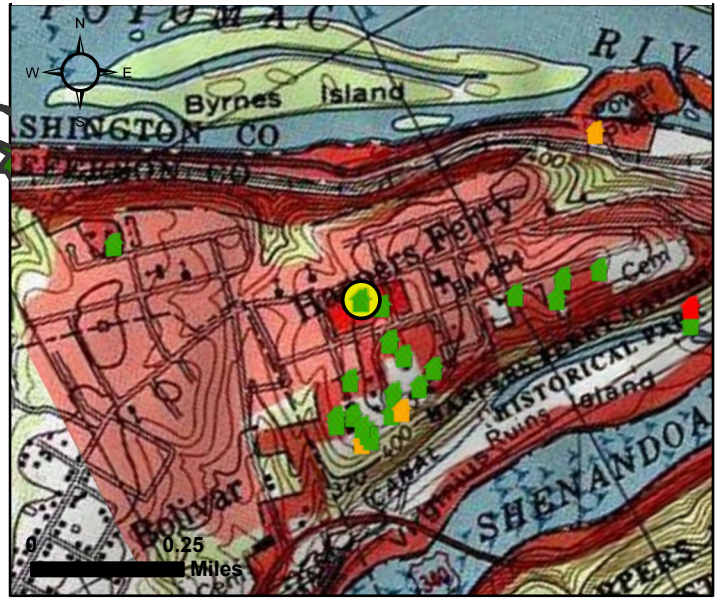
Facility Name: Camp Hill Shipley School
Unit - Location: HAFE - Harper's Ferry NHP
FMSS ID: 3775, ***Local ID:***
Structure Type, Use: Building, Administrative
Owner: National Park Service
Field Crew, Visit Date: CUGA WFM, May 20, 2015
Coordinates (DDM): 39° 19.52580942' N 077° 44.48561940' W

Rating: Low
ProtectionLevel: Not Designated,
Resources of Concern: Unknown
Occupied: No
In Community: Yes,
Revisit Interval: yrs
Map Label: 72

Primary Access: Road
Ingress Egress: 2 or more roads in/out
Access Width: 2 lanes (Greater than 24')
Access Condition: Surfaced-paved, gradeLess than 5%
Bridge Condition: Less than 300 ft with turnaround
Access and Turnarounds: Less than 300 ft with turnaround
Facility Number or Sign: Marked and clearly visible
Fuel Type: Grass/tundra,northern hardwood litter
Fuel Load: Light or no wildland fuels
Defensible Space: 100 ft treated
Topography: Slope 5% to 20%
Roof Material: Fire resistant- tar,rubberized
Siding Material: Rock, concrete, metal
Foundation: Closed, Greater than 30in masonry exposed or N/A
Firewood: None
Water Supply: Pressurized hydrant(s) or fixed sprinkler system
Propane: None
Overhead Hazards: No overhead hazards

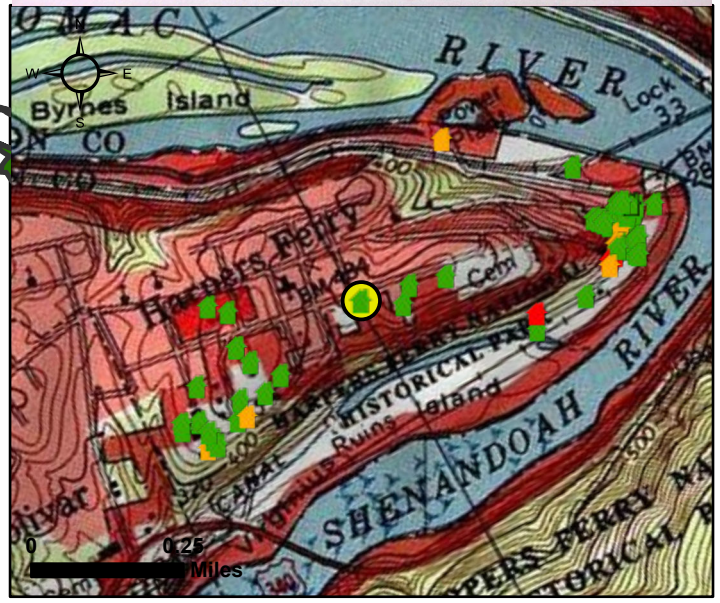
Facility Name: B58 Morrell house
Unit - Location: HAFE - Harper's Ferry NHP
FMSS ID: 1005, ***Local ID:***
Structure Type, Use: Building, Administrative
Owner: National Park Service
Field Crew, Visit Date: CUGA WFM, May 20, 2015
Coordinates (DDM): 39° 19.44372594' N 077° 44.26240878' W

Rating: Low
ProtectionLevel: Not Designated,
Resources of Concern: Unknown
Occupied: Yes
In Community: Yes, John Brownandapos;s Fort
Revisit Interval: 5 yrs
Map Label: 84

Primary Access: Road
Ingress Egress: 2 or more roads in/out
Access Width: 2 lanes (Greater than 24')
Access Condition: Surfaced-paved, gradeLess than 5%
Bridge Condition: Less than 300 ft with turnaround
Access and Turnarounds: Less than 300 ft with turnaround
Facility Number or Sign: Marked and clearly visible
Fuel Type: Grass/tundra,northern hardwood litter
Fuel Load: Light or no wildland fuels
Defensible Space: 30 ft treated
Topography: Slope 31% to 40%
Roof Material: Fire resistant- tar,rubberized
Siding Material: Rock, concrete, metal
Foundation: Open or deck
Firewood: None
Water Supply: Pressurized hydrant(s) or fixed sprinkler system
Propane: None
Overhead Hazards: No overhead hazards

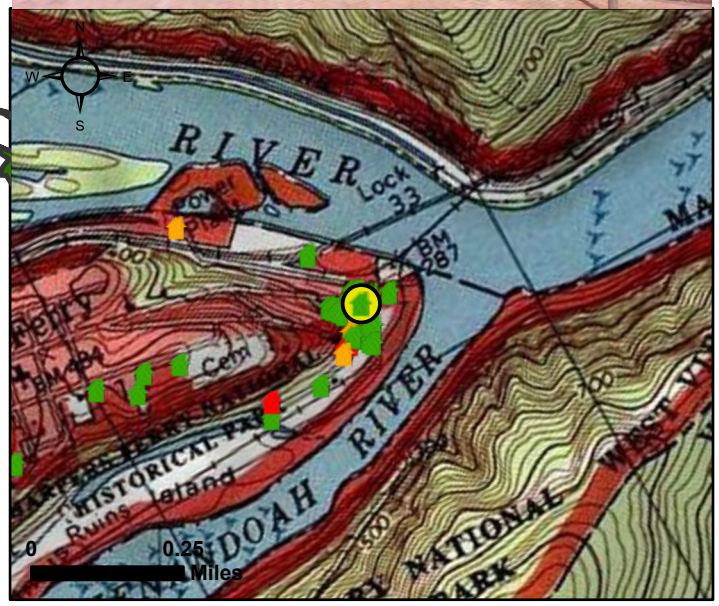
Rating: Low
ProtectionLevel: Not Designated,
Resources of Concern: Unknown
Occupied: Yes
In Community: Yes, John Brownandapos;s Fort
Revisit Interval: yrs
Map Label: 56

Primary Access: Road
Ingress Egress: 1 road in/out
Access Width: 1.5 lanes (Greater than 18')
Access Condition: Surfaced-paved, gradeGreater than 5%
Bridge Condition: Less than 300 ft with turnaround
Access and Turnarounds: Less than 300 ft with turnaround
Facility Number or Sign: Marked and clearly visible
Fuel Type: Grass/tundra,northern hardwood litter
Fuel Load: Light or no wildland fuels
Defensible Space: 30 ft treated
Topography: Slope Greater than 40%
Roof Material: Noncombustible or not applicable
Siding Material: Rock, concrete, metal
Foundation: Open or deck
Firewood: None
Water Supply: Pressurized hydrant(s) or fixed sprinkler system
Propane: None
Overhead Hazards: No overhead hazards

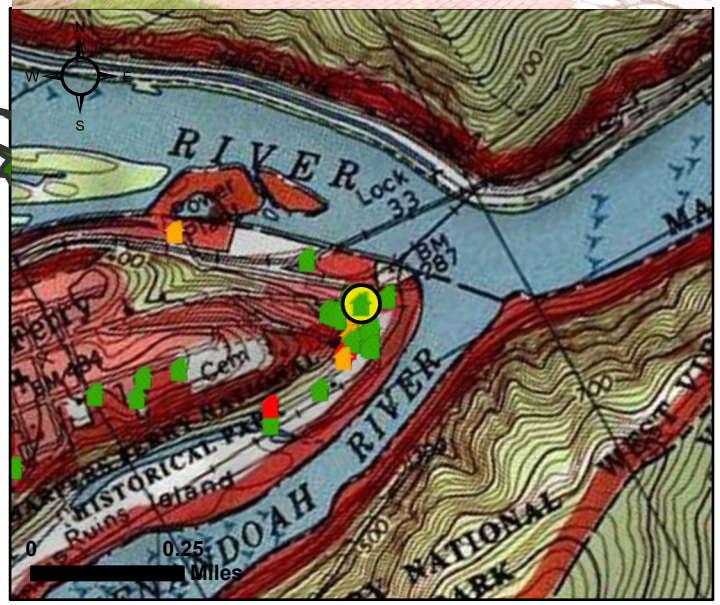
Facility Name: B11A - Anderson Annes
Unit - Location: HAFE - Harper's Ferry NHP
FMSS ID: 35966, ***Local ID:***
Structure Type, Use: Building, Administrative
Owner: National Park Service
Field Crew, Visit Date: CUGA WFM, May 20, 2015
Coordinates (DDM): 39° 19.39006758' N 077° 43.81666566' W

Rating: Low
ProtectionLevel: Not Designated,
Resources of Concern: Unknown
Occupied: Yes
In Community: Yes, John Brownandapos;s Fort
Revisit Interval: yrs
Map Label: 59

Primary Access: Road
Ingress Egress: 1 road in/out
Access Width: 1.5 lanes (Greater than 18')
Access Condition: Surfaced-paved, gradeGreater than 5%
Bridge Condition: Less than 300 ft with turnaround
Access and Turnarounds: Less than 300 ft with turnaround
Facility Number or Sign: Marked and clearly visible
Fuel Type: Grass/tundra,northern hardwood litter
Fuel Load: Light or no wildland fuels
Defensible Space: 30 ft treated
Topography: Slope Greater than 40%
Roof Material: Noncombustible or not applicable
Siding Material: Rock, concrete, metal
Foundation: Open or deck
Firewood: Adjacent to/under deck of facility
Water Supply: Pressurized hydrant(s) or fixed sprinkler system
Propane: None
Overhead Hazards: No overhead hazards

Comments: From FMSS_Export - FRPP_PREDUSE: Bldg. Museum Repository (GSF)
