NPS Wildfire Risk Assessments
Assessment Locations

Harpers Ferry National Historical Park - Overview

NPS Wildfire Risk Assessment Project

HAFE - Harpers Ferry National Historical Park

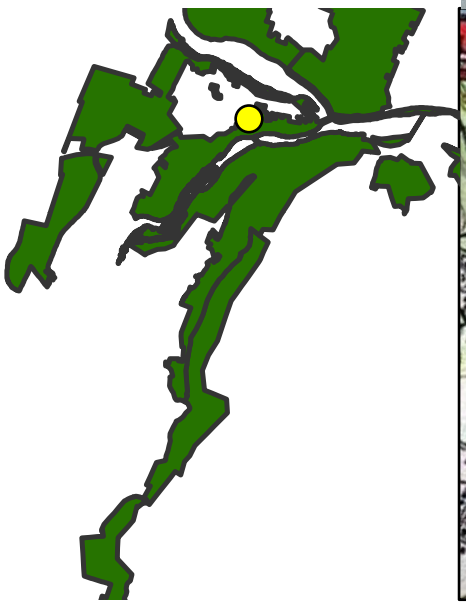
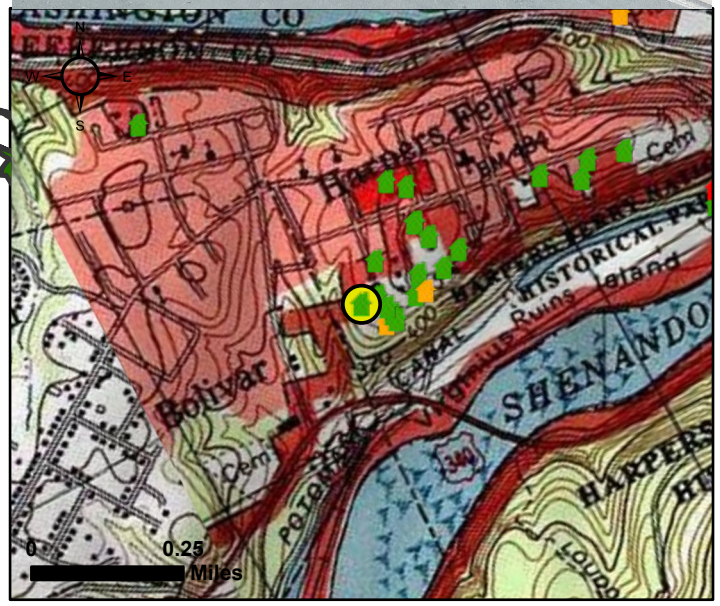
Facility Name: Salt Bin Shed Maintenance Yard
Unit - Location: HAFE - Harper's Ferry NHP
FMSS ID: 228520, ***Local ID:***
Structure Type, Use: Building, Administrative
Owner: National Park Service
Field Crew, Visit Date: NCR FIRE, March 8, 2023
Coordinates (DDM): 39° 19.404' N 77° 44.612' W

Rating: Low
ProtectionLevel: Not Designated,
Resources of Concern: Unknown
Occupied: No
In Community: Yes,
Revisit Interval: 5 yrs
Map Label: 4

Primary Access: Road
Ingress Egress: 2 or more roads in/out
Access Width: 2 lanes (Greater than 24')
Access Condition: Surfaced-paved, gradeLess than 5%
Bridge Condition: Less than 300 ft with turnaround
Access and Turnarounds: Less than 300 ft with turnaround
Facility Number or Sign: Marked and clearly visible
Fuel Type: Grass and shrub, hardwood litter
Fuel Load: Light or no wildland fuels
Defensible Space: 30 ft treated
Topography: Slope Greater than 40%
Roof Material: Noncombustible or not applicable
Siding Material: Wood or open sided
Foundation: Closed, Greater than 30in masonry exposed or N/A
Firewood: None
Water Supply: Pressurized hydrant(s) or fixed sprinkler system
Propane: None
Overhead Hazards: No overhead hazards
Comments:

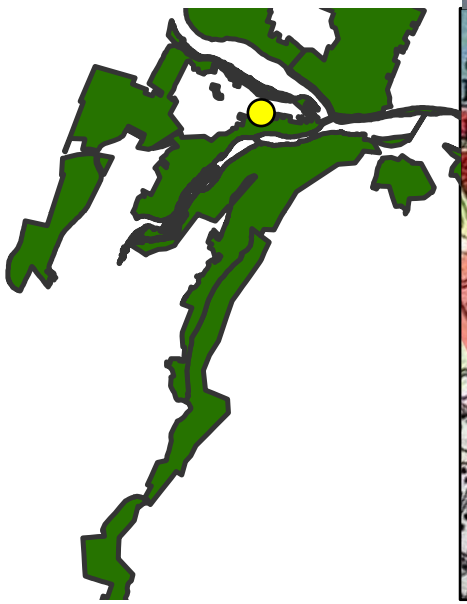
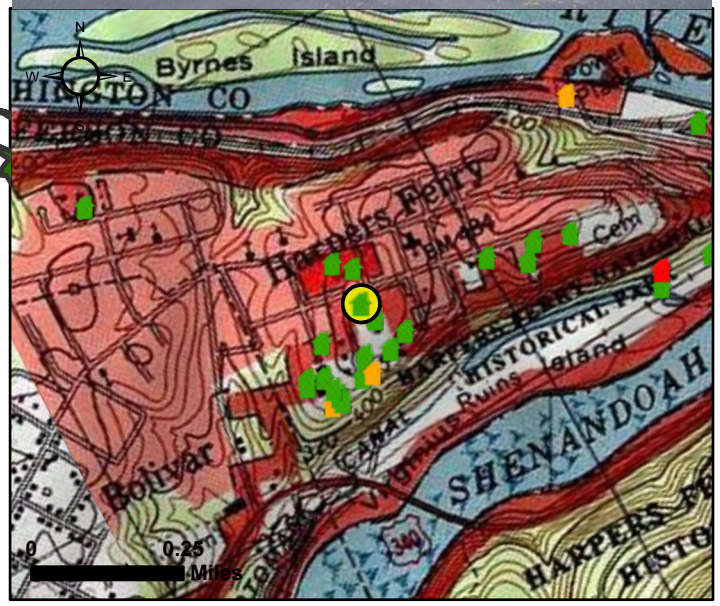
Rating: Low
ProtectionLevel: Not Designated,
Resources of Concern: Unknown
Occupied: Yes
In Community: Yes,
Revisit Interval: yrs
Map Label: 73

Primary Access: Road
Ingress Egress: 2 or more roads in/out
Access Width: 2 lanes (Greater than 24')
Access Condition: Surfaced-paved, gradeLess than 5%
Bridge Condition: Less than 300 ft with turnaround
Access and Turnarounds: Less than 300 ft with turnaround
Facility Number or Sign: Marked and clearly visible
Fuel Type: Grass/tundra,northern hardwood litter
Fuel Load: Light or no wildland fuels
Defensible Space: Greater than 100ft treated
Topography: Slope 21% to 30%
Roof Material: Noncombustible or not applicable
Siding Material: Rock, concrete, metal
Foundation: Closed, Greater than 30in masonry exposed or N/A
Firewood: None
Water Supply: Pressurized hydrant(s) or fixed sprinkler system
Propane: None
Overhead Hazards: No overhead hazards

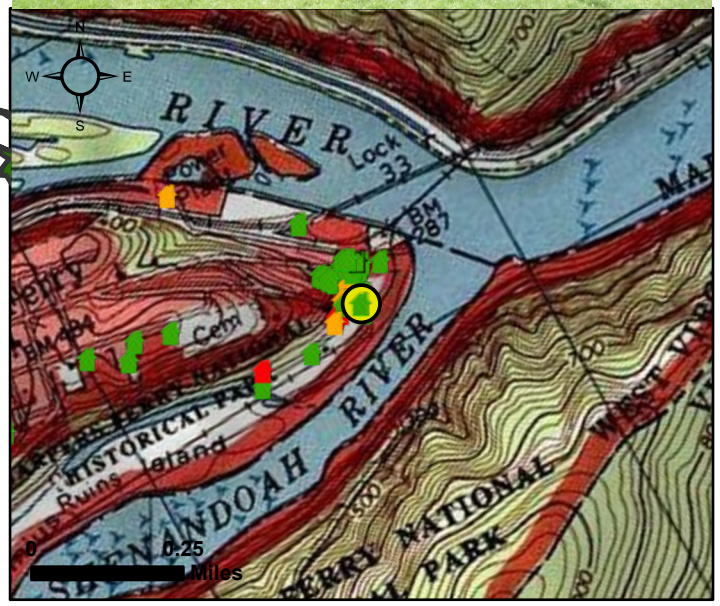
Facility Name: B34A - Smokehouse
Unit - Location: HAFE - Harper's Ferry NHP
FMSS ID: 35335, ***Local ID:***
Structure Type, Use: Building, Administrative
Owner: National Park Service
Field Crew, Visit Date: J shedd, October 12, 2022
Coordinates (DDM): 39° 19.34647020' N 077° 43.83170304' W

Rating: Low
ProtectionLevel: Not Designated,
Resources of Concern: Unknown
Occupied: No
In Community: Yes, John Brownandapos;s Fort
Revisit Interval: 5 yrs
Map Label: 49

Primary Access: Road
Ingress Egress: 2 or more roads in/out
Access Width: 1.5 lanes (Greater than 18')
Access Condition: Surfaced-paved, gradeGreater than 5%
Bridge Condition: Less than 300 ft with turnaround
Access and Turnarounds: Less than 300 ft with turnaround
Facility Number or Sign: Marked and clearly visible
Fuel Type: Grass and shrub, hardwood litter
Fuel Load: Light or no wildland fuels
Defensible Space: 100 ft treated
Topography: Slope 5% to 20%
Roof Material: Noncombustible or not applicable
Siding Material: Rock, concrete, metal
Foundation: Closed, Greater than 30in masonry exposed or N/A
Firewood: None
Water Supply: Pressurized hydrant(s) or fixed sprinkler system
Propane: None
Overhead Hazards: No overhead hazards
Comments:

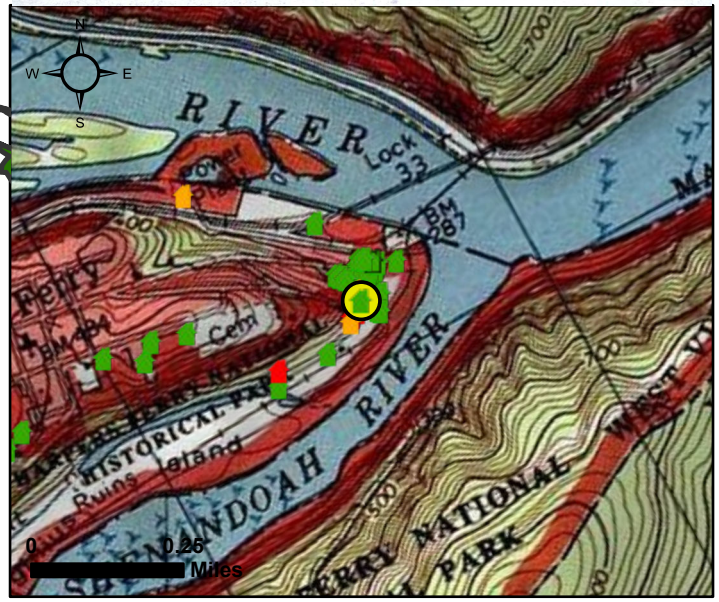
Facility Name: B43 - McCabemarmion Building (Industry Exhibit)
Unit - Location: HAFE - Harper's Ferry NHP
FMSS ID: 35344, ***Local ID:***
Structure Type, Use: Building, Administrative
Owner: National Park Service
Field Crew, Visit Date: J shedd , October 12, 2022
Coordinates (DDM): 39° 19.35872484' N 077° 43.85235558' W

Rating: Low
ProtectionLevel: Not Designated,
Resources of Concern: Unknown
Occupied: No
In Community: Yes, John Brownandapos;s Fort
Revisit Interval: 5 yrs
Map Label: 36

Primary Access: Road
Ingress Egress: 2 or more roads in/out
Access Width: 1.5 lanes (Greater than 18')
Access Condition: Surfaced-paved, gradeGreater than 5%
Bridge Condition: Less than 300 ft with turnaround
Access and Turnarounds: Less than 300 ft with turnaround
Facility Number or Sign: Marked and clearly visible
Fuel Type: Grass and shrub, hardwood litter
Fuel Load: Light or no wildland fuels
Defensible Space: 30 ft treated
Topography: Slope Greater than 40%
Roof Material: Noncombustible or not applicable
Siding Material: Rock, concrete, metal
Foundation: Closed, Greater than 30in masonry exposed or N/A
Firewood: None
Water Supply: Pressurized hydrant(s) or fixed sprinkler system
Propane: None
Overhead Hazards: No overhead hazards
Comments:

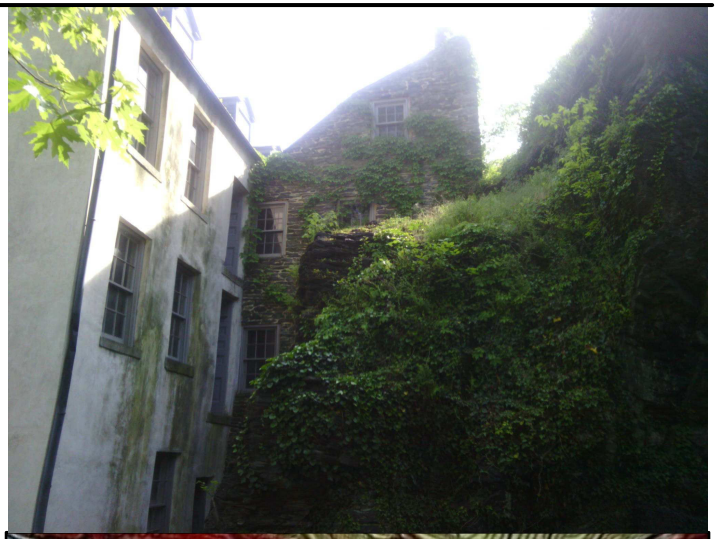
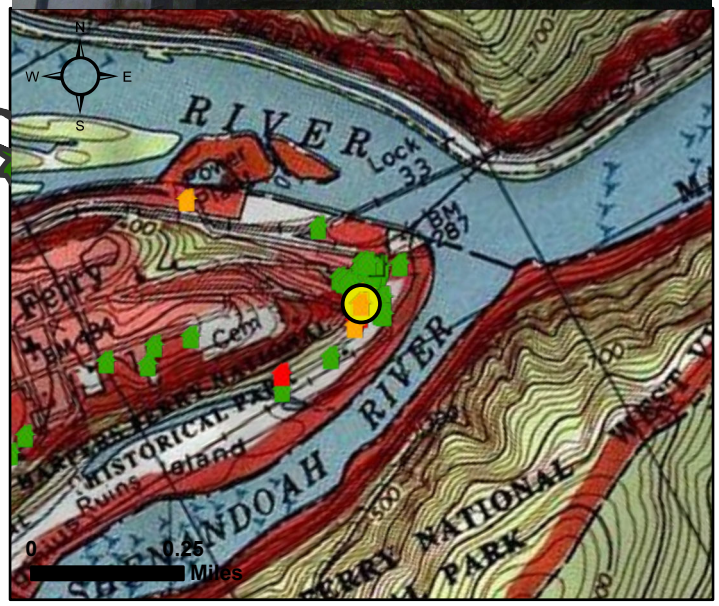
Facility Name: B43A - Cooling Tower
Unit - Location: HAFE - Harper's Ferry NHP
FMSS ID: 35345, ***Local ID:***
Structure Type, Use: Building, Administrative
Owner: National Park Service
Field Crew, Visit Date: J shedd, October 12, 2022
Coordinates (DDM): 39° 19.36099866' N 077° 43.85719812' W

Rating: Moderate
ProtectionLevel: Not Designated,
Resources of Concern: Unknown
Occupied: No
In Community: Yes, John Brownandapos;s Fort
Revisit Interval: 5 yrs
Map Label: 34

Primary Access: Road
Ingress Egress: 2 or more roads in/out
Access Width: 1.5 lanes (Greater than 18')
Access Condition: Surfaced-paved, gradeGreater than 5%
Bridge Condition: Less than 300 ft with turnaround
Access and Turnarounds: Less than 300 ft with turnaround
Facility Number or Sign: Marked and clearly visible
Fuel Type: Grass and shrub, hardwood litter
Fuel Load: Light or no wildland fuels
Defensible Space: No defensible space
Topography: Slope Greater than 40%
Roof Material: Noncombustible or not applicable
Siding Material: Rock, concrete, metal
Foundation: Closed, Greater than 30in masonry exposed or N/A
Firewood: None
Water Supply: Pressurized hydrant(s) or fixed sprinkler system
Propane: None
Overhead Hazards: No overhead hazards

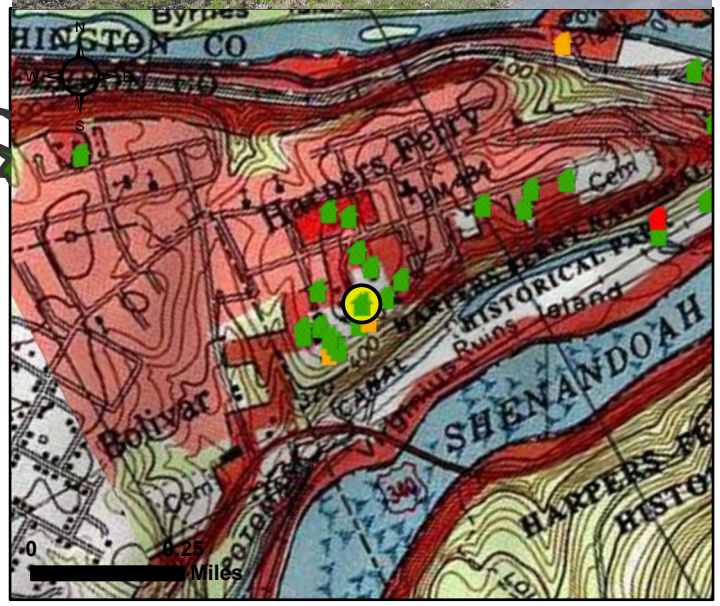
Facility Name: B64 - Anthony Library
Unit - Location: HAFE - Harper's Ferry NHP
FMSS ID: 28548, ***Local ID:***
Structure Type, Use: Building, Administrative
Owner: National Park Service
Field Crew, Visit Date: NCR Fire, March 8, 2023
Coordinates (DDM): 39° 19.404' N 77° 44.508' W

Rating: Low
ProtectionLevel: Not Designated,
Resources of Concern: Unknown
Occupied: Yes
In Community: Yes,
Revisit Interval: 5 yrs
Map Label: 71

Primary Access: Road
Ingress Egress: 2 or more roads in/out
Access Width: 1.5 lanes (Greater than 18')
Access Condition: Surfaced-paved, gradeLess than 5%
Bridge Condition: Less than 300 ft with turnaround
Access and Turnarounds: Less than 300 ft with turnaround
Facility Number or Sign: Marked and clearly visible
Fuel Type: Grass/tundra,northern hardwood litter
Fuel Load: Light or no wildland fuels
Defensible Space: Greater than 100ft treated
Topography: Slope 21% to 30%
Roof Material: Fire resistant- tar,rubberized
Siding Material: Rock, concrete, metal
Foundation: Closed, Greater than 30in masonry exposed or N/A
Firewood: None
Water Supply: Pressurized hydrant(s) or fixed sprinkler system
Propane: None
Overhead Hazards: No overhead hazards

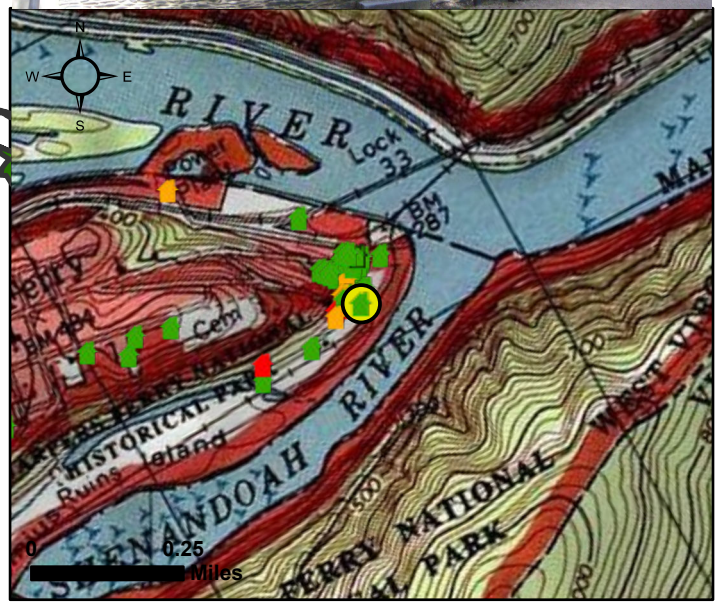
Facility Name: B33A
Unit - Location: HAFE - Harper's Ferry NHP
FMSS ID: 3731, ***Local ID:***
Structure Type, Use: Building, Public
Owner: National Park Service
Field Crew, Visit Date: J shedd, October 12, 2022
Coordinates (DDM): 39° 19.34011152' N 077° 43.83628290' W

Rating: Low
ProtectionLevel: Not Designated,
Resources of Concern: Unknown
Occupied: No
In Community: Yes, John Brownandapos;s Fort
Revisit Interval: 5 yrs
Map Label: 44

Primary Access: Road
Ingress Egress: 2 or more roads in/out
Access Width: 1.5 lanes (Greater than 18')
Access Condition: Surfaced-paved, gradeGreater than 5%
Bridge Condition: Less than 300 ft with turnaround
Access and Turnarounds: Less than 300 ft with turnaround
Facility Number or Sign: Marked and clearly visible
Fuel Type: Grass and shrub, hardwood litter
Fuel Load: Light or no wildland fuels
Defensible Space: 100 ft treated
Topography: Slope 5% to 20%
Roof Material: Combination of fire resisitant and combustible
Siding Material: Rock, concrete, metal
Foundation: Closed, Greater than 30in masonry exposed or N/A
Firewood: None
Water Supply: Pressurized hydrant(s) or fixed sprinkler system
Propane: None
Overhead Hazards: No overhead hazards

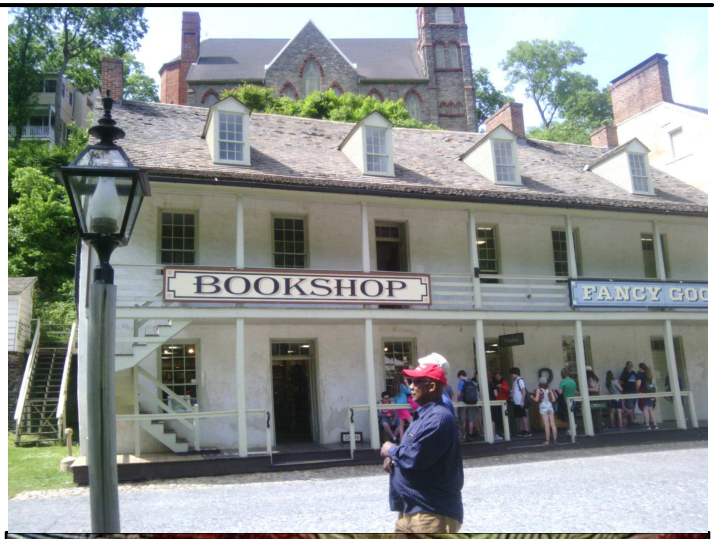
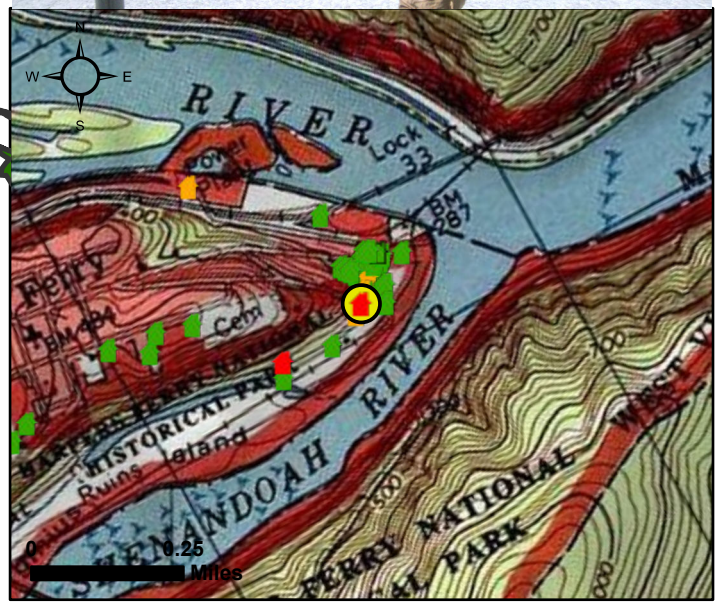
Facility Name: B45 - Bookstore
Unit - Location: HAFE - Harper's Ferry NHP
FMSS ID: 3739, ***Local ID:***
Structure Type, Use: Building, Public
Owner: National Park Service
Field Crew, Visit Date: J shedd , October 12, 2022
Coordinates (DDM): 39° 19.34891550' N 077° 43.86790896' W

Rating: High
ProtectionLevel: Not Designated,
Resources of Concern: Unknown
Occupied: Yes
In Community: Yes, John Brownandapos;s Fort
Revisit Interval: 5 yrs
Map Label: 29

Primary Access: Road
Ingress Egress: 2 or more roads in/out
Access Width: 1.5 lanes (Greater than 18')
Access Condition: Surfaced-paved, gradeGreater than 5%
Bridge Condition: Less than 300 ft with turnaround
Access and Turnarounds: Less than 300 ft with turnaround
Facility Number or Sign: Marked and clearly visible
Fuel Type: Grass and shrub, hardwood litter
Fuel Load: Light or no wildland fuels
Defensible Space: Less than 30 ft treated
Topography: Slope Greater than 40%
Roof Material: Combustible or no roof
Siding Material: Rock, concrete, metal
Foundation: Closed, Greater than 30in masonry exposed or N/A
Firewood: None
Water Supply: Pressurized hydrant(s) or fixed sprinkler system
Propane: None
Overhead Hazards: No overhead hazards
Comments:

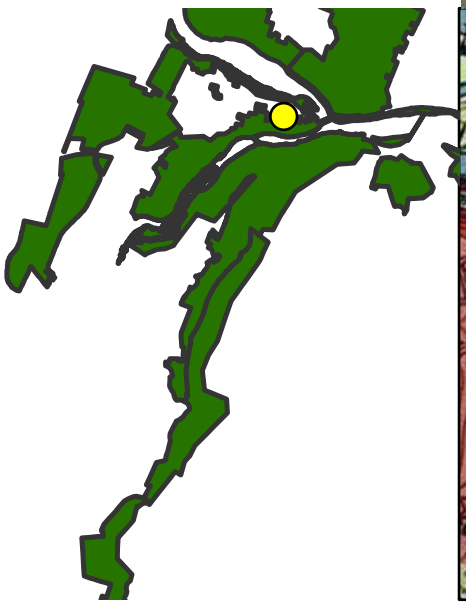
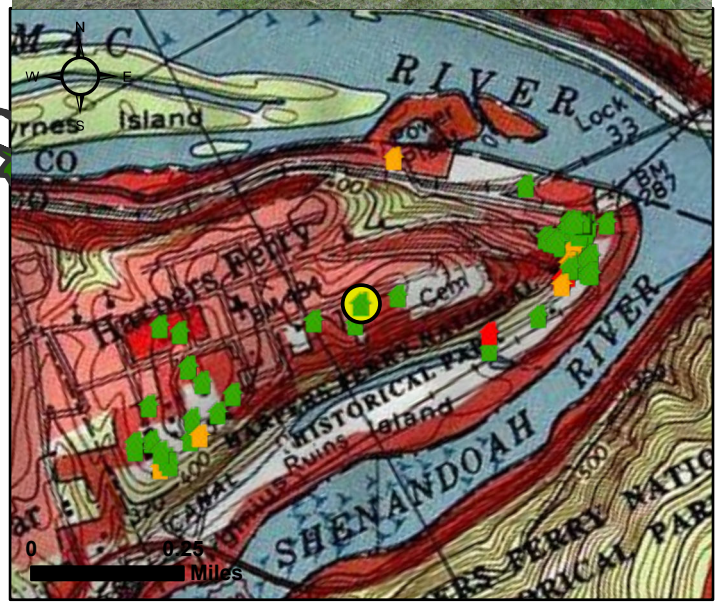
Facility Name: B57 Brackett House
Unit - Location: HAFE - Harper's Ferry NHP
FMSS ID: 28546, ***Local ID:***
Structure Type, Use: Building, Administrative
Owner: National Park Service
Field Crew, Visit Date: CUGA WFM, May 20, 2015
Coordinates (DDM): 39° 19.43440296' N 077° 44.18243796' W

Rating: Low
ProtectionLevel: Not Designated,
Resources of Concern: Unknown
Occupied: Yes
In Community: Yes, John Brownandapos;s Fort
Revisit Interval: 5 yrs
Map Label: 86

Primary Access: Road
Ingress Egress: 2 or more roads in/out
Access Width: 2 lanes (Greater than 24')
Access Condition: Surfaced-paved, gradeLess than 5%
Bridge Condition: Less than 300 ft with turnaround
Access and Turnarounds: Less than 300 ft with turnaround
Facility Number or Sign: Marked and clearly visible
Fuel Type: Grass/tundra,northern hardwood litter
Fuel Load: Light or no wildland fuels
Defensible Space: Greater than 100ft treated
Topography: Slope 31% to 40%
Roof Material: Fire resistant- tar,rubberized
Siding Material: Rock, concrete, metal
Foundation: Closed, Greater than 30in masonry exposed or N/A
Firewood: None
Water Supply: Pressurized hydrant(s) or fixed sprinkler system
Propane: None
Overhead Hazards: No overhead hazards

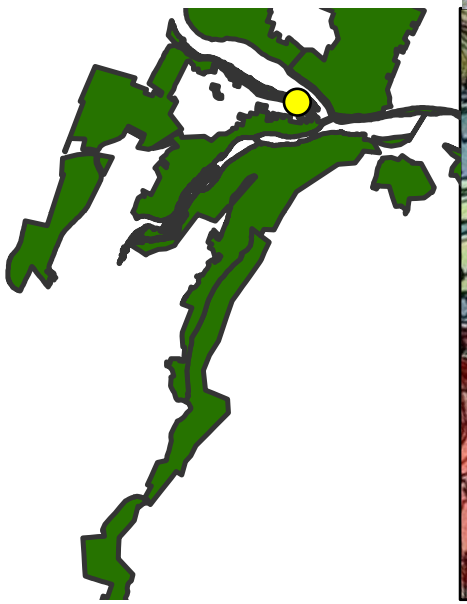
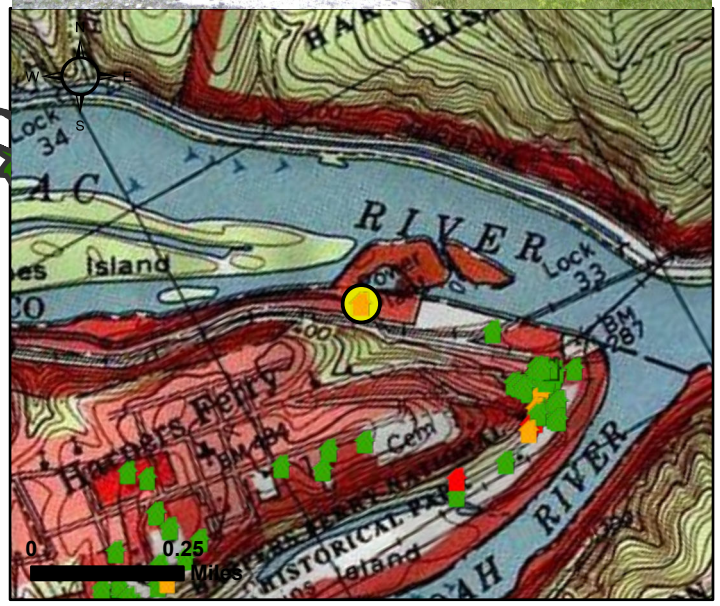
Facility Name: MF03 - Musket Factory; Rolling Mill Power Palnt
Unit - Location: HAFE - Harper's Ferry NHP
FMSS ID: 39960, ***Local ID:***
Structure Type, Use: Building, Administrative
Owner: National Park Service
Field Crew, Visit Date: CUGA WFM, May 20, 2015
Coordinates (DDM): 39° 19.57718616' N 077° 44.02817016' W

Rating: Moderate
ProtectionLevel: Not Designated,
Resources of Concern: Unknown
Occupied: No
In Community: No, John Brownandapos;s Fort
Revisit Interval: yrs
Map Label: 20

Primary Access: Road
Ingress Egress: 1 road in/out
Access Width: 1 lane (Less than 18')
Access Condition: Surfaced-paved, gradeLess than 5%
Bridge Condition: Less than 300 ft with no turnaround
Access and Turnarounds: Less than 300 ft with no turnaround
Facility Number or Sign: None or not clearly visible
Fuel Type: Grass and shrub, hardwood litter
Fuel Load: Light or no wildland fuels
Defensible Space: 30 ft treated
Topography: Slope 5% to 20%
Roof Material: Noncombustible or not applicable
Siding Material: Rock, concrete, metal
Foundation: Open or deck
Firewood: None
Water Supply: Reliable water source nearby
Propane: None
Overhead Hazards: No overhead hazards

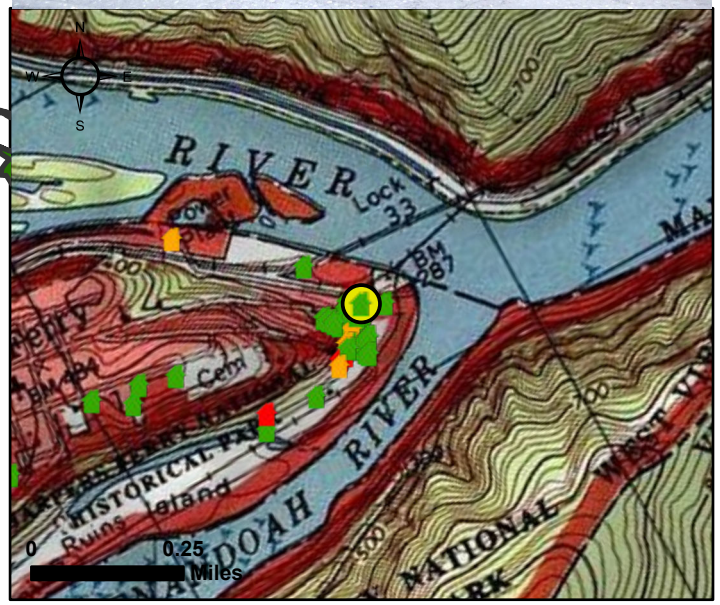
Facility Name: B8 Gerard Bond Wager Annex
Unit - Location: HAFE - Harper's Ferry NHP
FMSS ID: 34012, ***Local ID:***
Structure Type, Use: Building, Public
Owner: National Park Service
Field Crew, Visit Date: CUGA WFM, May 20, 2015
Coordinates (DDM): 39° 19.39622298' N 077° 43.80641760' W

Rating: Low
ProtectionLevel: Not Designated,
Resources of Concern: Unknown
Occupied: No
In Community: Yes, John Brownandapos;s Fort
Revisit Interval: yrs
Map Label: 62

Primary Access: Road
Ingress Egress: 1 road in/out
Access Width: 1.5 lanes (Greater than 18')
Access Condition: Surfaced-paved, gradeGreater than 5%
Bridge Condition: Less than 300 ft with turnaround
Access and Turnarounds: Less than 300 ft with turnaround
Facility Number or Sign: Marked and clearly visible
Fuel Type: Grass and shrub, hardwood litter
Fuel Load: Light or no wildland fuels
Defensible Space: 30 ft treated
Topography: Slope 31% to 40%
Roof Material: Noncombustible or not applicable
Siding Material: Rock, concrete, metal
Foundation: Closed, 6in to 30in masonry exposed
Firewood: None
Water Supply: Pressurized hydrant(s) or fixed sprinkler system
Propane: None
Overhead Hazards: No overhead hazards

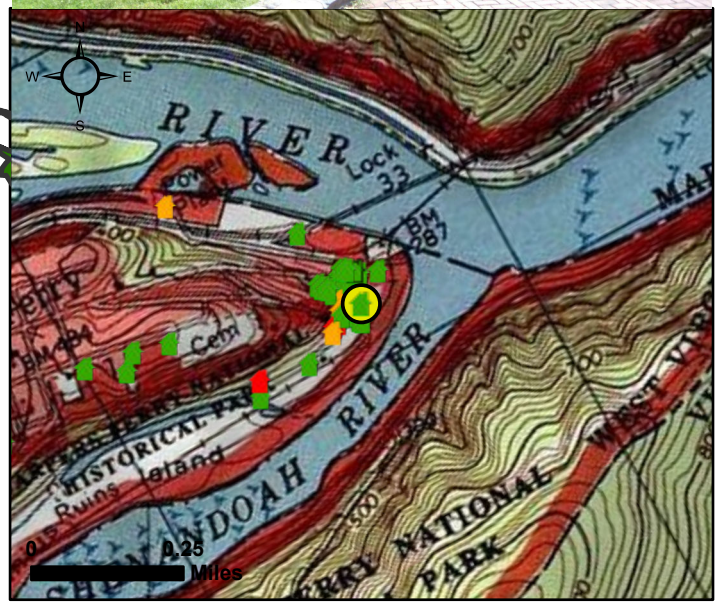
Facility Name: Q-00000036 H36 Quarters
Unit - Location: HAFE - Harper's Ferry NHP
FMSS ID: 3787, ***Local ID:***
Structure Type, Use: Building, Administrative
Owner: National Park Service
Field Crew, Visit Date: J shedd, October 12, 2022
Coordinates (DDM): 39° 19.35621936' N 077° 43.82126442' W

Rating: Low
ProtectionLevel: Not Designated,
Resources of Concern: Unknown
Occupied: Yes
In Community: Yes, John Brownandapos;s Fort
Revisit Interval: 5 yrs
Map Label: 55

Primary Access: Road
Ingress Egress: 2 or more roads in/out
Access Width: 1.5 lanes (Greater than 18')
Access Condition: Surfaced-paved, gradeGreater than 5%
Bridge Condition: Less than 300 ft with turnaround
Access and Turnarounds: Less than 300 ft with turnaround
Facility Number or Sign: Marked and clearly visible
Fuel Type: Grass and shrub, hardwood litter
Fuel Load: Light or no wildland fuels
Defensible Space: 100 ft treated
Topography: Slope 5% to 20%
Roof Material: Noncombustible or not applicable
Siding Material: Rock, concrete, metal
Foundation: Closed, 6in to 30in masonry exposed
Firewood: None
Water Supply: Pressurized hydrant(s) or fixed sprinkler system
Propane: None
Overhead Hazards: No overhead hazards
Comments: Upstairs

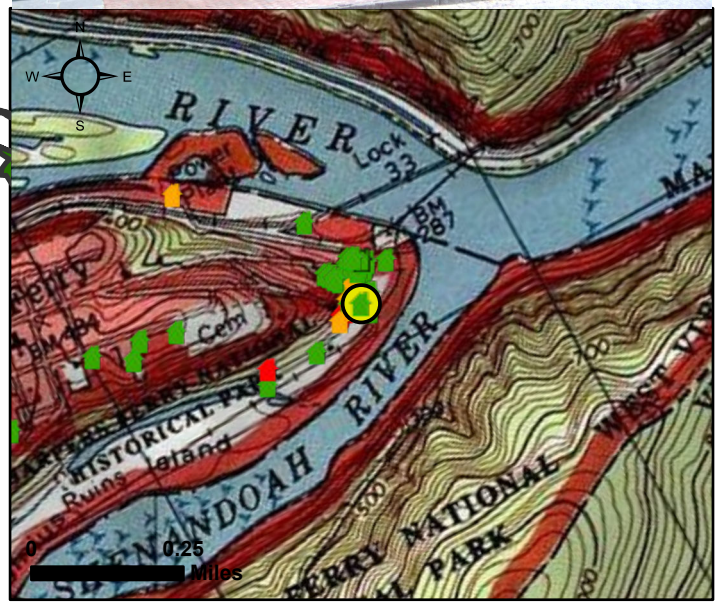
Facility Name: B33 - Ranger Headquarters and 33A
Unit - Location: HAFE - Harper's Ferry NHP
FMSS ID: 3731, ***Local ID:***
Structure Type, Use: Building, Public
Owner: National Park Service
Field Crew, Visit Date: J shedd , October 12, 2022
Coordinates (DDM): 39° 19.34787768' N 077° 43.83981666' W

Rating: Low
ProtectionLevel: Not Designated,
Resources of Concern: Unknown
Occupied: No
In Community: Yes, John Brownandapos;s Fort
Revisit Interval: 5 yrs
Map Label: 38

Primary Access: Road
Ingress Egress: 2 or more roads in/out
Access Width: 1.5 lanes (Greater than 18')
Access Condition: Surfaced-paved, gradeGreater than 5%
Bridge Condition: Less than 300 ft with turnaround
Access and Turnarounds: Less than 300 ft with turnaround
Facility Number or Sign: Marked and clearly visible
Fuel Type: Grass and shrub, hardwood litter
Fuel Load: Light or no wildland fuels
Defensible Space: 100 ft treated
Topography: Slope 5% to 20%
Roof Material: Noncombustible or not applicable
Siding Material: Rock, concrete, metal
Foundation: Closed, Greater than 30in masonry exposed or N/A
Firewood: None
Water Supply: Pressurized hydrant(s) or fixed sprinkler system
Propane: None
Overhead Hazards: No overhead hazards
Comments:

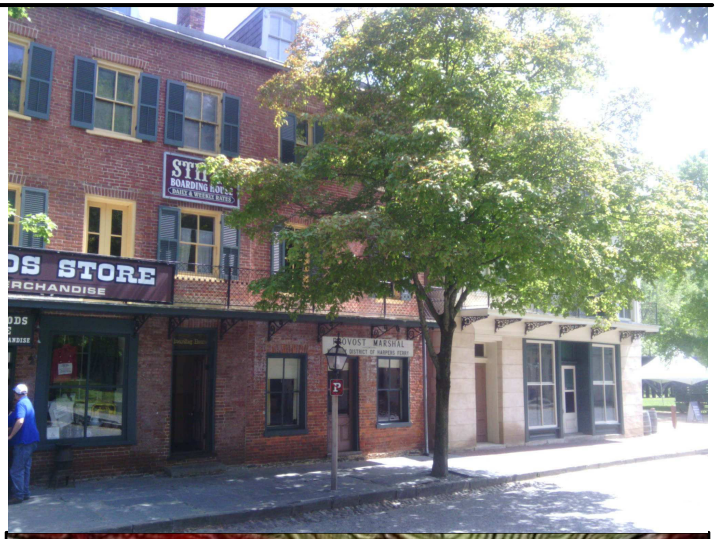
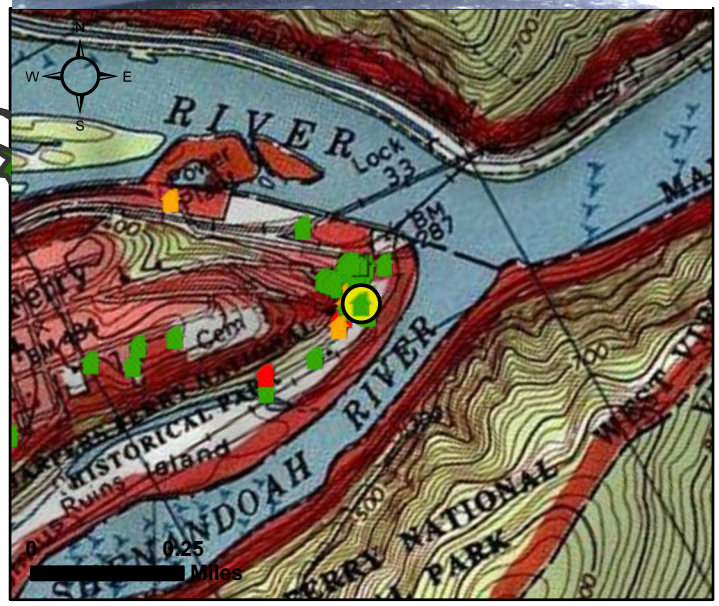
Facility Name: B34 - Provost Marshels Office
Unit - Location: HAFE - Harper's Ferry NHP
FMSS ID: 3732, ***Local ID:***
Structure Type, Use: Building, Public
Owner: National Park Service
Field Crew, Visit Date: J shedd, October 12, 2022
Coordinates (DDM): 39° 19.35248286' N 077° 43.83434148' W

Rating: Low
ProtectionLevel: Not Designated,
Resources of Concern: Unknown
Occupied: No
In Community: Yes, John Brownandapos;s Fort
Revisit Interval: 5 yrs
Map Label: 45

Primary Access: Road
Ingress Egress: 2 or more roads in/out
Access Width: 1.5 lanes (Greater than 18')
Access Condition: Surfaced-paved, gradeGreater than 5%
Bridge Condition: Less than 300 ft with turnaround
Access and Turnarounds: Less than 300 ft with turnaround
Facility Number or Sign: Marked and clearly visible
Fuel Type: Grass and shrub, hardwood litter
Fuel Load: Light or no wildland fuels
Defensible Space: 100 ft treated
Topography: Slope 5% to 20%
Roof Material: Noncombustible or not applicable
Siding Material: Rock, concrete, metal
Foundation: Closed, Greater than 30in masonry exposed or N/A
Firewood: None
Water Supply: Pressurized hydrant(s) or fixed sprinkler system
Propane: None
Overhead Hazards: No overhead hazards
Comments:

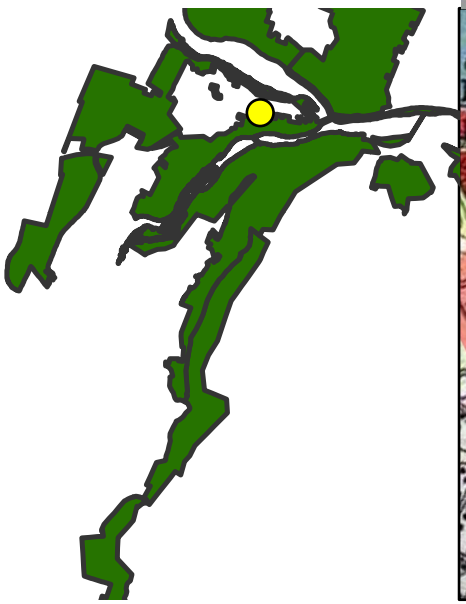
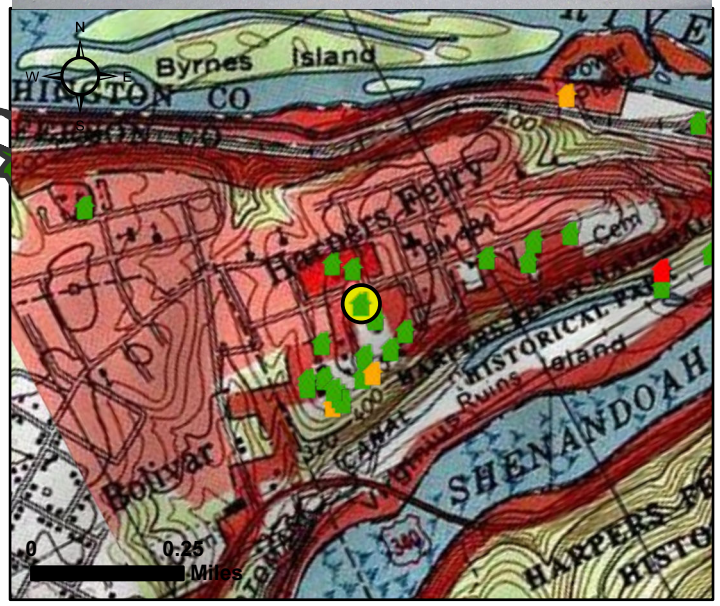
Facility Name: B81 Bomb Shelter Entrance
Unit - Location: HAFE - Harper's Ferry NHP
FMSS ID: 28550, ***Local ID:***
Structure Type, Use: Building, Administrative
Owner: National Park Service
Field Crew, Visit Date: CUGA WFM, May 20, 2015
Coordinates (DDM): 39° 19.46403564' N 077° 44.47487178' W

Rating: Low
ProtectionLevel: Not Designated,
Resources of Concern: Unknown
Occupied: Yes
In Community: Yes,
Revisit Interval: yrs
Map Label: 73

Primary Access: Road
Ingress Egress: 2 or more roads in/out
Access Width: 2 lanes (Greater than 24')
Access Condition: Surfaced-paved, gradeLess than 5%
Bridge Condition: Less than 300 ft with turnaround
Access and Turnarounds: Less than 300 ft with turnaround
Facility Number or Sign: Marked and clearly visible
Fuel Type: Grass/tundra,northern hardwood litter
Fuel Load: Light or no wildland fuels
Defensible Space: Greater than 100ft treated
Topography: Slope 21% to 30%
Roof Material: Noncombustible or not applicable
Siding Material: Rock, concrete, metal
Foundation: Closed, Greater than 30in masonry exposed or N/A
Firewood: None
Water Supply: Pressurized hydrant(s) or fixed sprinkler system
Propane: None
Overhead Hazards: No overhead hazards

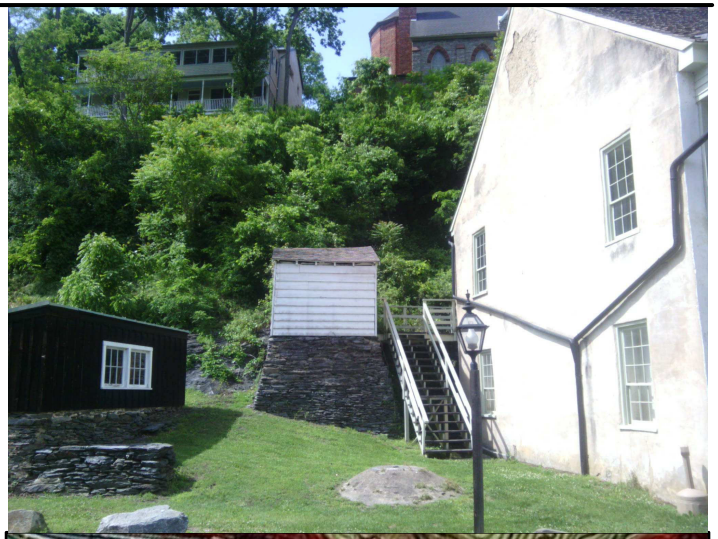
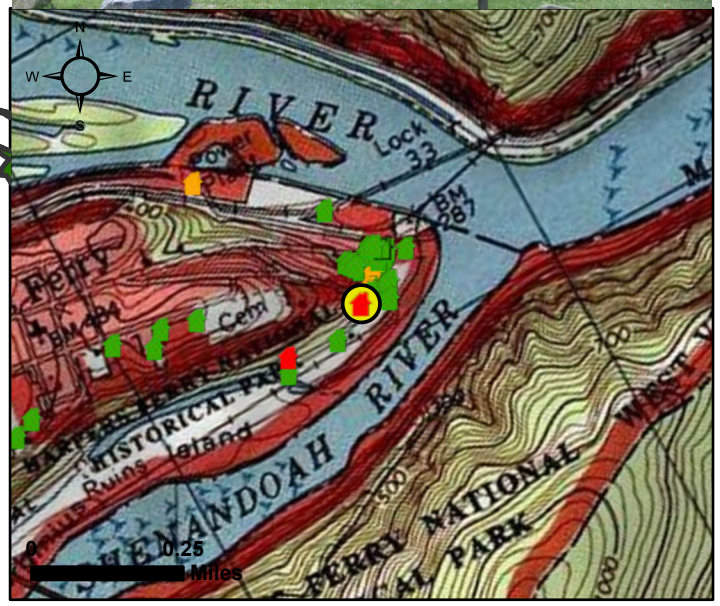
Facility Name: B45A - Outhouse
Unit - Location: HAFE - Harper's Ferry NHP
FMSS ID: 3741, ***Local ID:***
Structure Type, Use: Building, Administrative
Owner: National Park Service
Field Crew, Visit Date: J shedd, October 12, 2022
Coordinates (DDM): 39° 19.34634834' N 077° 43.87825800' W

Rating: High
ProtectionLevel: Not Designated,
Resources of Concern: Unknown
Occupied: No
In Community: Yes, John Brownandapos;s Fort
Revisit Interval: 5 yrs
Map Label: 27

Primary Access: Road
Ingress Egress: 2 or more roads in/out
Access Width: 1.5 lanes (Greater than 18')
Access Condition: Surfaced-paved, gradeGreater than 5%
Bridge Condition: Less than 300 ft with turnaround
Access and Turnarounds: Less than 300 ft with turnaround
Facility Number or Sign: None or not clearly visible
Fuel Type: Grass and shrub, hardwood litter
Fuel Load: Light or no wildland fuels
Defensible Space: Less than 30 ft treated
Topography: Slope Greater than 40%
Roof Material: Combustible or no roof
Siding Material: Wood or open sided
Foundation: Closed, Greater than 30in masonry exposed or N/A
Firewood: None
Water Supply: Pressurized hydrant(s) or fixed sprinkler system
Propane: None
Overhead Hazards: No overhead hazards
Comments:

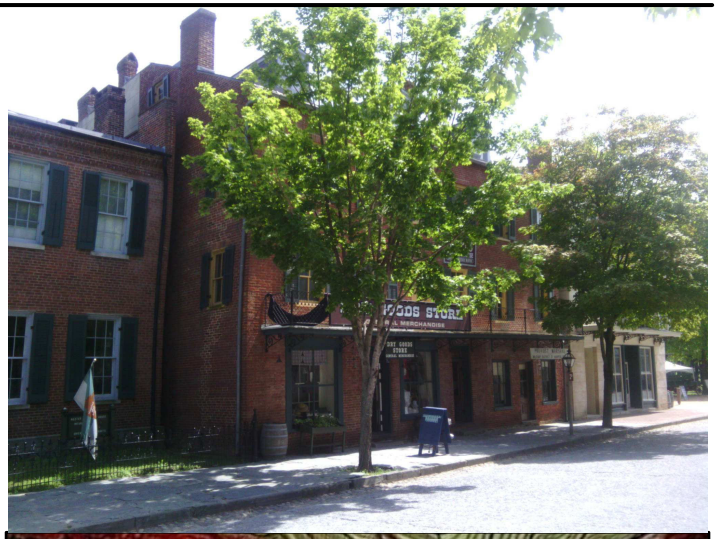
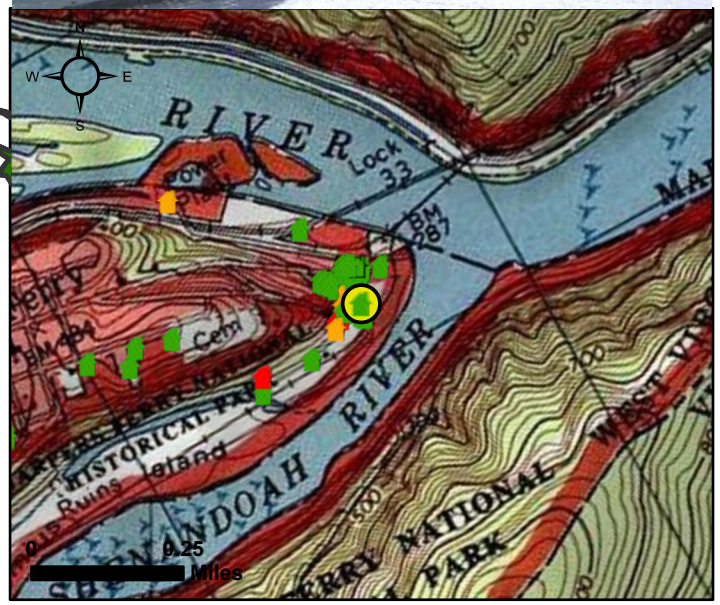
Facility Name: B35 - Dry Goods Store
Unit - Location: HAFE - Harper's Ferry NHP
FMSS ID: 35337, ***Local ID:***
Structure Type, Use: Building, Administrative
Owner: National Park Service
Field Crew, Visit Date: J shedd , October 12, 2022
Coordinates (DDM): 39° 19.35270090' N 077° 43.82821092' W

Rating: Low
ProtectionLevel: Not Designated,
Resources of Concern: Unknown
Occupied: No
In Community: Yes, John Brownandapos;s Fort
Revisit Interval: 5 yrs
Map Label: 53

Primary Access: Road
Ingress Egress: 2 or more roads in/out
Access Width: 1.5 lanes (Greater than 18')
Access Condition: Surfaced-paved, gradeGreater than 5%
Bridge Condition: Less than 300 ft with turnaround
Access and Turnarounds: Less than 300 ft with turnaround
Facility Number or Sign: Marked and clearly visible
Fuel Type: Grass and shrub, hardwood litter
Fuel Load: Light or no wildland fuels
Defensible Space: 100 ft treated
Topography: Slope 5% to 20%
Roof Material: Noncombustible or not applicable
Siding Material: Rock, concrete, metal
Foundation: Closed, Greater than 30in masonry exposed or N/A
Firewood: None
Water Supply: Pressurized hydrant(s) or fixed sprinkler system
Propane: None
Overhead Hazards: No overhead hazards
Comments:

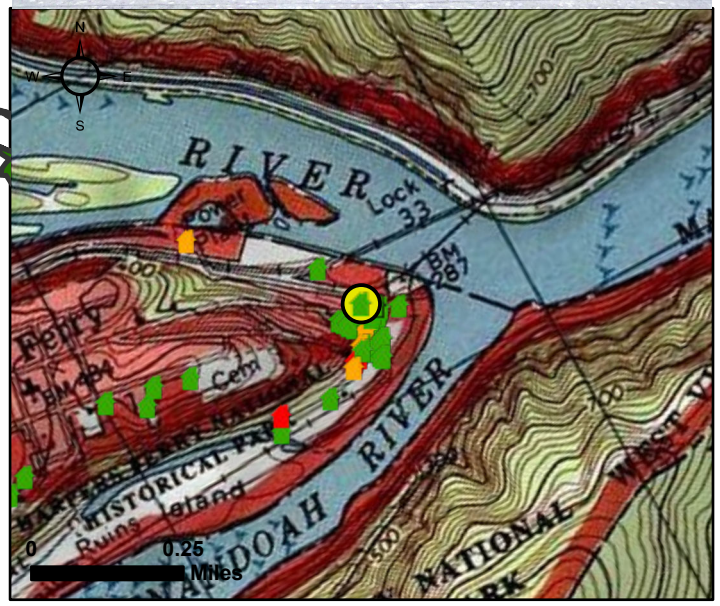
Facility Name: B5 - Frederick A Roeder Store
Unit - Location: HAFE - Harper's Ferry NHP
FMSS ID: 33998, ***Local ID:***
Structure Type, Use: Building, Public
Owner: National Park Service
Field Crew, Visit Date: CUGA WFM, May 20, 2015
Coordinates (DDM): 39° 19.40682882' N 077° 43.82540508' W

Rating: Low
ProtectionLevel: Not Designated,
Resources of Concern: Unknown
Occupied: Yes
In Community: Yes, John Brownandapos;s Fort
Revisit Interval: yrs
Map Label: 54

Primary Access: Road
Ingress Egress: 1 road in/out
Access Width: 1.5 lanes (Greater than 18')
Access Condition: Surfaced-paved, gradeGreater than 5%
Bridge Condition: Less than 300 ft with turnaround
Access and Turnarounds: Less than 300 ft with turnaround
Facility Number or Sign: Marked and clearly visible
Fuel Type: Grass/tundra,northern hardwood litter
Fuel Load: Light or no wildland fuels
Defensible Space: 100 ft treated
Topography: Slope 31% to 40%
Roof Material: Noncombustible or not applicable
Siding Material: Rock, concrete, metal
Foundation: Closed, Greater than 30in masonry exposed or N/A
Firewood: None
Water Supply: Pressurized hydrant(s) or fixed sprinkler system
Propane: None
Overhead Hazards: No overhead hazards

Comments: From FMSS_Export - FRPP_PREDUSE: Bldg. Shed/Outbuilding (GSF)

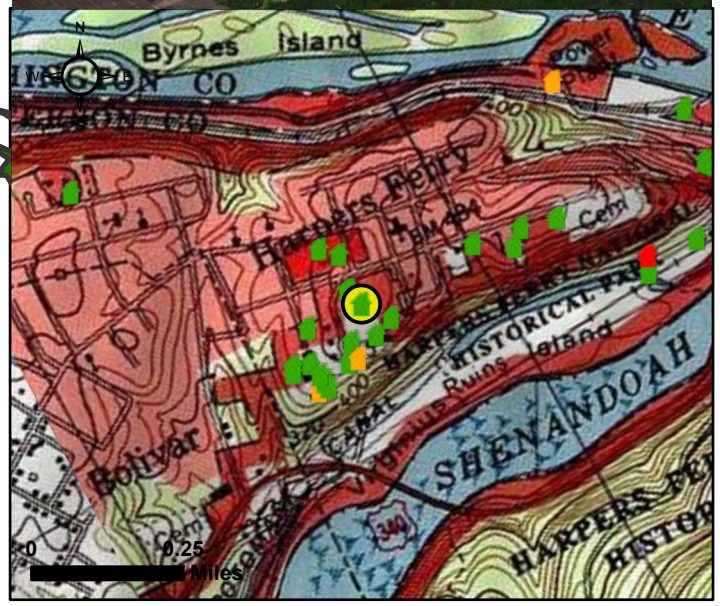
Facility Name: B59 - Mather Training Center
Unit - Location: HAFE - Harper's Ferry NHP
FMSS ID: 1028, ***Local ID:***
Structure Type, Use: Building, Administrative
Owner: National Park Service
Field Crew, Visit Date: CUGA WFM, May 20, 2015
Coordinates (DDM): 39° 19.43981328' N 077° 44.46598692' W

Rating: Low
ProtectionLevel: Not Designated,
Resources of Concern: Unknown
Occupied: Yes
In Community: Yes,
Revisit Interval: yrs
Map Label: 76

Primary Access: Road
Ingress Egress: 2 or more roads in/out
Access Width: 2 lanes (Greater than 24')
Access Condition: Surfaced-paved, gradeLess than 5%
Bridge Condition: Less than 300 ft with turnaround
Access and Turnarounds: Less than 300 ft with turnaround
Facility Number or Sign: Marked and clearly visible
Fuel Type: Grass/tundra,northern hardwood litter
Fuel Load: Light or no wildland fuels
Defensible Space: Greater than 100ft treated
Topography: Slope 21% to 30%
Roof Material: Noncombustible or not applicable
Siding Material: Rock, concrete, metal
Foundation: Closed, Greater than 30in masonry exposed or N/A
Firewood: None
Water Supply: Pressurized hydrant(s) or fixed sprinkler system
Propane: None
Overhead Hazards: No overhead hazards
Comments: From FMSS_Export - FRPP_PREDUSE:

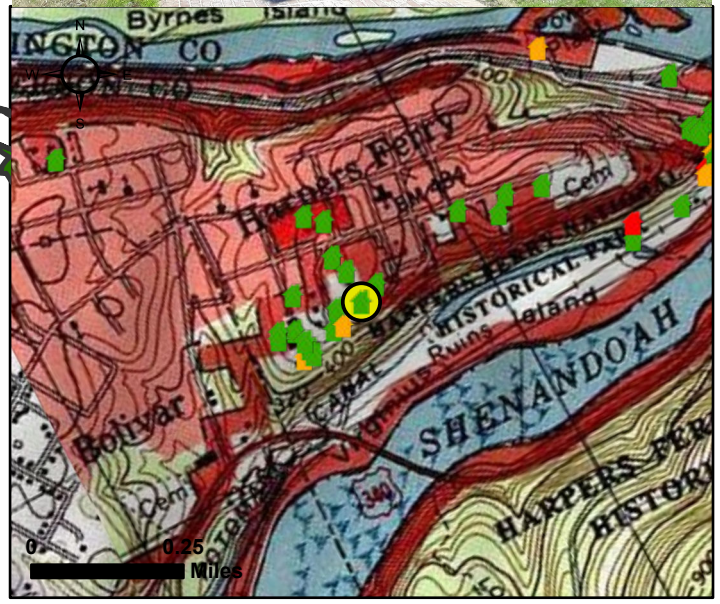
Facility Name: B83 - Interpretive Design Center
Unit - Location: HAFE - Harper's Ferry NHP
FMSS ID: 28551, ***Local ID:***
Structure Type, Use: Building, Administrative
Owner: National Park Service
Field Crew, Visit Date: NCR Fire, March 8, 2023
Coordinates (DDM): 39° 19.397' N 77° 44.467' W

Rating: Low
ProtectionLevel: Not Designated,
Resources of Concern: Unknown
Occupied: Yes
In Community: Yes, John Brownandapos;s Fort
Revisit Interval: 5 yrs
Map Label: 75

Primary Access: Road
Ingress Egress: 2 or more roads in/out
Access Width: 1.5 lanes (Greater than 18')
Access Condition: Surfaced-paved, gradeLess than 5%
Bridge Condition: Less than 300 ft with turnaround
Access and Turnarounds: Less than 300 ft with turnaround
Facility Number or Sign: Marked and clearly visible
Fuel Type: Grass and shrub, hardwood litter
Fuel Load: Moderate
Defensible Space: 30 ft treated
Topography: Slope Greater than 40%
Roof Material: Fire resistant- tar,rubberized
Siding Material: Rock, concrete, metal
Foundation: Closed, Greater than 30in masonry exposed or N/A
Firewood: None
Water Supply: Pressurized hydrant(s) or fixed sprinkler system
Propane: None
Overhead Hazards: No overhead hazards

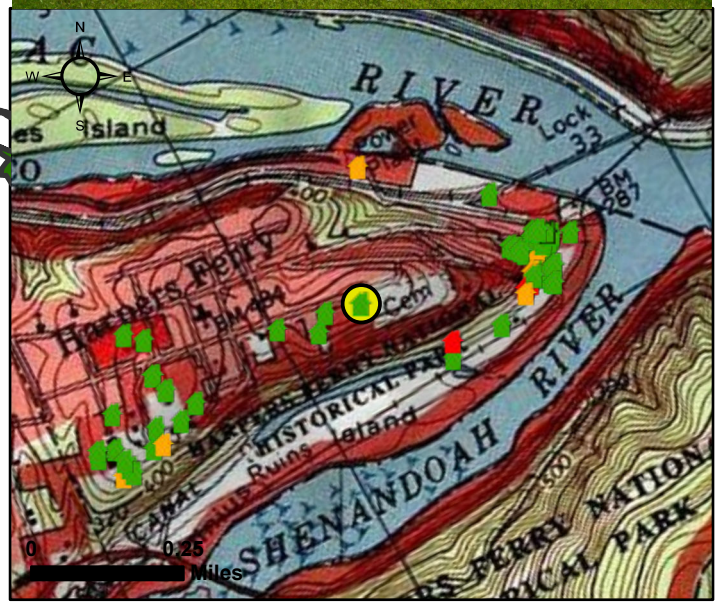
Rating: Low
ProtectionLevel: Not Designated,
Resources of Concern: Unknown
Occupied: No
In Community: Yes, John Brownandapos;s Fort
Revisit Interval: 5 yrs
Map Label: 87

Primary Access: Road
Ingress Egress: 2 or more roads in/out
Access Width: 2 lanes (Greater than 24')
Access Condition: Surfaced-paved, gradeLess than 5%
Bridge Condition: Less than 300 ft with turnaround
Access and Turnarounds: Less than 300 ft with turnaround
Facility Number or Sign: Marked and clearly visible
Fuel Type: Grass and shrub, hardwood litter
Fuel Load: Light or no wildland fuels
Defensible Space: 100 ft treated
Topography: Slope Greater than 40%
Roof Material: Noncombustible or not applicable
Siding Material: Rock, concrete, metal
Foundation: Closed, Greater than 30in masonry exposed or N/A
Firewood: None
Water Supply: Pressurized hydrant(s) or fixed sprinkler system
Propane: None
Overhead Hazards: No overhead hazards

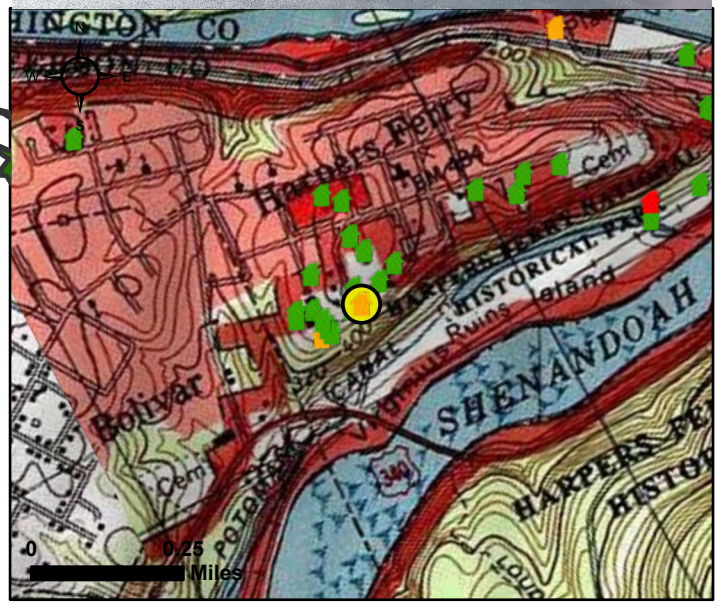
Facility Name: B69 - Bird Brady (IDC Asministration)
Unit - Location: HAFE - Harper's Ferry NHP
FMSS ID: 3749, ***Local ID:***
Structure Type, Use: Building, Administrative
Owner: National Park Service
Field Crew, Visit Date: NCR Fire, March 8, 2023
Coordinates (DDM): 39° 19.382' N 77° 44.510' W

Rating: Moderate
ProtectionLevel: Not Designated,
Resources of Concern: Unknown
Occupied: Yes
In Community: Yes,
Revisit Interval: 5 yrs
Map Label: 70

Primary Access: Road
Ingress Egress: 1 road in/out
Access Width: 1.5 lanes (Greater than 18')
Access Condition: Surfaced-paved, gradeLess than 5%
Bridge Condition: Less than 300 ft with turnaround
Access and Turnarounds: Less than 300 ft with turnaround
Facility Number or Sign: Marked and clearly visible
Fuel Type: Grass and shrub, hardwood litter
Fuel Load: Moderate
Defensible Space: Less than 30 ft treated
Topography: Slope Greater than 40%
Roof Material: Fire resistant- tar,rubberized
Siding Material: Rock, concrete, metal
Foundation: Closed, Less than 6in masonry exposed
Firewood: None
Water Supply: Pressurized hydrant(s) or fixed sprinkler system
Propane: None
Overhead Hazards: No overhead hazards

Comments: From FMSS_Export - FRPP_PREDUSE: Bldg. Office (GSF)

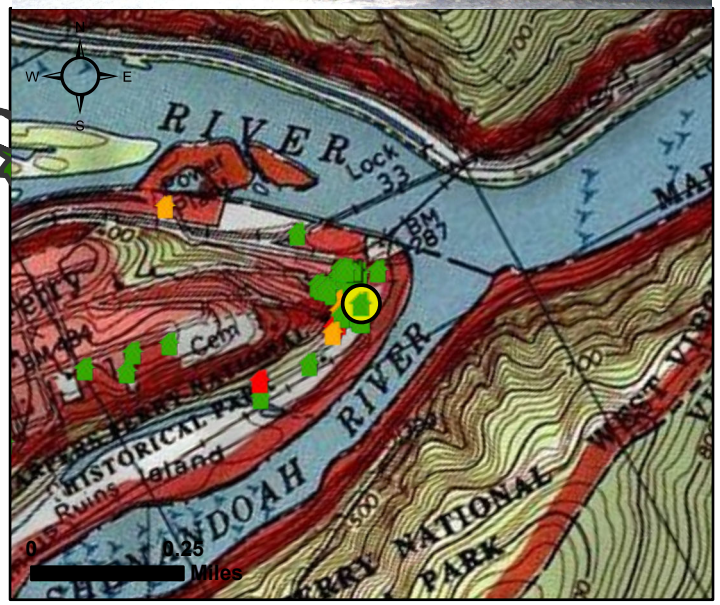
Rating: Low
ProtectionLevel: Not Designated,
Resources of Concern: Unknown
Occupied: Yes
In Community: Yes, John Brownandapos;s Fort
Revisit Interval: 5 yrs
Map Label: 57

Primary Access: Road
Ingress Egress: 1 road in/out
Access Width: 1.5 lanes (Greater than 18')
Access Condition: Surfaced-paved, gradeGreater than 5%
Bridge Condition: Less than 300 ft with turnaround
Access and Turnarounds: Less than 300 ft with turnaround
Facility Number or Sign: Marked and clearly visible
Fuel Type: Grass and shrub, hardwood litter
Fuel Load: Light or no wildland fuels
Defensible Space: 100 ft treated
Topography: Slope 31% to 40%
Roof Material: Noncombustible or not applicable
Siding Material: Rock, concrete, metal
Foundation:
Firewood:
Water Supply:
Propane:
Overhead Hazards:
Comments:

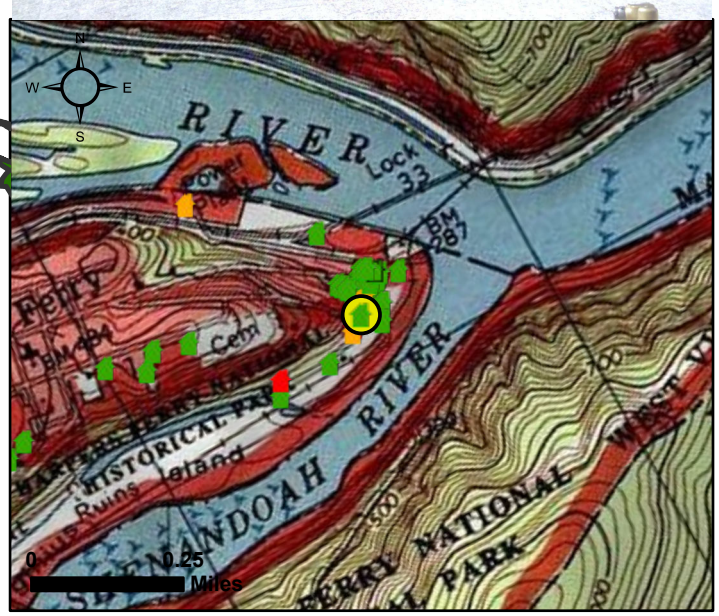
Rating: Low
ProtectionLevel: Not Designated,
Resources of Concern: Unknown
Occupied: Yes
In Community: Yes, John Brownandapos;s Fort
Revisit Interval: 5 yrs
Map Label: 33

Primary Access: Road
Ingress Egress: 2 or more roads in/out
Access Width: 1.5 lanes (Greater than 18')
Access Condition: Surfaced-paved, gradeGreater than 5%
Bridge Condition: Less than 300 ft with turnaround
Access and Turnarounds: Less than 300 ft with turnaround
Facility Number or Sign: Marked and clearly visible
Fuel Type: Grass and shrub, hardwood litter
Fuel Load: Light or no wildland fuels
Defensible Space: 30 ft treated
Topography: Slope Greater than 40%
Roof Material: Noncombustible or not applicable
Siding Material: Rock, concrete, metal
Foundation: Closed, Greater than 30in masonry exposed or N/A
Firewood: None
Water Supply: Pressurized hydrant(s) or fixed sprinkler system
Propane: None
Overhead Hazards: No overhead hazards
Comments:

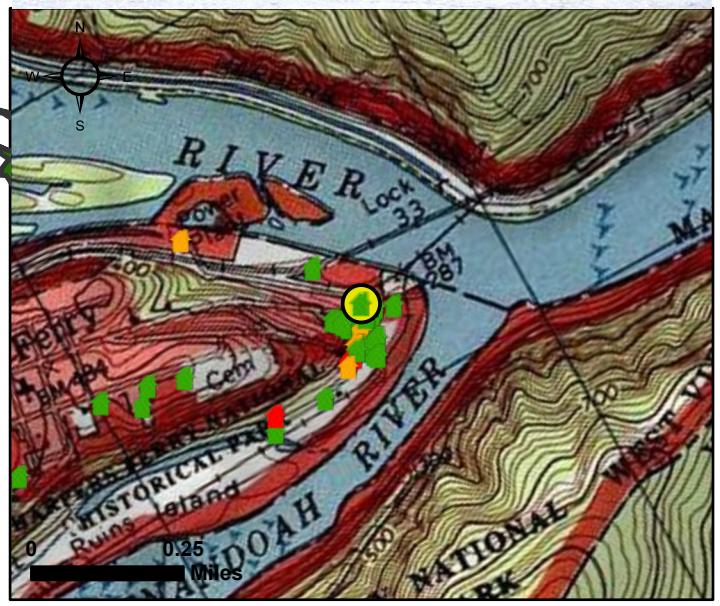
Facility Name: B7 - White Hall Tavern
Unit - Location: HAFE - Harper's Ferry NHP
FMSS ID: 3743, ***Local ID:***
Structure Type, Use: Building, Public
Owner: National Park Service
Field Crew, Visit Date: CUGA WFM, May 20, 2015
Coordinates (DDM): 39° 19.40328912' N 077° 43.81787520' W

Rating: Low
ProtectionLevel: Not Designated,
Resources of Concern: Unknown
Occupied: No
In Community: Yes, John Brownandapos;s Fort
Revisit Interval: yrs
Map Label: 58

Primary Access: Road
Ingress Egress: 1 road in/out
Access Width: 1.5 lanes (Greater than 18')
Access Condition: Surfaced-paved, gradeGreater than 5%
Bridge Condition: Less than 300 ft with turnaround
Access and Turnarounds: Less than 300 ft with turnaround
Facility Number or Sign: Marked and clearly visible
Fuel Type: Grass and shrub, hardwood litter
Fuel Load: Light or no wildland fuels
Defensible Space: 30 ft treated
Topography: Slope 31% to 40%
Roof Material: Noncombustible or not applicable
Siding Material: Rock, concrete, metal
Foundation: Closed, Greater than 30in masonry exposed or N/A
Firewood: None
Water Supply: Pressurized hydrant(s) or fixed sprinkler system
Propane: None
Overhead Hazards: No overhead hazards
