NPS Wildfire Risk Assessments
Assessment Locations

Harpers Ferry National Historical Park - Overview

NPS Wildfire Risk Assessment Project

HAFE - Harpers Ferry National Historical Park

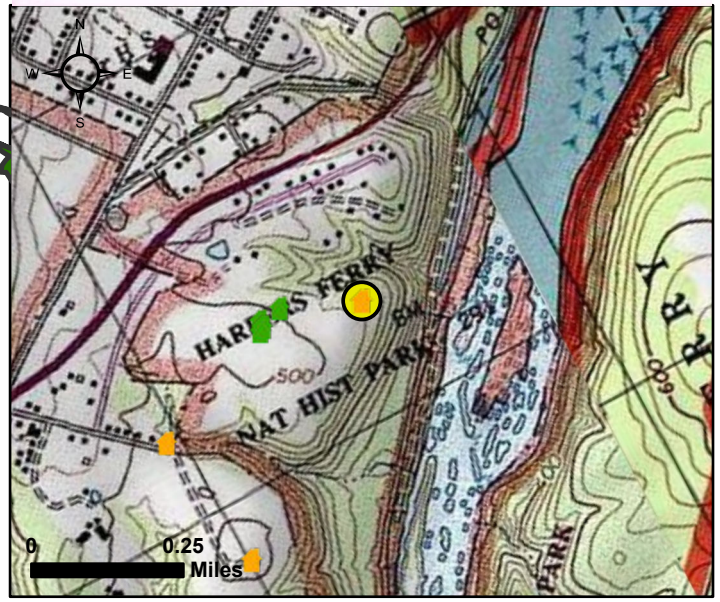
Rating: Moderate
ProtectionLevel: Full,
Resources of Concern: Unknown
Occupied: Yes
In Community: Yes,
Revisit Interval: 5 yrs
Map Label: 83

Primary Access: Road
Ingress Egress: 1 road in/out
Access Width: 1 lane (Less than 18')
Access Condition: Surfaced-paved, gradeLess than 5%
Bridge Condition: Less than 300 ft with turnaround
Access and Turnarounds: Less than 300 ft with turnaround
Facility Number or Sign: None or not clearly visible
Fuel Type: Grass and shrub, hardwood litter
Fuel Load: Light or no wildland fuels
Defensible Space: 30 ft treated
Topography: Slope Greater than 40%
Roof Material: Noncombustible or not applicable
Siding Material: Rock, concrete, metal
Foundation: Closed, Less than 6in masonry exposed
Firewood: None
Water Supply: Reliable water source nearby
Propane: Present and fuels clearance
Overhead Hazards: No overhead hazards

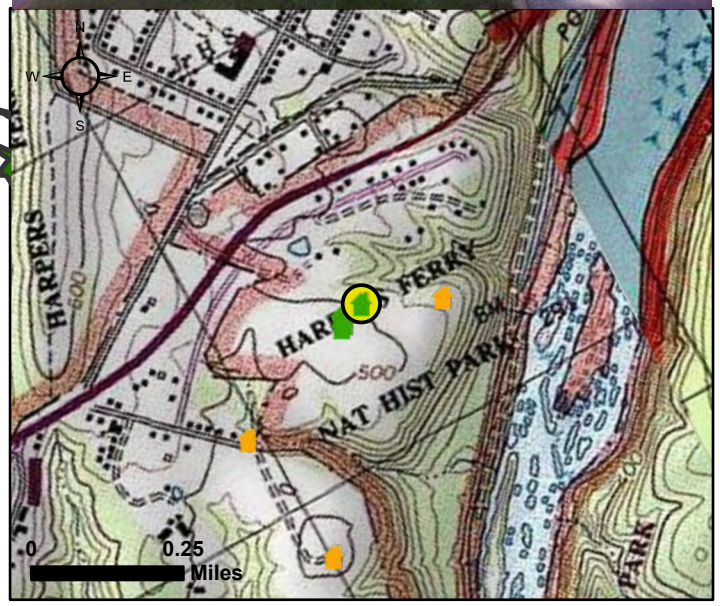
Facility Name: B97 Kiosk Cavalier Heights
Unit - Location: HAFE - Harper's Ferry NHP
FMSS ID: 3771, ***Local ID:***
Structure Type, Use: Building, Administrative
Owner: National Park Service
Field Crew, Visit Date: NCR Fire, June 3, 2022
Coordinates (DDM): 39° 19.00651764' N 077° 45.37909950' W

Rating: Low
ProtectionLevel: Full,
Resources of Concern: Unknown
Occupied: Yes
In Community: Yes,
Revisit Interval: 5 yrs
Map Label: 82

Primary Access: Road
Ingress Egress: 1 road in/out
Access Width: 2 lanes (Greater than 24')
Access Condition: Surfaced-paved, gradeLess than 5%
Bridge Condition: Less than 300 ft with turnaround
Access and Turnarounds: Less than 300 ft with turnaround
Facility Number or Sign: Marked and clearly visible
Fuel Type: Grass and shrub, hardwood litter
Fuel Load: Light or no wildland fuels
Defensible Space: 30 ft treated
Topography: Slope 5% to 20%
Roof Material: Noncombustible or not applicable
Siding Material: Rock, concrete, metal
Foundation: Closed, Less than 6in masonry exposed
Firewood: None
Water Supply: Pressurized hydrant(s) or fixed sprinkler system
Propane: None
Overhead Hazards: No overhead hazards

Comments: From FMSS_Export - FRPP_PREDUSE: Bldg. Entrance Station (GSF)

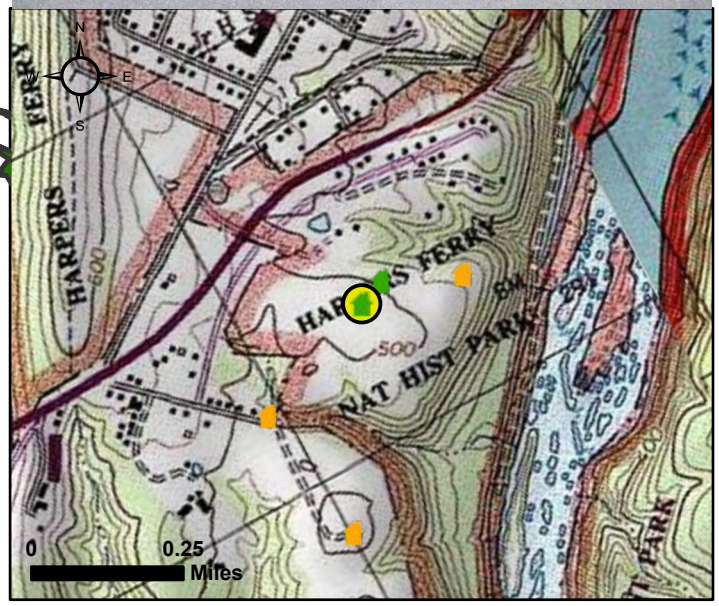
Facility Name: Bus Shelter Cavalier Heights
Unit - Location: HAFE - Harper's Ferry NHP
FMSS ID: 3770, ***Local ID:***
Structure Type, Use: Building, Administrative
Owner: National Park Service
Field Crew, Visit Date: NCR fire, June 3, 2022
Coordinates (DDM): 39° 18.99188952' N 077° 45.42499242' W

Rating: Low
ProtectionLevel: Not Designated,
Resources of Concern: No
Occupied: Yes
In Community: Yes,
Revisit Interval: 5 yrs
Map Label: 79

Primary Access: Road
Ingress Egress: 1 road in/out
Access Width: 2 lanes (Greater than 24')
Access Condition: Surfaced-paved, gradeLess than 5%
Bridge Condition: Less than 300 ft with turnaround
Access and Turnarounds: Less than 300 ft with turnaround
Facility Number or Sign: Marked and clearly visible
Fuel Type: Grass/tundra,northern hardwood litter
Fuel Load: Light or no wildland fuels
Defensible Space: Greater than 100ft treated
Topography: Slope Less than 5%
Roof Material: Combination of fire resisitant and combustible
Siding Material: Wood or open sided
Foundation: Closed, Greater than 30in masonry exposed or N/A
Firewood: None
Water Supply: Pressurized hydrant(s) or fixed sprinkler system
Propane: None
Overhead Hazards: No overhead hazards

Comments: From FMSS_Export - FRPP_PREDUSE: Bldg. Shed/Outbuilding (GSF)

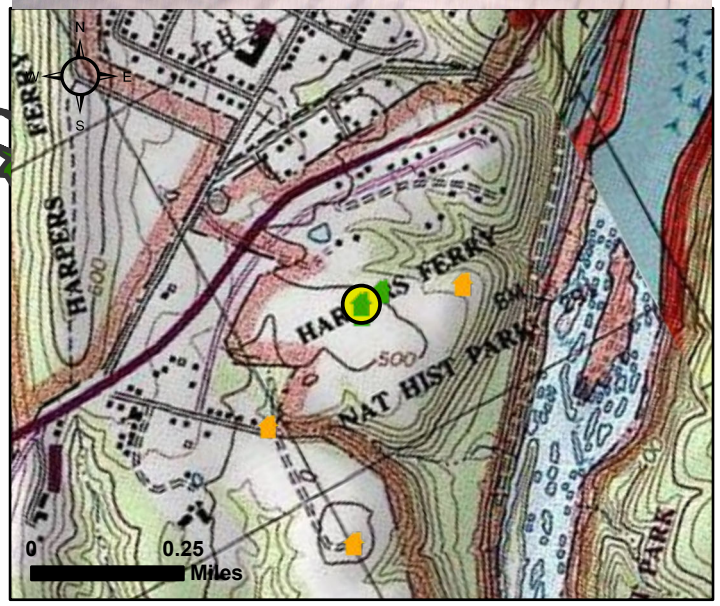
Facility Name: Restrooms Cavalier Heights
Unit - Location: HAFE - Harper's Ferry NHP
FMSS ID: 40571, ***Local ID:***
Structure Type, Use: Building, Public
Owner: National Park Service
Field Crew, Visit Date: NCR fire, June 3, 2022
Coordinates (DDM): 39° 19.00329546' N 077° 45.41770998' W

Rating: Low
ProtectionLevel: Full,
Resources of Concern: Unknown
Occupied: Yes
In Community: Yes,
Revisit Interval: 5 yrs
Map Label: 80

Primary Access: Road
Ingress Egress: 2 or more roads in/out
Access Width: 2 lanes (Greater than 24')
Access Condition: Surfaced-paved, gradeLess than 5%
Bridge Condition: Less than 300 ft with turnaround
Access and Turnarounds: Less than 300 ft with turnaround
Facility Number or Sign: Marked and clearly visible
Fuel Type: Grass/tundra,northern hardwood litter
Fuel Load: Light or no wildland fuels
Defensible Space: Greater than 100ft treated
Topography: Slope Less than 5%
Roof Material: Noncombustible or not applicable
Siding Material: Rock, concrete, metal
Foundation: Closed, Greater than 30in masonry exposed or N/A
Firewood: None
Water Supply: Pressurized hydrant(s) or fixed sprinkler system
Propane: None
Overhead Hazards: No overhead hazards

Comments: From FMSS_Export - FRPP_PREDUSE: Bldg. Comfort Station (GSF)

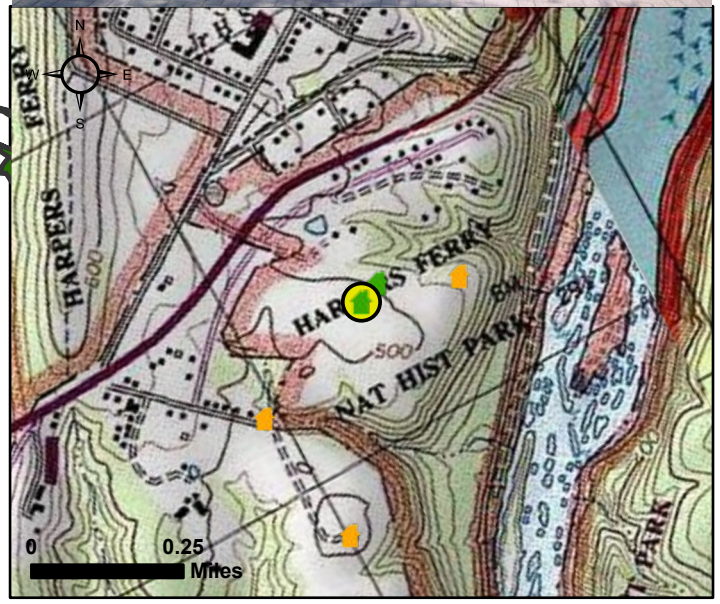
Facility Name: Visitor Center
Unit - Location: HAFE - Harper's Ferry NHP
FMSS ID: 3769, ***Local ID:***
Structure Type, Use: Building, Administrative
Owner: National Park Service
Field Crew, Visit Date: NCR Fire, June 3, 2022
Coordinates (DDM): 39° 18.99478020' N 077° 45.41731656' W

Rating: Low
ProtectionLevel: Not Designated,
Resources of Concern: No
Occupied: Yes
In Community: Yes,
Revisit Interval: 5 yrs
Map Label: 81

Primary Access: Road
Ingress Egress: 2 or more roads in/out
Access Width: 2 lanes (Greater than 24')
Access Condition: Surfaced-paved, gradeLess than 5%
Bridge Condition: Less than 300 ft with turnaround
Access and Turnarounds: Less than 300 ft with turnaround
Facility Number or Sign: Marked and clearly visible
Fuel Type: Grass/tundra,northern hardwood litter
Fuel Load: Light or no wildland fuels
Defensible Space: Greater than 100ft treated
Topography: Slope Less than 5%
Roof Material: Noncombustible or not applicable
Siding Material: Rock, concrete, metal
Foundation: Closed, Greater than 30in masonry exposed or N/A
Firewood: None
Water Supply: Pressurized hydrant(s) or fixed sprinkler system
Propane: None
Overhead Hazards: No overhead hazards

Comments: From FMSS_Export - FRPP_PREDUSE: Bldg. Museum Repository (GSF)

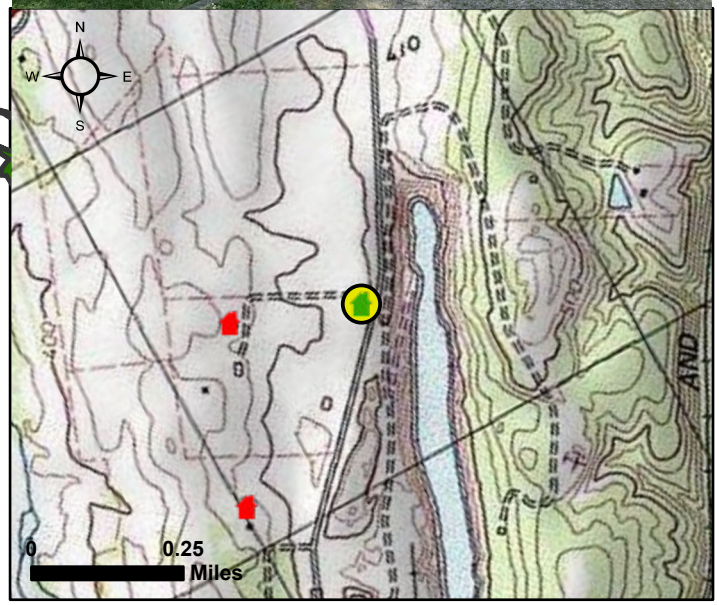
Facility Name: School House Privy
Unit - Location: HAFE - Harper's Ferry NHP
FMSS ID: N/A, ***Local ID:***
Structure Type, Use: Building, Public
Owner: National Park Service
Field Crew, Visit Date: NCR Fire, June 2, 2022
Coordinates (DDM): 39° 18.45747120' N 077° 46.66109544' W

Rating: Low
ProtectionLevel: Undesignated,
Resources of Concern: Unknown
Occupied: No
In Community: No,
Revisit Interval: 5 yrs
Map Label: 10

Primary Access: Road
Ingress Egress: 1 road in/out
Access Width: 2 lanes (Greater than 24')
Access Condition: Surfaced-paved, gradeLess than 5%
Bridge Condition: Less than 300 ft with turnaround
Access and Turnarounds: Less than 300 ft with turnaround
Facility Number or Sign: None or not clearly visible
Fuel Type: Grass and shrub, hardwood litter
Fuel Load: Light or no wildland fuels
Defensible Space: 30 ft treated
Topography: Slope 5% to 20%
Roof Material: Noncombustible or not applicable
Siding Material: Rock, concrete, metal
Foundation: Closed, Greater than 30in masonry exposed or N/A
Firewood: None
Water Supply: No reliable water source nearby
Propane: None
Overhead Hazards: Overhead hazards will limit aircraft
Comments:

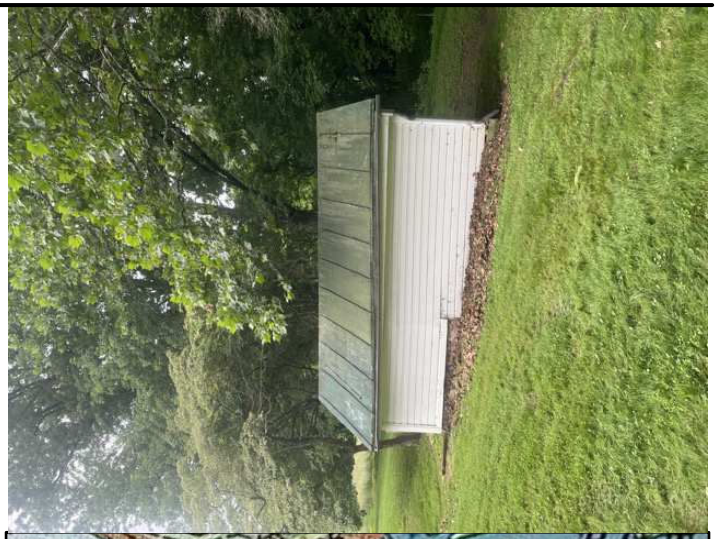
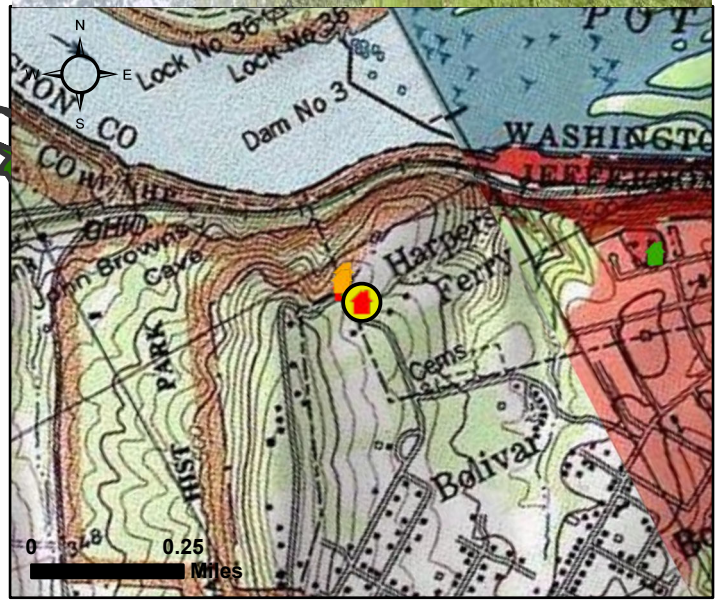
Rating: High
ProtectionLevel: Undesignated,
Resources of Concern: Unknown
Occupied: No
In Community: Yes,
Revisit Interval: 5 yrs
Map Label: 14

Facility Name: Nash Shed
Unit - Location: HAFE - Harper's Ferry NHP
FMSS ID: N/A, ***Local ID:***
Structure Type, Use: Building, Administrative
Owner: National Park Service
Field Crew, Visit Date: NCR Wildland Fire , June 14, 2022
Coordinates (DDM): 39° 19.84513242' N 077° 45.25165164' W

Primary Access: Road
Ingress Egress: 1 road in/out
Access Width: 1 lane (Less than 18')
Access Condition: Surfaced-paved, gradeLess than 5%
Bridge Condition: Less than 300 ft with turnaround
Access and Turnarounds: Less than 300 ft with turnaround
Facility Number or Sign: None or not clearly visible
Fuel Type: Shrub or timber
Fuel Load: Moderate
Defensible Space: Less than 30 ft treated
Topography: Slope 21% to 30%
Roof Material: Noncombustible or not applicable
Siding Material: Wood or open sided
Foundation: Closed, Less than 6in masonry exposed
Firewood: None
Water Supply: Pressurized hydrant(s) or fixed sprinkler system
Propane: None
Overhead Hazards: Overhead hazards will limit aircraft
Comments:

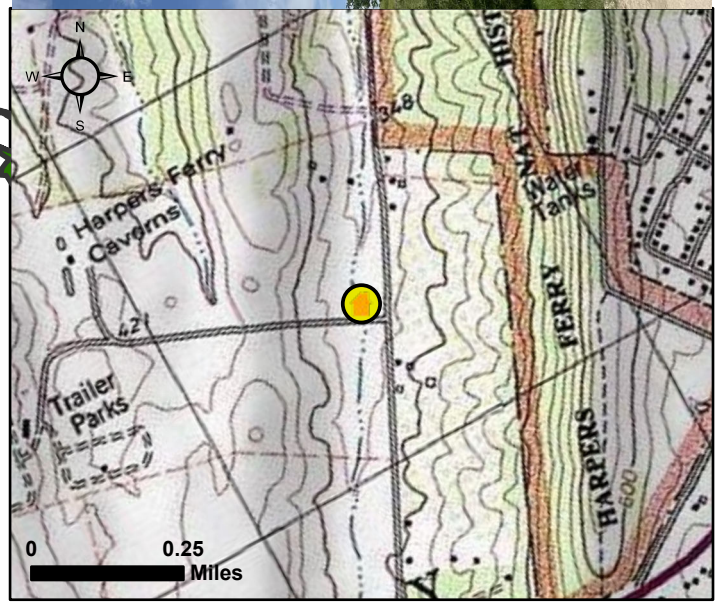
Rating: Moderate
ProtectionLevel: Undesignated,
Resources of Concern: Unknown
Occupied: No
In Community: No,
Revisit Interval: 5 yrs
Map Label: 3

Facility Name: Schoolhouse Ridge North Bathroom
Unit - Location: HAFE - Harper's Ferry NHP
FMSS ID: N/a, ***Local ID:***
Structure Type, Use: Building, Public
Owner: National Park Service
Field Crew, Visit Date: NCR Wildland Fire , July 21, 2022
Coordinates (DDM): 39° 19.54113654' N 077° 46.01654370' W

Primary Access: Road
Ingress Egress: 1 road in/out
Access Width: 2 lanes (Greater than 24')
Access Condition: Surfaced-paved, gradeLess than 5%
Bridge Condition: Less than 300 ft with turnaround
Access and Turnarounds: Less than 300 ft with turnaround
Facility Number or Sign: None or not clearly visible
Fuel Type: Grass and shrub, hardwood litter
Fuel Load: Light or no wildland fuels
Defensible Space: Less than 30 ft treated
Topography: Slope Less than 5%
Roof Material: Noncombustible or not applicable
Siding Material: Rock, concrete, metal
Foundation: Closed, Greater than 30in masonry exposed or N/A
Firewood: None
Water Supply: No reliable water source nearby
Propane: None
Overhead Hazards: Overhead hazards will limit aircraft
Comments:

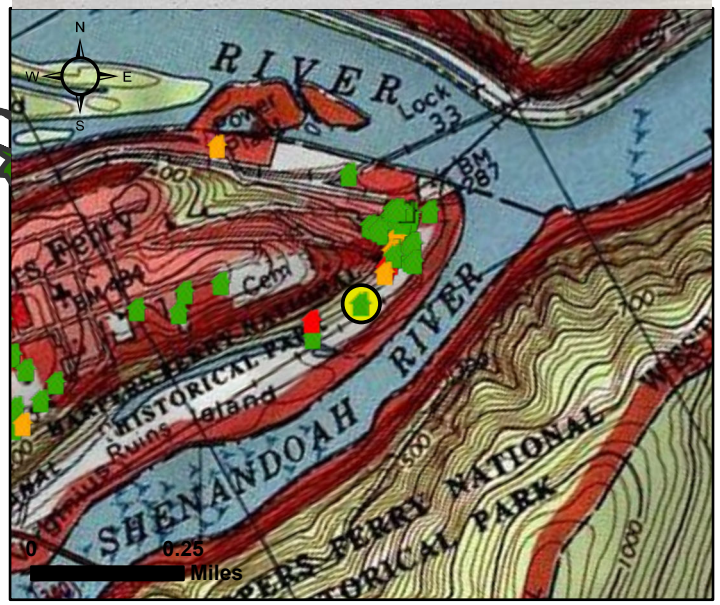
Rating: Low
ProtectionLevel: Undesignated,
Resources of Concern: Unknown
Occupied: No
In Community: No, John Brownandapos;s Fort
Revisit Interval: 5 yrs
Map Label: 89

Facility Name: Bus Shelter Lower Town
Unit - Location: HAFE - Harper's Ferry NHP
FMSS ID: 226673, ***Local ID:***
Structure Type, Use: Building, Public
Owner: National Park Service
Field Crew, Visit Date: J shedd, October 12, 2022
Coordinates (DDM): 39° 19.31982108' N 077° 43.93929852' W

Primary Access: Road
Ingress Egress: 2 or more roads in/out
Access Width: 1.5 lanes (Greater than 18')
Access Condition: Surfaced-paved, gradeLess than 5%
Bridge Condition: Less than 300 ft with turnaround
Access and Turnarounds: Less than 300 ft with turnaround
Facility Number or Sign: Marked and clearly visible
Fuel Type: Grass and shrub, hardwood litter
Fuel Load: Light or no wildland fuels
Defensible Space: 100 ft treated
Topography: Slope Less than 5%
Roof Material: Noncombustible or not applicable
Siding Material: Not applicable
Foundation: Open or deck
Firewood: None
Water Supply: Pressurized hydrant(s) or fixed sprinkler system
Propane: None
Overhead Hazards: No overhead hazards
Comments:

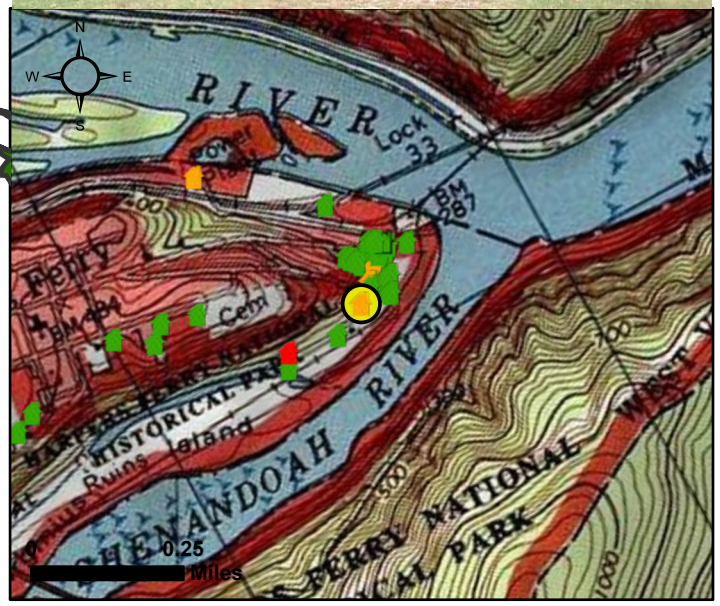
Rating: Moderate
ProtectionLevel: Undesignated,
Resources of Concern: Unknown
Occupied: No
In Community: Yes, John Brownandapos;s Fort
Revisit Interval: 5 yrs
Map Label: 90

Facility Name: New storage
Unit - Location: HAFE - Harper's Ferry NHP
FMSS ID: Na, ***Local ID:***
Structure Type, Use: Building, Administrative
Owner: National Park Service
Field Crew, Visit Date: J shedd , October 12, 2022
Coordinates (DDM): 39° 19.34065218' N 077° 43.88303364' W

Primary Access: Road
Ingress Egress: 2 or more roads in/out
Access Width: 1.5 lanes (Greater than 18')
Access Condition: Surfaced-paved, gradeLess than 5%
Bridge Condition: Less than 300 ft with turnaround
Access and Turnarounds: Less than 300 ft with turnaround
Facility Number or Sign: None or not clearly visible
Fuel Type: Grass and shrub, hardwood litter
Fuel Load: Light or no wildland fuels
Defensible Space: Less than 30 ft treated
Topography: Slope Greater than 40%
Roof Material: Noncombustible or not applicable
Siding Material: Wood or open sided
Foundation: Closed, Greater than 30in masonry exposed or N/A
Firewood: None
Water Supply: Pressurized hydrant(s) or fixed sprinkler system
Propane: None
Overhead Hazards: No overhead hazards

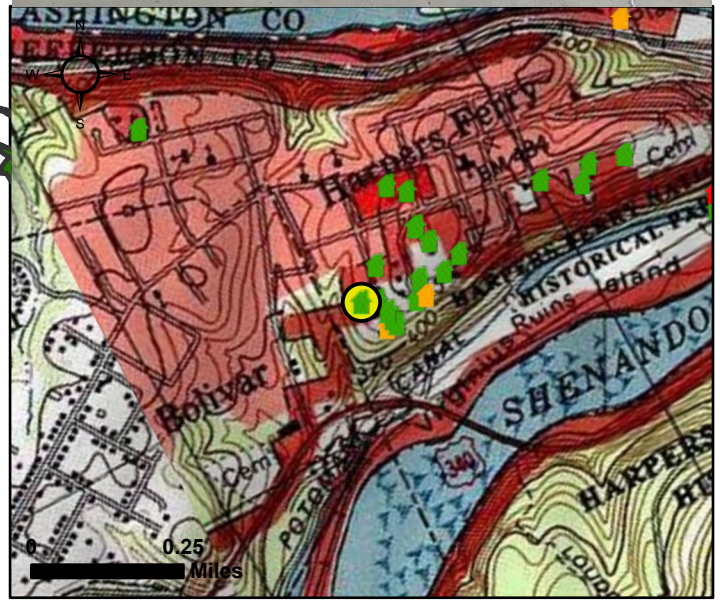
Rating: Low
ProtectionLevel: ,
Resources of Concern: No
Occupied: Yes
In Community: Yes,
Revisit Interval: 5 yrs
Map Label: 91

Facility Name: saw shed
Unit - Location: HAFE - Harper's Ferry NHP
FMSS ID: NA, ***Local ID:***
Structure Type, Use: Building, Administrative
Owner: National Park Service
Field Crew, Visit Date: NCR FIRE, March 8, 2023
Coordinates (DDM): 39° 19.411' N 77° 44.608' W

Primary Access: Road
Ingress Egress: 1 road in/out
Access Width: 1.5 lanes (Greater than 18')
Access Condition: Surfaced-paved, gradeGreater than 5%
Bridge Condition: Less than 300 ft with turnaround
Access and Turnarounds: Less than 300 ft with turnaround
Facility Number or Sign: Marked and clearly visible
Fuel Type: Grass/tundra,northern hardwood litter
Fuel Load: Moderate
Defensible Space: Greater than 100ft treated
Topography: Slope Less than 5%
Roof Material: Noncombustible or not applicable
Siding Material: Rock, concrete, metal
Foundation: Closed, Greater than 30in masonry exposed or N/A
Firewood: None
Water Supply: Pressurized hydrant(s) or fixed sprinkler system
Propane: None
Overhead Hazards: No overhead hazards
Comments:

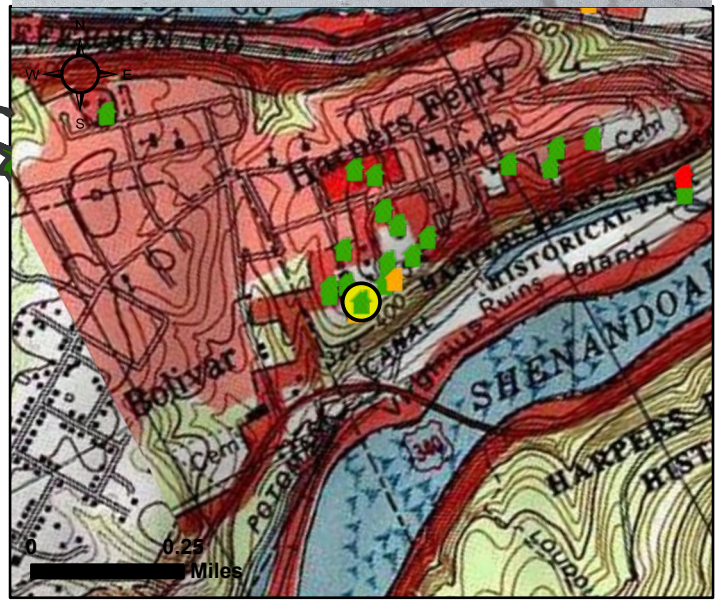
Rating: Low
ProtectionLevel: Not Designated,
Resources of Concern: No
Occupied: Yes
In Community: Yes,
Revisit Interval: 5 yrs
Map Label: 92

Facility Name: maintenance vehicle bay
Unit - Location: HAFE - Harper's Ferry NHP
FMSS ID: NA, ***Local ID:***
Structure Type, Use: Building, Administrative
Owner: National Park Service
Field Crew, Visit Date: NCR FIRE, March 8, 2023
Coordinates (DDM): 39° 19.375' N 77° 44.575' W

Primary Access: Road
Ingress Egress: 1 road in/out
Access Width: 1.5 lanes (Greater than 18')
Access Condition: Surfaced-paved, gradeGreater than 5%
Bridge Condition: Less than 300 ft with turnaround
Access and Turnarounds: Less than 300 ft with turnaround
Facility Number or Sign: Marked and clearly visible
Fuel Type: Grass and shrub, hardwood litter
Fuel Load: Light or no wildland fuels
Defensible Space: 30 ft treated
Topography: Slope 5% to 20%
Roof Material: Fire resistant- tar,rubberized
Siding Material: Wood or open sided
Foundation: Closed, Greater than 30in masonry exposed or N/A
Firewood: None
Water Supply: Pressurized hydrant(s) or fixed sprinkler system
Propane: None
Overhead Hazards: No overhead hazards
Comments:
