MANA - Manassas National Battlefield Park

National Park Service
U.S. Department of the Interior

NPS Wildland Fire Risk Assessment - Facility Assessment

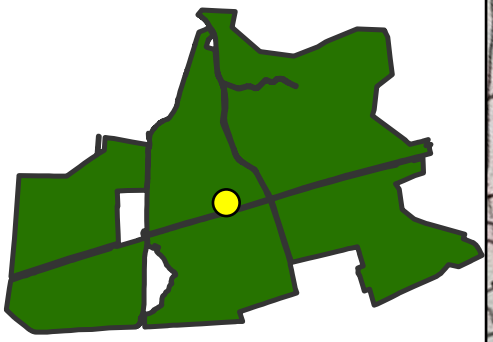
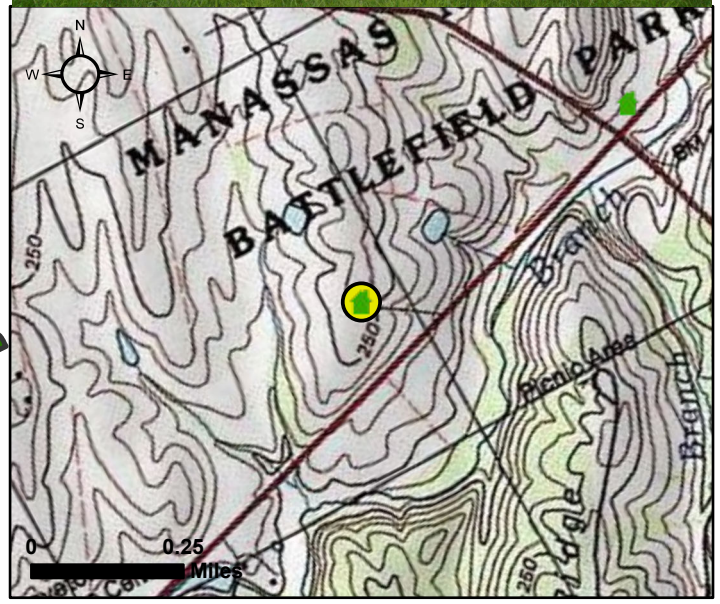
Rating: Low
ProtectionLevel: Not Designated,
Resources of Concern: Unknown
Occupied: Yes
In Community: No,
Revisit Interval: 7 yrs
Map Label: 15

Primary Access: Road
Ingress Egress: 2 or more roads in/out
Access Width: 1 lane (Less than 18')
Access Condition: Surfaced-paved, gradeLess than 5%
Bridge Condition: Greater than 300 ft with turnaround
Access and Turnarounds: Greater than 300 ft with turnaround
Facility Number or Sign: None or not clearly visible
Fuel Type: Grass/tundra,northern hardwood litter
Fuel Load: Moderate
Defensible Space: Greater than 100ft treated
Topography: Slope Less than 5%
Roof Material: Noncombustible or not applicable
Siding Material: Rock, concrete, metal
Foundation: Closed, 6in to 30in masonry exposed
Firewood: None
Water Supply: Reliable water source nearby
Propane: None
Overhead Hazards: No overhead hazards

Comments: From FMSS_Export - FRPP_PREDUSE: Bldg. Office (GSF)

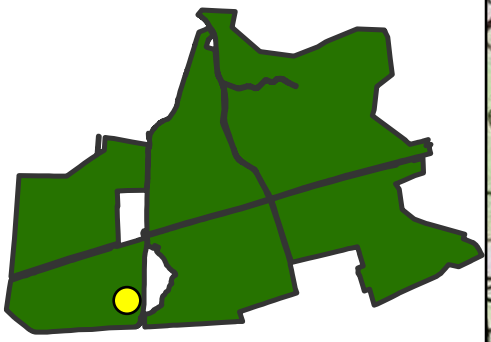
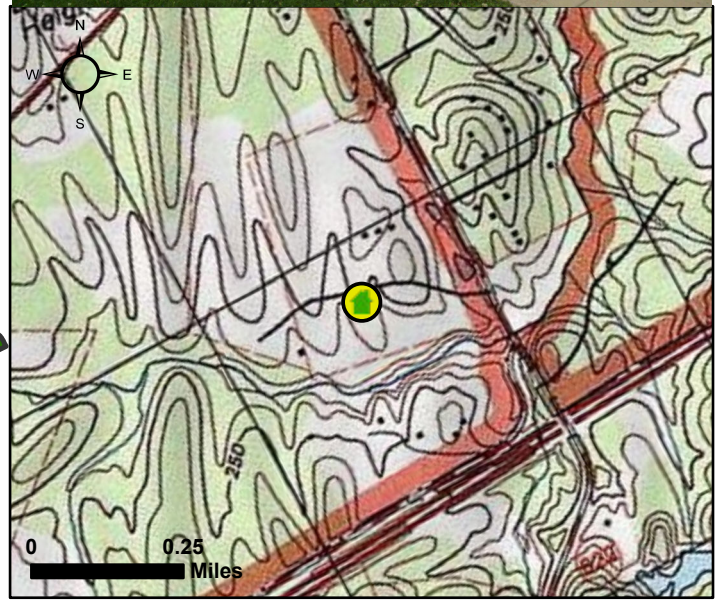
Rating: Low
ProtectionLevel: Not Designated,
Resources of Concern: Unknown
Occupied: No
In Community: No,
Revisit Interval: 7 yrs
Map Label: 6

Primary Access: Road
Ingress Egress: 2 or more roads in/out
Access Width: 2 lanes (Greater than 24')
Access Condition: Surfaced-paved, gradeLess than 5%
Bridge Condition: Less than 300 ft with turnaround
Access and Turnarounds: Less than 300 ft with turnaround
Facility Number or Sign: Marked and clearly visible
Fuel Type: Grass/tundra,northern hardwood litter
Fuel Load: Moderate
Defensible Space: 100 ft treated
Topography: Slope Less than 5%
Roof Material: Fire resistant- tar,rubberized
Siding Material: Wood or open sided
Foundation: Open or deck
Firewood: None
Water Supply: Reliable water source nearby
Propane: None
Overhead Hazards: No overhead hazards

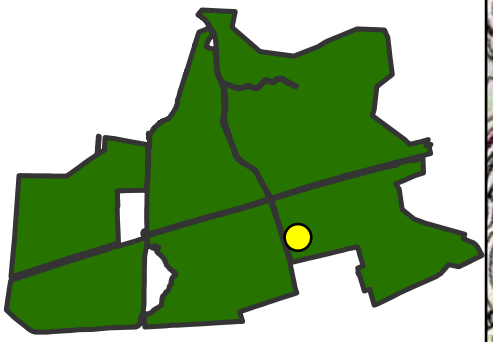
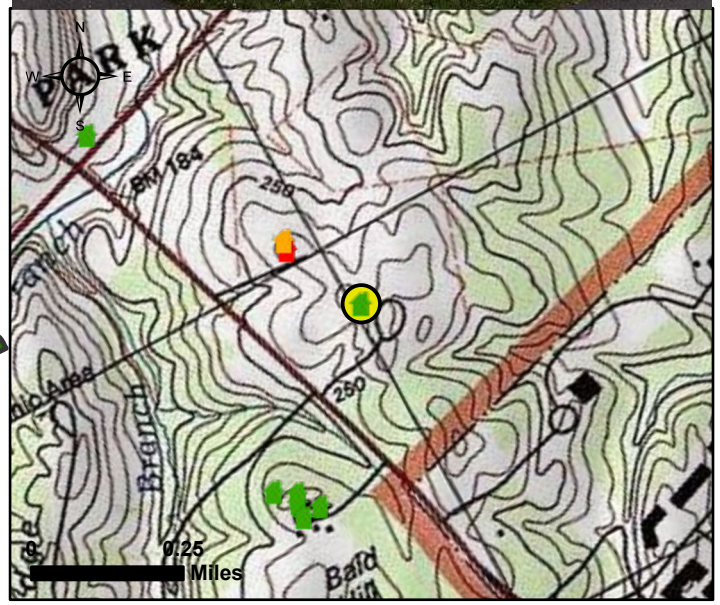
Facility Name: Henry Hill Visitor Center
Unit - Location: MANA - Manassas National Battlefield
FMSS ID: 47116, ***Local ID:***
Structure Type, Use: Building, Public
Owner:
Field Crew, Visit Date: ,
Coordinates (DDM):

Rating:
ProtectionLevel: ,
Resources of Concern: Unknown
Occupied: Yes
In Community: No,
Revisit Interval: 7 yrs
Map Label:

Primary Access: Road
Ingress Egress: 2 or more roads in/out
Access Width: 2 lanes (Greater than 24')
Access Condition: Surfaced-paved, gradeLess than 5%
Bridge Condition: Greater than 300 ft with turnaround
Access and Turnarounds: Greater than 300 ft with turnaround
Facility Number or Sign: Marked and clearly visible
Fuel Type: Grass/tundra,northern hardwood litter
Fuel Load: Light or no wildland fuels
Defensible Space: Greater than 100ft treated
Topography: Slope Less than 5%
Roof Material: Fire resistant- tar,rubberized
Siding Material: Rock, concrete, metal
Foundation: Closed, Greater than 30in masonry exposed or N/A
Firewood: None
Water Supply: Pressurized hydrant(s) or fixed sprinkler system
Propane: None
Overhead Hazards: No overhead hazards

Comments: From FMSS_Export - FRPP_PREDUSE: Bldg. Visitor Center (GSF)

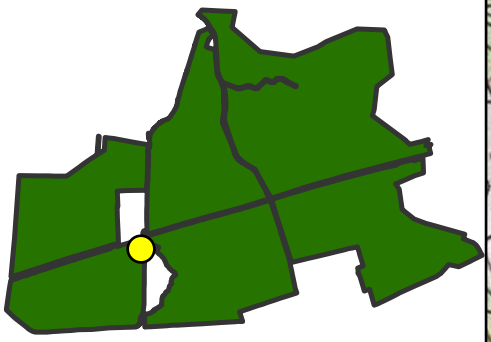
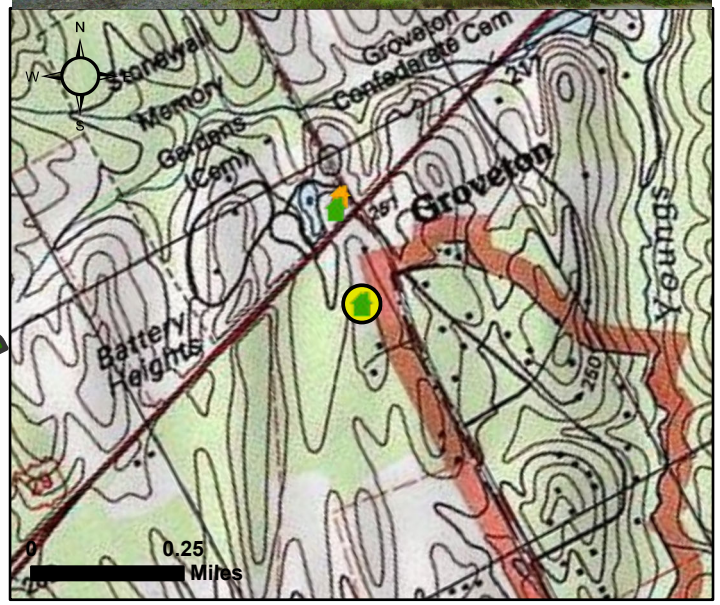
Rating: Low
ProtectionLevel: Not Designated,
Resources of Concern: Unknown
Occupied: No
In Community: No,
Revisit Interval: 7 yrs
Map Label: 8

Primary Access: Road
Ingress Egress: 2 or more roads in/out
Access Width: 1 lane (Less than 18')
Access Condition: Non-surfaced- gravel,dirt,gradeLess than 5%
Bridge Condition: Less than 300 ft with turnaround
Access and Turnarounds: Less than 300 ft with turnaround
Facility Number or Sign: None or not clearly visible
Fuel Type: Grass/tundra,northern hardwood litter
Fuel Load: Moderate
Defensible Space: 30 ft treated
Topography: Slope Less than 5%
Roof Material: Fire resistant- tar,rubberized
Siding Material: Wood or open sided
Foundation: Open or deck
Firewood: None
Water Supply: Reliable water source nearby
Propane: None
Overhead Hazards: No overhead hazards

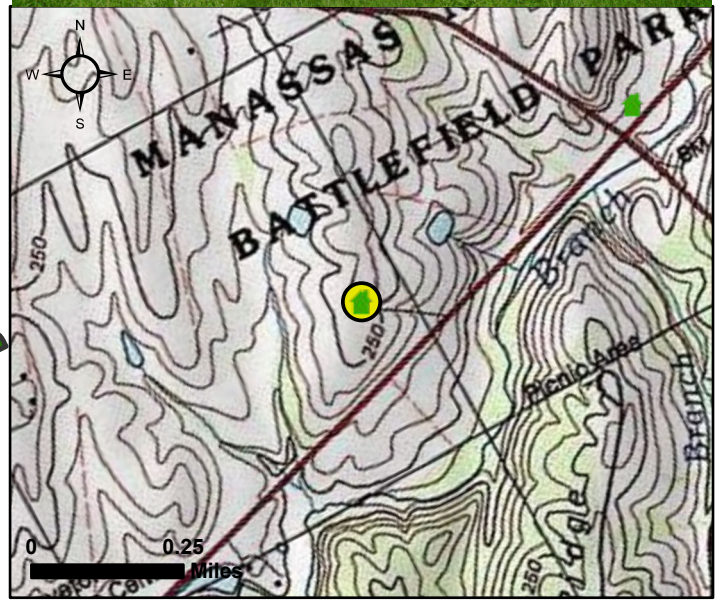
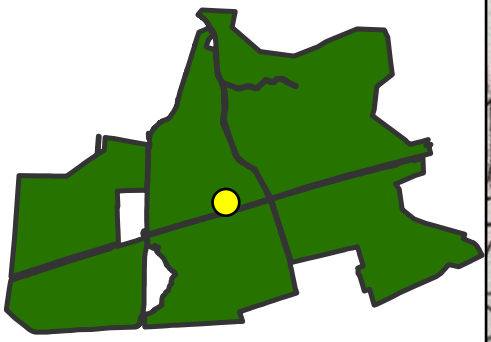
Facility Name: Quarters 5 garage
Unit - Location: MANA - Manassas National Battlefield
FMSS ID: 130148, ***Local ID:***
Structure Type, Use: Building, Administrative
Owner: National Park Service
Field Crew, Visit Date: Castillo , June 10, 2021
Coordinates (DDM): 38° 49.06513968' N 077° 32.08849032' W

Rating: Low
ProtectionLevel: Not Designated,
Resources of Concern: Unknown
Occupied: No
In Community: No,
Revisit Interval: 7 yrs
Map Label: 14

Primary Access: Road
Ingress Egress: 2 or more roads in/out
Access Width: 1 lane (Less than 18')
Access Condition: Surfaced-paved, gradeLess than 5%
Bridge Condition: Less than 300 ft with turnaround
Access and Turnarounds: Less than 300 ft with turnaround
Facility Number or Sign: None or not clearly visible
Fuel Type: Grass/tundra,northern hardwood litter
Fuel Load: Moderate
Defensible Space: 100 ft treated
Topography: Slope Less than 5%
Roof Material: Fire resistant- tar,rubberized
Siding Material: Vinyl
Foundation: Closed, Less than 6in masonry exposed
Firewood: None
Water Supply: Reliable water source nearby
Propane: None
Overhead Hazards: No overhead hazards
Comments:

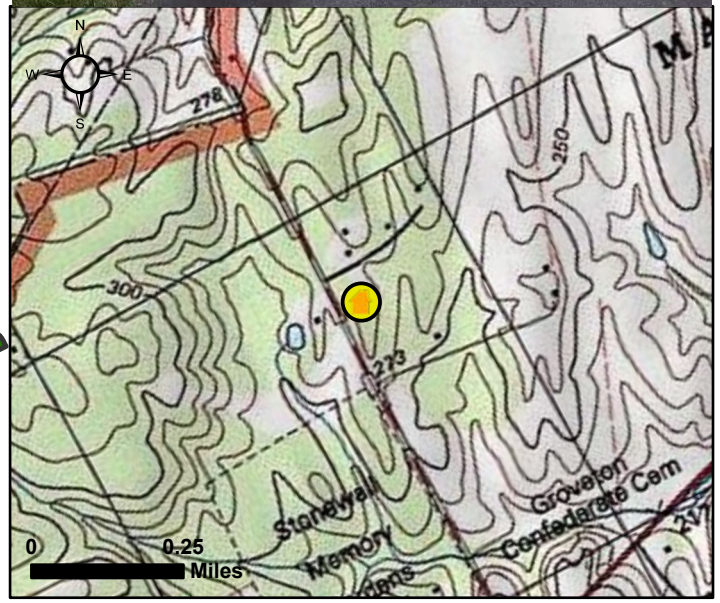
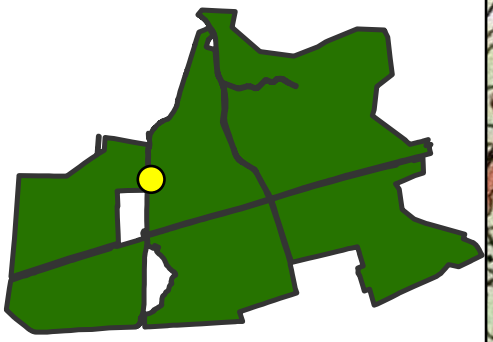
Facility Name: Featherbed Garage
Unit - Location: MANA - Manassas National Battlefield
FMSS ID: 239573, ***Local ID:***
Structure Type, Use: Building, Administrative
Owner: National Park Service
Field Crew, Visit Date: Castillo , June 10, 2021
Coordinates (DDM): 38° 49.24322052' N 077° 32.90262138' W

Rating: Moderate
ProtectionLevel: Not Designated,
Resources of Concern: Unknown
Occupied: No
In Community: No,
Revisit Interval: 7 yrs
Map Label: 12

Primary Access: Road
Ingress Egress: 2 or more roads in/out
Access Width: 1 lane (Less than 18')
Access Condition: Surfaced-paved, gradeLess than 5%
Bridge Condition: Less than 300 ft with turnaround
Access and Turnarounds: Less than 300 ft with turnaround
Facility Number or Sign: None or not clearly visible
Fuel Type: Grass/tundra,northern hardwood litter
Fuel Load: Moderate
Defensible Space: No defensible space
Topography: Slope Less than 5%
Roof Material: Fire resistant- tar,rubberized
Siding Material: Wood or open sided
Foundation: Closed, Less than 6in masonry exposed
Firewood: None
Water Supply: Reliable water source nearby
Propane: None
Overhead Hazards: No overhead hazards
Comments:

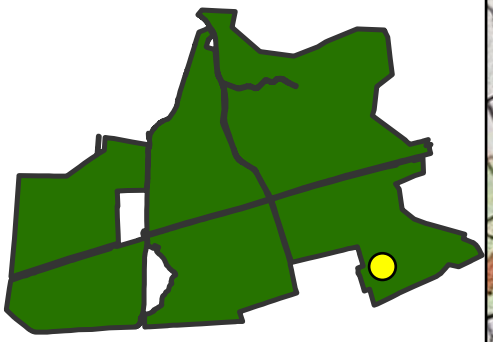
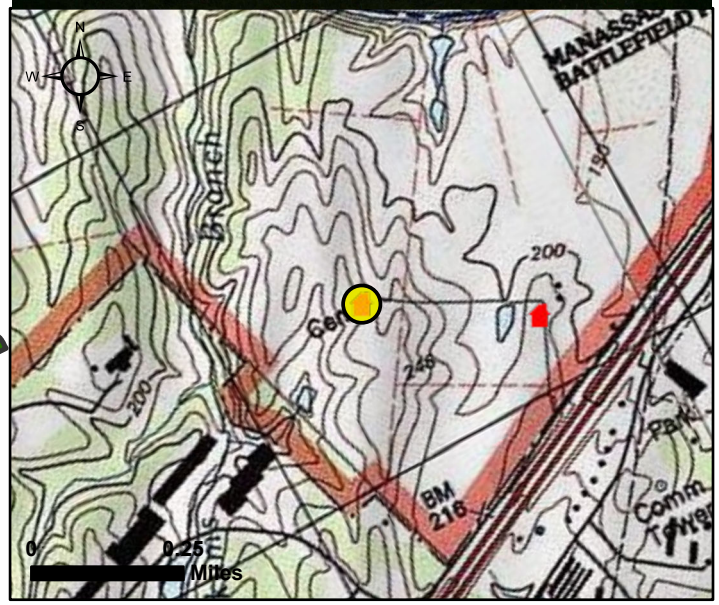
Facility Name: Hay Barn
Unit - Location: MANA - Manassas National Battlefield
FMSS ID: not found , ***Local ID:***
Structure Type, Use: Building, Unknown
Owner: National Park Service
Field Crew, Visit Date: Castillo , June 10, 2021
Coordinates (DDM): 38° 48.55740936' N 077° 30.37513800' W

Rating: Moderate
ProtectionLevel: Not Designated,
Resources of Concern: Unknown
Occupied: No
In Community: No,
Revisit Interval: 7 yrs
Map Label: 22

Primary Access: Road
Ingress Egress: 1 road in/out
Access Width: 2 lanes (Greater than 24')
Access Condition: Non-surfaced- gravel,dirt,gradeLess than 5%
Bridge Condition: Greater than 300 ft with turnaround
Access and Turnarounds: Greater than 300 ft with turnaround
Facility Number or Sign: None or not clearly visible
Fuel Type: Grass/tundra,northern hardwood litter
Fuel Load: Moderate
Defensible Space: No defensible space
Topography: Slope Less than 5%
Roof Material: Noncombustible or not applicable
Siding Material: Wood or open sided
Foundation: Open or deck
Firewood: None
Water Supply: Reliable water source nearby
Propane: None
Overhead Hazards: No overhead hazards

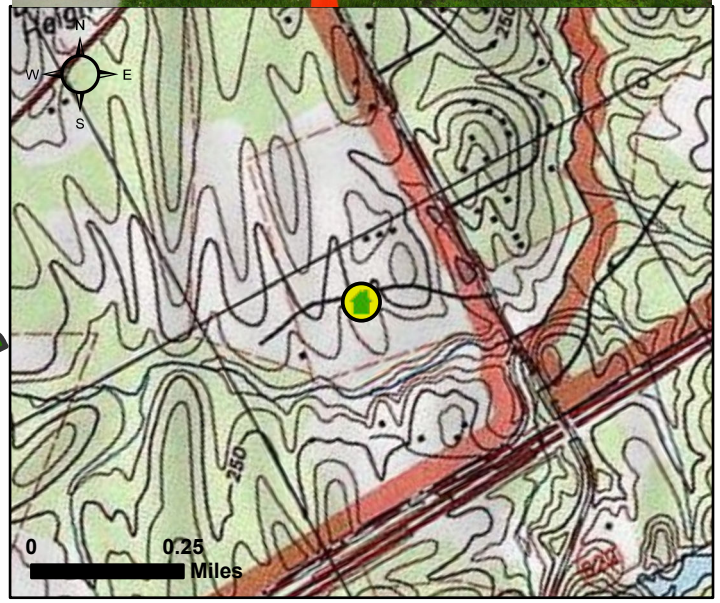
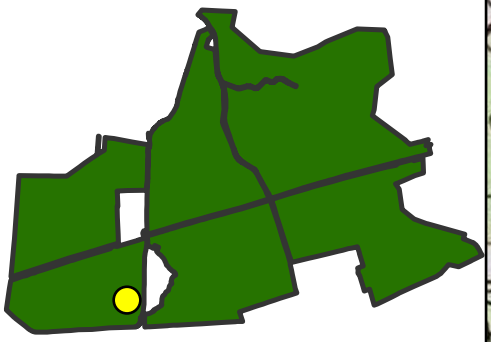
Facility Name: Brownsville bathroom
Unit - Location: MANA - Manassas National Battlefield
FMSS ID: 1581585, ***Local ID:***
Structure Type, Use: Building, Public
Owner: National Park Service
Field Crew, Visit Date: Castillo , June 10, 2021
Coordinates (DDM): 38° 48.21564528' N 077° 33.12695544' W

Rating: Low
ProtectionLevel: Not Designated,
Resources of Concern: Unknown
Occupied: No
In Community: No,
Revisit Interval: 7 yrs
Map Label: 7

Primary Access: Road
Ingress Egress: 2 or more roads in/out
Access Width: 2 lanes (Greater than 24')
Access Condition: Surfaced-paved, gradeLess than 5%
Bridge Condition: Greater than 300 ft with turnaround
Access and Turnarounds: Greater than 300 ft with turnaround
Facility Number or Sign: Marked and clearly visible
Fuel Type: Grass/tundra,northern hardwood litter
Fuel Load: Moderate
Defensible Space: 100 ft treated
Topography: Slope Less than 5%
Roof Material: Noncombustible or not applicable
Siding Material: Rock, concrete, metal
Foundation: Closed, Greater than 30in masonry exposed or N/A
Firewood: None
Water Supply: Reliable water source nearby
Propane: None
Overhead Hazards: No overhead hazards
Comments:

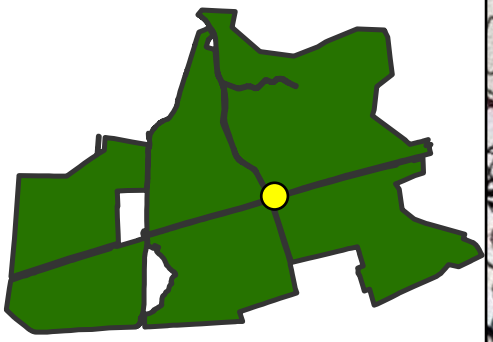
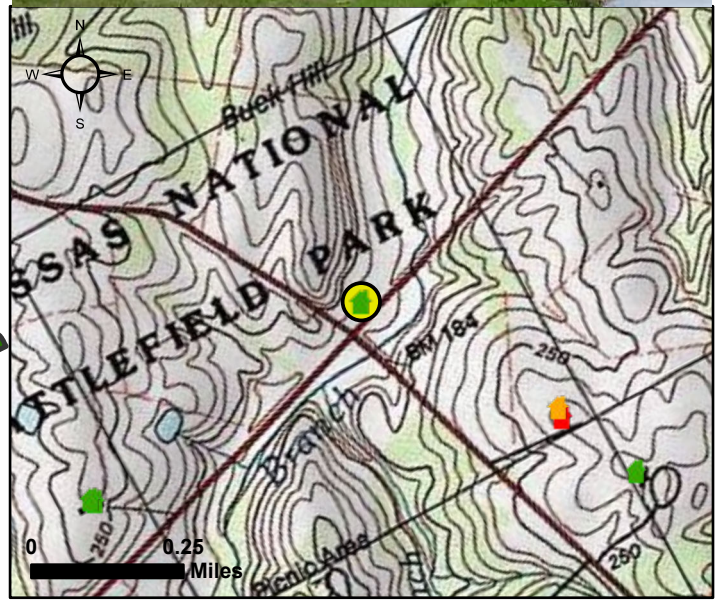
Facility Name: Stone House
Unit - Location: MANA - Manassas National Battlefield
FMSS ID: 47066, ***Local ID:***
Structure Type, Use: Building, Public
Owner: National Park Service
Field Crew, Visit Date: Castillo , June 10, 2021
Coordinates (DDM): 38° 49.12843974' N 077° 31.56248346' W

Rating: Low
ProtectionLevel: Not Designated,
Resources of Concern: Unknown
Occupied: No
In Community: No,
Revisit Interval: 7 yrs
Map Label: 17

Primary Access: Road
Ingress Egress: 2 or more roads in/out
Access Width: 2 lanes (Greater than 24')
Access Condition: Surfaced-paved, gradeLess than 5%
Bridge Condition: Less than 300 ft with turnaround
Access and Turnarounds: Less than 300 ft with turnaround
Facility Number or Sign: Marked and clearly visible
Fuel Type: Grass/tundra,northern hardwood litter
Fuel Load: Light or no wildland fuels
Defensible Space: Greater than 100ft treated
Topography: Slope Less than 5%
Roof Material: Combustible or no roof
Siding Material: Rock, concrete, metal
Foundation: Closed, Greater than 30in masonry exposed or N/A
Firewood: None
Water Supply: Reliable water source nearby
Propane: None
Overhead Hazards: No overhead hazards

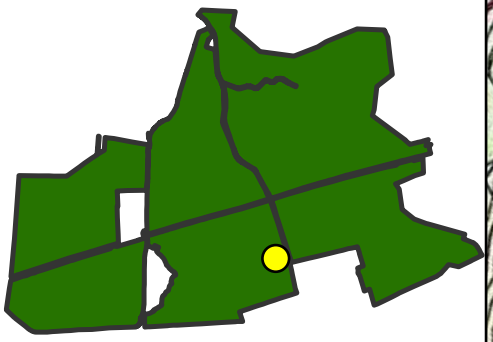
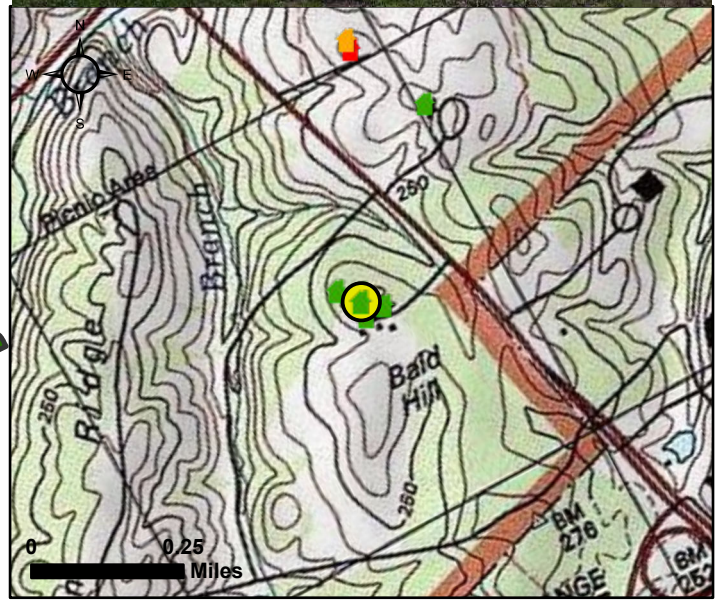
Rating: Low
ProtectionLevel: Not Designated,
Resources of Concern: Unknown
Occupied: No
In Community: Yes,
Revisit Interval: 7 yrs
Map Label: 26

Primary Access: Road
Ingress Egress: 2 or more roads in/out
Access Width: 2 lanes (Greater than 24')
Access Condition: Surfaced-paved, gradeLess than 5%
Bridge Condition: Less than 300 ft with turnaround
Access and Turnarounds: Less than 300 ft with turnaround
Facility Number or Sign: Marked and clearly visible
Fuel Type: Shrub or timber
Fuel Load: Moderate
Defensible Space: 30 ft treated
Topography: Slope Less than 5%
Roof Material: Fire resistant- tar,rubberized
Siding Material: Wood or open sided
Foundation: Open or deck
Firewood: None
Water Supply: Pressurized hydrant(s) or fixed sprinkler system
Propane: None
Overhead Hazards: No overhead hazards

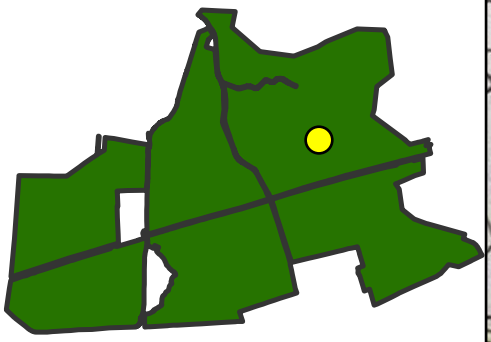
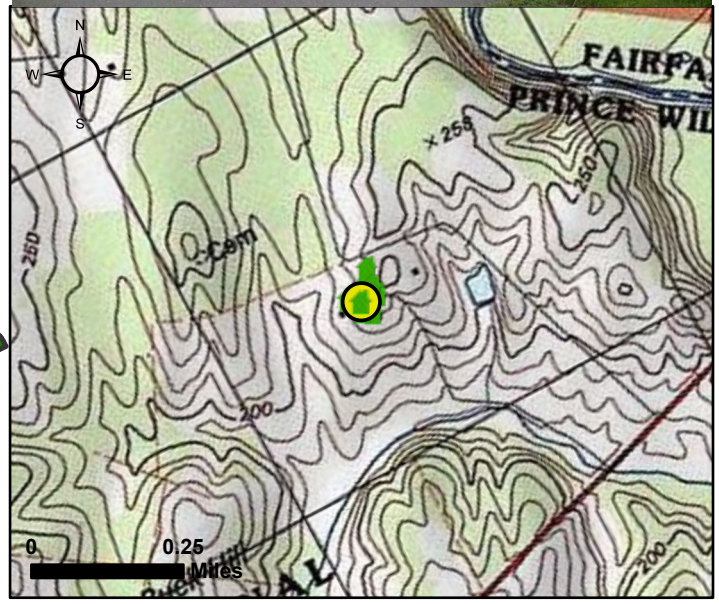
Rating: Low
ProtectionLevel: Not Designated,
Resources of Concern: Unknown
Occupied: No
In Community: Yes,
Revisit Interval: 7 yrs
Map Label: 31

Primary Access: Road
Ingress Egress: 2 or more roads in/out
Access Width: 1 lane (Less than 18')
Access Condition: Surfaced-paved, gradeLess than 5%
Bridge Condition: Greater than 300 ft with turnaround
Access and Turnarounds: Greater than 300 ft with turnaround
Facility Number or Sign: Marked and clearly visible
Fuel Type: Grass/tundra,northern hardwood litter
Fuel Load: Light or no wildland fuels
Defensible Space: Greater than 100ft treated
Topography: Slope Less than 5%
Roof Material: Fire resistant- tar,rubberized
Siding Material: Vinyl
Foundation: Closed, Greater than 30in masonry exposed or N/A
Firewood: None
Water Supply: Reliable water source nearby
Propane: None
Overhead Hazards: No overhead hazards

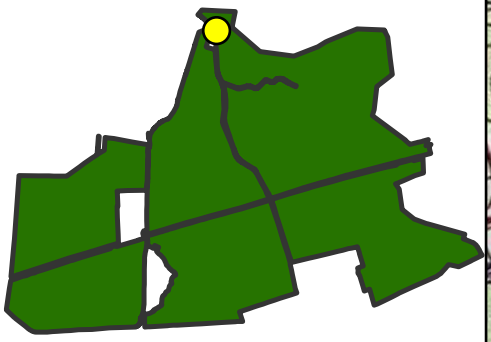
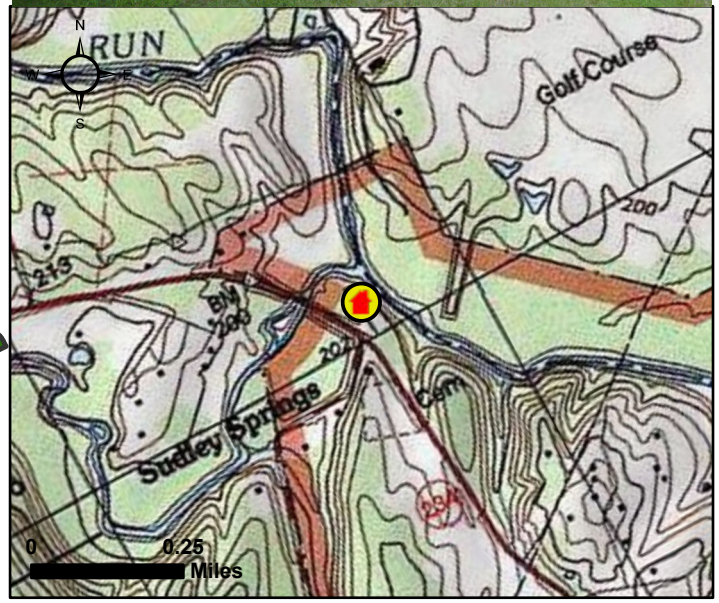
Facility Name: Thornberry House
Unit - Location: MANA - Manassas National Battlefield
FMSS ID: 47064, ***Local ID:***
Structure Type, Use: Building, Public
Owner: National Park Service
Field Crew, Visit Date: Castillo , June 10, 2021
Coordinates (DDM): 38° 50.51642658' N 077° 32.24159820' W

Rating: High
ProtectionLevel: Not Designated,
Resources of Concern: Unknown
Occupied: No
In Community: No,
Revisit Interval: 7 yrs
Map Label: 13

Primary Access: Road
Ingress Egress: 2 or more roads in/out
Access Width: 2 lanes (Greater than 24')
Access Condition: Non-surfaced- gravel,dirt,gradeLess than 5%
Bridge Condition: Less than 300 ft with turnaround
Access and Turnarounds: Less than 300 ft with turnaround
Facility Number or Sign: None or not clearly visible
Fuel Type: Shrub or timber
Fuel Load: Moderate
Defensible Space: 30 ft treated
Topography: Slope Less than 5%
Roof Material: Combustible or no roof
Siding Material: Wood or open sided
Foundation: Closed, Less than 6in masonry exposed
Firewood: None
Water Supply: Reliable water source nearby
Propane: None
Overhead Hazards: No overhead hazards

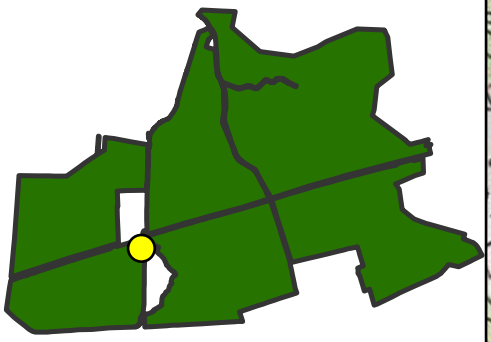
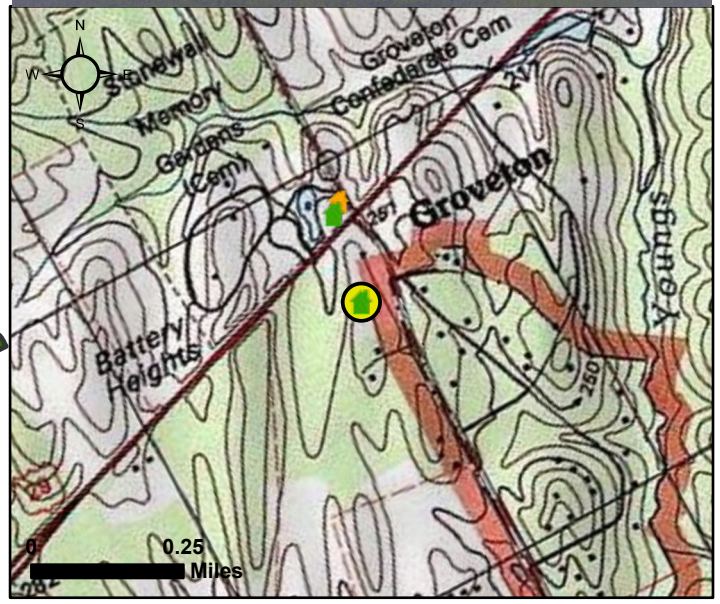
Facility Name: Quarters 10
Unit - Location: MANA - Manassas National Battlefield
FMSS ID: 47132, ***Local ID:***
Structure Type, Use: Building, Administrative
Owner: National Park Service
Field Crew, Visit Date: Castillo , June 10, 2021
Coordinates (DDM): 38° 48.65768166' N 077° 32.98553424' W

Rating: Low
ProtectionLevel: Not Designated,
Resources of Concern: Unknown
Occupied: No
In Community: No,
Revisit Interval: 7 yrs
Map Label: 9

Primary Access: Road
Ingress Egress: 2 or more roads in/out
Access Width: 2 lanes (Greater than 24')
Access Condition: Surfaced-paved, gradeLess than 5%
Bridge Condition: Less than 300 ft with turnaround
Access and Turnarounds: Less than 300 ft with turnaround
Facility Number or Sign: None or not clearly visible
Fuel Type: Grass/tundra,northern hardwood litter
Fuel Load: Moderate
Defensible Space: 100 ft treated
Topography: Slope Less than 5%
Roof Material: Fire resistant- tar,rubberized
Siding Material: Rock, concrete, metal
Foundation: Closed, Greater than 30in masonry exposed or N/A
Firewood: None
Water Supply: Reliable water source nearby
Propane: Present and fuels clearance
Overhead Hazards: No overhead hazards

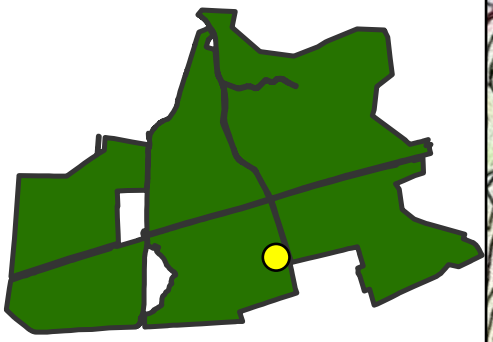
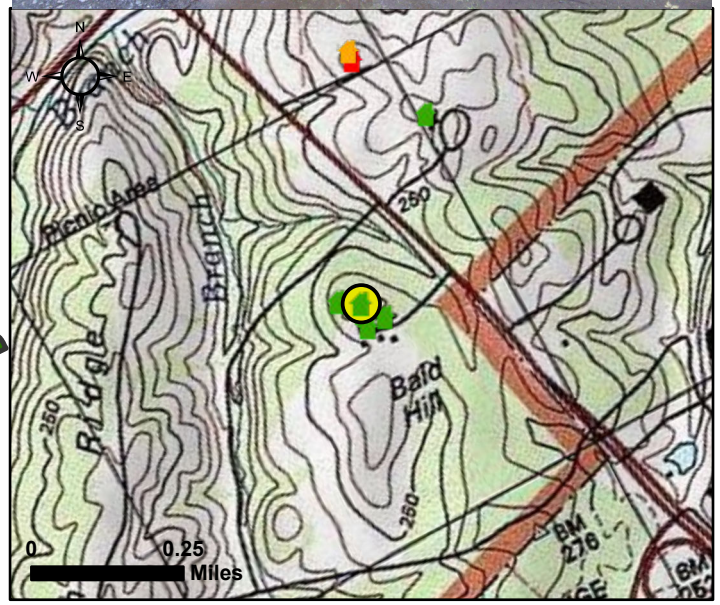
Rating: Low
ProtectionLevel: Not Designated,
Resources of Concern: Unknown
Occupied: No
In Community: Yes,
Revisit Interval: 7 yrs
Map Label: 27

Primary Access: Road
Ingress Egress: 2 or more roads in/out
Access Width: 2 lanes (Greater than 24')
Access Condition: Surfaced-paved, gradeLess than 5%
Bridge Condition: Less than 300 ft with turnaround
Access and Turnarounds: Less than 300 ft with turnaround
Facility Number or Sign: Marked and clearly visible
Fuel Type: Grass/tundra,northern hardwood litter
Fuel Load: Moderate
Defensible Space: 100 ft treated
Topography: Slope Less than 5%
Roof Material: Fire resistant- tar,rubberized
Siding Material: Rock, concrete, metal
Foundation: Closed, Greater than 30in masonry exposed or N/A
Firewood: Adjacent to/under deck of facility
Water Supply: Pressurized hydrant(s) or fixed sprinkler system
Propane: None
Overhead Hazards: No overhead hazards

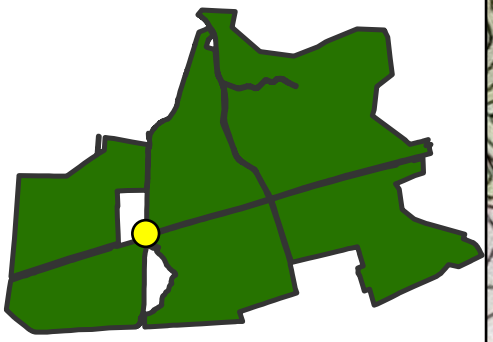
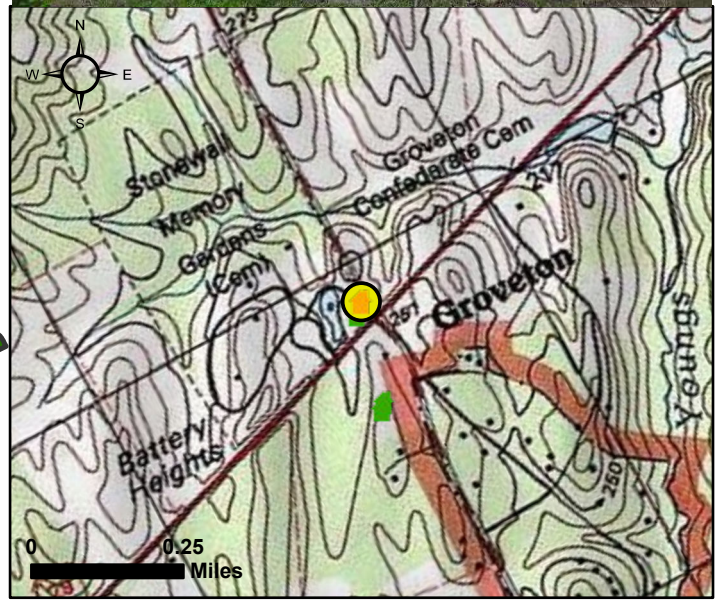
Facility Name: Lucinda Dogan House
Unit - Location: MANA - Manassas National Battlefield
FMSS ID: 47099, ***Local ID:***
Structure Type, Use: Building, Public
Owner: National Park Service
Field Crew, Visit Date: Castillo , June 10, 2021
Coordinates (DDM): 38° 48.78143994' N 077° 32.94389694' W

Rating: Moderate
ProtectionLevel: Not Designated,
Resources of Concern: Unknown
Occupied: No
In Community: No,
Revisit Interval: 7 yrs
Map Label: 11

Primary Access: Road
Ingress Egress: 2 or more roads in/out
Access Width: 2 lanes (Greater than 24')
Access Condition: Surfaced-paved, gradeLess than 5%
Bridge Condition: Less than 300 ft with turnaround
Access and Turnarounds: Less than 300 ft with turnaround
Facility Number or Sign: None or not clearly visible
Fuel Type: Grass/tundra,northern hardwood litter
Fuel Load: Light or no wildland fuels
Defensible Space: 100 ft treated
Topography: Slope Less than 5%
Roof Material: Combustible or no roof
Siding Material: Wood or open sided
Foundation: Closed, 6in to 30in masonry exposed
Firewood: None
Water Supply: Reliable water source nearby
Propane: Present and fuels clearance
Overhead Hazards: No overhead hazards

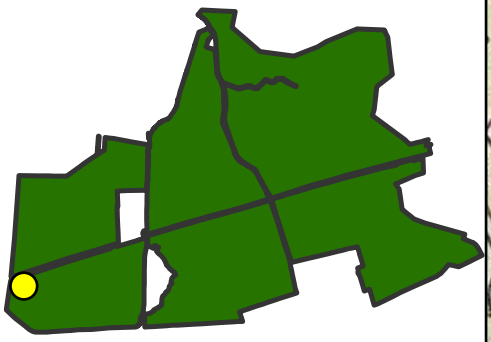
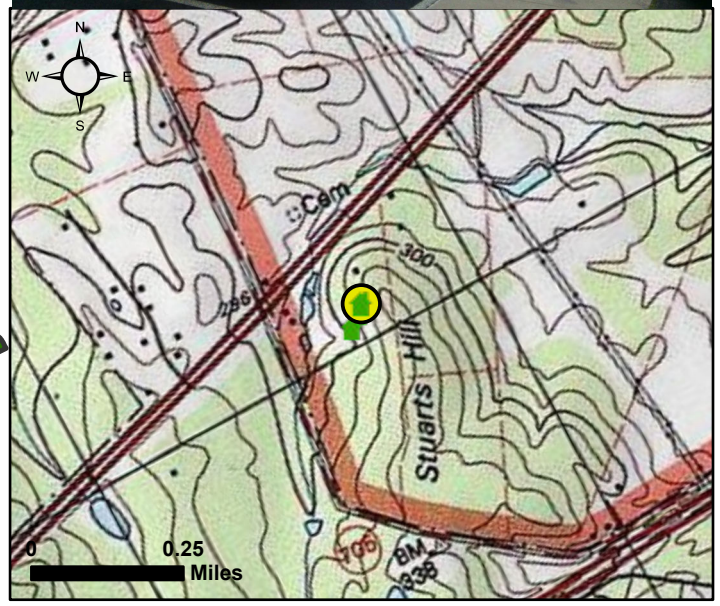
Facility Name: Stuarts Hill Center
Unit - Location: MANA - Manassas National Battlefield
FMSS ID: 47137, ***Local ID:***
Structure Type, Use: Building, Public
Owner: National Park Service
Field Crew, Visit Date: Castillo , June 10, 2021
Coordinates (DDM): 38° 48.30878982' N 077° 34.24972230' W

Rating: Low
ProtectionLevel: Not Designated,
Resources of Concern: Unknown
Occupied: Yes
In Community: No,
Revisit Interval: 7 yrs
Map Label: 3

Primary Access: Road
Ingress Egress: 2 or more roads in/out
Access Width: 2 lanes (Greater than 24')
Access Condition: Surfaced-paved, gradeLess than 5%
Bridge Condition: Greater than 300 ft with turnaround
Access and Turnarounds: Greater than 300 ft with turnaround
Facility Number or Sign: Marked and clearly visible
Fuel Type: Grass/tundra,northern hardwood litter
Fuel Load: Heavy
Defensible Space: 30 ft treated
Topography: Slope Less than 5%
Roof Material: Fire resistant- tar,rubberized
Siding Material: Wood or open sided
Foundation: Closed, Less than 6in masonry exposed
Firewood: None
Water Supply: Pressurized hydrant(s) or fixed sprinkler system
Propane: None
Overhead Hazards: Overhead hazards will limit aircraft

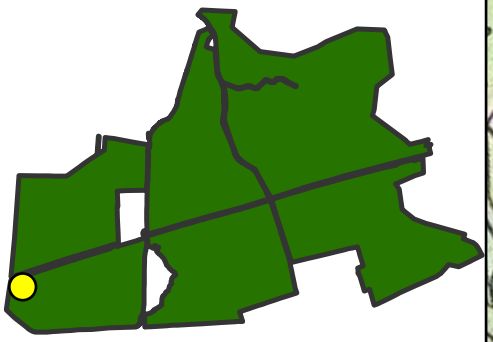
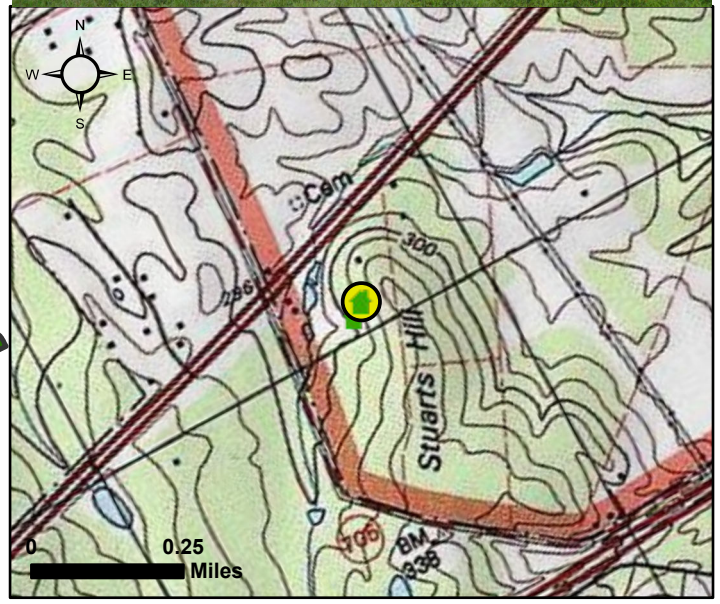
Facility Name: Park Headquarters
Unit - Location: MANA - Manassas National Battlefield
FMSS ID: 47134, ***Local ID:***
Structure Type, Use: Building, Administrative
Owner: National Park Service
Field Crew, Visit Date: Castillo , June 10, 2021
Coordinates (DDM): 38° 48.30046482' N 077° 34.25977230' W

Rating: Low
ProtectionLevel: Not Designated,
Resources of Concern: Unknown
Occupied: Yes
In Community: No,
Revisit Interval: 7 yrs
Map Label: 2

Primary Access: Road
Ingress Egress: 2 or more roads in/out
Access Width: 2 lanes (Greater than 24')
Access Condition: Surfaced-paved, gradeLess than 5%
Bridge Condition: Greater than 300 ft with turnaround
Access and Turnarounds: Greater than 300 ft with turnaround
Facility Number or Sign: Marked and clearly visible
Fuel Type: Grass/tundra,northern hardwood litter
Fuel Load: Heavy
Defensible Space: 30 ft treated
Topography: Slope Less than 5%
Roof Material: Fire resistant- tar,rubberized
Siding Material: Wood or open sided
Foundation: Closed, Less than 6in masonry exposed
Firewood: None
Water Supply: Pressurized hydrant(s) or fixed sprinkler system
Propane: None
Overhead Hazards: Overhead hazards will limit aircraft

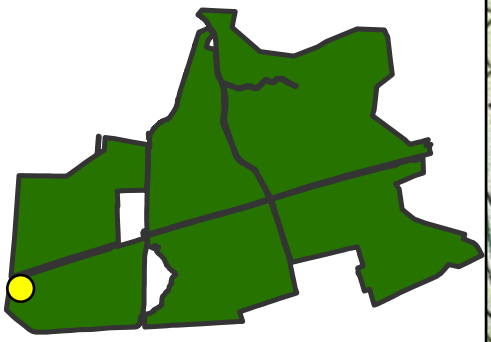
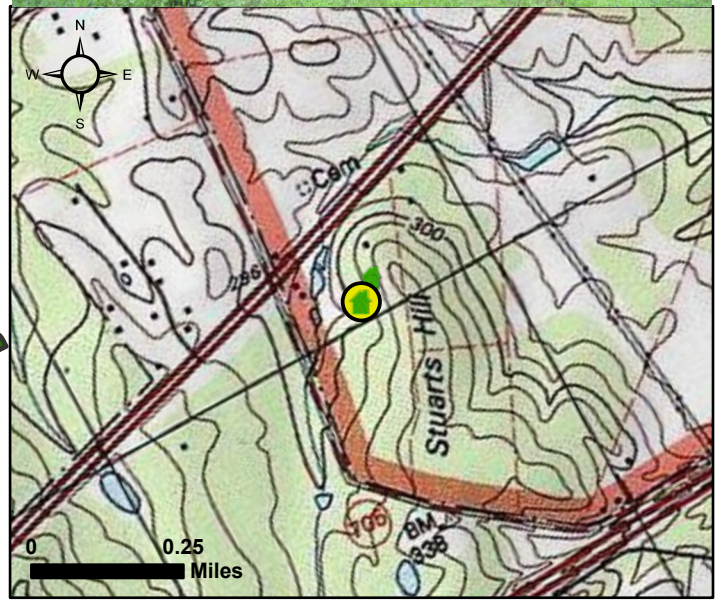
Rating: Low
ProtectionLevel: Not Designated,
Resources of Concern: Unknown
Occupied: No
In Community: No,
Revisit Interval: 7 yrs
Map Label: 1

Primary Access: Road
Ingress Egress: 2 or more roads in/out
Access Width: 2 lanes (Greater than 24')
Access Condition: Surfaced-paved, gradeLess than 5%
Bridge Condition: Greater than 300 ft with turnaround
Access and Turnarounds: Greater than 300 ft with turnaround
Facility Number or Sign: Marked and clearly visible
Fuel Type: Grass/tundra,northern hardwood litter
Fuel Load: Heavy
Defensible Space: Less than 30 ft treated
Topography: Slope Less than 5%
Roof Material: Fire resistant- tar,rubberized
Siding Material: Rock, concrete, metal
Foundation: Closed, Greater than 30in masonry exposed or N/A
Firewood: None
Water Supply: Pressurized hydrant(s) or fixed sprinkler system
Propane: None
Overhead Hazards: Overhead hazards will limit aircraft

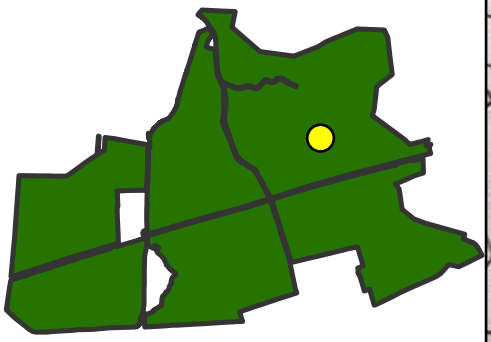
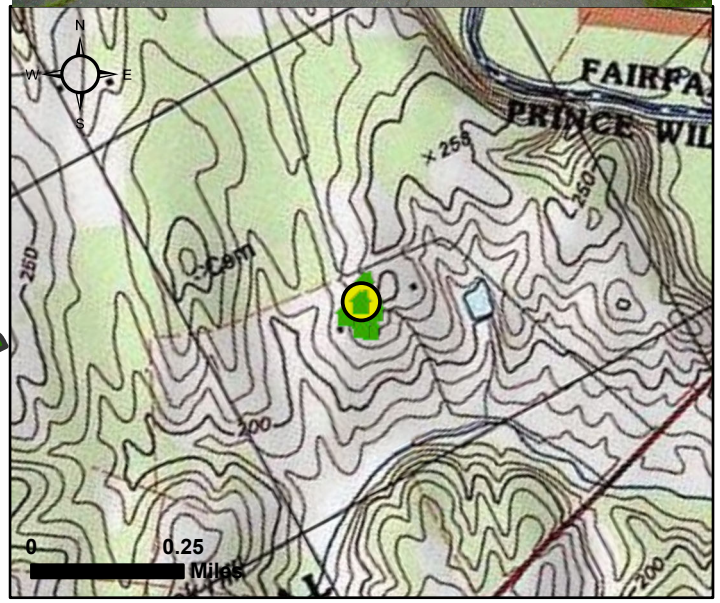
Rating: Low
ProtectionLevel: Not Designated,
Resources of Concern: Unknown
Occupied: Yes
In Community: Yes,
Revisit Interval: 7 yrs
Map Label: 33

Primary Access: Road
Ingress Egress: 2 or more roads in/out
Access Width: 1 lane (Less than 18')
Access Condition: Surfaced-paved, gradeLess than 5%
Bridge Condition: Greater than 300 ft with turnaround
Access and Turnarounds: Greater than 300 ft with turnaround
Facility Number or Sign: Marked and clearly visible
Fuel Type: Grass/tundra,northern hardwood litter
Fuel Load: Light or no wildland fuels
Defensible Space: Greater than 100ft treated
Topography: Slope Less than 5%
Roof Material: Fire resistant- tar,rubberized
Siding Material: Rock, concrete, metal
Foundation: Closed, Greater than 30in masonry exposed or N/A
Firewood: None
Water Supply: Reliable water source nearby
Propane: None
Overhead Hazards: No overhead hazards

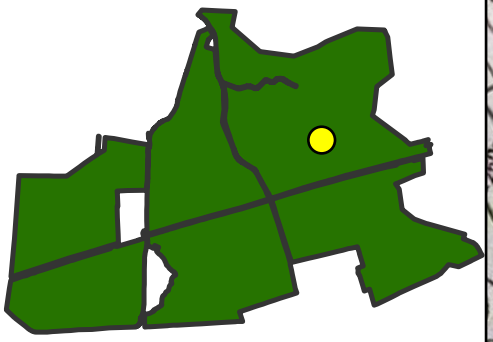
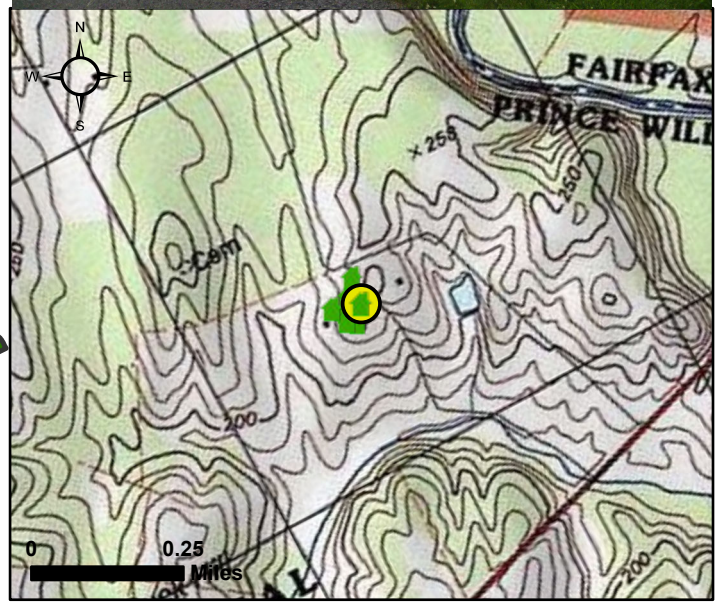
Facility Name: Tack Room
Unit - Location: MANA - Manassas National Battlefield
FMSS ID: 47070, ***Local ID:***
Structure Type, Use: Building, Administrative
Owner: National Park Service
Field Crew, Visit Date: Castillo , June 10, 2021
Coordinates (DDM): 38° 49.61424018' N 077° 31.06957140' W

Rating: Low
ProtectionLevel: Not Designated,
Resources of Concern: Unknown
Occupied: No
In Community: Yes,
Revisit Interval: 7 yrs
Map Label: 34

Primary Access: Road
Ingress Egress: 2 or more roads in/out
Access Width: 1 lane (Less than 18')
Access Condition: Surfaced-paved, gradeLess than 5%
Bridge Condition: Greater than 300 ft with turnaround
Access and Turnarounds: Greater than 300 ft with turnaround
Facility Number or Sign: Marked and clearly visible
Fuel Type: Grass/tundra,northern hardwood litter
Fuel Load: Light or no wildland fuels
Defensible Space: Greater than 100ft treated
Topography: Slope Less than 5%
Roof Material: Noncombustible or not applicable
Siding Material: Rock, concrete, metal
Foundation: Closed, Greater than 30in masonry exposed or N/A
Firewood: None
Water Supply: Reliable water source nearby
Propane: None
Overhead Hazards: No overhead hazards

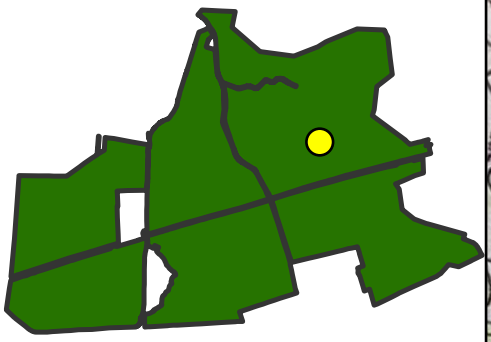
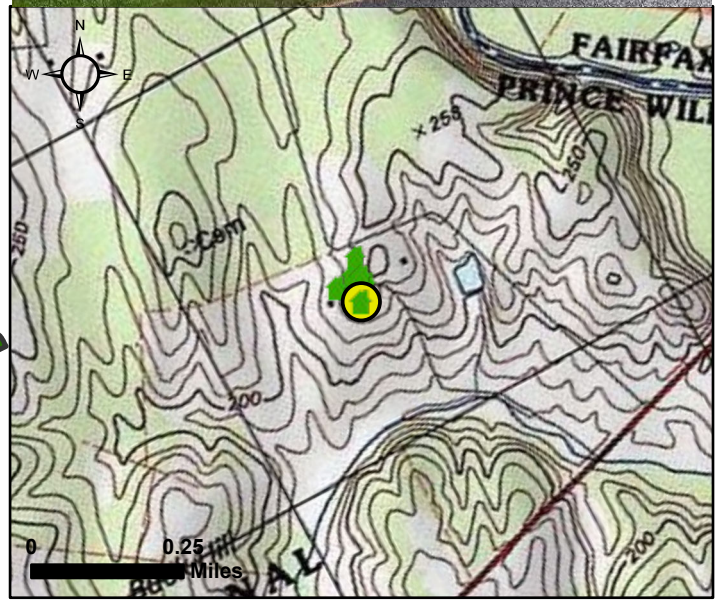
Rating: Low
ProtectionLevel: Not Designated,
Resources of Concern: Unknown
Occupied: Yes
In Community: Yes,
Revisit Interval: 7 yrs
Map Label: 32

Primary Access: Road
Ingress Egress: 2 or more roads in/out
Access Width: 1 lane (Less than 18')
Access Condition: Surfaced-paved, gradeLess than 5%
Bridge Condition: Greater than 300 ft with turnaround
Access and Turnarounds: Greater than 300 ft with turnaround
Facility Number or Sign: Marked and clearly visible
Fuel Type: Grass/tundra,northern hardwood litter
Fuel Load: Moderate
Defensible Space: 100 ft treated
Topography: Slope Less than 5%
Roof Material: Noncombustible or not applicable
Siding Material: Wood or open sided
Foundation: Open or deck
Firewood: None
Water Supply: Reliable water source nearby
Propane: None
Overhead Hazards: No overhead hazards

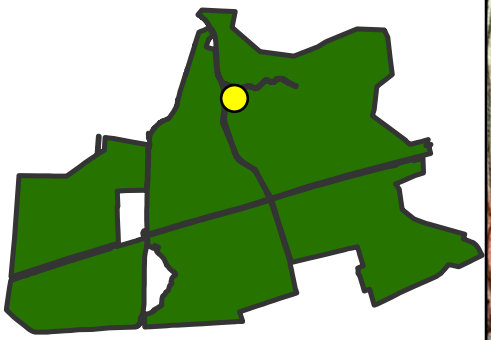
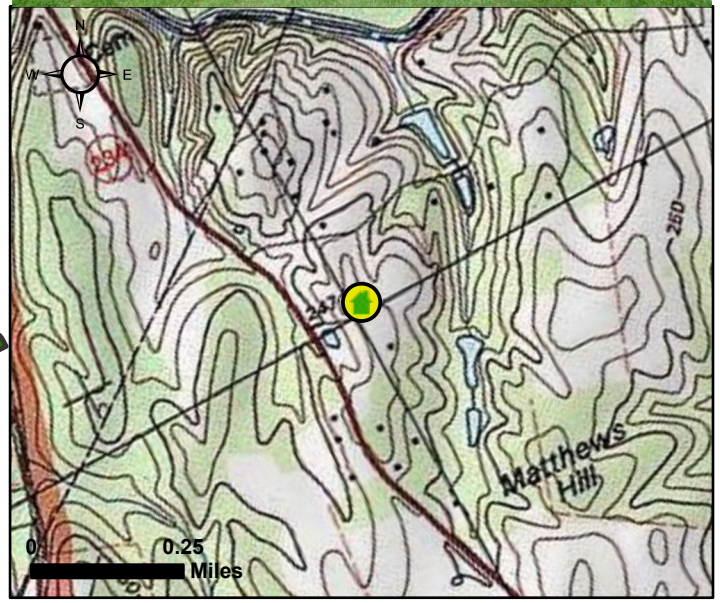
Facility Name: Quarters 9
Unit - Location: MANA - Manassas National Battlefield
FMSS ID: 47067, ***Local ID:***
Structure Type, Use: Building, Administrative
Owner: National Park Service
Field Crew, Visit Date: Castillo , June 10, 2021
Coordinates (DDM): 38° 49.94769024' N 077° 32.02762170' W

Rating: Low
ProtectionLevel: Not Designated,
Resources of Concern: Unknown
Occupied: Yes
In Community: No,
Revisit Interval: 7 yrs
Map Label: 16

Primary Access: Road
Ingress Egress: 2 or more roads in/out
Access Width: 1 lane (Less than 18')
Access Condition: Surfaced-paved, gradeLess than 5%
Bridge Condition: Less than 300 ft with turnaround
Access and Turnarounds: Less than 300 ft with turnaround
Facility Number or Sign: None or not clearly visible
Fuel Type: Grass/tundra,northern hardwood litter
Fuel Load: Heavy
Defensible Space: 100 ft treated
Topography: Slope Less than 5%
Roof Material: Fire resistant- tar,rubberized
Siding Material: Rock, concrete, metal
Foundation: Closed, Greater than 30in masonry exposed or N/A
Firewood: None
Water Supply: Reliable water source nearby
Propane: None
Overhead Hazards: No overhead hazards

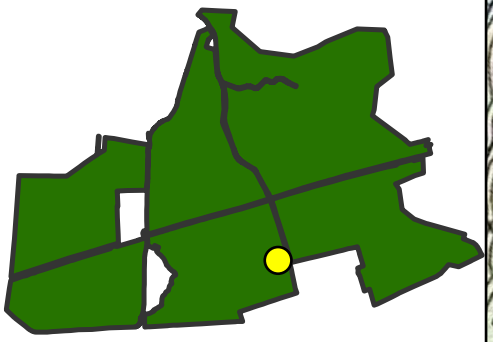
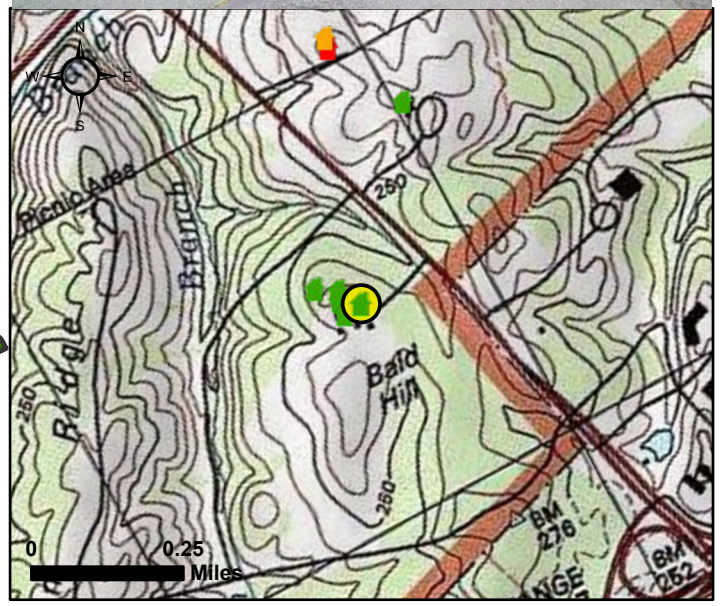
Rating: Low
ProtectionLevel: Not Designated,
Resources of Concern: Unknown
Occupied: Yes
In Community: Yes,
Revisit Interval: 7 yrs
Map Label: 28

Primary Access: Road
Ingress Egress: 2 or more roads in/out
Access Width: 2 lanes (Greater than 24')
Access Condition: Surfaced-paved, gradeLess than 5%
Bridge Condition: Less than 300 ft with turnaround
Access and Turnarounds: Less than 300 ft with turnaround
Facility Number or Sign: Marked and clearly visible
Fuel Type: Grass/tundra,northern hardwood litter
Fuel Load: Moderate
Defensible Space: 30 ft treated
Topography: Slope Less than 5%
Roof Material: Fire resistant- tar,rubberized
Siding Material: Rock, concrete, metal
Foundation: Closed, Greater than 30in masonry exposed or N/A
Firewood: None
Water Supply: Pressurized hydrant(s) or fixed sprinkler system
Propane: None
Overhead Hazards: No overhead hazards

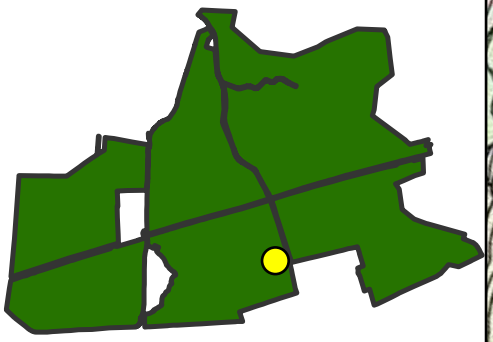
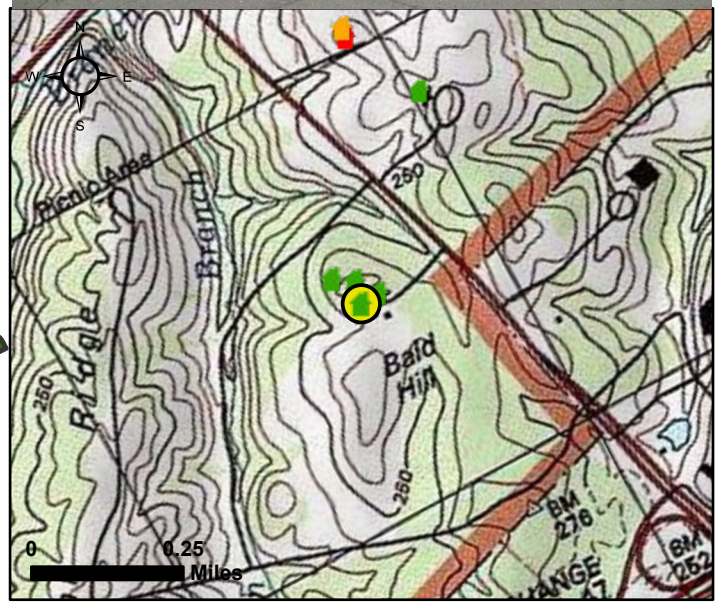
Facility Name: Maintenance Shop
Unit - Location: MANA - Manassas National Battlefield
FMSS ID: 47127, ***Local ID:***
Structure Type, Use: Building, Administrative
Owner: National Park Service
Field Crew, Visit Date: Castillo , June 10, 2021
Coordinates (DDM): 38° 48.58343994' N 077° 31.53554646' W

Rating: Low
ProtectionLevel: Not Designated,
Resources of Concern: Unknown
Occupied: Yes
In Community: Yes,
Revisit Interval: 7 yrs
Map Label: 25

Primary Access: Road
Ingress Egress: 2 or more roads in/out
Access Width: 2 lanes (Greater than 24')
Access Condition: Surfaced-paved, gradeLess than 5%
Bridge Condition: Less than 300 ft with turnaround
Access and Turnarounds: Less than 300 ft with turnaround
Facility Number or Sign: Marked and clearly visible
Fuel Type: No wildland fuel
Fuel Load: Light or no wildland fuels
Defensible Space: 100 ft treated
Topography: Slope Less than 5%
Roof Material: Fire resistant- tar,rubberized
Siding Material: Rock, concrete, metal
Foundation: Closed, Greater than 30in masonry exposed or N/A
Firewood: Adjacent to/under deck of facility
Water Supply: Pressurized hydrant(s) or fixed sprinkler system
Propane: None
Overhead Hazards: No overhead hazards

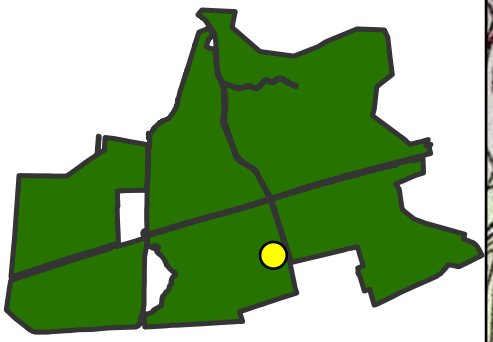
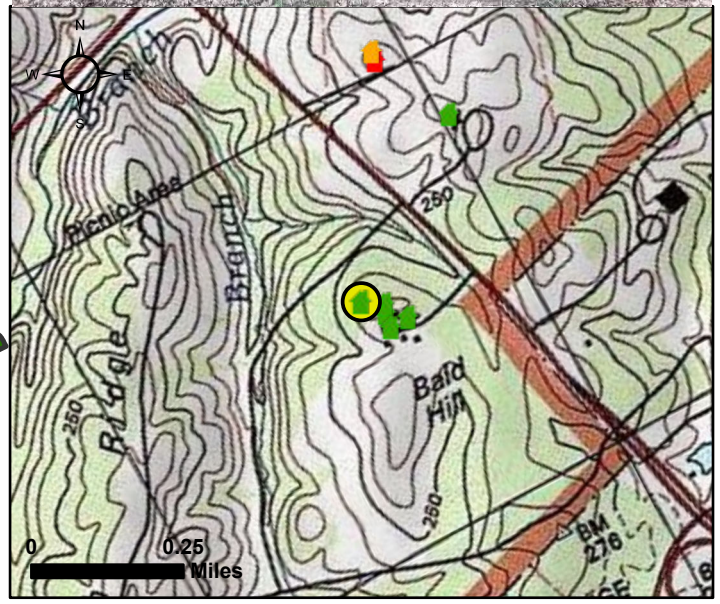
Rating: Low
ProtectionLevel: Not Designated,
Resources of Concern: Unknown
Occupied: No
In Community: Yes,
Revisit Interval: 7 yrs
Map Label: 24

Primary Access: Road
Ingress Egress: 2 or more roads in/out
Access Width: 2 lanes (Greater than 24')
Access Condition: Surfaced-paved, gradeLess than 5%
Bridge Condition: Less than 300 ft with turnaround
Access and Turnarounds: Less than 300 ft with turnaround
Facility Number or Sign: Marked and clearly visible
Fuel Type: Shrub or timber
Fuel Load: Moderate
Defensible Space: 30 ft treated
Topography: Slope Less than 5%
Roof Material: Noncombustible or not applicable
Siding Material: Rock, concrete, metal
Foundation: Closed, Greater than 30in masonry exposed or N/A
Firewood: None
Water Supply: Pressurized hydrant(s) or fixed sprinkler system
Propane: None
Overhead Hazards: No overhead hazards
