MANA - Manassas National Battlefield Park

National Park Service
U.S. Department of the Interior

NPS Wildland Fire Risk Assessment - Facility Assessment

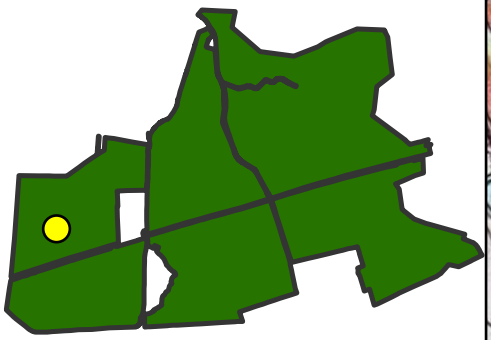
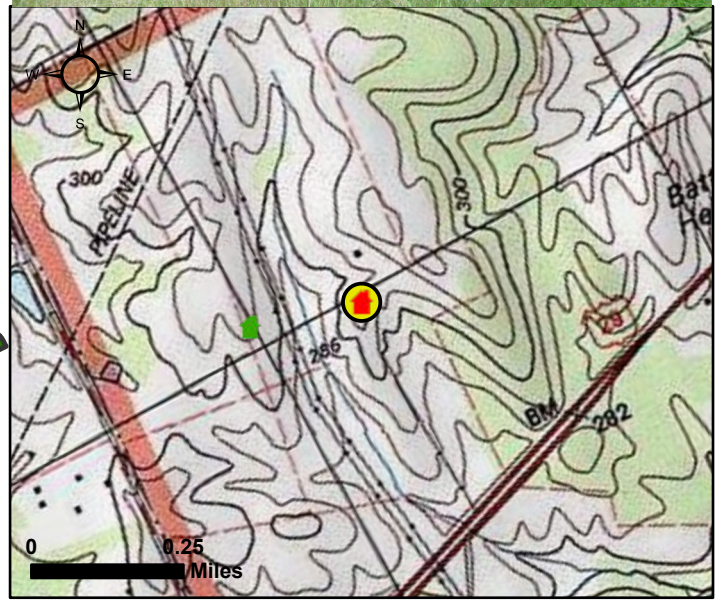
Facility Name: Brawner Farm House
Unit - Location: MANA - Manassas National Battlefield
FMSS ID: 47103, ***Local ID:***
Structure Type, Use: Building, Public
Owner: National Park Service
Field Crew, Visit Date: Castillo , June 10, 2021
Coordinates (DDM): 38° 48.79943994' N 077° 33.91199724' W

Rating: High
ProtectionLevel: Not Designated,
Resources of Concern: Unknown
Occupied: Yes
In Community: No,
Revisit Interval: 7 yrs
Map Label: 5

Primary Access: Road
Ingress Egress: 2 or more roads in/out
Access Width: 1 lane (Less than 18')
Access Condition: Non-surfaced- gravel,dirt,gradeLess than 5%
Bridge Condition: Greater than 300 ft with turnaround
Access and Turnarounds: Greater than 300 ft with turnaround
Facility Number or Sign: Marked and clearly visible
Fuel Type: Grass/tundra,northern hardwood litter
Fuel Load: Heavy
Defensible Space: 30 ft treated
Topography: Slope Less than 5%
Roof Material: Combustible or no roof
Siding Material: Wood or open sided
Foundation: Closed, 6in to 30in masonry exposed
Firewood: None
Water Supply: Reliable water source nearby
Propane: None
Overhead Hazards: No overhead hazards

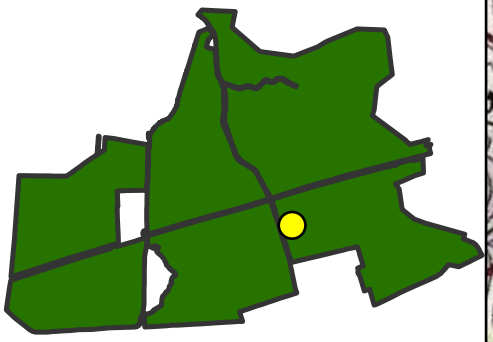
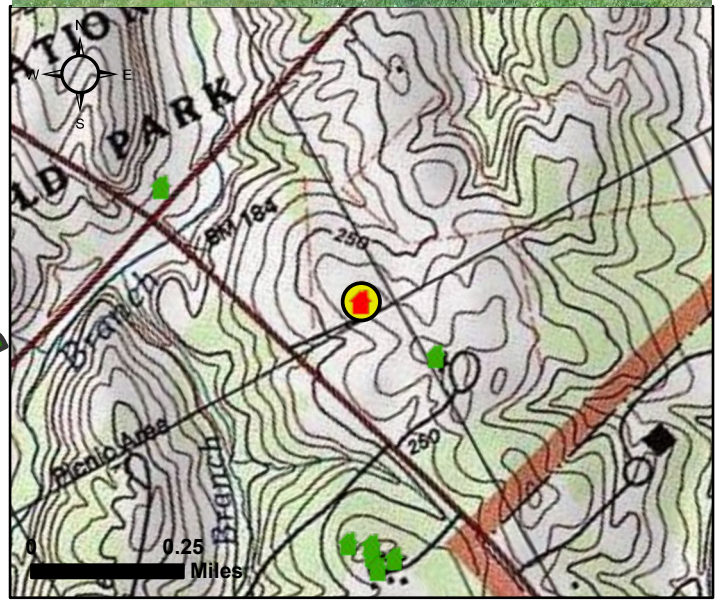
Facility Name: Henry House
Unit - Location: MANA - Manassas National Battlefield
FMSS ID: 47118, ***Local ID:***
Structure Type, Use: Building, Public
Owner: National Park Service
Field Crew, Visit Date: Castillo , June 10, 2021
Coordinates (DDM): 38° 48.88741500' N 077° 31.36364646' W

Rating: High
ProtectionLevel: Not Designated,
Resources of Concern: Unknown
Occupied: No
In Community: No,
Revisit Interval: 7 yrs
Map Label: 18

Primary Access: Road
Ingress Egress: 1 road in/out
Access Width: 1 lane (Less than 18')
Access Condition: Other than all season
Bridge Condition: Greater than 300 ft with turnaround
Access and Turnarounds: Greater than 300 ft with turnaround
Facility Number or Sign: None or not clearly visible
Fuel Type: Grass/tundra,northern hardwood litter
Fuel Load: Light or no wildland fuels
Defensible Space: 100 ft treated
Topography: Slope Less than 5%
Roof Material: Combustible or no roof
Siding Material: Wood or open sided
Foundation: Closed, Less than 6in masonry exposed
Firewood: None
Water Supply: Reliable water source nearby
Propane: None
Overhead Hazards: No overhead hazards

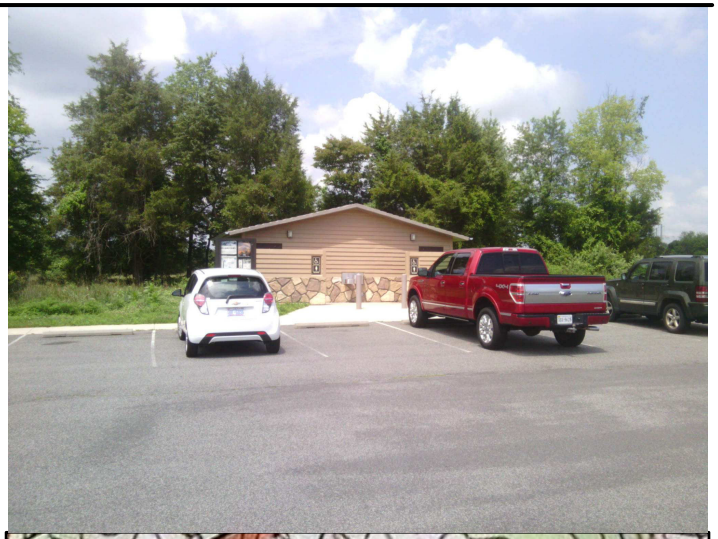
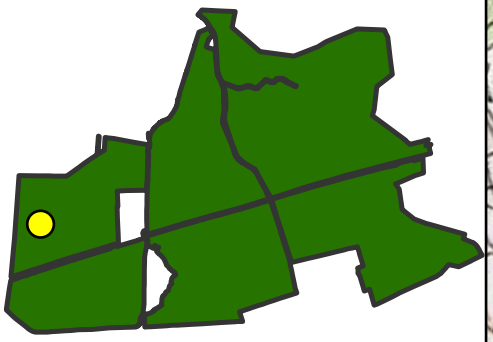
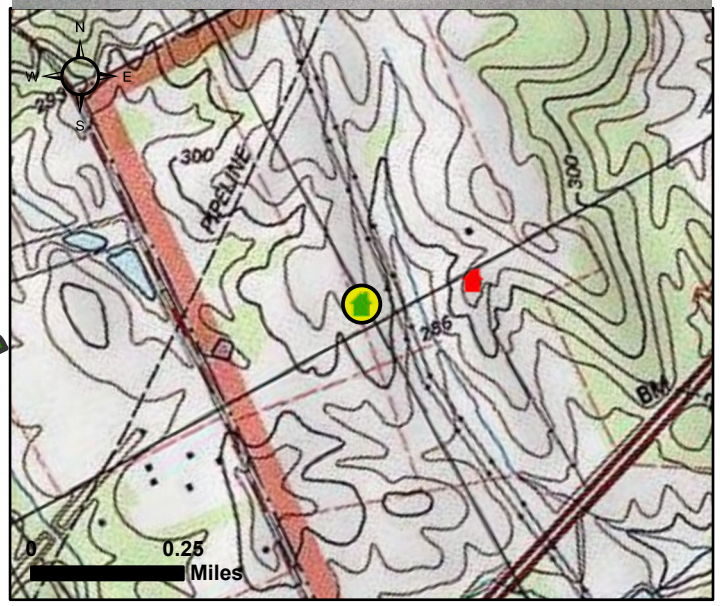
Facility Name: Brawner Farm Restroom Facility
Unit - Location: MANA - Manassas National Battlefield
FMSS ID: 225265, ***Local ID:***
Structure Type, Use: Building, Public
Owner: National Park Service
Field Crew, Visit Date: Castillo , June 10, 2021
Coordinates (DDM): 38° 48.83589552' N 077° 34.08662880' W

Rating: Low
ProtectionLevel: Not Designated,
Resources of Concern: Unknown
Occupied: No
In Community: No,
Revisit Interval: 7 yrs
Map Label: 4

Primary Access: Road
Ingress Egress: 2 or more roads in/out
Access Width: 2 lanes (Greater than 24')
Access Condition: Surfaced-paved, gradeLess than 5%
Bridge Condition: Less than 300 ft with turnaround
Access and Turnarounds: Less than 300 ft with turnaround
Facility Number or Sign: Marked and clearly visible
Fuel Type: Grass/tundra,northern hardwood litter
Fuel Load: Moderate
Defensible Space: 30 ft treated
Topography: Slope Less than 5%
Roof Material: Noncombustible or not applicable
Siding Material: Rock, concrete, metal
Foundation: Closed, Greater than 30in masonry exposed or N/A
Firewood: None
Water Supply: Reliable water source nearby
Propane: None
Overhead Hazards: No overhead hazards
Comments:

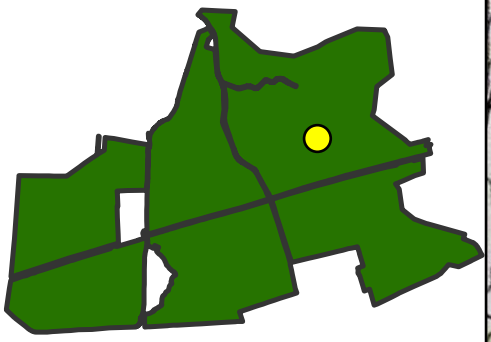
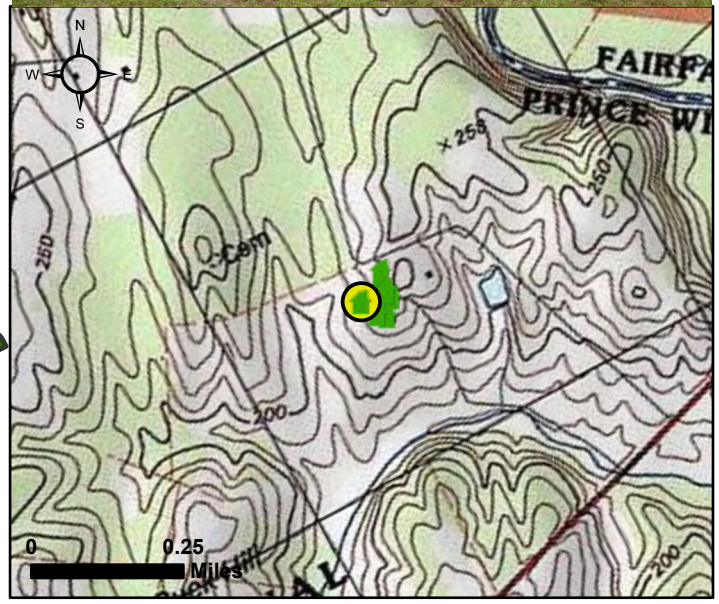
Rating: Low
ProtectionLevel: Not Designated,
Resources of Concern: Unknown
Occupied: No
In Community: Yes,
Revisit Interval: 7 yrs
Map Label: 29

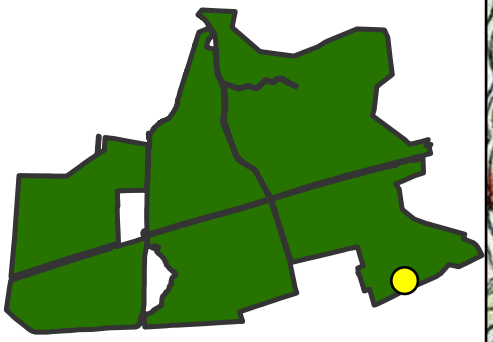
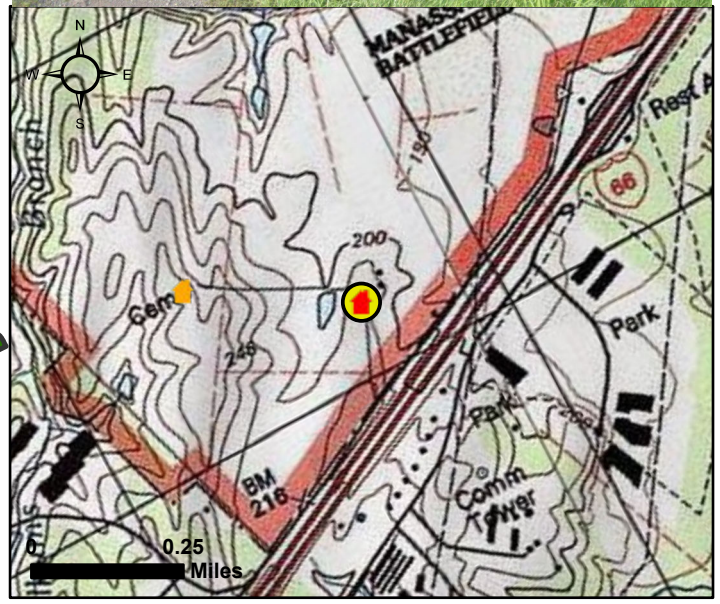
Facility Name: Portici Shed
Unit - Location: MANA - Manassas National Battlefield
FMSS ID: not found, ***Local ID:***
Structure Type, Use: Building, Administrative
Owner: National Park Service
Field Crew, Visit Date: Castillo , June 10, 2021
Coordinates (DDM): 38° 48.44354400' N 077° 30.13158504' W

Rating: High
ProtectionLevel: Not Designated,
Resources of Concern: Unknown
Occupied: No
In Community: No,
Revisit Interval: 7 yrs
Map Label: 23

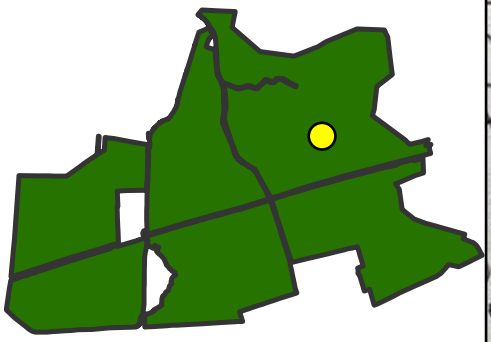
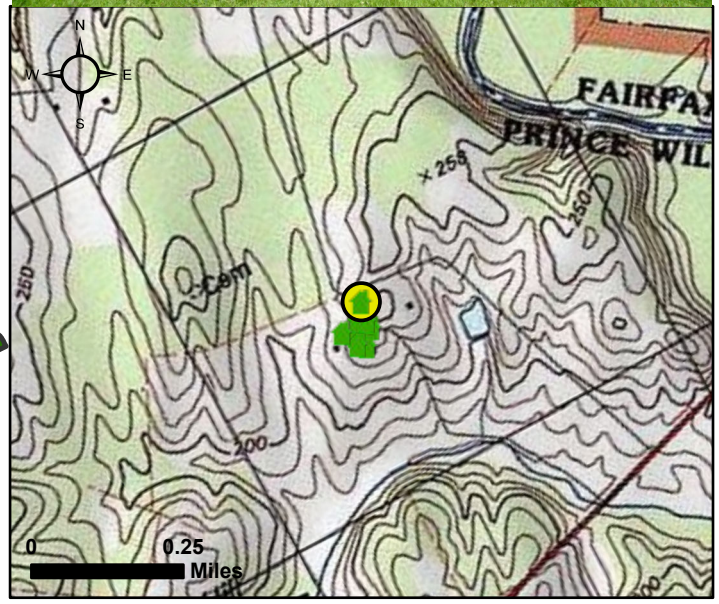
Facility Name: horse shed 3
Unit - Location: MANA - Manassas National Battlefield
FMSS ID: , ***Local ID:***
Structure Type, Use: Building, Administrative
Owner: National Park Service
Field Crew, Visit Date: Castillo , June 10, 2021
Coordinates (DDM): 38° 49.64888448' N 077° 31.06476744' W

Rating: Low
ProtectionLevel: Not Designated,
Resources of Concern: Unknown
Occupied: No
In Community: Yes,
Revisit Interval: 7 yrs
Map Label: 35

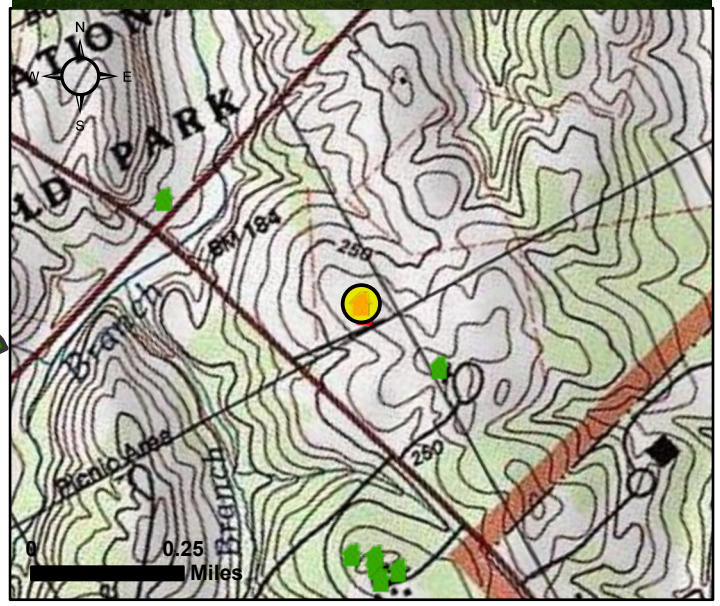
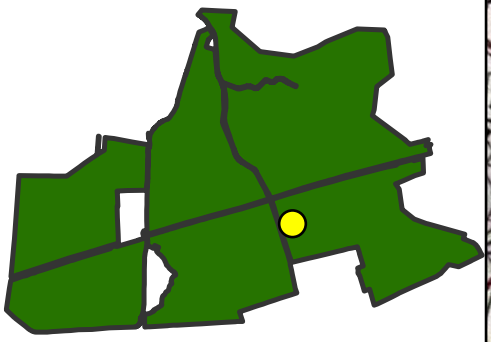
Facility Name: Henry House Outbuilding
Unit - Location: MANA - Manassas National Battlefield
FMSS ID: 1195277, ***Local ID:***
Structure Type, Use: Building, Public
Owner: National Park Service
Field Crew, Visit Date: Castillo , June 10, 2021
Coordinates (DDM): 38° 48.89954868' N 077° 31.36177542' W

Rating: Moderate
ProtectionLevel: Not Designated,
Resources of Concern: Unknown
Occupied: No
In Community: No,
Revisit Interval: 7 yrs
Map Label: 19

Primary Access: Road
Ingress Egress: 2 or more roads in/out
Access Width: 1 lane (Less than 18')
Access Condition: Non-surfaced- gravel,dirt,gradeLess than 5%
Bridge Condition: Less than 300 ft with turnaround
Access and Turnarounds: Less than 300 ft with turnaround
Facility Number or Sign: Marked and clearly visible
Fuel Type: Grass/tundra,northern hardwood litter
Fuel Load: Light or no wildland fuels
Defensible Space: 30 ft treated
Topography: Slope Less than 5%
Roof Material: Combustible or no roof
Siding Material: Wood or open sided
Foundation: Closed, Less than 6in masonry exposed
Firewood: None
Water Supply: Reliable water source nearby
Propane: None
Overhead Hazards: No overhead hazards

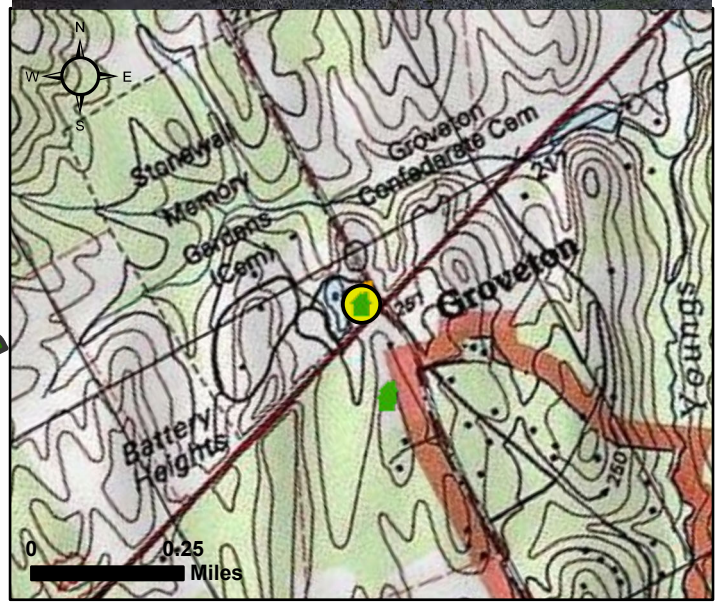
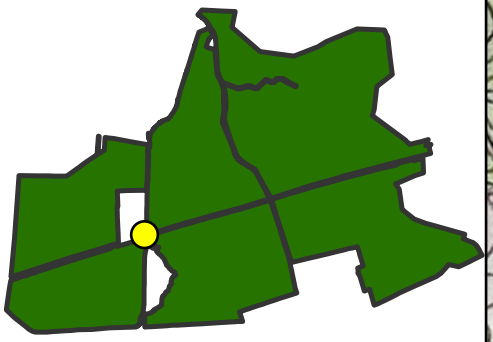
Facility Name: MJ Dogan House
Unit - Location: MANA - Manassas National Battlefield
FMSS ID: 249277, ***Local ID:***
Structure Type, Use: Building, Administrative
Owner: National Park Service
Field Crew, Visit Date: Castillo , June 10, 2021
Coordinates (DDM): 38° 48.77057352' N 077° 32.95968066' W

Rating: Low
ProtectionLevel: Undesignated,
Resources of Concern: Unknown
Occupied: No
In Community: No,
Revisit Interval: 7 yrs
Map Label: 10

Primary Access: Road
Ingress Egress: 2 or more roads in/out
Access Width: 2 lanes (Greater than 24')
Access Condition: Surfaced-paved, gradeLess than 5%
Bridge Condition: Less than 300 ft with turnaround
Access and Turnarounds: Less than 300 ft with turnaround
Facility Number or Sign: None or not clearly visible
Fuel Type: Shrub or timber
Fuel Load: Light or no wildland fuels
Defensible Space: 30 ft treated
Topography: Slope Less than 5%
Roof Material: Noncombustible or not applicable
Siding Material: Log construction
Foundation: Closed, Greater than 30in masonry exposed or N/A
Firewood: None
Water Supply: Pressurized hydrant(s) or fixed sprinkler system
Propane: None
Overhead Hazards: No overhead hazards
