NPS Wildfire Risk Assessments
Assessment Locations

Glen Canyon National Recreation Area - Overview

Glen Canyon National Recreation Area - Wahweap - Overview

GLCA - Glen Canyon National Recreation Area

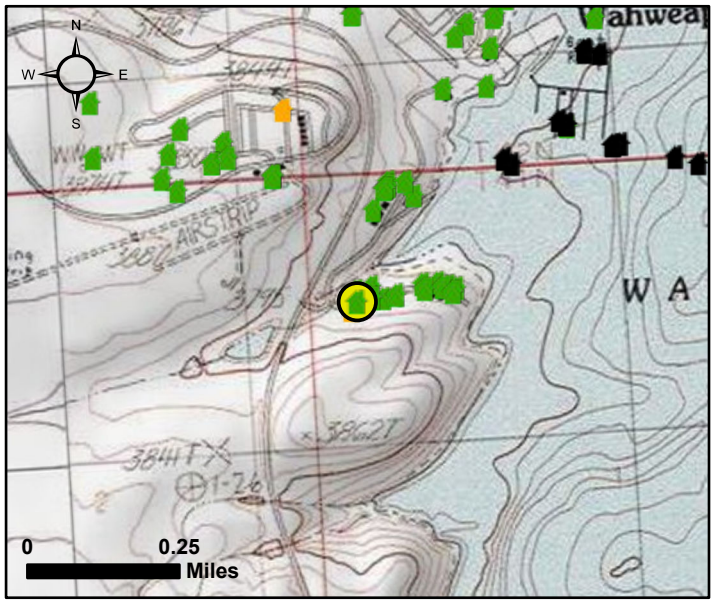
Facility Name: WW Housing #120
Unit - Location: GLCA - Wahweap
FMSS ID: 44563, ***Local ID:***
Structure Type, Use: Building, Administrative
Owner: National Park Service
Field Crew, Visit Date: ZION WFM, June 19, 2012
Coordinates (DDM): 36° 59.24200002' N 111° 29.51100000' W

Rating: Low
ProtectionLevel: Undesignated,
Resources of Concern: Unknown
Occupied: Yes
In Community: No,
Revisit Interval: yrs
Map Label: 438

Primary Access: Road
Ingress Egress: 2 or more roads in/out
Access Width: 2 lanes (Greater than 24')
Access Condition: Surfaced-paved, gradeLess than 5%
Bridge Condition: Less than 300 ft with turnaround
Access and Turnarounds: Less than 300 ft with turnaround
Facility Number or Sign: Marked and clearly visible
Fuel Type: Grass and shrub, hardwood litter
Fuel Load: Moderate
Defensible Space: Less than 30 ft treated
Topography: Slope Less than 5%
Roof Material: Noncombustible or not applicable
Siding Material: Rock, concrete, metal
Foundation: Closed, Greater than 30in masonry exposed or N/A
Firewood: None
Water Supply: Pressurized hydrant(s) or fixed sprinkler system
Propane: None
Overhead Hazards: No overhead hazards
Comments:

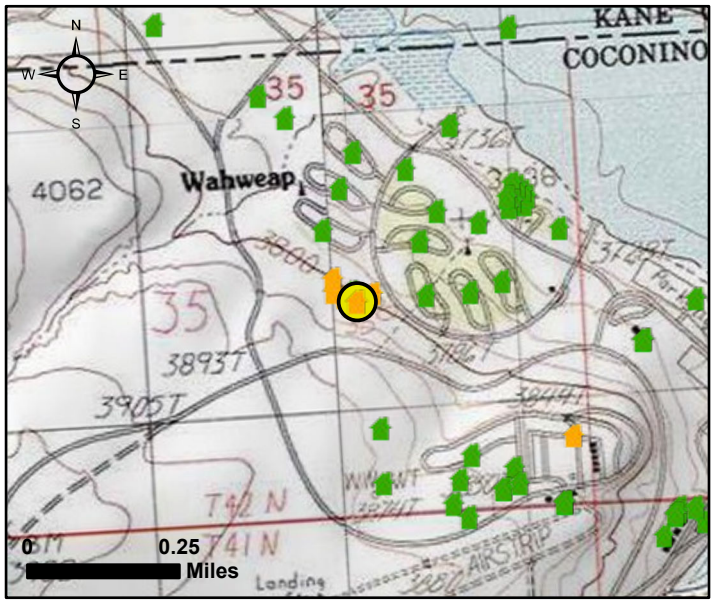
Rating: Moderate
ProtectionLevel: Undesignated,
Resources of Concern: Unknown
Occupied:
In Community: No,
Revisit Interval: yrs
Map Label: 392

Primary Access: Road
Ingress Egress: 2 or more roads in/out
Access Width: 2 lanes (Greater than 24')
Access Condition: Surfaced-paved, gradeLess than 5%
Bridge Condition: Less than 300 ft with turnaround
Access and Turnarounds: Less than 300 ft with turnaround
Facility Number or Sign: None or not clearly visible
Fuel Type: Grass and shrub, hardwood litter
Fuel Load: Light or no wildland fuels
Defensible Space: 30 ft treated
Topography: Slope 31% to 40%
Roof Material: Combustible or no roof
Siding Material: Rock, concrete, metal
Foundation: Closed, Greater than 30in masonry exposed or N/A
Firewood: None
Water Supply: Pressurized hydrant(s) or fixed sprinkler system
Propane: None
Overhead Hazards: No overhead hazards

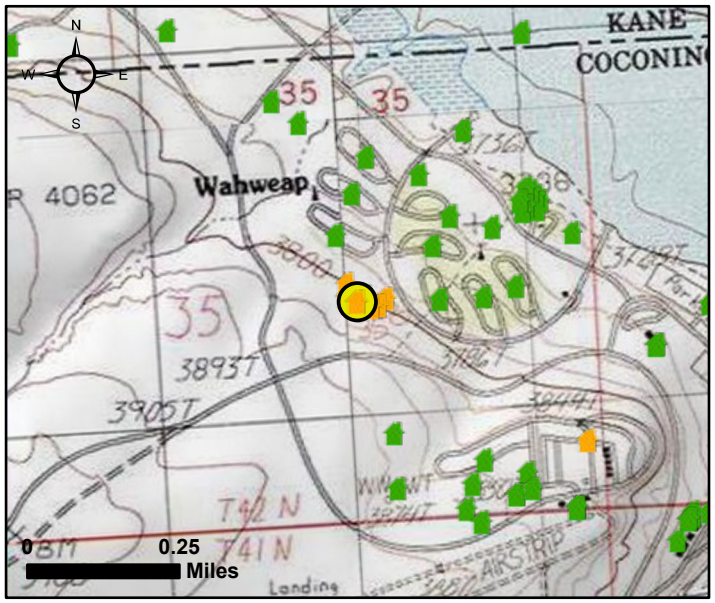
Rating: Moderate
ProtectionLevel: Undesignated,
Resources of Concern: Unknown
Occupied:
In Community: No,
Revisit Interval: yrs
Map Label: 388

Primary Access: Road
Ingress Egress: 2 or more roads in/out
Access Width: 2 lanes (Greater than 24')
Access Condition: Surfaced-paved, gradeLess than 5%
Bridge Condition: Less than 300 ft with turnaround
Access and Turnarounds: Less than 300 ft with turnaround
Facility Number or Sign: None or not clearly visible
Fuel Type: Grass and shrub, hardwood litter
Fuel Load: Light or no wildland fuels
Defensible Space: 30 ft treated
Topography: Slope 31% to 40%
Roof Material: Combustible or no roof
Siding Material: Rock, concrete, metal
Foundation: Closed, Greater than 30in masonry exposed or N/A
Firewood: None
Water Supply: Pressurized hydrant(s) or fixed sprinkler system
Propane: None
Overhead Hazards: No overhead hazards

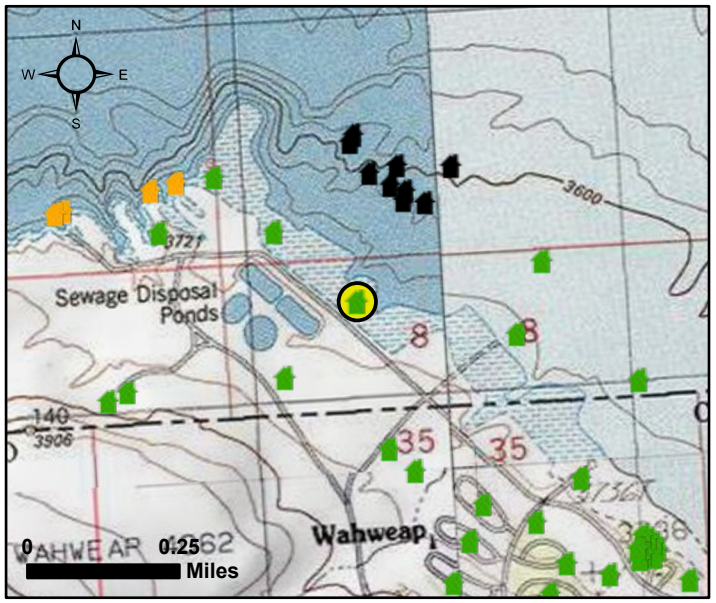
Rating: Low
ProtectionLevel: Undesignated,
Resources of Concern: Unknown
Occupied: Yes
In Community: No,
Revisit Interval: yrs
Map Label: 374

Primary Access: Road
Ingress Egress: 2 or more roads in/out
Access Width: 2 lanes (Greater than 24')
Access Condition: Surfaced-paved, gradeLess than 5%
Bridge Condition: Less than 300 ft with turnaround
Access and Turnarounds: Less than 300 ft with turnaround
Facility Number or Sign: None or not clearly visible
Fuel Type: Grass and shrub, hardwood litter
Fuel Load: Light or no wildland fuels
Defensible Space: 100 ft treated
Topography: Slope 5% to 20%
Roof Material: Noncombustible or not applicable
Siding Material: Rock, concrete, metal
Foundation: Closed, Greater than 30in masonry exposed or N/A
Firewood: None
Water Supply: Reliable water source nearby
Propane: None
Overhead Hazards: No overhead hazards

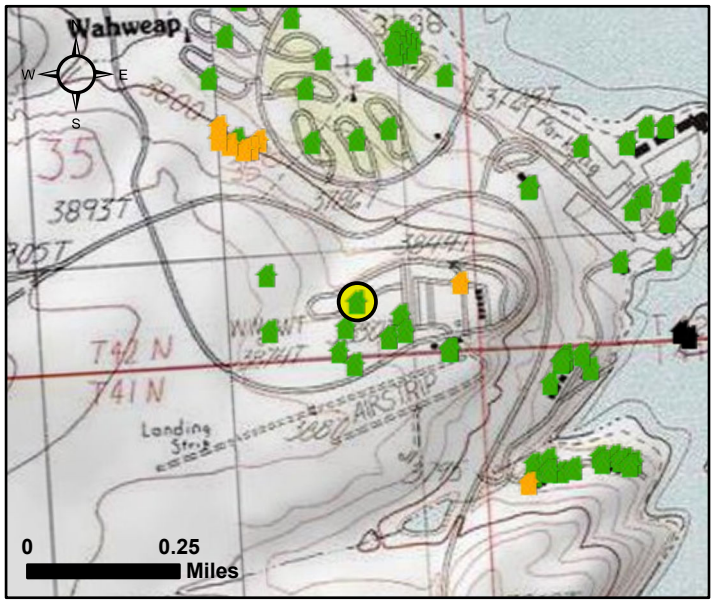
Facility Name: WW Aramark Dorm #1
Unit - Location: GLCA - Wahweap
FMSS ID: GLCA Dorm #1, ***Local ID:***
Structure Type, Use: Building, Unknown
Owner: National Park Service
Field Crew, Visit Date: ZION WFM, June 19, 2012
Coordinates (DDM): 36° 59.50300002' N 111° 29.80800000' W

Rating: Low
ProtectionLevel: Undesignated,
Resources of Concern: Unknown
Occupied: Yes
In Community: No,
Revisit Interval: yrs
Map Label: 409

Primary Access: Road
Ingress Egress: 2 or more roads in/out
Access Width: 2 lanes (Greater than 24')
Access Condition: Surfaced-paved, gradeLess than 5%
Bridge Condition: Less than 300 ft with turnaround
Access and Turnarounds: Less than 300 ft with turnaround
Facility Number or Sign: Marked and clearly visible
Fuel Type: Grass and shrub, hardwood litter
Fuel Load: Light or no wildland fuels
Defensible Space: 100 ft treated
Topography: Slope Less than 5%
Roof Material: Fire resistant- tar,rubberized
Siding Material: Rock, concrete, metal
Foundation: Closed, Greater than 30in masonry exposed or N/A
Firewood: None
Water Supply: Pressurized hydrant(s) or fixed sprinkler system
Propane: None
Overhead Hazards: No overhead hazards
Comments:

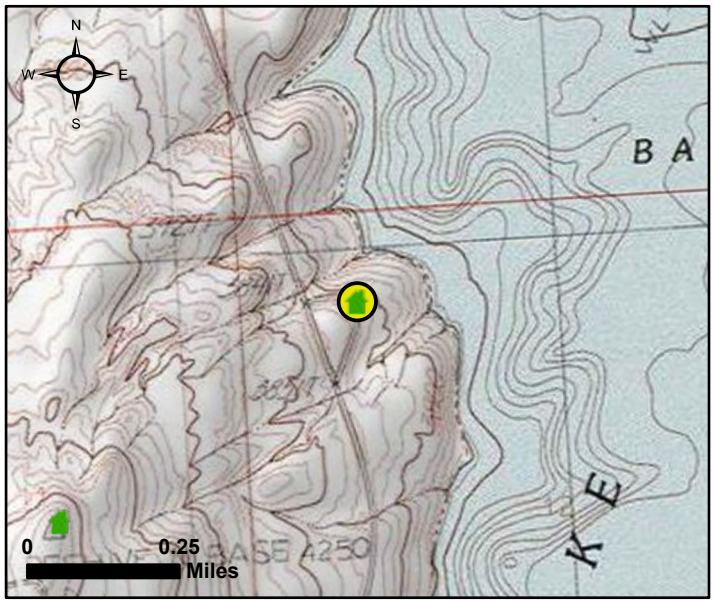
Facility Name: WW Wahweep Overlook Shade Structure
Unit - Location: GLCA - Wahweap
FMSS ID: 228392, ***Local ID:***
Structure Type, Use: Other, Unknown
Owner: National Park Service
Field Crew, Visit Date: ZION WFM, June 19, 2012
Coordinates (DDM): 36° 58.42000002' N 111° 29.38800000' W

Rating: Low
ProtectionLevel: Undesignated,
Resources of Concern: Unknown
Occupied:
In Community: No,
Revisit Interval: yrs
Map Label: 457

Primary Access: Road
Ingress Egress: 2 or more roads in/out
Access Width: 2 lanes (Greater than 24')
Access Condition: Surfaced-paved, gradeLess than 5%
Bridge Condition: Less than 300 ft with turnaround
Access and Turnarounds: Less than 300 ft with turnaround
Facility Number or Sign: None or not clearly visible
Fuel Type: Grass and shrub, hardwood litter
Fuel Load: Light or no wildland fuels
Defensible Space: 30 ft treated
Topography: Slope 21% to 30%
Roof Material: Noncombustible or not applicable
Siding Material: Rock, concrete, metal
Foundation: Closed, Greater than 30in masonry exposed or N/A
Firewood: None
Water Supply: No reliable water source nearby
Propane: None
Overhead Hazards: No overhead hazards

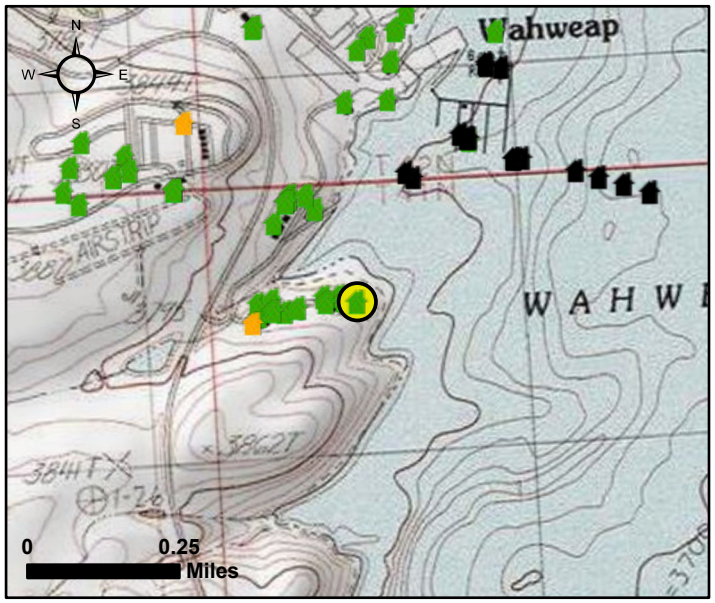
Facility Name: WW Housing 118
Unit - Location: GLCA - Wahweap
FMSS ID: 44536, ***Local ID:***
Structure Type, Use: Building, Administrative
Owner: National Park Service
Field Crew, Visit Date: ZION WFM, June 19, 2012
Coordinates (DDM): 36° 59.25300000' N 111° 29.33400000' W

Rating: Low
ProtectionLevel: Undesignated,
Resources of Concern: Unknown
Occupied: Yes
In Community: No,
Revisit Interval: yrs
Map Label: 463

Primary Access: Road
Ingress Egress: 1 road in/out
Access Width: 1.5 lanes (Greater than 18')
Access Condition: Surfaced-paved, gradeLess than 5%
Bridge Condition: Less than 300 ft with turnaround
Access and Turnarounds: Less than 300 ft with turnaround
Facility Number or Sign: Marked and clearly visible
Fuel Type: Grass and shrub, hardwood litter
Fuel Load: Moderate
Defensible Space: 30 ft treated
Topography: Slope Less than 5%
Roof Material: Noncombustible or not applicable
Siding Material: Rock, concrete, metal
Foundation: Closed, Greater than 30in masonry exposed or N/A
Firewood: None
Water Supply: Pressurized hydrant(s) or fixed sprinkler system
Propane: None
Overhead Hazards: Overhead hazards will limit aircraft
Comments:

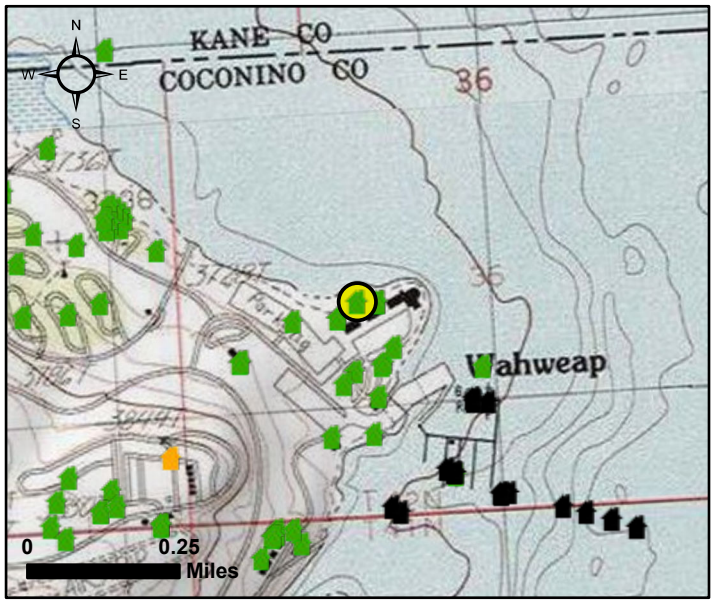
Facility Name: WW Pool Bar
Unit - Location: GLCA - Wahweap
FMSS ID: GLCA WW Pool Bar, ***Local ID:***
Structure Type, Use: Building, Unknown
Owner: National Park Service
Field Crew, Visit Date: ZION WFM, June 19, 2012
Coordinates (DDM): 36° 59.72899998' N 111° 29.27700000' W

Rating: Low
ProtectionLevel: Undesignated,
Resources of Concern: Unknown
Occupied: Yes
In Community: No,
Revisit Interval: yrs
Map Label: 468

Primary Access: Road
Ingress Egress: 2 or more roads in/out
Access Width: 2 lanes (Greater than 24')
Access Condition: Surfaced-paved, gradeLess than 5%
Bridge Condition: Less than 300 ft with turnaround
Access and Turnarounds: Less than 300 ft with turnaround
Facility Number or Sign: None or not clearly visible
Fuel Type: Grass and shrub, hardwood litter
Fuel Load: Light or no wildland fuels
Defensible Space: Greater than 100ft treated
Topography: Slope 5% to 20%
Roof Material: Noncombustible or not applicable
Siding Material: Rock, concrete, metal
Foundation: Closed, Greater than 30in masonry exposed or N/A
Firewood: None
Water Supply: Pressurized hydrant(s) or fixed sprinkler system
Propane: None
Overhead Hazards: No overhead hazards

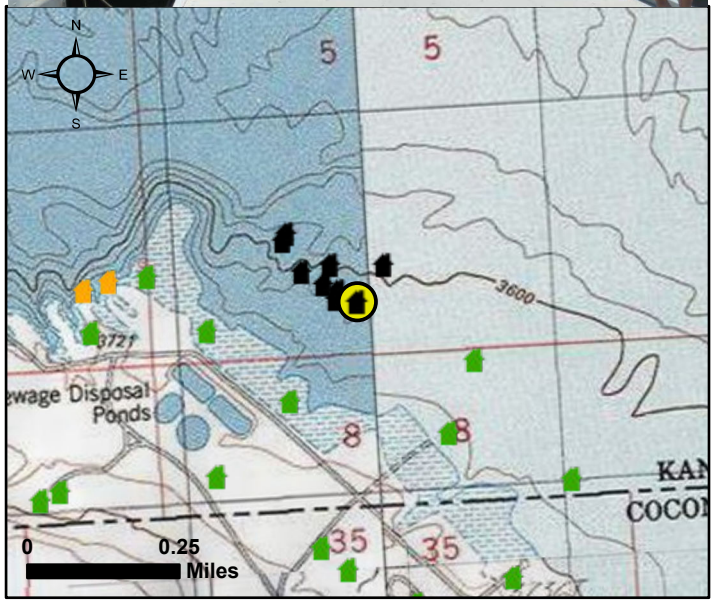
Facility Name: WW Stateline Shade Structure #1
Unit - Location: GLCA - Wahweap
FMSS ID: GLCA SL Shade # 1, ***Local ID:***
Structure Type, Use: No Wildland Risk, Unknown
Owner: National Park Service
Field Crew, Visit Date: ZION WFM, June 19, 2012
Coordinates (DDM): 37° 00.37900002' N 111° 30.06100002' W

Rating: No Wildland Risk
ProtectionLevel: Undesignated,
Resources of Concern: Unknown
Occupied:
In Community: No,
Revisit Interval: yrs
Map Label: 384

Comments: N/A. Structure is on the dock in the middle of the water.

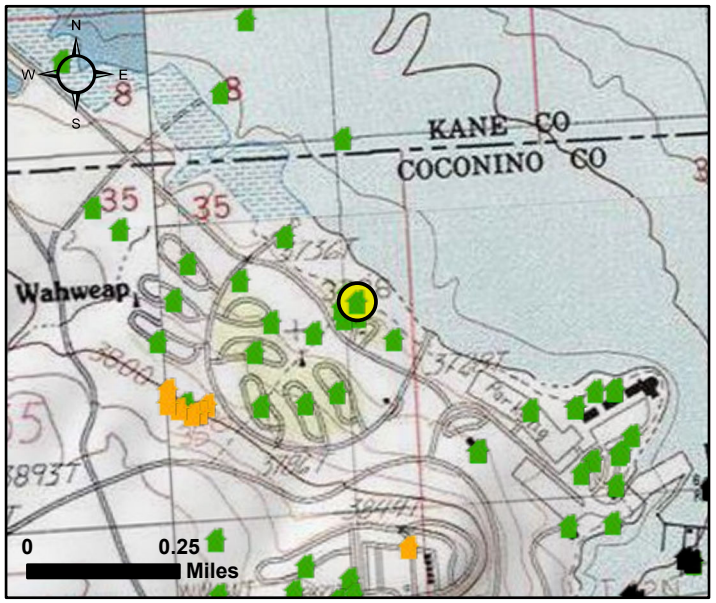
Facility Name: WW Picnic Area Shade Structure #3
Unit - Location: GLCA - Wahweap
FMSS ID: GLCA Picnic Area #3, ***Local ID:***
Structure Type, Use: Other, Unknown
Owner: National Park Service
Field Crew, Visit Date: ZION WFM, June 19, 2012
Coordinates (DDM): 36° 59.87500002' N 111° 29.68999998' W

Rating: Low
ProtectionLevel: Undesignated,
Resources of Concern: Unknown
Occupied:
In Community: No,
Revisit Interval: yrs
Map Label: 424

Primary Access: Road
Ingress Egress: 2 or more roads in/out
Access Width: 2 lanes (Greater than 24')
Access Condition: Surfaced-paved, gradeLess than 5%
Bridge Condition: Less than 300 ft with turnaround
Access and Turnarounds: Less than 300 ft with turnaround
Facility Number or Sign: None or not clearly visible
Fuel Type: Grass and shrub, hardwood litter
Fuel Load: Light or no wildland fuels
Defensible Space: Less than 30 ft treated
Topography: Slope 21% to 30%
Roof Material: Noncombustible or not applicable
Siding Material: Rock, concrete, metal
Foundation: Closed, Greater than 30in masonry exposed or N/A
Firewood: None
Water Supply: Pressurized hydrant(s) or fixed sprinkler system
Propane: None
Overhead Hazards: Overhead hazards will limit aircraft
Comments: Obstacles: Evacuation.

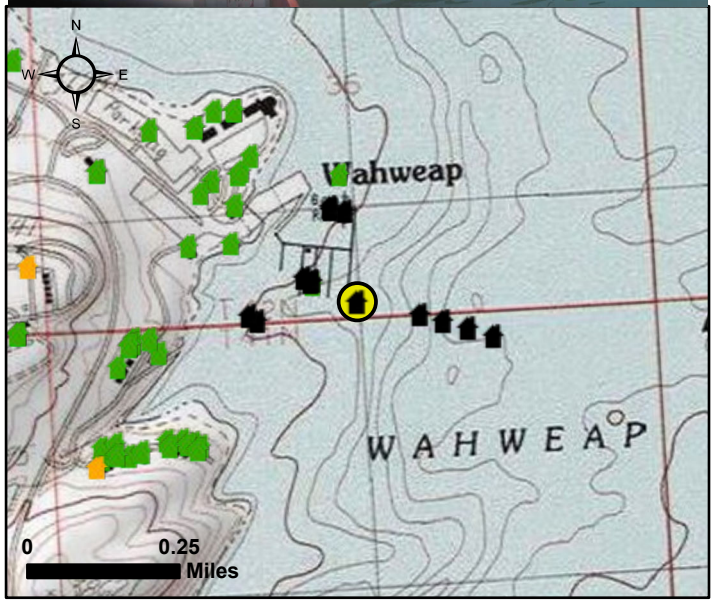
Facility Name: WW Marina Restroom Electrical Bldg. #001
Unit - Location: GLCA - Wahweap
FMSS ID: 230897, ***Local ID:***
Structure Type, Use: No Wildland Risk, Unknown
Owner: National Park Service
Field Crew, Visit Date: ZION WFM, June 19, 2012
Coordinates (DDM): 36° 59.44500000' N 111° 29.04199998' W

Rating: No Wildland Risk
ProtectionLevel: Undesignated,
Resources of Concern: Unknown
Occupied: Yes
In Community: No,
Revisit Interval: yrs
Map Label: 487

Comments: N/A. Structure is in the water on the docks.

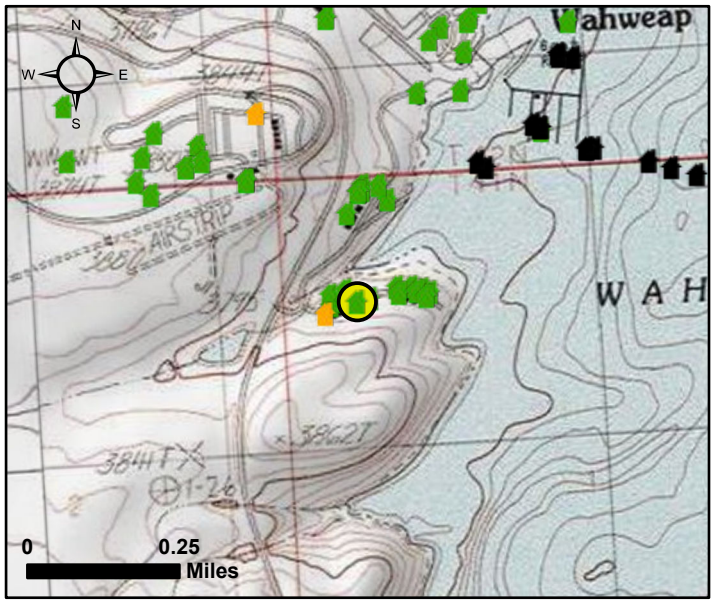
Facility Name: WW Quadplex #114
Unit - Location: GLCA - Wahweap
FMSS ID: 44552, ***Local ID:***
Structure Type, Use: Building, Administrative
Owner: National Park Service
Field Crew, Visit Date: ZION WFM, June 19, 2012
Coordinates (DDM): 36° 59.24500002' N 111° 29.46400002' W

Rating: Low
ProtectionLevel: Undesignated,
Resources of Concern: Unknown
Occupied: Yes
In Community: No,
Revisit Interval: yrs
Map Label: 446

Primary Access: Road
Ingress Egress: 2 or more roads in/out
Access Width: 2 lanes (Greater than 24')
Access Condition: Surfaced-paved, gradeLess than 5%
Bridge Condition: Less than 300 ft with turnaround
Access and Turnarounds: Less than 300 ft with turnaround
Facility Number or Sign: Marked and clearly visible
Fuel Type: Grass and shrub, hardwood litter
Fuel Load: Light or no wildland fuels
Defensible Space: 30 ft treated
Topography: Slope 5% to 20%
Roof Material: Noncombustible or not applicable
Siding Material: Rock, concrete, metal
Foundation: Closed, Less than 6in masonry exposed
Firewood: None
Water Supply: Pressurized hydrant(s) or fixed sprinkler system
Propane: None
Overhead Hazards: Overhead hazards will limit aircraft
Comments: Water Supply: 1.5 million gallon tank.

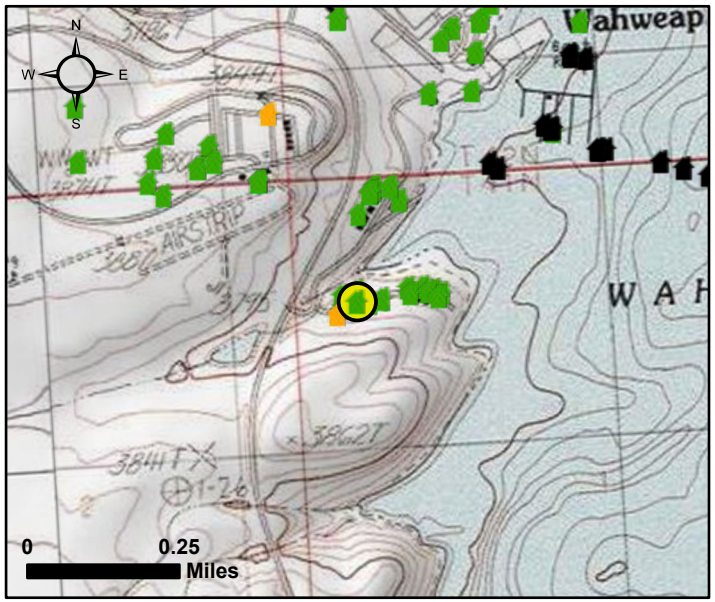
Facility Name: WW Housing #123
Unit - Location: GLCA - Wahweap
FMSS ID: 44569, ***Local ID:***
Structure Type, Use: Building, Administrative
Owner: National Park Service
Field Crew, Visit Date: ZION WFM, June 19, 2012
Coordinates (DDM): 36° 59.24700000' N 111° 29.48500002' W

Rating: Low
ProtectionLevel: Undesignated,
Resources of Concern: Unknown
Occupied: Yes
In Community: No,
Revisit Interval: yrs
Map Label: 442

Primary Access: Road
Ingress Egress: 2 or more roads in/out
Access Width: 2 lanes (Greater than 24')
Access Condition: Surfaced-paved, gradeLess than 5%
Bridge Condition: Less than 300 ft with turnaround
Access and Turnarounds: Less than 300 ft with turnaround
Facility Number or Sign: None or not clearly visible
Fuel Type: Grass and shrub, hardwood litter
Fuel Load: Light or no wildland fuels
Defensible Space: Less than 30 ft treated
Topography: Slope 5% to 20%
Roof Material: Noncombustible or not applicable
Siding Material: Rock, concrete, metal
Foundation: Closed, Less than 6in masonry exposed
Firewood: None
Water Supply: Pressurized hydrant(s) or fixed sprinkler system
Propane: None
Overhead Hazards: Overhead hazards will limit aircraft
Comments: Water Supply: 1.5 million gallon tank.

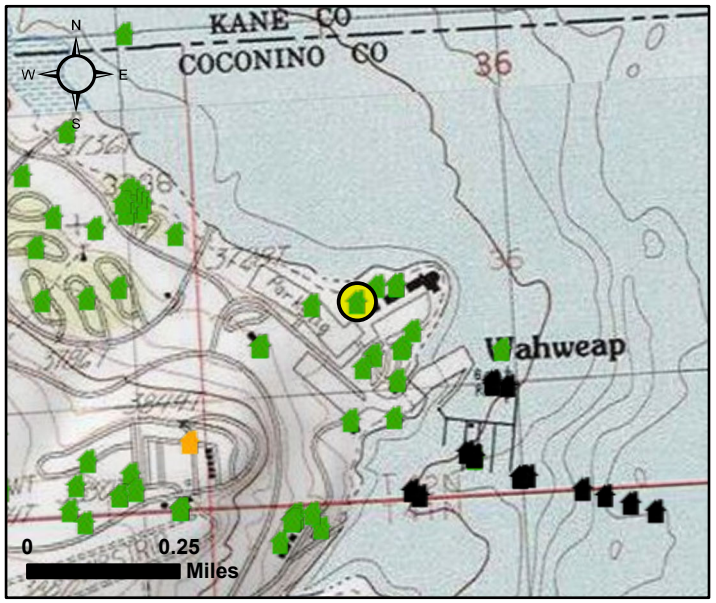
Rating: Low
ProtectionLevel: Undesignated,
Resources of Concern: Unknown
Occupied: Yes
In Community: No,
Revisit Interval: yrs
Map Label: 464

Primary Access: Road
Ingress Egress: 2 or more roads in/out
Access Width: 2 lanes (Greater than 24')
Access Condition: Surfaced-paved, gradeLess than 5%
Bridge Condition: Less than 300 ft with turnaround
Access and Turnarounds: Less than 300 ft with turnaround
Facility Number or Sign: Marked and clearly visible
Fuel Type: Grass and shrub, hardwood litter
Fuel Load: Light or no wildland fuels
Defensible Space: Greater than 100ft treated
Topography: Slope Less than 5%
Roof Material: Noncombustible or not applicable
Siding Material: Rock, concrete, metal
Foundation: Closed, Greater than 30in masonry exposed or N/A
Firewood: None
Water Supply: Pressurized hydrant(s) or fixed sprinkler system
Propane: None
Overhead Hazards: No overhead hazards

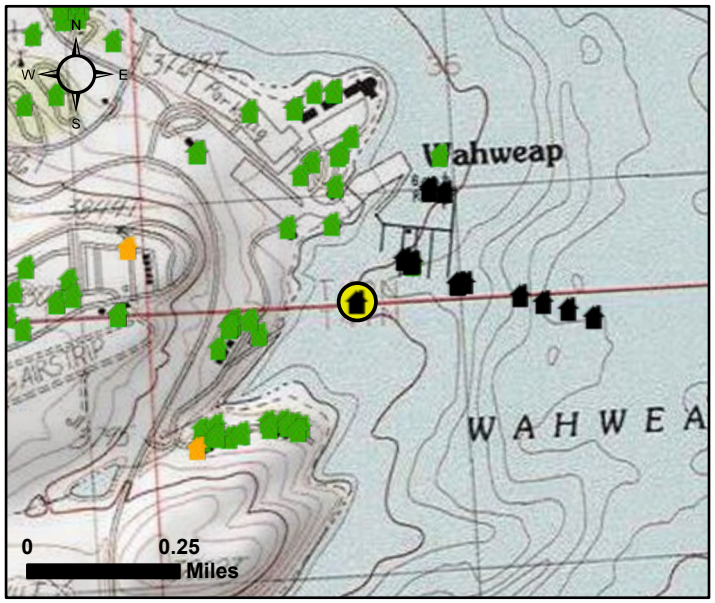
Rating: No Wildland Risk
ProtectionLevel: Undesignated,
Resources of Concern: Unknown
Occupied:
In Community: No,
Revisit Interval: yrs
Map Label: 476

Comments: N/A. Structure is on the docks in the middle of the water. Not at risk of wildfire.

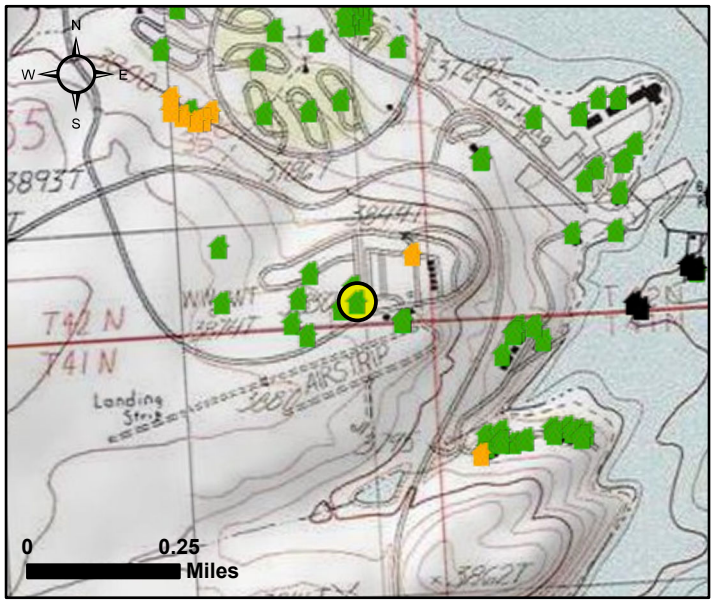
Rating: Low
ProtectionLevel: Undesignated,
Resources of Concern: Unknown
Occupied: Yes
In Community: No,
Revisit Interval: yrs
Map Label: 416

Primary Access: Road
Ingress Egress: 2 or more roads in/out
Access Width: 2 lanes (Greater than 24')
Access Condition: Surfaced-paved, gradeLess than 5%
Bridge Condition: Less than 300 ft with turnaround
Access and Turnarounds: Less than 300 ft with turnaround
Facility Number or Sign: Marked and clearly visible
Fuel Type: Grass and shrub, hardwood litter
Fuel Load: Light or no wildland fuels
Defensible Space: Greater than 100ft treated
Topography: Slope Less than 5%
Roof Material: Noncombustible or not applicable
Siding Material: Rock, concrete, metal
Foundation: Closed, Greater than 30in masonry exposed or N/A
Firewood: None
Water Supply: Pressurized hydrant(s) or fixed sprinkler system
Propane: None
Overhead Hazards: No overhead hazards
Comments:

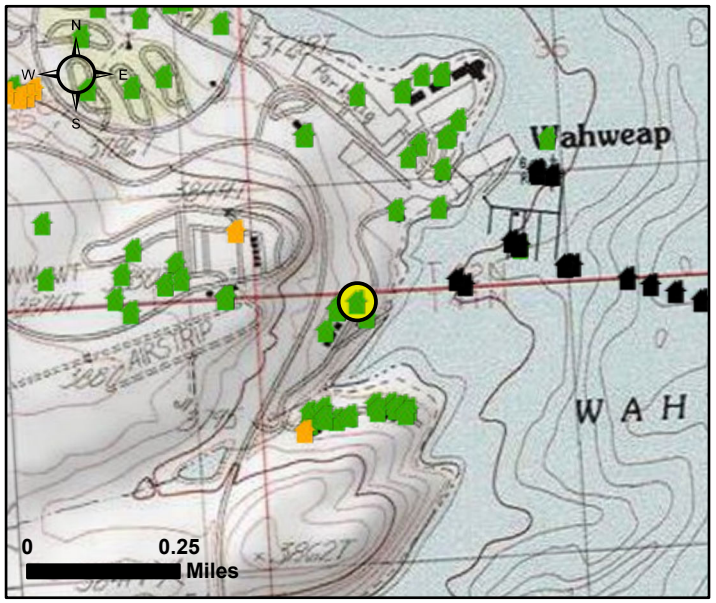
Rating: Low
ProtectionLevel: Undesignated,
Resources of Concern: Unknown
Occupied: Yes
In Community: No,
Revisit Interval: yrs
Map Label: 452

Primary Access: Road
Ingress Egress: 2 or more roads in/out
Access Width: 2 lanes (Greater than 24')
Access Condition: Surfaced-paved, gradeLess than 5%
Bridge Condition: Less than 300 ft with turnaround
Access and Turnarounds: Less than 300 ft with turnaround
Facility Number or Sign: Marked and clearly visible
Fuel Type: Grass and shrub, hardwood litter
Fuel Load: Light or no wildland fuels
Defensible Space: 100 ft treated
Topography: Slope 5% to 20%
Roof Material: Noncombustible or not applicable
Siding Material: Rock, concrete, metal
Foundation: Closed, 6in to 30in masonry exposed
Firewood: None
Water Supply: Pressurized hydrant(s) or fixed sprinkler system
Propane: None
Overhead Hazards: No overhead hazards

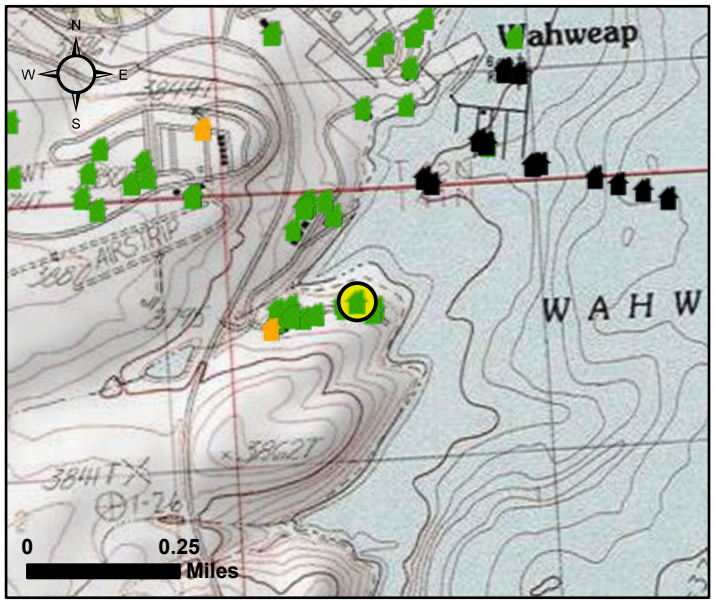
Rating: Low
ProtectionLevel: Undesignated,
Resources of Concern: Unknown
Occupied: Yes
In Community: No,
Revisit Interval: yrs
Map Label: 458

Primary Access: Road
Ingress Egress: 1 road in/out
Access Width: 1.5 lanes (Greater than 18')
Access Condition: Surfaced-paved, gradeLess than 5%
Bridge Condition: Less than 300 ft with turnaround
Access and Turnarounds: Less than 300 ft with turnaround
Facility Number or Sign: Marked and clearly visible
Fuel Type: Grass and shrub, hardwood litter
Fuel Load: Light or no wildland fuels
Defensible Space: 30 ft treated
Topography: Slope 5% to 20%
Roof Material: Noncombustible or not applicable
Siding Material: Rock, concrete, metal
Foundation: Closed, Greater than 30in masonry exposed or N/A
Firewood: None
Water Supply: Pressurized hydrant(s) or fixed sprinkler system
Propane: None
Overhead Hazards: Overhead hazards will limit aircraft
Comments: Topography: Drainage behind house.

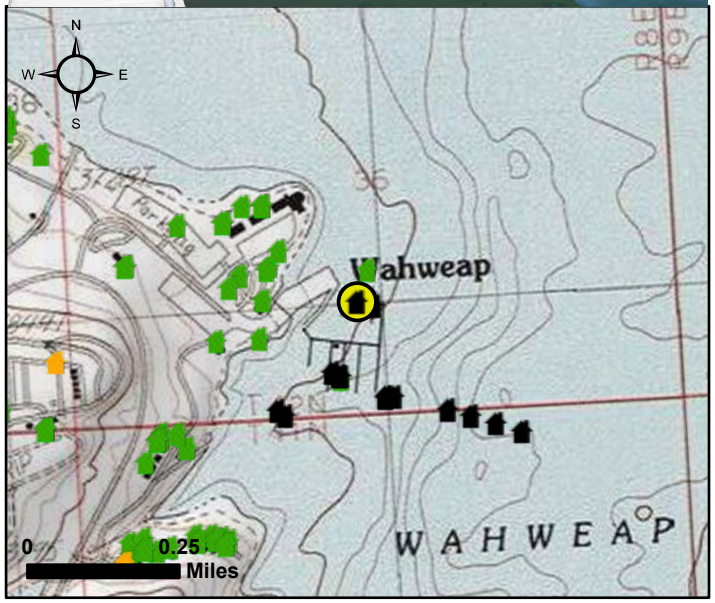
Rating: No Wildland Risk
ProtectionLevel: Undesignated,
Resources of Concern: Unknown
Occupied: Yes
In Community: No,
Revisit Interval: yrs
Map Label: 483

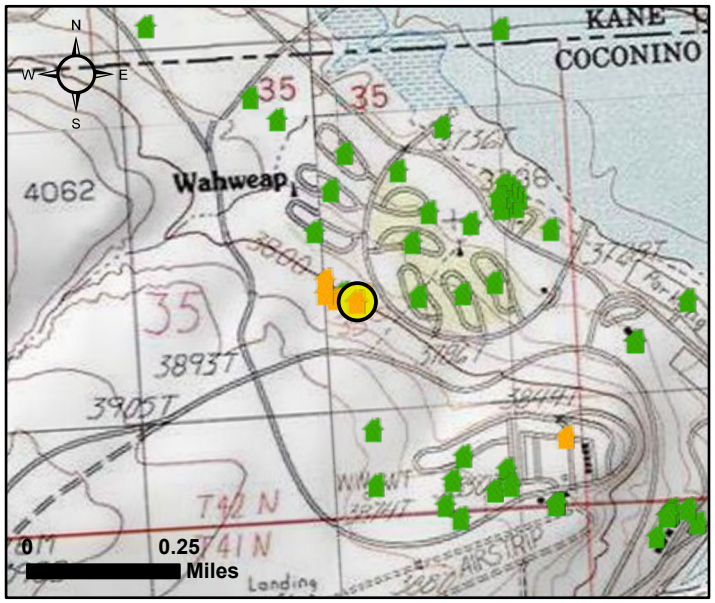
Rating: Moderate
ProtectionLevel: Undesignated,
Resources of Concern: Unknown
Occupied:
In Community: No,
Revisit Interval: yrs
Map Label: 394

Primary Access: Road
Ingress Egress: 2 or more roads in/out
Access Width: 2 lanes (Greater than 24')
Access Condition: Surfaced-paved, gradeLess than 5%
Bridge Condition: Less than 300 ft with turnaround
Access and Turnarounds: Less than 300 ft with turnaround
Facility Number or Sign: None or not clearly visible
Fuel Type: Grass and shrub, hardwood litter
Fuel Load: Light or no wildland fuels
Defensible Space: 30 ft treated
Topography: Slope 31% to 40%
Roof Material: Combustible or no roof
Siding Material: Rock, concrete, metal
Foundation: Closed, Greater than 30in masonry exposed or N/A
Firewood: None
Water Supply: Pressurized hydrant(s) or fixed sprinkler system
Propane: None
Overhead Hazards: No overhead hazards

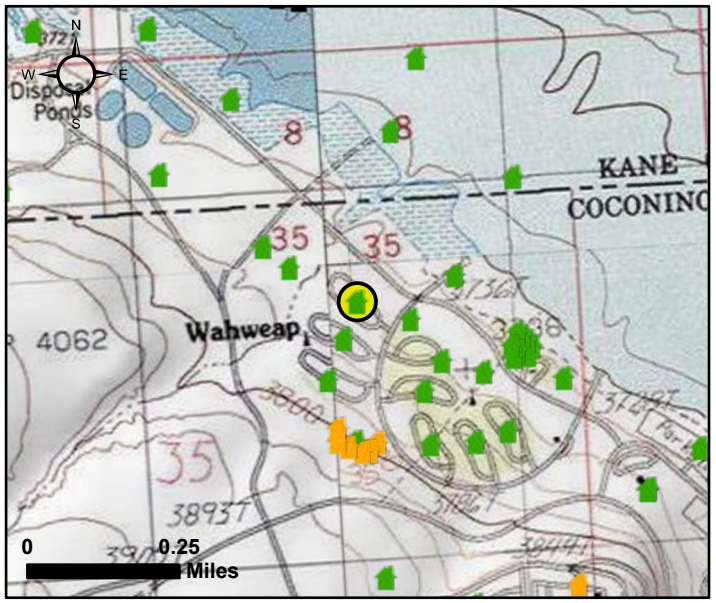
Rating: Low
ProtectionLevel: Undesignated,
Resources of Concern: Unknown
Occupied: Yes
In Community: No,
Revisit Interval: yrs
Map Label: 393

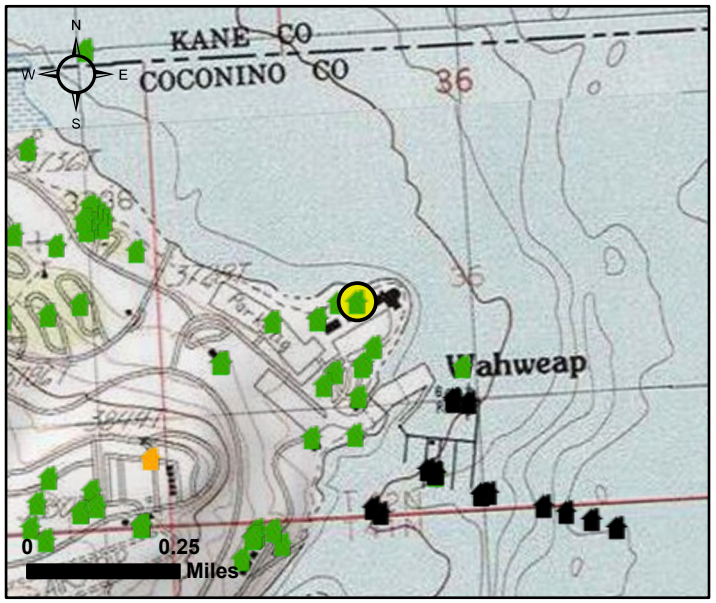
Rating: Low
ProtectionLevel: Undesignated,
Resources of Concern: Unknown
Occupied: Yes
In Community: No,
Revisit Interval: yrs
Map Label: 471

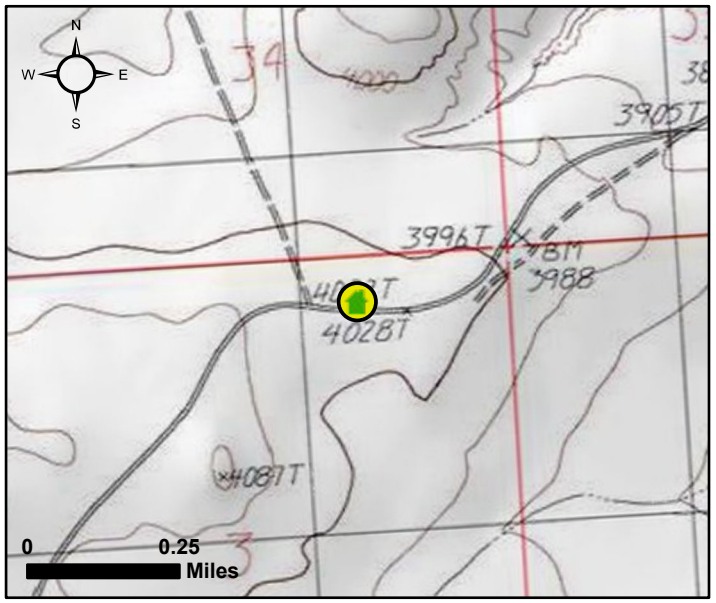
Rating: Low
ProtectionLevel: Undesignated,
Resources of Concern: Unknown
Occupied: Yes
In Community: No,
Revisit Interval: 999 yrs
Map Label: 362

Primary Access: Road
Ingress Egress: 2 or more roads in/out
Access Width: 2 lanes (Greater than 24')
Access Condition: Surfaced-paved, gradeLess than 5%
Bridge Condition: Less than 300 ft with turnaround
Access and Turnarounds: Less than 300 ft with turnaround
Facility Number or Sign: None or not clearly visible
Fuel Type: Grass and shrub, hardwood litter
Fuel Load: Light or no wildland fuels
Defensible Space: 30 ft treated
Topography: Slope 5% to 20%
Roof Material: Noncombustible or not applicable
Siding Material: Rock, concrete, metal
Foundation: Closed, Greater than 30in masonry exposed or N/A
Firewood: None
Water Supply: No reliable water source nearby
Propane: None
Overhead Hazards: No overhead hazards

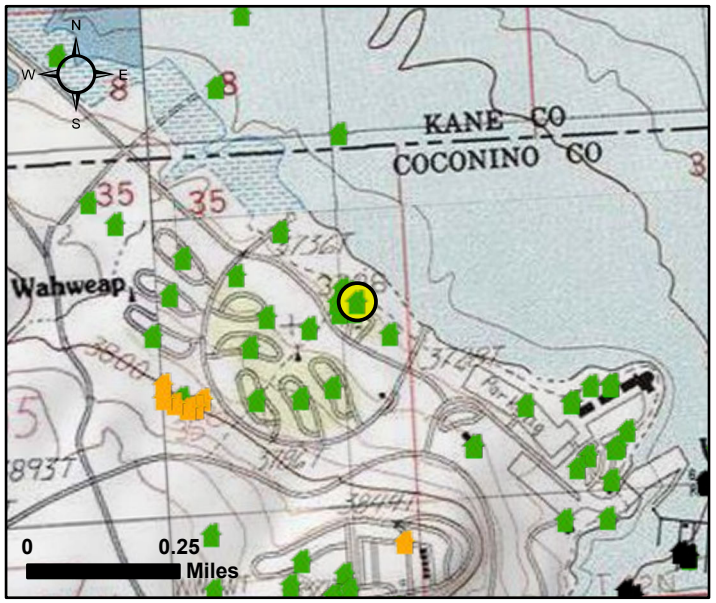
Rating: Low
ProtectionLevel: Undesignated,
Resources of Concern: Unknown
Occupied:
In Community: No,
Revisit Interval: yrs
Map Label: 426

Primary Access: Road
Ingress Egress: 2 or more roads in/out
Access Width: 2 lanes (Greater than 24')
Access Condition: Surfaced-paved, gradeLess than 5%
Bridge Condition: Less than 300 ft with turnaround
Access and Turnarounds: Less than 300 ft with turnaround
Facility Number or Sign: None or not clearly visible
Fuel Type: Grass and shrub, hardwood litter
Fuel Load: Light or no wildland fuels
Defensible Space: Less than 30 ft treated
Topography: Slope 21% to 30%
Roof Material: Noncombustible or not applicable
Siding Material: Rock, concrete, metal
Foundation: Closed, Greater than 30in masonry exposed or N/A
Firewood: None
Water Supply: Pressurized hydrant(s) or fixed sprinkler system
Propane: None
Overhead Hazards: Overhead hazards will limit aircraft
Comments: Obstacles: Evacuation.

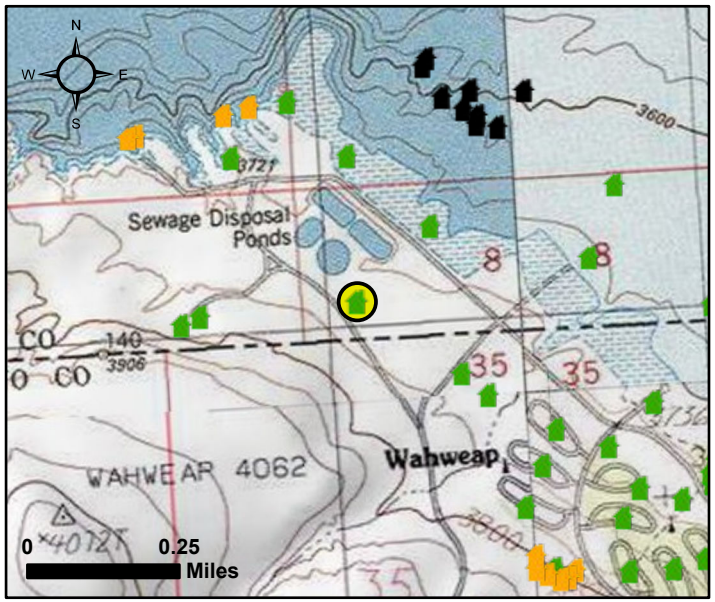
Facility Name: WW Boat Repair Shop
Unit - Location: GLCA - Wahweap
FMSS ID: GLCA Boat Repair, ***Local ID:***
Structure Type, Use: Building, Unknown
Owner: National Park Service
Field Crew, Visit Date: ZION WFM, June 19, 2012
Coordinates (DDM): 37° 00.14100000' N 111° 30.32800002' W

Rating: Low
ProtectionLevel: Undesignated,
Resources of Concern: Unknown
Occupied: Yes
In Community: No,
Revisit Interval: yrs
Map Label: 373

Primary Access: Road
Ingress Egress: 2 or more roads in/out
Access Width: 2 lanes (Greater than 24')
Access Condition: Surfaced-paved, gradeLess than 5%
Bridge Condition: Less than 300 ft with turnaround
Access and Turnarounds: Less than 300 ft with turnaround
Facility Number or Sign: Marked and clearly visible
Fuel Type: Grass and shrub, hardwood litter
Fuel Load: Light or no wildland fuels
Defensible Space: 100 ft treated
Topography: Slope 5% to 20%
Roof Material: Noncombustible or not applicable
Siding Material: Rock, concrete, metal
Foundation: Closed, Greater than 30in masonry exposed or N/A
Firewood: None
Water Supply: Pressurized hydrant(s) or fixed sprinkler system
Propane: None
Overhead Hazards: No overhead hazards

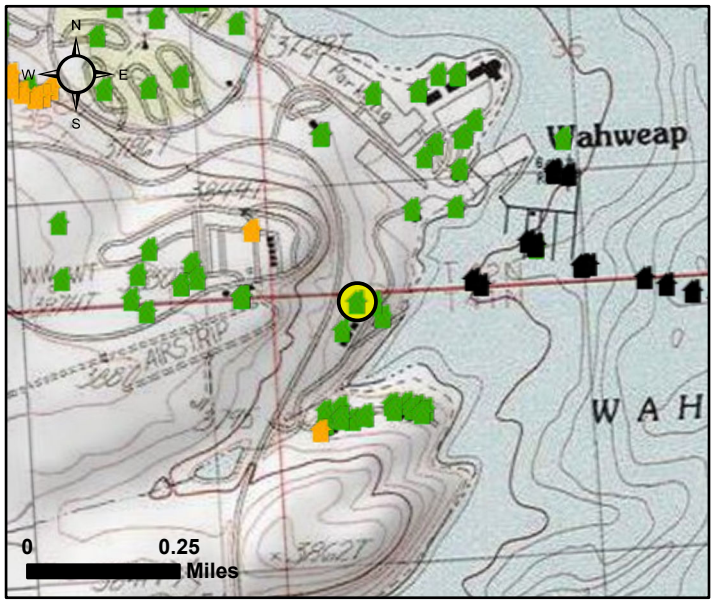
Rating: Low
ProtectionLevel: Undesignated,
Resources of Concern: Unknown
Occupied: No
In Community: No,
Revisit Interval: yrs
Map Label: 450

Primary Access: Road
Ingress Egress: 2 or more roads in/out
Access Width: 2 lanes (Greater than 24')
Access Condition: Surfaced-paved, gradeLess than 5%
Bridge Condition: Less than 300 ft with turnaround
Access and Turnarounds: Less than 300 ft with turnaround
Facility Number or Sign: Marked and clearly visible
Fuel Type: Grass and shrub, hardwood litter
Fuel Load: Light or no wildland fuels
Defensible Space: Less than 30 ft treated
Topography: Slope 21% to 30%
Roof Material: Noncombustible or not applicable
Siding Material: Rock, concrete, metal
Foundation: Closed, Less than 6in masonry exposed
Firewood: None
Water Supply: Pressurized hydrant(s) or fixed sprinkler system
Propane: None
Overhead Hazards: No overhead hazards
Comments: Water Supply: 1.5 million gallon tank in WW.

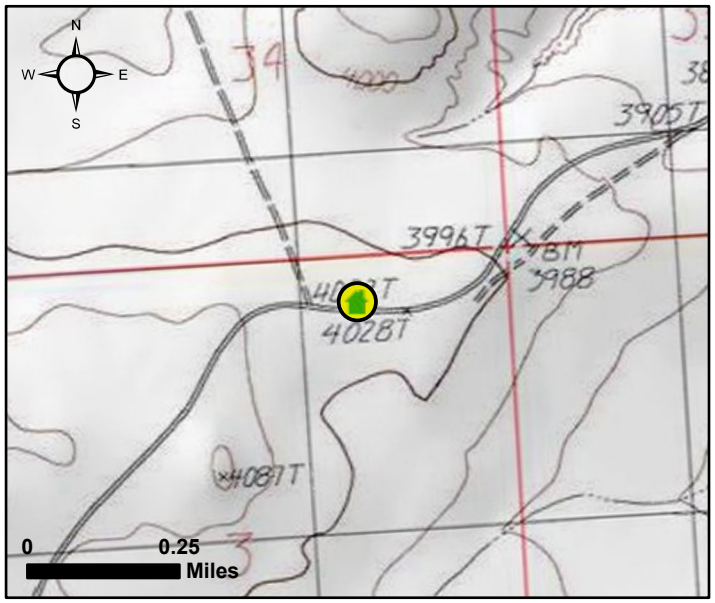
Rating: Low
ProtectionLevel: Undesignated,
Resources of Concern: Unknown
Occupied: Yes
In Community: No,
Revisit Interval: yrs
Map Label: 361

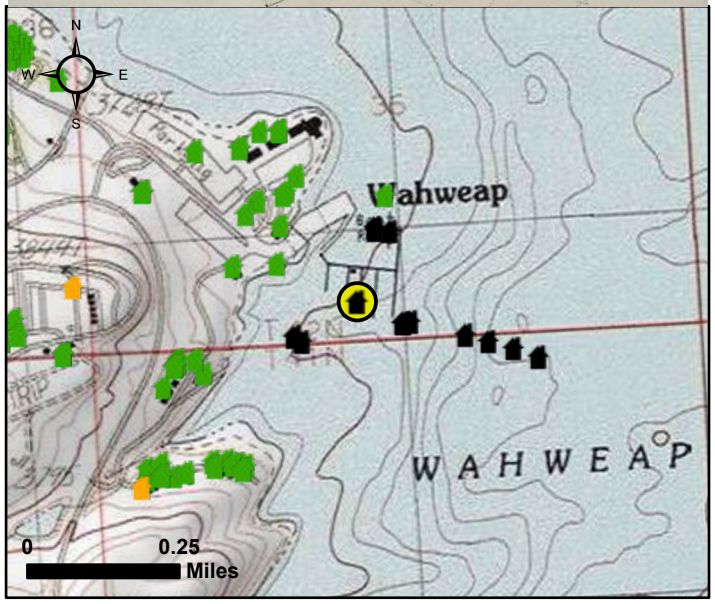
Rating: No Wildland Risk
ProtectionLevel: Undesignated,
Resources of Concern: Unknown
Occupied: Yes
In Community: No,
Revisit Interval: yrs
Map Label: 481

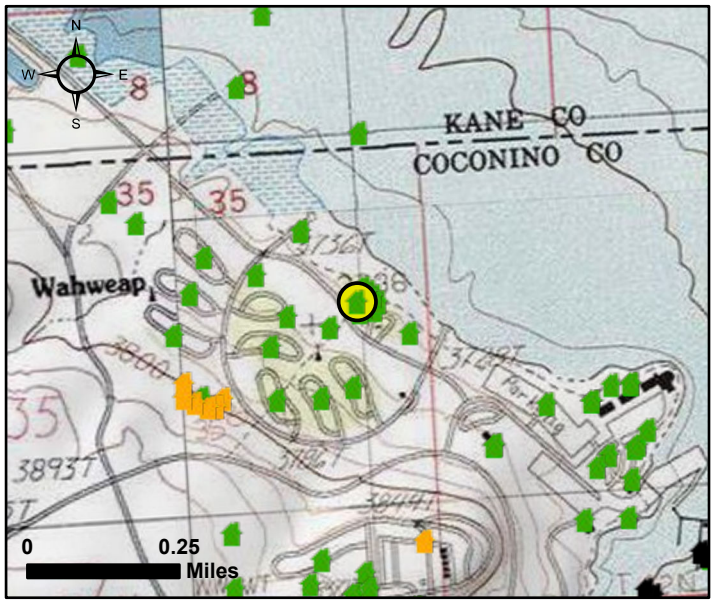
Rating: Low
ProtectionLevel: Undesignated,
Resources of Concern: Unknown
Occupied:
In Community: No,
Revisit Interval: yrs
Map Label: 417

Primary Access: Road
Ingress Egress: 2 or more roads in/out
Access Width: 2 lanes (Greater than 24')
Access Condition: Surfaced-paved, gradeLess than 5%
Bridge Condition: Less than 300 ft with turnaround
Access and Turnarounds: Less than 300 ft with turnaround
Facility Number or Sign: None or not clearly visible
Fuel Type: Grass and shrub, hardwood litter
Fuel Load: Light or no wildland fuels
Defensible Space: Less than 30 ft treated
Topography: Slope 21% to 30%
Roof Material: Noncombustible or not applicable
Siding Material: Rock, concrete, metal
Foundation: Closed, Greater than 30in masonry exposed or N/A
Firewood: None
Water Supply: Pressurized hydrant(s) or fixed sprinkler system
Propane: None
Overhead Hazards: Overhead hazards will limit aircraft
Comments: Obstacles: Evacuation.

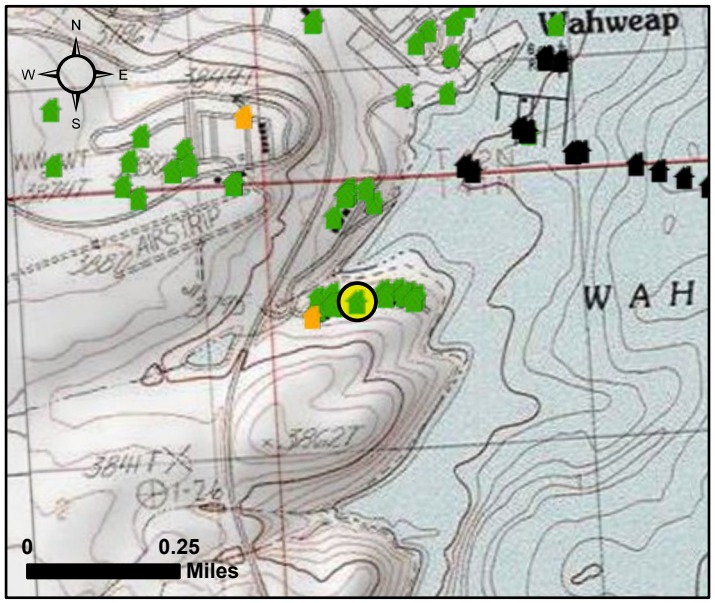
Rating: Low
ProtectionLevel: Undesignated,
Resources of Concern: Unknown
Occupied: Yes
In Community: No,
Revisit Interval: yrs
Map Label: 451

Primary Access: Road
Ingress Egress: 2 or more roads in/out
Access Width: 2 lanes (Greater than 24')
Access Condition: Surfaced-paved, gradeLess than 5%
Bridge Condition: Less than 300 ft with turnaround
Access and Turnarounds: Less than 300 ft with turnaround
Facility Number or Sign: Marked and clearly visible
Fuel Type: Grass and shrub, hardwood litter
Fuel Load: Light or no wildland fuels
Defensible Space: 30 ft treated
Topography: Slope 5% to 20%
Roof Material: Noncombustible or not applicable
Siding Material: Rock, concrete, metal
Foundation: Closed, Less than 6in masonry exposed
Firewood: None
Water Supply: Pressurized hydrant(s) or fixed sprinkler system
Propane: None
Overhead Hazards: Overhead hazards will limit aircraft
Comments: Water Supply: 1.5 million gallon tank for the Wahweep area.

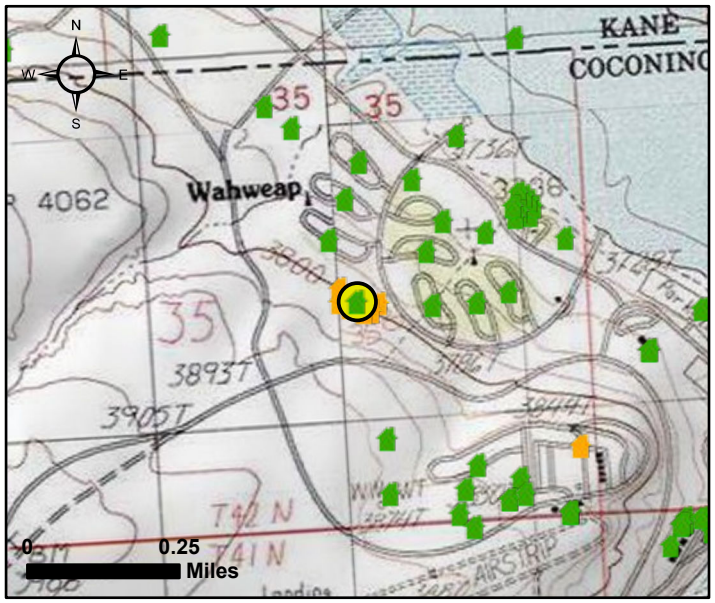
Rating: Low
ProtectionLevel: Undesignated,
Resources of Concern: Unknown
Occupied: Yes
In Community: No,
Revisit Interval: yrs
Map Label: 391

Primary Access: Road
Ingress Egress: 2 or more roads in/out
Access Width: 2 lanes (Greater than 24')
Access Condition: Surfaced-paved, gradeLess than 5%
Bridge Condition: Less than 300 ft with turnaround
Access and Turnarounds: Less than 300 ft with turnaround
Facility Number or Sign: None or not clearly visible
Fuel Type: Grass and shrub, hardwood litter
Fuel Load: Light or no wildland fuels
Defensible Space: Less than 30 ft treated
Topography: Slope 5% to 20%
Roof Material: Noncombustible or not applicable
Siding Material: Rock, concrete, metal
Foundation: Closed, Greater than 30in masonry exposed or N/A
Firewood: None
Water Supply: Pressurized hydrant(s) or fixed sprinkler system
Propane: None
Overhead Hazards: No overhead hazards
Comments: Obstacles: Evacuation.

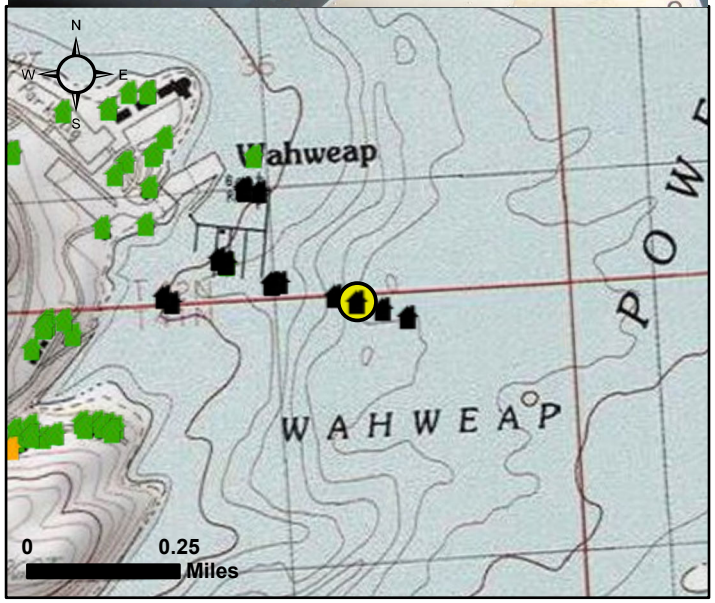
Rating: No Wildland Risk
ProtectionLevel: Undesignated,
Resources of Concern: Unknown
Occupied: Yes
In Community: No,
Revisit Interval: yrs
Map Label: 491

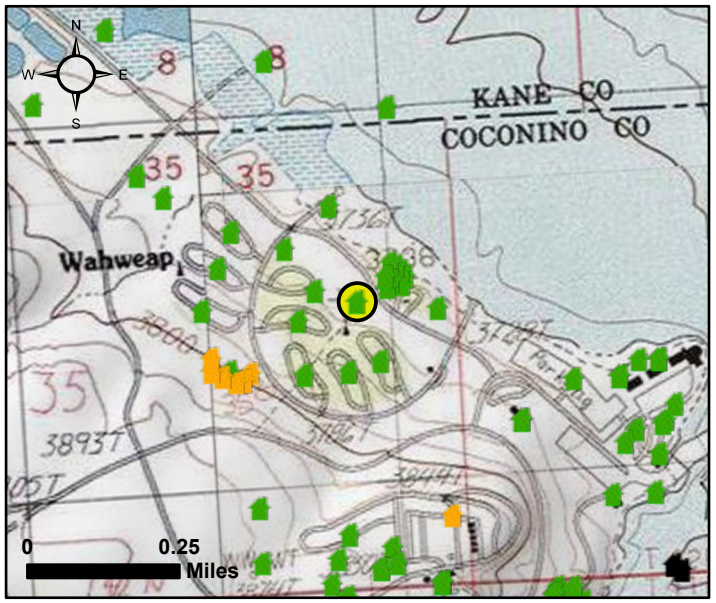
Rating: Low
ProtectionLevel: Undesignated,
Resources of Concern: Unknown
Occupied: No
In Community: No,
Revisit Interval: yrs
Map Label: 411

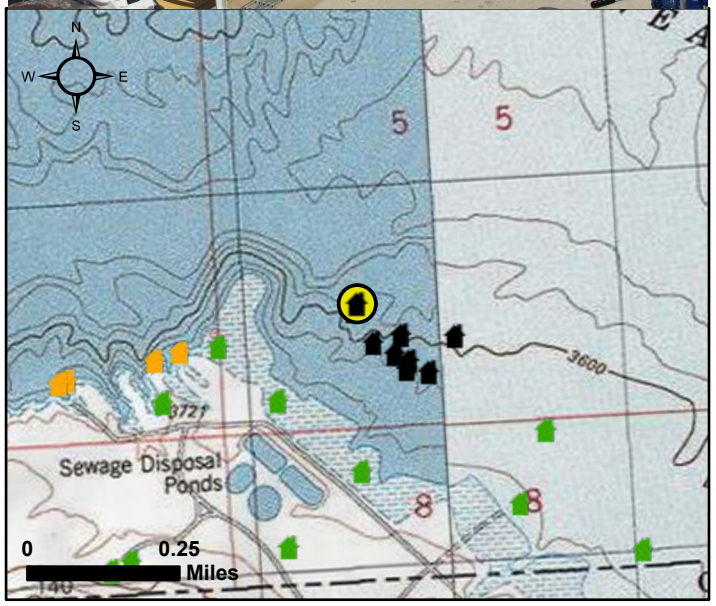
Rating: No Wildland Risk
ProtectionLevel: Undesignated,
Resources of Concern: Unknown
Occupied: Yes
In Community: No,
Revisit Interval: yrs
Map Label: 376

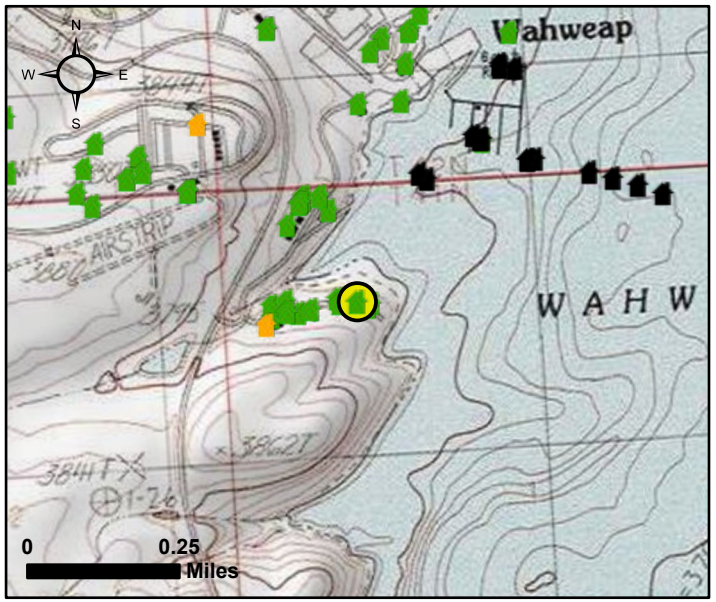
Rating: Low
ProtectionLevel: Undesignated,
Resources of Concern: Unknown
Occupied: Yes
In Community: No,
Revisit Interval: yrs
Map Label: 459

Primary Access: Road
Ingress Egress: 2 or more roads in/out
Access Width: 2 lanes (Greater than 24')
Access Condition: Surfaced-paved, gradeLess than 5%
Bridge Condition: Less than 300 ft with turnaround
Access and Turnarounds: Less than 300 ft with turnaround
Facility Number or Sign: Marked and clearly visible
Fuel Type: Grass and shrub, hardwood litter
Fuel Load: Light or no wildland fuels
Defensible Space: 100 ft treated
Topography: Slope 5% to 20%
Roof Material: Noncombustible or not applicable
Siding Material: Wood or open sided
Foundation: Closed, Less than 6in masonry exposed
Firewood: None
Water Supply: Pressurized hydrant(s) or fixed sprinkler system
Propane: None
Overhead Hazards: Overhead hazards will limit aircraft
Comments: Water Supply: 1.5 million gallon tank.
