NPS Wildfire Risk Assessments
Assessment Locations

Glen Canyon National Recreation Area - Overview

Glen Canyon National Recreation Area - Wahweap - Overview

GLCA - Glen Canyon National Recreation Area

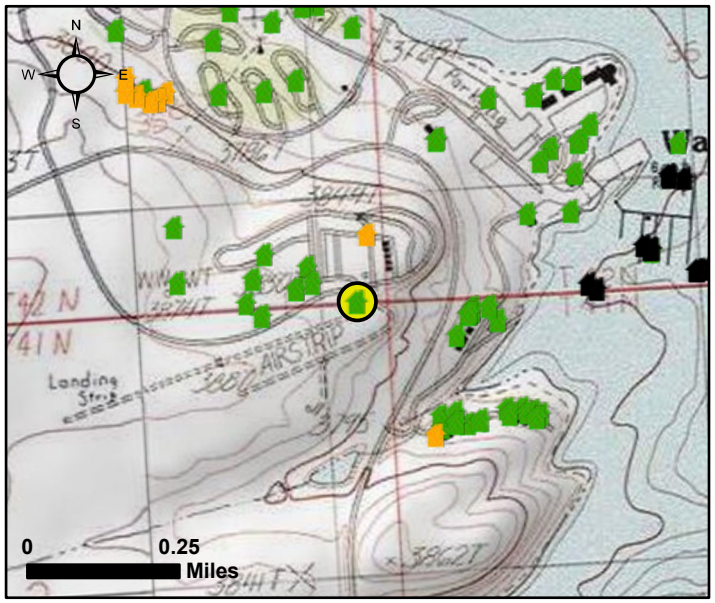
Rating: Low
ProtectionLevel: Undesignated,
Resources of Concern: Unknown
Occupied: Yes
In Community: No,
Revisit Interval: yrs
Map Label: 429

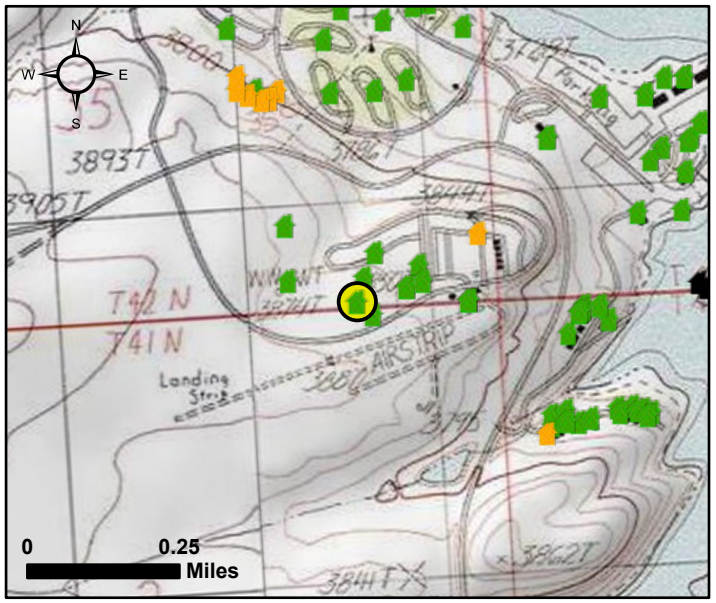
Facility Name: WW Aramark Cafeteria
Unit - Location: GLCA - Wahweap
FMSS ID: GLCA Aramark Cafeteria, ***Local ID:***
Structure Type, Use: Building, Unknown
Owner: National Park Service
Field Crew, Visit Date: ZION WFM, June 19, 2012
Coordinates (DDM): 36° 59.43400002' N 111° 29.84500002' W

Rating: Low
ProtectionLevel: Undesignated,
Resources of Concern: Unknown
Occupied: Yes
In Community: No,
Revisit Interval: yrs
Map Label: 405

Primary Access: Road
Ingress Egress: 2 or more roads in/out
Access Width: 2 lanes (Greater than 24')
Access Condition: Surfaced-paved, gradeLess than 5%
Bridge Condition: Less than 300 ft with turnaround
Access and Turnarounds: Less than 300 ft with turnaround
Facility Number or Sign: Marked and clearly visible
Fuel Type: Grass and shrub, hardwood litter
Fuel Load: Light or no wildland fuels
Defensible Space: 100 ft treated
Topography: Slope Less than 5%
Roof Material: Noncombustible or not applicable
Siding Material: Rock, concrete, metal
Foundation: Closed, Greater than 30in masonry exposed or N/A
Firewood: None
Water Supply: Pressurized hydrant(s) or fixed sprinkler system
Propane: None
Overhead Hazards: No overhead hazards
Comments:

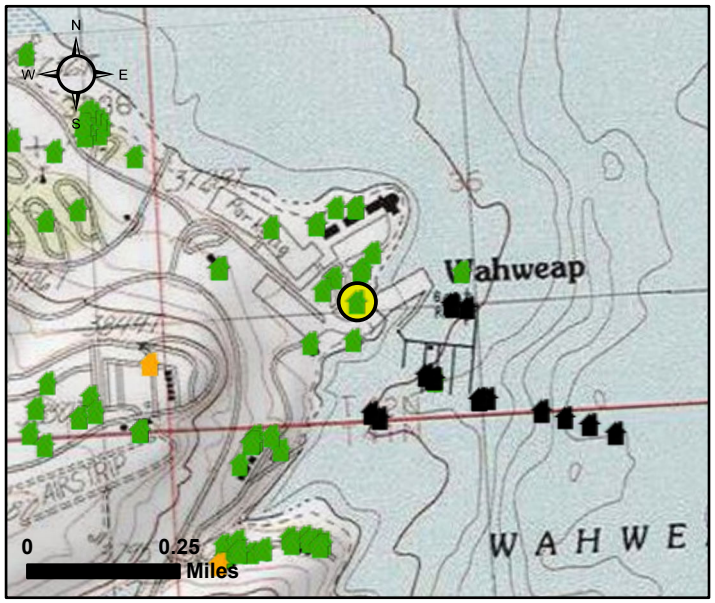
Facility Name: WW Wahweep Grille
Unit - Location: GLCA - Wahweap
FMSS ID: GLCA Wahweap Grille, ***Local ID:***
Structure Type, Use: Building, Unknown
Owner: National Park Service
Field Crew, Visit Date: ZION WFM, June 19, 2012
Coordinates (DDM): 36° 59.59300002' N 111° 29.24899998' W

Rating: Low
ProtectionLevel: Undesignated,
Resources of Concern: Unknown
Occupied: Yes
In Community: No,
Revisit Interval: yrs
Map Label: 470

Primary Access: Road
Ingress Egress: 2 or more roads in/out
Access Width: 2 lanes (Greater than 24')
Access Condition: Surfaced-paved, gradeLess than 5%
Bridge Condition: Less than 300 ft with turnaround
Access and Turnarounds: Less than 300 ft with turnaround
Facility Number or Sign: Marked and clearly visible
Fuel Type: Grass and shrub, hardwood litter
Fuel Load: Light or no wildland fuels
Defensible Space: 100 ft treated
Topography: Slope Less than 5%
Roof Material: Noncombustible or not applicable
Siding Material: Rock, concrete, metal
Foundation: Closed, Greater than 30in masonry exposed or N/A
Firewood: None
Water Supply: Pressurized hydrant(s) or fixed sprinkler system
Propane: None
Overhead Hazards: No overhead hazards

Comments: Obstacles: Evacuation.

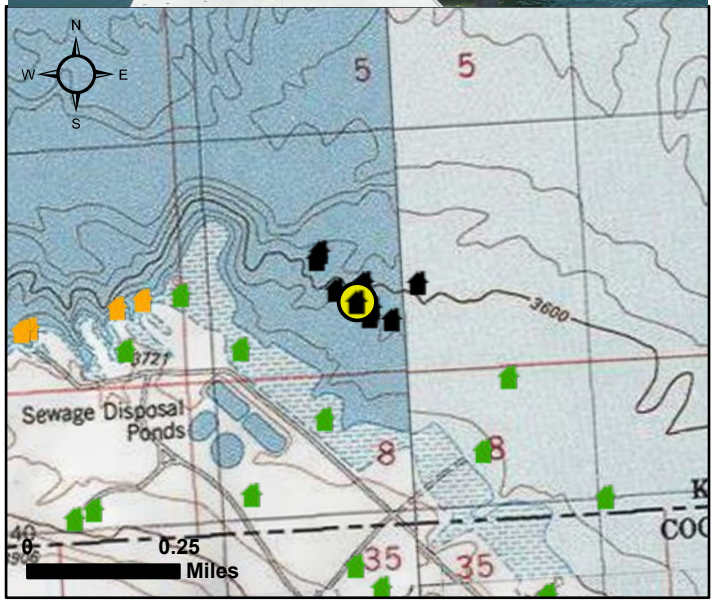
Facility Name: WW Stateline Shade Structure #2
Unit - Location: GLCA - Wahweap
FMSS ID: GLCA SL Shade Structure, ***Local ID:***
Structure Type, Use: No Wildland Risk, Unknown
Owner: National Park Service
Field Crew, Visit Date: ZION WFM, June 19, 2012
Coordinates (DDM): 37° 00.40699998' N 111° 30.12000000' W

Rating: No Wildland Risk
ProtectionLevel: Undesignated,
Resources of Concern: Unknown
Occupied:
In Community: No,
Revisit Interval: yrs
Map Label: 379

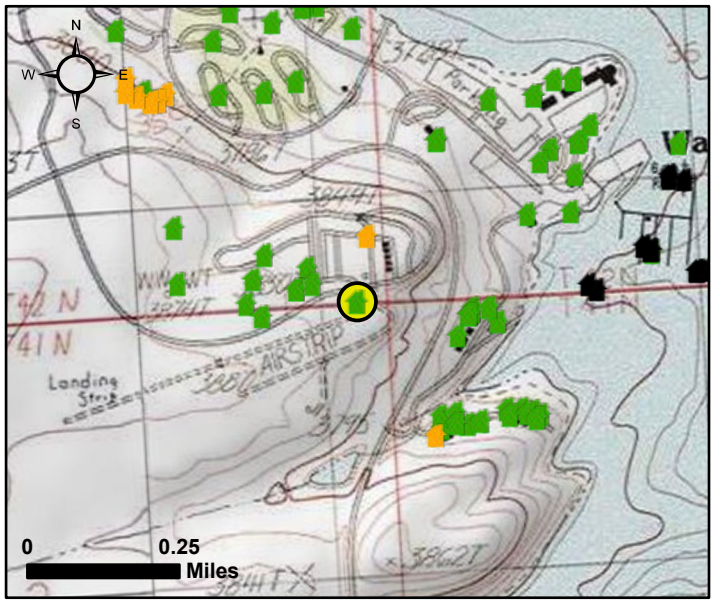
Facility Name: WW Aramark Dry Storage Office Risk Management
Unit - Location: GLCA - Wahweap
FMSS ID: GLCA Dry Storage, ***Local ID:***
Structure Type, Use: Building, Unknown
Owner: National Park Service
Field Crew, Visit Date: ZION WFM, June 19, 2012
Coordinates (DDM): 36° 59.42800002' N 111° 29.64799998' W

Rating: Low
ProtectionLevel: Undesignated,
Resources of Concern: Unknown
Occupied: Yes
In Community: No,
Revisit Interval: yrs
Map Label: 427

Primary Access: Road
Ingress Egress: 2 or more roads in/out
Access Width: 2 lanes (Greater than 24')
Access Condition: Surfaced-paved, gradeLess than 5%
Bridge Condition: Less than 300 ft with turnaround
Access and Turnarounds: Less than 300 ft with turnaround
Facility Number or Sign: None or not clearly visible
Fuel Type: Grass and shrub, hardwood litter
Fuel Load: Light or no wildland fuels
Defensible Space: 30 ft treated
Topography: Slope Less than 5%
Roof Material: Noncombustible or not applicable
Siding Material: Rock, concrete, metal
Foundation: Closed, Greater than 30in masonry exposed or N/A
Firewood: None
Water Supply: Pressurized hydrant(s) or fixed sprinkler system
Propane: None
Overhead Hazards: No overhead hazards
Comments:

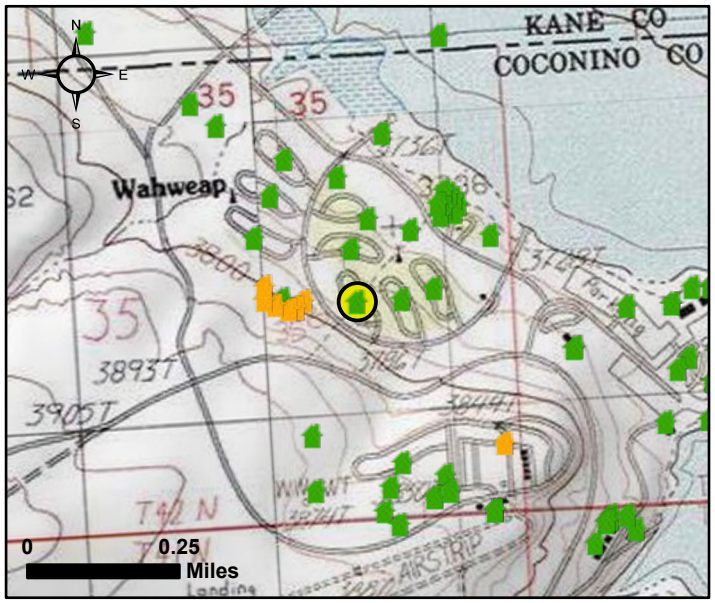
Facility Name: WW Campground Comfort Station Loop 3
Unit - Location: GLCA - Wahweap
FMSS ID: GLCA WW CCS loop 3, ***Local ID:***
Structure Type, Use: Building, Unknown
Owner: National Park Service
Field Crew, Visit Date: ZION WFM, June 19, 2012
Coordinates (DDM): 36° 59.73499998' N 111° 29.87200002' W

Rating: Low
ProtectionLevel: Undesignated,
Resources of Concern: Unknown
Occupied: Yes
In Community: No,
Revisit Interval: yrs
Map Label: 402

Primary Access: Road
Ingress Egress: 2 or more roads in/out
Access Width: 2 lanes (Greater than 24')
Access Condition: Surfaced-paved, gradeLess than 5%
Bridge Condition: Less than 300 ft with turnaround
Access and Turnarounds: Less than 300 ft with turnaround
Facility Number or Sign: None or not clearly visible
Fuel Type: Grass and shrub, hardwood litter
Fuel Load: Light or no wildland fuels
Defensible Space: 30 ft treated
Topography: Slope 5% to 20%
Roof Material: Noncombustible or not applicable
Siding Material: Rock, concrete, metal
Foundation: Closed, Greater than 30in masonry exposed or N/A
Firewood: None
Water Supply: Pressurized hydrant(s) or fixed sprinkler system
Propane: None
Overhead Hazards: No overhead hazards
Comments: Obstacles: Evacuation.

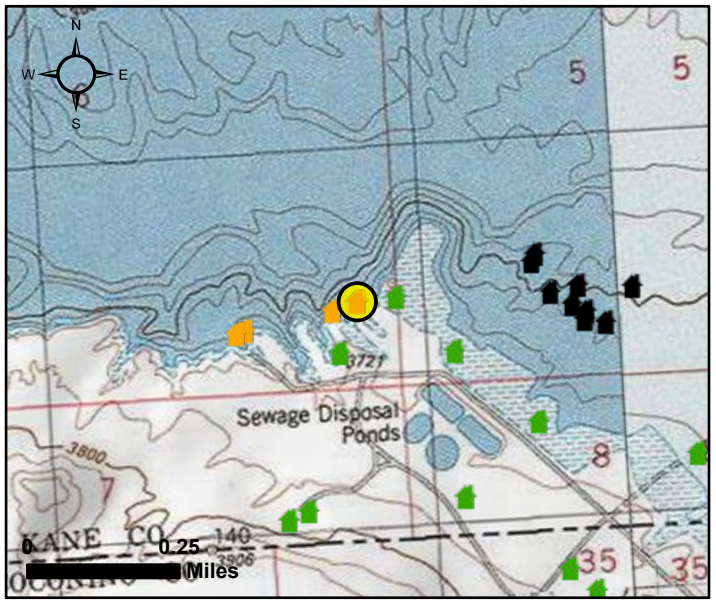
Facility Name: WW Coves Shade Structure #1
Unit - Location: GLCA - Wahweap
FMSS ID: GLCA Cove Shade # 1, ***Local ID:***
Structure Type, Use: Other, Unknown
Owner: National Park Service
Field Crew, Visit Date: ZION WFM, June 19, 2012
Coordinates (DDM): 37° 00.42799998' N 111° 30.50100000' W

Rating: Moderate
ProtectionLevel: Undesignated,
Resources of Concern: Unknown
Occupied:
In Community: No,
Revisit Interval: yrs
Map Label: 370

Primary Access: Road
Ingress Egress: 2 or more roads in/out
Access Width: 2 lanes (Greater than 24')
Access Condition: Surfaced-paved, gradeLess than 5%
Bridge Condition: Less than 300 ft with turnaround
Access and Turnarounds: Less than 300 ft with turnaround
Facility Number or Sign: None or not clearly visible
Fuel Type: Grass and shrub, hardwood litter
Fuel Load: Light or no wildland fuels
Defensible Space: Greater than 100ft treated
Topography: Slope 31% to 40%
Roof Material: Combustible or no roof
Siding Material: Rock, concrete, metal
Foundation: Closed, Greater than 30in masonry exposed or N/A
Firewood: None
Water Supply: Reliable water source nearby
Propane: None
Overhead Hazards: No overhead hazards

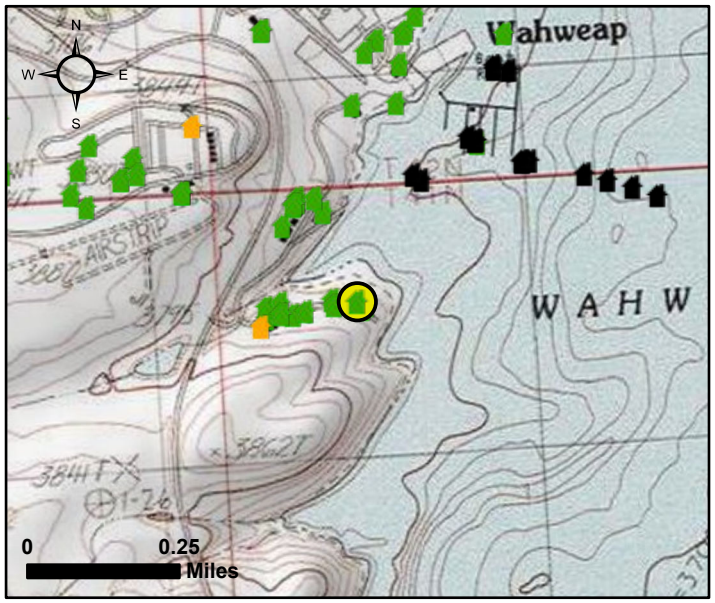
Facility Name: WW Housing 117
Unit - Location: GLCA - Wahweap
FMSS ID: 44534, ***Local ID:***
Structure Type, Use: Building, Administrative
Owner: National Park Service
Field Crew, Visit Date: ZION WFM, June 19, 2012
Coordinates (DDM): 36° 59.25799998' N 111° 29.34799998' W

Rating: Low
ProtectionLevel: Undesignated,
Resources of Concern: Unknown
Occupied: Yes
In Community: No,
Revisit Interval: yrs
Map Label: 460

Primary Access: Road
Ingress Egress: 1 road in/out
Access Width: 1.5 lanes (Greater than 18')
Access Condition: Surfaced-paved, gradeLess than 5%
Bridge Condition: Less than 300 ft with turnaround
Access and Turnarounds: Less than 300 ft with turnaround
Facility Number or Sign: Marked and clearly visible
Fuel Type: Grass and shrub, hardwood litter
Fuel Load: Moderate
Defensible Space: 30 ft treated
Topography: Slope Less than 5%
Roof Material: Noncombustible or not applicable
Siding Material: Rock, concrete, metal
Foundation: Closed, Greater than 30in masonry exposed or N/A
Firewood: None
Water Supply: Pressurized hydrant(s) or fixed sprinkler system
Propane: None
Overhead Hazards: Overhead hazards will limit aircraft
Comments:

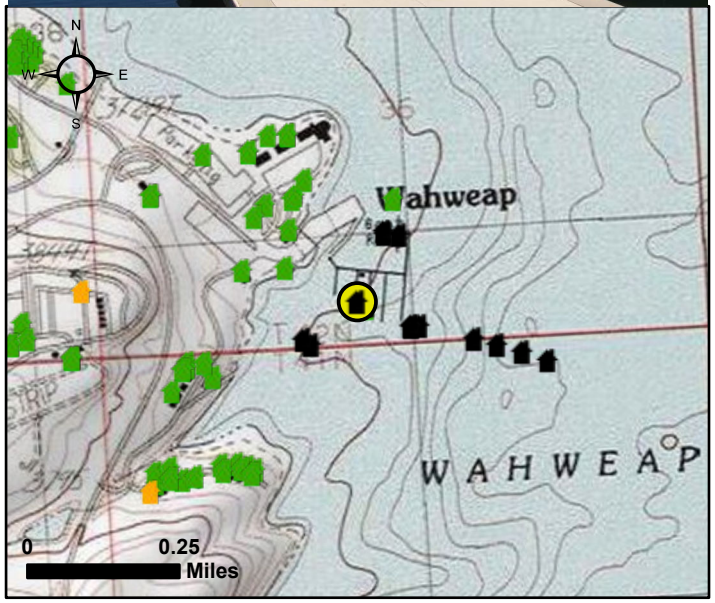
Facility Name: WW Marina Fishing Dock Shade Structure #1
Unit - Location: GLCA - Wahweap
FMSS ID: GLCA WW Marina Fishing Dock, ***Local ID:***
Structure Type, Use: No Wildland Risk, Unknown
Owner: National Park Service
Field Crew, Visit Date: ZION WFM, June 19, 2012
Coordinates (DDM): 36° 59.48400000' N 111° 29.13499998' W

Rating: No Wildland Risk
ProtectionLevel: Undesignated,
Resources of Concern: Unknown
Occupied:
In Community: No,
Revisit Interval: yrs
Map Label: 479

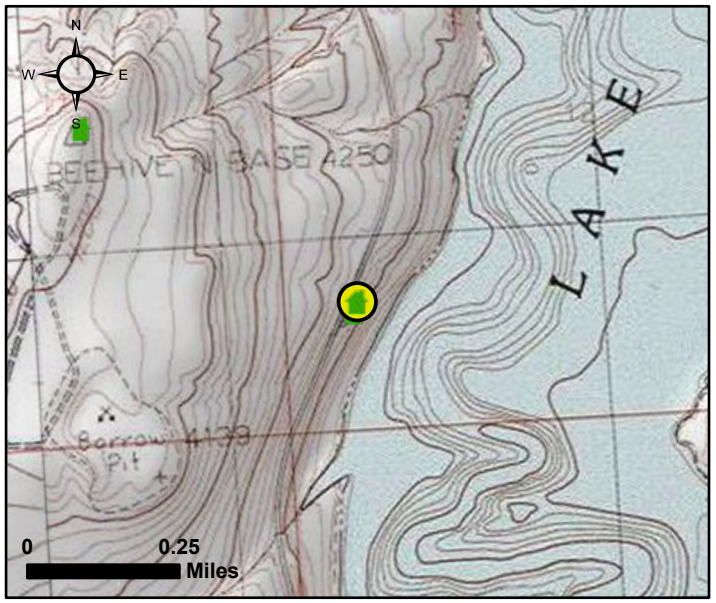
Facility Name: WW Navajo Mtn Viewpoint Shade Structure #2
Unit - Location: GLCA - Wahweap
FMSS ID: GLCA WW Navajo Mtn Shade #2, ***Local ID:***
Structure Type, Use: Other, Unknown
Owner: National Park Service
Field Crew, Visit Date: ZION WFM, June 19, 2012
Coordinates (DDM): 36° 57.86200002' N 111° 29.46600000' W

Rating: Low
ProtectionLevel: Undesignated,
Resources of Concern: Unknown
Occupied:
In Community: No,
Revisit Interval: yrs
Map Label: 445

Primary Access: Road
Ingress Egress: 2 or more roads in/out
Access Width: 2 lanes (Greater than 24')
Access Condition: Surfaced-paved, gradeLess than 5%
Bridge Condition: Less than 300 ft with turnaround
Access and Turnarounds: Less than 300 ft with turnaround
Facility Number or Sign: None or not clearly visible
Fuel Type: Grass and shrub, hardwood litter
Fuel Load: Light or no wildland fuels
Defensible Space: 30 ft treated
Topography: Slope 31% to 40%
Roof Material: Noncombustible or not applicable
Siding Material: Rock, concrete, metal
Foundation: Closed, Greater than 30in masonry exposed or N/A
Firewood: None
Water Supply: Reliable water source nearby
Propane: None
Overhead Hazards: No overhead hazards

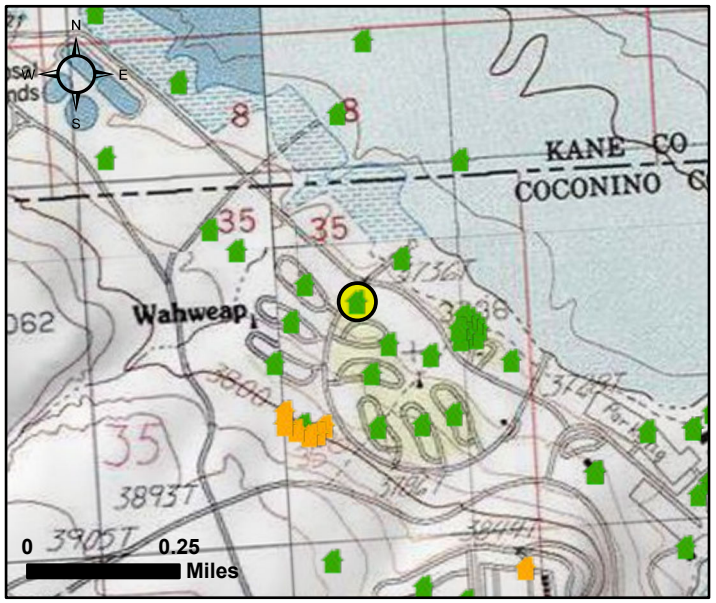
Facility Name: WW Campground Restrooms/Showers
Unit - Location: GLCA - Wahweap
FMSS ID: 236769, ***Local ID:***
Structure Type, Use: Building, Unknown
Owner: National Park Service
Field Crew, Visit Date: ZION WFM, June 19, 2012
Coordinates (DDM): 36° 59.91499998' N 111° 29.89600002' W

Rating: Low
ProtectionLevel: Undesignated,
Resources of Concern: Unknown
Occupied: Yes
In Community: No,
Revisit Interval: yrs
Map Label: 400

Primary Access: Road
Ingress Egress: 2 or more roads in/out
Access Width: 2 lanes (Greater than 24')
Access Condition: Surfaced-paved, gradeLess than 5%
Bridge Condition: Less than 300 ft with turnaround
Access and Turnarounds: Less than 300 ft with turnaround
Facility Number or Sign: None or not clearly visible
Fuel Type: Grass and shrub, hardwood litter
Fuel Load: Light or no wildland fuels
Defensible Space: 30 ft treated
Topography: Slope 5% to 20%
Roof Material: Noncombustible or not applicable
Siding Material: Rock, concrete, metal
Foundation: Closed, Greater than 30in masonry exposed or N/A
Firewood: None
Water Supply: Pressurized hydrant(s) or fixed sprinkler system
Propane: Present and fuels clearance
Overhead Hazards: No overhead hazards

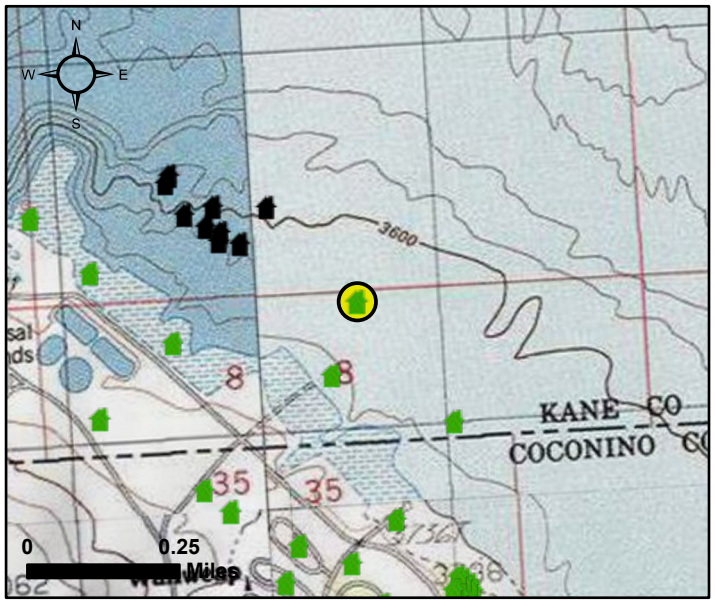
Facility Name: WW Stateline Boat Pumpout Station
Unit - Location: GLCA - Wahweap
FMSS ID: 52502, ***Local ID:***
Structure Type, Use: Utility Site (Water, Gas,Elec), Public
Owner: National Park Service
Field Crew, Visit Date: ZION WFM, June 19, 2012
Coordinates (DDM): 37° 00.28699998' N 111° 29.85900000' W

Rating: Low
ProtectionLevel: Undesignated,
Resources of Concern: Unknown
Occupied: No
In Community: No,
Revisit Interval: yrs
Map Label: 403

Primary Access: Road
Ingress Egress: 2 or more roads in/out
Access Width: 2 lanes (Greater than 24')
Access Condition: Surfaced-paved, gradeLess than 5%
Bridge Condition: Less than 300 ft with turnaround
Access and Turnarounds: Less than 300 ft with turnaround
Facility Number or Sign: None or not clearly visible
Fuel Type: Grass and shrub, hardwood litter
Fuel Load: Light or no wildland fuels
Defensible Space: Greater than 100ft treated
Topography: Slope 21% to 30%
Roof Material: Noncombustible or not applicable
Siding Material: Rock, concrete, metal
Foundation: Closed, Greater than 30in masonry exposed or N/A
Firewood: None
Water Supply: Pressurized hydrant(s) or fixed sprinkler system
Propane: None
Overhead Hazards: No overhead hazards

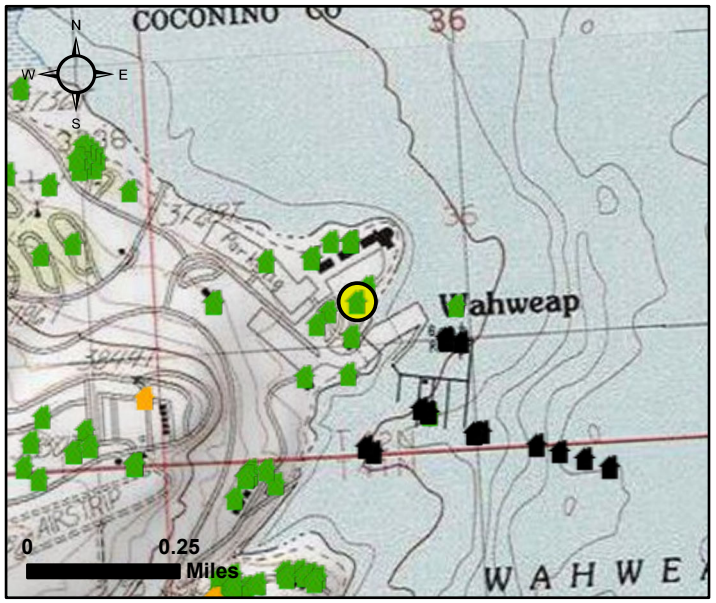
Facility Name: WW Lodge Building #2
Unit - Location: GLCA - Wahweap
FMSS ID: GLCA Lodge Building #2, ***Local ID:***
Structure Type, Use: Building, Unknown
Owner: National Park Service
Field Crew, Visit Date: ZION WFM, June 19, 2012
Coordinates (DDM): 36° 59.64100002' N 111° 29.23600002' W

Rating: Low
ProtectionLevel: Undesignated,
Resources of Concern: Unknown
Occupied: Yes
In Community: No,
Revisit Interval: yrs
Map Label: 474

Primary Access: Road
Ingress Egress: 2 or more roads in/out
Access Width: 2 lanes (Greater than 24')
Access Condition: Surfaced-paved, gradeLess than 5%
Bridge Condition: Less than 300 ft with turnaround
Access and Turnarounds: Less than 300 ft with turnaround
Facility Number or Sign: Marked and clearly visible
Fuel Type: Grass and shrub, hardwood litter
Fuel Load: Light or no wildland fuels
Defensible Space: 30 ft treated
Topography: Slope 21% to 30%
Roof Material: Noncombustible or not applicable
Siding Material: Rock, concrete, metal
Foundation: Closed, Greater than 30in masonry exposed or N/A
Firewood: None
Water Supply: Pressurized hydrant(s) or fixed sprinkler system
Propane: None
Overhead Hazards: No overhead hazards
Comments:

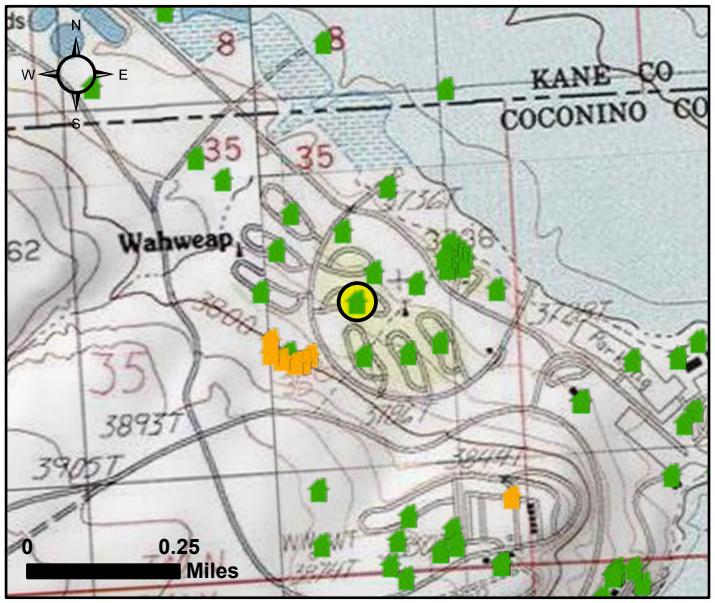
Facility Name: WW Campground Comfort Station Loop 4
Unit - Location: GLCA - Wahweap
FMSS ID: GLCA WW CCS Loop 4, ***Local ID:***
Structure Type, Use: Building, Unknown
Owner: National Park Service
Field Crew, Visit Date: ZION WFM, June 19, 2012
Coordinates (DDM): 36° 59.81200002' N 111° 29.87800002' W

Rating: Low
ProtectionLevel: Undesignated,
Resources of Concern: Unknown
Occupied: Yes
In Community: No,
Revisit Interval: yrs
Map Label: 401

Primary Access: Road
Ingress Egress: 2 or more roads in/out
Access Width: 2 lanes (Greater than 24')
Access Condition: Surfaced-paved, gradeLess than 5%
Bridge Condition: Less than 300 ft with turnaround
Access and Turnarounds: Less than 300 ft with turnaround
Facility Number or Sign: None or not clearly visible
Fuel Type: Grass and shrub, hardwood litter
Fuel Load: Light or no wildland fuels
Defensible Space: 30 ft treated
Topography: Slope 5% to 20%
Roof Material: Noncombustible or not applicable
Siding Material: Rock, concrete, metal
Foundation: Closed, Greater than 30in masonry exposed or N/A
Firewood: None
Water Supply: Pressurized hydrant(s) or fixed sprinkler system
Propane: None
Overhead Hazards: No overhead hazards
Comments: Water Supply: 1.5 million gallon tank.

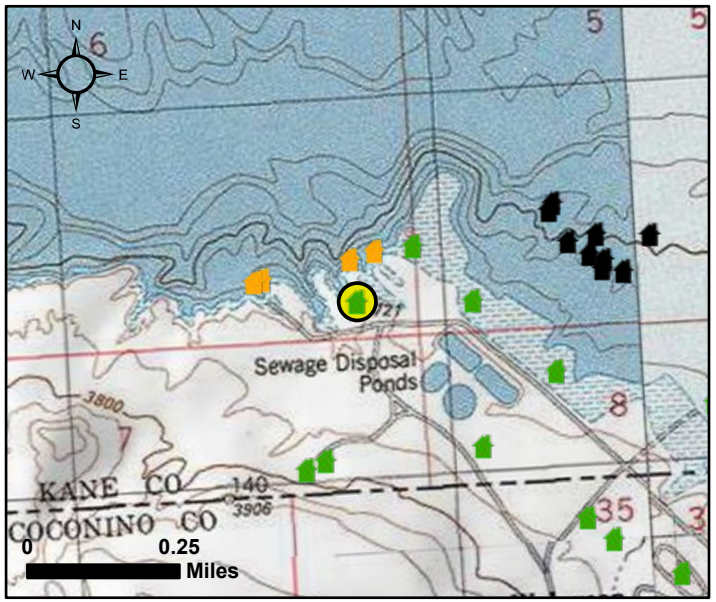
Facility Name: WW Coves Comfort Station
Unit - Location: GLCA - Wahweap
FMSS ID: 44420, ***Local ID:***
Structure Type, Use: Building, Public
Owner: National Park Service
Field Crew, Visit Date: ZION WFM, June 19, 2012
Coordinates (DDM): 37° 00.35700000' N 111° 30.53700000' W

Rating: Low
ProtectionLevel: Undesignated,
Resources of Concern: Unknown
Occupied: Yes
In Community: No,
Revisit Interval: yrs
Map Label: 369

Primary Access: Road
Ingress Egress: 2 or more roads in/out
Access Width: 2 lanes (Greater than 24')
Access Condition: Surfaced-paved, gradeLess than 5%
Bridge Condition: Less than 300 ft with turnaround
Access and Turnarounds: Less than 300 ft with turnaround
Facility Number or Sign: Marked and clearly visible
Fuel Type: Grass and shrub, hardwood litter
Fuel Load: Light or no wildland fuels
Defensible Space: Greater than 100ft treated
Topography: Slope 5% to 20%
Roof Material: Noncombustible or not applicable
Siding Material: Rock, concrete, metal
Foundation: Closed, Greater than 30in masonry exposed or N/A
Firewood: None
Water Supply: Pressurized hydrant(s) or fixed sprinkler system
Propane: None
Overhead Hazards: No overhead hazards
Comments: Treatment: None. Sparse fuels.

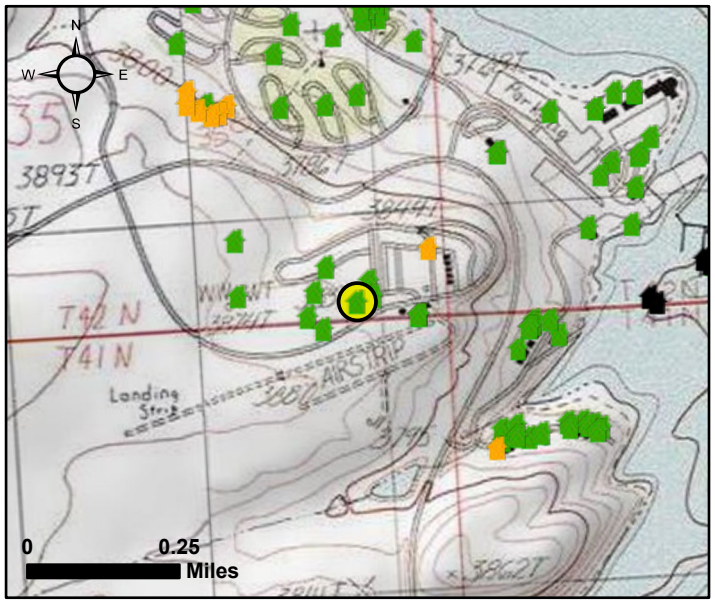
Facility Name: WW Aramark Dorm #3
Unit - Location: GLCA - Wahweap
FMSS ID: GLCA Aramark Dorm, ***Local ID:***
Structure Type, Use: Building, Unknown
Owner: National Park Service
Field Crew, Visit Date: ZION WFM, June 19, 2012
Coordinates (DDM): 36° 59.45100000' N 111° 29.75500002' W

Rating: Low
ProtectionLevel: Undesignated,
Resources of Concern: Unknown
Occupied: Yes
In Community: No,
Revisit Interval: yrs
Map Label: 412

Primary Access: Road
Ingress Egress: 2 or more roads in/out
Access Width: 2 lanes (Greater than 24')
Access Condition: Surfaced-paved, gradeLess than 5%
Bridge Condition: Less than 300 ft with turnaround
Access and Turnarounds: Less than 300 ft with turnaround
Facility Number or Sign: Marked and clearly visible
Fuel Type: Grass and shrub, hardwood litter
Fuel Load: Light or no wildland fuels
Defensible Space: 100 ft treated
Topography: Slope Less than 5%
Roof Material: Noncombustible or not applicable
Siding Material: Rock, concrete, metal
Foundation: Closed, Greater than 30in masonry exposed or N/A
Firewood: None
Water Supply: Pressurized hydrant(s) or fixed sprinkler system
Propane: None
Overhead Hazards: No overhead hazards
Comments:

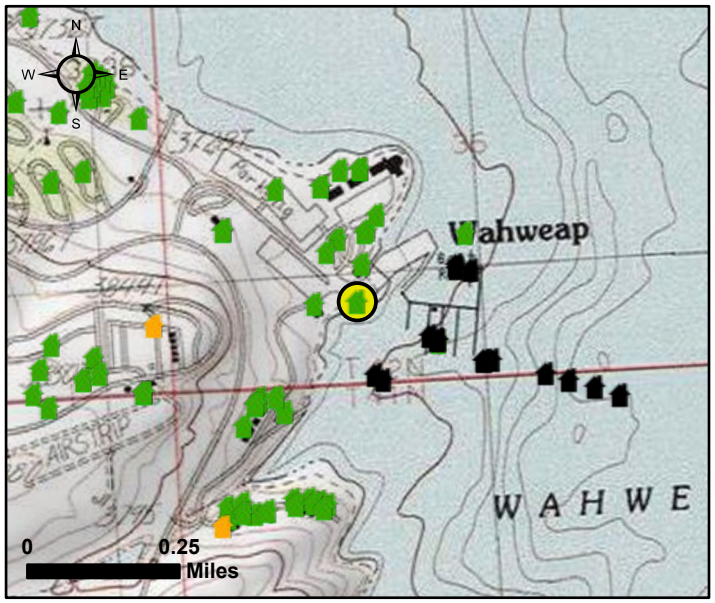
Facility Name: WW Main Ramp Comfort Station
Unit - Location: GLCA - Wahweap
FMSS ID: 44422, ***Local ID:***
Structure Type, Use: Building, Public
Owner: National Park Service
Field Crew, Visit Date: ZION WFM, June 19, 2012
Coordinates (DDM): 36° 59.53900002' N 111° 29.26000002' W

Rating: Low
ProtectionLevel: Undesignated,
Resources of Concern: Unknown
Occupied: Yes
In Community: No,
Revisit Interval: yrs
Map Label: 469

Primary Access: Road
Ingress Egress: 2 or more roads in/out
Access Width: 2 lanes (Greater than 24')
Access Condition: Surfaced-paved, gradeLess than 5%
Bridge Condition: Less than 300 ft with turnaround
Access and Turnarounds: Less than 300 ft with turnaround
Facility Number or Sign: Marked and clearly visible
Fuel Type: Grass and shrub, hardwood litter
Fuel Load: Light or no wildland fuels
Defensible Space: 30 ft treated
Topography: Slope 21% to 30%
Roof Material: Noncombustible or not applicable
Siding Material: Rock, concrete, metal
Foundation: Closed, Greater than 30in masonry exposed or N/A
Firewood: None
Water Supply: Pressurized hydrant(s) or fixed sprinkler system
Propane: None
Overhead Hazards: No overhead hazards
Comments: Obstacles: Evacuation.

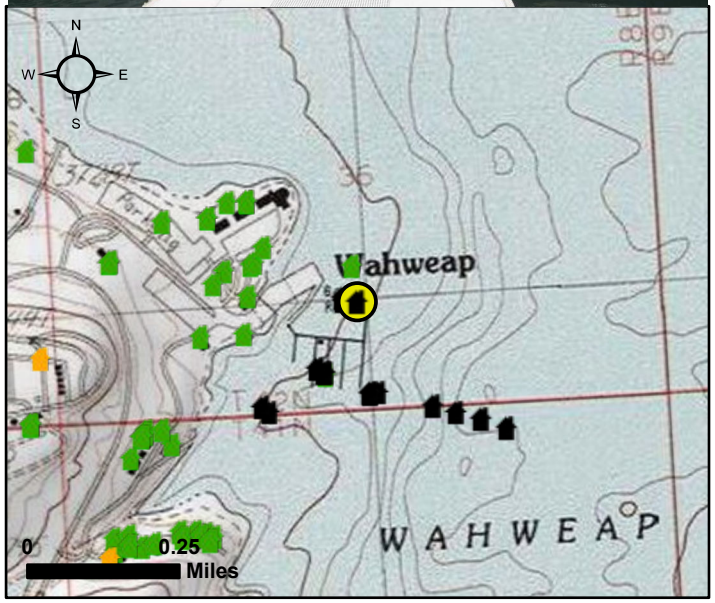
Facility Name: WW Main Ramp Fuel Dock Store Restroom Office Shade
Unit - Location: GLCA - Wahweap
FMSS ID: GLCA WW Main Fuel Dock Restroom Office Shade, ***Local ID:***
Structure Type, Use: No Wildland Risk, Unknown
Owner: National Park Service
Field Crew, Visit Date: ZION WFM, June 19, 2012
Coordinates (DDM): 36° 59.57599998' N 111° 29.05500000' W

Rating: No Wildland Risk
ProtectionLevel: Undesignated,
Resources of Concern: Unknown
Occupied: Yes
In Community: No,
Revisit Interval: yrs
Map Label: 486

Comments: N/A. Buildings are at the end of the dock in the middle of the water.

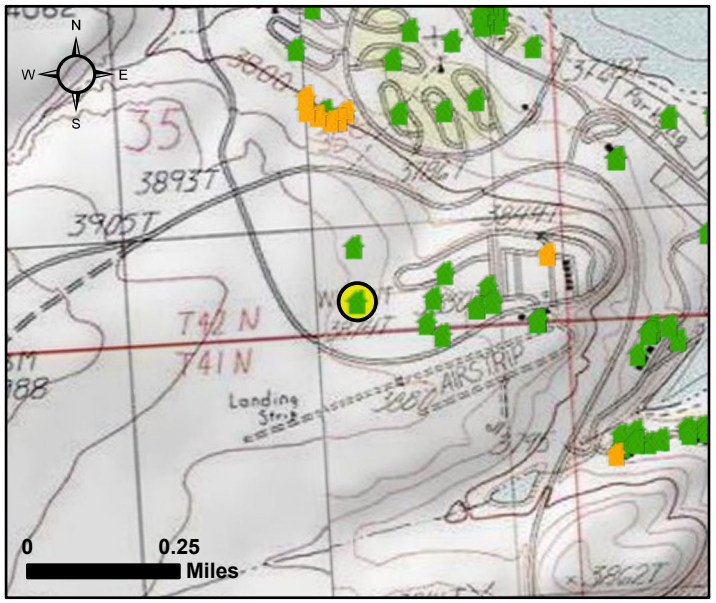
Facility Name: WW Pressure Building Trailer Village
Unit - Location: GLCA - Wahweap
FMSS ID: 52490, ***Local ID:***
Structure Type, Use: Utility Site (Water, Gas,Elec), Administrative
Owner: National Park Service
Field Crew, Visit Date: ZION WFM, June 19, 2012
Coordinates (DDM): 36° 59.46900000' N 111° 29.96599998' W

Rating: Low
ProtectionLevel: Undesignated,
Resources of Concern: Unknown
Occupied: No
In Community: No,
Revisit Interval: yrs
Map Label: 397

Primary Access: Road
Ingress Egress: 2 or more roads in/out
Access Width: 2 lanes (Greater than 24')
Access Condition: Surfaced-paved, gradeLess than 5%
Bridge Condition: Less than 300 ft with turnaround
Access and Turnarounds: Less than 300 ft with turnaround
Facility Number or Sign: None or not clearly visible
Fuel Type: Grass and shrub, hardwood litter
Fuel Load: Light or no wildland fuels
Defensible Space: 30 ft treated
Topography: Slope 5% to 20%
Roof Material: Noncombustible or not applicable
Siding Material: Rock, concrete, metal
Foundation: Closed, Greater than 30in masonry exposed or N/A
Firewood: None
Water Supply: Pressurized hydrant(s) or fixed sprinkler system
Propane: None
Overhead Hazards: No overhead hazards
Comments: Obstacles: Hazmat.

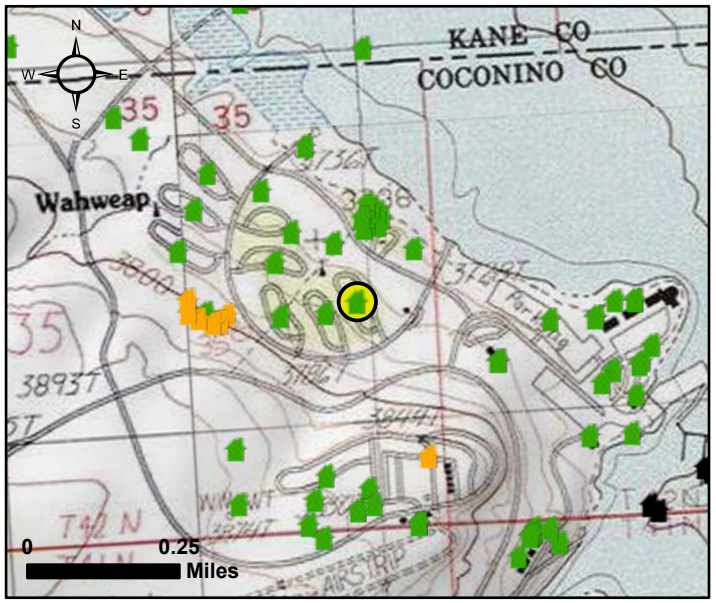
Rating: Low
ProtectionLevel: Undesignated,
Resources of Concern: Unknown
Occupied: Yes
In Community: No,
Revisit Interval: yrs
Map Label: 414

Facility Name: WW Campground Comfort Station Loop 1
Unit - Location: GLCA - Wahweap
FMSS ID: GLCA WW CCS Loop 1, ***Local ID:***
Structure Type, Use: Building, Unknown
Owner: National Park Service
Field Crew, Visit Date: ZION WFM, June 19, 2012
Coordinates (DDM): 36° 59.74800000' N 111° 29.73499998' W

Primary Access: Road
Ingress Egress: 2 or more roads in/out
Access Width: 2 lanes (Greater than 24')
Access Condition: Surfaced-paved, gradeLess than 5%
Bridge Condition: Less than 300 ft with turnaround
Access and Turnarounds: Less than 300 ft with turnaround
Facility Number or Sign: None or not clearly visible
Fuel Type: Grass and shrub, hardwood litter
Fuel Load: Light or no wildland fuels
Defensible Space: 30 ft treated
Topography: Slope 5% to 20%
Roof Material: Noncombustible or not applicable
Siding Material: Rock, concrete, metal
Foundation: Closed, Greater than 30in masonry exposed or N/A
Firewood: None
Water Supply: Pressurized hydrant(s) or fixed sprinkler system
Propane: None
Overhead Hazards: No overhead hazards

Comments: Water Supply: 1.5 million gallon tank.
Obstacles: Evacuation.

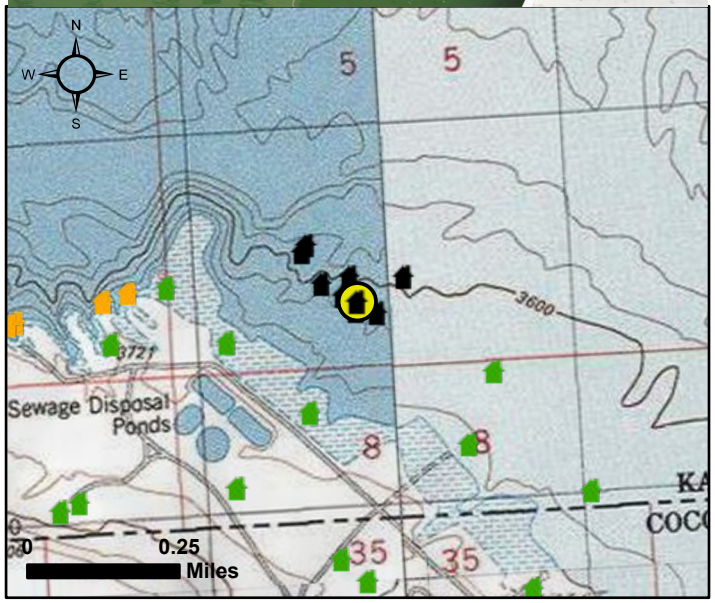
Rating: No Wildland Risk
ProtectionLevel: Undesignated,
Resources of Concern: Unknown
Occupied: Yes
In Community: No,
Revisit Interval: yrs
Map Label: 383

Facility Name: WW Stateline Boat Rental Shop Shade Bldg.
Unit - Location: GLCA - Wahweap
FMSS ID: GLCA SL Boat Rent Shade, ***Local ID:***
Structure Type, Use: No Wildland Risk, Unknown
Owner: National Park Service
Field Crew, Visit Date: ZION WFM, June 19, 2012
Coordinates (DDM): 37° 00.39700002' N 111° 30.09499998' W

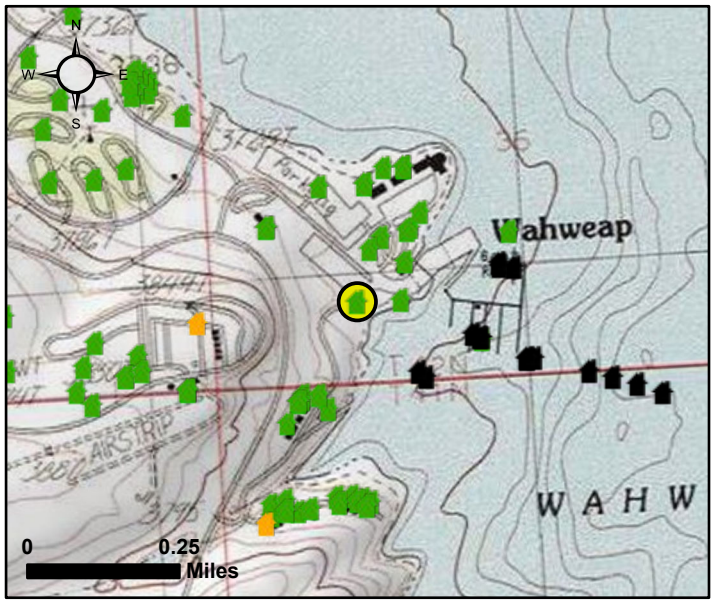
Rating: Low
ProtectionLevel: Undesignated,
Resources of Concern: Unknown
Occupied: Yes
In Community: No,
Revisit Interval: yrs
Map Label: 462

Facility Name: WW Lake Powell Sports
Unit - Location: GLCA - Wahweap
FMSS ID: GLCA Lake Powell Sports, ***Local ID:***
Structure Type, Use: Building, Unknown
Owner: National Park Service
Field Crew, Visit Date: ZION WFM, June 19, 2012
Coordinates (DDM): 36° 59.53900002' N 111° 29.33700000' W

Primary Access: Road
Ingress Egress: 2 or more roads in/out
Access Width: 2 lanes (Greater than 24')
Access Condition: Surfaced-paved, gradeLess than 5%
Bridge Condition: Less than 300 ft with turnaround
Access and Turnarounds: Less than 300 ft with turnaround
Facility Number or Sign: Marked and clearly visible
Fuel Type: Grass and shrub, hardwood litter
Fuel Load: Light or no wildland fuels
Defensible Space: 30 ft treated
Topography: Slope 5% to 20%
Roof Material: Noncombustible or not applicable
Siding Material: Rock, concrete, metal
Foundation: Closed, Greater than 30in masonry exposed or N/A
Firewood: None
Water Supply: Pressurized hydrant(s) or fixed sprinkler system
Propane: None
Overhead Hazards: No overhead hazards
Comments: Obstacles: Evacuation.

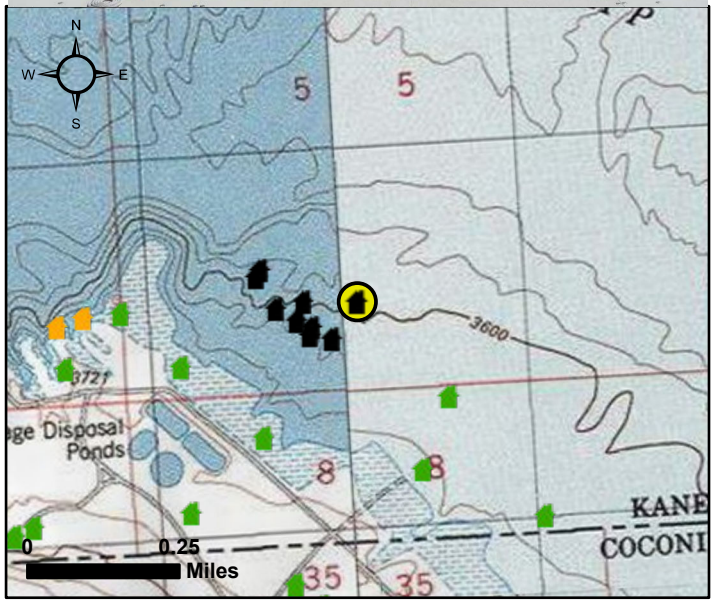
Rating: No Wildland Risk
ProtectionLevel: Undesignated,
Resources of Concern: Unknown
Occupied: Yes
In Community: No,
Revisit Interval: yrs
Map Label: 390

Facility Name: WW Stateline Fuel Dock Bldg.
Unit - Location: GLCA - Wahweap
FMSS ID: GLCA SL Fuel Dock, ***Local ID:***
Structure Type, Use: No Wildland Risk, Unknown
Owner: National Park Service
Field Crew, Visit Date: ZION WFM, June 19, 2012
Coordinates (DDM): 37° 00.42900000' N 111° 30.01099998' W

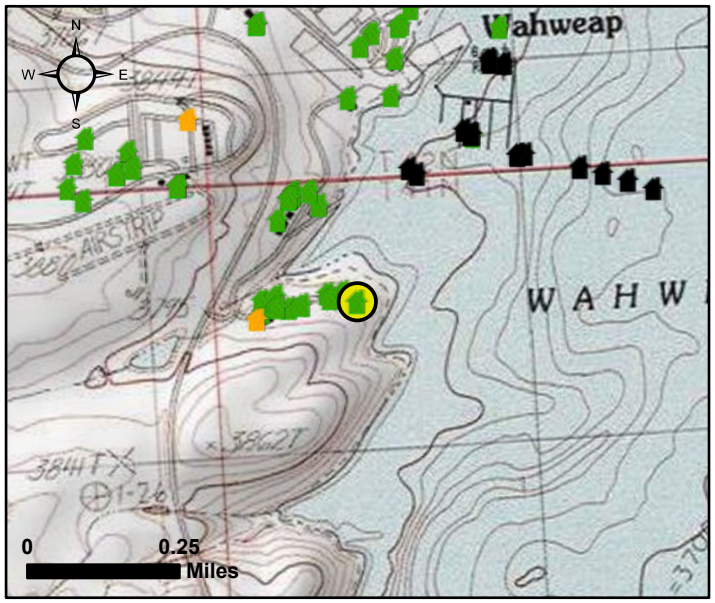
Rating: Low
ProtectionLevel: Undesignated,
Resources of Concern: Unknown
Occupied: Yes
In Community: No,
Revisit Interval: yrs
Map Label: 461

Facility Name: WW Housing #126
Unit - Location: GLCA - Wahweap
FMSS ID: 44575, ***Local ID:***
Structure Type, Use: Building, Administrative
Owner: National Park Service
Field Crew, Visit Date: ZION WFM, June 19, 2012
Coordinates (DDM): 36° 59.24800002' N 111° 29.34100002' W

Primary Access: Road
Ingress Egress: 2 or more roads in/out
Access Width: 2 lanes (Greater than 24')
Access Condition: Surfaced-paved, gradeLess than 5%
Bridge Condition: Less than 300 ft with turnaround
Access and Turnarounds: Less than 300 ft with turnaround
Facility Number or Sign: Marked and clearly visible
Fuel Type: Grass and shrub, hardwood litter
Fuel Load: Light or no wildland fuels
Defensible Space: 30 ft treated
Topography: Slope 5% to 20%
Roof Material: Noncombustible or not applicable
Siding Material: Wood or open sided
Foundation: Closed, Less than 6in masonry exposed
Firewood: None
Water Supply: Pressurized hydrant(s) or fixed sprinkler system
Propane: None
Overhead Hazards: Overhead hazards will limit aircraft
Comments: Water Supply: 1.5 million gallon tank.

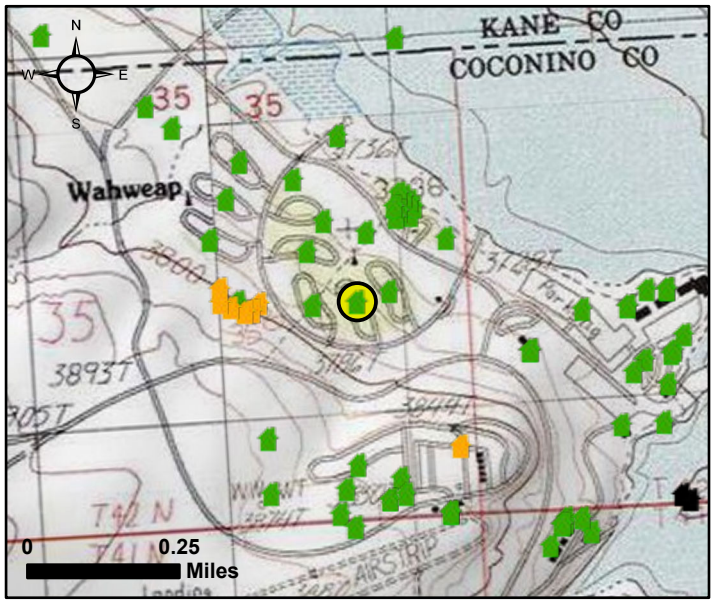
Rating: Low
ProtectionLevel: Undesignated,
Resources of Concern: Unknown
Occupied: Yes
In Community: No,
Revisit Interval: yrs
Map Label: 410

Facility Name: WW Campground Comfort Station Loop 2
Unit - Location: GLCA - Wahweap
FMSS ID: GLCA WW CCS loop 2, ***Local ID:***
Structure Type, Use: Building, Unknown
Owner: National Park Service
Field Crew, Visit Date: ZION WFM, June 19, 2012
Coordinates (DDM): 36° 59.73499998' N 111° 29.79300000' W

Primary Access: Road
Ingress Egress: 2 or more roads in/out
Access Width: 2 lanes (Greater than 24')
Access Condition: Surfaced-paved, gradeLess than 5%
Bridge Condition: Less than 300 ft with turnaround
Access and Turnarounds: Less than 300 ft with turnaround
Facility Number or Sign: None or not clearly visible
Fuel Type: Grass and shrub, hardwood litter
Fuel Load: Light or no wildland fuels
Defensible Space: 30 ft treated
Topography: Slope 5% to 20%
Roof Material: Noncombustible or not applicable
Siding Material: Rock, concrete, metal
Foundation: Closed, Greater than 30in masonry exposed or N/A
Firewood: None
Water Supply: Pressurized hydrant(s) or fixed sprinkler system
Propane: None
Overhead Hazards: No overhead hazards
Comments: Obstacles: Evacuation.

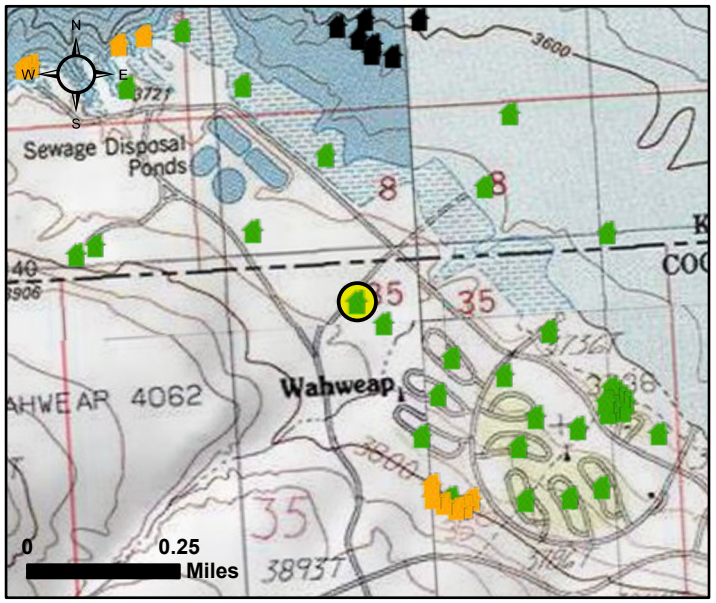
Rating: Low
ProtectionLevel: Undesignated,
Resources of Concern: Unknown
Occupied: Yes
In Community: No,
Revisit Interval: yrs
Map Label: 378

Facility Name: WW Campground Comfort Station Loop D #2
Unit - Location: GLCA - Wahweap
FMSS ID: 236768, ***Local ID:***
Structure Type, Use: Building, Unknown
Owner: National Park Service
Field Crew, Visit Date: ZION WFM, June 19, 2012
Coordinates (DDM): 37° 00.03100002' N 111° 30.15000000' W

Primary Access: Road
Ingress Egress: 2 or more roads in/out
Access Width: 2 lanes (Greater than 24')
Access Condition: Surfaced-paved, gradeLess than 5%
Bridge Condition: Less than 300 ft with turnaround
Access and Turnarounds: Less than 300 ft with turnaround
Facility Number or Sign: None or not clearly visible
Fuel Type: Grass and shrub, hardwood litter
Fuel Load: Light or no wildland fuels
Defensible Space: 30 ft treated
Topography: Slope 5% to 20%
Roof Material: Noncombustible or not applicable
Siding Material: Rock, concrete, metal
Foundation: Closed, Greater than 30in masonry exposed or N/A
Firewood: None
Water Supply: Pressurized hydrant(s) or fixed sprinkler system
Propane: None
Overhead Hazards: No overhead hazards
Comments: Obstacles: Evacuation.

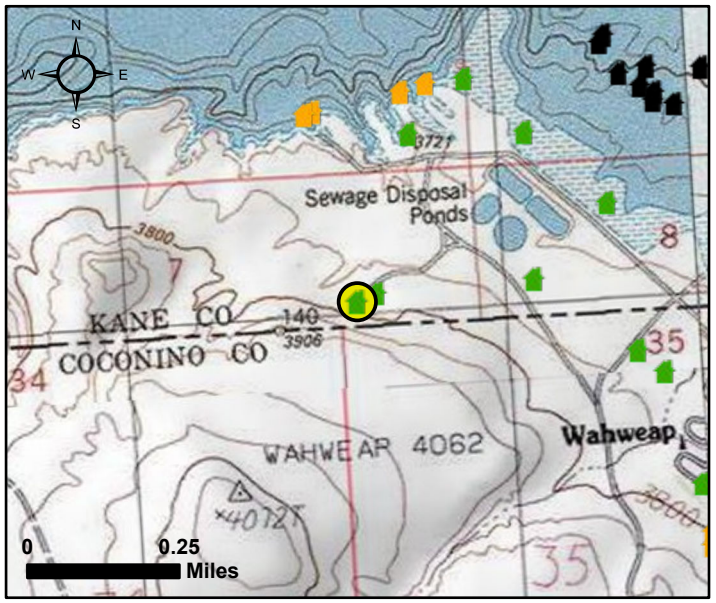
Rating: Low
ProtectionLevel: Undesignated,
Resources of Concern: Unknown
Occupied: Yes
In Community: No,
Revisit Interval: yrs
Map Label: 366

Facility Name: WW Living Qtrs Garage and Warehouse
Unit - Location: GLCA - Wahweap
FMSS ID: GLCA Living Qtrs, ***Local ID:***
Structure Type, Use: Building, Unknown
Owner: National Park Service
Field Crew, Visit Date: ZION WFM, June 19, 2012
Coordinates (DDM): 37° 00.12199998' N 111° 30.64399998' W

Primary Access: Road
Ingress Egress: 2 or more roads in/out
Access Width: 2 lanes (Greater than 24')
Access Condition: Surfaced-paved, gradeLess than 5%
Bridge Condition: Less than 300 ft with turnaround
Access and Turnarounds: Less than 300 ft with turnaround
Facility Number or Sign: None or not clearly visible
Fuel Type: Grass and shrub, hardwood litter
Fuel Load: Light or no wildland fuels
Defensible Space: 30 ft treated
Topography: Slope 21% to 30%
Roof Material: Noncombustible or not applicable
Siding Material: Rock, concrete, metal
Foundation: Closed, Greater than 30in masonry exposed or N/A
Firewood: None
Water Supply: Pressurized hydrant(s) or fixed sprinkler system
Propane: Present and fuels clearance
Overhead Hazards: No overhead hazards

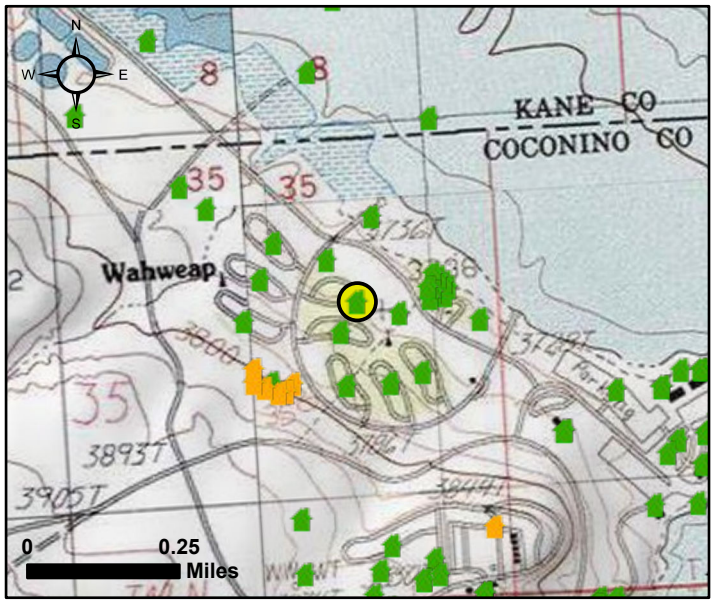
Rating: Low
ProtectionLevel: Undesignated,
Resources of Concern: Unknown
Occupied: Yes
In Community: No,
Revisit Interval: yrs
Map Label: 404

Facility Name: WW Campground Comfort Station Loop F
Unit - Location: GLCA - Wahweap
FMSS ID: GLCA WW CCS Loop F, ***Local ID:***
Structure Type, Use: Building, Unknown
Owner: National Park Service
Field Crew, Visit Date: ZION WFM, June 19, 2012
Coordinates (DDM): 36° 59.85300000' N 111° 29.84500002' W

Primary Access: Road
Ingress Egress: 2 or more roads in/out
Access Width: 2 lanes (Greater than 24')
Access Condition: Surfaced-paved, gradeLess than 5%
Bridge Condition: Less than 300 ft with turnaround
Access and Turnarounds: Less than 300 ft with turnaround
Facility Number or Sign: None or not clearly visible
Fuel Type: Grass and shrub, hardwood litter
Fuel Load: Light or no wildland fuels
Defensible Space: 100 ft treated
Topography: Slope Less than 5%
Roof Material: Noncombustible or not applicable
Siding Material: Rock, concrete, metal
Foundation: Closed, Greater than 30in masonry exposed or N/A
Firewood: None
Water Supply: Pressurized hydrant(s) or fixed sprinkler system
Propane: None
Overhead Hazards: No overhead hazards

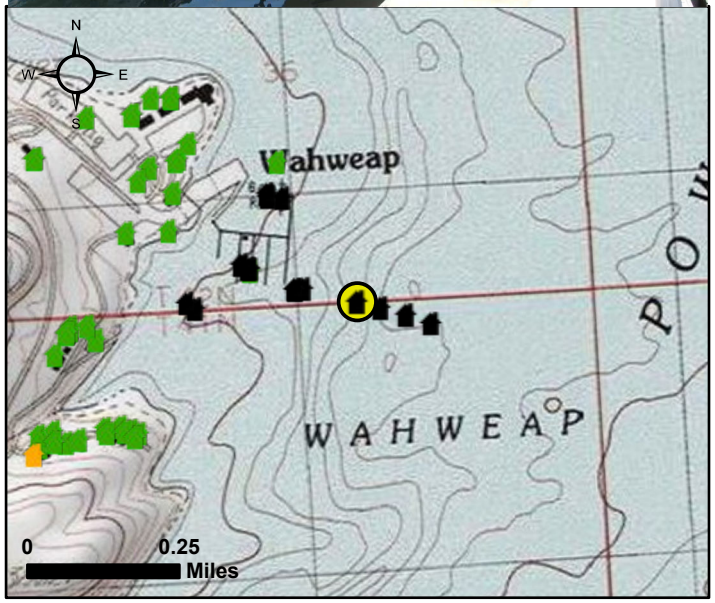
Rating: No Wildland Risk
ProtectionLevel: Undesignated,
Resources of Concern: Unknown
Occupied: Yes
In Community: No,
Revisit Interval: yrs
Map Label: 490

Facility Name: WW Marina Restroom Electrical Shade #1
Unit - Location: GLCA - Wahweap
FMSS ID: GLCA WW Marina Restroom #1, ***Local ID:***
Structure Type, Use: No Wildland Risk, Unknown
Owner: National Park Service
Field Crew, Visit Date: ZION WFM, June 19, 2012
Coordinates (DDM): 36° 59.42200002' N 111° 28.93200000' W

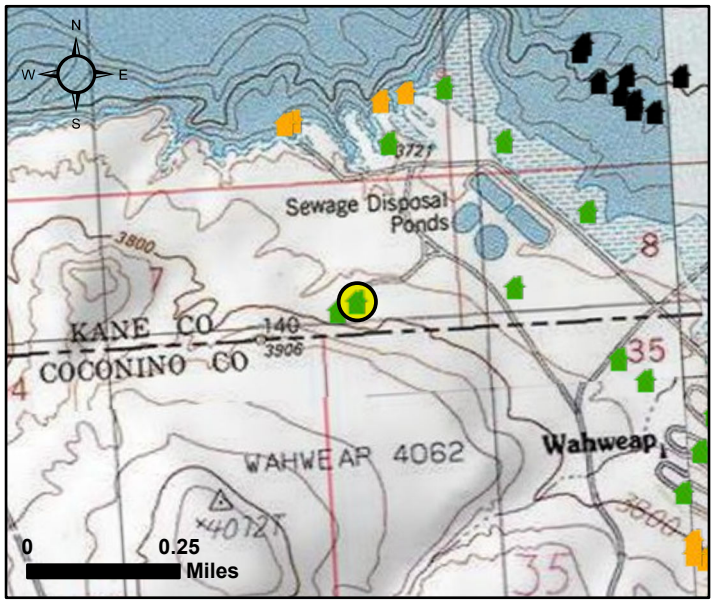
Rating: Low
ProtectionLevel: Undesignated,
Resources of Concern: Unknown
Occupied: Yes
In Community: No,
Revisit Interval: yrs
Map Label: 367

Facility Name: WW Offices 751
Unit - Location: GLCA - Wahweap
FMSS ID: GLCA WW Offices, ***Local ID:***
Structure Type, Use: Building, Unknown
Owner: National Park Service
Field Crew, Visit Date: ZION WFM, June 19, 2012
Coordinates (DDM): 37° 00.13300002' N 111° 30.60900000' W

Primary Access: Road
Ingress Egress: 2 or more roads in/out
Access Width: 2 lanes (Greater than 24')
Access Condition: Surfaced-paved, gradeLess than 5%
Bridge Condition: Less than 300 ft with turnaround
Access and Turnarounds: Less than 300 ft with turnaround
Facility Number or Sign: None or not clearly visible
Fuel Type: Grass and shrub, hardwood litter
Fuel Load: Light or no wildland fuels
Defensible Space: Greater than 100ft treated
Topography: Slope 21% to 30%
Roof Material: Noncombustible or not applicable
Siding Material: Rock, concrete, metal
Foundation: Closed, Greater than 30in masonry exposed or N/A
Firewood: None
Water Supply: Pressurized hydrant(s) or fixed sprinkler system
Propane: None
Overhead Hazards: No overhead hazards
Comments:

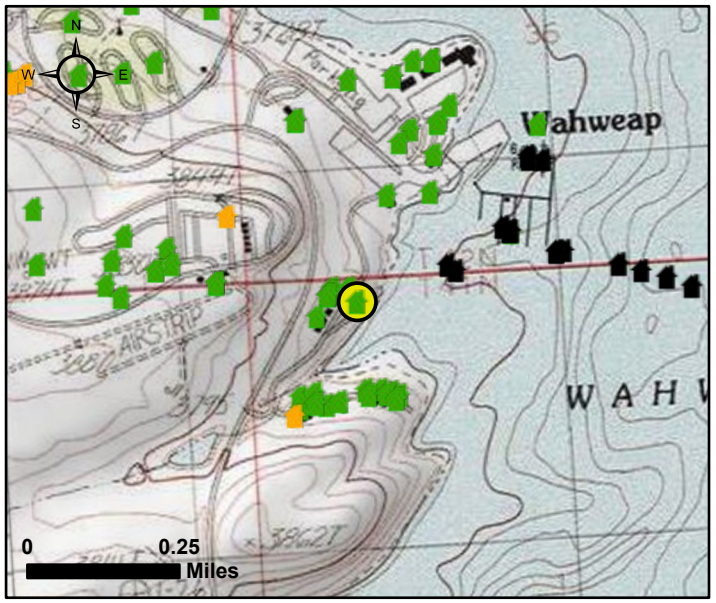
Rating: Low
ProtectionLevel: Undesignated,
Resources of Concern: Unknown
Occupied: Yes
In Community: No,
Revisit Interval: yrs
Map Label: 453

Facility Name: WW Lower Warehouse
Unit - Location: GLCA - Wahweap
FMSS ID: 44408, ***Local ID:***
Structure Type, Use: Building, Administrative
Owner: National Park Service
Field Crew, Visit Date: ZION WFM, June 19, 2012
Coordinates (DDM): 36° 59.38900002' N 111° 29.40000000' W

Primary Access: Road
Ingress Egress: 2 or more roads in/out
Access Width: 2 lanes (Greater than 24')
Access Condition: Surfaced-paved, gradeGreater than 5%
Bridge Condition: Less than 300 ft with turnaround
Access and Turnarounds: Less than 300 ft with turnaround
Facility Number or Sign: None or not clearly visible
Fuel Type: Grass and shrub, hardwood litter
Fuel Load: Light or no wildland fuels
Defensible Space: 30 ft treated
Topography: Slope 5% to 20%
Roof Material: Noncombustible or not applicable
Siding Material: Rock, concrete, metal
Foundation: Closed, 6in to 30in masonry exposed
Firewood: None
Water Supply: Pressurized hydrant(s) or fixed sprinkler system
Propane: None
Overhead Hazards: No overhead hazards
