NPS Wildfire Risk Assessments
Assessment Locations

Glen Canyon National Recreation Area - Overview

Glen Canyon National Recreation Area - Wahweap - Overview

GLCA - Glen Canyon National Recreation Area

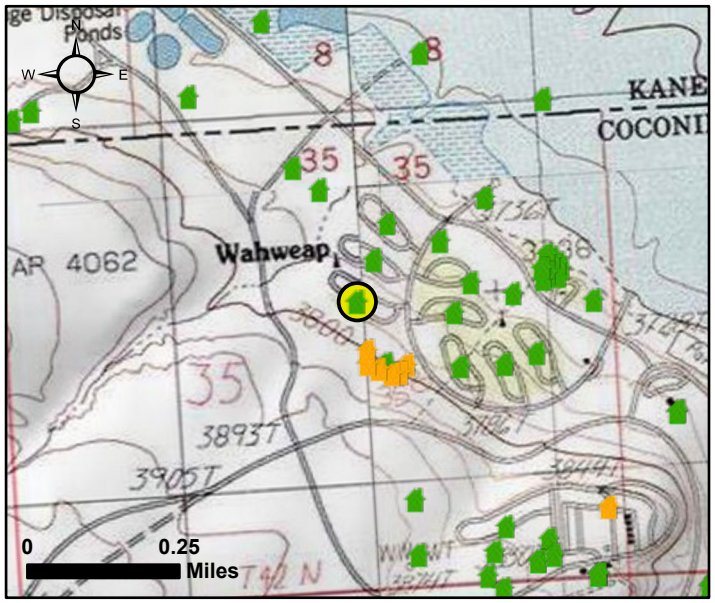
Rating: Low
ProtectionLevel: Undesignated,
Resources of Concern: Unknown
Occupied: Yes
In Community: No,
Revisit Interval: yrs
Map Label: 385

Facility Name: WW Campground Comfort Station Loop C
Unit - Location: GLCA - Wahweap
FMSS ID: GLCA WW CCS Loop C, ***Local ID:***
Structure Type, Use: Building, Unknown
Owner: National Park Service
Field Crew, Visit Date: ZION WFM, June 19, 2012
Coordinates (DDM): 36° 59.83500000' N 111° 30.04900002' W

Primary Access: Road
Ingress Egress: 2 or more roads in/out
Access Width: 2 lanes (Greater than 24')
Access Condition: Surfaced-paved, gradeLess than 5%
Bridge Condition: Less than 300 ft with turnaround
Access and Turnarounds: Less than 300 ft with turnaround
Facility Number or Sign: None or not clearly visible
Fuel Type: Grass and shrub, hardwood litter
Fuel Load: Light or no wildland fuels
Defensible Space: 30 ft treated
Topography: Slope 5% to 20%
Roof Material: Noncombustible or not applicable
Siding Material: Rock, concrete, metal
Foundation: Closed, Greater than 30in masonry exposed or N/A
Firewood: None
Water Supply: Pressurized hydrant(s) or fixed sprinkler system
Propane: None
Overhead Hazards: No overhead hazards

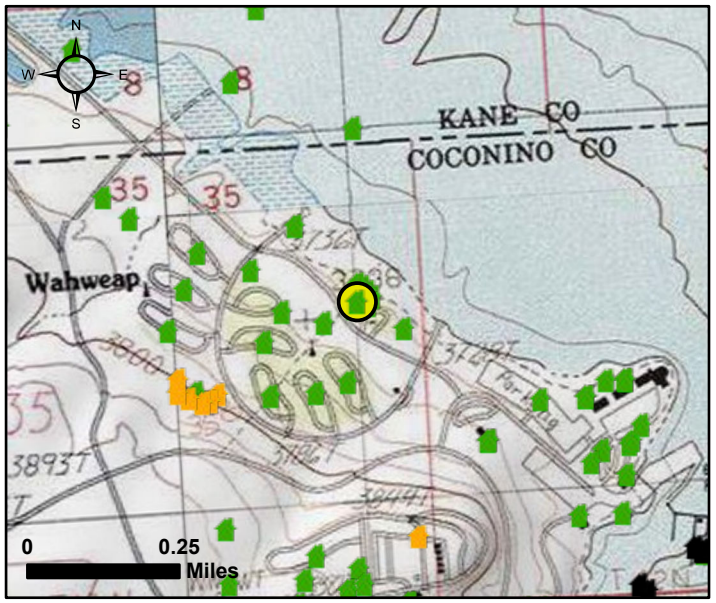
Rating: Low
ProtectionLevel: Undesignated,
Resources of Concern: Unknown
Occupied:
In Community: No,
Revisit Interval: yrs
Map Label: 419

Facility Name: WW Picnic Area Shade Structure #6
Unit - Location: GLCA - Wahweap
FMSS ID: GLCA Picnic Area #6, ***Local ID:***
Structure Type, Use: Other, Unknown
Owner: National Park Service
Field Crew, Visit Date: ZION WFM, June 19, 2012
Coordinates (DDM): 36° 59.86099998' N 111° 29.70900000' W

Primary Access: Road
Ingress Egress: 2 or more roads in/out
Access Width: 2 lanes (Greater than 24')
Access Condition: Surfaced-paved, gradeLess than 5%
Bridge Condition: Less than 300 ft with turnaround
Access and Turnarounds: Less than 300 ft with turnaround
Facility Number or Sign: None or not clearly visible
Fuel Type: Grass and shrub, hardwood litter
Fuel Load: Light or no wildland fuels
Defensible Space: Less than 30 ft treated
Topography: Slope 21% to 30%
Roof Material: Noncombustible or not applicable
Siding Material: Rock, concrete, metal
Foundation: Closed, Greater than 30in masonry exposed or N/A
Firewood: None
Water Supply: Pressurized hydrant(s) or fixed sprinkler system
Propane: None
Overhead Hazards: Overhead hazards will limit aircraft
Comments: Obstacles: Evacuation.

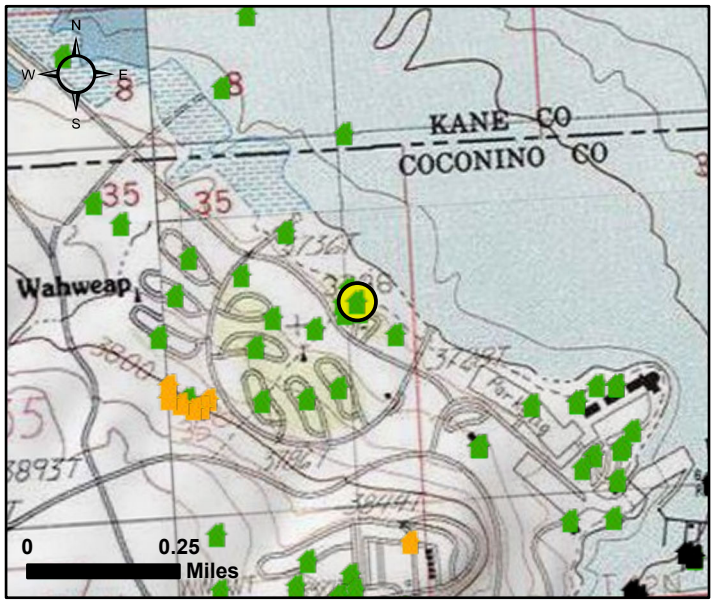
Rating: Low
ProtectionLevel: Undesignated,
Resources of Concern: Unknown
Occupied:
In Community: No,
Revisit Interval: yrs
Map Label: 423

Facility Name: WW Picnic Area Shade Structure #1
Unit - Location: GLCA - Wahweap
FMSS ID: GLCA Picnic Area, ***Local ID:***
Structure Type, Use: Other, Unknown
Owner: National Park Service
Field Crew, Visit Date: ZION WFM, June 19, 2012
Coordinates (DDM): 36° 59.86800000' N 111° 29.69299998' W

Primary Access: Road
Ingress Egress: 2 or more roads in/out
Access Width: 2 lanes (Greater than 24')
Access Condition: Surfaced-paved, gradeLess than 5%
Bridge Condition: Less than 300 ft with turnaround
Access and Turnarounds: Less than 300 ft with turnaround
Facility Number or Sign: None or not clearly visible
Fuel Type: Grass and shrub, hardwood litter
Fuel Load: Light or no wildland fuels
Defensible Space: Less than 30 ft treated
Topography: Slope 21% to 30%
Roof Material: Noncombustible or not applicable
Siding Material: Rock, concrete, metal
Foundation: Closed, Greater than 30in masonry exposed or N/A
Firewood: None
Water Supply: Pressurized hydrant(s) or fixed sprinkler system
Propane: None
Overhead Hazards: Overhead hazards will limit aircraft
Comments: Obstacles: Evacuation.

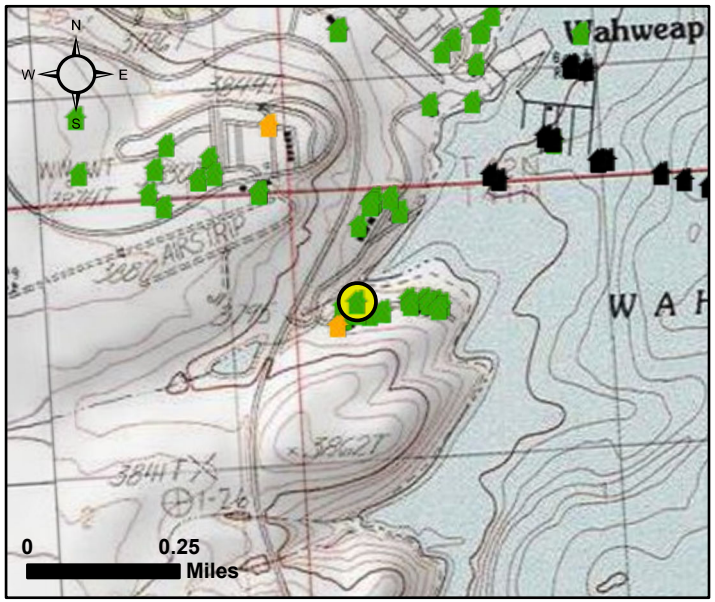
Rating: Low
ProtectionLevel: Undesignated,
Resources of Concern: Unknown
Occupied: Yes
In Community: No,
Revisit Interval: yrs
Map Label: 441

Facility Name: WW Housing #122
Unit - Location: GLCA - Wahweap
FMSS ID: 44567, ***Local ID:***
Structure Type, Use: Building, Administrative
Owner: National Park Service
Field Crew, Visit Date: ZION WFM, June 19, 2012
Coordinates (DDM): 36° 59.26300002' N 111° 29.48500002' W

Primary Access: Road
Ingress Egress: 2 or more roads in/out
Access Width: 2 lanes (Greater than 24')
Access Condition: Surfaced-paved, gradeLess than 5%
Bridge Condition: Less than 300 ft with turnaround
Access and Turnarounds: Less than 300 ft with turnaround
Facility Number or Sign: Marked and clearly visible
Fuel Type: Grass and shrub, hardwood litter
Fuel Load: Moderate
Defensible Space: Less than 30 ft treated
Topography: Slope Less than 5%
Roof Material: Noncombustible or not applicable
Siding Material: Rock, concrete, metal
Foundation: Closed, Greater than 30in masonry exposed or N/A
Firewood: Adjacent to/under deck of facility
Water Supply: Pressurized hydrant(s) or fixed sprinkler system
Propane: None
Overhead Hazards: No overhead hazards
Comments:

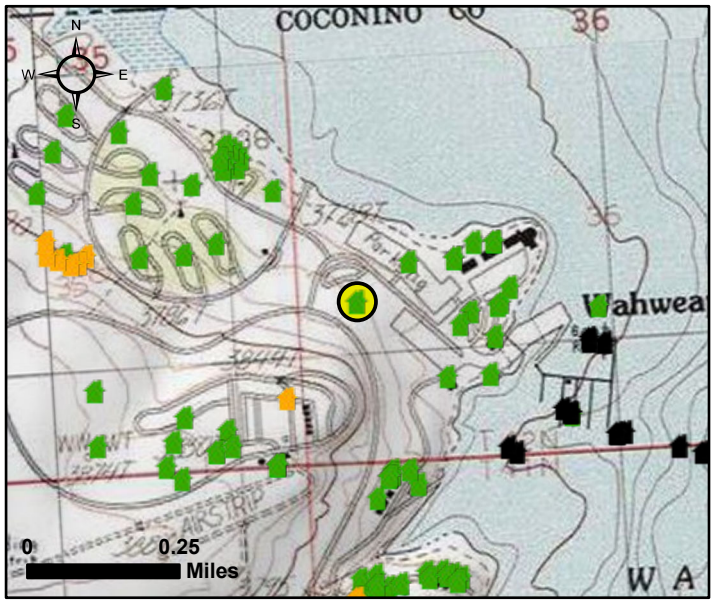
Rating: Low
ProtectionLevel: Undesignated,
Resources of Concern: Unknown
Occupied: Yes
In Community: No,
Revisit Interval: yrs
Map Label: 440

Facility Name: WW Fire Station
Unit - Location: GLCA - Wahweap
FMSS ID: 44424, ***Local ID:***
Structure Type, Use: Building, Administrative
Owner: National Park Service
Field Crew, Visit Date: ZION WFM, June 19, 2012
Coordinates (DDM): 36° 59.65300002' N 111° 29.49000000' W

Primary Access: Road
Ingress Egress: 2 or more roads in/out
Access Width: 2 lanes (Greater than 24')
Access Condition: Surfaced-paved, gradeLess than 5%
Bridge Condition: Less than 300 ft with turnaround
Access and Turnarounds: Less than 300 ft with turnaround
Facility Number or Sign: Marked and clearly visible
Fuel Type: Grass and shrub, hardwood litter
Fuel Load: Light or no wildland fuels
Defensible Space: 100 ft treated
Topography: Slope 5% to 20%
Roof Material: Noncombustible or not applicable
Siding Material: Rock, concrete, metal
Foundation: Closed, Greater than 30in masonry exposed or N/A
Firewood: None
Water Supply: Pressurized hydrant(s) or fixed sprinkler system
Propane: None
Overhead Hazards: No overhead hazards
Comments:

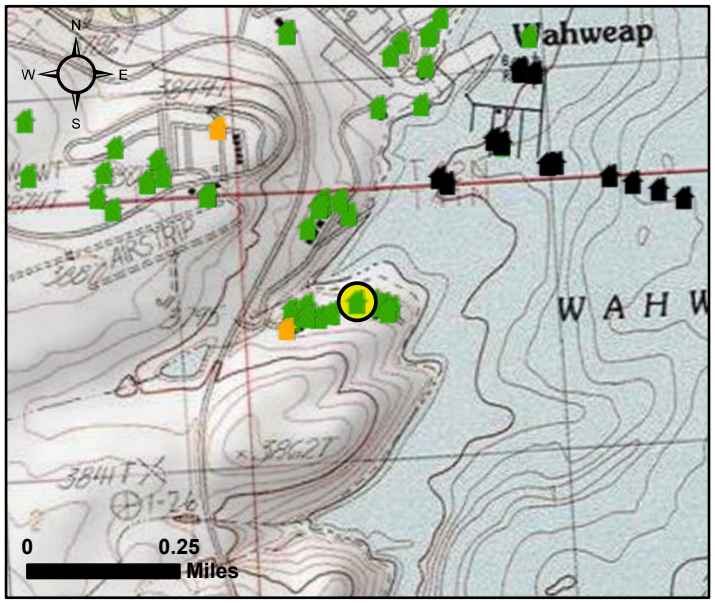
Rating: Low
ProtectionLevel: Undesignated,
Resources of Concern: Unknown
Occupied: Yes
In Community: No,
Revisit Interval: yrs
Map Label: 455

Facility Name: WW Housing 115
Unit - Location: GLCA - Wahweap
FMSS ID: 44527, ***Local ID:***
Structure Type, Use: Building, Administrative
Owner: National Park Service
Field Crew, Visit Date: ZION WFM, June 19, 2012
Coordinates (DDM): 36° 59.26300002' N 111° 29.39400000' W

Primary Access: Road
Ingress Egress: 1 road in/out
Access Width: 1.5 lanes (Greater than 18')
Access Condition: Surfaced-paved, gradeLess than 5%
Bridge Condition: Less than 300 ft with turnaround
Access and Turnarounds: Less than 300 ft with turnaround
Facility Number or Sign: Marked and clearly visible
Fuel Type: Grass and shrub, hardwood litter
Fuel Load: Moderate
Defensible Space: 30 ft treated
Topography: Slope 5% to 20%
Roof Material: Noncombustible or not applicable
Siding Material: Rock, concrete, metal
Foundation: Closed, Greater than 30in masonry exposed or N/A
Firewood: None
Water Supply: Pressurized hydrant(s) or fixed sprinkler system
Propane: None
Overhead Hazards: Overhead hazards will limit aircraft
Comments: Topography: Drainage to the N below the house.

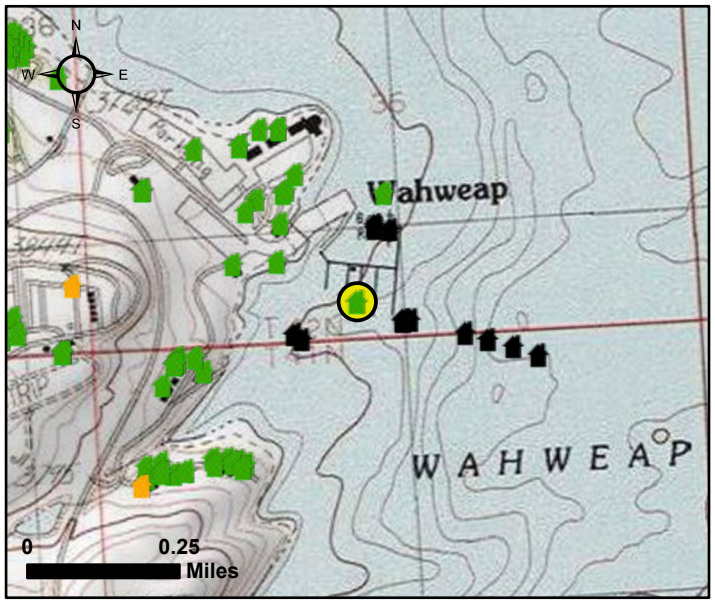
Rating: Low
ProtectionLevel: Undesignated,
Resources of Concern: Unknown
Occupied:
In Community: No,
Revisit Interval: yrs
Map Label: 482

Primary Access: Road
Ingress Egress: 1 road in/out
Access Width: 2 lanes (Greater than 24')
Access Condition: Surfaced-paved, gradeLess than 5%
Bridge Condition: Less than 300 ft with turnaround
Access and Turnarounds: Less than 300 ft with turnaround
Facility Number or Sign: None or not clearly visible
Fuel Type: Grass/tundra,northern hardwood litter
Fuel Load: Light or no wildland fuels
Defensible Space: Greater than 100ft treated
Topography: Slope Less than 5%
Roof Material: Noncombustible or not applicable
Siding Material: Rock, concrete, metal
Foundation: Closed, Greater than 30in masonry exposed or N/A
Firewood: None
Water Supply: Pressurized hydrant(s) or fixed sprinkler system
Propane: None
Overhead Hazards: No overhead hazards

Comments: Water Supply: In the water. Fuel Type: All water. Obstacles: Evacuation. Treatment: None. All water.

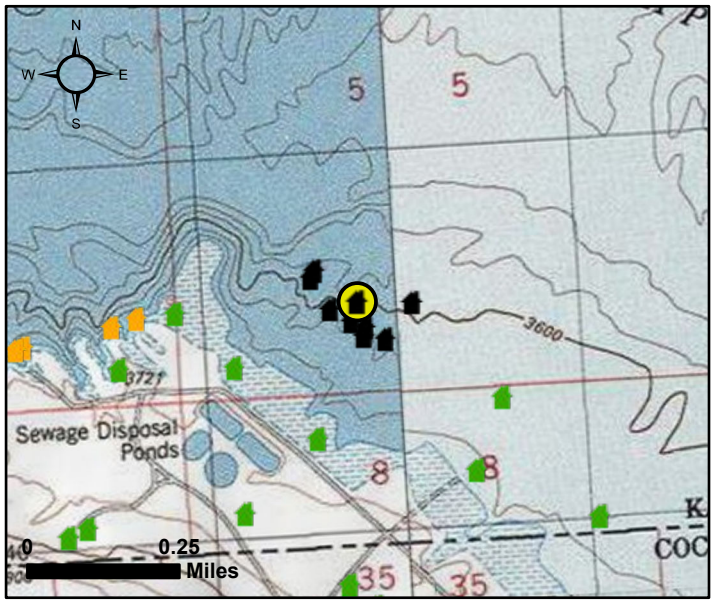
Rating: No Wildland Risk
ProtectionLevel: Undesignated,
Resources of Concern: Unknown
Occupied: No
In Community: No,
Revisit Interval: yrs
Map Label: 380

Comments: N/A. Building is on a dock in the middle of the water.

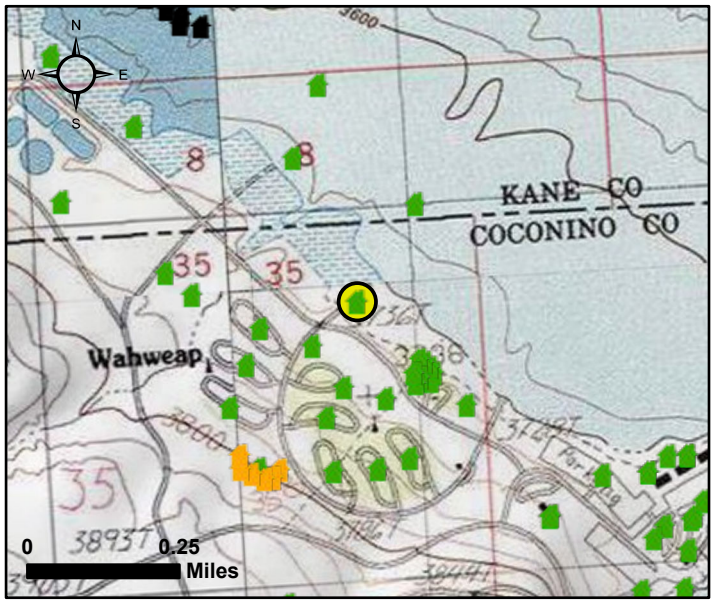
Facility Name: WW Swim Beach Comfort Station
Unit - Location: GLCA - Wahweap
FMSS ID: 44416, ***Local ID:***
Structure Type, Use: Building, Public
Owner: National Park Service
Field Crew, Visit Date: ZION WFM, June 19, 2012
Coordinates (DDM): 36° 59.97400002' N 111° 29.81200002' W

Rating: Low
ProtectionLevel: Undesignated,
Resources of Concern: Unknown
Occupied: Yes
In Community: No,
Revisit Interval: yrs
Map Label: 408

Primary Access: Road
Ingress Egress: 2 or more roads in/out
Access Width: 2 lanes (Greater than 24')
Access Condition: Surfaced-paved, gradeLess than 5%
Bridge Condition: Less than 300 ft with turnaround
Access and Turnarounds: Less than 300 ft with turnaround
Facility Number or Sign: None or not clearly visible
Fuel Type: Grass and shrub, hardwood litter
Fuel Load: Light or no wildland fuels
Defensible Space: 100 ft treated
Topography: Slope 5% to 20%
Roof Material: Noncombustible or not applicable
Siding Material: Rock, concrete, metal
Foundation: Closed, Greater than 30in masonry exposed or N/A
Firewood: None
Water Supply: Pressurized hydrant(s) or fixed sprinkler system
Propane: None
Overhead Hazards: No overhead hazards
Comments:

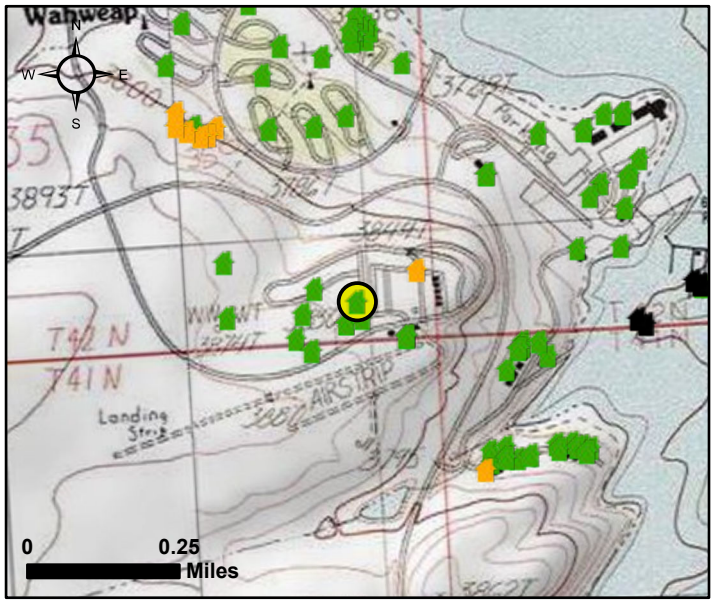
Facility Name: WW Aramark Dorm #2
Unit - Location: GLCA - Wahweap
FMSS ID: GLCA Dorm #2, ***Local ID:***
Structure Type, Use: Building, Unknown
Owner: National Park Service
Field Crew, Visit Date: ZION WFM, June 19, 2012
Coordinates (DDM): 36° 59.48100000' N 111° 29.73300000' W

Rating: Low
ProtectionLevel: Undesignated,
Resources of Concern: Unknown
Occupied: Yes
In Community: No,
Revisit Interval: yrs
Map Label: 415

Primary Access: Road
Ingress Egress: 2 or more roads in/out
Access Width: 2 lanes (Greater than 24')
Access Condition: Surfaced-paved, gradeLess than 5%
Bridge Condition: Less than 300 ft with turnaround
Access and Turnarounds: Less than 300 ft with turnaround
Facility Number or Sign: Marked and clearly visible
Fuel Type: Grass and shrub, hardwood litter
Fuel Load: Light or no wildland fuels
Defensible Space: 100 ft treated
Topography: Slope Less than 5%
Roof Material: Noncombustible or not applicable
Siding Material: Rock, concrete, metal
Foundation: Closed, Greater than 30in masonry exposed or N/A
Firewood: None
Water Supply: Pressurized hydrant(s) or fixed sprinkler system
Propane: None
Overhead Hazards: No overhead hazards

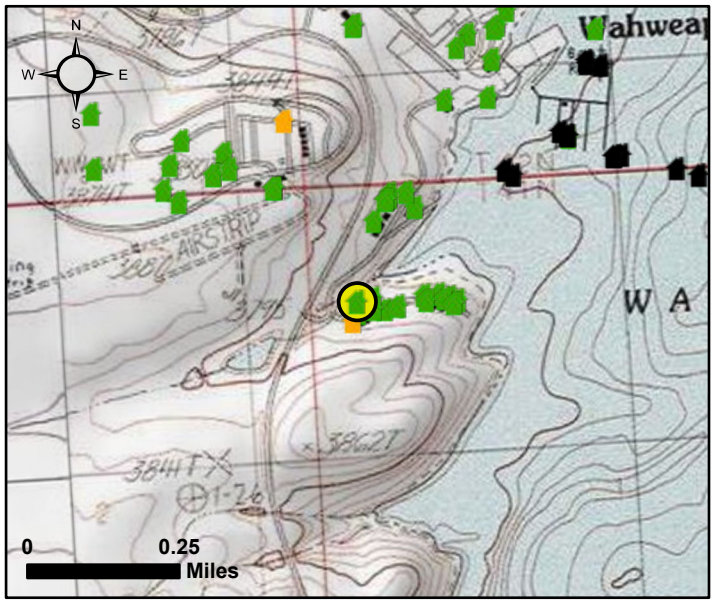
Facility Name: WW Housing #121
Unit - Location: GLCA - Wahweap
FMSS ID: 44566, ***Local ID:***
Structure Type, Use: Building, Administrative
Owner: National Park Service
Field Crew, Visit Date: ZION WFM, June 19, 2012
Coordinates (DDM): 36° 59.25799998' N 111° 29.51200002' W

Rating: Low
ProtectionLevel: Undesignated,
Resources of Concern: Unknown
Occupied: Yes
In Community: No,
Revisit Interval: yrs
Map Label: 437

Primary Access: Road
Ingress Egress: 2 or more roads in/out
Access Width: 2 lanes (Greater than 24')
Access Condition: Surfaced-paved, gradeLess than 5%
Bridge Condition: Less than 300 ft with turnaround
Access and Turnarounds: Less than 300 ft with turnaround
Facility Number or Sign: Marked and clearly visible
Fuel Type: Grass and shrub, hardwood litter
Fuel Load: Moderate
Defensible Space: 30 ft treated
Topography: Slope 5% to 20%
Roof Material: Noncombustible or not applicable
Siding Material: Wood or open sided
Foundation: Closed, Less than 6in masonry exposed
Firewood: None
Water Supply: Pressurized hydrant(s) or fixed sprinkler system
Propane: None
Overhead Hazards: Overhead hazards will limit aircraft
Comments: Water Supply: 1.5 million gallon tank.

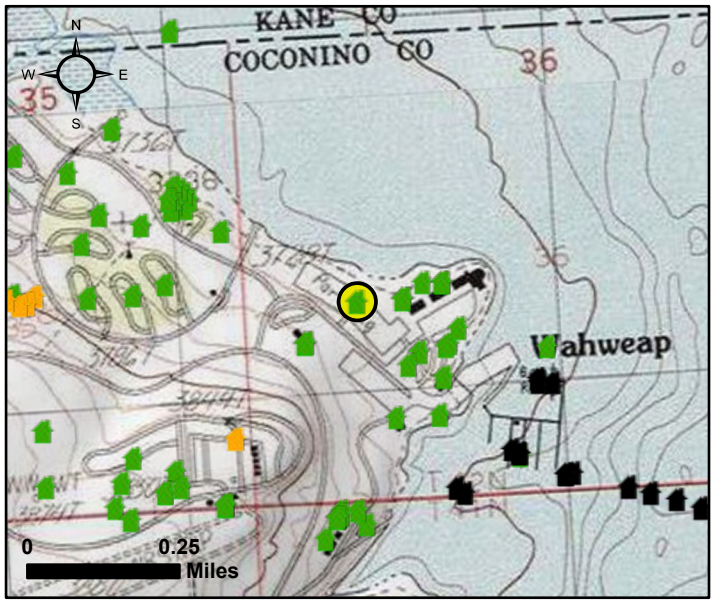
Facility Name: WW Lodge Building #8
Unit - Location: GLCA - Wahweap
FMSS ID: GLCA Lodge Building #8, ***Local ID:***
Structure Type, Use: Building, Unknown
Owner: National Park Service
Field Crew, Visit Date: ZION WFM, June 19, 2012
Coordinates (DDM): 36° 59.70700002' N 111° 29.39400000' W

Rating: Low
ProtectionLevel: Undesignated,
Resources of Concern: Unknown
Occupied: Yes
In Community: No,
Revisit Interval: yrs
Map Label: 454

Primary Access: Road
Ingress Egress: 2 or more roads in/out
Access Width: 2 lanes (Greater than 24')
Access Condition: Surfaced-paved, gradeLess than 5%
Bridge Condition: Less than 300 ft with turnaround
Access and Turnarounds: Less than 300 ft with turnaround
Facility Number or Sign: Marked and clearly visible
Fuel Type: Grass and shrub, hardwood litter
Fuel Load: Light or no wildland fuels
Defensible Space: 30 ft treated
Topography: Slope 5% to 20%
Roof Material: Noncombustible or not applicable
Siding Material: Rock, concrete, metal
Foundation: Closed, Greater than 30in masonry exposed or N/A
Firewood: None
Water Supply: Pressurized hydrant(s) or fixed sprinkler system
Propane: None
Overhead Hazards: No overhead hazards
Comments:

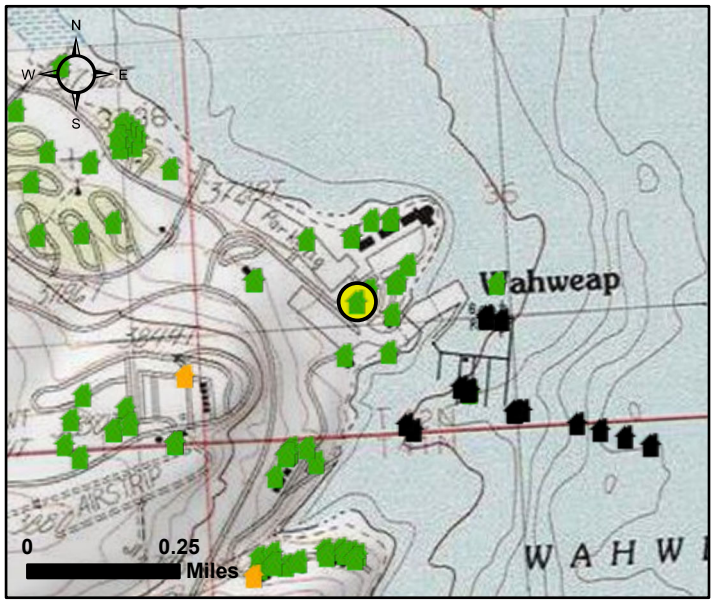
Facility Name: WW Sinclair Gas Station
Unit - Location: GLCA - Wahweap
FMSS ID: GLCA Sinclair Gas Station, ***Local ID:***
Structure Type, Use: Building, Unknown
Owner: National Park Service
Field Crew, Visit Date: ZION WFM, June 19, 2012
Coordinates (DDM): 36° 59.61300000' N 111° 29.31000000' W

Rating: Low
ProtectionLevel: Undesignated,
Resources of Concern: Unknown
Occupied: Yes
In Community: No,
Revisit Interval: yrs
Map Label: 466

Primary Access: Road
Ingress Egress: 2 or more roads in/out
Access Width: 2 lanes (Greater than 24')
Access Condition: Surfaced-paved, gradeLess than 5%
Bridge Condition: Less than 300 ft with turnaround
Access and Turnarounds: Less than 300 ft with turnaround
Facility Number or Sign: Marked and clearly visible
Fuel Type: Grass and shrub, hardwood litter
Fuel Load: Light or no wildland fuels
Defensible Space: 100 ft treated
Topography: Slope Less than 5%
Roof Material: Noncombustible or not applicable
Siding Material: Rock, concrete, metal
Foundation: Closed, Greater than 30in masonry exposed or N/A
Firewood: None
Water Supply: Pressurized hydrant(s) or fixed sprinkler system
Propane: Adjacent to facility and no fuels clearance
Overhead Hazards: No overhead hazards

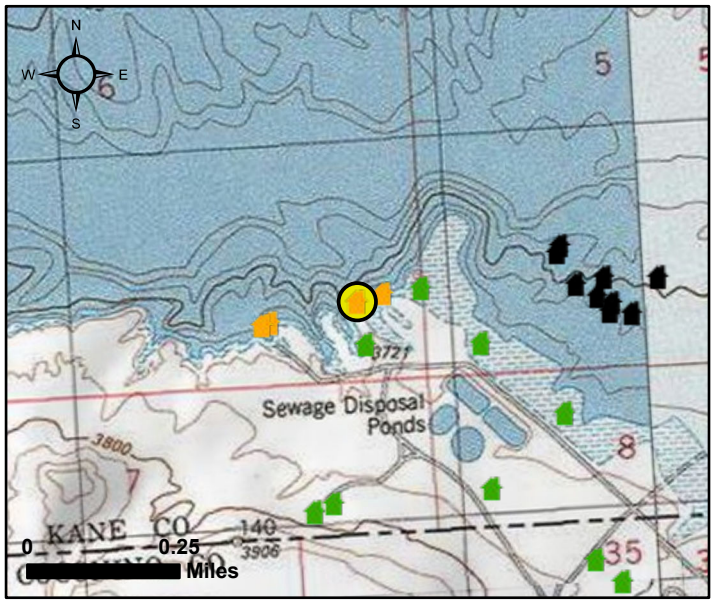
Rating: Moderate
ProtectionLevel: Undesignated,
Resources of Concern: Unknown
Occupied:
In Community: No,
Revisit Interval: yrs
Map Label: 368

Primary Access: Road
Ingress Egress: 2 or more roads in/out
Access Width: 2 lanes (Greater than 24')
Access Condition: Surfaced-paved, gradeLess than 5%
Bridge Condition: Less than 300 ft with turnaround
Access and Turnarounds: Less than 300 ft with turnaround
Facility Number or Sign: None or not clearly visible
Fuel Type: Grass and shrub, hardwood litter
Fuel Load: Light or no wildland fuels
Defensible Space: Greater than 100ft treated
Topography: Slope 31% to 40%
Roof Material: Combustible or no roof
Siding Material: Rock, concrete, metal
Foundation: Closed, Greater than 30in masonry exposed or N/A
Firewood: None
Water Supply: Reliable water source nearby
Propane: None
Overhead Hazards: No overhead hazards

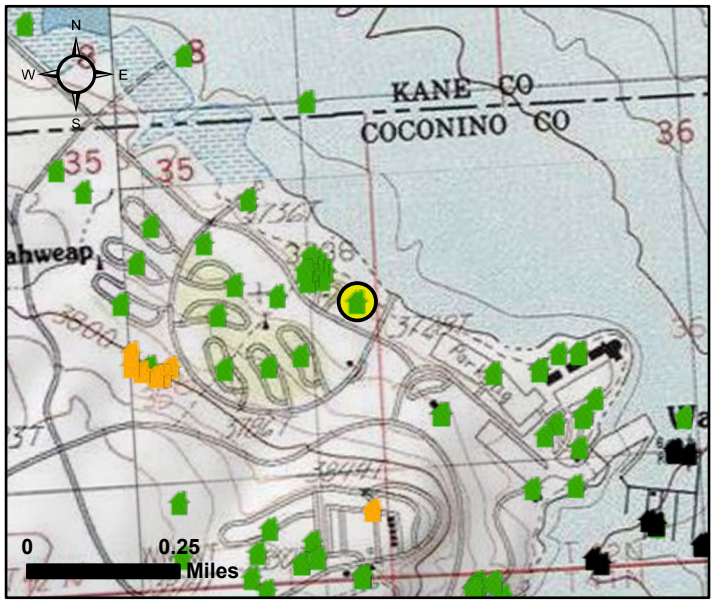
Facility Name: WW Fish Cleaning Station
Unit - Location: GLCA - Wahweap
FMSS ID: 52504, ***Local ID:***
Structure Type, Use: Other, Public
Owner: National Park Service
Field Crew, Visit Date: ZION WFM, June 19, 2012
Coordinates (DDM): 36° 59.81899998' N 111° 29.62900002' W

Rating: Low
ProtectionLevel: Undesignated,
Resources of Concern: Unknown
Occupied: No
In Community: No,
Revisit Interval: yrs
Map Label: 430

Primary Access: Road
Ingress Egress: 2 or more roads in/out
Access Width: 2 lanes (Greater than 24')
Access Condition: Surfaced-paved, gradeLess than 5%
Bridge Condition: Less than 300 ft with turnaround
Access and Turnarounds: Less than 300 ft with turnaround
Facility Number or Sign: Marked and clearly visible
Fuel Type: Grass and shrub, hardwood litter
Fuel Load: Light or no wildland fuels
Defensible Space: 30 ft treated
Topography: Slope 5% to 20%
Roof Material: Noncombustible or not applicable
Siding Material: Rock, concrete, metal
Foundation: Closed, Greater than 30in masonry exposed or N/A
Firewood: None
Water Supply: Pressurized hydrant(s) or fixed sprinkler system
Propane: None
Overhead Hazards: No overhead hazards
Comments:

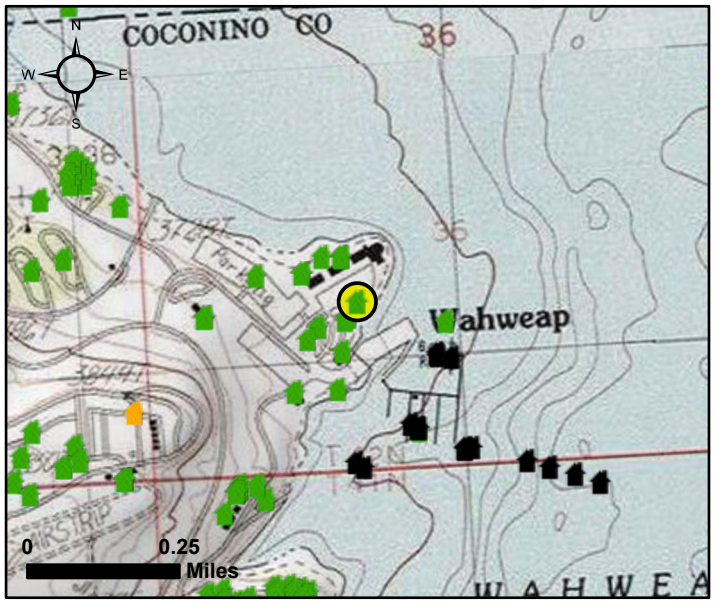
Facility Name: WW Lodge Building #3
Unit - Location: GLCA - Wahweap
FMSS ID: GLCA Lodge Building #3, ***Local ID:***
Structure Type, Use: Building, Unknown
Owner: National Park Service
Field Crew, Visit Date: ZION WFM, June 19, 2012
Coordinates (DDM): 36° 59.66200002' N 111° 29.21700000' W

Rating: Low
ProtectionLevel: Undesignated,
Resources of Concern: Unknown
Occupied: Yes
In Community: No,
Revisit Interval: yrs
Map Label: 477

Primary Access: Road
Ingress Egress: 2 or more roads in/out
Access Width: 2 lanes (Greater than 24')
Access Condition: Surfaced-paved, gradeLess than 5%
Bridge Condition: Less than 300 ft with turnaround
Access and Turnarounds: Less than 300 ft with turnaround
Facility Number or Sign: Marked and clearly visible
Fuel Type: Grass and shrub, hardwood litter
Fuel Load: Light or no wildland fuels
Defensible Space: 30 ft treated
Topography: Slope 21% to 30%
Roof Material: Noncombustible or not applicable
Siding Material: Rock, concrete, metal
Foundation: Closed, Greater than 30in masonry exposed or N/A
Firewood: None
Water Supply: Pressurized hydrant(s) or fixed sprinkler system
Propane: None
Overhead Hazards: No overhead hazards
Comments:

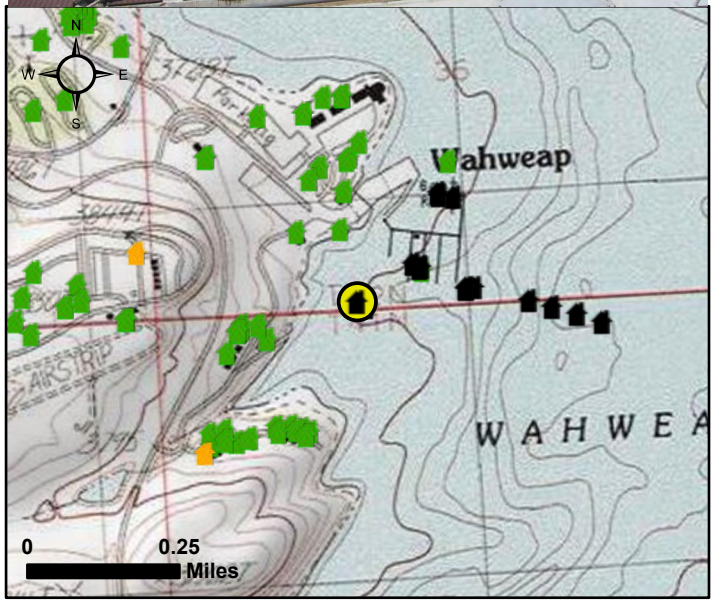
Rating: No Wildland Risk
ProtectionLevel: Undesignated,
Resources of Concern: Unknown
Occupied: No
In Community: No,
Revisit Interval: yrs
Map Label: 475

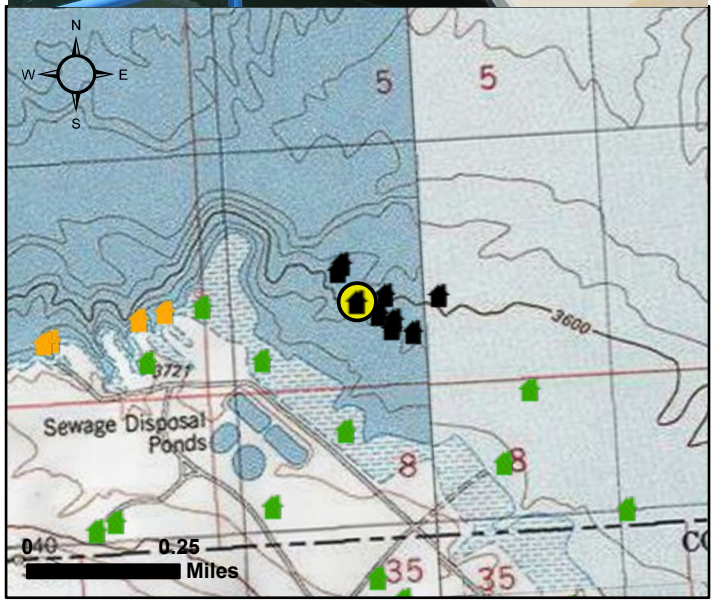
Rating: No Wildland Risk
ProtectionLevel: Undesignated,
Resources of Concern: Unknown
Occupied: Yes
In Community: No,
Revisit Interval: yrs
Map Label: 377

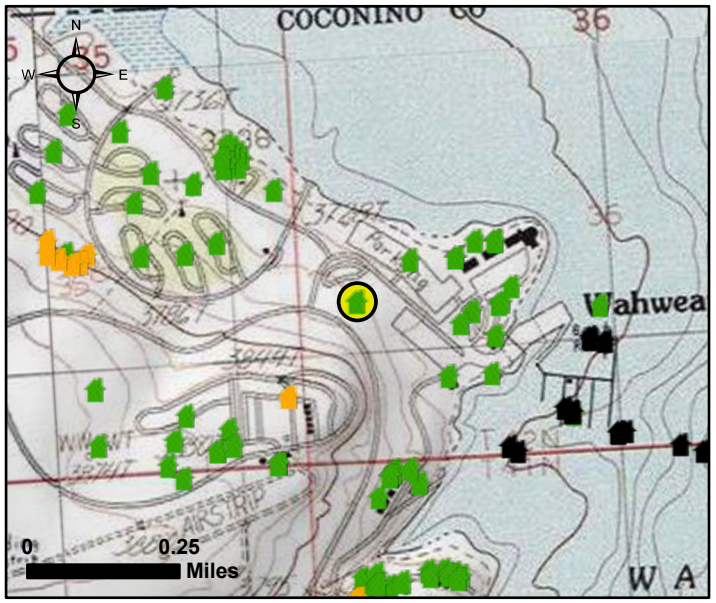
Facility Name: WW District Ranger Office (Historic)
Unit - Location: GLCA - Wahweap
FMSS ID: 44401, ***Local ID:***
Structure Type, Use: Building, Administrative
Owner: National Park Service
Field Crew, Visit Date: ZION WFM, June 19, 2012
Coordinates (DDM): 36° 59.65200000' N 111° 29.49199998' W

Rating: Low
ProtectionLevel: Undesignated,
Resources of Concern: Unknown
Occupied: Yes
In Community: No,
Revisit Interval: yrs
Map Label: 439

Primary Access: Road
Ingress Egress: 2 or more roads in/out
Access Width: 2 lanes (Greater than 24')
Access Condition: Surfaced-paved, gradeLess than 5%
Bridge Condition: Less than 300 ft with turnaround
Access and Turnarounds: Less than 300 ft with turnaround
Facility Number or Sign: Marked and clearly visible
Fuel Type: Grass and shrub, hardwood litter
Fuel Load: Light or no wildland fuels
Defensible Space: 30 ft treated
Topography: Slope 5% to 20%
Roof Material: Noncombustible or not applicable
Siding Material: Rock, concrete, metal
Foundation: Closed, Greater than 30in masonry exposed or N/A
Firewood: None
Water Supply: Pressurized hydrant(s) or fixed sprinkler system
Propane: None
Overhead Hazards: No overhead hazards
Comments:

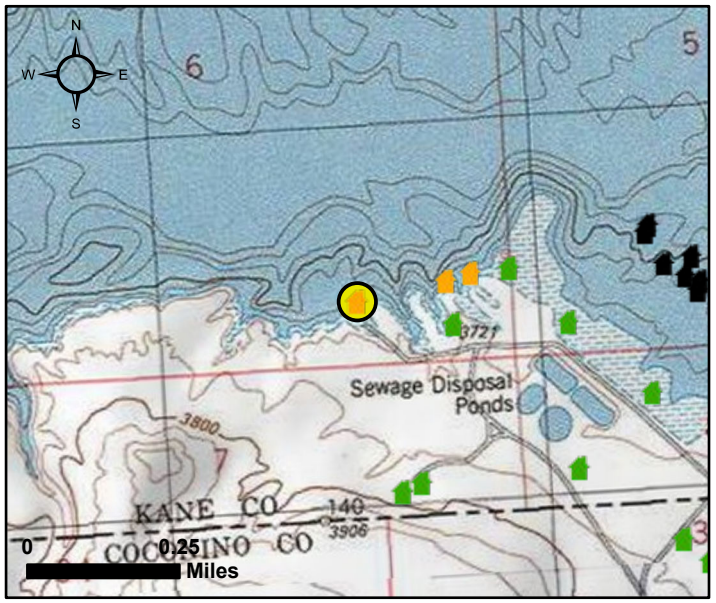
Facility Name: WW Coves Shade Structure #3
Unit - Location: GLCA - Wahweap
FMSS ID: GLCA Cove Shade # 3, ***Local ID:***
Structure Type, Use: Other, Unknown
Owner: National Park Service
Field Crew, Visit Date: ZION WFM, June 19, 2012
Coordinates (DDM): 37° 00.39600000' N 111° 30.70500000' W

Rating: Moderate
ProtectionLevel: Undesignated,
Resources of Concern: Unknown
Occupied:
In Community: No,
Revisit Interval: yrs
Map Label: 365

Primary Access: Road
Ingress Egress: 2 or more roads in/out
Access Width: 2 lanes (Greater than 24')
Access Condition: Surfaced-paved, gradeLess than 5%
Bridge Condition: Less than 300 ft with turnaround
Access and Turnarounds: Less than 300 ft with turnaround
Facility Number or Sign: None or not clearly visible
Fuel Type: Grass and shrub, hardwood litter
Fuel Load: Light or no wildland fuels
Defensible Space: Greater than 100ft treated
Topography: Slope 31% to 40%
Roof Material: Combustible or no roof
Siding Material: Rock, concrete, metal
Foundation: Closed, Greater than 30in masonry exposed or N/A
Firewood: None
Water Supply: Reliable water source nearby
Propane: None
Overhead Hazards: No overhead hazards

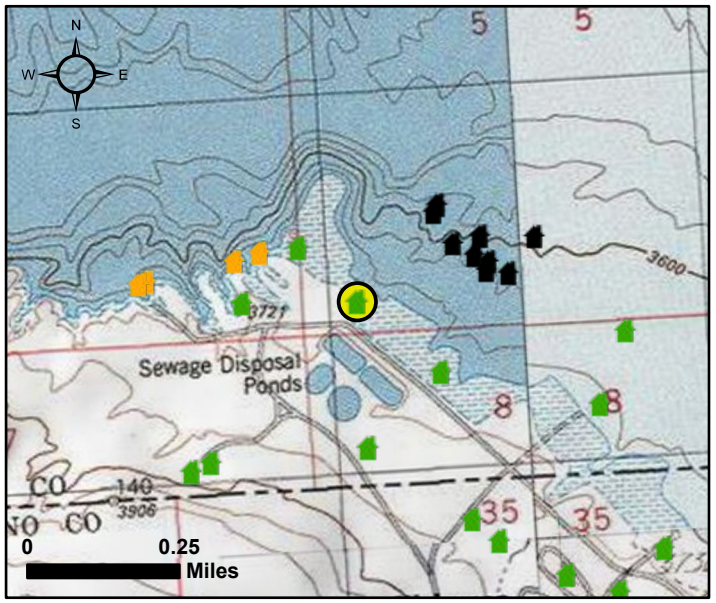
Facility Name: WW Boat Rental Building
Unit - Location: GLCA - Wahweap
FMSS ID: GLCA Boat Rental Bldg, ***Local ID:***
Structure Type, Use: Building, Unknown
Owner: National Park Service
Field Crew, Visit Date: ZION WFM, June 19, 2012
Coordinates (DDM): 37° 00.34999998' N 111° 30.33199998' W

Rating: Low
ProtectionLevel: Undesignated,
Resources of Concern: Unknown
Occupied: Yes
In Community: No,
Revisit Interval: yrs
Map Label: 372

Primary Access: Road
Ingress Egress: 2 or more roads in/out
Access Width: 2 lanes (Greater than 24')
Access Condition: Surfaced-paved, gradeLess than 5%
Bridge Condition: Less than 300 ft with turnaround
Access and Turnarounds: Less than 300 ft with turnaround
Facility Number or Sign: None or not clearly visible
Fuel Type: Grass and shrub, hardwood litter
Fuel Load: Light or no wildland fuels
Defensible Space: 30 ft treated
Topography: Slope 5% to 20%
Roof Material: Noncombustible or not applicable
Siding Material: Rock, concrete, metal
Foundation: Closed, Greater than 30in masonry exposed or N/A
Firewood: None
Water Supply: Pressurized hydrant(s) or fixed sprinkler system
Propane: None
Overhead Hazards: No overhead hazards

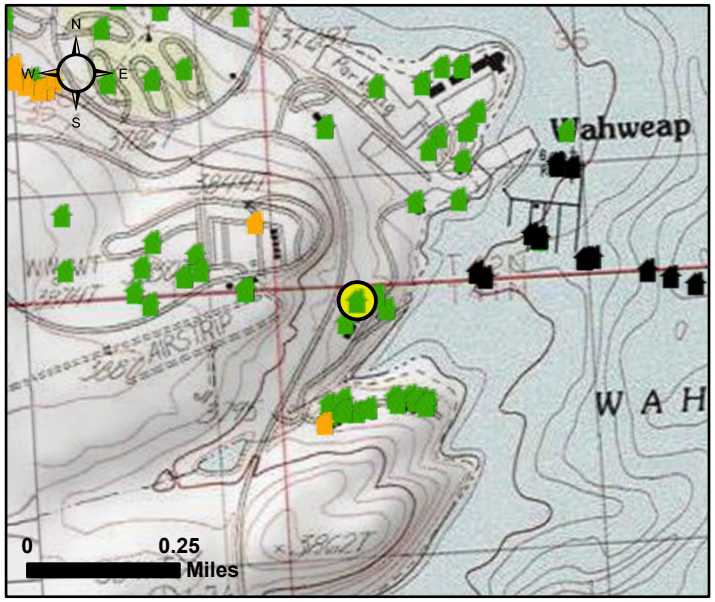
Facility Name: WW Paint Storage Building
Unit - Location: GLCA - Wahweap
FMSS ID: 44430, ***Local ID:***
Structure Type, Use: Building, Administrative
Owner: National Park Service
Field Crew, Visit Date: ZION WFM, June 19, 2012
Coordinates (DDM): 36° 59.40199998' N 111° 29.45100000' W

Rating: Low
ProtectionLevel: Undesignated,
Resources of Concern: Unknown
Occupied: No
In Community: No,
Revisit Interval: yrs
Map Label: 448

Primary Access: Road
Ingress Egress: 2 or more roads in/out
Access Width: 2 lanes (Greater than 24')
Access Condition: Surfaced-paved, gradeLess than 5%
Bridge Condition: Less than 300 ft with turnaround
Access and Turnarounds: Less than 300 ft with turnaround
Facility Number or Sign:
Fuel Type:
Fuel Load:
Defensible Space: Less than 30 ft treated
Topography: Slope 21% to 30%
Roof Material:
Siding Material:
Foundation: Closed, Less than 6in masonry exposed
Firewood: None
Water Supply:
Propane:
Overhead Hazards:
Comments:

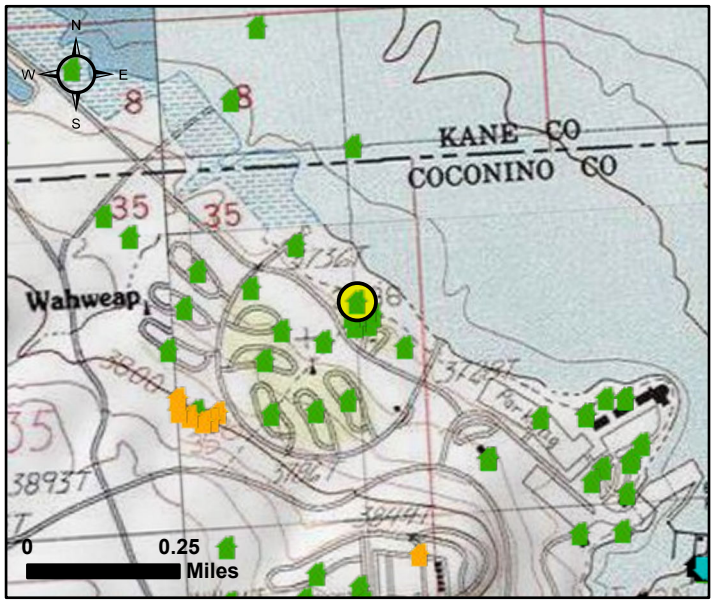
Facility Name: WW Picnic Area Shade Structure #5
Unit - Location: GLCA - Wahweap
FMSS ID: GLCA Picnic Area #5, ***Local ID:***
Structure Type, Use: Other, Unknown
Owner: National Park Service
Field Crew, Visit Date: ZION WFM, June 19, 2012
Coordinates (DDM): 36° 59.88700002' N 111° 29.70799998' W

Rating: Low
ProtectionLevel: Undesignated,
Resources of Concern: Unknown
Occupied:
In Community: No,
Revisit Interval: yrs
Map Label: 420

Primary Access: Road
Ingress Egress: 2 or more roads in/out
Access Width: 2 lanes (Greater than 24')
Access Condition: Surfaced-paved, gradeLess than 5%
Bridge Condition: Less than 300 ft with turnaround
Access and Turnarounds: Less than 300 ft with turnaround
Facility Number or Sign: None or not clearly visible
Fuel Type: Grass and shrub, hardwood litter
Fuel Load: Light or no wildland fuels
Defensible Space: Less than 30 ft treated
Topography: Slope 21% to 30%
Roof Material: Noncombustible or not applicable
Siding Material: Rock, concrete, metal
Foundation: Closed, Greater than 30in masonry exposed or N/A
Firewood: None
Water Supply: Pressurized hydrant(s) or fixed sprinkler system
Propane: None
Overhead Hazards: Overhead hazards will limit aircraft
Comments: Obstacles: Evacuation.

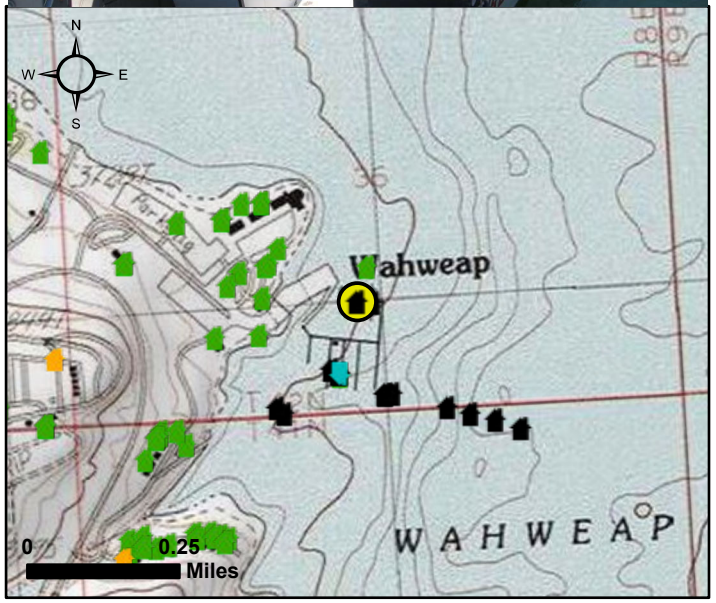
Rating: No Wildland Risk
ProtectionLevel: Undesignated,
Resources of Concern: Unknown
Occupied: No
In Community: No,
Revisit Interval: yrs
Map Label: 484

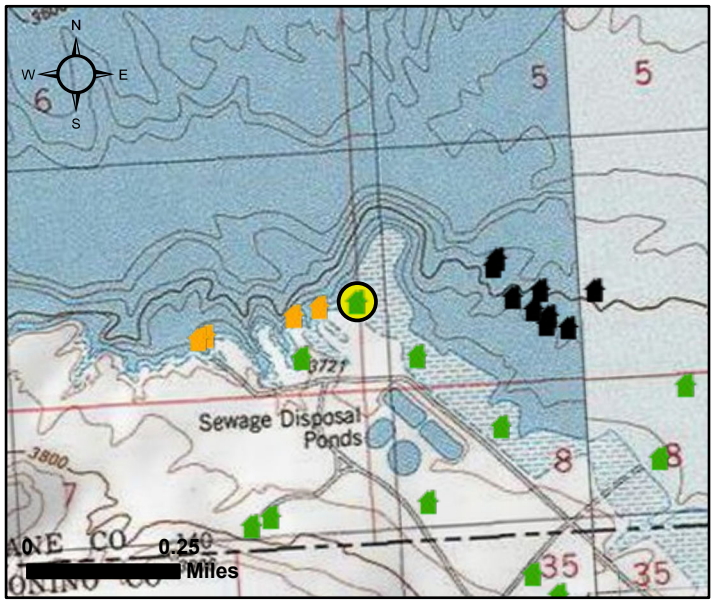
Facility Name: WW Well House #4
Unit - Location: GLCA - Wahweap
FMSS ID: 52481, ***Local ID:***
Structure Type, Use: Utility Site (Water, Gas,Elec), Administrative
Owner: National Park Service
Field Crew, Visit Date: ZION WFM, June 19, 2012
Coordinates (DDM): 37° 00.43200000' N 111° 30.43300002' W

Rating: Low
ProtectionLevel: Undesignated,
Resources of Concern: Unknown
Occupied: No
In Community: No,
Revisit Interval: yrs
Map Label: 371

Primary Access: Road
Ingress Egress: 2 or more roads in/out
Access Width: 2 lanes (Greater than 24')
Access Condition: Surfaced-paved, gradeLess than 5%
Bridge Condition: Less than 300 ft with turnaround
Access and Turnarounds: Less than 300 ft with turnaround
Facility Number or Sign: None or not clearly visible
Fuel Type: Grass and shrub, hardwood litter
Fuel Load: Light or no wildland fuels
Defensible Space: 30 ft treated
Topography: Slope 5% to 20%
Roof Material: Noncombustible or not applicable
Siding Material: Rock, concrete, metal
Foundation: Closed, Greater than 30in masonry exposed or N/A
Firewood: None
Water Supply: Pressurized hydrant(s) or fixed sprinkler system
Propane: None
Overhead Hazards: No overhead hazards

Comments: Water Supply: 1.5 million gallon tank for all of Wahweep. Obstacles: Hazmat.

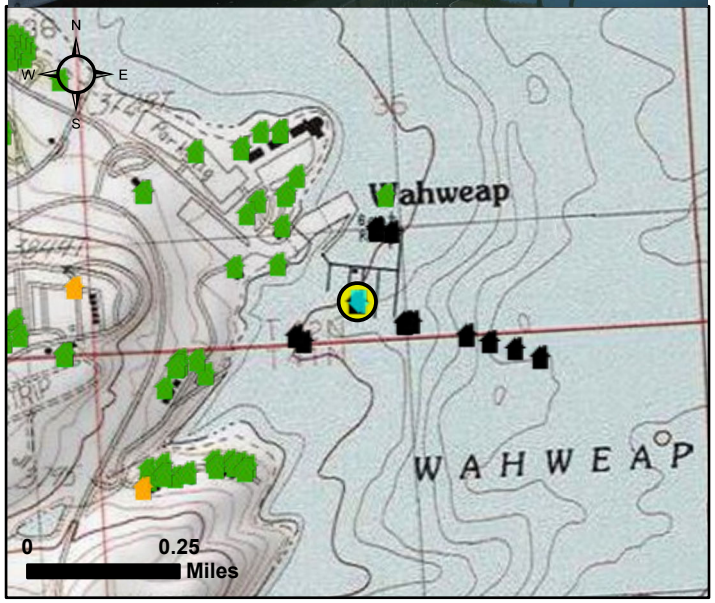
Facility Name: WW Marina Fishing Dock Shade Structure #2
Unit - Location: GLCA - Wahweap
FMSS ID: GLCA WW Marina Fishing Dock #2, ***Local ID:***
Structure Type, Use: No Wildland Risk, Unknown
Owner: National Park Service
Field Crew, Visit Date: ZION WFM, June 19, 2012
Coordinates (DDM): 36° 59.47800000' N 111° 29.12299998' W

Rating: No Wildland Risk
ProtectionLevel: Undesignated,
Resources of Concern: Unknown
Occupied:
In Community: No,
Revisit Interval: yrs
Map Label: 480

Comments: N/A. Not at wildfire risk. Structure is in the water on a dock.

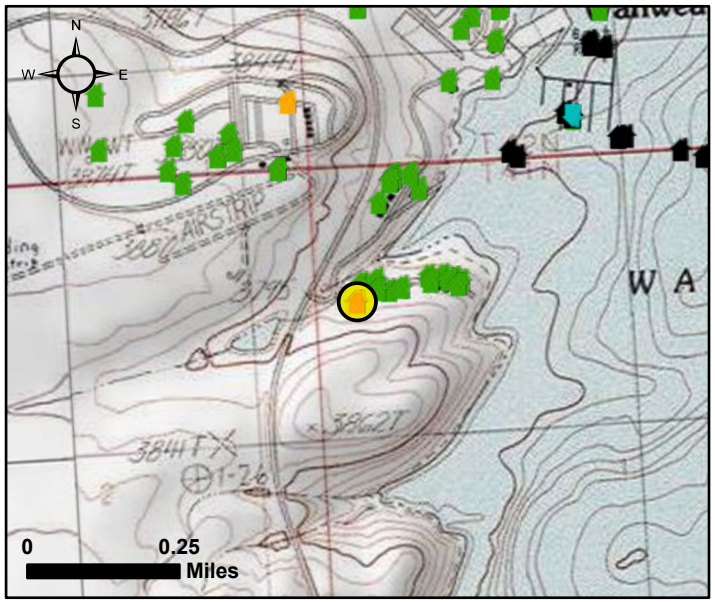
Facility Name: WW Housing RV Pergola
Unit - Location: GLCA - Wahweap
FMSS ID: GLCA RV Pergola, ***Local ID:***
Structure Type, Use: Other, Unknown
Owner: National Park Service
Field Crew, Visit Date: ZION WFM, June 19, 2012
Coordinates (DDM): 36° 59.23099998' N 111° 29.52199998' W

Rating: Moderate
ProtectionLevel: Undesignated,
Resources of Concern: Unknown
Occupied:
In Community: No,
Revisit Interval: yrs
Map Label: 436

Primary Access: Road
Ingress Egress: 2 or more roads in/out
Access Width: 2 lanes (Greater than 24')
Access Condition: Surfaced-paved, gradeLess than 5%
Bridge Condition: Less than 300 ft with turnaround
Access and Turnarounds: Less than 300 ft with turnaround
Facility Number or Sign: None or not clearly visible
Fuel Type: Grass and shrub, hardwood litter
Fuel Load: Light or no wildland fuels
Defensible Space: 30 ft treated
Topography: Slope 21% to 30%
Roof Material: Combustible or no roof
Siding Material: Rock, concrete, metal
Foundation: Closed, Less than 6in masonry exposed
Firewood: None
Water Supply: Pressurized hydrant(s) or fixed sprinkler system
Propane: None
Overhead Hazards: Overhead hazards will limit aircraft

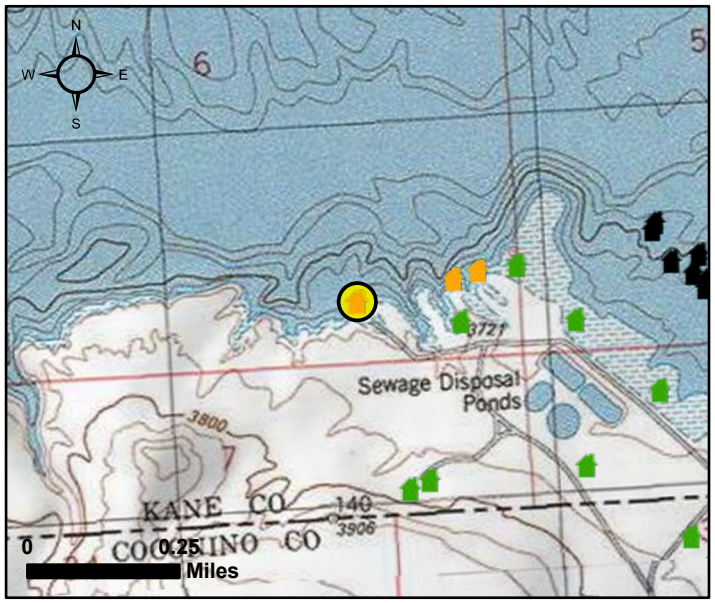
Facility Name: WW Coves Shade Structure #4
Unit - Location: GLCA - Wahweap
FMSS ID: GLCA Coves Structure, ***Local ID:***
Structure Type, Use: Other, Unknown
Owner: National Park Service
Field Crew, Visit Date: ZION WFM, June 19, 2012
Coordinates (DDM): 37° 00.39300000' N 111° 30.71899998' W

Rating: Moderate
ProtectionLevel: Undesignated,
Resources of Concern: Unknown
Occupied:
In Community: No,
Revisit Interval: yrs
Map Label: 364

Primary Access: Road
Ingress Egress: 2 or more roads in/out
Access Width: 2 lanes (Greater than 24')
Access Condition: Surfaced-paved, gradeLess than 5%
Bridge Condition: Less than 300 ft with turnaround
Access and Turnarounds: Less than 300 ft with turnaround
Facility Number or Sign: None or not clearly visible
Fuel Type: Grass and shrub, hardwood litter
Fuel Load: Light or no wildland fuels
Defensible Space: Greater than 100ft treated
Topography: Slope 31% to 40%
Roof Material: Combustible or no roof
Siding Material: Rock, concrete, metal
Foundation: Closed, Greater than 30in masonry exposed or N/A
Firewood: None
Water Supply: Reliable water source nearby
Propane: None
Overhead Hazards: No overhead hazards

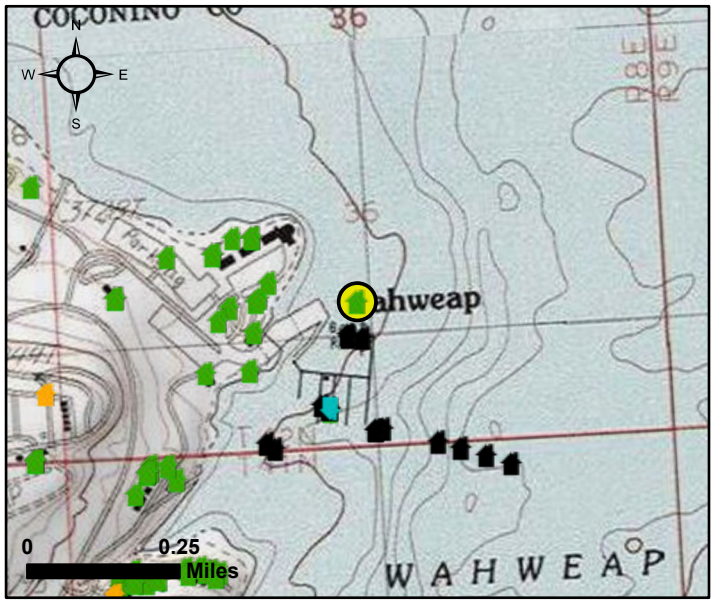
Facility Name: WW Main Ramp Boat Pumpout Building
Unit - Location: GLCA - Wahweap
FMSS ID: 52494, ***Local ID:***
Structure Type, Use: Utility Site (Water, Gas,Elec), Public
Owner: National Park Service
Field Crew, Visit Date: ZION WFM, June 19, 2012
Coordinates (DDM): 36° 59.62800000' N 111° 29.06100000' W

Rating: Low
ProtectionLevel: Undesignated,
Resources of Concern: Unknown
Occupied: No
In Community: No,
Revisit Interval: yrs
Map Label: 485

Primary Access: Road
Ingress Egress: 1 road in/out
Access Width: 2 lanes (Greater than 24')
Access Condition: Surfaced-paved, gradeLess than 5%
Bridge Condition: Less than 300 ft with turnaround
Access and Turnarounds: Less than 300 ft with turnaround
Facility Number or Sign: Marked and clearly visible
Fuel Type: Grass/tundra,northern hardwood litter
Fuel Load: Light or no wildland fuels
Defensible Space: Greater than 100ft treated
Topography: Slope Less than 5%
Roof Material: Noncombustible or not applicable
Siding Material: Rock, concrete, metal
Foundation: Closed, Greater than 30in masonry exposed or N/A
Firewood: None
Water Supply: Pressurized hydrant(s) or fixed sprinkler system
Propane: None
Overhead Hazards: No overhead hazards

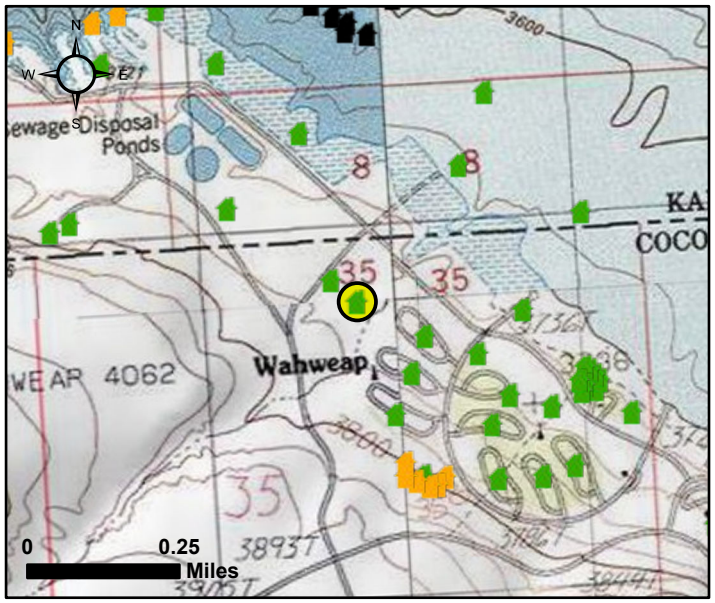
Facility Name: WW Campground Comfort Station Loop D #1
Unit - Location: GLCA - Wahweap
FMSS ID: GLCA WW Campground, ***Local ID:***
Structure Type, Use: Building, Unknown
Owner: National Park Service
Field Crew, Visit Date: ZION WFM, June 19, 2012
Coordinates (DDM): 37° 00.00000000' N 111° 30.10500000' W

Rating: Low
ProtectionLevel: Undesignated,
Resources of Concern: Unknown
Occupied: Yes
In Community: No,
Revisit Interval: yrs
Map Label: 381

Primary Access: Road
Ingress Egress: 2 or more roads in/out
Access Width: 2 lanes (Greater than 24')
Access Condition: Surfaced-paved, gradeLess than 5%
Bridge Condition: Less than 300 ft with turnaround
Access and Turnarounds: Less than 300 ft with turnaround
Facility Number or Sign: None or not clearly visible
Fuel Type: Grass and shrub, hardwood litter
Fuel Load: Light or no wildland fuels
Defensible Space: 30 ft treated
Topography: Slope 5% to 20%
Roof Material: Noncombustible or not applicable
Siding Material: Rock, concrete, metal
Foundation: Closed, Greater than 30in masonry exposed or N/A
Firewood: None
Water Supply: Pressurized hydrant(s) or fixed sprinkler system
Propane: None
Overhead Hazards: No overhead hazards
Comments: Obstacles: Evacuation.

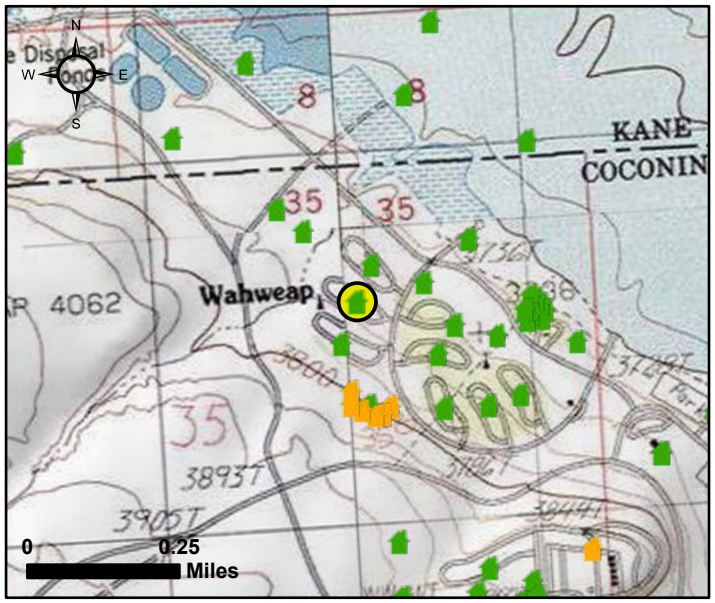
Facility Name: WW Campground Comfort Station Loop B
Unit - Location: GLCA - Wahweap
FMSS ID: GLCA WW Campground loop B, ***Local ID:***
Structure Type, Use: Building, Unknown
Owner: National Park Service
Field Crew, Visit Date: ZION WFM, June 19, 2012
Coordinates (DDM): 36° 59.89300002' N 111° 30.01600002' W

Rating: Low
ProtectionLevel: Undesignated,
Resources of Concern: Unknown
Occupied: Yes
In Community: No,
Revisit Interval: yrs
Map Label: 389

Primary Access: Road
Ingress Egress: 2 or more roads in/out
Access Width: 2 lanes (Greater than 24')
Access Condition: Surfaced-paved, gradeLess than 5%
Bridge Condition: Less than 300 ft with turnaround
Access and Turnarounds: Less than 300 ft with turnaround
Facility Number or Sign: None or not clearly visible
Fuel Type: Grass and shrub, hardwood litter
Fuel Load: Light or no wildland fuels
Defensible Space: Less than 30 ft treated
Topography: Slope 5% to 20%
Roof Material: Noncombustible or not applicable
Siding Material: Rock, concrete, metal
Foundation: Closed, Greater than 30in masonry exposed or N/A
Firewood: None
Water Supply: Pressurized hydrant(s) or fixed sprinkler system
Propane: None
Overhead Hazards: No overhead hazards
Comments: Obstacles: Evacuation.
