NPS Wildfire Risk Assessments
Assessment Locations

Glen Canyon National Recreation Area - Overview

Glen Canyon National Recreation Area - Wahweap - Overview

GLCA - Glen Canyon National Recreation Area

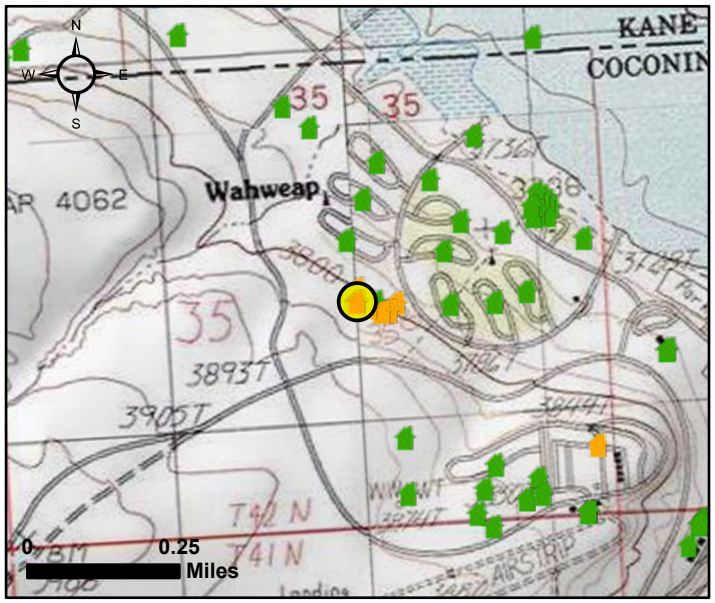
Facility Name: WW Campground Group Site Shade Structure #5
Unit - Location: GLCA - Wahweap
FMSS ID: GLCA Campground Groupsite #5, ***Local ID:***
Structure Type, Use: Other, Unknown
Owner: National Park Service
Field Crew, Visit Date: ZION WFM, June 19, 2012
Coordinates (DDM): 36° 59.74600002' N 111° 30.03700002' W

Rating: Moderate
ProtectionLevel: Undesignated,
Resources of Concern: Unknown
Occupied:
In Community: No,
Revisit Interval: yrs
Map Label: 386

Primary Access: Road
Ingress Egress: 2 or more roads in/out
Access Width: 2 lanes (Greater than 24')
Access Condition: Surfaced-paved, gradeLess than 5%
Bridge Condition: Less than 300 ft with turnaround
Access and Turnarounds: Less than 300 ft with turnaround
Facility Number or Sign: None or not clearly visible
Fuel Type: Grass and shrub, hardwood litter
Fuel Load: Light or no wildland fuels
Defensible Space: 30 ft treated
Topography: Slope 31% to 40%
Roof Material: Combustible or no roof
Siding Material: Rock, concrete, metal
Foundation: Closed, Greater than 30in masonry exposed or N/A
Firewood: None
Water Supply: Pressurized hydrant(s) or fixed sprinkler system
Propane: None
Overhead Hazards: No overhead hazards

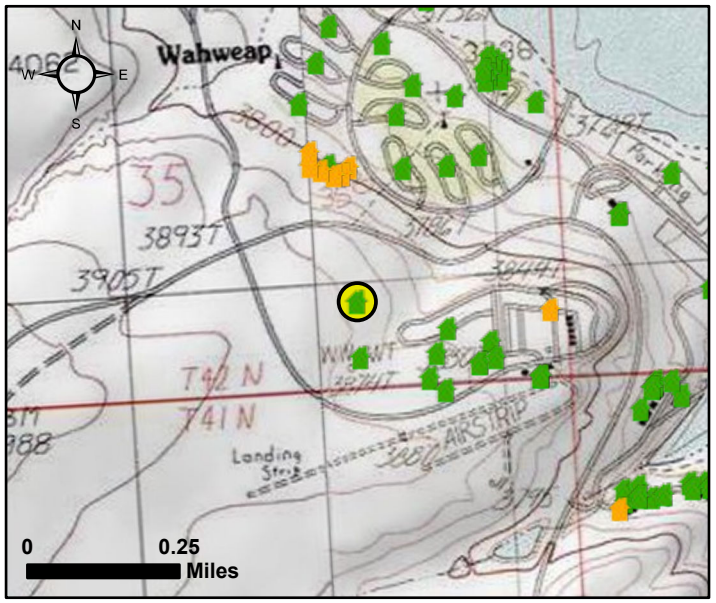
Facility Name: WW Well House #3
Unit - Location: GLCA - Wahweap
FMSS ID: 52485, ***Local ID:***
Structure Type, Use: Utility Site (Water, Gas,Elec), Public
Owner: National Park Service
Field Crew, Visit Date: ZION WFM, June 19, 2012
Coordinates (DDM): 36° 59.54800002' N 111° 29.96599998' W

Rating: Low
ProtectionLevel: Undesignated,
Resources of Concern: Unknown
Occupied: No
In Community: No,
Revisit Interval: yrs
Map Label: 396

Primary Access: Road
Ingress Egress: 2 or more roads in/out
Access Width: 2 lanes (Greater than 24')
Access Condition: Surfaced-paved, gradeLess than 5%
Bridge Condition: Less than 300 ft with turnaround
Access and Turnarounds: Less than 300 ft with turnaround
Facility Number or Sign: None or not clearly visible
Fuel Type: Grass and shrub, hardwood litter
Fuel Load: Light or no wildland fuels
Defensible Space: 30 ft treated
Topography: Slope 5% to 20%
Roof Material: Noncombustible or not applicable
Siding Material: Rock, concrete, metal
Foundation: Closed, Greater than 30in masonry exposed or N/A
Firewood: None
Water Supply: Pressurized hydrant(s) or fixed sprinkler system
Propane: None
Overhead Hazards: No overhead hazards
Comments:

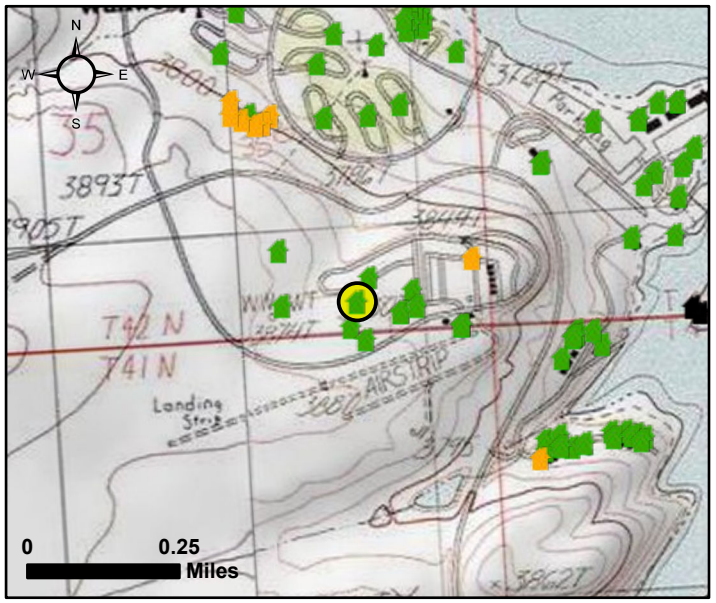
Facility Name: WW Aramark Human Resources/Rec Center
Unit - Location: GLCA - Wahweap
FMSS ID: GLCA Aramark HR/RC, ***Local ID:***
Structure Type, Use: Building, Unknown
Owner: National Park Service
Field Crew, Visit Date: ZION WFM, June 19, 2012
Coordinates (DDM): 36° 59.46900000' N 111° 29.83099998' W

Rating: Low
ProtectionLevel: Undesignated,
Resources of Concern: Unknown
Occupied: Yes
In Community: No,
Revisit Interval: yrs
Map Label: 406

Primary Access: Road
Ingress Egress: 2 or more roads in/out
Access Width: 2 lanes (Greater than 24')
Access Condition: Surfaced-paved, gradeLess than 5%
Bridge Condition: Less than 300 ft with turnaround
Access and Turnarounds: Less than 300 ft with turnaround
Facility Number or Sign: Marked and clearly visible
Fuel Type: Grass and shrub, hardwood litter
Fuel Load: Light or no wildland fuels
Defensible Space: 100 ft treated
Topography: Slope Less than 5%
Roof Material: Noncombustible or not applicable
Siding Material: Rock, concrete, metal
Foundation: Closed, Greater than 30in masonry exposed or N/A
Firewood: None
Water Supply: Pressurized hydrant(s) or fixed sprinkler system
Propane: None
Overhead Hazards: No overhead hazards
Comments:

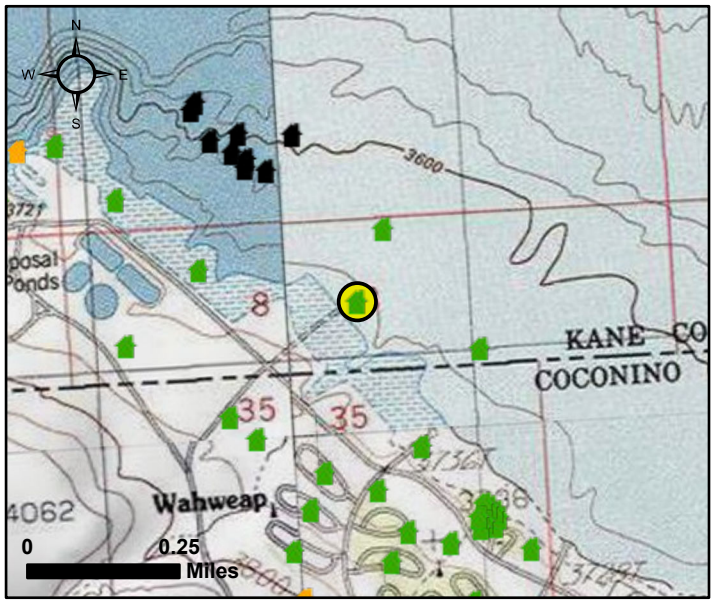
Facility Name: WW Stateline Comfort Station
Unit - Location: GLCA - Wahweap
FMSS ID: 44412, ***Local ID:***
Structure Type, Use: Building, Public
Owner: National Park Service
Field Crew, Visit Date: ZION WFM, June 19, 2012
Coordinates (DDM): 37° 00.18499998' N 111° 29.91199998' W

Rating: Low
ProtectionLevel: Undesignated,
Resources of Concern: Unknown
Occupied: Yes
In Community: No,
Revisit Interval: yrs
Map Label: 399

Primary Access: Road
Ingress Egress: 2 or more roads in/out
Access Width: 2 lanes (Greater than 24')
Access Condition: Surfaced-paved, gradeLess than 5%
Bridge Condition: Less than 300 ft with turnaround
Access and Turnarounds: Less than 300 ft with turnaround
Facility Number or Sign: Marked and clearly visible
Fuel Type: Grass and shrub, hardwood litter
Fuel Load: Light or no wildland fuels
Defensible Space: 30 ft treated
Topography: Slope 21% to 30%
Roof Material: Noncombustible or not applicable
Siding Material: Rock, concrete, metal
Foundation: Closed, Greater than 30in masonry exposed or N/A
Firewood: None
Water Supply: Pressurized hydrant(s) or fixed sprinkler system
Propane: None
Overhead Hazards: No overhead hazards
Comments:

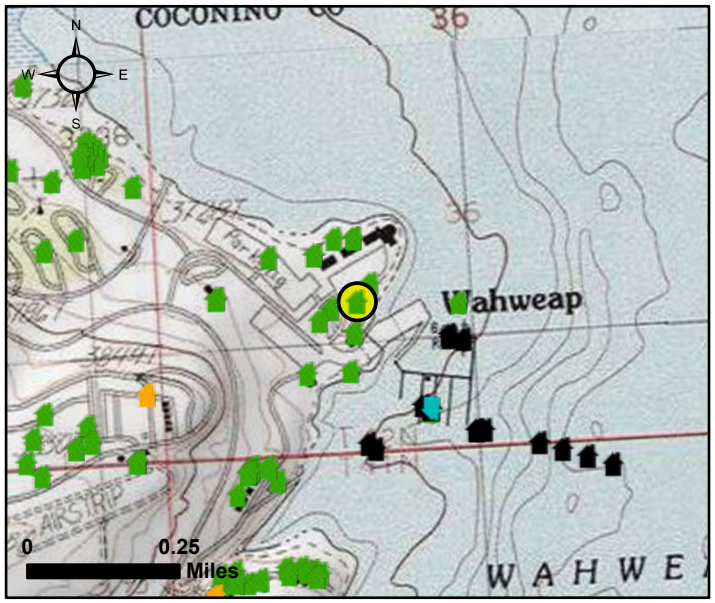
Facility Name: WW Lodge Building #1
Unit - Location: GLCA - Wahweap
FMSS ID: GLCA Lodge Building #1, ***Local ID:***
Structure Type, Use: Building, Unknown
Owner: National Park Service
Field Crew, Visit Date: ZION WFM, June 19, 2012
Coordinates (DDM): 36° 59.63700000' N 111° 29.24100000' W

Rating: Low
ProtectionLevel: Undesignated,
Resources of Concern: Unknown
Occupied: Yes
In Community: No,
Revisit Interval: yrs
Map Label: 473

Primary Access: Road
Ingress Egress: 2 or more roads in/out
Access Width: 2 lanes (Greater than 24')
Access Condition: Surfaced-paved, gradeLess than 5%
Bridge Condition: Less than 300 ft with turnaround
Access and Turnarounds: Less than 300 ft with turnaround
Facility Number or Sign: Marked and clearly visible
Fuel Type: Grass and shrub, hardwood litter
Fuel Load: Light or no wildland fuels
Defensible Space: 30 ft treated
Topography: Slope 21% to 30%
Roof Material: Noncombustible or not applicable
Siding Material: Rock, concrete, metal
Foundation: Closed, Greater than 30in masonry exposed or N/A
Firewood: None
Water Supply: Pressurized hydrant(s) or fixed sprinkler system
Propane: None
Overhead Hazards: No overhead hazards
Comments:

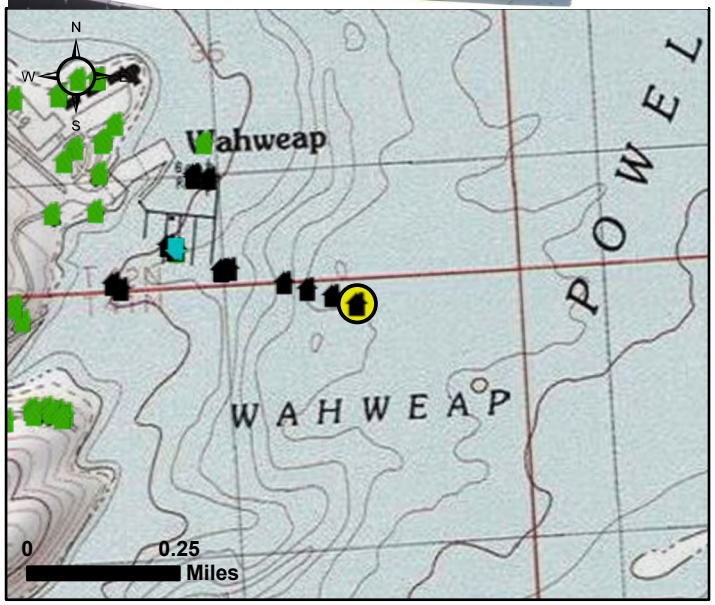
Facility Name: WW Marina Restroom Electrical Shade #4
Unit - Location: GLCA - Wahweap
FMSS ID: GLCA WW Marina Restroom Shade #4, ***Local ID:***
Structure Type, Use: No Wildland Risk, Unknown
Owner: National Park Service
Field Crew, Visit Date: ZION WFM, June 19, 2012
Coordinates (DDM): 36° 59.38500000' N 111° 28.80400002' W

Rating: No Wildland Risk
ProtectionLevel: Undesignated,
Resources of Concern: Unknown
Occupied: Yes
In Community: No,
Revisit Interval: yrs
Map Label: 493

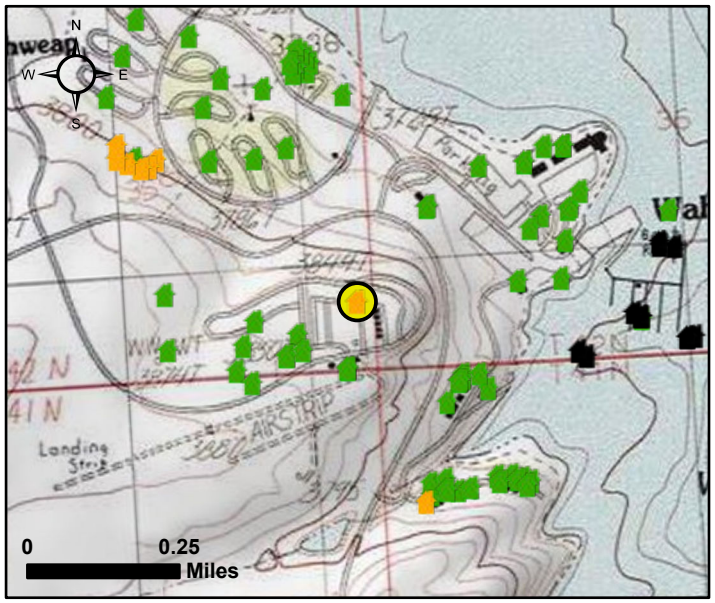
Facility Name: WW Wahweep Trailer Village Community
Unit - Location: GLCA - Wahweap
FMSS ID: GLCA Trailer Village, ***Local ID:***
Structure Type, Use: Building, Unknown
Owner: National Park Service
Field Crew, Visit Date: ZION WFM, June 19, 2012
Coordinates (DDM): 36° 59.52199998' N 111° 29.62399998' W

Rating: Moderate
ProtectionLevel: Undesignated,
Resources of Concern: Unknown
Occupied: Yes
In Community: No,
Revisit Interval: yrs
Map Label: 431

Primary Access: Road
Ingress Egress: 2 or more roads in/out
Access Width: 2 lanes (Greater than 24')
Access Condition: Surfaced-paved, gradeLess than 5%
Bridge Condition: Less than 300 ft with turnaround
Access and Turnarounds: Less than 300 ft with turnaround
Facility Number or Sign: None or not clearly visible
Fuel Type: Grass and shrub, hardwood litter
Fuel Load: Light or no wildland fuels
Defensible Space: Less than 30 ft treated
Topography: Slope 31% to 40%
Roof Material: Noncombustible or not applicable
Siding Material: Vinyl
Foundation: Closed, Less than 6in masonry exposed
Firewood: 5ft to 30ft from facility
Water Supply: Pressurized hydrant(s) or fixed sprinkler system
Propane: None
Overhead Hazards: No overhead hazards

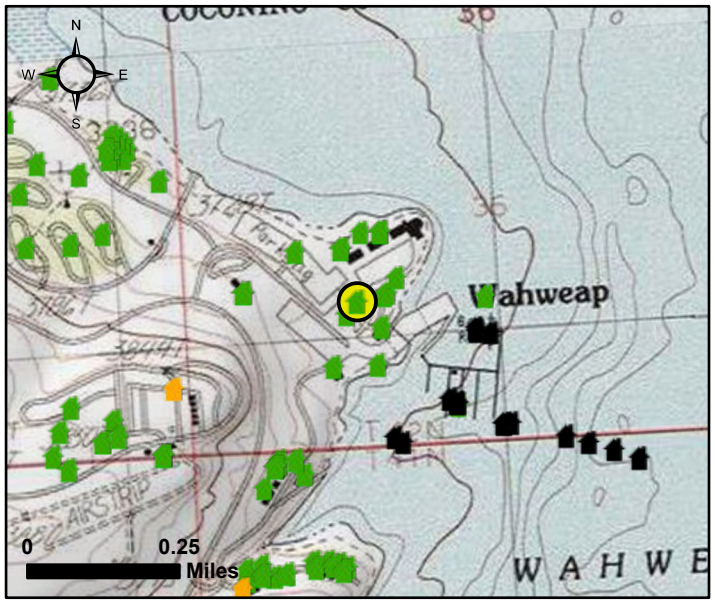
Facility Name: WW Decontamination Station Shade Structure/Storage
Unit - Location: GLCA - Wahweap
FMSS ID: 225377, ***Local ID:***
Structure Type, Use: Building, Unknown
Owner: National Park Service
Field Crew, Visit Date: ZION WFM, June 19, 2012
Coordinates (DDM): 36° 59.62999998' N 111° 29.28900000' W

Rating: Low
ProtectionLevel: Undesignated,
Resources of Concern: Unknown
Occupied: No
In Community: No,
Revisit Interval: yrs
Map Label: 467

Primary Access: Road
Ingress Egress: 2 or more roads in/out
Access Width: 2 lanes (Greater than 24')
Access Condition: Surfaced-paved, gradeLess than 5%
Bridge Condition: Less than 300 ft with turnaround
Access and Turnarounds: Less than 300 ft with turnaround
Facility Number or Sign: Marked and clearly visible
Fuel Type: Grass and shrub, hardwood litter
Fuel Load: Light or no wildland fuels
Defensible Space: Greater than 100ft treated
Topography: Slope Less than 5%
Roof Material: Noncombustible or not applicable
Siding Material: Rock, concrete, metal
Foundation: Closed, Greater than 30in masonry exposed or N/A
Firewood: None
Water Supply: Pressurized hydrant(s) or fixed sprinkler system
Propane: None
Overhead Hazards: No overhead hazards

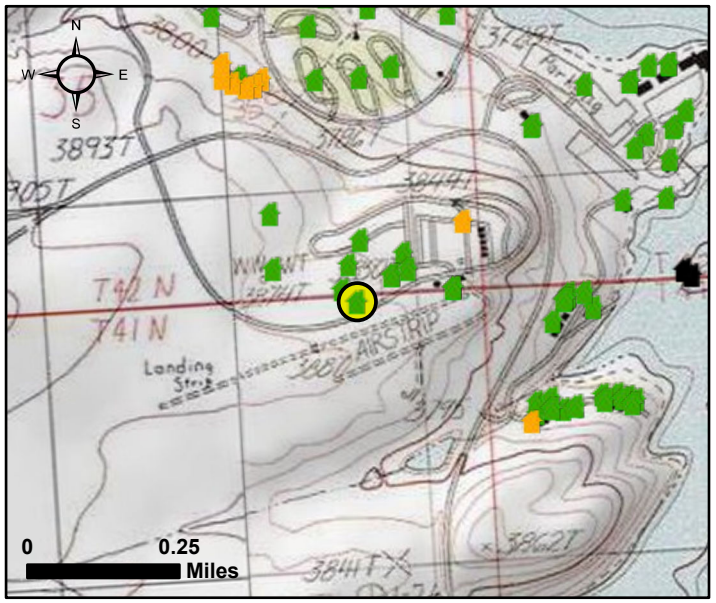
Facility Name: WW Aramark Dormitory #5
Unit - Location: GLCA - Wahweap
FMSS ID: GLCA Aramark Dorm #5, ***Local ID:***
Structure Type, Use: Building, Unknown
Owner: National Park Service
Field Crew, Visit Date: ZION WFM, June 19, 2012
Coordinates (DDM): 36° 59.41500000' N 111° 29.81899998' W

Rating: Low
ProtectionLevel: Undesignated,
Resources of Concern: Unknown
Occupied: Yes
In Community: No,
Revisit Interval: yrs
Map Label: 407

Primary Access: Road
Ingress Egress: 2 or more roads in/out
Access Width: 2 lanes (Greater than 24')
Access Condition: Surfaced-paved, gradeLess than 5%
Bridge Condition: Greater than 300 ft with turnaround
Access and Turnarounds: Greater than 300 ft with turnaround
Facility Number or Sign: Marked and clearly visible
Fuel Type: Grass and shrub, hardwood litter
Fuel Load: Light or no wildland fuels
Defensible Space: 30 ft treated
Topography: Slope Less than 5%
Roof Material: Fire resistant- tar,rubberized
Siding Material: Rock, concrete, metal
Foundation: Closed, Greater than 30in masonry exposed or N/A
Firewood: None
Water Supply: Pressurized hydrant(s) or fixed sprinkler system
Propane: None
Overhead Hazards: No overhead hazards
Comments:

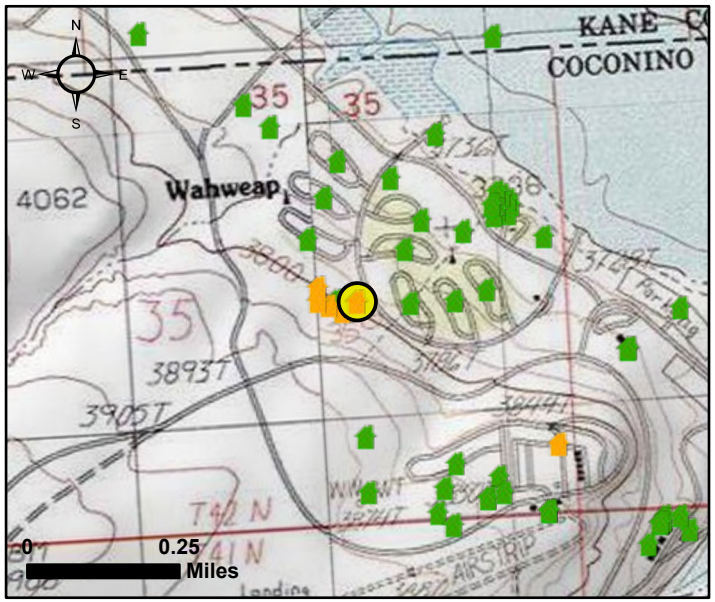
Facility Name: WW Campground Group Site Shade Structure #1
Unit - Location: GLCA - Wahweap
FMSS ID: GLCA Campground Groupsite, ***Local ID:***
Structure Type, Use: Other, Unknown
Owner: National Park Service
Field Crew, Visit Date: ZION WFM, June 19, 2012
Coordinates (DDM): 36° 59.74099998' N 111° 29.96700000' W

Rating: Moderate
ProtectionLevel: Undesignated,
Resources of Concern: Unknown
Occupied:
In Community: No,
Revisit Interval: yrs
Map Label: 395

Primary Access: Road
Ingress Egress: 2 or more roads in/out
Access Width: 2 lanes (Greater than 24')
Access Condition: Surfaced-paved, gradeLess than 5%
Bridge Condition: Less than 300 ft with turnaround
Access and Turnarounds: Less than 300 ft with turnaround
Facility Number or Sign: None or not clearly visible
Fuel Type: Grass and shrub, hardwood litter
Fuel Load: Light or no wildland fuels
Defensible Space: 30 ft treated
Topography: Slope 31% to 40%
Roof Material: Combustible or no roof
Siding Material: Rock, concrete, metal
Foundation: Closed, Greater than 30in masonry exposed or N/A
Firewood: None
Water Supply: Pressurized hydrant(s) or fixed sprinkler system
Propane: None
Overhead Hazards: No overhead hazards

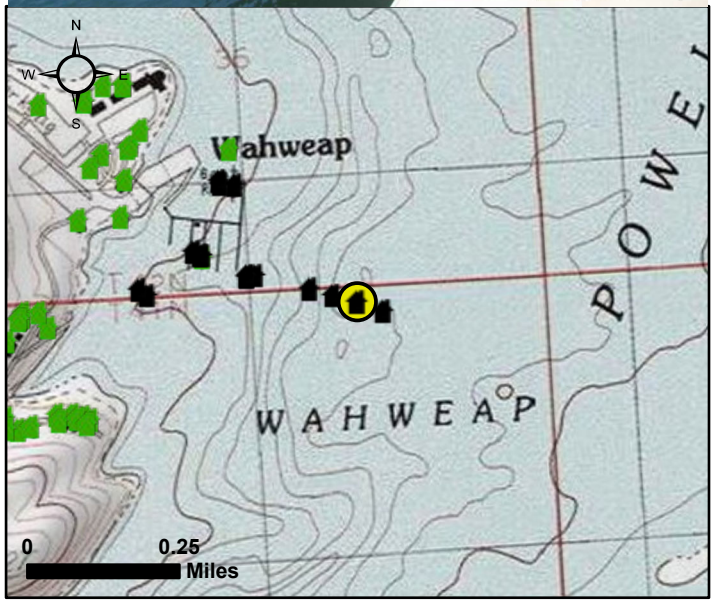
Facility Name: WW Marina Restroom Electrical Shade #3
Unit - Location: GLCA - Wahweap
FMSS ID: GLCA WW Marina Restroom #3, ***Local ID:***
Structure Type, Use: No Wildland Risk, Unknown
Owner: National Park Service
Field Crew, Visit Date: ZION WFM, June 19, 2012
Coordinates (DDM): 36° 59.39899998' N 111° 28.84800000' W

Rating: No Wildland Risk
ProtectionLevel: Undesignated,
Resources of Concern: Unknown
Occupied: Yes
In Community: No,
Revisit Interval: yrs
Map Label: 492

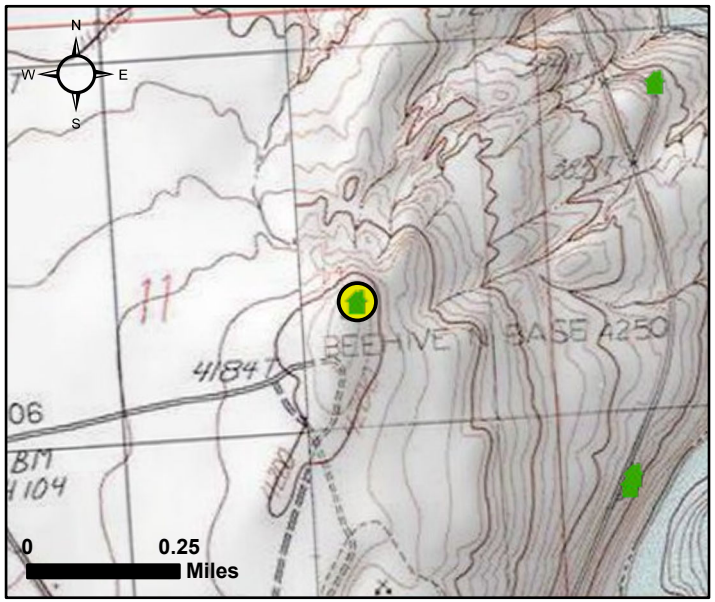
Facility Name: WW Wahweep View Overlook Shade Structure
Unit - Location: GLCA - Wahweap
FMSS ID: 228393, ***Local ID:***
Structure Type, Use: Other, Unknown
Owner: National Park Service
Field Crew, Visit Date: ZION WFM, June 19, 2012
Coordinates (DDM): 36° 58.13100000' N 111° 29.93899998' W

Rating: Low
ProtectionLevel: Undesignated,
Resources of Concern: Unknown
Occupied:
In Community: No,
Revisit Interval: yrs
Map Label: 398

Primary Access: Road
Ingress Egress: 2 or more roads in/out
Access Width: 2 lanes (Greater than 24')
Access Condition: Surfaced-paved, gradeGreater than 5%
Bridge Condition: Less than 300 ft with turnaround
Access and Turnarounds: Less than 300 ft with turnaround
Facility Number or Sign: None or not clearly visible
Fuel Type: Grass and shrub, hardwood litter
Fuel Load: Light or no wildland fuels
Defensible Space: Greater than 100ft treated
Topography: Slope 21% to 30%
Roof Material: Noncombustible or not applicable
Siding Material: Rock, concrete, metal
Foundation: Closed, Greater than 30in masonry exposed or N/A
Firewood: None
Water Supply: No reliable water source nearby
Propane: None
Overhead Hazards: No overhead hazards

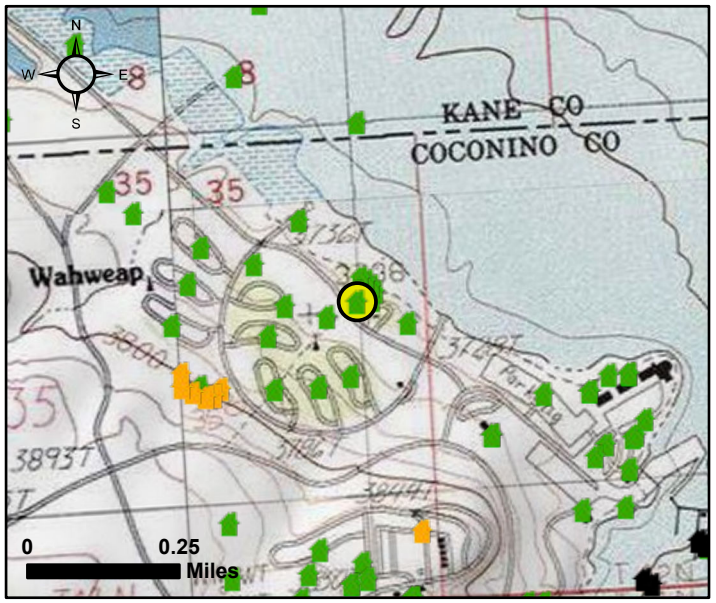
Facility Name: WW Picnic Area Shade Structure #7
Unit - Location: GLCA - Wahweap
FMSS ID: GLCA Picnic Area #7, ***Local ID:***
Structure Type, Use: Other, Unknown
Owner: National Park Service
Field Crew, Visit Date: ZION WFM, June 19, 2012
Coordinates (DDM): 36° 59.85300000' N 111° 29.71600002' W

Rating: Low
ProtectionLevel: Undesignated,
Resources of Concern: Unknown
Occupied:
In Community: No,
Revisit Interval: yrs
Map Label: 418

Primary Access: Road
Ingress Egress: 2 or more roads in/out
Access Width: 2 lanes (Greater than 24')
Access Condition: Surfaced-paved, gradeLess than 5%
Bridge Condition: Less than 300 ft with turnaround
Access and Turnarounds: Less than 300 ft with turnaround
Facility Number or Sign: None or not clearly visible
Fuel Type: Grass and shrub, hardwood litter
Fuel Load: Light or no wildland fuels
Defensible Space: Less than 30 ft treated
Topography: Slope 21% to 30%
Roof Material: Noncombustible or not applicable
Siding Material: Rock, concrete, metal
Foundation: Closed, Greater than 30in masonry exposed or N/A
Firewood: None
Water Supply: Pressurized hydrant(s) or fixed sprinkler system
Propane: None
Overhead Hazards: Overhead hazards will limit aircraft
Comments: Obstacles: Evacuation.

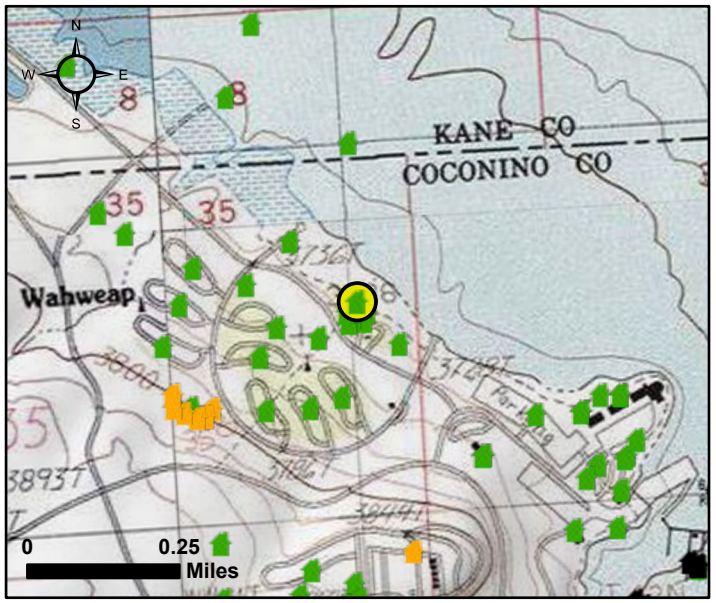
Facility Name: WW Picnic Area Shade Structure #4
Unit - Location: GLCA - Wahweap
FMSS ID: GLCA Picnic Area #4, ***Local ID:***
Structure Type, Use: Other, Unknown
Owner: National Park Service
Field Crew, Visit Date: ZION WFM, June 19, 2012
Coordinates (DDM): 36° 59.88199998' N 111° 29.69899998' W

Rating: Low
ProtectionLevel: Undesignated,
Resources of Concern: Unknown
Occupied:
In Community: No,
Revisit Interval: yrs
Map Label: 422

Primary Access: Road
Ingress Egress: 2 or more roads in/out
Access Width: 2 lanes (Greater than 24')
Access Condition: Surfaced-paved, gradeLess than 5%
Bridge Condition: Less than 300 ft with turnaround
Access and Turnarounds: Less than 300 ft with turnaround
Facility Number or Sign: None or not clearly visible
Fuel Type: Grass and shrub, hardwood litter
Fuel Load: Light or no wildland fuels
Defensible Space: Less than 30 ft treated
Topography: Slope 21% to 30%
Roof Material: Noncombustible or not applicable
Siding Material: Rock, concrete, metal
Foundation: Closed, Greater than 30in masonry exposed or N/A
Firewood: None
Water Supply: Pressurized hydrant(s) or fixed sprinkler system
Propane: None
Overhead Hazards: Overhead hazards will limit aircraft
Comments: Obstacles: Evacuation.

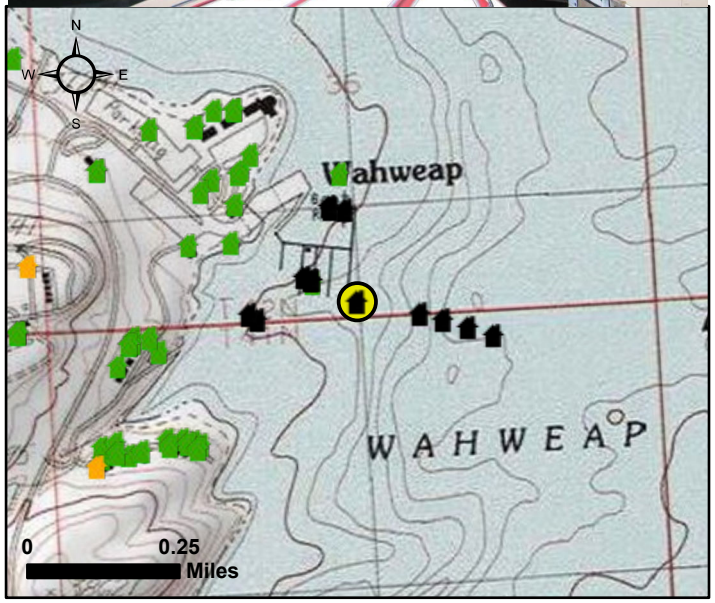
Facility Name: WW Marina Office Store
Unit - Location: GLCA - Wahweap
FMSS ID: GLCA WW Marina Office Store, ***Local ID:***
Structure Type, Use: No Wildland Risk, Unknown
Owner: National Park Service
Field Crew, Visit Date: ZION WFM, June 19, 2012
Coordinates (DDM): 36° 59.44399998' N 111° 29.04199998' W

Rating: No Wildland Risk
ProtectionLevel: Undesignated,
Resources of Concern: Unknown
Occupied: Yes
In Community: No,
Revisit Interval: yrs
Map Label: 488

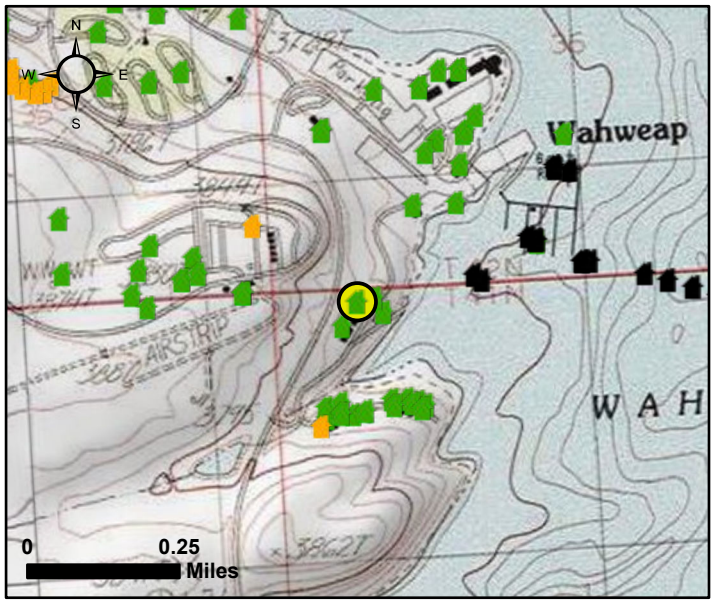
Facility Name: WW Maintenance Building
Unit - Location: GLCA - Wahweap
FMSS ID: 44403, ***Local ID:***
Structure Type, Use: Building, Administrative
Owner: National Park Service
Field Crew, Visit Date: ZION WFM, June 19, 2012
Coordinates (DDM): 36° 59.40499998' N 111° 29.44500000' W

Rating: Low
ProtectionLevel: Undesignated,
Resources of Concern: Unknown
Occupied: Yes
In Community: No,
Revisit Interval: yrs
Map Label: 449

Primary Access: Road
Ingress Egress: 2 or more roads in/out
Access Width: 2 lanes (Greater than 24')
Access Condition: Surfaced-paved, gradeLess than 5%
Bridge Condition: Less than 300 ft with turnaround
Access and Turnarounds: Less than 300 ft with turnaround
Facility Number or Sign: Marked and clearly visible
Fuel Type: Grass and shrub, hardwood litter
Fuel Load: Light or no wildland fuels
Defensible Space: 100 ft treated
Topography: Slope 5% to 20%
Roof Material: Noncombustible or not applicable
Siding Material: Rock, concrete, metal
Foundation: Closed, Greater than 30in masonry exposed or N/A
Firewood: None
Water Supply: Pressurized hydrant(s) or fixed sprinkler system
Propane: None
Overhead Hazards: No overhead hazards

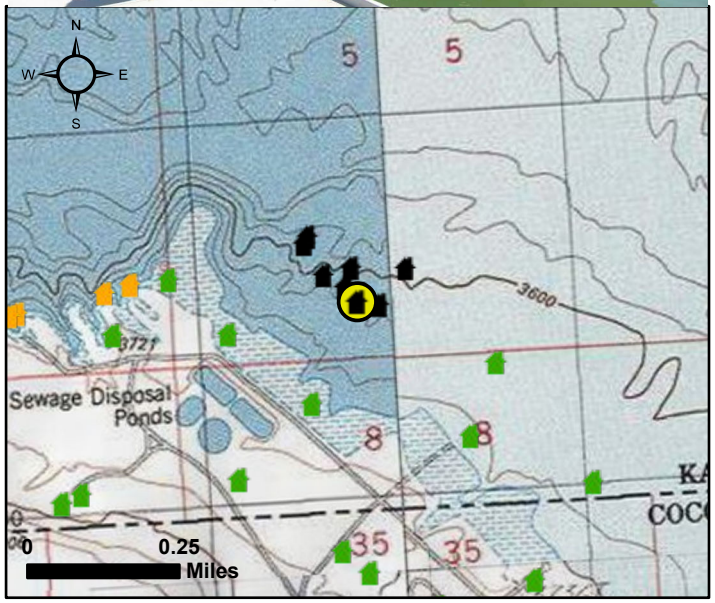
Facility Name: WW Stateline Store Bldg.
Unit - Location: GLCA - Wahweap
FMSS ID: GLCA SL Store Bldg, ***Local ID:***
Structure Type, Use: No Wildland Risk, Unknown
Owner: National Park Service
Field Crew, Visit Date: ZION WFM, June 19, 2012
Coordinates (DDM): 37° 00.38500002' N 111° 30.09900000' W

Rating: No Wildland Risk
ProtectionLevel: Undesignated,
Resources of Concern: Unknown
Occupied: Yes
In Community: No,
Revisit Interval: yrs
Map Label: 382

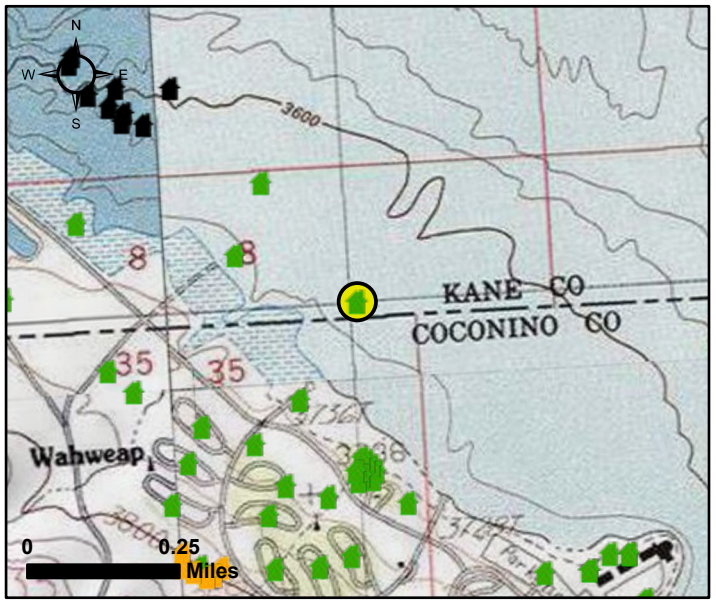
Facility Name: WW Swim Beach Microflush #2
Unit - Location: GLCA - Wahweap
FMSS ID: GLCA Swim Beach Microflush, ***Local ID:***
Structure Type, Use: Building, Unknown
Owner: National Park Service
Field Crew, Visit Date: ZION WFM, June 19, 2012
Coordinates (DDM): 37° 00.10900002' N 111° 29.69899998' W

Rating: Low
ProtectionLevel: Undesignated,
Resources of Concern: Unknown
Occupied: Yes
In Community: No,
Revisit Interval: yrs
Map Label: 421

Primary Access: Road
Ingress Egress: 2 or more roads in/out
Access Width: 2 lanes (Greater than 24')
Access Condition: Surfaced-paved, gradeLess than 5%
Bridge Condition: Less than 300 ft with turnaround
Access and Turnarounds: Less than 300 ft with turnaround
Facility Number or Sign: None or not clearly visible
Fuel Type: Grass and shrub, hardwood litter
Fuel Load: Light or no wildland fuels
Defensible Space: Greater than 100ft treated
Topography: Slope 5% to 20%
Roof Material: Noncombustible or not applicable
Siding Material: Rock, concrete, metal
Foundation: Closed, Greater than 30in masonry exposed or N/A
Firewood: None
Water Supply: Reliable water source nearby
Propane: None
Overhead Hazards: No overhead hazards

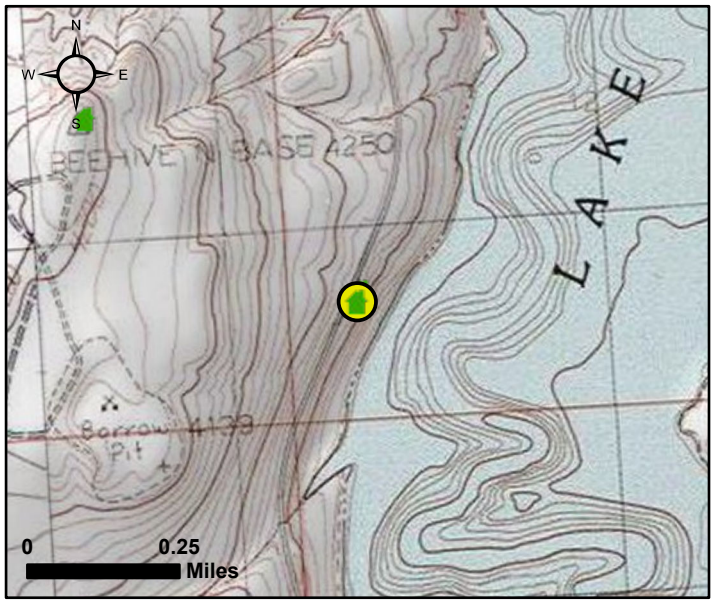
Facility Name: WW Navajo Mtn Viewpoint Shade Structure #1
Unit - Location: GLCA - Wahweap
FMSS ID: GLCA WW Navajo Mtn Shade #1, ***Local ID:***
Structure Type, Use: Other, Unknown
Owner: National Park Service
Field Crew, Visit Date: ZION WFM, June 19, 2012
Coordinates (DDM): 36° 57.84700002' N 111° 29.47300002' W

Rating: Low
ProtectionLevel: Undesignated,
Resources of Concern: Unknown
Occupied:
In Community: No,
Revisit Interval: yrs
Map Label: 444

Primary Access: Road
Ingress Egress: 2 or more roads in/out
Access Width: 2 lanes (Greater than 24')
Access Condition: Surfaced-paved, gradeLess than 5%
Bridge Condition: Less than 300 ft with turnaround
Access and Turnarounds: Less than 300 ft with turnaround
Facility Number or Sign: None or not clearly visible
Fuel Type: Grass and shrub, hardwood litter
Fuel Load: Light or no wildland fuels
Defensible Space: Less than 30 ft treated
Topography: Slope 31% to 40%
Roof Material: Noncombustible or not applicable
Siding Material: Rock, concrete, metal
Foundation: Closed, Greater than 30in masonry exposed or N/A
Firewood: None
Water Supply: Reliable water source nearby
Propane: None
Overhead Hazards: No overhead hazards

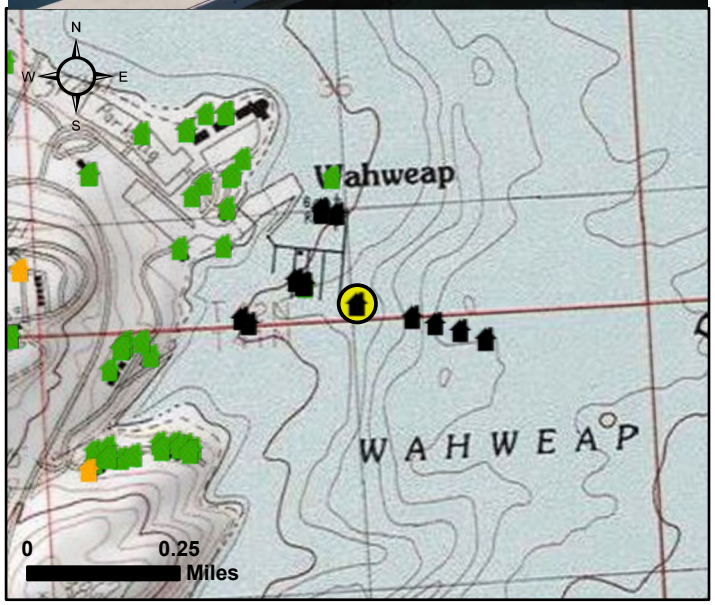
Facility Name: WW Marina Office Store Storage
Unit - Location: GLCA - Wahweap
FMSS ID: GLCA WW Marina Office Store Storage, ***Local ID:***
Structure Type, Use: No Wildland Risk, Unknown
Owner: National Park Service
Field Crew, Visit Date: ZION WFM, June 19, 2012
Coordinates (DDM): 36° 59.44500000' N 111° 29.02800000' W

Rating: No Wildland Risk
ProtectionLevel: Undesignated,
Resources of Concern: Unknown
Occupied: No
In Community: No,
Revisit Interval: yrs
Map Label: 489

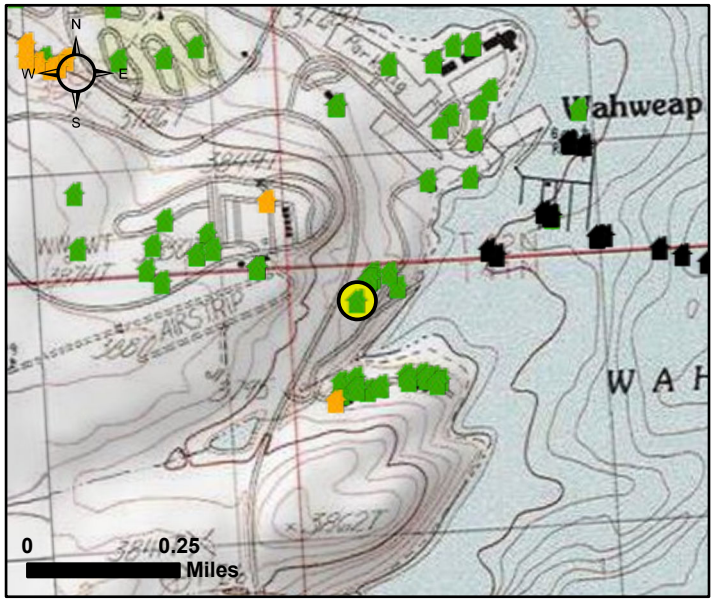
Facility Name: WW Hazmat Storage
Unit - Location: GLCA - Wahweap
FMSS ID: 44428, ***Local ID:***
Structure Type, Use: Building, Administrative
Owner: National Park Service
Field Crew, Visit Date: ZION WFM, June 19, 2012
Coordinates (DDM): 36° 59.37199998' N 111° 29.47399998' W

Rating: Low
ProtectionLevel: Undesignated,
Resources of Concern: Unknown
Occupied: No
In Community: No,
Revisit Interval: yrs
Map Label: 443

Primary Access: Road
Ingress Egress: 2 or more roads in/out
Access Width: 2 lanes (Greater than 24')
Access Condition: Surfaced-paved, gradeLess than 5%
Bridge Condition: Less than 300 ft with turnaround
Access and Turnarounds: Less than 300 ft with turnaround
Facility Number or Sign: Marked and clearly visible
Fuel Type: Grass and shrub, hardwood litter
Fuel Load: Light or no wildland fuels
Defensible Space: 100 ft treated
Topography: Slope 5% to 20%
Roof Material: Noncombustible or not applicable
Siding Material: Rock, concrete, metal
Foundation: Closed, Greater than 30in masonry exposed or N/A
Firewood: None
Water Supply: Pressurized hydrant(s) or fixed sprinkler system
Propane: None
Overhead Hazards: No overhead hazards
Comments:

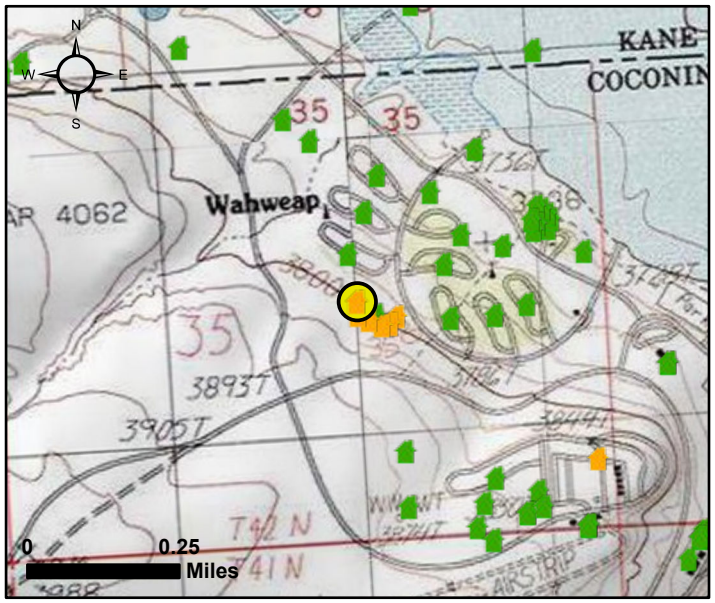
Facility Name: WW Campground Group Site Shade Structure #6
Unit - Location: GLCA - Wahweap
FMSS ID: GLCA Campground Groupsite #6, ***Local ID:***
Structure Type, Use: Other, Unknown
Owner: National Park Service
Field Crew, Visit Date: ZION WFM, June 19, 2012
Coordinates (DDM): 36° 59.76499998' N 111° 30.03600000' W

Rating: Moderate
ProtectionLevel: Undesignated,
Resources of Concern: Unknown
Occupied:
In Community: No,
Revisit Interval: yrs
Map Label: 387

Primary Access: Road
Ingress Egress: 2 or more roads in/out
Access Width: 2 lanes (Greater than 24')
Access Condition: Surfaced-paved, gradeLess than 5%
Bridge Condition: Less than 300 ft with turnaround
Access and Turnarounds: Less than 300 ft with turnaround
Facility Number or Sign: None or not clearly visible
Fuel Type: Grass and shrub, hardwood litter
Fuel Load: Light or no wildland fuels
Defensible Space: 30 ft treated
Topography: Slope 31% to 40%
Roof Material: Combustible or no roof
Siding Material: Rock, concrete, metal
Foundation: Closed, Greater than 30in masonry exposed or N/A
Firewood: None
Water Supply: Pressurized hydrant(s) or fixed sprinkler system
Propane: None
Overhead Hazards: No overhead hazards
