FRANK SLAVEN'S ROADHOUSE

HISTORIC STRUCTURE REPORT

STEVEN N. PETERSON, REGIONAL HISTORIC ARCHITECT

MARCH, 1990

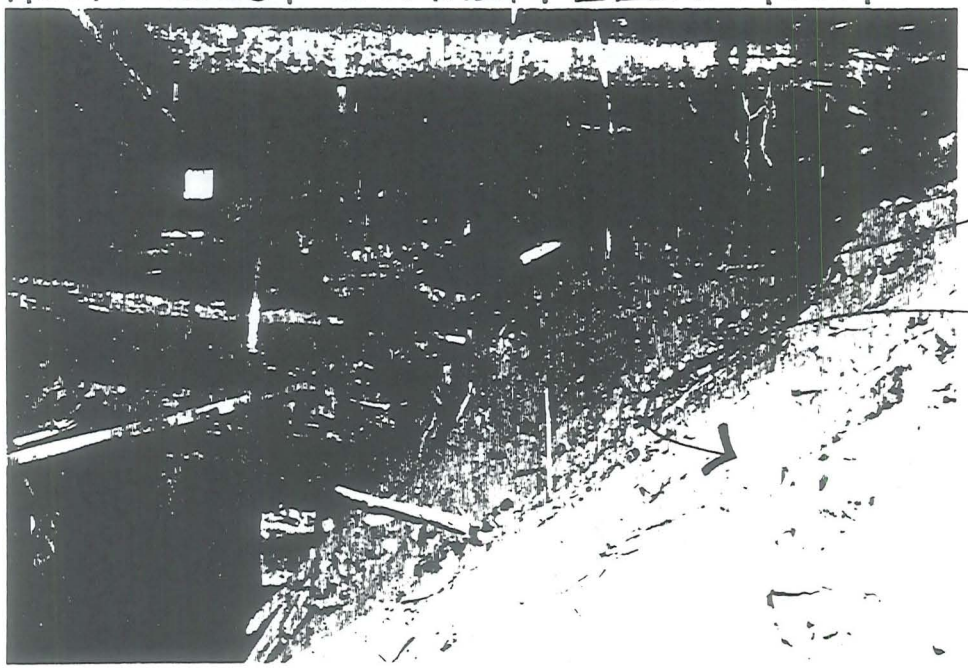
NORTHWEST CORNER ELEVATION

ROLLED CORRUGATED GALV. METAL ROOFING, REPAIR AS PART OF PHASE II

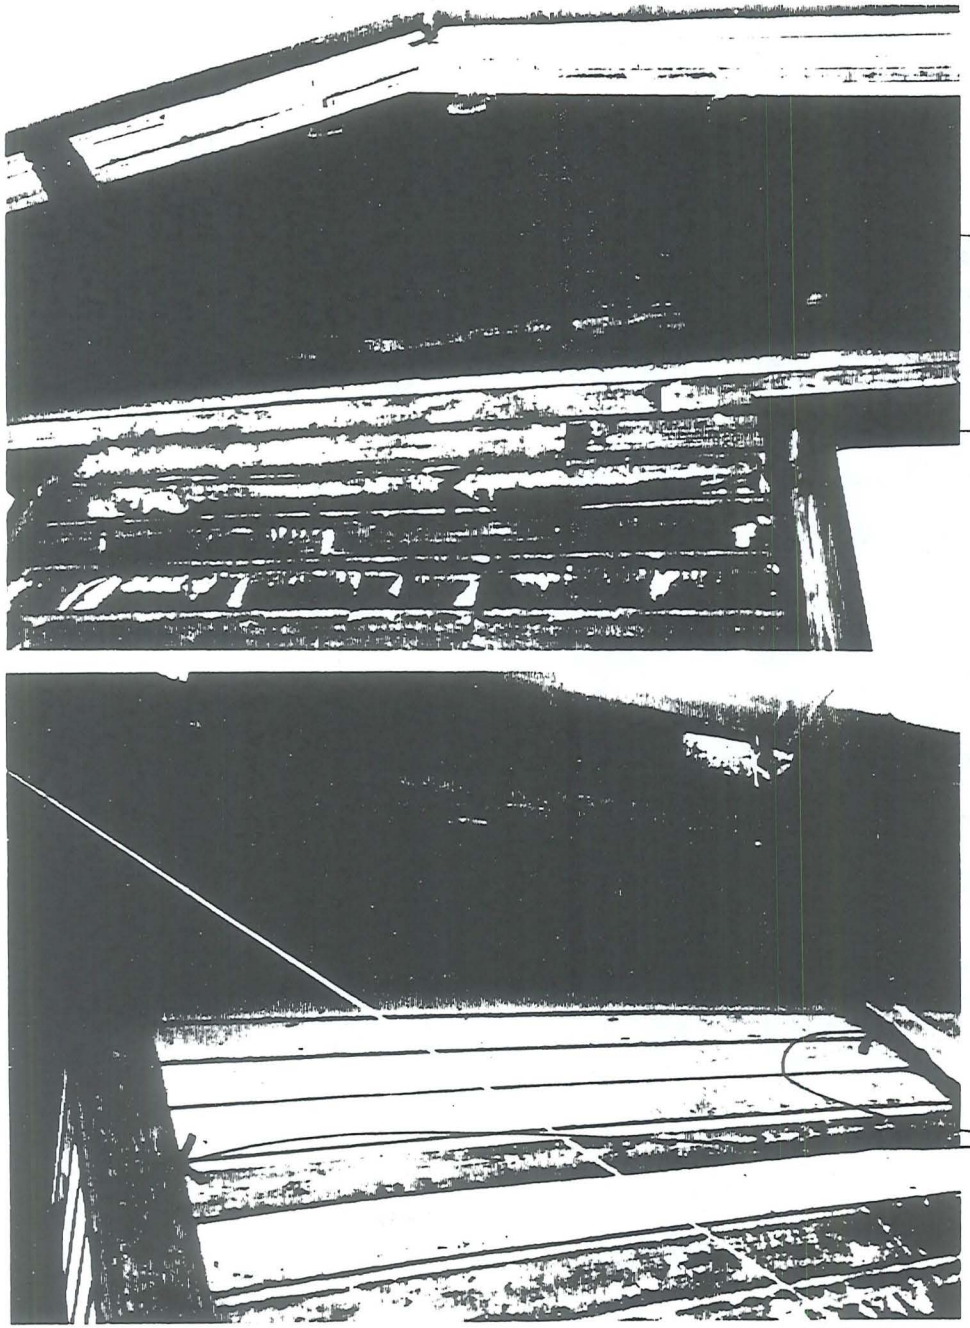
ROOF DETAIL

ROLLED CORR. GALV. METAL ROOFING, CA 35
"BEAD. BOARD" SIDING AT FASCIA
LOG FASCIA
LOG PURLIN
VERTICAL DOWL AT LOG END

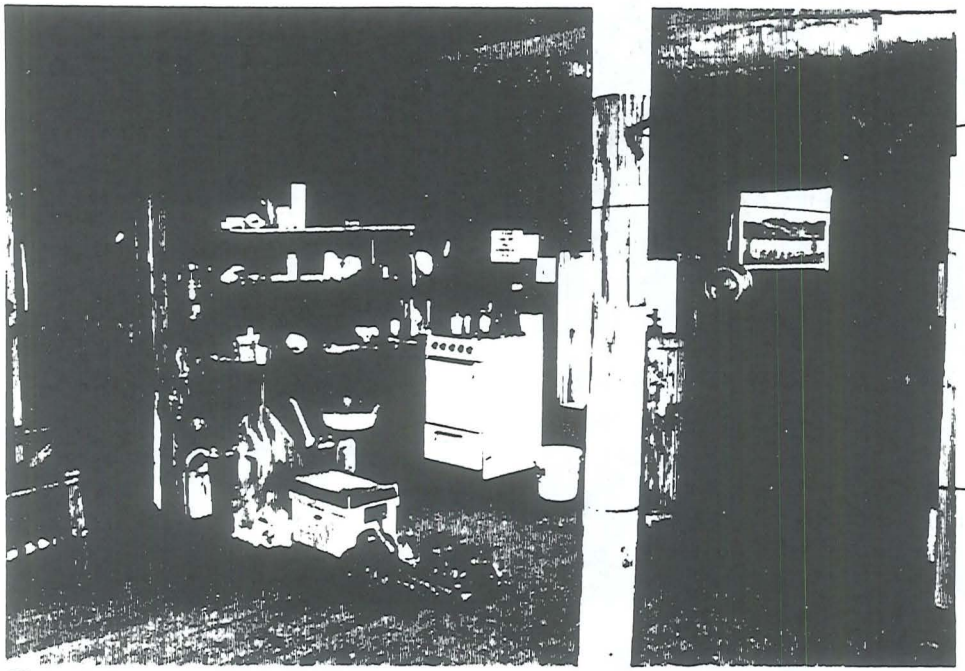
LODGE ROOM – SOUTHEAST CORNER

SINGLE WALL, GALV METAL CHIMNEY

REMOVE EXISTING KITCHEN, REDESIGN NEW KITCHEN AREA COMPATABLE W/ BUILDING

RELOCATE PROPANE TANK TO A VENTILATED AREA AWAY FROM THE ROADHOUSE

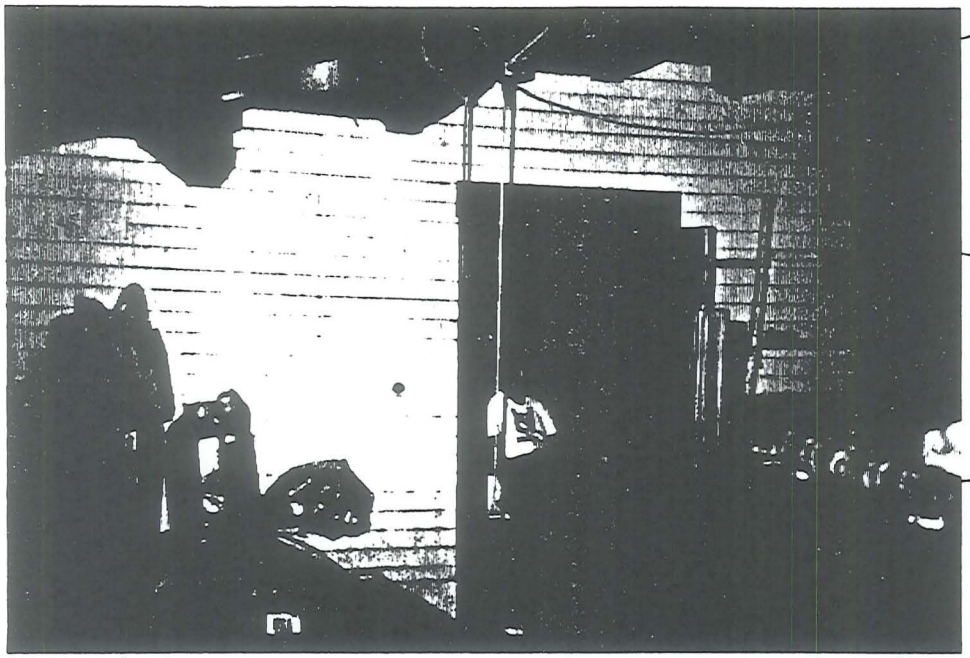
CONTINUOUS LOG PURLINS THROUGH BOTH ROOMS, SQUARE WHERE THEY PENETRATE WALLS

PAINTED WOOD PANELING - DETERMINE ORIGINAL COLOR AND REPAINT.

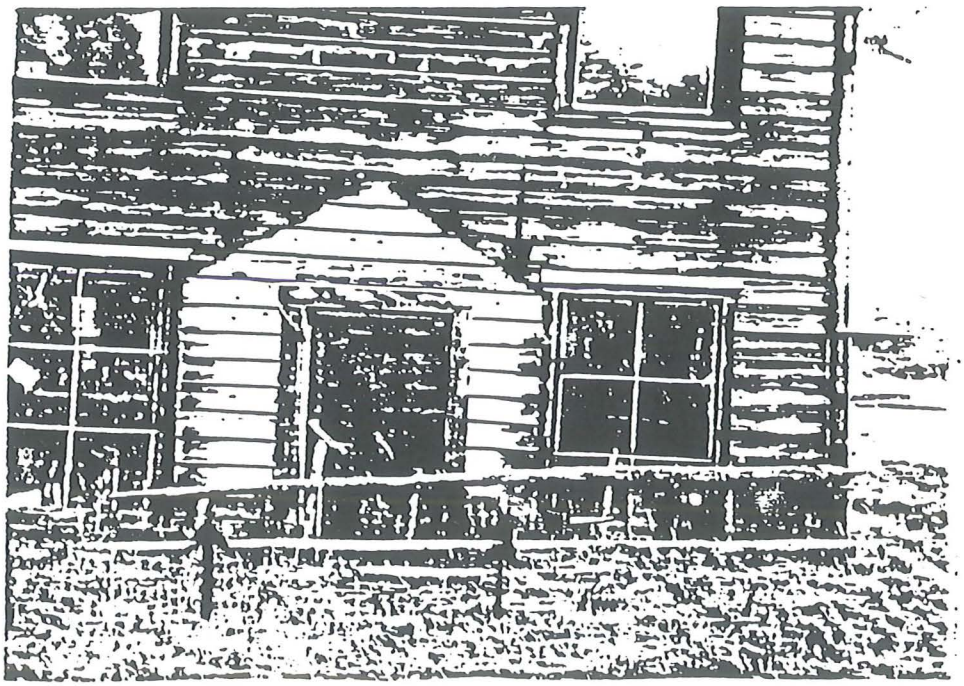
Slaven Roadhouse, August, 1938 (photo by J.B. Mertie, USGS) with entryway in place.

Recent photo of roadhouse. Arrows locate walls of entryway based on historic photo, weathering, and archeological evidence.
