Review of Potential Rockfall Hazards at El Morro National Monument, New Mexico

Administrative Report

December 2000

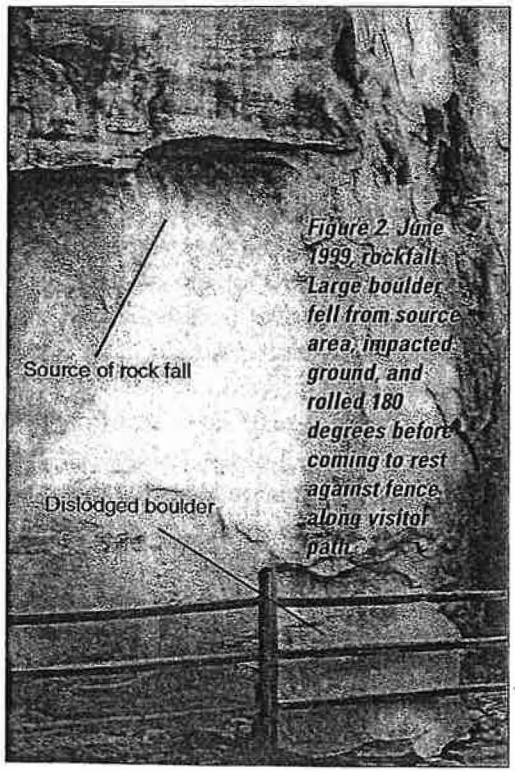
Figure 2. June 1999, rockfall. Large boulder fell from source area, impacted ground, and rolled 180 degrees before coming to rest against fence along visitor path.

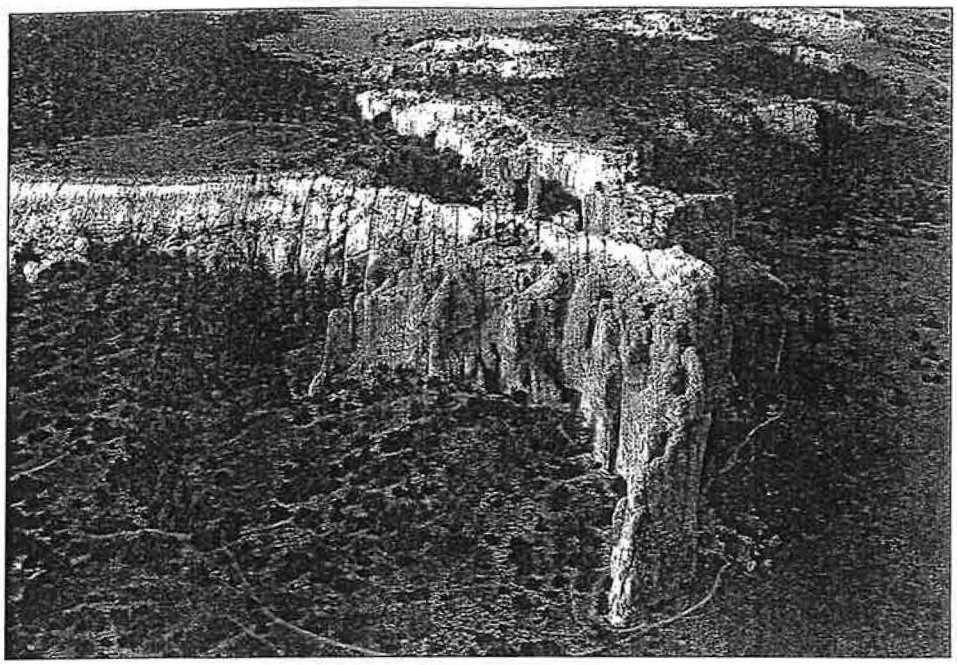
At El Morro, the Zuni Formation exhibits a very well defined and prominent northeast-trending vertical joint system (fig. 3). It is these predominant northeast-trending joints that form many of the cliff exposures at El Morro. Smooth remnants of the old joint surfaces, composed of joint infilling material up to several centimeters thick, are exposed at several locations on the cliff face. Another well-defined but less prominent vertical joint system trends perpendicular to the main set. A third, very poorly defined and inconsistent set of near-horizontal joints and planes of weakness, probably related to depositional sequences in the sandstone, is sometimes visible. Such near-horizontal weakness planes can sometimes be the locus of failure of large, overhanging rock slabs, such for the June 1999, rockfall (fig. 2). Because the weakness planes are often hidden, it is difficult to identify specific areas of potential failure or to predict when and where failure might occur.

Figure 3. Cuesta that forms Inscription Rock at El Morro National Monument. Inscription Rock is in right center to foreground with visitor trail visible around base. View is to southwest. Note prominent northeast-southwest-oriented vertical joint set. The pool is visible at the curve in the base of the cliff just below and to the right of the center of photograph. [Photograph by Douglas E. Enry]

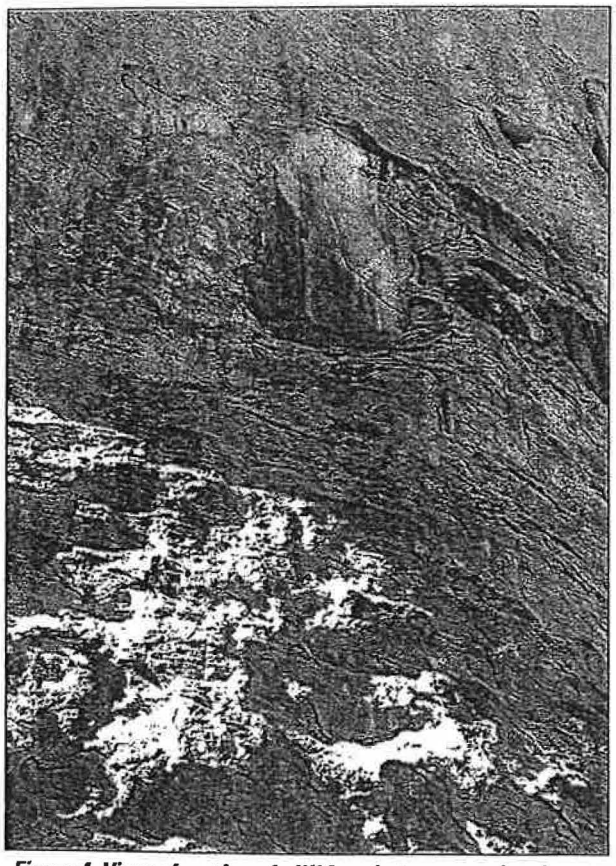
Figure 4. View of portion of cliff face between pool and marker 4, showing thin slabbing and flaking of rock surface. Also shown in top part of photo are remnants of old joint surface and joint infilling material (dark patches) typical of several locations on the southeast-facing cliff.

At several locations along the southeast-facing cliff are patches of dark, smooth, remnants of joint surfaces (fig. 4). These patches are up to several centimeters thick and several square meters in area, and occur high on the cliff. Although the stability of these remnant joint surfaces/infilling patches is difficult to assess, they represent potential slab detachment. Periodic inspection and scaling of these old remnant joint surfaces could be done to identify and remove any loosened material.

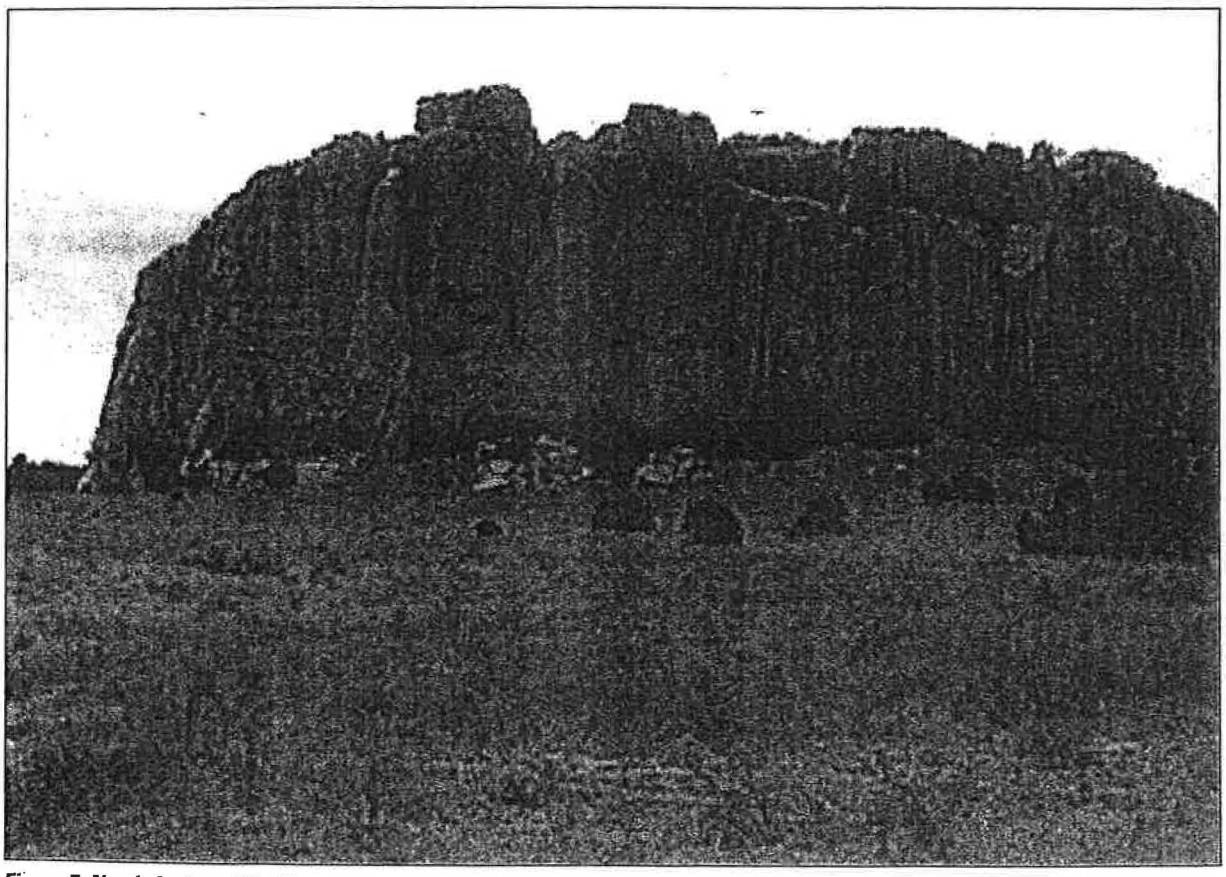
The north-facing cliff of Inscription Rock, between markers 14 and 21, is also an area of active rockfall, as indicated by the accumulated deposit of sandstone blocks and slabs ranging from a few centimeters to several meters in thickness. Numerous overhanging slabs can also be seen on the cliff above the trail where it passes very near the base of the cliff. The spalling and slabbing that is occurring here may be enhanced by more pronounced freezing and thawing action on the north-facing exposure. The area is also the location of a large rockfall that can be seen in the right foreground of figure 3 and in the center of figure 5. Inscriptions along the cliff above the old rockfall debris date to the early 1600's, indicating that the rockfall is older than 400 years.

Figure 5. North-facing cliff of Inscription Rock. Note abundant dark staining caused by flow and seepage of water on older cliff exposure. Rockfall debris can be seen in center of photo below where dark staining is absent.

The recommendations of previous investigators that this portion of the trail be closed during periods of freeze and thaw are probably the best approach to reducing risk to visitors in this area. According to Park officials, this part of the trail is usually closed until late spring owing to the presence of ice on the trail surface. Careful inspection of the cliff face should be done each spring prior to opening of the trail to look for the presence of slabs that may have been loosened over the winter and early spring months.

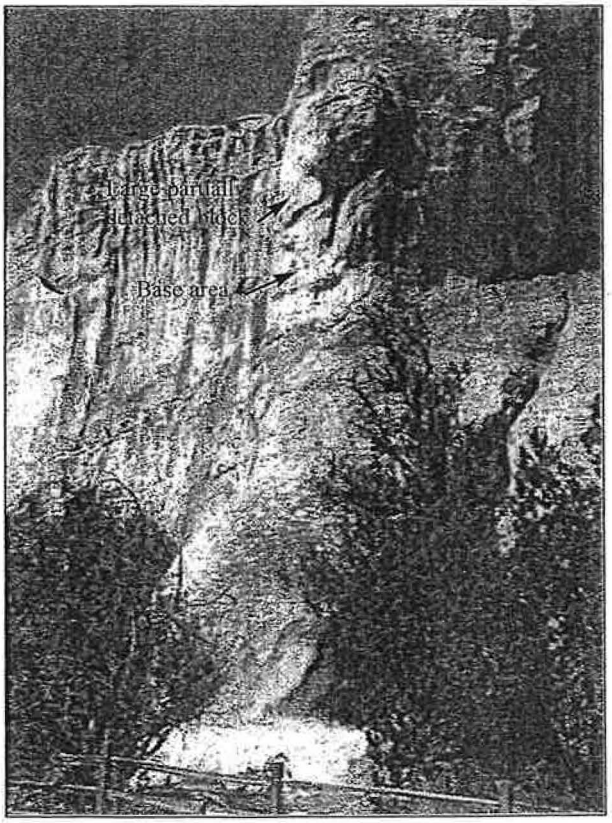
A large, partially detached block sits about midway up the bluff above marker #1 (fig. 6). Although the block appears to be stable, its mass is supported by a small base that could be susceptible to shear failure. The block should be examined periodically by Park staff for any signs of developing instability, such as new fractures or deterioration in the base area of the block. Because the visitor trail is located several meters from the cliff at this location, the risk from possible failure of the block is primarily limited by how far the block might travel after impacting the ground surface. A detailed analysis of the possible roll-out distance would be required to assess the risk, but because the trail is removed from the likely impact area the risk is considered to be low.

Figure 6. Large, partially detached block on bluff near trail marker #1.

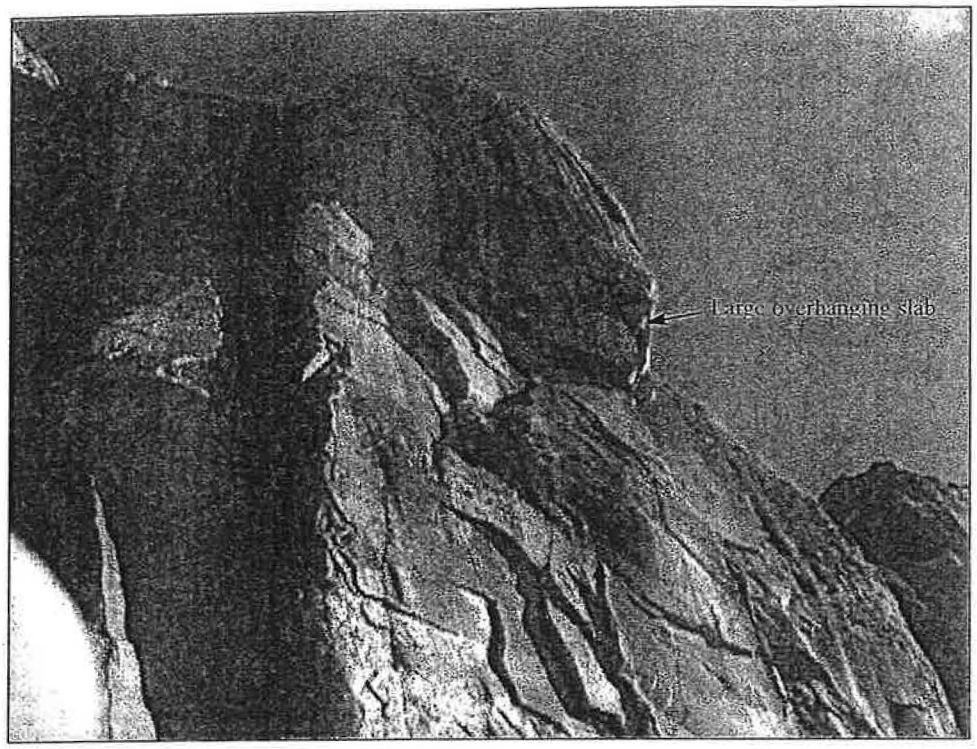
Above trail marker #4, near the top of the cliff, there is a large overhanging slab with no support from below (fig. 7). Some fracturing is

Figure 7. Large overhanging slab near top of cliff above trail marker #4. Numerous thin slabs are also present in this area.

apparent within the slab, but the presence of mud from swallow nests below the slab make it difficult to determine by visual inspection from the trail if fracturing occurs behind the slab. Several thinner slabs also are present on the cliff face in this area, but appear to be well attached to the cliff. The critical concern for the overhanging slab is its location above the trail. Separation of any part of the slab would impact the trail directly with little or no warning. No inscriptions are present in the area directly beneath the overhanging slab, so this is one area where the trail could be re-routed away from the cliff to reduce the risk. Careful inspection by a climber rappelling from above to determine if the slabs are firmly attached to the cliff may be warranted. Tapping along the outer surface of the slab with a hammer or pry bar is a method often used by experienced rock scalers to detect the presence of open fractures behind rock faces. Scaling could be done to remove unstable parts of the slab(s).

3. The areas of concern for possible slab failure noted above trail markers #4 and #11 should receive a closer inspection by a climber suspended by rope from above. Soundings by tap-

ping with a hammer or pry bar can be used to distinguish if the slabs are firmly attached or perhaps contain significant fracturing behind the slab. Any slabs found to be unstable should be scaled from the cliff. Re-routing of the existing trail below the slab area near marker #4 to bypass the area directly below the slabs is a practical alternative to reduce potential risk, as no inscriptions are present at that location. However, because the locations of the slabs are high on the cliff and increase the potential for rock bounce, it is probably not practical to re-route the trail far enough away to eliminate the hazard altogether.

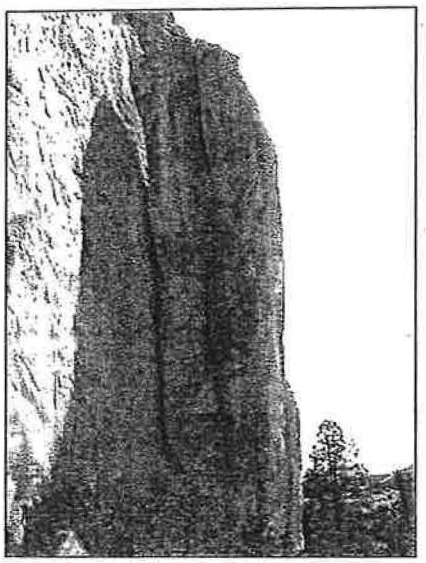
Near trail markers #12 and #13 is one of the most dramatic features with respect to potential rockfall hazards in the Park. This feature is a very large, approximately 50-m-high column of rock that is split by a vertical fracture (fig. 9). The fracture appears to be 10-15 cm wide near the top of the column, and disappears into hairline fractures near the base. The geometry of the fracture indicates that the outer part of the column has rotated outward relative to the inner part, and that the motion is hinged near the base of the column. The sharp, angular edges of the fracture indicated that it is much younger than the separation between the main column and the cliff. The defor-

Figure 9A and 9B. Two views of large split column of rock located between trail markers #12 and #13. Visitor trail, visible in view B, passes next to the base of the column.

The fracture appears in 1929 photos and again in a 1978 photograph taken by Wachter (1978). Although it is difficult to determine, the fracture appears to be wider in the 1978 photo, suggesting that there has been recent outward rotation of the outer portion of the split column. Such rotation could be a gradual, ongoing process. Inspection of the fracture for this review indicates a small, wedge of rock about mid-way up the column has separated and fallen downward a few centimeters within the fracture since the 1978 photograph was taken (fig. 10). While the separation and downward movement of this small wedge does not necessarily mean the fracture has widened since 1978, it does indicate that geologic processes are actively at work along the fracture surface.

Although there is no reason to expect that failure of this rock column is imminent, it's size, location, and indication of possible ongoing movement make it advisable to re-initiate a monitoring effort to determine if movement or further separation of the fracture is occurring. Because any further movement or fracture separation leading up to potential failure is likely to be gradual, instrumental monitoring is a viable and potentially valuable alternative at this site. Obtaining long-term baseline data is critical to assessing current or future hazard potential from this feature. Details of the recommended instrumental monitoring are discussed later under *Suggested Actions*.

7. Instrumental monitoring of the large, split monolith between markers #12 and #13 should be re-initiated as soon as practical. Although there is no evidence that the central fracture is currently widening, this is one area of the Park where instrumental monitoring could be of possible value in assessing the potential hazard. Long-term background data is necessary to determine if movement is occurring, or to look for acceleration of movement, which could indicate approaching failure.

A combination of both mechanical measurement and electronic sensors is recommended. The installation of an array of six monitoring pins, three on each side of the central fracture, should be installed on the south face of the column. The distance between the pins would be measured periodically by a sensitive dial or LCD display gage (accurate to 0.02 mm). The pins should be arranged in a rosette pattern, such that the distance between three sets of pins would be measured. In this way the amount and direction of relative movement in the plane of the pins (approximately perpendicular to the fracture) can be determined. The pins should be placed as high as can safely be installed and subsequently reached for measurement using an extension ladder (approximately 10-12 m above the ground surface). While measurement of fracture separation would be best made near the top of the column, the accuracy and resolution of the instrument is sensitive enough that movement can be detected at heights reachable by extension ladder, thus eliminating the need of a technical rock climber.

In addition to the mechanical pins, it is recommended that a dual-axis inclinometer be installed on the north face of the outer rock column. It appears that access to a suitable location for mounting the inclinometer on the rock surface can be gained through the large fissure just behind trail marker #13. The services of a professional rock climber would be advisable to complete the installation. Lead wires for readout of the inclinometer could be located at the base of the cliff behind the fence at marker #13. The location of the inclinometer on the north side of the monolith will shield it from daily exposure to the sun, and thus reduce the effects of daily temperature excursions on the instrumental readings.

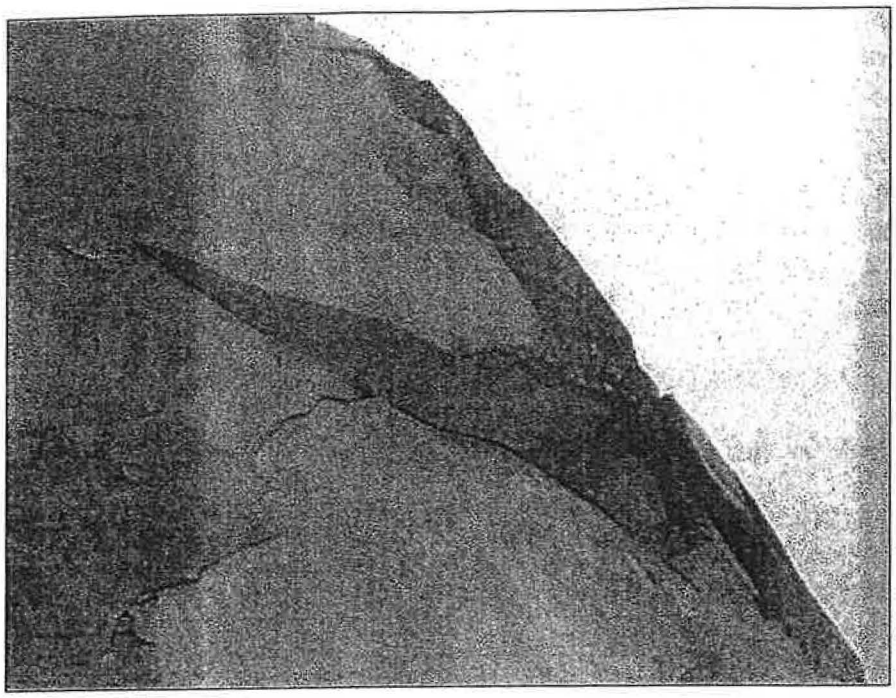
Figure 12. Close-up photo of large slab near top of cliff above trail markers #18 and #19. Note fracturing behind slab.

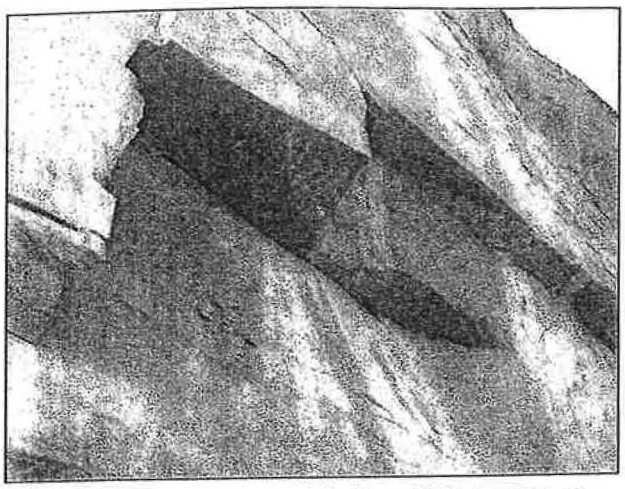
Figure 14. Close-up view of slab in figure 13. Note presence of fracturing behind and on left side of slab. A horizontal weakness plane, exposed by previous slab failure, can be seen above and to right of slab. This weakness plane probably extends into the inplace slab.

unsupported from below (figs. 13 and 14). This slab is perhaps the most ominous threat to visitors on the trail below. The slab overhangs directly above the trail, and any failure would be sudden and without warning. The consequences would most certainly be deadly for anyone located beneath the slab.

Other than removal, there is little that can be done to eliminate the hazard posed by this slab. Removal of the slab would likely just expose yet another section of the overhanging rock to potential slab failure. Rock bolting of the slab and the surrounding area would stabilize the potential failures, but is considered dangerous and impractical.

Fortunately, this potential hazard is in an area where trail relocation can mitigate the risk to visitors. The trail in this area contains steps as it traverses up and over the boulders and debris left from the old rockfall discussed previously and visible in Figures 3 and 5. Apparently, this section of the trail is under consideration by Park management for re-routing in order to improve accessibility for disabled visitors. Relocation of the existing trail in this area would therefore serve dual purposes; provide handicapped accessibility to marker #21 and a greater length of the Mesa Top Loop Trail, and also eliminate visitor traffic directly below the potential rockfall hazard. A portion of the existing trail to marker #20 could remain open as a dead-end spur of the trail, with the new section of trail traversing around the old rockfall debris. Another dead-end spur could then extend to marker #21. The area directly under the overhanging slab, where no inscriptions are present, would then be closed to public access. Because of the potential seriousness of a rock failure at this location it is recommended that trail re-routing be implemented as soon as possible

1. Re-routing of the visitor trail near markers 20 and 21 is considered a high priority. The existing trail between markers 20 and 21 should be closed, thus eliminating public exposure to the overhanging slab directly above the trail. As noted earlier, re-routing of the trail would also provide handicapped accessibility to marker 21 and further reaches of the trail. As no inscriptions are present between markers 20 and 21, the only inconvience to the public is a small amount of additional walking to gain access to the inscriptions at marker 21.

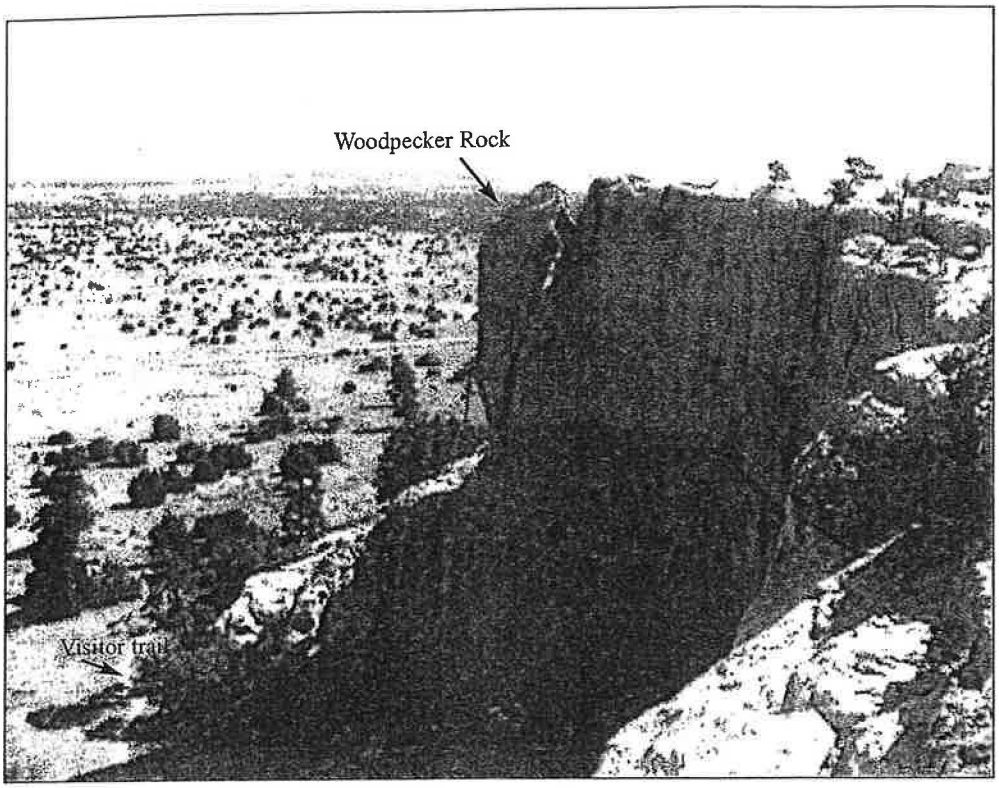
Woodpecker Rock (fig. 15) is located along the Mesa Top Loop Trail about mid-way between trail markers #22 and #23. The rock is a spectacular feature in that it is a large, approximately 30- to 40-m-tall fragment of the mesa front that is completely detached except for a very narrow intact base. The rock appears to be very precariously balanced on the small base. As noted by Wachter (1978), the rock does not show any signs of recent movement, but that the narrow base appears to be weathering and contains some diagonal fracturing. The feature appears in a historic 1929 photo from nearly the same camera location as in figure 15. No noticeable changes in the geometry or configuration of the rock are detectable between the two photos. I agree with Wachter's observation that failure would most likely be sudden, and that instrumental monitoring for motion would therefore be of little or no value.

Toppling of Woodpecker Rock is not considered likely, as the center of gravity of the rock mass is toward the cliff face. The most likely mode of failure for the rock would be shearing across the narrow pedestal base. Motion resulting from such shearing would be a downward sliding of the entire rock mass, which would likely be arrested by the ledge located below the rock. Sideways toppling of the rock might then occur.

Figure 15. Woodpecker rock, looking northeast from upper section of Mesa Top Loop Trail. Rock is completely detached from the mesa except for the small base on which it rests. Note location of visitor trail in lower part of photo.

Because the trail is somewhat removed from the base of the cliff at this location, the potential hazard imposed by Woodpecker Rock is not considered as severe as for some of the other locations described in this report. It would, however, be a relatively simple matter to relocate the trail further from the mesa in this area in order to bypass possible impact areas should the rock fail

and topple sideways. Park staff should periodically inspect the base area of the rock from the trail to look for any signs of new fracturing or fresh spalling that might indicate further deterioration of the base.

4. Woodpecker Rock is not considered by this review to be as serious a risk as other areas, primarily because of the location of the trail relative to the rock feature. However, re-routing of the asphalt-surface trail further to the north and west of the existing trail would be a relatively simple matter. Such re-routing would provide a larger buffer zone between visitors and the potential impact area should sideward toppling of the large rock formation occur.

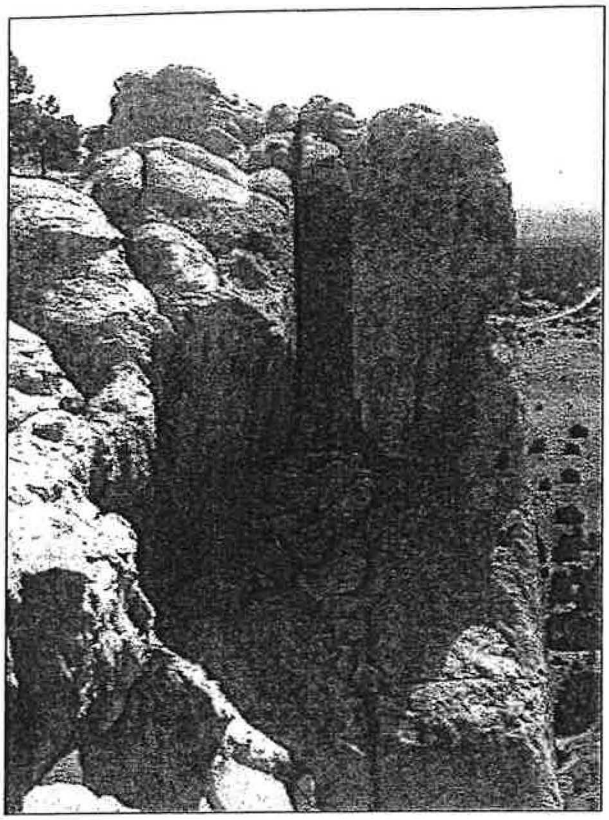
The source area for the 1942 rockfall that filled the historic pool was examined to determine if any further instabilities were present or developing. The 1942 rockfall included or was later followed by the outward toppling of an approximately 1-m-thick tabular section of rock between two vertical joints near the top of the mesa (fig. 16). Toppling was probably promoted by weathering-induced undercutting in a thin weaker layer of sandstone.

Although a number of boulders and smaller rock fragments remain on the ledge just below the original failure, the rocks appear to be stable with further movement unlikely. No fresh jointing or separations were observed behind the existing intact rock exposures.

Figure 16. Source area of 1942 rockfall above pool. Failure and outward toppling of tabular section of rock bounded by vertical joints resulted in rockfall that filled historic pool below. Note remaining boulders and rock fragments from the original failure.

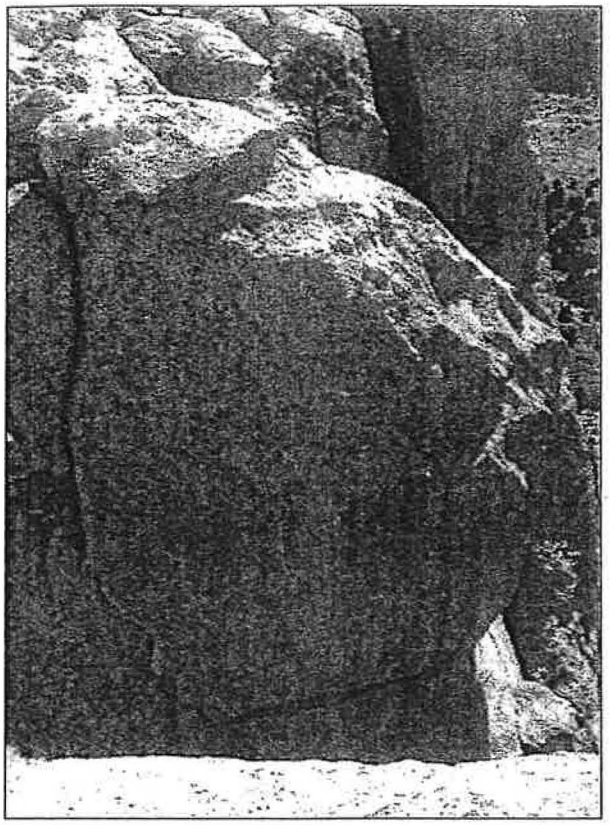
Large, overhanging sections of sandstone visible above the pool area were also examined for any evidence of impending instability. Although the overhanging rocks appear ominous from below, their center of gravity is located behind the cliff face (fig. 17). Although jointing is present behind the cliff, no open or fresh jointing that would indicate developing instabilities in the overhanging sections of sandstone were observed. In summary, nothing was evident on the mesa top above the pool area to prompt concern for potential rockfall hazards to the area below.

Figure 17. Section of overhanging mesa rim above pool area. Center of gravity of rock mass is well behind cliff face, indicating that topping failure is unlikely. Joint behind large section of rock shows no indication of recent movement.
