FORT HANCOCK GATEHOUSE

Sandy Hook Unit, Sandy Hook, New Jersey
Gateway National Recreation Area

HISTORIC STRUCTURE REPORT

April 2004

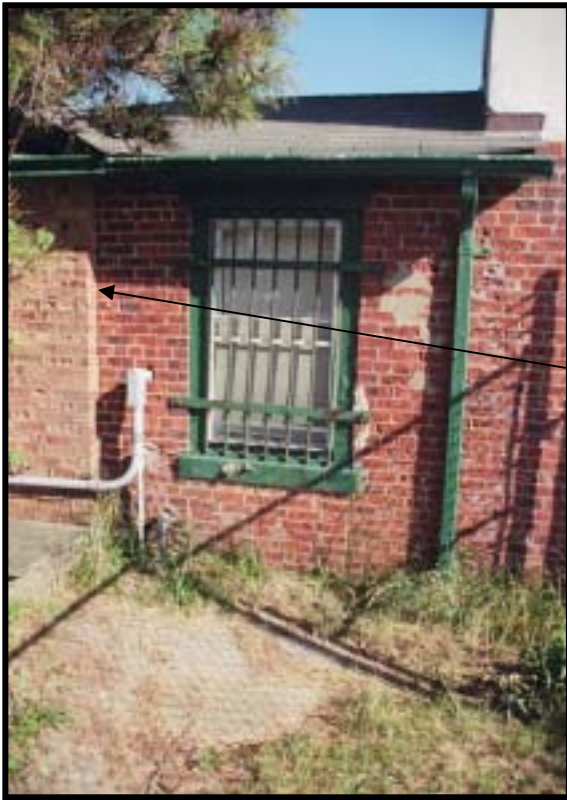
Figure 12. South elevation of annex between Gatehouse's main building at left and watchtower at right.

Note difference in brick types and set back between annex and main building.

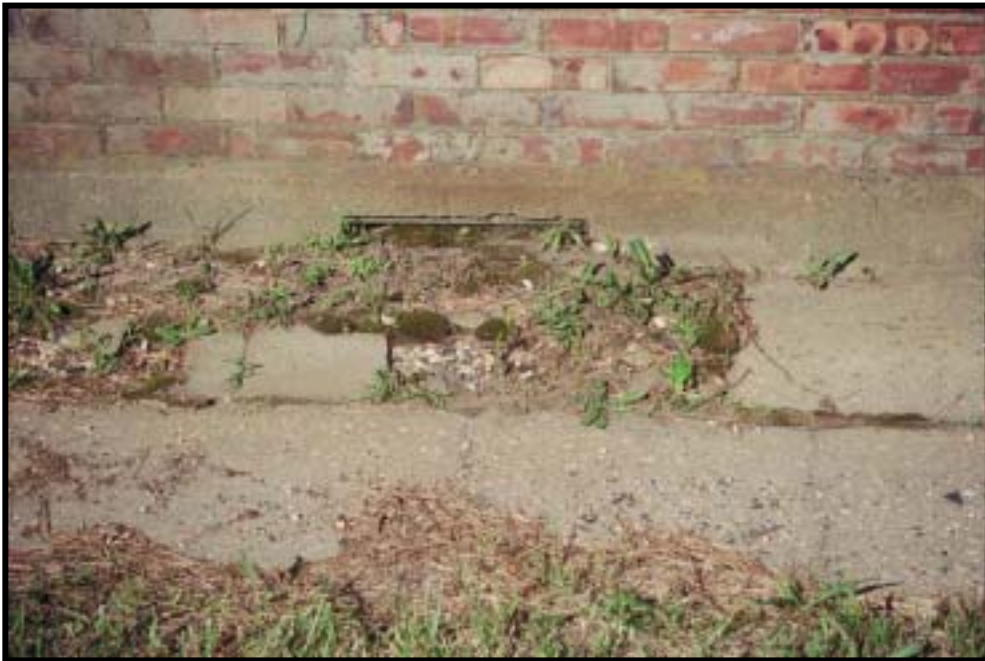
- Foundation:** Poured concrete slab. Two small openings of unknown function at ground level of building, now partially in-filled (Figs. 14- 15).
- Walls:** At the south end of the building's east elevation is the two- story watchtower. The watchtower is brick at the first- story level and stucco at the second- tory level. A narrow brick chimney with protruding clay liner attached to the center of the watchtower's east wall extends from the ground to above the structure's roofline. The wall of the center and north portions of the gatehouse's east elevation consist of the brick, one- story main building (Fig. 16). The annex, located between the watchtower and the main building of the gatehouse, is not a visible part of the gatehouse's east elevation.

Figures 14 & 15. Detail of opening found in foundation at north end of Gatehouse's east elevation. A second filled in opening is located south of window W- 113 seen at the left side of the picture.

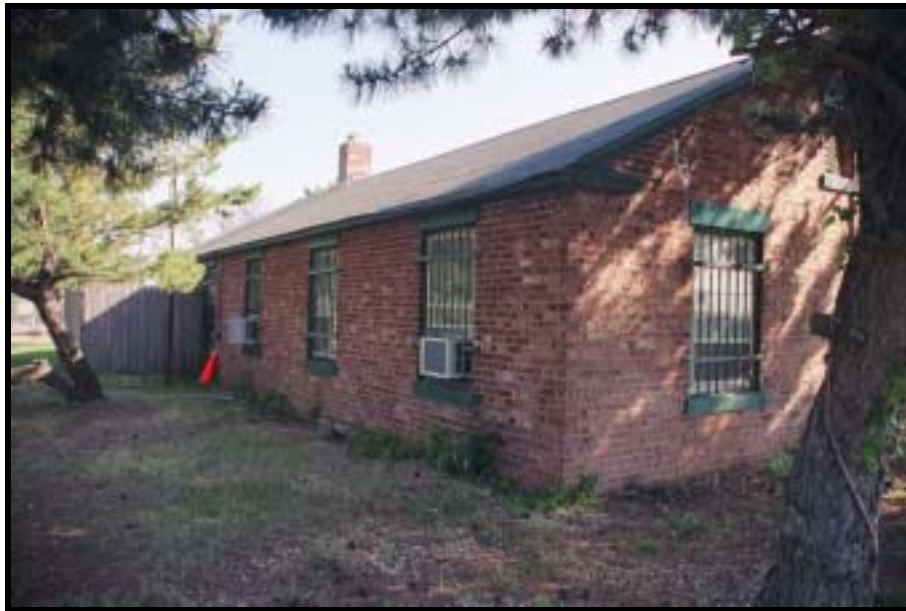
- Doorways:** No doorways are associated with the gatehouse's west elevation.
- Other:** Brick at south west corner of building and along south gable-end wall of gatehouse's main building is extremely weathered, likely due to the building's proximity to the ocean, and the apparently weaker salmon colored brick that was used on this portion of the building (Fig. 22).

Figure 20. Southeast corner of Gatehouse, showing south section of main building's west elevation.

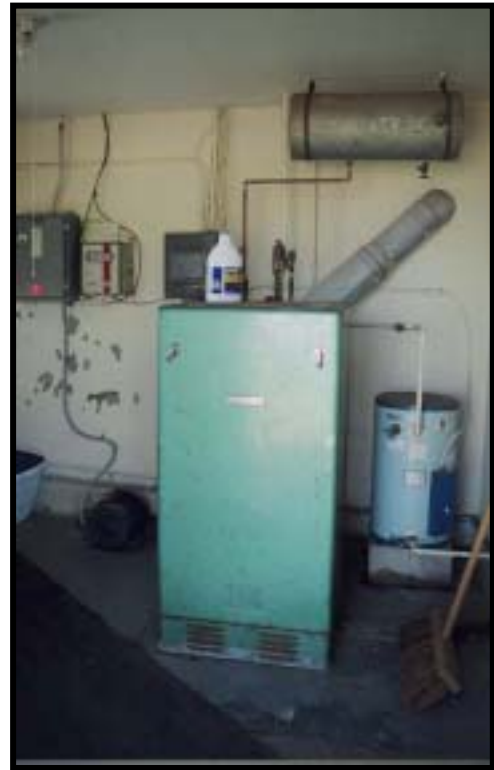
⁴³ The Weil- McLain #57 furnace was produced by the company between the years 1956 and 1962, suggesting that the original furnace originally associated with the building was replace when the State of New Jersey took over the building in 1962 or shortly thereafter.

Figure 35. Weil- McLain #57 furnace, expansion tank, and hot- water heater located in southwest corner of kitchen.

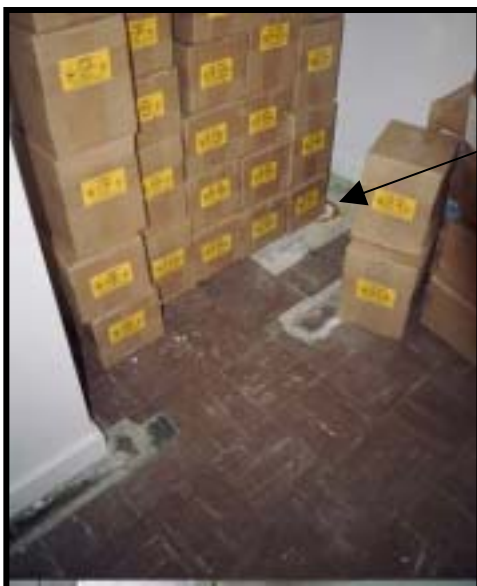
Evidence of original water- closet located in northwest corner of watchtower.

Figure 41. Detail of location of early toilet stall in room 107.

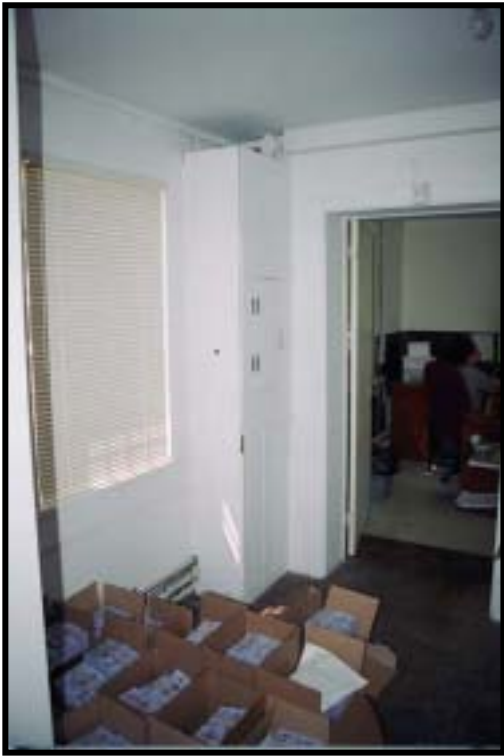
Figure 42. Southwest corner of room 107.

Other: One incandescent light fixture and one ceiling- mounted smoke detector exist in the room. A newer 200- amp circuit breaker box is located in southwest corner (Fig. 42). A large safe, likely dating to the days when the New Jersey Parks Department occupied the building (1962- 1972), sits along the north wall of the annex portion of the room (Fig. 43). An enclosed stairway to the second story of the watchtower is located in northeast corner of the room (Fig. 44).

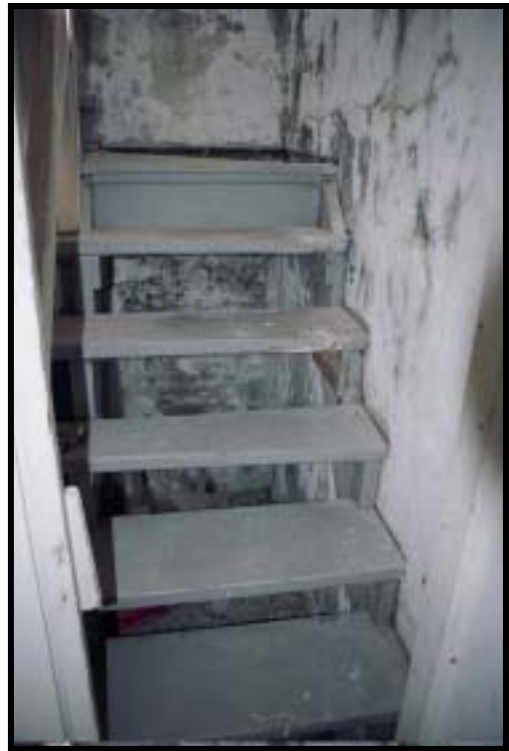
Figure 44. Enclosed stairway leading to second story of watchtower, located in northeast corner of room 107.

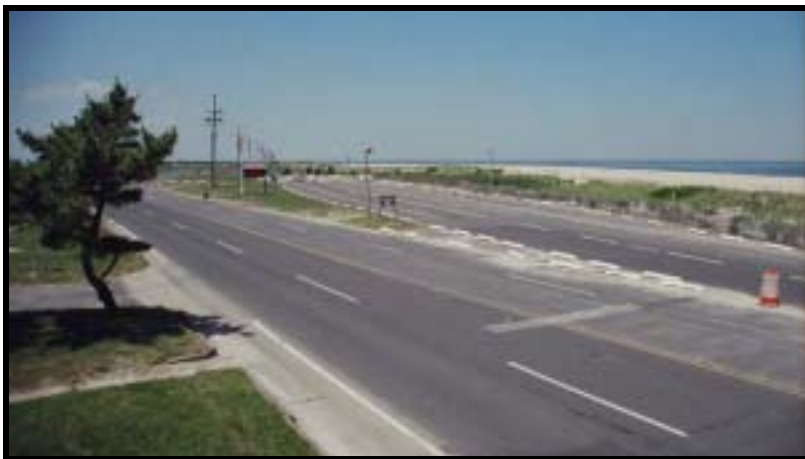
Room 201 consists of the second- story room in the gatehouse's watchtower. With large windows containing 1/1 double- hung sashes in each wall of the room, the room would offer a sentry assigned to the post an unobscured 360- degree view of the surrounding ocean and land (Fig. 45).

Figure 45. View of Sandy Hook peninsula and the Atlantic Ocean, looking north from watchtower.

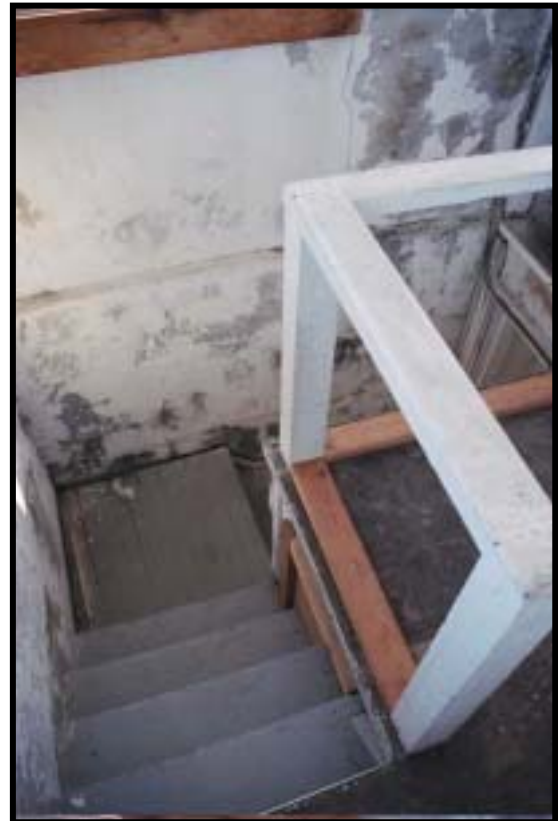
Other: One- incandescent light fixture. Wooden benches found along west and south walls of room and on south portion of east wall. Cast- iron vent pipe 4 inches in diameter originally associated with bathroom in room 107 located in northwest corner of room (Fig. 46). Parged- over flue opening between two east windows suggests room was originally heated by a small stove. Stairway descending to room 107 located in northeast corner of room (Fig. 47).

Figure 47. View of stairway in northeast corner of watchtower descending to room 107.
