HISTORIC STRUCTURE REPORT

JAMES MORSE HOUSE
LINCOLN HOME NATIONAL HISTORIC SITE
SPRINGFIELD, ILLINOIS

HISTORICAL DATA SECTION
ARCHITECTURAL DATA SECTION
EXTERIOR RESTORATION PROPOSAL

ALAN W. O'BRIGHT

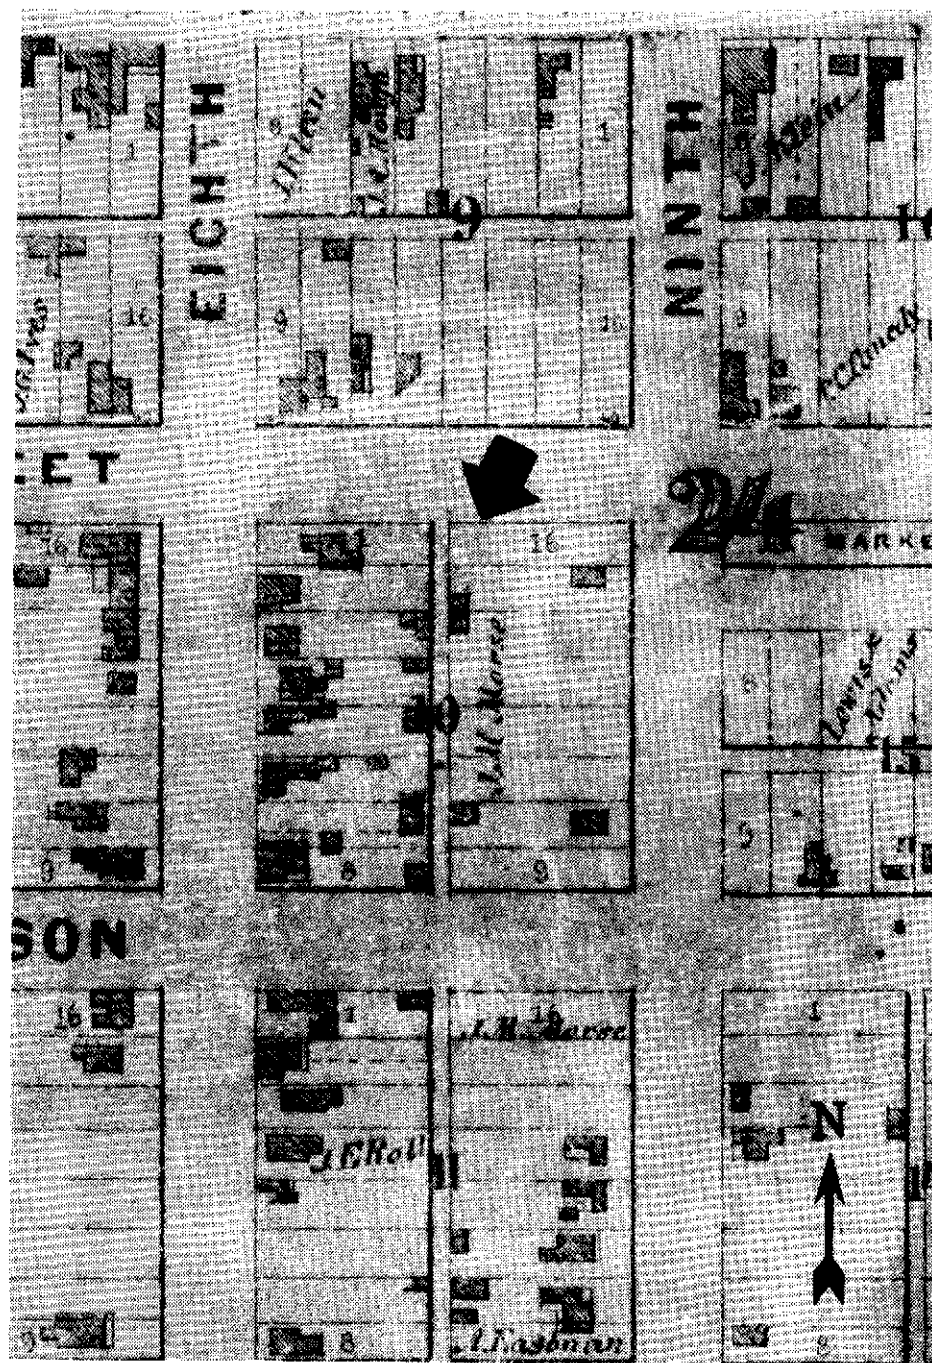
FIGURE NO. 1

This map indicates that the Morse House
(HS-09) had not been constructed by 1854
on Lot 16, but James Morse's house was
built by that time on Lot 15.

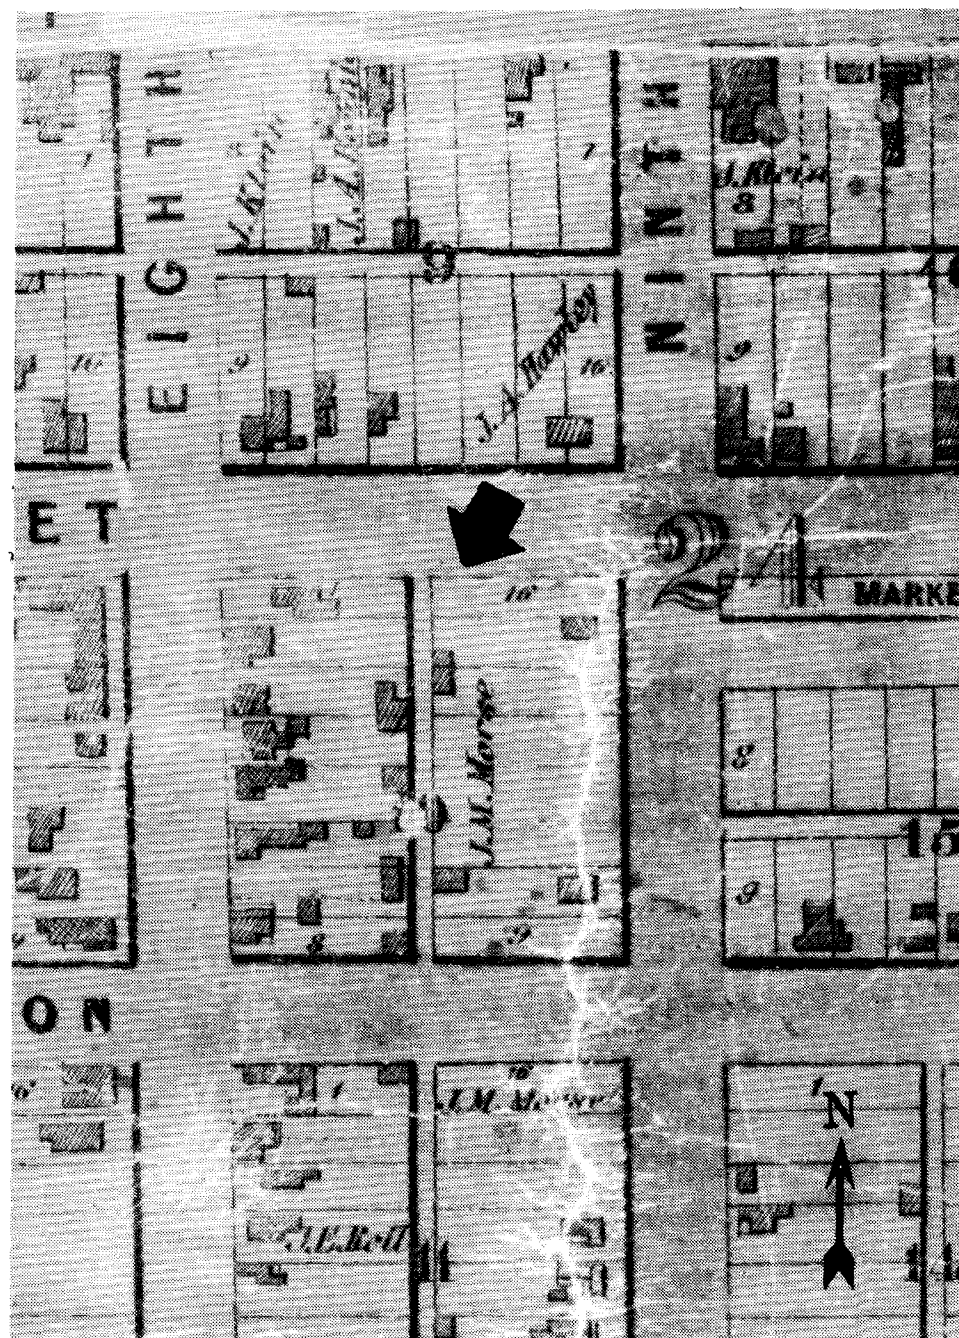
FIGURE NO. 2

In comparing this 1858 map with the
1854 map (Figure No. 1), no changes
had taken place on the James Morse
property.

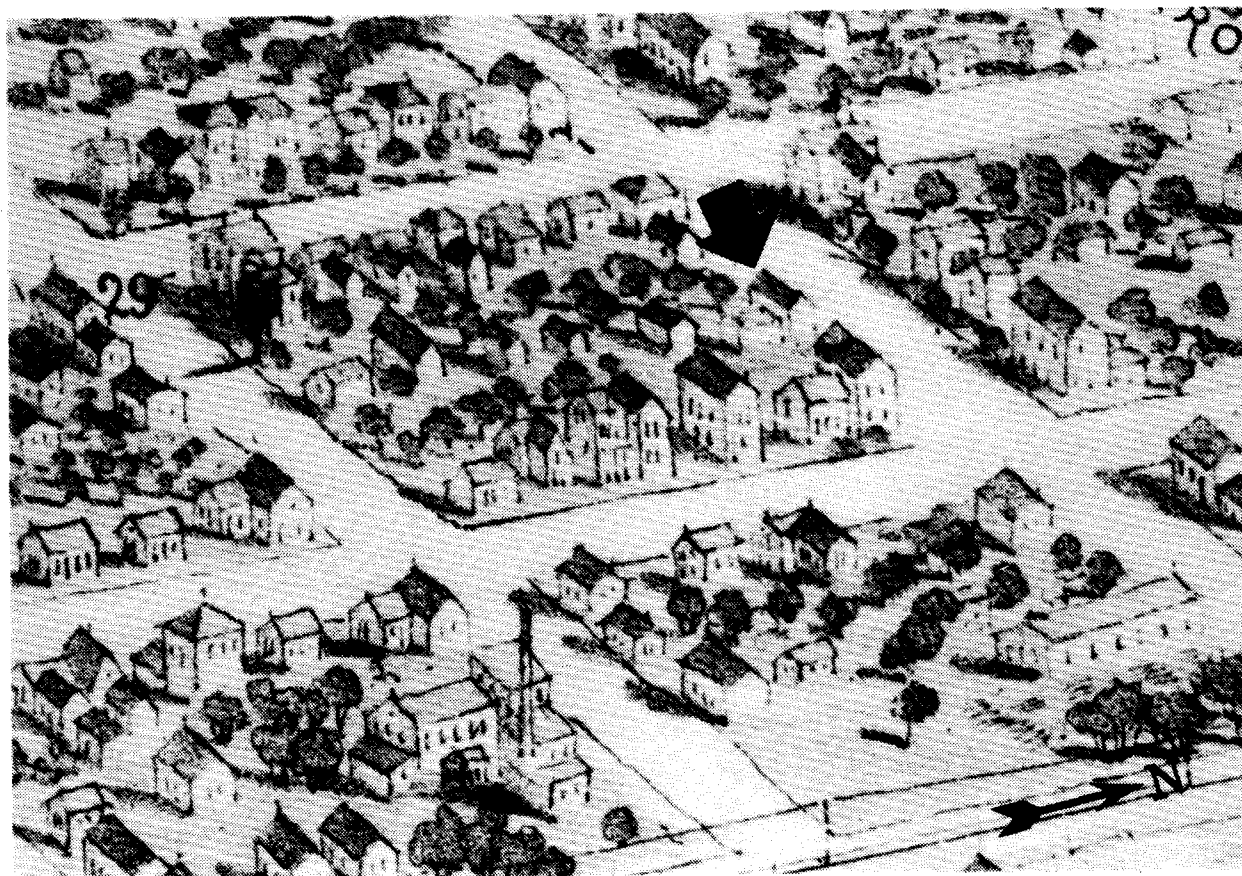
FIGURE NO. 3

This portion of an 1867 panorama of Springfield shows the
Morse House as a two story structure with a single floor south
wing. No porches, windows or doors are indicated.

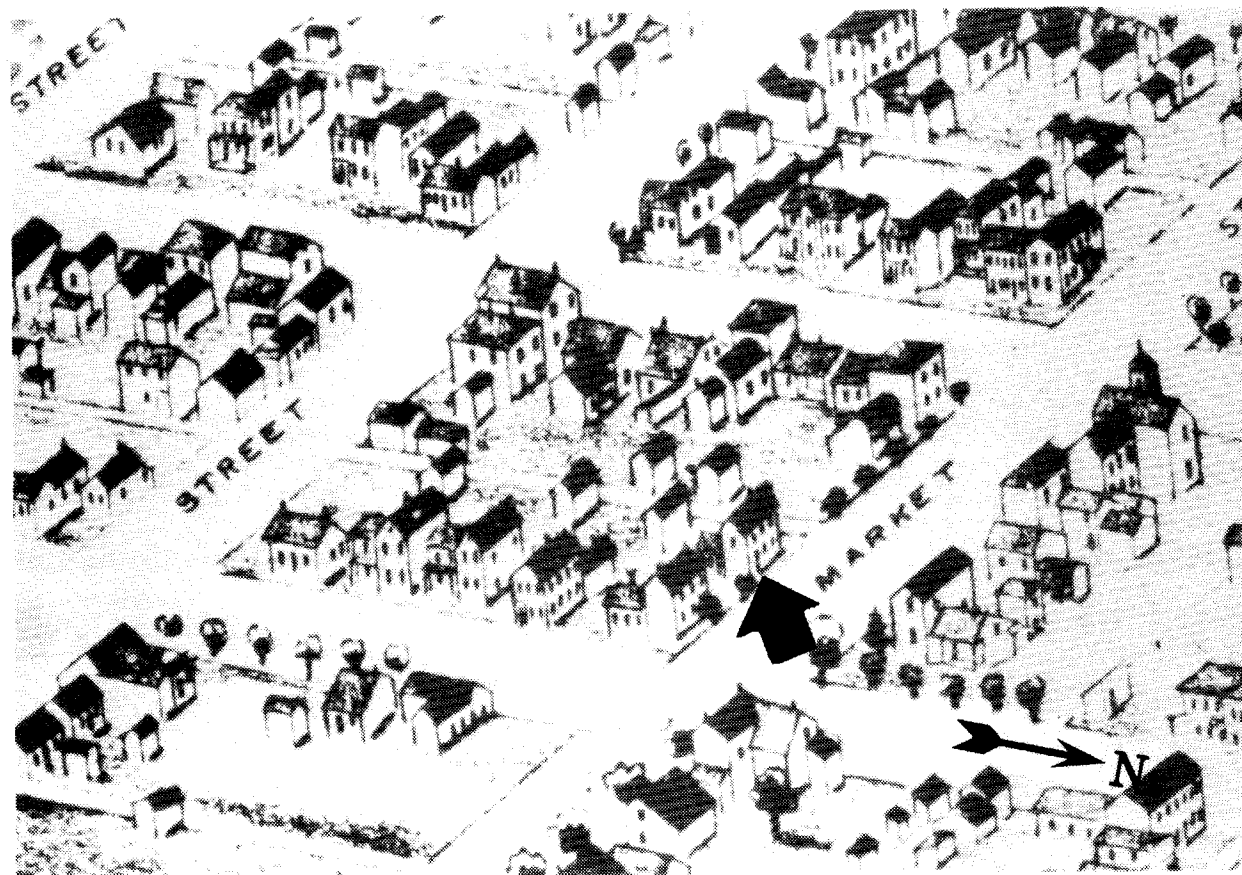
FIGURE NO. 6

View from the northeast shows a two story structure with a south wing as with the previous panoramas. However, the front entry is shown on the north elevation and only one window is shown on the east elevation.

Window 103-W1 was once the front entry to the original portion of the structure (see Figure No. 6). Base moulding at 103-W1 has been butted flush with adjacent moulding and its dimensions are not consistent with other windows in the house.

The circa 1872 panorama (see Figure No. 6) indicates that a door was located on the east wall near the northeast corner of Room 104 leading to the east porch. However, a wood door sill and the irregularity in stud framing indicates that an exterior door was located along the east wall of Room 104 near the southeast corner. A wood door sill was also found beneath the finished floor between the jambs of door 107-W1. The door may have been a rear entry into the circa 1867 kitchen wing.

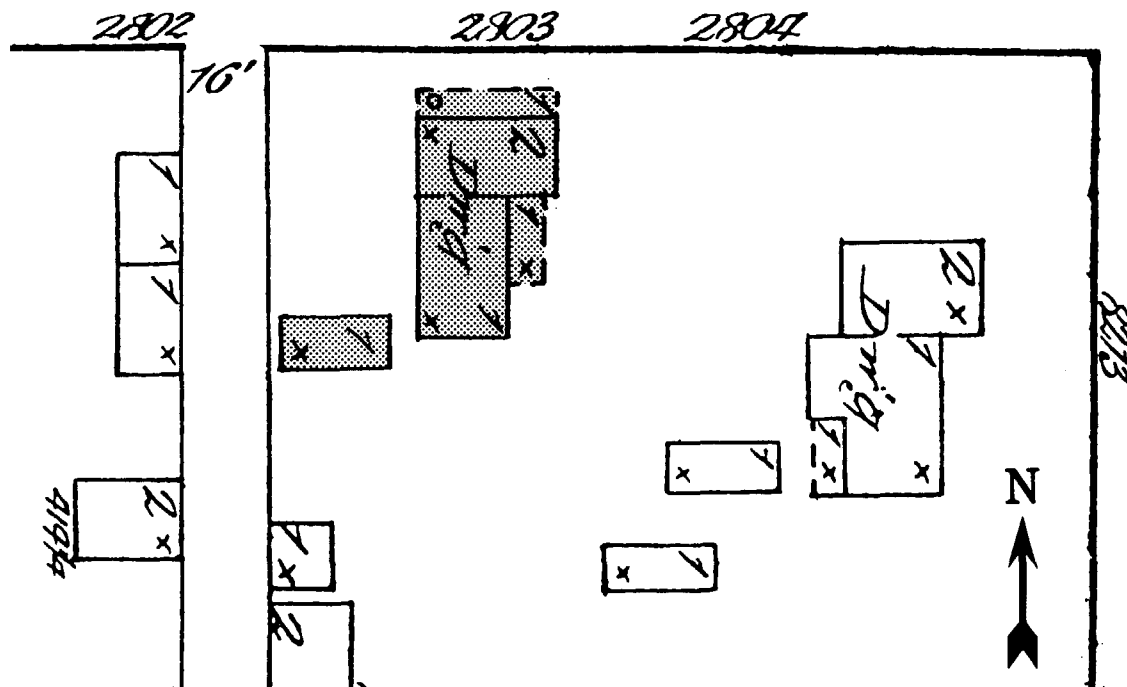
FIGURE NO. 7

First map documentation showing all porches. Note the 1875
south wing extension past the east porch.

Historic maps and bird's-eye views indicate that a shed-type structure once existed along the alley to the southwest of the Morse House (see Figure No. 7). The structure's precise location, composition of construction, and fenestration are unknown.

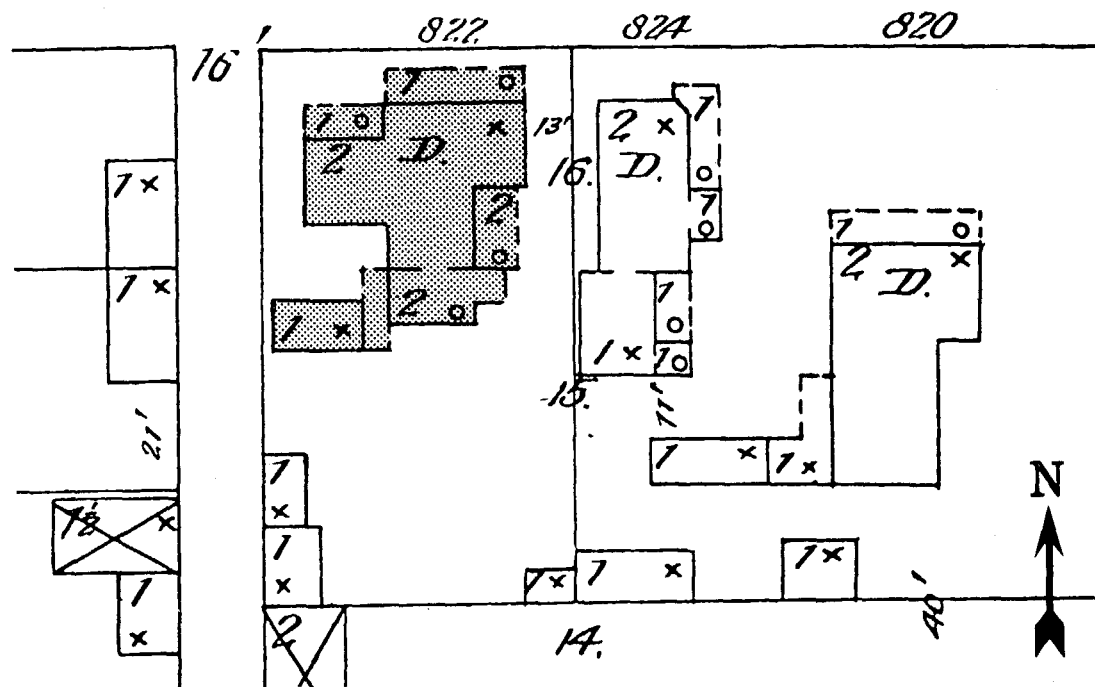
FIGURE NO. 9

Extensive additions since 1890 included the west wing with a north porch, a two floor east porch, a small room to the southeast corner, and a link to the shed. The map indicates that a second floor existed over the south wing kitchen, but no physical evidence has been uncovered to support this documentation.

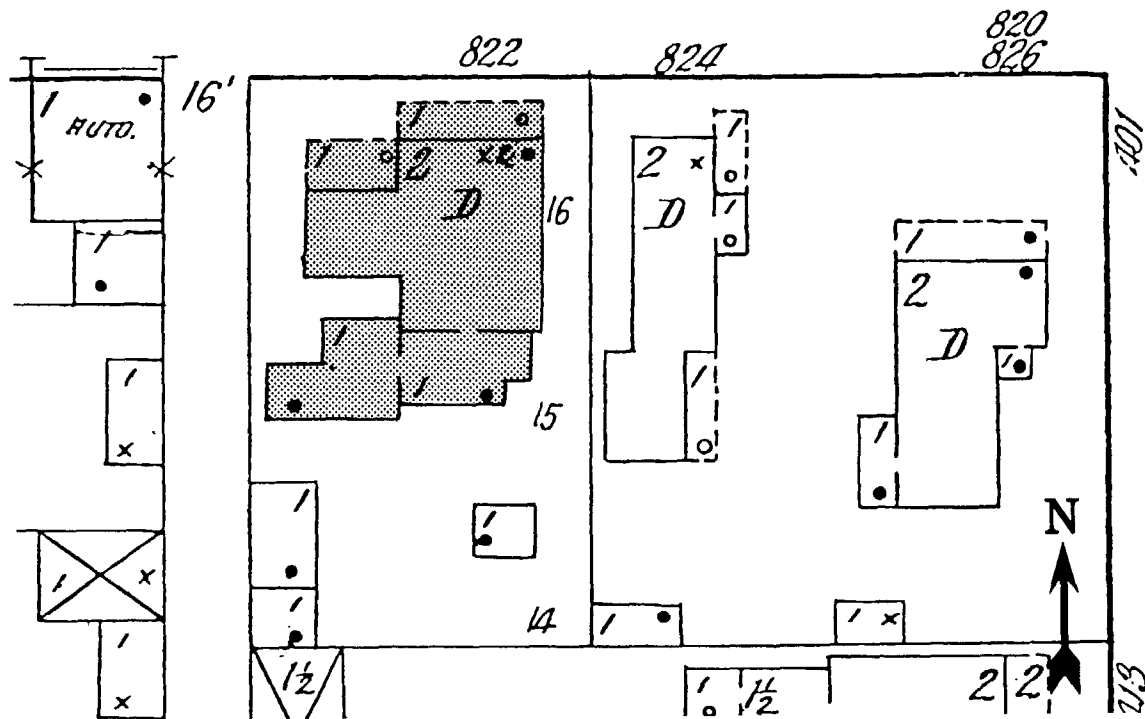
FIGURE NO. 10

The map indicates that the link to the shed had grown slightly and the east porch had been completely enclosed by 1917.

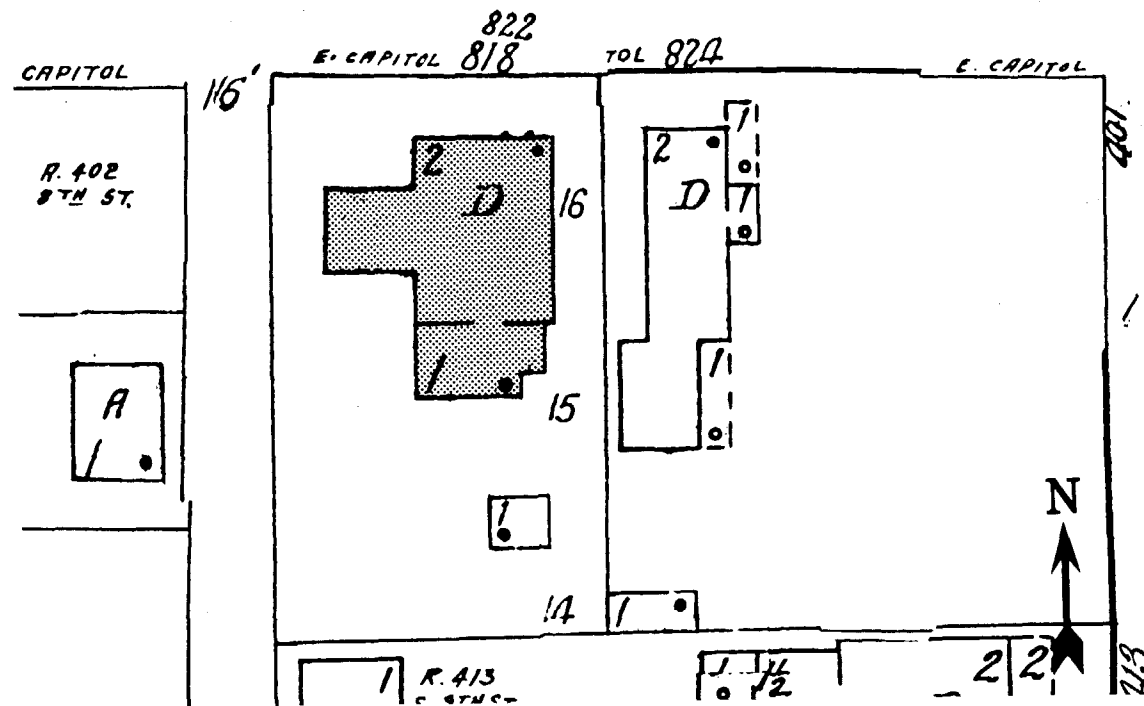
FIGURE NO. 11

This map essentially indicates conditions as they exist
today.

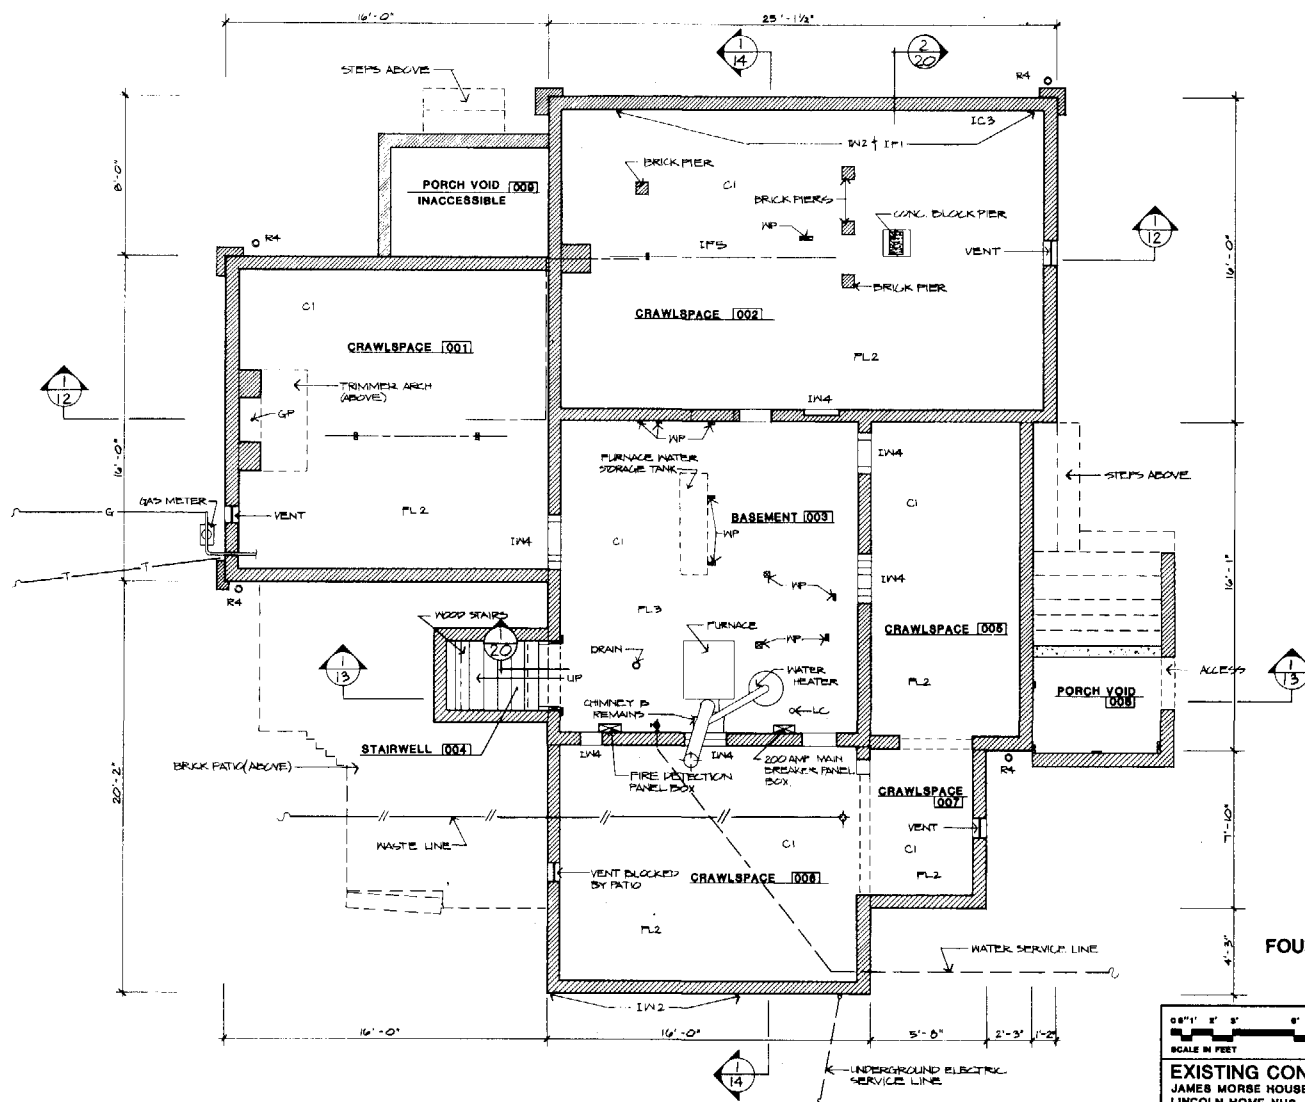
FOUNDATION PLAN

FLOORS	IF 1 TERMITE DAMAGE TO JOIST/SILL
	IF 2 RODENT DAMAGE
	IF 3 WATER DAMAGE
	IF 4 WORN FINISH
	IF 5 4X4 SUPPORTED BY MECHANICAL PIPES
	IF 6 FLOOR SETTLING
	IF 7 CARPET WORN/DIRTY
	IF 8 FIRST FLOOR PARTITION POORLY SUPPORTED
	IF 9 HALL PARTITION POORLY SUPPORTED
WALLS	INTERIOR
	IW 1 WATER DAMAGE
	IW 2 DETERIORATED BRICK
	IW 3 STUD SEVERED
	IW 4 PORTION OF BRICK WALL REMOVED
	IW 5 INADEQUATE HEADER ABOVE DOOR/WINDOW
	IW 6 SECOND FLOOR STUDS INADEQUATELY SUPPORTED
	IW 7 WALL PLATE NOT SUPPORTED FROM BELOW
	IW 8 TERMITE DAMAGE TO STUDS
	IW 9 STUDS NOT ORIGINAL TO INITIAL CONSTRUCTION
	EXTERIOR
	EW 1 SPALLED BRICK
	EW 2 MORTAR JOINTS FAILING
	EW 3 ROTTED SIDING
CEILINGS	IC 1 WATER DAMAGE
	IC 2 PLATE CUT FOR WASTE VENT
	IC 3 ROTTED SILL/PLATE
	IC 4 ROTTED JOIST END
ROOF	ER 1 SHINGLES FADED
	ER 2 ROTTED CORNICE
	ER 3 DETERIORATED SHEATHING
