HISTORIC STRUCTURE REPORT

JULIA SPRIGG HOUSE (HS-11)

Lincoln Home National Historic Site
Springfield, Illinois

May 1995

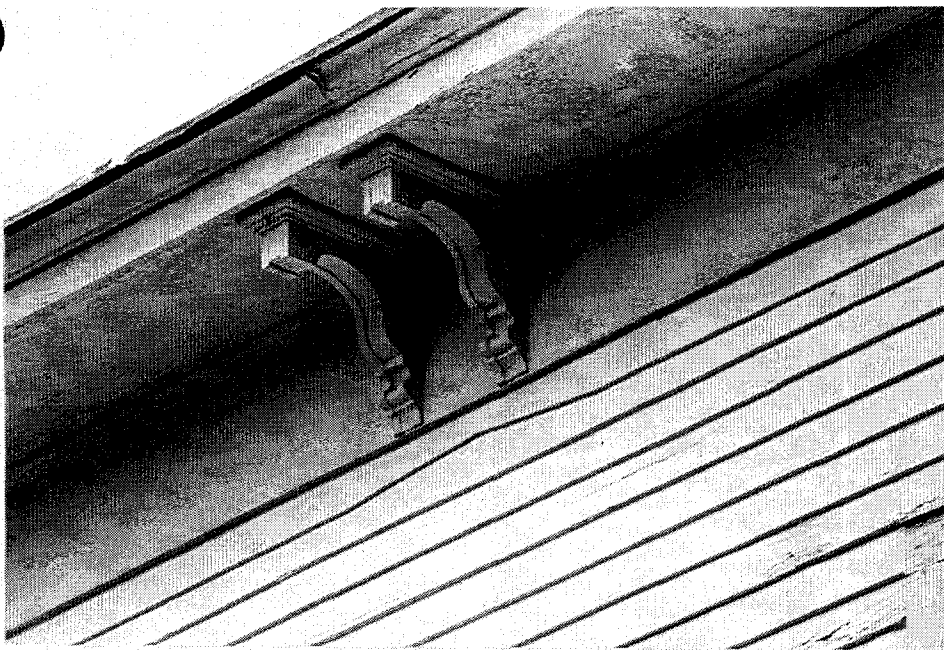
**FIGURE 3.5 TOP
CLAPBOARD AT
SOUTH WALL
1874/1879 ADDITION**

This angle cut profile most likely was cut to match the head trim profile at an 1874/1879 window in this location.

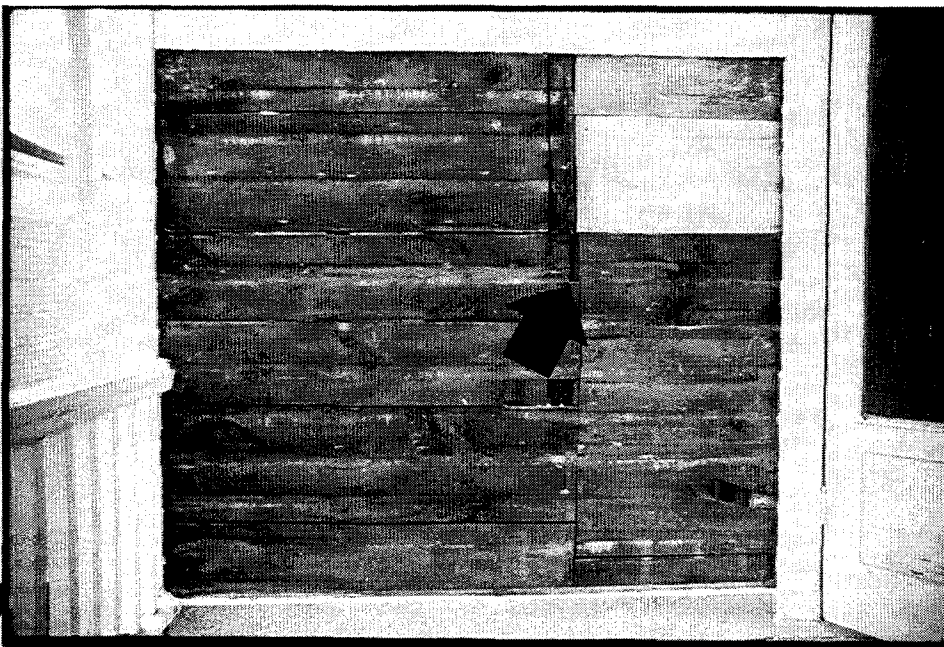
**FIGURE 3.6 SECOND
FLOOR SHEATHING**

This is a view of the sheathing at the south end of the east wall on the second floor of the 1874/1879 addition. Note the slight cut in the sheathing apparently indicating a window location.

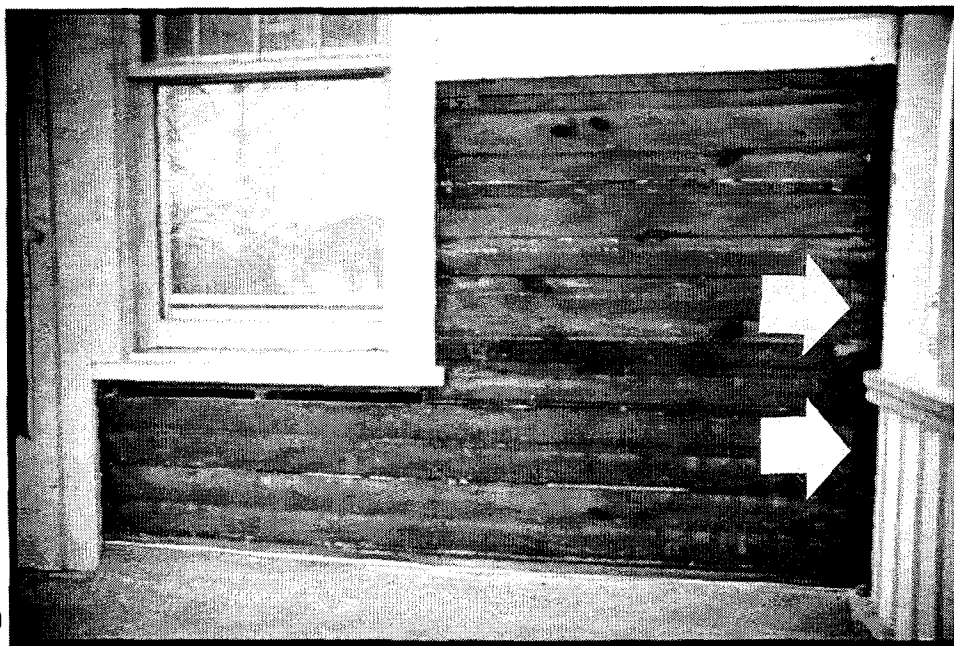
FIGURE 3.8 SECOND FLOOR SHEATHING

The north, east, and south walls of the 1874/1879 addition are sheathed with a 1" x wide board sheathing (see Figure 3.8), varying in width from 8" to 12½". Where removals allowed for examination, this sheathing appeared to be in good condition. No sheathing was found at the west elevation. It may be that no sheathing ever existed at this surface; rather, the interior side of the studs (see Figure 3.63) was sheathed, or perhaps the sheathing was removed as part of the 1922/1924 renovations. No conclusive evidence has been found to confirm either possibility.

A view of the sheathing at the north end of the east wall at the second floor of the 1874/1879 addition. Note the opening in the sheathing for the window. Also note the two areas of sheathing cut outs (one is infilled) near the corner board and handrail.

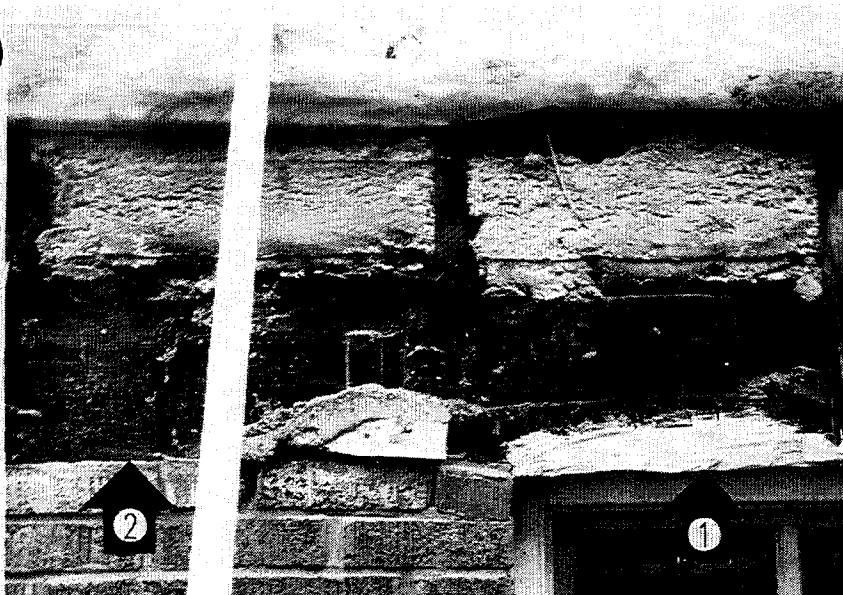
**FIGURE 3.9 SILL
BEAM AT THE
SOUTHWEST PORCH**

View of sill beam (1)
and box sill (2) junction
in the south wall of the
1851 cottage. This junc-
tion is near the limits of
the southwest porch.

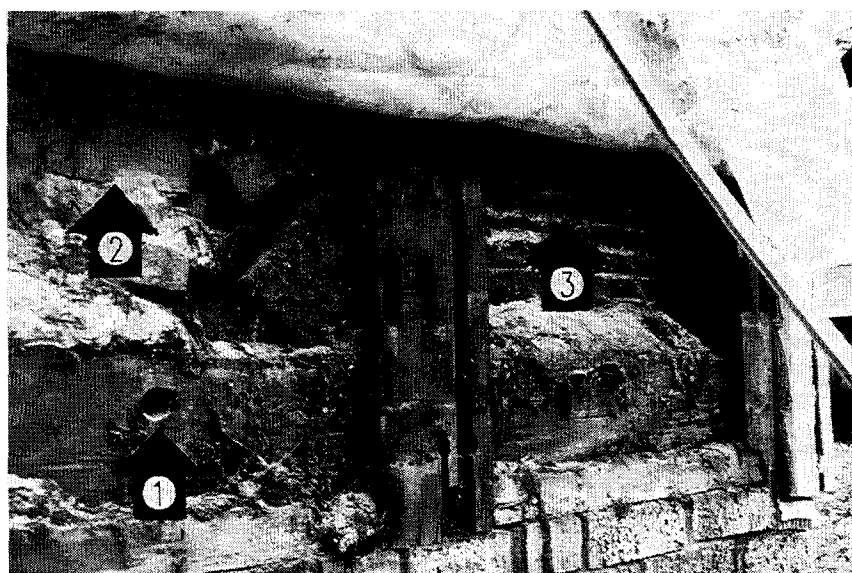
**FIGURE 3.10 NORTH-
WEST CORNER OF
THE 1851 COTTAGE**

A view of the diagonal
bracing at the northwest
corner (north wall).
Note the treenail loca-
tion (now only a hole)
(1), the brick nogging
(2), and hand hewn lath
to the right side of the
photograph (3).

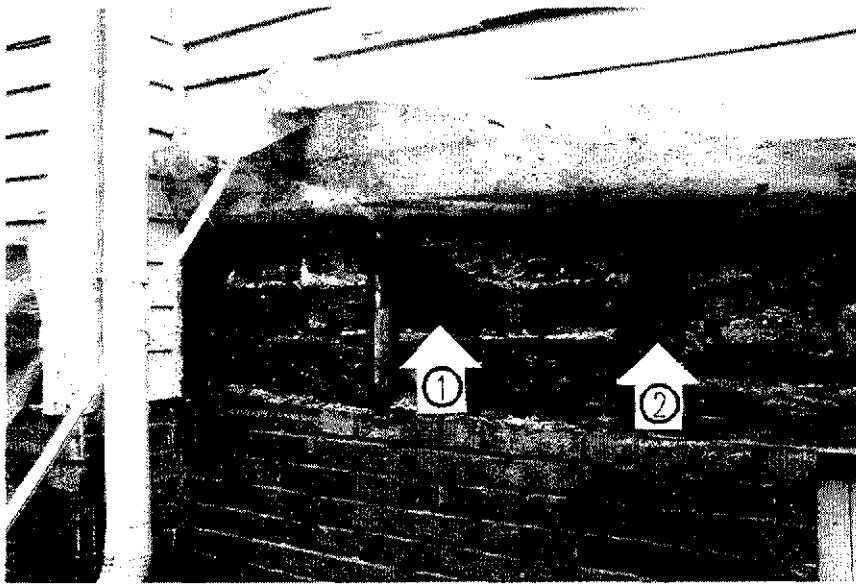
FIGURE 3.11 NORTH-EAST CORNER OF THE 1851 COTTAGE

A view of diagonal bracing (1) at the northeast corner (north wall) of the 1851 cottage. Note the furring strips on the face of the studs (2). These studs were furred-out to allow alignment with the sheathing at the second floor.

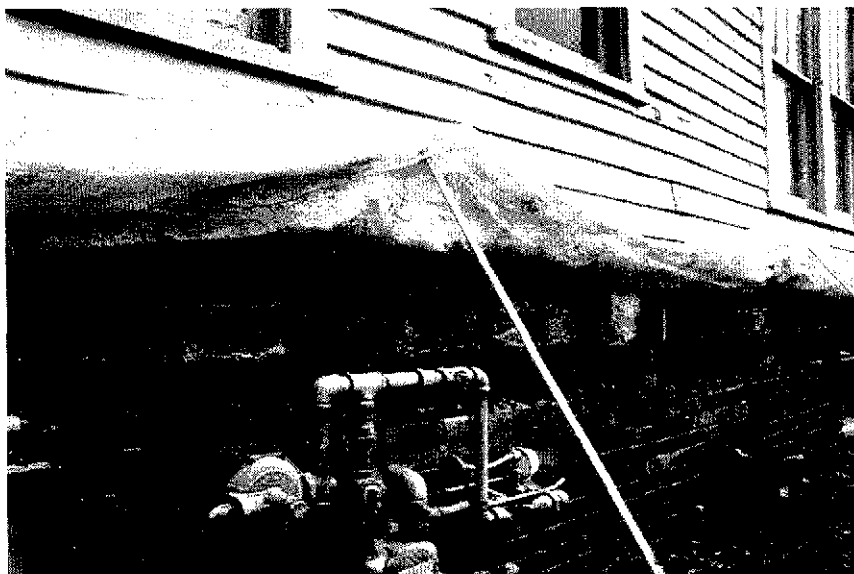
FIGURE 3.12 VIEW OF THE NORTH WALL OF THE 1851 COTTAGE

A view of the north wall showing studs, stud furring, and brick nogging.

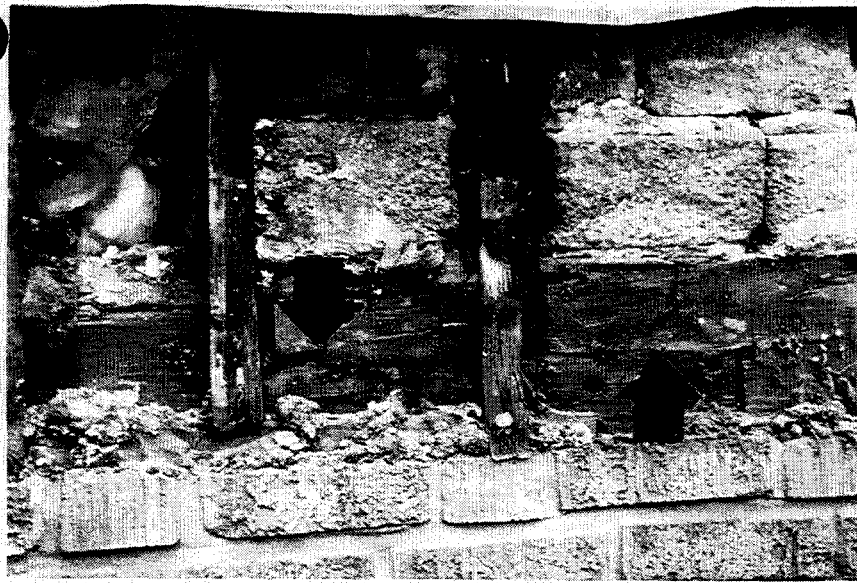
FIGURE 3.13 SHOULDER LAP AT THE 1851 COTTAGE SILL BEAM

This is a view of the shoulder lap at the north sill beam at the west ell.

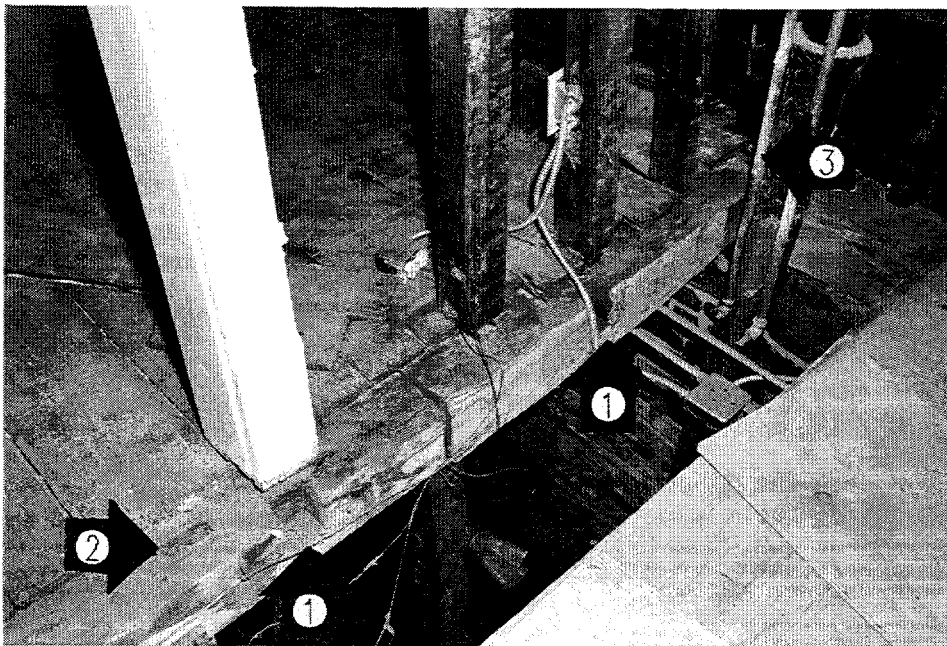
**FIGURE 3.19 JOIST
POCKETS AT THE
SOUTHWEST PORCH**

This wood sill beam, severed into two pieces, is located at the east limits of the southwest porch of the 1851 cottage. Note the joist pockets in the beam (1). At one time the porch floor joists framed into these pockets. Also note the mortise for a stud tenon (2) and the dovetailed joint (3) where this sill beam intersects the perimeter sill beam.

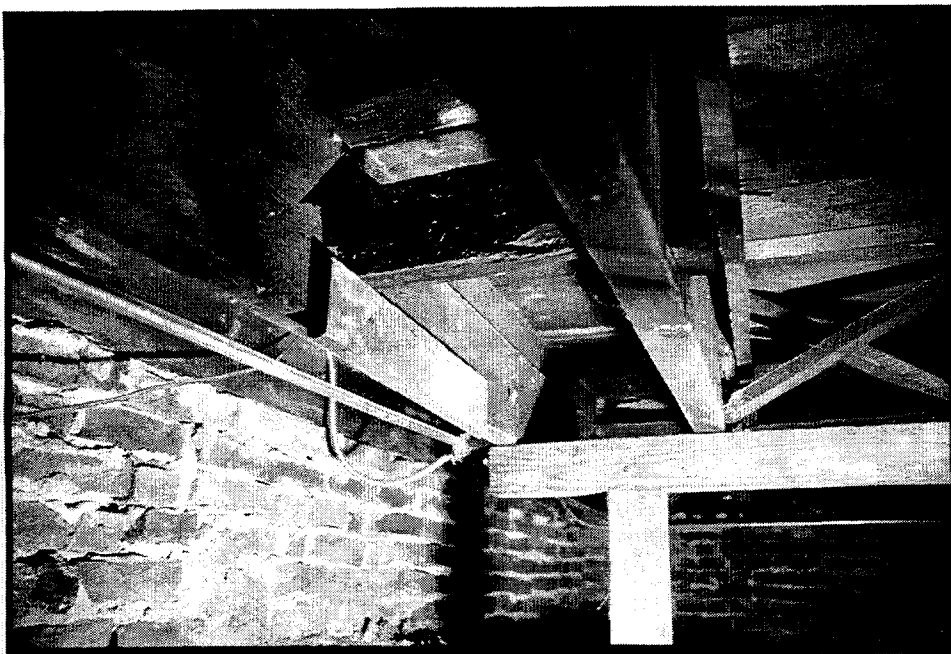
**FIGURE 3.25 LOCA-
TION OF THE CHIM-
NEY STACK AND
HEARTH**

There are several pieces of evidence of a chimney and fireplace associated with the 1874/1879 addition. The two northernmost floor joists at Room 102 suggest a hearth location and the size of a nineteenth-century chimney stack (see Figure 3.25). These joists have been notched to a depth of 3 $\frac{7}{8}$ " at a length of 4'-10 $\frac{1}{4}$ ", beginning 6'-4" \pm from the west sill beam. There is a 1"x6" nailer at the southernmost of these two joists to catch the ends of the floorboards cut at this hearth opening. The chimney stack was probably as wide as the hearth (4'-10 $\frac{1}{4}$ ") and filled the space between the northernmost joist and the adjacent sill beam. No evidence of this chimney stack or a fireplace has been revealed at the second floor joists. There are mortar markings on the face of two north wall studs in

These notches in the first floor joists of the 1874/1879 addition are near the north wall in Crawl Space 001 and indicate the limits of the hearth at the non-extant fireplace and, probably, the east and west limits of the fireplace itself.

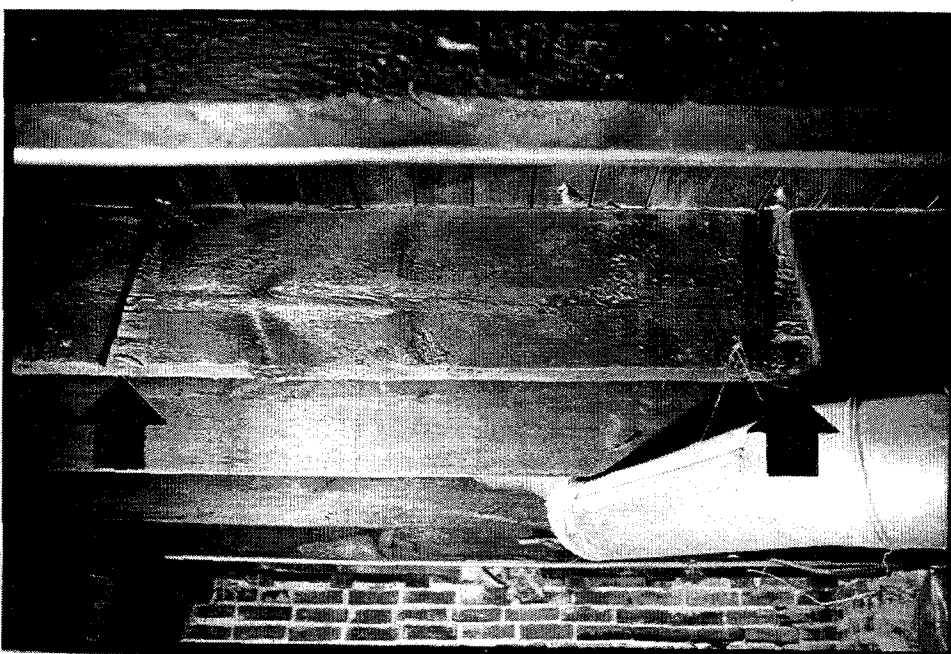
**FIGURE 3.26 INDICA-
TION OF THE
1874/1879 ADDITION
STAIR**

This is a view of the newel post indications at the joist in Crawl Space 001.

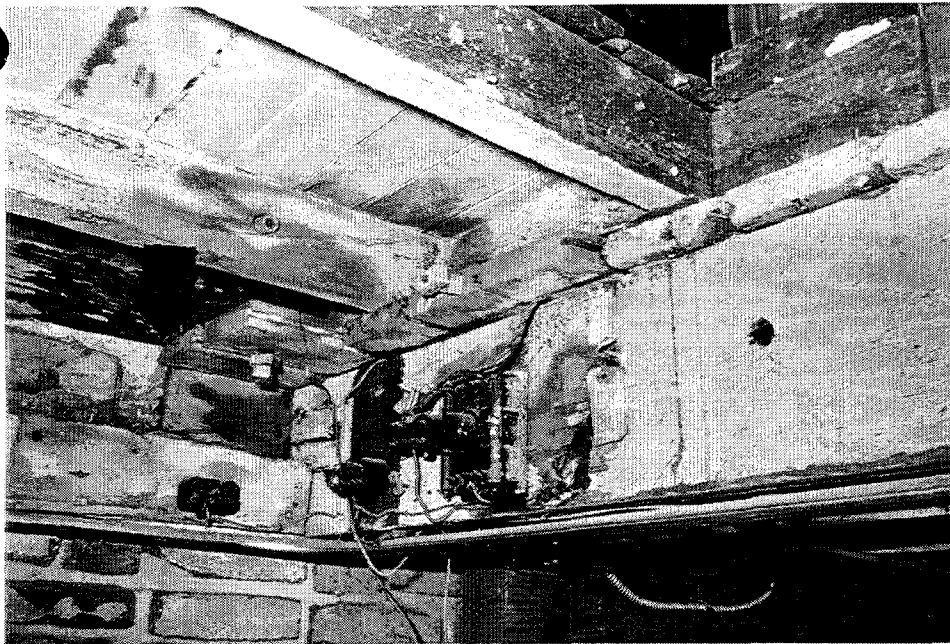
FIGURE 3.27 CELLAR ACCESS EVIDENCE

While there is no documentation of an original stair to the basement (or cellar), physical evidence suggests that there may have always been a stair to the basement (see Figure 3.27). The stair opening would have been no wider than 2'-0" \pm and would have been framed by the west sill beam and the adjacent floor joist (now-severed) within the limits of the present floor opening at the northwest corner of the house. The floor opening was likely always 7'-6" \pm long (its present length) since there is no evidence to indicate that the floor boards were ever nailed into the west sill beam north of this point. However, it is possible that these holes are filled with paint and not visible. Additionally, some of the floor boards end at the location of the former joist.

This cut in the subfloor at this sill beam notch represents the probable width of an interior cellar access.

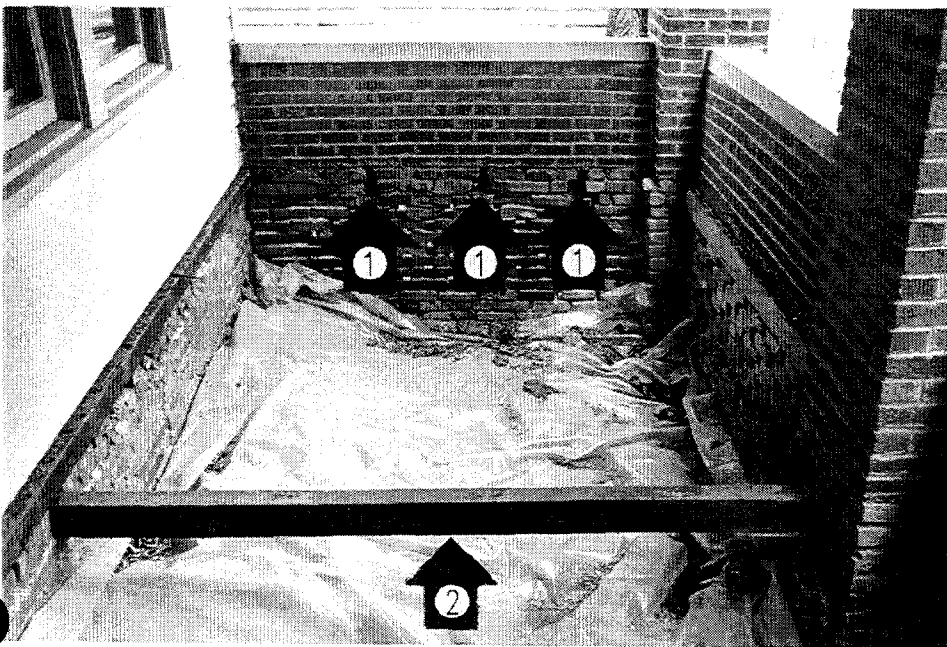
FIGURE 3.28 EAST PORCH FRAMING

Nominal 2x6 framing rested in these notches (1) at the brick wall. Wood beams (2) are located at the intermediate brick piers.

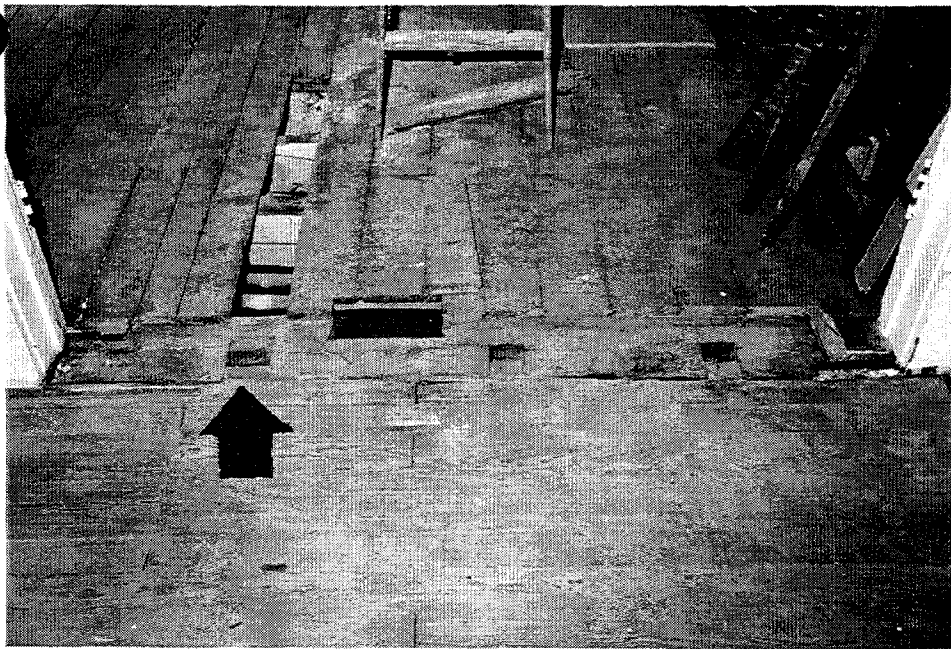
FIGURE 3.29 TOP OF SILL BEAM AT EAST WALL OF 1851 COTTAGE

This sill beam indicates the mortise locations for tenoned wall framing including studs and an intermediate post. The intermediate post location (see arrow) sets at the east end of an interior wall.

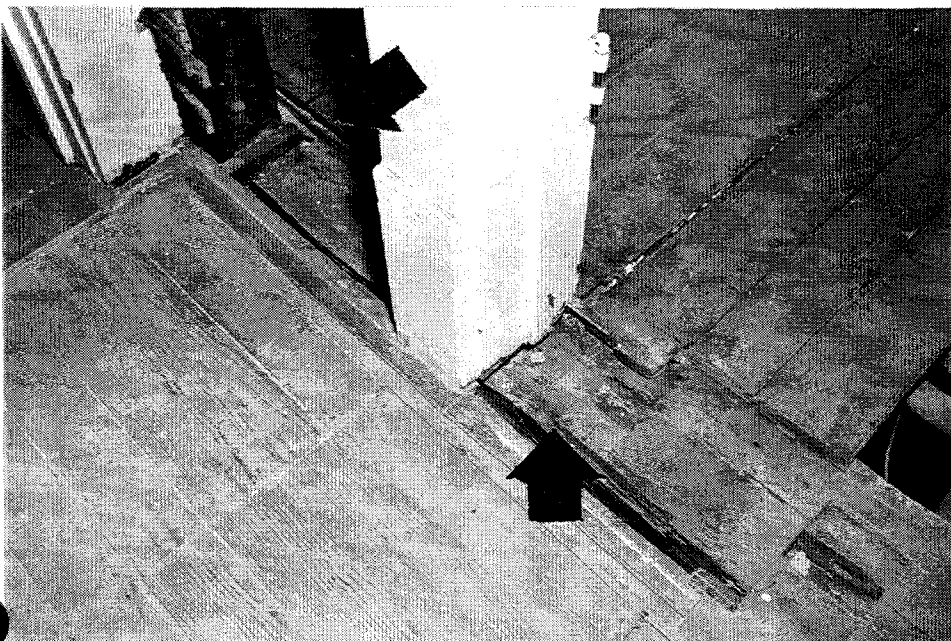
FIGURE 3.30 TOP OF SILL BEAM AT EAST WALL OF 1851 COTTAGE

This sill beam indicates the notched location for the door sill at the east (front) door to the cottage.

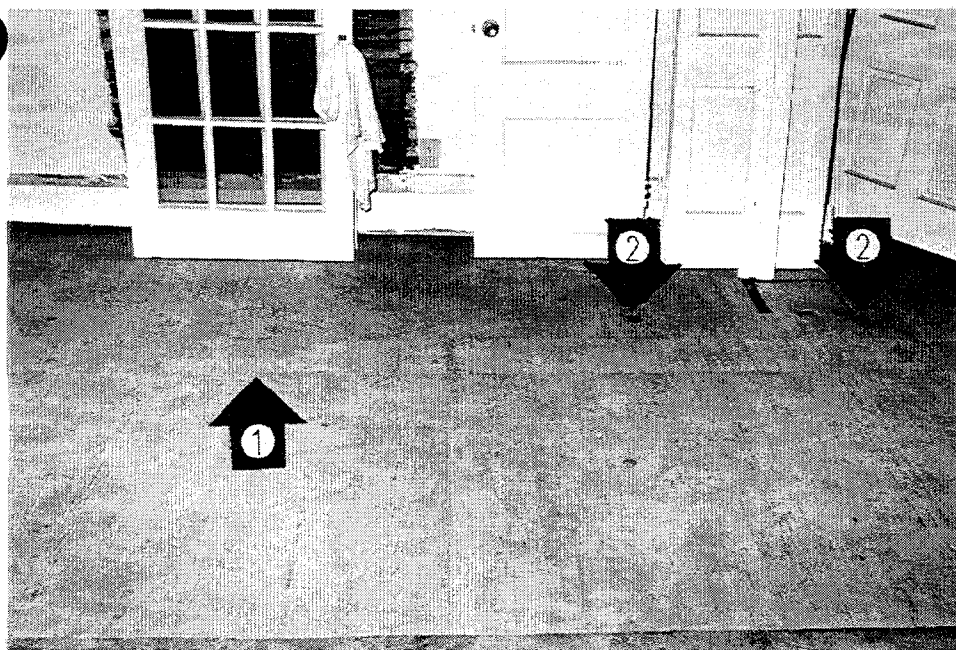
**FIGURE 3.31 GHOST-
ED WALL LOCATION
AT FLOOR OF ROOM
101**

This wall location—with a door at its east end (1)—travels directly in front of the location of nineteenth-century stair newel posts locations (2).

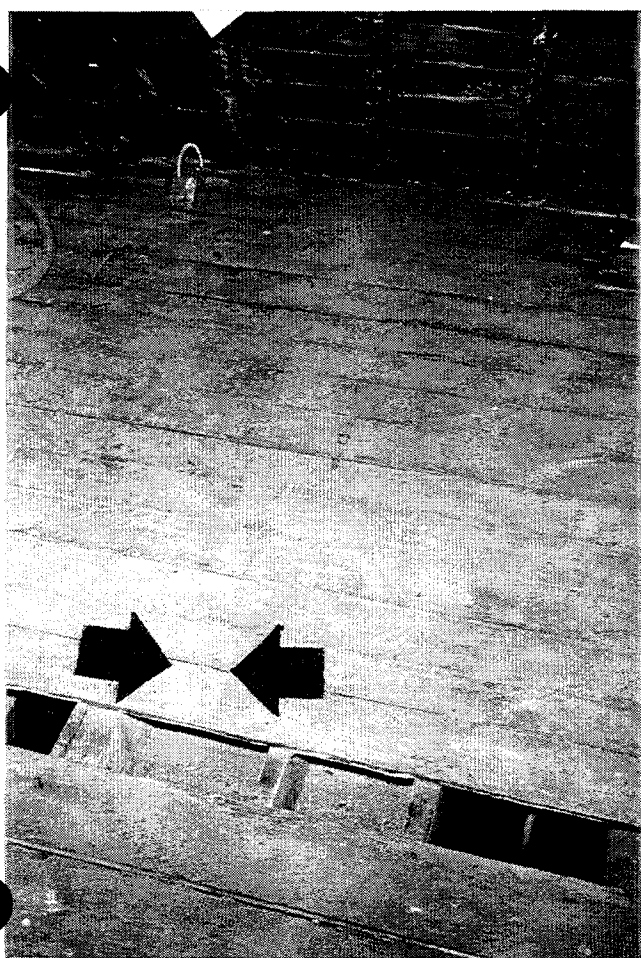
**FIGURE 3.32 GHOST-
ED WALL LOCATION
AT FLOOR OF ROOM
103**

This faint mark (see arrow) at the subfloor indicates the wall which set at the west limit of the entry vestibule of the 1851 cottage.

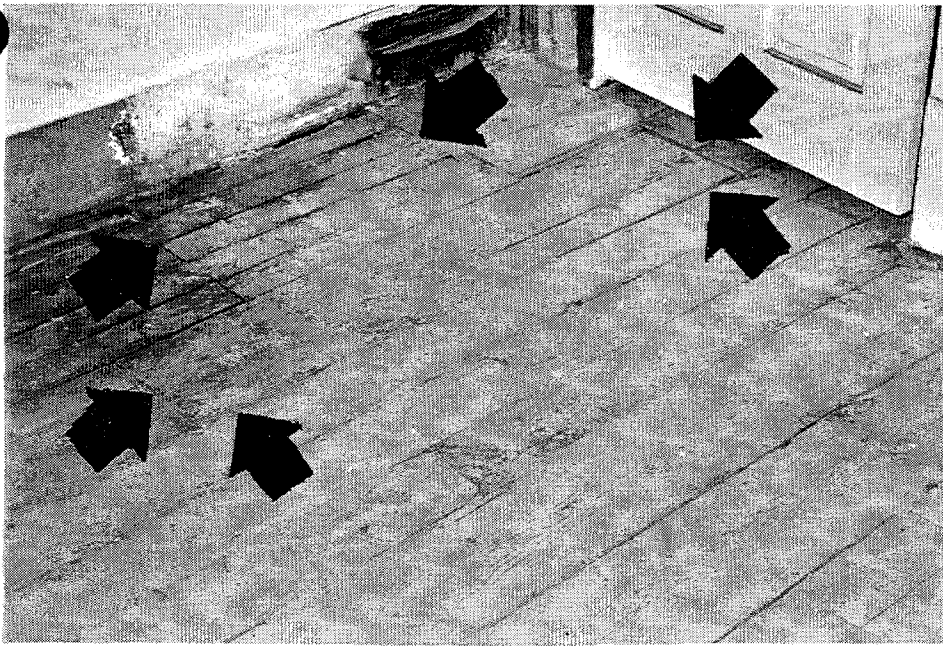
FIGURE 3.33 SUB-FLOOR AT ROOM 104

These infill boards at the subfloor indicates the location of the passage of a chimney flue. The location of these boards aligns with the largest framed opening seen in Figure 3.34.

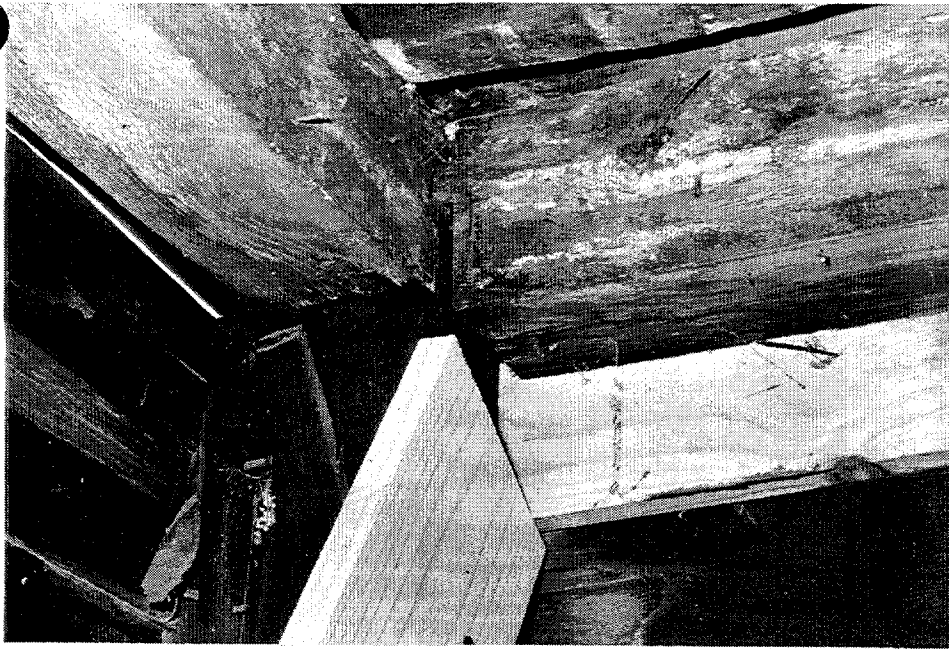
**FIGURE 3.41 SOUTH-
WEST PORCH COR-
NER POST**

This 1851 cornerpost was discovered in place in the wall of Room 107. Note the framing conditions of the post's intersection with the beams.

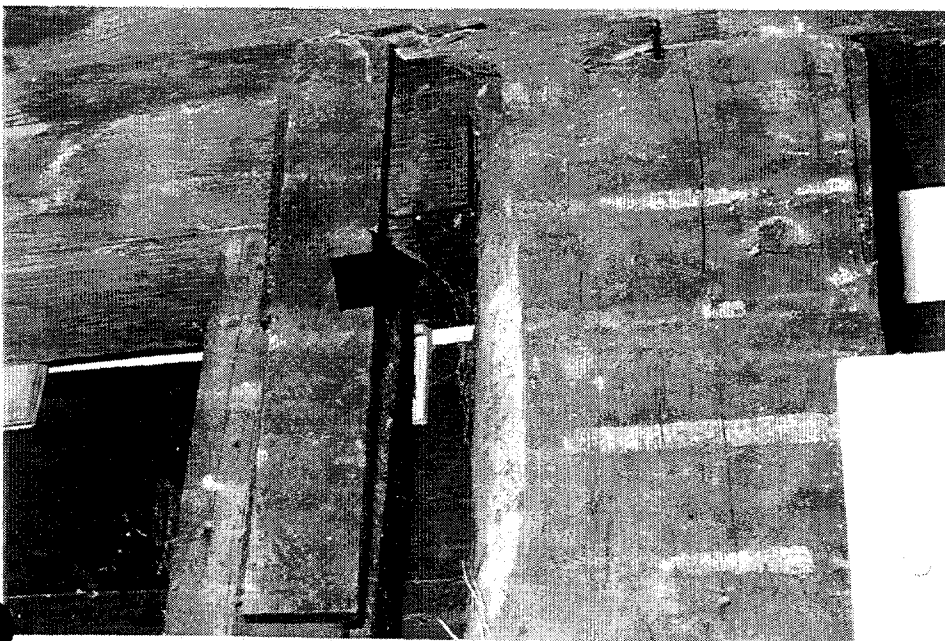
**FIGURE 3.42 WEST
PORCH BEAM OF
SOUTHWEST PORCH**

This view shows the framing condition of the west beam of the southwest porch at the west wall corner post. Note the paint line at what would have been a cornerboard (see arrow).

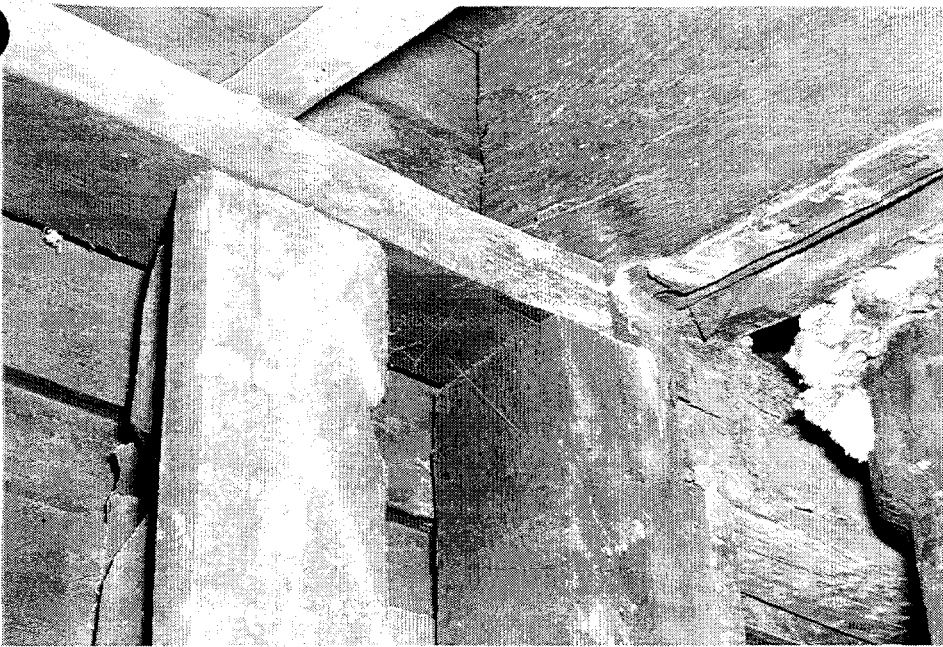
FIGURE 3.43 SOUTH PORCH BEAM OF SOUTHWEST PORCH

This view shows the framing condition of the south beam of the southwest porch at the south wall corner post.

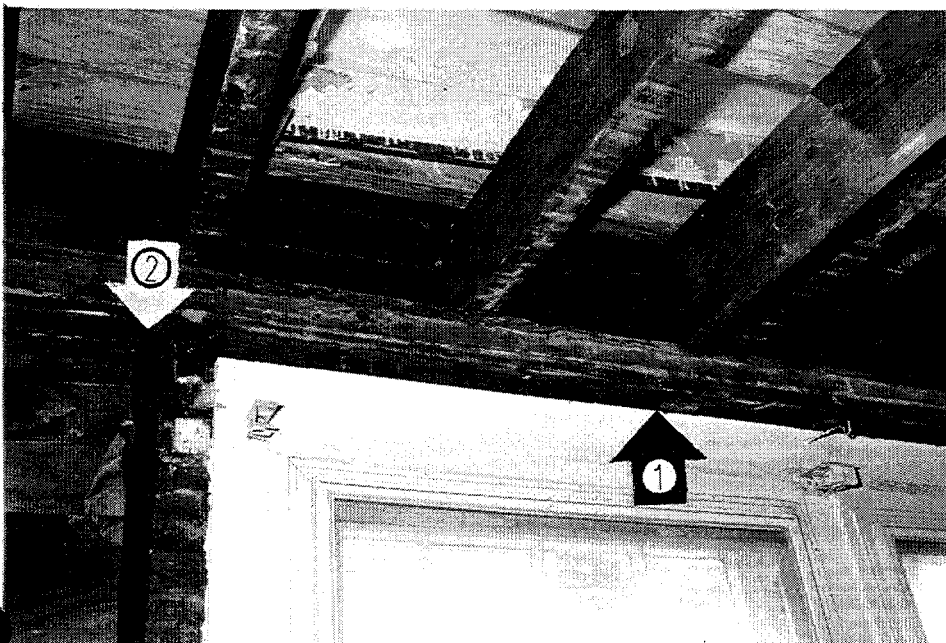
FIGURE 3.44 UNDER-SIDE OF SOUTH BEAM OF SOUTHWEST PORCH

This unpainted area (1) is most likely indicates the 1851 single intermediate post location at this porch. This mortise (2) and a similar one 5'-9"± to the south probably represents the location of a second set of intermediate porch posts.

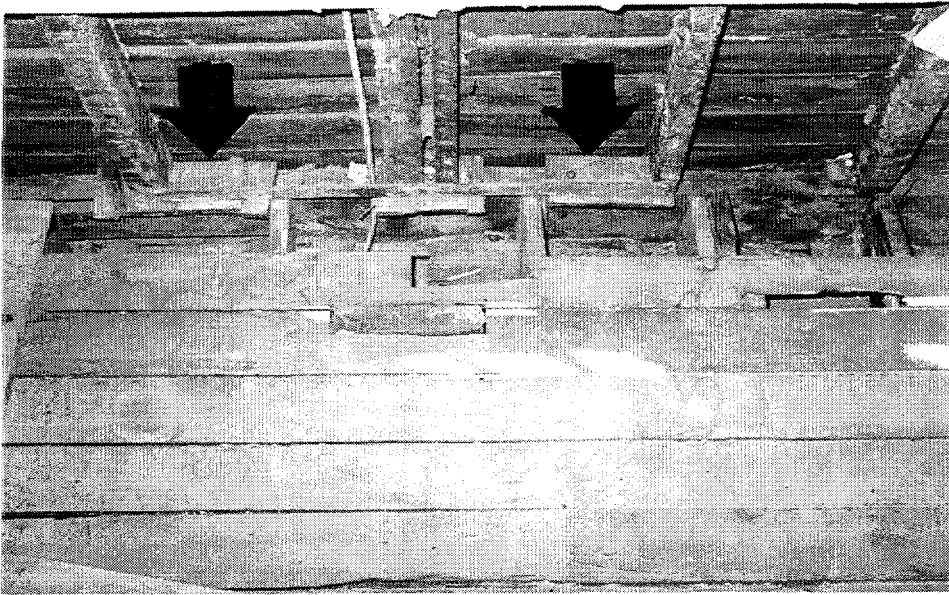
**FIGURE 3.45 SOUTH-
WEST PORCH FLOOR
BOARDS**

These remnant floor board ends remain at the location of the non-existent southwest porch.

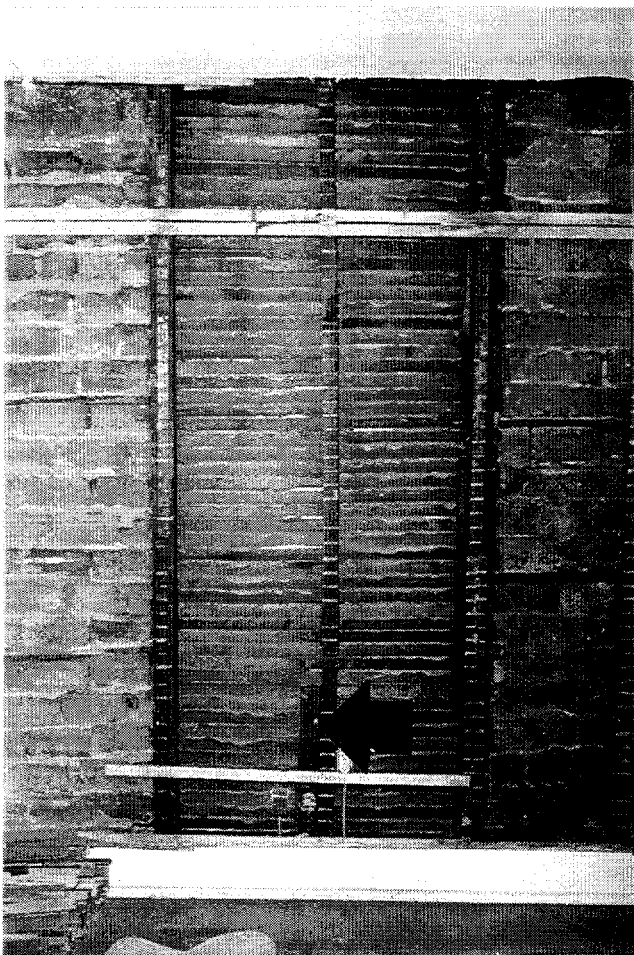
**FIGURE 3.46 1851
COTTAGE WINDOW
ROUGH OPENING**

This rough opening provided information which helped to size the window openings. Note the 1851 stud cripple (see arrow) which would have supported the sill framing of the window. Also note the brick nogging at either side of the rough opening.

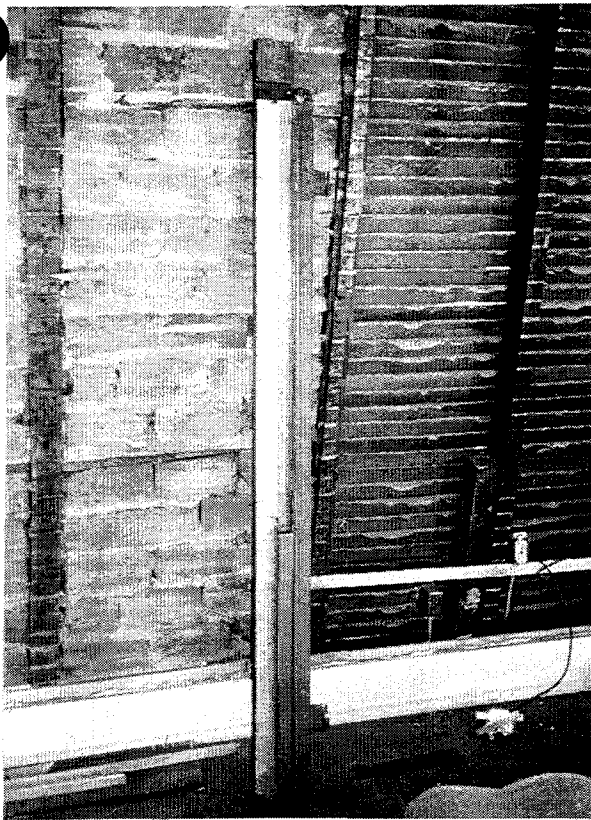
**FIGURE 3.47 1851
COTTAGE WINDOW
JAMB DISCOVERED
IN WALL CAVITY**

This jamb, discovered during field investigations, provided information concerning not only the 1851 cottage windows and shutters, but also the painted interior and exterior finishes of the cottage.

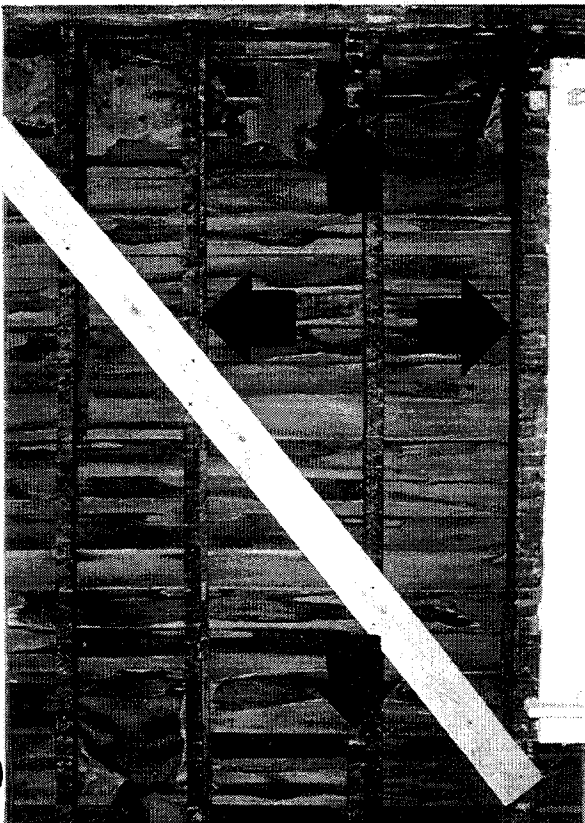
**FIGURE 3.48 1874/1879
WINDOW LOCATION
AT SOUTH WALL OF
ROOM 107**

One additional window location can be attributed to the 1874/1879 Hofferkamp renovations to the cottage (see Figure 3.48). A section of lath not aligned with the adjacent lath at the east end of the south wall of Room 107 (formerly the cottage's southwest porch) indicates a window location which was likely removed as part of the 1922/1924 renovations. The removal of the lath revealed a $2'-11" \pm \times 6'-0"$ rough opening with a sill cripple height 24" above the

This rough opening was most likely the location of a window salvaged from the north wall of the 1851 cottage southwest porch.

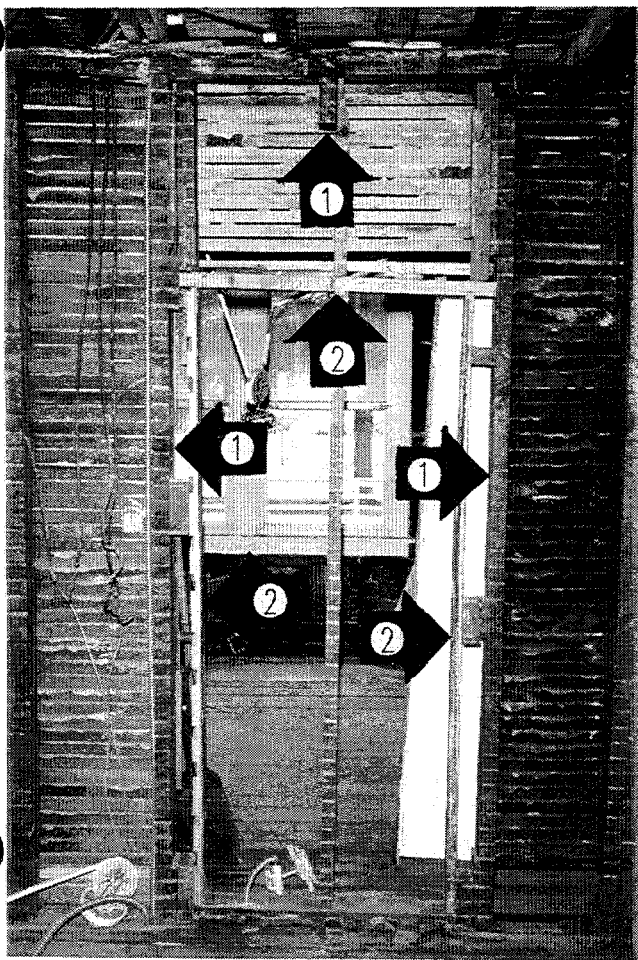
**FIGURE 3.49 DOOR
ROUGH OPENING**

Investigative removals at the wall between Rooms 103 and 104 revealed two remanent pieces of a stair stringer used to frame a twentieth-century door rough opening inside an 1874/1879 door rough opening (see Figure 3.49). These 1 1/4" thick stringer remnants are rabbeted out; one indicating the 90 degree intersection of the tread and riser and the other indicating the nosing. It is believed that this stringer may have been part of the stair installed as part of the 1874/1879 additions. During later renovations, these remnants were used with other scrap lumber to infill walls. Both stringer remnants appear to be cut from the same piece, and when analyzed together provide evidence of an 8 1/2" riser height and 8 1/2" tread depth with a 3/4" nosing. If these remnants are, in fact, from the 1874/1879 addition, then the total stair length would have been 11'-4" \pm .

This rough opening, framed-in as part of the 1874/1879 construction episode, was the opening between Rooms 103 and 104. (See arrows #1 for limits of rough opening.) As part of the 1922/24 construction opening, this rough opening was infilled for a smaller door. (See arrow #2 for limits of rough opening.) The jamb framing for the later door opening was framed with salvaged stair stringers, probably from the 1874/1879 addition.

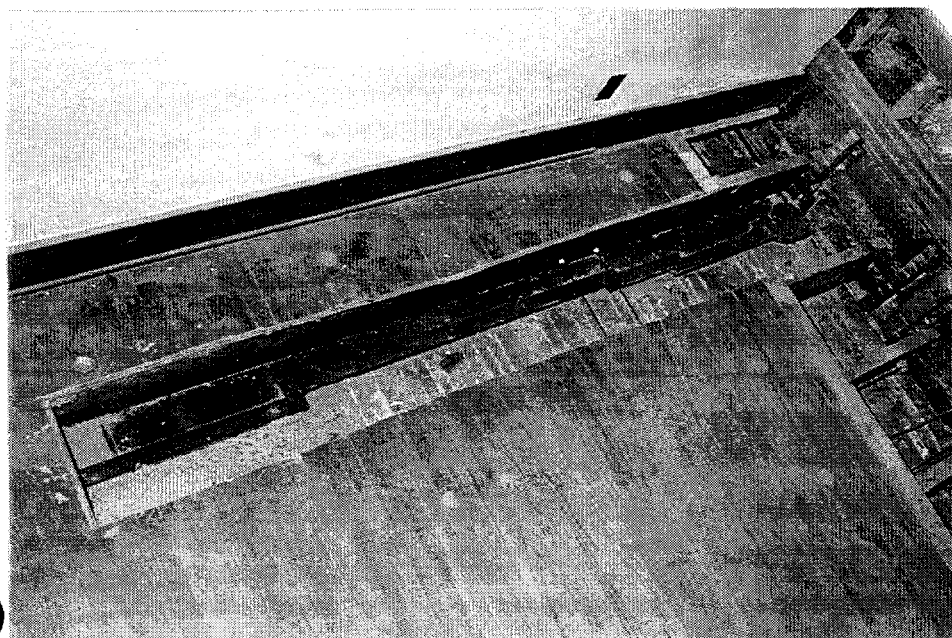
**FIGURE 3.50 DOOR
JAMB TRIM**

This ornate trim board was discovered in a floor joist cavity at Room 201. This trim is believed to be from the front (east) door of the 1874/1879 addition.

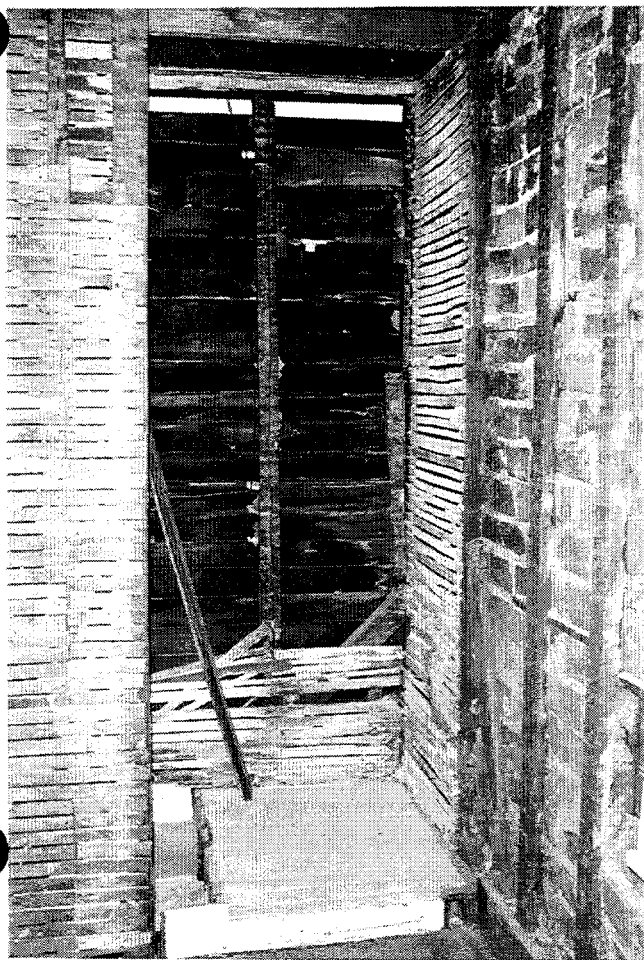
FIGURE 3.51 HAND-SPLIT LATH

During the selective removal process, a small area of hand-split lath was discovered on the north and west walls at the northwest corner of the 1851 cottage (see Figure 3.51). The handsplit lath at the west wall only extended to $1'-8" \pm$ above the floor and the plaster over this lath had a distinctive yellowish tint, indicative of nineteenth-century plaster. The hand-split lath at the north wall extended the full height of the wall. Analysis of the plaster spread over this lath (Sample P1, see Appendix B) determined that its composition was very similar to that of the mortar from the nogging in the wall, suggesting a similar age.³⁴

This hand-split lath, discovered in Room 108, is a remnant of the 1851 cottage lath. Similar remnant lath was found above the top plate of the 1874/1879 walls between Rooms 103 and 104, and Rooms 107 and 108.

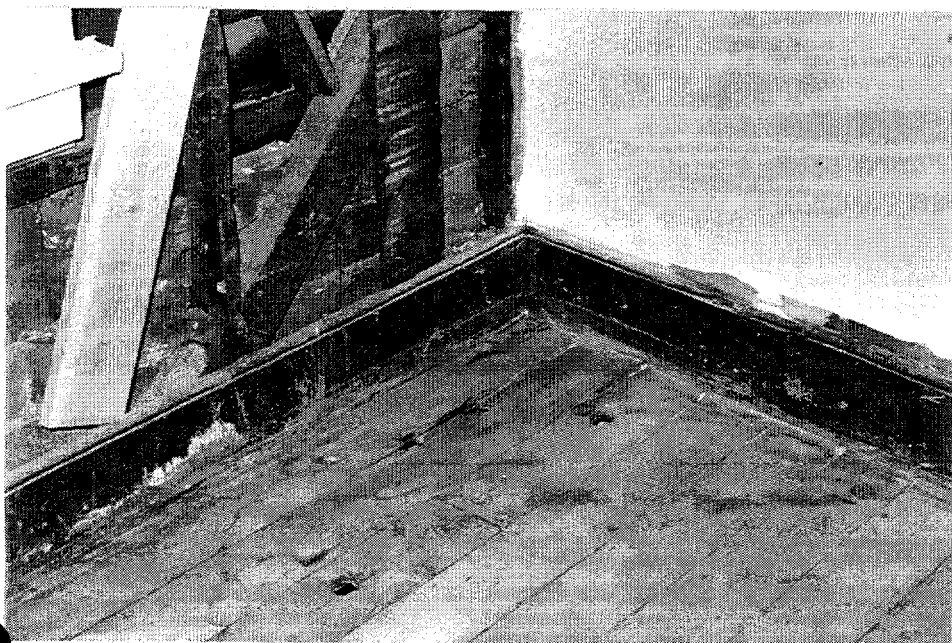
FIGURE 3.52 WOOD BASE

Removals of the existing baseboards at the north, east, and south walls of Room 104 and part of the south wall of Room 105 revealed nineteenth-century baseboards behind (see Figure 3.52). These baseboards are believed to be from the 1851 cottage. The baseboards at the south wall of both rooms were probably relocated when this wall was constructed as part of the 1874/1879 construction episode. These baseboards are simple $1" \pm \times 6\frac{1}{2}"$ boards with a quirk bead cut at the top. These baseboards are installed over the lath and were themselves the plaster ground. Paint analysis of this feature revealed a gray (Munsell N 5.75/) base layer with a white (Munsell 5Y 9/1) layer over that, with a present finish of a dark brown varnish.⁴⁷ The top two layers are the same layers found at other features, including the porch beam and the remnant siding board (see EXTERIOR FINISHES in this Division).

This simple wood base with a quirk bead at its top is probably the original baseboard in the large east room (most likely a parlor) of the 1851 cottage.

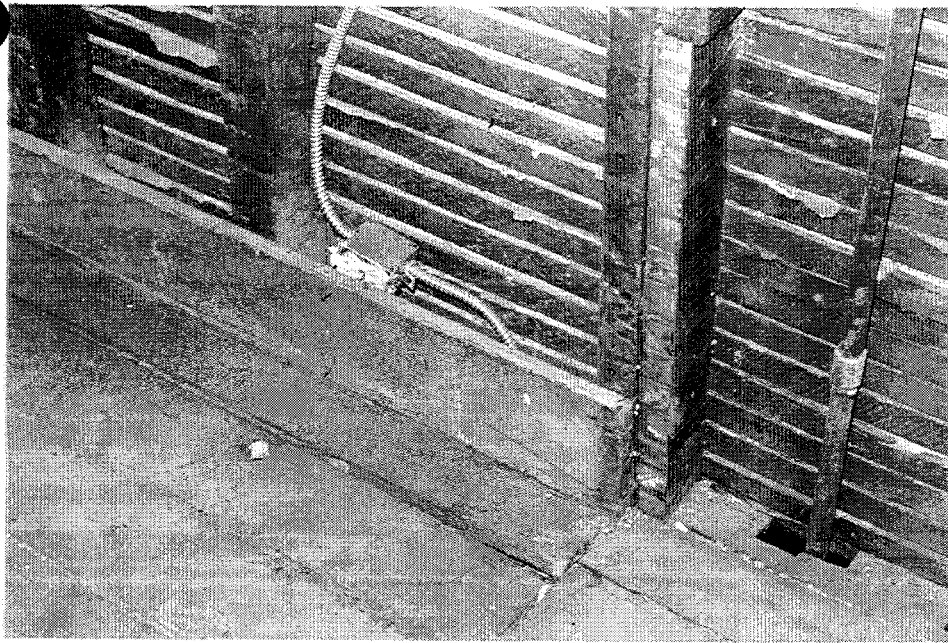
FIGURE 3.53 WOOD BASE

Removal of the existing baseboards at the north and south wall of Room 108 revealed a nineteenth-century baseboard behind (see Figure 3.53). These

This plain wood base is probably the original baseboard in the large west room (most likely a kitchen) of the 1851 cottage.

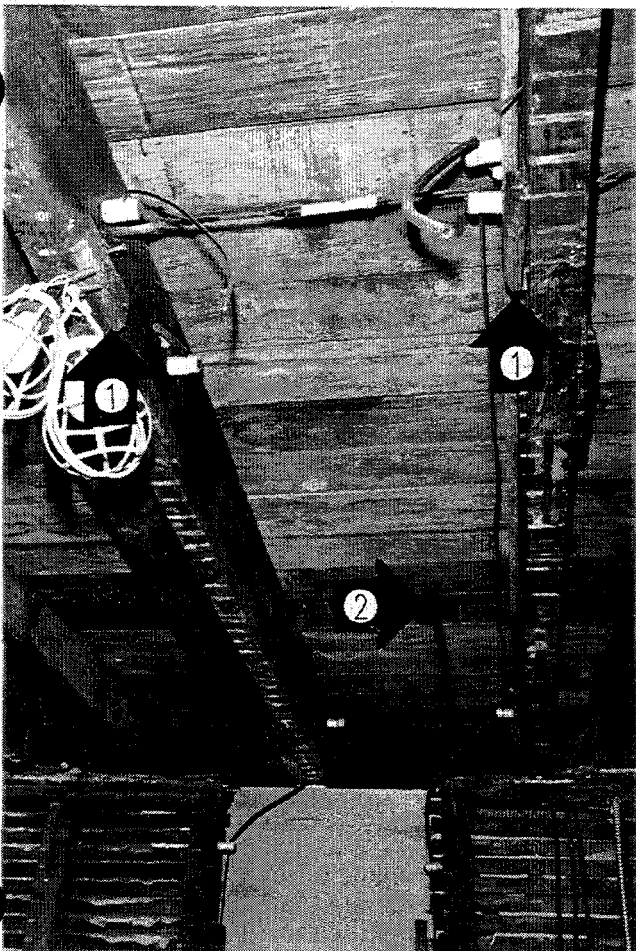
FIGURE 3.54 GAS LAMP LOCATION

These framing features (1) were likely installed to support a hanging gaslight fixture, probably installed during the Hofferkamp ownership. A "T" fitting at the gas piping (2) would have allowed a line to service a fixture in this location, centered in Room 103.
