HISTORIC STRUCTURE REPORT

JULIA SPRIGG HOUSE (HS-11)

Lincoln Home National Historic Site
Springfield, Illinois

May 1995

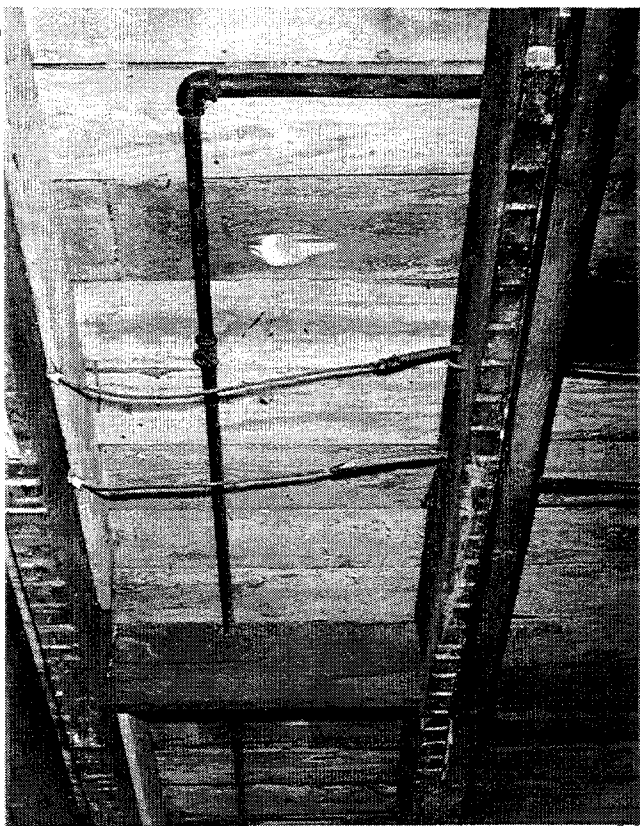
**FIGURE 3.55 GAS
LAMP LOCATION**

In the ceilings of rooms 103 and 104, there are 1" and ¾" gas light piping.⁵⁰ This piping is cast iron and has one down-turned "T" connection (see Figure 3.55) indicating the location of a lamp fixture in Room 104. This fixture was located approximately 5'-6" off the south wall and 8'-0" off the east wall. A second fixture location in Room 103 was located approximately 6'-4" off the south wall and 8'-0" off the east wall (see Figure 3.54). Evidence of gas lamp locations—and the existence of piping for gas lamps—was also discovered in Room 107 and 108; however, this evidence was not as compelling. Notches in the top of the ceiling framing of Room 108 which align with the pipe discovered in adjacent Room 104, suggest the pipe continued into this room. The fixture would most certainly have been centered in the room. The pipe likely elbowed into Room 107. A single wood bracket feature—a remnant of what was certainly a pair—similar to that found at Room 103, indicate the location of a lamp approximately 8'-6" from the west wall and aligned with the fixture location in Room 103.

This downward facing "T" fitting at the gas piping indicates the probable location of a gaslight fixture, centered in Room 104.

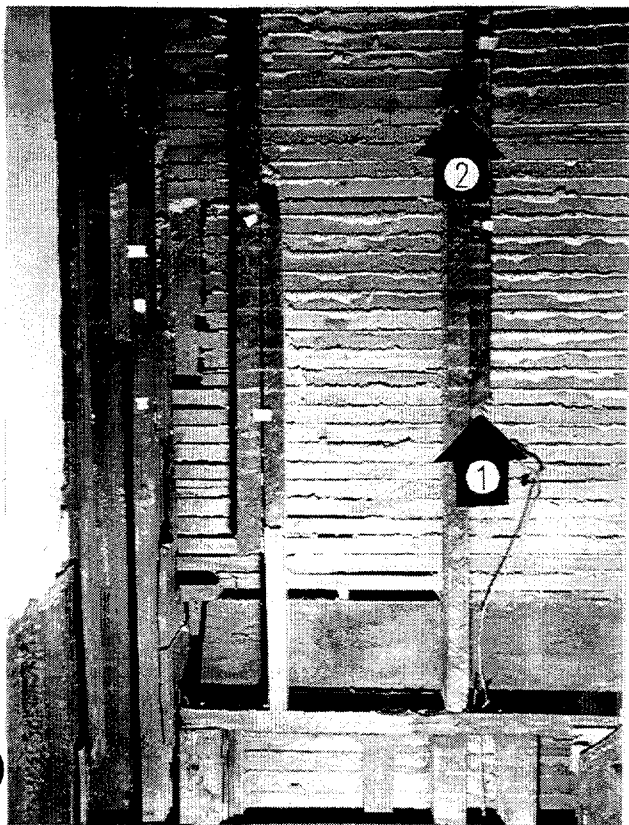
**FIGURE 3.56 INDICA-
TION OF THE 1851
COTTAGE ROOF
SLOPE**

These angled bottom studs (1) in the west wall of the 1874/1879 addition indicate the roof slope of the cottage prior to 1922/1924. Note the angled tops of some of the scabbed-on studs (2). These are the salvaged ends of other 1874/1879 wall studs from this wall which have been severed.

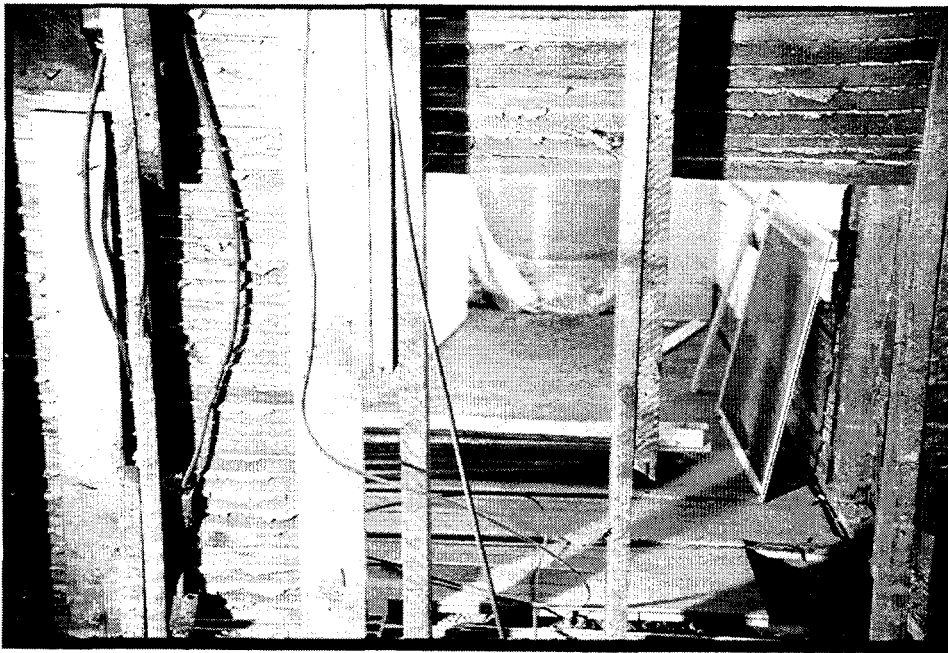
FIGURE 3.57 INDICATION OF THE 1851 COTTAGE ROOF SLOPE

These angled studs in the west wall of the 1874/1879 addition indicate the roof slope of the 1851 cottage. This evidence, coupled with other similar evidence, suggests that the roof peak was $11\frac{1}{2}^\circ \pm$ to the south of center.

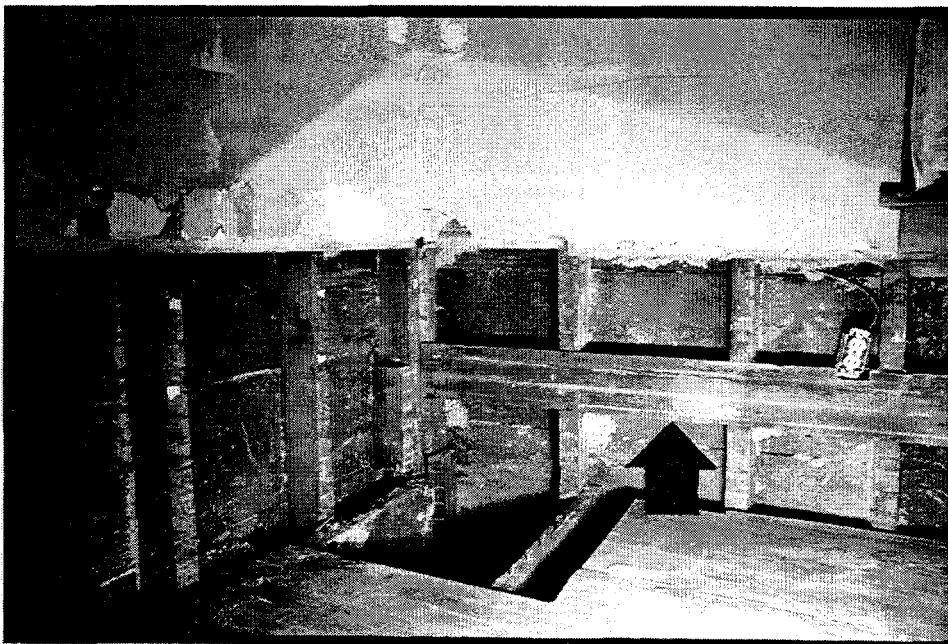
FIGURE 3.58 LEDGER BOARD AT THE 1874/1879 ADDITION

This is the 1874/1879 ledger board at the east wall of Room 202. From 1874/1879 until 1922/1924, the existing floor joists rested atop this ledger.

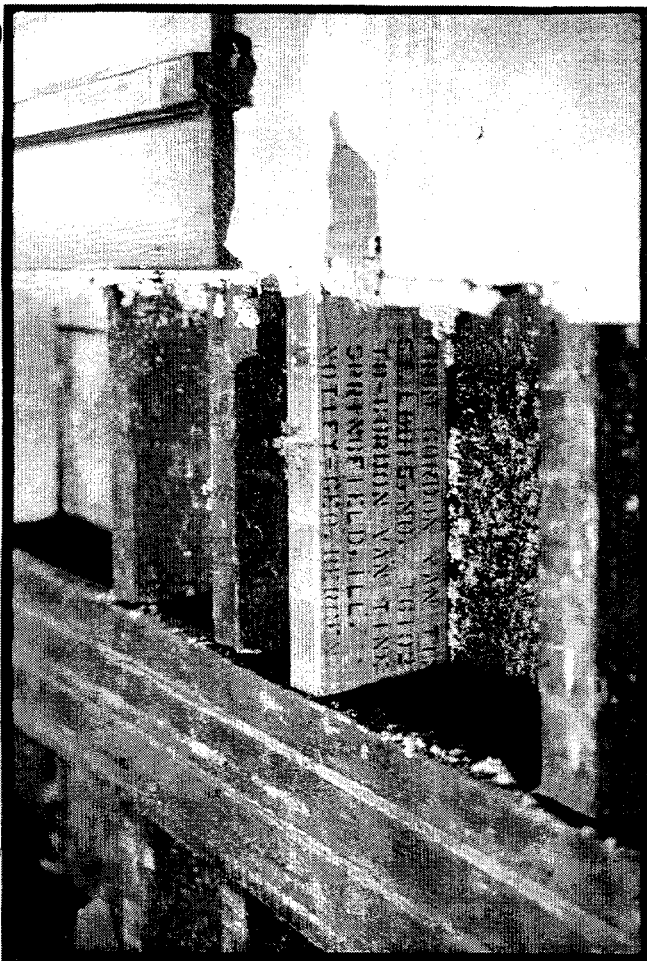
**FIGURE 3.59 MARK-
INGS ON THE STUD
FRAMING BELOW
WINDOW 201B**

It is likely that, as part of the 1922/1924 renovations, George Bergen replaced the original windows of the house with windows purchased from the Gordon-Van Tine Company factory in St. Louis, Missouri (see Figure 3.59).²⁸ The existing, vertically muntined four-over-one and three-over-one, double-hung windows are these replacement windows and match a Gordon-Van Tine window style called "Pasadena."²⁹ The smaller windows (201A and 207A) at Rooms 201A and 207D were likely installed when these bathrooms were added as part of the 1938 George Bergen renovations of the second floor. These windows, like Door 202A (see EXTERIOR DOORS in this Division) are trimmed out differently at the head than the other twentieth-century fenestrations.

This mark reads:

"From Gordon Van Tine
St. Louis, MO. 1G192
To - Gordon Van Tine
Springfield, ILL.
Notify - Geo. Bergen"
This stud probably dates
to 1924 during the reno-
vations begun by Carl
Mund, but completed by
George Bergen.

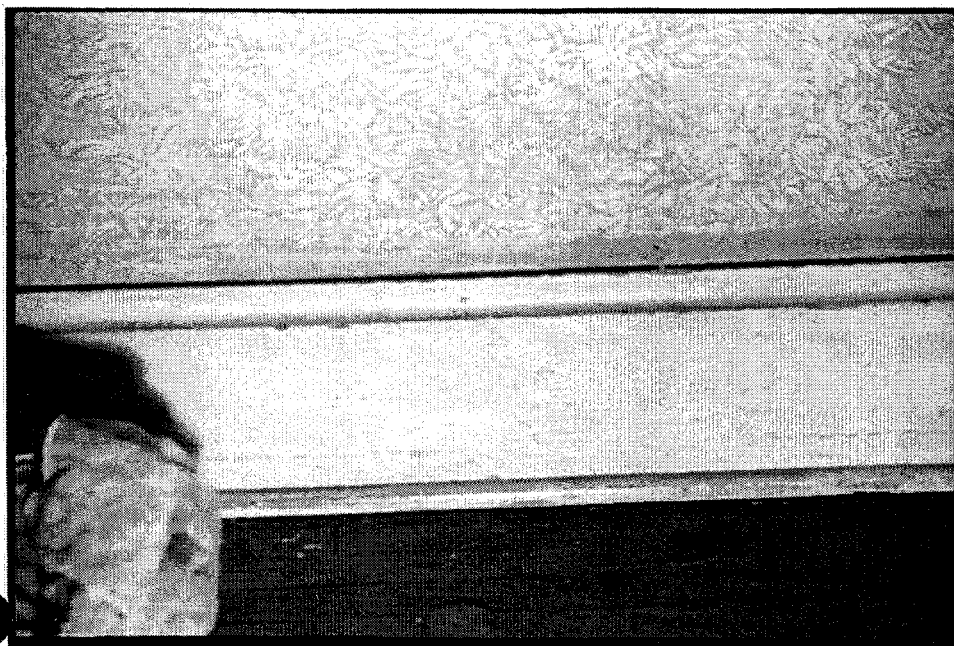
**FIGURE 3.60 BASE
TRIM AT CLOSET
204A**

Paint analysis indicates
that this base was proba-
bly wood grained. This
base is obviously sal-
vaged, perhaps from
elsewhere in this house
during the 1922/1924
renovations. A similar
base exists in Closet
101A.

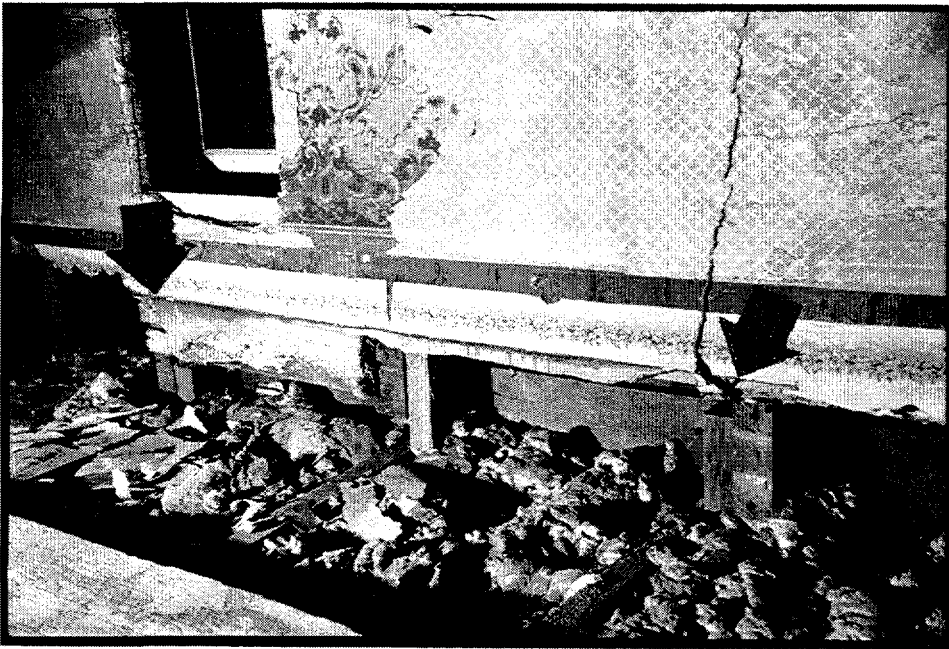
FIGURE 3.61 EVIDENCE OF WINDOW LOCATION IN THE 1874/1879 ADDITION

This evidence indicates the 1874/1879 window head at the northernmost window location on the east wall in the intermediate attic space (above Room 202). Also note the wallpaper layers which pre-date 1922/1924.

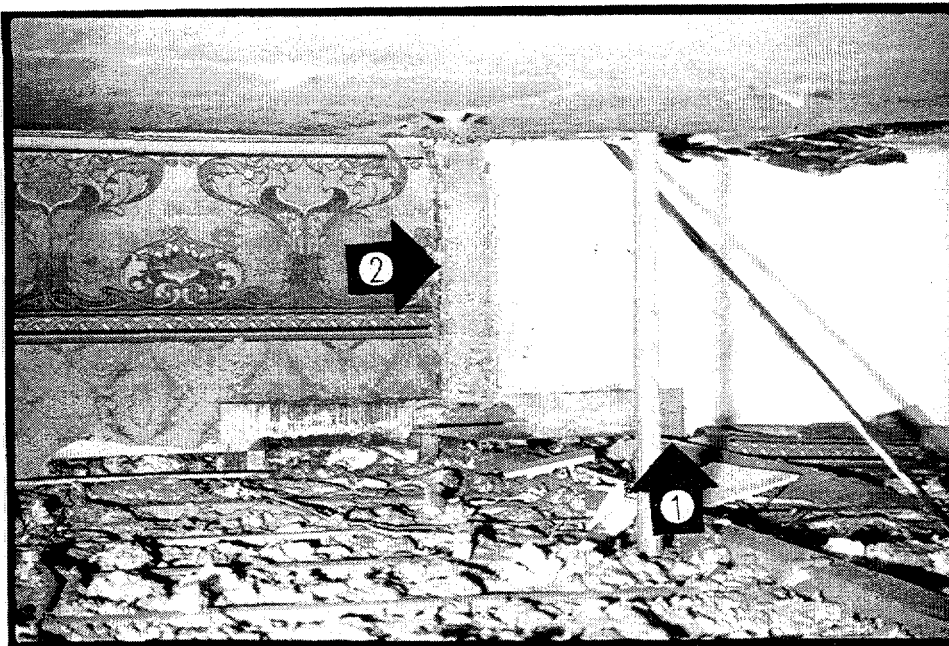
FIGURE 3.62 EVIDENCE OF WINDOW LOCATION IN THE 1874/1879 ADDITION

In this view is seen an 1874/1879 window head (1) at the south wall in the intermediate attic space (above Stair S1). Note the wall indications (2) above the window head trim limits.

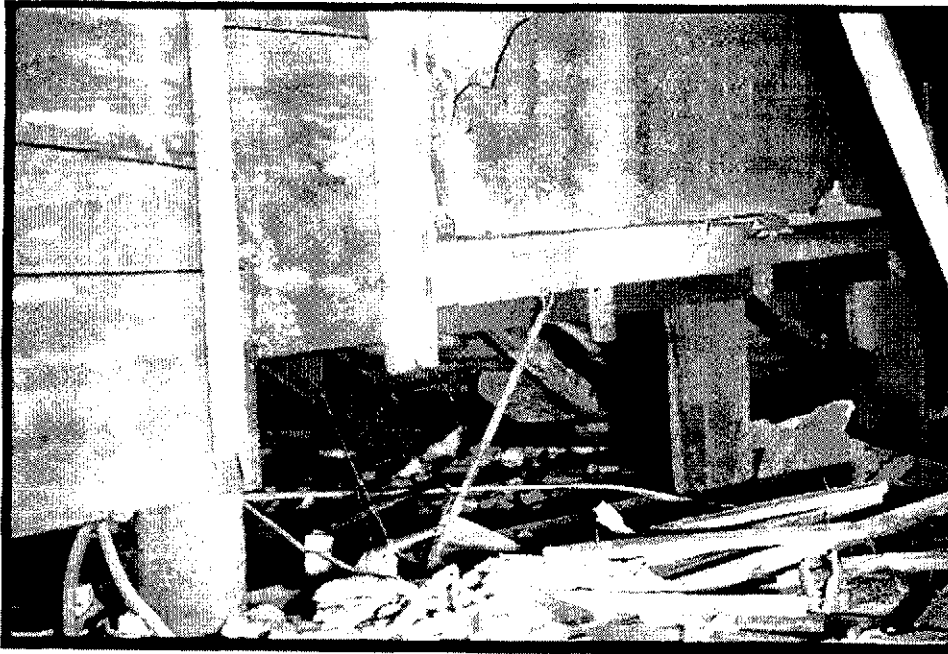
FIGURE 3.63 EVIDENCE OF WINDOW LOCATION IN THE 1874/1879 ADDITION

This evidence indicates the 1874/1879 window head at the northernmost window location on the west wall in the intermediate attic (above Room 202).

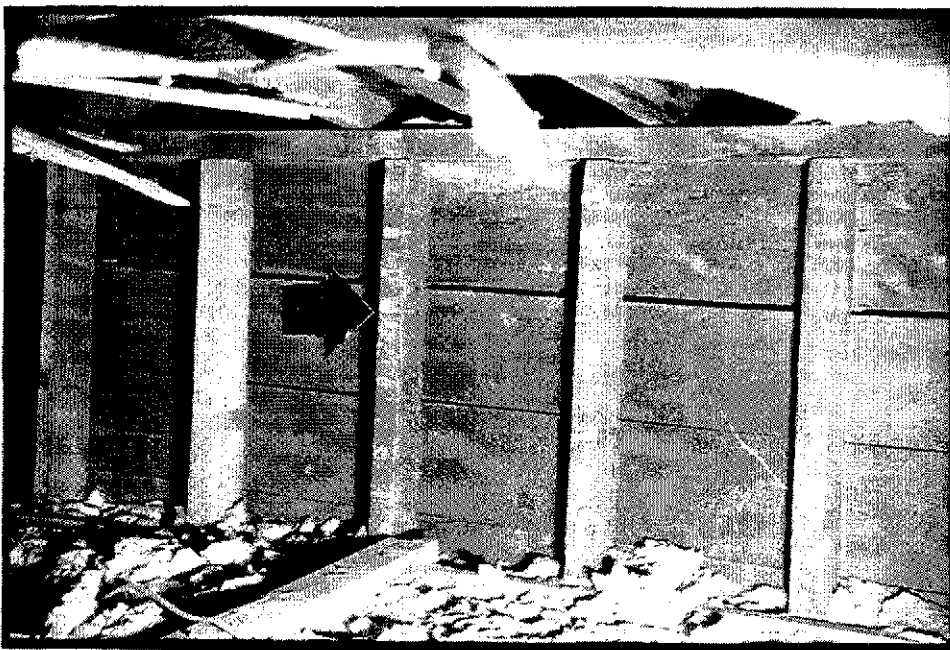
FIGURE 3.64 EVIDENCE OF CHIMNEY STACK LOCATION IN THE 1874/1879 ADDITION

Attic A202 (see Figure 3.64) suggesting the passage of the chimney stack through this space. Finally, there is an inconspicuously infilled opening in the roof sheathing, which indicates the location of the chimney stack's passage through the roof (see Figure 3.71).

These water marks on studs indicating the fireplace chimney location on the north wall in the intermediate attic (above Room 202).

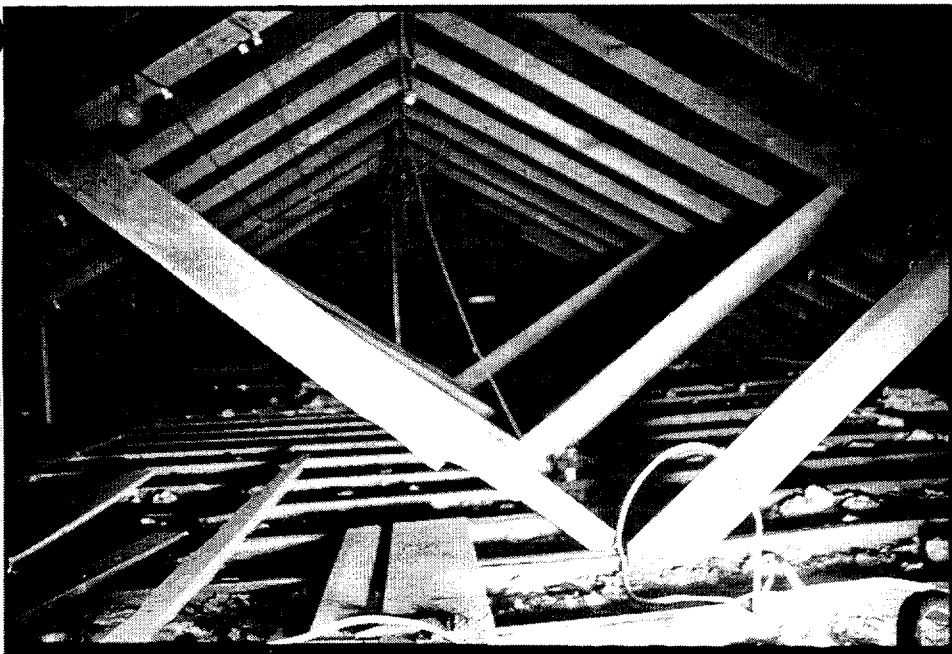
**FIGURE 3.65 FRAM-
ING AT WEST WING
ATTIC**

This is a view of the west attic looking west. The brace framing was added by the National Park Service.

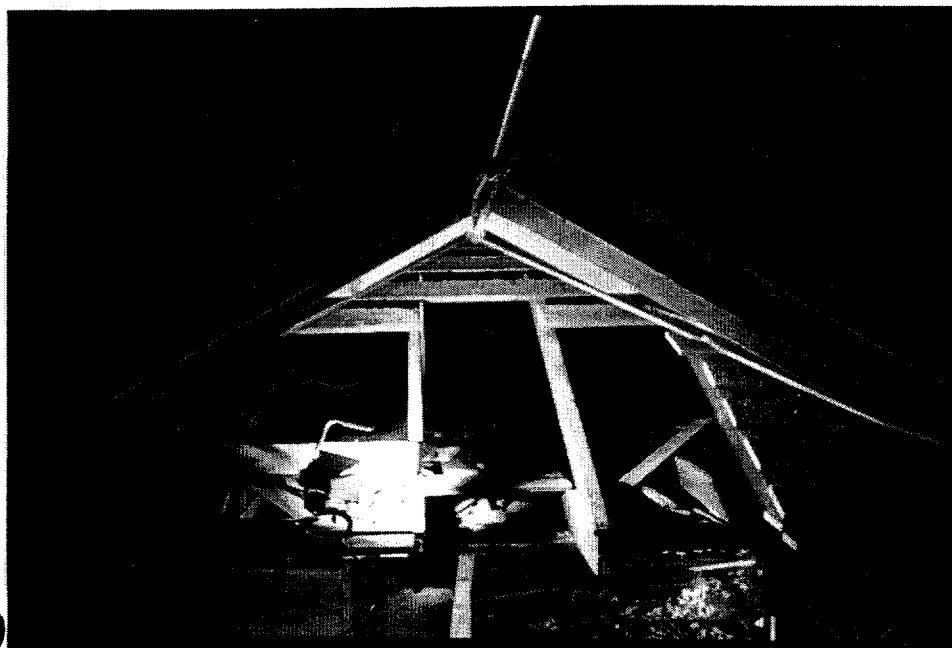
**FIGURE 3.66 FRAM-
ING AT THE ROOF
INTERSECTION**

This is a view of the west attic looking east toward the intersection of the two roof structures.

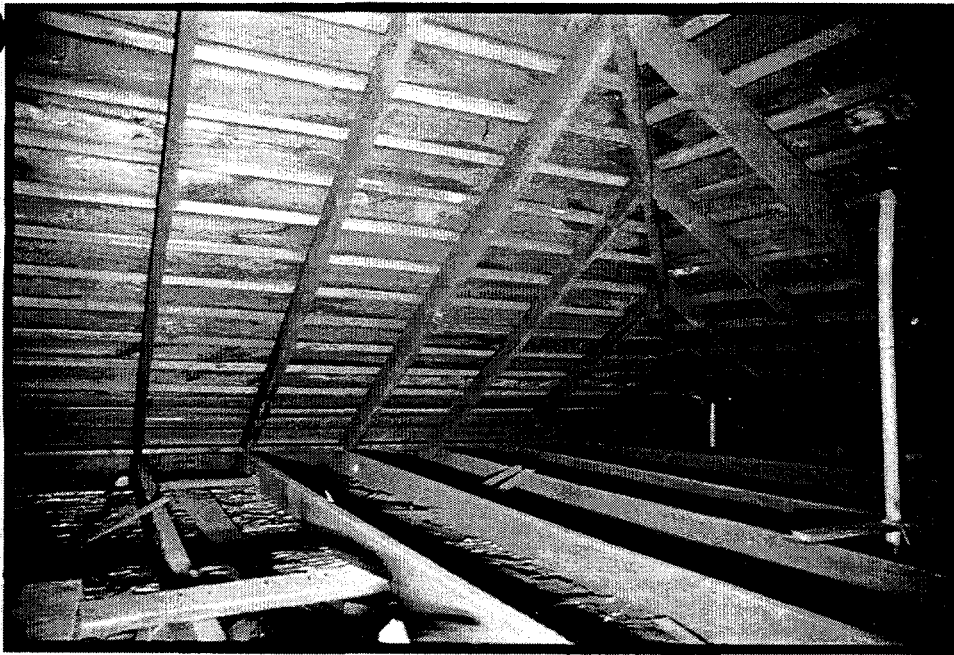
FIGURE 3.69 ROOF FRAMING AT THE 1874/1879 ADDITION

This is a view of the attic looking southeast.

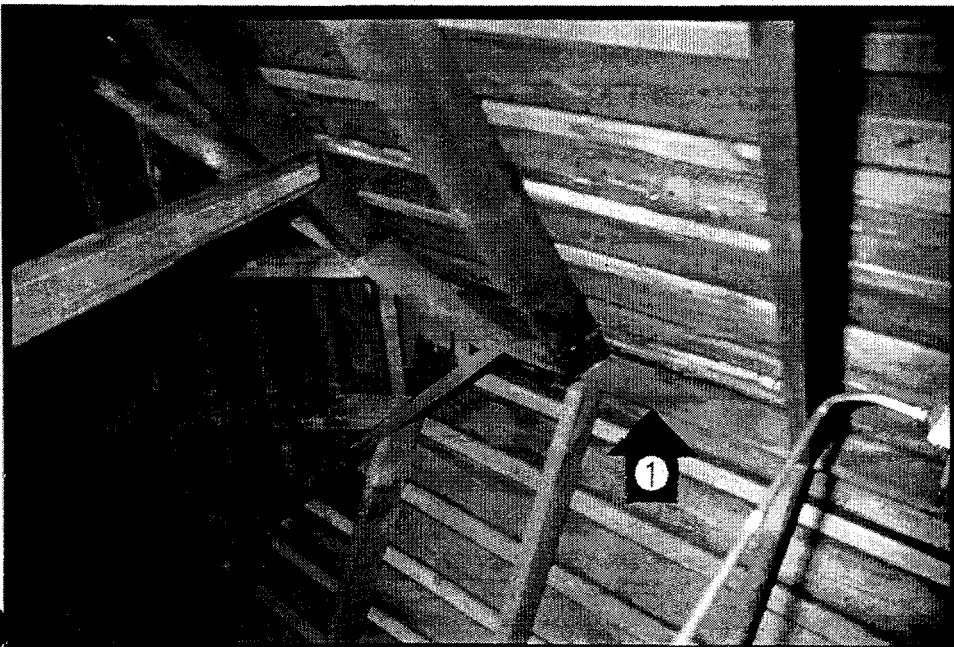
FIGURE 3.70 ROOF FRAMING AT THE 1874/1879 ADDITION

This is a view of the junction of the rafters to the ridge board (1).

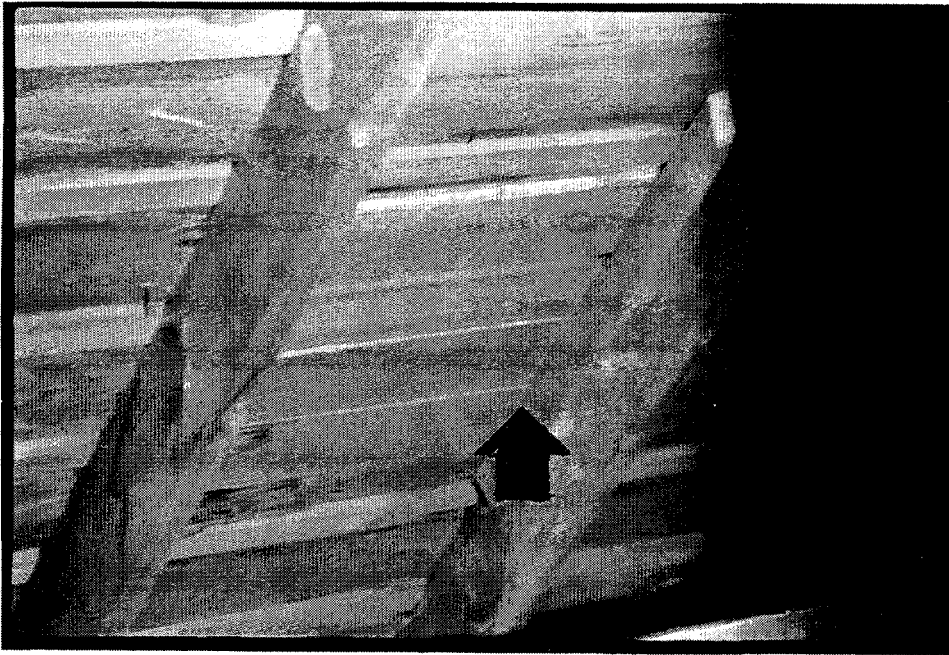
FIGURE 3.71 EVIDENCE OF CHIMNEY STACK LOCATION IN THE 1874/1879 ADDITION

This is a view of the opening in roof sheathing at the 1874/1879 chimney location.

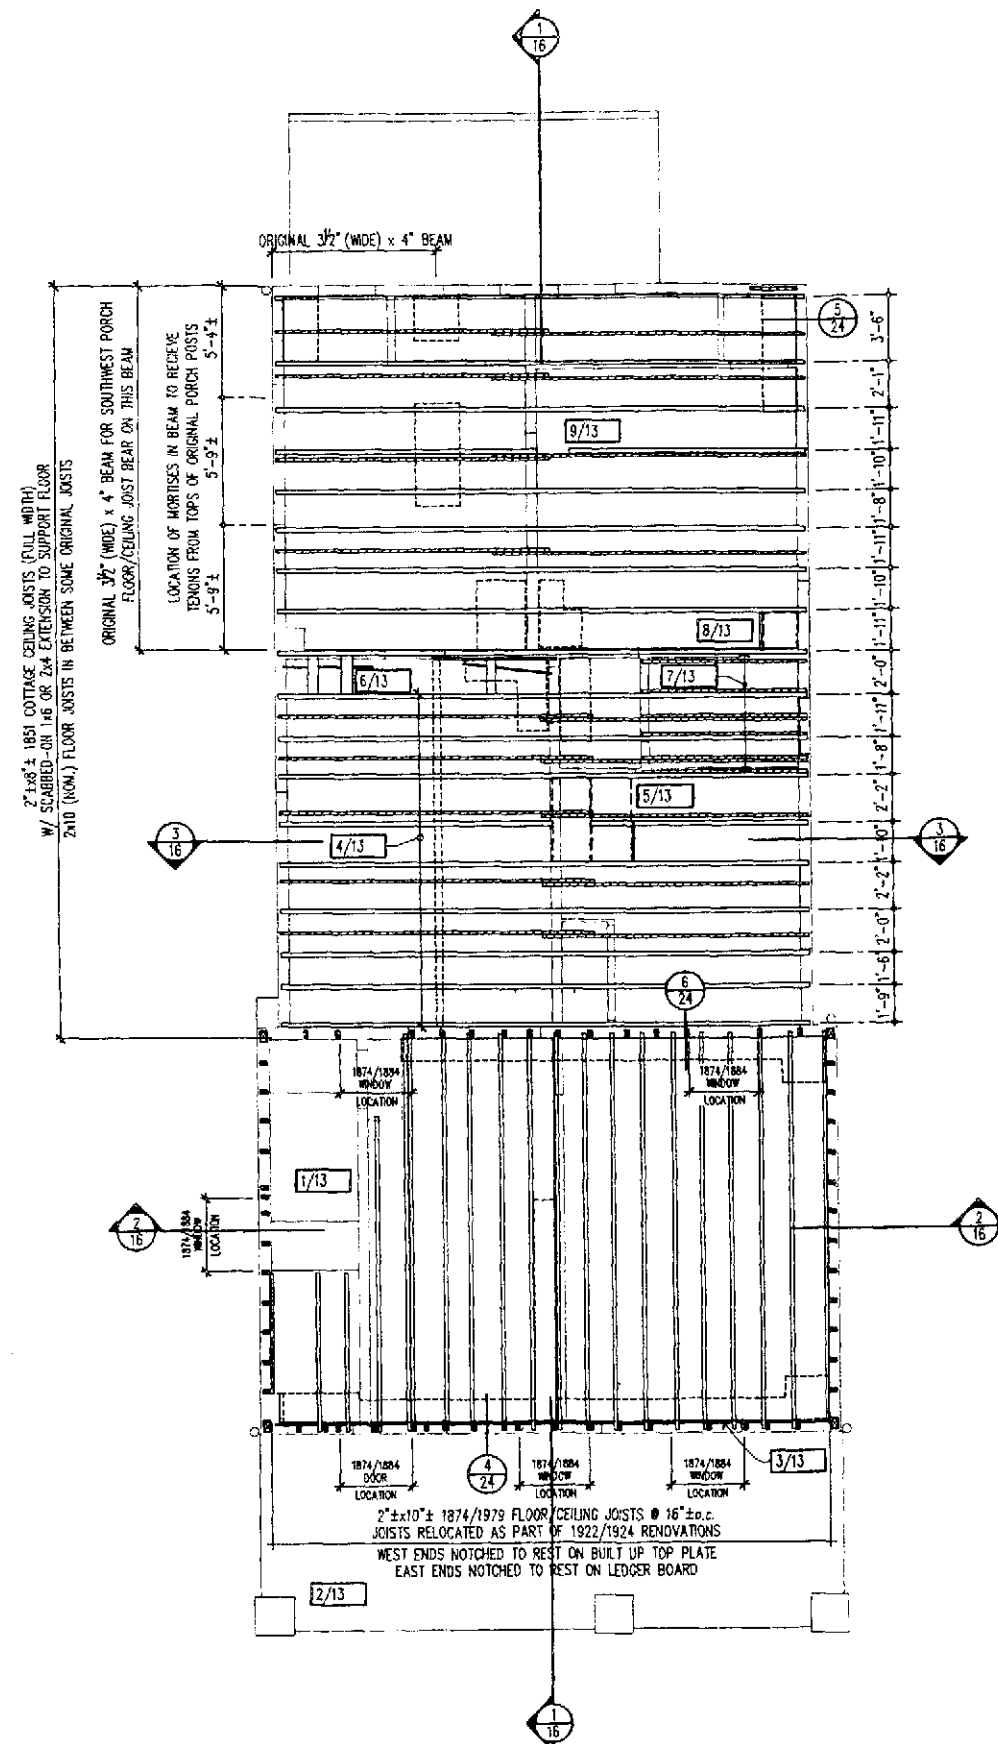
SECOND FLOOR FRAMING PLAN
 SCALE: 1/4" = 1'-0"
 0 5 10 FEET

1. FRAMING CONDITIONS AT STAIR UNKNOWN
2. FRAMING AT EAST PORCH UNKNOWN
3. 7/8" x 3/2" LEDGER (CIRCA 1922)
4. 8" WIDE, 1" DEEP NOTCHES IN THE BOTTOMS OF THE 1851 COTTAGE CEILING JOISTS IN THIS AREA, INDICATE THE LOCATION OF AN ORIGINAL PARTITION WALL.

8. THESE DASHED LINES REPRESENT THE LIMITS OF REPLACEMENT SECOND FLOOR SUBFLOOR BOARDS. THIS AREA MAY HAVE BEEN THE LOCATION OF CHASE FOR THE 1922/1924 STACKED DUPLEX.

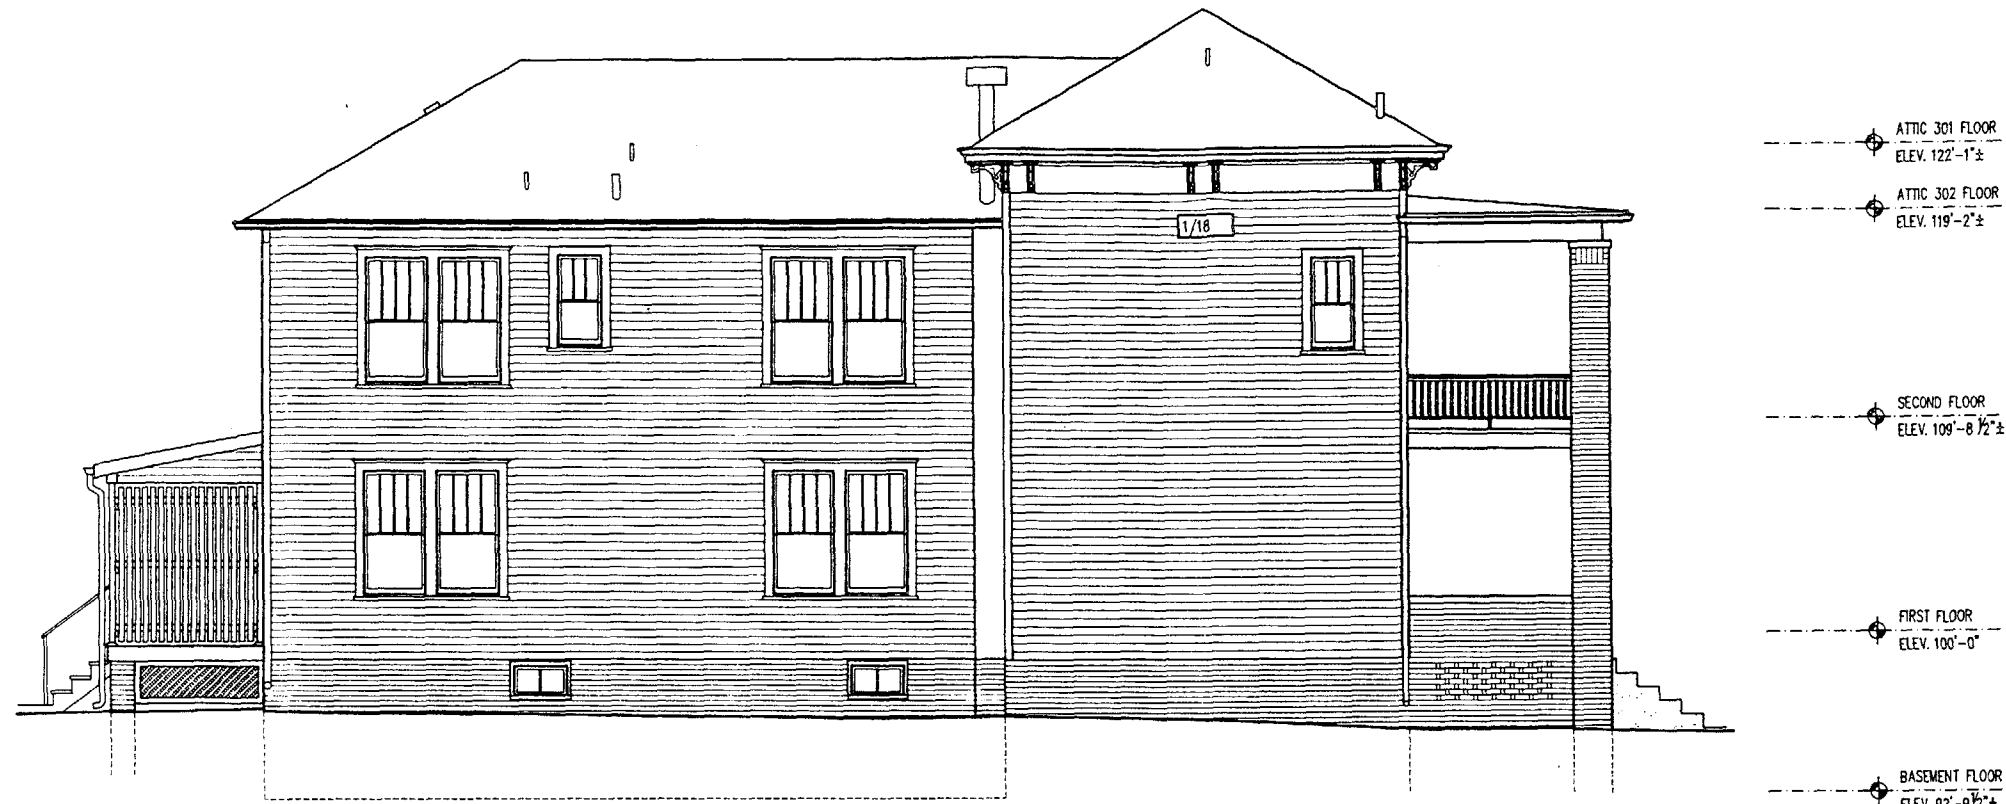
SOUTH ELEVATION

1. THIS ANGLED PROFILE, CUT IN THE BOTTOM OF THIS CLAPBOARD, IS AT THE FORMER LOCATION OF A WINDOW DATING TO THE HOFFERKAMP ADDITION (1874/1879). THIS PROFILE PROBABLY FOLLOWS THAT OF THE HEAD TRIM AT THE WINDOWS (AND DOOR) OF THE HOFFERKAMP ADDITION.

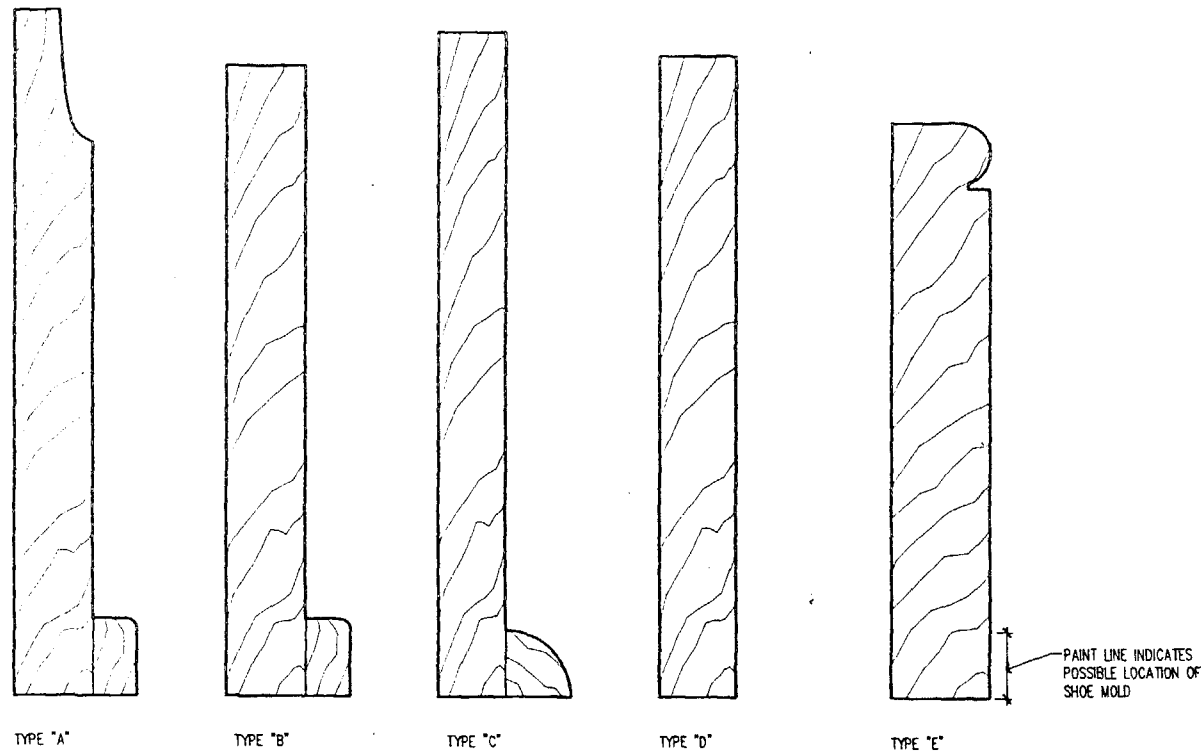
BASE TYPES
BASE TYPES "A" AND "E" DATE TO AT LEAST 1874/1879, HOWEVER, IT IS LIKELY THAT TYPE "E" DATES TO THE 1851 COTTAGE.

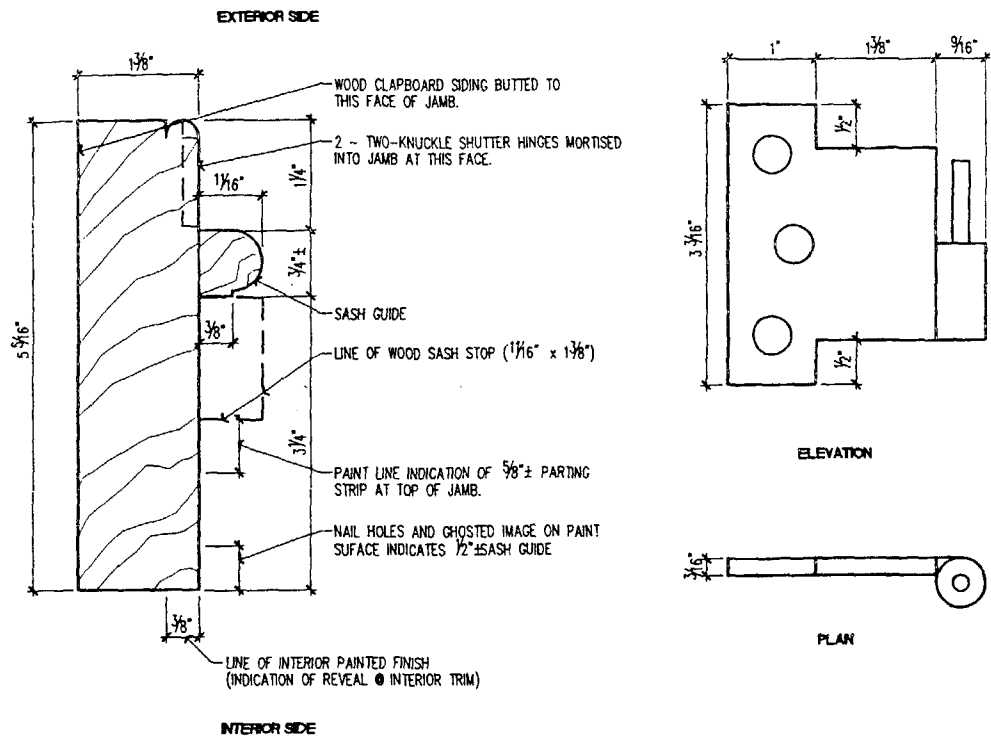
1851 COTTAGE WINDOW JAMB & HARDWARE
DISCOVERED IN EAST WALL CAVITY AT ORIGINAL NORTHERN-MOST WINDOW LOCATION

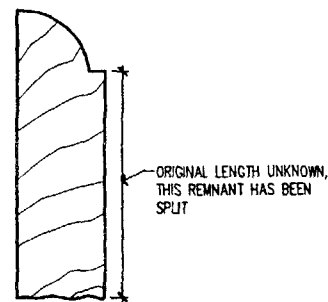
MISCELLANEOUS TRIM
TYPE 1 (FOUND AT WALL CAVITY ROOM 108A)

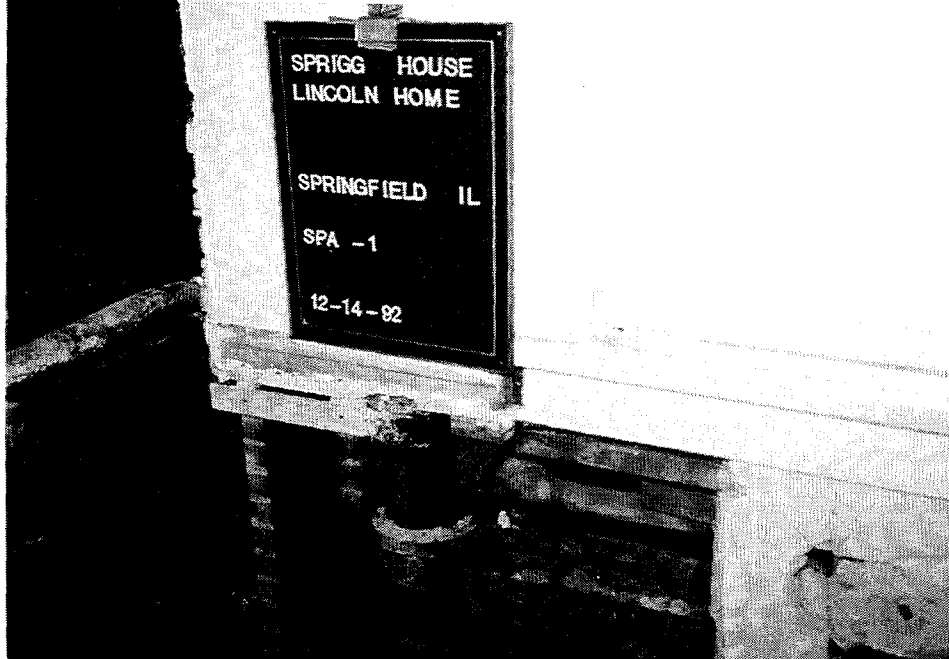
Photo SPA-1
1922 Plaster
Bathroom 201A-Wall

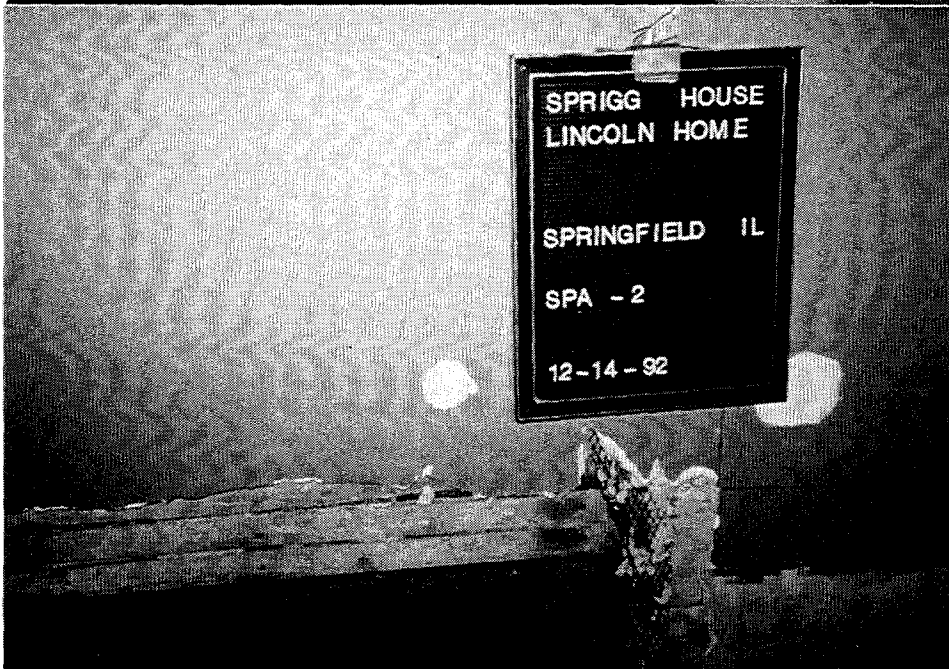
Photo SPA-2
1922 Plaster
Room 208-Wall

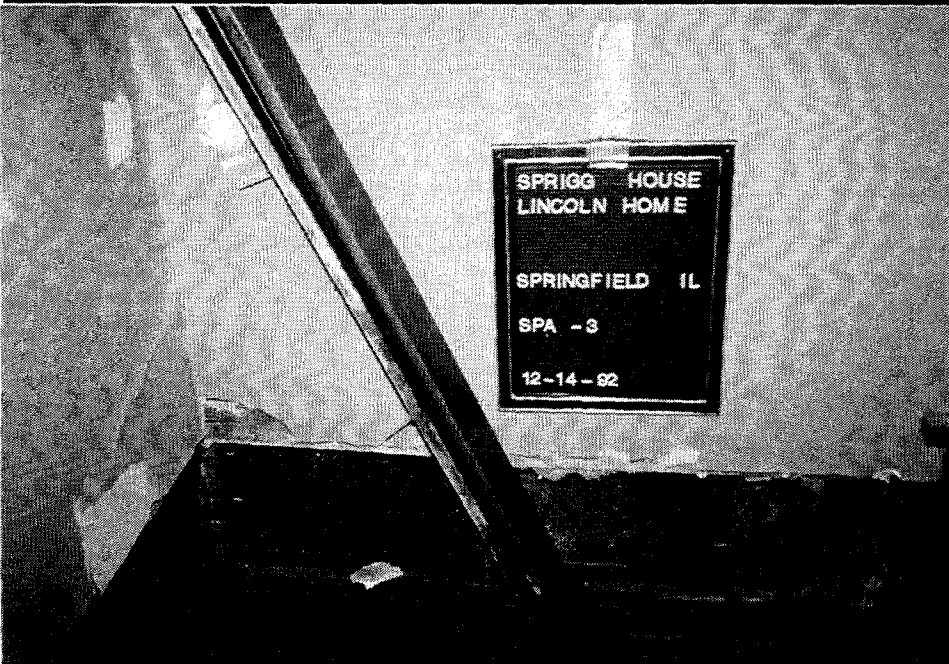
Photo SPA-3
1922 Plaster
Room 202-Wall

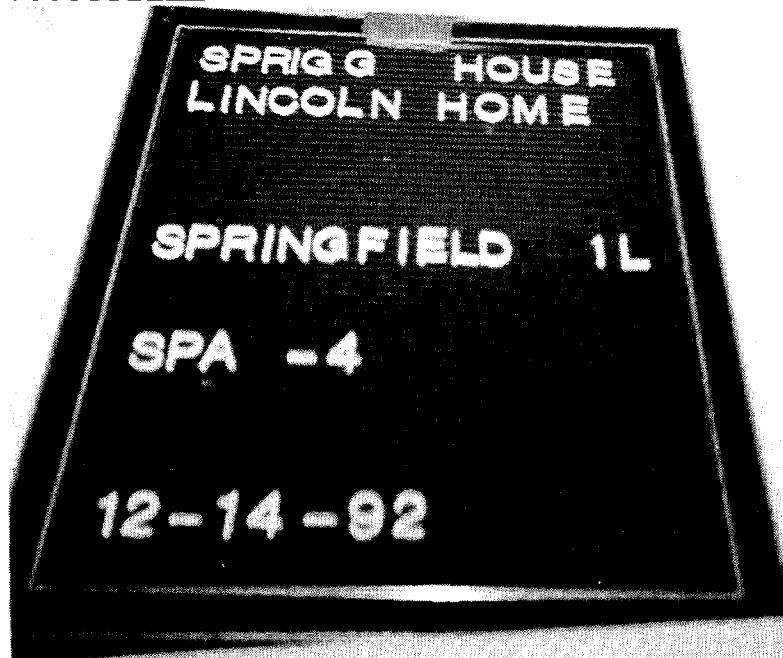
Photo SPA-4
1922 Plaster
Bathroom 206-Ceiling

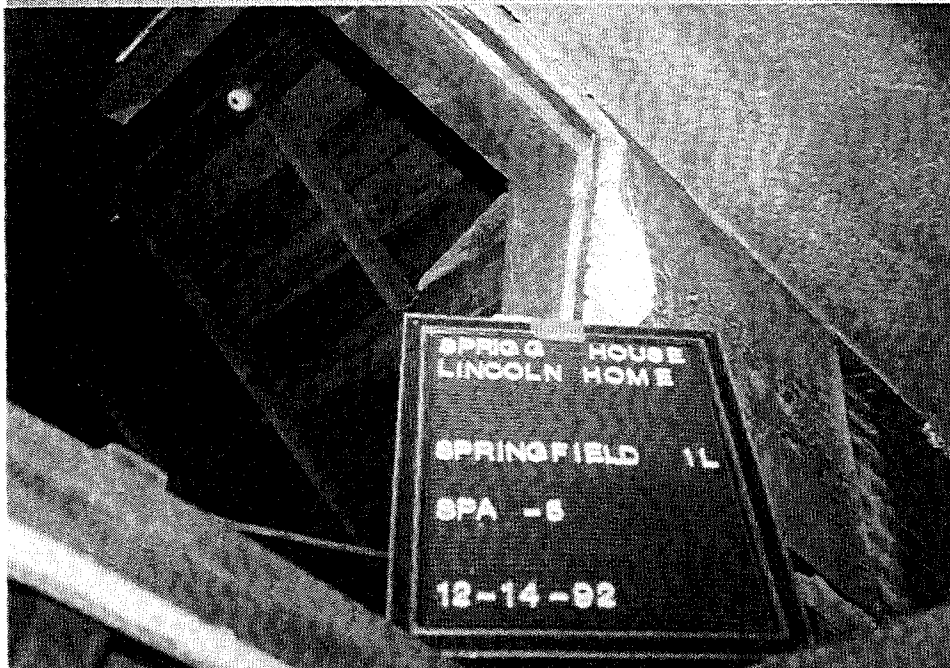
Photo SPA-5
1922 Plaster
Hall 201D-Ceiling

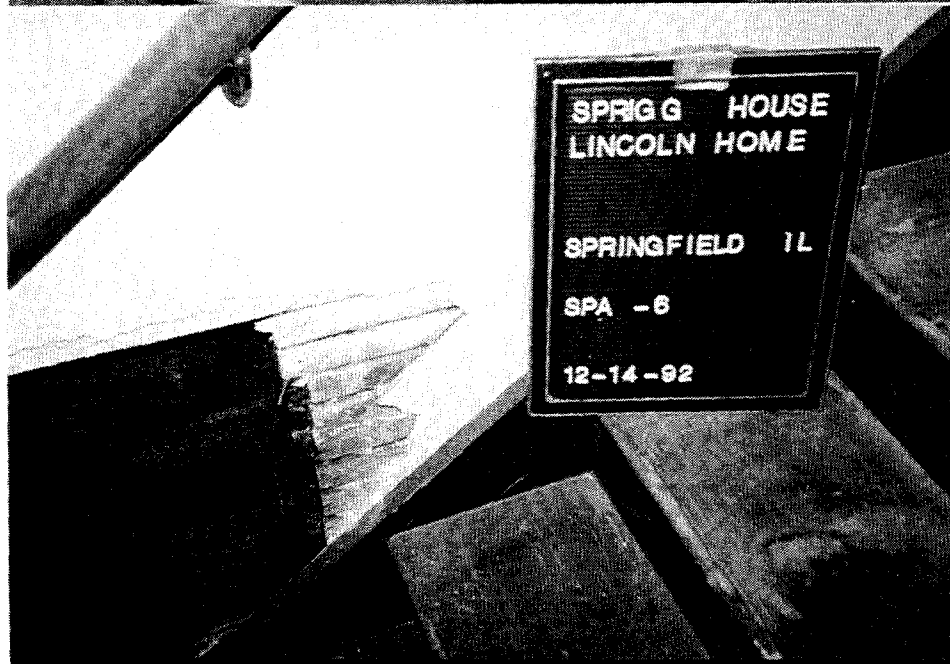
Photo SPA-6
1922 Plaster
Stair S1-Wall

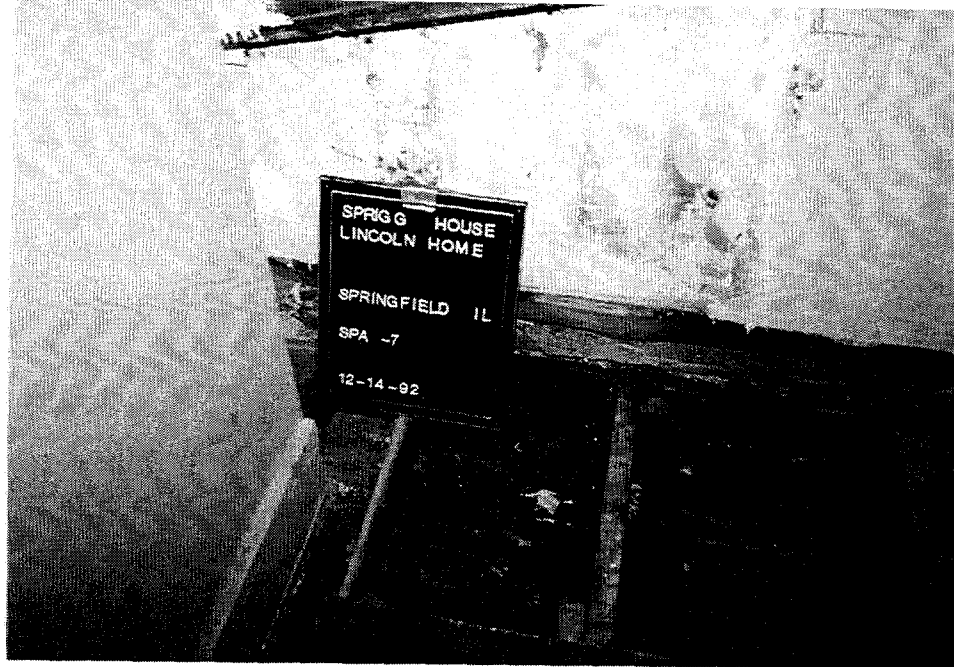
Photo SPA-7
1922 Plaster
Room 207-Wall

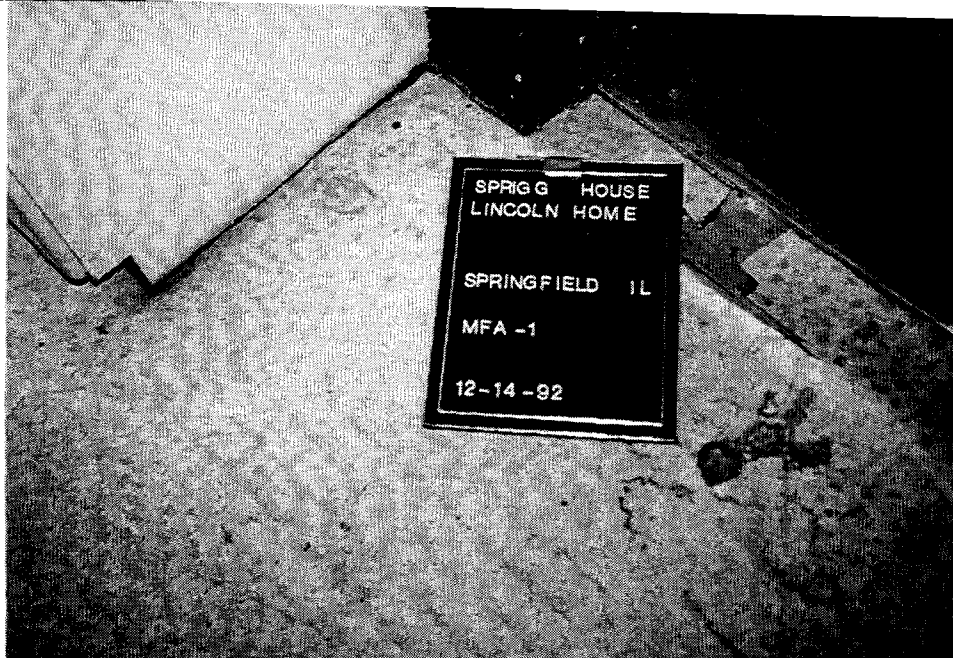
Photo MFA-1
Sheet Flooring-Linoleum
Room 208

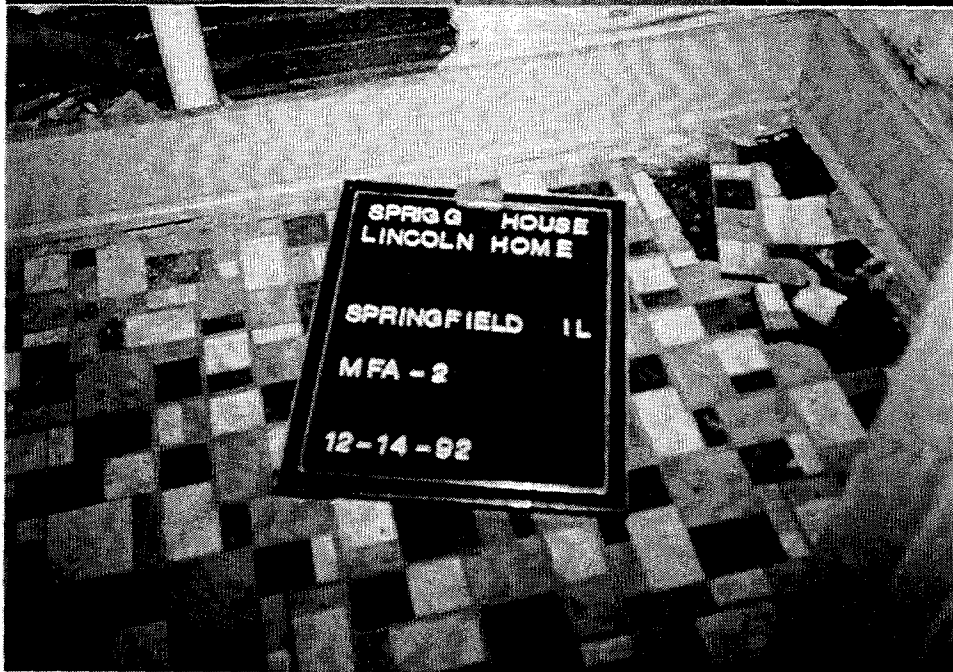
Photo MFA-2
Sheet Flooring-Linoleum
Closet 207B

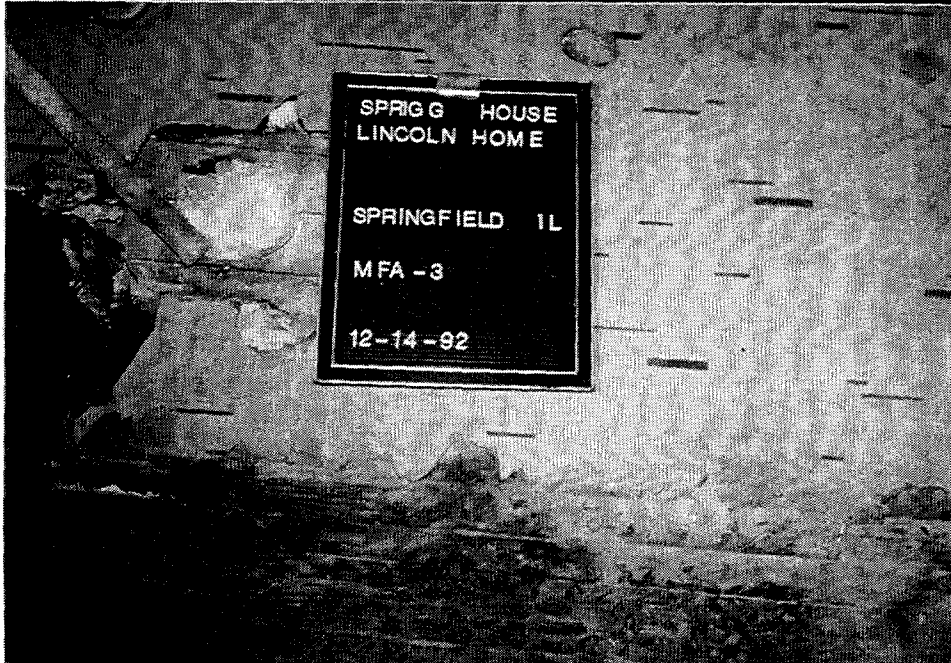
Photo MFA-3
Sheet Flooring-Linoleum
Bathroom 201A

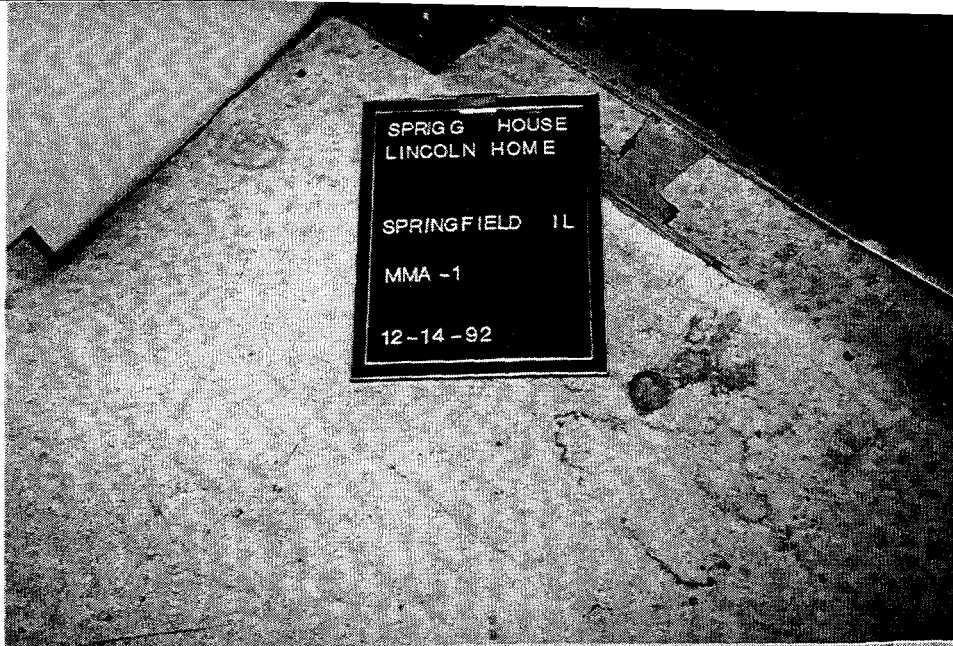
Photo MMA-1
Mastic Under Sheet
Flooring Room 208
