HISTORIC STRUCTURE REPORT

JULIA SPRIGG HOUSE (HS-11)

Lincoln Home National Historic Site
Springfield, Illinois

May 1995

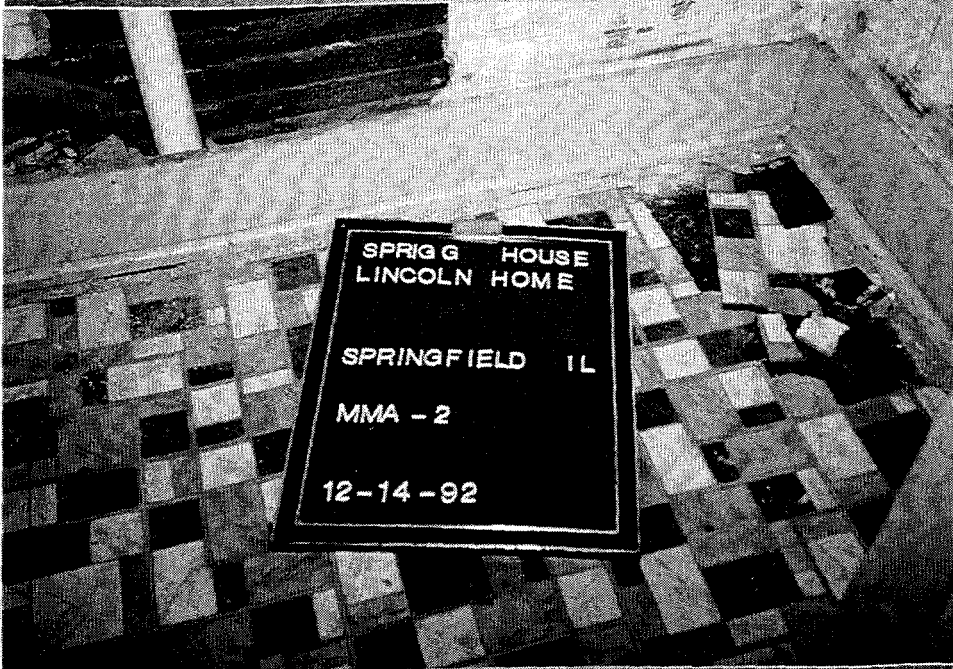
Photo MMA-2
Mastic Under Sheet
Flooring Closet 207B

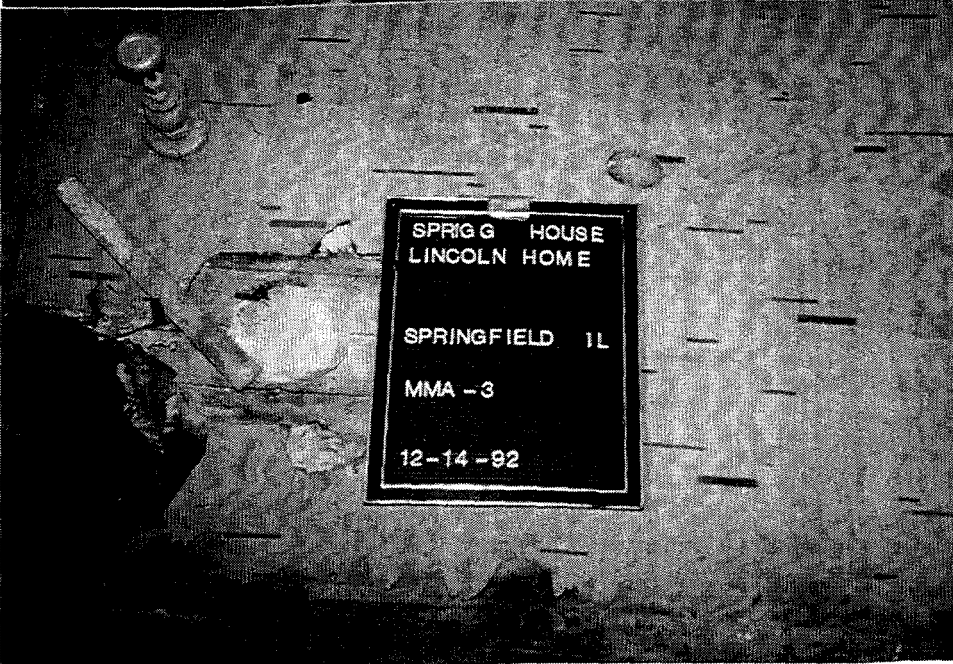
Photo MMA-3
Mastic Under Sheet
Flooring Bathroom 201A

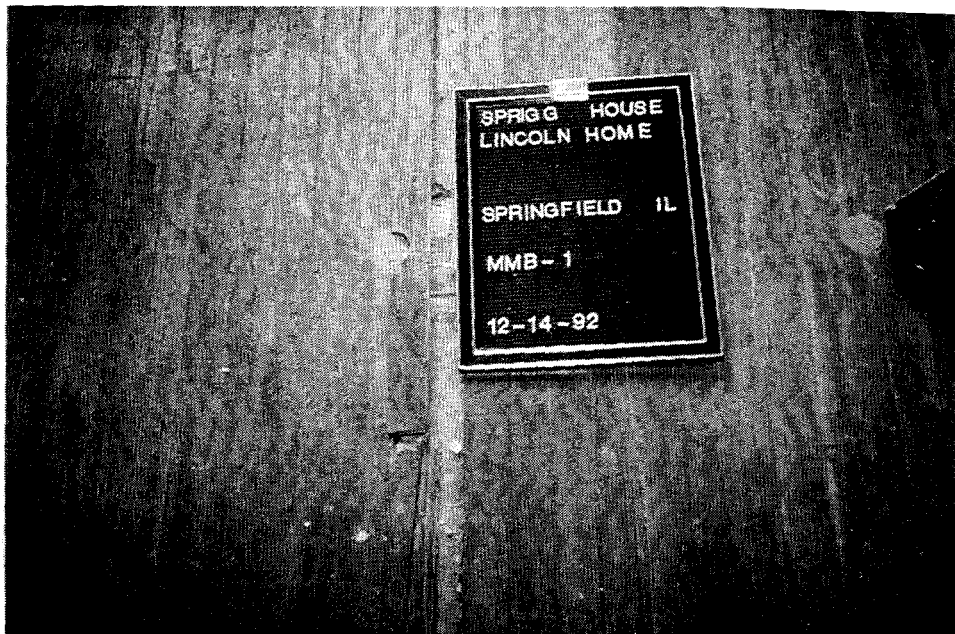
Photo MMB-1
Felt Paper Under Wood
Floor Room 204

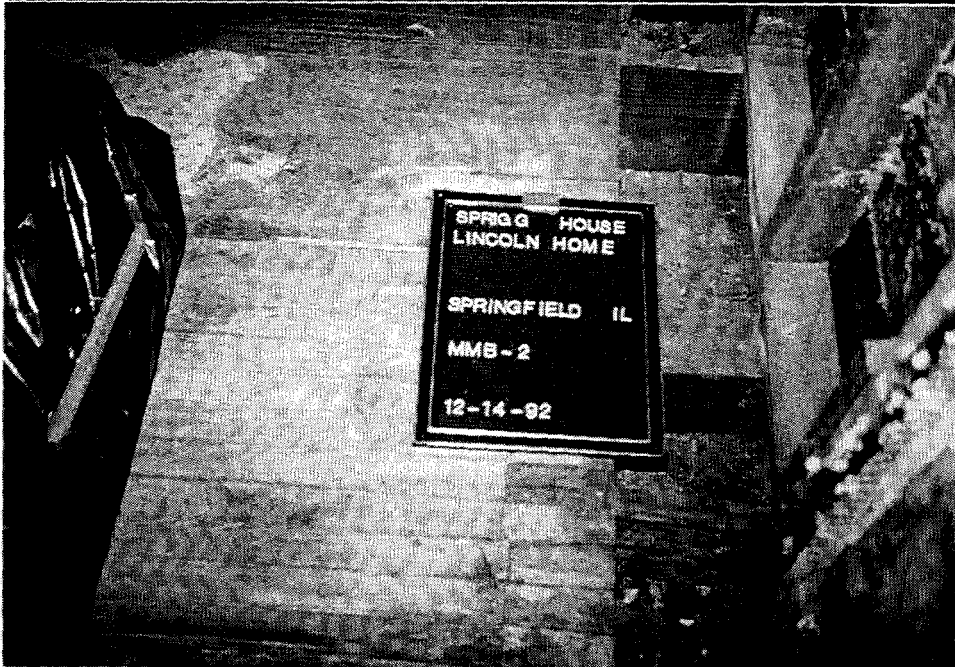
Photo MMB-2
Felt Paper Under Wood
Floor Room 208

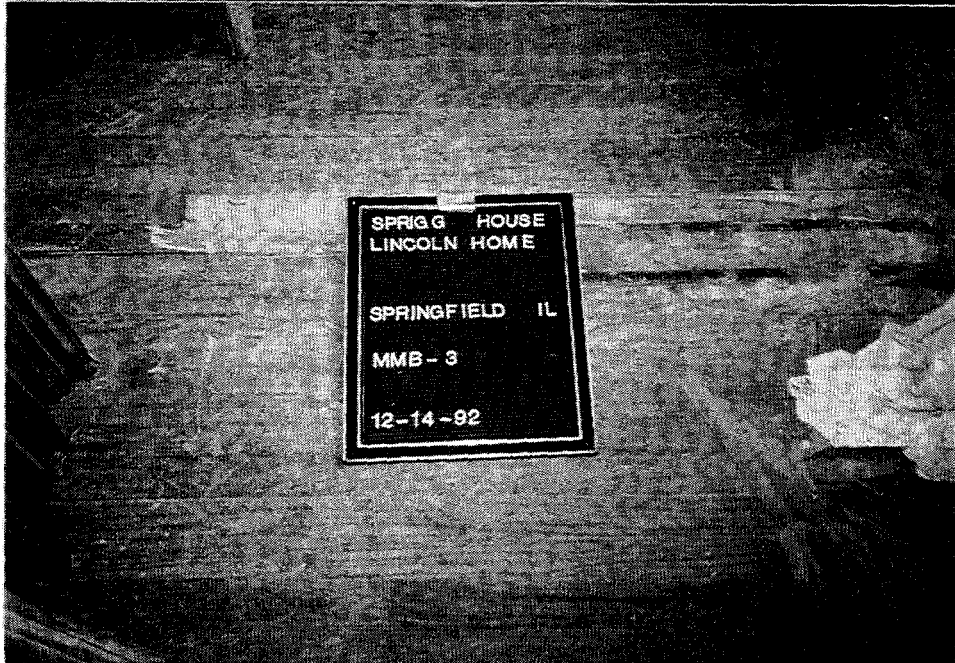
Photo MMB-3
Felt Paper Under Wood
Floor Room 202

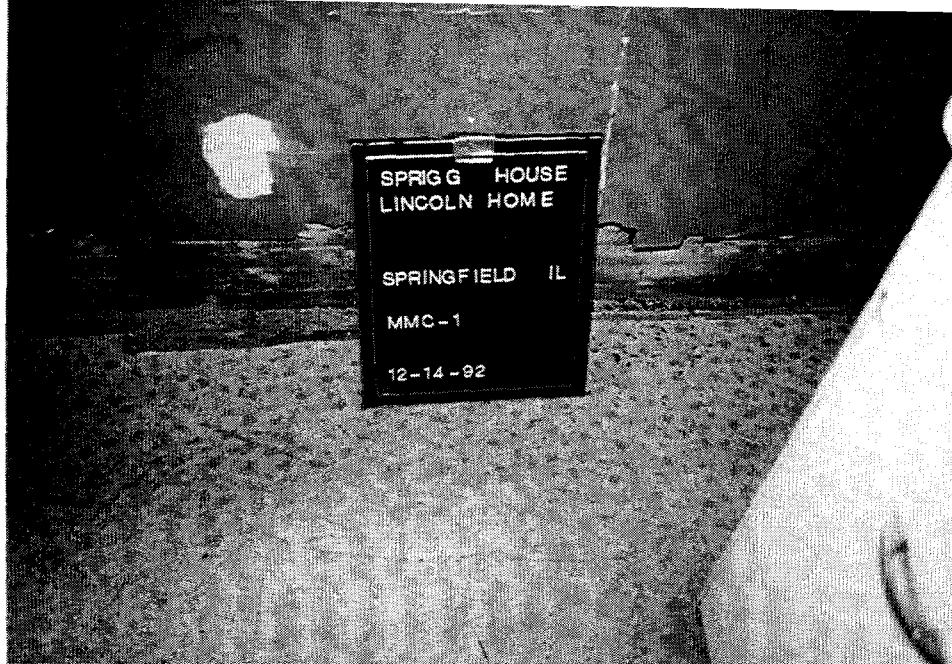
Photo MMC-1
Fibrous Wall Board
Room 208

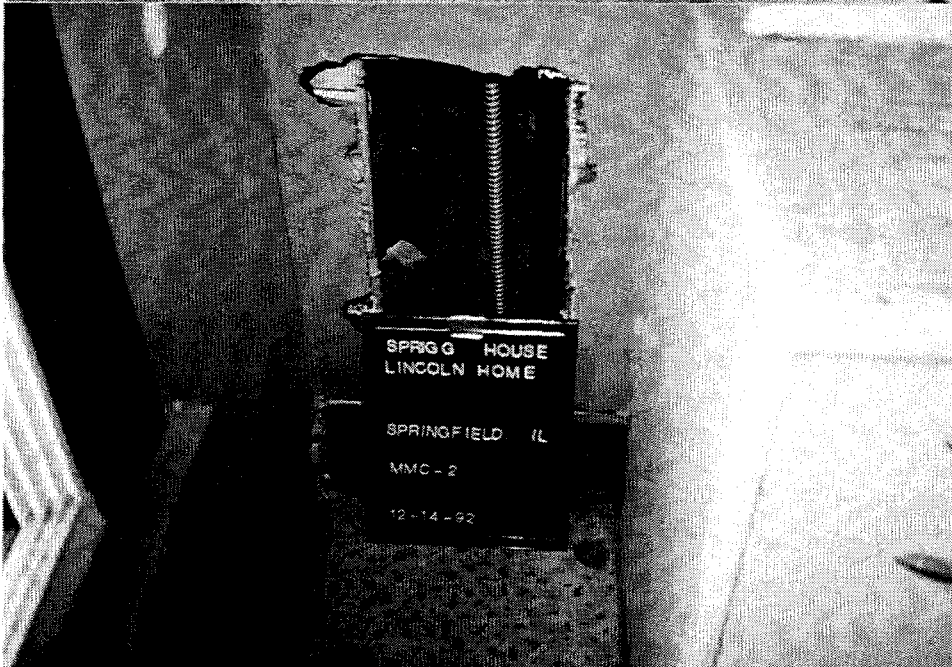
Photo MMC-2
Fibrous Wall Board
Room 208

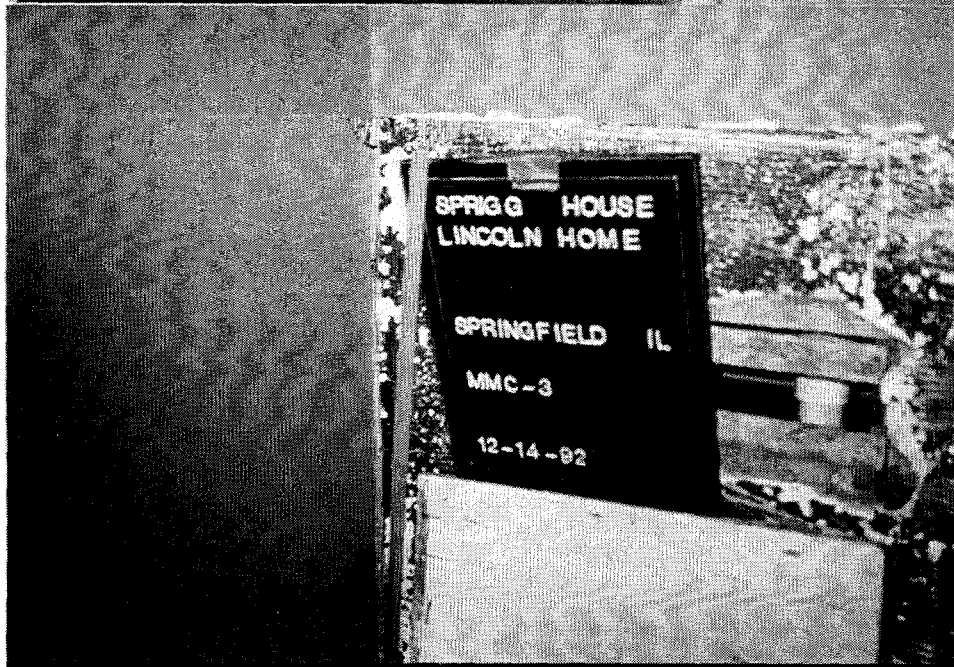
Photo MMC-3
Fibrous Wall Board
Room 208

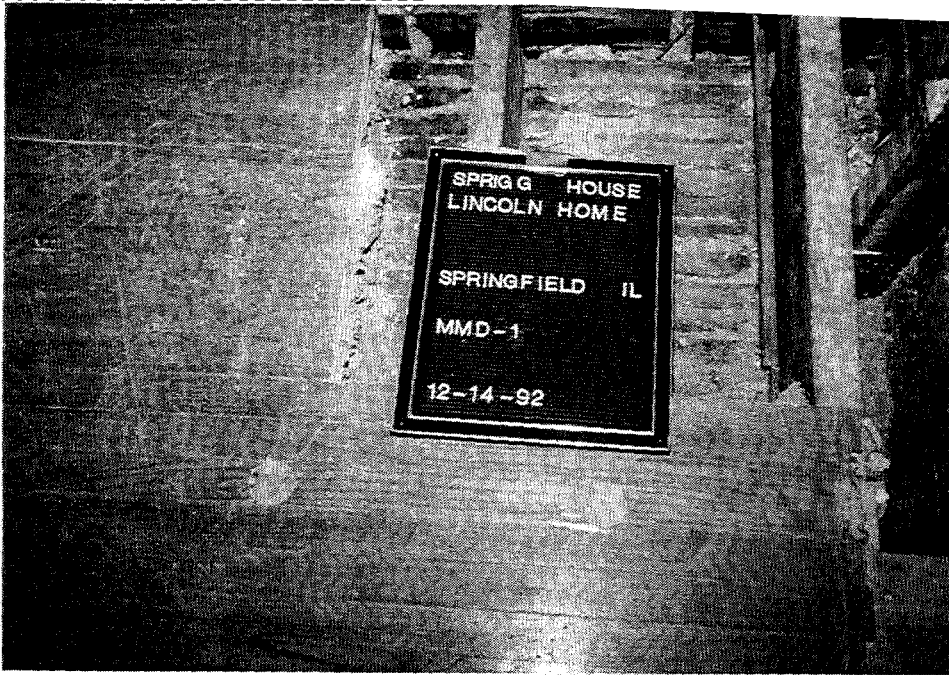
Photo MMD-1
Blown-in Insulation
Room 202

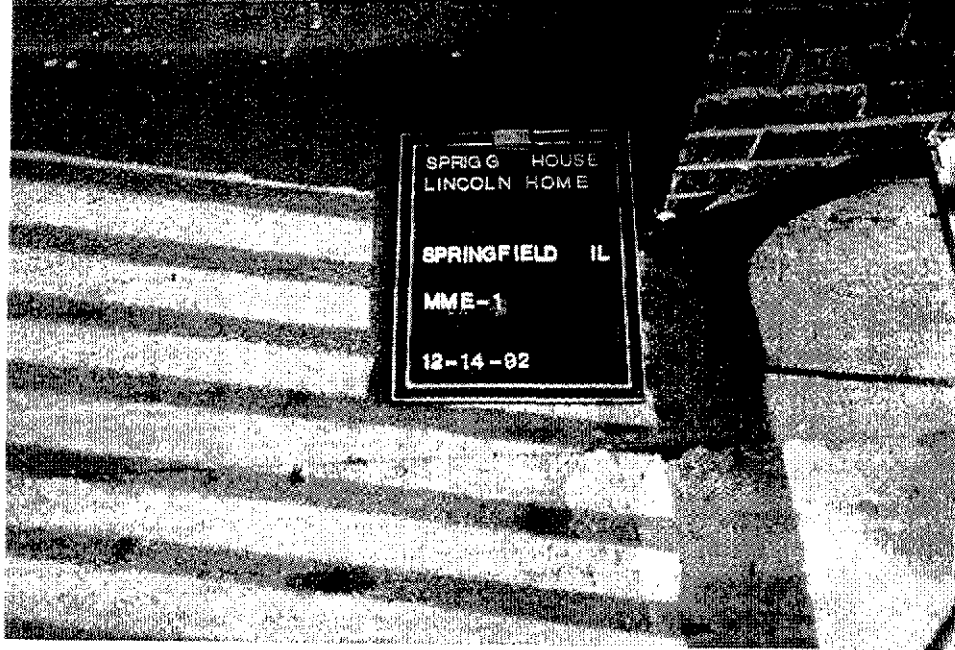
Photo MME-1
Roofing
Second Floor Balcony

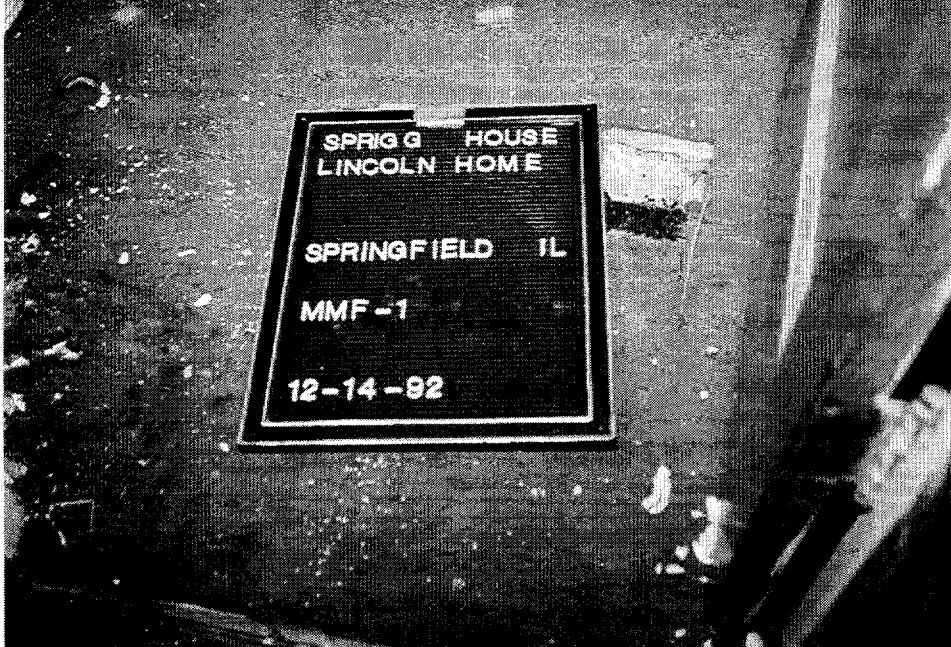
Photo MMF-1
Mastic Under Carpet
Room 207D

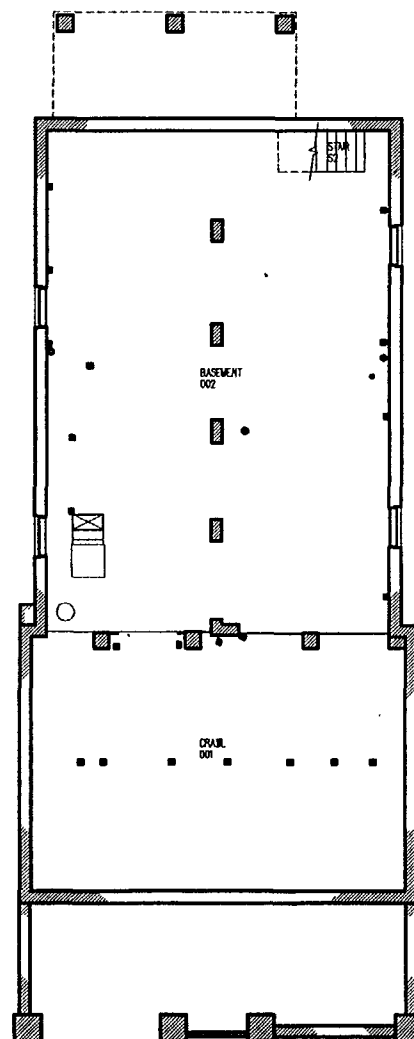
BASEMENT FLOOR PLAN
 SCALE: 1/4" = 1'-0"
 0 5 10 FEET

NO SUSPECT MATERIAL ON THIS FLOOR

Since the first floor was inaccessible to the inspector, we recommend that it be inspected when it becomes accessible to determine if there may be additional areas of suspect material.
