Lake Area Fish Hatchery

Historic Structure Report

Prepared by Sievert & Sievert Cultural Resource Consultants
in conjunction with the Montana Preservation Alliance

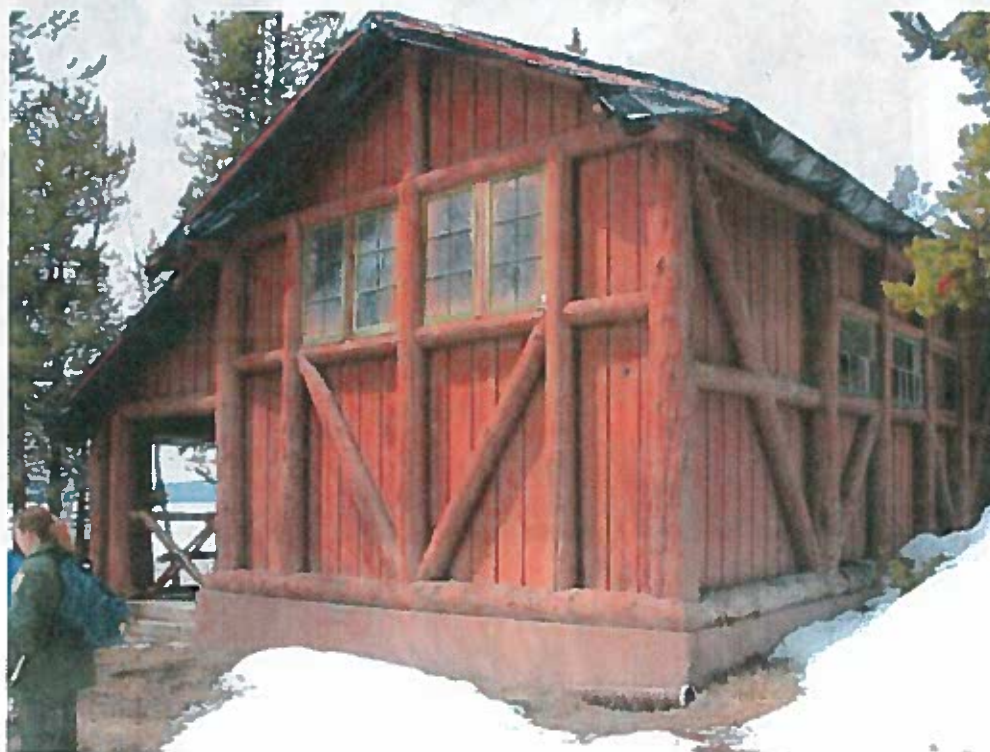
Winter environment that Hatchery structure is subjected to; note depth of snowdrift at right in photo and encroachment of snow onto base of log structure. Photo by Herbert Dawson, May 2006.

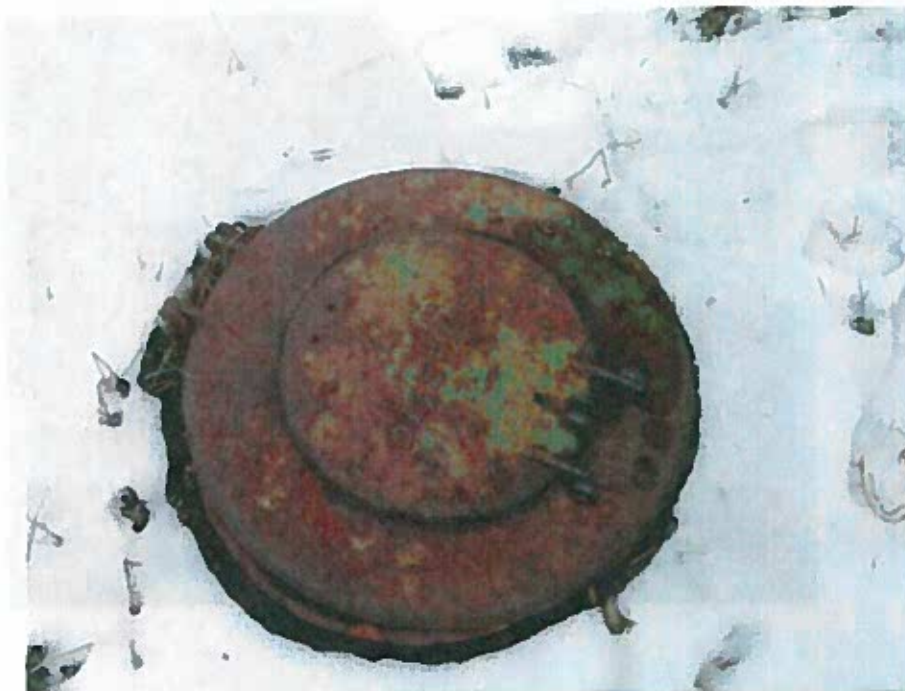
"Majestic Breakproof" manhole cover located north of east end of structure. Photo by Herbert Dawson, November 2007.

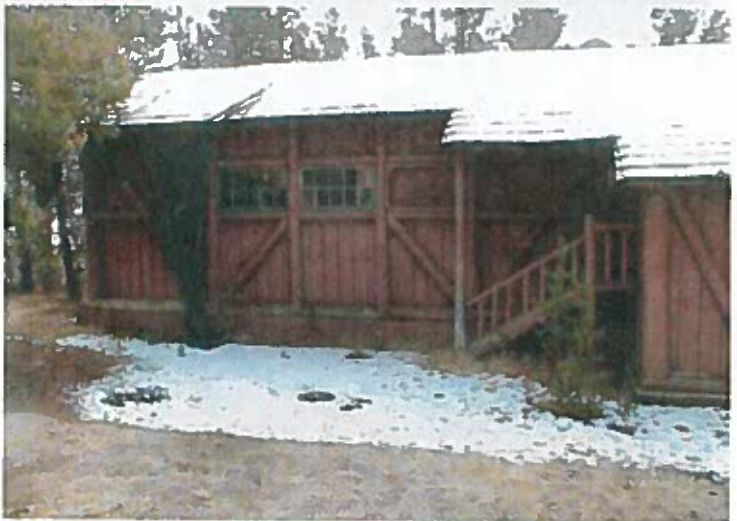
West elevation; the walls are spaced 1x12s with 1x4 battens over the joints on the interior. Total wall thickness is 1½". Photo by Ken Sievert, November 2007.

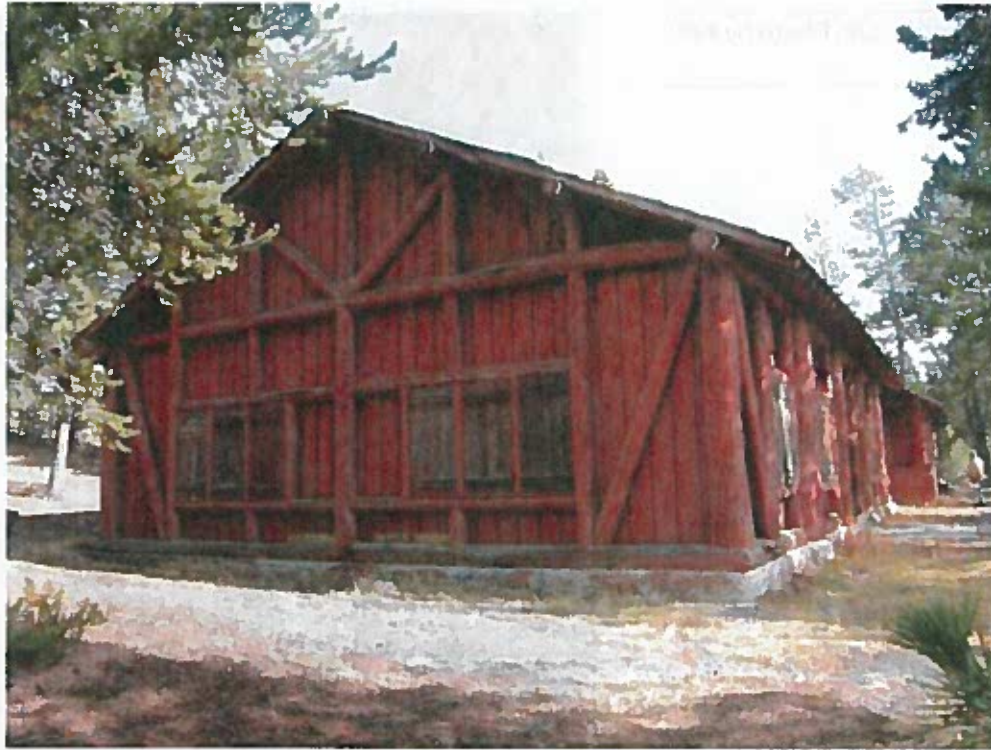
West elevation; note different sizes of log members in wall. Photo by Herbert Dawson, November 2007.

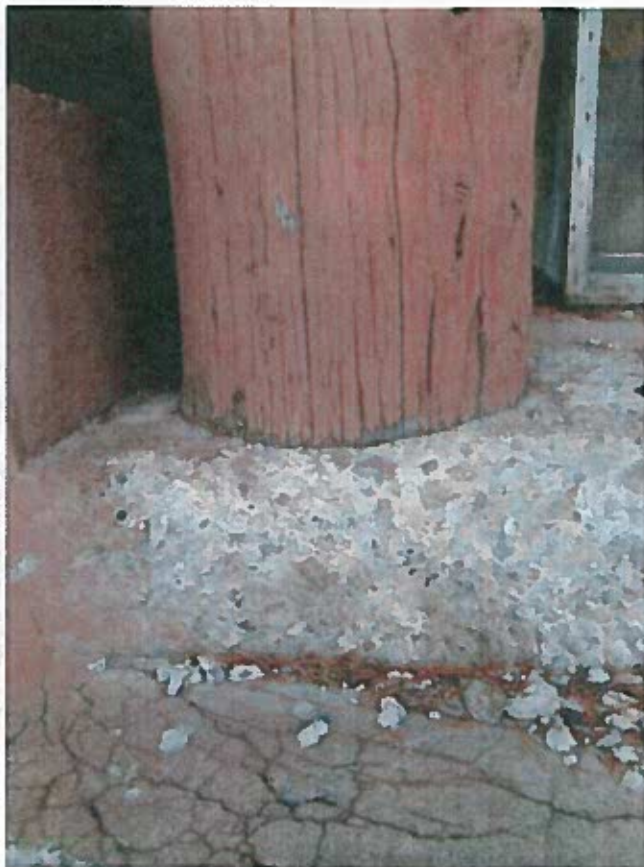
Log column at west end of concrete terrace that serves as main visitors entrance into facility; note that column base appears to be sound at this location although the concrete is severely weathered. Photo by Herbert Dawson, November 2007.

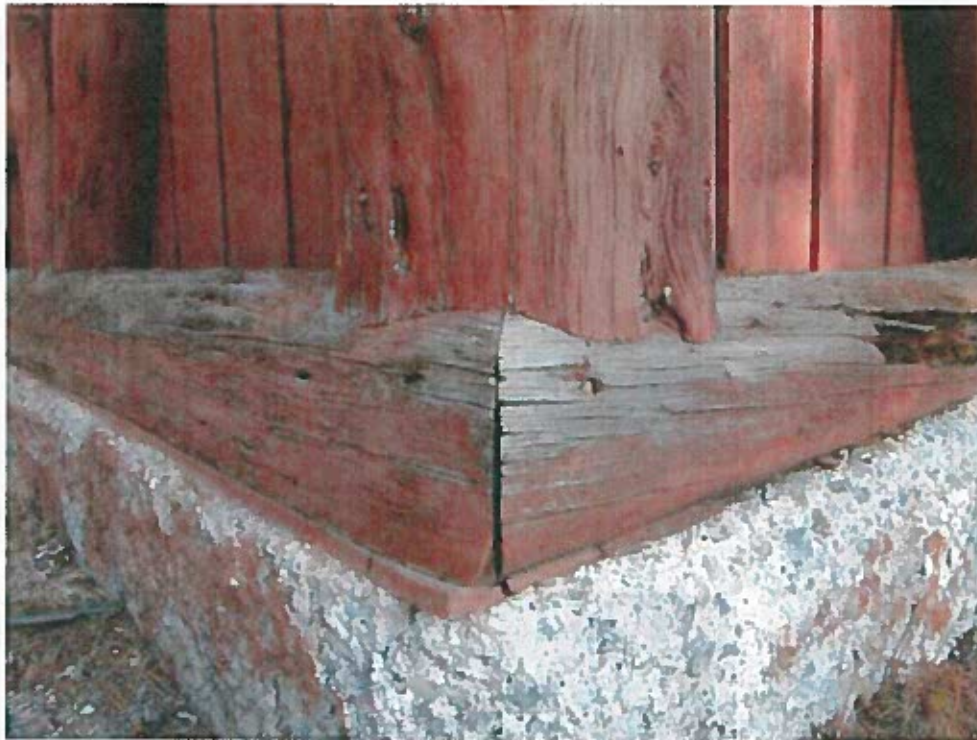
Sill log detail at southwest corner of structure; note shim stock installed along bottom edge of sill log. Photo by Herbert Dawson, November 2007.

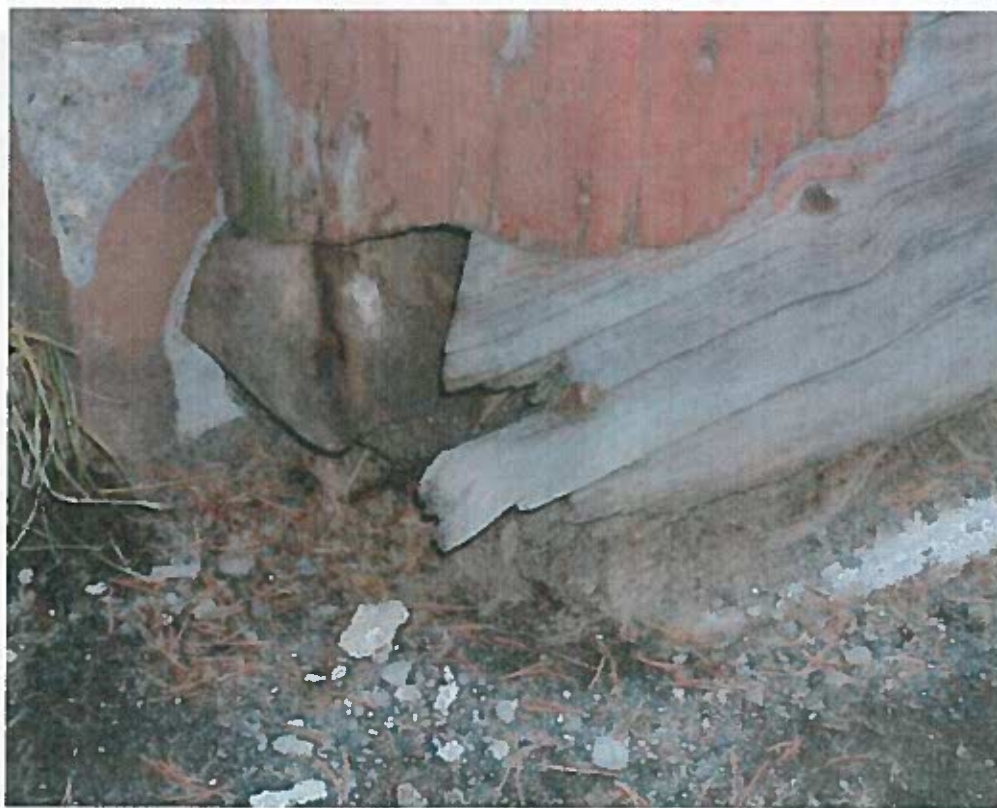
Detail of the photo above showing the Dutchman log return at the corner of the structure. Photo by Herbert Dawson, November 2007.

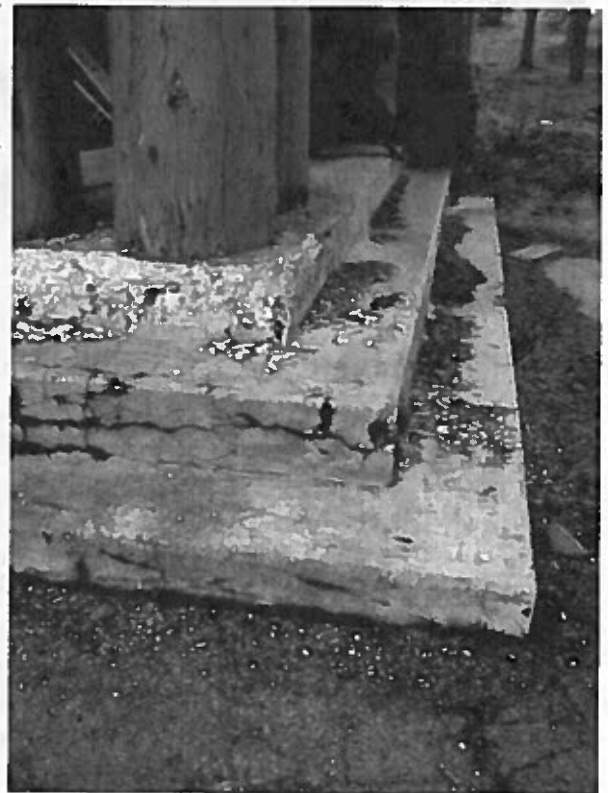
Additional photo at same location; note alligatoring in concrete surfaces on both horizontal and vertical faces. Moss is growing in the cracks further accelerating the deterioration. Photo by Ken Sievert, November 2007.

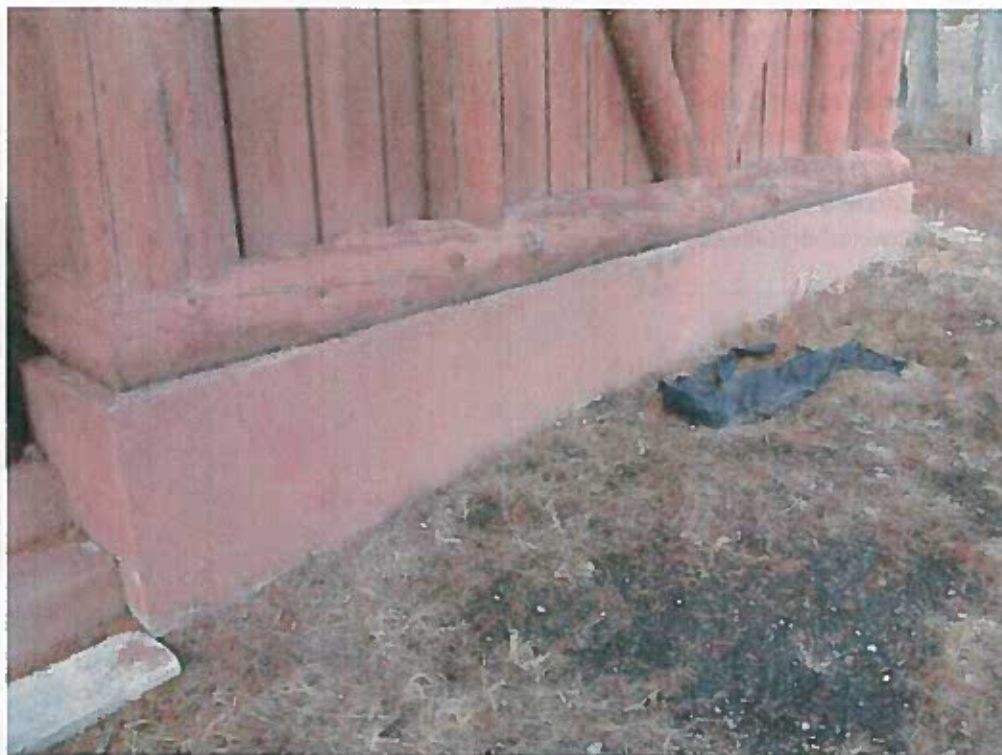
East wall foundation wall. This concrete is in relatively good condition and has not weathered to the same extent as other exposures of the building. A crack was recorded at the northeast corner (right end of the wall above) that is attributed to stress concentrations at the corner location. Photo by Herbert Dawson, November 2007.

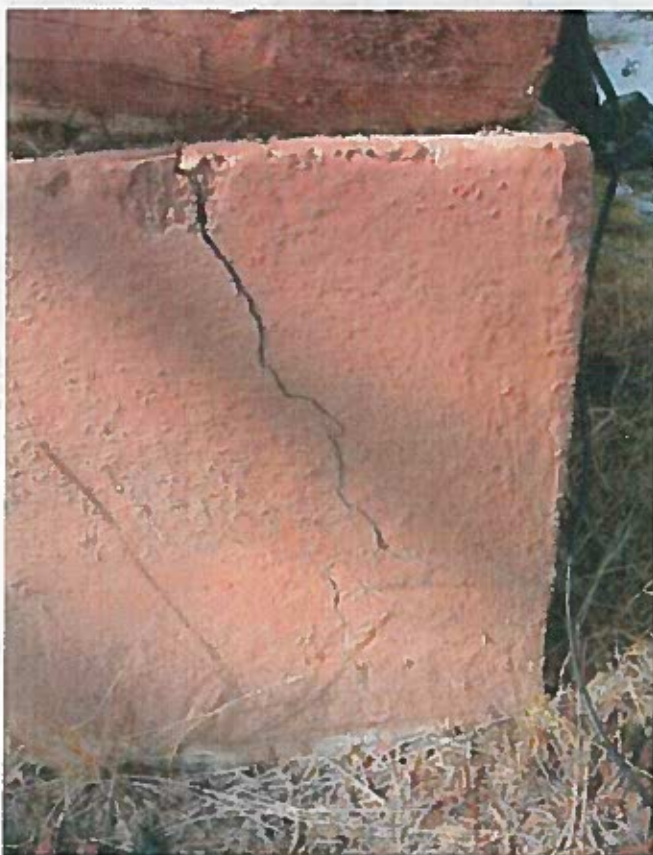
Concrete grade beam that surrounds terrace platform and that is protected by roof above is in very good condition and has not weathered. The concrete slab-on-grade floor surface of the terrace area is also in relatively good condition although the exterior steps along the south and east perimeter of the slab are not. Photo by Herbert Dawson, November 2007.

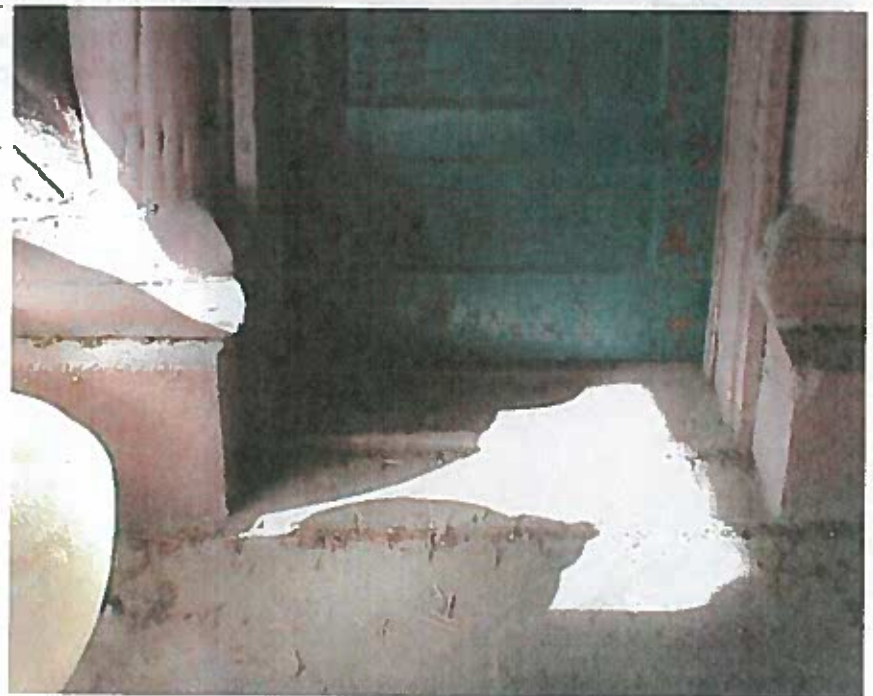
Note the crispness of the concrete forming on the perimeter grade beam. Photo by Ken Sievert, November 2007.

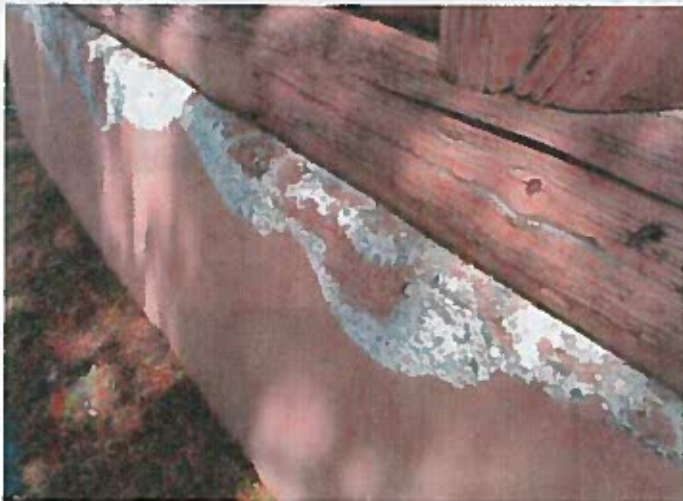
Detailed view of top of wall in photo above. Photo by Herbert Dawson, November 2007.

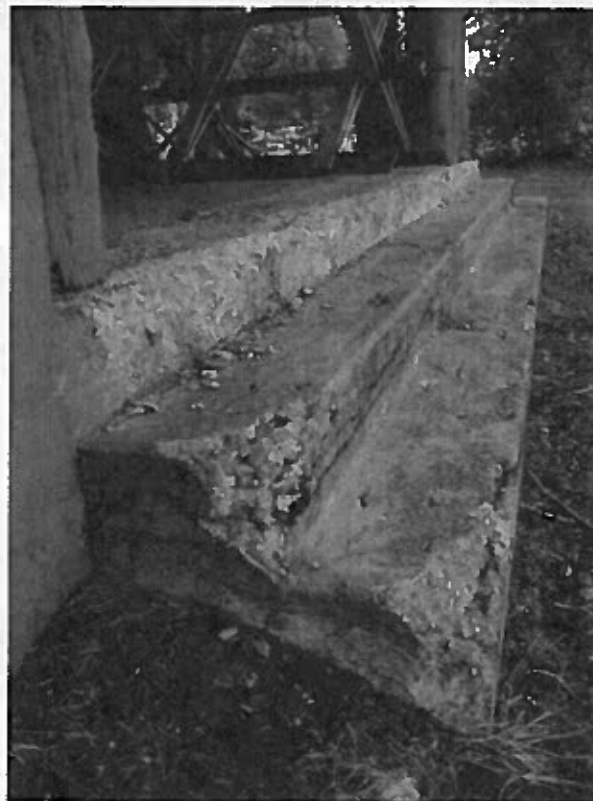
Concrete deterioration adjacent to the side entry doors into the hatchery raceway area. Concrete at this location is in an advanced state of deterioration and is becoming soft and "punky." Photo by Ken Sievert, November 2007.

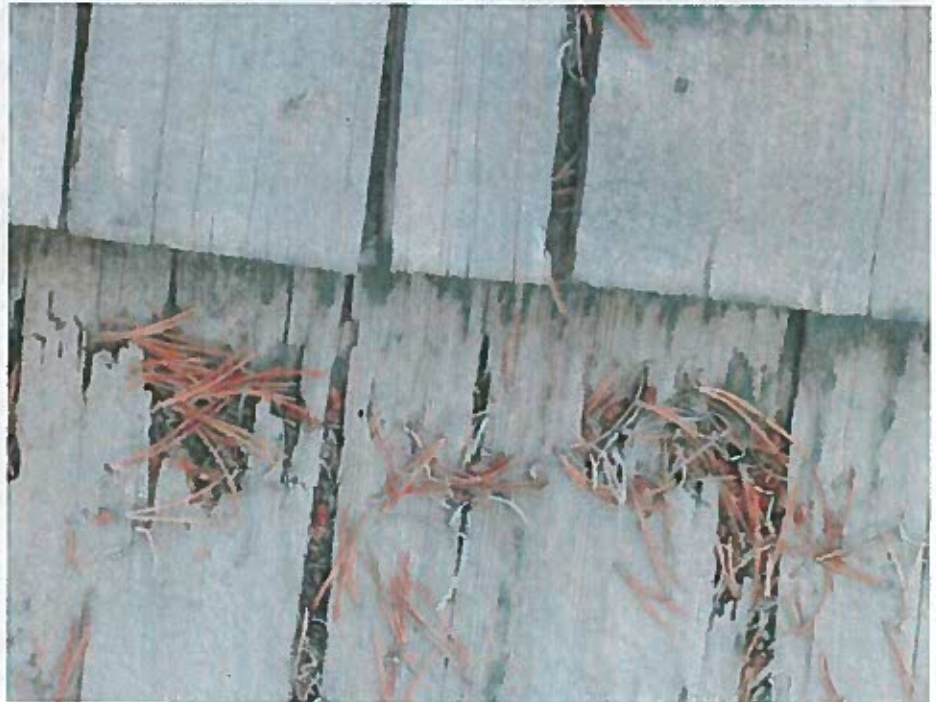
Condition of roof shingle ridge; it appears that the lap was intended to be a Boston Lap although the gap at the ridge is inordinantly large. Note the deteriorated shingles midway down the ridge. Tie-offs for ropes can be seen at periodic intervals along the length of the ridge. Photo by Herbert Dawson, November 2007.

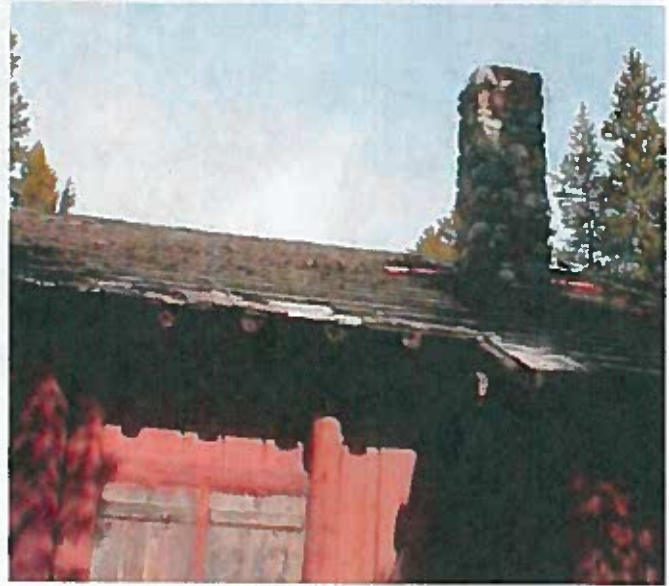
As part of the Parkitecture style of design, the roof shingles have 16" exposure and are double coursed. The result is a unique textural scale that is visually pleasing and very important to the appearance of the building. Photo by Herbert Dawson, November 2007.

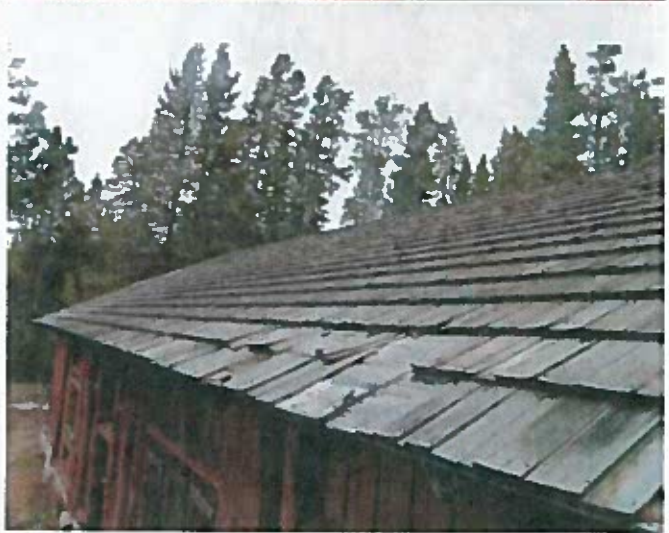
The roof construction does not indicate any building paper or "slip sheet" as part of the original roofing. Photo by Herbert Dawson, November 2007.

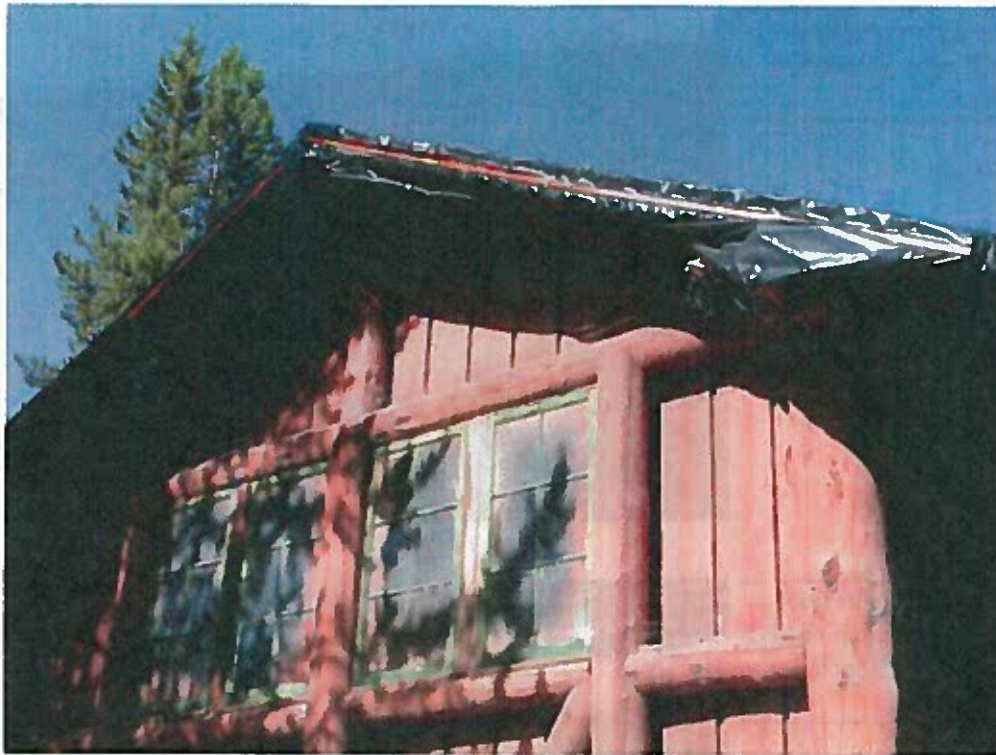
Emergency roof covering that has been applied over the east end of the building (consisting of a heavy gauge of Visqueen). Photo by Herbert Dawson, November 2007.

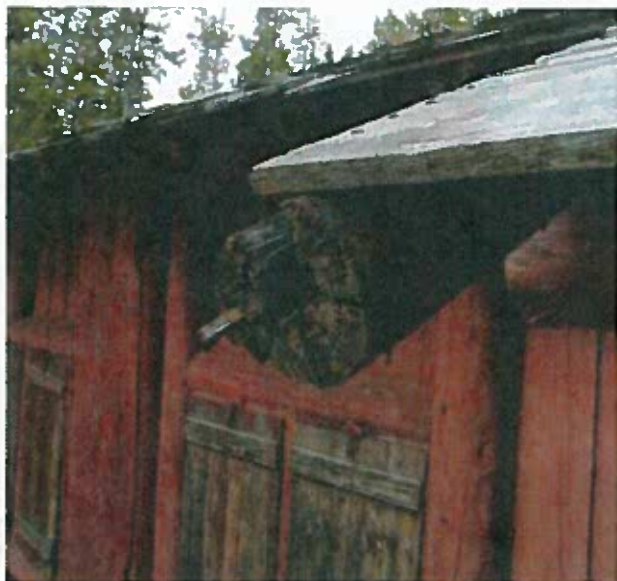
Rafter tail along south wall at corner of Office. Photo by Herbert Dawson, November 2007.

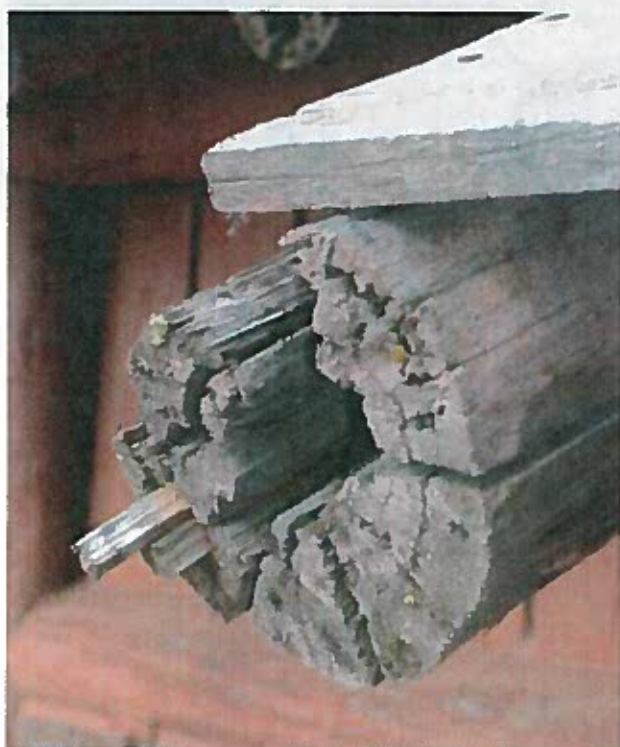
Detail of above rafter. Photo by Herbert Dawson, November 2007.

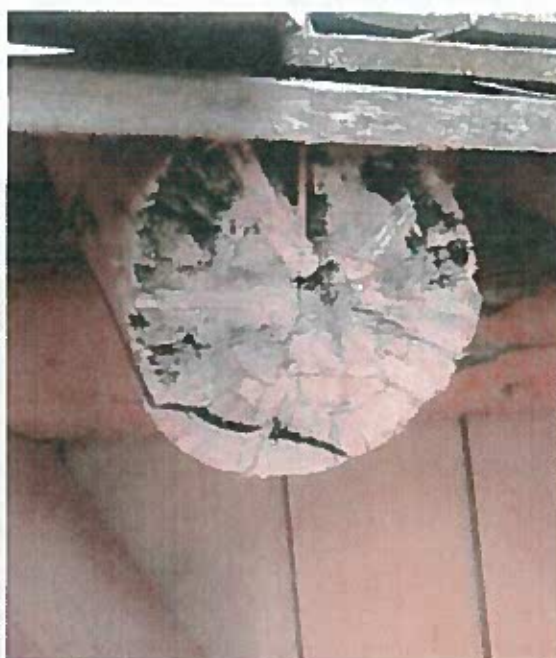
Typical rafter tail. Note loss of wood around sheathing nail. Photo by Herbert Dawson, November 2007.

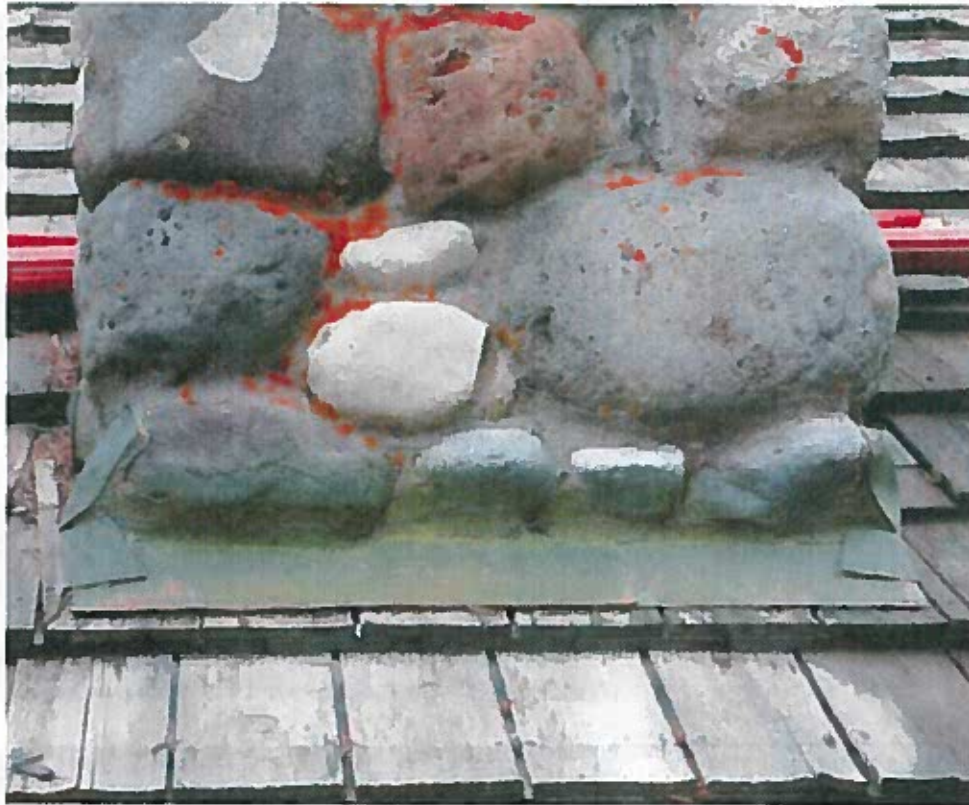
Copper flashing at base of chimney (the flashing has been painted green). The flashing is in very good shape. Photo by Herbert Dawson, November 2007.

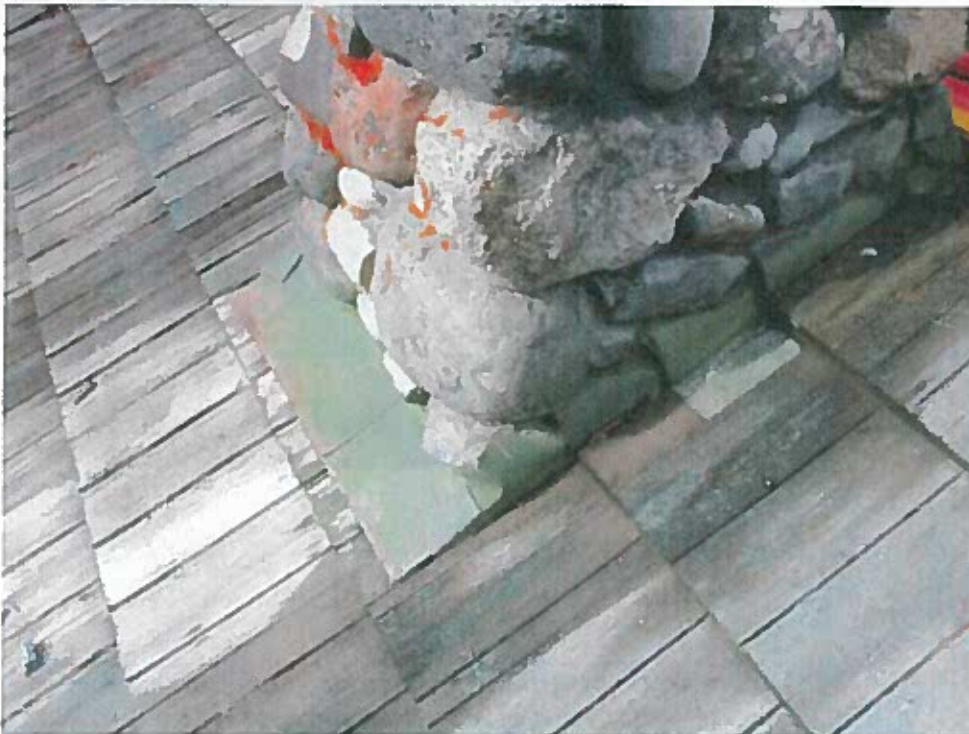
The craftsmanship of the step flashing along the sides of the chimney is remarkable and of very high quality. Photo by Herbert Dawson, November 2007.

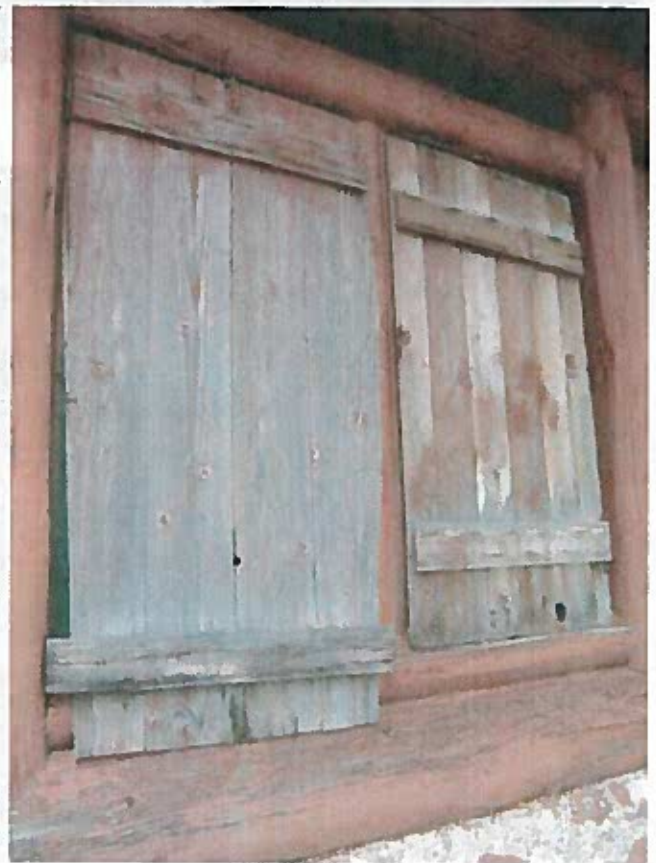
Window sill log that requires replacement. Note that dimensioned lumber sill plate for window is also partially missing. Photo by Herbert Dawson, November 2007.

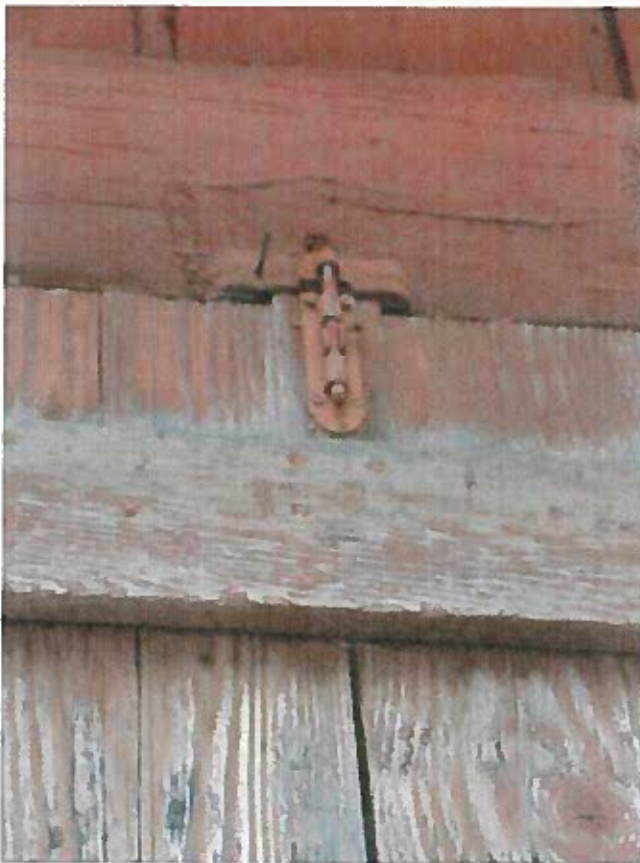
Detail of barrel bolt that was used to hold winter window shutters in place; many of these are missing at the existing window locations. Photo by Herbert Dawson, November 2007.

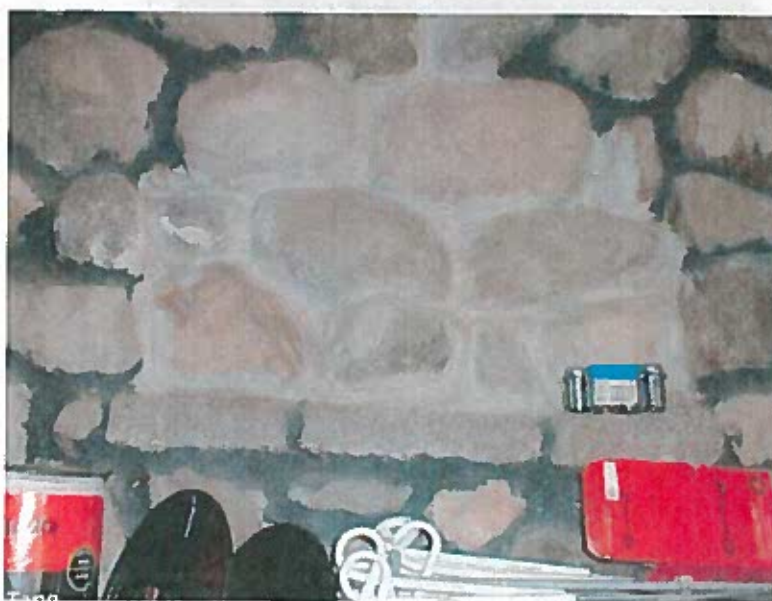
Inset in face of fireplace above mantle; the cause of this inset is not known at this time. Photo by Ken Sievert, November 2007.

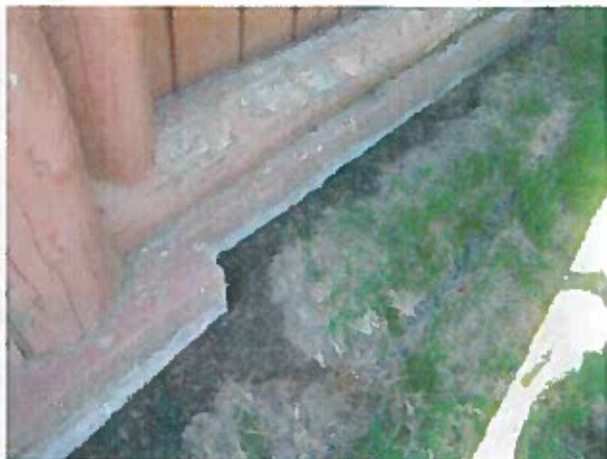
Drainage trench along north wall, installed by YNP volunteer crews. Photo by Herbert Dawson, November 2007.

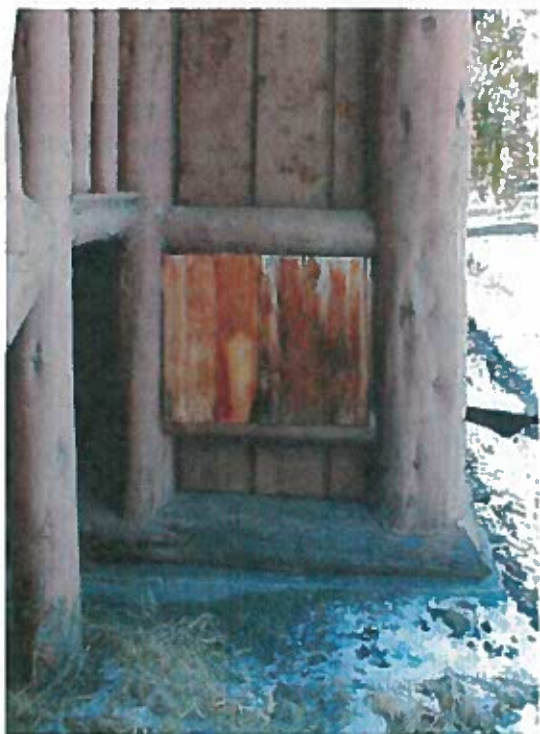
Access panel located at northeast corner of hatchery floor (adjacent to exterior stair). Photo by Ken Sievert, November 2007.

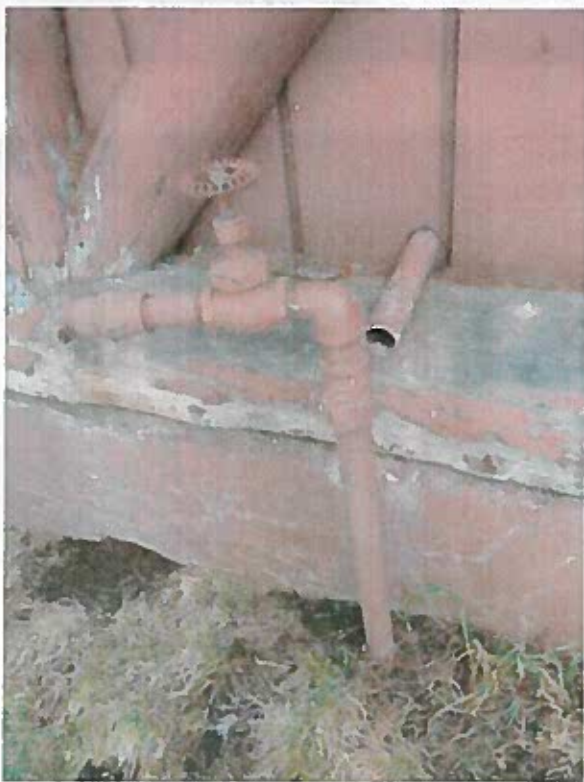
Piping for original water supply to aquarium exhibit area; located near the east end of the north wall and in proximity to the manhole shown with the site photos. Photo by Herbert Dawson, November 2007.

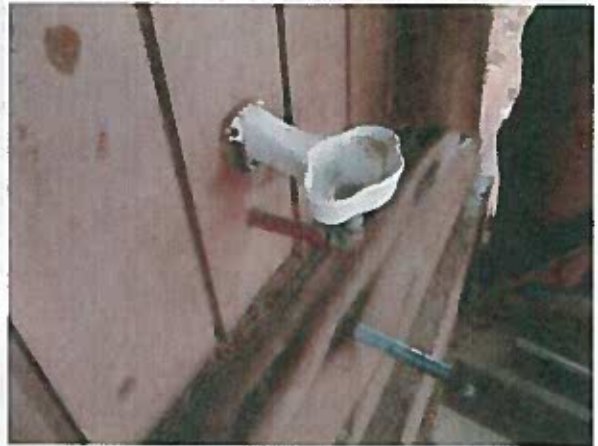
Electrical service to facility is located midway along the north wall and is served underground. Photo by Ken Sievert, November 2007.

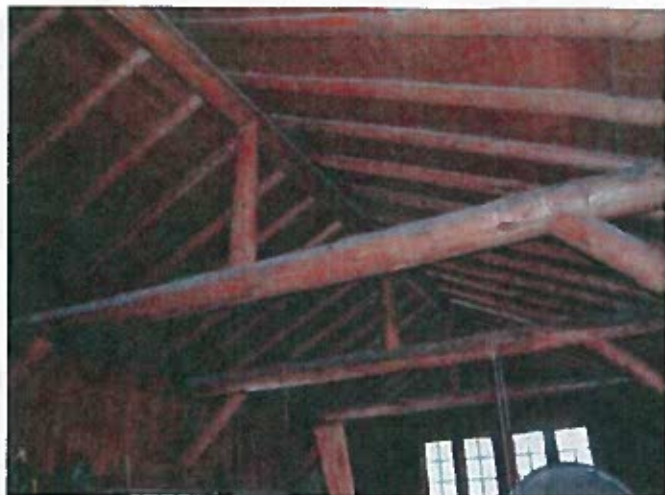
King-post truss configuration over aquarium exhibit area. Photo by Herbert Dawson, November 2007.

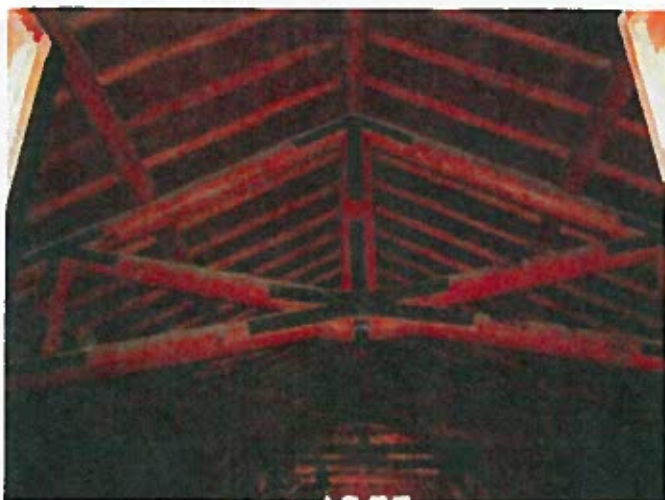
Modified scissors truss configuration over hatchery area. Photo by Herbert Dawson, November 2007.

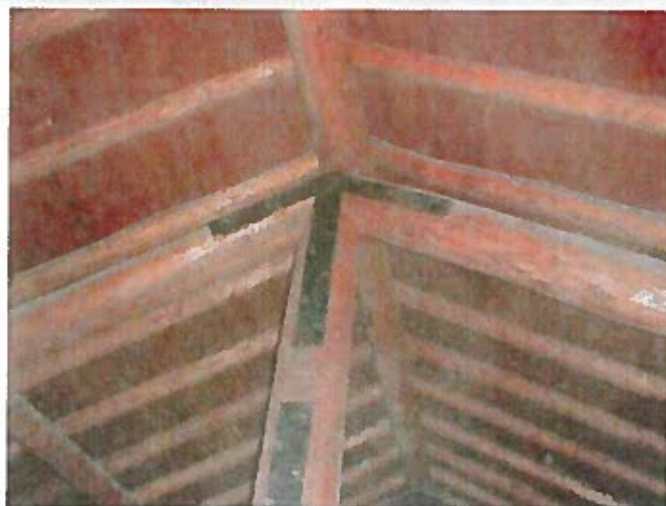
Top connection detail—modified scissors truss. Photo by Ken Sievert, November 2007.

Bottom connection detail—modified scissors truss. This particular truss is located at the top of the storage platform stair and has wrapped head protection. Photo by Ken Sievert, November 2007.

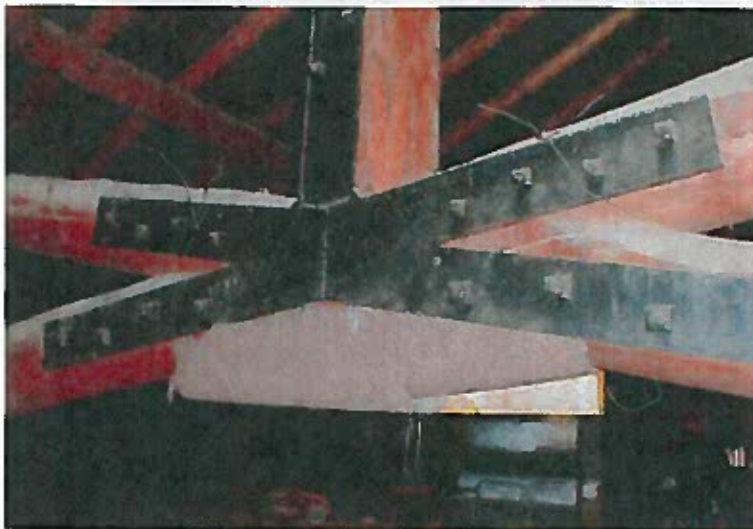
Vertical web details—modified scissors truss. Top of vertical web. Photo by Ken Sievert, November 2007.

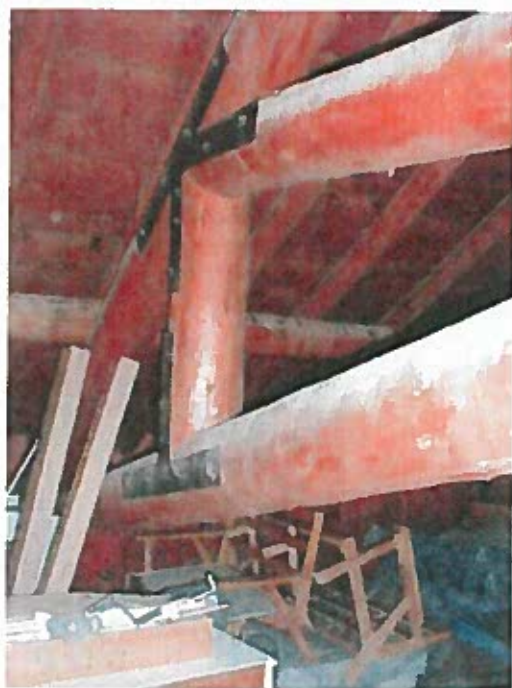
Composite photo of vertical web assembly taken from storage platform build at the west end of the original hatchery raceway area.

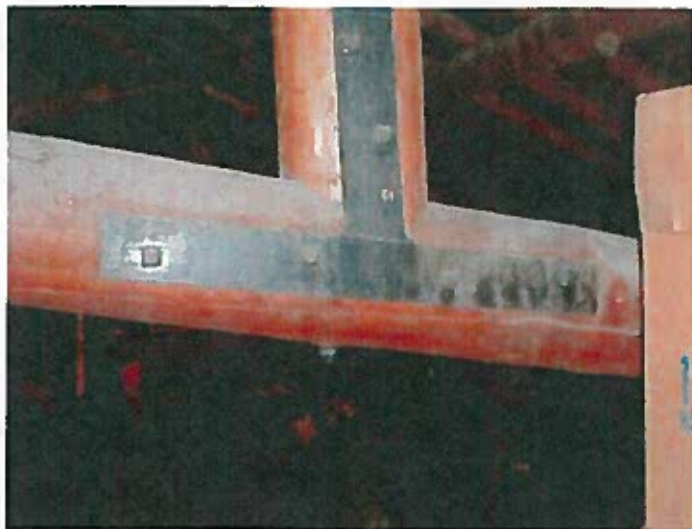
Bottom of vertical web.

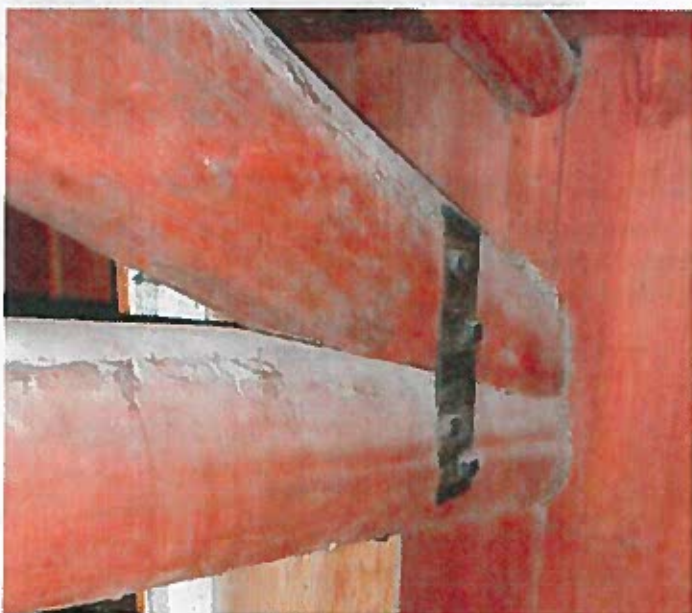
Heel joint of modified scissors truss showing connection of top to bottom chord including steel plates and bolt pattern. The combined chord members socket into the coupled log columns at the exterior of the building walls. Photo by Ken Sievert, November 2007.

Knee brace details—modified scissors truss. Note through bolt and careful coping of the log members. Photo by Ken Sievert, November 2007.

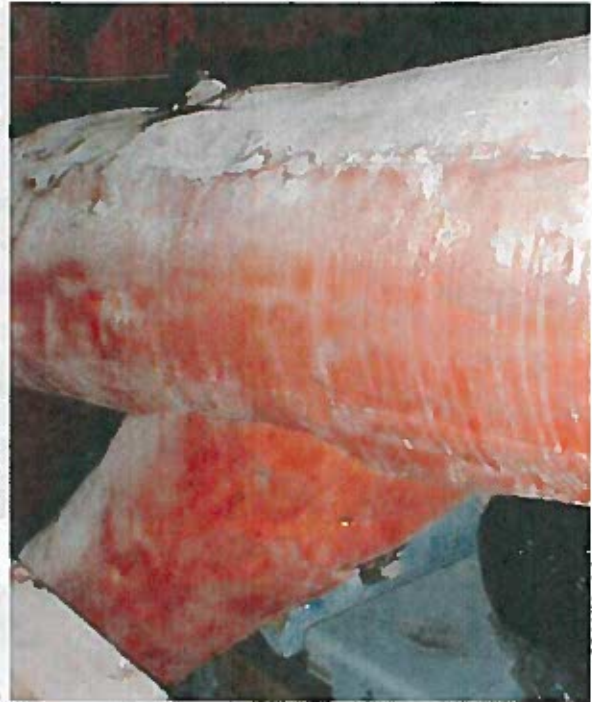
Composite photo showing knee brace from modified scissors truss as it engages the wall (and coupled columns at the exterior) and the heel joint of the truss above. Note the through bolt at the heel joint (similar to the brace bolt in the photo above). Photo by Ken Sievert, November 2007.

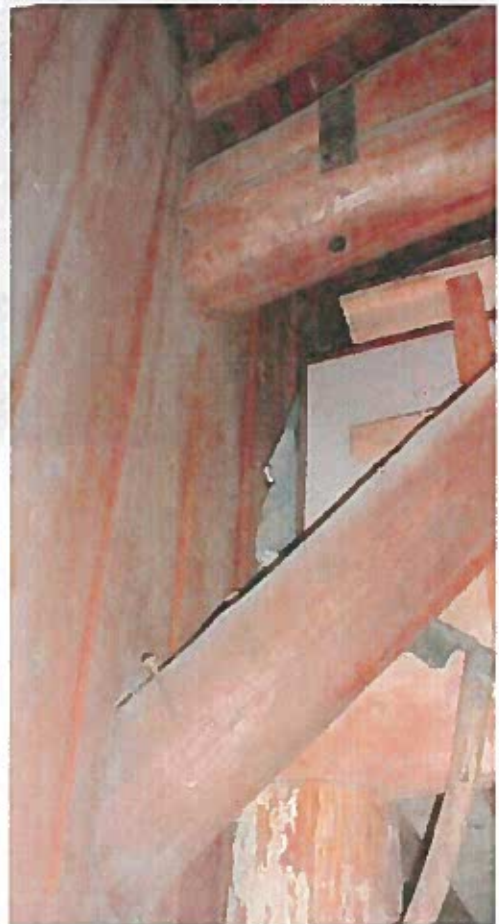
Knee brace details at the aquarium King-post truss; note that these braces were nailed only and that this brace has slipped out of position and requires (minor) repair and stabilization to be effective. Photo by Herbert Dawson, November 2007.

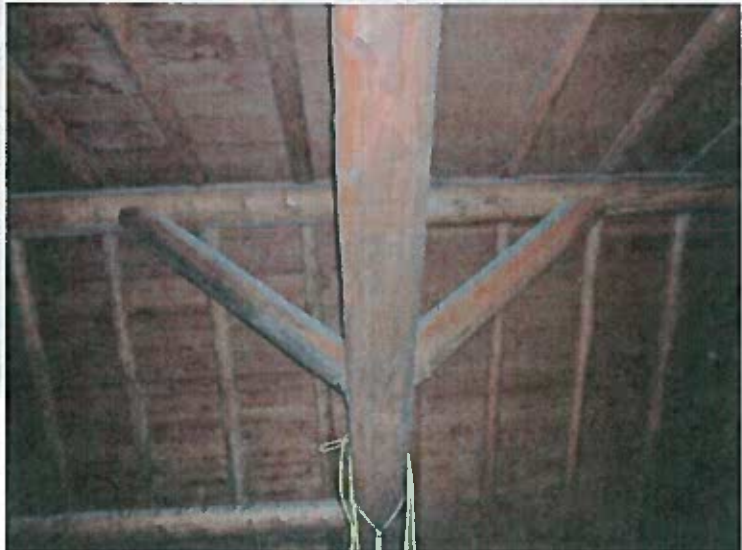
Knee brace detail between the roof ridge purlin and one of the King-post trusses. Note that this bracing detail occurs at only one location (near the balcony) and that the brace connection is totally reliant on nailing. Photo by Herbert Dawson, November 2007.
