HISTORIC STRUCTURE REPORT
HAMILTON / LAKE GENERAL STORE
Yellowstone National Park

June 26, 2008

HAMILTON STORE, YELLOWSTONE LAKE

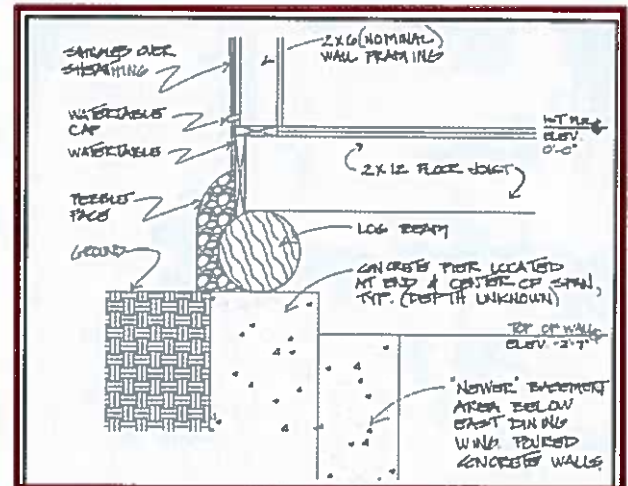
Stone facing on original log beam structure. This detail is extant at the east wing and the south and east walls of the south wing.

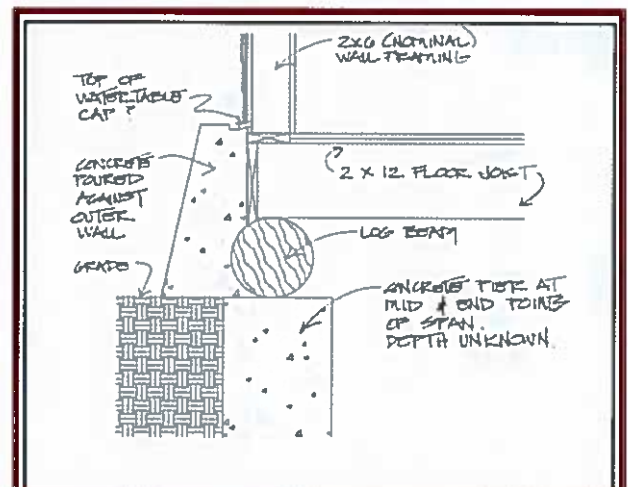
Concrete facing on original log beam structure. This detail is extant at the north wing and the west wall of the south wing.

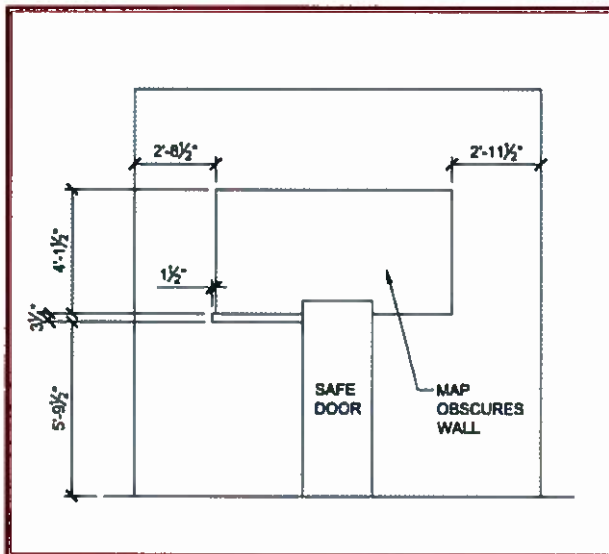
The northwest wall of the office, where the vault engages the office, was originally an outside wall. Beadboard infill clearly marks the outline of the window opening and the stool. It is presumed that the vault addition occurred after 1924 (when not shown on the site plan) and 1928, when it was depicted on the Contract Delivery Post Office plan.

Northwest wall of the office, indicating where the original window opening has been patched with beadboard.

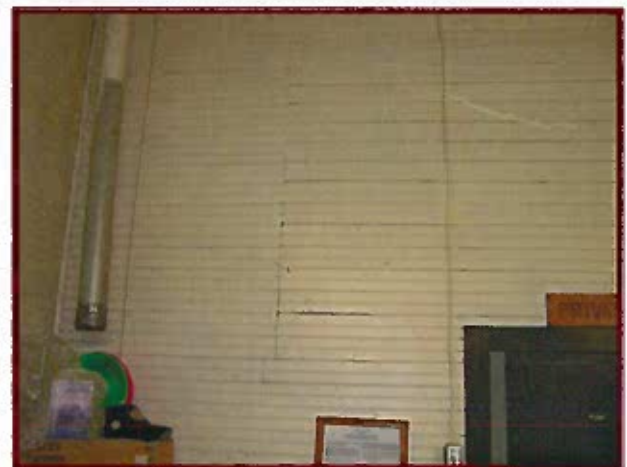
Northwest wall of the office, with clear demarcations of the beadboard patch at the original window opening.

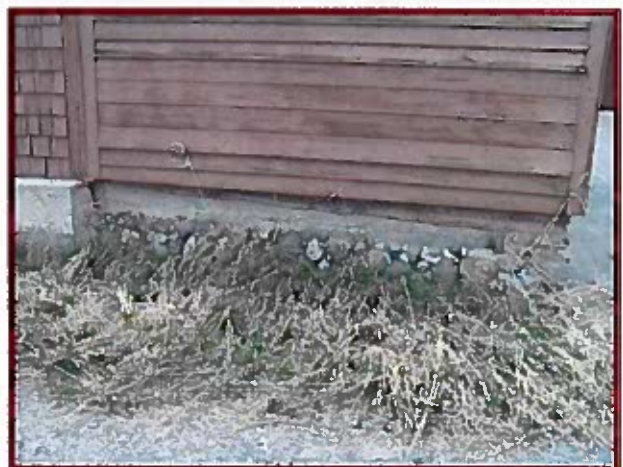
Current physical evidence of stone veneer at the east side only of the existing concrete loading dock,³⁵ and the low height of the loading dock indicate that this was probably an early construction. A dock would certainly have been critical to the operations of the store.

2007 close-up of loading dock at shed. The stone at the base of the concrete implies a c.1922 construction here.

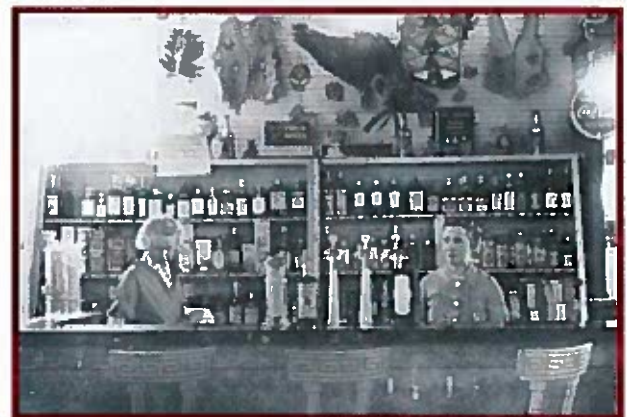
c.1940 photograph of the soda fountain, with Ellie and her mother May Hamilton. The marble counter and bar front have been replaced. The stools remain. Photograph courtesy of Eleanor Povah.

This 1938 soda fountain was updated by the Northwest Fixture Company of Billings. The firm was operating under this name since 1930, and might have been involved in the 1938 construction. The current fountain retains the same stools, but the countertop was replaced with a plastic and the bar was faced with pine paneling.

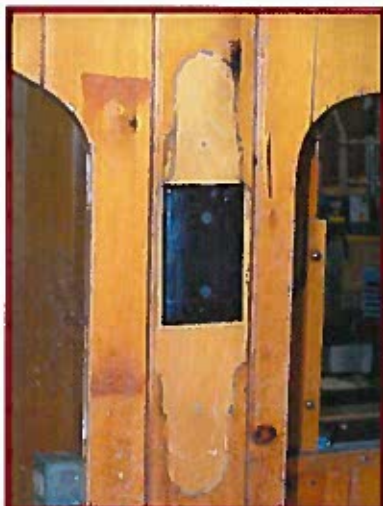
One of four scone ghosts on the back wall of the soda fountain.

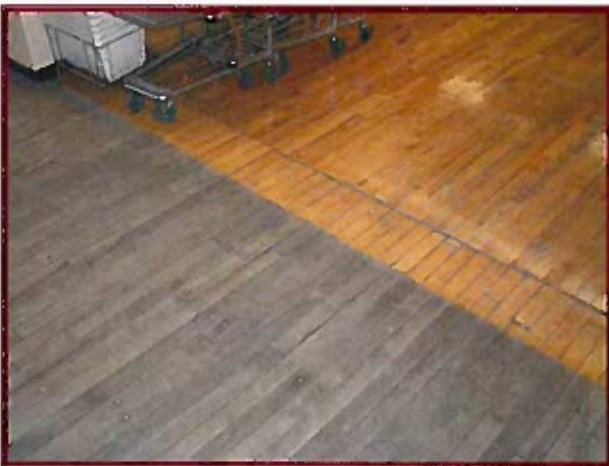
The strip (tongue-and-groove) maple flooring throughout the building is 2¼" wide hard maple in standard lengths of 10-12'. Wax build-up, wear, and buckling indicate that this flooring is probably original to the building. Hard maple is suitable flooring for the wear and tear expected for a busy retail space. The subflooring is of 6"-7" wide diagonal pine planks, covered with standard building paper.

There are several floor areas that have been patched – some with matching maple flooring and some with 2¼" tongue-and-groove oak. The west wing flooring was entirely replaced with plain sawn oak when the foundation and floor framing were replaced c. 1995.⁶⁴

The flooring at the left is the original maple; the flooring at right is the replacement oak in the west wing.

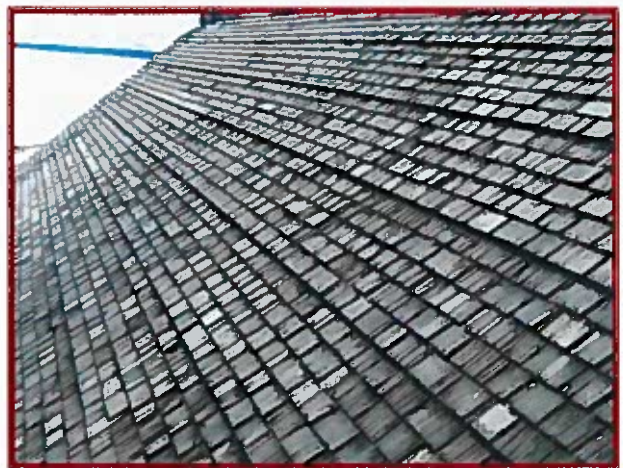
The shingles are quite worn, supporting the claim that they are probably the original shingles. A trace of dark olive green finish was revealed on a sample shingle. This finish appears to have been applied in the 1950's.¹⁰ This might have been a decorative application, and perhaps one intended to increase the longevity of the shingles.

The smooth sawn shingles are doubled up every sixth course, generating a shadow line at a regular interval.

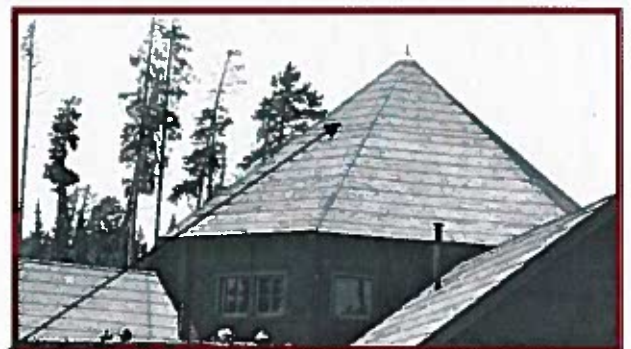
An error in the coursing pattern of the pyramidal roof is apparent in the historic photographs from 1923 through the 1950's. This is further proof that the current roofing is the original.¹¹

Error in shingle coursing pattern, where doubled-up shingle is less than standard 6-course spacing. Visible on the 1920's and 1950's photographs (the latter shown for clarity) and today.

1950's image of store. Courtesy of the Gardiner Research Center.

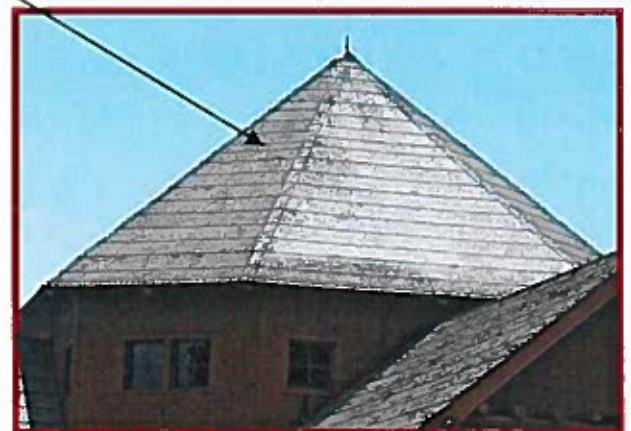
Current image of the store.

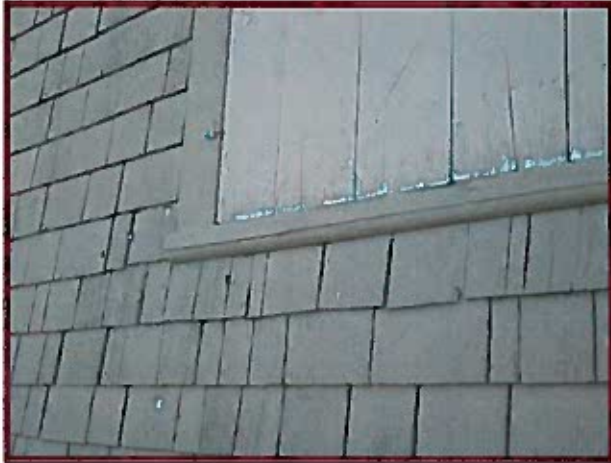
Typical exterior window treatment. Many of the quarter-rounds below the sill have been replaced. Typical winter treatment involves boarding the windows.

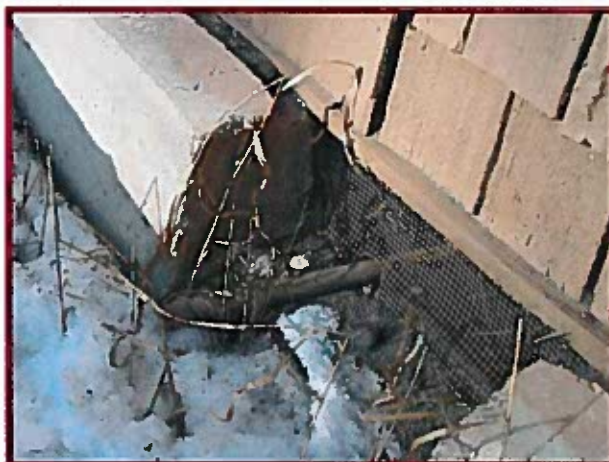
The concrete facing at the base of the north wing, 2007.

The concrete base has settled away from the building and stone has fallen from rim joist.

Recommendations: If the concrete and stone are to remain, the isolated areas of damage should be repaired. The concrete should be patched, the wood columns resecured, and the stone readhered to the substrate. See Structural Assessment for recommendations to remove this facing system.

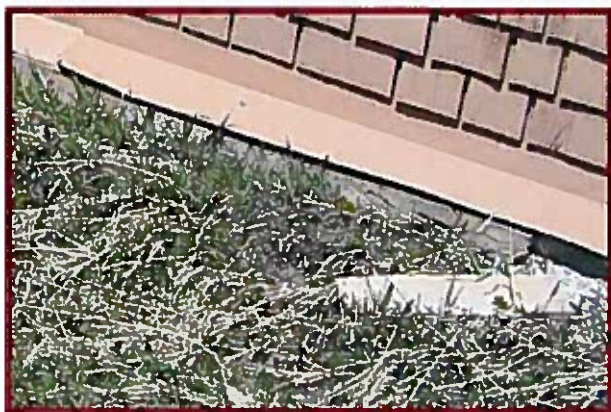
Condition: The concrete facing is generally in good condition; there are a few shrinkage cracks. However, due to the heavy snow load at the base of the west side of the building, some of the concrete is spalling (from the freeze-thaw cycles of the wet snow).

The concrete facing at the south face of the west wing, 2007. Concrete is spalling to the left of the vent.

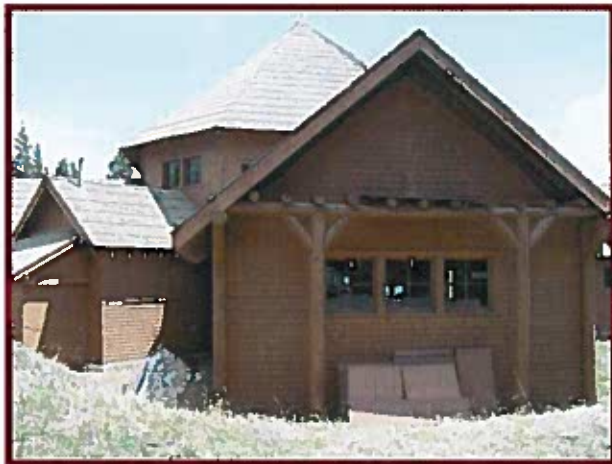
West end of west wing, with log columns supporting and entablature and log ends.

Condition: The logs are generally in good condition. At the bearing points – as noted above – some of the columns has shifted off the concrete base, and all have wicked up moisture. The log beams at the chimney end are rotting from excessive moisture, probably coming with the prevailing winds off the lake.

Recommendations: The bases of the log columns should be treated with a clear penetrating water repellent or liquid epoxy consolidant and repainted. The rotted beams flanking the exterior chimney should be replaced.

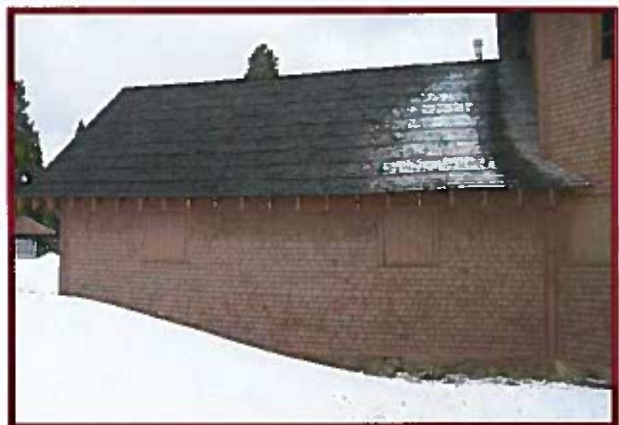
South elevation of west wing, 2007. The shingles have been replaced from the midpoint of the windows down to the base of the building.

Condition: Due to exposure to heavy snows, typical weathering, UV-exposure, and wind, many of the shingles are heavily worn and warped, although most currently have an adequate protective layer of paint. Shingles located towards the base of the walls, below windowsill, and adjacent to the roofs are the most vulnerable to water penetration. Several large wall areas have had all the shingles replaced, whereas shingles in other large sections warrant replacement. Many of the newer shingles are too wide, which promotes warping. At least 3/8 of the shingles are replacements or need to be replaced.

Recommendations: Replace the thin and warped shingles. Refasten or replace the shingles that have slipped. New shingles shouldn't be wider than 6", in order to prevent warping. If wall surfaces are replaced for structural reasons, integral flashing should be installed at the windowsills.

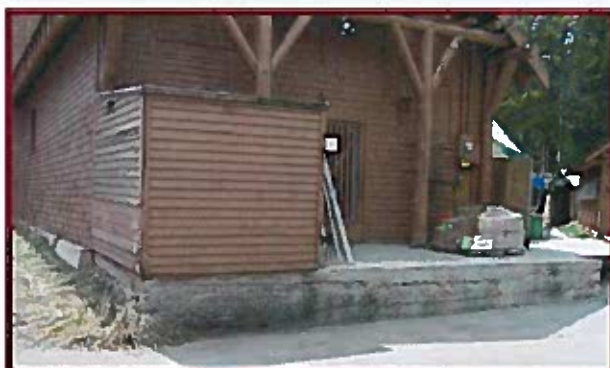
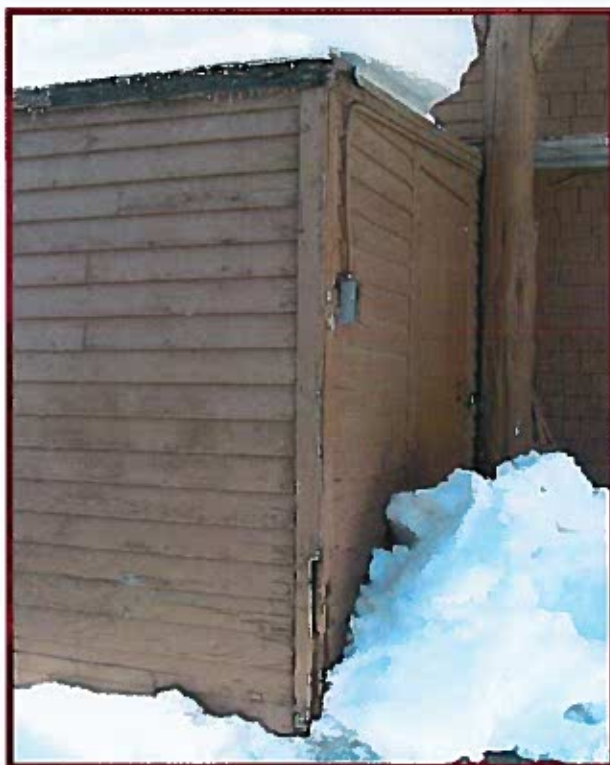
The c.1951 shed at north loading dock is finished with wood clapboards.

Condition: Several clapboards on each elevation are split excessively. A number of the boards have taken in moisture at the end, where they butt to the trim and the joint has opened. The double-nailing of many of the clapboards – quite a few of which have been replaced – is exacerbating the splitting of the wood.

Recommendations: Replace the clapboards that have split along their length. Treat the board ends with water repellent preservative and seal the joint between the trim and the board ends.

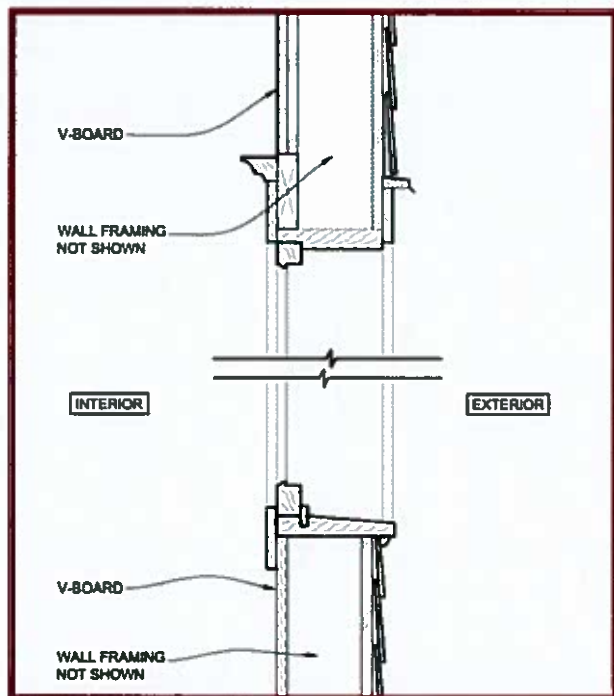
Condition: Most of the trim is in good condition, although the more vulnerable dripcaps which aren't flashed are typically worn to bare wood. Because the windowsills aren't flashed, the quarter-round trim below has often rotted and been replaced. The more recent replacements have been of finger-jointed pine which isn't holding up well (the joints are opening up and allowing water penetration into the wood and the wall beyond). As seen in the prior discussion of the shed clapboarding, the corner trim there has been subject to what appears to have been impact damage. Some of the paint is worn to expose bare wood.

Typical window trim.

Recommendations: If feasible, the window and door heads and windowsills should be flashed. The finger-jointed trim should be replaced with solid wood trim. All surfaces worn of paint should be prepared and repainted. See below for further discussion of windowsills.

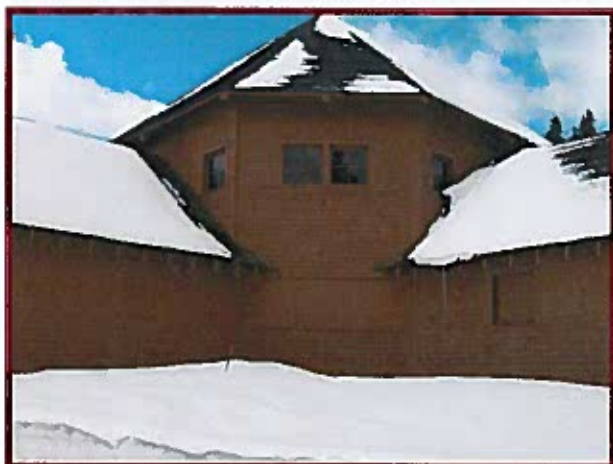
Southwest facet of building showing single, paired, and windows in triplet.

Condition: The first floor windows are covered with wood storm units in the winter, for protection. The more exposed clerestory windows withstand the most wind and snow conditions. Often the snow is piled high up against the clerestory windows, melting water onto the wood sills during warming cycles. The putty on the sash is typically worn, as is the paint on the sash, jamb, and sill. Yet the condition of the sash joints is unknown, since the windows aren't operable.

Recommendations: Strip the windows, carefully remove the original glass, apply water repellent preservative, prepare and repaint, refasten any racked joints, and reglaze/putty the windows with the original glass. Strip the windowsills and jamb, apply water repellent preservative, then prepare and repaint. Each window should be installed in its original location.

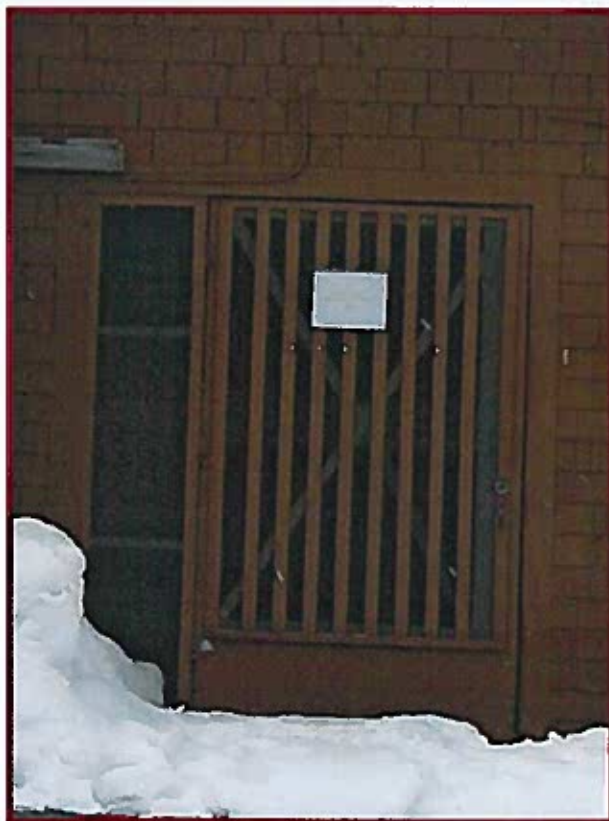
Rear door at loading dock, with exterior screen door.

The doors at the shed and storage room are in good condition.

Recommendations: Prepare and refinish all the doors and thresholds. Provide kickplates at both sides of each door. Provide smooth transition from the flooring to the thresholds that are higher than the ¾" maximum allowable.

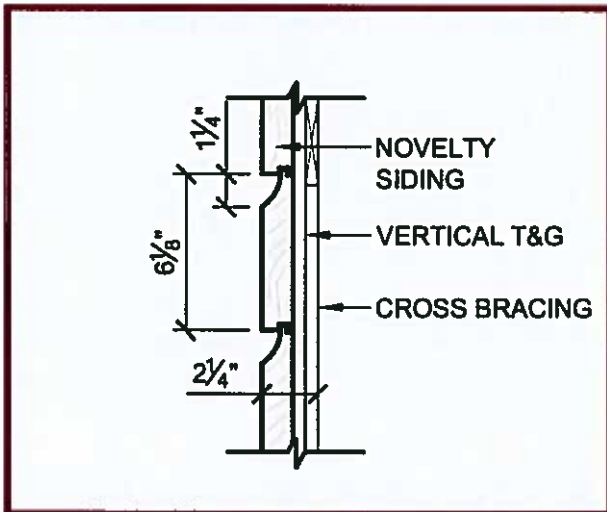
The exterior of the sliding door to the storage room is faced with novelty siding.

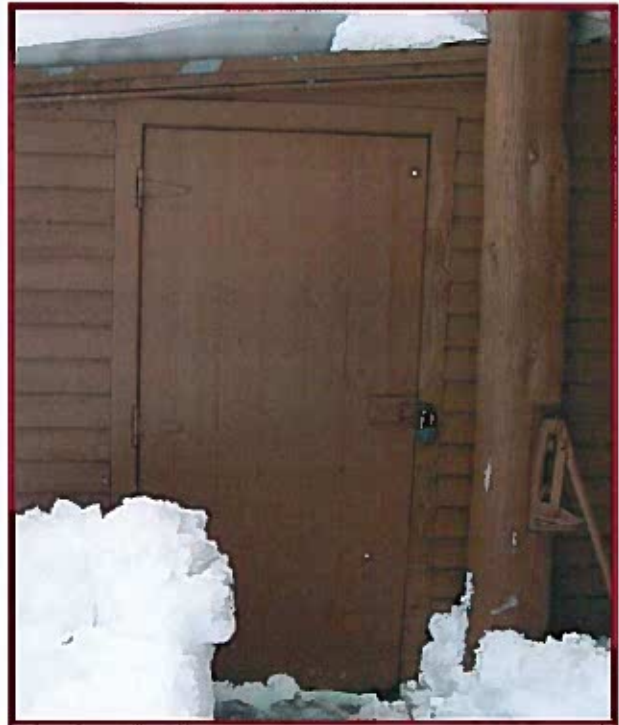
Wood door to the storage shed.

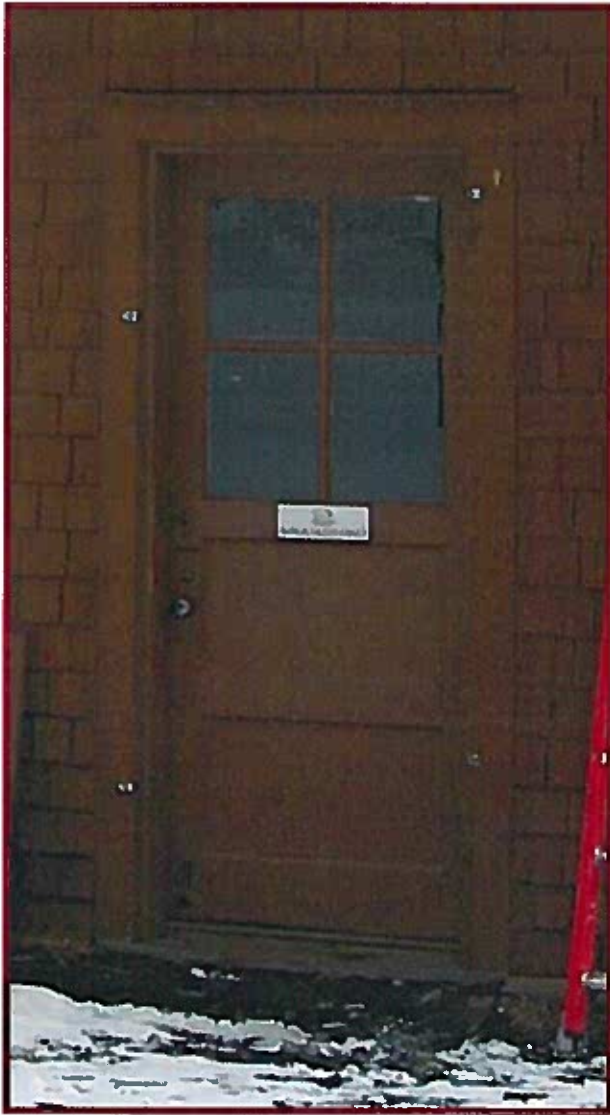
Exit door at west wall of south wing.

The exit door and threshold at the south wing is worn at the edges from use. The lower veneer panel is wrinkled from expansion and contraction, but is stable. The paint at the base of the trim is worn, as expected for trim subject to the snow exposure.

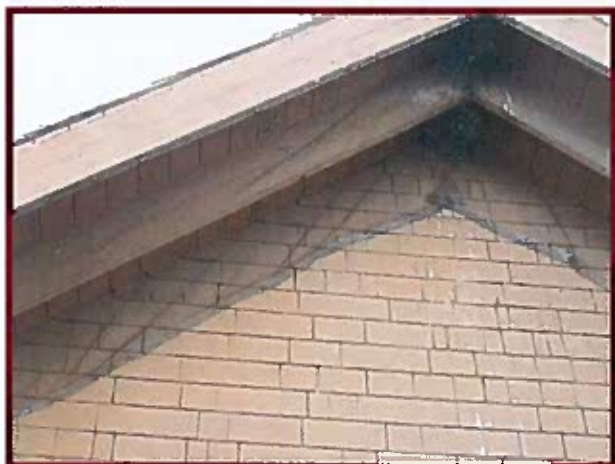
Some of the netting has loosened from the building.

Black netting blocking access to the soffit.

Recommendations: The soffit/decking boards that are rotted at the front entry should be replaced (after the roofing is replaced). The wet boards there should be sanded and repainted. The netting should be refastened to the building and replaced where necessary.

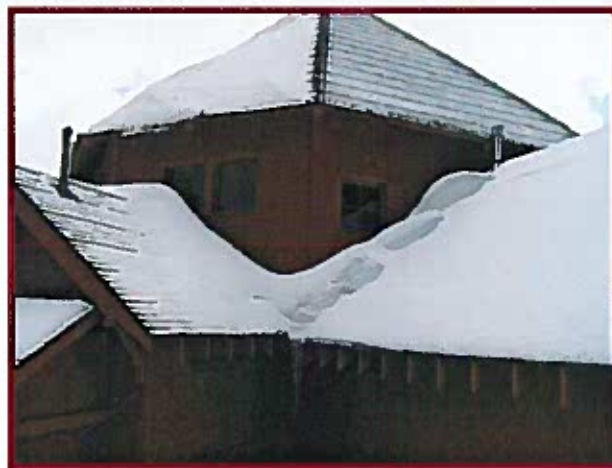
Condition: The roof shingles are excessively worn. Some locations are more effected by snow load and melt than others. The portions of the wing roofs directly underneath the edges of the pyramidal roof are particularly damaged. The water runs off the upper roof and bores holes in straight lines down the shingles of the lower roof. The lower shingles are thin, missing, string, and slippery. The lower roofs – especially at the north and west slopes – are subject to deep snow loads and drifts in the winter season. There are gaps as large as 1" between the ridge shingles of the lower roofs, contributing to water leaking through the ridge onto the floor about 8 feet north of the fireplace.

Typical snowload at the west and north slopes of the roofs.

Recommendations: The wood shingles should be replaced with replica shingles in the same pattern, with every sixth course doubled. The ridges and hips should be capped with wood shingles. Consideration should be given to using a fire retardant shingle in order to lessen the potential for fire. The eaves, ridges, valleys, and hips should be covered with protective membrane underlayment and cedar breather. The first will protect the sheathing and structure; the latter will allow the shingles to breathe and last longer.

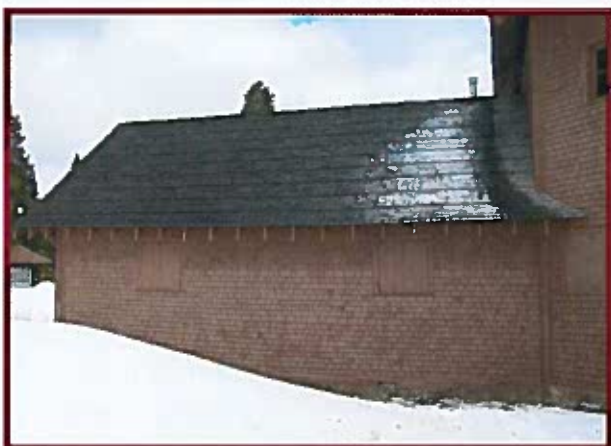
The lower roofs receive run-off from the upper roof.

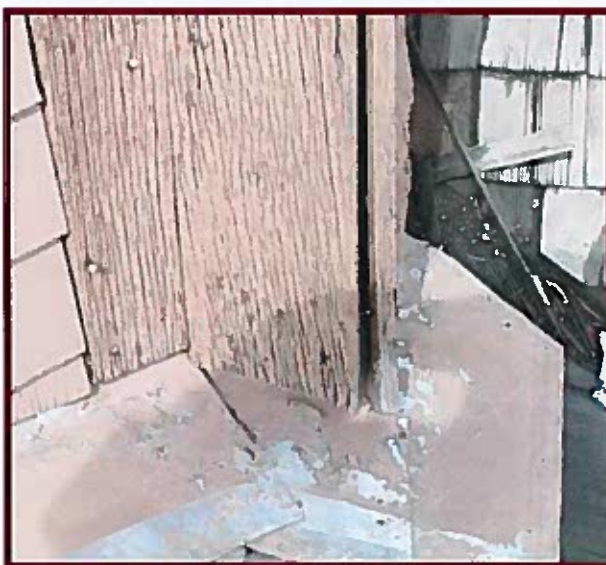
Condition: The chimney's base flashing curls out and isn't counter flashed. At the juncture of the entry roof to the wall, the nails are popping out and the flashing is lifting up.⁶ The valley flashing, while rusting, is in good condition.

The painted aluminum flashing covering the joint between the entry roof and the wall.

Recommendations: When the roofing is replaced, replace all the flashing with a heavy gauge galvanized sheet steel. See Roofing above for recommendation of drip edges, and gutters and downspouts at the rear of the building. Reinstall the original sheet metal finial at the top of the pyramidal roof.

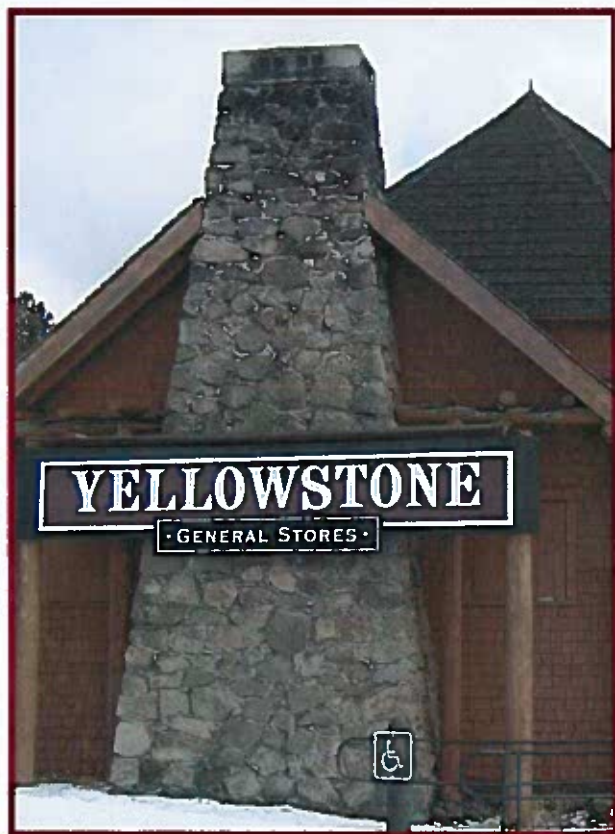
The stone chimney has a powerful presence at the end of the south wing.

Condition: The stone is in good condition, although darkened at the top from soot. Some of the stone is stained from overspray during painting of the wall shingles. The mortar joints are generally good and tight, with isolated locations of joints where some mortar is missing. There are some hairline cracks in the concrete cap. The condition of the flue is not known.

Recommendations: The open mortar joints should be repointed, and the stone cleaned of soot and paint. If the fireplace is to be made operable – gas operation would be recommended over wood burning – the flues should be examined and relined as required.

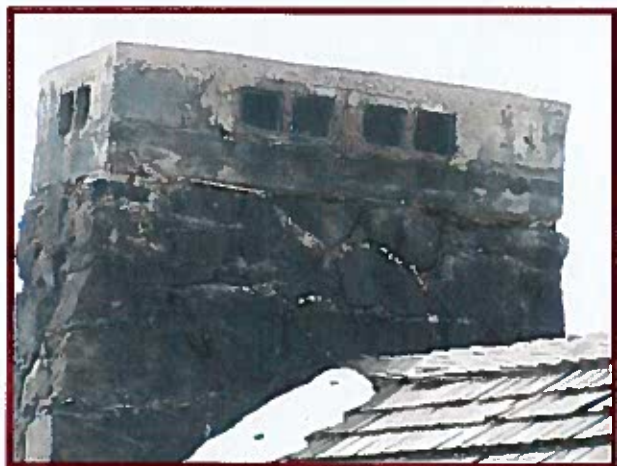
The stone chimney, as visible from the roof of the south wing.

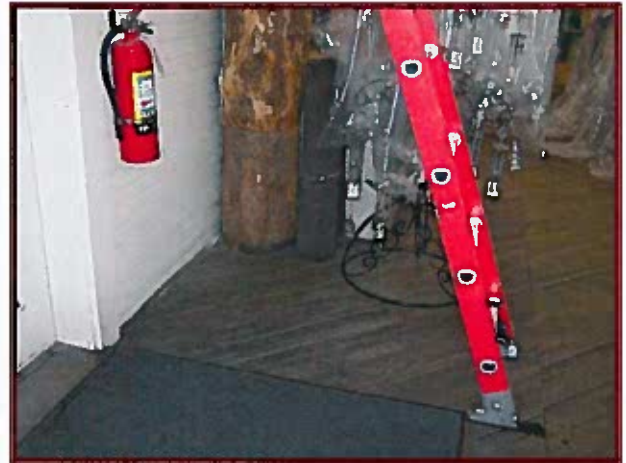
Condition: The maple flooring is worn, buckled in a few areas, and - because the boards have expanded and contracted - the joints have widened. There are split boards in the rotunda and many boards have been face-nailed to prevent the boards from popping up. Large sections of patching - some with maple and some with plain-sawn oak - are interspersed throughout the building, but concentrated in the southern third portion of the rotunda. The largest of these at the main building entry facilitated repairs, and beam replacement, in the crawlspace below.

The large maple patch at the front entry allowed for access of materials for crawlspace repairs in the past.

Recommendations: Replace the damaged sections of flooring and the mismatched patches of oak. If the crawlspace needs to be accessed for construction of new footings and beams (see *Structural Assessment*), the

height the building is lifted would be greatly reduced by removing the flooring. If possible, the flooring should be reinstalled. If not feasible, the maple flooring should be replaced in kind, in long lengths.

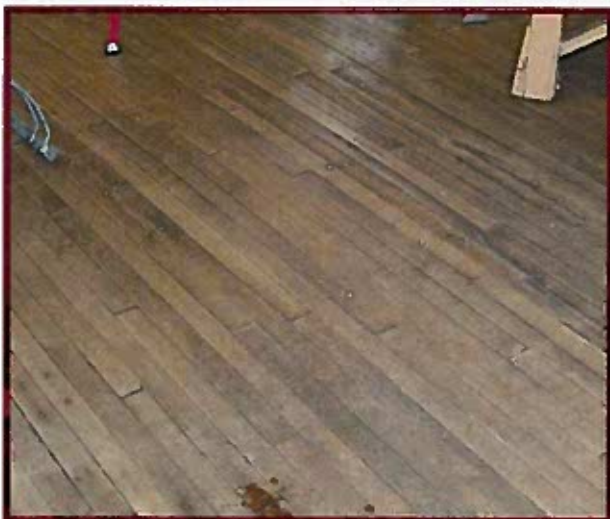
Frequent face-nailing is common throughout the central rotunda area.

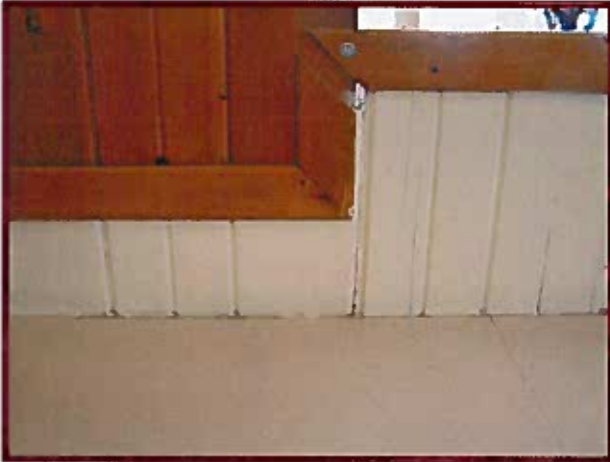
Bay with painted pine panelling. Mitered cap is split.

Recommendations: After the roof is replaced, clean all the boards and cut the buckled boards to lie flat. Prepare and paint.

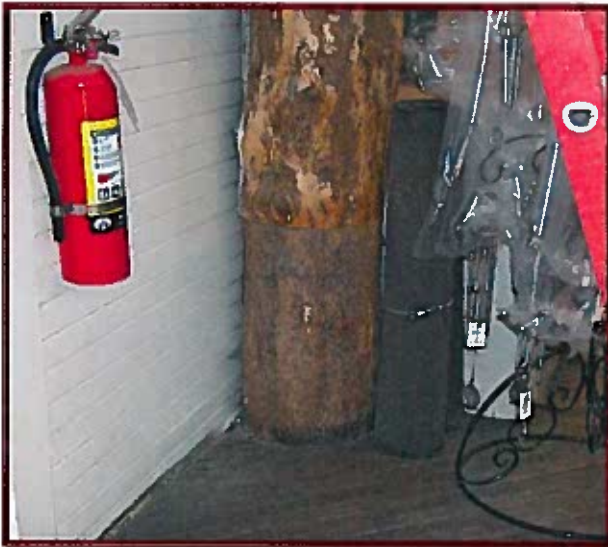
One of two columns which has been fitted with a replacement bottom section.

Condition: The lower two feet of each column flanking the main entry is a replacement log. This appears to relate to the sizable oak flooring patch here and the probable crawlspace repairs. See **Structural Assessment** for further information.

Recommendations: See **Structural Assessment**.

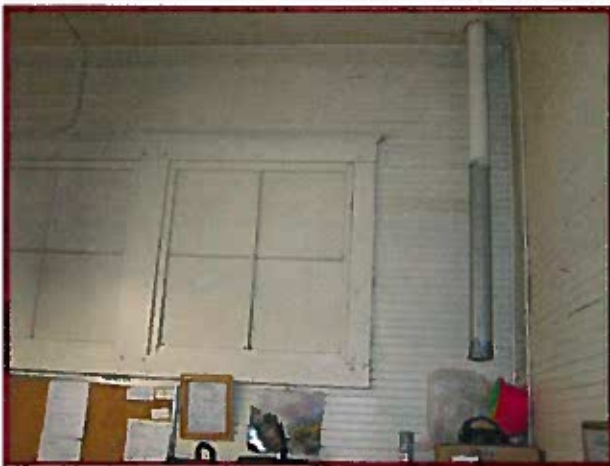
Condition: The accessible windows (on the first floor) appear to be in generally good condition. The tops of the bottom rails are typically worn from condensation, exposing the bare wood. The condition of the clerestory windows is unknown.

The paired windows on the south wall of the office.

Recommendations: When construction work is begun on the building – particularly if the building is lifted – the windows should be removed in order to protect them, examine them, and proceed with required repairs. The intact original glass and old growth wood should be retained.

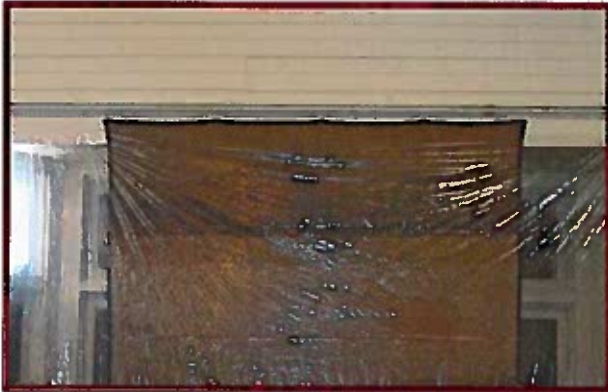
The shifting in the beadboard above the head of the south bay might be due to deflection of the header.

Recommendations: The condition of the bays should be examined when the exterior wall construction of the building is revealed during the proposed improvements.

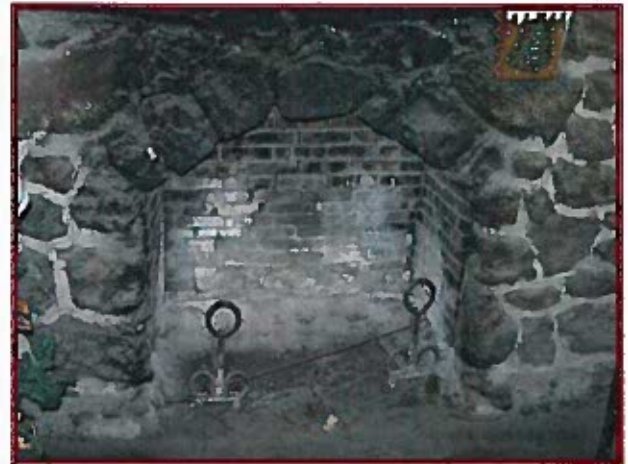
Condition: There is a crack which continues from the firebrick through the mantel. Open mortar joints in the firebox brick coincide with the crack; the brick is bulging away from the wall at the crack. The hearth has flush cracks that are stable. The hearth is level with the adjacent wood flooring.

The fireplace features the large stone used for the entire chimney mass.

Recommendations: The crack in the mantel should be filled with a flexible sealant colored to blend with the mortar. The dislocated firebrick should be reset and the mortar joints between the firebrick should be repointed. The soot should be cleaned from the stone and the brick.

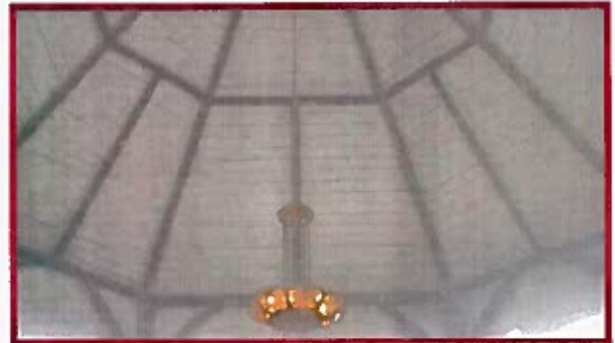
*Octagonal Roof – Visual Structure Limits
Upgrades without changing aesthetic*

A structural renovation should comply with the *International Existing Building Code* and *International Building Code*, with the exception of the octagonal roof under snow loading. As stated previously, we recommend designing for code required life safety loads. The octagonal roof should be designed to prevent complete collapse of the structure under snow loading, but not against isolated roof member failure. For example, the individual octagonal roof purlins will not be structurally adequate with respect to code mandated loading and could possibly experience isolated excessive deflection and even failure under heavy snow loads. However, the octagonal roof as a whole should remain intact.

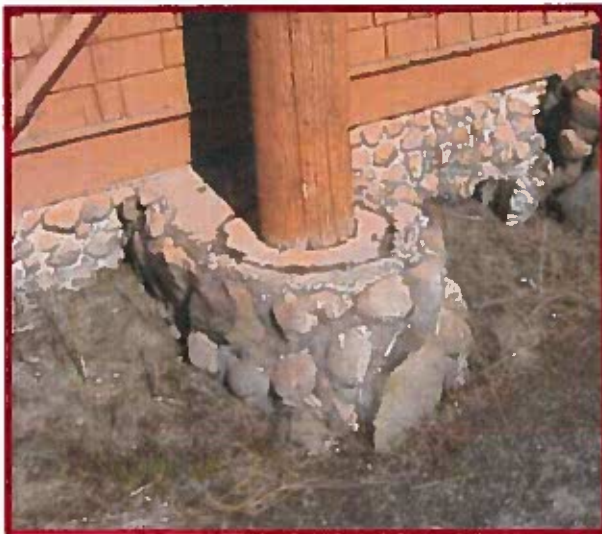
Exterior Base Stone Facade

Condition: The foundation is in fair condition, as there is some deterioration and distress in the log floor beams. However, there are also limited connections and stability. The exterior exposed stone and concrete bases are generally in good condition. During the winter, much of the base and lower wall structure are surrounded by deep snow cover. This cover is deepest at the west and north sides of the building where drifts can be as deep as five feet. The spring run-off and melting snow penetrate the cracks in the concrete and stone bases. The condition of the outside face of the log beams is not visible; hence the degree of water penetration – and probable damage to the wood – cannot be determined. However, the interior surfaces of some of these log beams show signs of serious distress and deterioration. Some beams have deflected and some are of questionable quality.

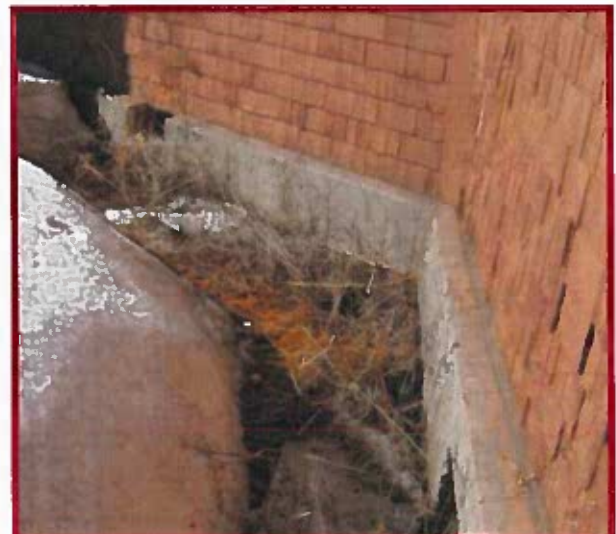
Exterior Base Concrete Curb Facade

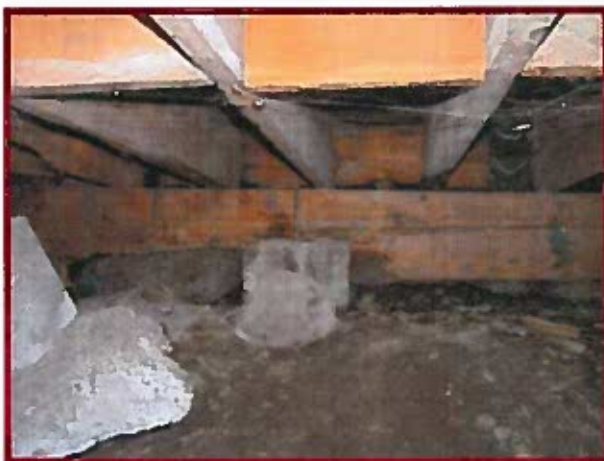
The south wall of the Snack Area (east wing) has settled substantially and the bay window is sloping into the dining area. The maple floor is buckled here (to a height of 2½"), extensive water is located in the dirt crawlspace beneath, and the log beam along this south wall has been replaced with a heavy timber that has been compromised by notching at the bottom in order to bear on the supports.

Looking south toward the spliced beam under the window bay of the east wing.

Recommendations: The main floor upgrades are dependent upon the upgrades to the foundation and the deterioration and strength of existing members. The log beams are substantially insufficient for code required retail loading. As described in the *Foundation Assessment* section, the exterior log floor beam will be replaced with a continuous concrete foundation. The interior log floor beams should be replaced with new beams that are adequate for the code required loading. The joists are sufficient; only deteriorated or excessively notched joists should be upgraded with "sisters" (additional joists attached to the existing joists). A sister joist, matching the size of the existing joist, will suffice. Additional support is required for the second floor joists adjacent to the stairway in the storage area.

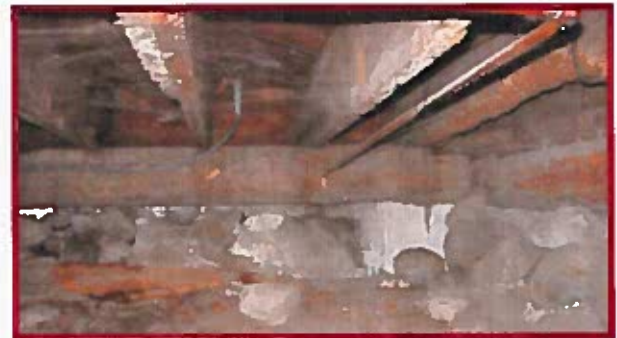
Condition: The floor joists are in fair condition; there are areas of deterioration which compromise the strength of the joist. The floor joists are acceptable for code required retail live loads. The interior floor beams are not sufficiently sized to support the live retail load. The floor beams are not consistent in size and generally do not have positive connections. Further, the beams are supported by make-shift cribbing and miscellaneous footings spaced about 6'-8' on center.

Deteriorated Floor Joists

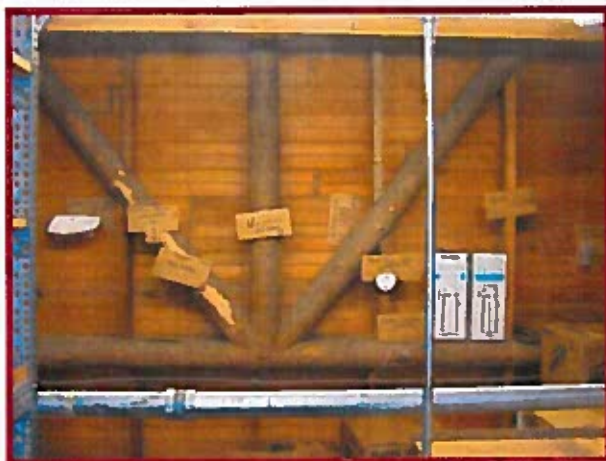
Condition: Most of the walls are concealed behind exterior and interior finishes and sheathing. The exposed stud walls in the storage room appear to be in good condition.

The stud and king-post truss in the storage room, looking south towards the beadboard finish in the rotunda.

Recommendations: To enable the building to withstand the lateral loads, a new plywood or oriented strand board (osb) layer of sheathing should be attached to all exterior walls. The new wall sheathing may be installed on either the inside or outside face of the wall. Given the condition of the exterior wall shingles, it is recommended that the exterior finish and sheathing be removed to install the new diaphragm. Consideration could be given to removing the interior finish instead, but the interior V-groove boards and beadboards do not otherwise require replacement and they are probably too dry to survive removal and reinstallation.

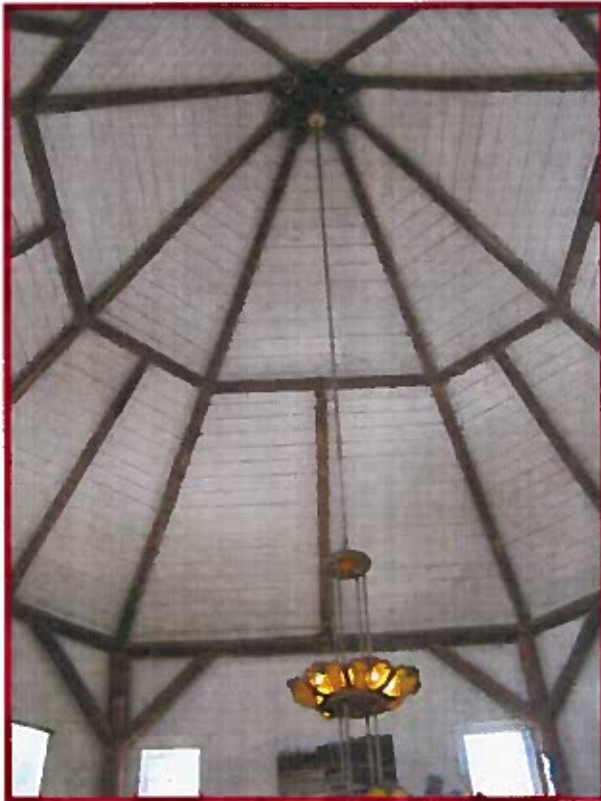
Small logs form tension rings and purlins for the pyramidal roof structure.

Conditions: The roof is in good condition. The wing roof rafters will not be visible until the roof is removed, but the visible portions of the roof exhibit limited deterioration or distress. However, the connections have limited capacity and both roof types are significantly overstressed for code required snow loads.

Recommendations: The perpendicular roof planking is an inadequate diaphragm to distribute the lateral forces to the new shear walls. The entire roof should be resheathed with plywood. The sheathing will not only provide an adequate diaphragm, but will provide additional stiffness for the octagonal roof.

On the octagonal roof, strapping can be fastened over the plywood sheathing to provide needed restraint for the 'hoop' forces. The strapping will help prevent an overall catastrophic, complete collapse of the octagonal roof. However, the upgrades will not prevent isolated member failure. As discussed previously, the building is unoccupied during the large snow events; however maintenance personnel will require limited occupancy. Any localized member failure will be preceded by

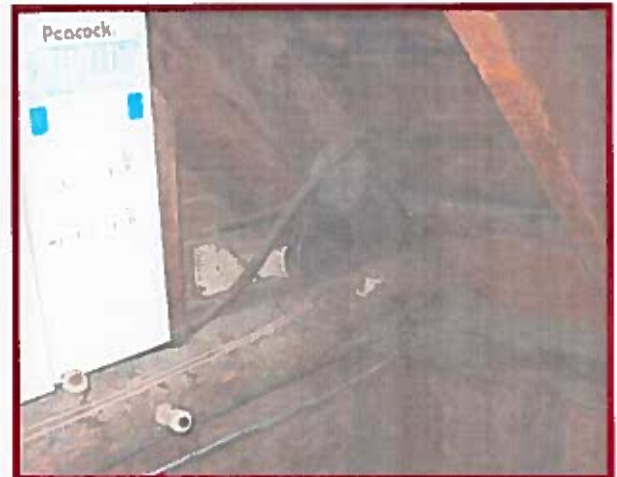
The rafter to wing wall connection is insufficient.

The wing roofs can be fully upgraded with minimal visual changes. The wing roofs have larger snow loads than the octagonal roof, as the octagonal roof dumps snow onto the lower wing roofs. Consequently, the wing roofs should be upgraded for code specified snow loads. As discussed previously, the majority of the wing roof upgrades can be conducted from above, leaving the interior beadboard intact. All roof members should be sistered for strength. The ridge consists of a ridge board, not a ridge beam, and the top plate of the wall is inadequate for the kick-out forces incurred. This can be resisted with a steel angle along the top of the wall on the interior. The angle can be concealed with beadboard or trim. The steel angle would be tied in to steel cables which would run along the bottom chord of the existing log trusses. Many of the log trusses currently have a steel rod along the bottom chord, and these will be removed and replaced with the steel cables. The log trusses will become ornamental.

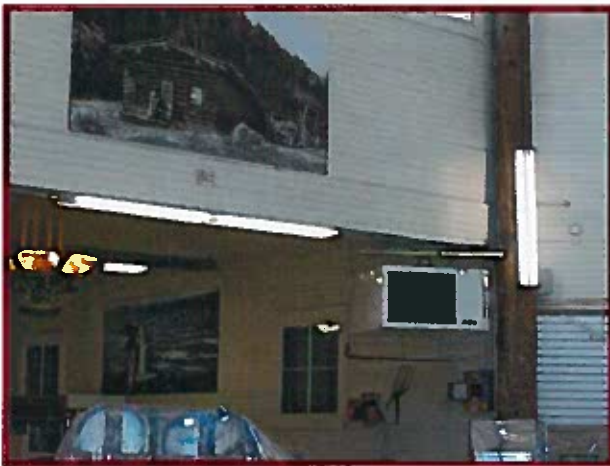
The Renzor heating unit in the rotunda.

Condition: The unit heaters and baseboard heating units are new and functioning properly.

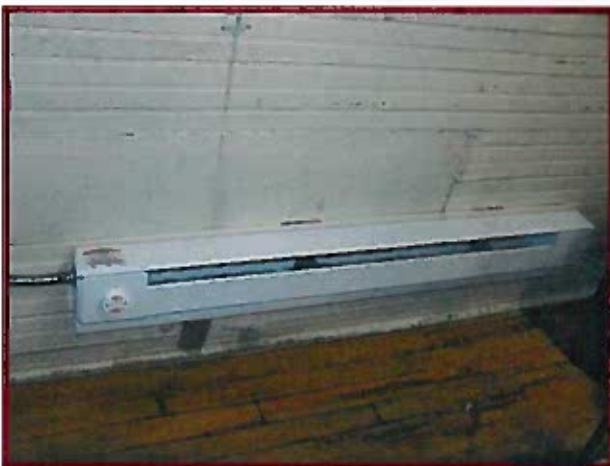
One of the electric baseboard units in the office.

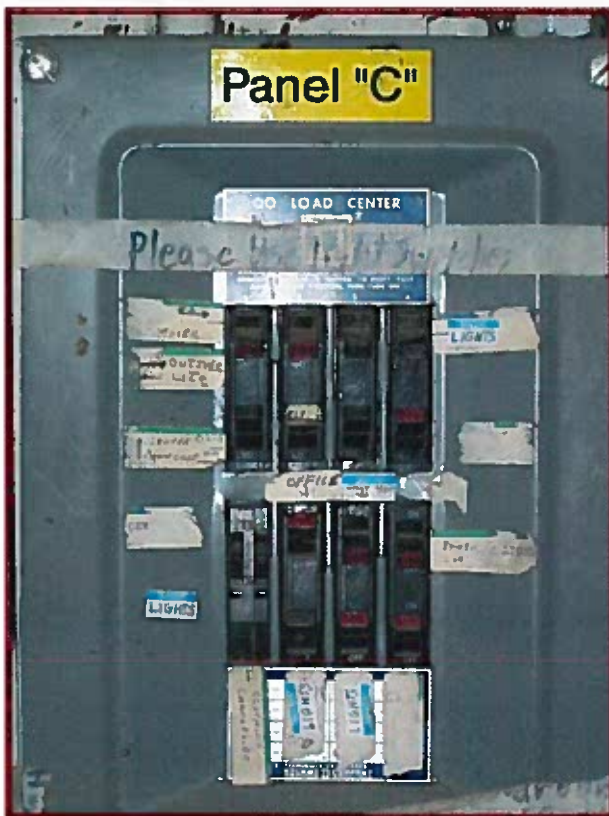
2. Panel B at the northeast facet of the rotunda: These 20-Amp breakers control the coolers, dairy cases, and freezer.
3. Panel C at the southwest facet of the rotunda: This panel controls the interior and exterior lighting and one of the unit heaters. This panel does not have a door.
4. Panel D at the north wall of the east wing: These 20-Amp breakers control the receptacles and unit heater in the Snack Area.

Panel C at the southwest facet of the rotunda.

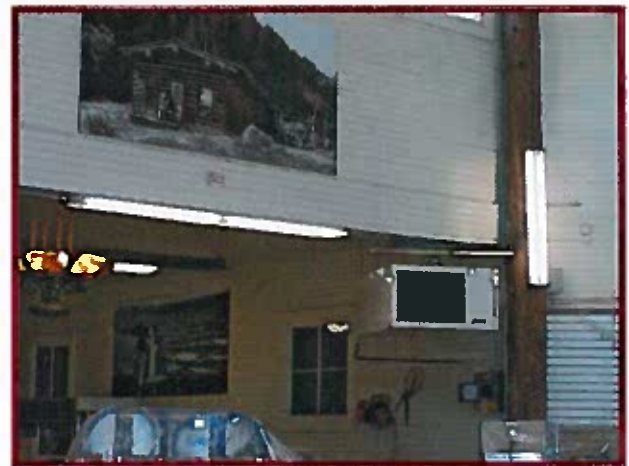
Fluorescent lighting in the central space detracts from the historic architecture.
