HISTORIC STRUCTURE REPORT

NICHOLS RESIDENCE Mammoth, Wyoming

August 5, 2008

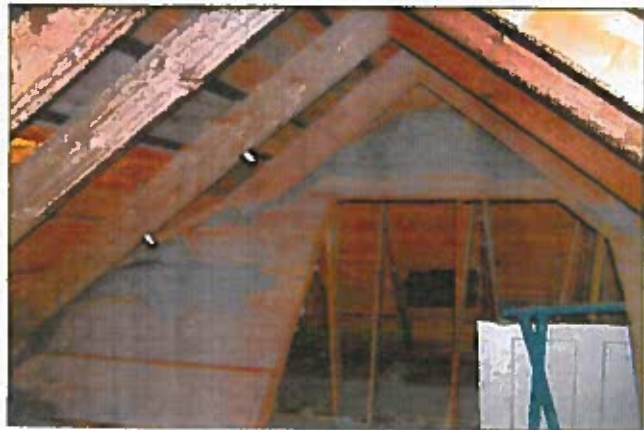
Figure 18: Framing of attic in Zone K onto existing finished roof slope of Zone H. Looking west from Zone K attic. This establishes Zone C/H as the initial mass of the building, to which other building wings – some of which (Zone D/K-L specifically) were of older materials – were added.

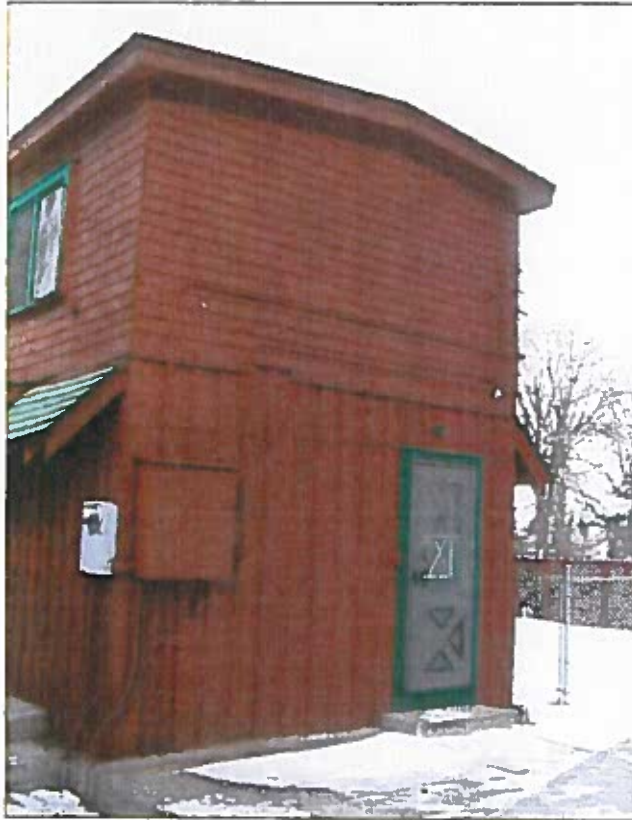
Figure 19: South elevation of the Kitchen Wing - Zone F - utilizes low-slope roofing 2x4 framing. Both first & second floor exterior cladding differ from each other and from the horizontal board-and-batten finish on the primary elevations.

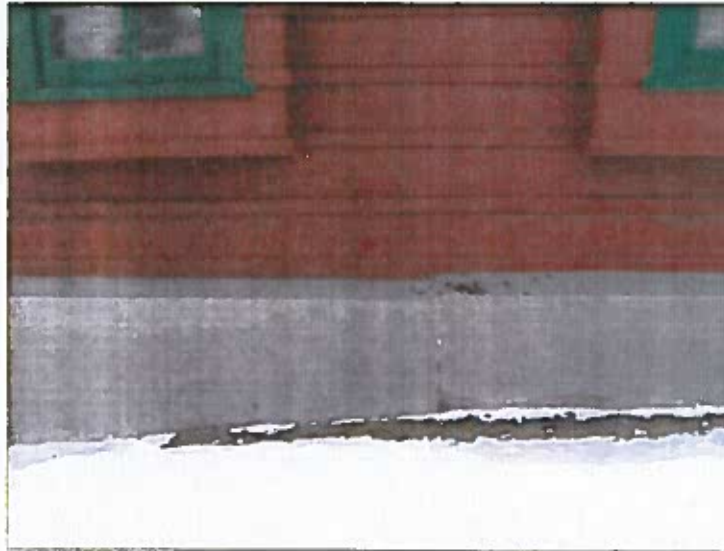
Figure 21: The concrete watertable of the Nichols House is chamfered and painted. This joint is located between Zone D and E.

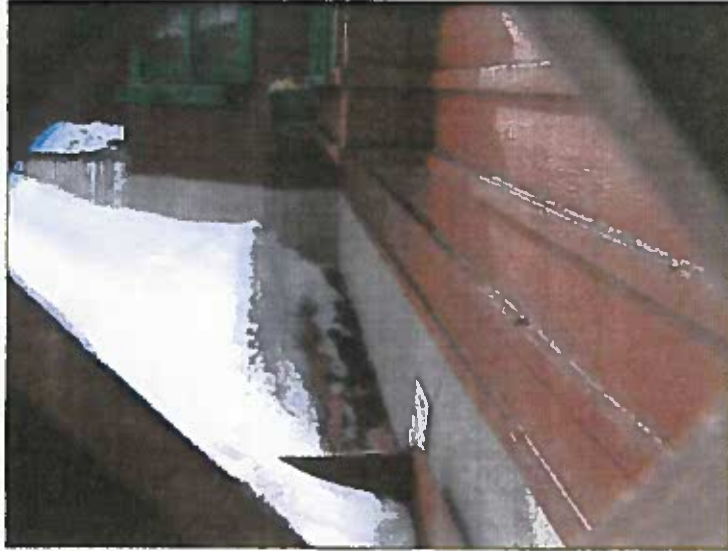
Where the foundation is of later construction along the south and bay walls of Corridor #105, the concrete walls are thinner and flush with the finished wall above.

Figure 24: Watertable at south wall of Corridor #105, looking west, is flush with the wall above.

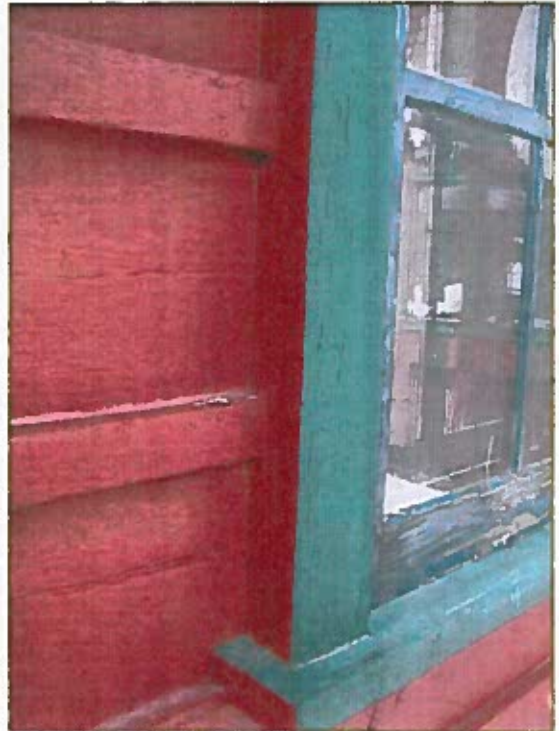
Within the horizontal board-and-batten wall treatment, five windows are set directly in the wall plane and not within bays. These windows are all on the south side of the building. The trim on these windows is built-out to extend the window further out into the plane of the wall. Because this occurs on what would have been the new south wall of the corridor, this is believed to have been an intentional aesthetic treatment, and not one resolving an existing condition.

Figure 29: Trim extension at south window of Bathroom #108.

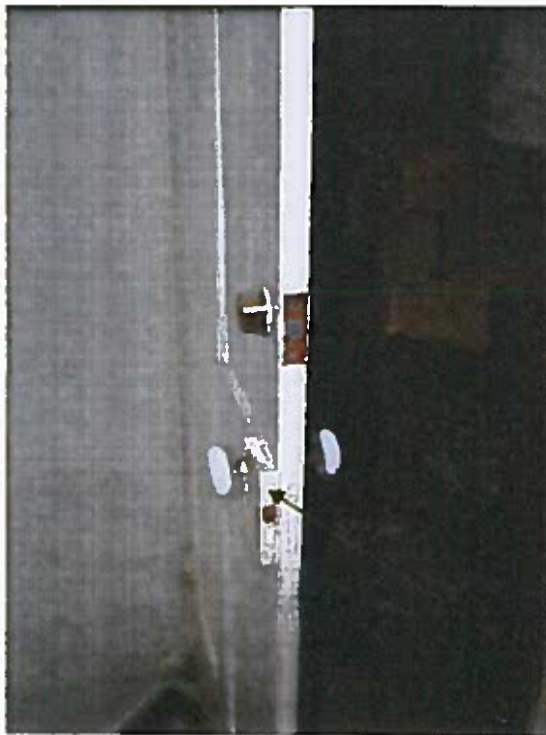
- a) The door to Stair #112 is 1-1/16" thick and has a painted steel rimlock typical of the 1850s, with white porcelain knobs.
- b) The door to Closet #103A is 1-1/8" thick; the mortise lock faceplate is neatly fit into the stile.
- c) The door to Closet #100A is 1-1/16" thick; the mortise lock faceplate has split the stile.
- d) The door to Bedroom #103 is 1-1/8" thick.

Figure 46: Older door, with rimlock, at entry to Stair #112.

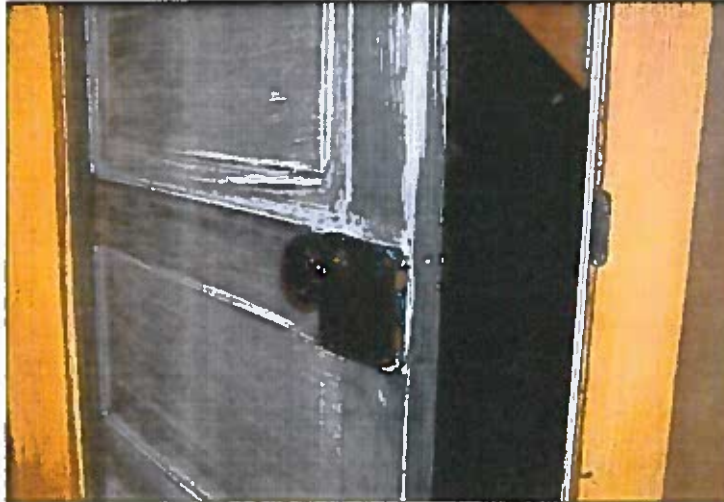
The second floor doors are also wood stile-and-rail style. The doors to the Bedroom and Bathroom #211 match the typical first floor doors. Two closet doors in Bedroom #210 and the door to the attic space are five flat panel stile and rail wood doors. The door to the attic has five raised panels has a steel rimlock typical of the 1850s, and black porcelain knobs.

Figure 49: The rimlock on the raised panel door from Room #206 to the attic.

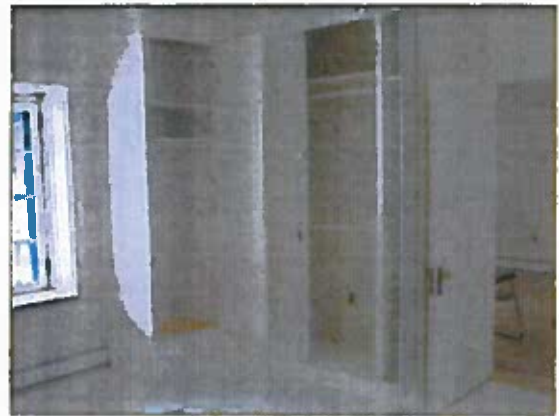
The closet in Bedroom #107 has been modified from its earlier c.1910 configuration. The closet was originally only along the north wall; an extension built of particle board has been added perpendicularly to it along the east wall.

Figure 57: Closet in Bedroom #107.

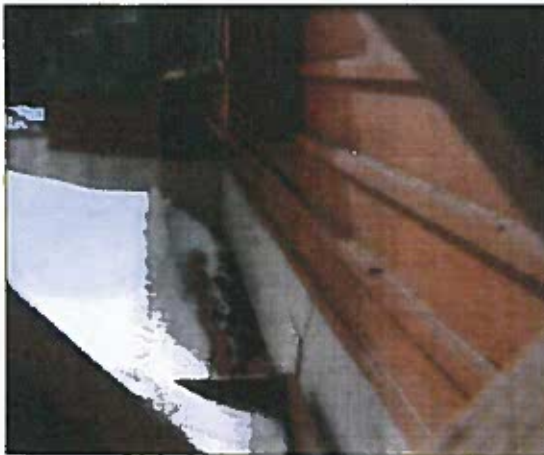
The concrete watertable extends from the wall plane at most of the exterior walls. It ranges in projection from the wall plane from 5½" (west wall of kitchen) to 10½" (street-face walls) and ranges in height from approximately 6" to 1'-10" above grade. The wall steps up to accommodate the raised grade at the west end of the building. The portion of wall that defines Corridor #105 does not have a projecting watertable; it is flush with the wall above.

Figure 62: The foundation at the perimeter of Corridor #105 is flush with the wall above.

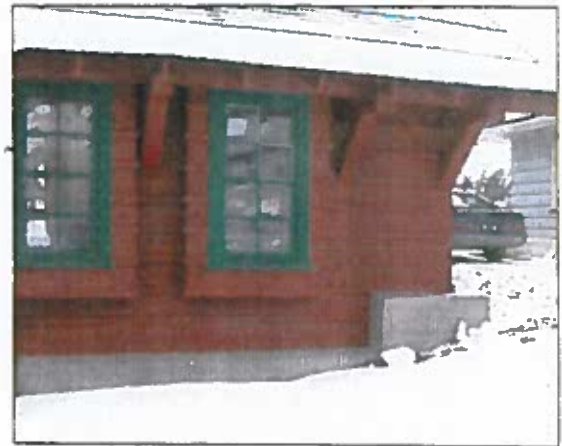
Figure 63: The typical concrete watertable as visible from the street. The raised portion to the right meets the raised grade at the adjacent driveway.

With two exceptions that follow, the majority of the watertable is in excellent shape. There are also isolated locations of minor cracking. The watertable at the inside southwest corner at the building (at Gridline intersection 2C) is level with grade and subject to much water penetration. The resultant spalling exacerbates the deterioration. It appears that this inside corner is at a lower elevation than the hill that rises to the south and west. In addition, the watertable along the east wall of the Kitchen wing has water penetration as well – probably from a dripping hose bibb - resulting in spalling concrete and organic growth (not uncommon for a north-facing wall). The water penetration has rotted the end of at least one of the floor joists that bears on this wall.

The concrete foundation at the southwest inside corner should be replaced for the extent determined in the Structural Analysis. The watertable along the east wall of the Kitchen should be patched, cleaned of organic growth, and painted. The top surface of the remainder of the watertables that extends from the wall surface should be removed and replaced with a compatible concrete patch. The hose bibb should be extended away from the watertable. Further examination of the watertable will be necessary after the spring thaw.

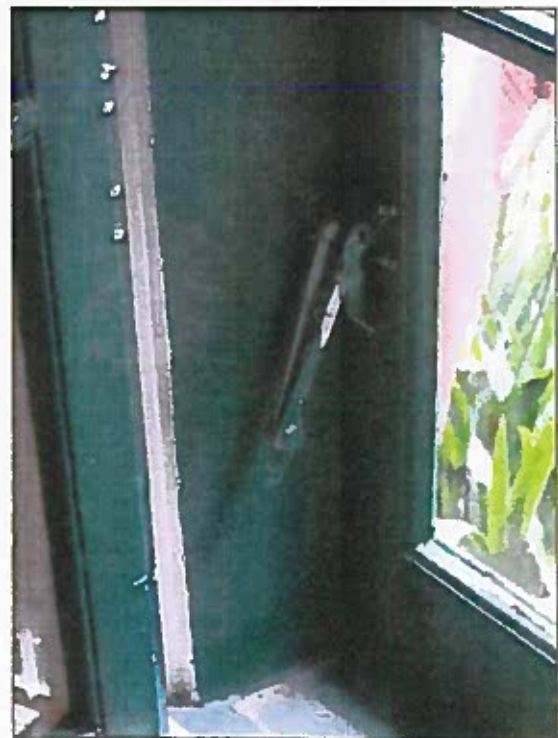
The hinges of the exterior storm windows are under-sized and bending under the weight and operation of the storms. About half of the hinge arms are missing in full, missing a part, bent, or detached from the jamb. The storms are secured with exterior screws.

Figure 76: Ventilating hinge arms extend to hold the storm sash open.

The hinges of the storm sash should be replaced and missing and broken portions of the hinge arms should be replaced. The hinge arms should be lubricated to ensure smooth operation.

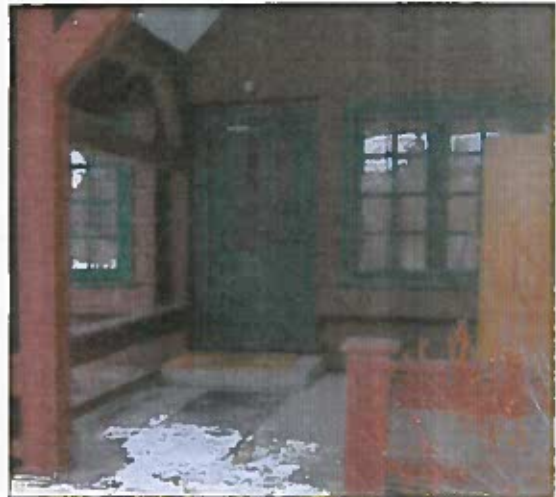
Figure 77: The front entry has a c.1908 wood screen door at the exterior.

The doors are in good condition, except for the exterior storm doors at Corridor #105. The joints of these doors have become unglued due to moisture penetration from the snow. The paint finish of the east door has degraded excessively, providing little protection to the wood beneath.

The Kitchen door should be replaced with a Craftsman style door and the other two exterior doors should be fitted with weatherstripping to make them weathertight. The storm doors at Corridor #105 should have their joints refit and glued, and they should be refinished.

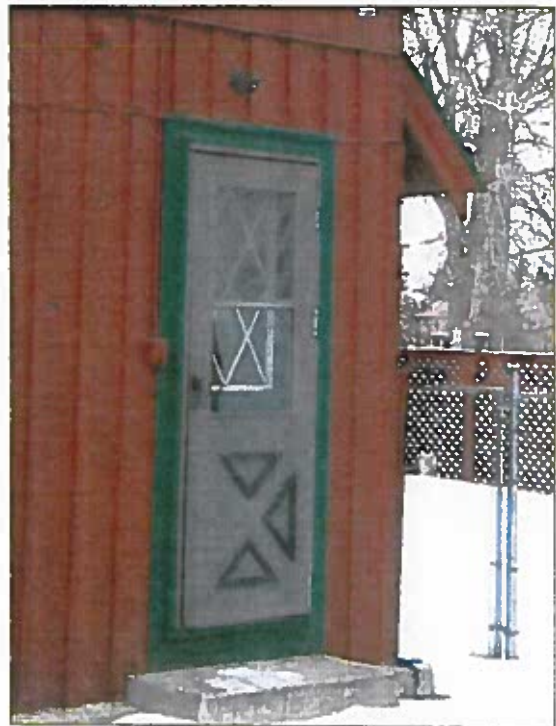
Figure 78: The door to the kitchen was replaced c.1980s.

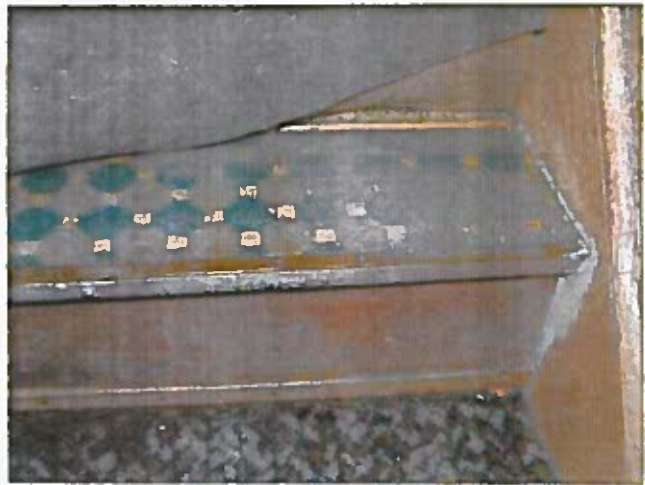
Figure 86: The upper run of wooden stair treads were covered with an octagon-patterned linoleum prior to the installation of the padded carpet.

The linoleum on the stairs is generally in good condition, with a few areas of abrasion and tearing. The linoleum, treads, and risers will have penetration holes from the tack strips that secure the carpeting. The clear finish of the risers is in fair condition, with a few abrasions probably coincident with earlier use.

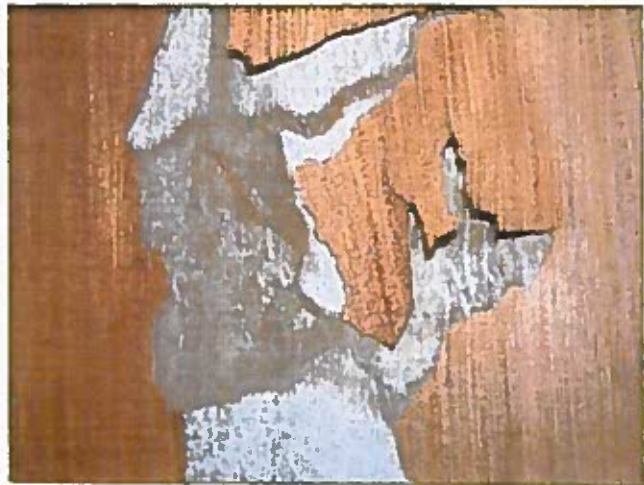
Figure 88: South wall of stairway, where water has swollen the fiberboard and caused the paint to flake off.

Some of the second floor fiberboard has expanded and swelled from the water penetration of the piping leak.

Replace the water-damaged wall and ceiling finishes; provide replica faux painting to infill new areas. Replace the Celotex ceiling panels with ½" Type X gypsum board, covering the joints with a batten system similar to that currently concealing the ceiling joints.

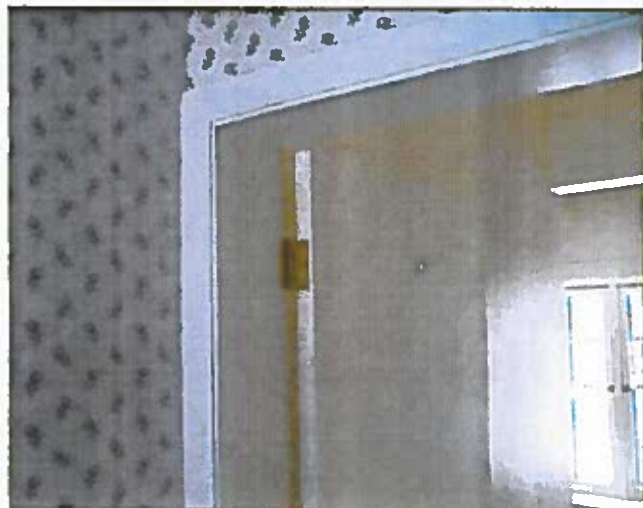
The trim described in Character-Defining Features. The trim – the baseboard, window trim, and the door trim – in the Kitchen and the first floor bathrooms is from the c.1980s remodeling and is not in keeping with the Craftsman style of the building. The casing is ranch style and mitered at the corners, whereas the original side casing is butted at the head trim of the windows and doors.

Figure 91: The first floor bathroom door casing was replaced in the c.1980s remodeling.

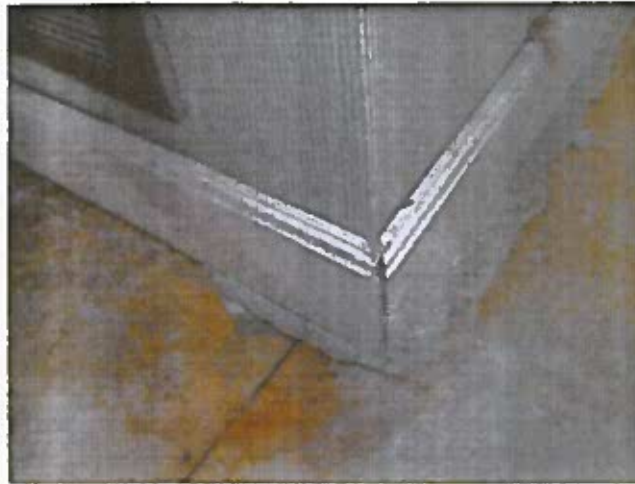
Figure 92:
Kitchen trim
from c.1980s
remodeling.

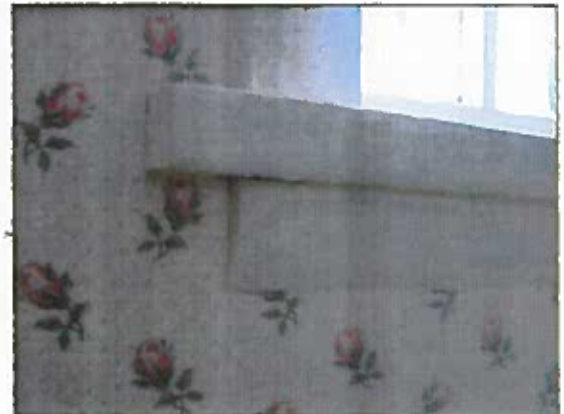
Figure 94: Original stool surrounded by replacement casing and apron from 1980's remodeling.

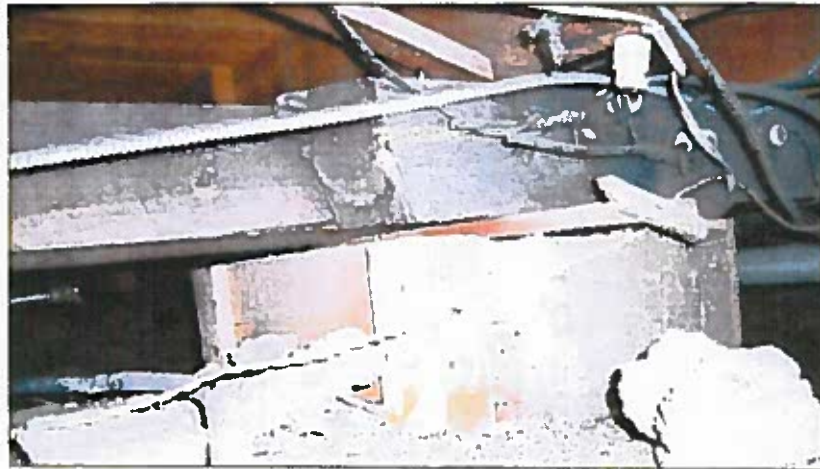
Zones B & C exhibit numerous locations of screw jack steel pipe supports and wood debris shims. Shims occur both at the pier to floor beam connections, as well as random locations, where the shims rest only on the earth/limestone floor.

Figure S-2: Floor beam lap splice at pier.

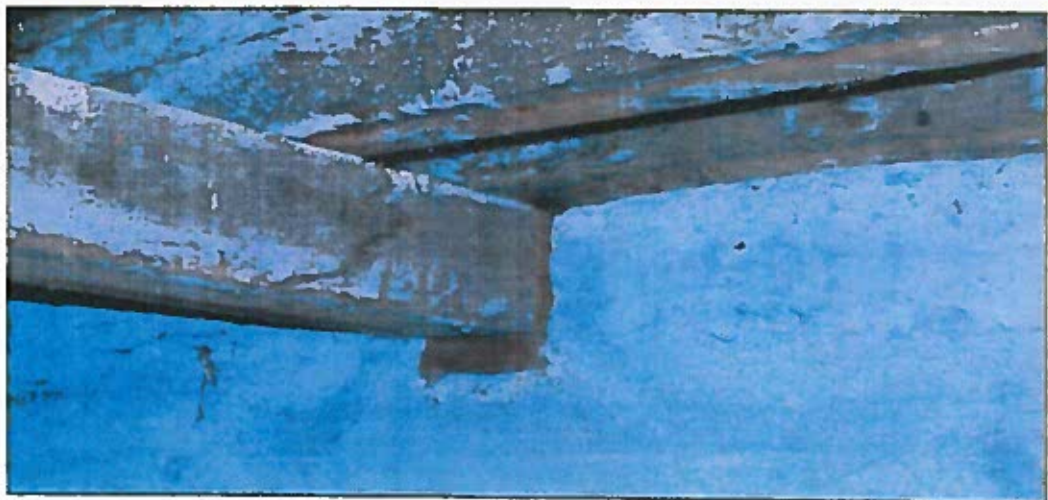
Zone E exhibits much of the same characteristics of Zones B & C. In general the members and supports are in good condition. However, the floor in both the corridor and Bedroom #100 of Zone E are significantly bowed upward, suggesting the beams have been overshimmed at the beam to pier connection. The floor beam at the perimeter foundation wall appears like it might have been replaced. The concrete which supports the floor beam along Gridline 5 appears to be an original foundation wall; it has been busted through to accommodate expansion, possibly damaging the floor beam bearing material. The pier at grid intersection 3D is significantly damaged at the floor beam bearing. The integrity of that beam and supports is very poor.

Figure S-9: Beam pocket at foundation wall.

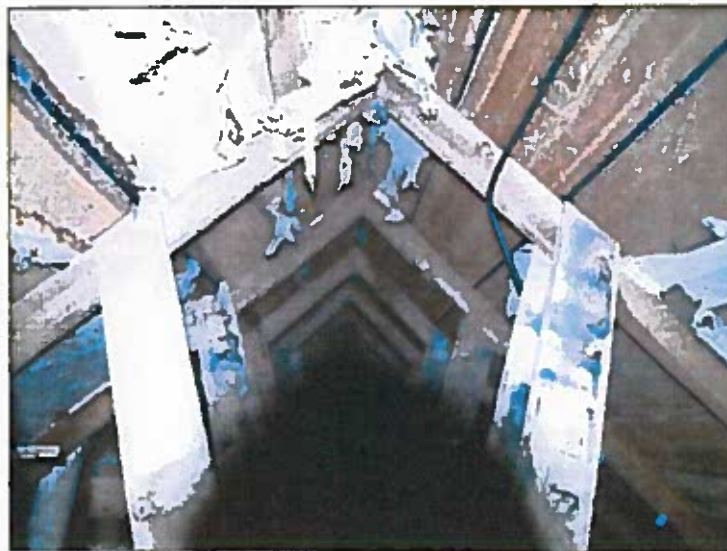
The condition of the framing and sheathing in Zone H is generally good. There is no evidence of moisture damage or other deterioration to the members themselves. The system appears to be performing adequately; however, there are some spot locations where the wood members making up the attic truss are separating at their connection points.

Figure S-13: Zone H rafter truss with 1x web members.

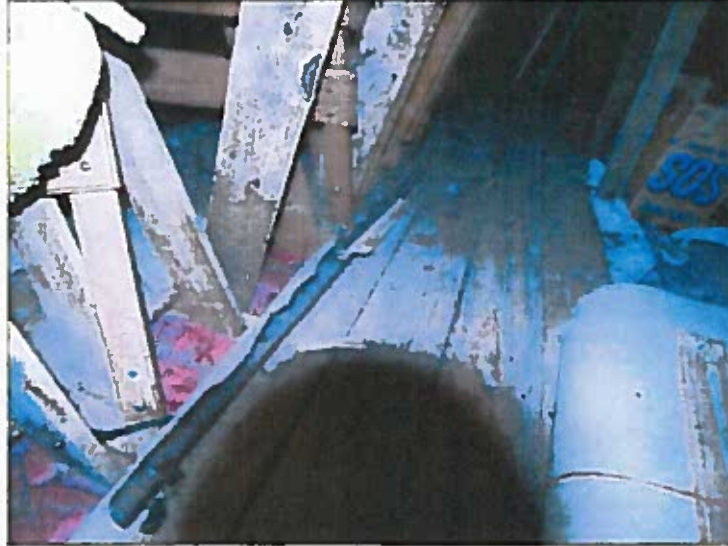
Figure S-14: Zone H truss web members to floor joist connection.

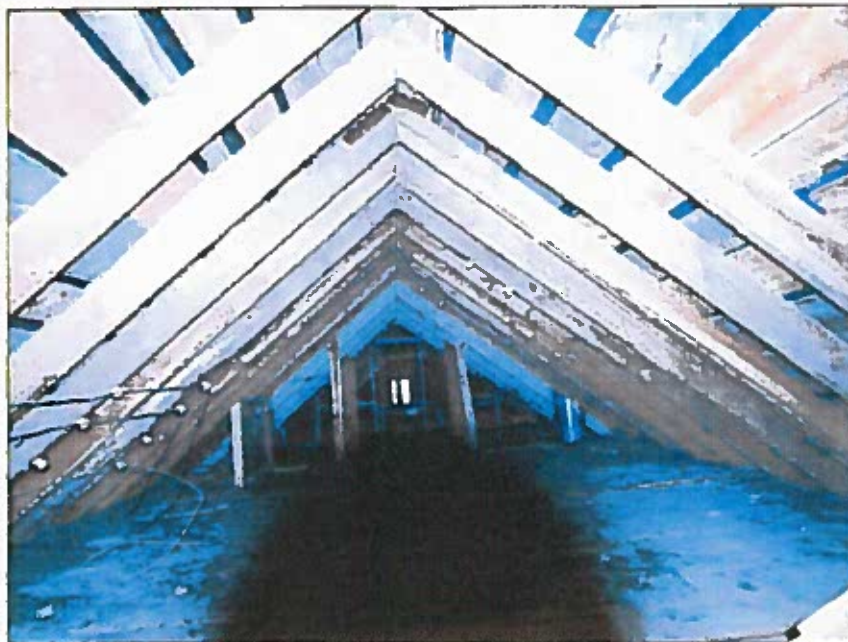
The condition of the framing and sheathing in Zone K, L, & M is generally good. There is no evidence of moisture damage or other deterioration to the members themselves. The system appears to be performing adequately, without noticeable deflection. The roof truss top chords are exhibiting some separation at the ridge of the gable roof, which is significant in some locations.

Figure S-15: Zones K & L attic framing.

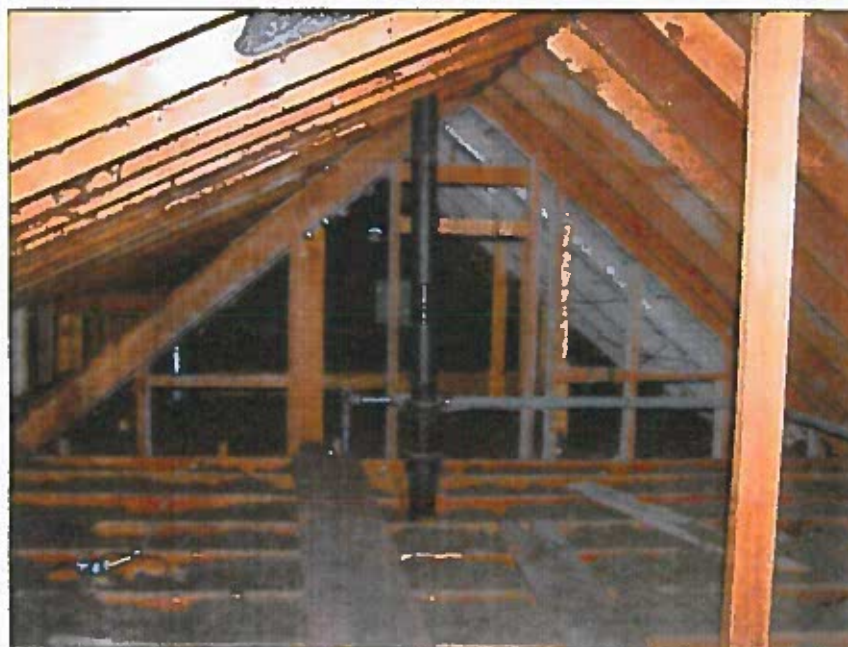
Figure S-16: Zone M framing, looking west towards framing over Zone L.

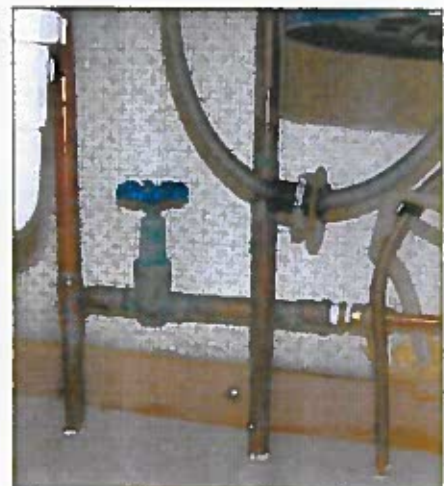
Figure P-2: Corroded valve underneath Kitchen sink

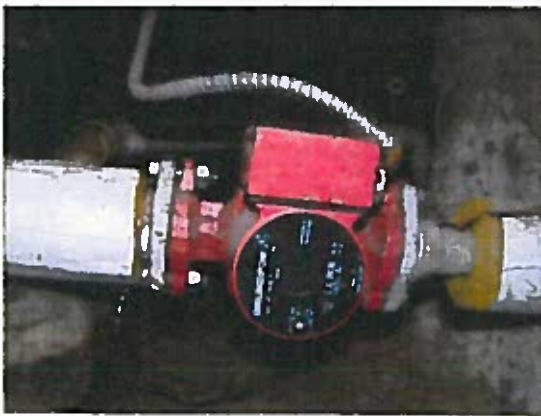
Figure M-1: Hydronic circulator pump

The hydronic piping located in the crawl space varies in condition from fair to poor. This copper piping shows its worst signs of corrosion at its older sections and joints. This piping also is not fully insulated. This violates the International Mechanical Code (IMC). See Figure M-4 below.

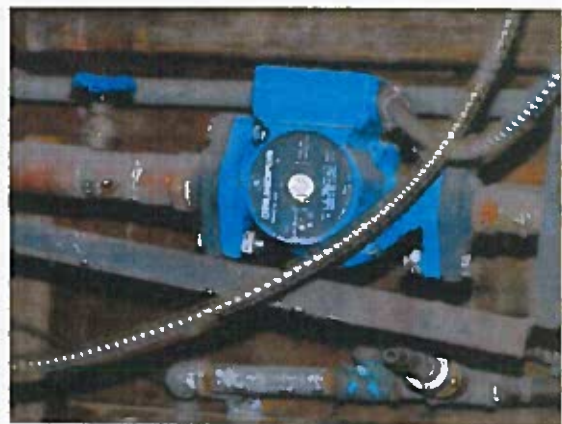
Figure M-2: Hydronic circulator pump

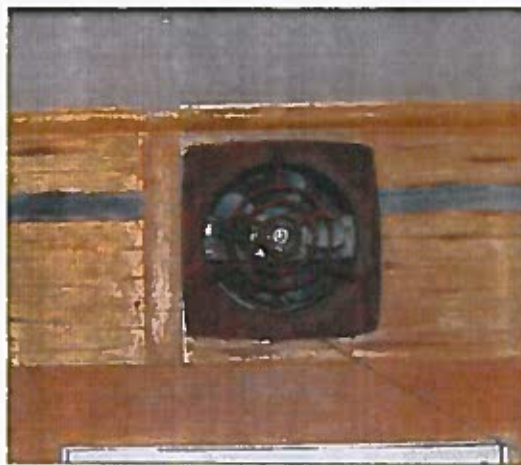
There is only one bathroom exhaust fan in the house. This fan located in Bathroom #108 works properly but the internal heater does not; it emitted a burning smell when turned on. An exhaust rate of 50 cfm per bathroom is required by the International Mechanical Code. In order to meet the IMC, installation of new exhaust fans would be required. Recently, a Kitchen exhaust fan in the island was removed due to the recent water damage in that area. Kitchens are required by the IMC to have at least 100 cfm of intermittent exhaust. A sidewall fan is installed in the upstairs hall where the King Mini-Kitchen used to be. This fan is not working and appears to be from the 1950's, see Figure M-7.

Figure M-7: Second floor wall fan

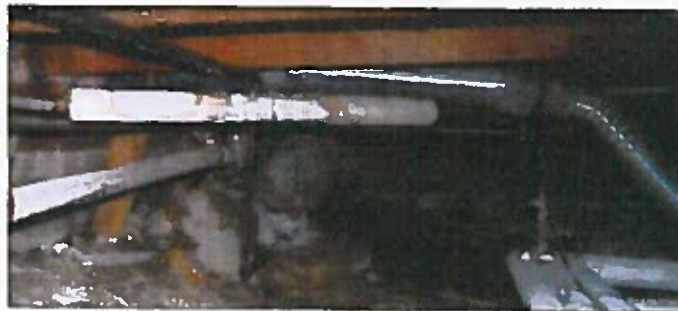
Figure M-8: Kitchen exhaust duct

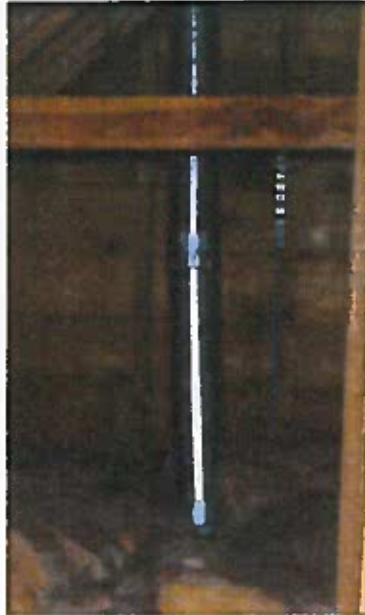
The ductwork for the exhaust fan in Bathroom #108 is in fair shape. However, the ductwork is connected using duct tape which is an IMC code violation as seen in the Figure M-9. The exhaust ductwork for the dryer vent was removed from the crawl space but the dryer cap on the exterior wall remains. The exhaust duct for the Kitchen exhaust is in poor condition. It is connected with duct tape in the same way as the Bathroom #108 exhaust and connected to the floor opening with flexible ductwork; refer to Figure M-8. A double-walled flue pipe (16" dia.) is abandoned in Bedroom #103. The walls of this flue pipe are capped in the attic below the abandoned roof penetration and capped about 6" below the ceiling.

**Figure M-9: Master Bath
exhaust duct**

After analysis of the mechanical system, CTA recommends that the hydronic system should be further investigated. This investigation should include internal inspection of pipe and fin tubes, hydronic pumps and analysis of controls. If the hydronic piping is not adversely affected by internal corrosion, the piping should be properly insulated. The two Rinnai direct vent ductless furnaces should be replaced by more efficient and centralized radiant baseboard heating. The electric wall heater in the Kitchen should be removed and the Kitchen should be incorporated into the hydronic system. The thermostat containing mercury in the first floor's Corridor 105 should be replaced. The Kitchen and bathrooms should be properly exhausted to meet IMC code requirements. The capped double walled flue duct can be removed from the ceiling if desired. However, in order to retain physical evidence of the building's construction history, the attic portion of the duct should be retained. Dryer exhaust ductwork should be replaced with proper materials and workmanship to meet the IMC.

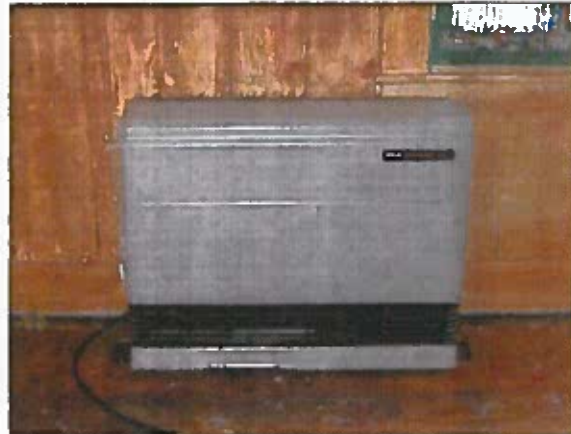
**Figure M-10: Rinnai direct vent ductless
furnace**

The two second floor Bedrooms are heated via gas-fired Rinnai direct vent ductless furnaces, as shown in Figure M-10 above. The temperature controls are unit mounted. The heaters maintain adequate temperature in the space but are not the most efficient way to heat a space when a hydronic system is available.

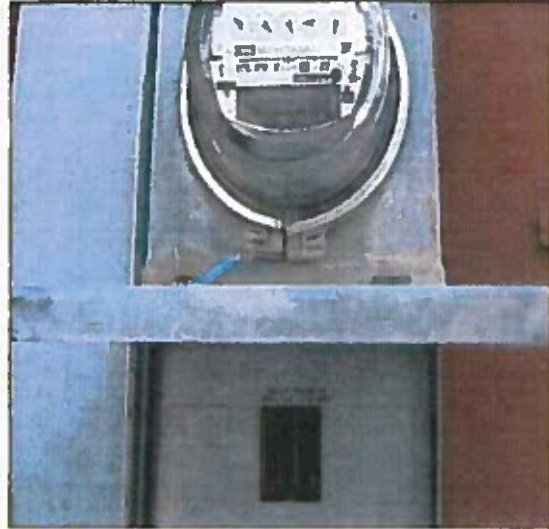
The building has a 120/240 volt underground service with a 100 amp main circuit breaker located in the metering equipment as shown in Figure E-1 to the right. The metering equipment is located at the south end of the west exterior wall of the Kitchen. The main panel is a Federal Pacific load center as shown in Figure E-2 below. It is a 200 amp, 24 circuit panel, with no space for additional breakers. There is an additional panel upstairs in room 210 that is a Square D load center rated at 100 amps with a 50 amp main circuit breaker. This panel is shown in Figure E-3 below.

Figure E-1: Electrical service entry.

It is recommended that a new electrical service be brought into the building rated at 200 amps given the size of the building. The main electrical panel should be replaced because it is obsolete and there is no spare room for future electrical loads. The disconnect cabinet on the exterior of the building next to the service meter should be consolidated into a main distribution panel. This is because the disconnects are aged, obsolete, and in poor condition. The interior of the cabinet is shown in Figure E-7 at left.

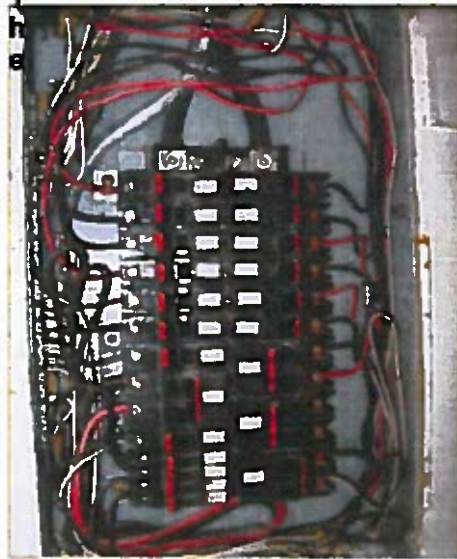
Figure E-2: Main electrical panel.

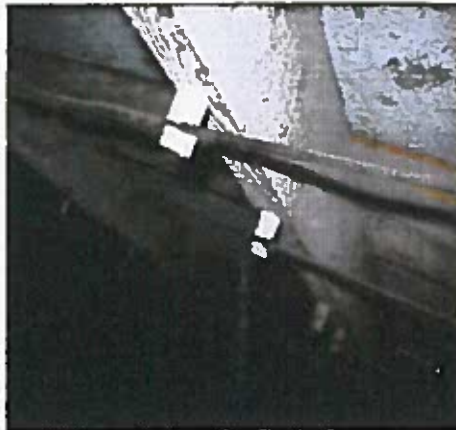
**Figure E-4: Knob-and-Tube style
wiring in attic space.**

All "knob and tube" wiring and all wiring with braided type insulation should be abandoned and removed throughout the building. All circuits should be wired with NM type insulated wires throughout. All circuits not connected should have the wires pulled back to a junction box and capped, or pulled back to the source completely. An example of this shown in Figure E-8 below.

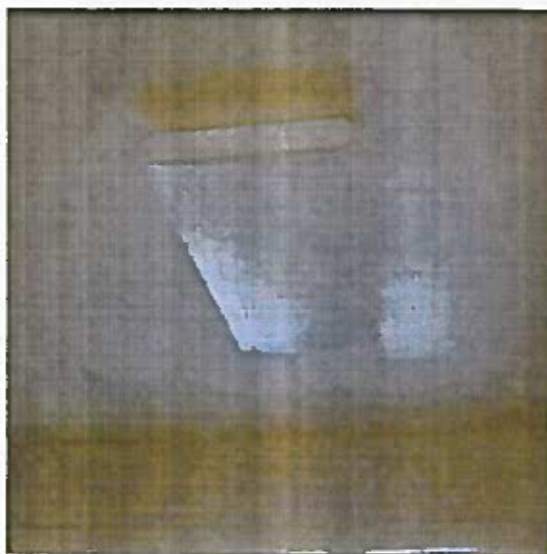
The lighting throughout the building is a mixture of incandescent and fluorescent fixtures. Existing fluorescent fixtures utilize T12 lamps and are probably from the 1980's remodel. Existing incandescent fixtures are dated as well. The majority of the ceiling fixtures in habitable rooms of the first floor are recessed incandescent lights with flush-mounted chrome frames supporting a sandblasted lens. A fluorescent fixture is shown in Figure E-5 below. The interior of a typical ceiling incandescent fixture is shown in Figure E-6.

**Figure E-6: Incandescent fixture in
Bathroom #101**

It is recommended that all interior lighting devices be removed and replaced with new energy efficient fluorescent and compact fluorescent fixtures. Included in this would be to replace all dated lighting switching devices. All exterior fixtures should be replaced with weatherproof fixtures. An example of an existing exterior light fixture is shown in Figure E-10 below.

When the light switches are replaced, consideration should be given to installing push-button switches as would have been installed with the original electrical system. The existing incandescent light fixtures should be retrofitted with compact fluorescent bulbs wherever possible. If the fixtures are replaced with fixtures more in keeping with the Craftsman period of the house, selection should allow for insertion of compact fluorescent bulbs.

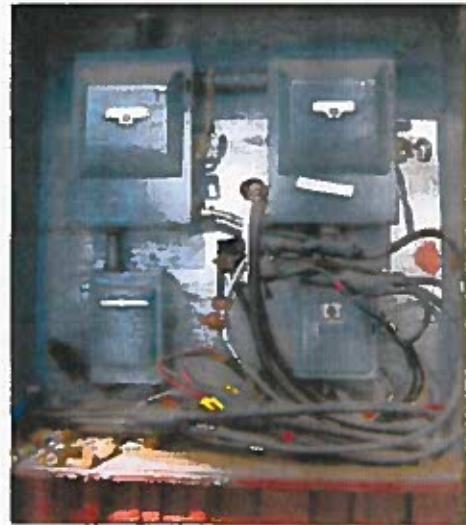
Figure E-7: Aged disconnects in poor condition with building code violations.

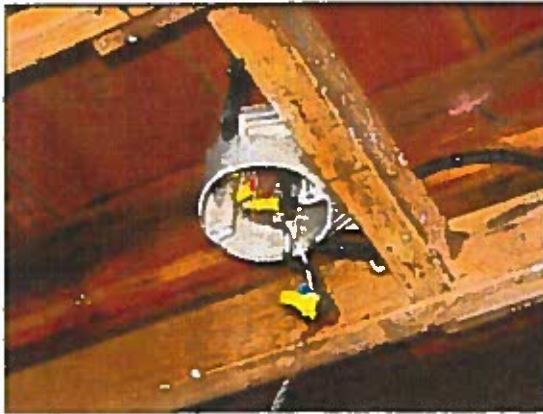
Figure E-9: Example of exposed junction box

cord. Also all exposed junction boxes in the Kitchen and attic space should be capped with cover plates. An example of this is shown in Figure E-9.

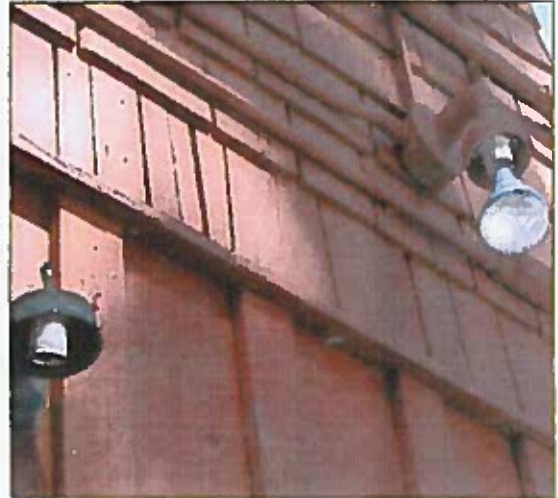
Figure E-10: An existing exterior light fixture.

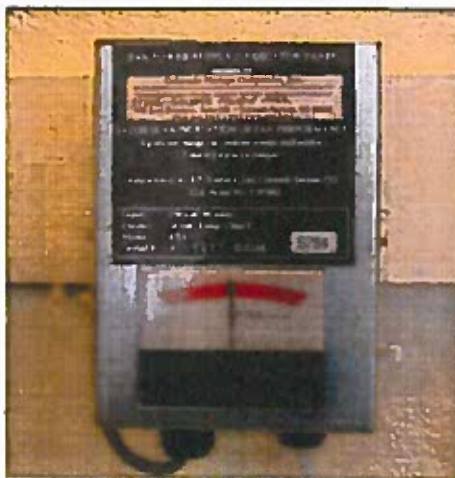
The radon mitigation system was installed around May 1994, according to the plate on the fan power supply/indicator panel. The fan was working on Feb. 20, 2008 but was malfunctioning on Feb. 7, 2008, as illustrated in the following Figures. The PVC duct work is in good condition.

Figure R-1: Properly Running Radon Indicator Panel, as observed on February 28, 2008.

CTA recommends that the radon fan should be retained as is, but monitored for failure.

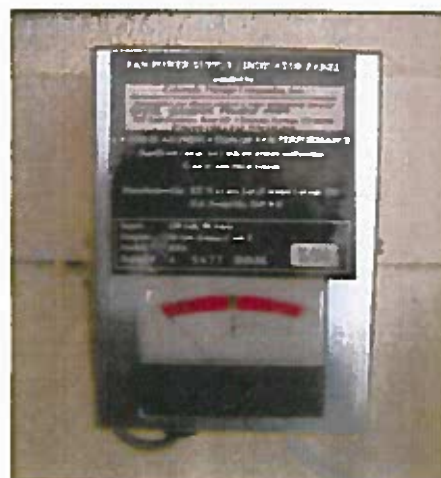
Figure R-2: Malfunctioning Radon Indicator Panel, as observed on February 7, 2008.

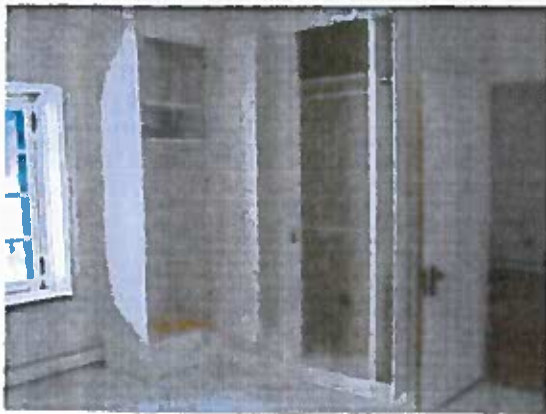
Figure 27: Closet 107A & 107B, looking northeast.

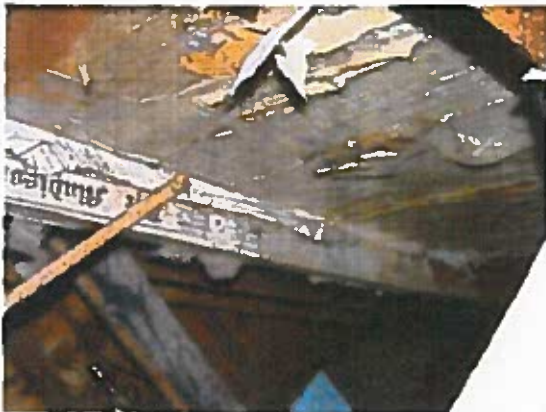
Figure 52: Attic, Sheathing of Zone H, with 1888 newspaper glued to underside.

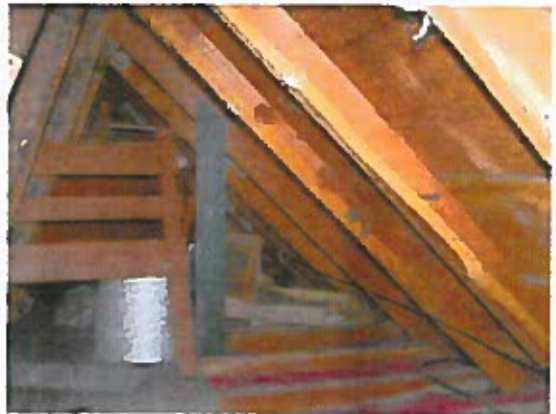
Figure 51: Attic Zone H, looking south towards Family Room 206.

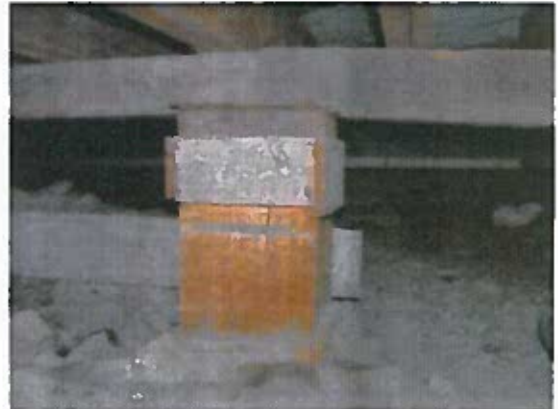
Figure 63: Crawlspace under Zone E, looking north towards west concrete support and beam splice.

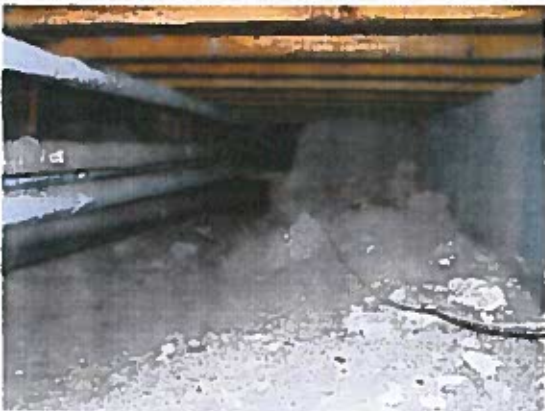
Figure 66: Crawlspace under Corridor 105, looking west.

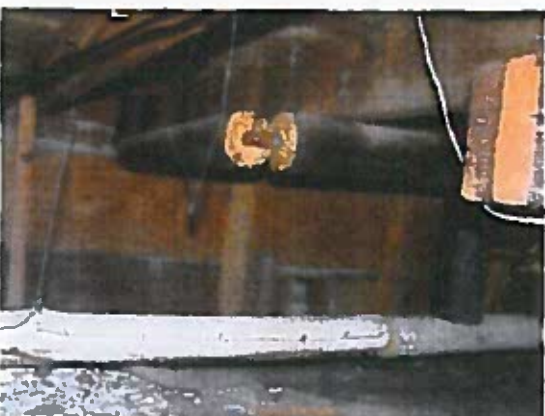
Figure 65: Crawlspace below Bedroom 103, looking northwest toward central concrete pier and beam supporting the mid-span of the joists.

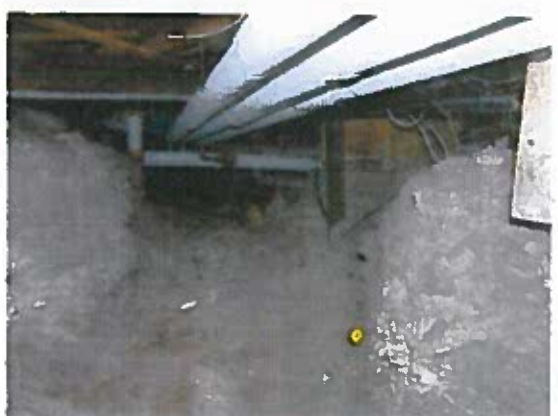
Figure 68: Crawlspace below Bedroom 103, looking northeast towards the exterior wall vent (with loose brick infill) and typical board form of the concrete walls.

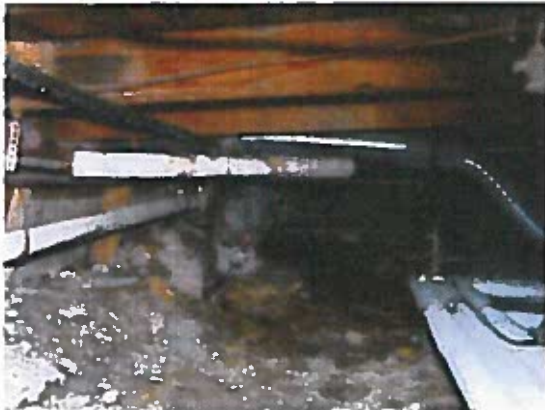
Figure 67: Crawlspace below Living Room 106, looking northwest through travertine tunnel leading to area below Bedroom 107.

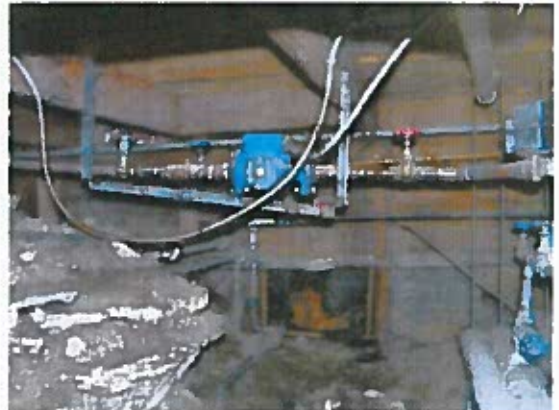
Figure 70: Crawlspace below Kitchen 110, looking south from floor access opening.

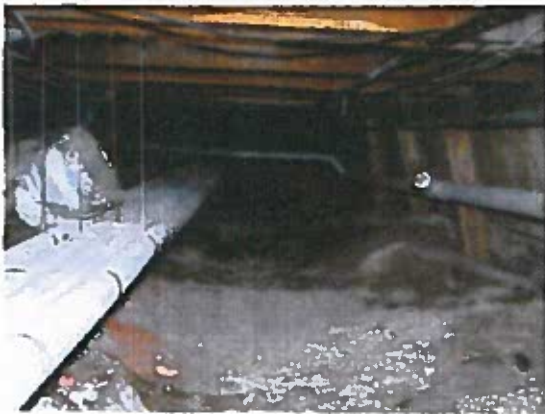
Figure 69: Crawlspace below Kitchen 110, looking west towards exterior access opening.
