HISTORIC
STRUCTURES REPORT

LAKE LODGE

YELLOWSTONE
NATIONAL PARK,
WYOMING

July 1997

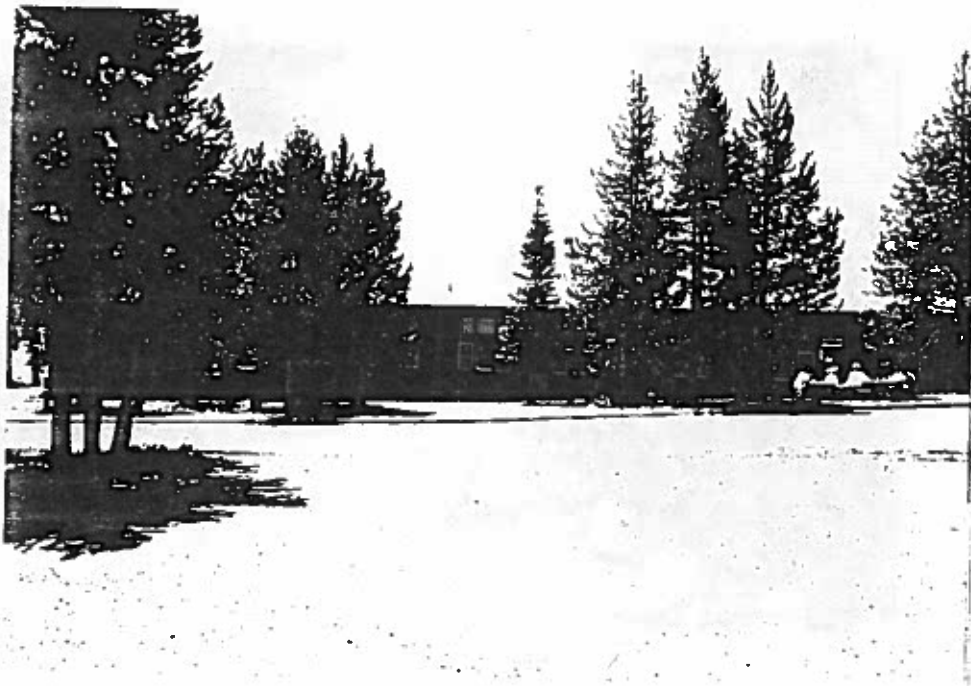
Figure 3: Looking south at the Lodge from the parking areas on the north side of the building. The parking is a large gravel area where the original cabins were located. The rows of cars are divided by some trees and grassy areas.

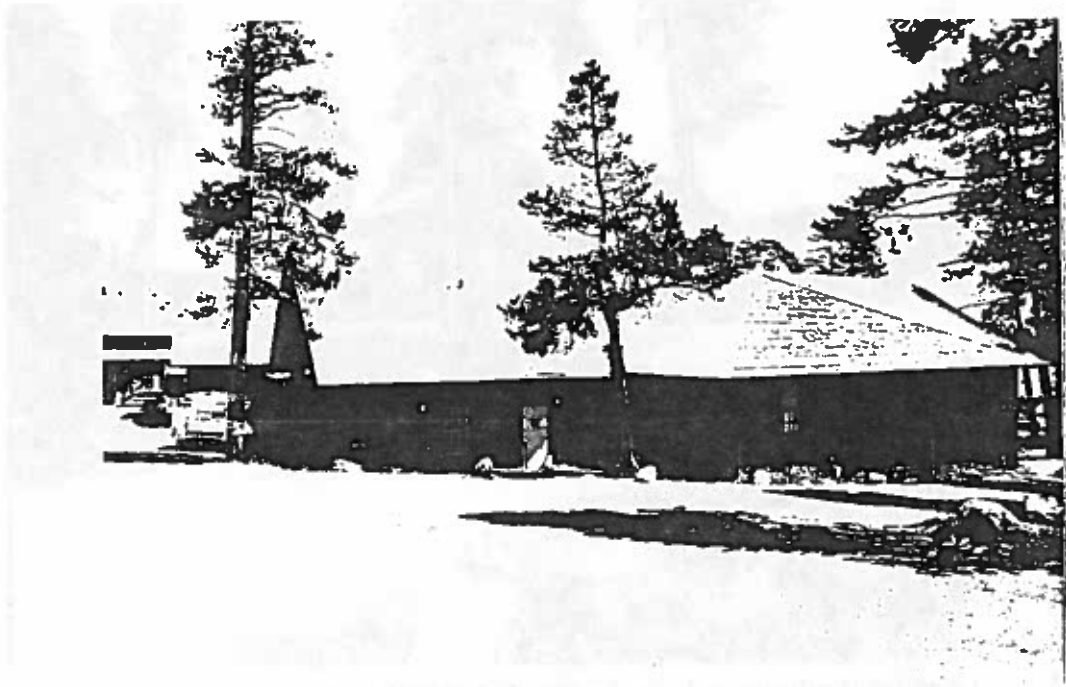
Figure 4: Looking north at the Lodge from the service parking area on the south side. Note drainage is towards the building on the south and west.

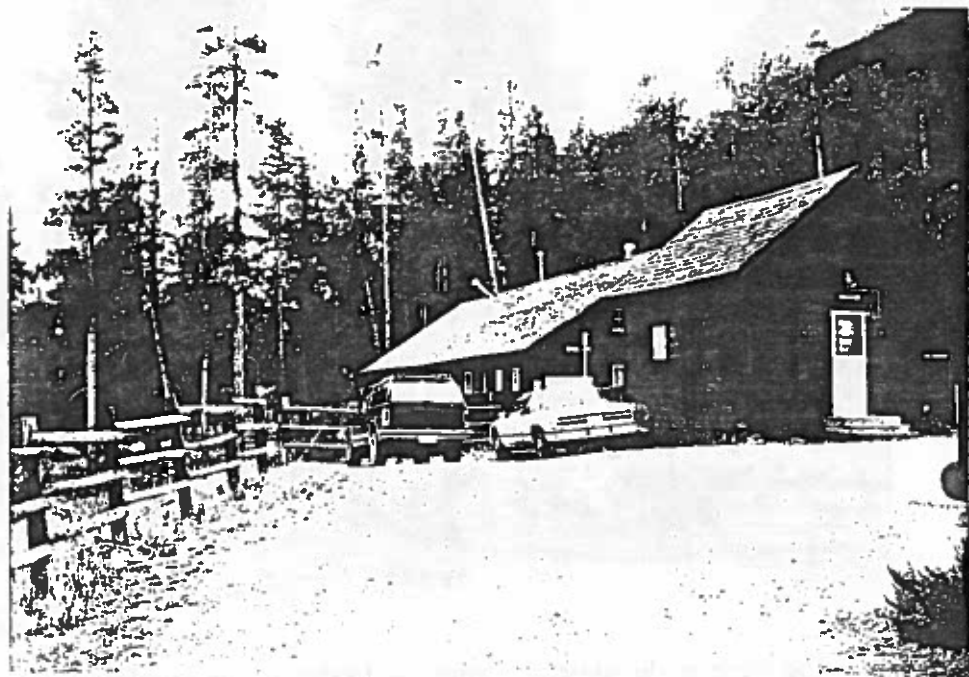
Figure 9: Looking south at the Personnel Building and Seagull Dorm (HS# 7006). Note the large gravel parking areas.

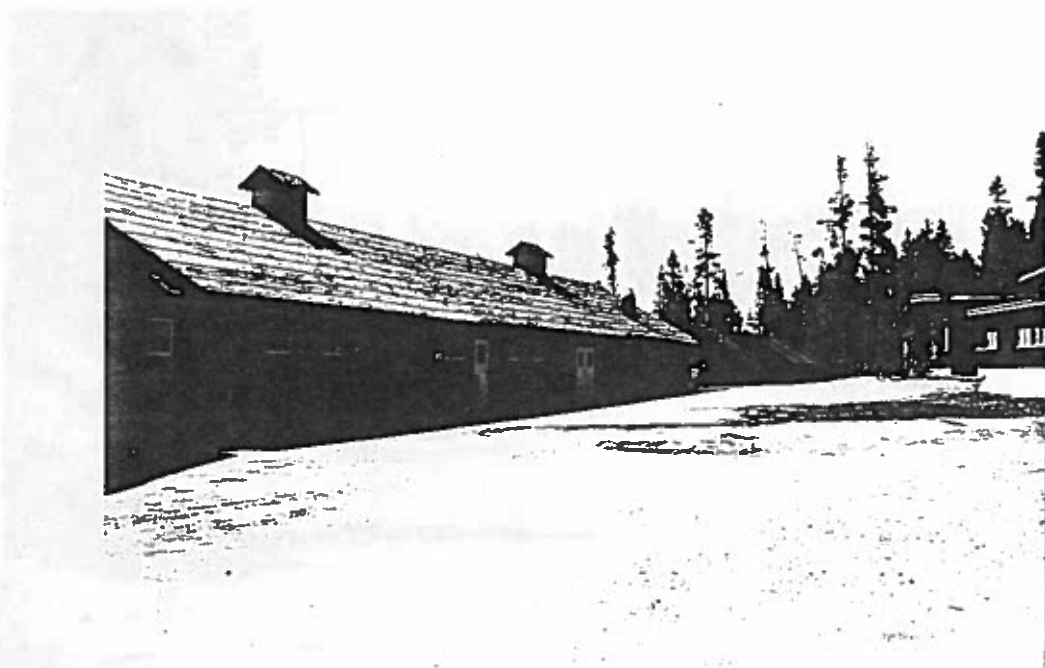
Figure 14: Looking south at the area between the Pub (HS #4053) and Mallard Dorm (HS #4055). Note the large gravel area that is viewed from the guest cabin area. Parking is kept to a minimum in this area.

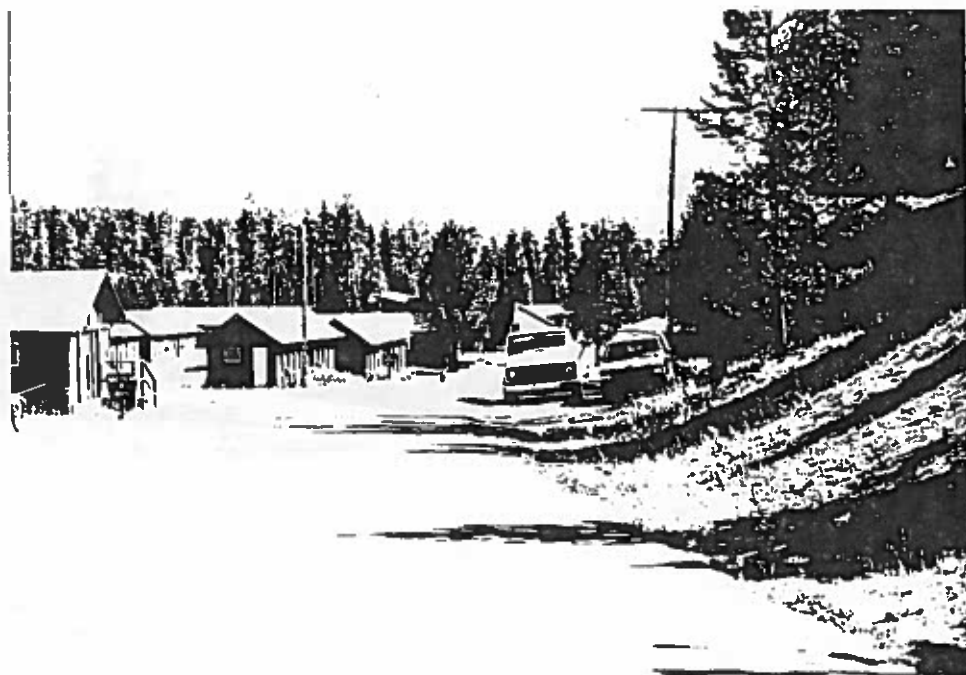
Figure 16: Looking north at the roadway on the east side of the guest cabin area. Note the trees on the right but lack of trees in the guest cabin area.

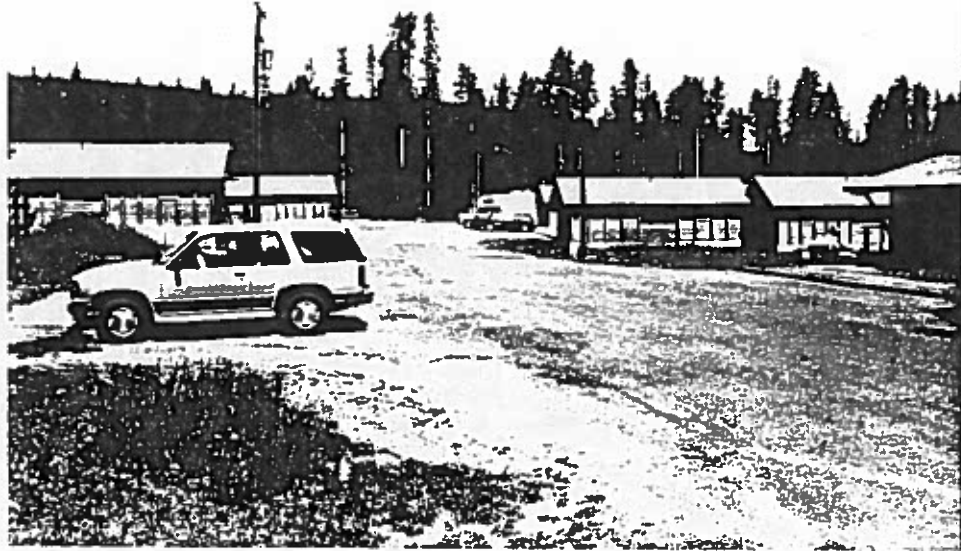
Figure 18: Looking west at a typical roadway between B and C cabins. Note the large graveled roadway and lack of vegetation and trees.

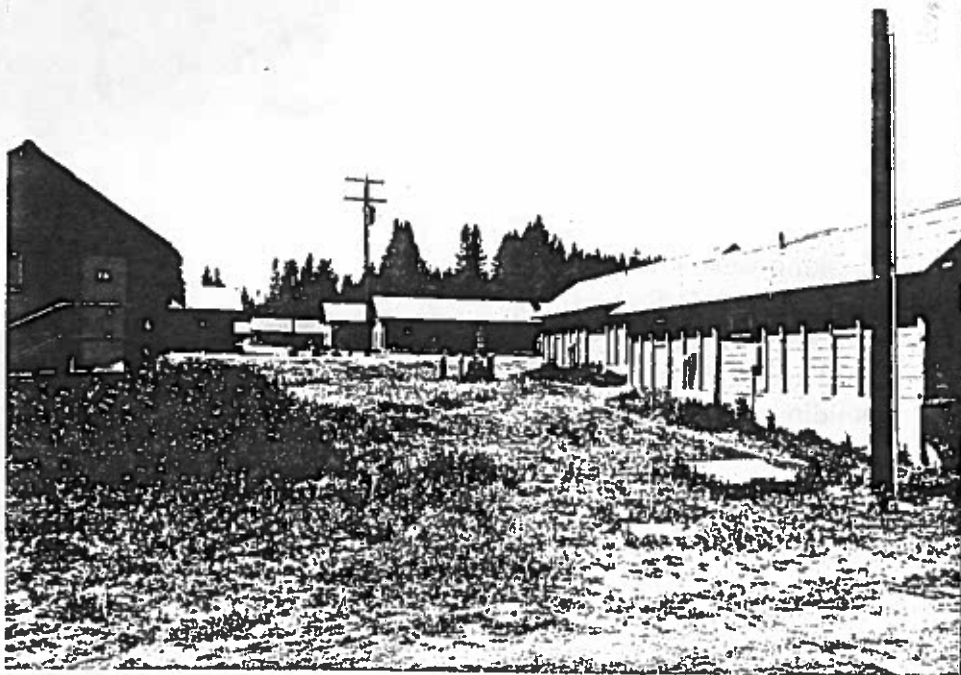
Figure 19: Looking south at an area between cabins in the C Section. There appears to be a high water table or spring in this area that allows the grass to grow and is causing high moisture under the cabins.

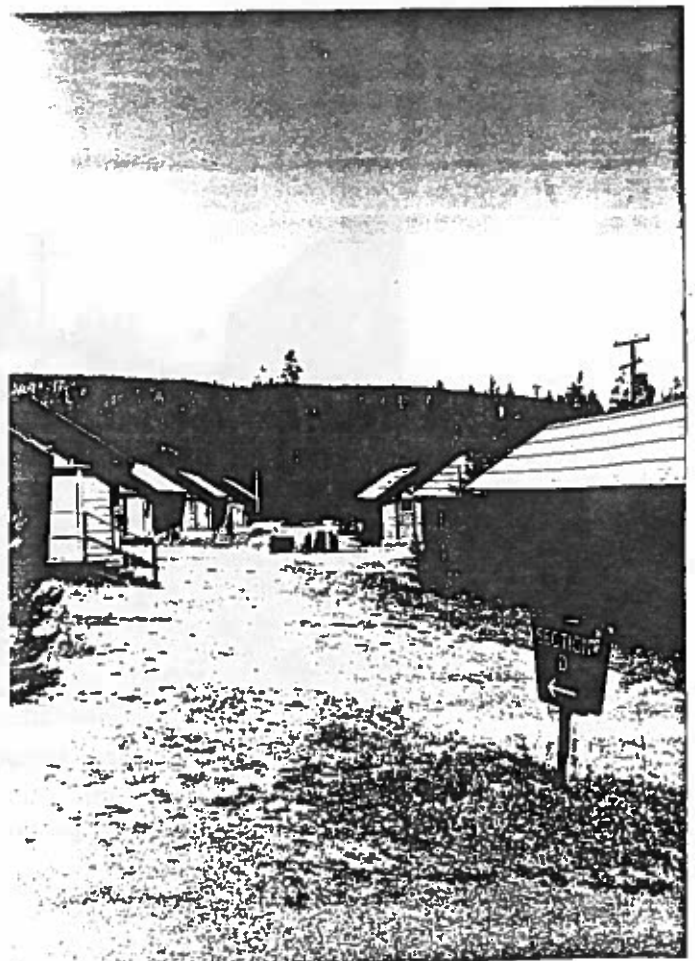
Figure 21: Looking west at an area between cabins in the D Section. The roadway has been developed to access the doorways to the buildings on this side.

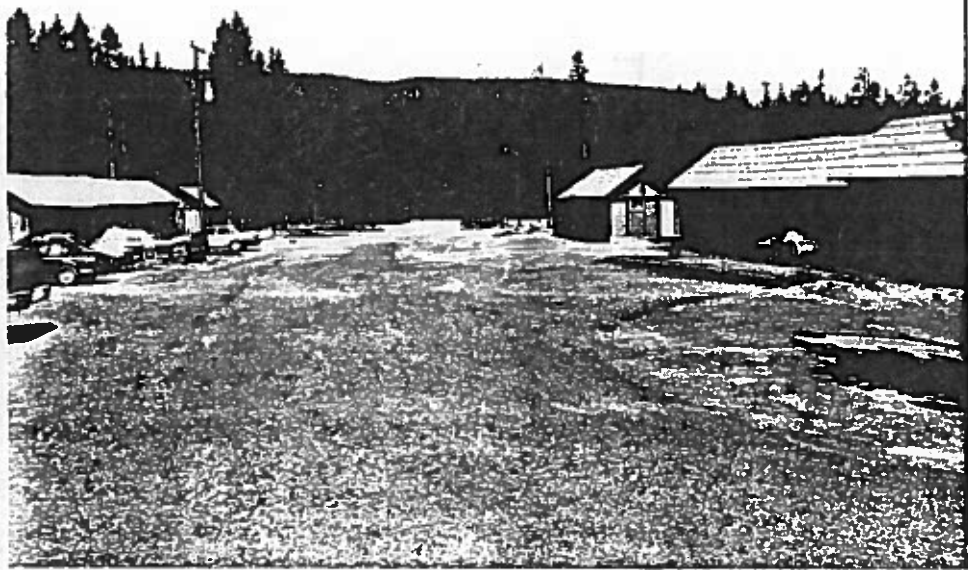
Figure 22: Looking west at the roadway between D and E cabins. Note the large gravel area.

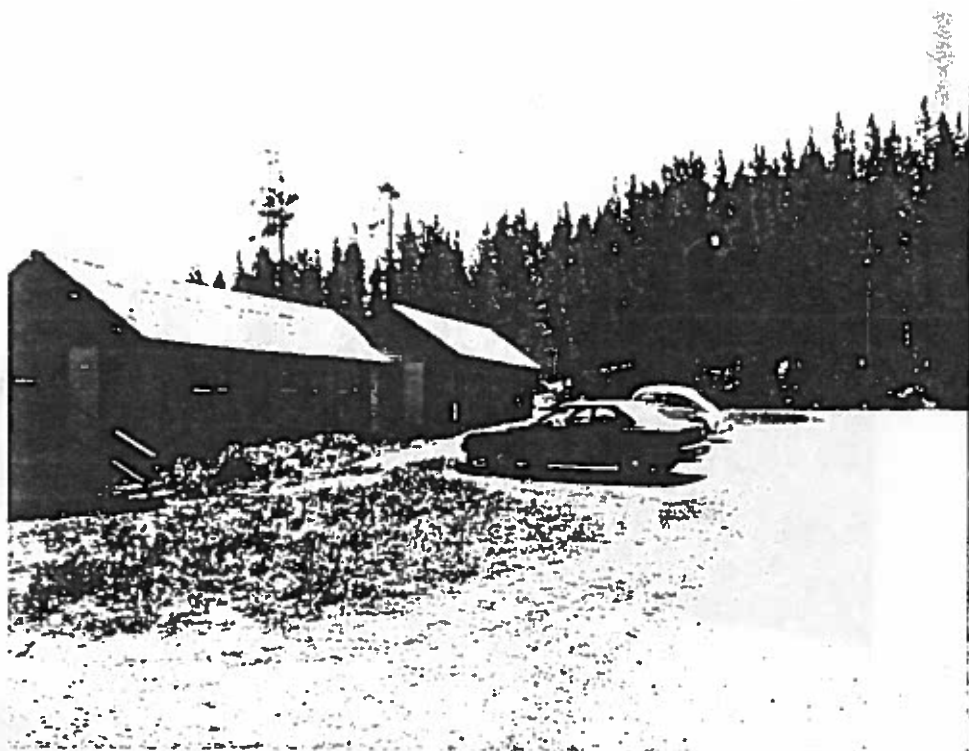
Figure 23: Looking east at a typical parking area in front of the E Section cabins. There are no pathways leading to the cabin entrances.

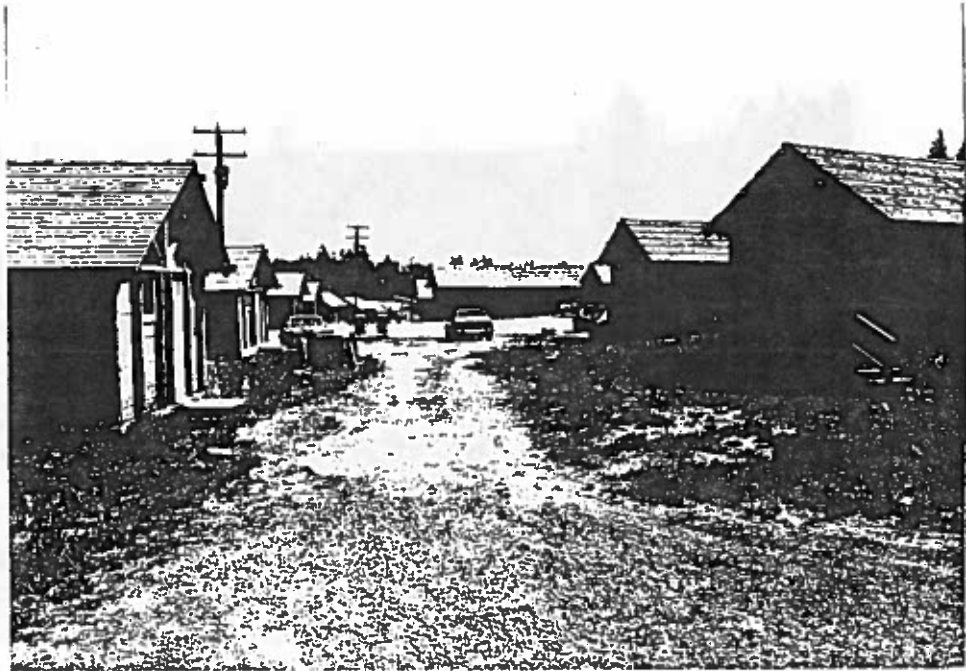
Figure 24: Looking north at an area between cabins in the E Section where a roadway has developed.

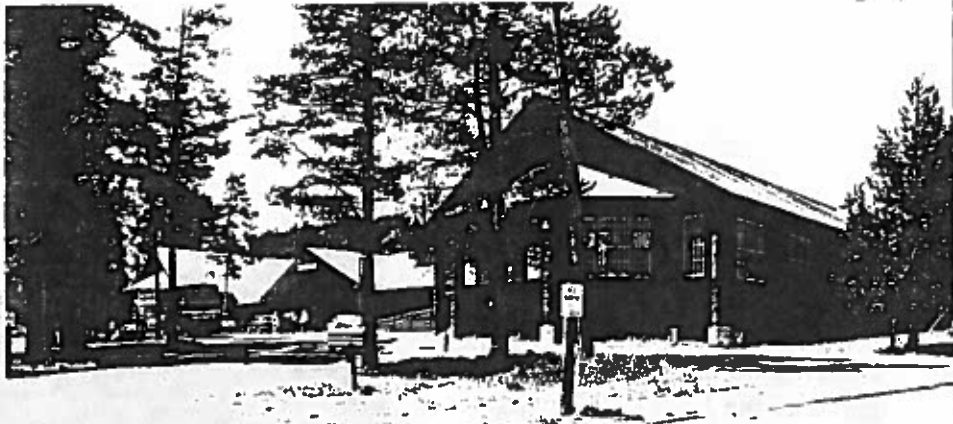
Figure 31: Looking southwest at Lake Lodge (HS #4050). Note the driveway along the front of the building. The building appears to be in good structural condition but needs some maintenance.

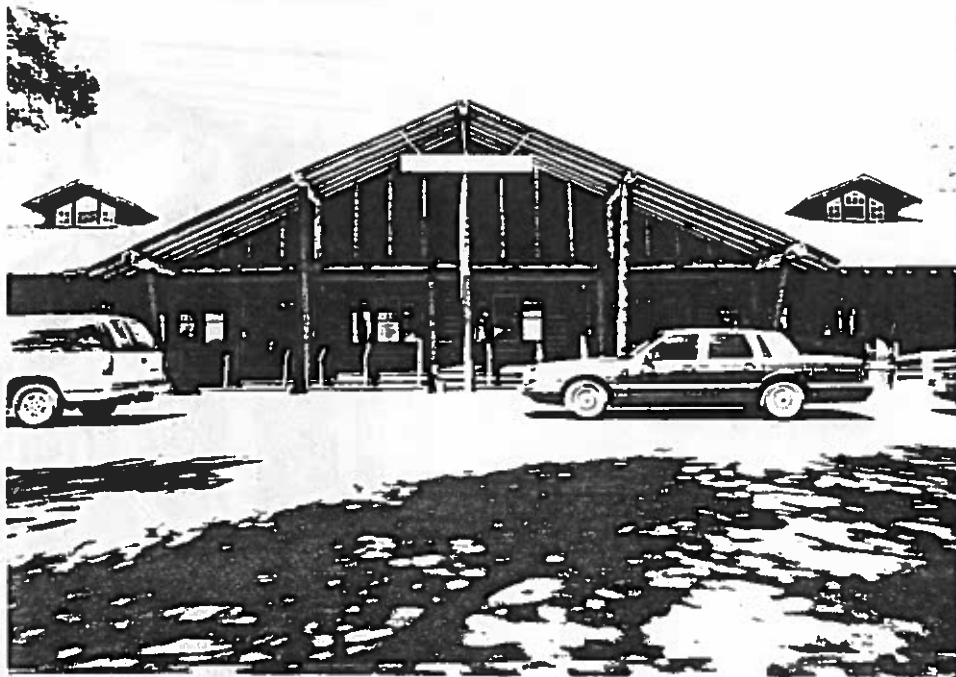
Figure 32: Looking west at the entrance to Lake Lodge. The gable is part of an extended portico that was cut back in the 1960's. Most of the structure is in good condition.

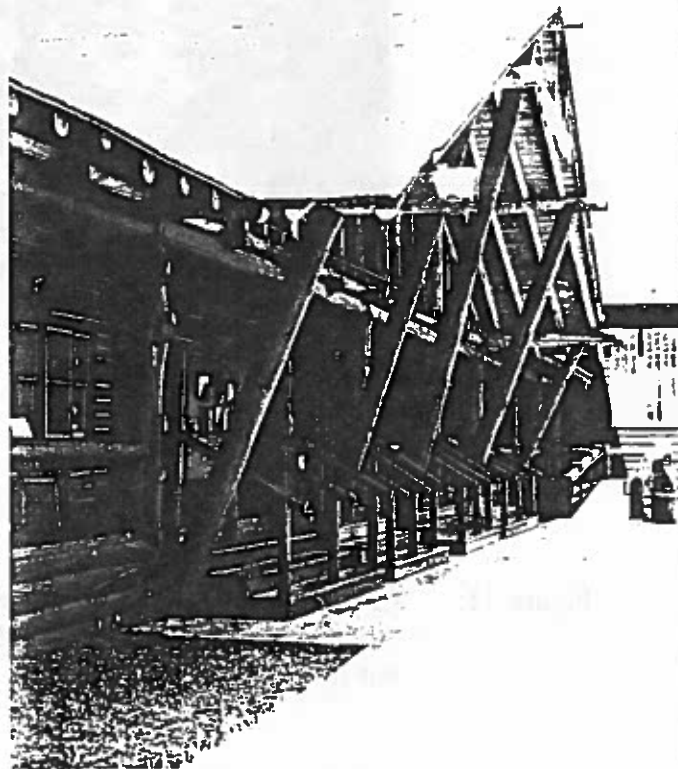
Figure 34: Looking northwest at the structure of the entrance gable. The logs appear to be in good condition with some minor rot and checking of the wood at the base.

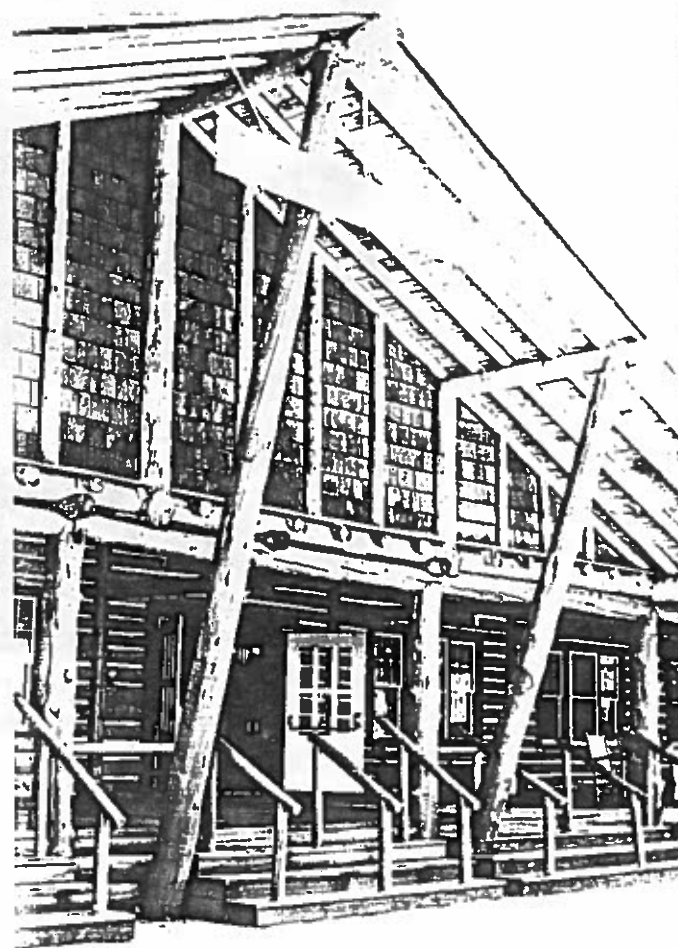
Figure 35: Looking at a detail of the structure of the entrance gable. All of the logs appear to be in good condition.

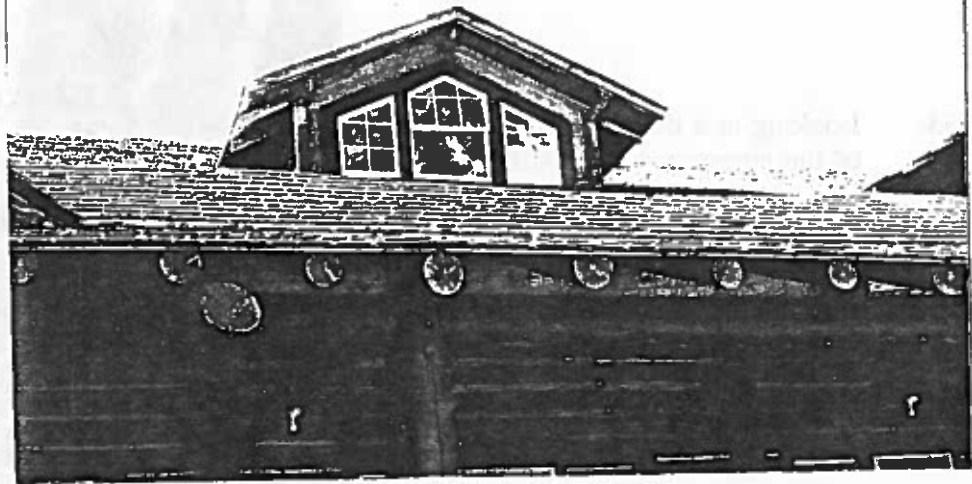
Figure 37: Looking west at one of the gables on the roof of the Lodge. The roof dormer and shingles appear to be in good condition.

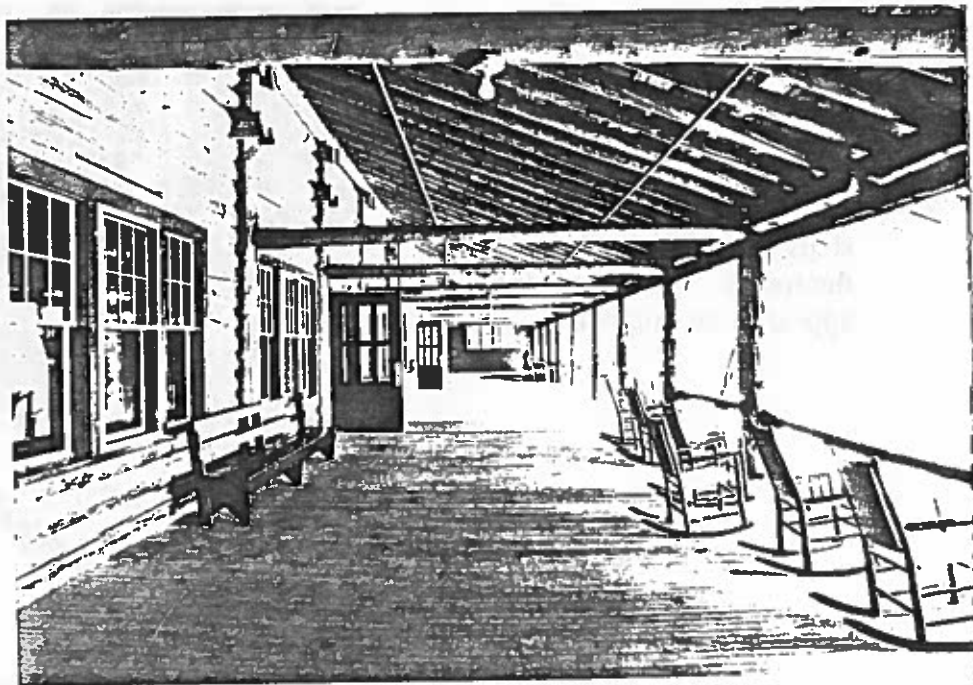
Figure 38: Looking north at the front porch area. The materials and structure appear to be in good condition.

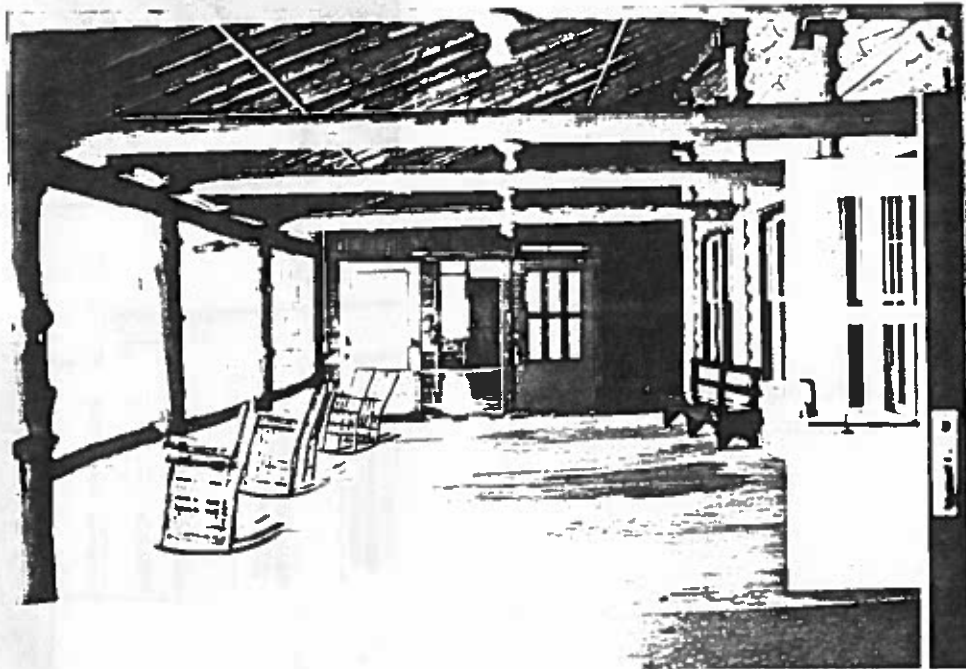
Figure 39: Looking south at the front porch towards the doors to the Employee Recreation Hall. Note the incandescent light fixtures and the fire sprinkler system along the roof rafters.

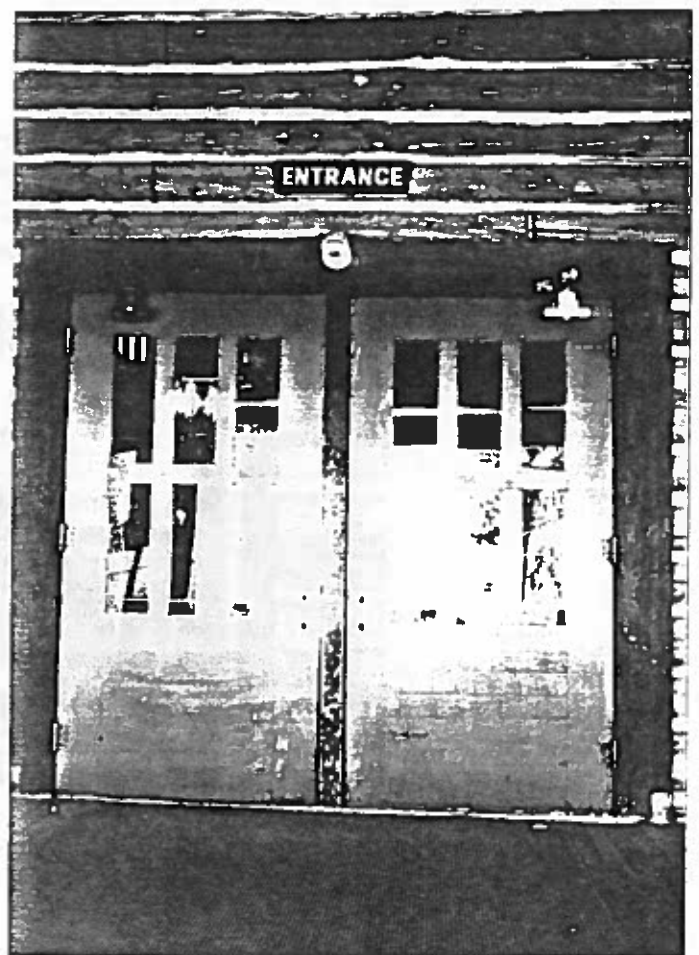
Figure 40: Looking west at the main entrance doors to the Lodge. They appear to be original and in good condition.

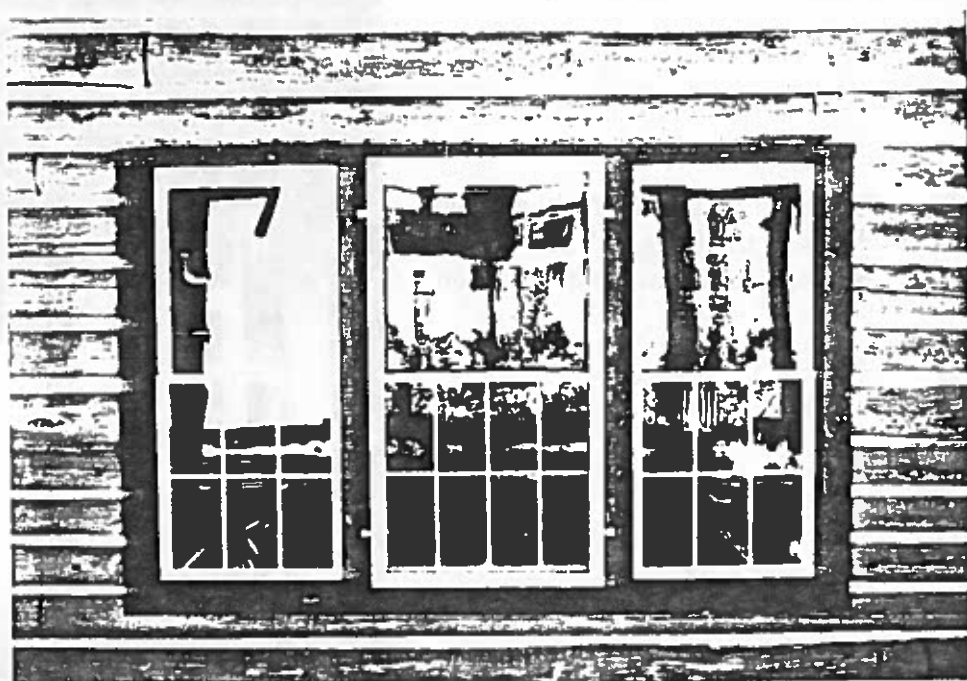
Figure 43: Looking west at some deteriorated paint on the window trim of one of the porch windows.

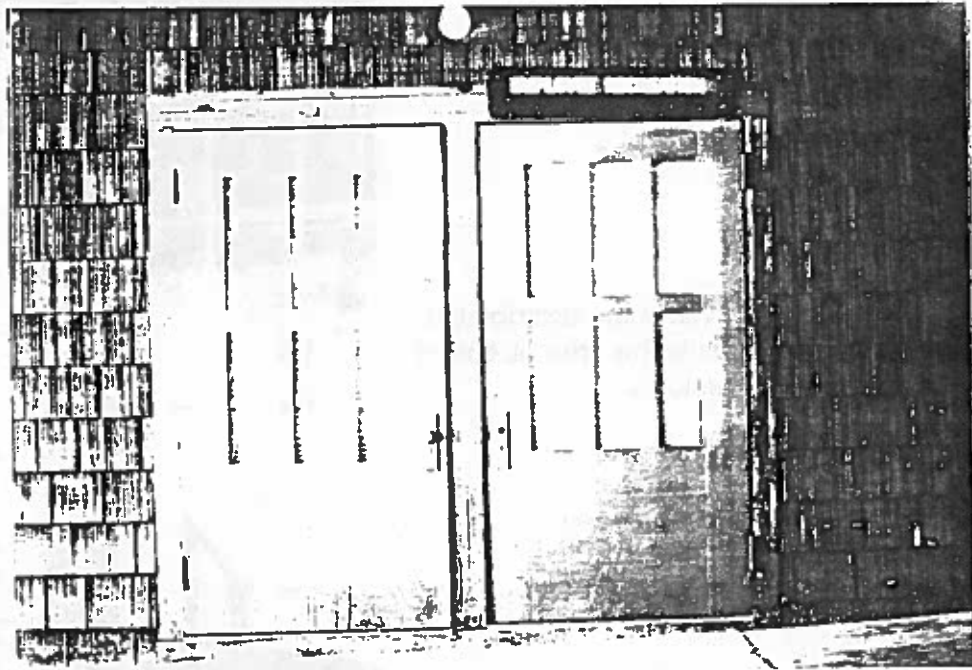
Figure 45: Looking south at the exterior entrance doors to the Employee Recreation Hall from the porch. Note some deterioration of the bottom of the door, the sill and shingles to left of the door.

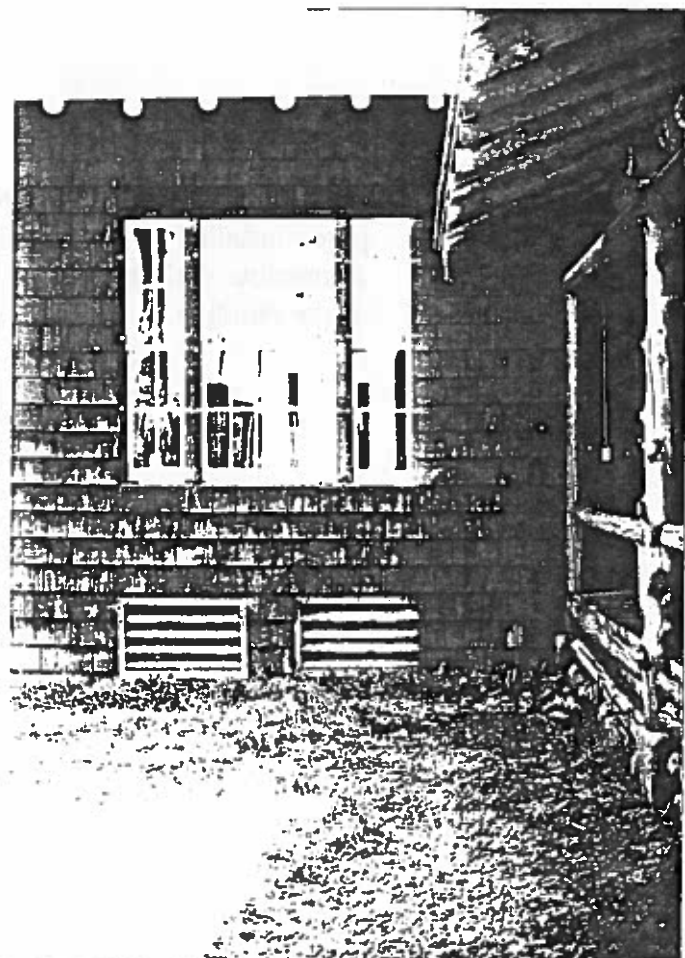
Figure 51: Looking southwest at the window sill and base of the wall on the Recreation Hall. Note the deteriorated sill, shingles and wood vents.

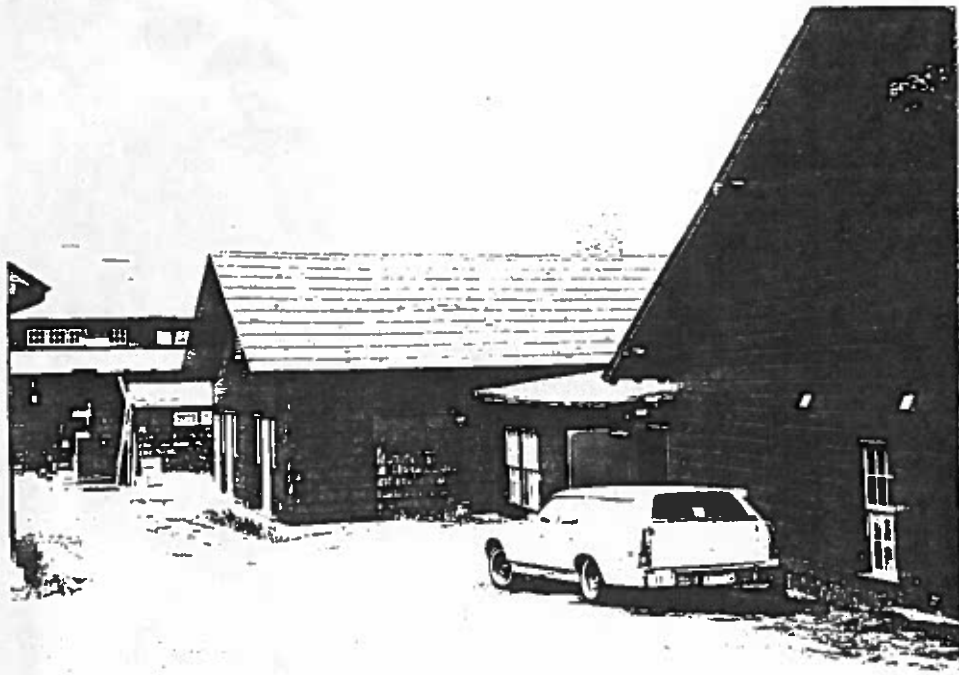
Figure 57: Looking northeast at the service area of the Lodge.

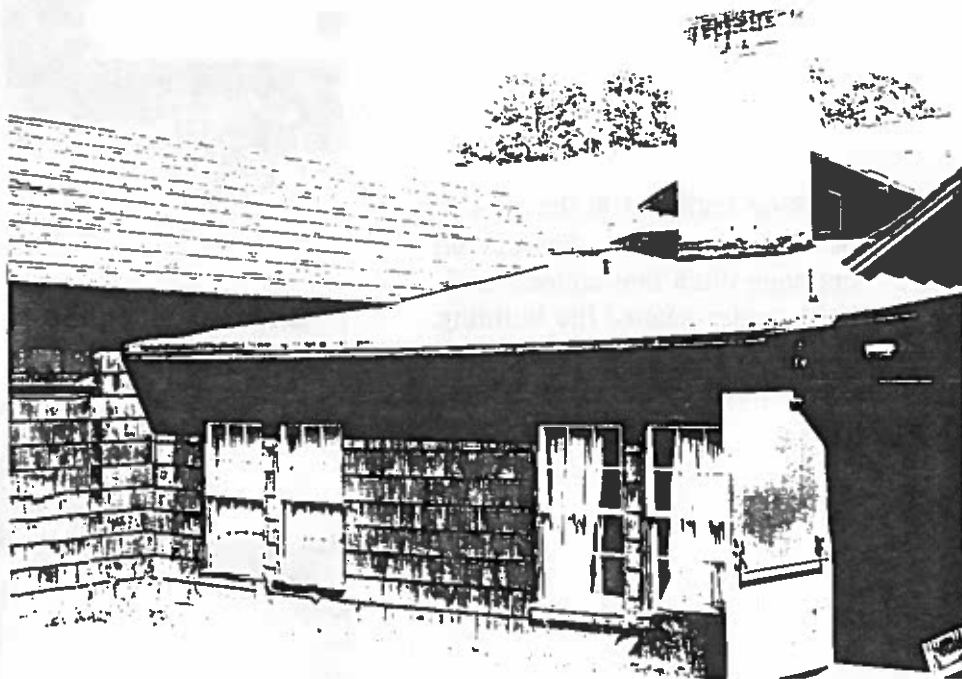
Figure 58: Looking east at a section of the west wall of the Lodge. Note the gravel roof and concrete chimney. The flashing around the chimney is in poor condition.

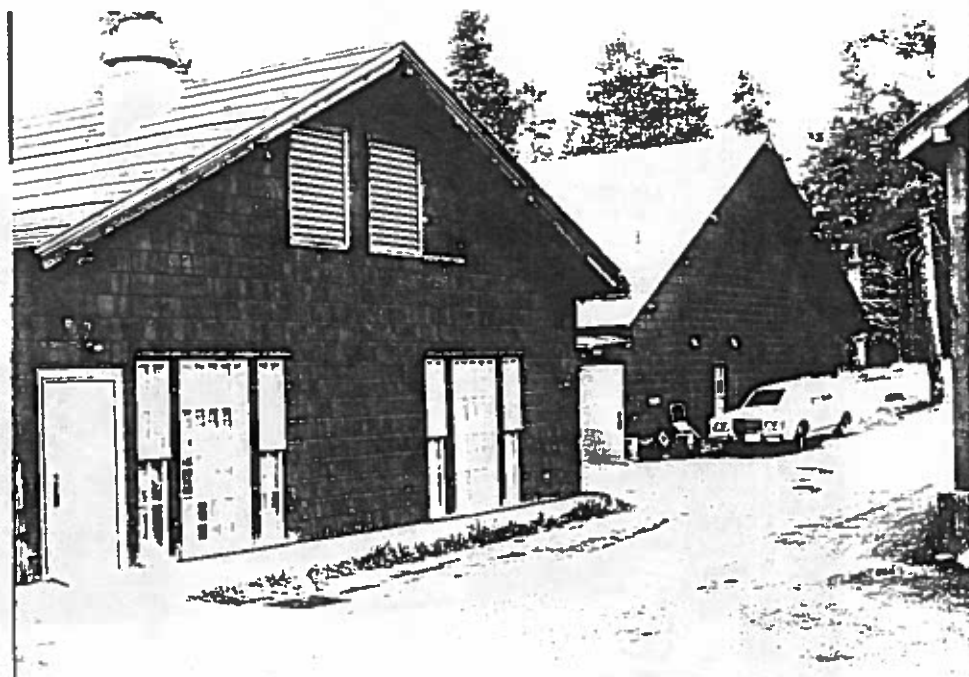
Figure 60: Looking southeast at the back of the gift shop area of the Lodge. The wall shingles are dry and weathered.

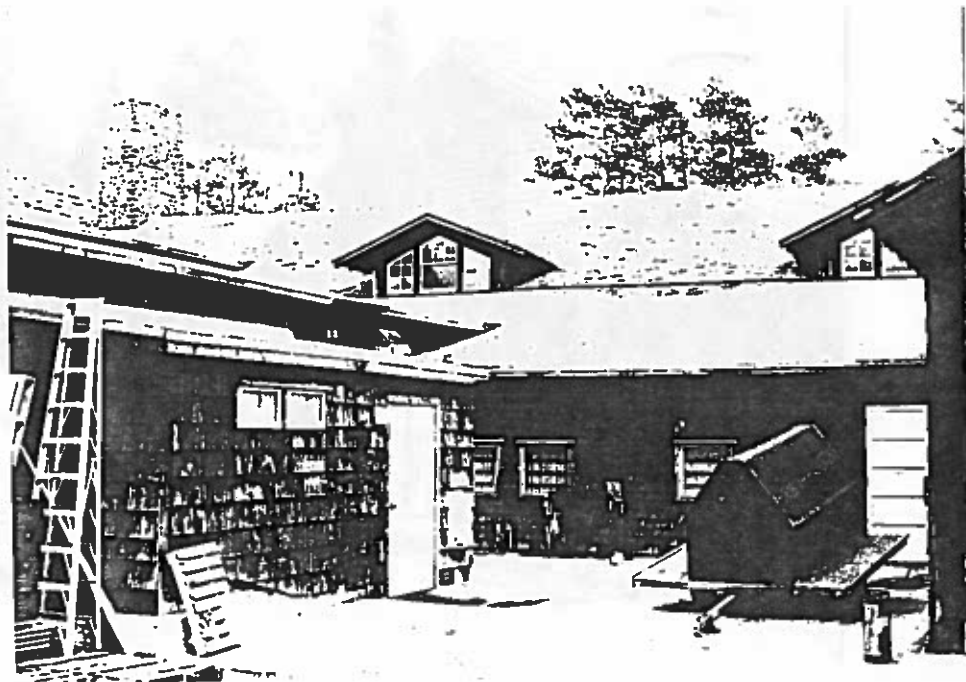
Figure 62: Looking east at the area around the warehouse section of the Lodge on the west side. The shingle roof is in good condition but the gravel built-up roof is starting to deteriorate. The wall shingles, doors, windows, and trim are weathered and rotted in this area.

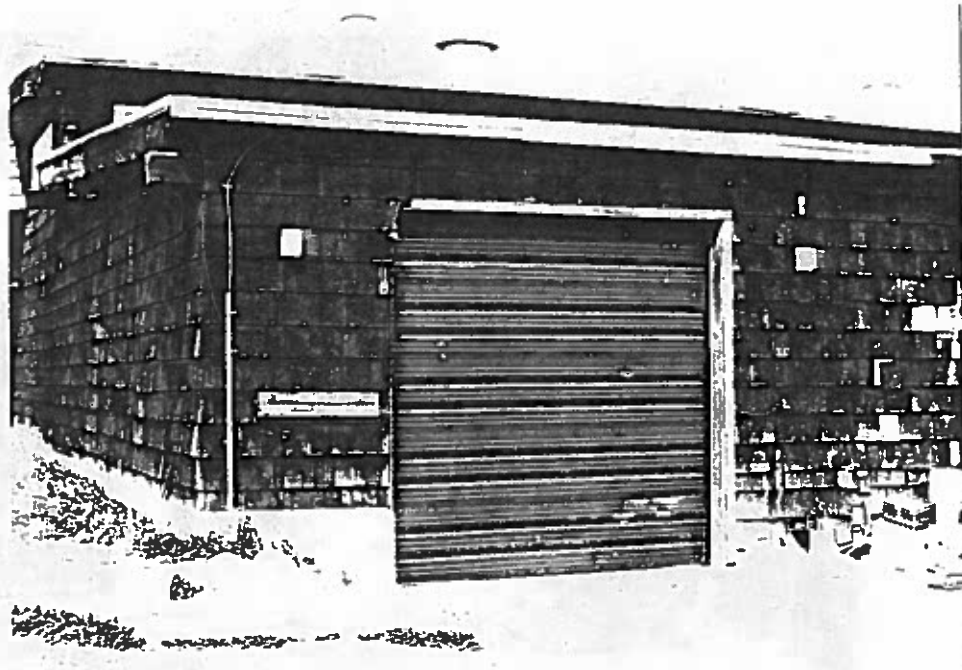
Figure 63: Looking northeast at the warehouse area of the Lodge. Note the metal door and deteriorating wall shingles.

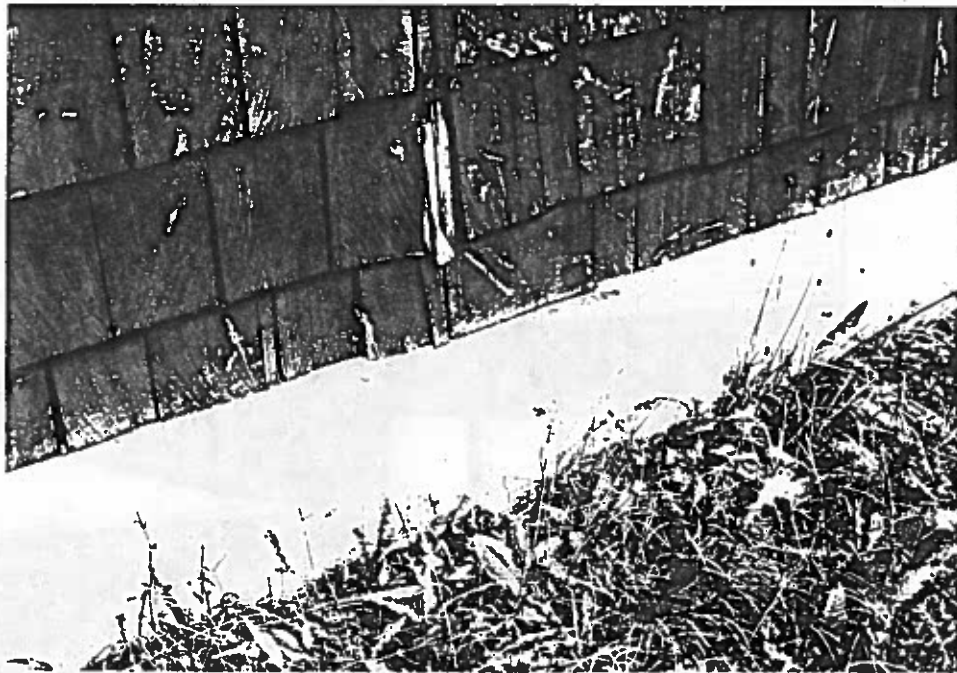
Figure 64: Looking at a concrete base detail at the wall on the west side of the Lodge.

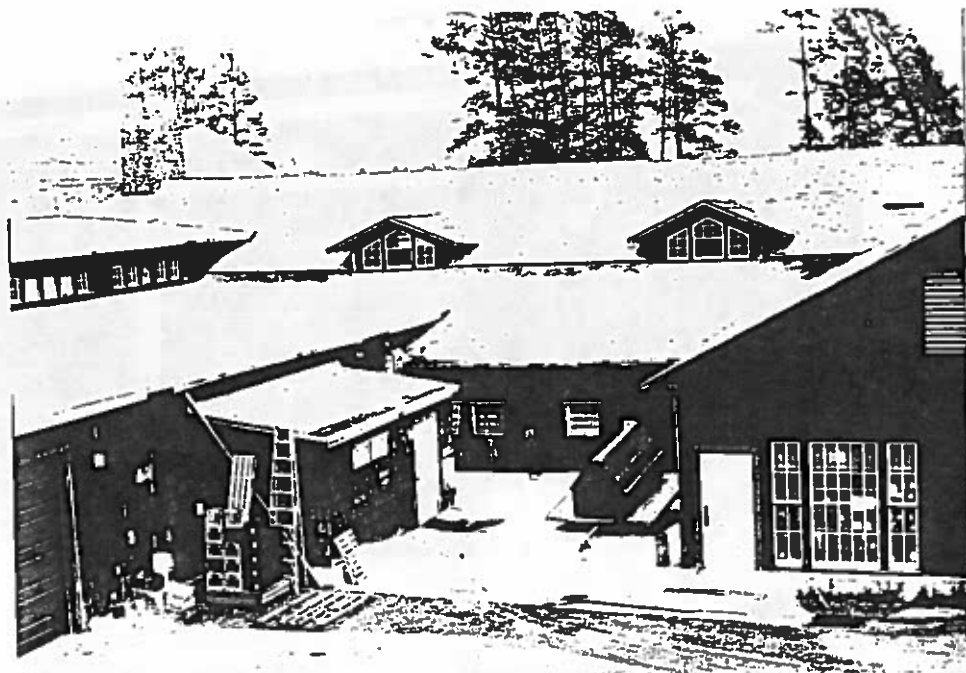
The wood shingle roofs are in good condition requiring only minor repair to flashings and ongoing maintenance. The flat roofs are in fair to good condition. Because the potential for leaks is greater on the flat areas and joints with the sloping roofs, these areas require regular monitoring so that any water penetration can be repaired immediately.

Figure 65: Looking east at the roofs on the west side of the Lodge. Note the built-up gravel roofs where there are many areas for potential leaks.

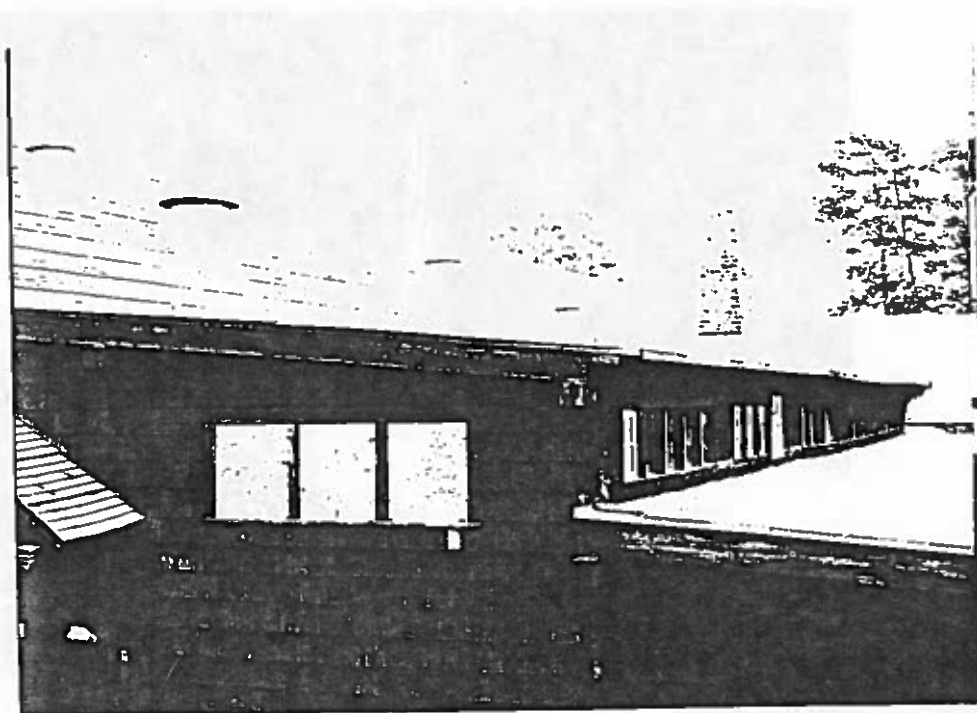
Figure 66: Looking at the upper windows over the roof of the warehouse. Some of the windows are boarded over; many of the windows and trim are in poor condition.

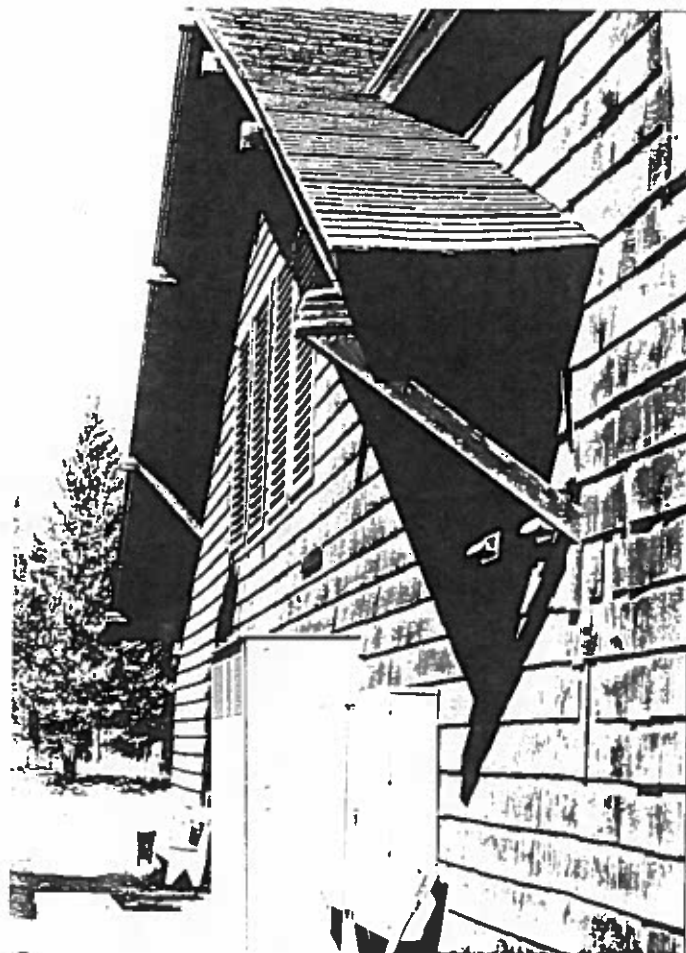
Figure 68: Looking at a detail of the lumber bracket under the gable end of the roof. The bracket appears to be falling away and causing damage to the wall shingles. It replaced an original log bracket.

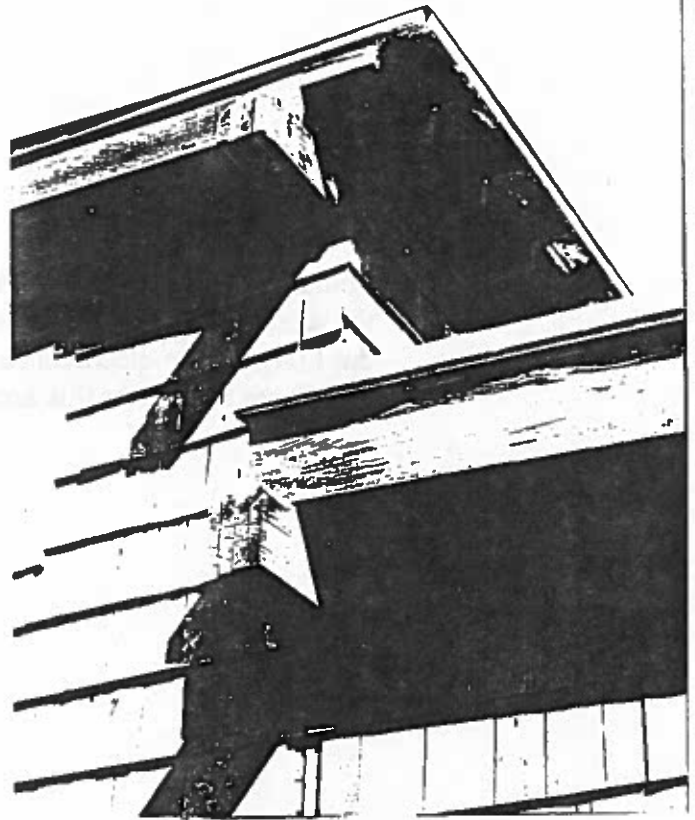
Figure 70: Looking northeast at the end wall of the kitchen area of the Lodge. This wall appears to be in good condition.

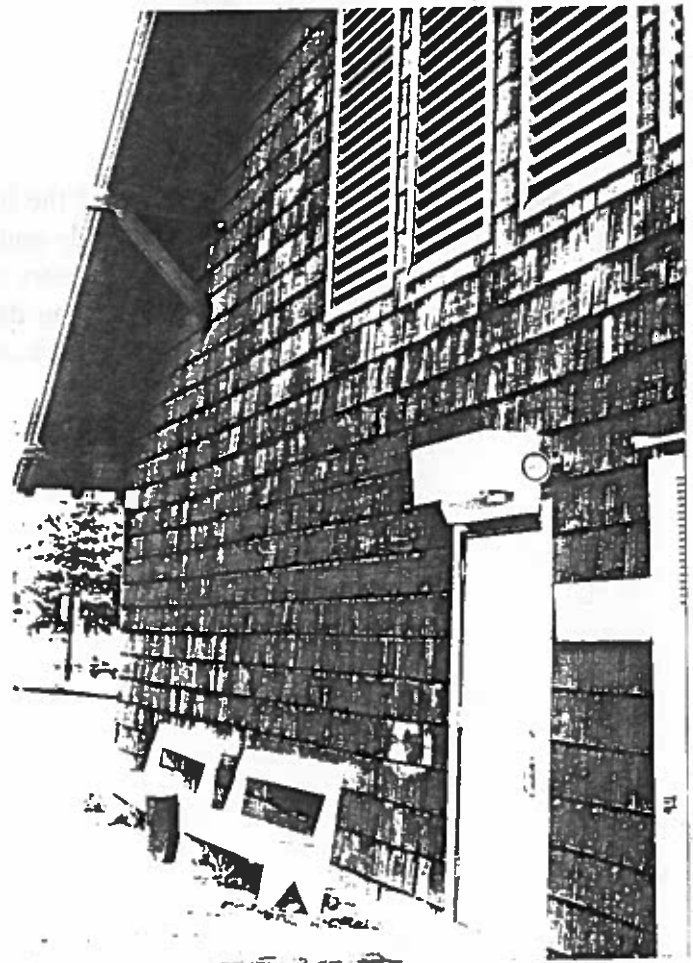
Figure 71: Looking southeast at the northwest corner of the kitchen wing of the Lodge. The column bases and bottom of the shingle walls are deteriorating due to the water flowing against the building in this area.

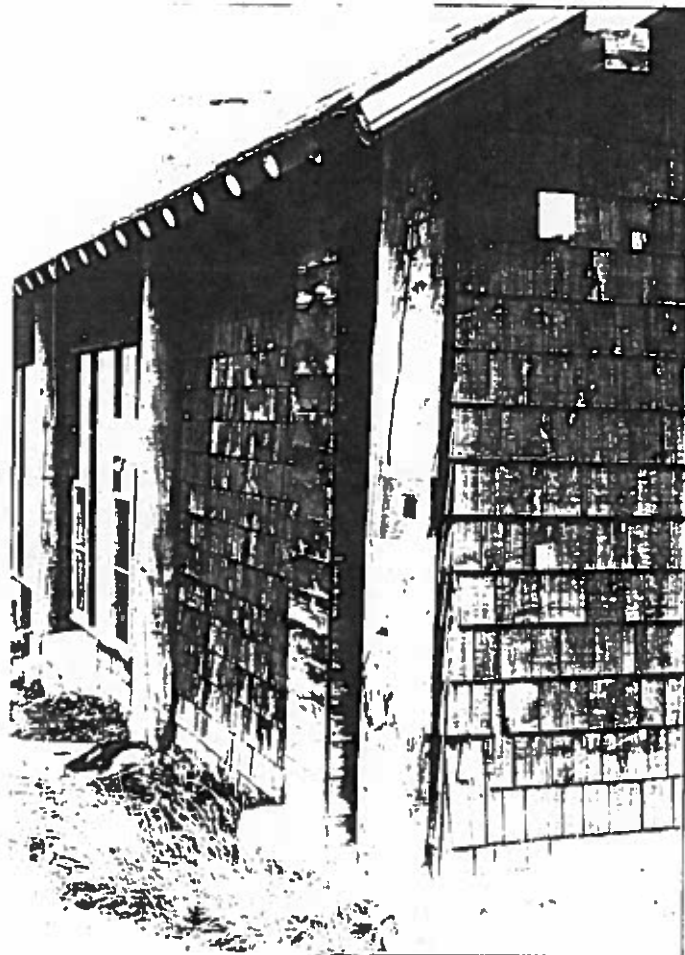
Figure 72: Detail of the log rafters on this end of the building. The log rafters appear to be turned logs and were used as replacements for the originals.
