HISTORIC
STRUCTURES REPORT

LAKE LODGE

YELLOWSTONE
NATIONAL PARK,
WYOMING

July 1997

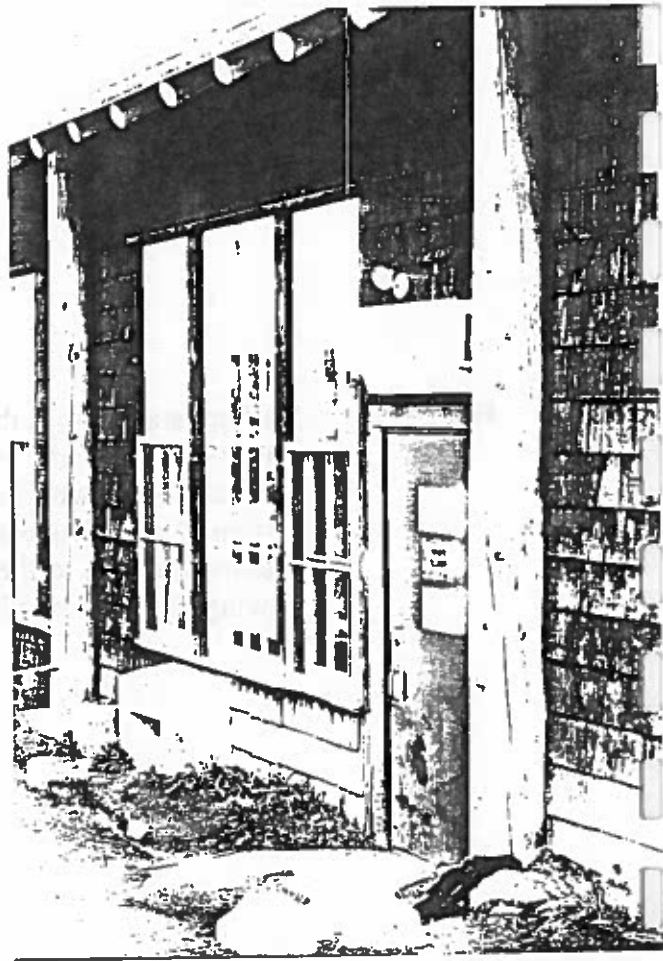
Figure 74: Looking southeast at a section of the north wall of the Lodge in the cafeteria area.

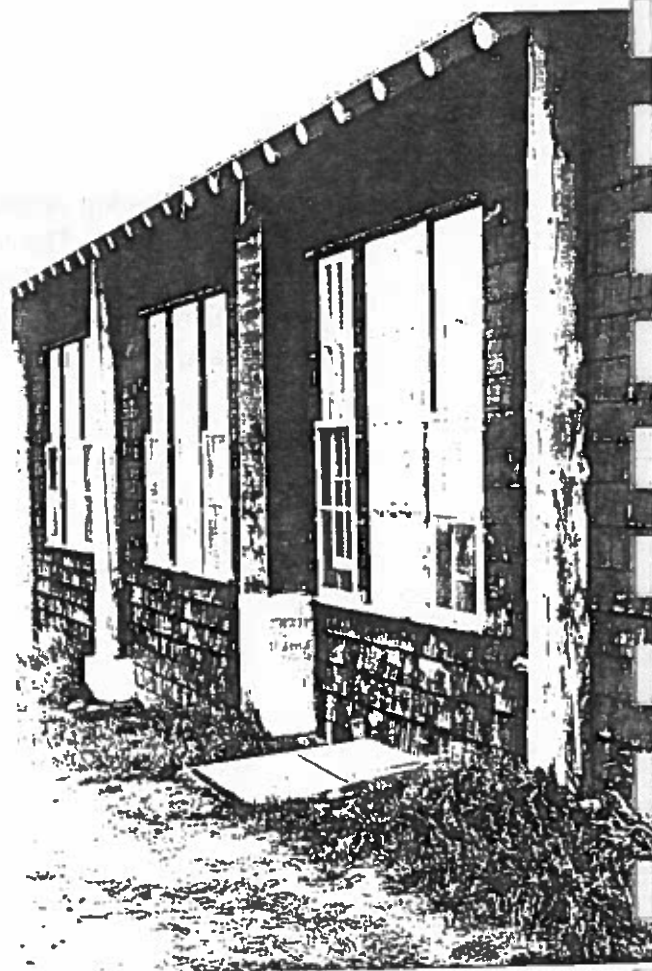
Figure 75: Looking south at a typical window sash, trim and sill which are deteriorating badly on the north wall of the Lodge in the cafeteria area.

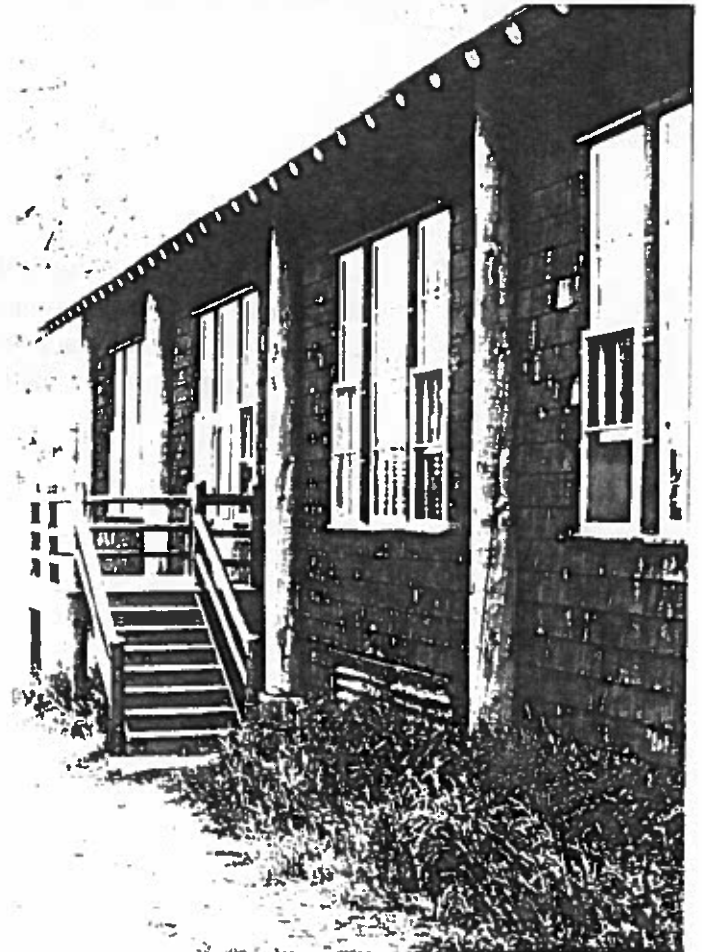
Figure 77: Looking southeast at the exit door and surrounding windows from the cafeteria. The windows and door are in good condition with some weathering at the base.

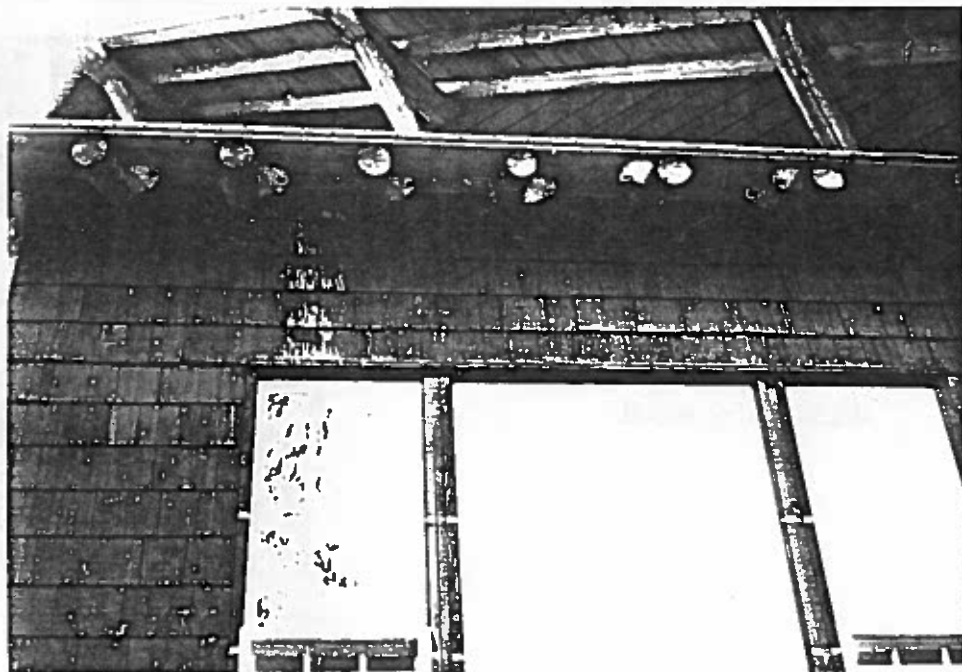
Figure 80: Looking at the soffit detail on the bay of the cafeteria. Note the swallow nests.

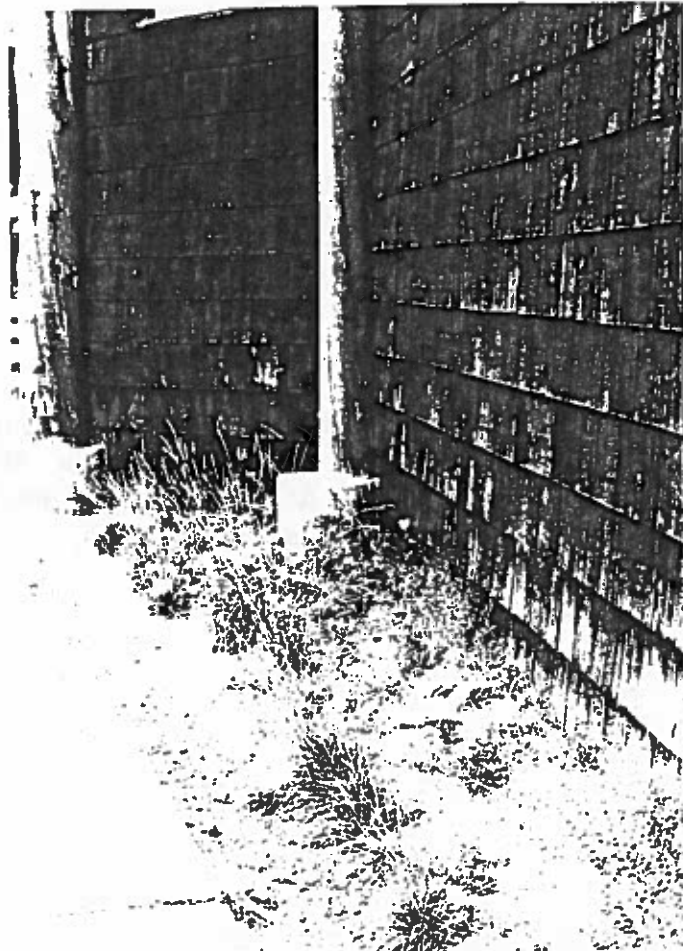
Figure 81: Looking west at the base of the bay of the cafeteria. Note the deteriorated shingles and the poor drainage.

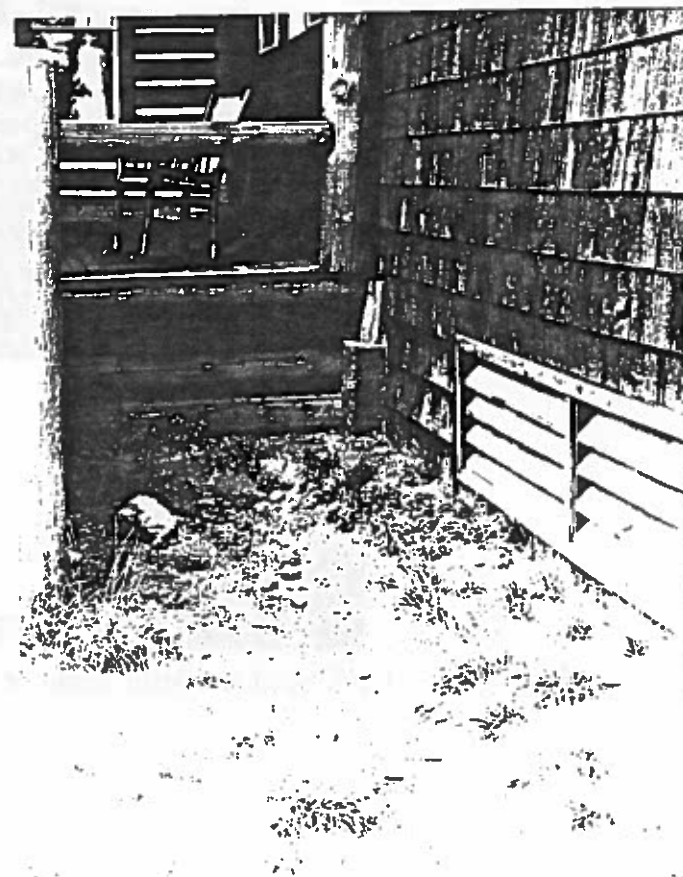
Figure 82: Looking west at the base of the wall at the intersection of the front porch and the cafeteria wing. Note the poor drainage and the deteriorating wood.

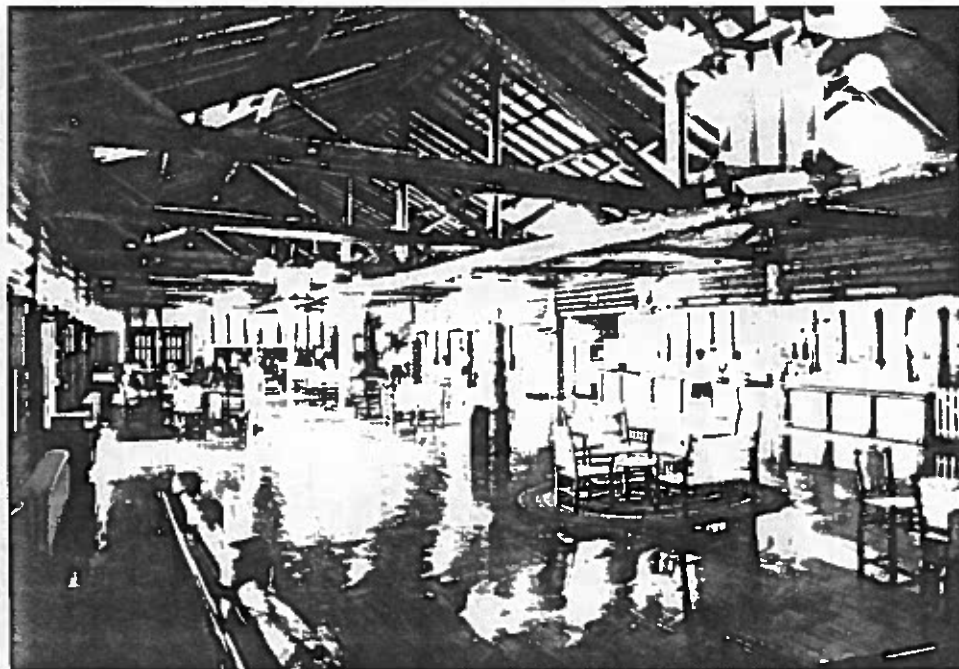
Figure 83: Looking south at the lobby of the Lodge. The general structure appears to be in good condition.

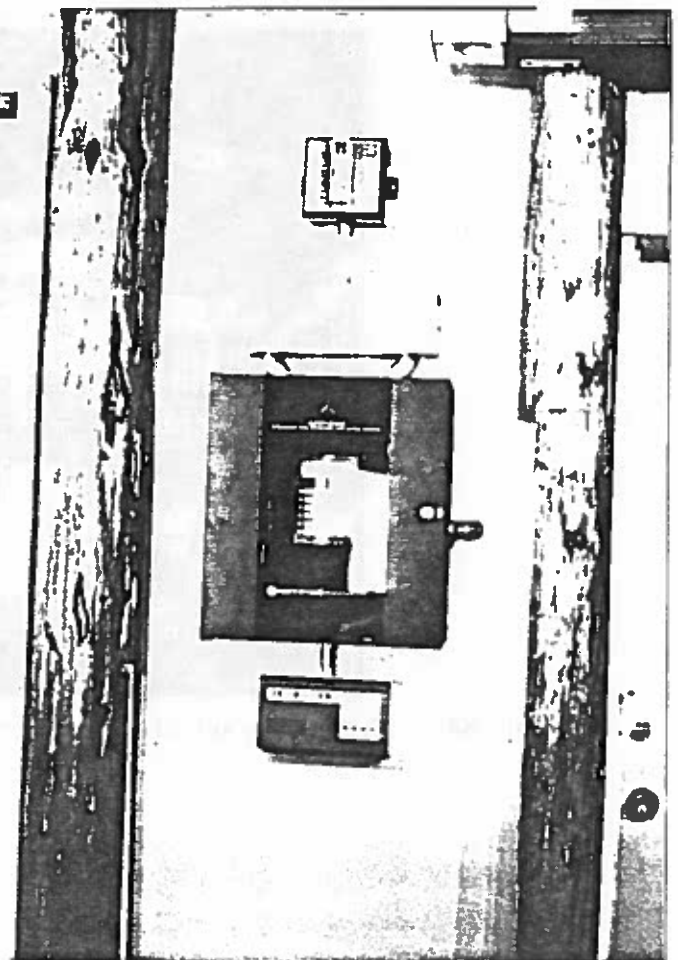
Figure 86: Looking at the main fire detection panel which is located in the center of the registration area. This was added in 1996.

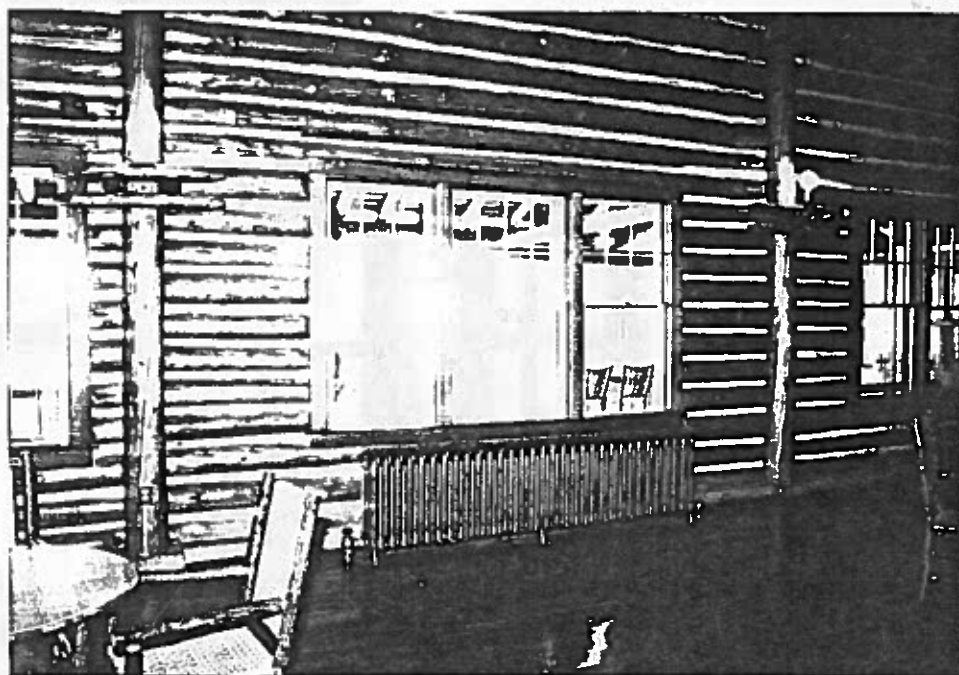
Figure 88: Looking east at one of the windows in the Lobby. Note the original cast-iron radiator.

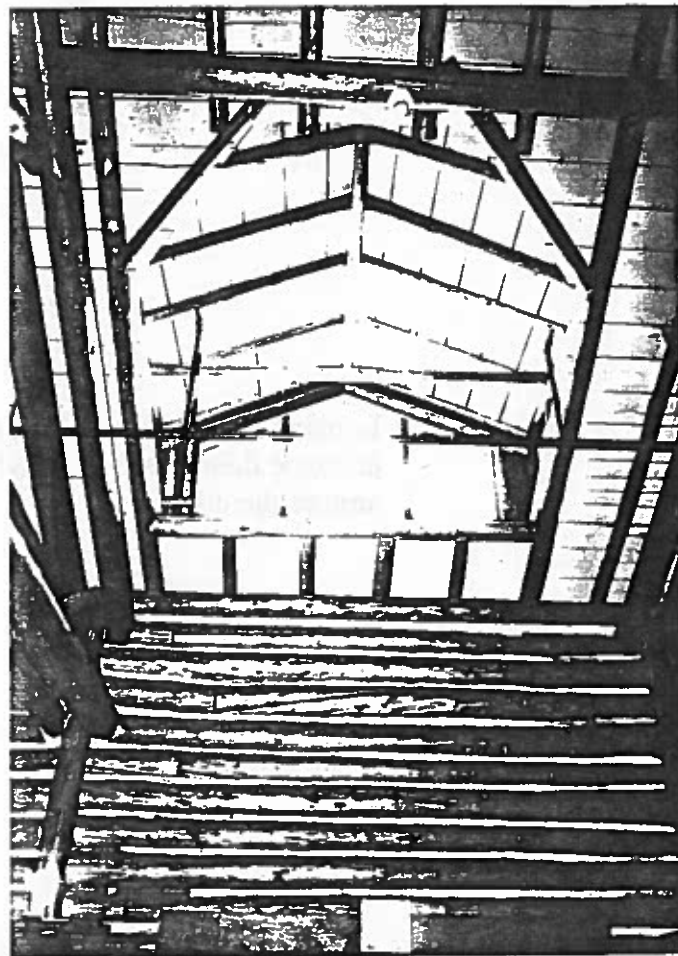
Figure 89: Looking at a typical dormer window in the lobby of the Lodge. The fire suppression and fire/smoke detection systems work well with the historic structure.

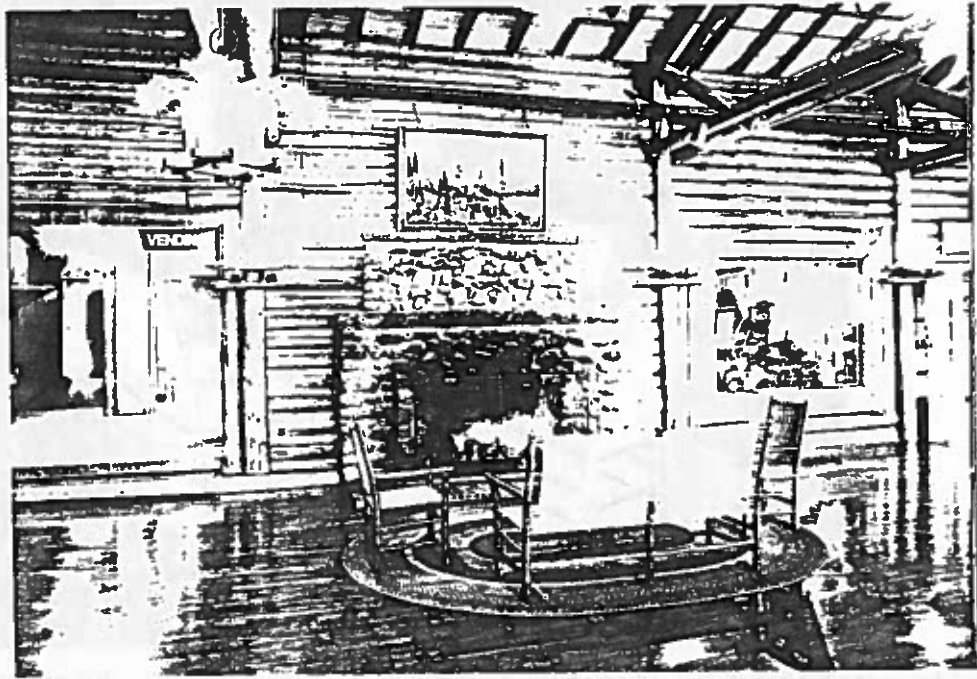
Figure 93: Looking west at the south fireplace. Other than the soot on the face of the stone, the fireplace is in good condition. Gas logs are now used for the fire.

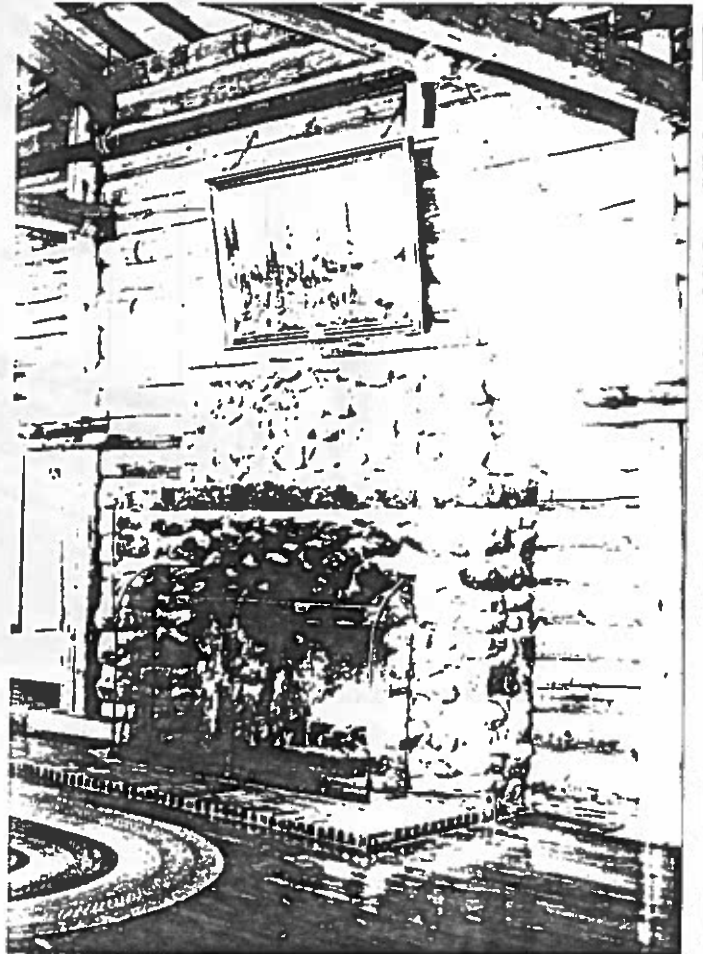
Figure 94: Looking west at the fireplace. Note the stonework, logs and daubing, all in good condition.

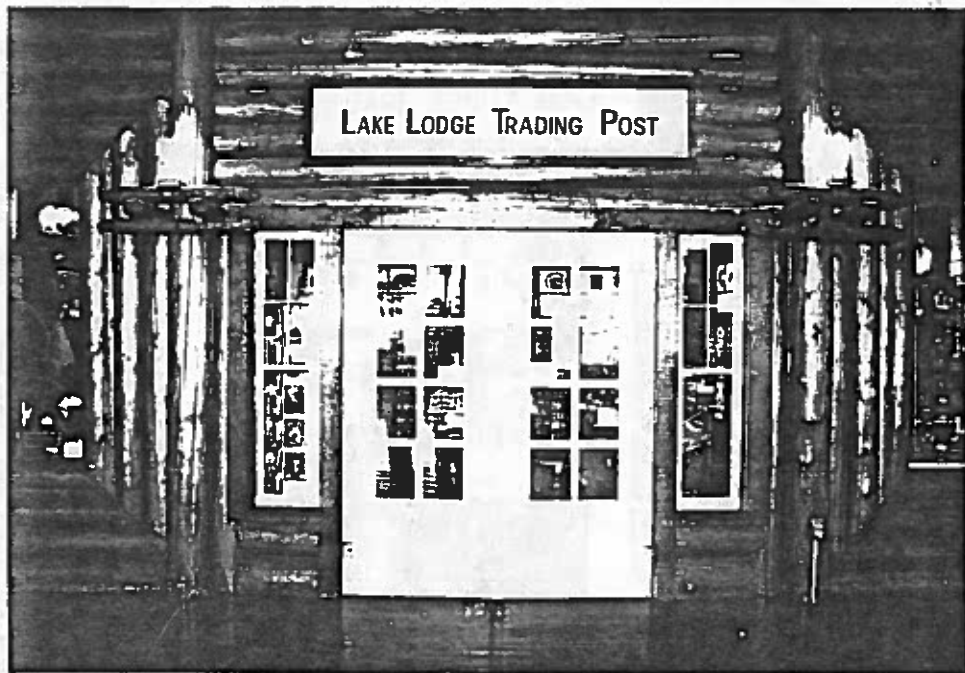
Figure 96: Looking west at the entrance doors and surrounding windows to the gift shop. They are in good condition.

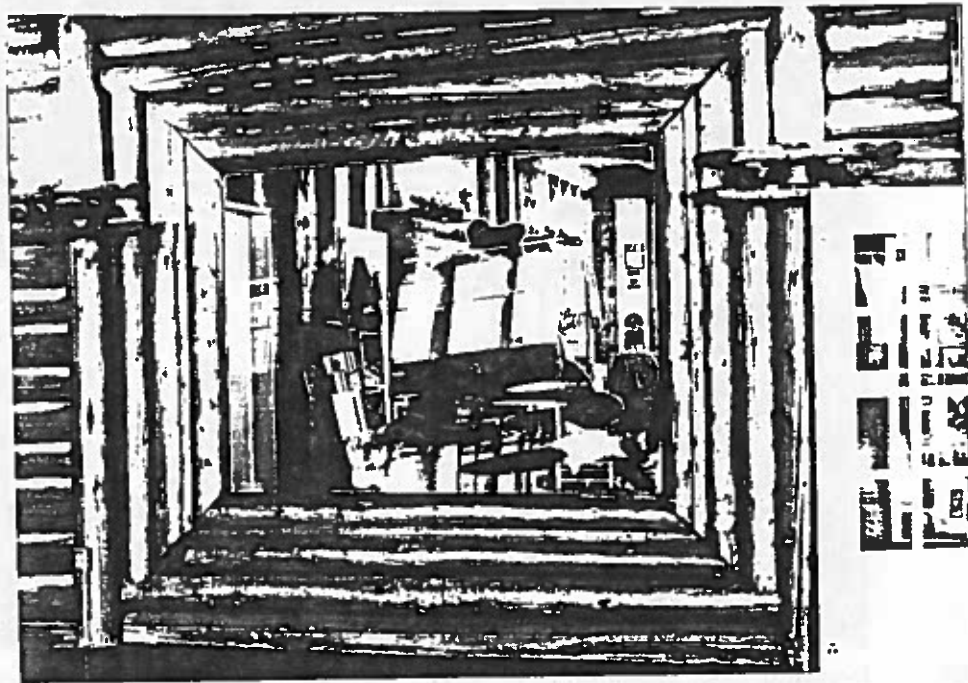
Figure 97: Looking at the log surround on the gift shop display windows. There is no daubing in these windows.

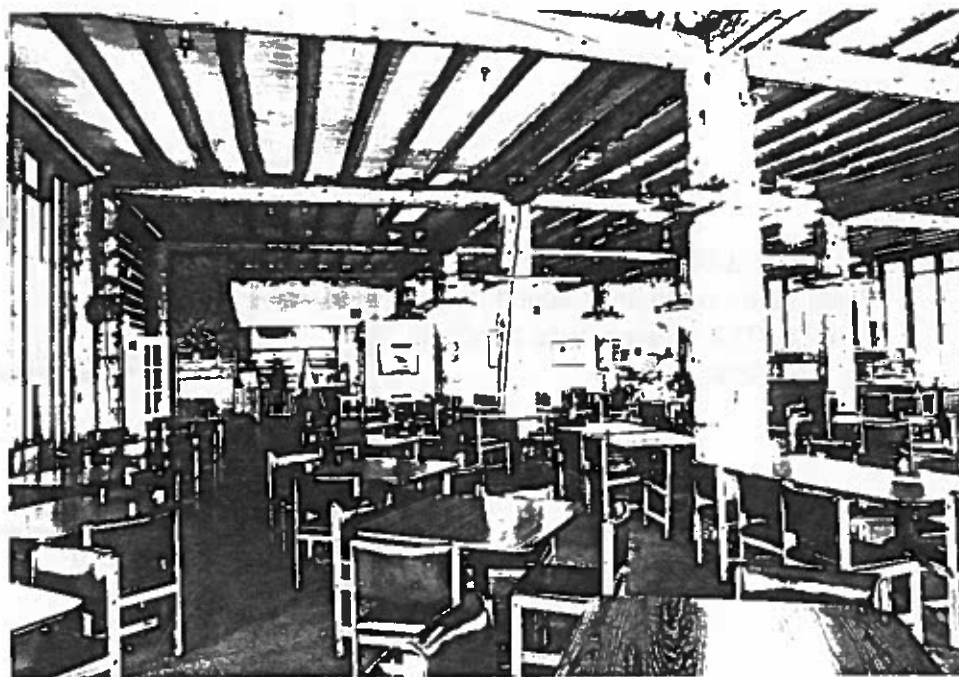
Figure 104: Looking west at the interior of the cafeteria wing. Note the columns and flat ceiling which are all original and in good condition.

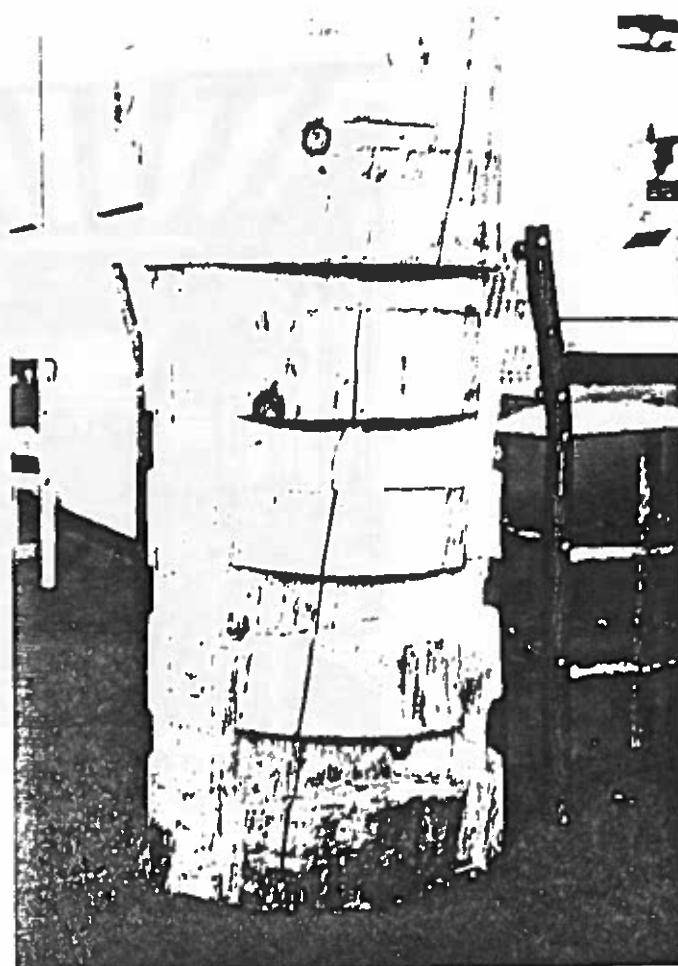
Figure 106: Detail of a column grooved by the installation of shelves added in the 1960s. The shelves were removed in the 1980's.

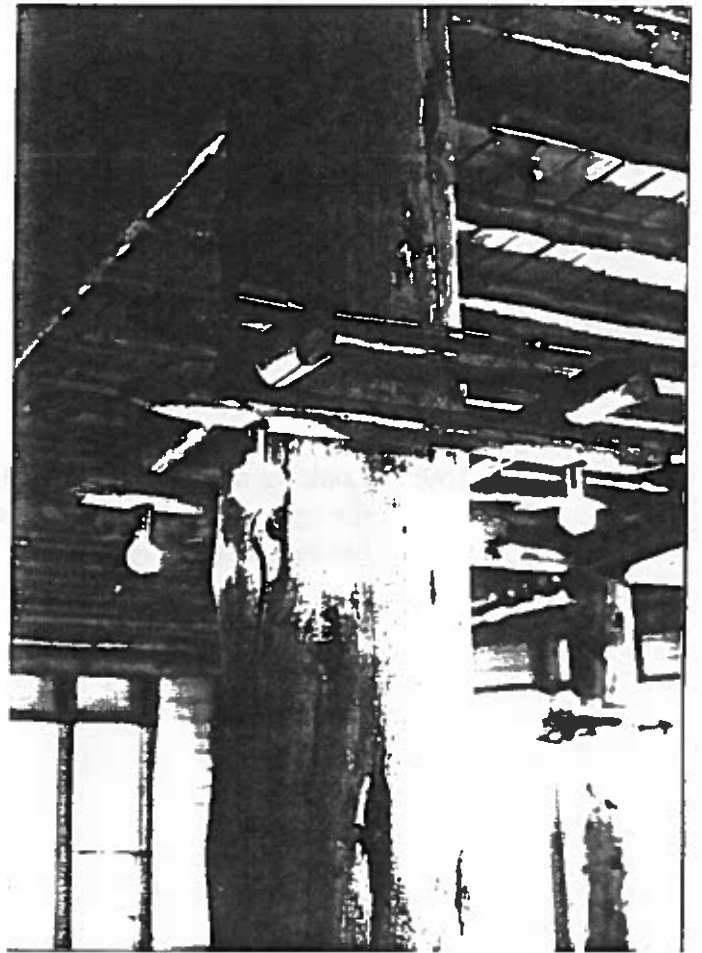
Figure 108: Looking at a typical window in the cafeteria. Most of the interior windows are in good condition.

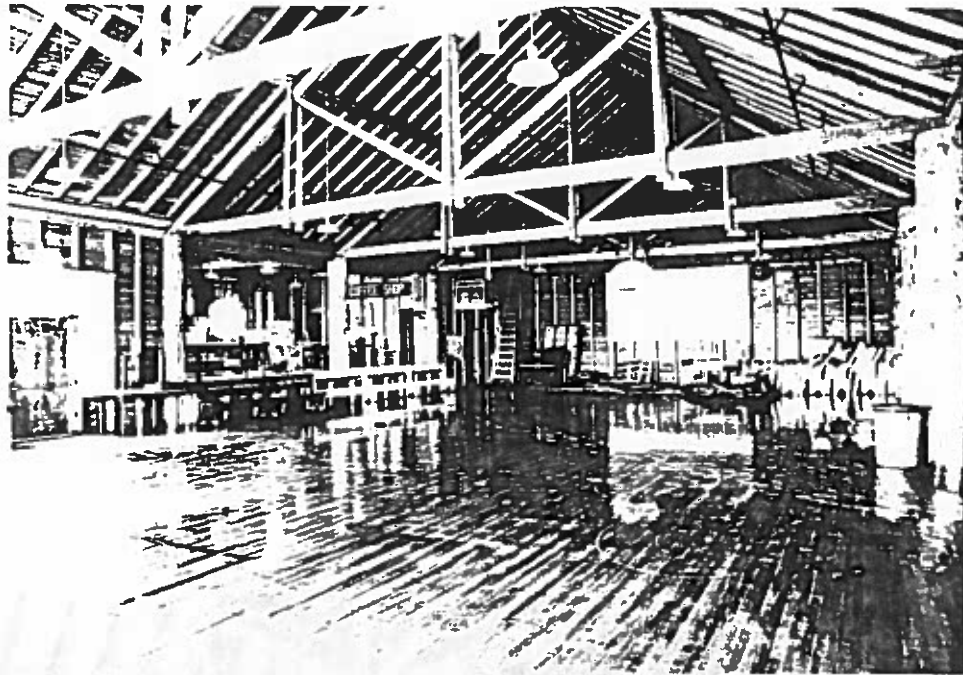
Figure 115: Looking west at the interior of the Recreation Hall. Note the original stage to the left. The structure appears to be in fair condition with cracks in the beams in front of the stage.

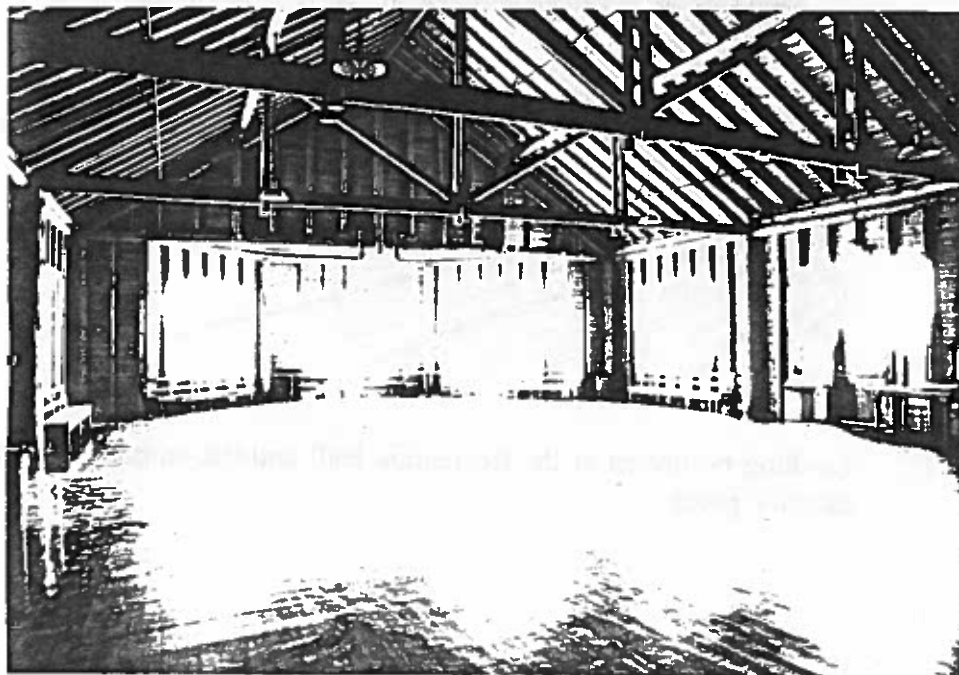
Figure 116: Looking east at the bay windows of the Recreation Hall. The floor is worn but is well maintained.

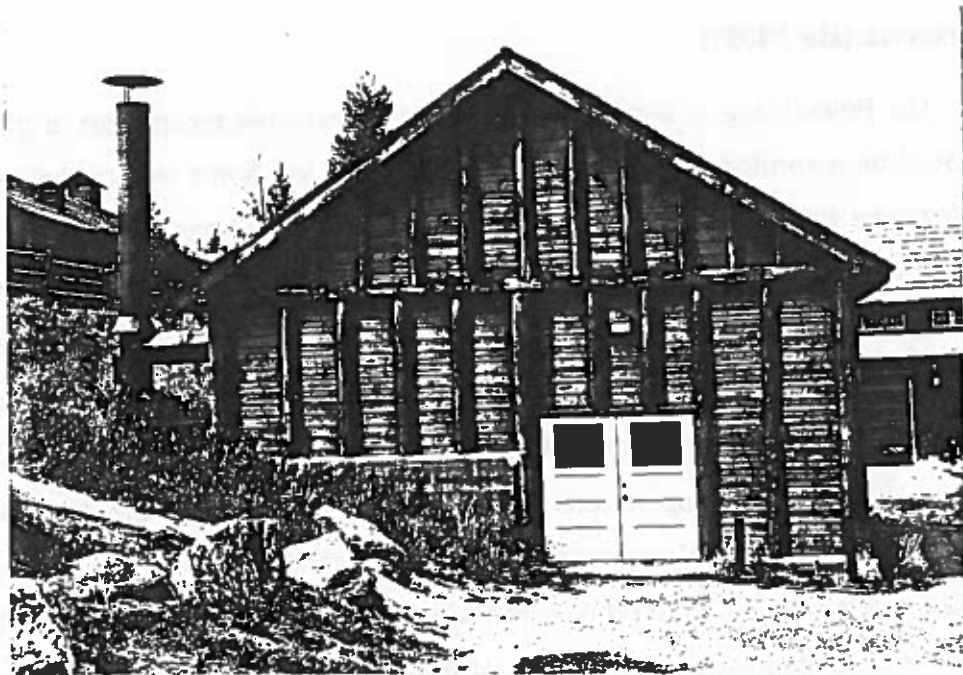
Figure 118: Looking north at the Powerhouse (HS #4051) at Lake Lodge. Note the steep grade that slopes down to the doors.

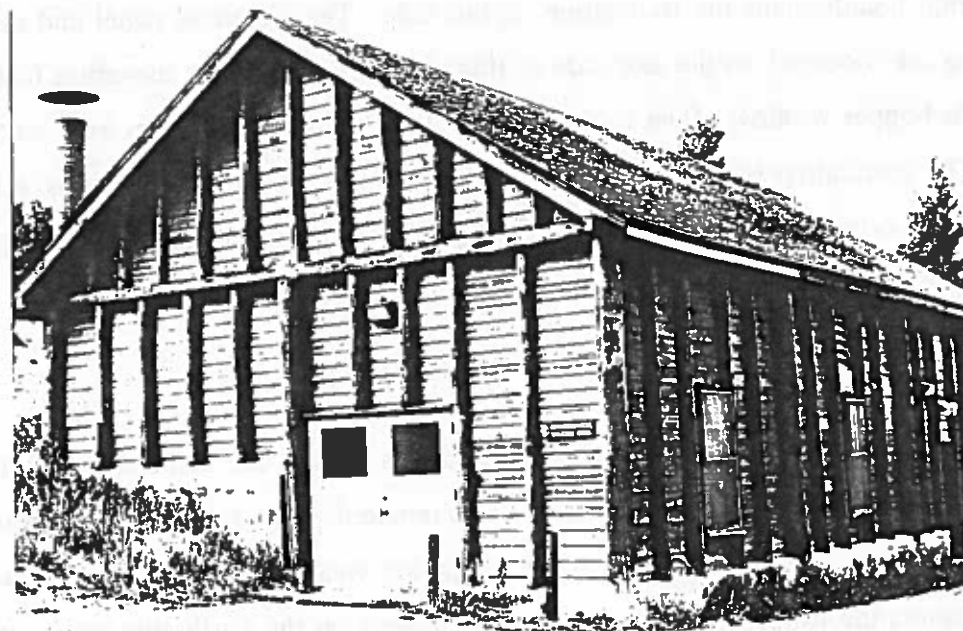
The Powerhouse is in fair to good condition. There are some significant cracks in the foundation on the north side which need to be repaired. The exterior wood elements are in fair to good condition. The windows and doors are weathered and require some general maintenance; the frames of the double-hung windows on the north side are in poor condition and require repair. The roof is new and is in excellent condition.

Figure 119: Looking northwest at the Powerhouse. The wood shingle roof is in good condition, however the walls are dry and there is some rot in the base of the columns.

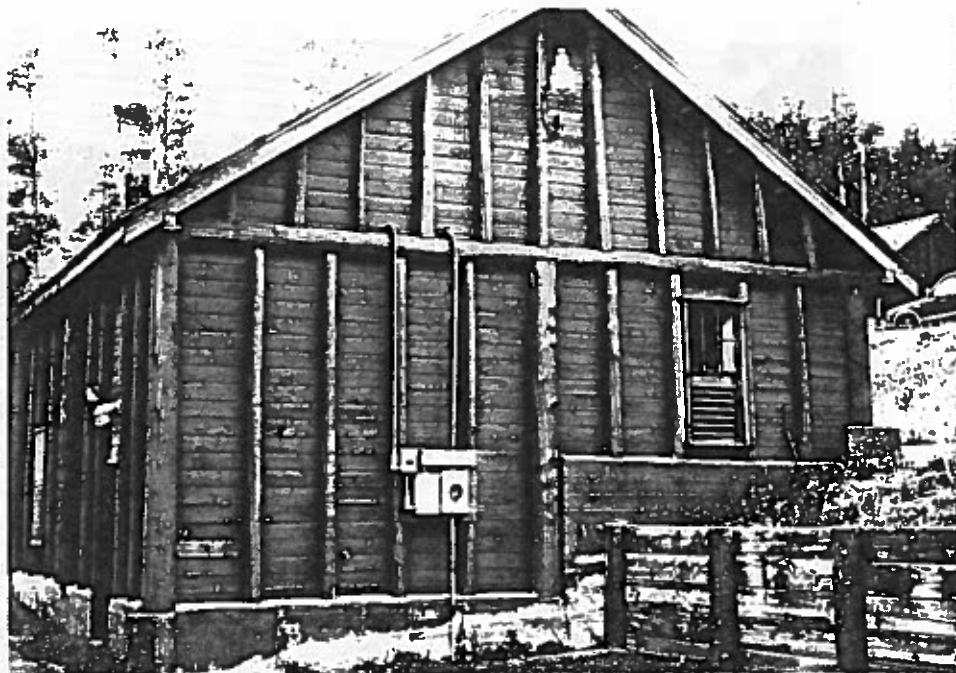
Figure 124: Looking south at the Powerhouse. Note the efflorescence on the base of the building due to water penetrating into the surface.

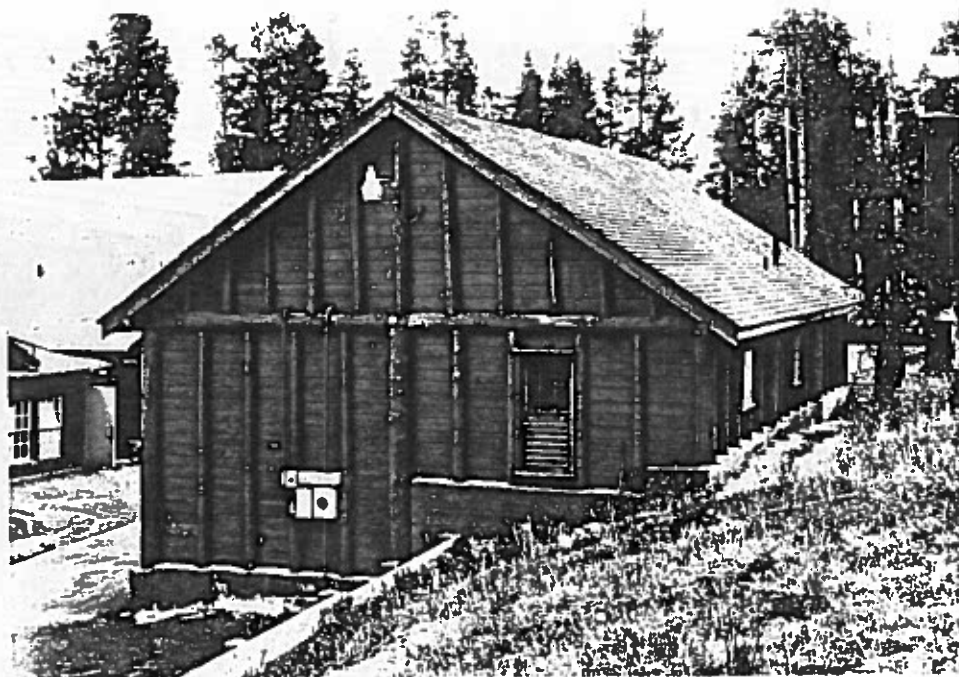
Figure 125: Looking south at the Powerhouse. Note the retaining wall and high bank on the west side of the building.

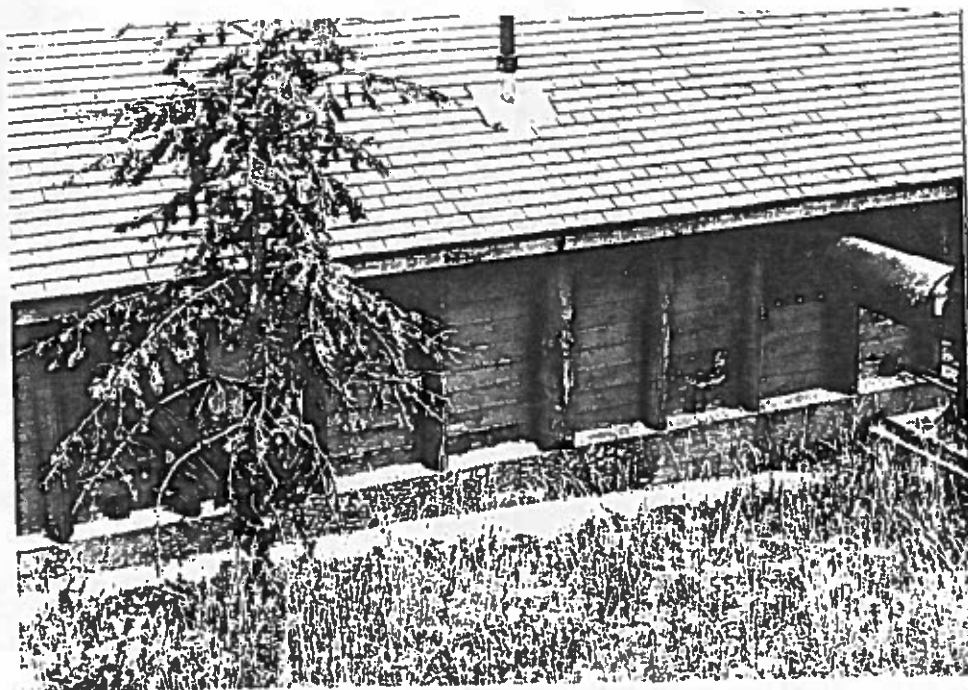
Figure 127: Looking east at the west wall of the building. Note the variegated surface of the concrete foundation.

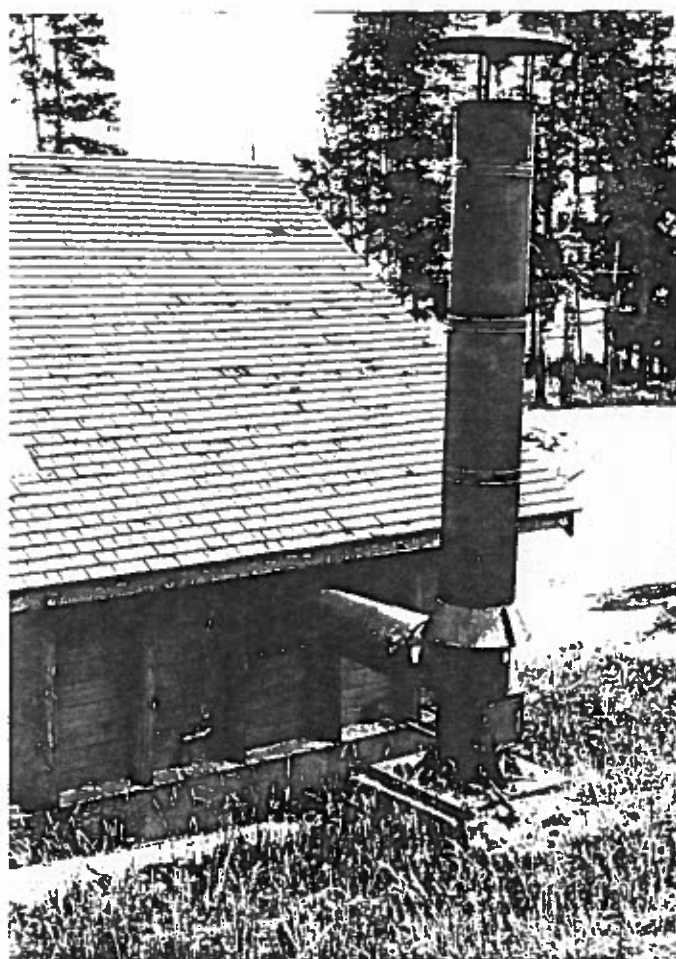
Figure 128: Looking east at the metal smokestack on the side of the building. Note the deteriorated concrete base on the stack.

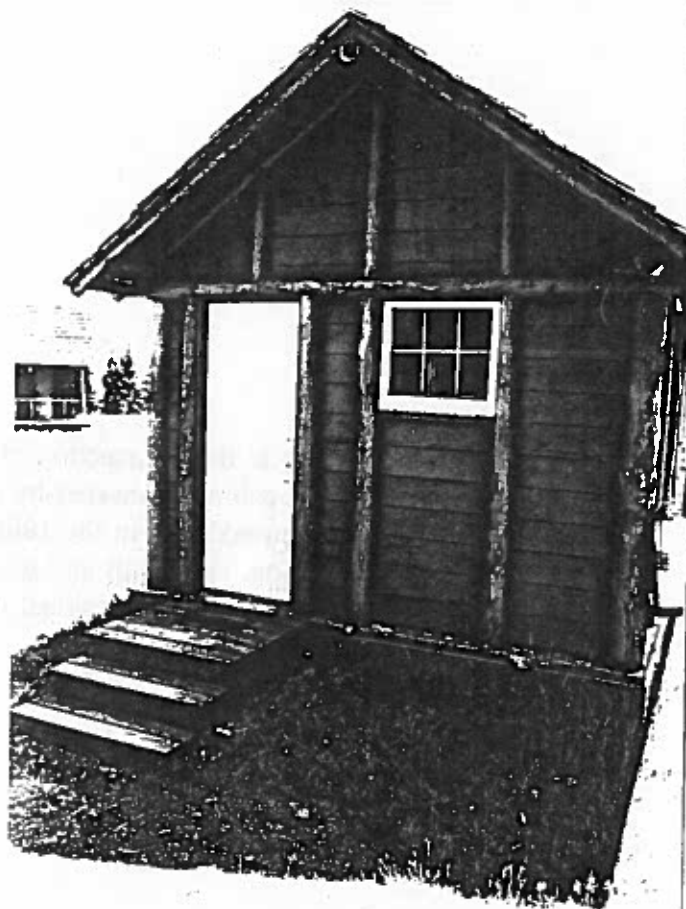
Figure 130: Looking south at the end wall of Cabin A17-20 (HS #7049). Note the flush panel door which is a hardboard surface over the original wood panelled door.

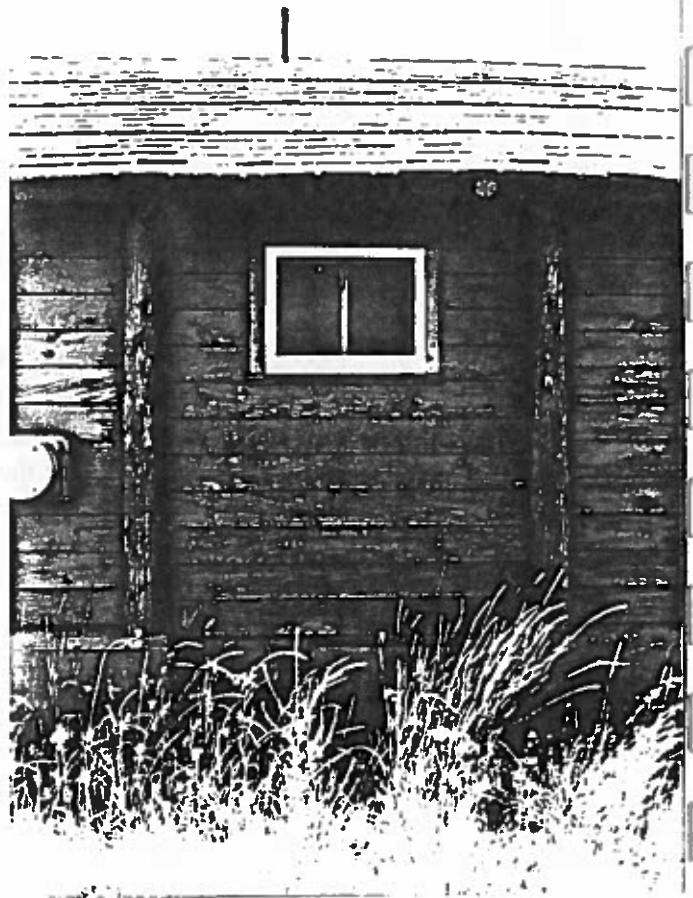
The crawlspaces under the cabins have been enclosed with masonite or hardboard skirting to hide the pipe columns that form the main structural support. This skirting is not vented, therefore moisture collecting in the crawlspaces is not allowed to evaporate. The result has been rotting in the sill logs, rim joists and floor joists of most of the structures. The structures of the raised decks and entry steps where they attach to the cabin walls also show signs of rotting.

Figure 133: Looking at the intersection of two sets of two cabins connected by a closet addition in the 1960's renovation. Note the masonite or asbestos board base covering the crawl space with no ventilation.

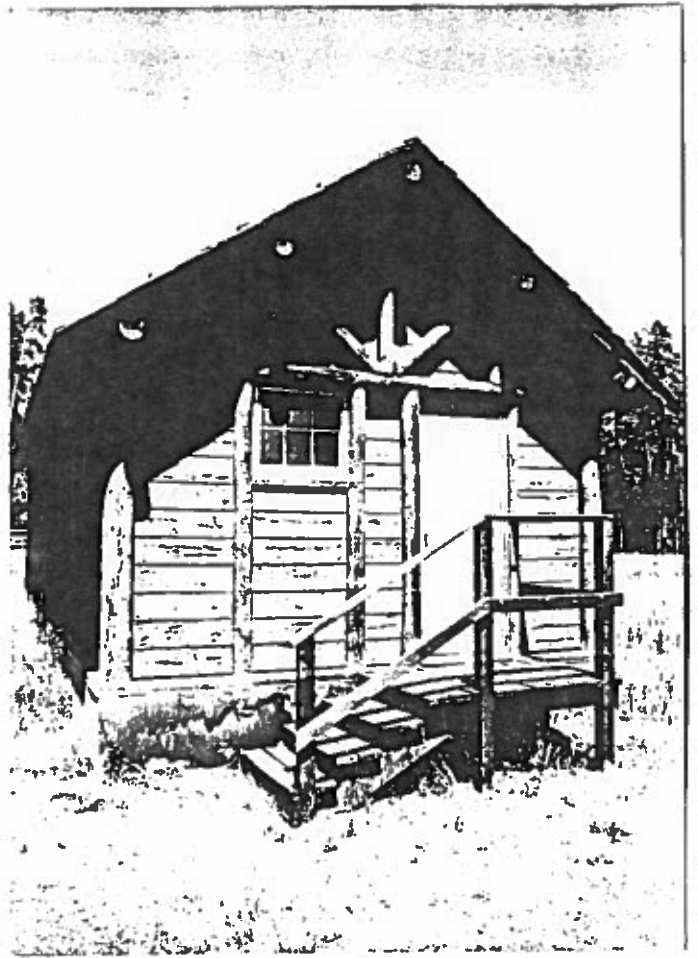
The roofs of the cabins have been recently refinished with wood shingles which are in good condition; there is rot in a number of the exposed rafter tips. The exterior walls throughout feature peeling and deteriorated paint. The steps and decks are also weathered and in need of paint. The original sliding windows remain in the bedrooms and are in need of repair and refinishing. Some original doors remain; other entries feature flush panel doors. All doors are in need of repair and refinishing.

Figure 136: Looking north at the end wall of Cabin A17-20. Note the deteriorated steps and deck, and the peeling paint on the wall.

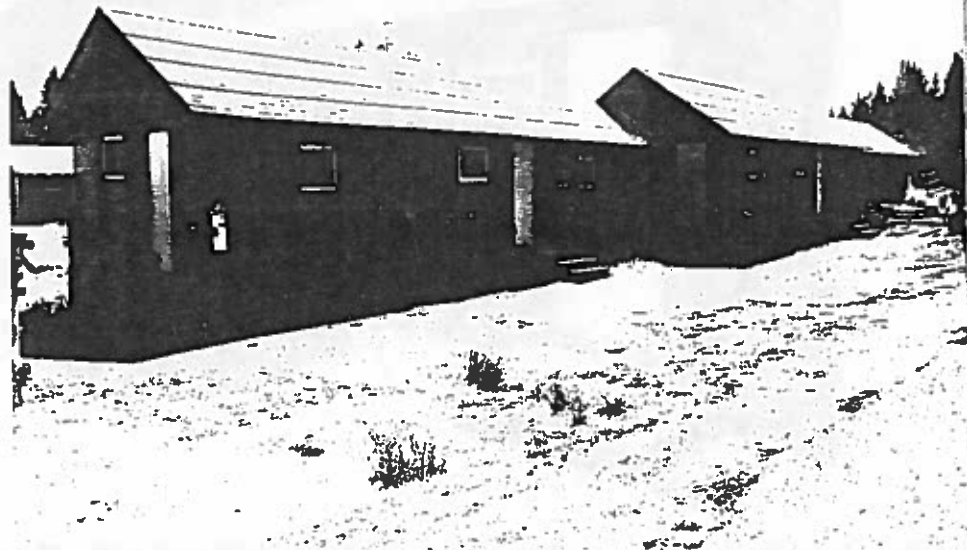
Figure 140: Looking southwest at Cabin B17-22 (HS #7055). This structure is a group of six cabins tied together by bathroom and closet additions.

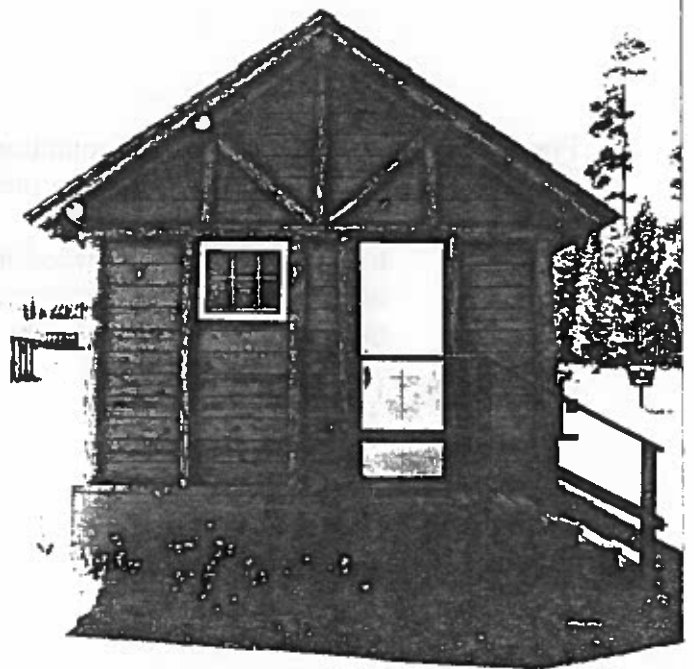
Figure 141: Looking south at the front elevation of Unit B17. Note the masonite or asbestos board base that skirts the crawl space.

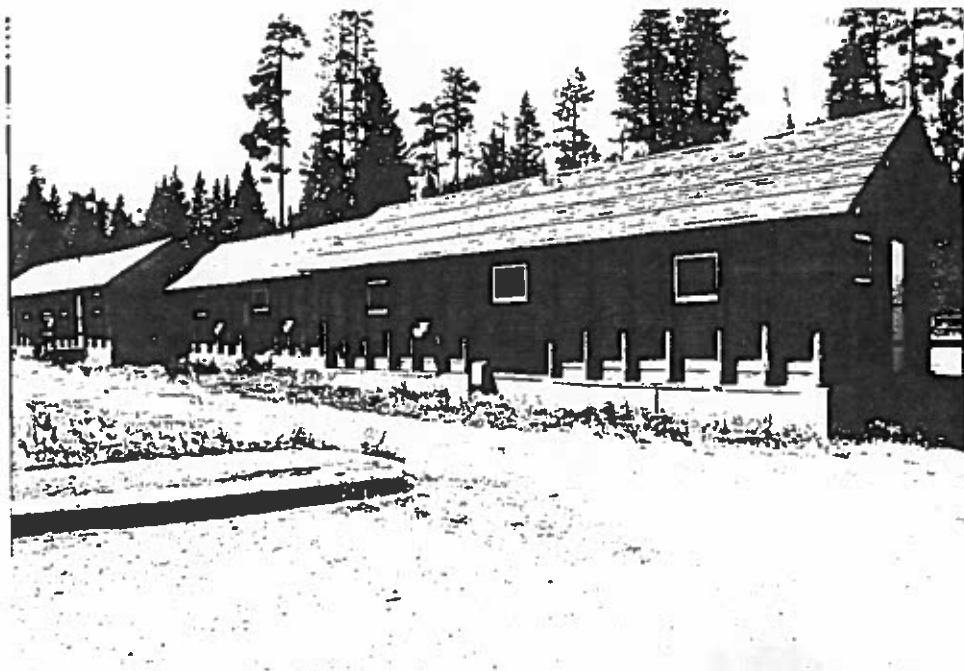
Figure 142: Looking southwest at Cabin B17-22. This configuration was created by connecting three pairs of original single room log-out cabins into the offset grouping. The integrity of the original single cabin is gone.

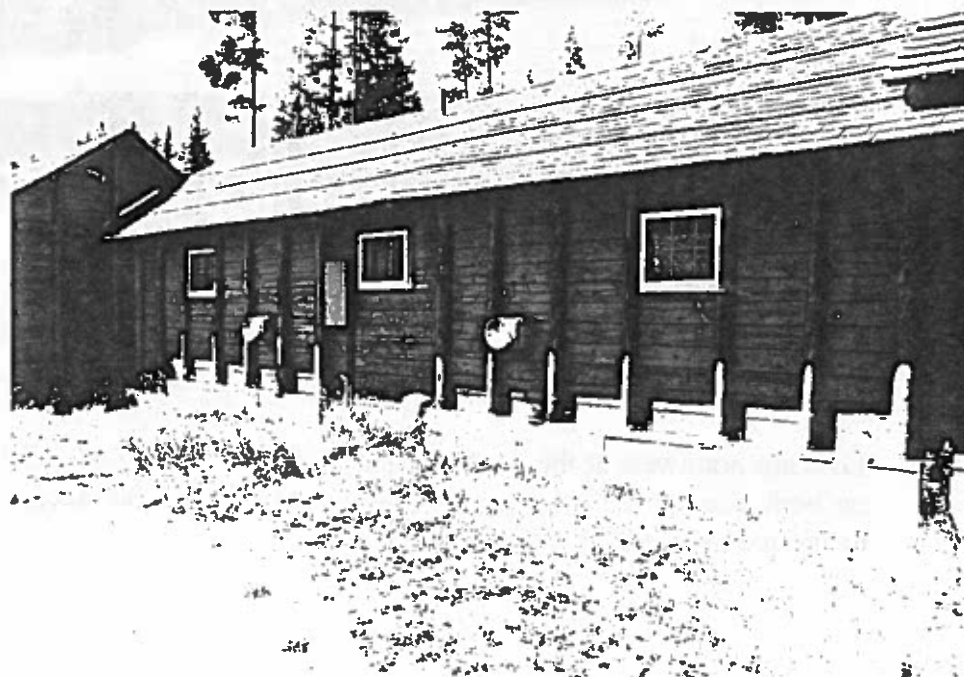
Figure 143: Looking southwest at the center section of Cabin B17-22. Note the utilities, peeling paint and base skirting without vents.

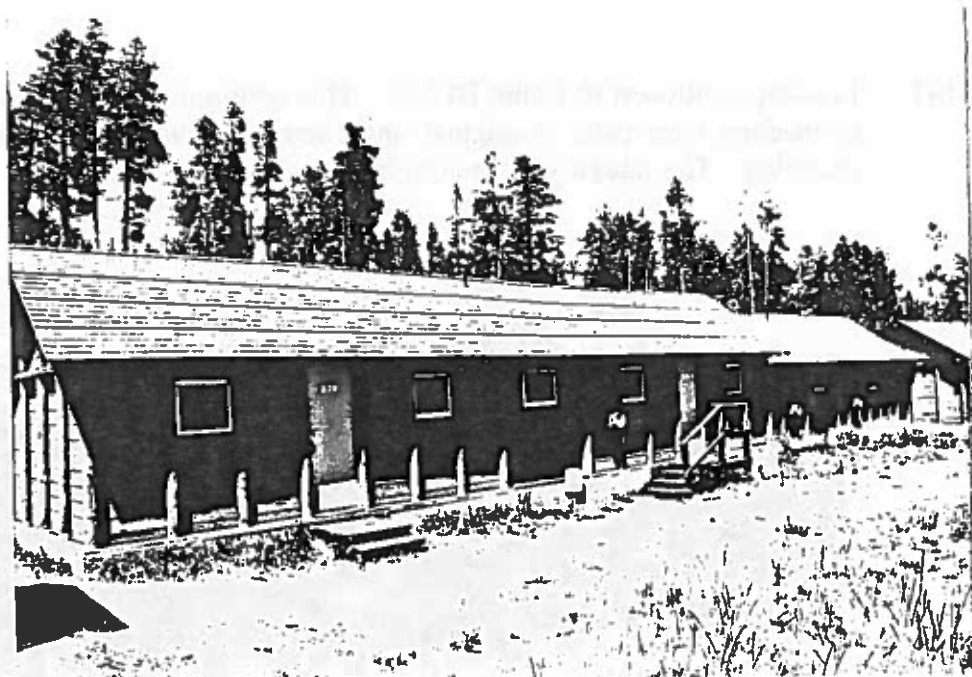
Figure 144: Looking northwest at the south section of the Cabin B17-22. Entrances occur on both sides of the structure; this causes confusion about access to the site and to the rooms from the parking area.
