HISTORIC
STRUCTURES REPORT

LAKE LODGE

YELLOWSTONE
NATIONAL PARK,
WYOMING

July 1997

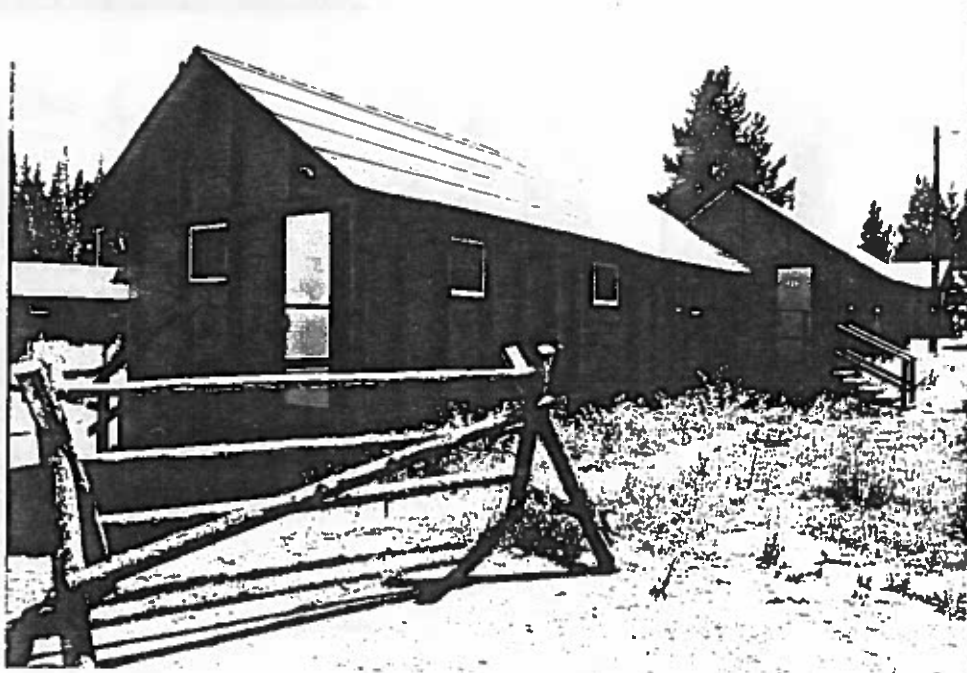
Figure 162: Looking southeast at Cabin C13-16 (HS #7045). Many problems associated with other cabins also exist in this group. There seems to be a high water table in the C Group of cabins.

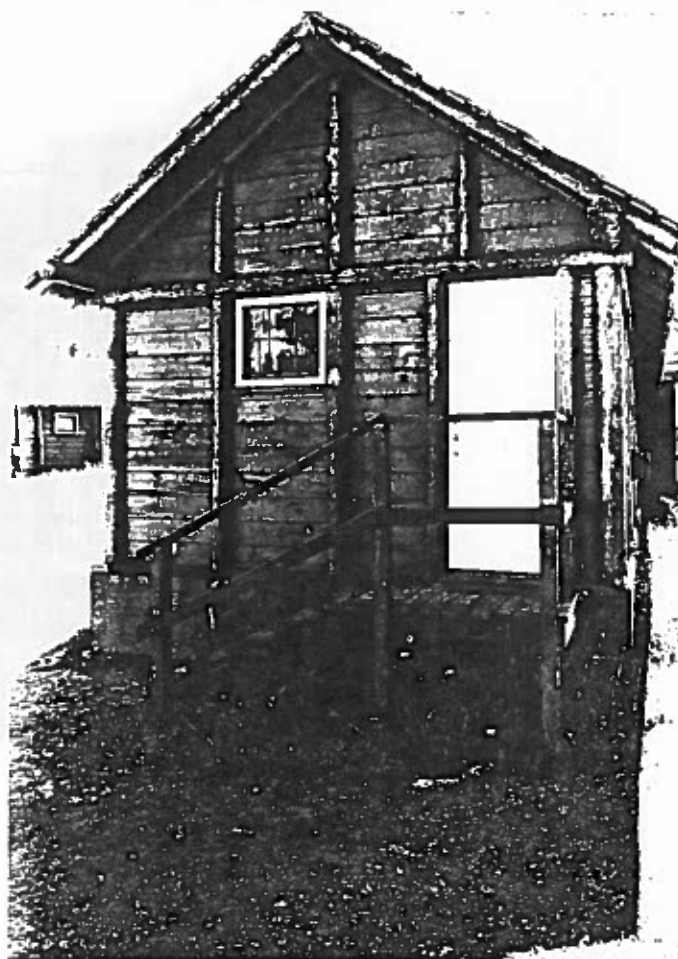
Figure 163: Looking south at the north end of Cabin C13-16. The structural members in the base of these cabins are rotting.

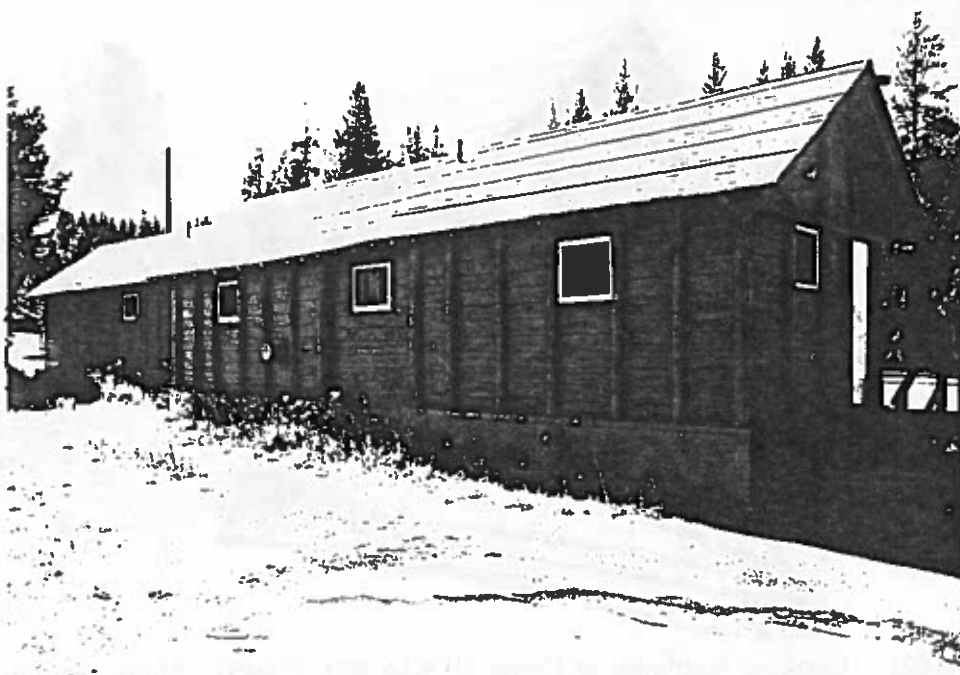
Figure 164: Looking southwest at Cabin C13-16. Note the peeling paint on this side of the building.

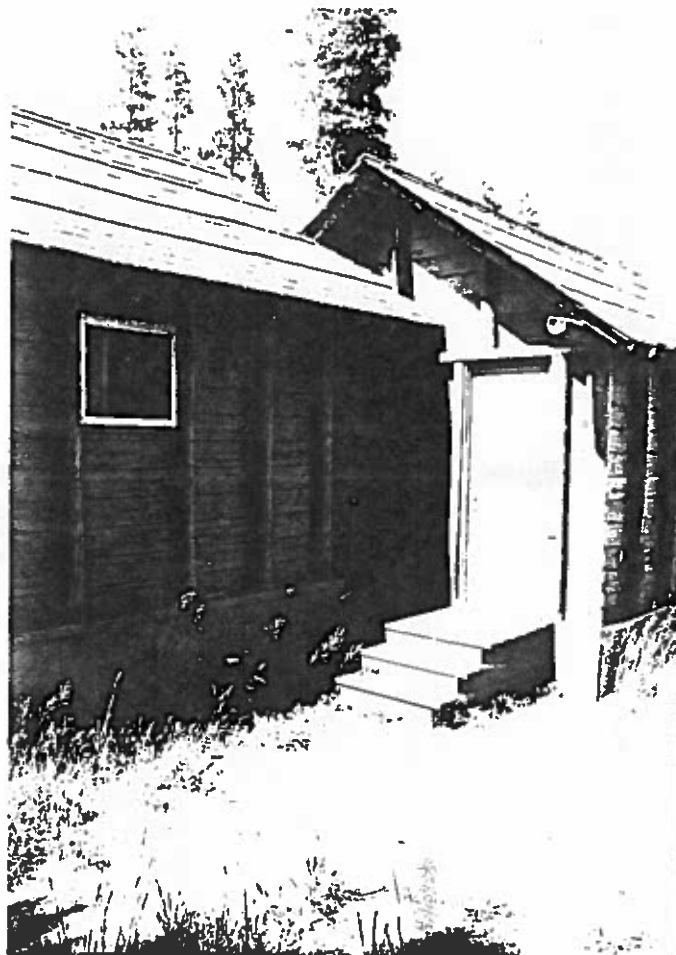
Figure 166: Looking west at the south end of Cabin C13-16. Note the high grass around the building. The area tends to be wet suggesting some high water or a spring.

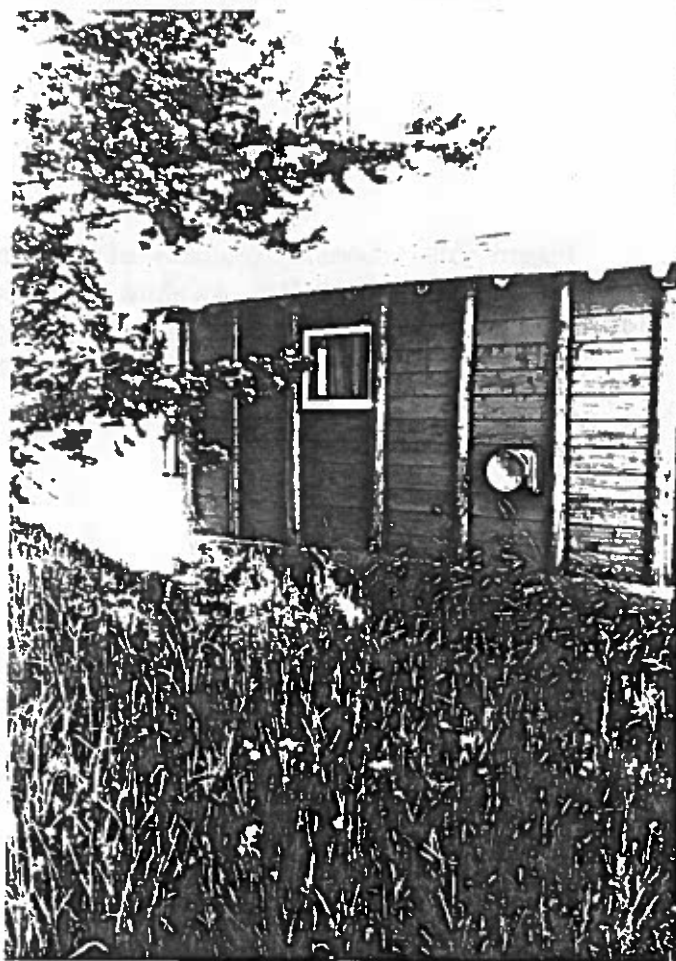
Figure 167: Looking north at the south end of Cabin C13-16. Note the weathered wood on this side of the building.

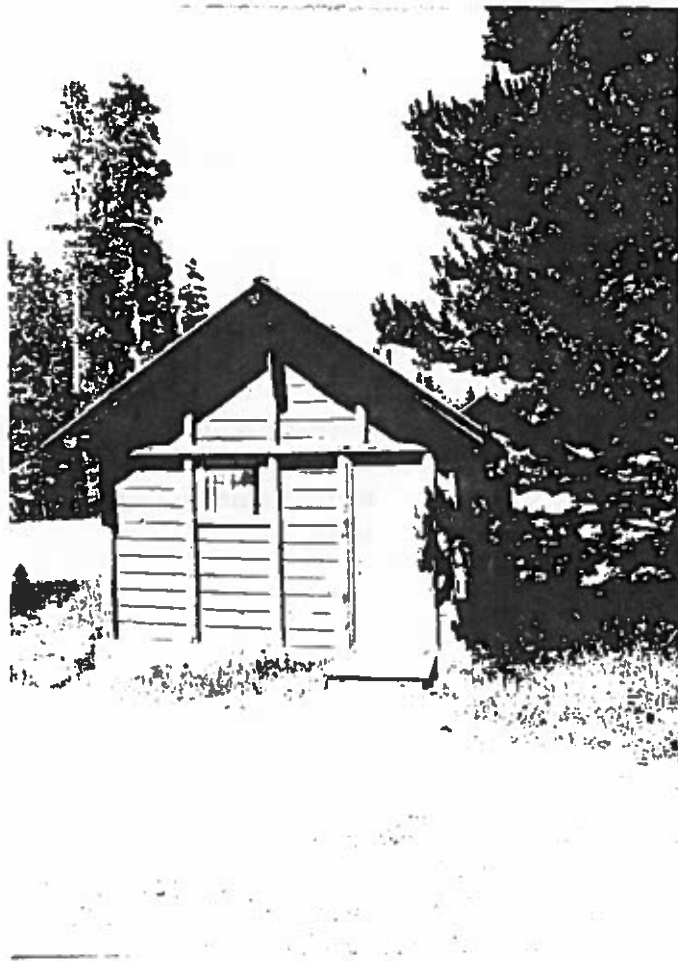
Figure 168: Looking southeast at the entrance to Unit C15. As shown here, some cabins placed parallel to the slope of the site have entrances high off the ground.

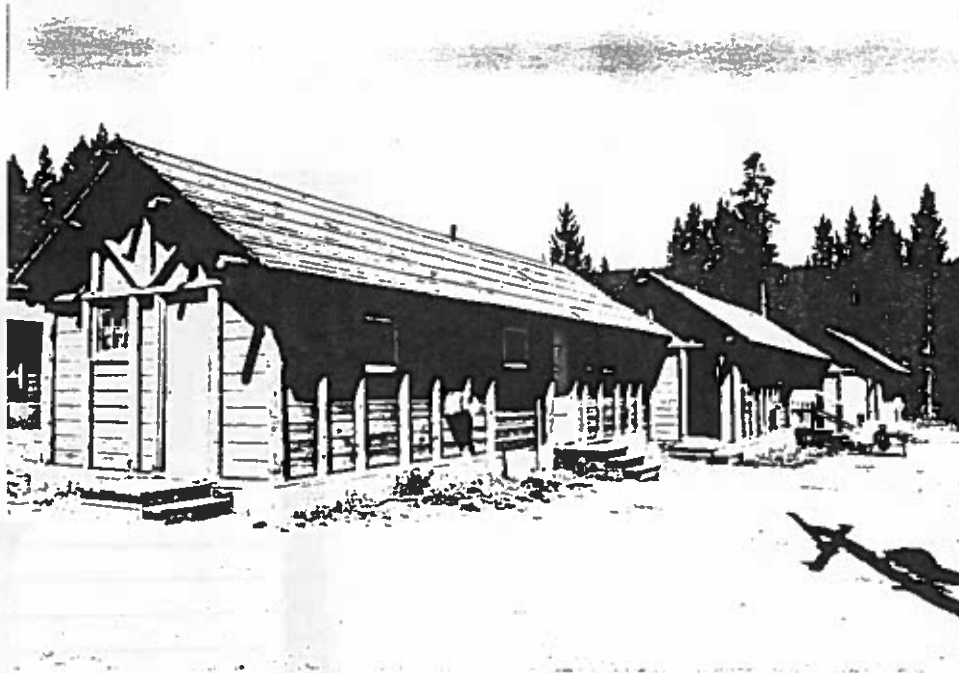
Figure 169: Looking northwest at Cabin D5-10 (HS #7056). Note the weathered wood on all of the vertical surfaces.

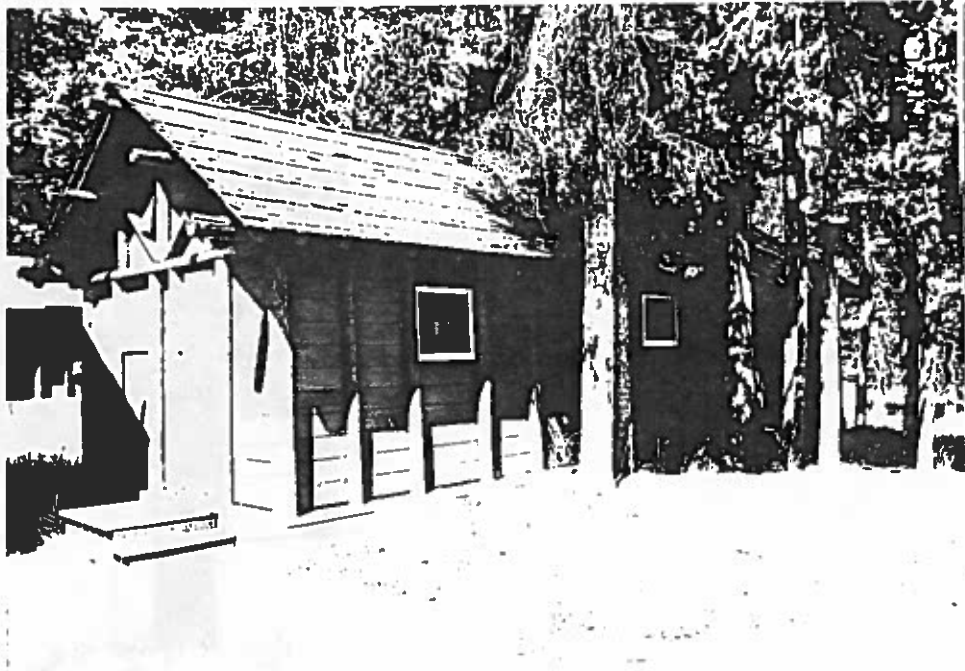
Figure 175: Looking southwest at Cabin E9-10 (HS #7040).

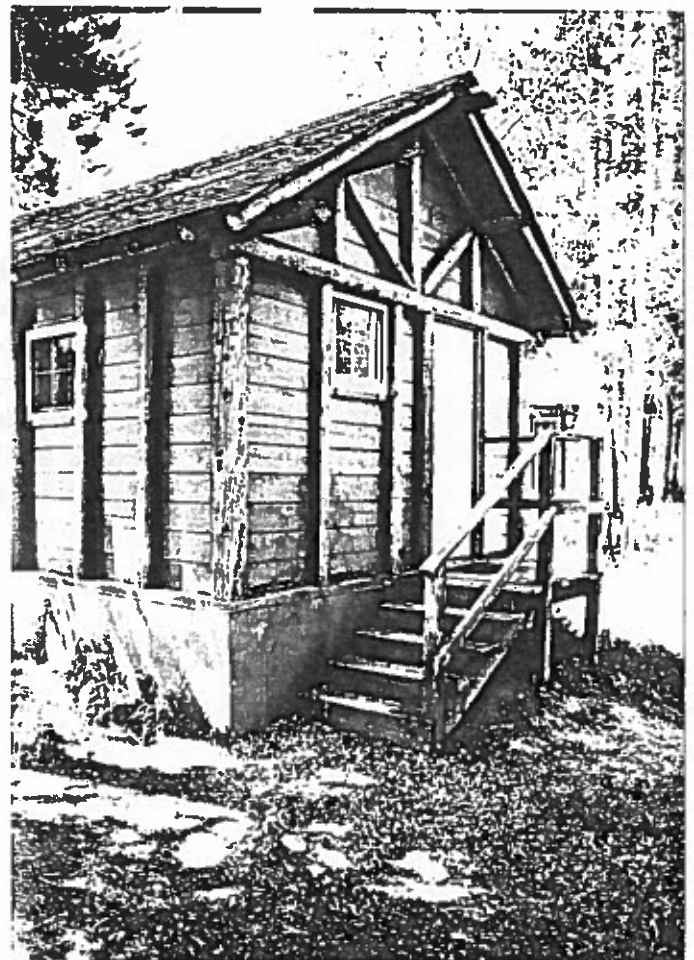
Figure 176: Looking southeast at Cabin E9-10. Note the rotted purlins and non-historic flush door.

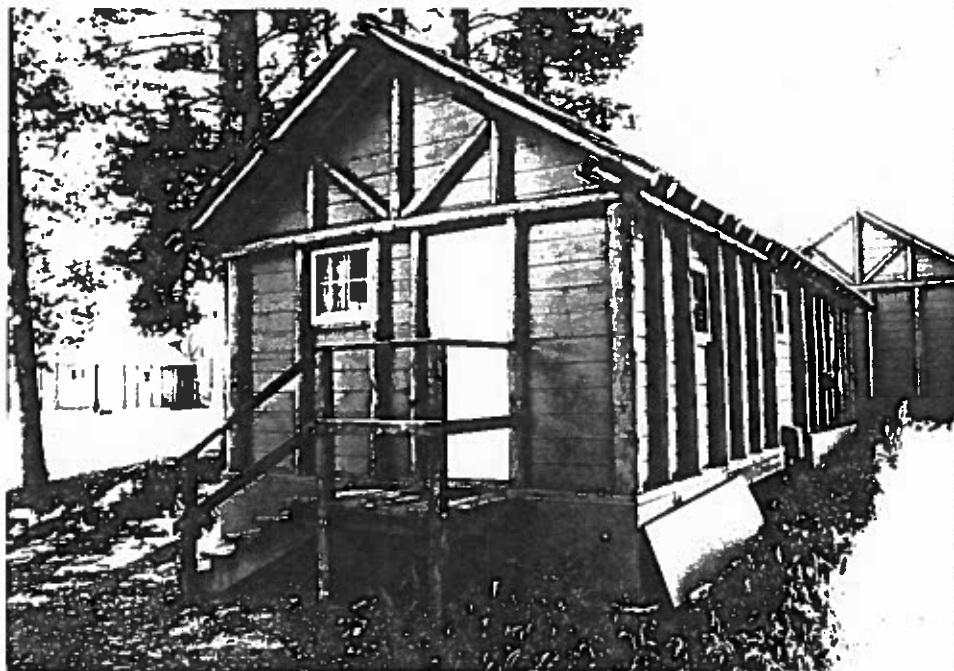
Figure 177: Looking northeast at the entrance to Unit E10. Astream runs along side the building on the righthand side.

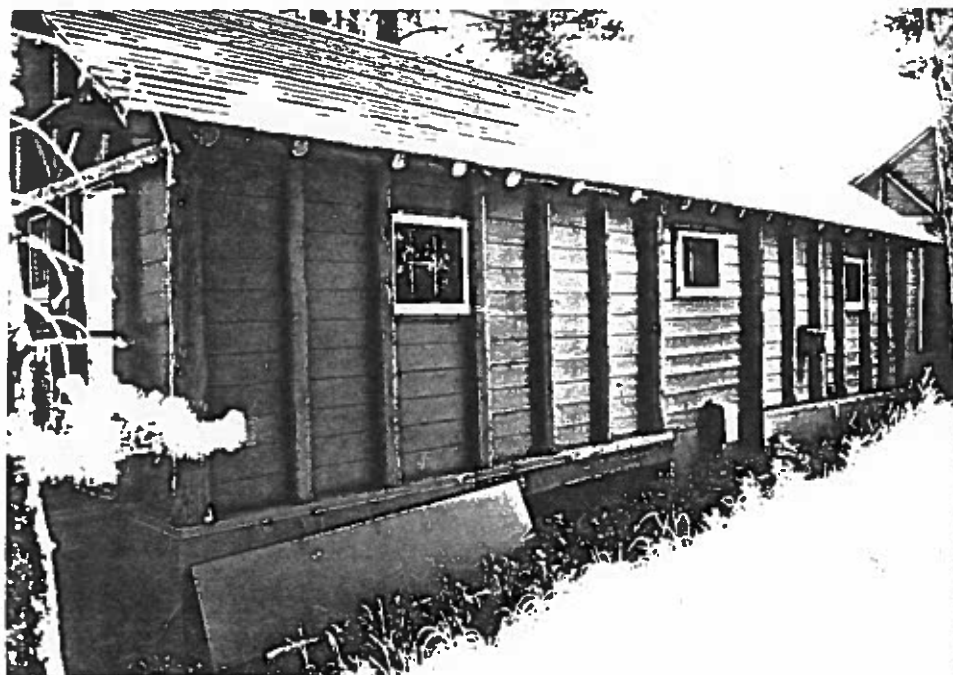
In the C, D and E groupings, where the slope of the site is most extreme, there are areas of high grade against the skirting on many of the cabins creating deterioration along the materials at the base. High ground water is especially evident in the C group of cabins and shows up in the rotting of the base skirtings and the amount of vegetation growing against the bases of these buildings. High ground water related to the adjacent stream has resulted in settling of the foundation on Cabin E5-10 to the point that some of the floor joists are unsupported.

Figure 178: Looking northeast at Cabin E9-10. Due to proximity of the stream and lack of ventilation, the crawl space stays wet. Some of the floor joists are no longer supported by the steel post foundation.

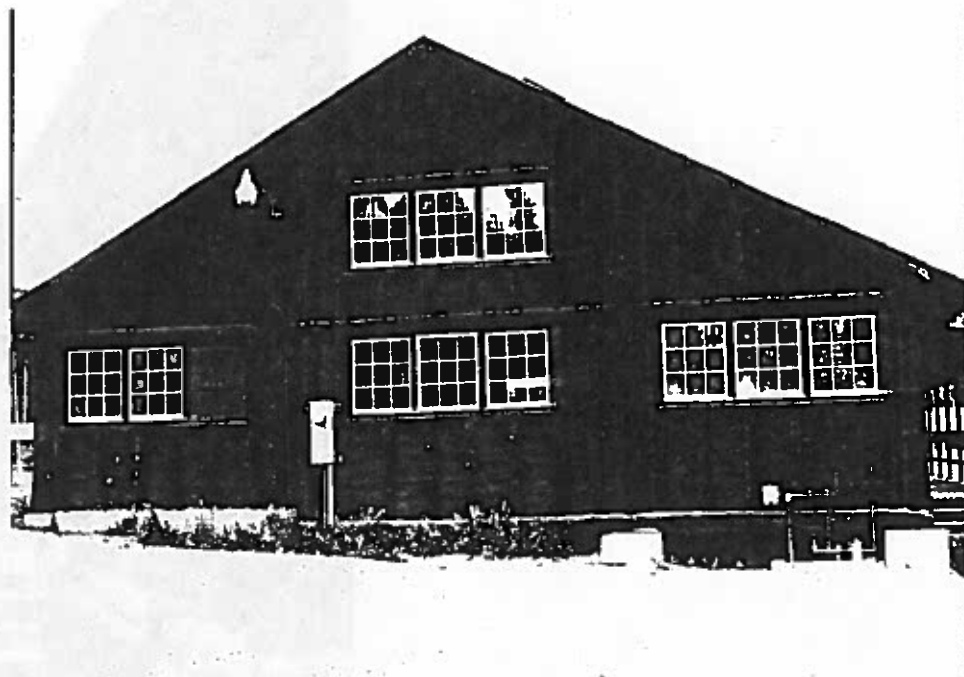
Figure 180: Looking north at the south end of the Employee Pub (HS #4053). The walls are in good condition with the exception of some rot at the base.

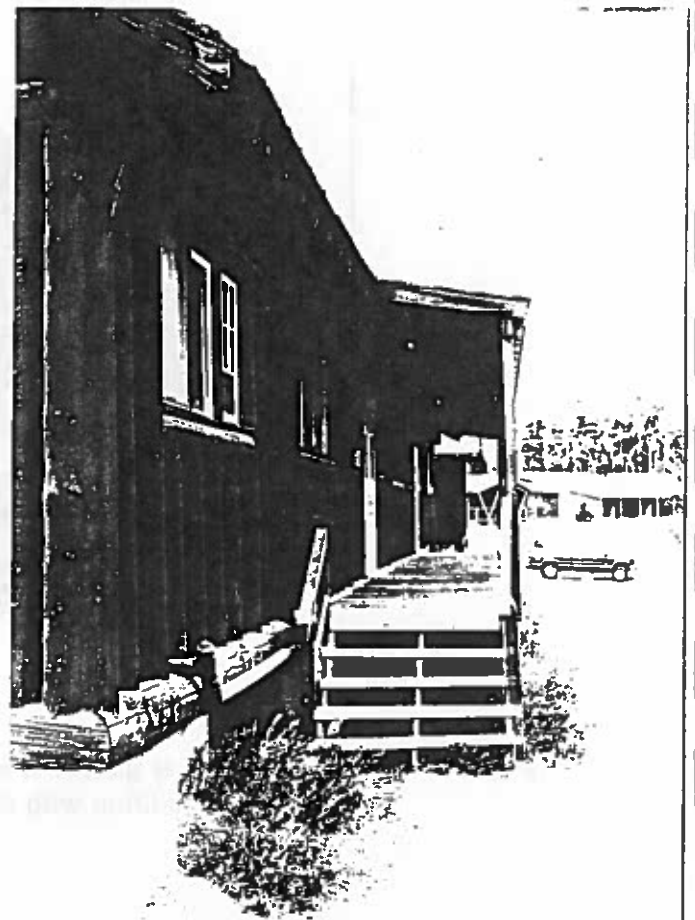
Figure 183: Looking at a section of the Pub foundation. The foundation includes concrete piers and short sections of foundation walls especially at the corners.

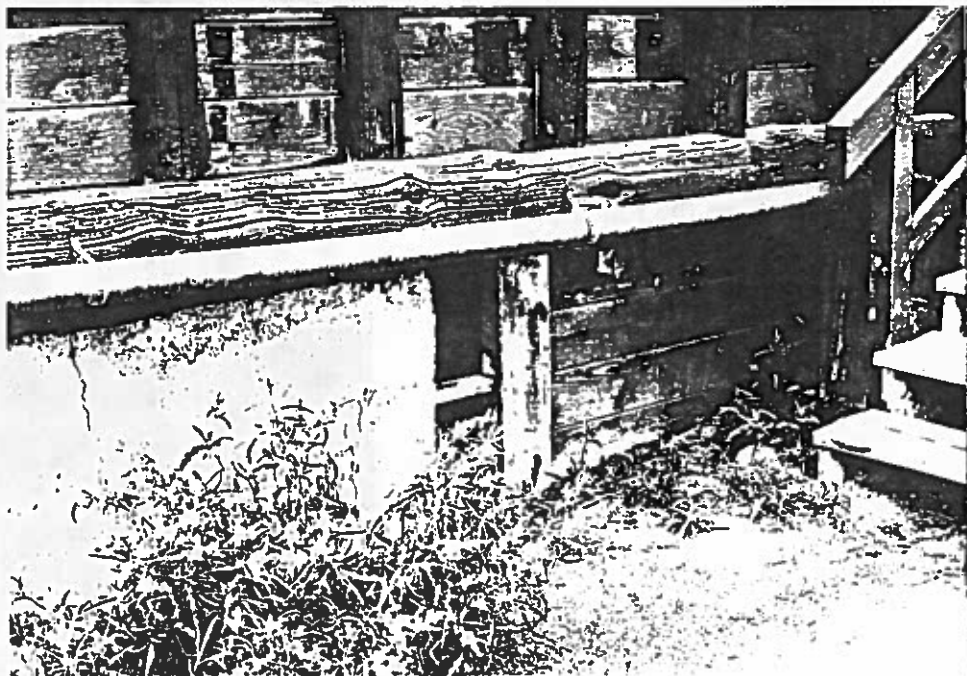
Figure 184: Looking northwest at the Pub entrance porch. Note the rotted areas around the rafters.

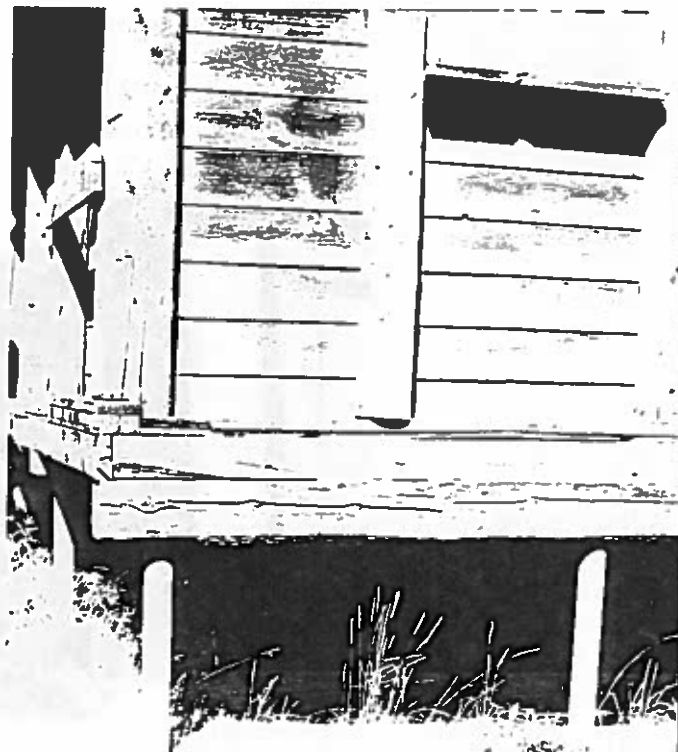
Figure 189: Looking west at the east elevation of the Linen Building. Note the weathered wood on the walls of the building.

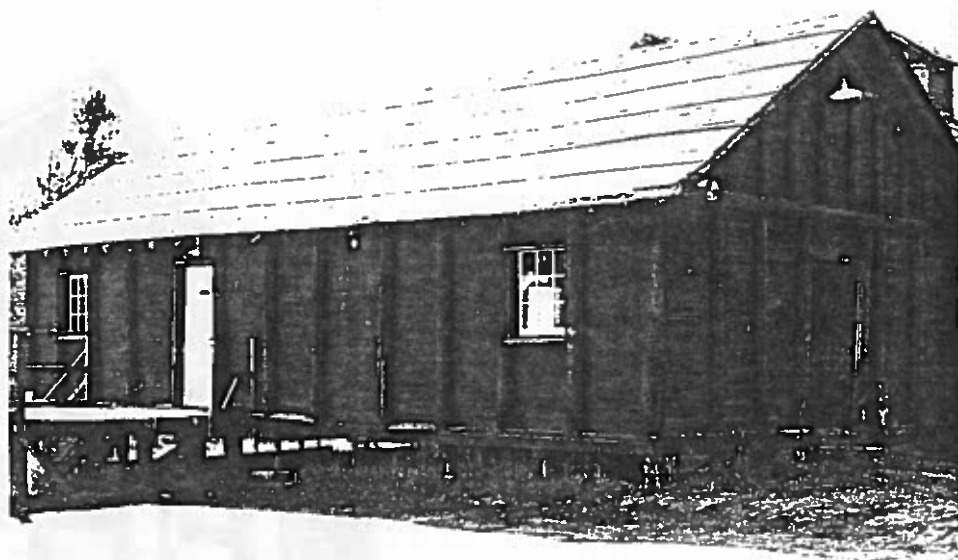
Figure 191: Looking southeast at the Linen Building. Note the new flush wood door. The roof is in good condition.

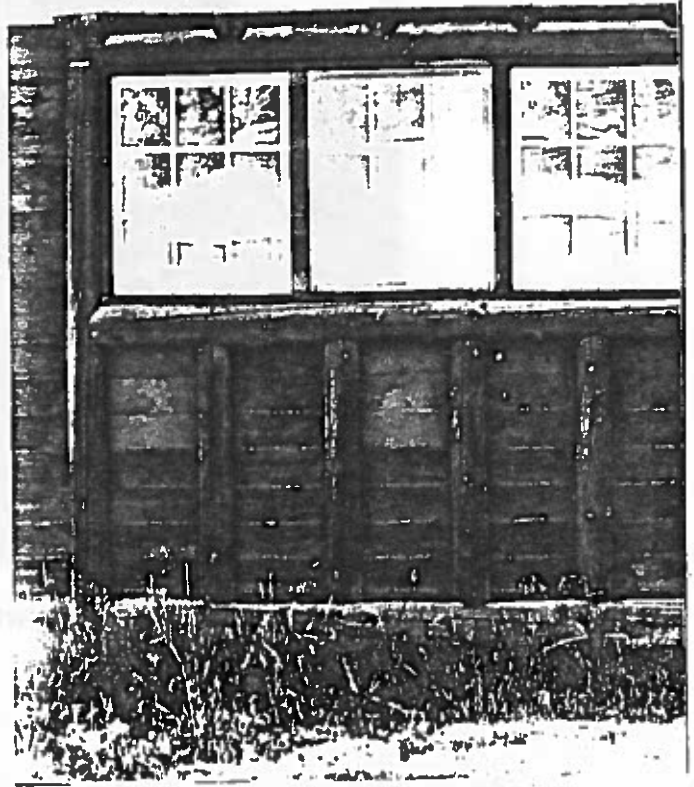
The Employee Pub is in fair to good condition. The major areas of concern are the structure of the floor which has deteriorated, and the rafter tips under the eaves which have rotted. Water draining from the parking lot penetrates the foundation wall on the west side and pools in the crawlspace. There is rot present at the base of the exterior walls and porch structure. The doors and windows are in generally good condition with minor deterioration at the sashes, sills and trim.

Figure 195: Looking at a typical foundation detail on the west side of the Pub Building. Water flowing from the large parking area on the west flows into the crawl space and against the foundation and sill logs.

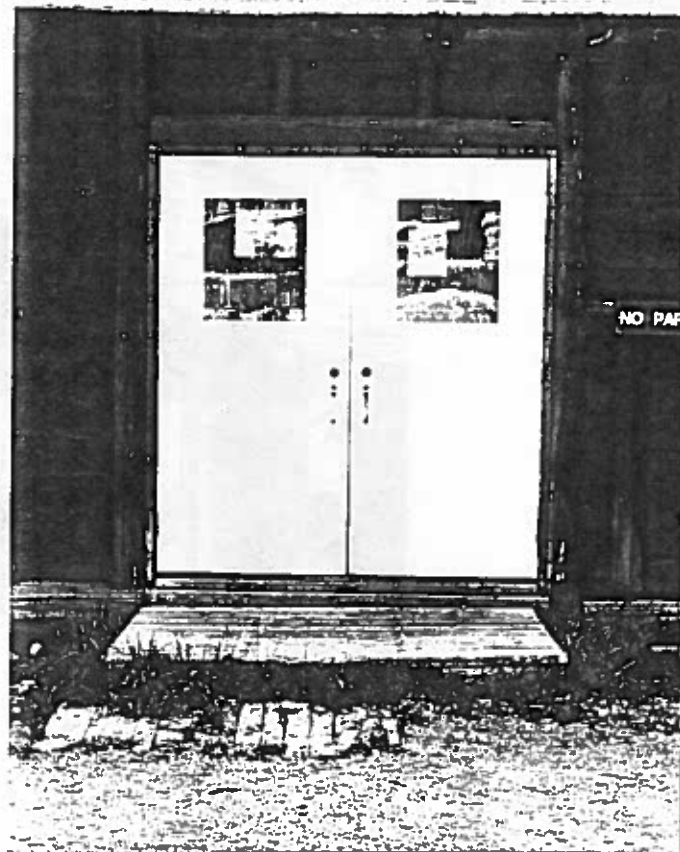
Figure 196: Looking east at the doors on the west side of the Pub. Note the water damage on the base of the doors and base of the building.

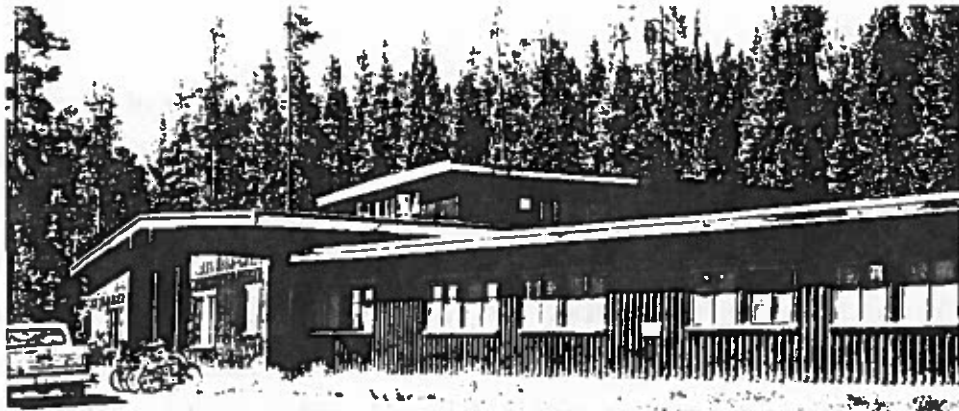
Figure 207: Looking southeast at Mallard Dormitory (HS #4055). Most of the materials are weathered and in need of maintenance.

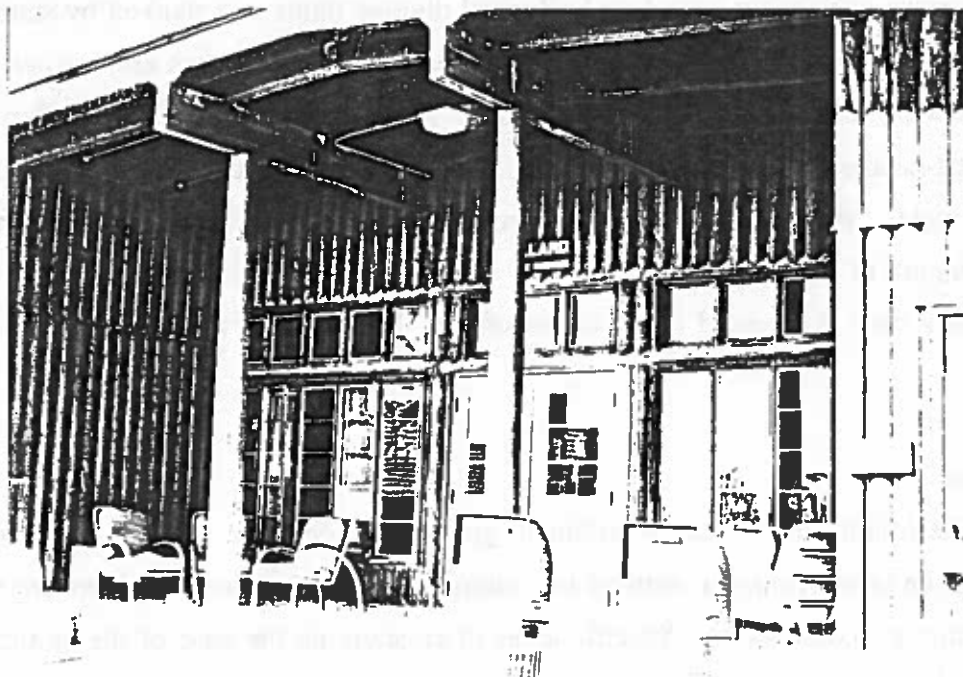
Figure 208: Looking southeast at the main entrance to Mallard Dorm. Most of the surfaces that are protected are in good condition.

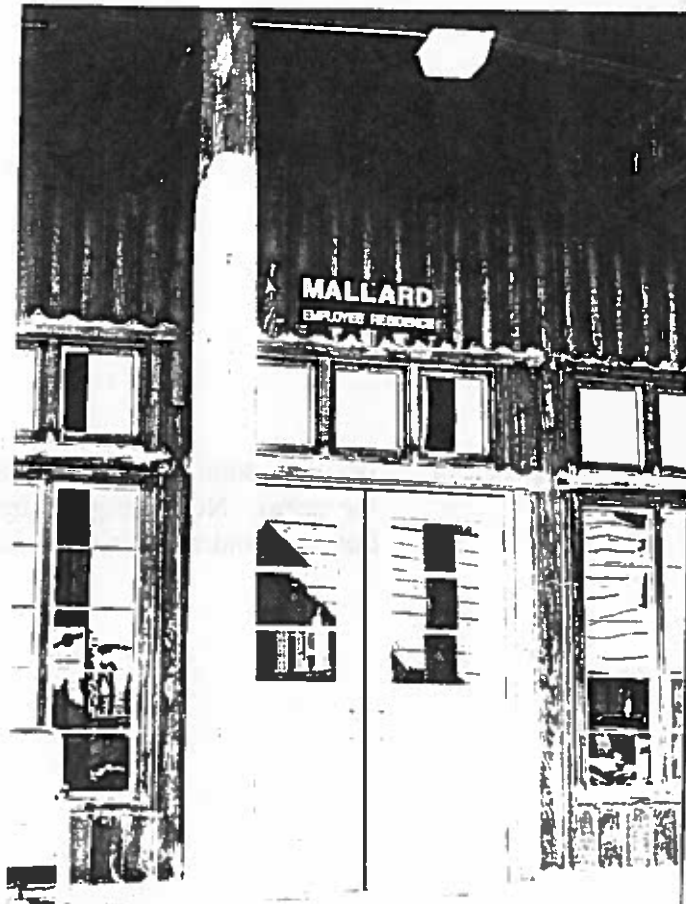
Figure 210: Looking southwest at the one story section of the dorm. Note the weathered siding and fascia.

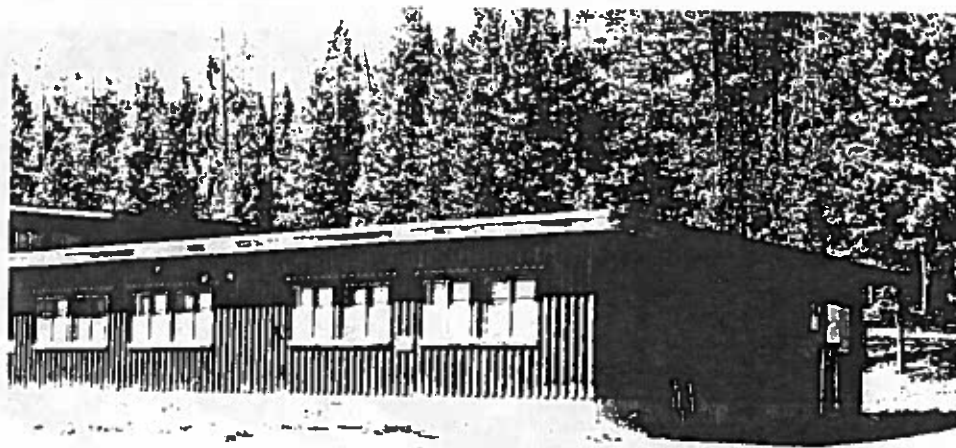
Figure 211: Looking south at the back side of the dorm. Note the poor drainage down to and against the building.

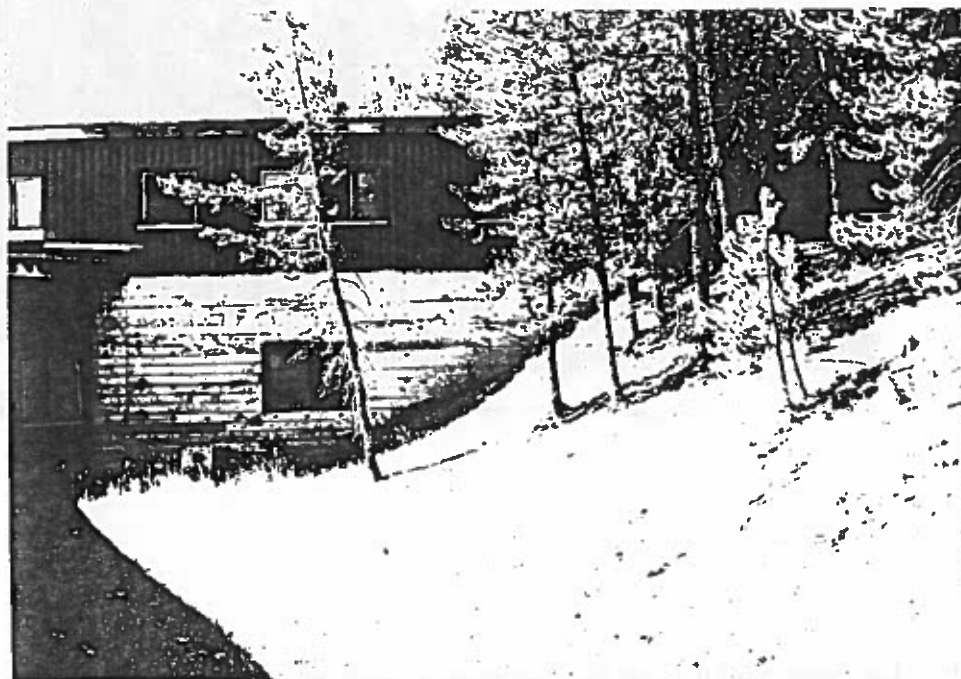
Figure 212: Looking south at the west wing of Mallard Dorm.

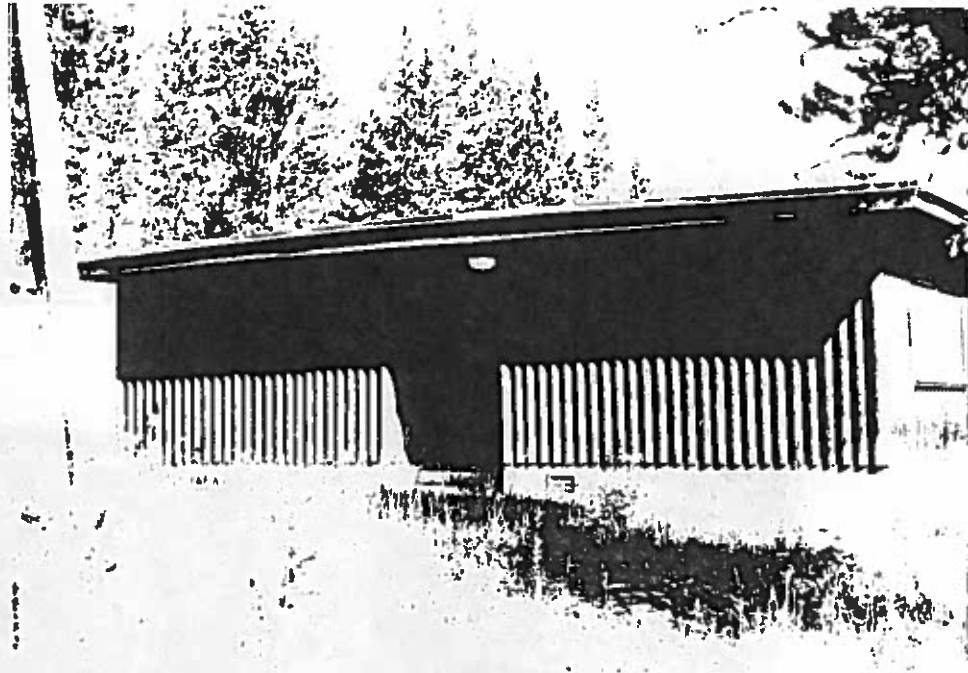
Figure 213: Looking east at the west wing of Mallard Dorm. The walls and materials are also weathered in this area.

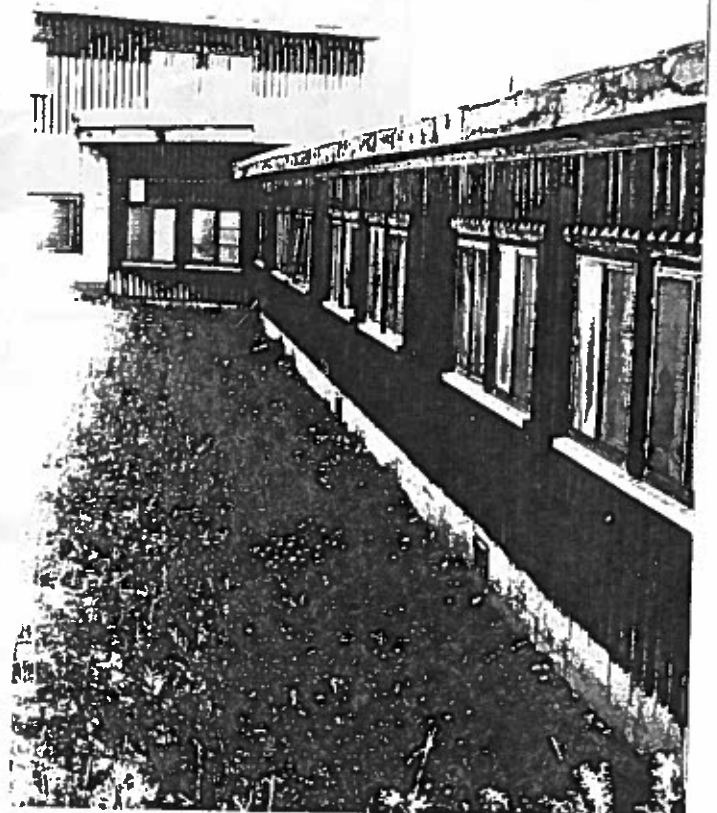
Figure 214: Looking north at the back of the south wing of the dorm. Note the weathered materials on the siding, fascia, and the windows.

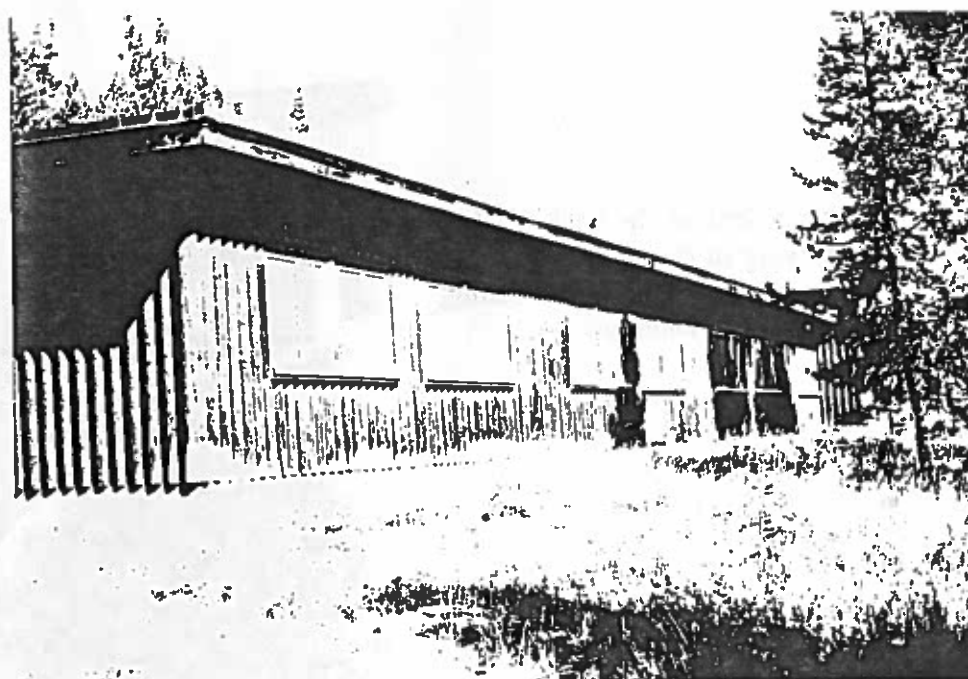
Figure 216: Looking northwest at the dorm.

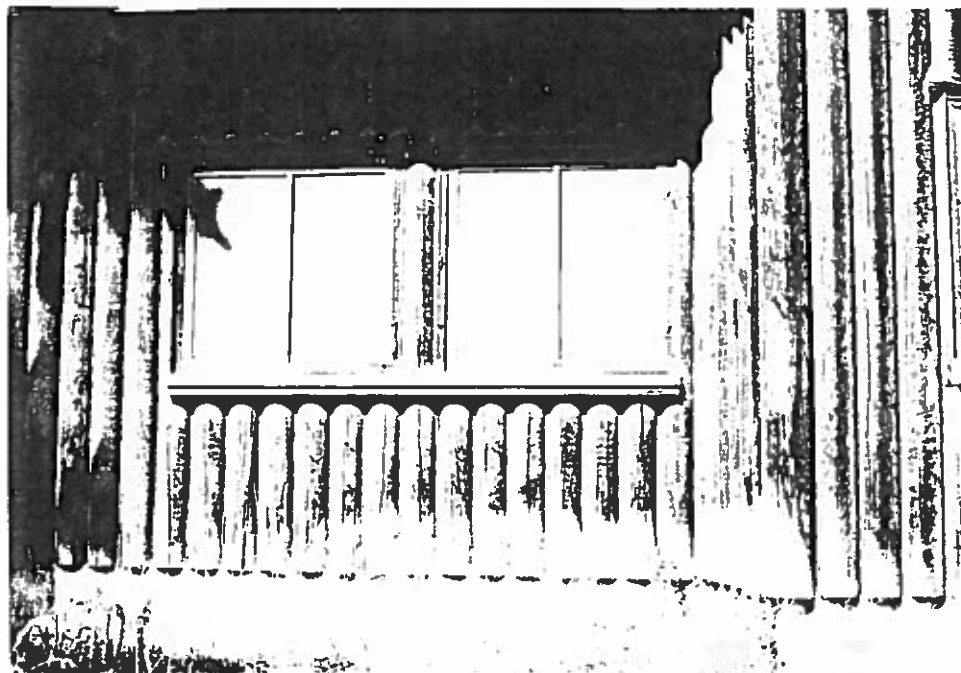
Figure 217: Looking west at a typical casement window. Note the weathered and rotted base.

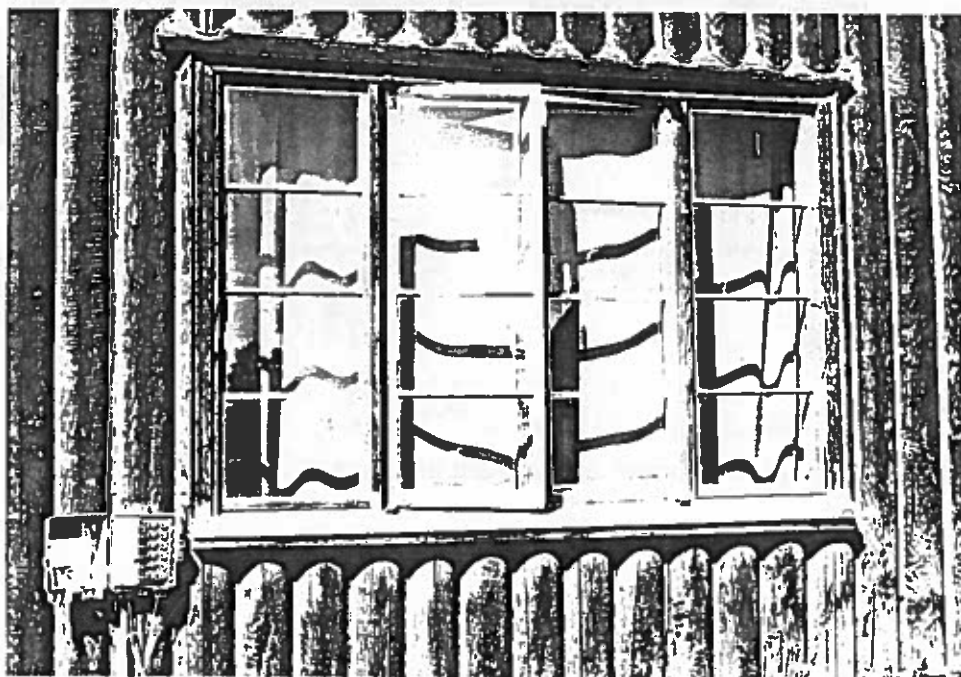
Figure 218: Looking west at a typical casement window adjacent to the entrance which is in poor condition.

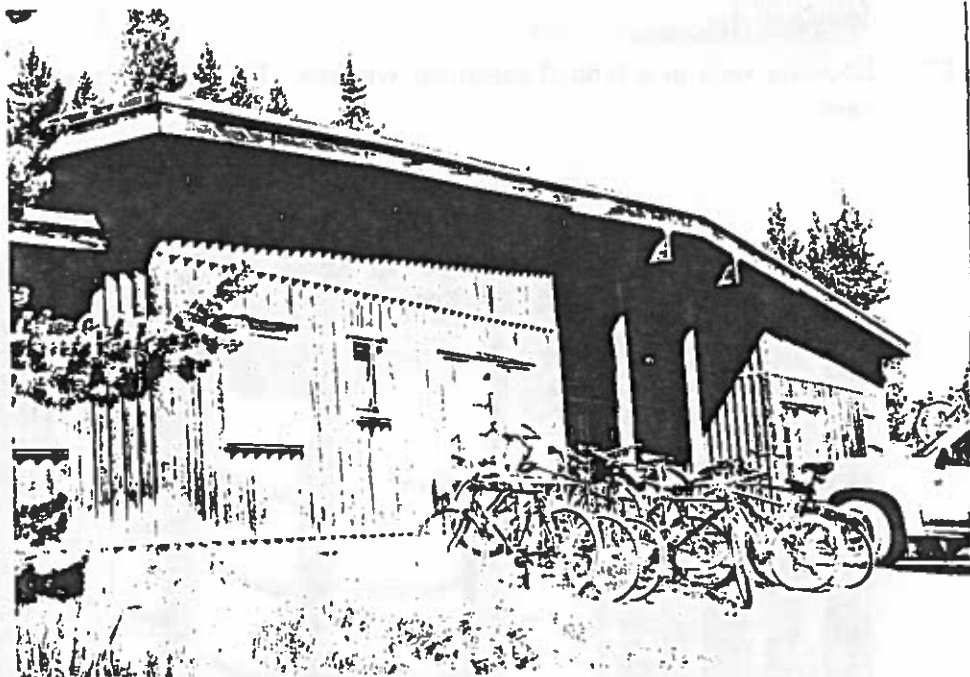
Figure 219: Looking northwest at the main entrance to Mallard Dorm.

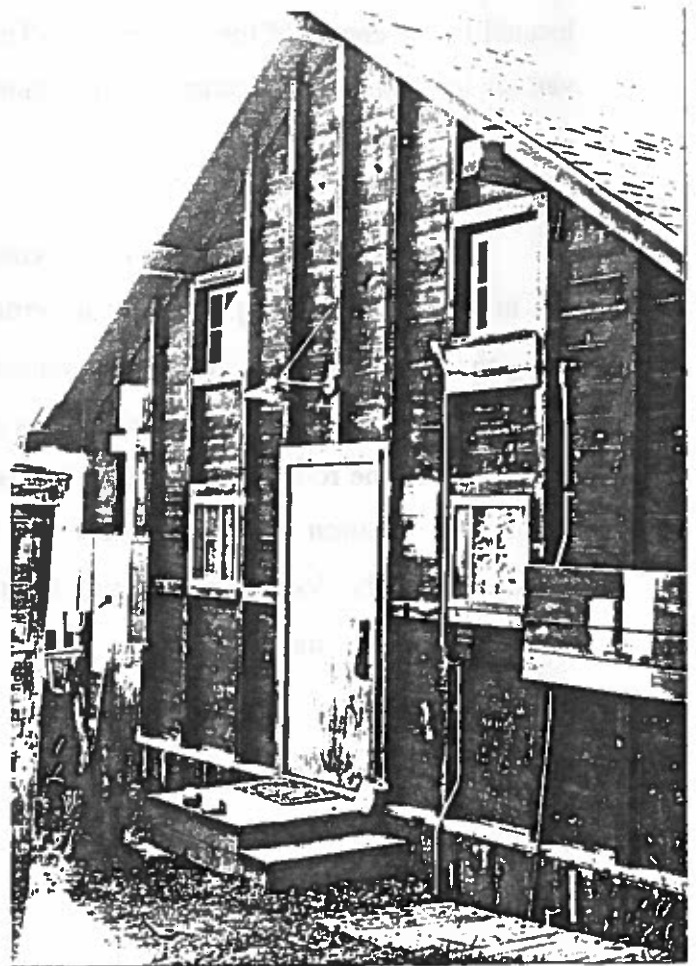
Figure 221: Looking southeast at the entrance to the dorm. Note the electrical service panels on the front of the dorm.

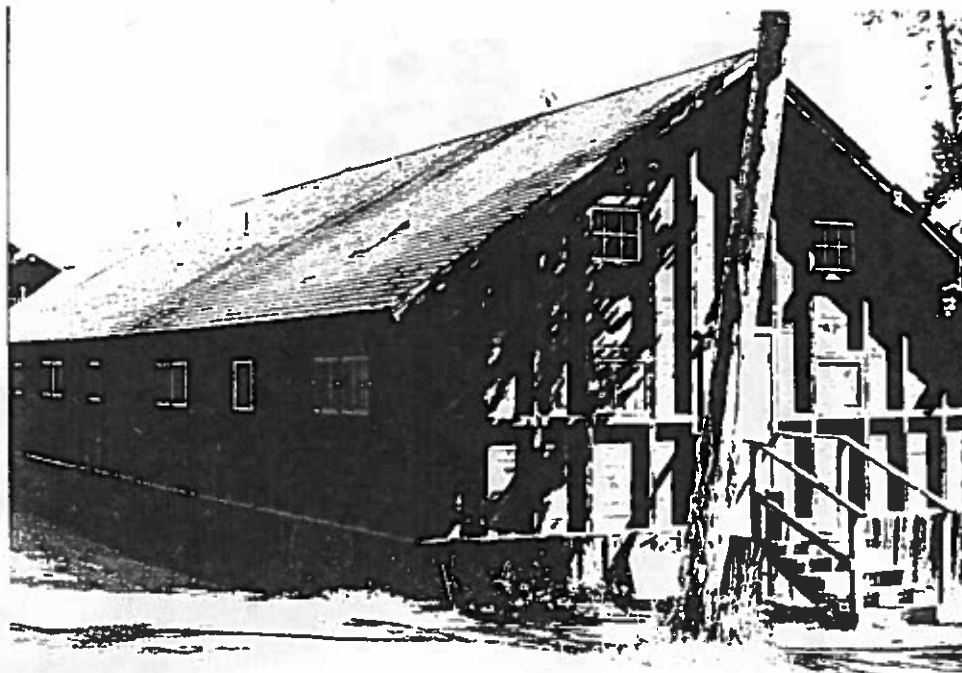
Figure 222: Looking northeast at the dorm. The roof is in good condition except for the center section where two halves of the buildings intersect.

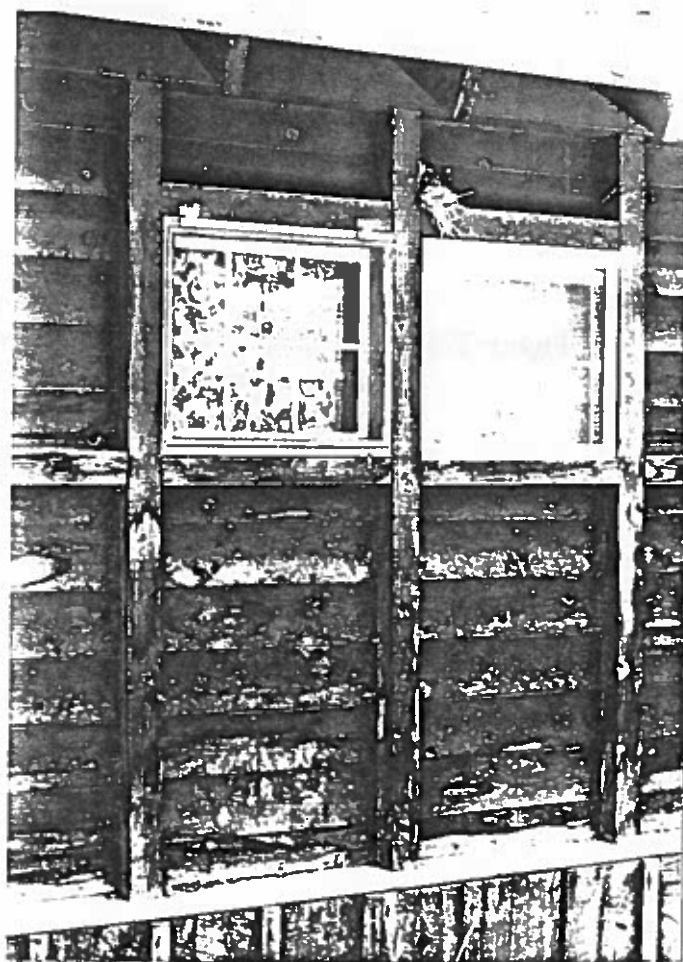
Figure 223: Looking at a typical set of windows in fair condition on the dorm. Note the rotted base of the wall.

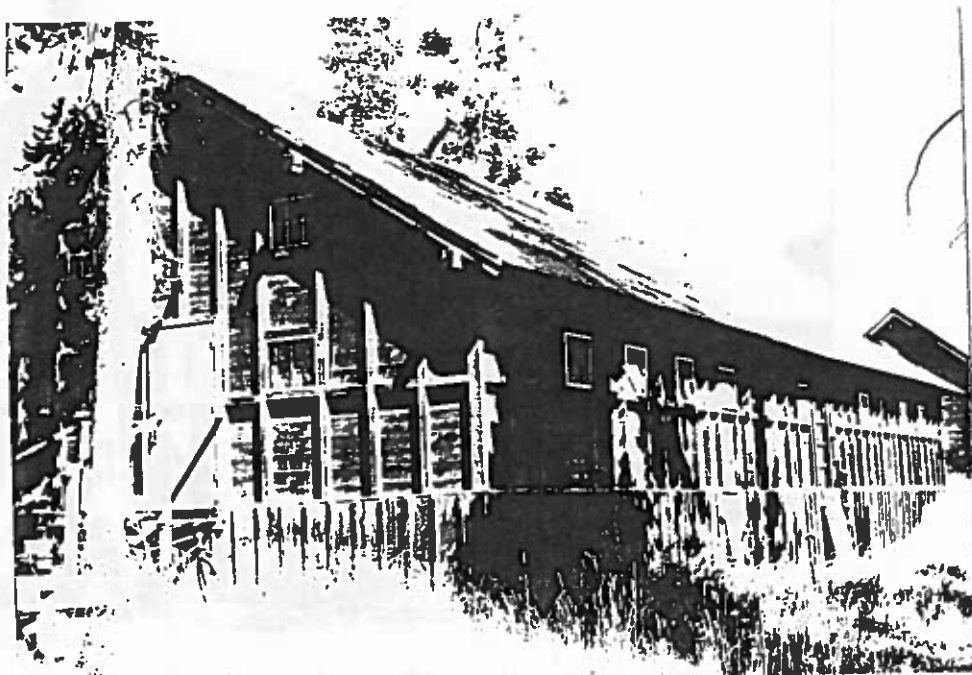
Figure 224: Looking northwest at Seagull Dorm. The board and batten skirting covers up a crawl space, the pipe columns and concrete piers.

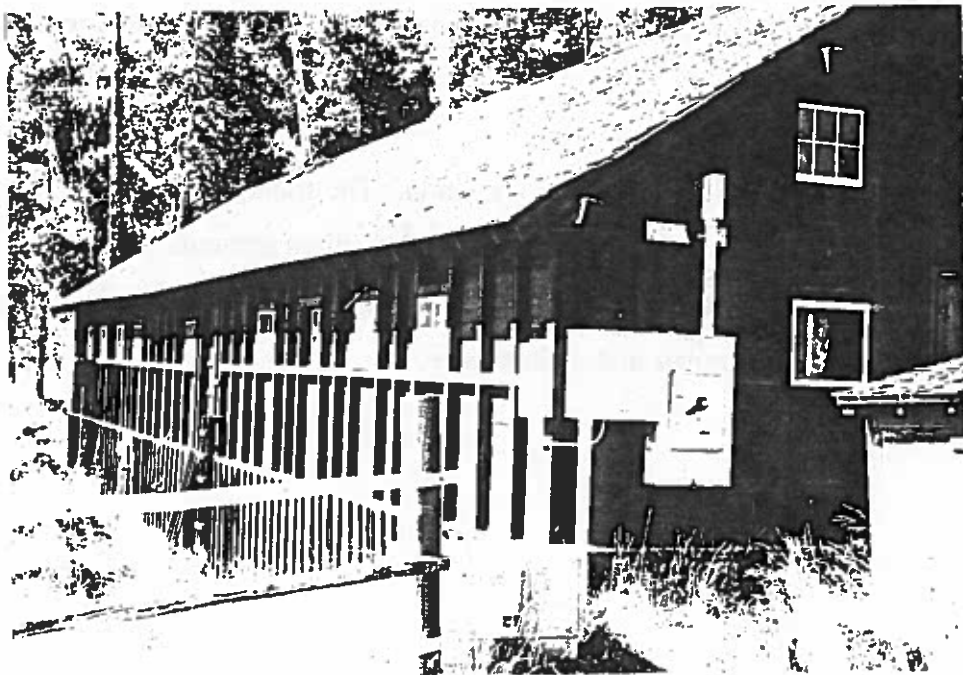
Figure 226: Looking southwest at Seagull Dorm.

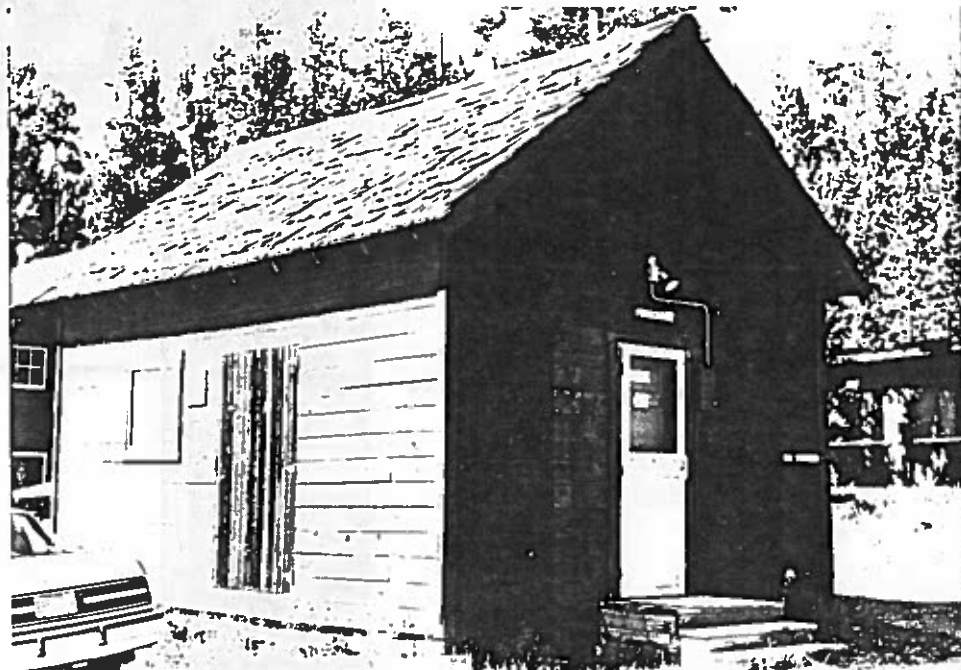
Figure 227: Looking southwest at the Personnel Building. The roof is in poor condition along with the siding and elements of the windows and the doors.
