HISTORIC
STRUCTURES REPORT

LAKE LODGE

YELLOWSTONE
NATIONAL PARK,
WYOMING

July 1997

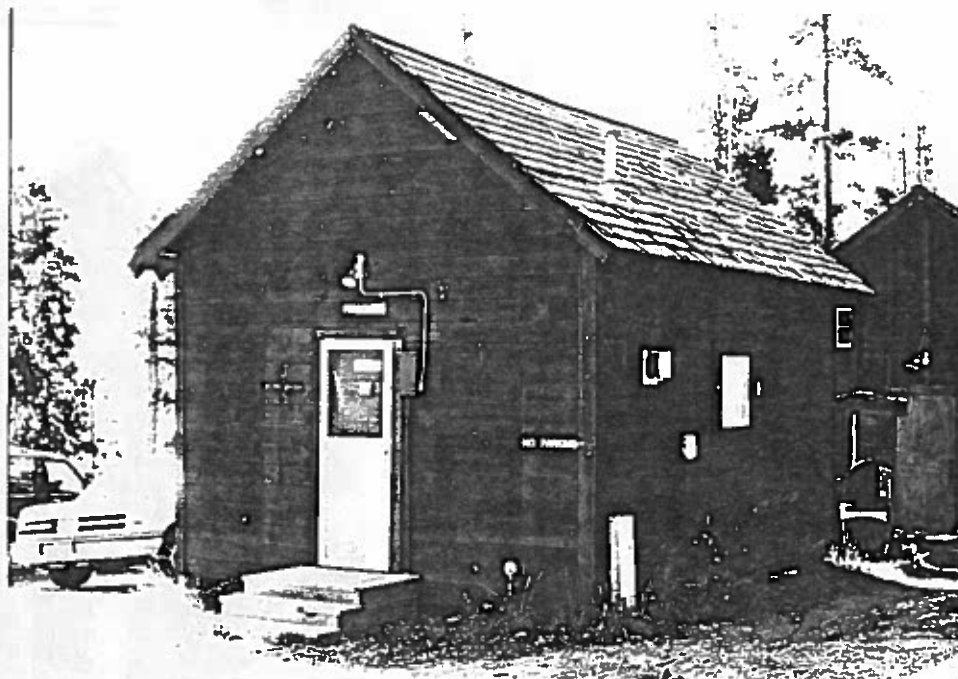
Figure 228: Looking southeast at the building. The building sits on a concrete pier foundation.

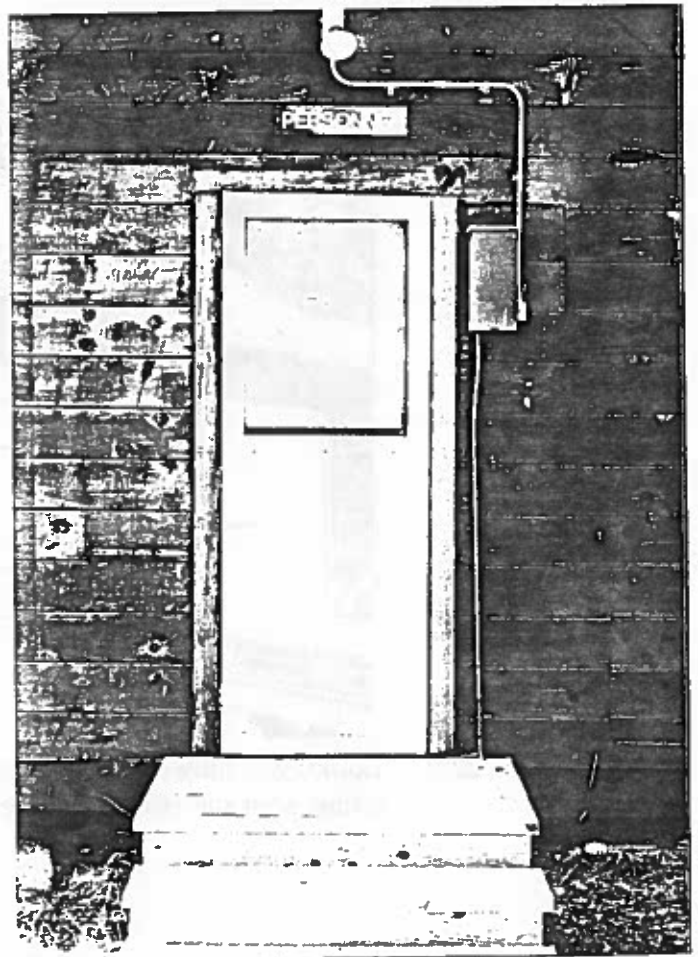
Figure 230: Looking northwest at the Personnel Building.

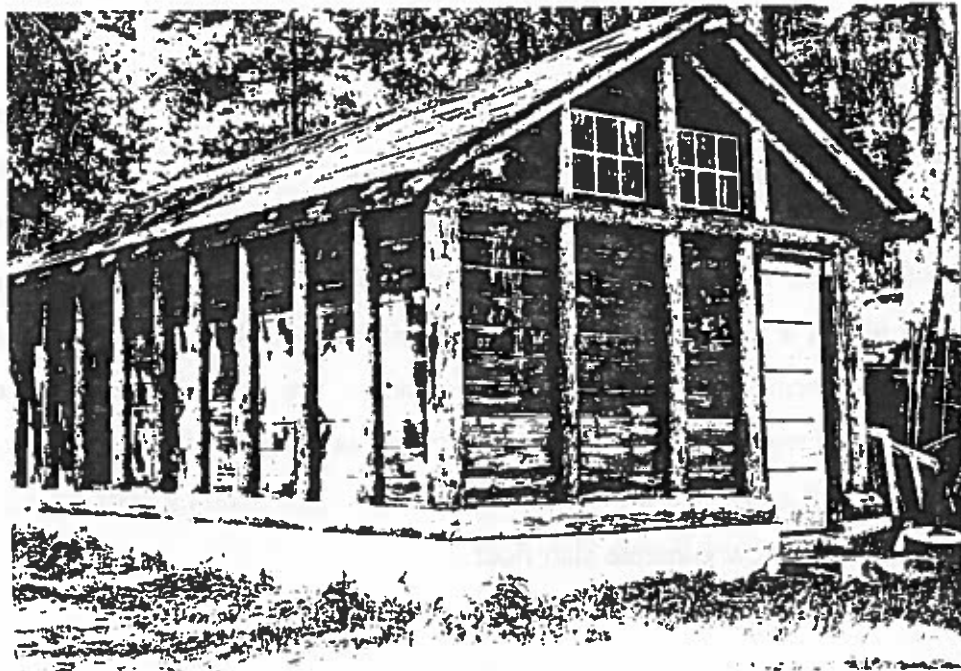
Figure 231: Looking southwest at the Storage Building (HS #4059). Note rotted wood purlins, rafters and sill log.

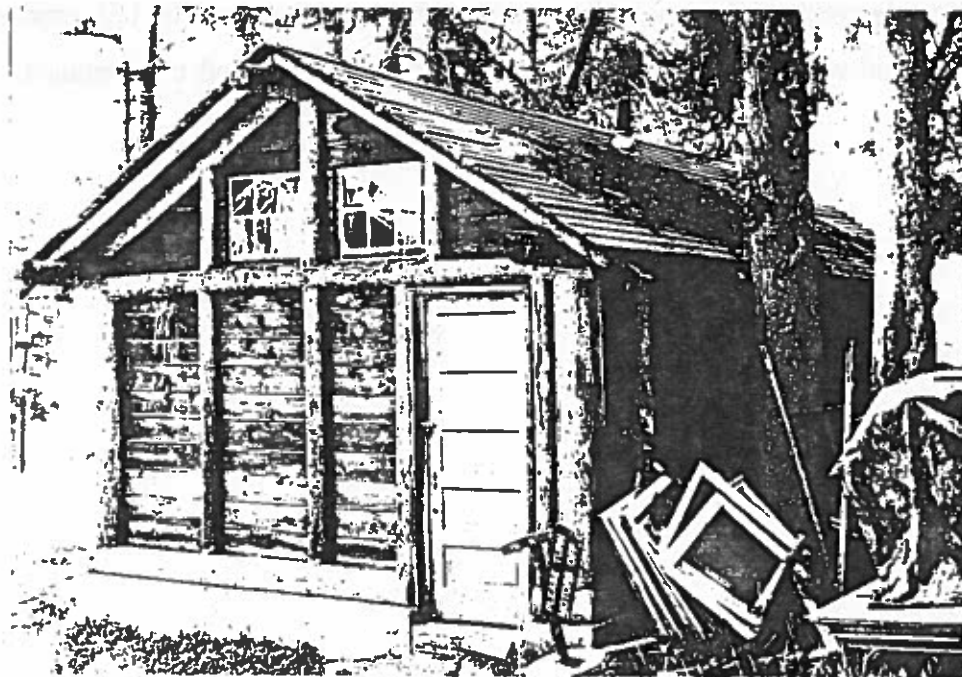
Figure 232: Looking southeast at the Storage Building. Note the original wood panelled door and windows.

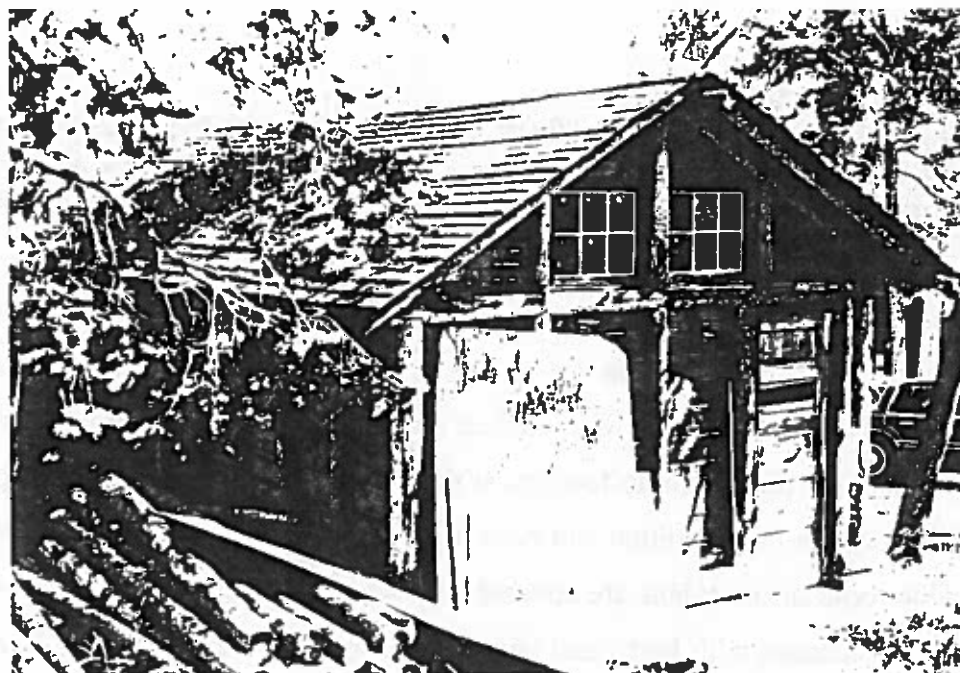
Figure 233: Looking northeast at the Storage Building. The roof is in good condition.

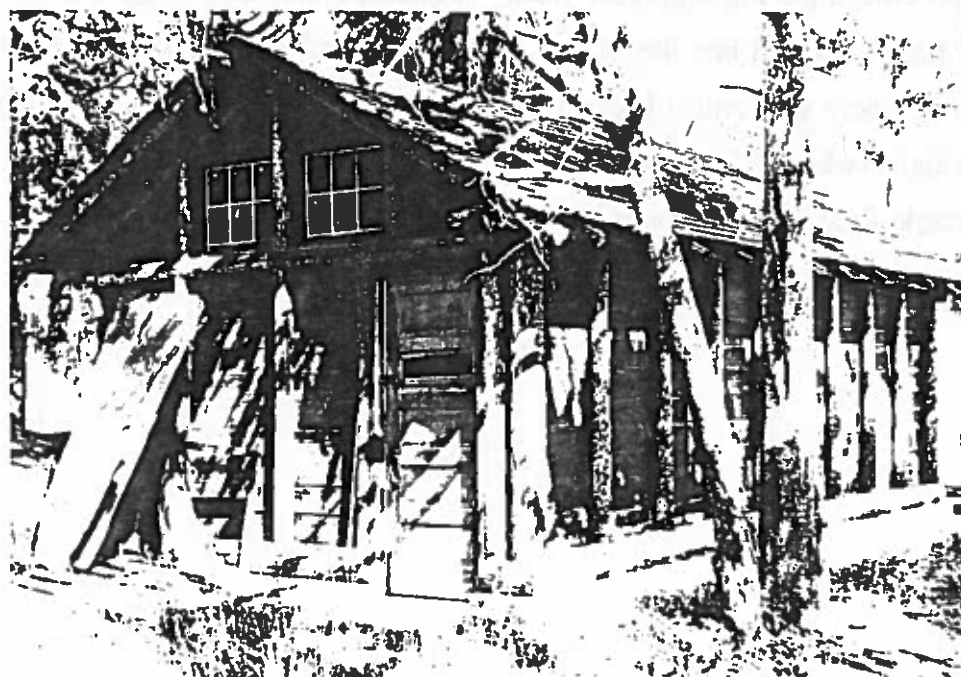
Figure 234: Looking northwest at the Storage Building. Note the deteriorated door and wall finishes.

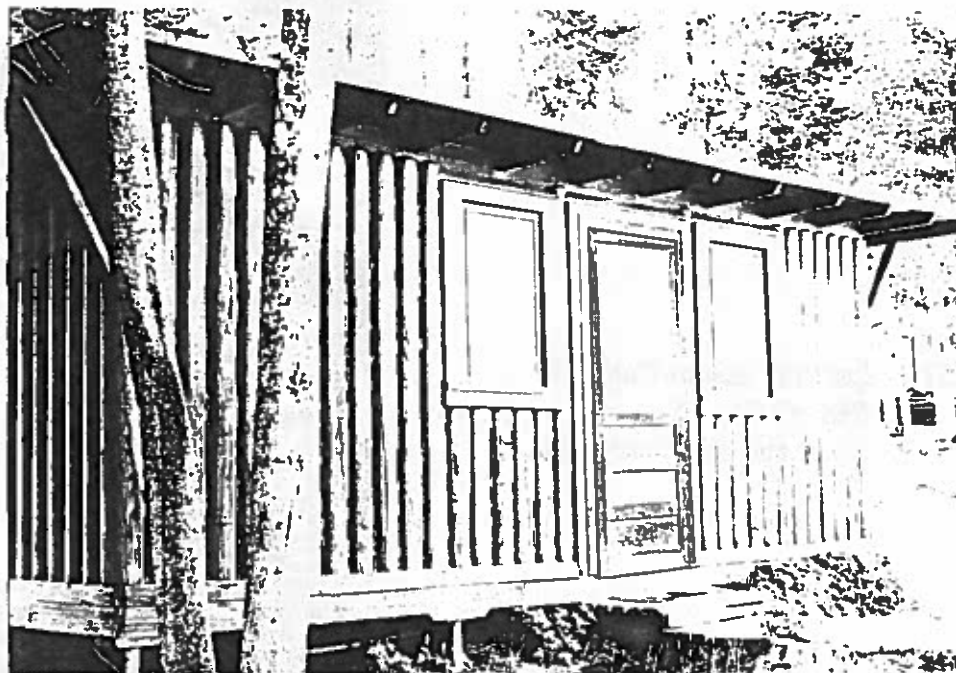
Figure 235: Looking southwest at Cabin 0 (HS #7024). Note the pipe column foundation and flat built-up roof. The materials are weathered and there is rot at the base of the walls.

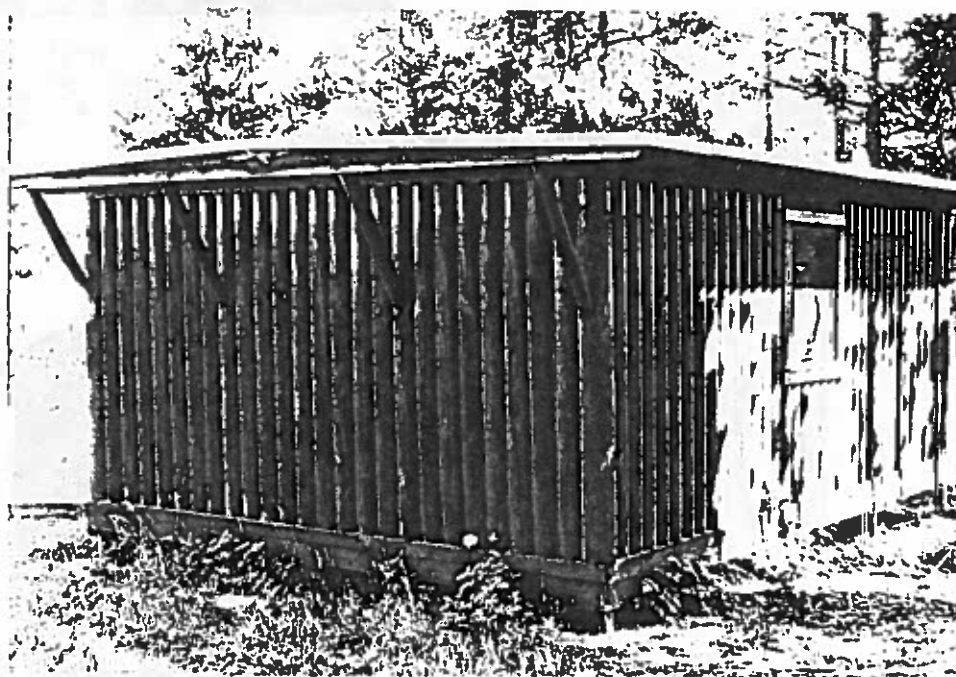
Figure 236: Looking northeast at Cabin 0. Grade around the building is good.

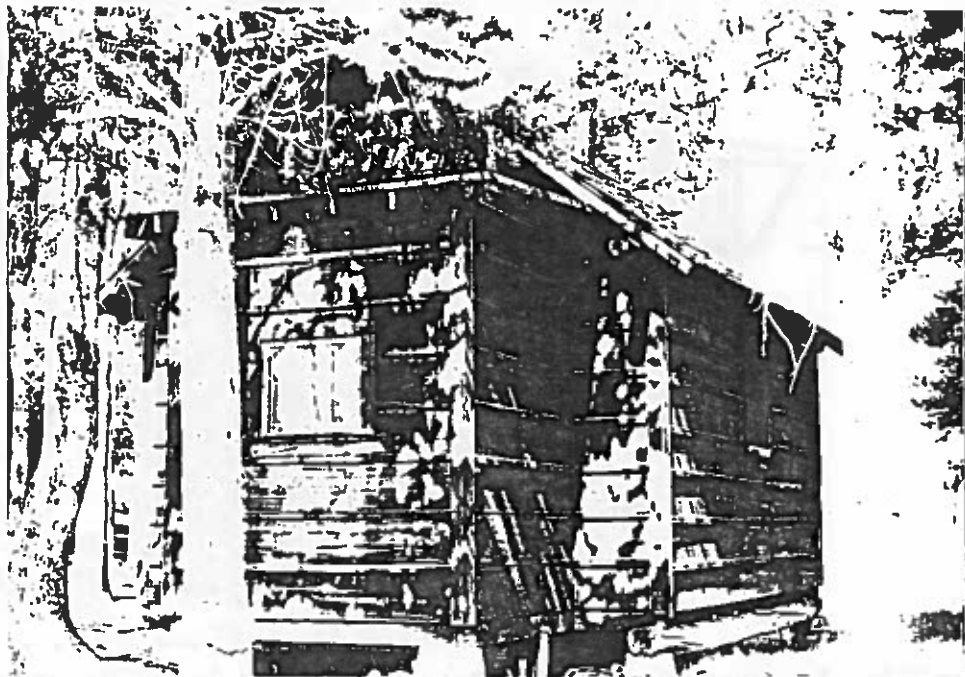
Figure 238: Looking northeast at Cabin 00. The windows and doors are weathered and require repair.

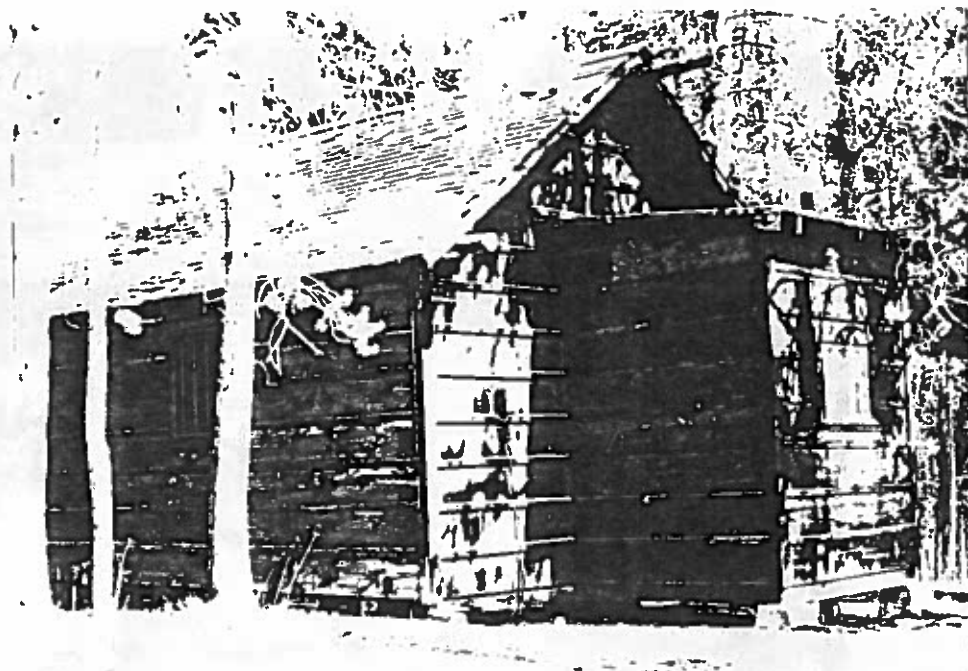
Figure 239: Looking southeast at Cabin 00. The grade around the building appears to be good. The roof is in good condition with some minor curling and breakage of the wood shingles.

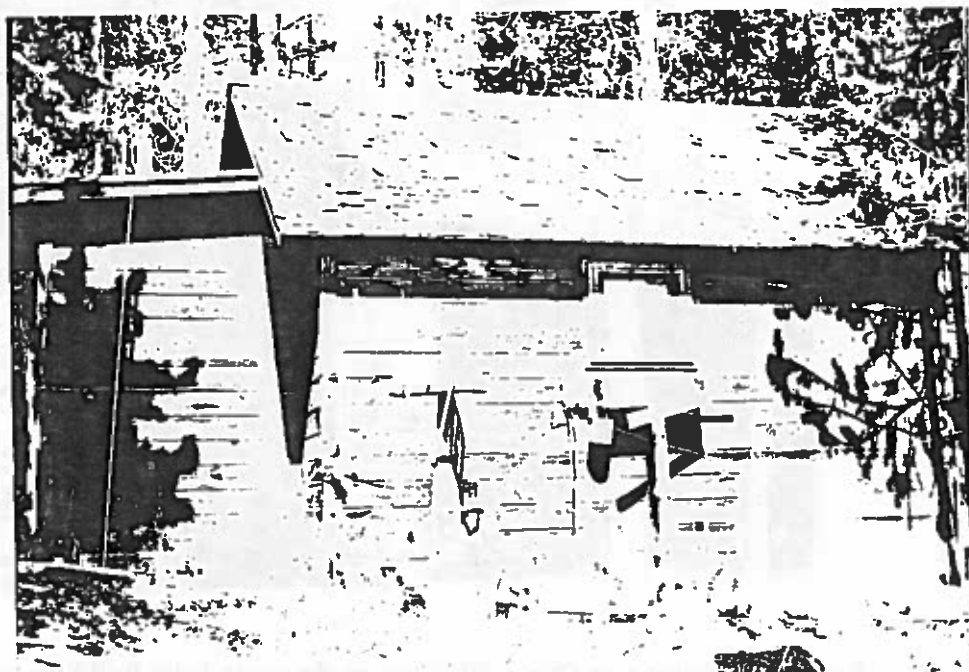
Figure 241: Looking southeast at Cabin 000. The wood shingle roof is in poor condition on this side but good on the other.

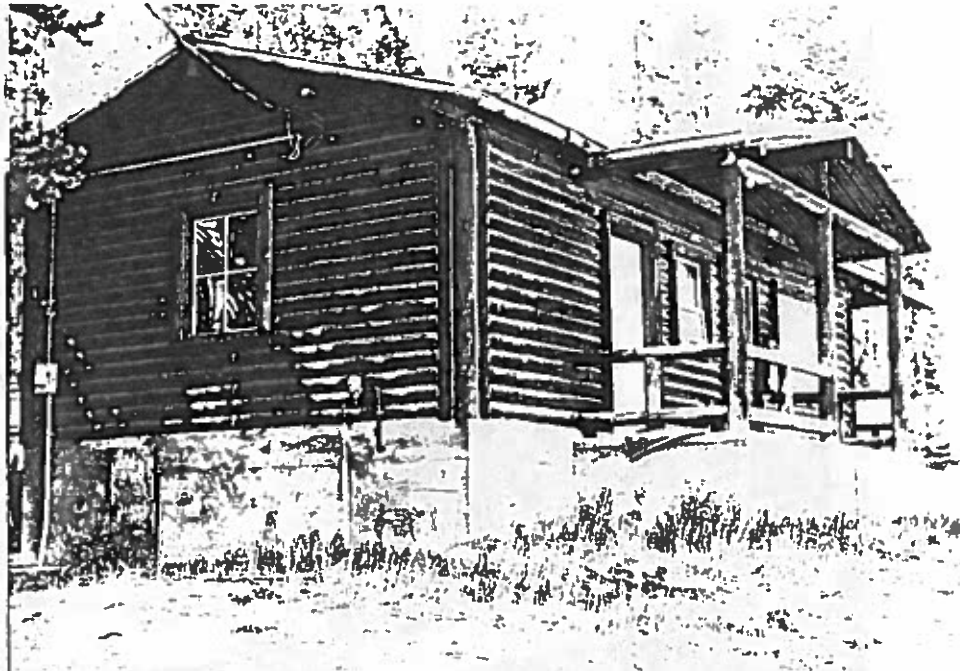
Figure 244: Looking south at Cabin 1. Note the high concrete foundation.

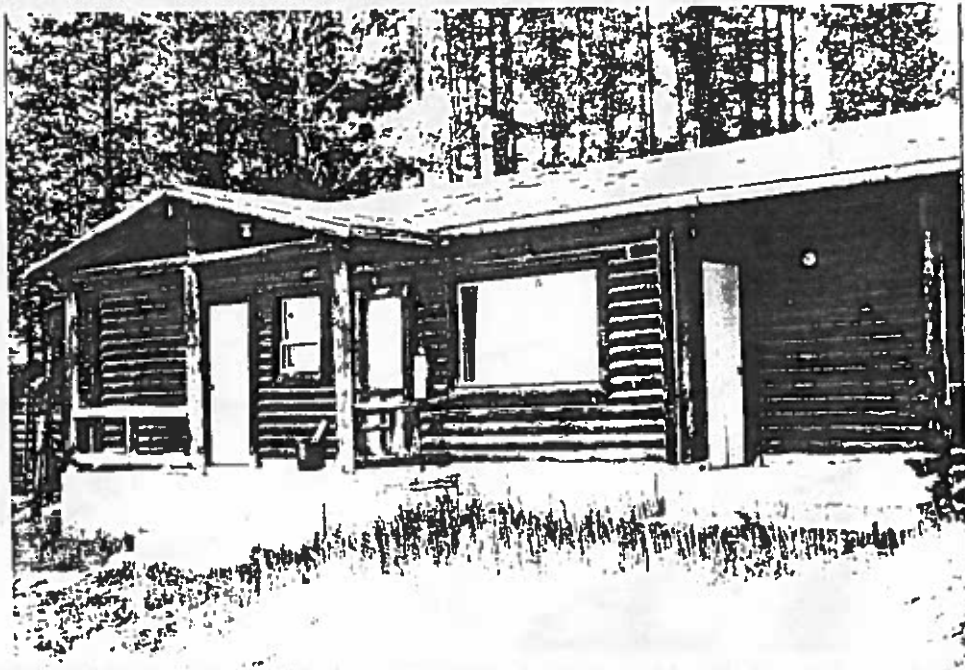
Figure 245: Looking southeast at Cabin 1. The roof is in good condition but the wall materials are weathered and dry.

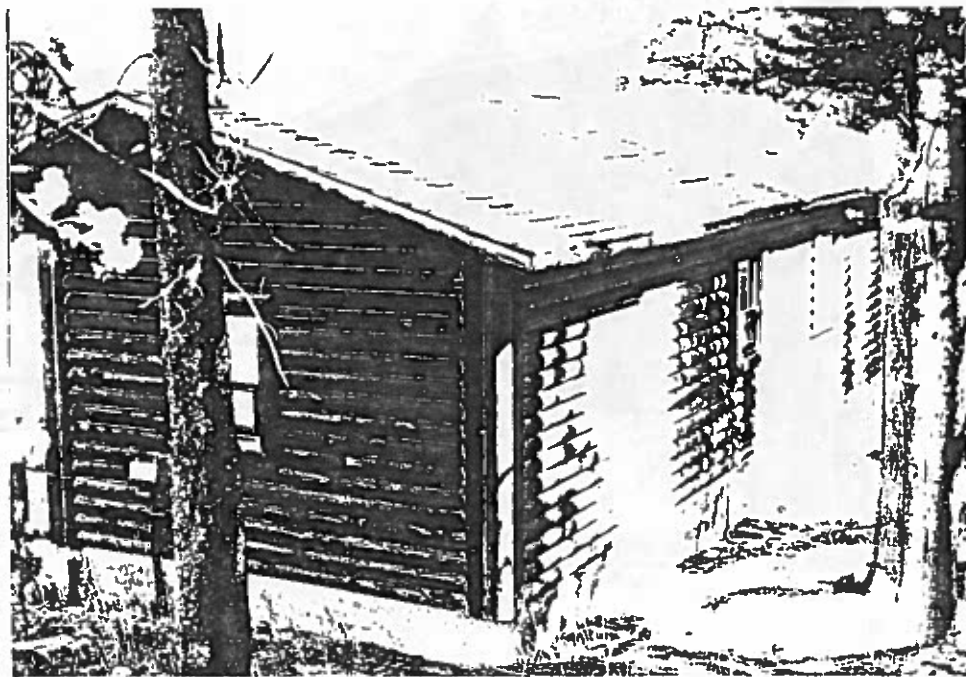
Figure 246: Looking northeast at Cabin 1. The grade condition is poor causing water to flow towards the foundation.

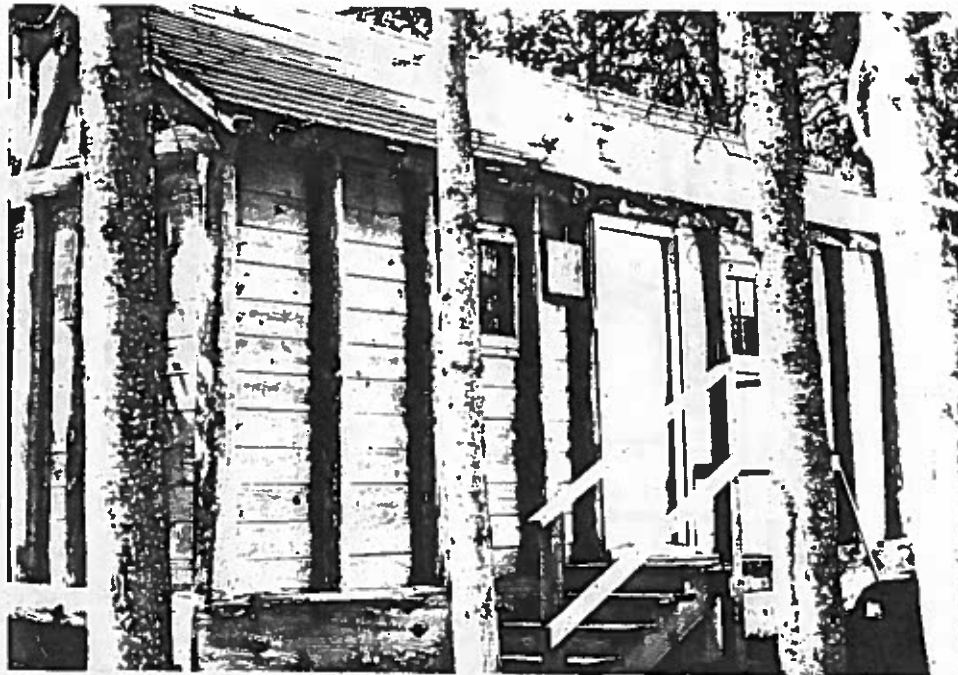
Figure 247: Looking southwest at Cabin 2 (HS #7597). Note the unfinished surface of the walls, and flush wood door. The roof appears to be in good condition.

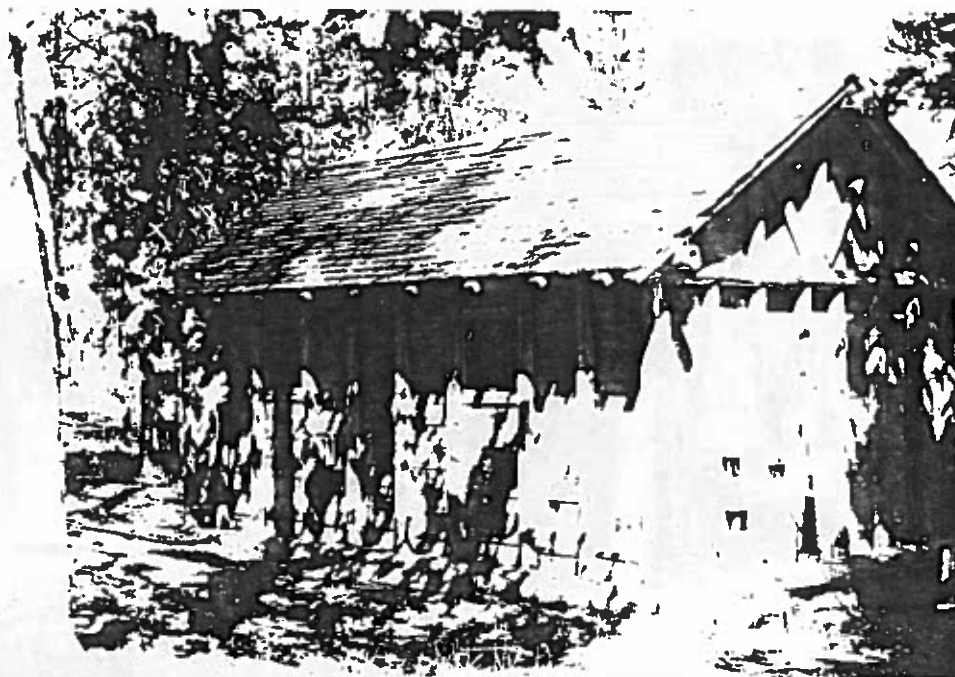
Figure 248: Looking northwest at Cabin 2. Note the rotted purlins and rafters, and the broken siding.

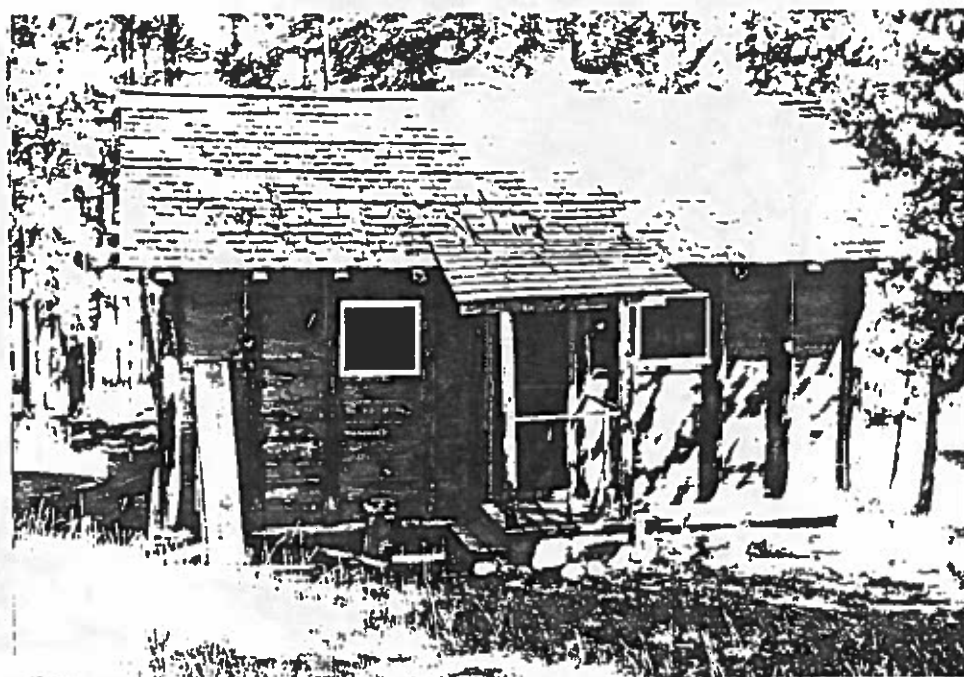
Figure 250: Looking north at Cabin 3 (HS #7580). Note the poor condition of the shingle roof and the weathered wood siding; grade is high against the walls around this side of the building.

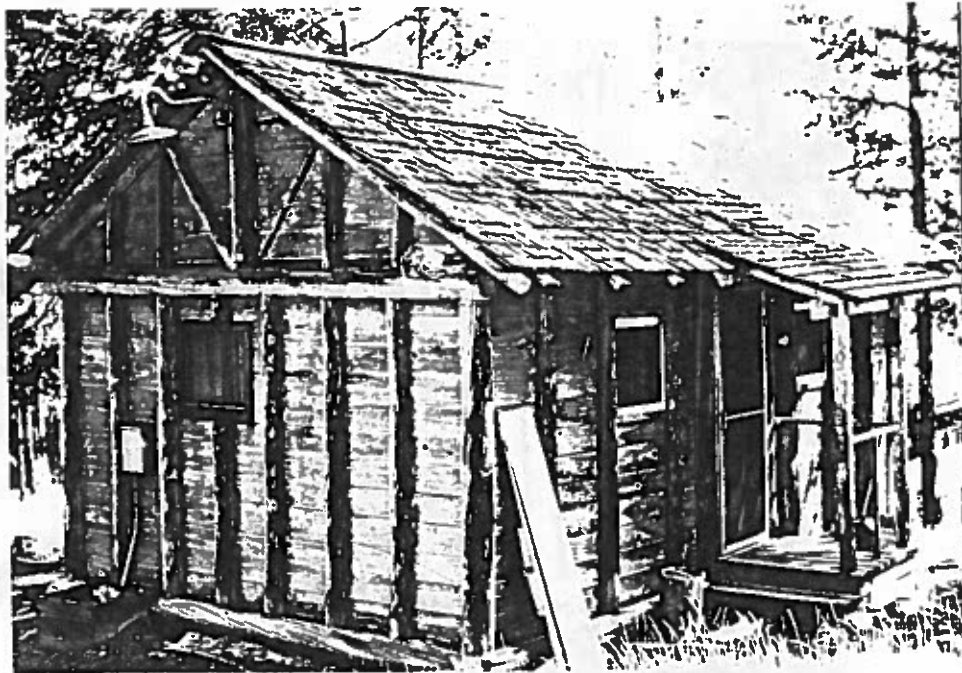
Figure 251: Looking northeast at Cabin 3. Note the rotted purlins and rafter tips, and the rotted sill log.

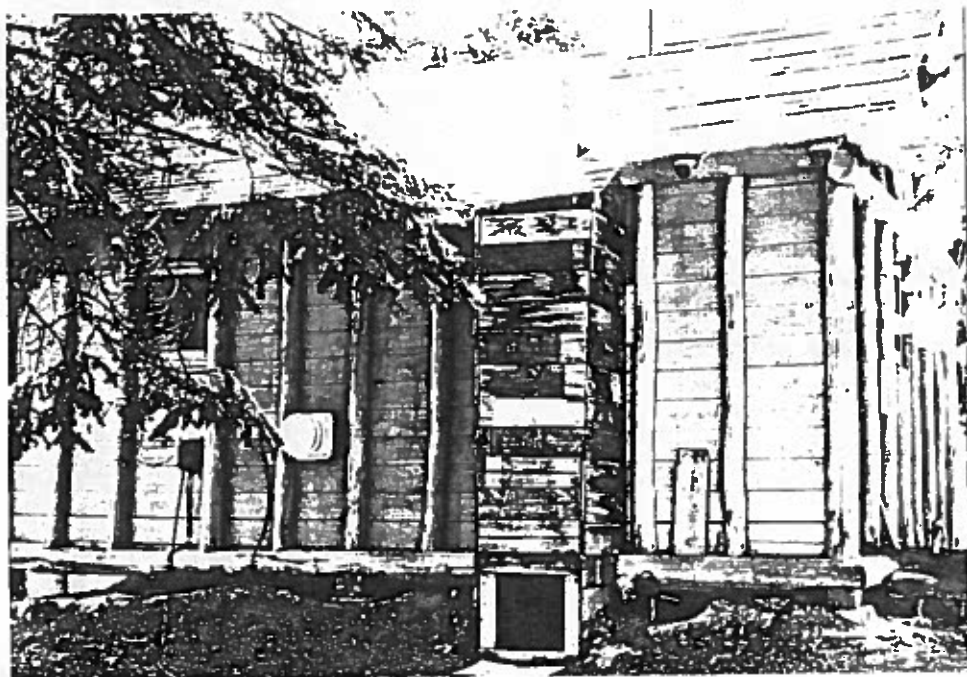
Figure 252: Looking southeast at Cabin 3. Note the temporary foundation.

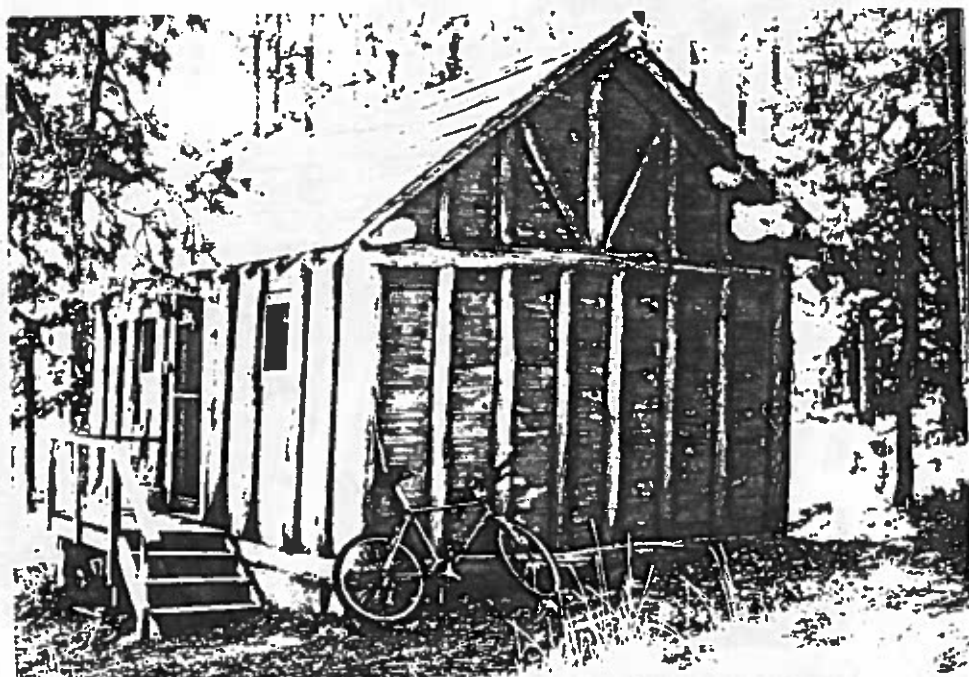
Figure 253: Looking southeast at Cabin 5 (HS #7022). Note the unfinished and weathered siding. The roof appears to be in good condition.

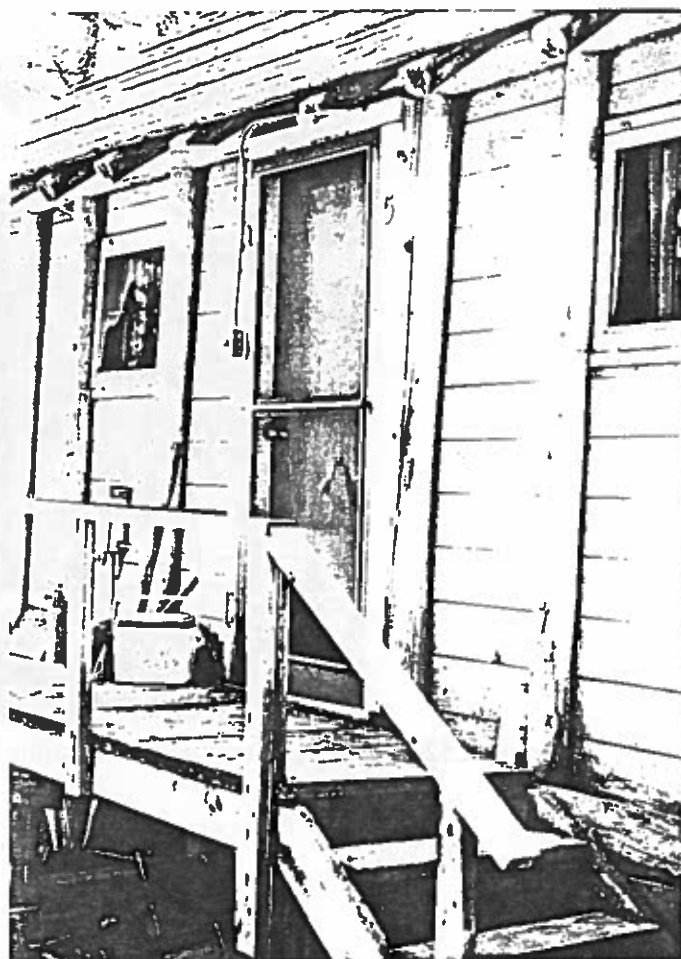
Figure 254: Looking southeast at the entrance door to Cabin 5. Note the rotted base of the columns and sill area.

4. Repair the bases of the log columns which have been set into the concrete piers. Remove the rotted portions and splice a new matching base in place. Set the columns on top of the concrete piers and caulk the joints so that water will not penetrate.

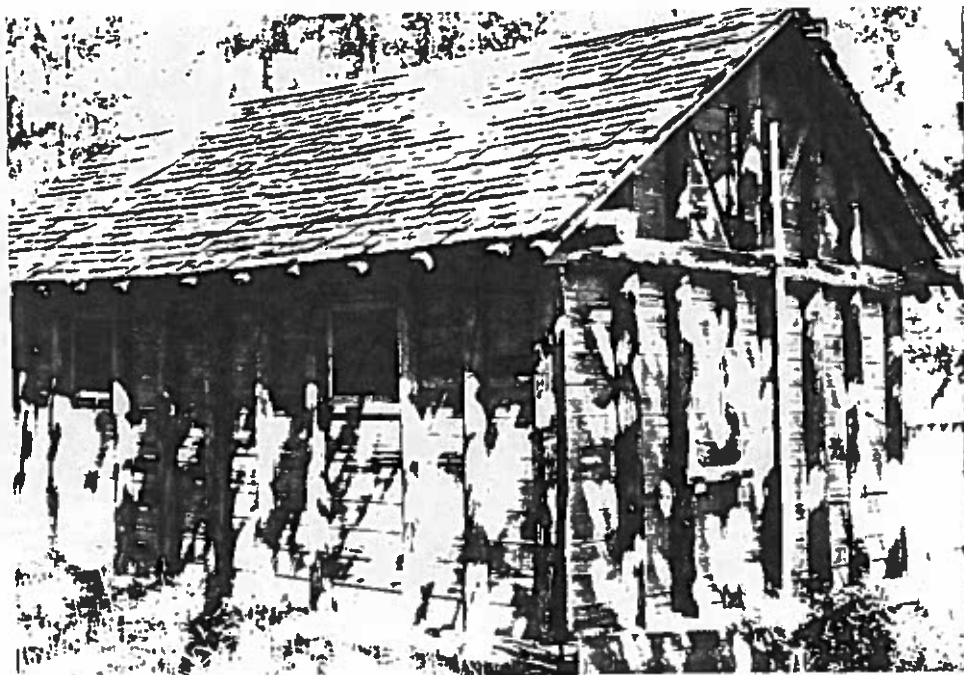
Figure 255: Looking northwest at Cabin 5. Note the broken wood siding and the high grade around the building.

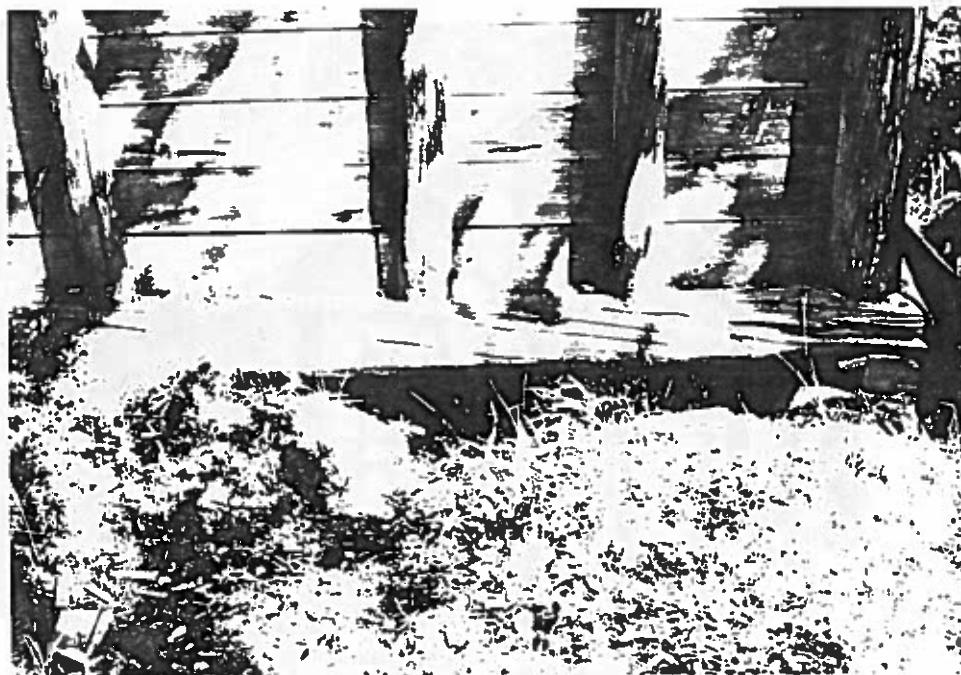
Figure 256: Looking north at a sill log detail on the south side of Cabin 5. Note the rotted sill log, and the high grade.

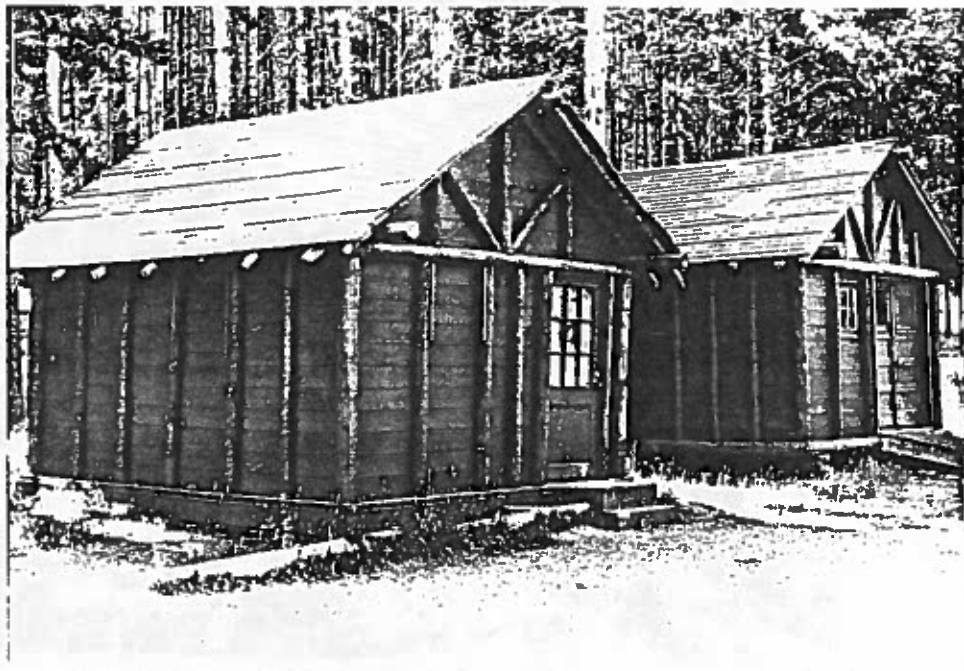
Figure 257: Looking south at two storage units that were original cabins on the site. The buildings are in good condition.

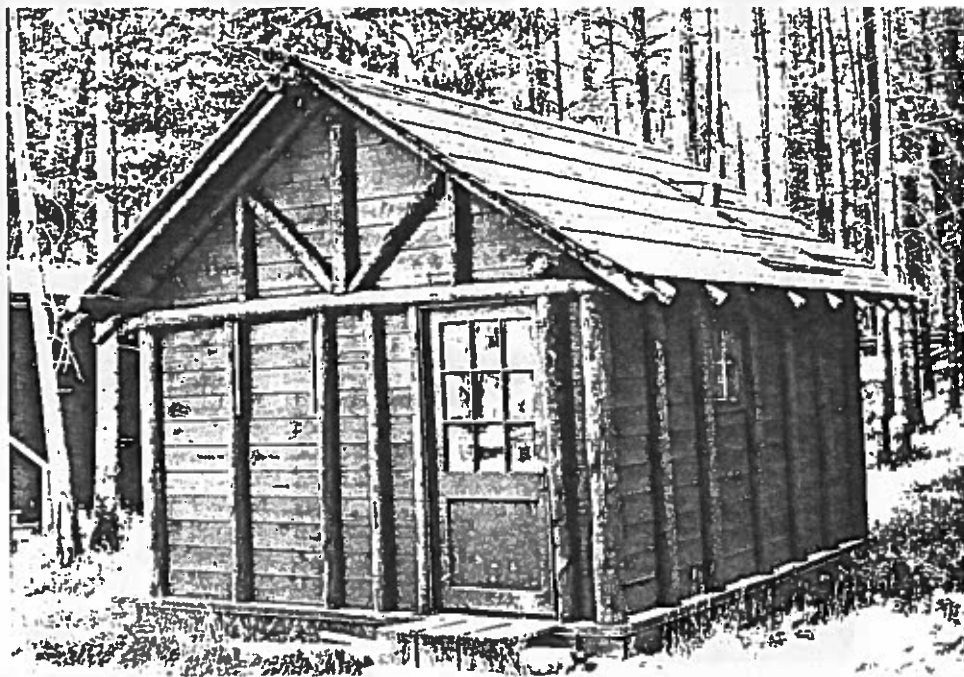
Figure 258: Looking northeast at the first building. There is rot present in the purlins and rafter tips.

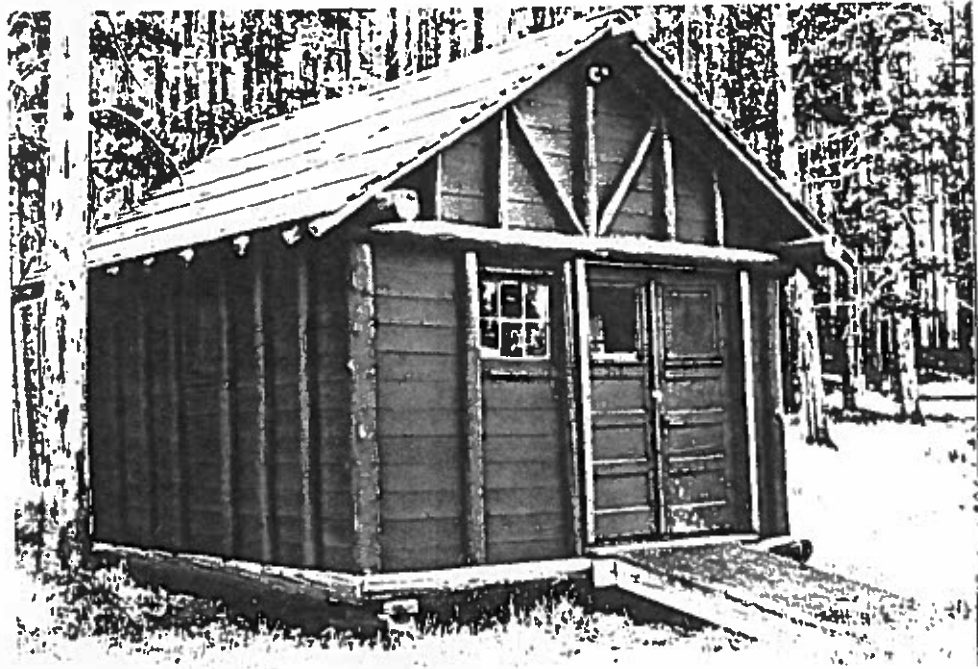
Figure 259: Looking southeast at the second storage building. Note the temporary piers; the double doors were added to the building.

4. **Repair/replace doors, frames and trim in-kind to the original; paint.**
5. **Replace deteriorated structural members at walls and floors. Stabilize the pier foundations; install additional piers at areas of settling. Level the building as necessary.**
6. **Provide on-going preservation maintenance for this structure.**
