HISTORIC STRUCTURES REPORT

**MOUNT WASHBURN
FIRE LOOKOUT
Yellowstone National Park**

April 2011

Prepared by Sievert & Sievert CRC
in conjunction with
Montana Preservation Alliance

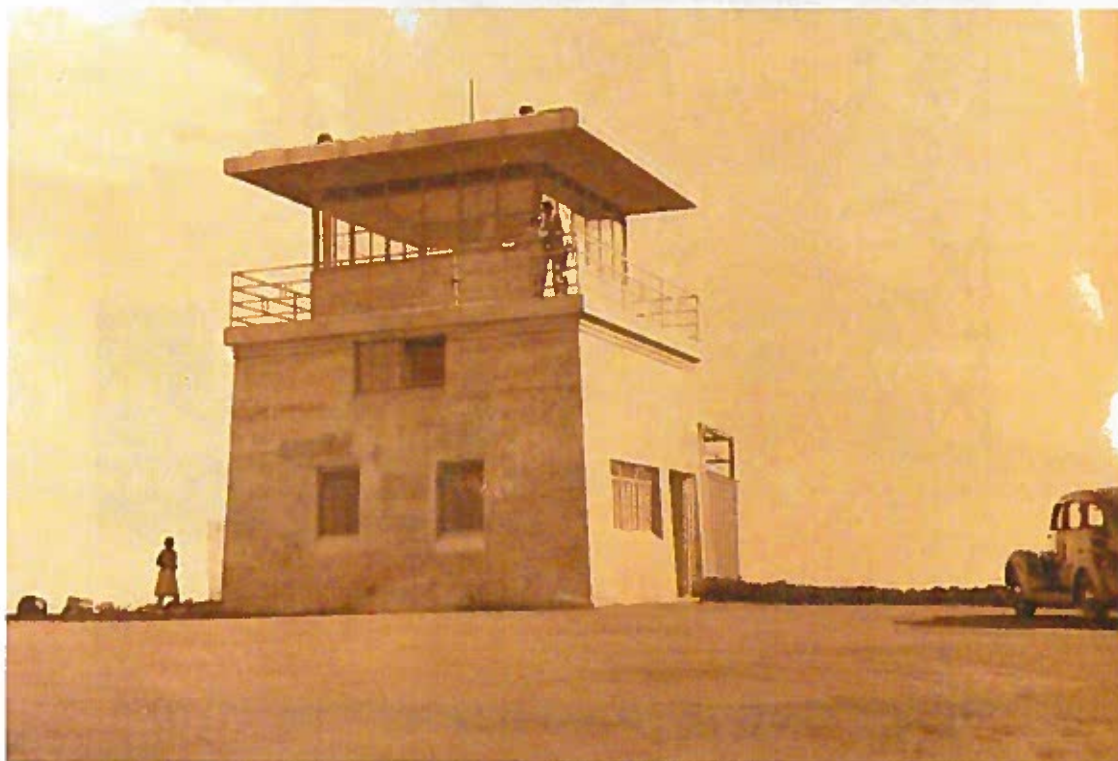
THIS 1946 PHOTO SHOWS A WOOD-FRAME, ENCLOSED VIEWING SPACE ATTACHED TO THE SOUTH WALL (VISIBLE FAR RIGHT). ALTHOUGH THE CONCRETE WALLS WERE BUSH-HAMMERED THE BOARD FORMING IS STILL VISIBLE AND THE WALLS ARE UNCOATED. THE ARTICULATED FASCIA AROUND THE ROOF IS VISIBLE IN THIS PHOTOGRAPH.
(PHOTO: SKINNER YELL 29893-1)

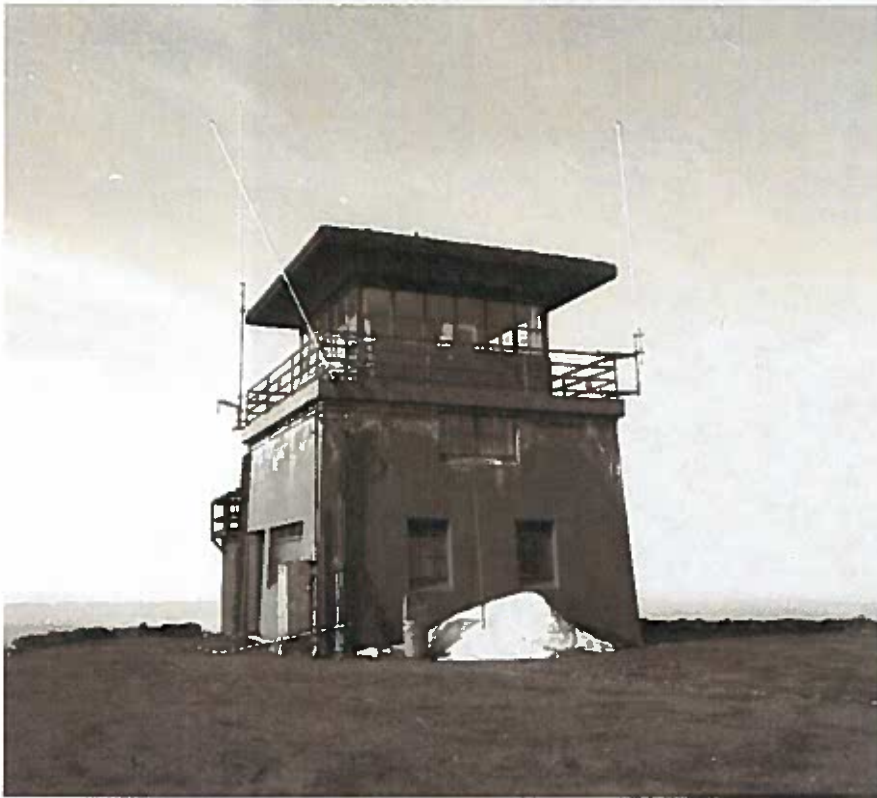
NORTH ELEVATION AS SEEN FROM THE PARKING AREA (1980). COATING OF THE CONCRETE EXHIBITS WEATHERING IN THIS PHOTO. NOTE THAT THE ORIGINAL WINDOWS ARE ALL STILL IN USE IN THIS PICTURE. (YELL 29897-2c)

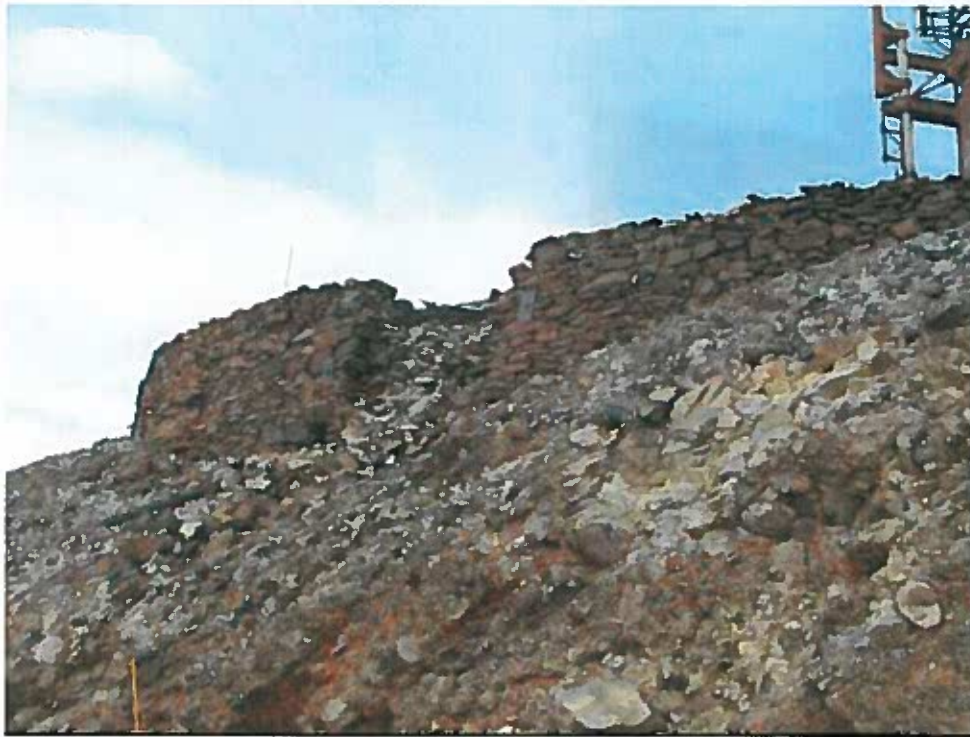
Small sections of the retainage structures have failed along the access drive and at the perimeter of the parking area. Although beyond the scope of this report, it is recommended that the deficient walls be re-built to match the appearance of the intact walls.

BREACH IN NW CORNER OF RETAINING WALL AROUND PARKING AREA; NOTE STEEL PLATES AND ANCHOR BOLTS IN CENTER OF WALL. Photo credit: Herb Dawson, NPS.

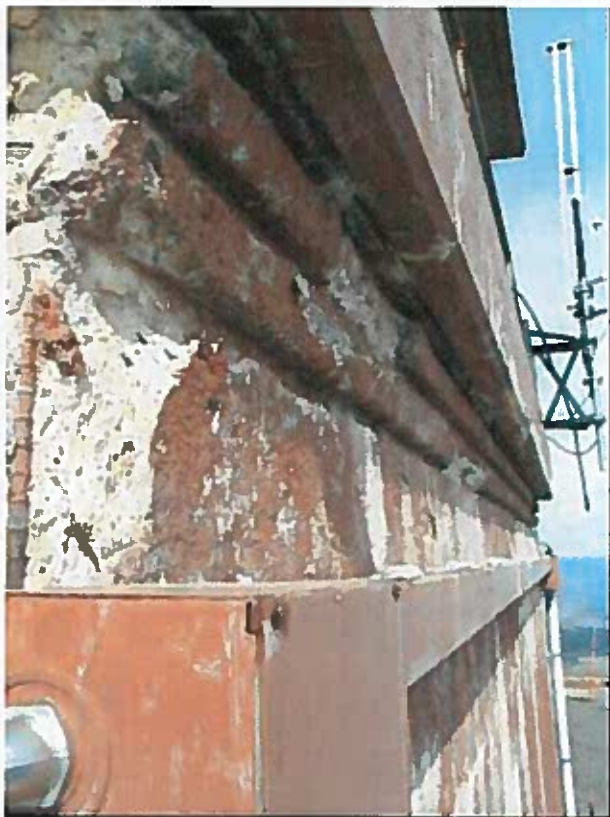
smooth surface concrete located immediately above a series of (3) narrow linear articulations that were regressed into the plane of the wall. These features underscore the subtle Art Deco stylistic influence of the 1939 tower and are significant design features. Portions of this fascia treatment are in poor condition (see appendix 'B' for further discussion regarding concrete materials). It is recommended that the concrete articulations be repaired and be preserved.

STREAMLINED MODERN "SPEED LINES" IN THE CONCRETE AT THE TOP OF THE BATTERED WALLS OF THE 1939 STRUCTURE. Photo credit: Herb Dawson, NPS.

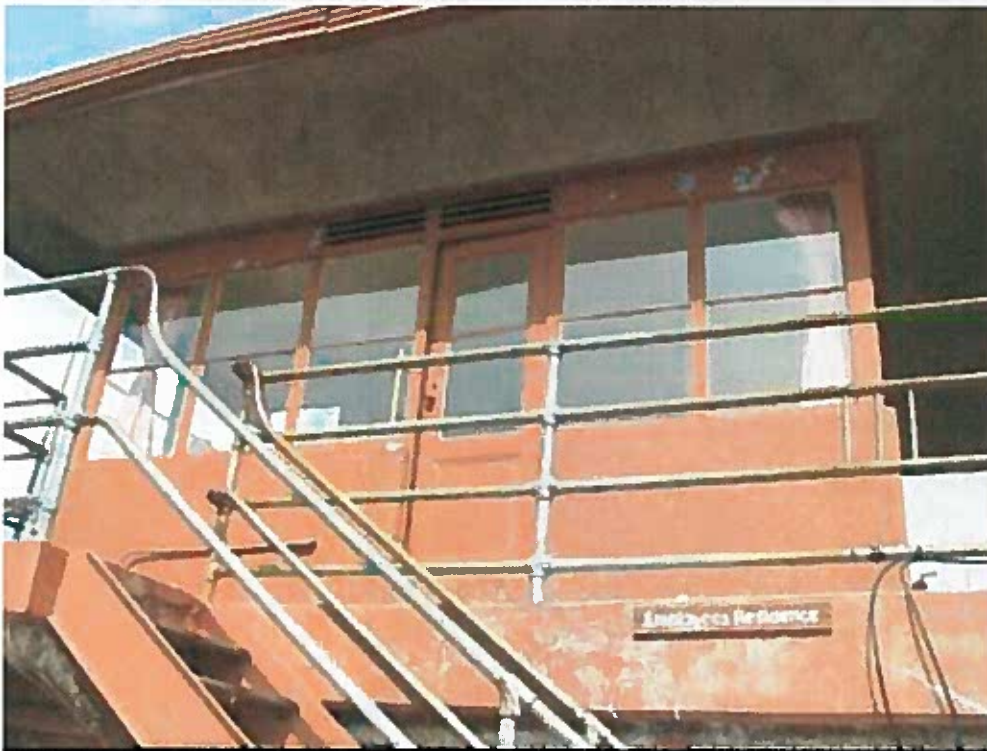
1. The fascia at the upper overhanging roof of the firewatch is a linear design of (3) shaped sheet metal bands that is believed to be attached to wood supporting nailers below. The linear design is important to the Art-Deco stylistic influence of the tower and is an original design feature. With the exception of (1) bent section it is in generally good condition.
2. The fascias of the lower metal roofs around the perimeter of the interpretive area roof and the communication antenna roof consist of preformed flat metal profiles with a bottom drip (or watershed).
3. Although it is not a traditional application in the sense of fascias defining the edge of overhanging roofs, a form of fascia occurs at the top of the cast-in-place concrete walls that surround the 1939 construction. The fascia was formed to be integral with the concrete walls and consists of a wide projecting band of

THIS PHOTO SHOWS THE ARTICULATED METAL FASCIA AT THE EDGE OF THE ROOF ABOVE THE FIREWATCH; NOTE THAT ONE AREA HAS BEEN DISPLACED AND REQUIRES REPAIR. Photo credit: Herb Dawson, NPS.

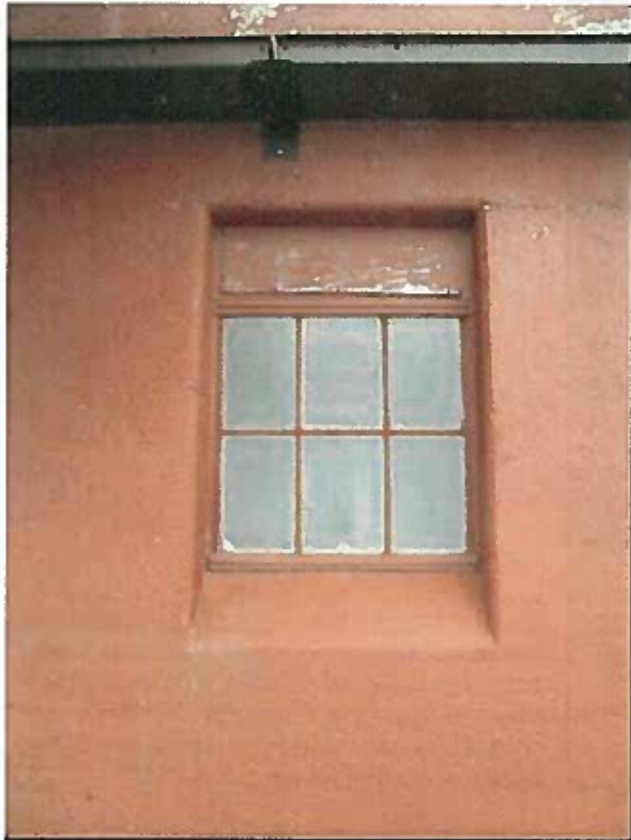
1. Windows in the lower two floors of the 1939 section of the Lookout are painted industrial steel sash with divided lites, are operable awning assemblies, and are glazed with hexagonal patterned wireglass. Selected panes of glass are cracked, overspray from exterior coating is evident on some windows, and glazing and perimeter sealant is missing at some locations. Paint on interior wall surfaces that are immediately adjacent to the windows is peeling; this is attributed to failure of window weather stripping and severe temperature variations at these locations.

LOWER FLOOR WINDOW AT THE NORTH WALL OF THE 1939 STRUCTURE. THE WINDOW IS AN INDUSTRIAL STEEL SASH WITH OBSCURE WIREGLASS. THE ORIGINAL VENTILATOR ABOVE THE WINDOW HAS BEEN COVERED WITH PLYWOOD. Photo credit: Herb Dawson, NPS.

It is recommended that these windows be rehabilitated and preserved.

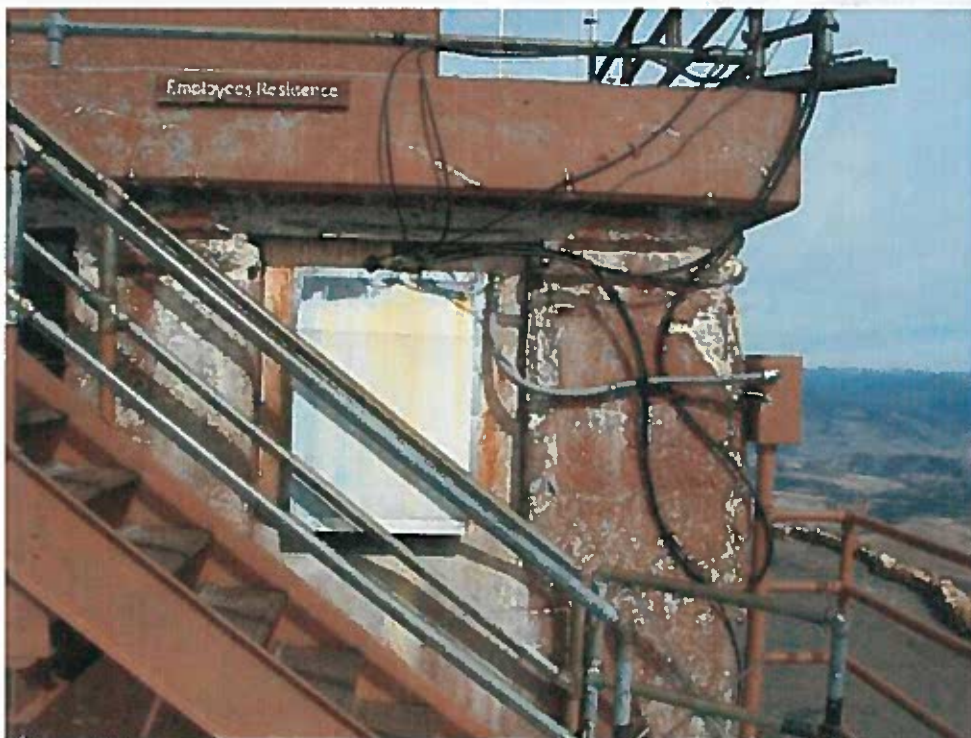
The 2nd floor of the 1939 tower originally was used as a place of residence for the fire staff of the lookout. Changing the second floor spaces from residential use to spaces that house electrical / communication equipment (which generates heat) prompted the conversion of the three original window openings to use by portable air conditioners. The quality of materials used to infill the window openings around the perimeter of the air conditioners is not commensurate with other materials used at the exterior of the facility, is a source of maintenance, and is in poor condition. It is recommended that these openings be re-worked and re-designed using more permanent materials.

WINDOW INFILL AT THE UPPER BANK OF NORTH FACING WINDOWS OF THE 1939 STRUCTURE. Photo credit: Herb Dawson, NPS.

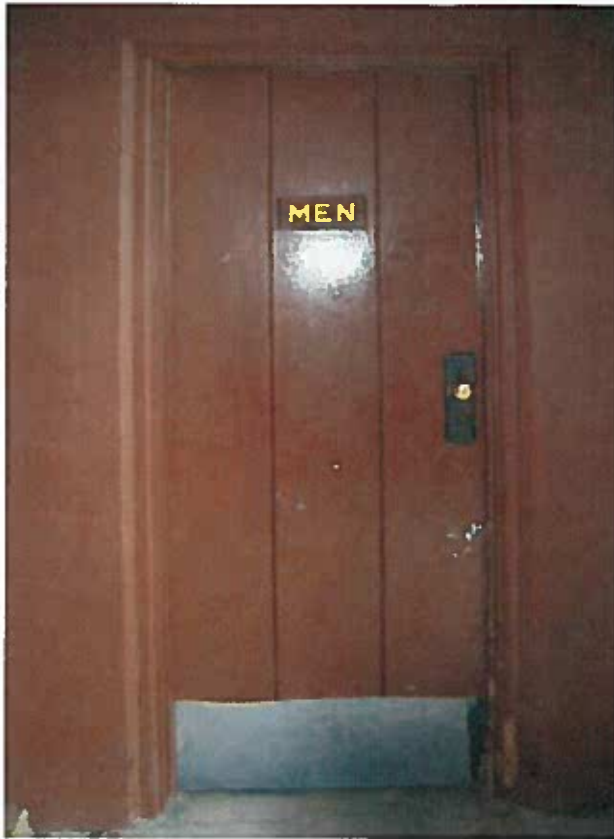
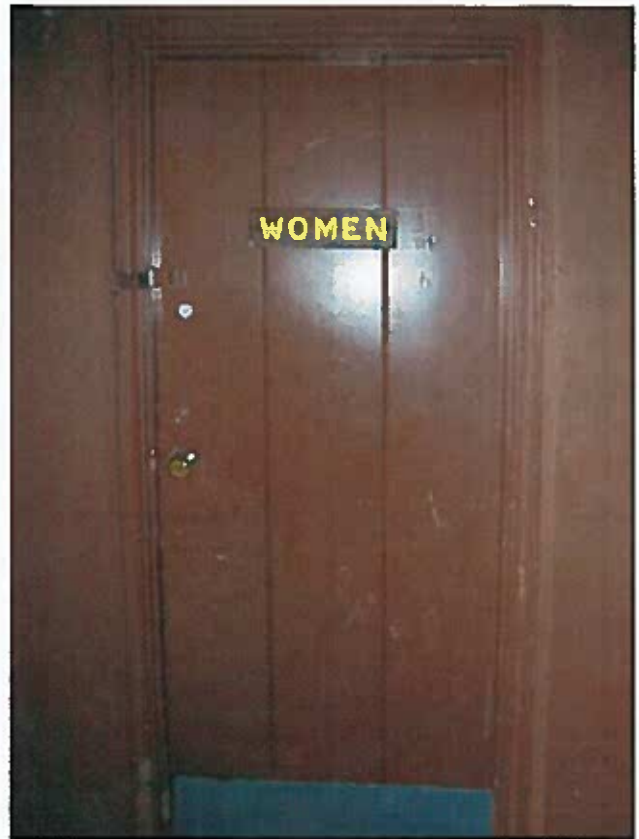
Exterior doors: There are (2) wood plank doors serving each of the toilet rooms; they are recessed in alcoves with the door into the women's restroom located in the west alcove and the door to the men's room mirrored in the east alcove. The doors are in good condition.

ORIGINAL 1939 PLANKED ENTRY DOORS FROM THE EXTERIOR ENTRANCE RECESSES INTO THE RESTROOM AREAS. NOTE THE VARIOUS APPLICATIONS OF DOOR HARDWARE. Photo credits: Herb Dawson, NPS.

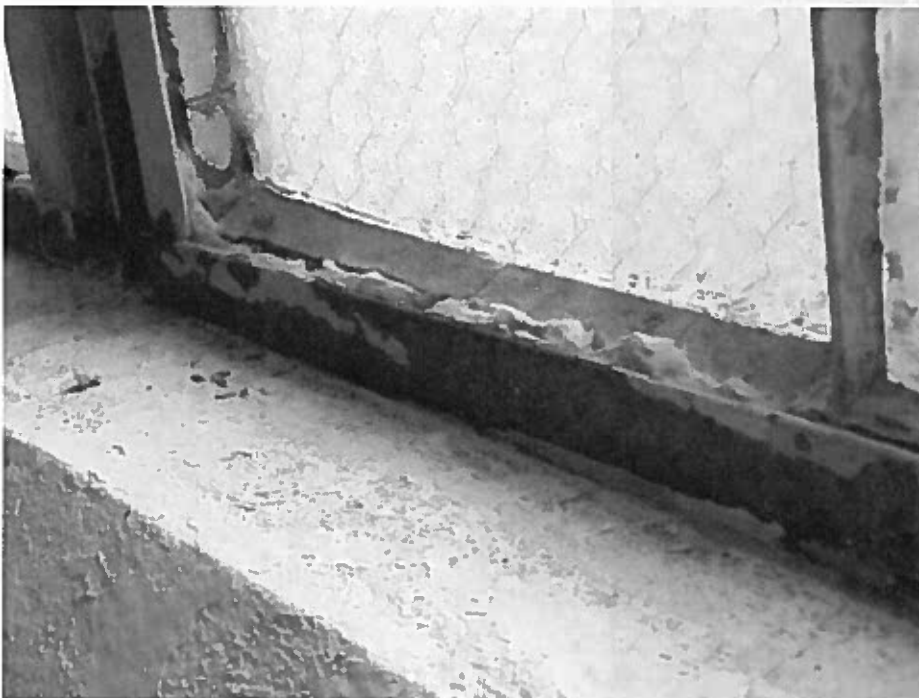
CONDITION OF INDUSTRIAL STEEL SASH WINDOWS IN 1939 BATHROOMS; NOTE THE OBSCURE GLAZING AND THE HEXAGONAL PATTERN WIREGLASS. Photo credit: Herb Dawson, NPS.

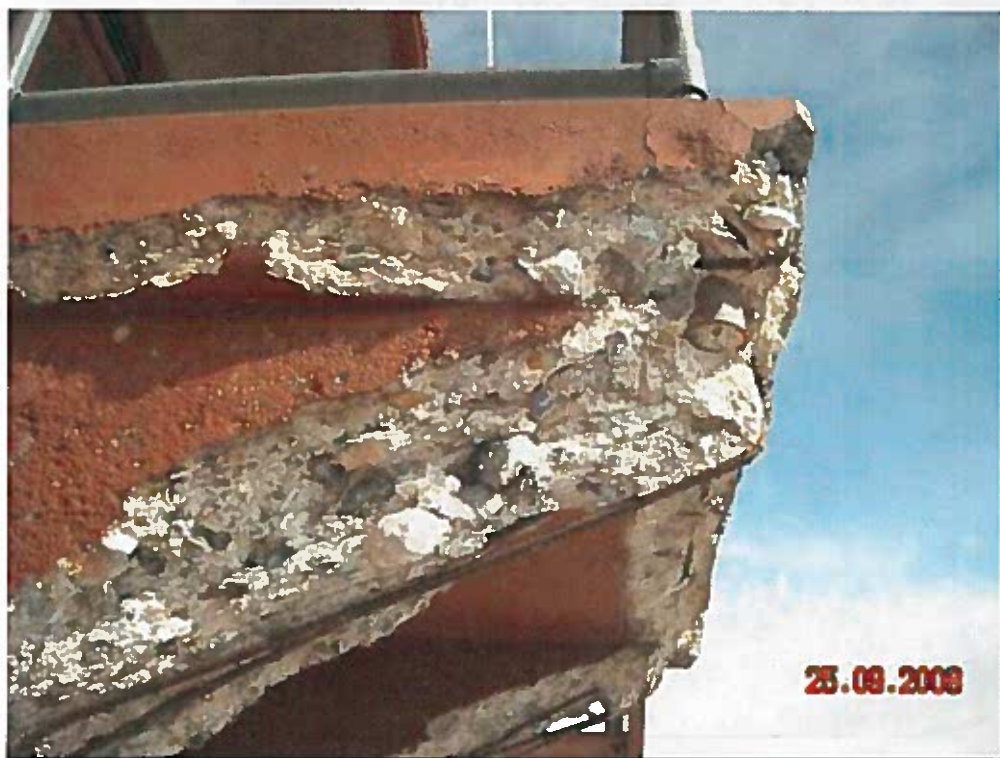
SW CORNER OF THE UPPER LANDING AT THE EXTERIOR STAIR; THE EMBEDDED SUPPORT FOR THE RAILING AT THE LANDING HAS BEEN EXPOSED BY SPALLING OF THE CONCRETE. Photo credit: Herb Dawson, NPS.

VIEW OF LANDING CORNER FROM WEST SIDE. Photo credit: Ken Sievert

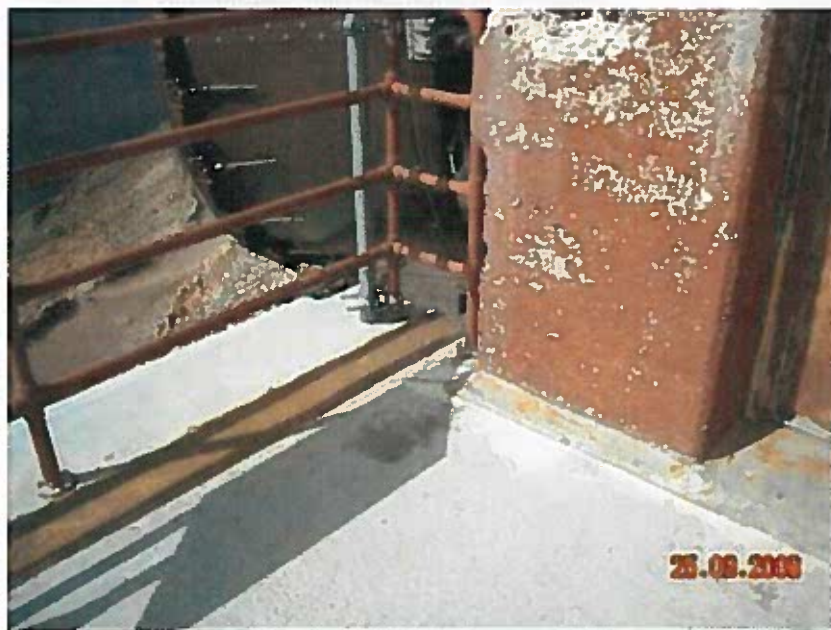
CONDITION OF TOPPING AT OUTDOOR VIEWING AREA ABOVE ENCLOSED INTERPRETIVE AREA. THE SUBSTRATE HAS BEEN COATED AND DOES NOT EXHIBIT AREAS OF DETERIORATION OR FAILURE. Photo credit: Ken Sievert.

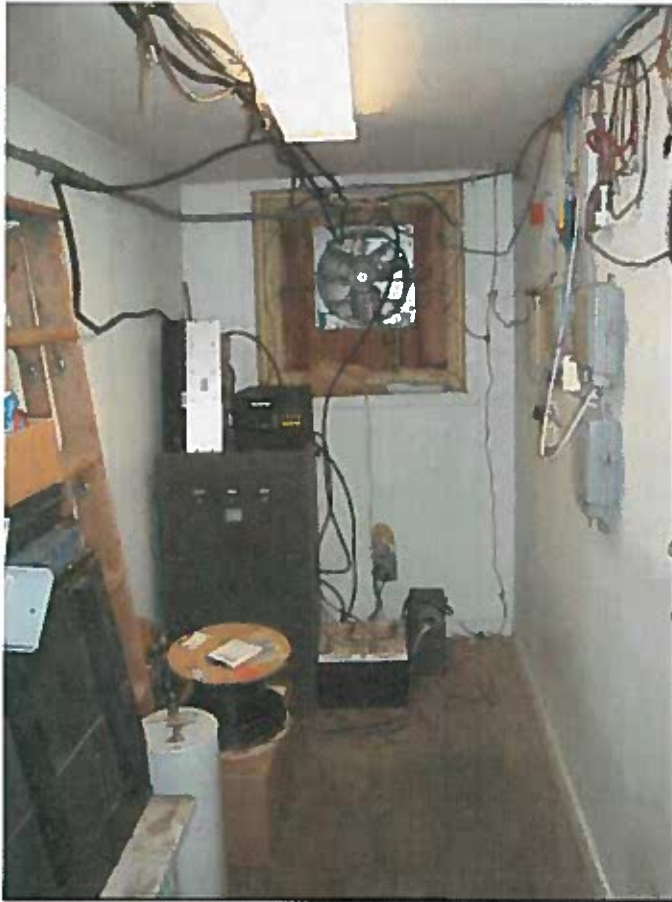
VENTILATION EQUIPMENT INSERTED INTO ORIGINAL WINDOW OPENING AT SE CORNER OF SECOND FLOOR (WORK AREA). Photo credit: Herb Dawson, NPS.

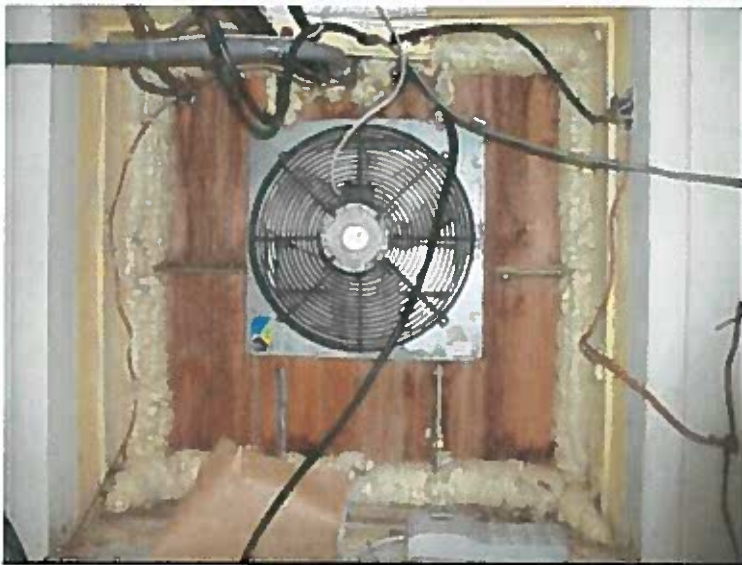
CLOSE-UP VIEW OF EXPANDING FOAM AND PLYWOOD USED FOR THE FAN INSTALLATION SHOWN ABOVE. Photo credit: Herb Dawson, NPS.

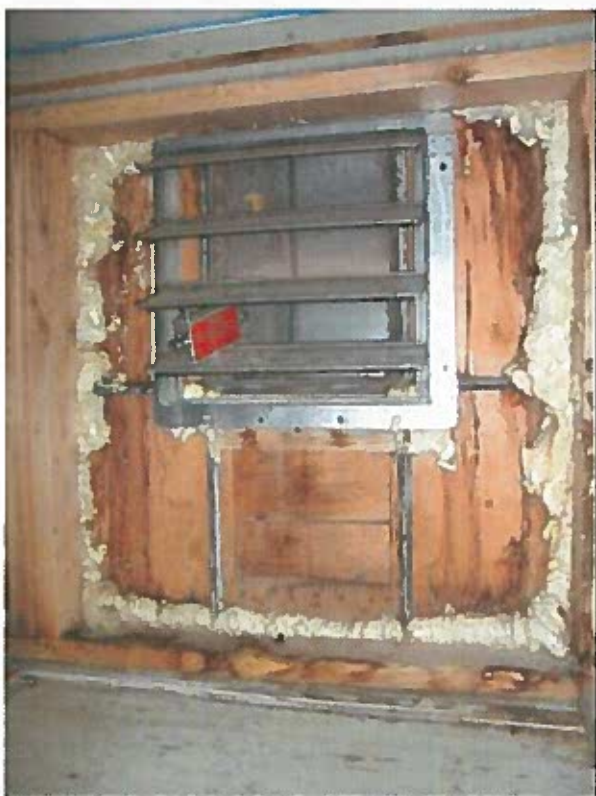
INTERIOR VIEW OF INSTALLATION SHOWN ABOVE, Photo credit: Herb Dawson, NPS.

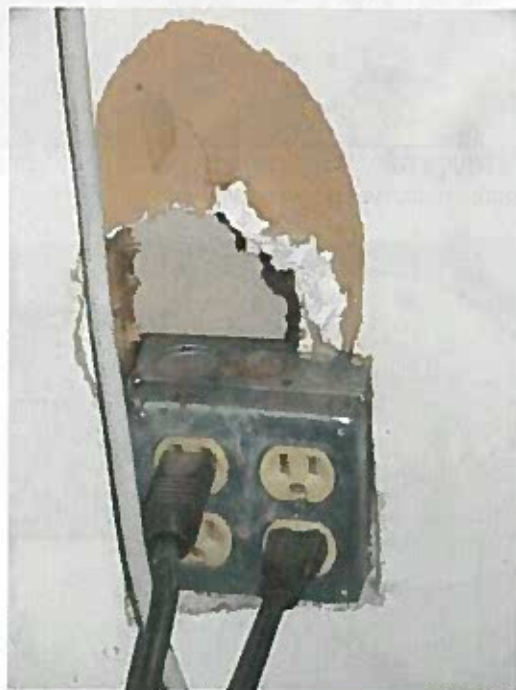
CONTEMPORARY WIRING DEVICES HAVE BEEN INCORPORATED INTO THE FURRED WALLS OF THE SECOND FLOOR OF THE 1939 STRUCTURE. Photo credit: Herb Dawson, NPS.

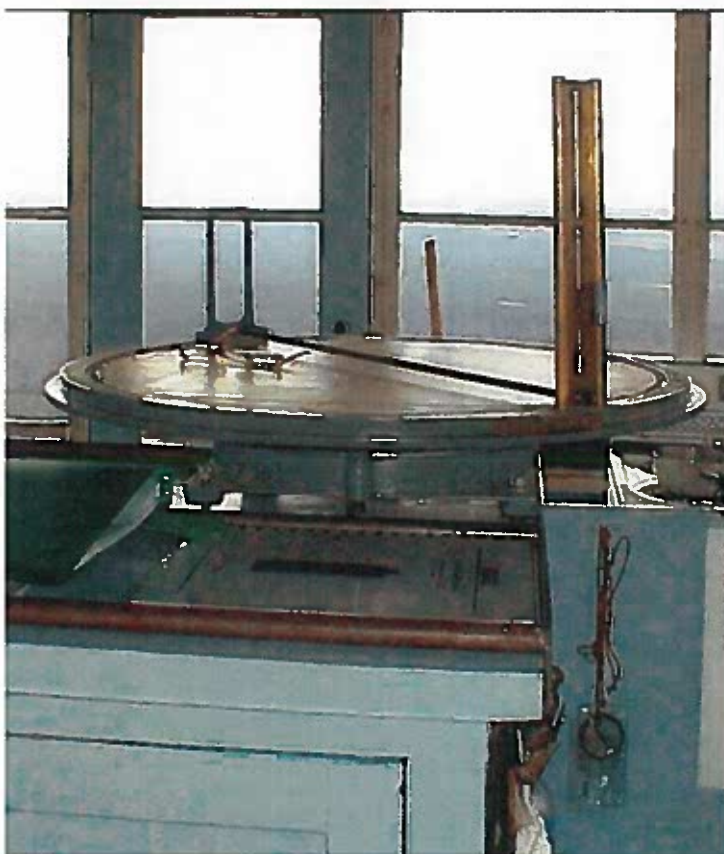
THIS FASCINATING DEVICE FOR PIN-POINTING THE LOCATION OF FIRES COULD BE FURTHER EXPLAINED FOR VISITORS IN THE INTERPRATIVE AREA BELOW. IT MAY ALSO BE DESTINED FOR REDUCED USE IN THE FUTURE DUE TO OTHER TECHNOLOGICAL ADVANCES. Photo credit: Ken Sievert.

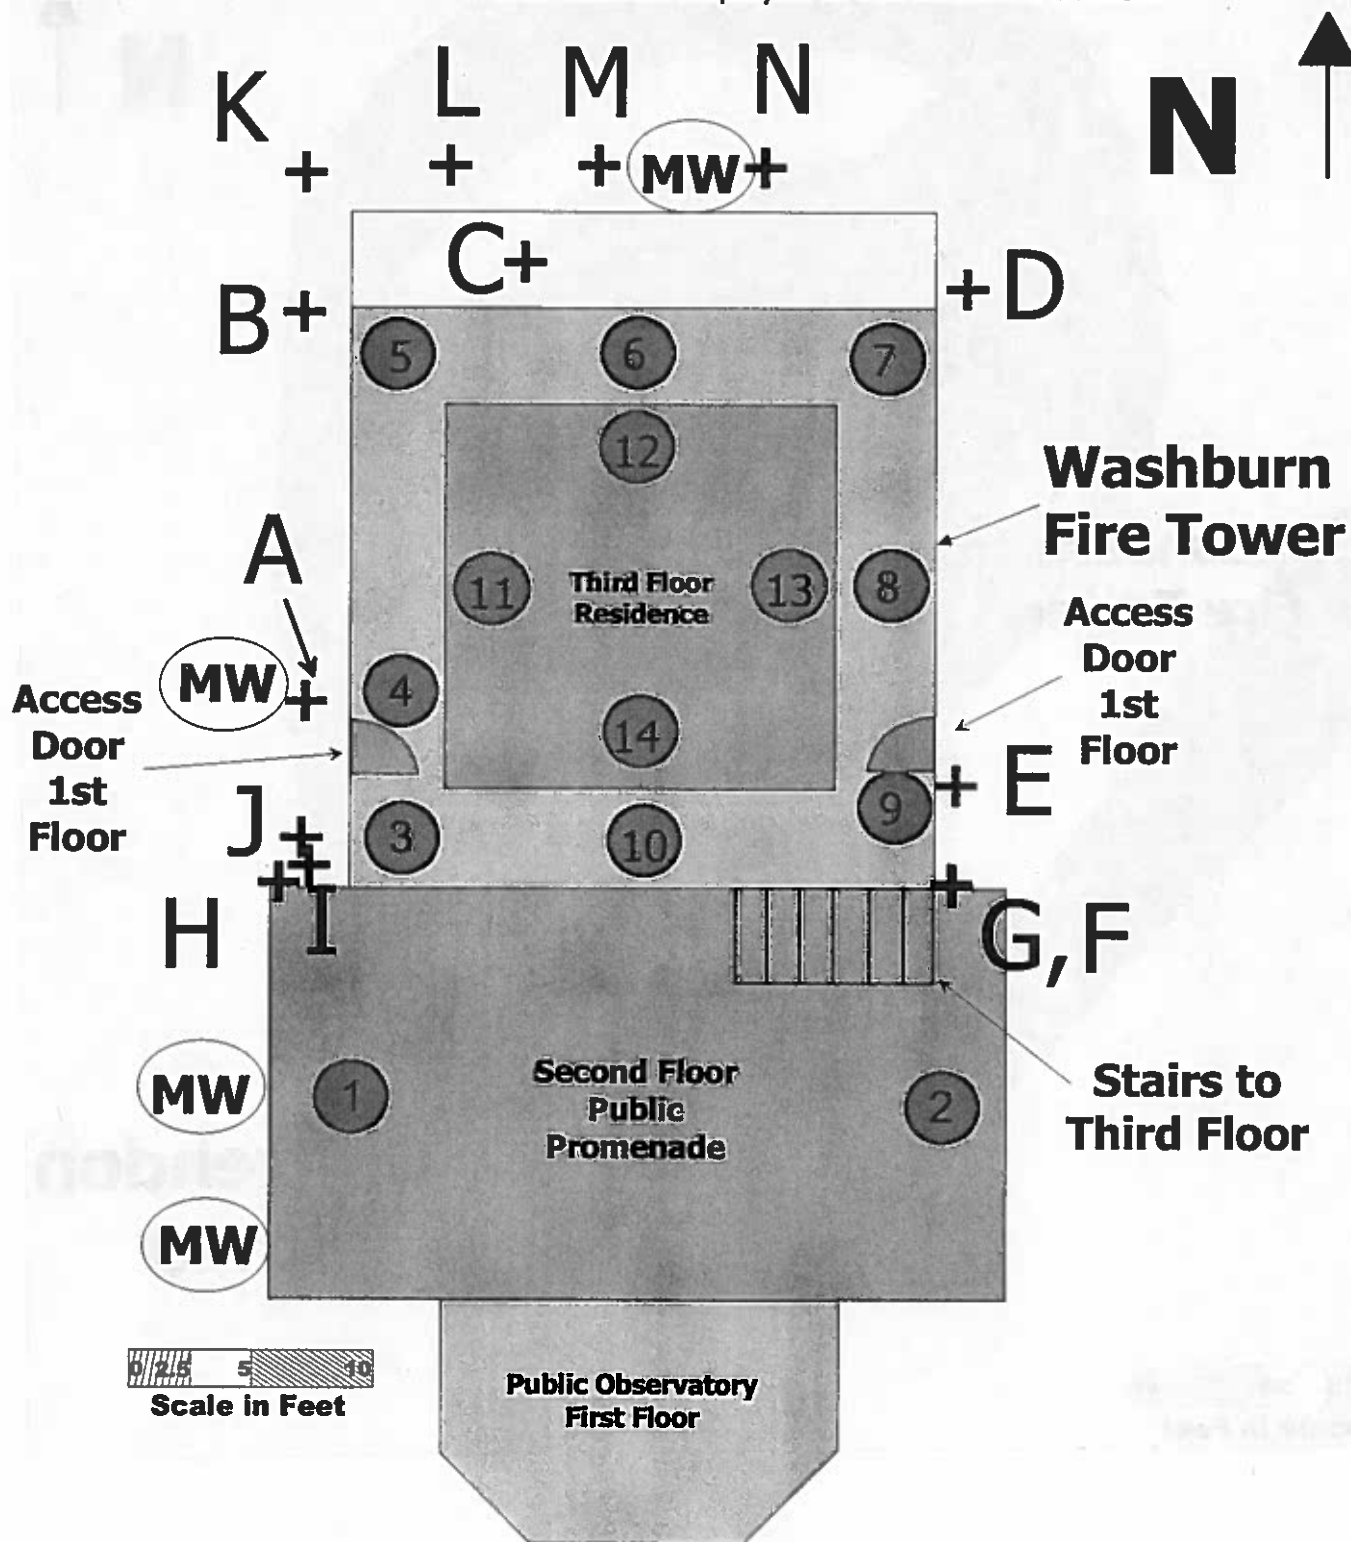
This drawing depicts the details of the antenna layout of the Washburn communications facility. The antenna legend is on the next page. The red circles represent measurement locations with values that are displayed in the RESULTS section.

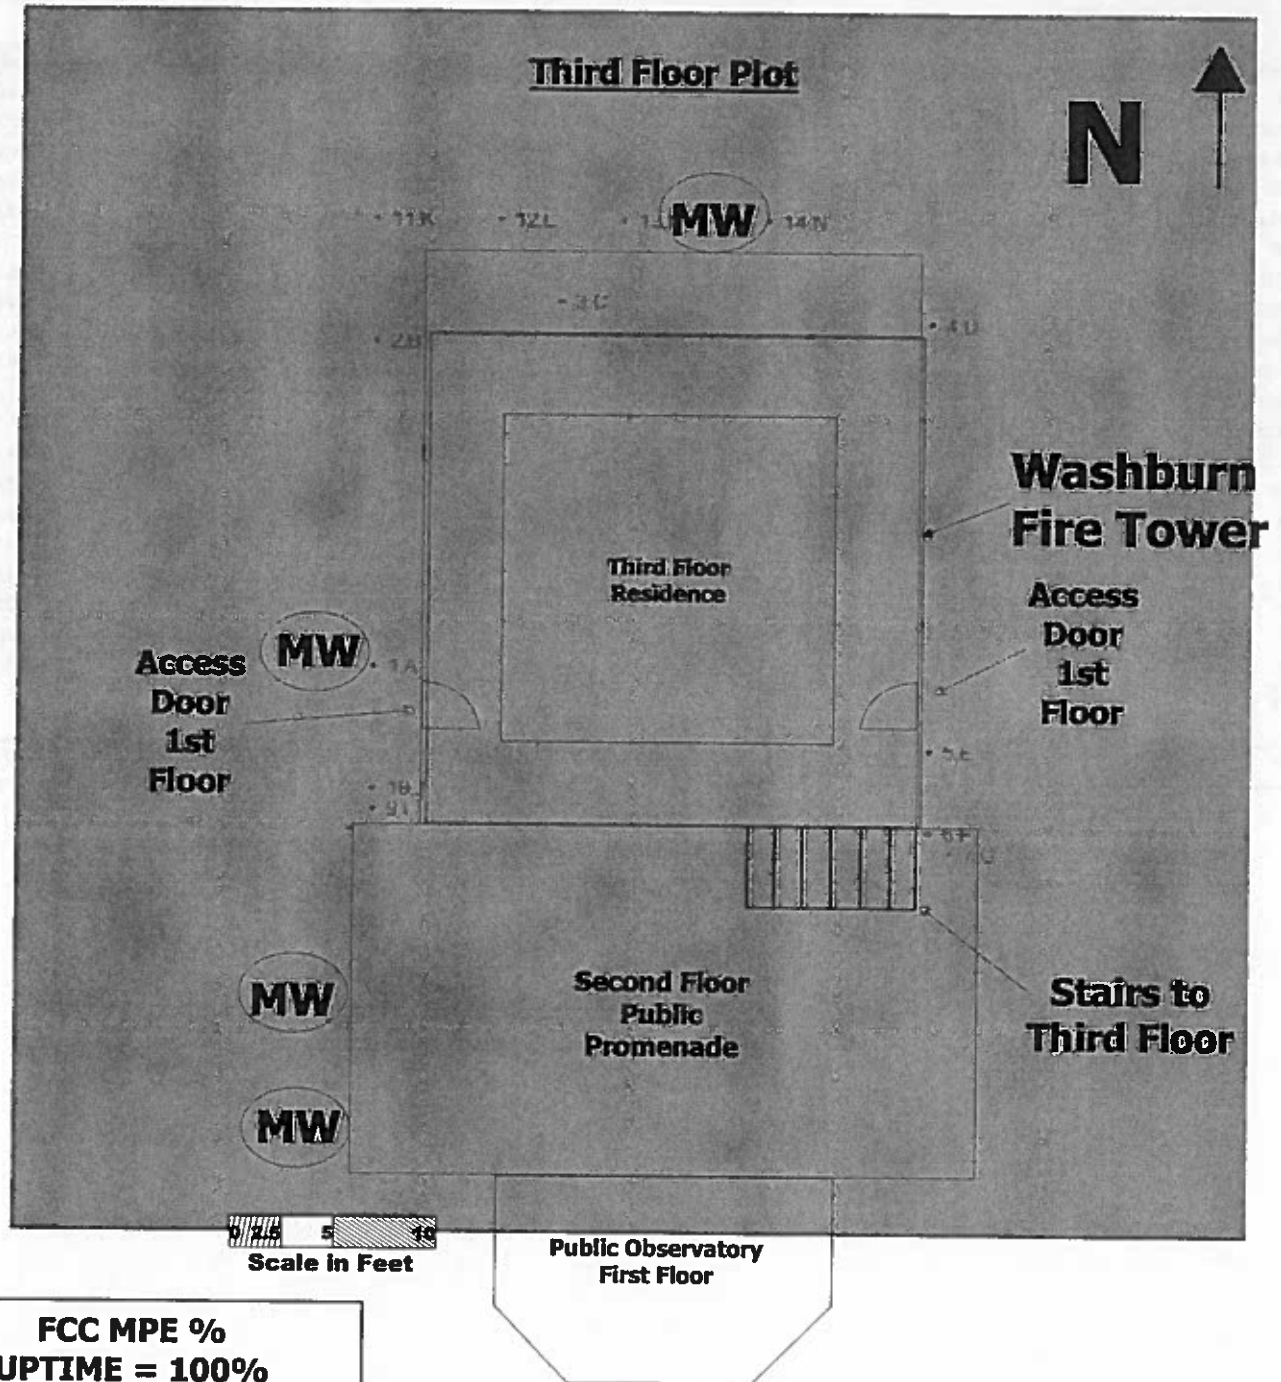
This is the predicted software plot for the third level (top floor) using the FCC PUBLIC and FCC OCCUPATIONAL standard. The grid is in 10-foot increments. This shows that the FCC Public MPE limits can be exceeded at this site but mostly in inaccessible locations.

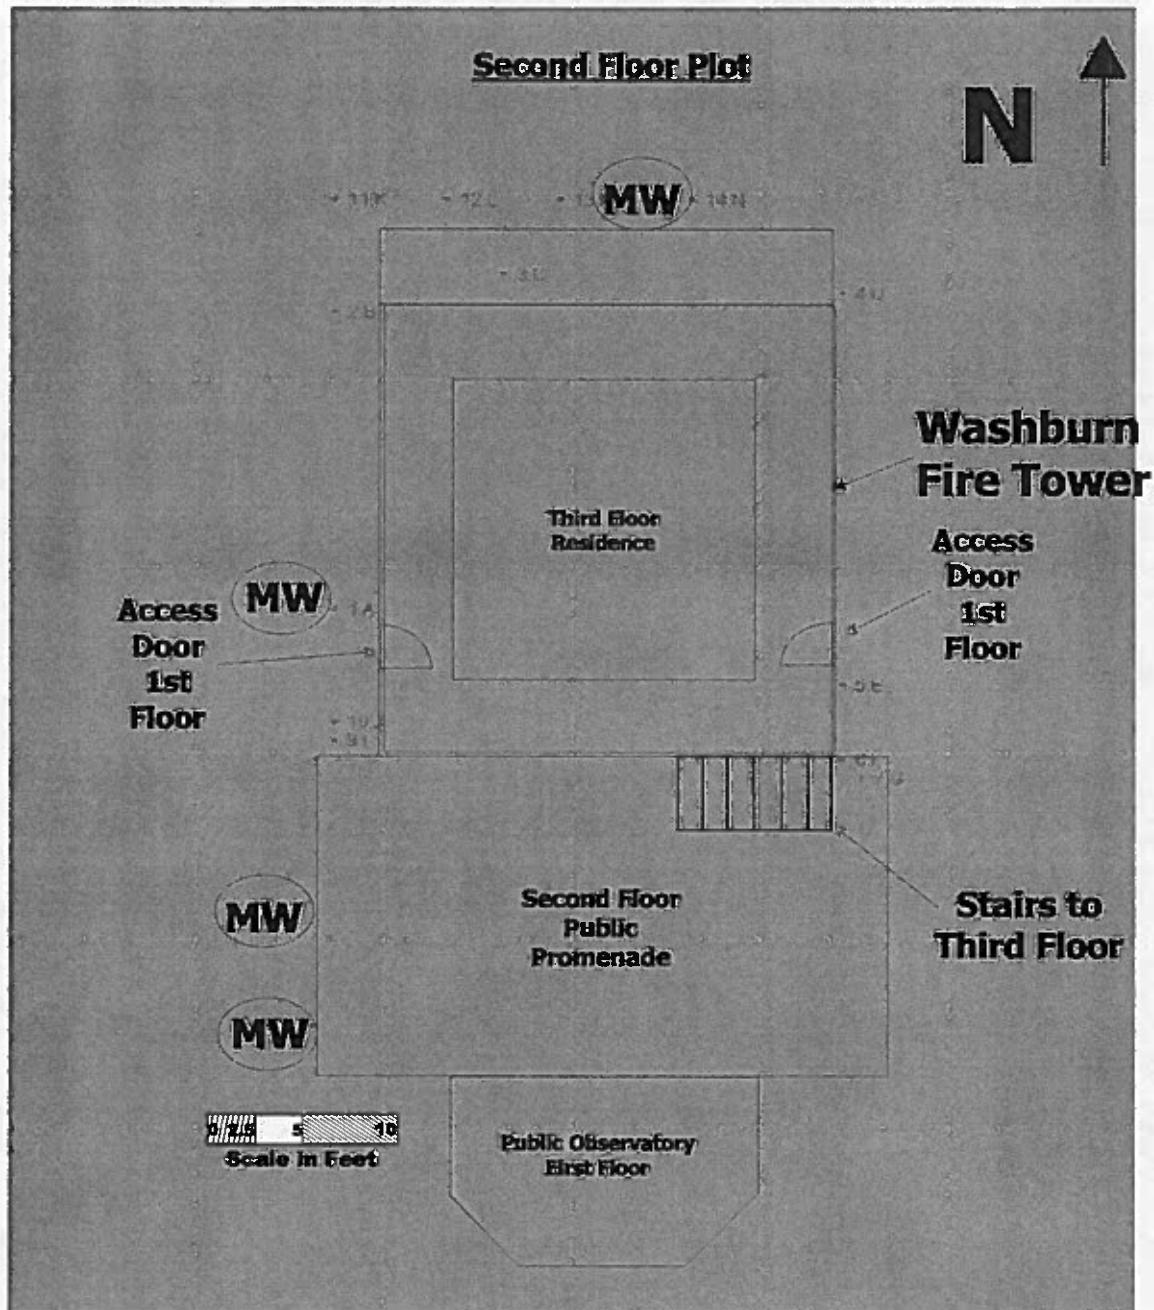
This is the predicted software plot for the second level using the FCC PUBLIC and FCC OCCUPATIONAL standard. The grid is in 10-foot increments. This shows that the FCC Public and OCCUPATIONAL MPE limits cannot be exceeded at this level.

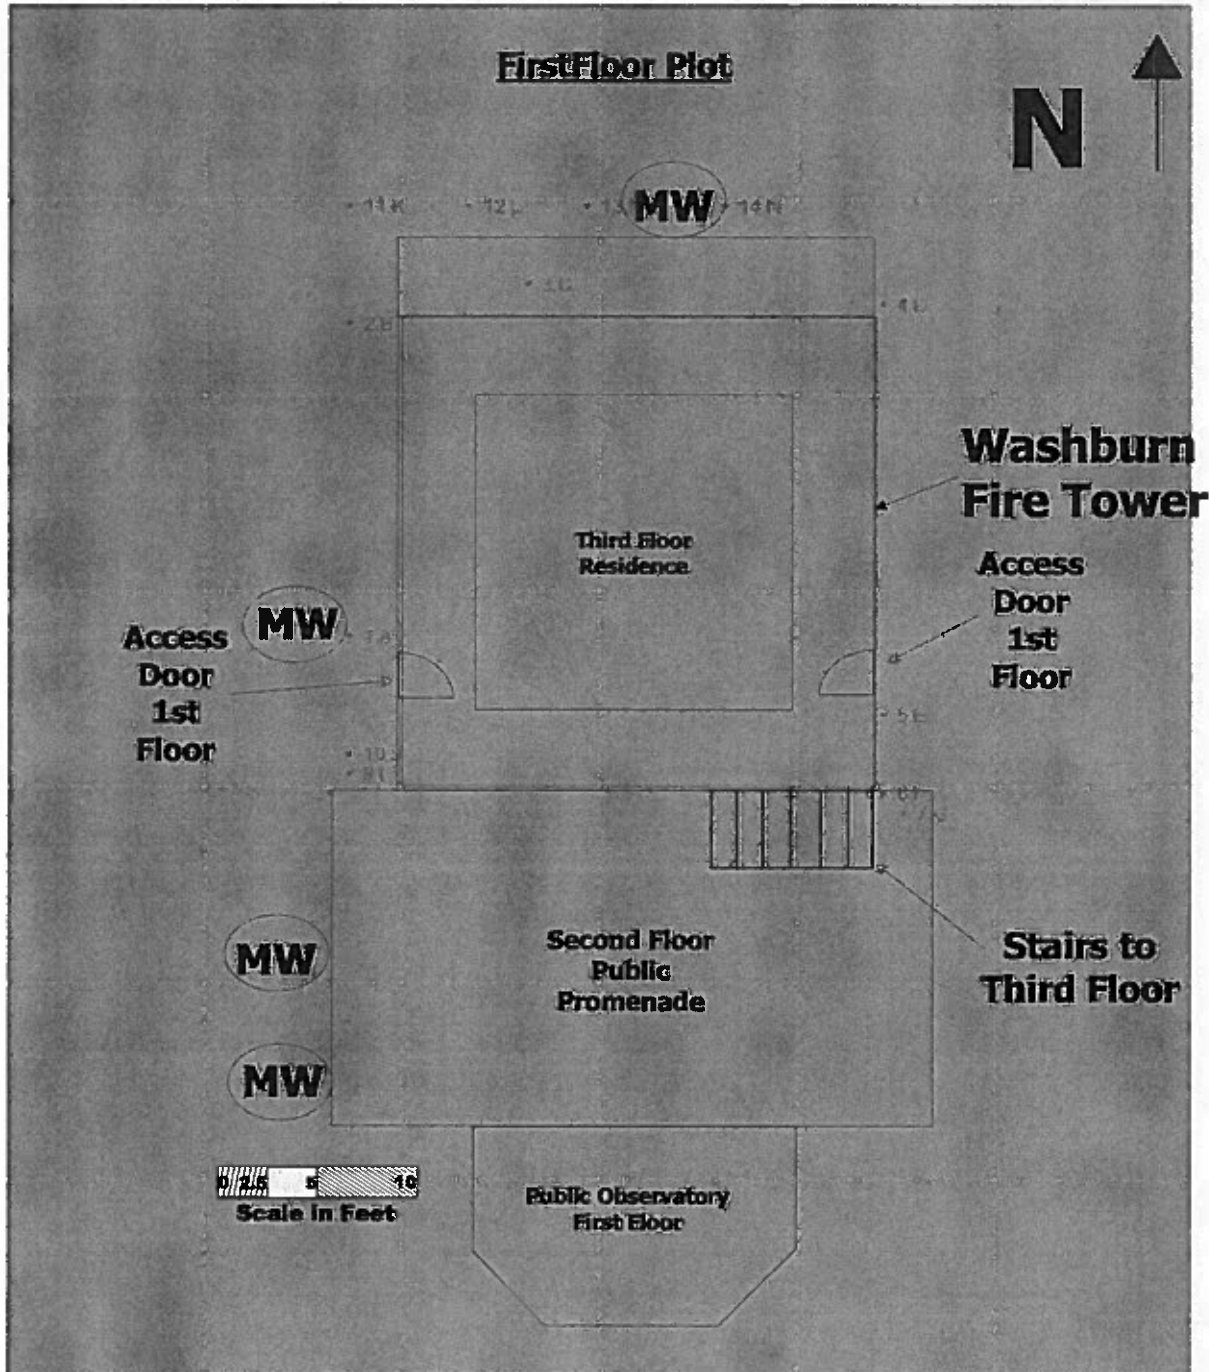
This is the predicted software plot for the first level (ground) using the FCC PUBLIC and FCC OCCUPATIONAL standard. The grid is in 10-foot increments. This shows that the FCC Public and OCCUPATIONAL MPE limits cannot be exceeded at this level.

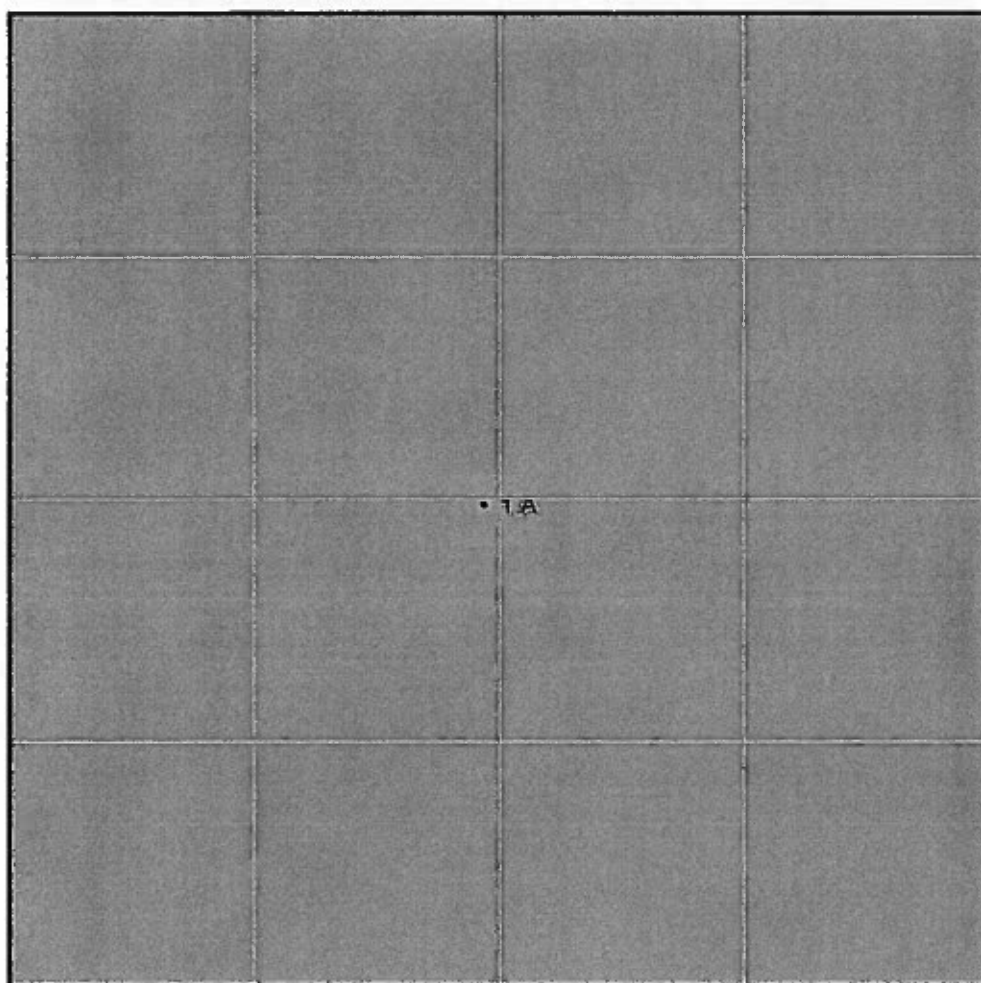
This is the predicted software plot for the area around the NPS Bluewave VHF 165 MHz transmitter located to the South of the watch tower using the FCC PUBLIC and FCC OCCUPATIONAL standard. The grid is in 10-foot increments. This shows that the FCC Public MPE limits can be exceeded at this level up to a distance of 1 foot from the antenna.

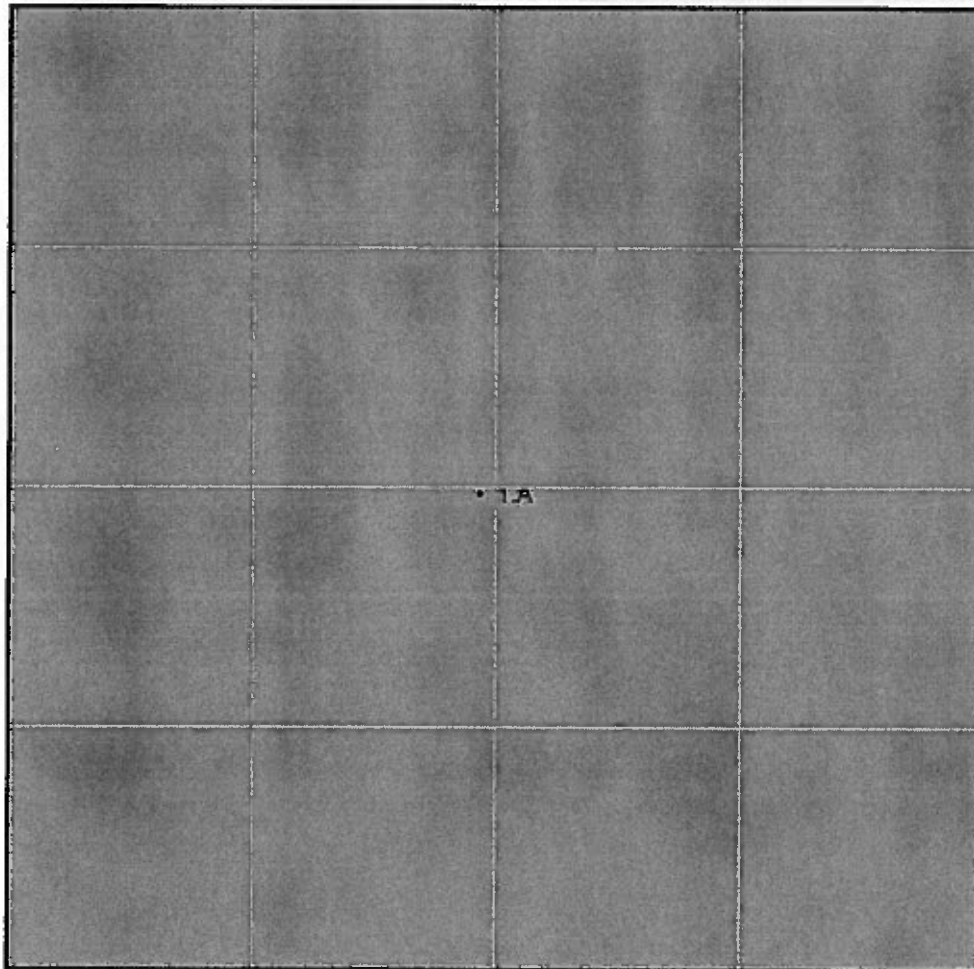
This is the predicted software plot for the area around the NPS Bluewave VHF 165 MHz transmitter located to the South of the watch tower using the FCC PUBLIC and FCC OCCUPATIONAL standard. The grid is in 10-foot increments. The transmit duty cycle was reduced to 10% to present a more probable exposure situation. This shows that the FCC Public and OCCUPATIONAL MPE limits cannot be exceeded at this location.
