REDWOOD N. P.  
LIBRARY  
South Operations Center

REPORT ON EROSION CONTROL WORK ON TEST AREA FOUR, REDWOOD NATIONAL PARK, SEPTEMBER - OCTOBER, 1977

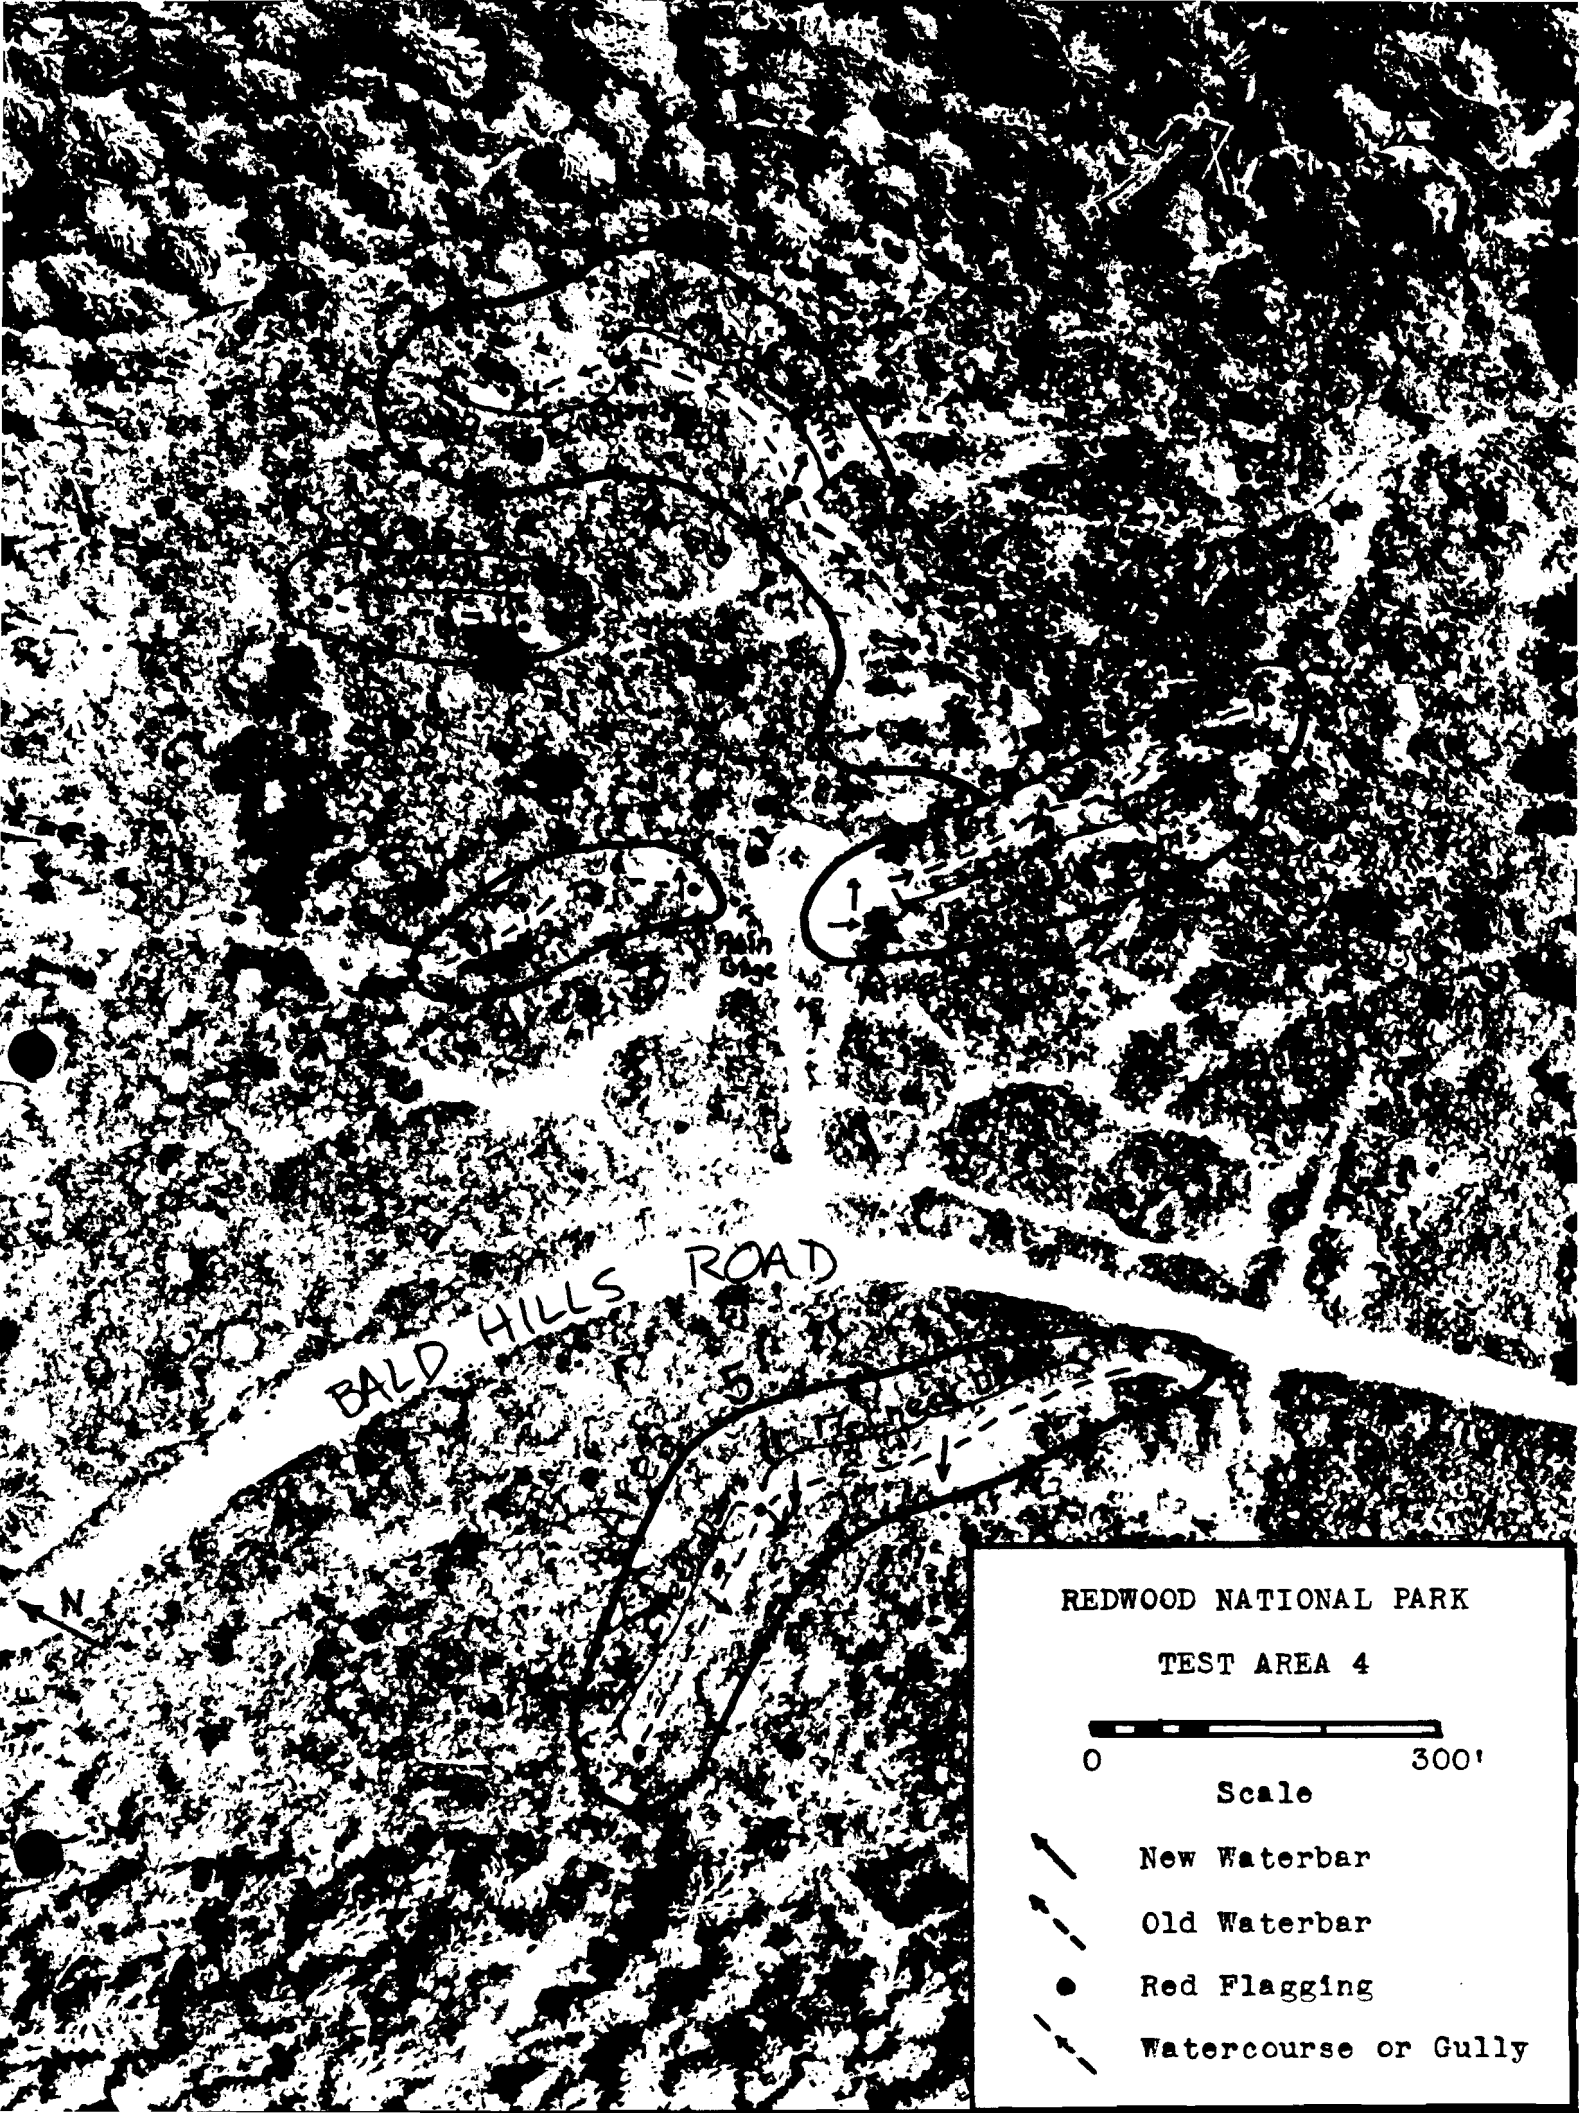
TEST AREA 4

Area #4 Area four is a steeply sloping skid trail, about 175 feet long, gullied to a maximum of about one and a half feet deep. It is moderately revegetated. It can be found as follows: Angle sharply leftward at the double streamer on the fir tree in area one, indicated on the map. Plough through a thicket of fir trees for about 30' to 40', until you reach skid trail, flagged in blue at the beginning.
