REPORT ON THE REHABILITATION  
OF SITE 80-6

REDWOOD NATIONAL PARK

by  
Patrick Teti

June 1981

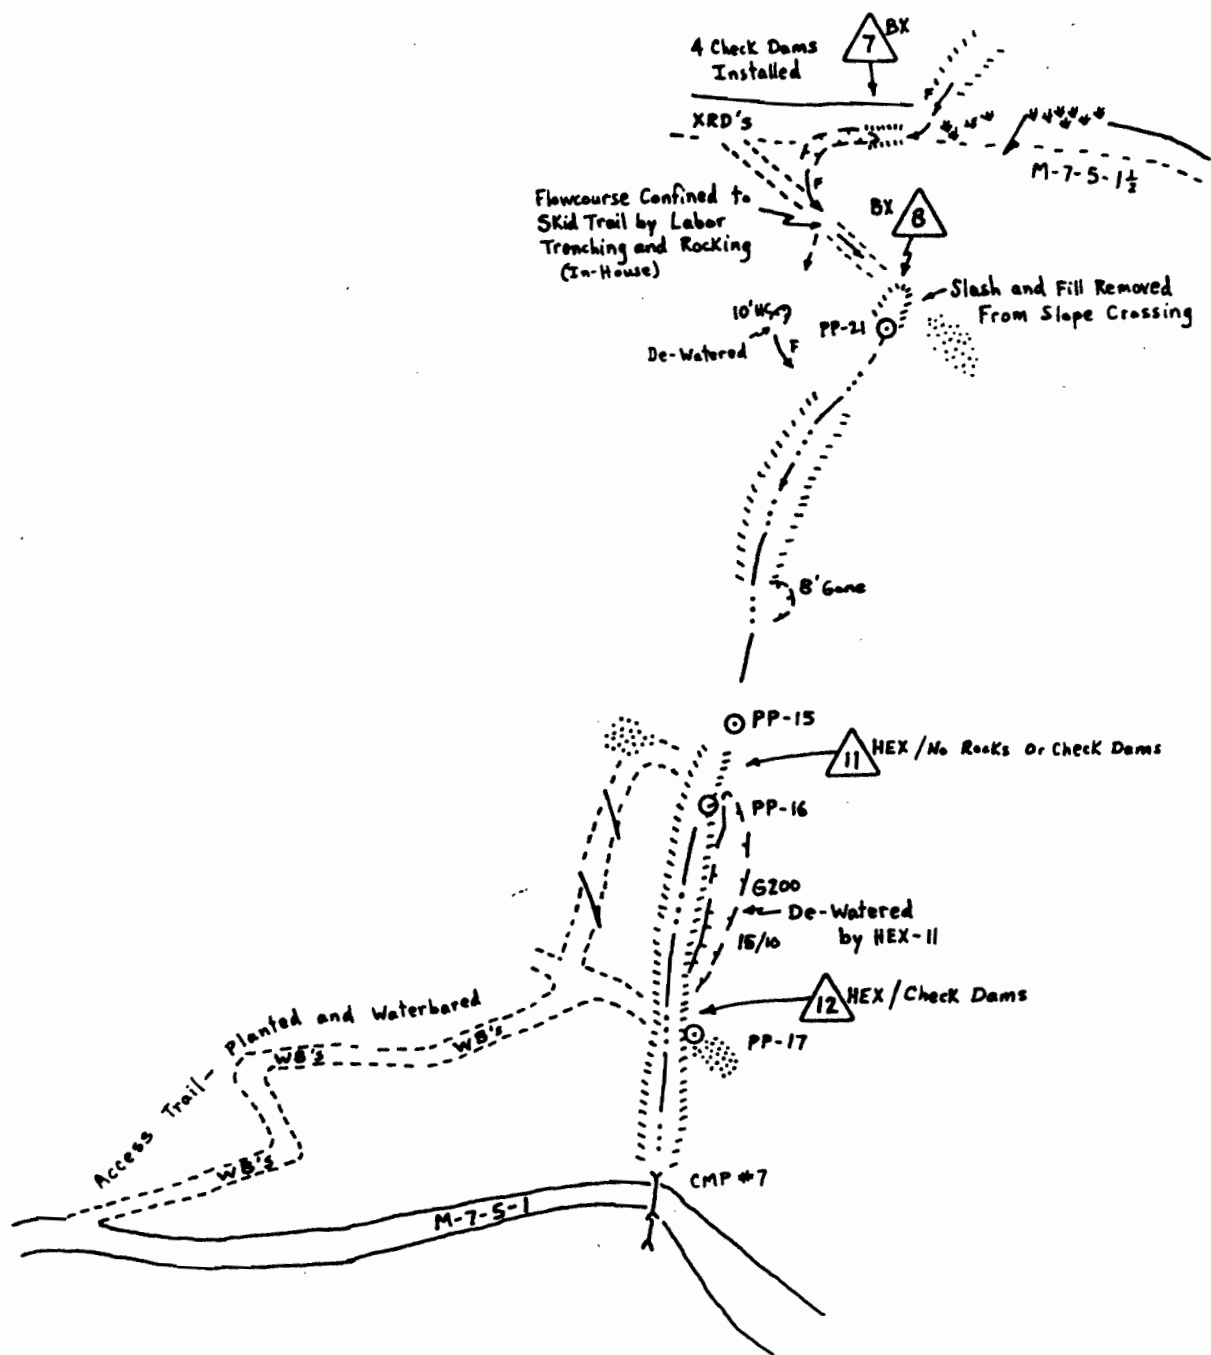
Figure 6. Geomorphic Features: Sites 7, 8, 11, and 12

The haul road crossing at Site 7 (figure 6, p. 23) was treated by attempting to stabilize the present, diverted channel with rocks and check dams instead of by excavating the road fill from the original thalweg. This treatment was prescribed before the magnitudes of the 10 and 25 year peak flows were calculated. It is now apparent, that the check dams and the diverted channel are not designed to contain the flows with a recurrence interval of much more than two years. This will almost certainly lead to reactivation of a ten foot headcut with an ultimate sediment yield of up to 170 cubic yards. This site could have been more effectively treated by re-establishing the natural channel gradient, especially considering the lesser need for labor intensive work associated with de-watering the headcut and skid trail compared with armoring them. This is a good example of a site where treatment might have been more effectively prescribed, had the rational method for peak flow estimation been implemented earlier.
