# **SOIL EROSION STUDY**

**HUBBELL TRADING POST, NATIONAL HISTORIC SITE**

**Ganado, Arizona**

SOIL EROSION STUDY  
HUBBELL TRADING POST NATIONAL HISTORIC SITE  
GANADO, ARIZONA  
CX 702930008

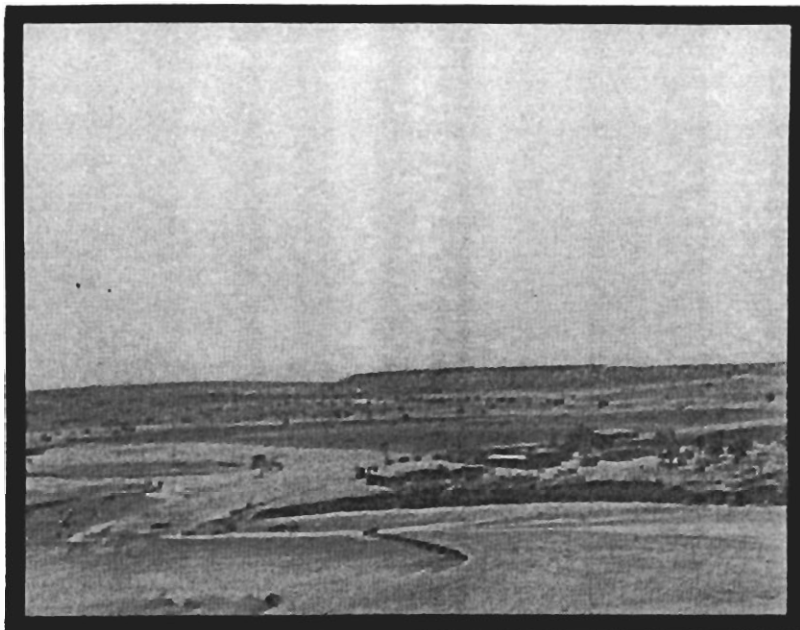
Photo 1: Hubbell Trading Post (ca. 1906) showing the post situated on a rather narrow point of land on the inside of a meander in the Pueblo Colorado Wash. At this time there is little evidence of channel incision within the flood plain, particularly upstream from the Trading Post (view from Hubbell Hill looking southeast).

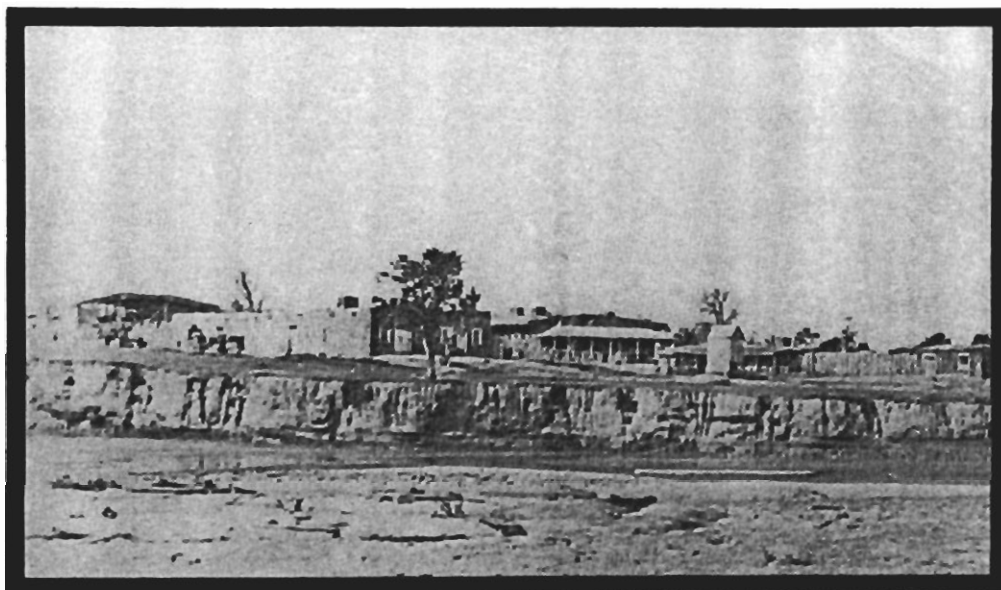
Photo 3: A view from the floor of the wash (ca. 1910) showing the cut bank forming the south bank of Pueblo Colorado Wash (view to the south-southwest).

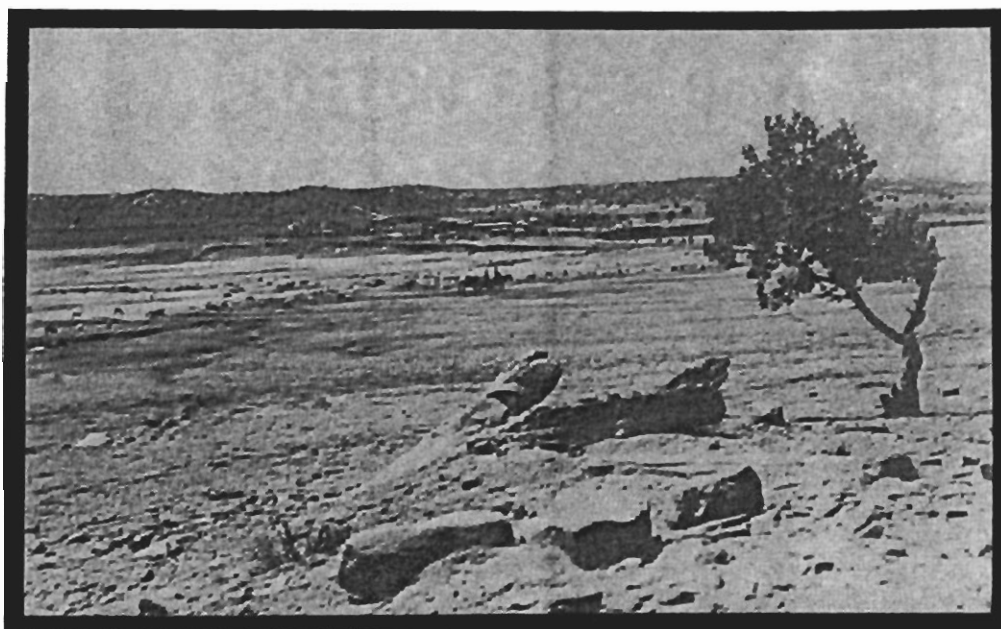
Photo 4: A view of the Trading Post from low ground northeast of the Trading Post (ca. 1913, view to the southwest). Note the lack of vegetation and the flat, unincised channel.

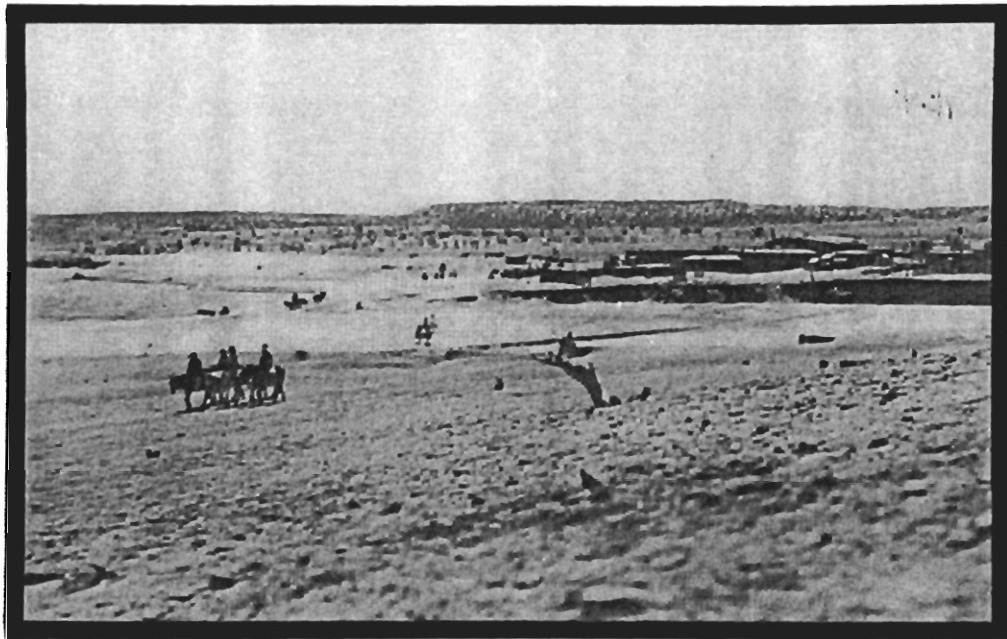
Photo 5: A view from Hubbell Hill (ca. 1913, looking southeast) showing an unincised channel and the establishment of a road crossing the wash.

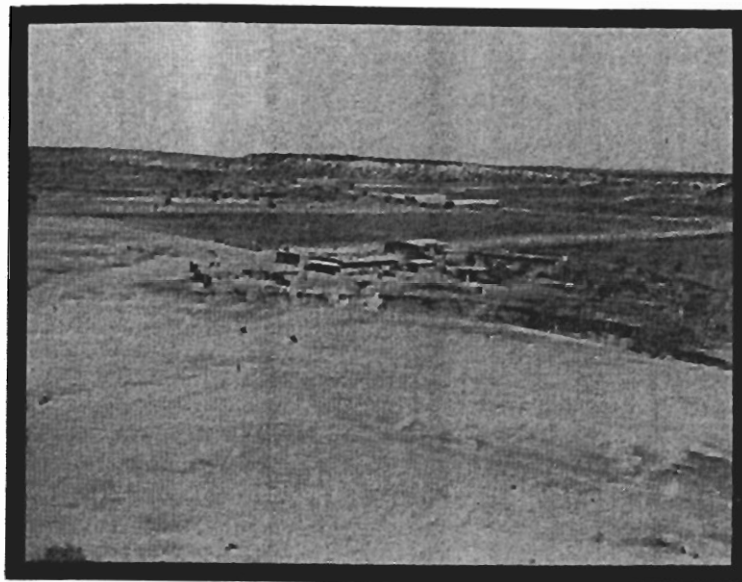
Photo 7: View from Hubbell Hill (ca. 1915) showing a flat, sandy wash floor (view to the south-east).

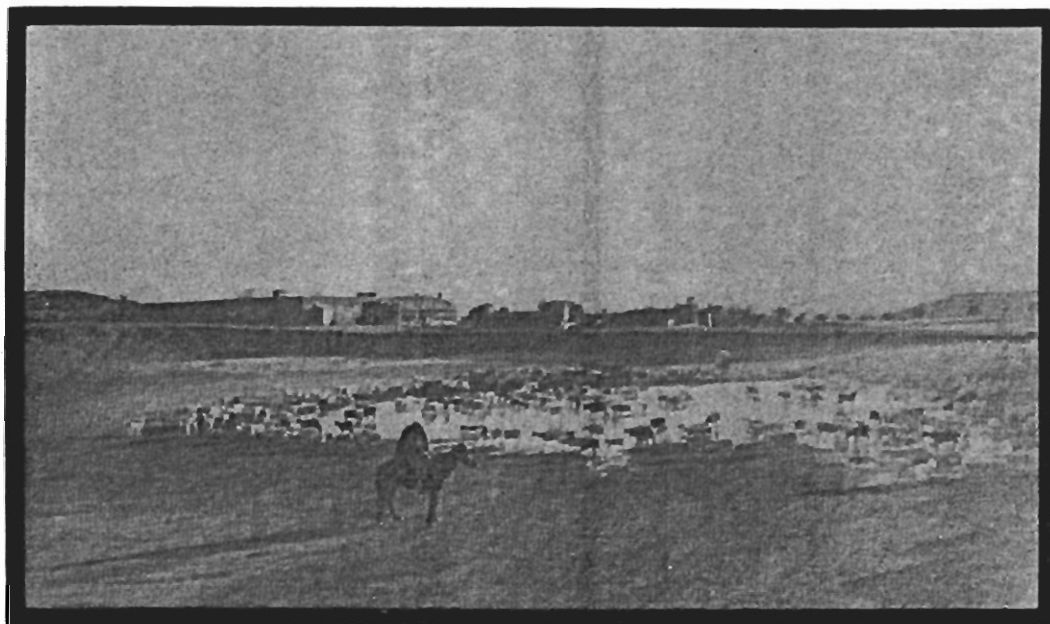
Photo 8: A view to the west-southwest from upstream of the Trading Post (ca. 1915). Cut bank walls of the inside of the meander on which the post is located are evident. The wash floor is flat, broad, and unincised.

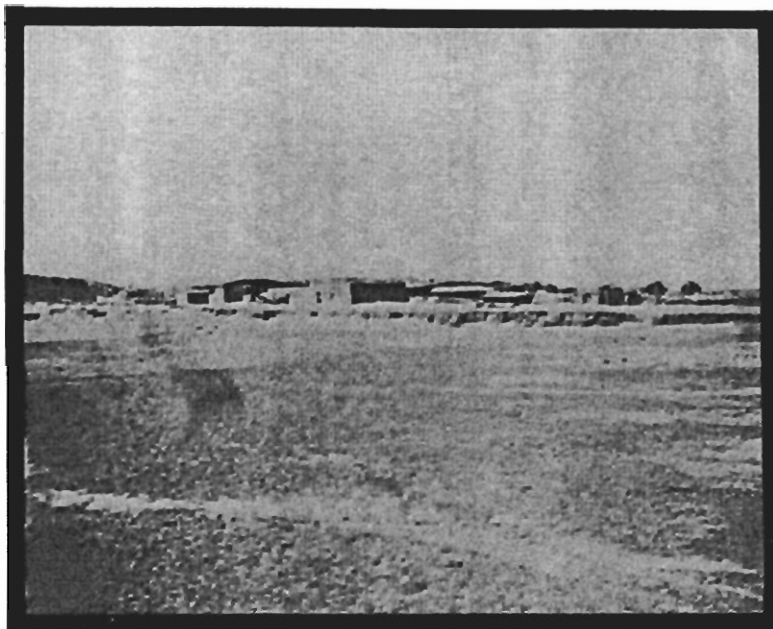
Photo 9: Hubbell Trading Post (view to the south, ca. 1920).

One photo (ca. 1920) indicates a broad, unvegetated, unincised arroyo floor.

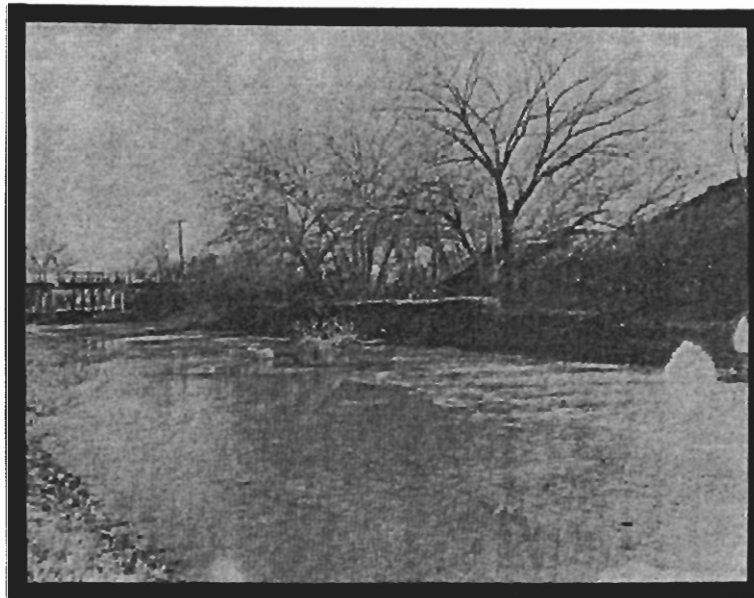
Photo 12: Completed stabilization (ca. fall, 1974); broad, unincised wash floor.

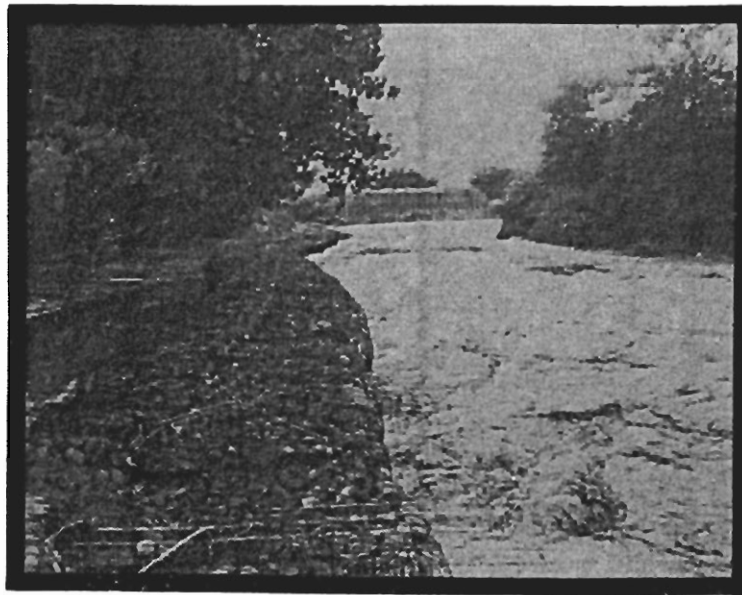
Photo 16: A view downstream (29 July 1976, looking southwest) from the gabion toward the Sand Dune Archaeological Site.

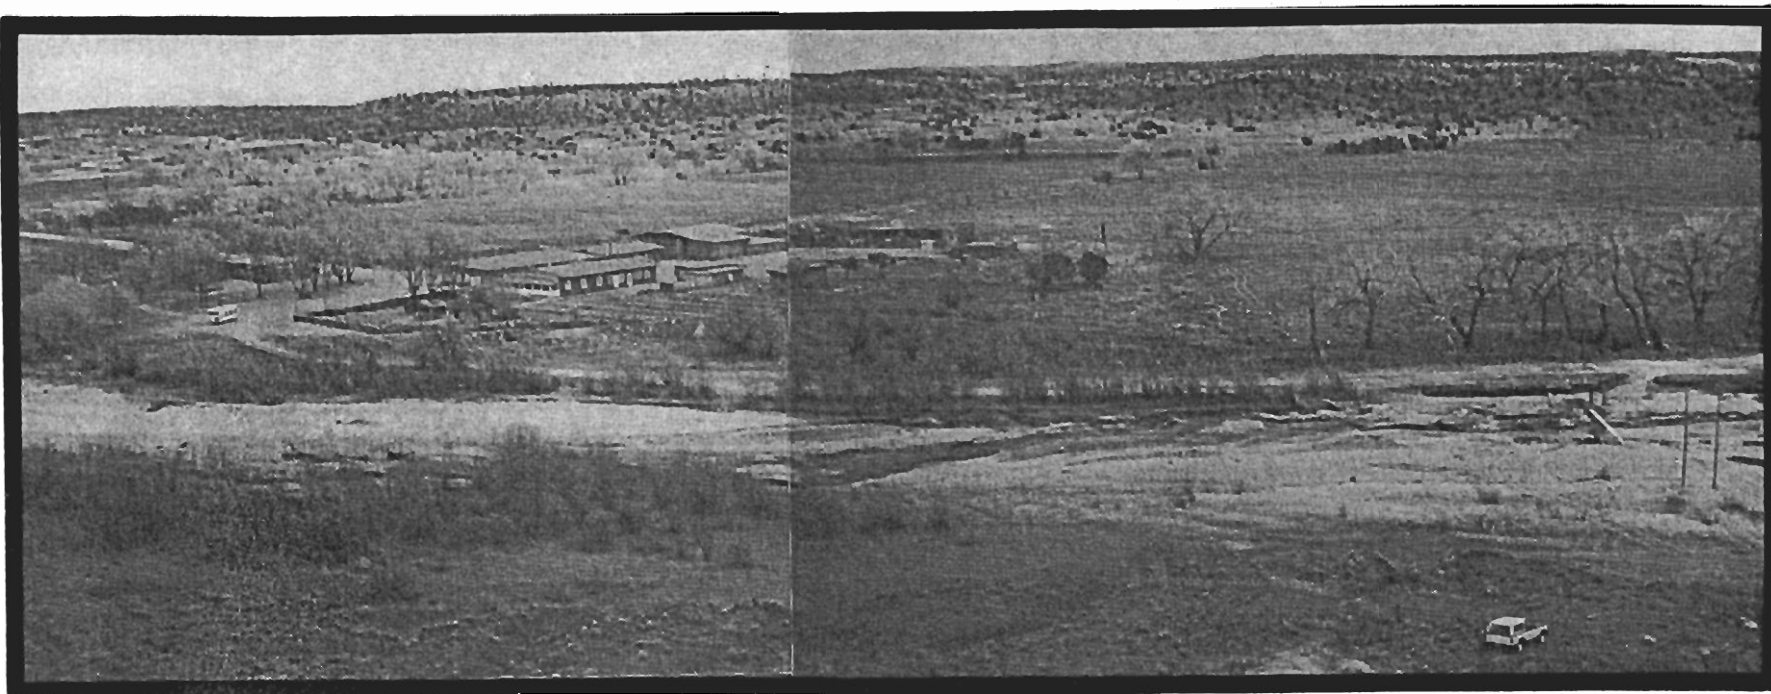
Photo 18: A composite photo (1983) of the Pueblo Colorado Wash and the Hubbell Trading Post from the top of Hubbell Hill, view to the southeast.
