SUMMARY OF EROSION CONTROL REHABILITATION WORK

LOWER SLIDE CREEK

UNIT 81-2

May 1982

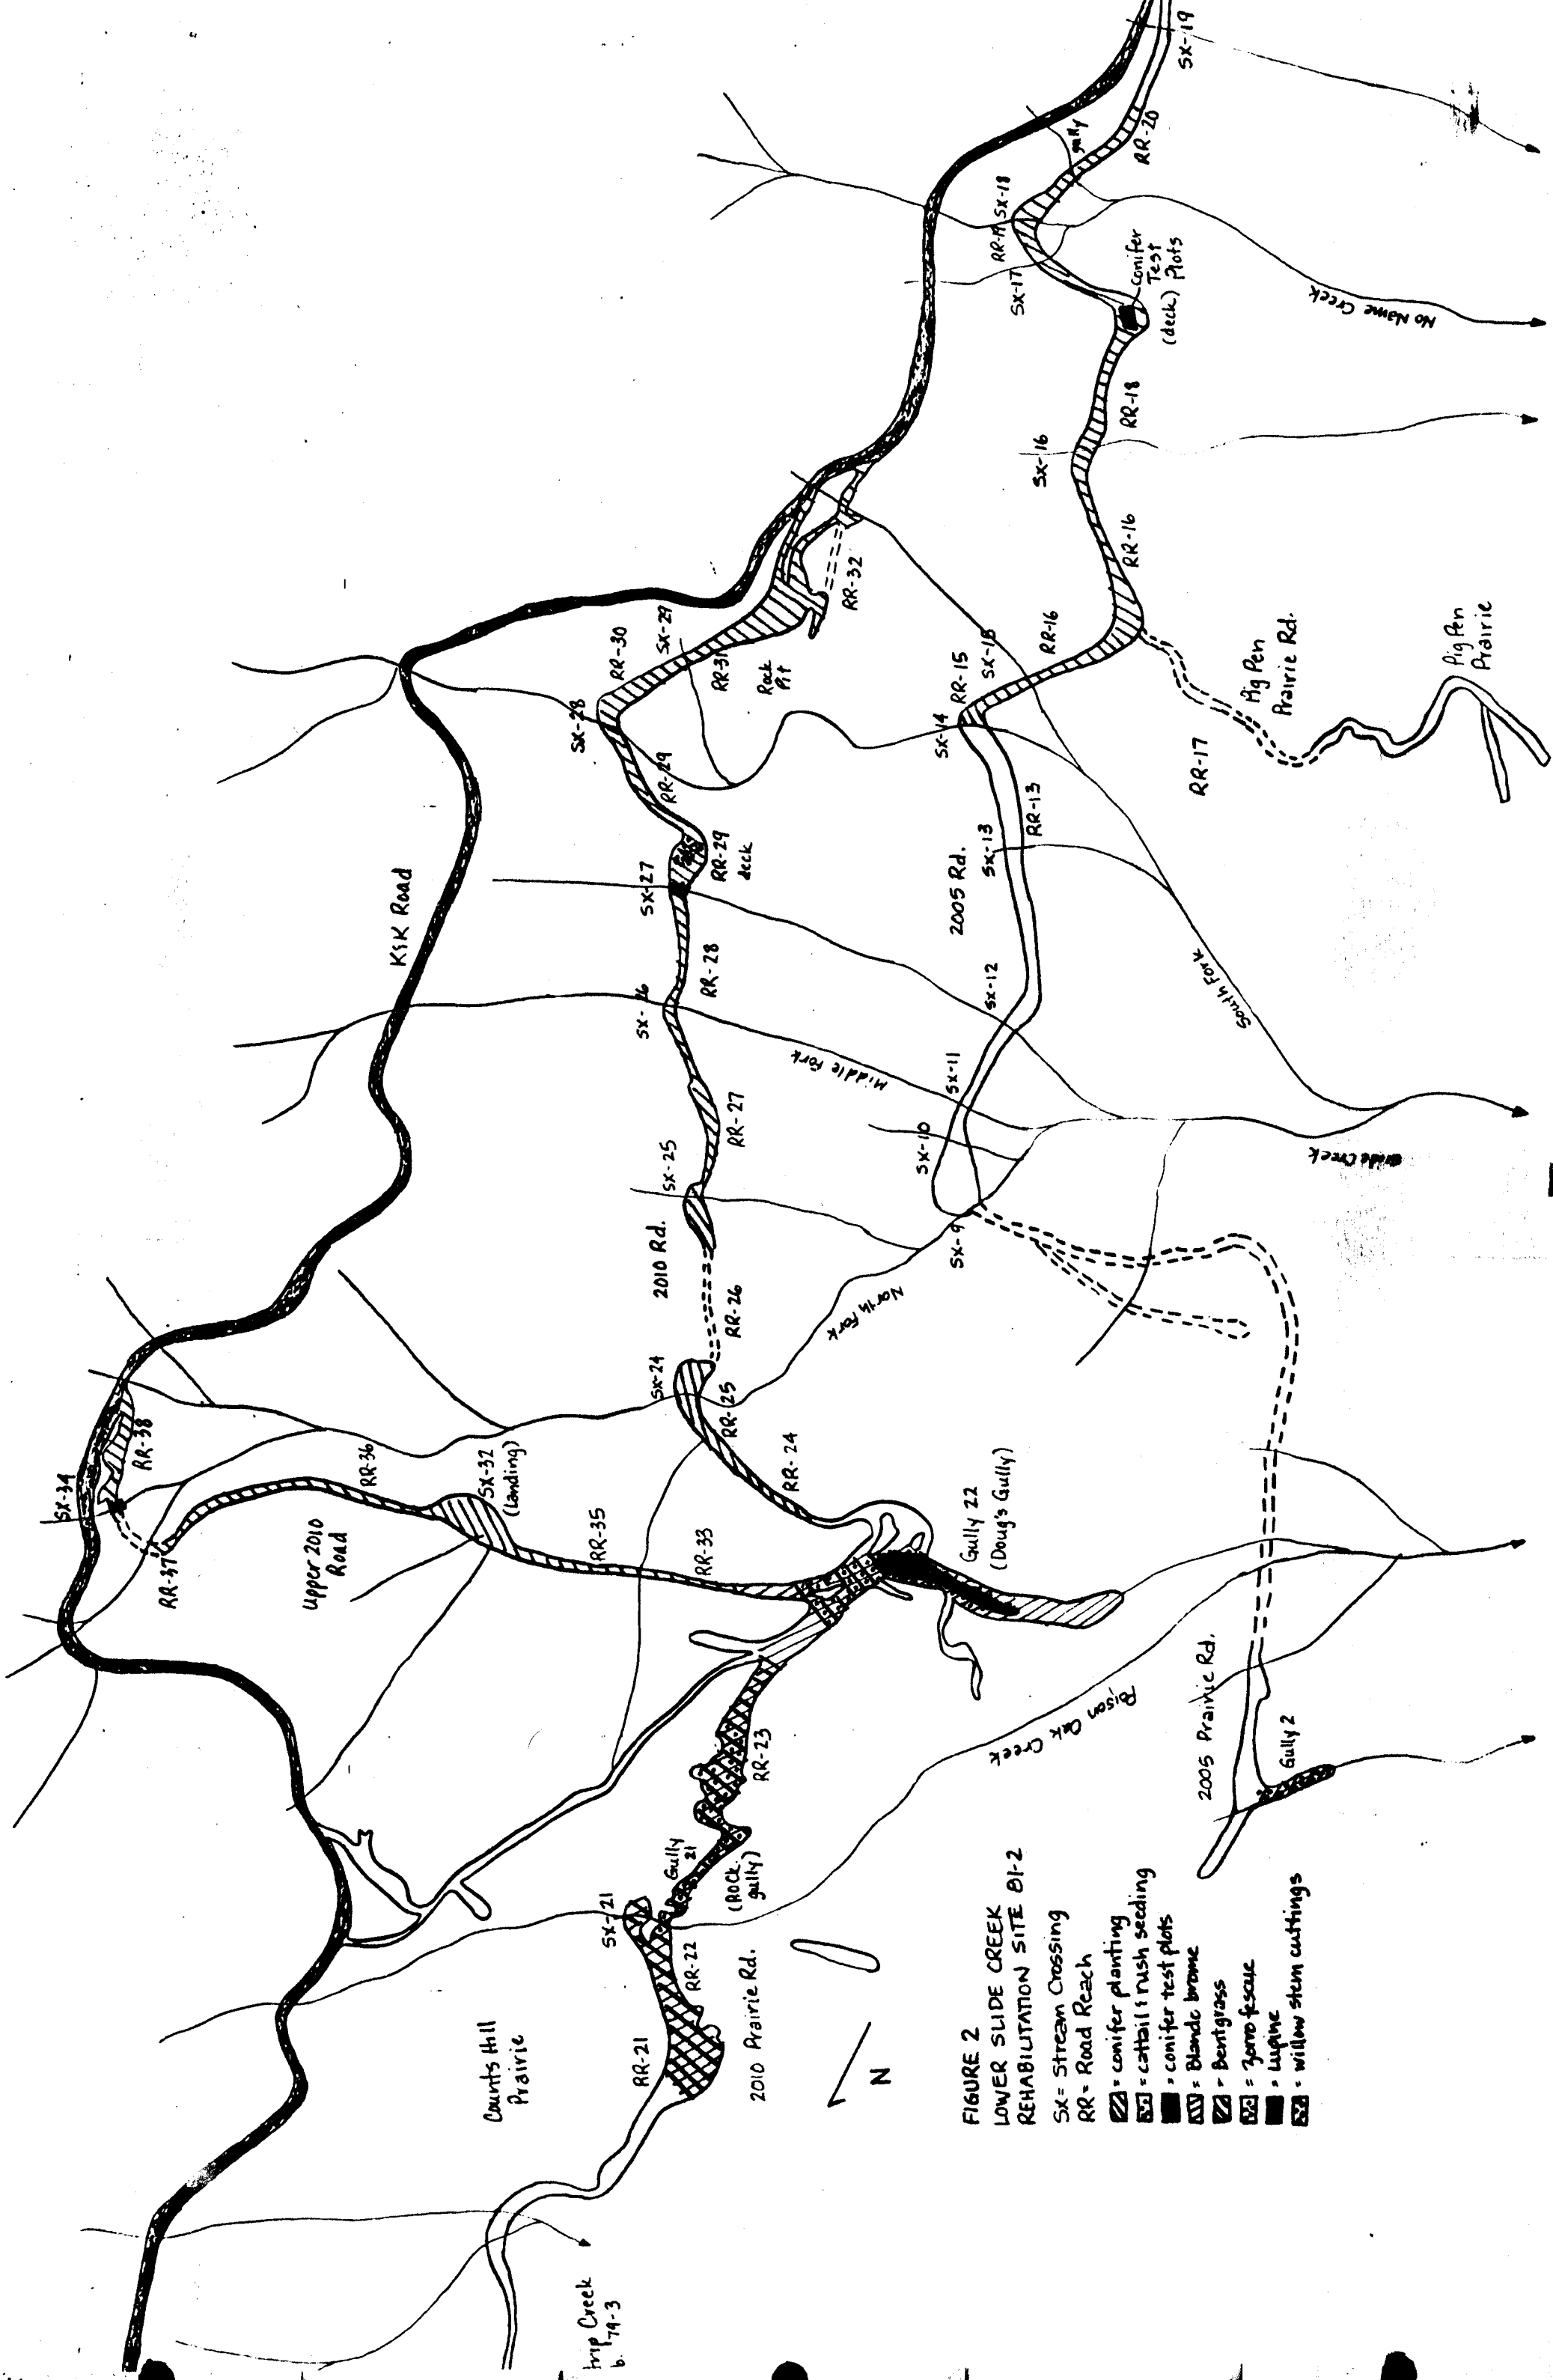
Minimal vegetation treatments were done this year (see Figure 2). Natural revegetation had effectively covered some of the roads and skid trails. Those that were disturbed in forested areas were planted with 6,170 conifers by in-house laborers. Pseudotsuga menziesii (Douglas-fir) was alternated with Sequoia sempervirens (coast redwood) at 8 to 10 foot spacing. No grass seeding was done on forest roads. Grass seeding was done on prairie roads in areas of greatest disturbance to speed revegetation. Remaining prairie areas were left to reseed naturally from the adjacent prairie. Three species were seeded separately this year: Agrostis tenuis (Highland colonial bent-grass), Bromus mollis (Blando brome), and Festuca megalura (Zorro fescue). The application of a mixture of these grasses did not prove efficient. Seeding was done by in-house laborers and biological technician. Tables 1 and 2 list the vegetation treatments and locations.
