AN EVALUATION OF 1978 REHABILITATION SITES  
AND EROSION CONTROL TECHNIQUES IN  
REDWOOD NATIONAL PARK

NATIONAL PARK SERVICE  
REDWOOD NATIONAL PARK  
ARCATA, CALIFORNIA  
JANUARY, 1980

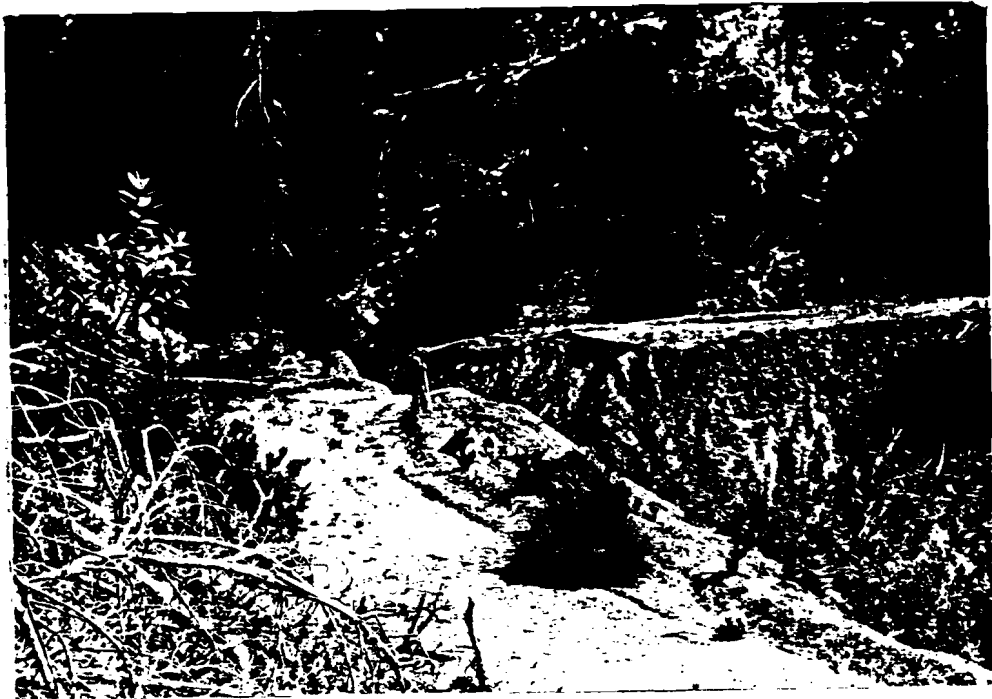
Figure 8: PP5a 8/22/78  
 Before photograph of former culvert in Drainage 6. Culvert became plugged with debris and winter flows washed out about 800 cubic yards of road fill into the stream channel.

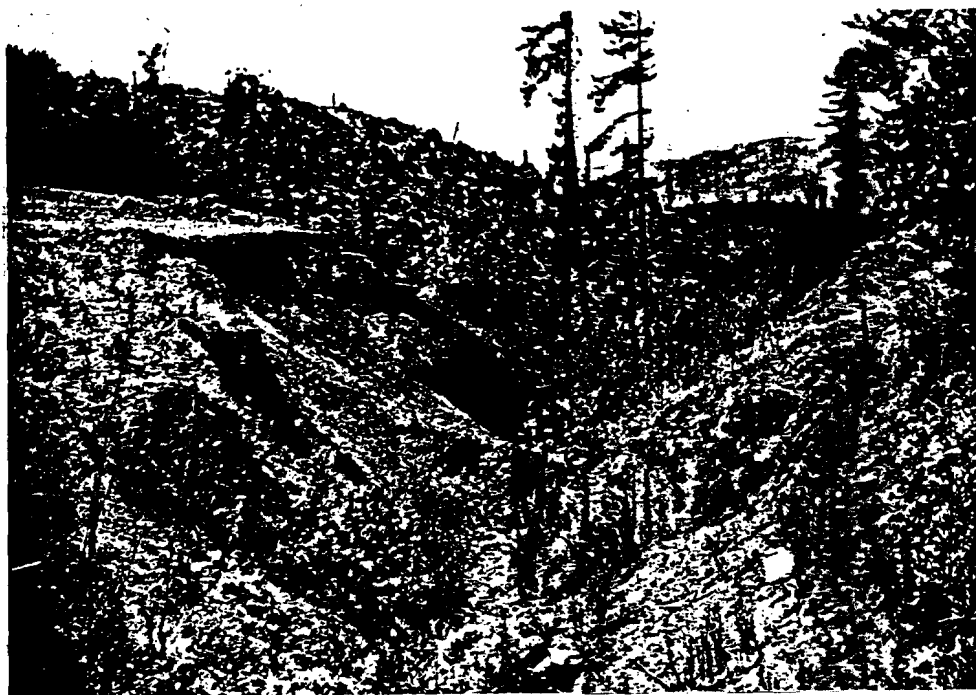
Figure 10: PP7 8/22/78  
 Before photograph of culvert washout in  
 Drainage 6, close-up view looking downstream.  
 Note person in channel for scale.

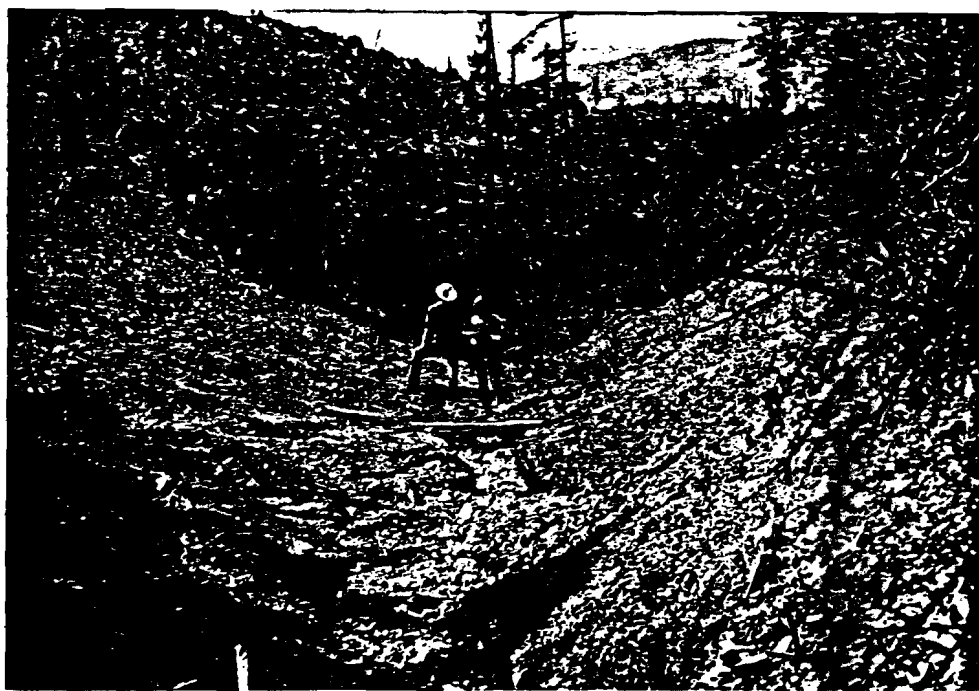
Figure 11: PP7 3/12/79  
 After photograph of Drainage 6. Newly excavated  
 channel exhibiting more gentle banks. Note rows  
 of willow wattle installed on both banks.

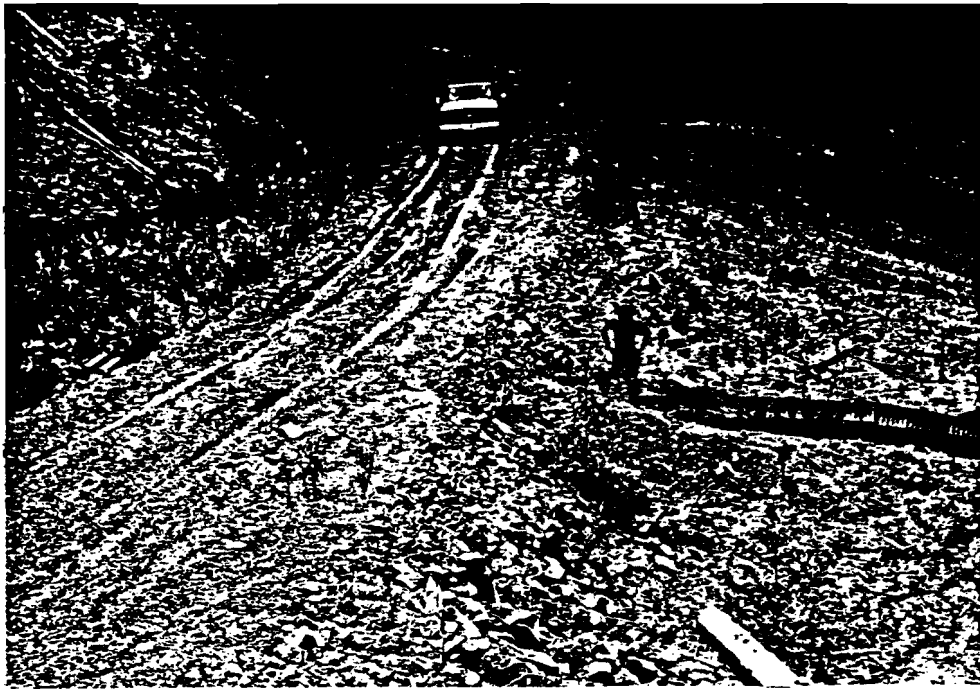
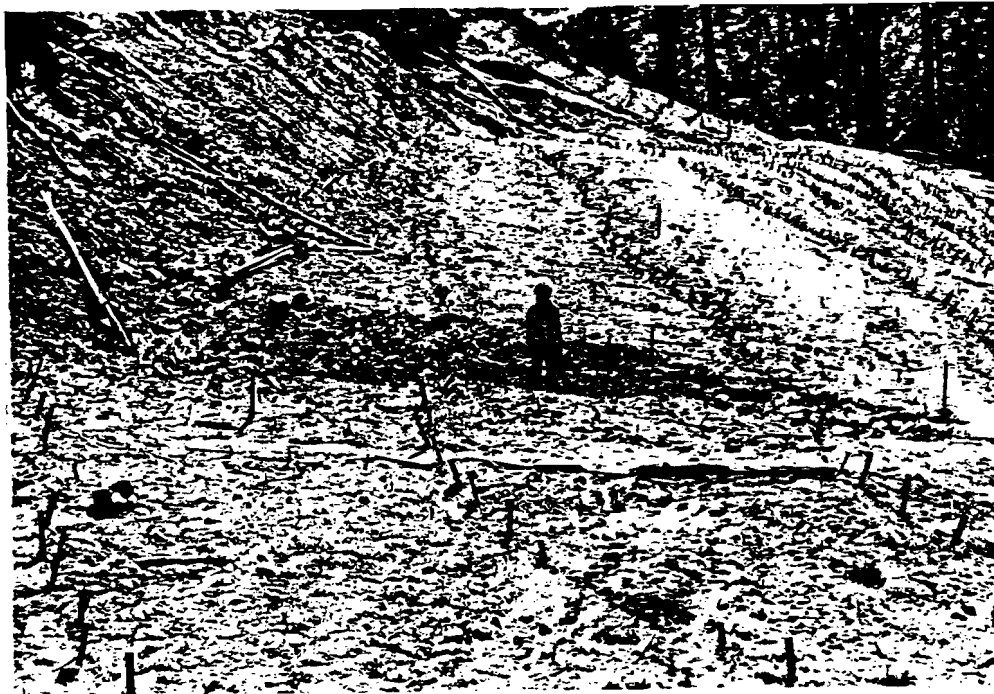
Figure 23: PP24 8/23/78  
Before and after sequence of culvert removal  
and road outslipping. A backhoe excavated a  
cross road drain in the former culvert location.

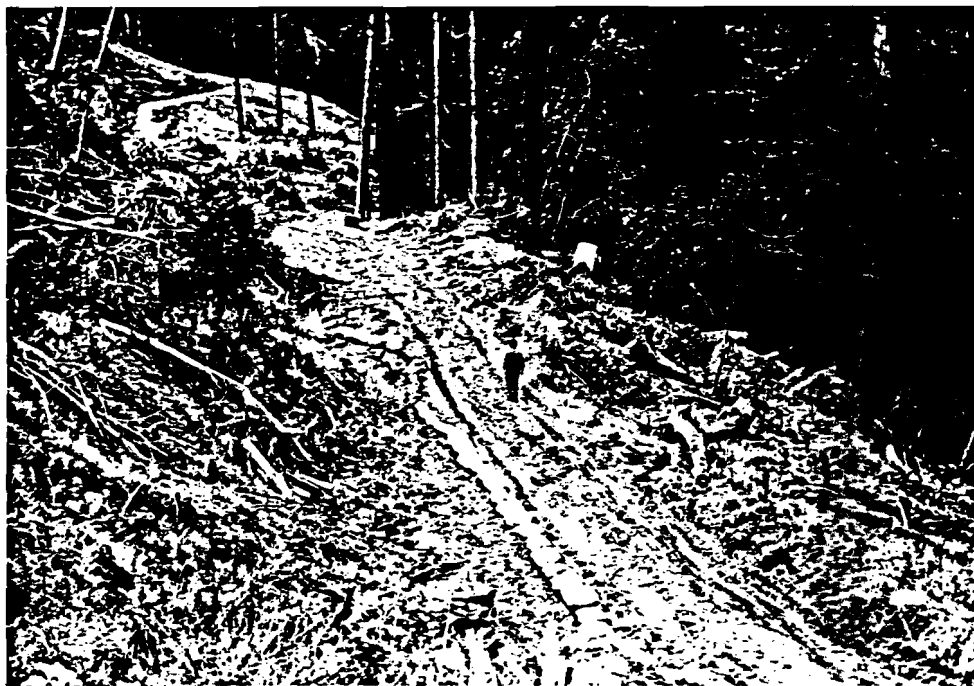
Figure 25: PP16c 8/23/78  
C-90 road prior to rehabilitation. Sandbags line the unstable inboard ditch of the rocky haul road.

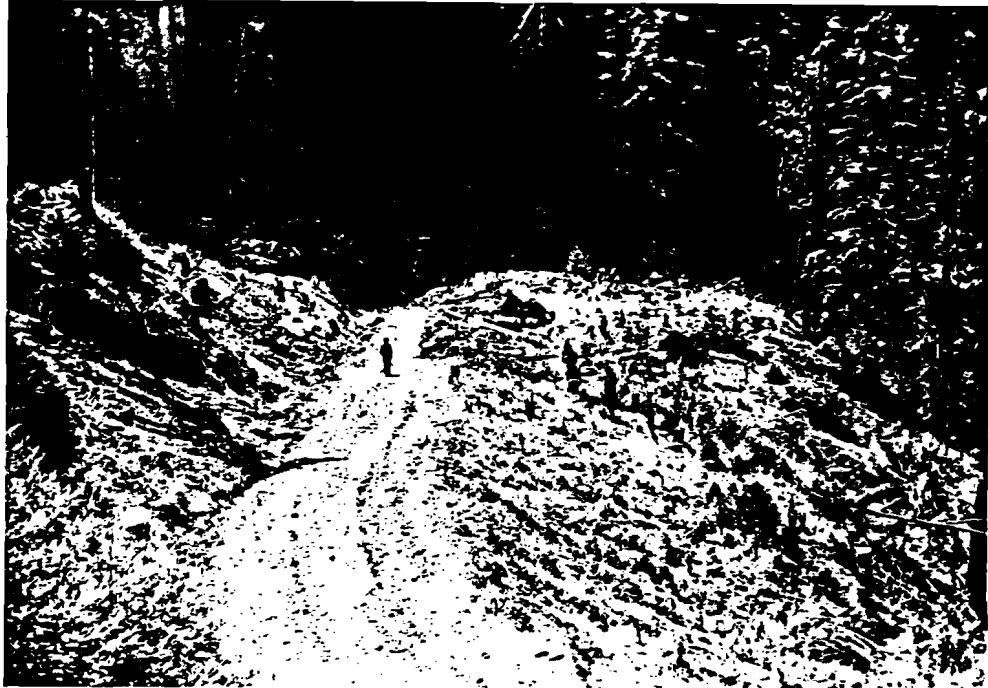
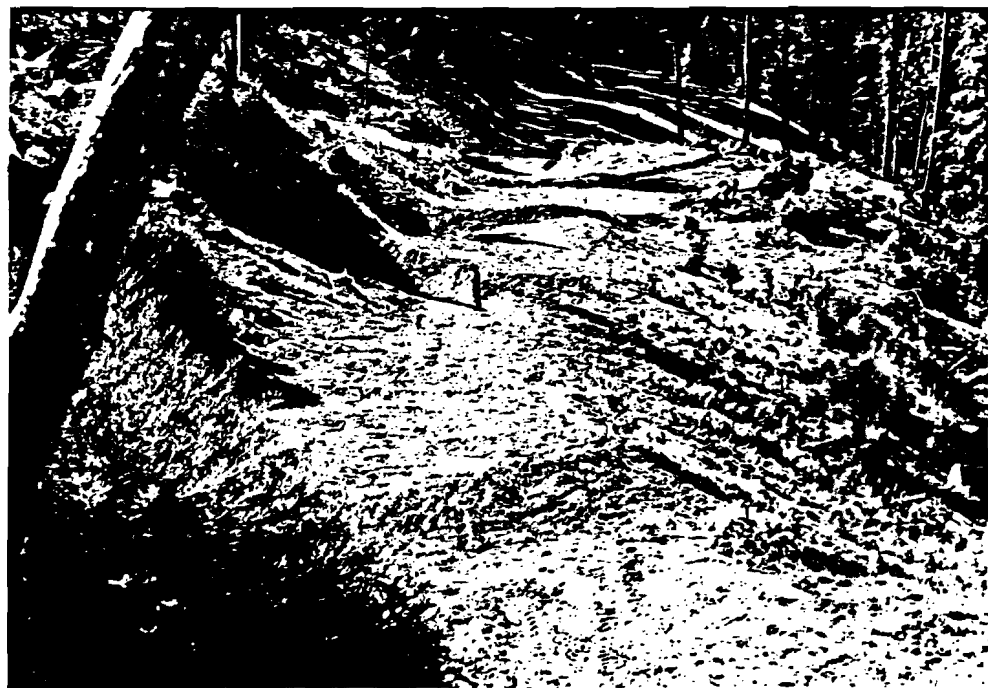
Figure 27: PP19b 8/23/78  
Before and after sequence showing removal of  
road and construction of cross road drains  
on a portion of the C-90 road.

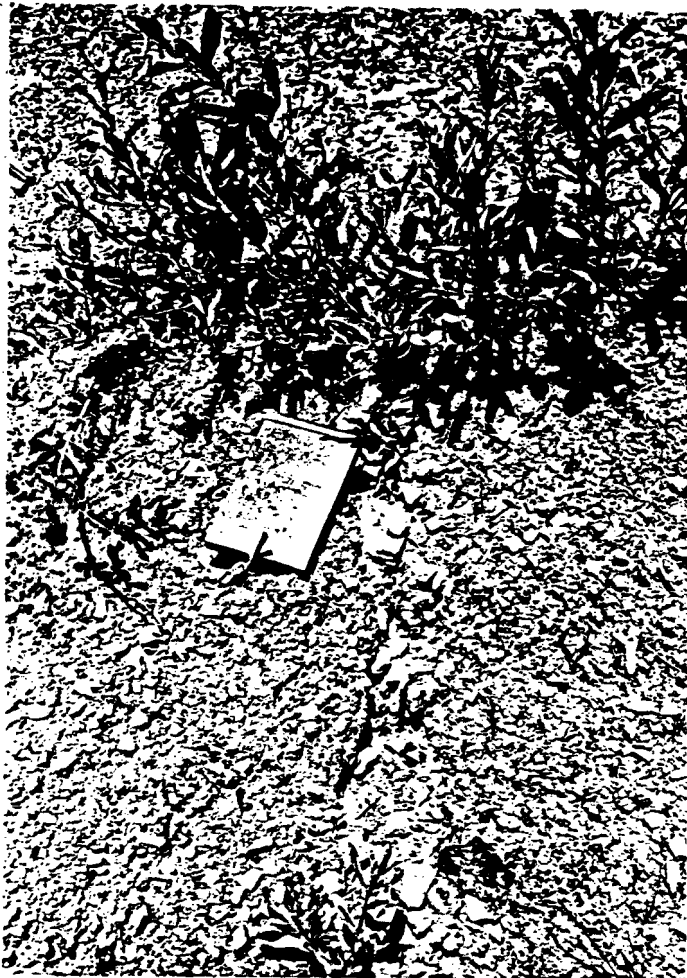
Figure 35: Although willow wattles can disperse small amounts of runoff and impede rilling, they are less effective when subjected to concentrated runoff. Here, a rill beginning upslope of a wattle row carries enough runoff to undercut the wattle and continue rilling downslope.

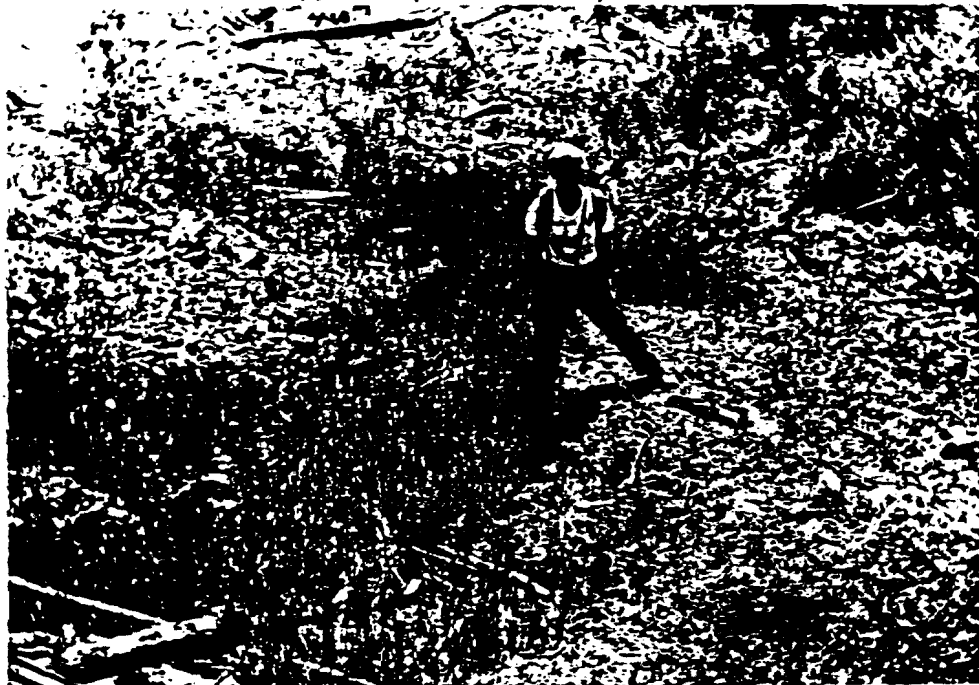
Figure 55: Grass seed and fertilizer were applied at equal rates on all areas of this skid road. The moist site on the left side of the photo has a fairly good grass cover developed; survival of grass is much poorer on the drier site on the right-hand side.

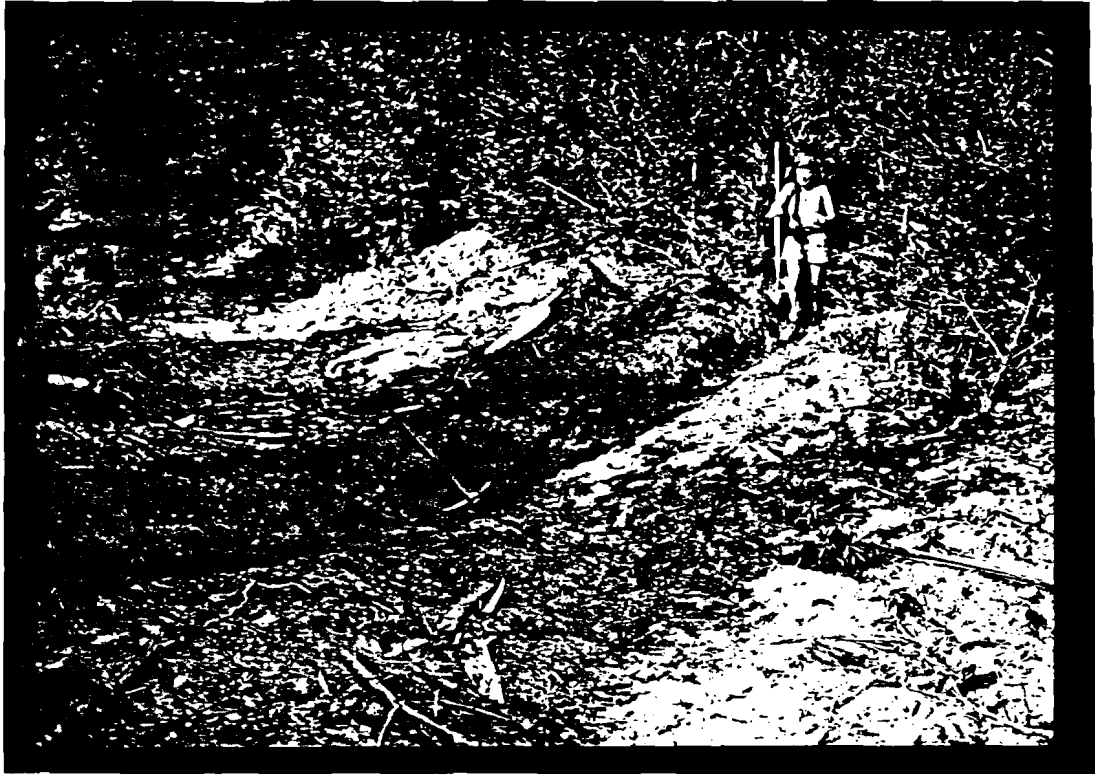
Figure 61: June, 1979  
A hand-constructed waterbar on the Lower  
Bond Creek Unit. Runoff from the skid  
road is diverted into heavily vegetated  
area behind the person in the photo.

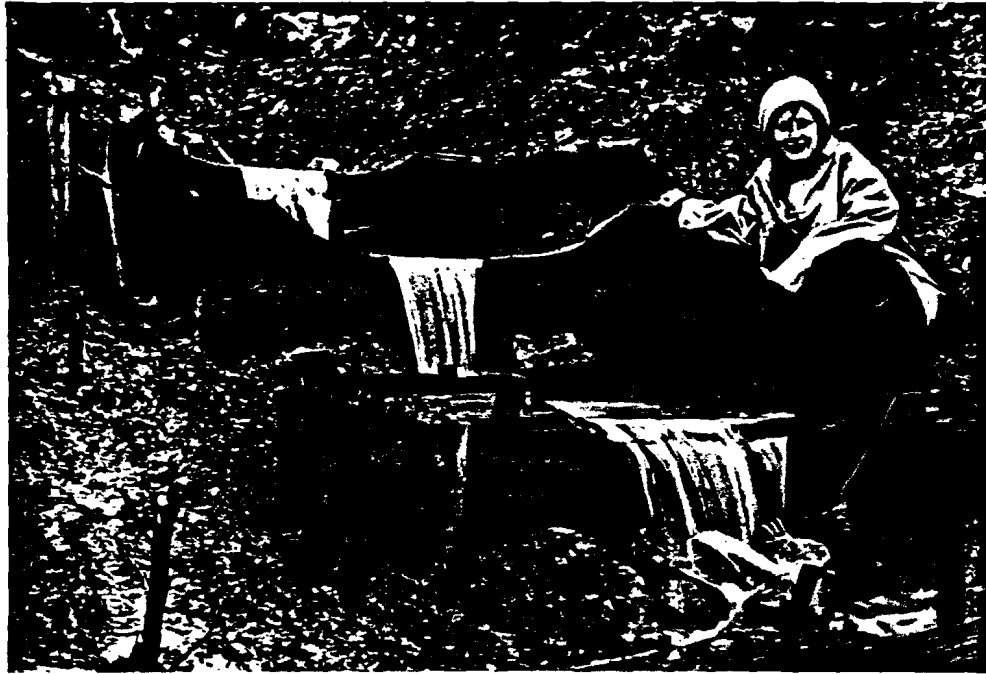
Figure 66: January, 1979  
Miller Creek Unit check dams convey winter flows through broad, high-flow spillways. Large rocks are used as energy dissipators below spillways. Note willow stem cuttings on both channel banks.

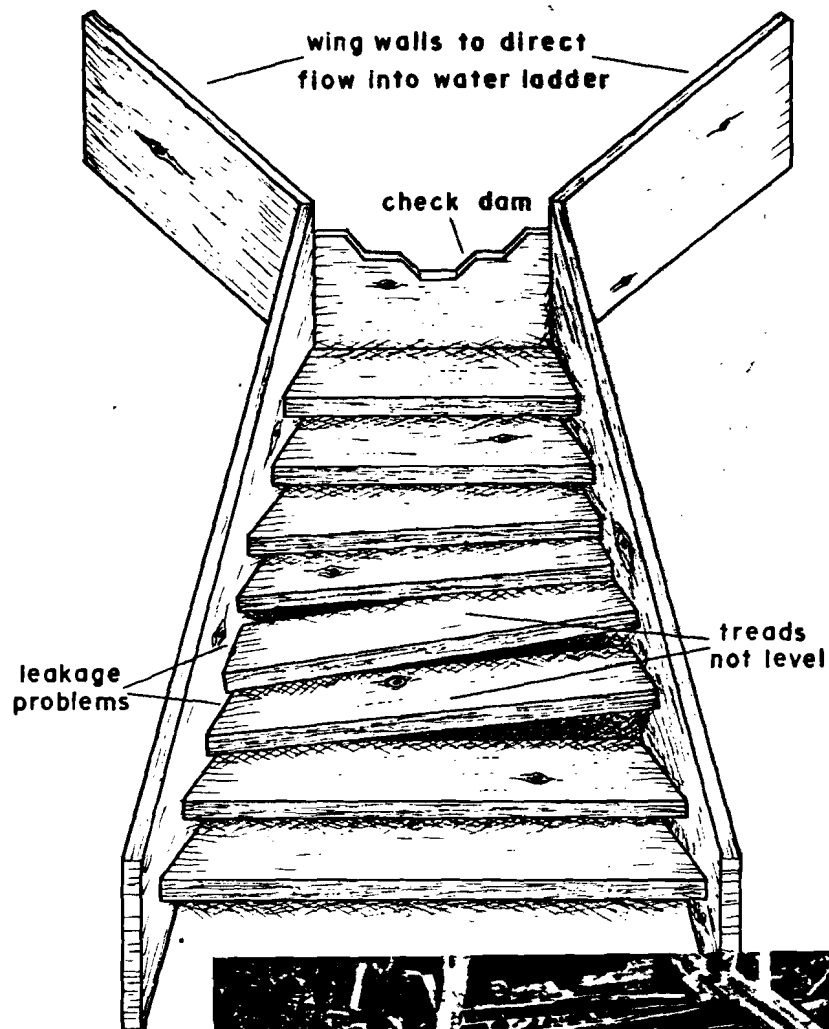
Figure 69:

Three designs of water ladders were used on the Miller Creek Unit (see sketches). Type 1 was built of hand-split and hand-sawed redwood slabs. Because the hand-split wood had an uneven surface, ladder treads were not flush with side pieces, and water seeped through these cracks to flow below the ladder. In addition, ladder treads were not level and water flowed towards the side of the ladder, accentuating leakage problems. Although the knickpoint under the top of the ladder was still protected, undercutting of the ladder would continue and eventually

Type 1 Water Ladder

undermine the structure unless leakage problems were corrected. A solution to the leakage problem is to nail short slats of wood over and under the treads parallel and flush with the side pieces. Caulking leaks is another possibility. Also grooves can be cut on top of the treads to direct low flow towards the center of the ladder. In June, 1979, a CETA work crew repaired the water ladder to prevent further leakage. Figure 69 shows a Type 1 water ladder before repairs were made.

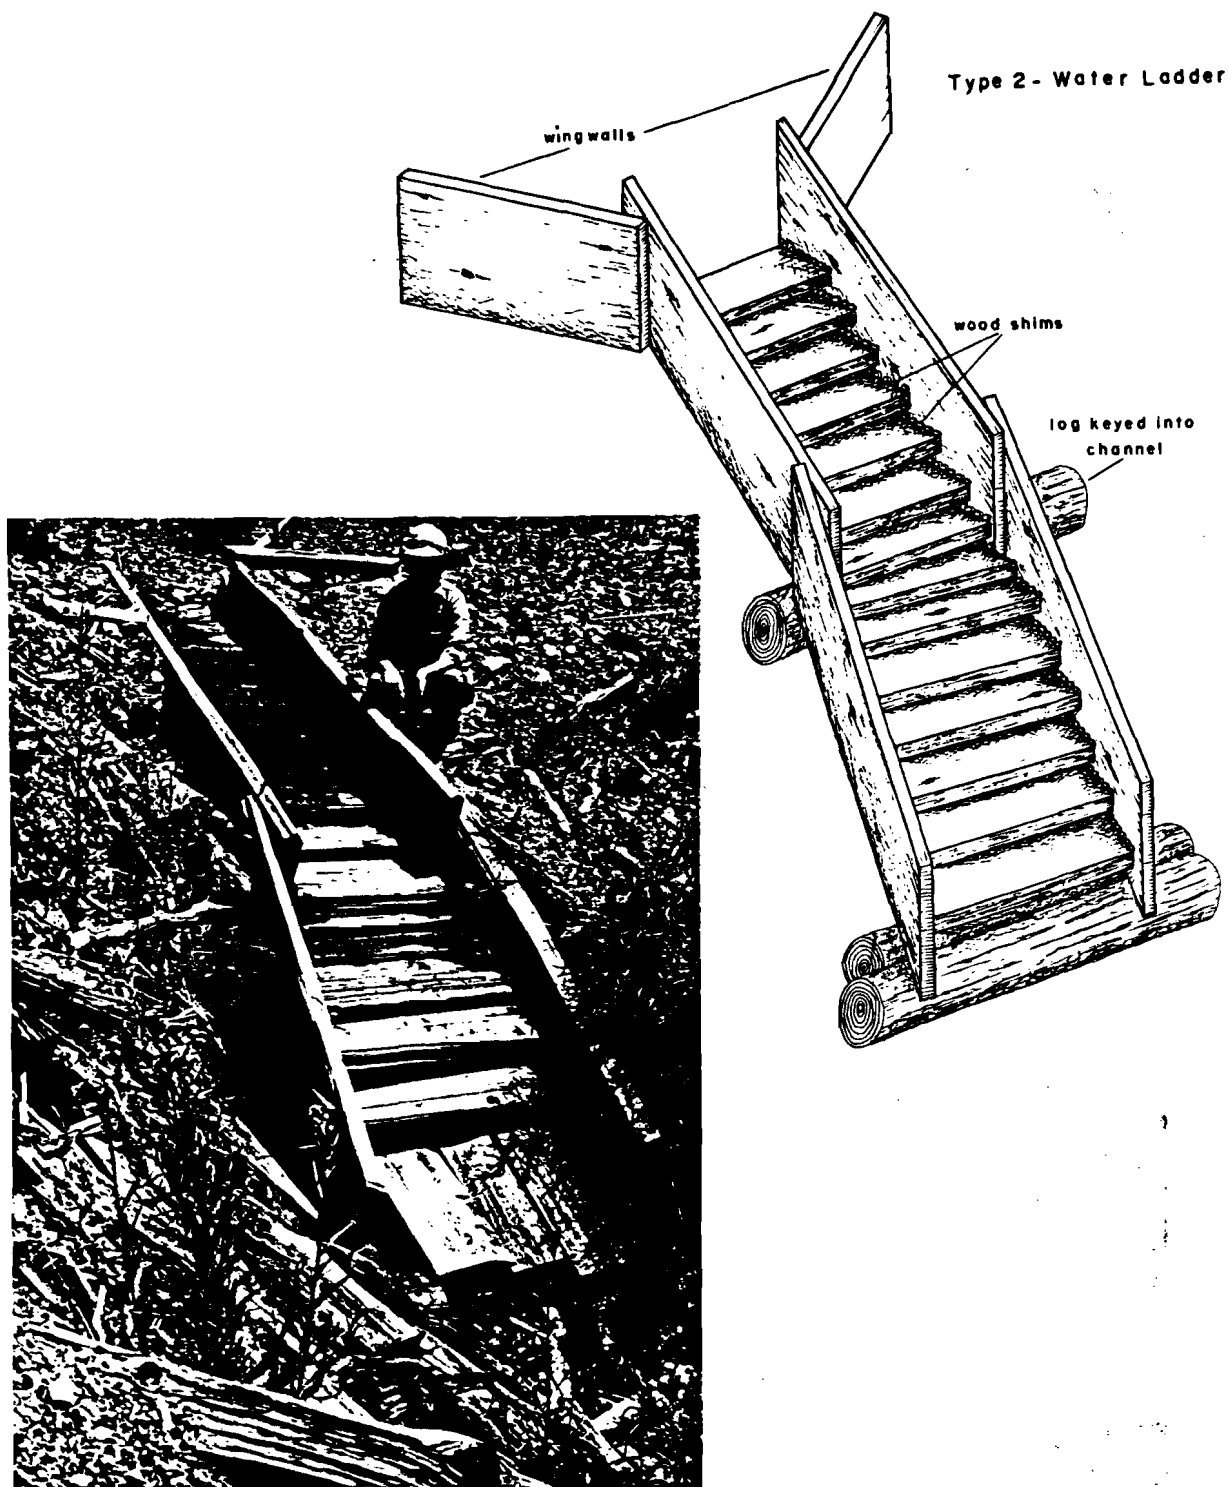
Figure 70: Type 2 Water Ladder

Type 2 water ladder (Figure 70) at Miller Creek is fully functional, and is also built from hand-split redwood. Wing walls above the ladder have been effective in directing flow over the ladder. The ladder is built in two overlapping sections, conforming to the channel configuration and in-channel debris. The top tread of the ladder is keyed into a partially buried log. Some scour (4 inches deep) occurred upstream of the log, but rocks were deposited in the scour hole. There is little danger of the entire log being undercut. The ladder was large enough for 1978-1979 winter flows; however, a large storm event would probably overtop the structure. Little leakage occurred between the ladder treads and the side pieces. Dry wood shims were hammered into all cracks. The shims swelled upon wetting and sealed the seams of the ladder. The energy dissipator at the foot of the ladder is composed of large logs in the channel (some of which were already keyed into the channel before the ladder was built). No downcutting occurred below the ladder.

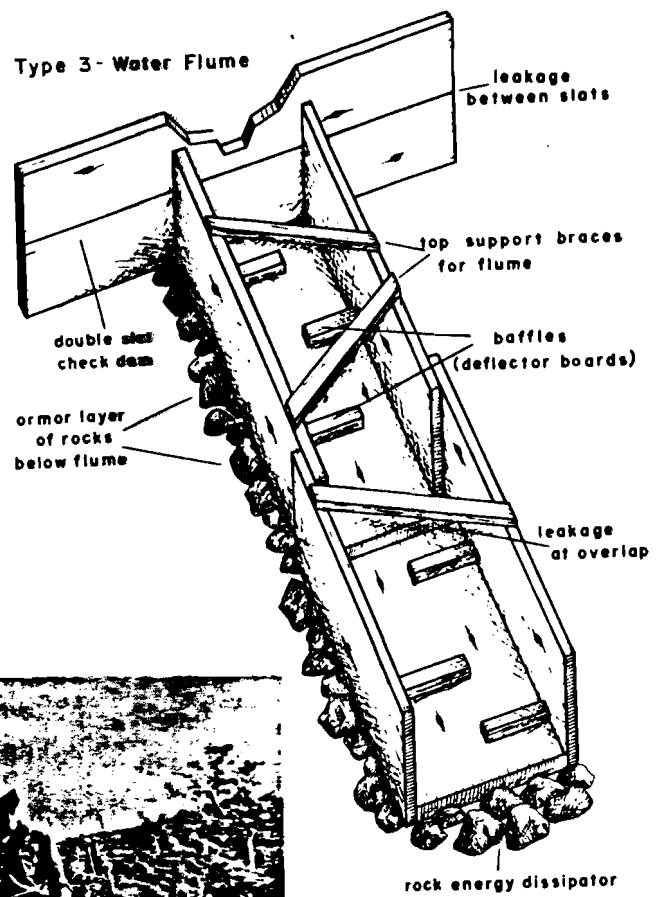
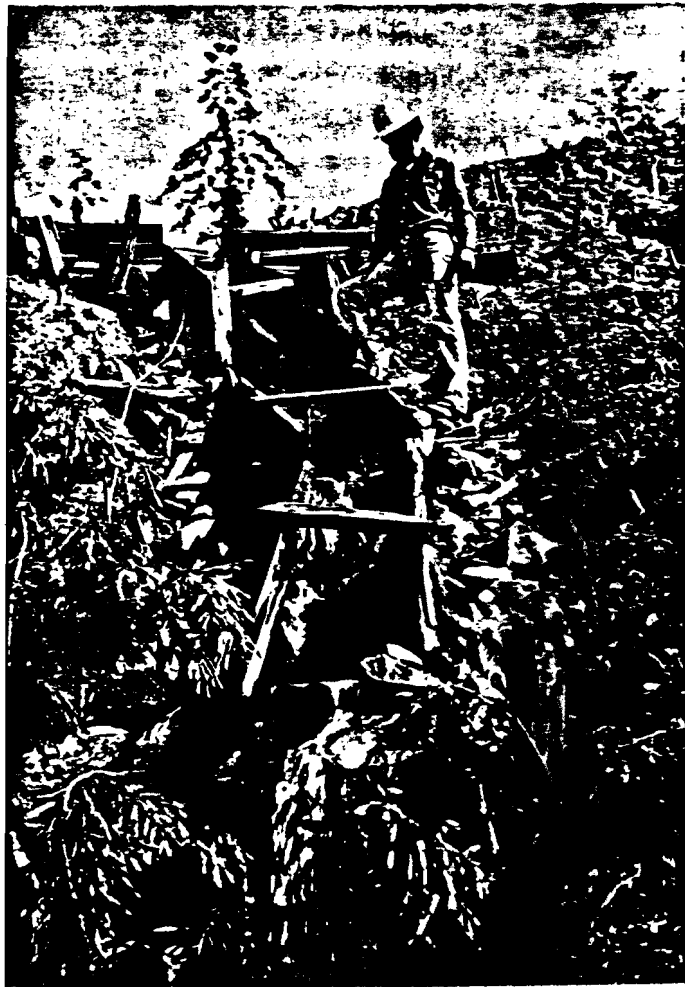
Figure 71: Type 3 Water Flume

Type 3 design at Miller Creek has several problems. Cracks between the two slats of the check dam allowed water to leak through and discharge into the channel outside of the flume. The area of the flume (18 x 18 inches) is too small to handle high flows. Some settling of the rocks under the flume occurred, and the flume has shifted slightly as a result. Overlap of the three sections is not adequate. Leakage occurs between sections, allowing water to flow through the rocks below, possibly causing the rocks to shift. Some of the baffles or deflection boards in the flume cause the water to jump over the sides at high flows. The water ladder outlet does not face downstream, but is slightly directed towards the left bank. An energy dissipator of large rocks placed in and around a trash rack was not sufficient to prevent bank erosion below the ladder.

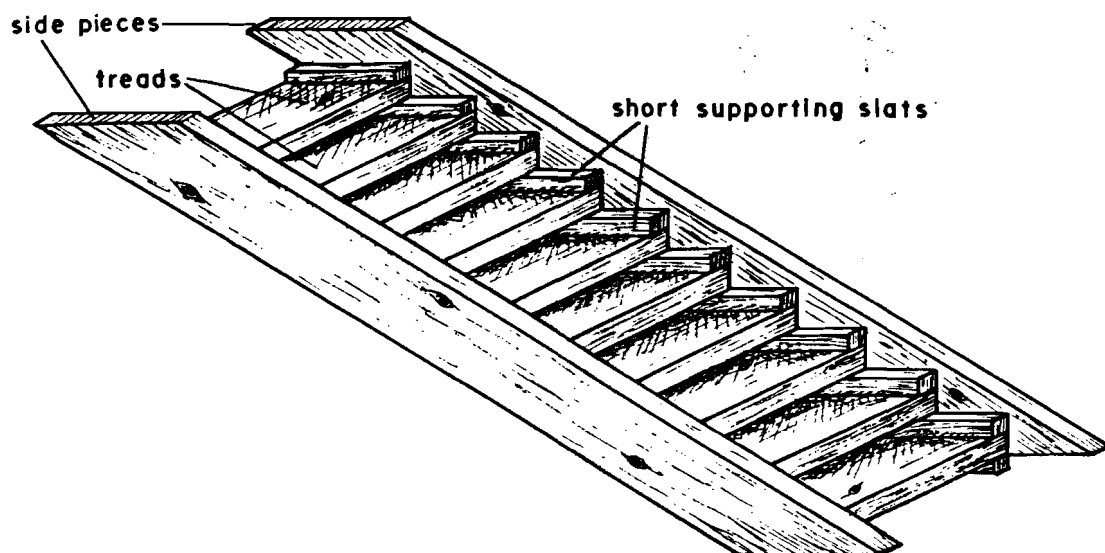
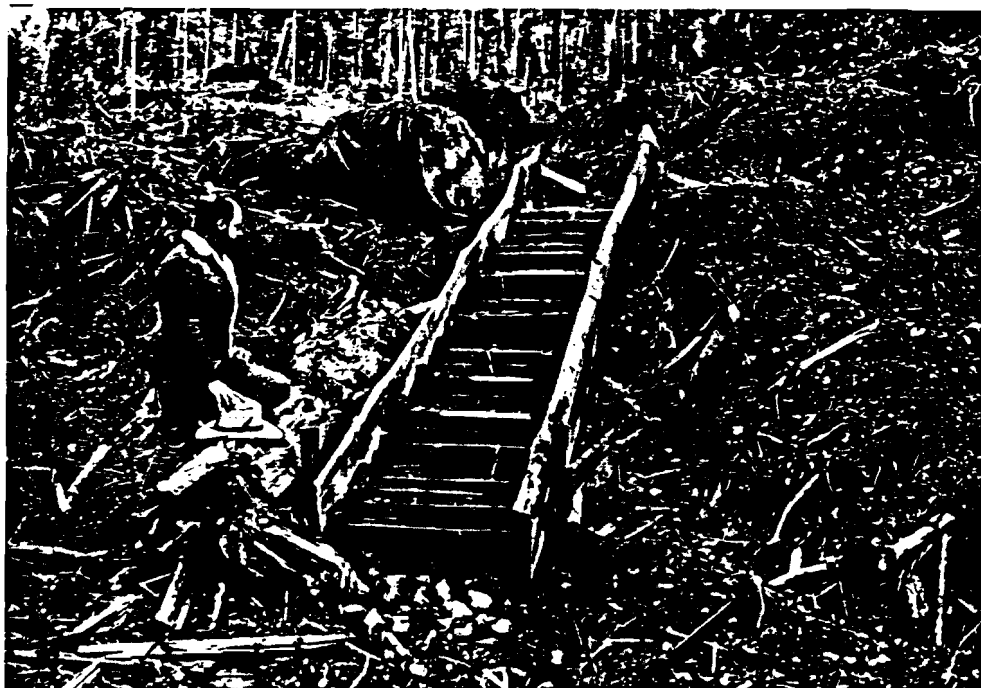
At Emerald Creek, four of five water ladders were Type 4 design (Figure 72). The fifth was a one-section waterflume. All five were constructed at the downstream end of major cross-road drains. Wood for the

Figure 72: Type 4 Water Ladder

Grooves (about  $\frac{1}{2}$  inch deep) were cut into the top side of the Type 4 ladder treads to direct flow towards the center of the ladder. With Type 4 ladders at low flow and other three ladder types as well, drops of water tend to go over the edge of the tread, cling to the bottom of the tread while moving upstream slightly, and finally drip down (Figure 73 - top tread). If the overlap of the treads is not sufficient, the drops will fall on unprotected soil and flow under the ladder. Slats of wood nailed under the treads will prevent leakage from this source; cutting the downstream edge of the tread at an angle may also help (Figure 73).

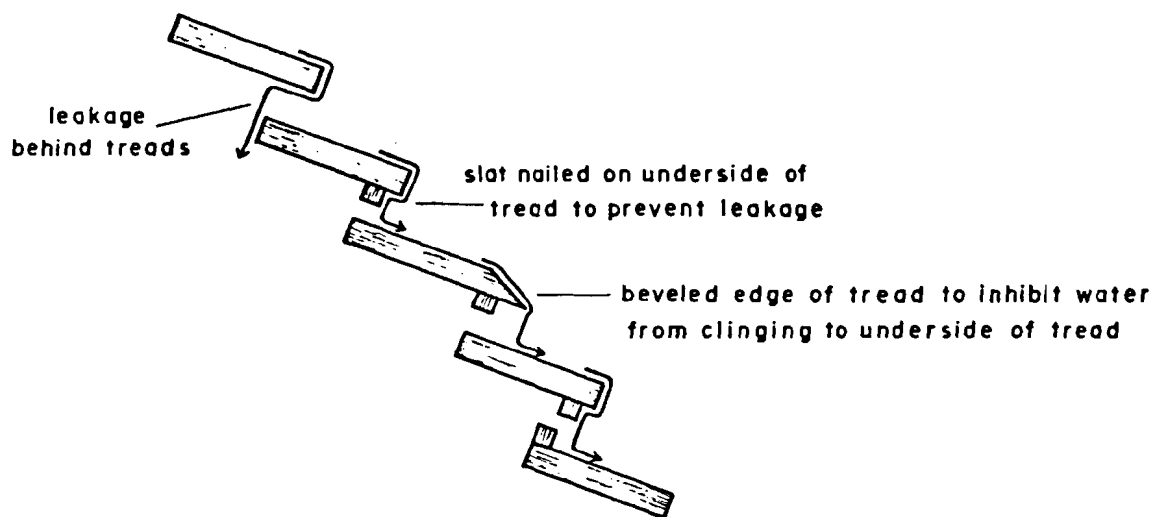
Figure 73: Side view of water ladder treads

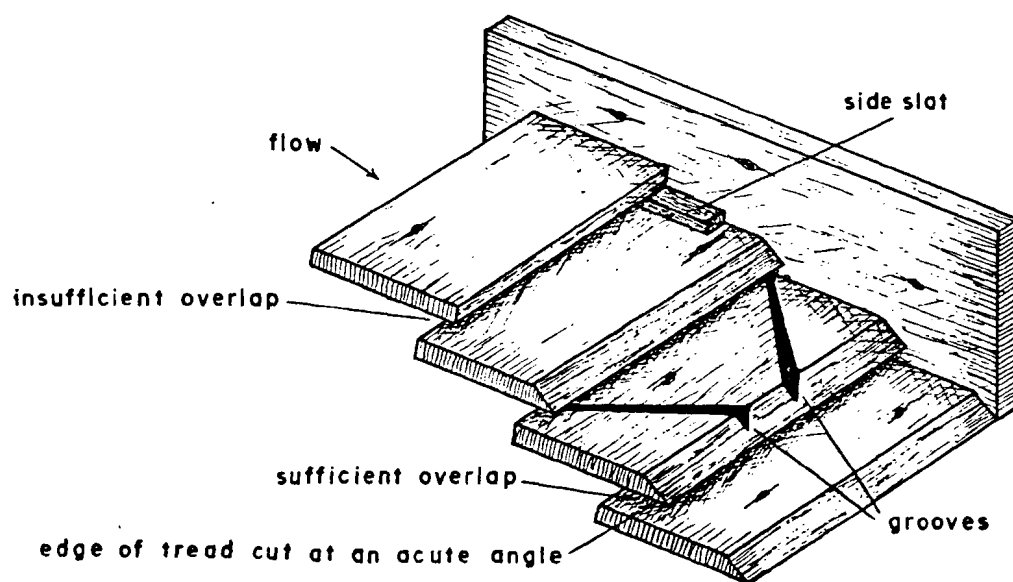
Short slats nailed below treads parallel and adjacent to side pieces on Type 4 ladders seem to work well in preventing side leakage (Figure 74) except when the slats extend beyond the downstream edge of the tread. In those cases, water flowed over the treads onto the slats and leaked between the slats and the side piece of the ladder.

Figure 74: Oblique view of water ladder treads

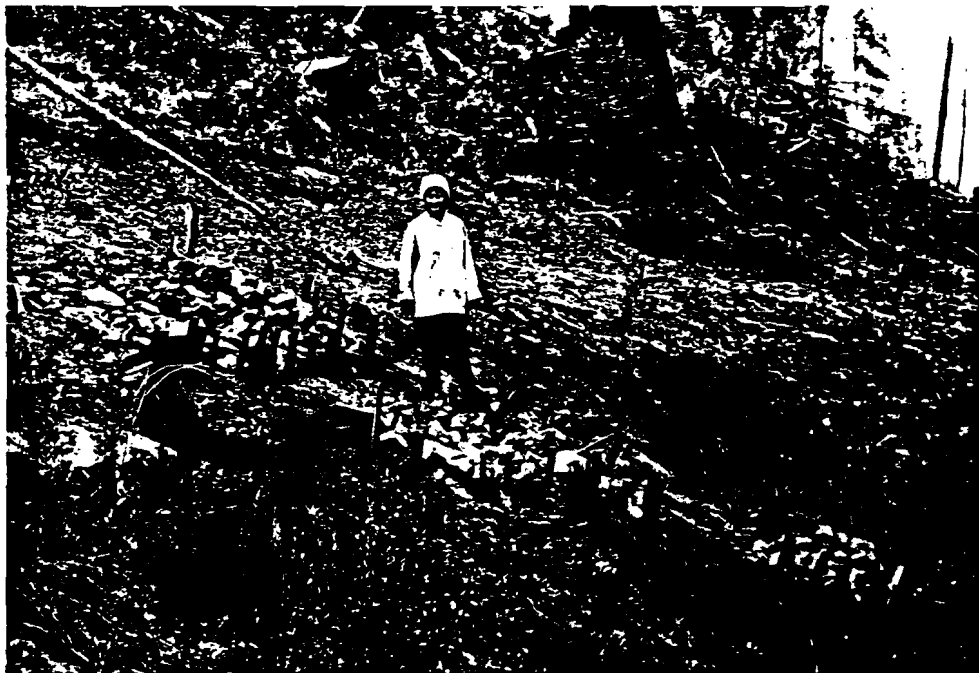
Successive piles of rock held in place by redwood stakes in the channel is another type of energy dissipator (Figure 79). The drain in which this dissipator was installed did not receive much flow; therefore, the efficiency of these staked rocks was not rigorously tested. Nevertheless, the energy dissipator did handle the low-to-intermediate flows well, and no signs of undercutting are evident. More testing of all types of energy dissipators under high flow conditions is necessary.

Figure 79: Emerald Creek CRD 15  
Piles of rock anchored to the slope below a cross road  
drain, filter runoff through them and dissipate erosive  
energy.

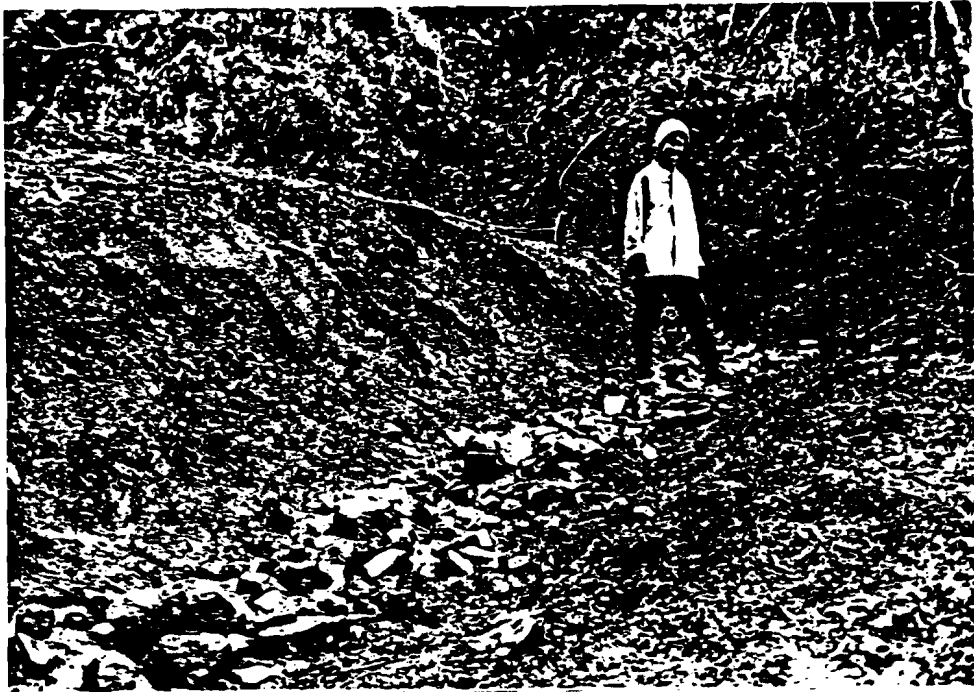
rocks (greater than four inches in diameter) in the channel worked well in protecting the drains from downcutting. Because the lower three-quarters of the former C-90 road had been rocked, there was a plentiful supply of suitable rocks available for the drains. Over the winter, fine sediment settled in between the rocks, tightly packing them together, and armoring the channel bed (Figures 80 and 81).

Figure 80: Manually-placed coarse rock on the bed of a cross road drain prevents downcutting of the channel bed while allowing unhindered flow of runoff through the drain.

It is important to completely cover the channel bed with rocks, and the rocks must abut directly against the banks. Where the toe of the banks or the bed was exposed, lateral erosion and downcutting occurred during winter. Once a new channel starts eroding the toe of banks adjacent to the protective layer of rocks, the rocked channel bed is abandoned and rendered useless. In addition, adequate energy dissipation is needed at the outlet of the cross road drains because downcutting below the drain can migrate upstream and undermine the rocked channel lining. In a few cross road drains, an otherwise successfully rocked drain was starting to downcut at the downslope end because of inadequate slope protection below the break-in-slope. This is a serious problem that will probably be encountered at many different sites and may best be handled by check dams below the break-in-slope that protect the slope between the rocked drain and the naturally vegetated slope below.

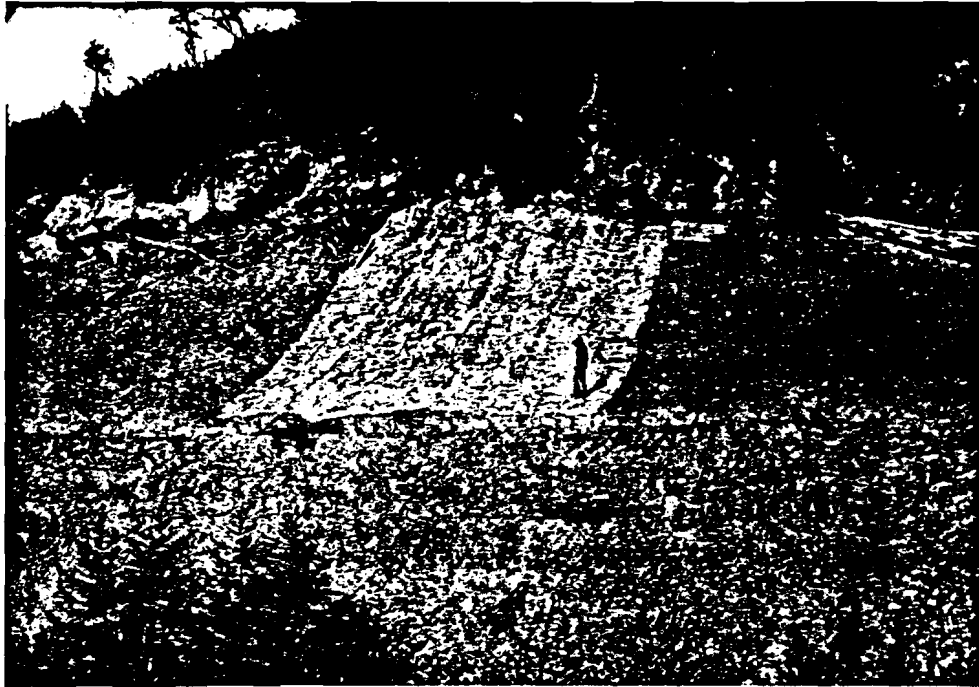
In general, the mulch has shifted slightly downslope over the winter, but little movement of large soil particles has occurred. In June the ground under the mulches (especially the redwood chip mulch) was moist, while on the control sites the soil was dry. The mulches prevented some rockfall from upslope from continuing downslope onto wattled areas, and they intercepted and dispersed rills that originated upslope. This was especially evident on the straw mulch site.

Figure 82: Redwood chip and brush mulch was spread on the outsloped road and Miller Creek, and was then covered with jute netting.

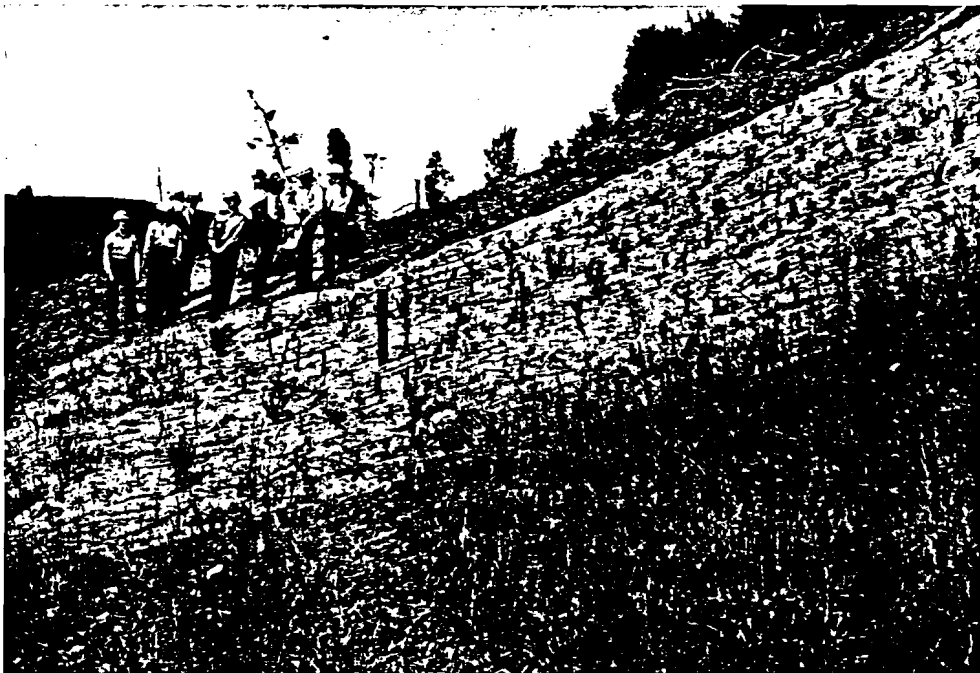
Figure 83: A close-up view at Miller Creek of the jute netting showing the stem cuttings which were used to secure the netting to the slope.

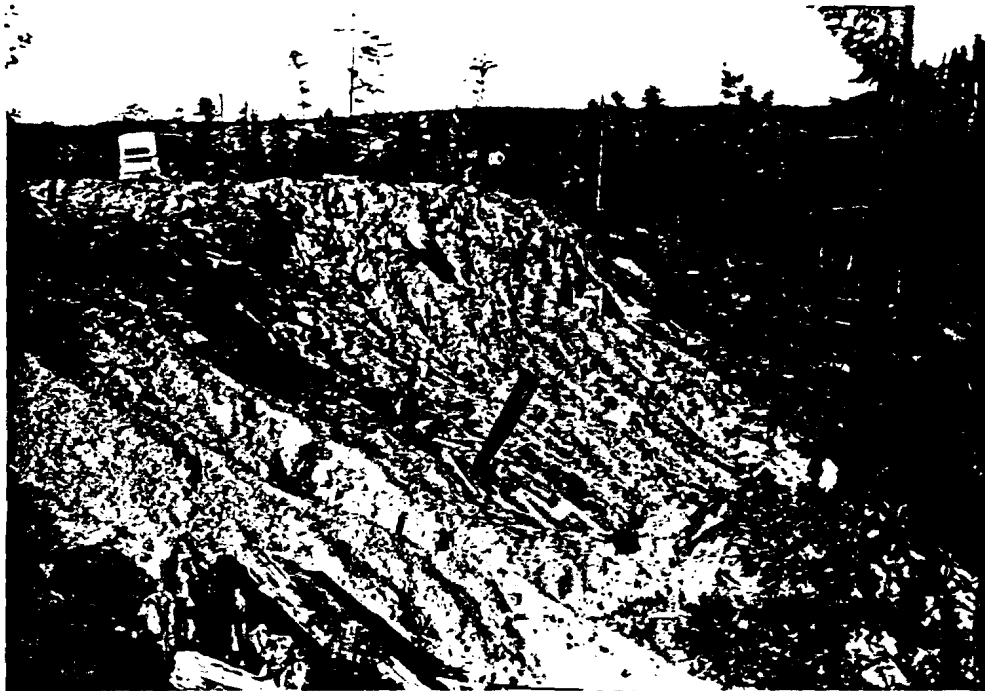
Figure 58: PP6 10/2/78

Before and after sequence showing the removal of the C-Line landing. The upper slopes have willow wattles; the steep lower slopes are protected by planter boxes.

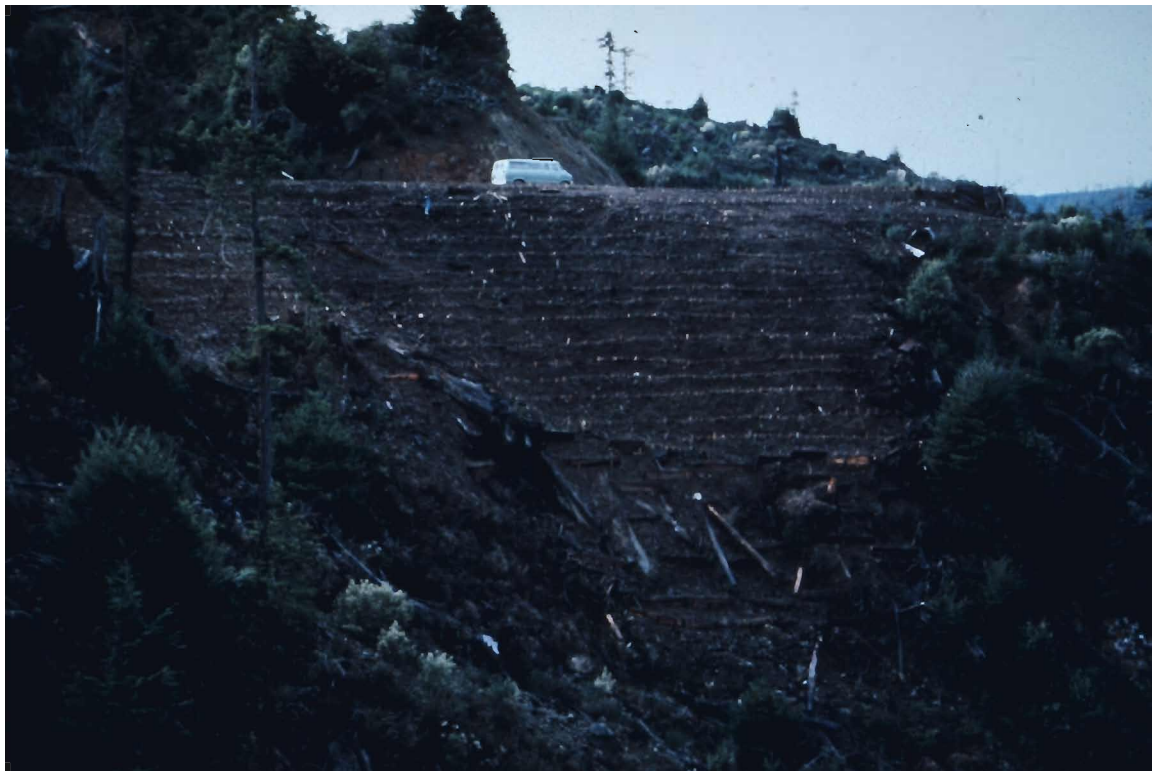
Unit: 78-5 Date: 10-2-1978, PP3, SOC

The site was the location of a large log landing composed of loose soil, rock, logs, and smaller organic debris, all of which were compacted by heavy equipment. The outer edge of the log landing catastrophically failed about five years ago, sending tons of sediment and organic debris into the stream channel below. In 1978, the remainder of the landing was precariously perched above the stream, and failure of more debris into the stream was imminent.

Figure 56: PP3 10/2/78  
View towards C-Line landing prior to any rehabilitation work. Part of the landing failed, leaving much of the organic and inorganic debris perched precariously.
