**ALL-TERRAIN VEHICLE (ATV) TRAIL MITIGATION STUDY:  
COMPARISON OF NATURAL AND GEOSYNTHETIC MATERIALS  
FOR SURFACE HARDENING**

Wrangell-St. Elias National Park and Preserve, Alaska.

Wrangell-St. Elias National Park and Preserve Research and Resource Management Report

No. 2001-1

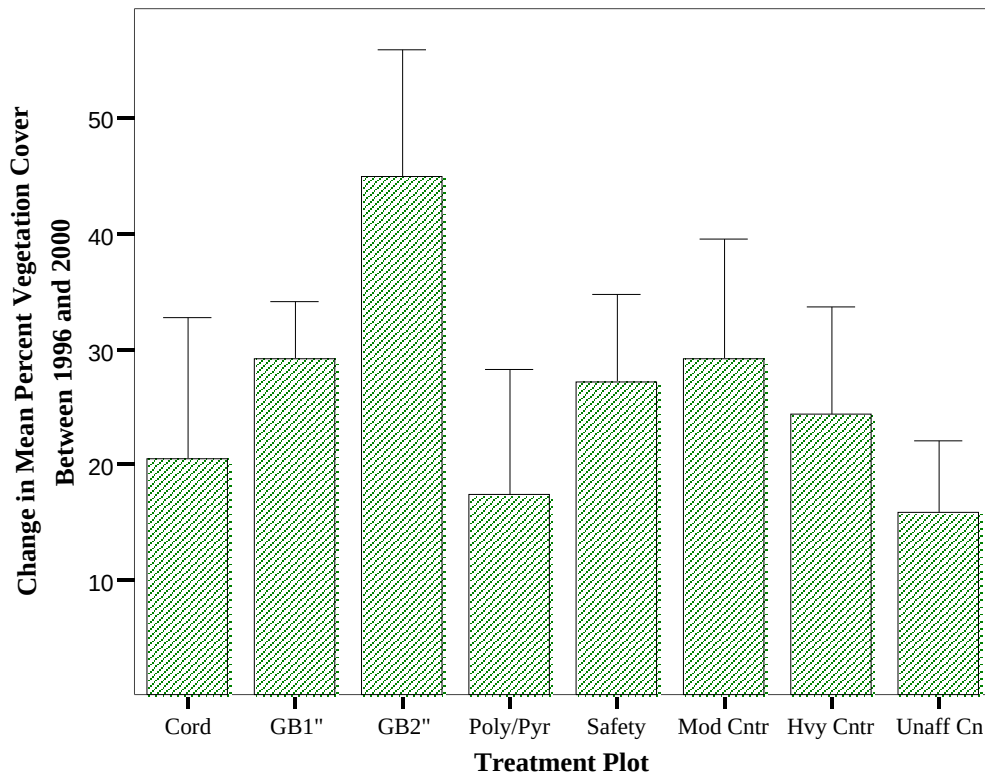
All of the materials provided a certain level of re-vegetation, which provides soil insulation and stabilization. Between 1996 and 2000 there was an increase in average total vegetation cover for all of the treatment plots, including the control plots (shown in Figure A). By 2000, most of the hardened study plots had vegetation cover comparable to the Unaffected Control Plots, although species composition still remained different. At all three sites, the unprotected Heavy Control plots still had significantly lower vegetation cover than the Unaffected areas. Geoblock ® 2" had the greatest increase in vegetation cover, while Polynet/Pyramat and Corduroy had the lowest increase. Cotton grass (*Eriophorum* spp.) was the most common species of vegetation to increase for most of the sites.

Figure A. The average change in total percent vegetation cover for each plot type between 1996 and 2000. Averaged over the three study sites, excluding Tanada Lake site because vegetation was not measured in 2000. Wood Matrix is not shown, because this material was removed in 1997. A positive bar indicates the vegetation cover increased. Treatment plot acronyms used in the graph are: Cord = Corduroy, GB2''= Geoblock® 2'', GB1'' = Geoblock® 1 ¼'', Poly/Pyr = Polynet/Pyramat, Safety = Safety Deck®, Mod Cntr = Moderate Control, Hvy Cntr = Heavy Control, and Unaff Cn = Unaffected Control.

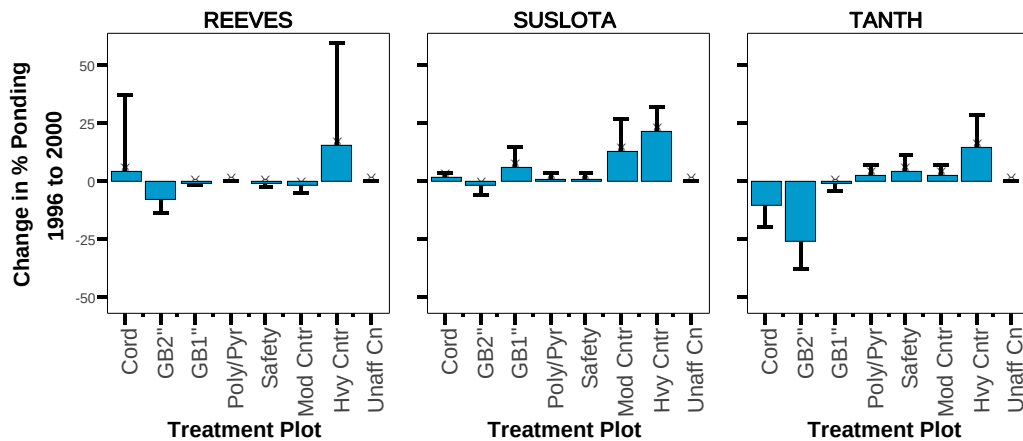
Comparing the level of ponding and thaw rates for the different materials provided information on the materials ability to reduce ponding and trail degradation. It was possible to compare the change in ponding over the past four years using the vegetation monitoring data. Ponding on the ATV trails generally develops because of thermokarsting (melting of the permafrost), however it can also occur due to excessive rain and poor drainage. Regardless, it is generally undesirable and causes greater resource damage. The chart in Figure 5 shows the change in percent cover of ponding for each test plot between 1996 and 2000. Due to the stratification in to moderate and heavily impacted segments, not all of the sites originally had ponding. Overall, there was a significant increase in ponding for the unprotected Heavy Control plots at all sites, and at Suslota both the Moderate and Heavy control plots had increased ponding (Figures 17 - 24). On the other hand, the hardening materials either reduced ponding or did not significantly change it from 1996, which suggests that ponding did not worsen due to the materials. In 2000, there was a significant amount of rainfall previous to and during the sampling period, therefore it is not suspected that the decreases would be due to a drier season. Geoblock 2” showed the most significant decrease in ponding, of all the materials. Thaw rate analyses are presented under the soil monitoring section below.

Figure 5. Bar graph showing the change in percent cover of ponding (standing water) from the vegetation monitoring plots between 1996 and 2000 at each study site (Tanth = Tanada Trailhead). A positive bar indicates the ponding had increased by 2000, a negative bar indicates the ponding had decreased by 2000. Treatment plot acronyms used in the graph are: Cord = Corduroy, GB2”= Geoblock® 2”, GB1” = Geoblock® 1 ¼”, Poly/Pyr = Polynet/Pyramat, Safety = Safety Deck®, Mod Cntr = Moderate Control, Hvy Cntr = Heavy Control, and Unaff Cn = Unaffected Control.

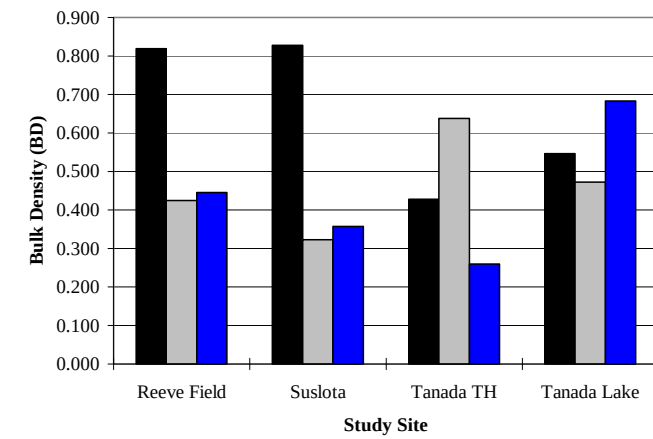
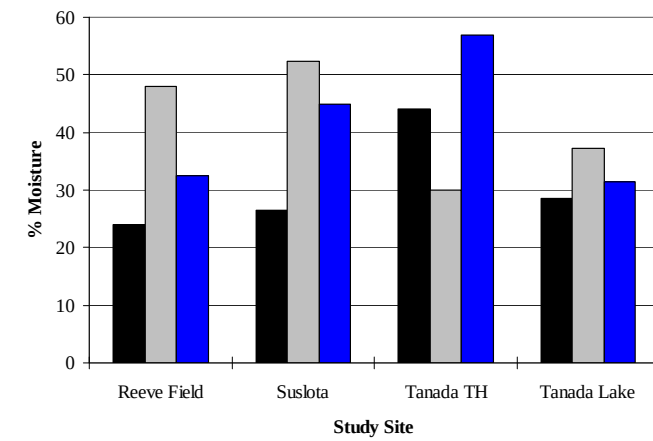
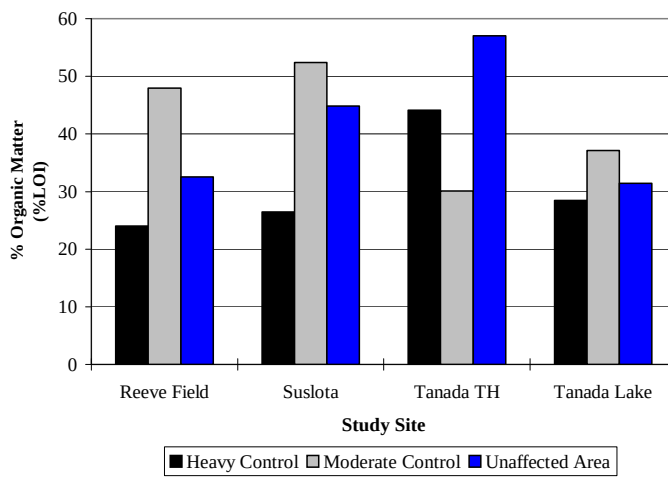
Figure 6. Average laboratory values for bulk density (BD), percentage moisture (%MOIST), and percentage lost on ignition (%LOI) for soil samples within each control plot at each site.

Heavily impacted plots generally had higher BD values than the unaffected area, except at the Tanada Lake site (Figure 6). Soils with higher BD values naturally had lower %MOIST values and lower %LOI values. At the Tanada Lake and Tanada Trailhead sites, soils in the heavy control plots appear to be generally lower in BD in comparison with the other two sites, and higher in moisture. Lower %LOI values were also found in heavy control plots in comparison to moderate control and unaffected area plots, except at Tanada Trailhead where the moderate control plot had less organic matter than both the heavy control and unaffected area plots. Bulk density is the mass of soil in a given volume. Higher levels of organic matter (estimated by % LOI) in a soil tend to decrease bulk density because organic material weighs less than minerals. Organic matter promotes aggregation of soil, resulting in a more porous soil structure, which allows for the soil to hold water and also allows for water to move through the soil. Soil compaction and loss of organic matter due to loss of vegetation will result in an increase in bulk density and increase in ponding.

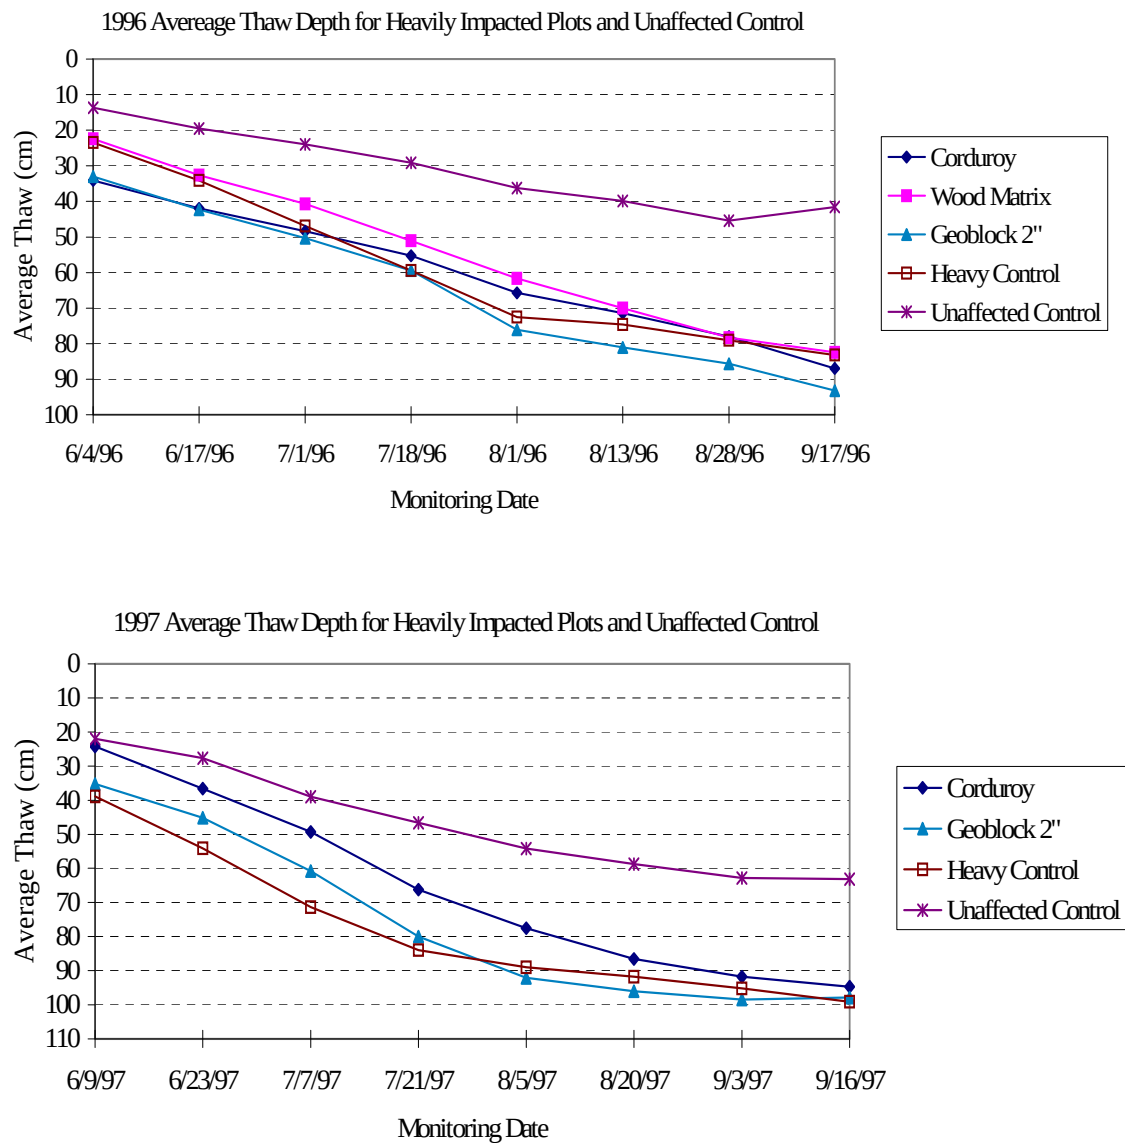
Average thaw depths of all sites for the 1996 and 1997 monitoring periods are depicted in Figure 7 for the heavily impacted plots and Figure 8 for the moderately impacted plots. Linear regression lines were compared in order to determine differences in the thaw rates for each treatment or control plot for each study site. Table 9 lists the average thaw rates (slopes) for each test plot by site for 1996 and 1997. Greater slopes (higher numbers) indicate a faster thaw rate and more rapid melting of the soils.

Figure 7. Average thaw depths for the heavily impacted test plots during the 1996 and 1997 monitoring periods. Averaged across all four sampling sites.

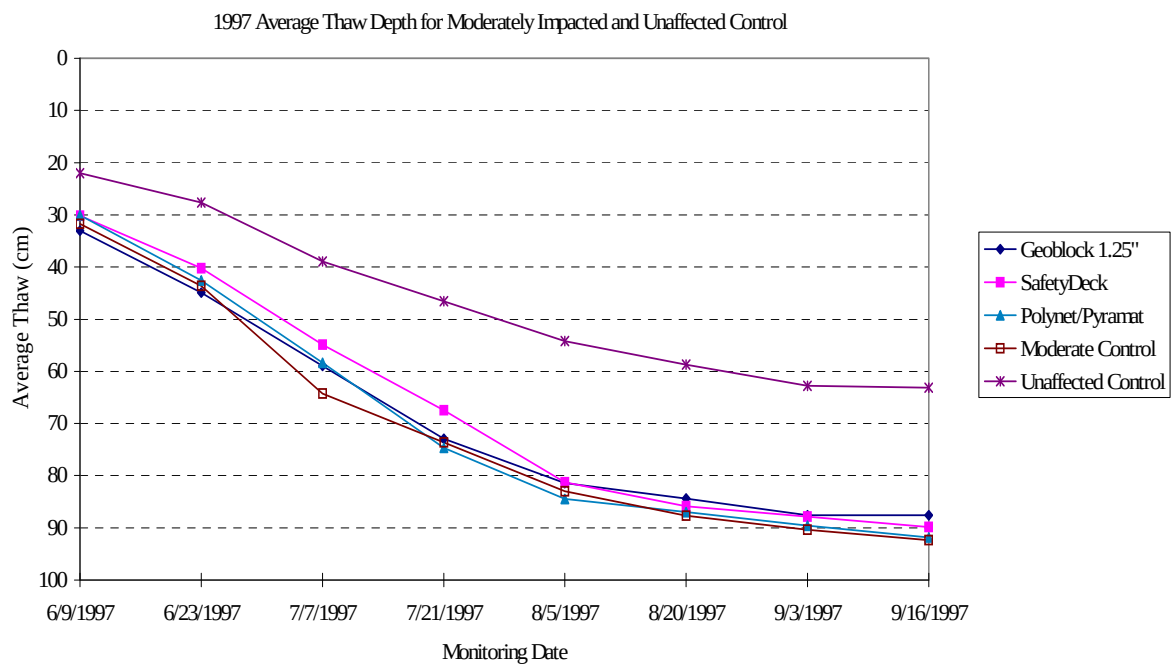
Figure 8. Average thaw depths for moderately impacted test plots during the 1996 and 1997 monitoring periods. Averaged across all four sampling sites.

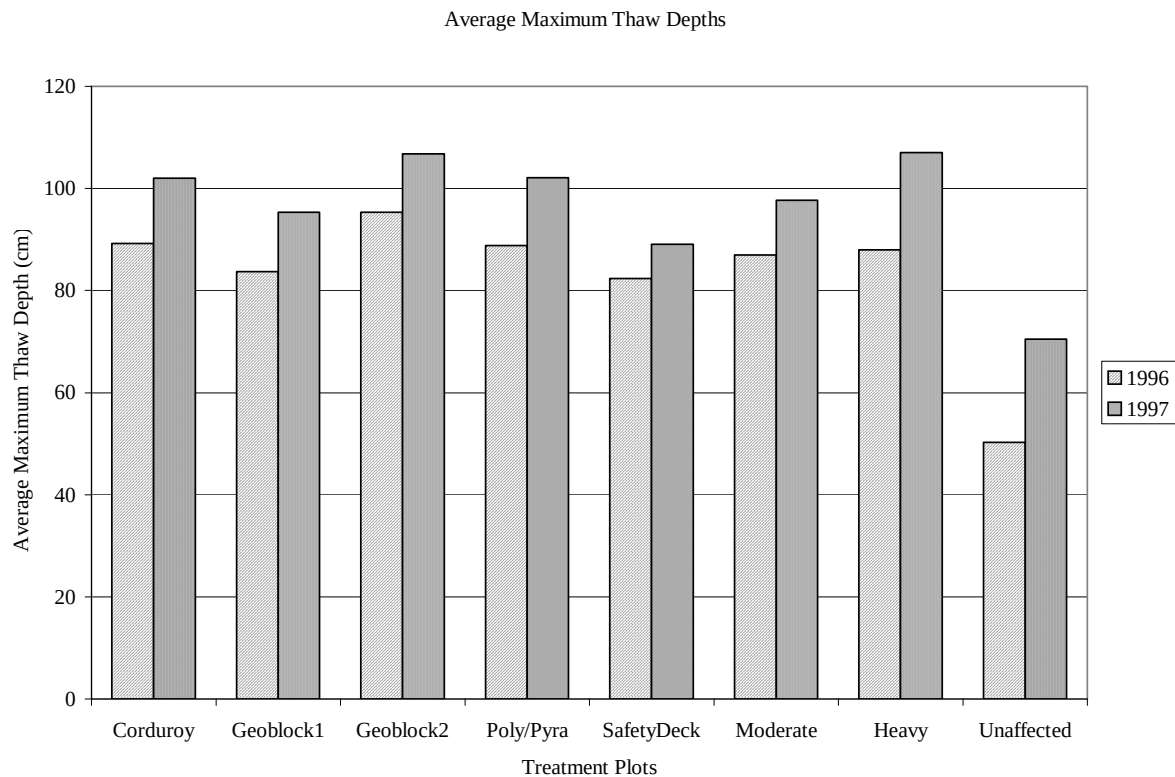
The maximum average thaw depth was calculated by determining the average thaw depth for each monitoring period by transect for each test plot, then selecting the maximum value for each test plot for the sampling year. Figure 9 shows the average maximum thaw depths averaged across the study sites. To assess changes within plots between years, comparisons were made between 1996 and 1997 maximum thaw depth for each treatment or control type. There was a significant difference in thaw depths by sample year, with 1997 having greater thaw depths than 1996 and among the test plots (Table 12). Maximum average thaw depths were then compared by year for each plot type. During 1996, there was a significant difference in maximum thaw depth among the plots ( $P = 0.04$ ) (Table 13). The post-hoc analysis indicated that only Geoblock® 2" (average maximum thaw depth of 95.3 cm) had significantly greater thaw depths than the Unaffected Control (50.2 cm). By 1997, although the Unaffected Plots still had lower maximum thaw rates, there was no significant difference among the maximum thaw depths among the test plots (Table 14).

Figure 9. The average maximum thaw depth in centimeters for each plot type during 1996 and 1997. Thaw depths were averaged across sites.

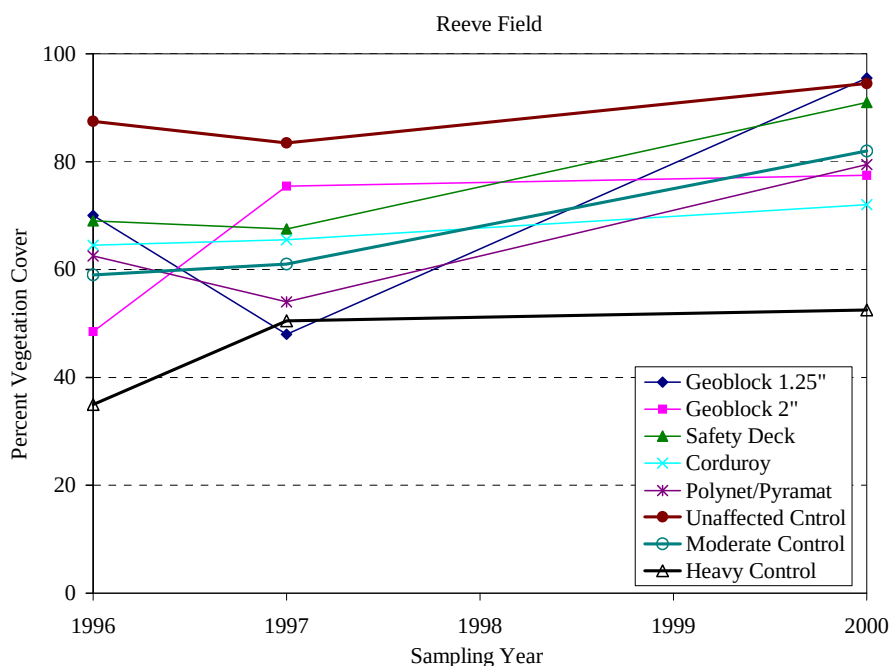
At Reeve Field, there was significantly greater vegetation cover during 2000 across all of the plots ( $P < 0.000$ ) in comparison to 1996 and 1997 (Table 15 and Figure 10). There was no significant difference in total vegetation cover between 1996 and 1997. In comparing the total percent vegetation cover among the eight plots there was a significant difference among all eight plots for the three years of data (Table 16). The post-hoc analysis revealed that five of the plots in 1996 had significantly lower total percent vegetation cover than the Unaffected control plot, these were: Corduroy, Polynet/Pyramat, Geoblock® 2", Moderate Control and Heavy Control. Four years later in 2000, only the Heavy Control plot had significantly lower vegetation cover than the Unaffected plot (See Table 17, Figure 10). A photo series of the Reeve Field test plots over time is presented in the Photo Series Section, and shows the changes in vegetation over time.

Figure 10. Display of the average percent cover of all vegetation by test plot type. Each point symbol represents the average percent cover taken during that sampling year for Reeve Field.

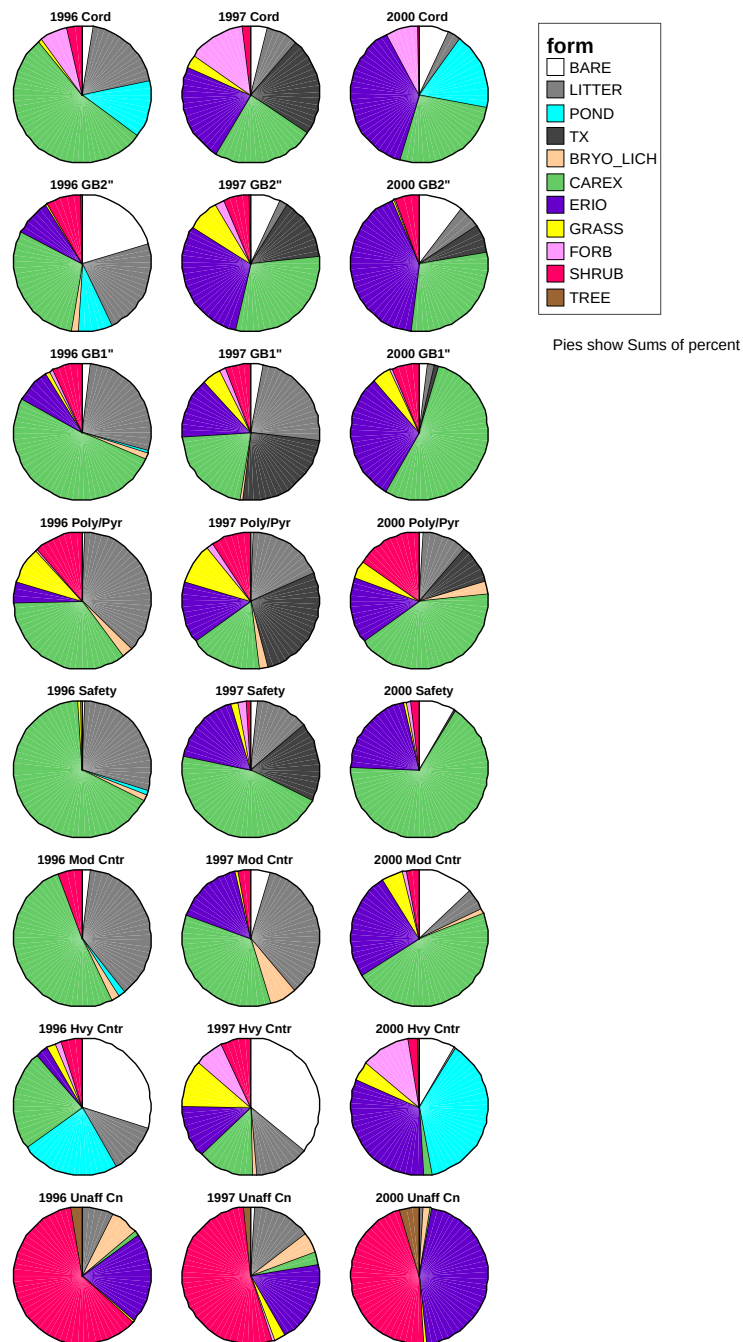
It is of interest to compare the relative change in vegetation cover to determine whether the hardening treatment plots had an increase or decrease in vegetation growth in comparison to the untreated trail controls or the unaffected control. As seen in Figure 11, the change in vegetation cover between 1996 and 1997 showed a drop in vegetation cover for several of the plots (Geoblock® 1 ¼", Safety Deck®, Polynet/Pyramat and Unaffected Control). However only Geoblock® 1 ¼" had a significant decrease in cover compared to heavy control, while Geoblock® 2" had a significant increase in cover when compared to the unaffected control. Although the overall cover increased by 2000, the amount of increase was not significantly different among the plots. Indicating there was a general increase, but it occurred throughout all of the plots (Figure 11). The majority of the vegetation increase was attributed to an increase in cotton grass, *Eriophorum* species (generally *E. angustifolium*), with a decrease in litter or *Carex* (Table 18).

Figure 11. General species composition for major types of vegetation and ground cover, during 1996, 1997 and 2000 of each test plot at the Reeve Field study site. Pie slices represent the average percent cover of vegetation or ground cover of each test plot.

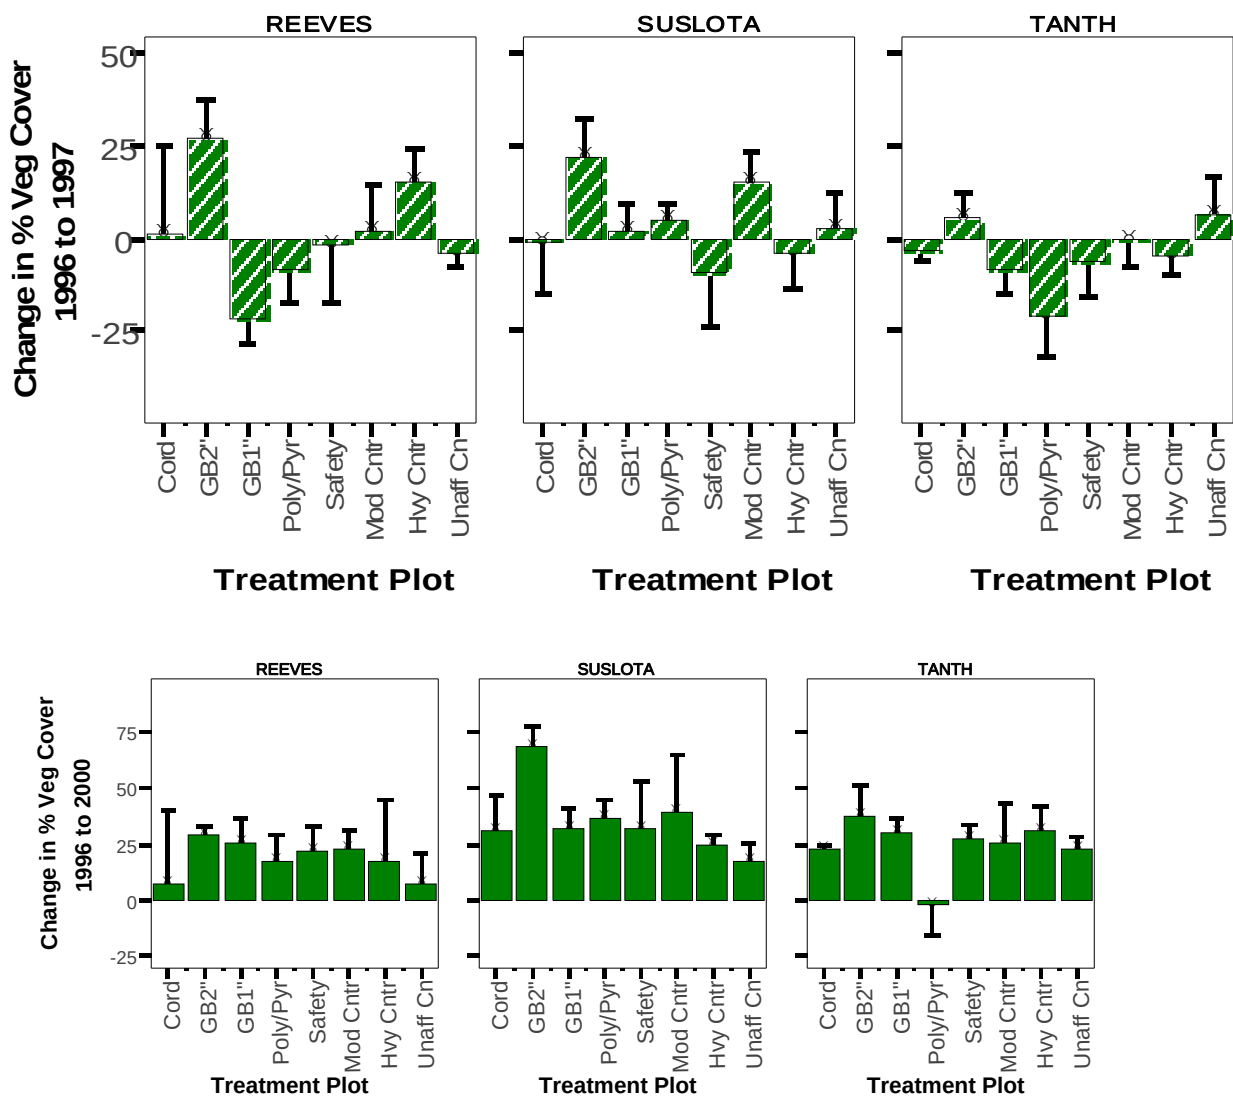
Figure 12. Bar graphs showing the average change in percent total vegetation cover for each test plot between 1996 to 2000 (top graph) and between 1996 to 2000 (bottom graph). A positive bar indicates the vegetation cover increased, a negative bar indicates a decrease in vegetation cover.

significantly lower vegetation cover than the Unaffected Control. The change in vegetation cover between the sampling years is shown in Figure 12. In comparing the change in vegetation cover from 1996 to 2000, it was found that Polynet/Pyramat had a significant decrease in vegetation when compared to the control plots (moderate, heavy and unaffected).

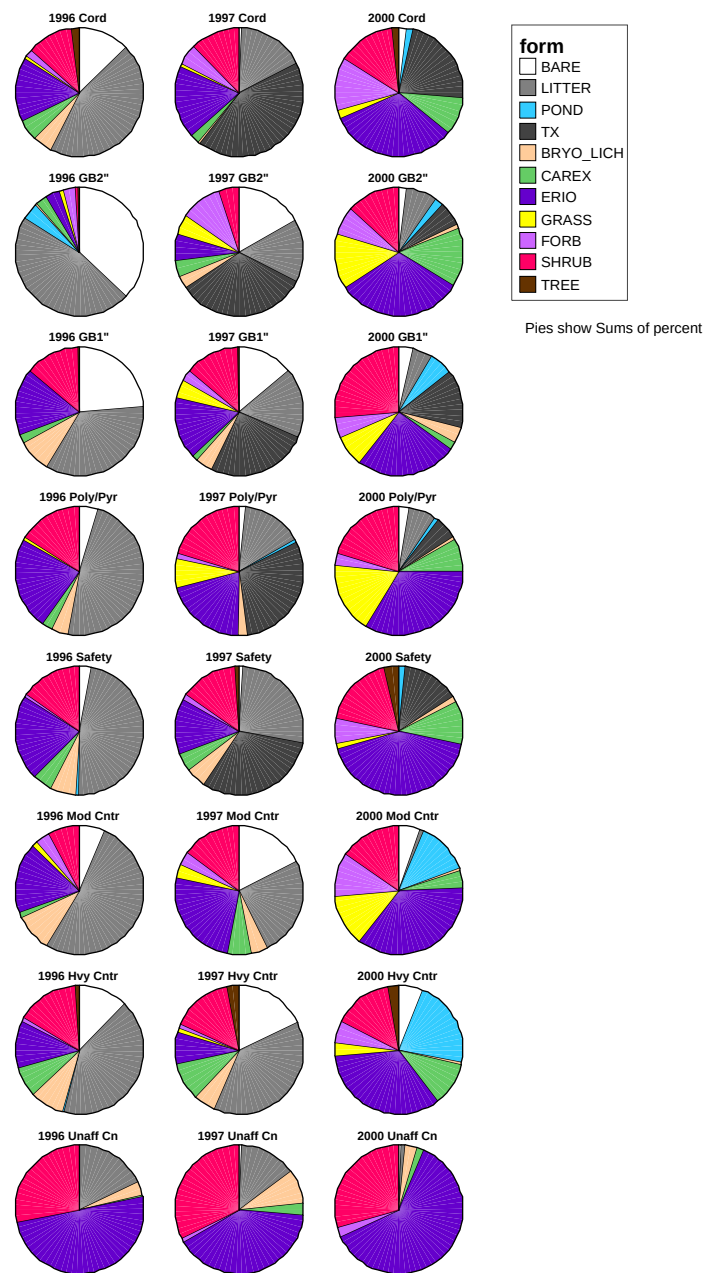
Figure 13. General species composition for major types of vegetation and ground cover, during 1996, 1997 and 2000 of each test plot at the Suslota study site. Pie slices represent the average percent cover of vegetation or ground cover of each test plot.

The majority of the vegetation increase for all of the plots was attributed to an increase in tussocks cotton grass, *Eriophorum vaginatum*, with a decrease in litter (Table 22). From Figure 13 it can also be seen that several of the plots showed a slight increase in grasses – primarily *Calamagrostis canadensis* and *Arctagrostis latifolia*. Slough grass, *Beckmannia erucaeformis*, also increased in cover.

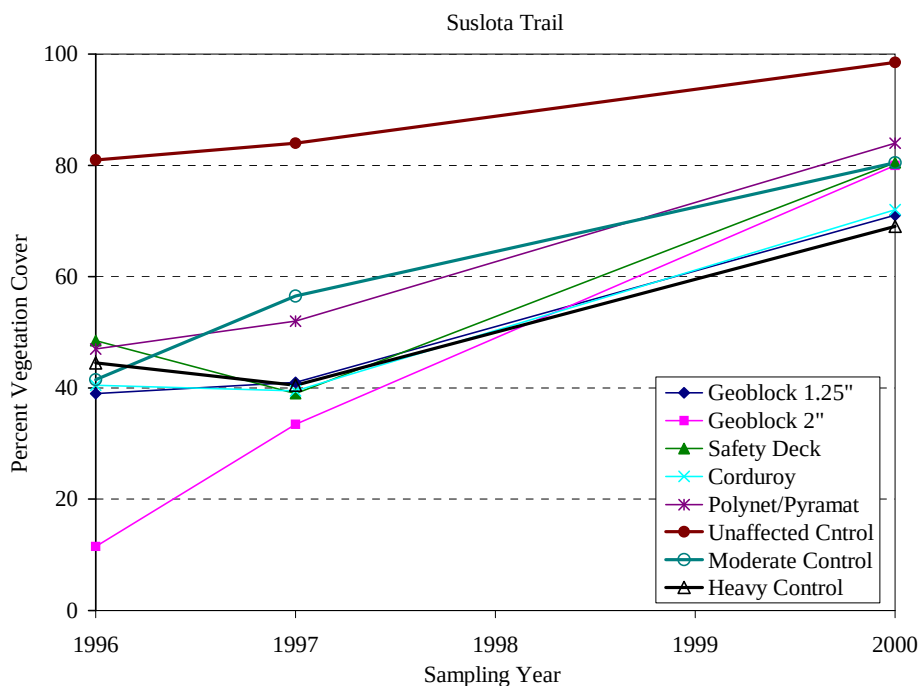
Similar to Reeve Field, there was significantly greater vegetation cover in 2000 compared to 1996 and 1997 (Table 19 and Figure 14). There was no significant difference in total vegetation cover between 1996 and 1997. In 1996 all of the plots at Suslota had significantly lower total vegetation cover than the Unaffected Control in 1996, as seen in Figure 14 and Table 21.

Figure 14. Display of the average percent cover of all vegetation by test plot at Suslota study site. Each point symbol represents the average percent cover measured for the sampling year.

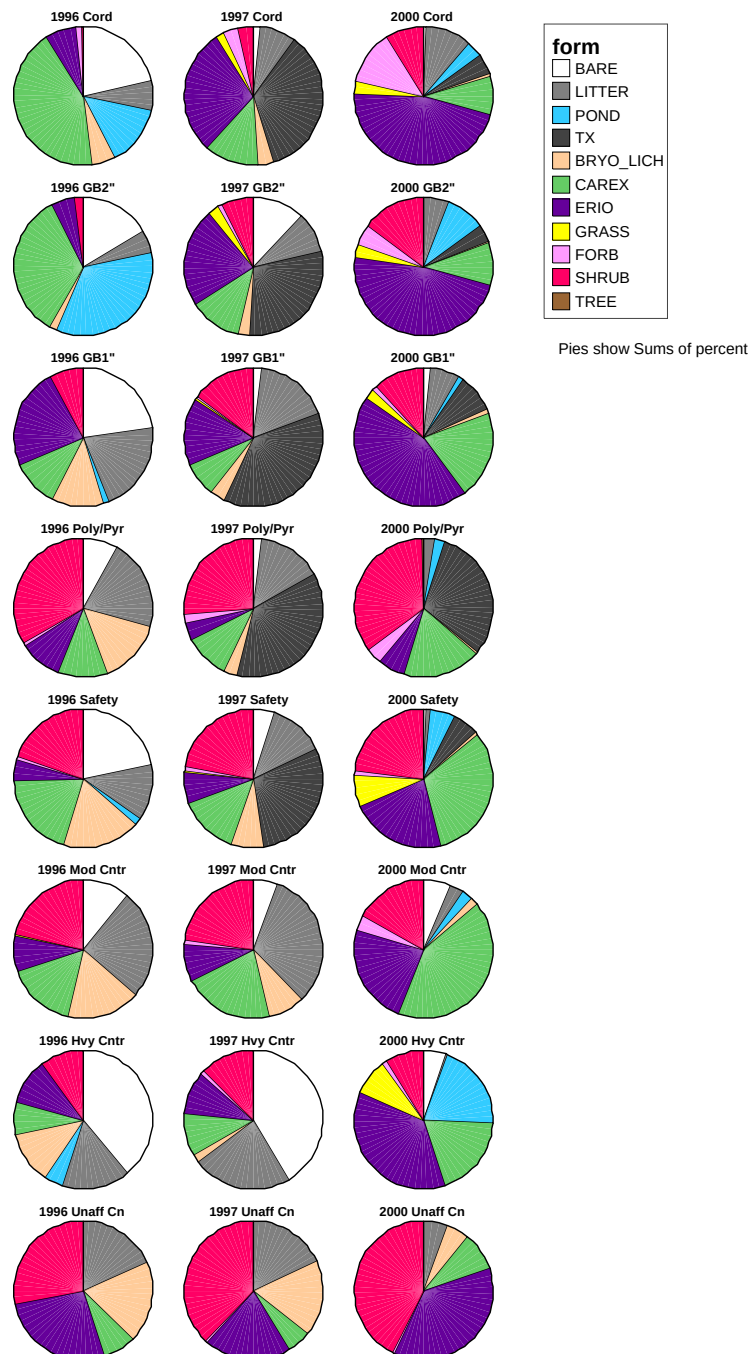
The type of vegetation increase varied among the plots, but included *Eriophorum angustifolium* and *Eriophorum vaginatum*, low shrubs (*Betula*) and *Carex* (Table 26 and Figure 15). From Figure 15 it can also be seen that Heavy Control and Safety Deck plots had an increase in grasses – primarily slough grass, *Beckmannia eruaeformis*, which is a weedy annual, although not introduced.

Figure 15. General species composition for major types of vegetation and ground cover, during 1996, 1997 and 2000 of each test plot at the Tanada Trailhead study site. Pie slices represent the average percent cover of vegetation or ground cover of each test plot.

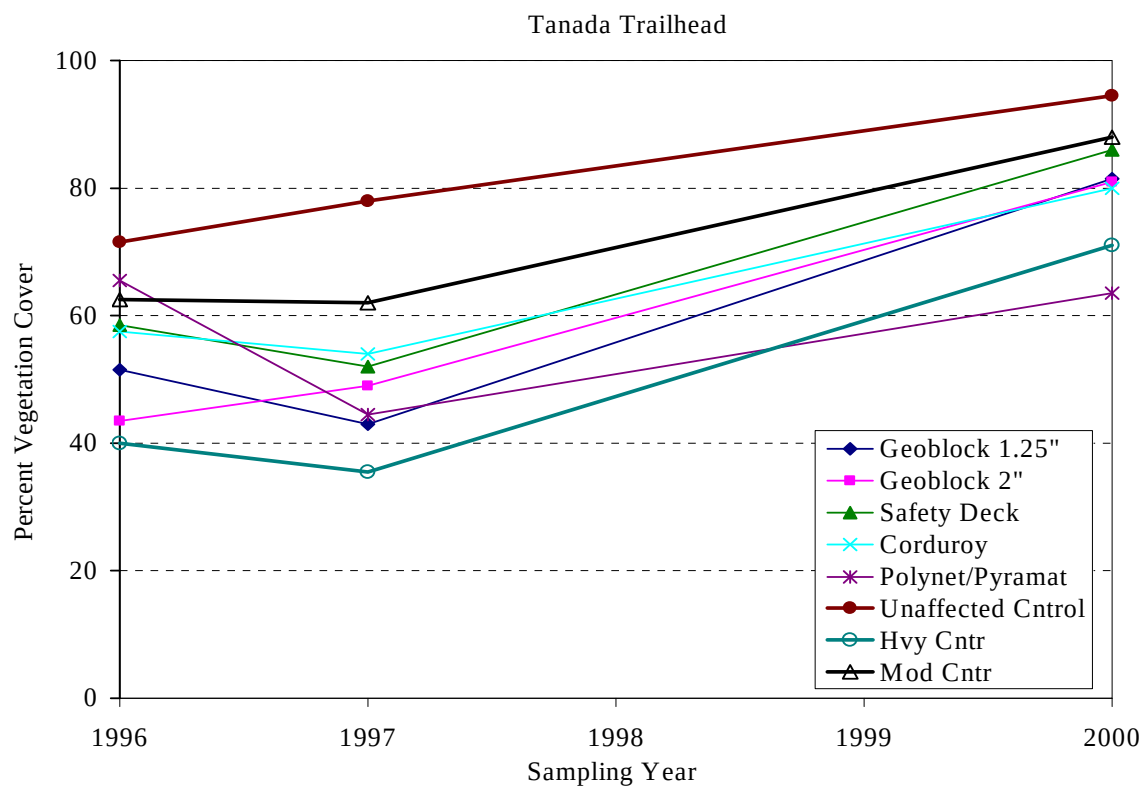
Again, there was a significant increase in vegetation cover in 2000, compared to 1996 and 1997 (Table 23 and Figure 16). There was no significant difference in total vegetation cover between 1996 and 1997. In 1996 only three of the plots (Geoblock 1 ¼" and 2" and Heavy Control) had significantly lower vegetation cover than the unaffected control plot (Tables 24 and 25). In 1997 all of the plots had lower vegetation cover than the Unaffected Control, probably due to the cover caused by the hardening materials. But by 2000, only Polynet/Pyramat and Heavy Control plots had

Figure 16. Display of the average percent cover of all vegetation by test plot at Tanada Trailhead. Each point symbol represents the average percent cover measured for the sampling year.
