## **Harding Icefield Trail Impact Monitoring Report 2009**

**Christina Kriedeman and Deborah Kurtz  
Kenai Fjords National Park  
Resource Management Division  
P.O. Box 1727  
Seward, AK 99664**

**September 2009**

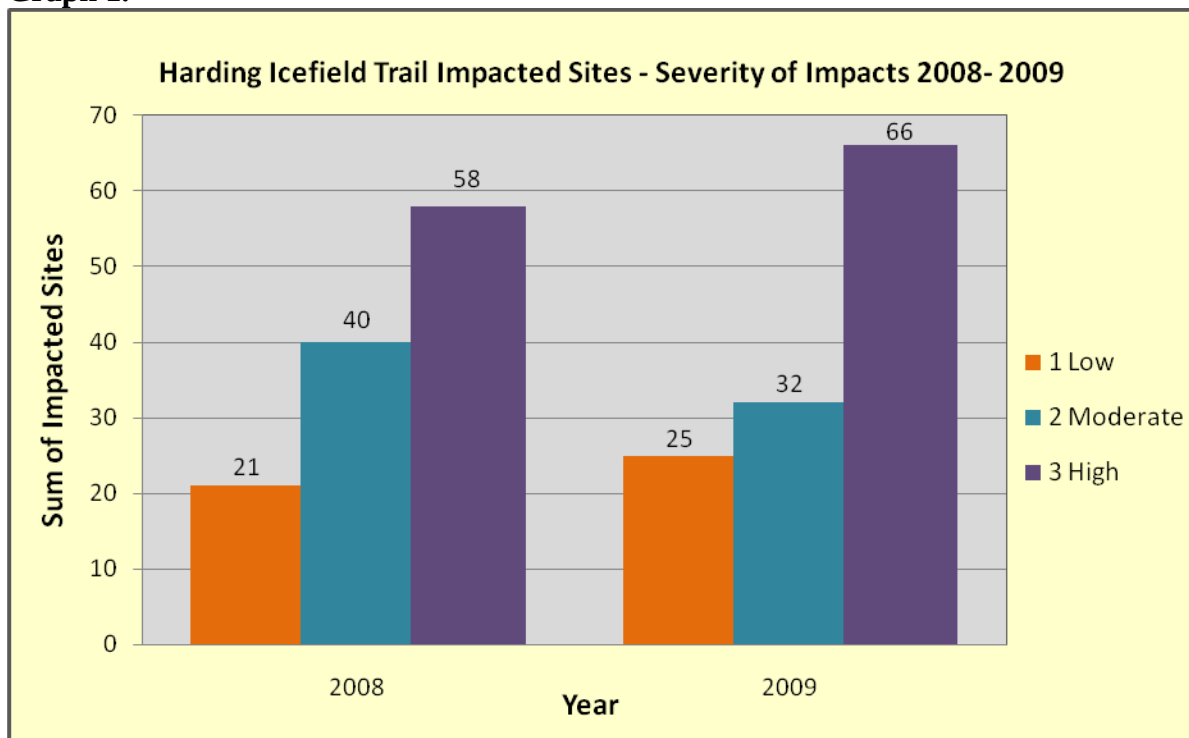
**Graph 1.**

The graph below illustrates the number of sites in each impact category comparing changes from 2008 to 2009. Sites with a Low (1) severity of impact have increased slightly from the previous year. The numbers of sites with a Moderate (2) severity of impact decreased slightly, and High (3) severity of impact sites have increased.

The increase in highly impacted sites in 2009 may have been associated with the high snow year in 2008. Snow remained on the trail much longer than a typical summer, which caused the trail to be muddier and less desirable for visitors to walk on. This may have caused an increase in impacts along the trail. Some impacted sites in 2008 were still under snow when impact monitoring was conducted and were never evaluated.

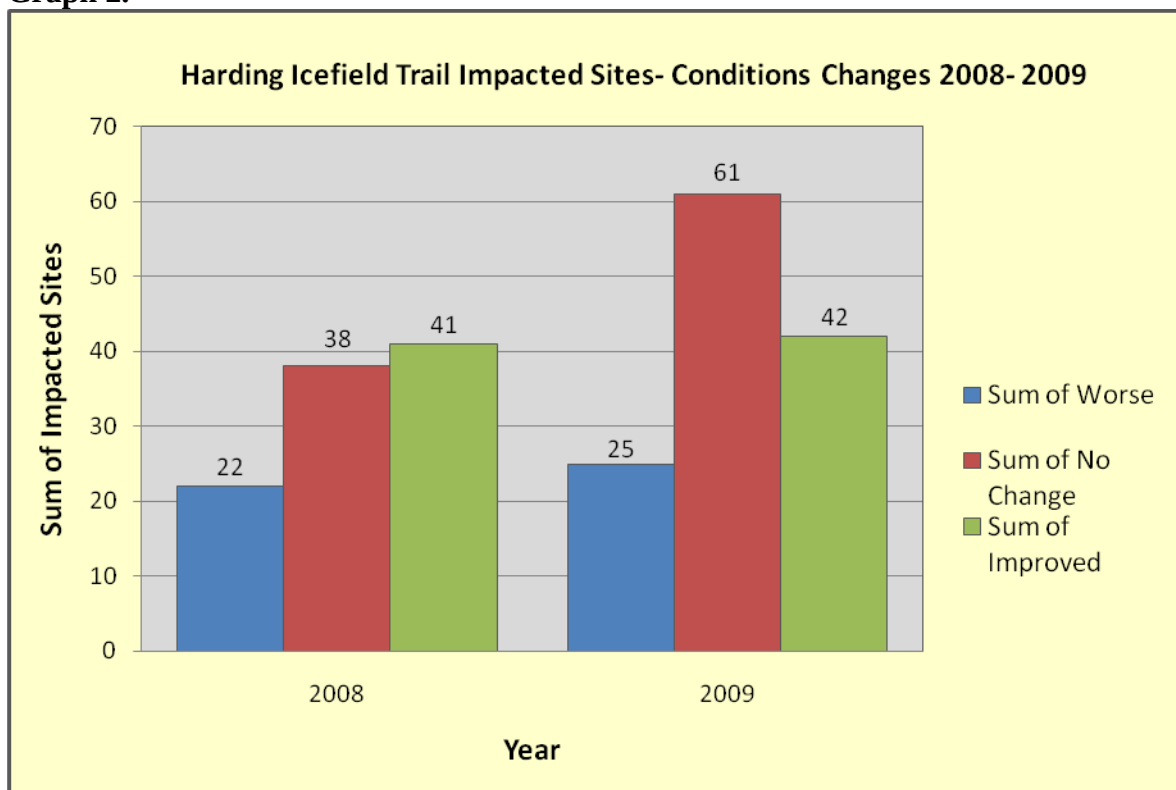
**Graph 2.**

The change in condition (worse, no change or improved) of the impacted sites from the previous year is illustrated in Graph 2. The number of sites that are in worse condition increased slightly from last year. The sites with no change increased dramatically. The sites that improved have only increased by one site.

Again, the trail condition may have been affected by the unusually wet, snowy trails that lasted throughout the summer season in 2008. The high number of sites with No Change in condition may be due to the fact that vegetation on these sites did not have much time to grow or increase cover due to the increased amount of time that vegetation was covered in snow and the poor trail conditions that lead visitors to walk off trail, impacting vegetation and soils.

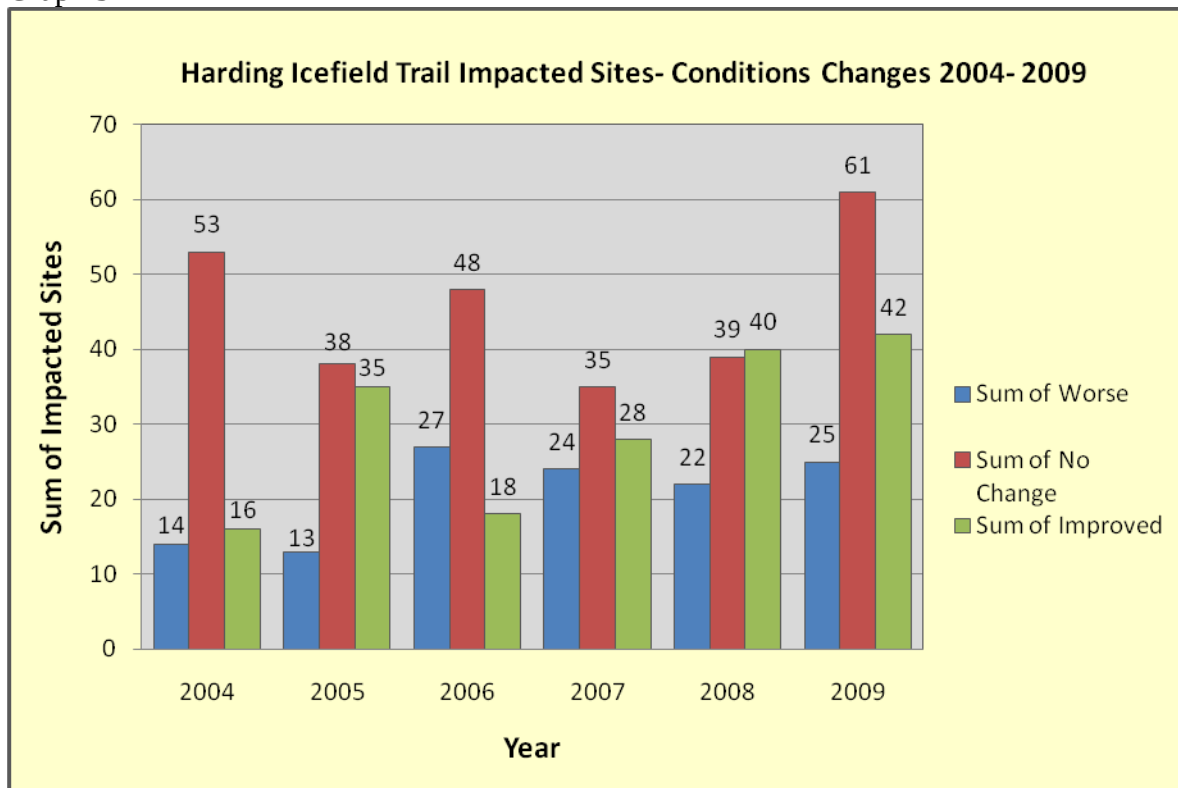
2007 it was suggested that impacts should be compared over more than two consecutive years to judge trends in impact changes over a longer period of time. Sites that have been eliminated due to the rerouting of the trail have been removed from the previous years so that the data is more comparable. The Graphs 3 and 4 look at surveys from 2004-2009. Graph 3 looks at condition class changes over time and it looks like sites with no change in their condition are increasing since 2006. Sites that are improving are also on an upward trend. Sites that have a condition class that is worse seems to be pretty stable over time. Graph 4 looks at the severity of impact at a site and there is an upward trend in the number of impacted sites as well as an increase in the number of highly impacted sites. The number of sites that have a low and medium severity of impact have not increased much over time. This could be because as new sites are being added they are lower impacted sites, but many sites are getting worse over time if nothing is being done to improve the trail where hikers are causing impacts and once a site becomes highly impacted it takes much longer for the site to recover.
