# HISTORIC STRUCTURE REPORT FOR THE HEADQUARTERS HISTORIC DISTRICT

## OLYMPIC NATIONAL PARK WASHINGTON

2010

Frederick L. Walters  
Historical Architect  
2752 Burton Lane, P.O. Box 437, Cambridge, Idaho 83610

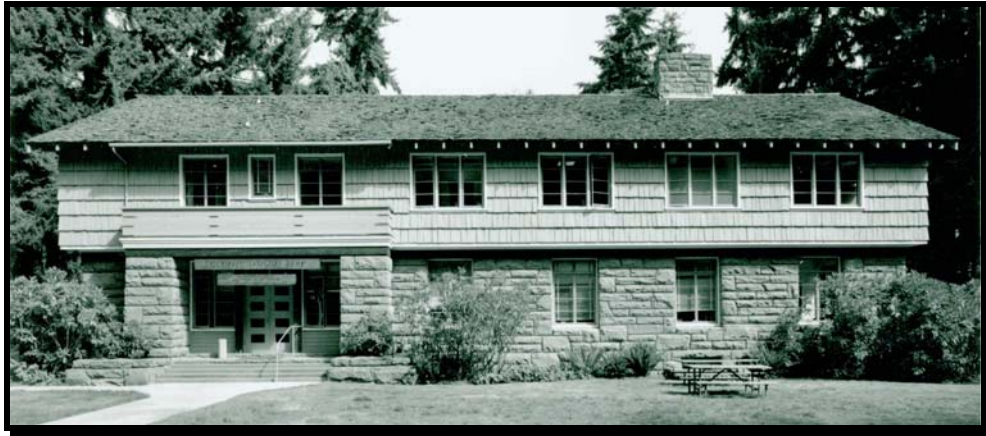
Figure No. 1-5: Administration Building, 1983; note lack of gutters and downspouts except over entry.

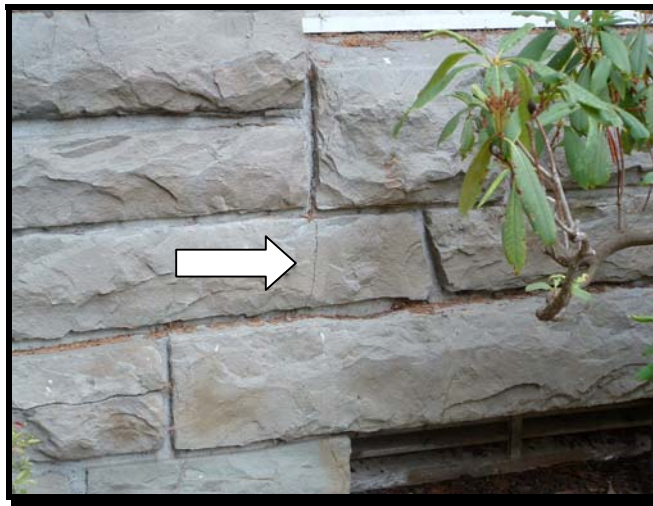
Figure No. 1-8: In the center of the picture there is a crack in the stone below the sill stone

In three places on the exterior walls there are vertical cracks in wall stones, all associated with windowsills.

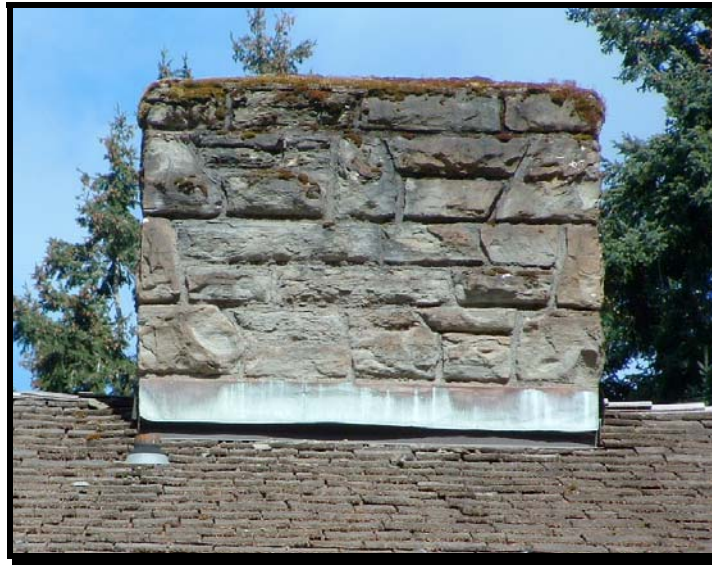
Figure No. 1-10:North side of the chimney

A double flue masonry chimney originally served the basement boiler and the lobby fireplace. The chimney rests on a reinforced concrete foundation and is constructed of brick (fire brick around the fireplace) until just below the roofline, where it transitions to stone. Visually, the chimney top is covered with lichen, the mortar joints, where visible appear sound, but the stone has signs of deterioration on the surface.

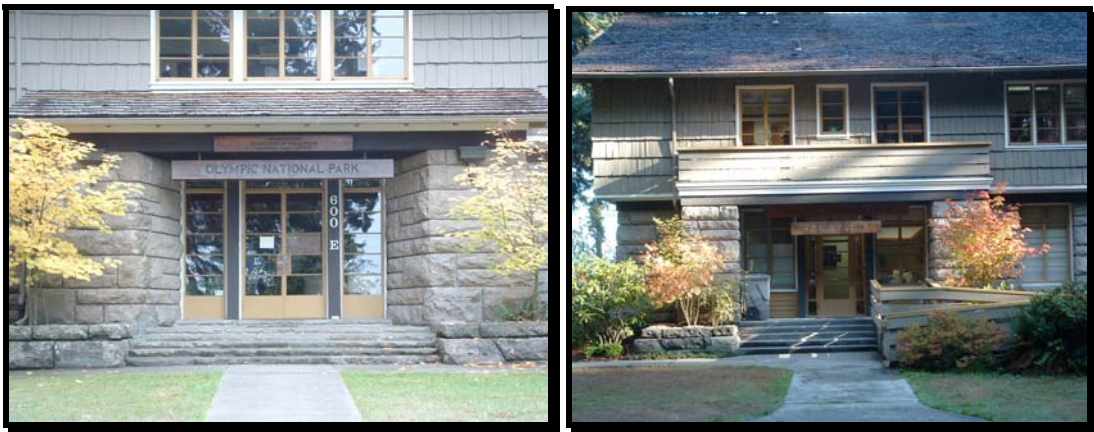
Figure No. 1-11: North entry on the left and south entry on the right

The stone used in construction of the Administration Building is local sandstone. When used in highly exposed environment such as the planters, steps, and landings, it appears to undergo accelerated deterioration. The stone in these locations exhibits a high degree of delamination of the natural bedding layers of this sedimentary stone. In addition, when wet the steps and landings become very slippery. At the rear entry, the original stone steps were covered with a concrete overlay. The front entry still has its original stone steps and landing.

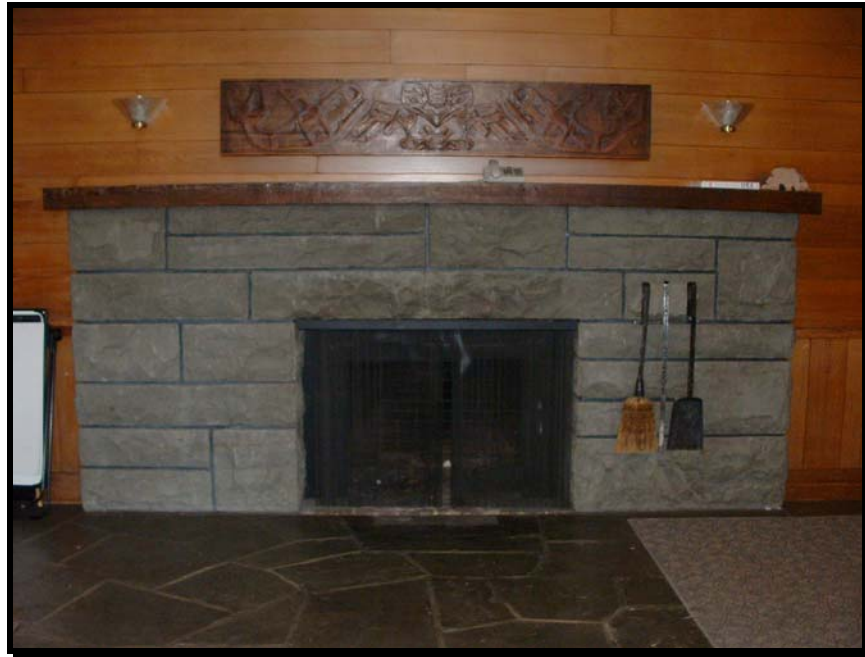
Figure No. 1-17: Lobby Fireplace

The fireplace in the lobby is a major design element of the room. The surround is of native sandstone. The large lintel stone is cracked in the center. The chimney has a metal cap and is not operational.

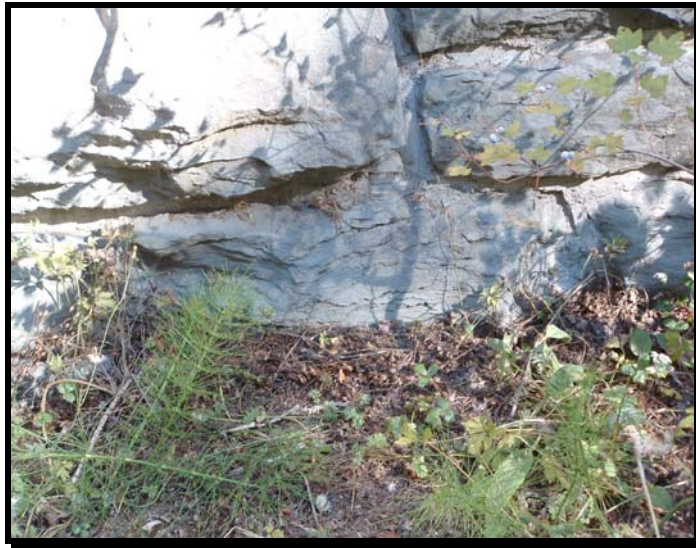
The other issues of concerns are the foundation vents and the rear basement window. The basement window was part of the original design, but was to be in a stairwell that led down the backside of the building into the basement. In this location, its elevation was below finished grade, but did not matter being in the stairwell. With the abandonment of the stairwell, the window ended up below grade and a shallow stone window well was created for it.

Figure No. 2-7: Veneer foundation stone deterioration

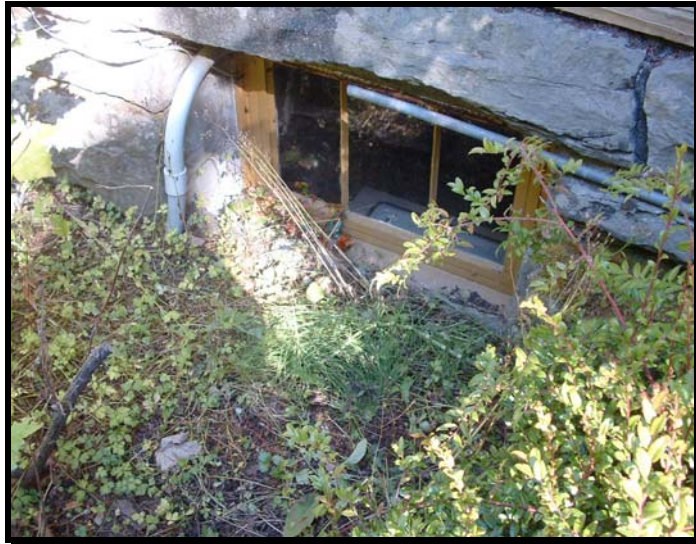
Figure No. 2-8: Shallow window well

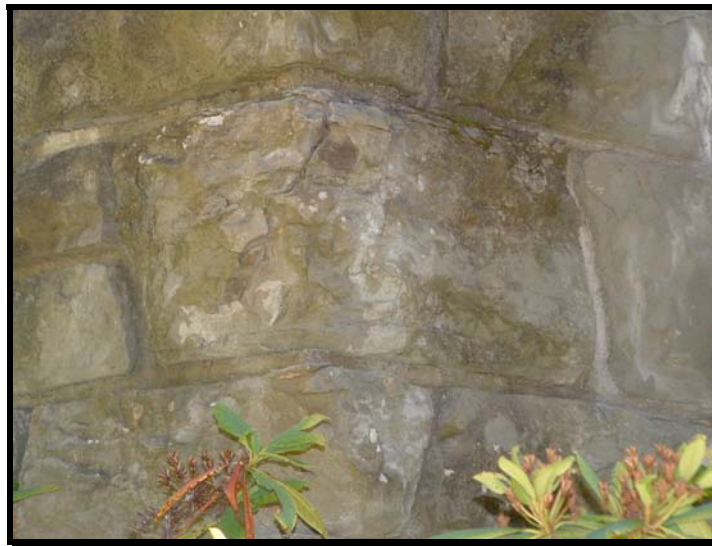
There are two chimneys on the building. One serves the living room fireplace and the other is a double flue chimney for the kitchen vent and basement furnace. The fireplace chimney was a concern in the seismic study of 2001 but was found to be of such a design and mass as to not be considered a risk for overturning in an earthquake. There does appear to be some open mortar joints at the top of the chimney. The chimney has a metal weather cap. The other chimney is not capped, as it is active for the furnace. Being highly exposed to the weather, the stones of the chimneys are beginning to show signs of deterioration in the form of cracked exterior faces and delamination. This is most apparent on the corner stones of the living room chimney.

Figure No. 2-9: Surface deterioration on the chimney base.

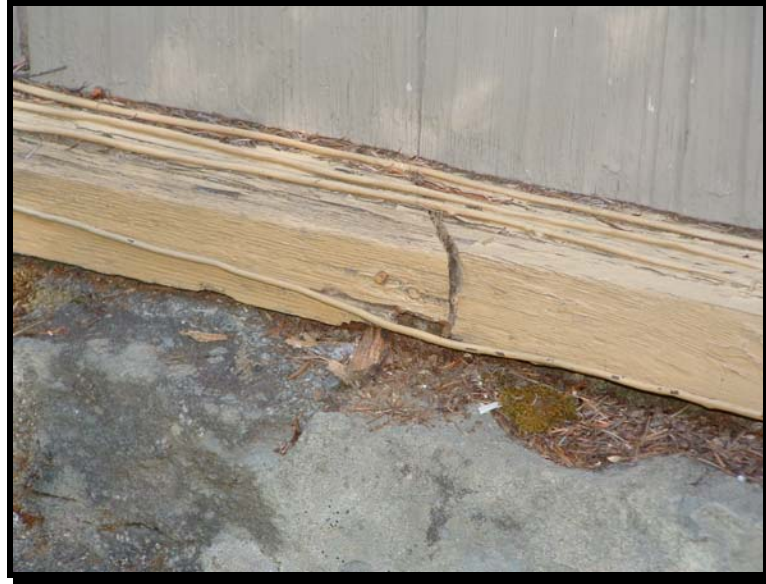
Figure No. 2-12: The foundation trim moldings is quite weathered and deteriorated.

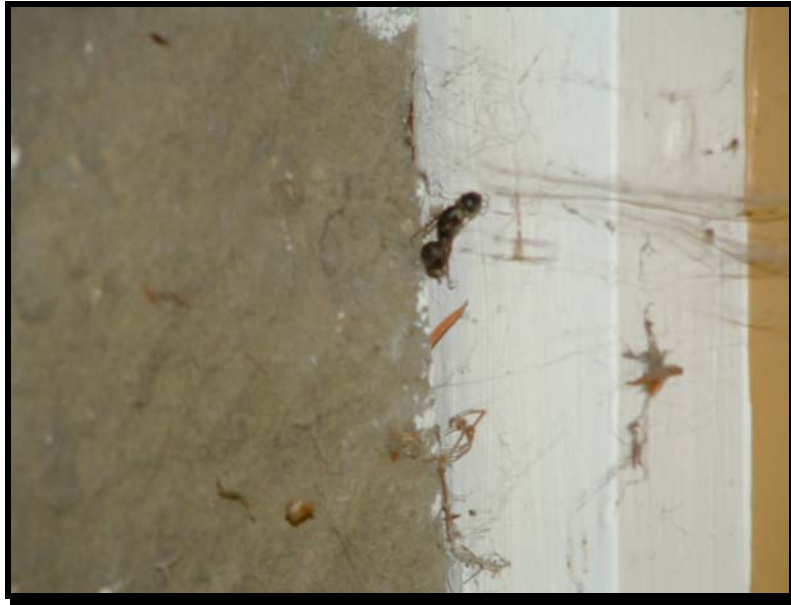
At the first floor stonewalls, the construction detail of the wood frames that hold the steel windows and doors were altered. In changing the design, wood frames were set into a rebate of the outer stone wythe. This created an irregular joint between stone and milled wood. This open joint is accessible to insects.

Figure No. 2-14: Pest control of carpenter ants by a helpful arachnid

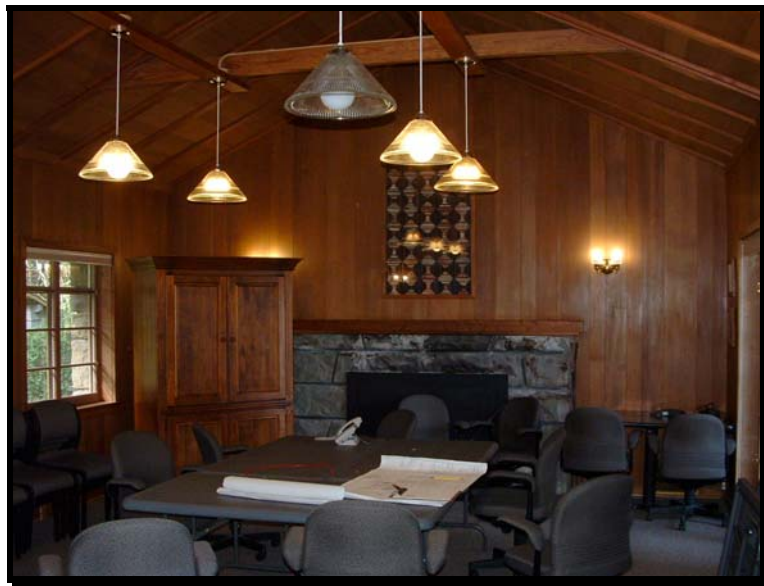
Figure No. 2-18: Former Living Room, now conference room.

The former living room is now used as a conference and meeting space. Its natural wood interior finish and vault ceiling, coupled with limited natural lighting, makes for a dark space. This has been augmented by running a surface mounted conduit from an original wall sconce outlet to a series of overhead lights mounted on wood members that were added to the original the open ceiling rafters. The stone surround of the fireplace exhibits stains and efflorescence deposits either from a flashing leak or rain penetrating the flue. The stains are from flue soot and the white stains from leaking of calcium from the mortar joints. This leakage did not appear active. It may have been curtailed with the installation of the metal chimney cap. The lintel stone is cracked. Where it cracked there was a small amount of spalling. The crack appears old and inactive. The fireplace is closed off and not used.

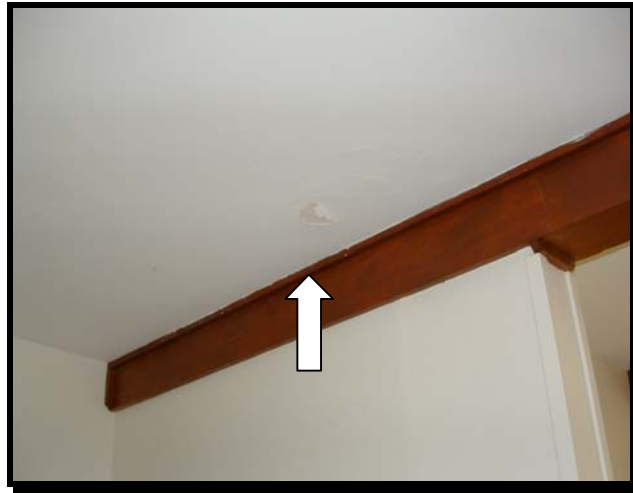
small loss of plaster is present. From the original drawings, at this location there is a cool water supply line to the upstairs restroom.

Figure No. 2-19: Plaster deterioration in the ceiling of kitchen hallway.

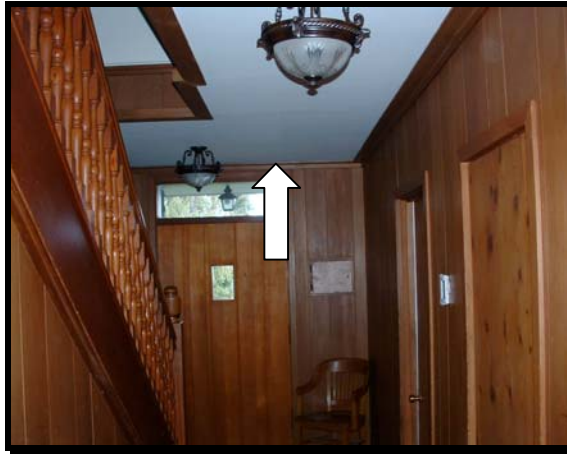
In the ceiling of the stairway hall is a crack in the plaster just above the foot of the stairs. This is the location of a double trimmer joist that spans the hallway and carries the floor joists of the northwest corner bedroom. According to the original drawings, the bedroom has 2 x 8 floor joists. The former bedroom is now an office.

Figure No. 2-20: Crack in ceiling plaster

The crack in the ceiling of the stairway hall is directly below a wall of the second story bedroom above. With 2 x 8 joists under this room, spanning 12 feet, this is reaching the limit for an office loading. Residence construction reused for office needs to take into consideration the additional weight of office files and equipment. The crack in the plaster is a concern of overloading the floor framing system. A review of the current office equipment should be conducted and if it exceeds standards

for deflection and bending of the floor joists, then such equipment should be moved to the first floor.

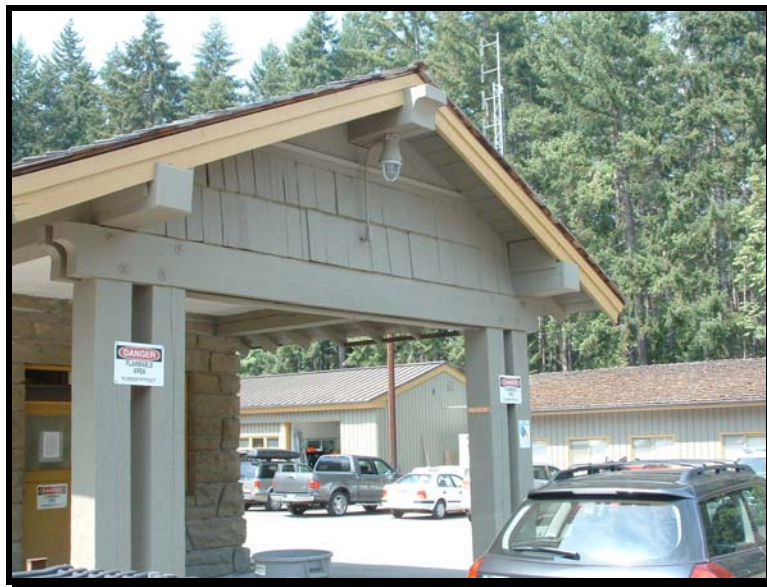
Figure No. 3-6: Note the cavetto profiles on the ridge outlooker and cross girders.

The original drawings show the two plate beams as having a cavetto profile. Either they were never executed or developed deterioration and have been cut off. All the exposed beam-ends have been covered with sheet metal for protection against moisture.

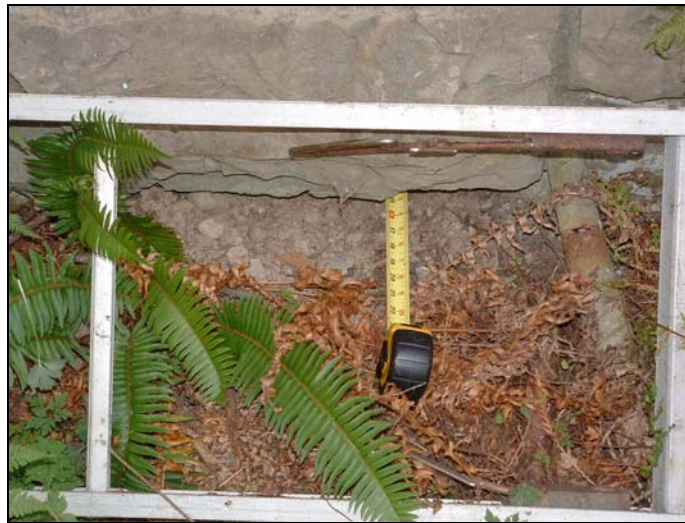
Original construction drawings for this building have not been discovered, but as it was constructed in the same summer as the Gas & Oil House, and is similarly detailed, it probably has no concrete foundation. This is further evident along the south elevation where former underground electrical lines entered the building and no concrete foundation is present. <sup>1</sup>The stone at this point is 16 inches wide and below the interior concrete slab floor, suggesting there was a shelf built into the stonewall to support the slab.

Figure No. 4-4: Opening through stone foundation to under interior floor slab.

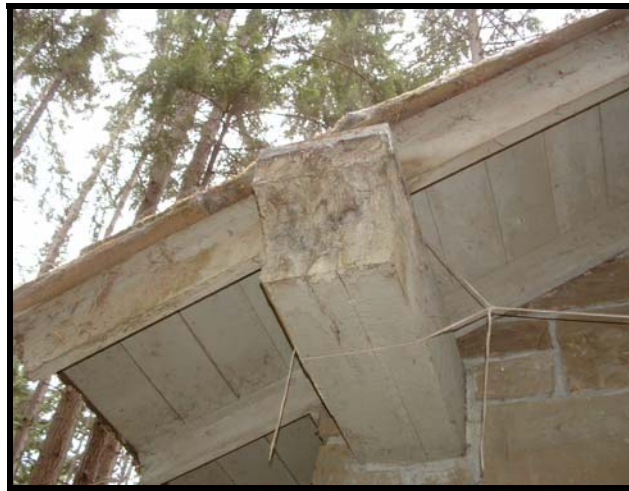
At the gable ends there are false outlooker beams with a cavetto profile. The beam tops have been covered with sheet metal for weather protection. The sheet metal does not go down the face of the beam and there are cracks and checks, along with discoloration, present.

Figure No. 4-5: The false beam-ends are cracked and checked.

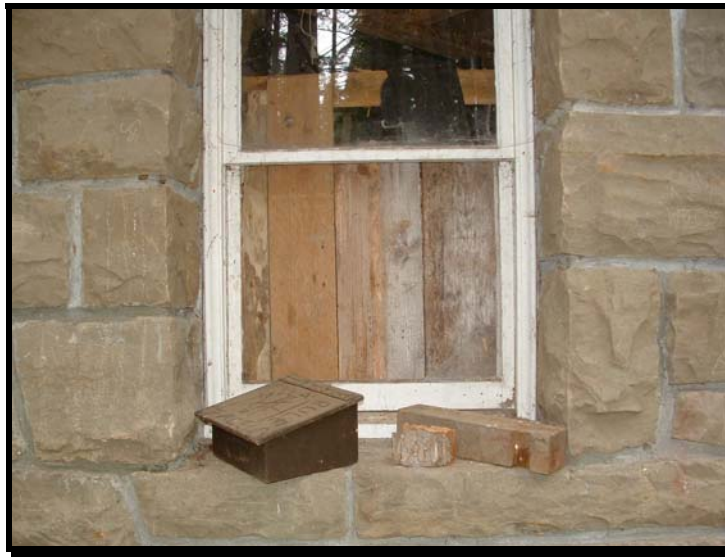
The paint coating of the three double hung windows and entry door are in poor condition. Both the windows and door have gaps around the trim and stone interface. On the north elevation, the lower sash is missing glass. The windows have been crudely boarded over from the inside.

Figure No. 4-6: Missing glass in north window

Repair and paint windows; install exterior sealant components; if required, design, fabricate, and install a more appropriate security system.

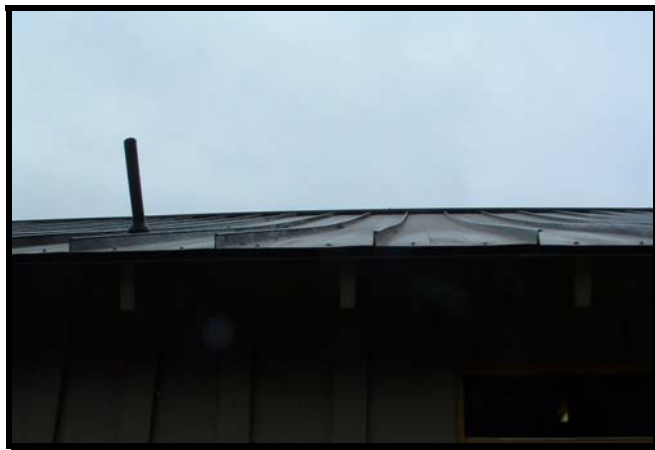
The structure is composed of 2 x 6 rafters with 1 x 8 straight sheathing. Along the north slope there is a deflection in the plane of roof.

Figure No. 5-4:Roof deflection along the north slope

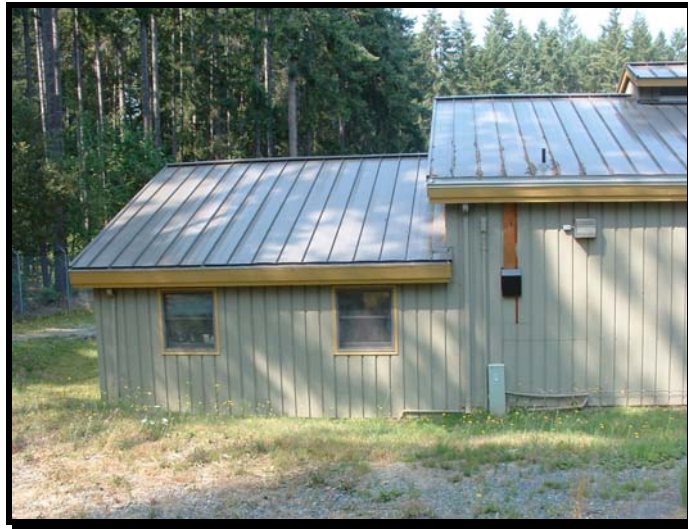
of the building. Here it appears a portion of a board and batten were removed to install a thru-wall assembly and was closed but never painted.

Figure No. 1000-6: Unpainted siding repair at southwest corner.

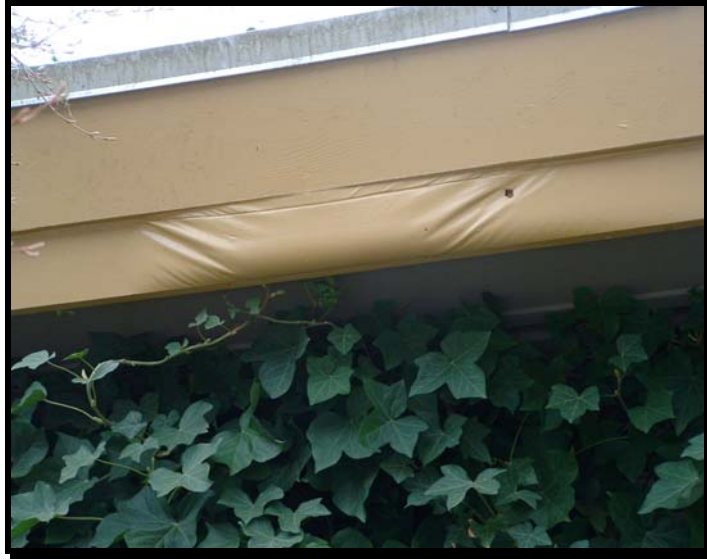
where deterioration is occurring in the fascia and gable ends. In addition, the paint coating of the fascia has numerous “bubbles” of liquid water. Such “bubbles”, some full during the assessment and some broken, are indicative of leaks in the metal gutter, most commonly found at joints in the gutter pans.

Figure No. 1000-7: Paint “bubble” on fascia full of water.

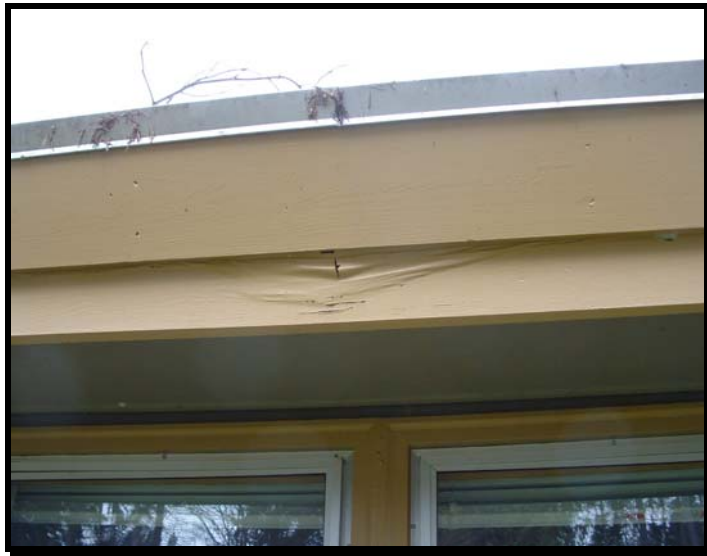
Figure No. 1000-8: Paint “bubble” on fascia that has broken.

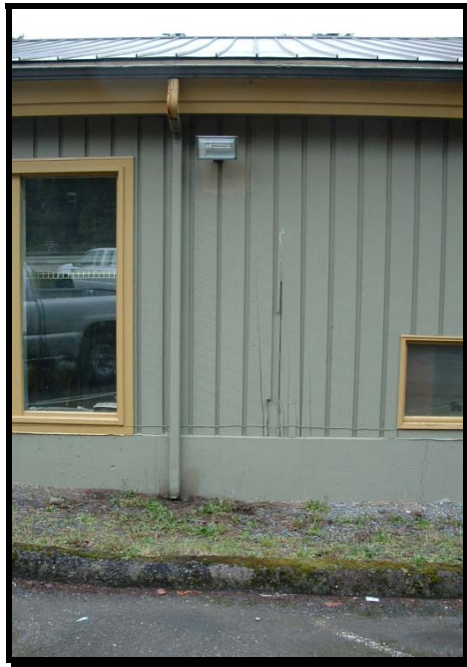
Figure No. 9-2: The central downspout on the south elevation is deteriorated at its base; note moisture absorption on concrete foundation.

gutter though drains into an underground line. The connection at this drain point is not complete, some moisture is absorbed by the concrete foundation, and it appears the gutter is somewhat clogged with debris. It is assumed this line connects to an underground foundation drain. The original drawings indicated downspouts were to drain into bell end terra cotta tiles that were connected to underground drains on the north side of the building "...that were to terminate as directed by the contracting officer."

The connection with the middle downspout and drain line should be repaired and if moisture is backing up, the drain line flushed open. The gutter needs to be cleaned.

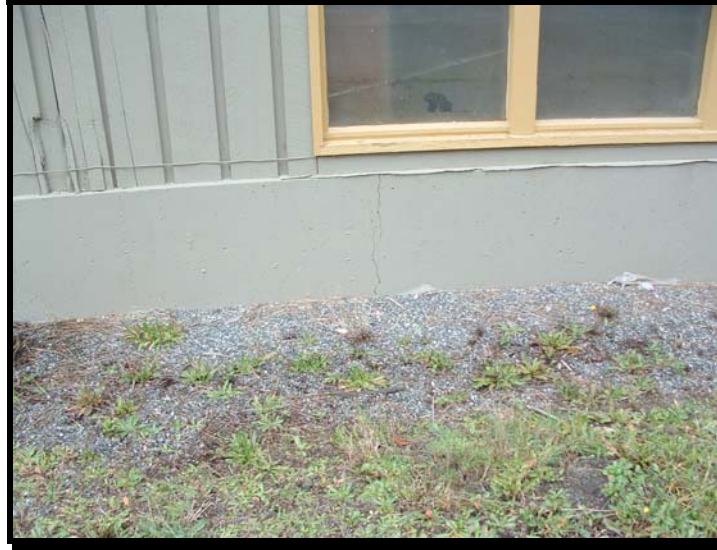
The cracks in the concrete foundations should be addressed to prevent any moisture entry. If left unrepaired, moisture entry can cause corrosion of reinforcing steel, additional cracking, and spalling. Cracks are either dormant or active, and are signs or symptoms of underlying causes. There is no sign presently of the cracks causing concrete deterioration. The small cracks are most likely from shrinkage. Tolerances for cracks left un--repaired vary with environment and function. In a saltwater environment, the American Concrete Institute guidelines recommend that

the maximum size of a crack left un-repaired should not exceed 0.007", or about the thickness of two new dollar bills.

Figure No. 9-6: View of hairline crack under beneath the window

The shrinkage cracks should be repaired using a paint-able epoxy grout. Existing paint will have to be removed and the repair repainted after it cures.

In both instances of the cold joint and the shrinkage cracks, the soil at grade should be removed down to the existing applied foundation waterproof coating when repairs are made.

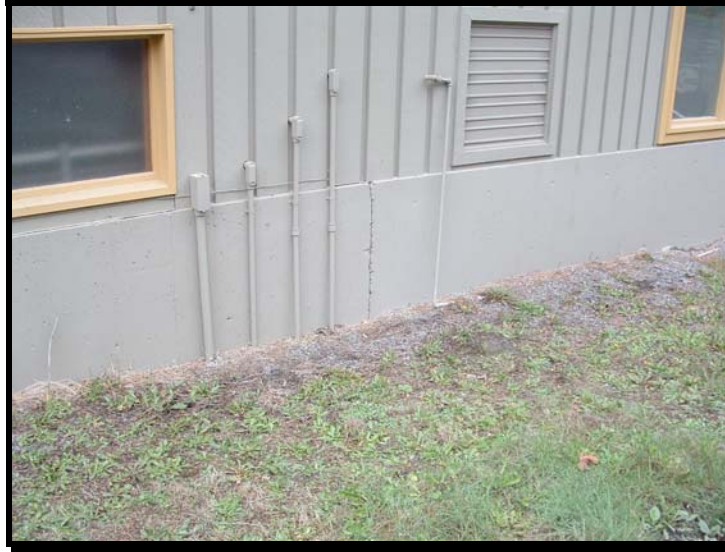
Cold joints are where two separate “pours” of concrete meet. Often, good practice involves the installation of a “water-stop” at such joints within the body of the structure. If a “water-stop” was not used, then a cold joint can open completely through a wall. Such cold joints also act as expansion-contract joints, so should be considered an “active” joint.

Figure No. 9-7: View of “cold joint”.

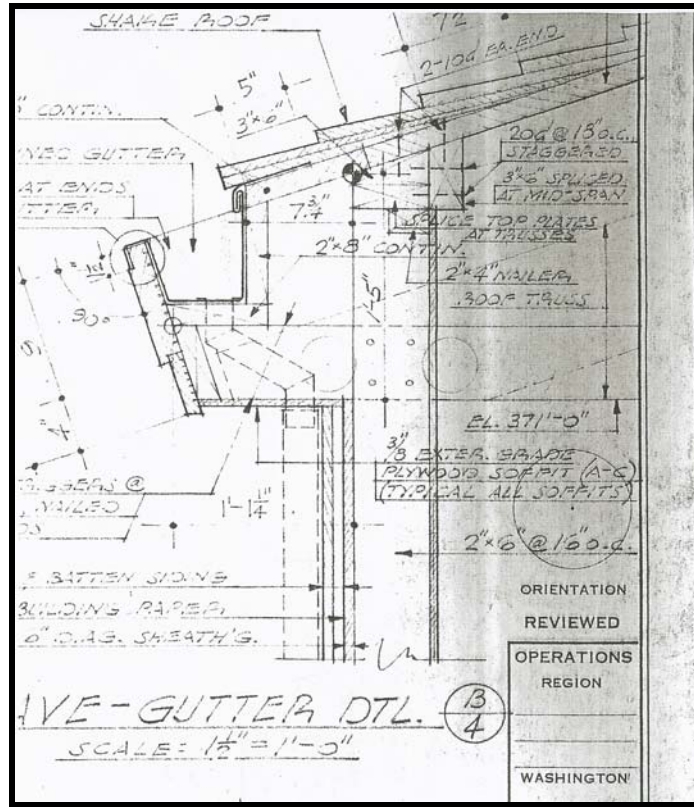
To date, no details have been located describing exactly the method used to cover over the original built-in gutter. When a built-in gutter is covered over there is always the concern that any leaking will allow the gutter to fill up, allowing for deterioration in a closed space that cannot

be monitored until damage occurs. Any sign of peeling paint, paint “bubbles, or other indication of moisture accumulation should be investigated.

Figure No. 9-8: Original detail of built-in gutter

Periodic inspection of the fascia and soffit of the eaves should be conducted to insure no moisture is entering the concealed gutter.

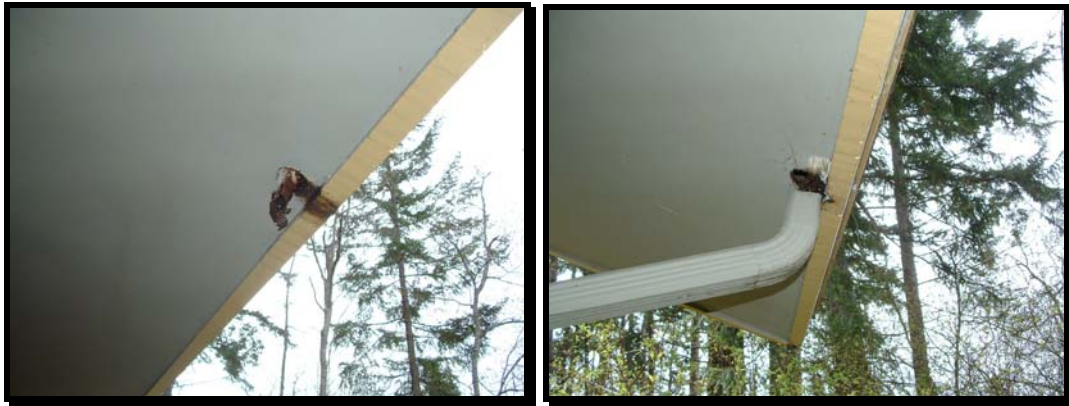
According to the original documents, the roof was originally wood shakes. The shakes have been replaced (time unknown) with a standing seam metal roof. The roof was framed to include a built-in gutter along the eaves. The gutter was metal lined and flowed to three downspouts, one at end and one in the center of the gutter. Most of the downspouts are very deteriorated at the point of where they go through the eave soffit.

Figure No. 16-3: Deterioration of downspouts on west elevation

When there is deterioration of the downspout leader that goes through a soffit from a built-in gutter, it often indicates deterioration has spread within the framing of the eave. The type of decay found is rotting of the rafter tails, associated blocking, and the cradle supports for the metal gutter.

Conduct soffit removal in the area of the downspouts and assess hidden conditions; then choose a course of action depending on extent of damage.

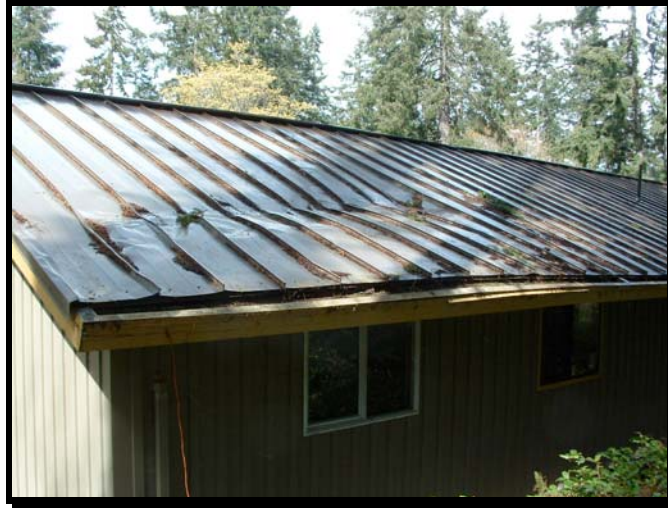
While there is no visible leakage in the ceiling under the roof area crushed by the falling tree, it is difficult to believe it has not created damage to the water tightness of gutter and deterioration in the framing below.

Figure No. 16-5: Southeast corner of roof eave showing current damage.

Conduct soffit removal in the area gutter damage and assess hidden conditions; if modest, remove selected sections of roofing, conduct truss repair, and install new roof. See discussion of gutters below for options for the gutters.

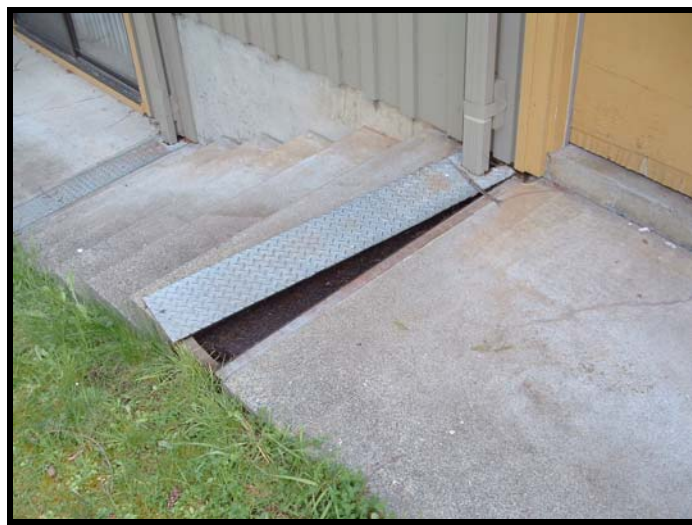
Though on a sloping site, the original construction drawings show a perimeter underground drainage system to serve the downspouts of the front roof slope. At the rear of the building the downspouts empty into troughs cut in the sidewalk that daylight into the yard. These troughs are plugged at the yard line in several cases.

Figure No. 17-2: Drain troughs for rear elevation downspouts.

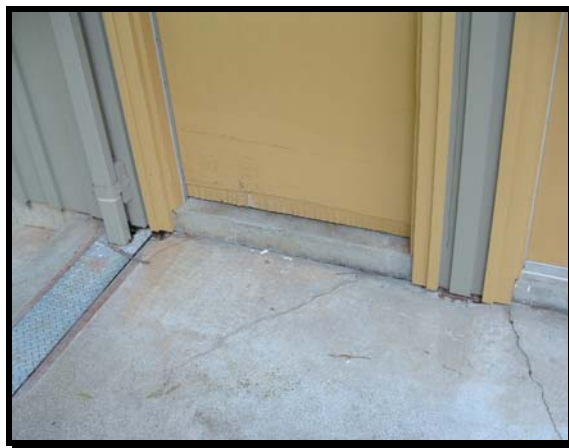
The doors are solid core, plywood veneer with a paint finish. Where protected under the eaves they are in good condition, but where exposed to weather and sun on the rear elevation, some are beginning to delaminate.

Figure No. 17-4: Delamination on exterior doors

In the short term, repaint the doors seasonally, and make sure the sill of the door is sealed. In the long term, plan on replacing the doors.
