## Historic Structures Report

## HISTORIC STRUCTURES REPORT FOR HARBOR DEFENSE STRUCTURES

*Prepared for the*  
**United States Department of the Interior**  
National Park Service

**April 15, 2000**

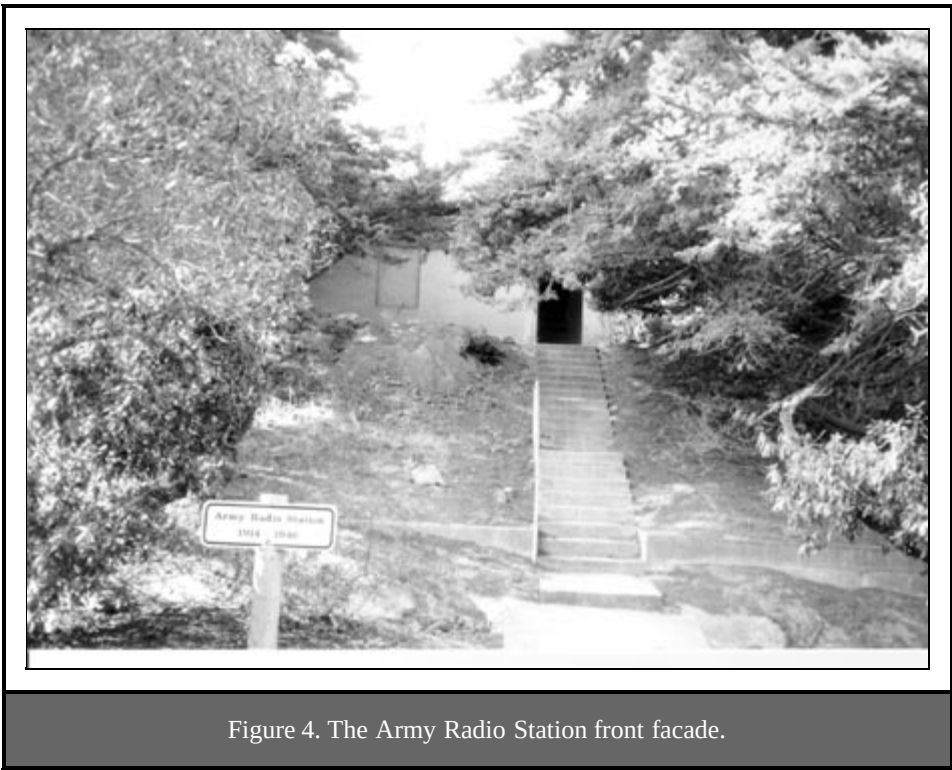
Figure 4. The Army Radio Station front facade.

The exterior is in good condition overall. However, the concrete foundations and walls are in fair condition with spalls, exposed reinforcing rod, and cracks visible on the exposed north facade. At the time of this survey, the south foundation was partially covered by the hillside and excavation to clear a path around the building was in progress. The wood trim at the roof fascia needs paint, while the roof itself was recently replaced. Nails attaching the non-original plywood infill have punctured the door and the surrounding trim. The windows are in good condition.

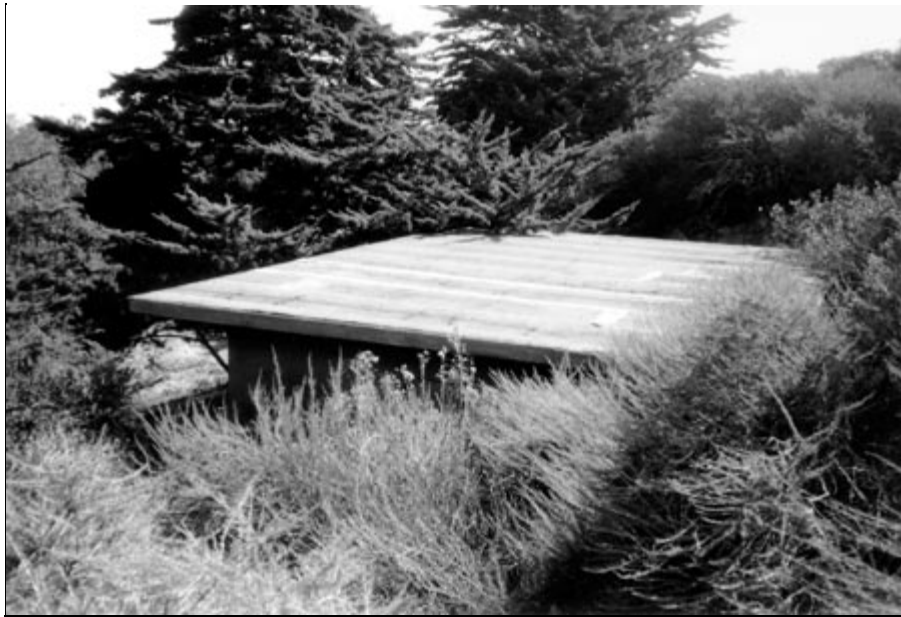
Figure 5. Roll-roofing clads the roof of the Army Radio Station.

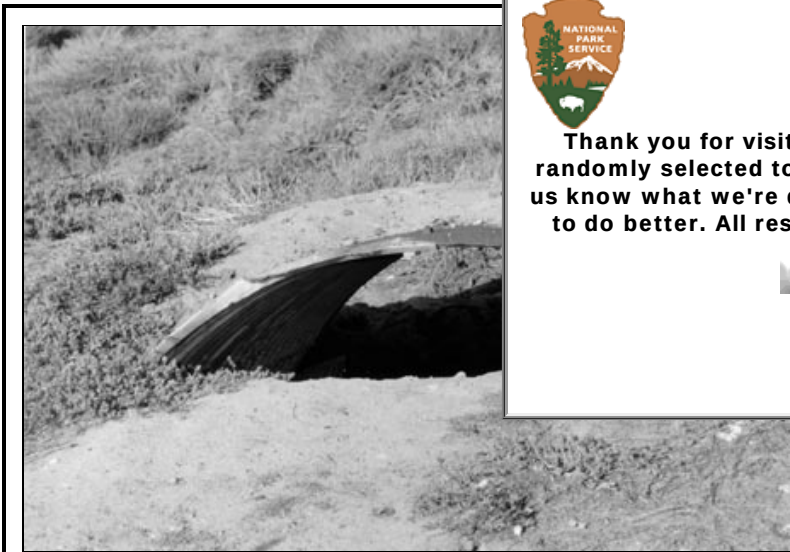
Figure 29. Small corrugated metal structures served the four Panama Mounts once here.

The corrugated metal bunkers range from partially infilled to almost entirely infilled with earth and vegetation from the site. Their condition is difficult to access. The exterior exposed portions of the metal structures are heavily corroded and the interiors viewed showed signs of galvanization.

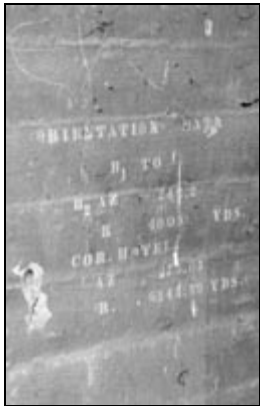
Figure 40. Transit graffiti at the Base-End Station, Batteries Calef & Wilkeson.

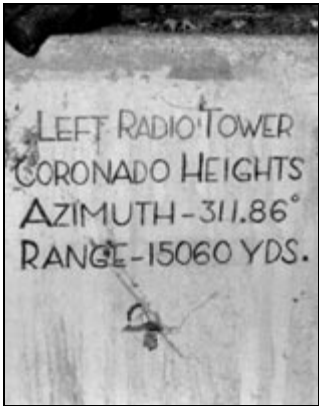
Figure 41. Transit graffiti at the Battery Commander Station, Battery Humphreys.

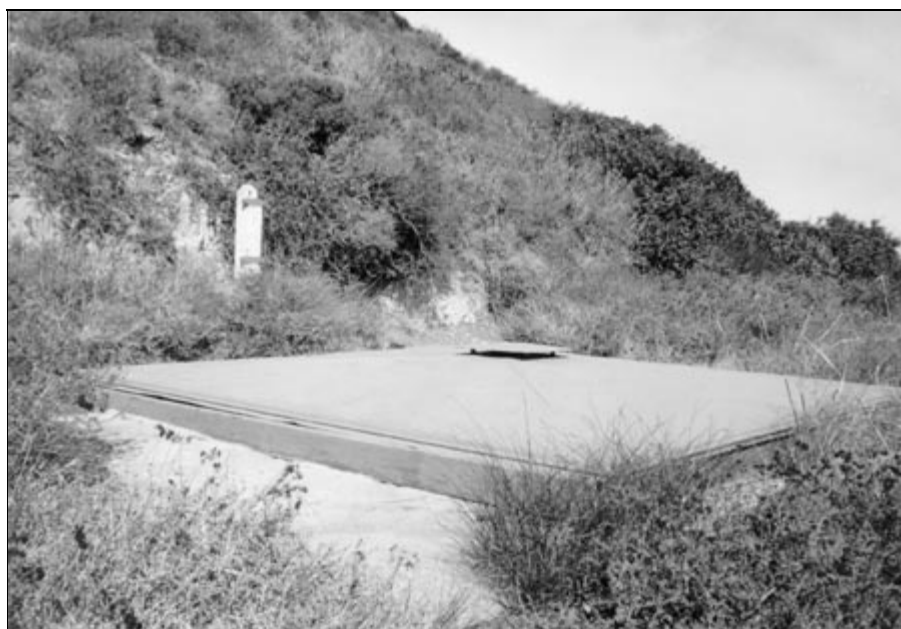
Figure 12. Only the metal roofs and a concrete post are visible above ground.

As noted above, the concrete surfaces have some spalling and cracking, which is relatively minor and does not at this time appear to compromise the structure's capacity. The spalling and exposed reinforcing rod at the concrete post appears to be the result of inadequate concrete cover to the reinforcing during the original construction.

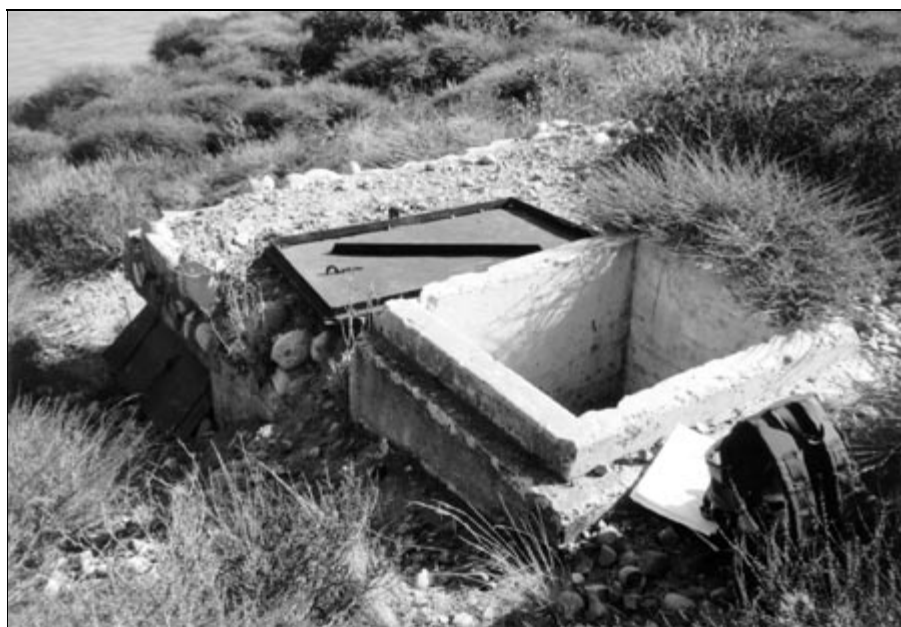
Figure 20. These structures are accessed through hatchways or observation slots.

The spalled concrete and exposed reinforcing rod at the front and side areas of the roof appears to be a consequence of casting the large stones into the face for camouflage. The deterioration at the front and sides of the roof appears primarily as a result of shrinkage over time of the concrete surrounding the large stones. This shrinkage would have caused cracks around the stones, which would have then allowed water, salts and air to penetrate down to the rebar. The reinforcing rod would have then begun to corrode, and the resulting expansive forces would then have spalled the stones. The only structural concern is that this deterioration reduces the capacity of the anchors that support the steel shutters. The cracks at the interior concrete surfaces are relatively minor and do not at this time appear to compromise the structure's capacity.

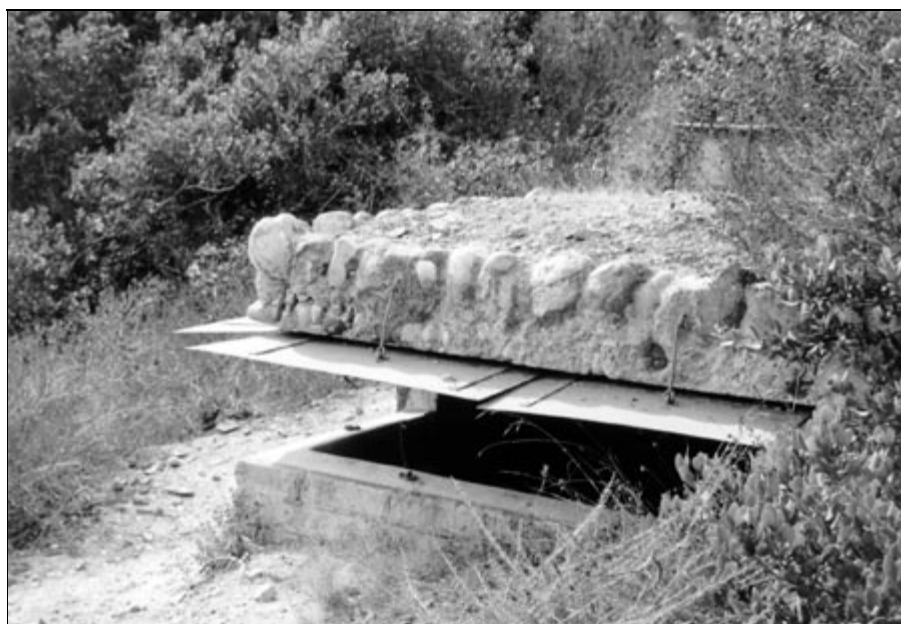
Figure 18. Metal shutters in the open position allow visual access through observation slots.

As noted above, the concrete surfaces have significant cracking and spalling, particularly at the front and side areas of the roof, where the large stones were cast into the concrete. The square reinforcing rod is exposed in several places. This deterioration does not appear to compromise the capacity of the structure at this time, however it does reduce the capacity of the anchors which support the steel shutters. The deterioration at the front and sides of the roof appears primarily as a result of shrinkage over time of the concrete surrounding the large stones. This shrinkage would have caused cracks around the stones, which would have then allowed water, salts and air to penetrate down to the rebar. The reinforcing rod would have then begun to corrode, and the resulting expansive forces would then have spalled the stones. As noted above, the cracking at the hatch curb at the battery commander station is reasonably advanced. Other than supporting the hatch, this curb does not have a significant structural function. The remaining cracks and spalling at the interior concrete surfaces are relatively minor and do not at this time appear to compromise the structure's capacity.
