# Weather station maintenance in Southwest Alaska Network parks

*Summary for the 2011 hydrologic year*

Natural Resource Data Series NPS/SWAN/NRDS—2011/196

Chuck Lindsay

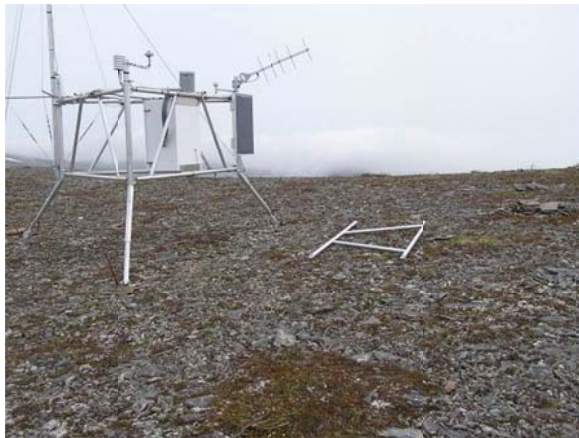
During annual station maintenance in 2010 it was discovered that welds on one of the tri-leg tower panel sections (NE) panel were broken. FTS considered this part to be under warranty and provided a replacement panel section at no charge. Pathfinder Aviation delivered the panel section on June 6 (Figure 11). It was transported in a R44 with the backdoors off (only pilot on-board). Maintenance wasn't completed at this time because the necessary equipment had been sent to King Salmon and access was planned using the park wheel plane.

**Figure 11.** Replacement panel and weather station (Fourpeaked RAWS).

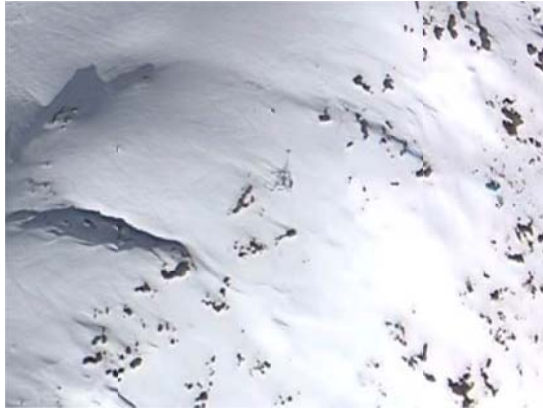
**Figure 24.** Google Earth image (reportedly from April 16, 2011). The station's shadow is visible (McArthur Pass RAWS).

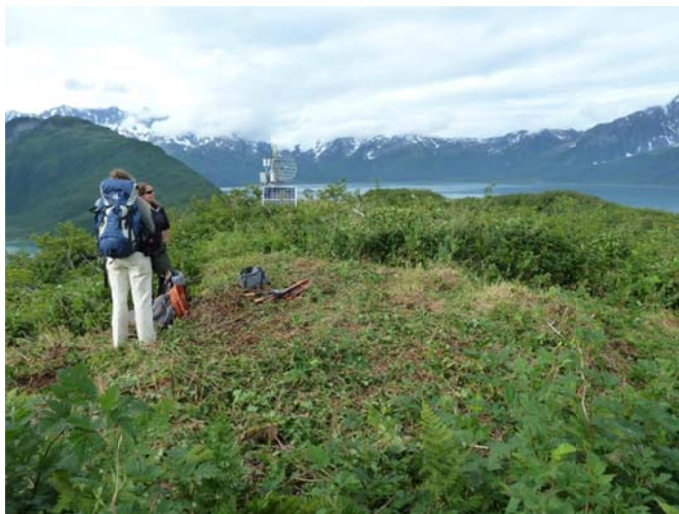
**Figure 30.** The weather station site after brushing alder and salmon berry (Pedersen Lagoon RAWS).

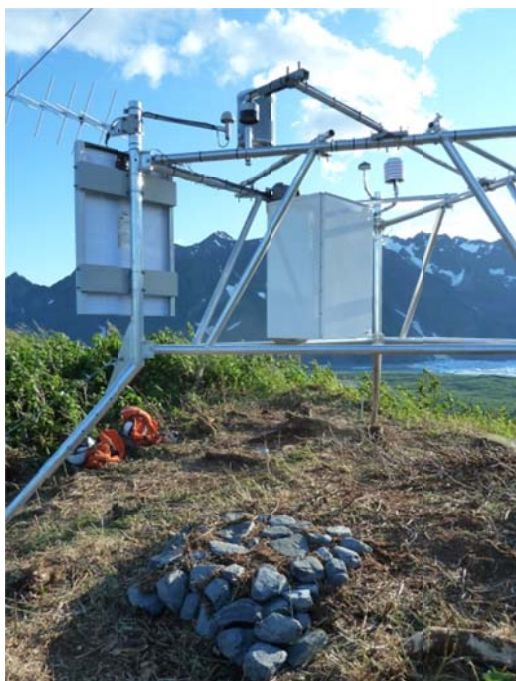
**Figure 35.** Snow depth sensor (sonic distance ranger) and reflector surface constructed of beach rock and soil (Pedersen Lagoon RAWS).

The station was completely assembled by 1815 (Figures 38 and 39). The first data transmission occurred at 18:28 (AKDST). Successful data transmission was verified by satellite phone with Fritz Klasner (KEFJ) who checked the NIFC WFMI website. Snow depth transmissions are below the physical minimum (0.0 inches) as intended in order to not transmit misleading snow depths when there is no snow present. Snow depth was set to a tare of -0.4 inches in order to account for thermal expansion of the reflector and sensor drift.

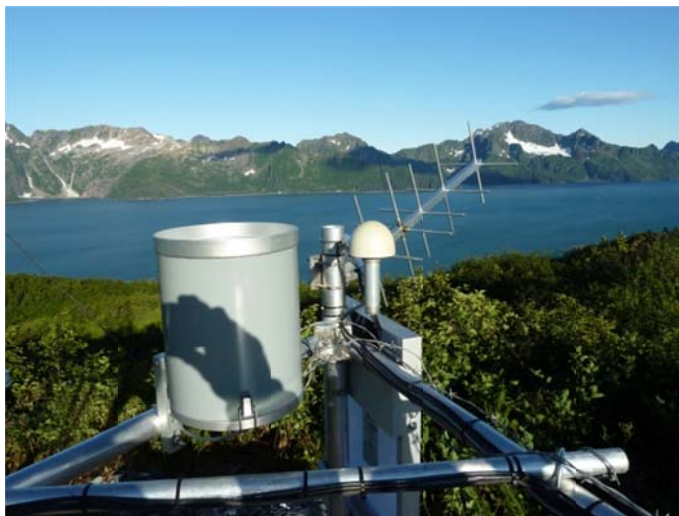
**Figure 36.** Rain gauge, satellite antenna, and GPS antenna (Pedersen Lagoon RAWS). Barb wire was mounted above the sensor cables on the southern frame section in order to mitigate damage from wildlife (bears).

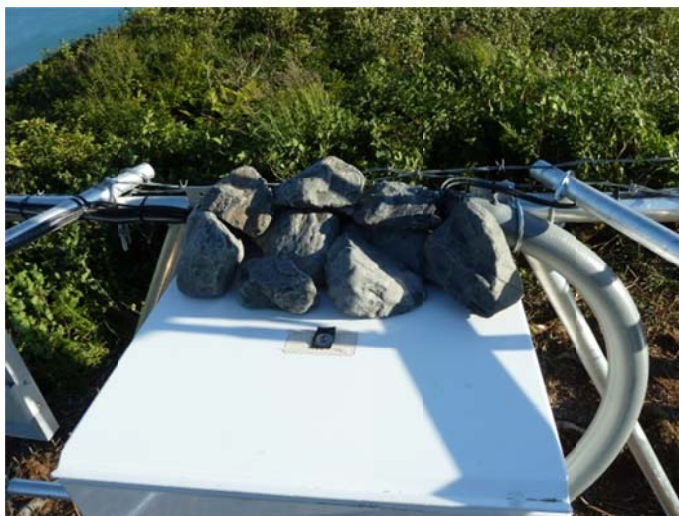
**Figure 37.** Rocks were piled on top of the instrument enclosure to help mitigate damage from wildlife (Pedersen Lagoon RAWS).

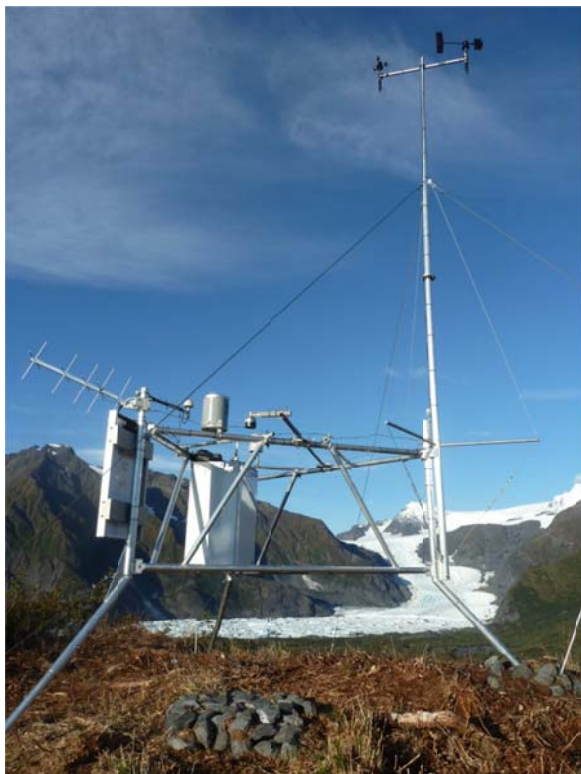
**Figure 42.** Photograph of the station and Pedersen Glacier after maintenance was completed (Pedersen Lagoon RAWS). Barbed wire was added to the top of the tri-leg tower in order to protect sensor cables from damage by wildlife.
