**Bates Well Ranch**

**Organ Pipe National Monument**

## **Emergency Treatment Recommendations**

### Emergency Stabilization Report

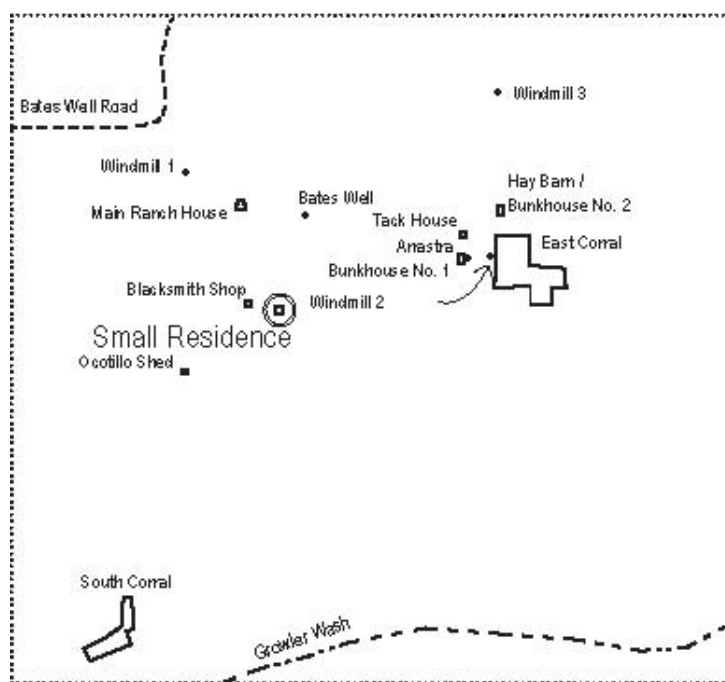
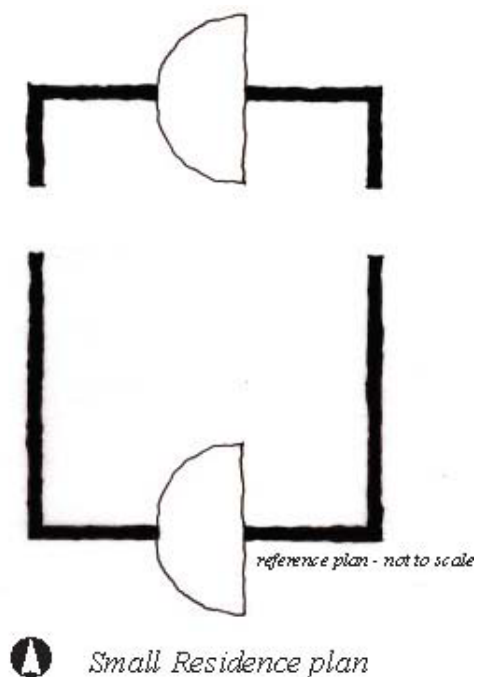
this structure will be lost. It is very important to a comprehensive understanding of the site, as all auxiliary structures are in ranch landscapes. It is a lightly framed one room structure. The northeast corner has failed and the roof is collapsing in the corner. As with many of the ranch structures the posts are set into the ground and they have rotted at their bases. The northeast end rafter is no longer in place.. Within the last five years the ramada on the west side of the house was destroyed by a tree falling on it. Much of the debris from the ramada is piled next to the house. A pie safe located on the southwest corner is collapsing and almost completely deteriorated. Some remaining floor boards for the house are set in the dirt.

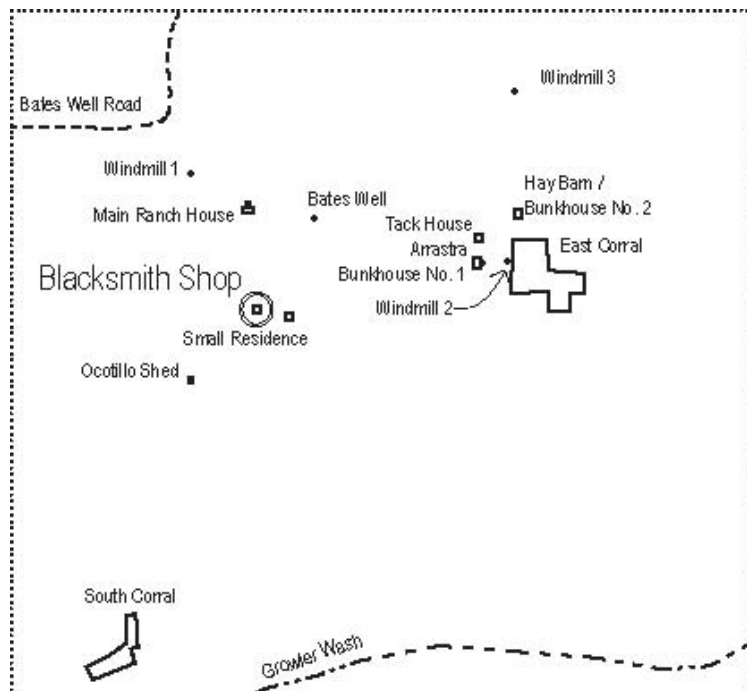
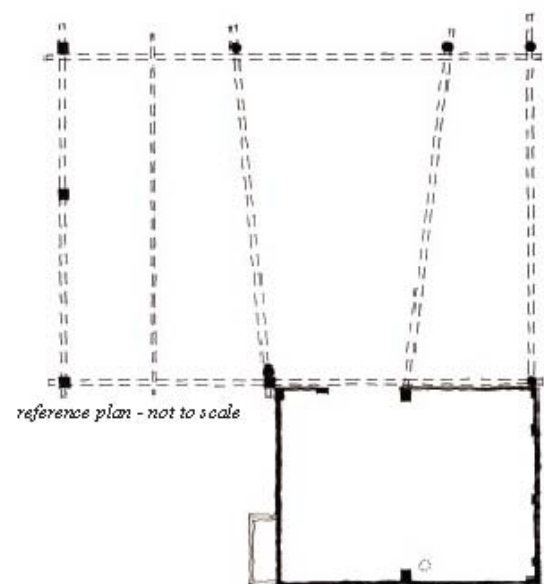
*Blacksmith Shop and ramada plan*

After the water source and delivery structures, The Blacksmiths Shop may be the most important auxillary structure on site due to the essential nature of this enterprise to a ranching operation. The shop consists of an boards and sheet metal sided enclosed section with a low roof and a ramada on the north side of the enclosed part. The ramada consists of steel pipes set on timber posts and mesquite logs. It was once covered with Saguaro ribs some of which are in place and some are on the ground. Some features such as a collapsing saw horse remain. The shop is currently in an active state of collapse. Left without treatment, this structure will be a pile of debris in the near term. Several key elements replaced will prevent immanent collapse.

*Figure 3: The Blacksmith Shop with the ramada shown to the left. This building has suffered significant deterioration over the past two years, but has not yet reached the point where it cannot be preserved. Photo: Randall Skeirik, NPS*

If pieces of wood lying on the ground can be reinstated by locating where they came from with certitude, they should be replaced. It is not the intent to reintegrate the structure totally at this time.

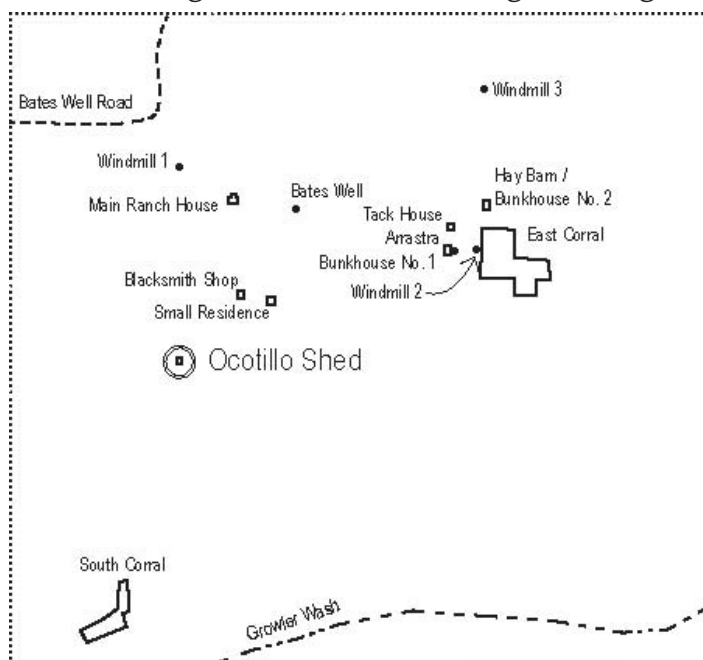
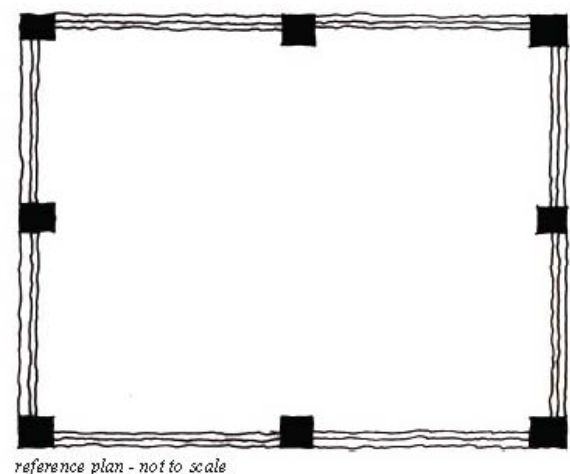
*Ocotillo Shed plan*

The Ocotillo Shed (Figure 4), which is actually constructed of posts set into the ground with saguaro ribs wired together to serve as siding, is falling down. A few important measures can prevent imma-

*Figure 4: Jake Barrow, VT exhibit specialist inspecting the Ocotillo Shed. Actually constructed of saguaro ribs strung between railroad tie posts, this small structure needs immediate treatment to prevent collapse.*

nent collapse. The fallen debris from inside the structure should be examined carefully noting the provenience of the pieces. Pieces will be wired back in place if the original location can be determined. Saguaro laying around will be wired back in place. Some corrugated roofing pieces can be screwed or wired back down in a few places where enough deck can be reinstated to provide minimal support. On either side two 1 by 4 boards which serve as outside rafter roof supports have been nailed out of place probably in an effort to alter the roof to a shed from a pitch. Earlier photos show this roof as a pitch. These should be fastened in their original position and a 1 by 4 header across the door opening will be replaced in kind. Keeping the doorway integral to the shed is important. Loose pieces laying on the ground which can be re-attached where they were originally should be reattached.

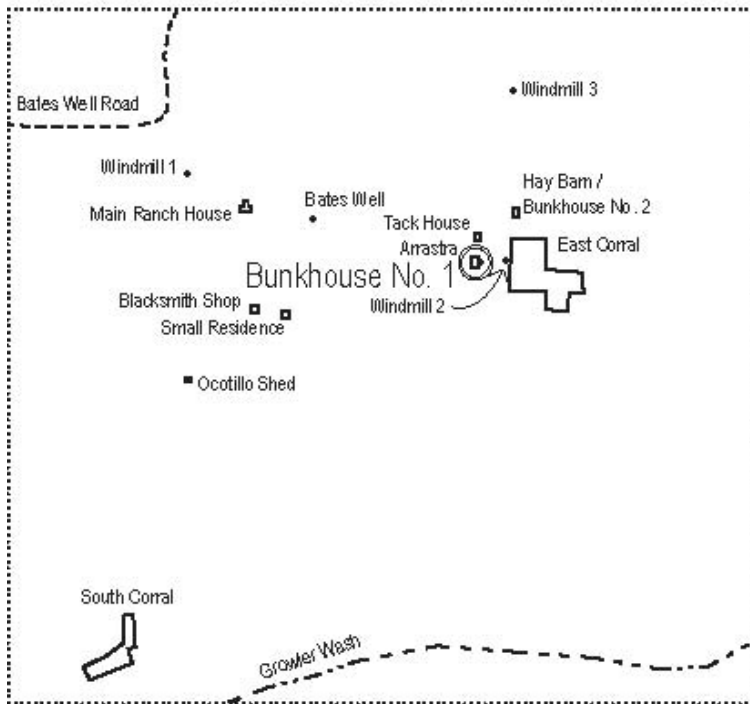
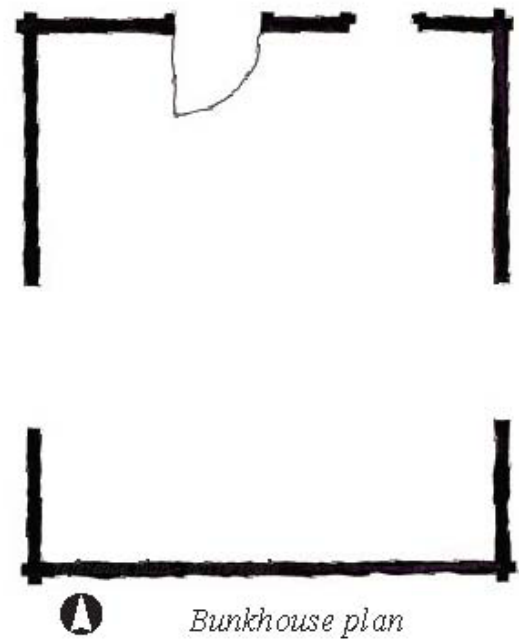
The bunkhouse is a lightly framed structure with emergency conditions related to flooring and substrate floor framing. Only the most serious issues are being addressed at this time. The building is constructed on 8 by 8 wood post piers buried in the ground on the perimeter. For some reason these posts are not on the outside corners but set as much as 12 inches with the corners cantilevered in space. Flat laid plates (2 by 6) are set on these posts along the north south axis. A 2 ½" by 7 ½" beam laid flat runs down the center supporting 2

by 4 floor joists which are on approximate 24" centers and bear on the 2 by 6 plates. The center of this beam has termite damage and the timber supports in the center are out of place. The  $\frac{3}{4}$ " by 11  $\frac{1}{2}$ " floor decking is nailed all the way to the outside edge of the structure and the wall studs are set on a plate on top of the flooring. Flooring has rotted and deteriorated in some areas leaving very spongy sections or holes in the floor. Extensive termite damage exists throughout. One joist is cracked. It is possible to crawl under the building just barely. Due to deterioration of the post and framing in the southeast corner, the structure is listing in this direction. The interior is littered with animal waste and debris. Protective screening has been torn partly off the openings. The north elevation window NW1 was a 4 over 4 double hung window with portions of the original sash still in place. The top has glazing while the bottom sash has only one vertical muntin left. These features require protection.

The emergency treatment recommendations are limited to replacing the rotted post, supporting the floor, selective replacement of deteriorated floor boards, and securing widows and doors.

In order to replace the SE corner post the original one will have to be excavated under the supervision of the archeologist. Temporary interior diagonal bracing can be added to keep framing in place, but this might not be necessary as the structure is so light weight. A new treated post can be installed on top of a solid rock set on undisturbed ground. Shimming will be required to maintain loading. The 2 by 4 joist has deteriorated in the corner and will have to be supplemented with a new piece to pick up the floor and frame above. It is not necessary to attempt to level the building as it is likely that this condition has existed for a very long time. The goal is the stabilize the structure and prevent further settlement.

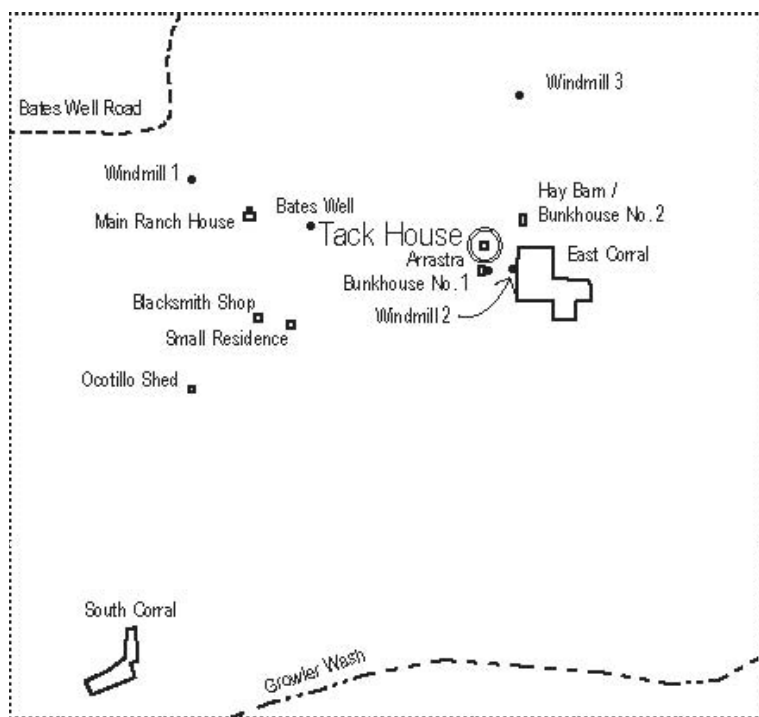
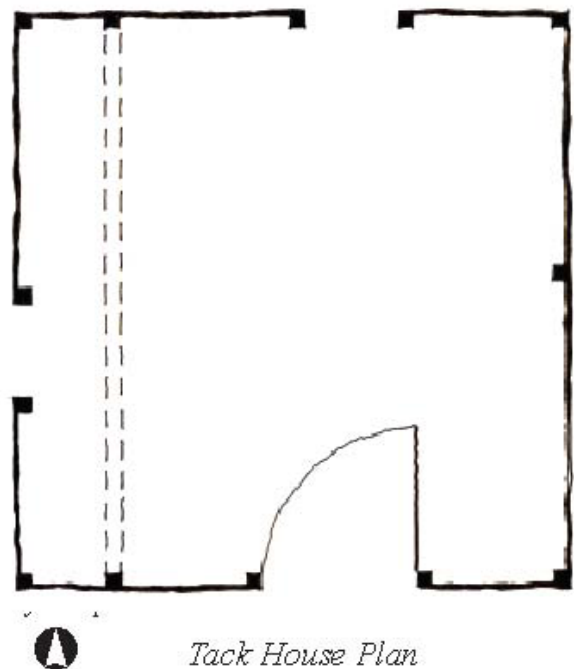
*Tack House Plan*

The tack house (Figure 10) is constructed of 4 by 4 posts set directly into the ground and horizontal 1 by 4 siding is nailed to the exterior of these posts. There is no floor. It has a corrugated roof. The basic problem with the tack house is that the posts have rotted at the base. Therefore the building is settling and could be moved by a heavy wind. Emergency treatment recommended is to install 1 by 4 diagonal bracing throughout the interior attached with double headed nails to the existing 4 by 4 posts. Pre-drilling will prevent split outs of the diagonals. In some locations blocking will have to be added to keep the braces in line and where the 4 by 4s have deteriorated the braces will be nailed onto the solid wood portions. Borate treatment as has been specified for wood in contact with the soil is recommended.

*Figure 10: The Tack House is an important component of the ranch complex. Constructed with posts buried directly into the ground, the bottom ends of those posts have completely deteriorated.*

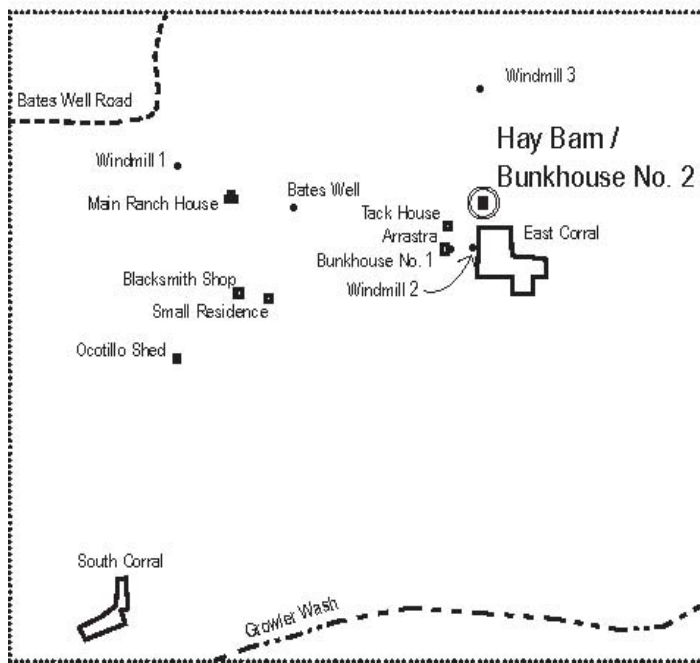
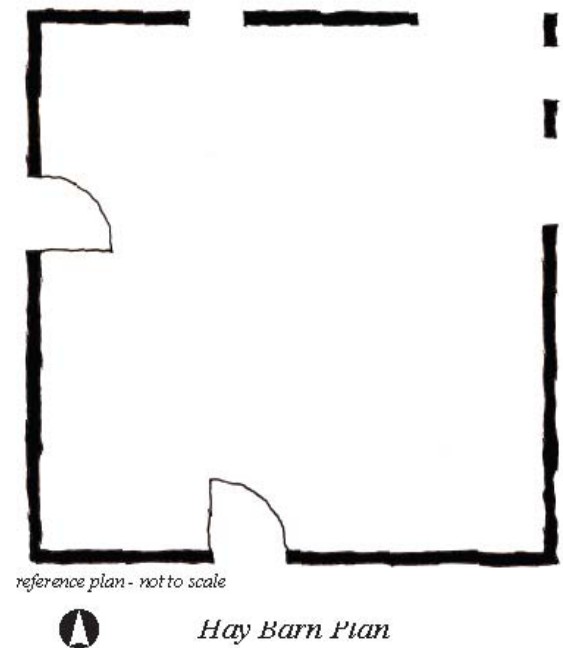
The hay barn (Figure 11) is a very unusual structure due to the unique framing. It is basically constructed of assembled panels which are approximately 4' by 8'. The panels are made of 2 by 4 framing and have horizontal siding of various types attached. These panels are then nailed together edge to edge to make the walls. The walls had no diagonal bracing and it might be assumed that the panels performed some kind of diaphragm action to resist racking. Perhaps the way the barn is constructed contributes to the idea that this building was moved from another location and may be composed of pieces from different buildings. Now that deterioration has taken its toll, modifications are required.

The hay barn has benefitted from temporary bracing that was installed to prevent collapse. (Figure 12) The basic problem with this structure is that the framing has no internal bracing mechanism to prevent racking and the gable ends are not tied to the rafters to prevent over turning. Diagonal and end wall bracing installed in 2007 has helped prevent collapse but these elements should be replaced for more efficient framing. In addition the northeast corner and north side of the sill and plate are completely deteriorated and have fallen out of place. If left, this side of the building will likely collapse. There are a significant number of holes in the roof and much missing siding. The barn has two doors and what appear to be five windows openings without sash. Doors are in place. Gaps exist where siding has deteriorated and fallen off. Siding has been prepared and is on hand to match the various types.

Emergency treatments will address the most serious and pressing problems only. The sill and plate on the northeast side (Figure 13) need to be replaced and pulled back into alignment. As with all wood replacement any solid portion of a piece will be retained and only the rotted deteriorated portion will be replaced. This will be done by splicing using adhesives, pins, and joints cut into the wood. A solid block footing is required to maintain the existing level and prevent further

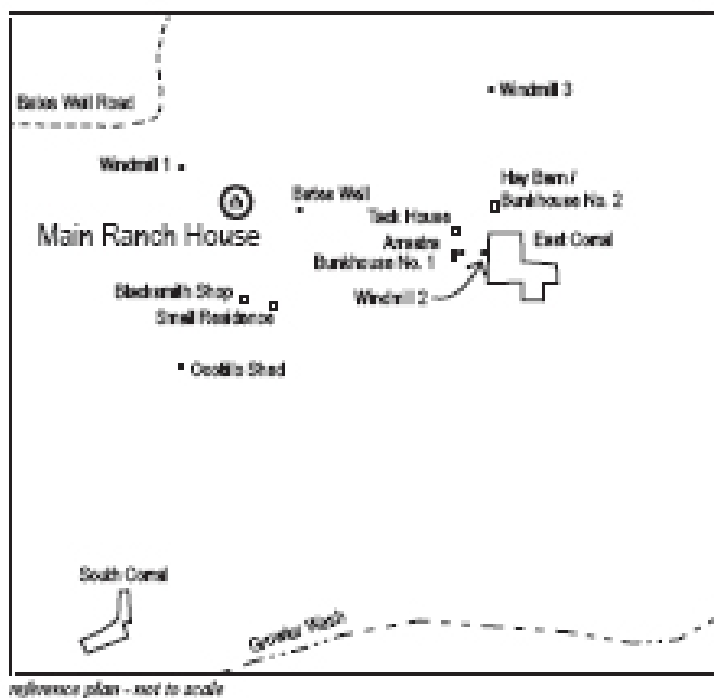
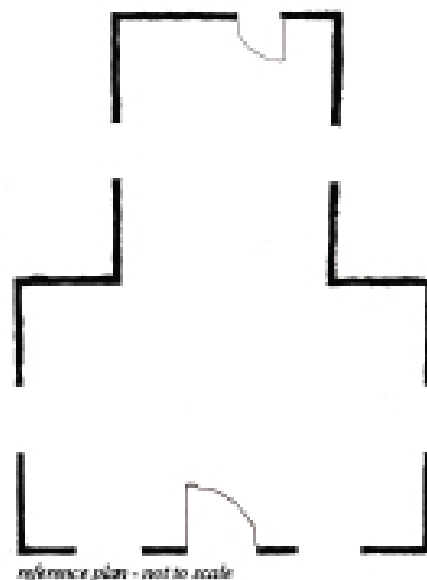
**Plan of Main Ranch House**

The Main Ranch House (Figure 14) is the most conventionally built of any of the structures at Bates Well. It consists of 2 by 4 framing set on timber sills with a poured concrete floor. Conventional but lightly construct-

floors were poured within the form of these sills and frame walls were set up on the sills. At one window opening the top of the concrete floor is approximately 3 ½ " above exterior grade. At the southeast corner where a rodent hole had tunneled toward the sill, a little bit of further excavation revealed the remains of the wood sill. It has rotted. A good assumption is that this condition is universal. Where visible the plates on the sill are deteriorated from both rot and termite activity. The baseboard is sound and it is tightly nailed to the plates and the 2 by 4 studs. It rests on the slab and contributes secondarily to holding up the walls which no longer are supported by the rotted sills. While at present this condition is not exhibiting settlement, its only a matter of time until these fabrics will fail and compress. Correcting this problem now will prevent further more serious deterioration in the future. Supervised test pits can be dug at intervals along the foundation to verify the conditions.

Rotted sills or sections of sills will have to be replaced. Rodent proofing will be installed during this action. In order to accomplish this task, excavation along the sides of the building will be required to be accomplished one side at a time. Bracing the interior roof rafters at bearing points with a temporary superstructure mounted on the interior set onto the concrete slab can prevent any settling from occurring during the construction. Excavations will have to be monitored by the park archeologist. This is very important since archeological record of the site is limited and much useful information may be retrieved which can inform the record. When the excavation is complete and the rotted sill removed and documented, a new treated sill may be installed. If any part of the historic sill is viable, it will be saved by splicing in the new to the old. It will be necessary to establish solid bearing on the disturbed soil by setting solid block on undisturbed soil and shimming up the sill to the plates. Where visible the base plates have been destroyed by termite activity and these will also have to be replaced. These can be removed from the excavation side and the nails cut or pulled out as well. New plates can be installed from the excavation side, inserted up to the studs, braced and fastened with galvanized framing screws. Concealed "TECO" type connections may be used to connect pieces. Care should be taken to pre-

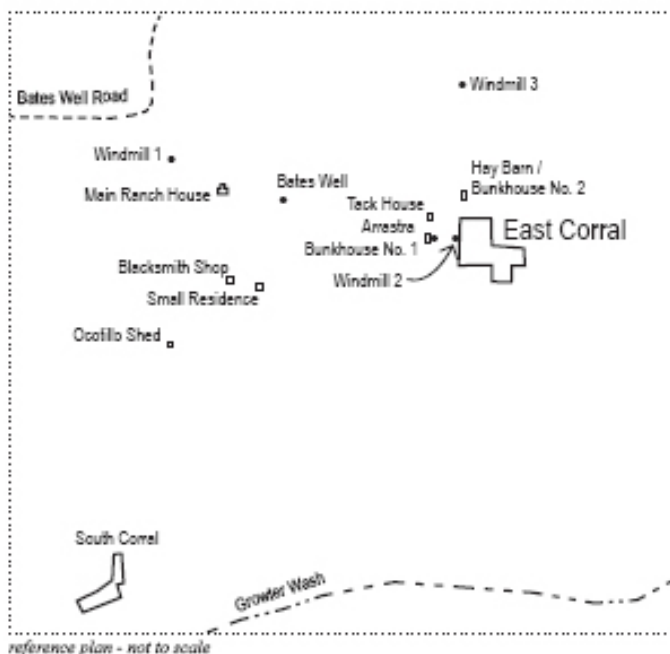
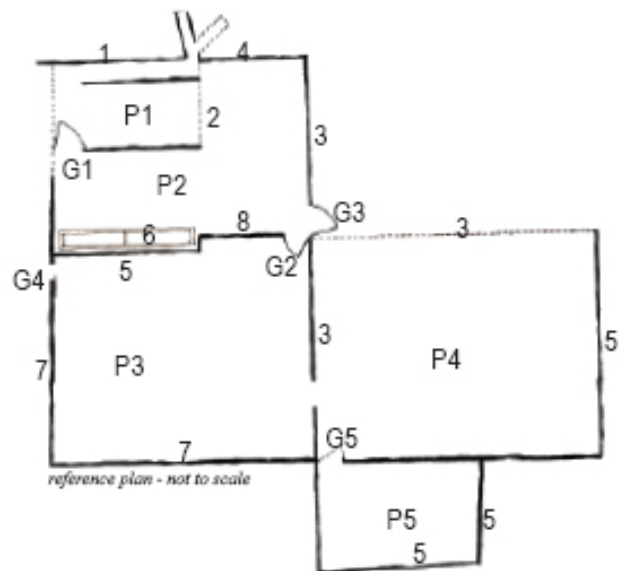
Plan view of the East Corral. P signifies Pen, G signifies Gate and along with the numbers correspond with the illustrations on the following pages. Dashed lines signify collapsed fencing.

The corral remains in fair condition, although substantial sections of the fence types that use mesquite posts are lying on the ground. The majority of the timber posts, because they were typically treated with creosote, are still standing although the below grade sections are seriously deteriorated.

As a significant feature of the ranch, the fences that form the corral should be maintained. Those that are still standing should be preserved as they are, and those that have fallen should be restored to their original appearance. Because the below grade sections of the posts that have fallen are gone, and the below grade sections of the standing posts area all compromised, an alternative support structure will be needed to allow the

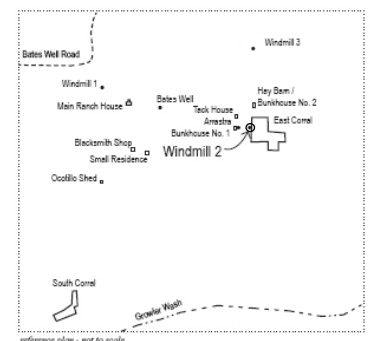
center. All three sill beams are approximately 7 ½ inches wide, 7 inches deep and are between 6'-1" and 6'-6" long. The central and south sill beams, and the east end of the north beam are badly deteriorated and are being crushed by the weight of the platform and tank above. This has caused the platform to settle unevenly. As a result, the posts and platform are now leaning, with some posts as much as 6" out-of-plumb over their length.

*Figure 27: Water tank associated with Windmill Number 2. Note that the sill beam at the bottom front is badly deteriorated. This deterioration has allowed the support frame to wrack and has required the installation of additional diagonal bracing. Because the tank no longer holds water, the danger of collapse is small, nevertheless, the deteriorated framing members should be repaired or replaced.*

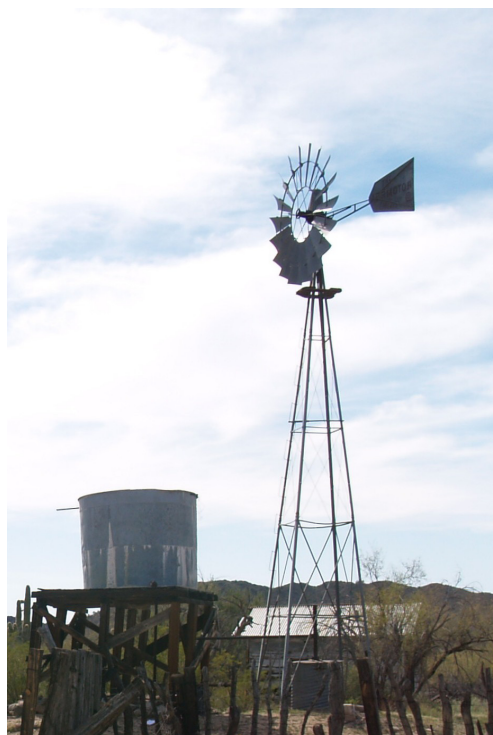
*Figure 29: Windmill Number 2 with adjacent water tank.  
Photo: Randall Skeirik, NPS*
