National Park Service  
U.S. Department of the Interior

Organ Pipe Cactus  
National Monument

**Biological Assessment**  
**Emergency Actions to Stabilize Quitobaquito Pond**  
**Part II: Renovating the Southeast Corner**  
**ESA Emergency Consultation #22410-2008-FE-0273**  
**October 2009**

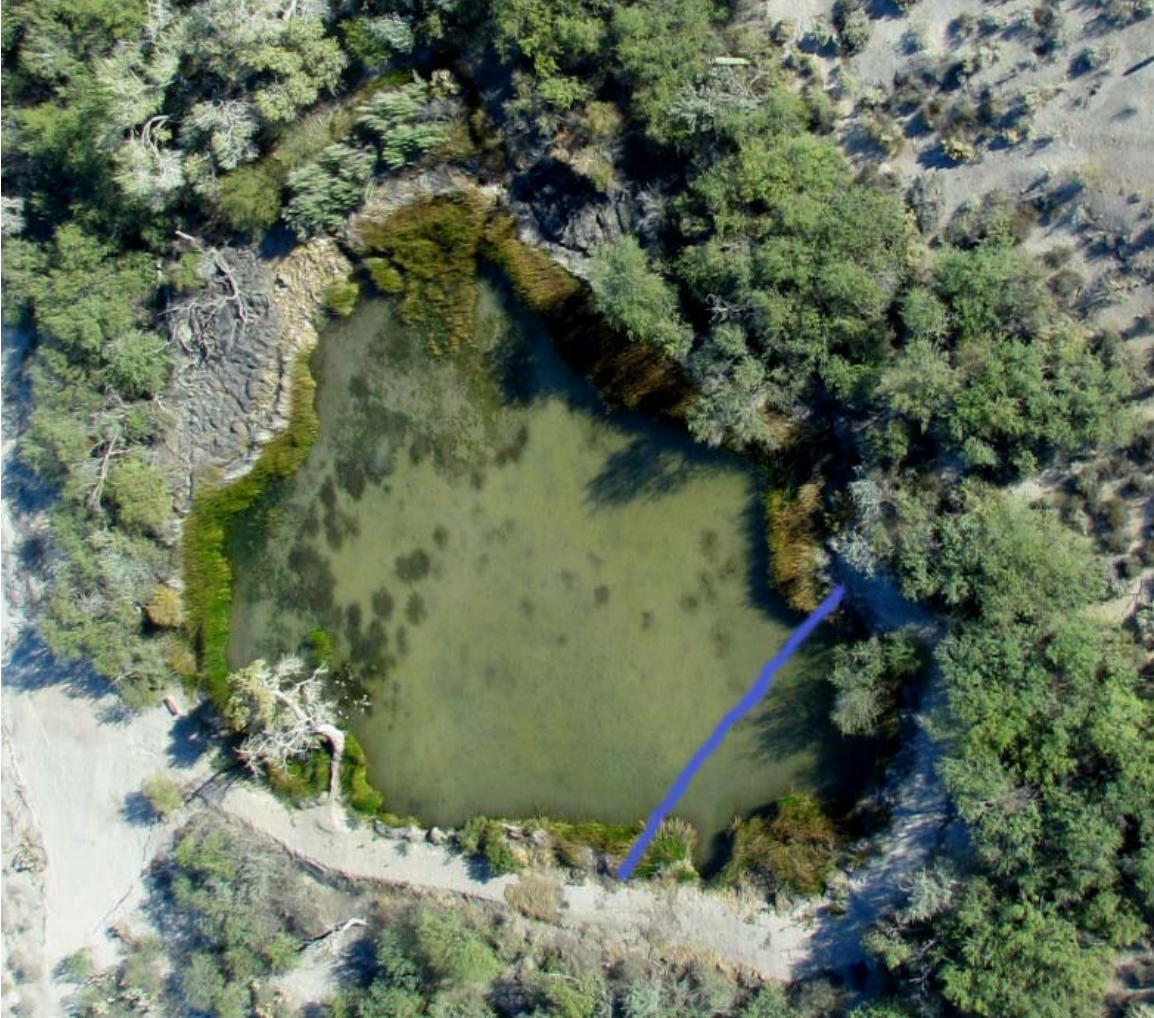
Figure 2. Aerial view, Quitobaquito Pond. Blue line indicates alignment of the temporary coffer dam, separating the southeast corner from the remainder of the pond. Photograph December 10, 2008.

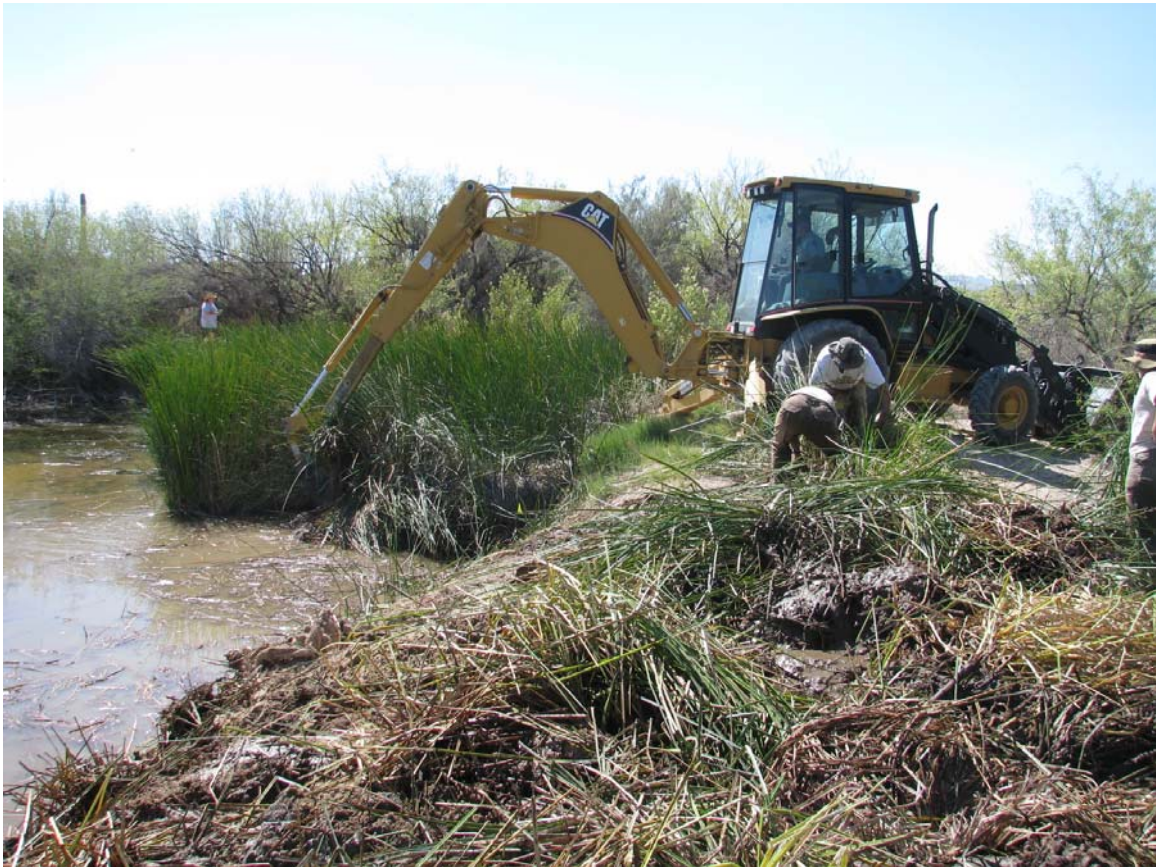
Figure 7. Removing bulrush encroachment and inspecting for Sonoyta mud turtles, southeast corner of Quitobaquito Pond, August 17, 2009.

On-site project activities began with removing extensive, dense new growths of American bulrush (*Shoenoplectus americana*) that had established on the inner face of the retaining berm. This was done primarily to expose the area of the southeast corner to be renovated. However, removing this bulrush also served to reclaim pond volume that had been lost due to the bulrush encroachment. In the southeast corner since 2006, bulrush had expanded up to 25 feet and more inward, from the retaining berm into the pond. Bulrush was removed with a backhoe. At Quitobaquito Pond, bulrush tends to establish in dense stands whose root masses lay on top of, but do not penetrate, the hard pond bottom. Once cut into manageable-sized clumps, it lifts free of the pond bottom easily. The backhoe operator carefully placed the bucket against the firm pond bottom, then pulled toward the bank, tearing up the bulrush by the root masses, and deposited it on the retaining berm (Figure 7). Bulrush was removed up to the point where the original inner face of the berm was exposed, without cutting into the berm itself. Personnel inspected the removed bulrush for Sonoyta mud turtles, as it lay draining water on the berm. Four mud turtles were found in the removed bulrush. The bulrush was then removed from Quitobaquito. The total area of bulrush was a semicircle approximately 150 feet long and averaged 12 feet wide, or about 1,500 to 1,800 ft<sup>2</sup>.

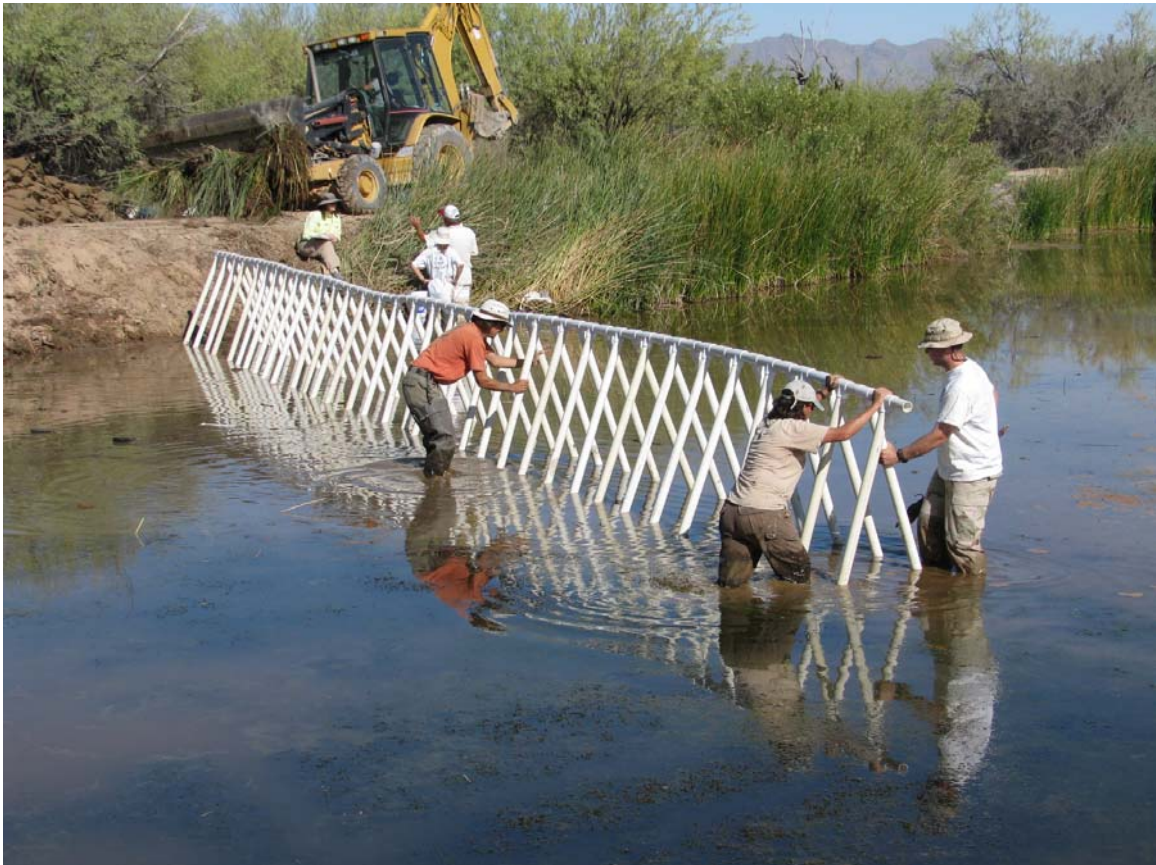
Figure 8. Assembling the frame for the coffer dam, Quitobaquito Pond, August 18, 2009.

Concurrent with the above activities, a temporary coffer dam was installed, to isolate the southeast corner of the pond from the remainder. The coffer dam consisted of a PVC frame, supporting a pond liner water barrier. Sandbags were used to stabilize the structure and seal it against the pond bottom and banks (Figures 8 and 9). The coffer dam was 100 feet long, extending from the main berm, just west of the old spillway, then to the northeast, ending near the east shore bench. The coffer dam was placed at the top of a gentle slope in the pond bottom, which slopes down to the deeper water of the southeast corner.

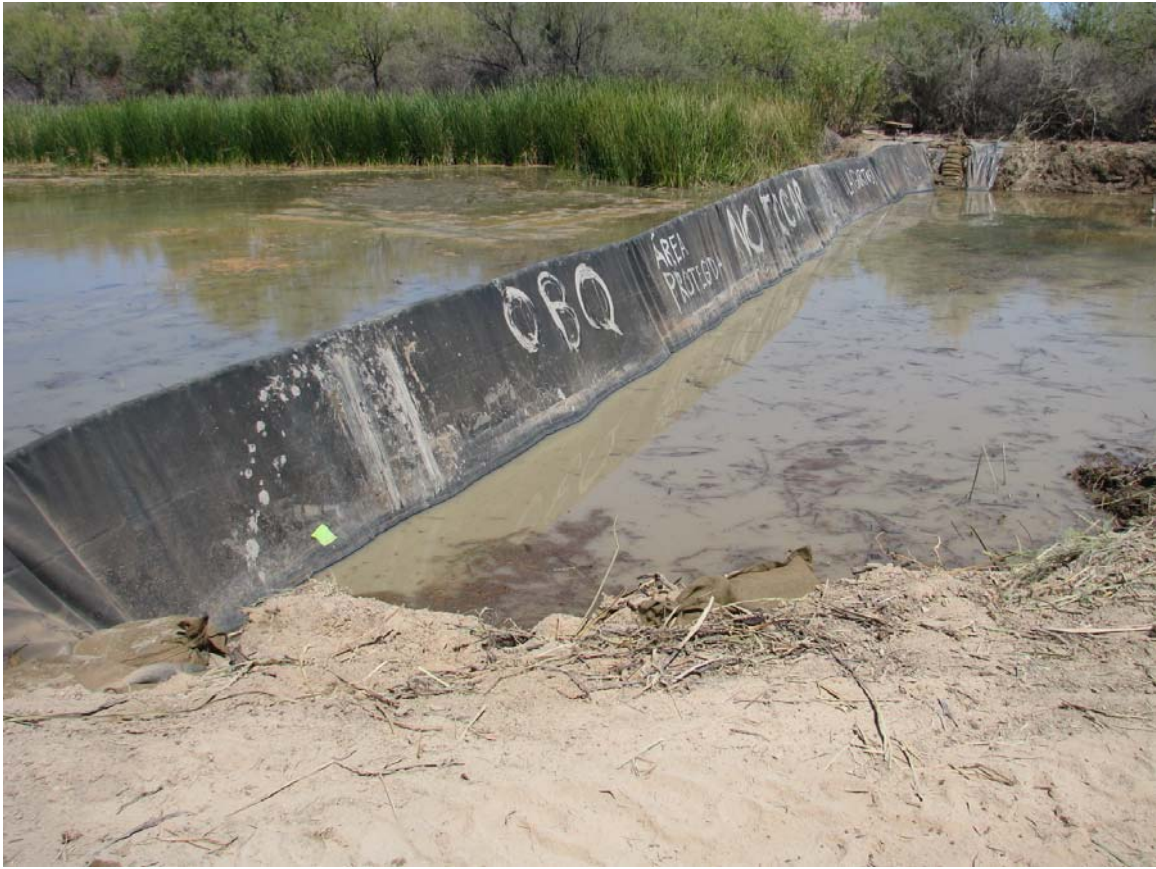
Figure 9. Completed coffer dam, Quitobaquito Pond, August 18, 2009.

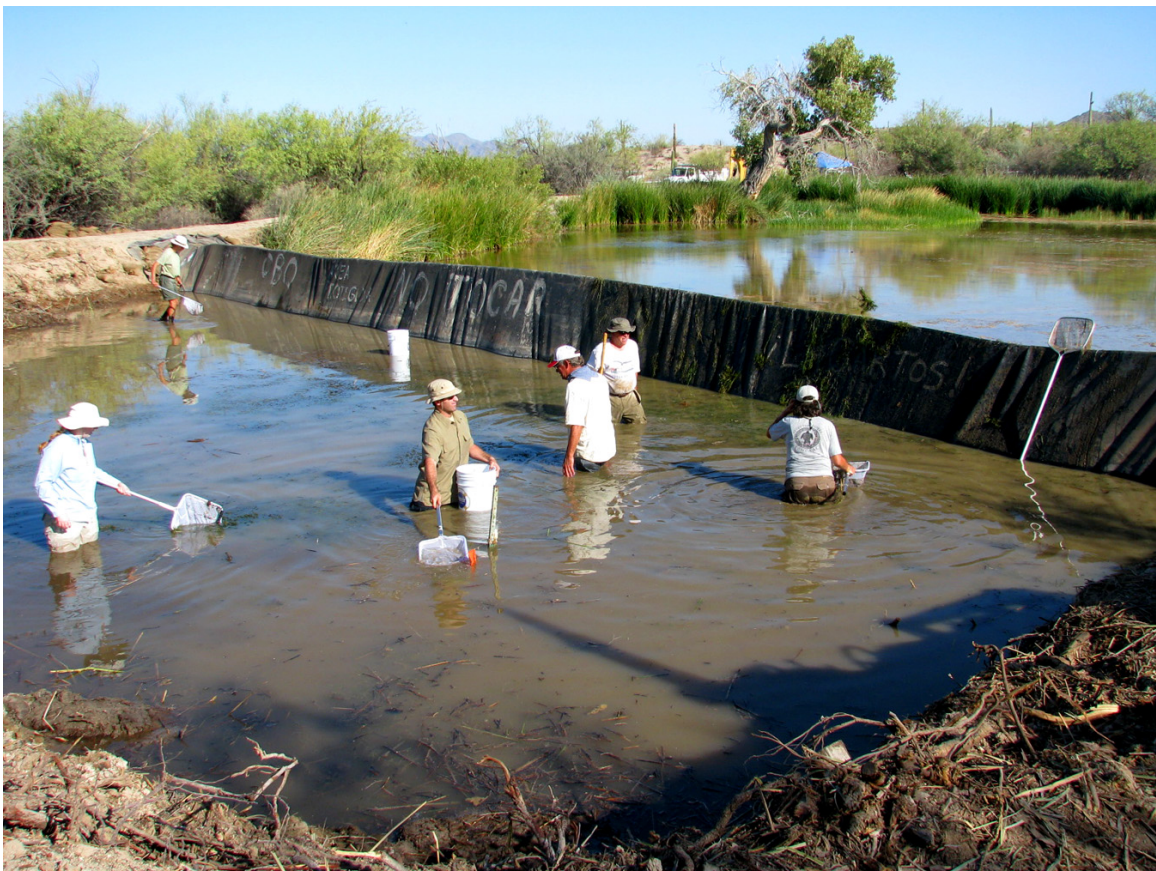
Figure 10. Removing Quitobaquito pupfish and Sonoyta mud turtles from the southeast corner, Quitobaquito Pond. August 19, 2009.

This third project day was primarily dedicated to attempting to remove all possible Quitobaquito pupfish and Sonoyta mud turtles from the southeast corner. Dipnets were the primary method, although seine nets were also employed (Figure 10). Captured fish were immediately released, pouring them over the coffer dam into the remaining pond. After substantial numbers had been relocated, efforts began to remove the water from the southeast corner. Water pumps were used, having screens sufficient to exclude pupfish. Water was pumped from the southeast corner into the remaining pond. As water was drawn down in the southeastern corner, the pool contracted in surface area. This facilitated pupfish capture, as the remaining fish became more concentrated in a diminishing water volume. Work this day was terminated when the 3<sup>rd</sup> of three water pumps became inoperable, due to increasing volumes of detritus in the water.

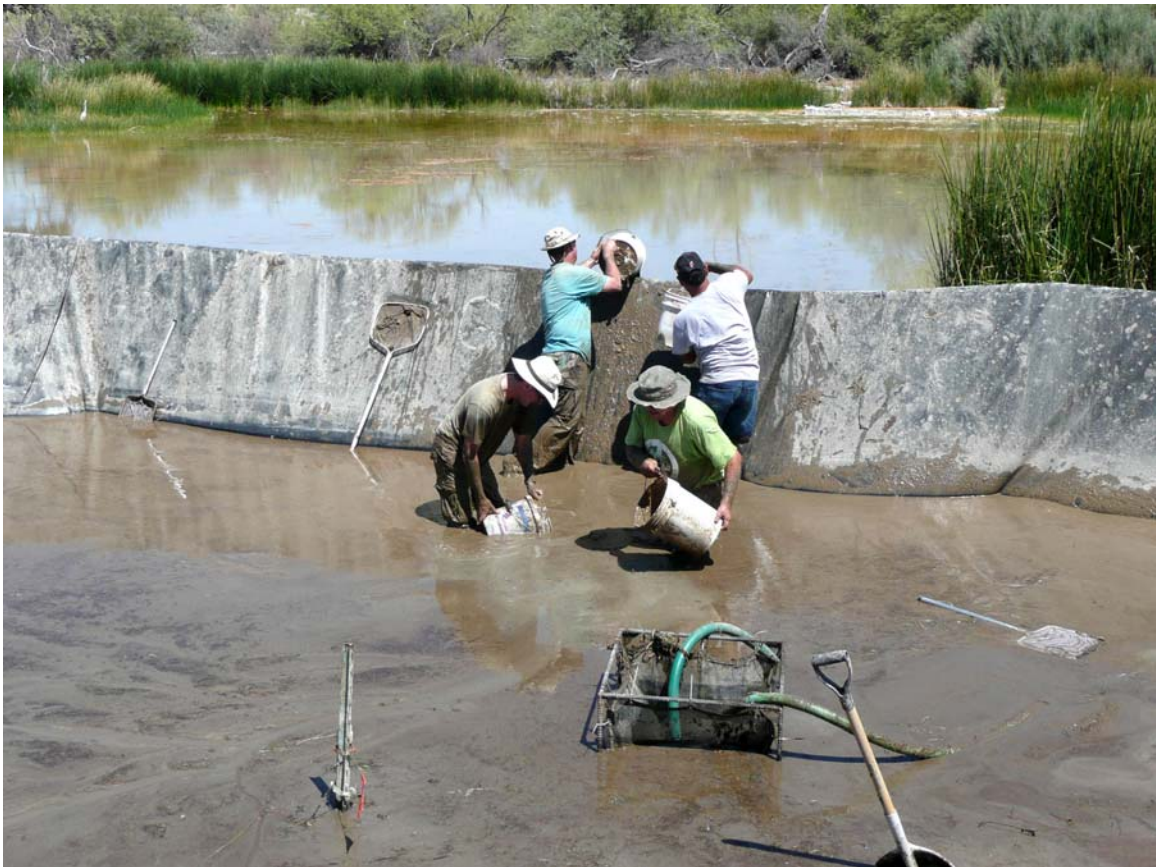
Figure 11 Bucket-hauling turbid water and mud, containing pupfish fry. Water pump filtration system is visible in right center. Quitobaquito Pond, August 20, 2009.

On this date, effort resumed to clear the southeast corner of pupfish, mud turtles, water, and detritus. Modified pumping/filtration systems devised overnight were employed, with limited success. As the pool of relatively fluid water diminished to a small area in the deepest part of the corner, pumping and filtration were no longer possible. Organic detritus and mobilized sediment completely overwhelmed filtration systems, and threatened to damage the pumps. In addition, although netting pupfish had been effective, fairly large numbers of very small pupfish fry became visible in the diminishing and turbid water. These fry concentrated at the surface, apparently attempting to access oxygenated and relatively clear water. At this point, the last several hundred gallons of turbid water were moved over the coffer dam via bucket-brigade (Figure 11). An estimated 1,500 pupfish were relocated from the southeast corner into the remaining pond. In this process, 82 mortalities were observed. We suspect that additional mortalities occurred. These additional mortalities would have been very small fry (<10 mm), which became trapped in mud as the last relatively fluid water was moved over the coffer dam into the remaining pond. It is possible up to 300 small fry may have been lost in this manner.

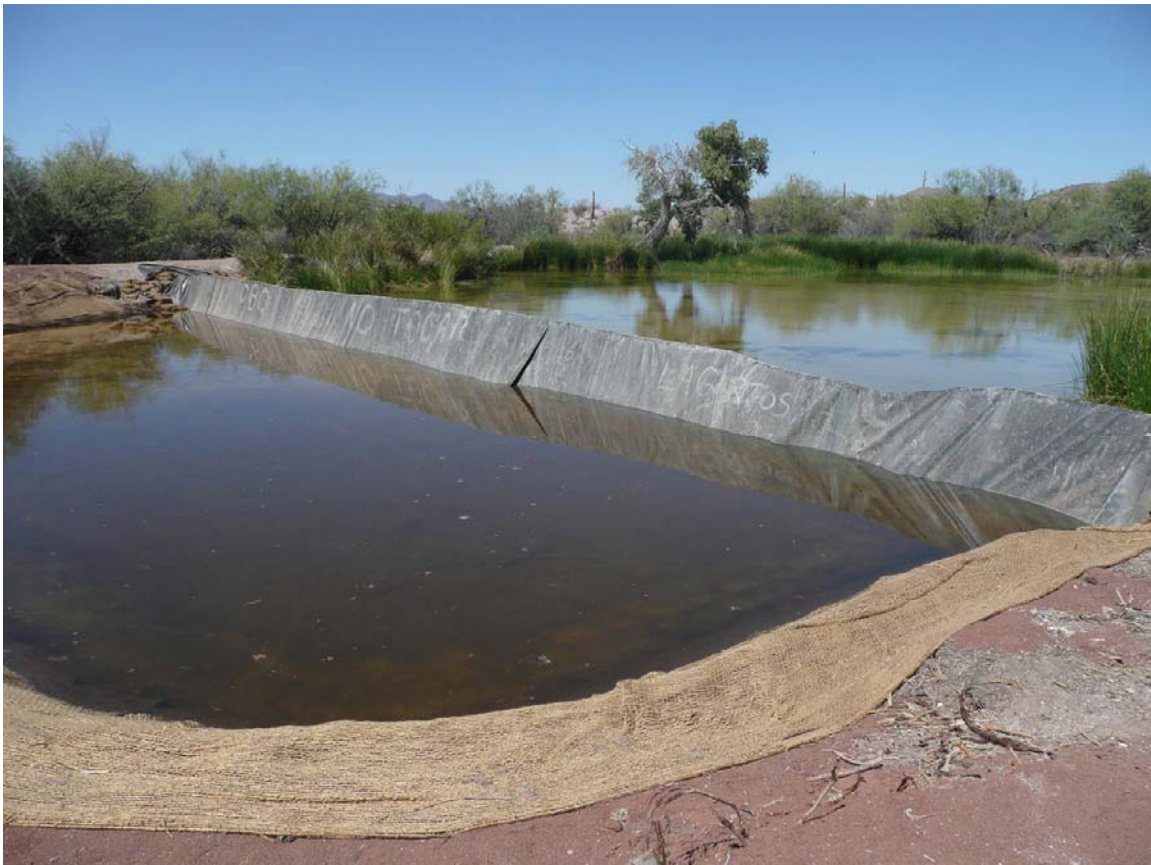
Figure 16. Quitobaquito Pond, September 23, 2009. Southeast corner (foreground) has refilled.

With the southeast corner re-filled to a level equal to the rest of the pond, on this date the coffer dam was removed. The dam was disassembled fairly quickly, and all components removed from the pond, including sandbags. This process was carried out with little or no disturbance of the new pond bottom in the southeast corner (Figures 16 and 17). On this date, swelling of the bentonite-containing fill was observed on the new pond bottom and banks.

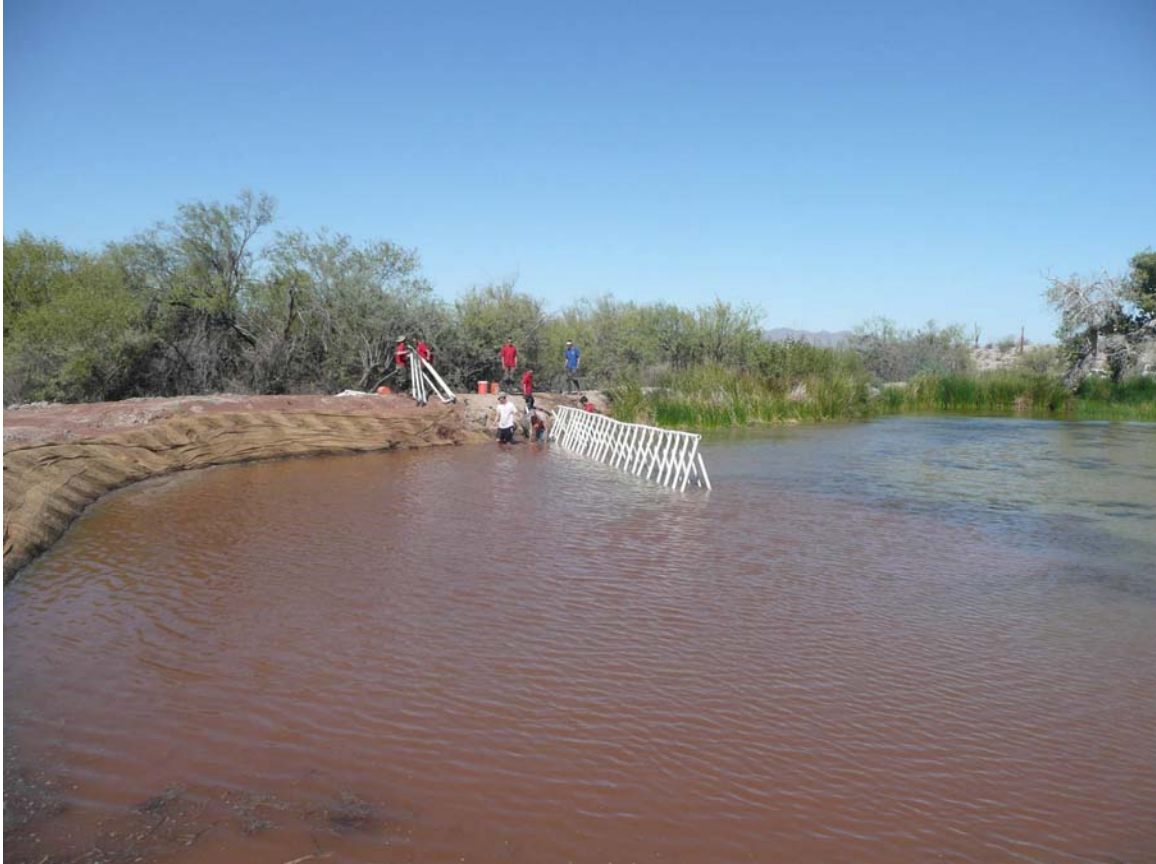
Figure 17. Quitobaquito Pond, September 23, 2009. Removing the last parts of the temporary coffer dam. Renovated/sealed southeast corner is left of the white dam frame.
