**Project Summary**  
**Quitobaquito Pond – Cottonwood Sealing**  
**October 18 - 28, 2010**

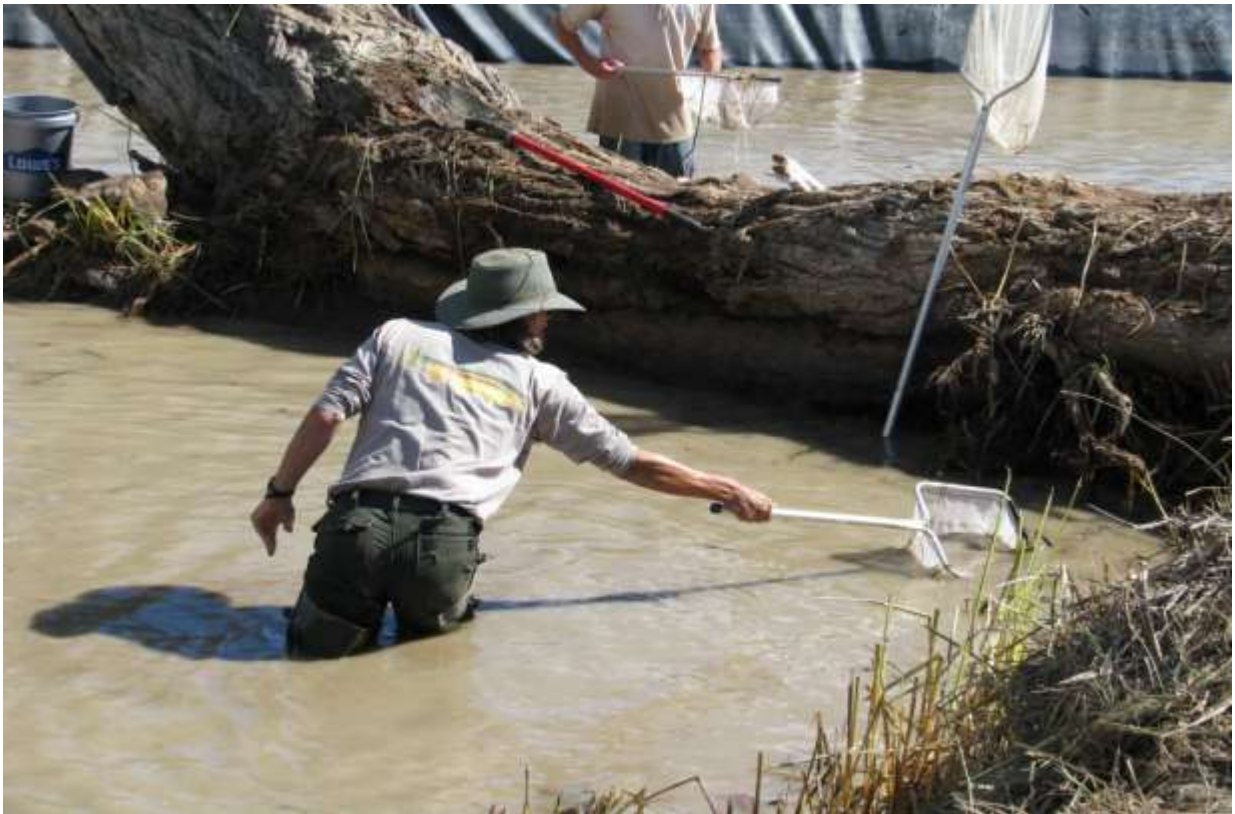
Figure 5. Netting for Quitobaquito pupfish and Sonoyta mud turtles. October 21, 2010.

4) October 20, the pond surface had raised 0.4" overnight, which was 3 times the rate of normal seasonal rise observed in the week or more before the project (see Discussion). With the coffer dam in place, workers removed as many Quitobaquito pupfish and Sonoyta mud turtles as possible from the project area (Figure 5). Approximately 1,000 pupfish were removed, relocated immediately into the main part of the pond. Two powered pumps (with pupfish-excluding screens) and bailing buckets were used to move the water inside the coffer dam, surrounding the cottonwood, over into the main pond body. After the water level in the project area had been lowered about 6", one side of the coffer dam failed. That side was taken apart, and rebuilt with additional interior and exterior reinforcement. The other side of the dam was reinforced with additional exterior sandbags, without taking it apart. By day's end, the dam was again sealed in place but water pumping had not resumed.

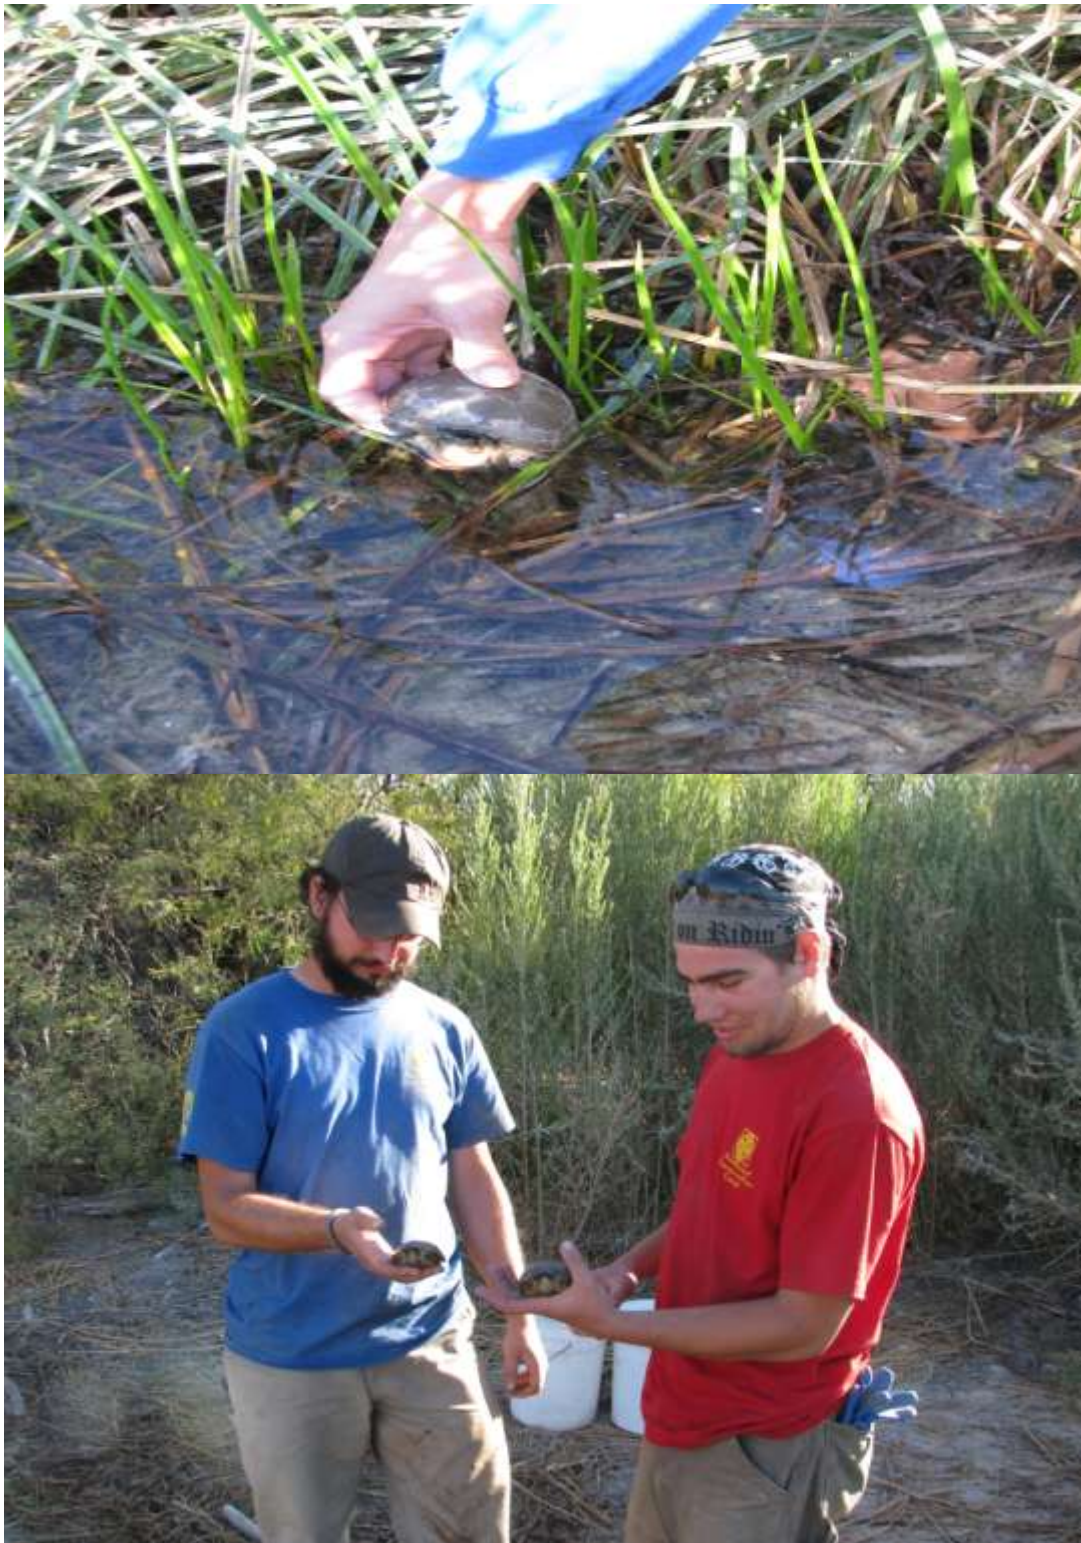
Figure 8. Releasing Sonoyta mud turtles (*Kinosternon longifemorale sonoriensis*) back into Quitobaquito pond after project activities. October 27, 2010.

8) October 27, the pond surface had again raised 0.25” overnight (18 hrs). On this date, general project clean-up and routine Quitobaquito maintenance took place. Vegetation was cleared from the northeast and southwest springheads, and stream channel. All 28 Sonoyta mud turtles removed from Quitobaquito on earlier days of the project were returned and released (Figure 8). At the project area, another hole was inspected that had drawn interest earlier in the year. The hole was about 4” in diameter, and was located in the middle of the tree trunk, on the retaining berm, at the point where the tree trunk bifurcates and flares out into the root system (Figure 9). The hole appeared to be used, though not created by, a ground squirrel (no excavated material was outside the hole). The hole was probed with an iron bar and found to extend nearly 4 feet down, slanting slightly toward the pond. It suggested a large void, in the area between and among the tree’s roots and the interior of the berm. On this day, about 30 pounds of dry bentonite were poured down the hole.

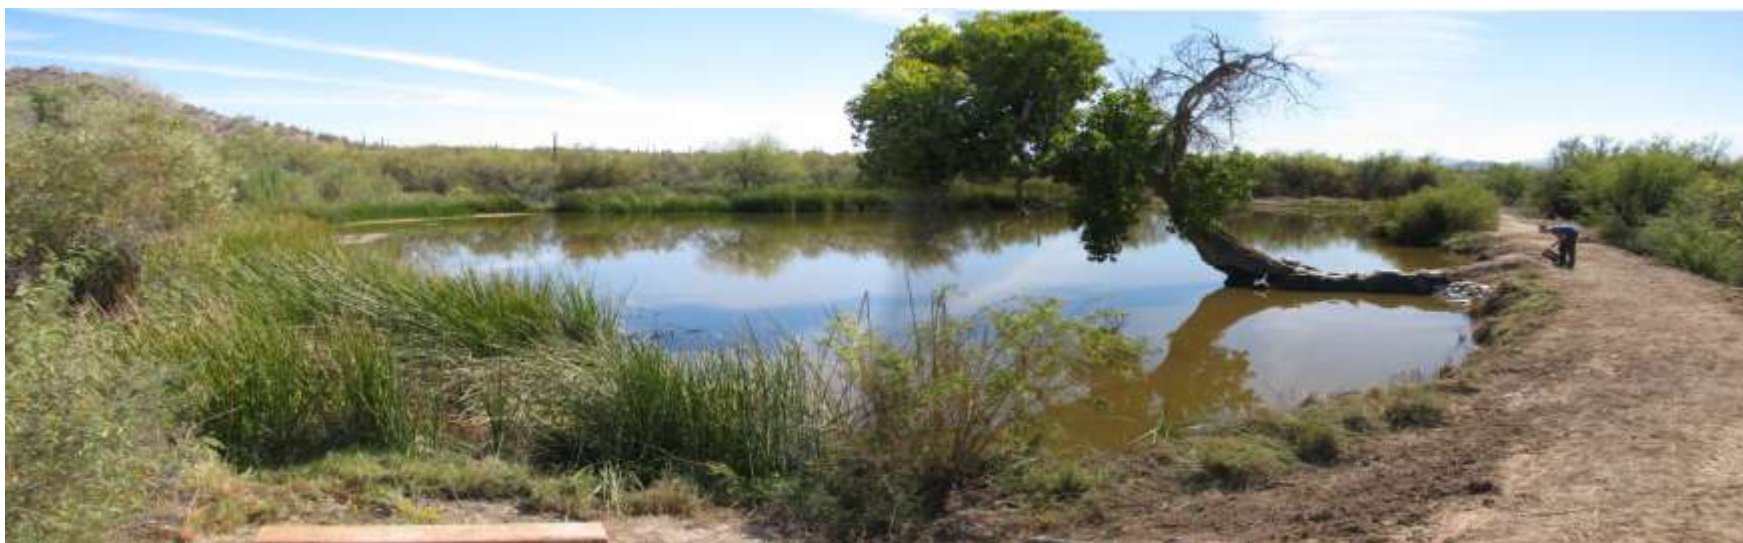
As of November 1, the pond was at minus 8.2". This was the highest, most stable pond level since early 2006 (Figures 11 and 12), and was nearly 4" higher than a maximum capacity of minus 12" that was believed to exist through most of 2010. It is not possible to conclude how much temporarily sealing the cottonwood tree is contributing to the current increase in pond level, or the pond's ability to continue rising above the minus 12" level. It is possible that the positive trend in late 2010 would have persisted even without temporarily sealing the cottonwood. It is possible the positive trend in late 2010 is a delayed effect of the August 2009 southeast corner renovation. That project had immediate positive effect (Figure 1), but a full year may have been required for its full effects to develop. It is also possible that some unknown leak (e.g. rodent burrow or tree root cavity) that opened naturally 3 to 4 years ago has now closed naturally. Regardless of the reason, Quitobaquito Pond has been restored to approximately 80% of its normal post-1962 depth, and may continue to rise. The increasing water pressure may re-activate leakage, but that remains to be seen. Considerable pond area (possibly 25%) has been displaced by bulrush encroachment during the low-water period of 2006-2010. However, the deeper water should now inhibit further rapid bulrush encroachment.

Figure 12a. Quitobaquito Pond, Organ Pipe Cactus National Monument, after the project. October 28, 2010. Pond level: minus 8.8 inches.

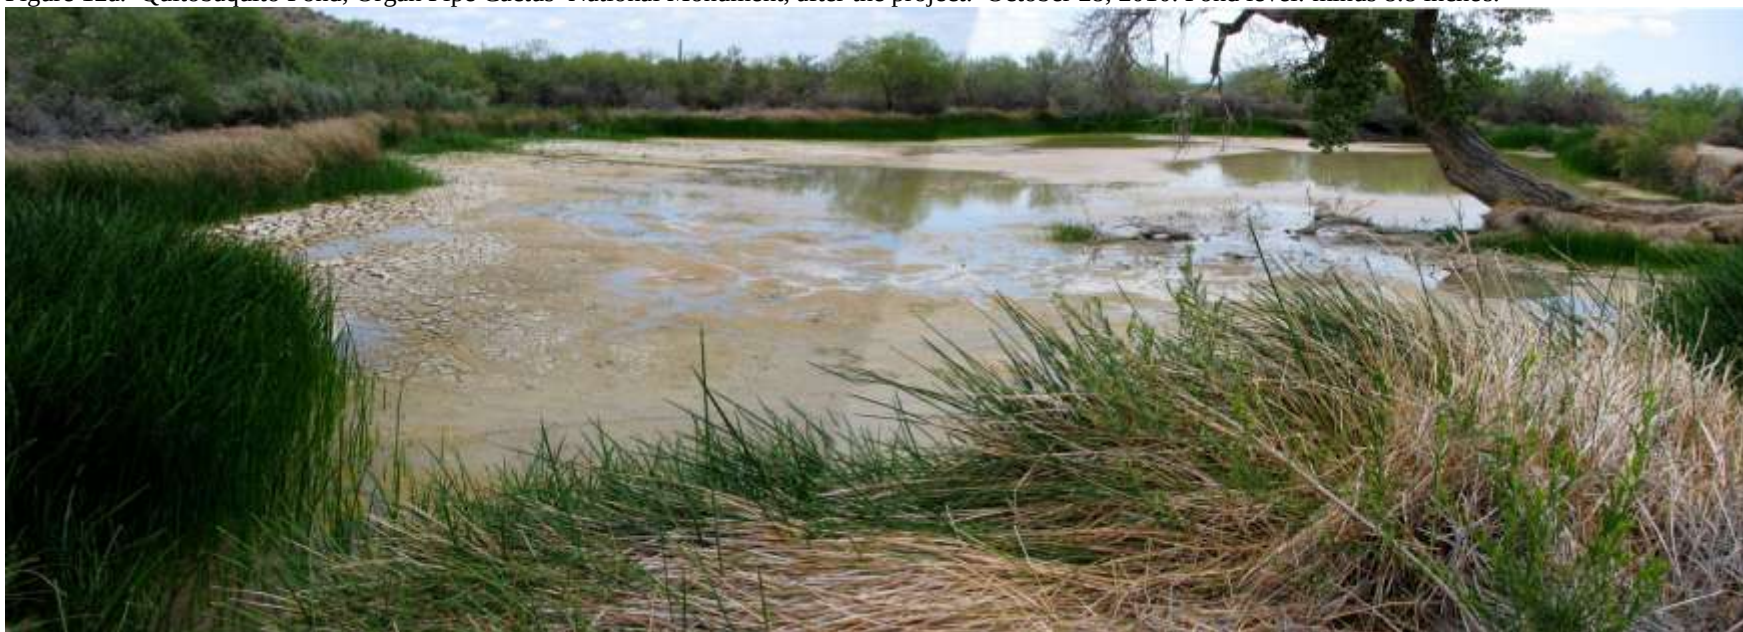
Figure 12b. Quitobaquito Pond, Organ Pipe Cactus National Monument. July 26, 2008. Pond level: minus 28 inches.
