**National Park Service  
Cultural Landscapes Inventory  
2005**

**Anacapa Island Light Station  
Channel Islands National Park**

# Cultural Landscape Inventory: Anacapa Island Light Station

CONDITION ASSESSMENT: **GOOD**

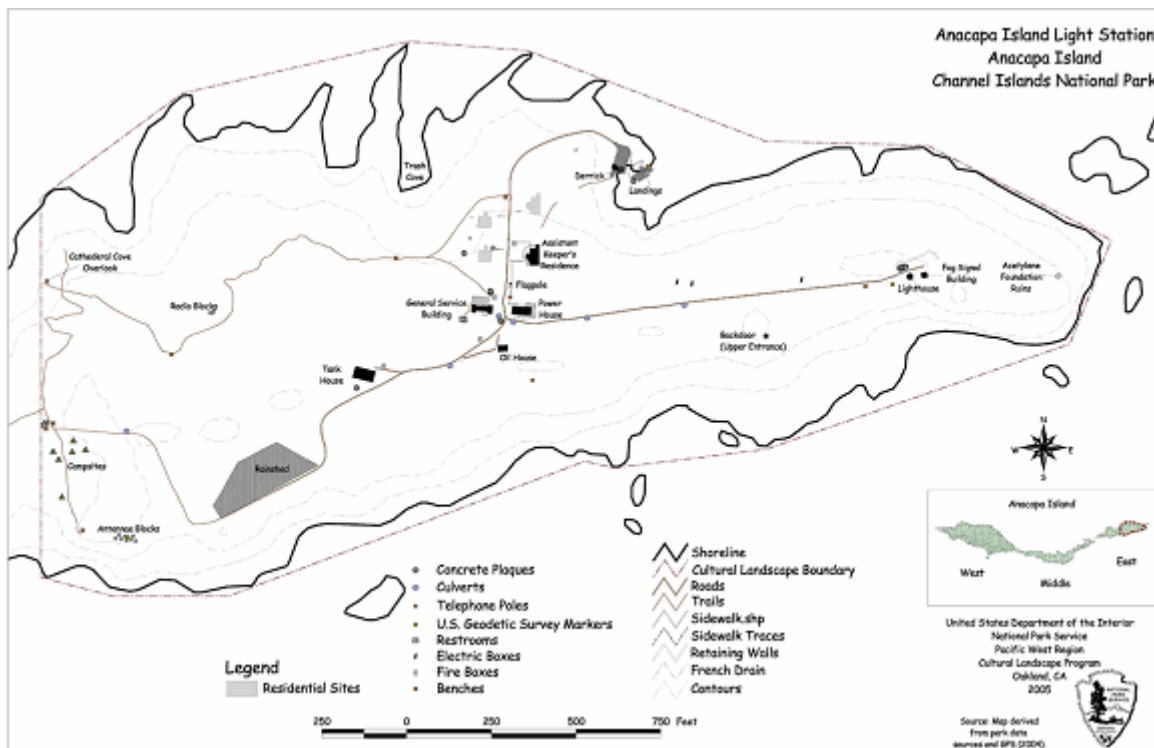
*An existing conditions site map of Anacapa Island Light Station Historic District. A larger version is located in the Appendix at the end of the inventory in Supplemental Information.*
