# **RUINS STABILIZATION IN THE SOUTHWESTERN UNITED STATES**

Compiled by  
ROLAND VON S. RICHERT and  
R. GORDON VIVIAN

**National Park Service**

U. S. Department of the Interior  
Washington 1974

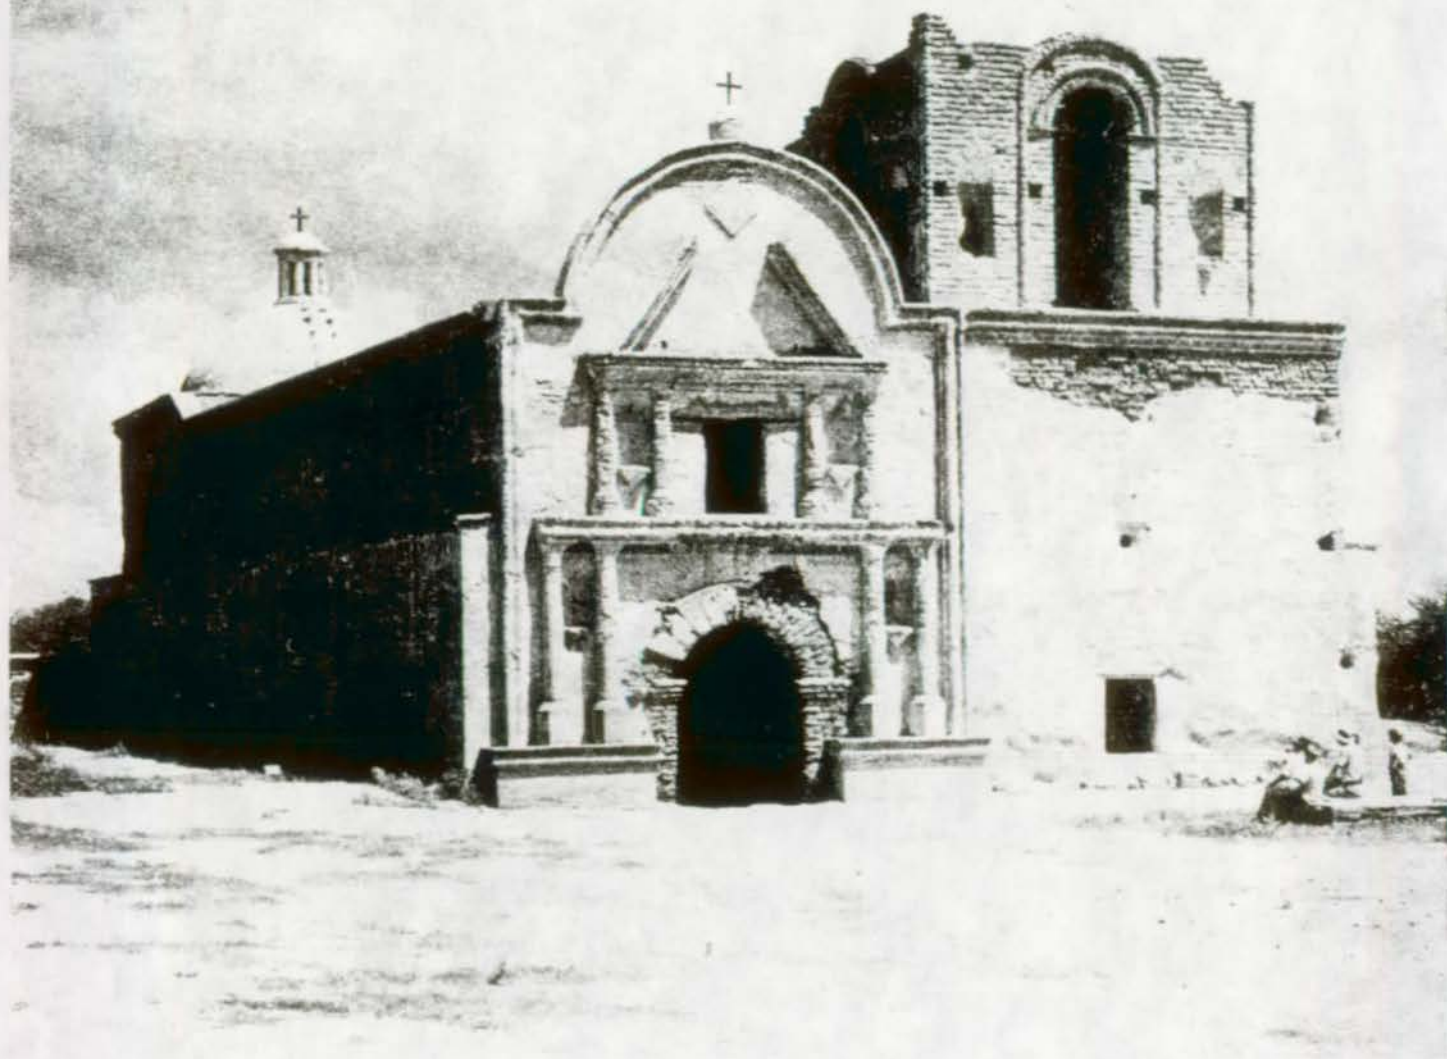
The Mission Church, Tumacacori National Monument, Tumacacori, Arizona. Comprehensive stabilization, repair, and partial restoration of the Mission Church was performed in 1921 by Frank Pinkley. Lower portions of the columns and bases of the facade were restored in 1945. Since that time, all efforts by the National Park Service have been directed to preserving existing original construction. Replacement plaster, where required to cover eroded original lime plaster and adobe brick surfaces, consists of a tinted cement-lime-sand mortar employed with a bonding agent.

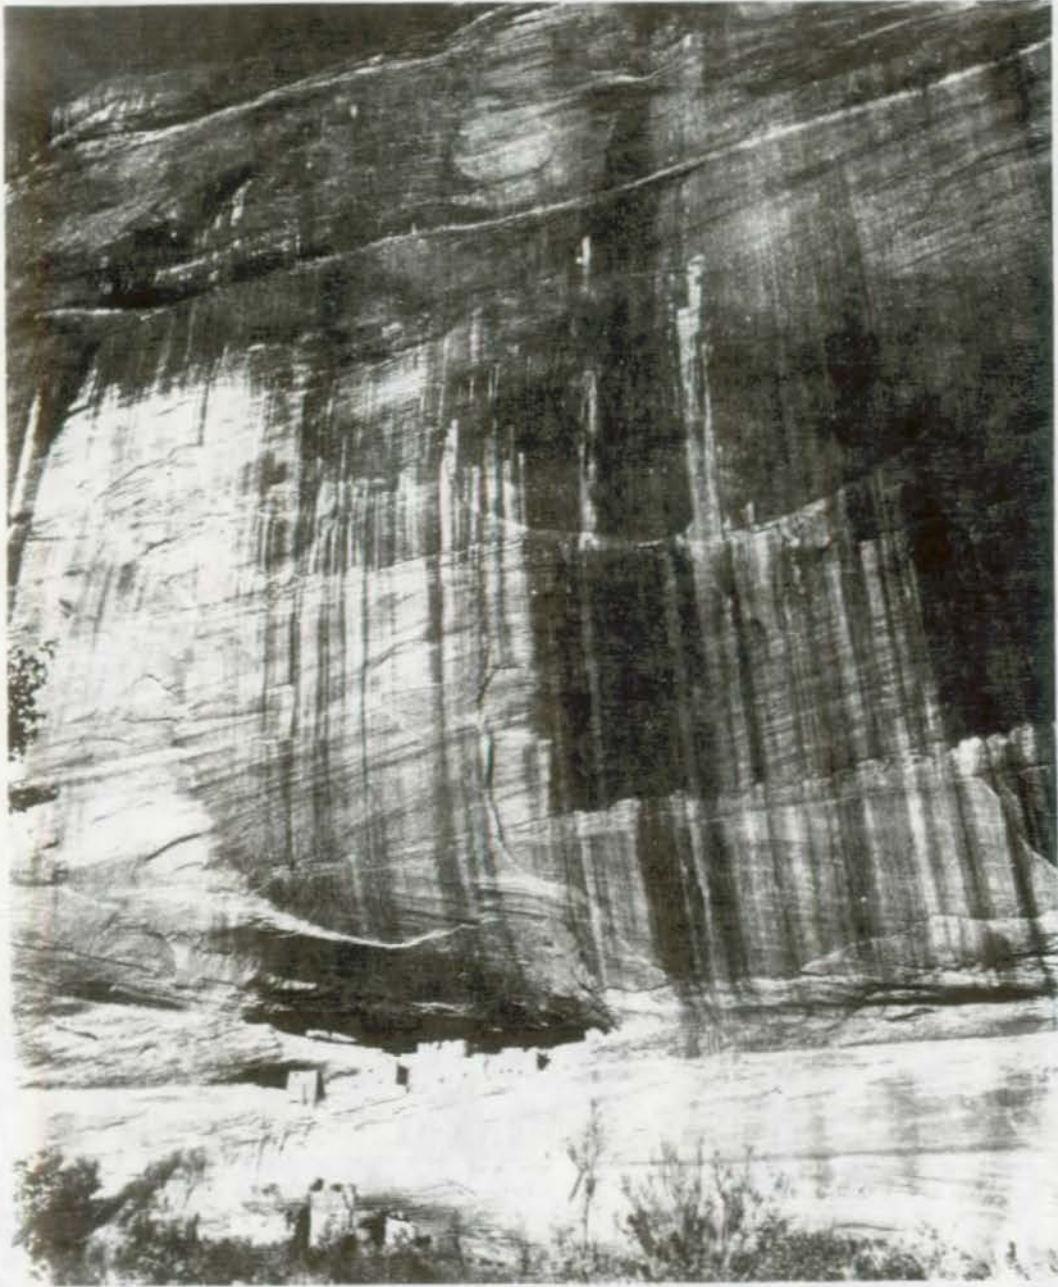
White House Ruin, Canyon de Chelly National Monument, Chinle, Arizona. The main occupation took place within the period A.D. 1000-1300. The White House was so-named for the conspicuous white plaster which covers a long wall in the upper, cave portion of the ruin. The remaining architecture has been stabilized by repairing, grouting, respalling and capping of walls and, additionally, by sub-soil intrusion grouting. The magnificent, water-stained, red sandstone cliff rises a sheer 600 to 700 feet above the canyon floor.

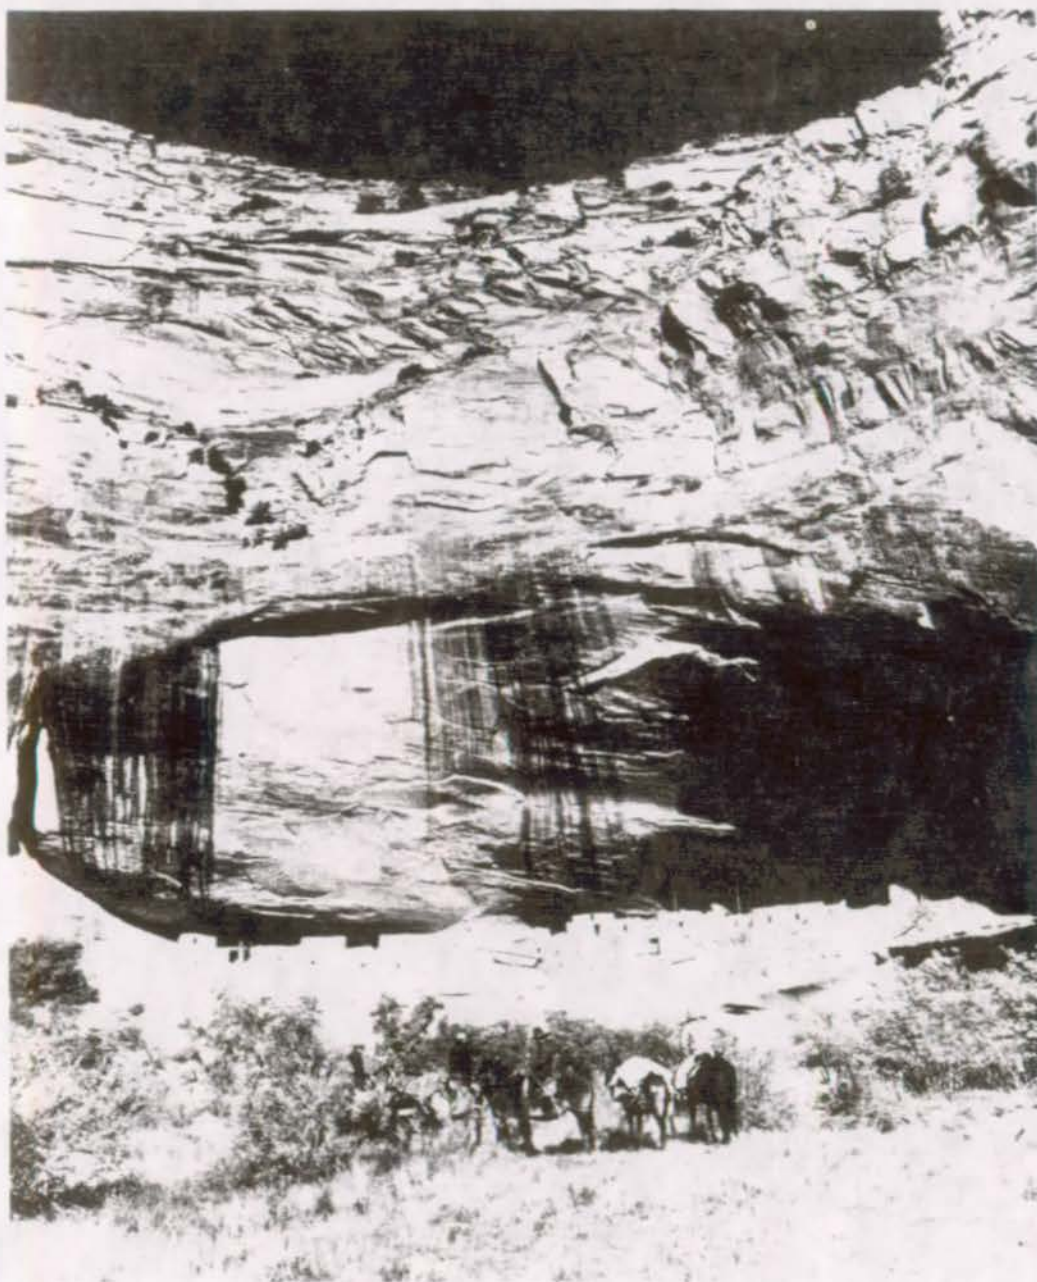
Keet Seel Ruin, Navajo National Monument, Arizona. Occupied intermittently through Pueblo I and Pueblo II periods (A.D. 1250-1286), the ruin was first excavated and stabilized in 1934 by a Civil Works Administration crew under the sponsorship of the Museum of Northern Arizona. Additional work by the National Park Service in 1958 and 1970 corrected numerous weaknesses, and recorded areas of the 1934 research not previously documented. Several types of wall construction are evident, including wattle and daub, masonry, vertical post-reinforced and horizontal post-reinforced.

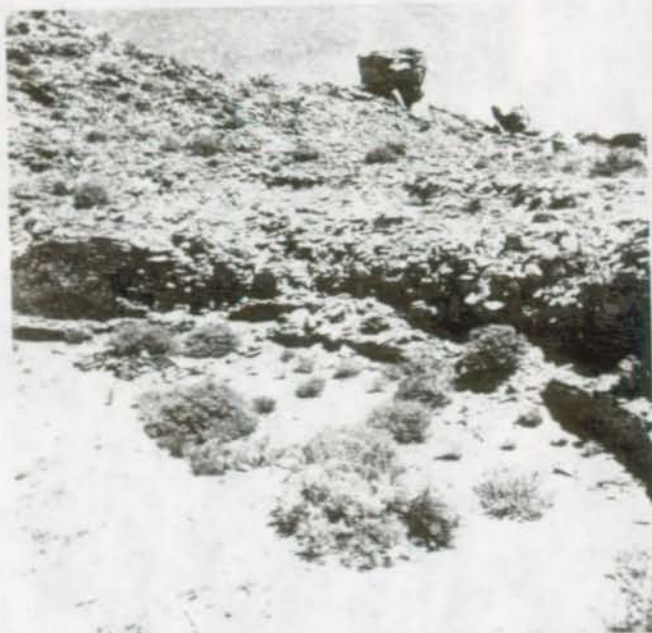
Regardless of the condition in which standing walls are found, it must be remembered that the entire depth of the wall is seldom exposed, and that the exposed portions—which form a base over which the stabilization is being done—have been subject to nearly all the forces listed above, i.e., surface weathering, construction over loose fill or partial walls, breakdown or theft of wood members, erosion at the base, buckling from pressure, excavation, and backfill (fig. 5).

FIGURE 5. Clearing of depressed areas leaves them open to surface runoff and rapid destruction. (The Great Kiva, Kin Nahasbas Ruin, Chaco Canyon National Monument, N. M.)

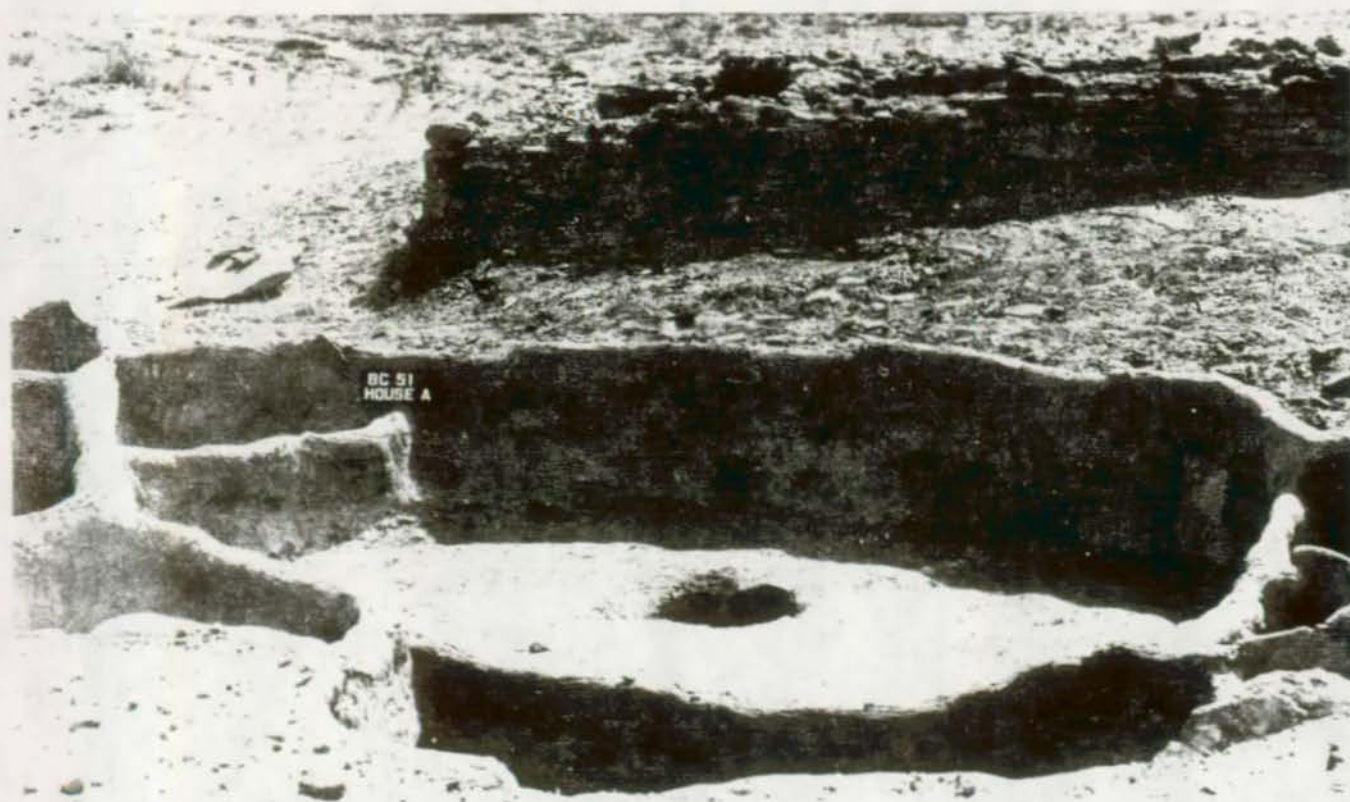
FIGURE 9 Soil-cement in heavy cross section; shown here for the repair of slab-house walls. (Basket Maker III pithouse, Site Bc-51, Chaco Canyon National Monument, N. M.)

The prehistoric wall was dampened and the mix placed between it and the form (fig. 53) well tamped in place to fill undercut spots. It was placed at a depth sufficient to cover the rise of the wall face and was then sloped to conform to the irregular, sloping surface of the wall top. After curing, the forms were removed and when completely dry the entire surface was treated with silicone water repellent (fig. 54). This use of heavier, self-supporting coverings of native materials parallels the already proven use of heavy sections of soil-cement in the repair of pit houses and for making facings in cuts in soft fill (figs. 9 and 10).

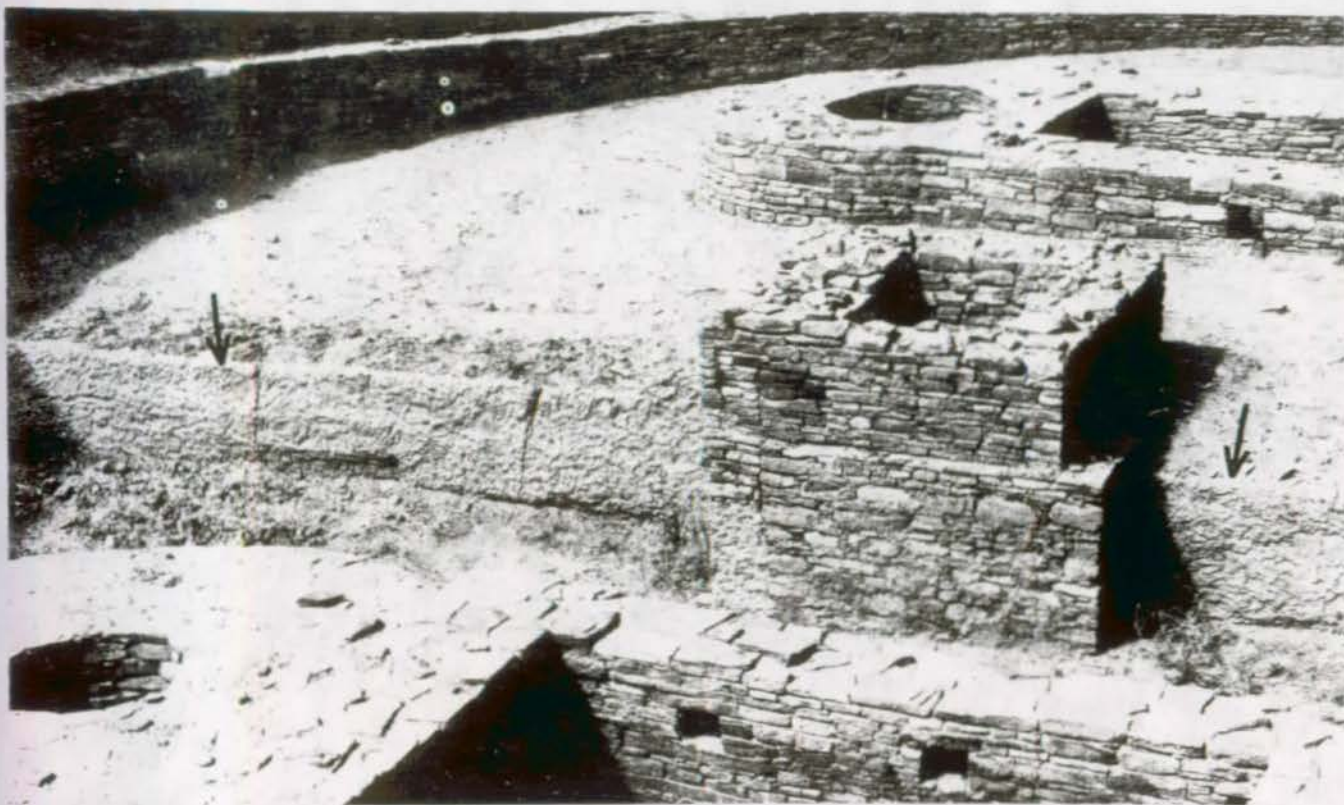
FIGURE 10. Formed soil-cement in retaining sections of fill which must be stabilized to show portions of structures on varying levels. (Great Kiva in the plaza of Chetro Kettle Ruin, Chaco Canyon National Monument, N. M.)

Soil-cement is particularly suited to large repair sections in monolithic soil structures, and is also valuable in stabilizing the sides or ends of cuts in excavations which must be left open for interpretive purposes (fig. 10).

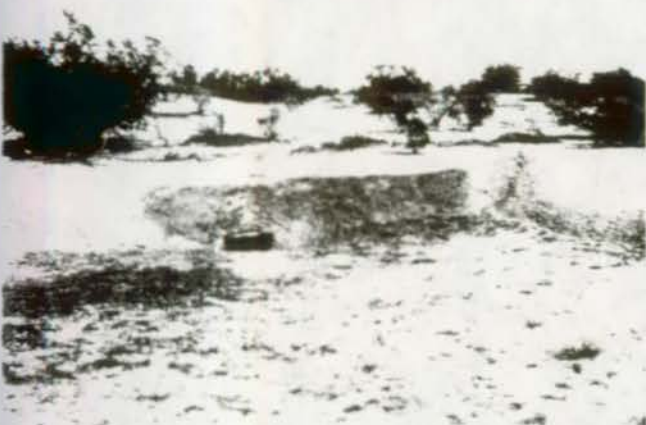
FIGURE 13. West wall of Compound A immediately after a rain. The light areas treated with silicone repelled water. The darker areas were untreated and absorbed moisture rapidly. (Casa Grande Ruins National Monument, Ariz.)

To date, applications of silicone water repellents have been made on the following structures: south wall of the "Big House" at Casa Grande and numerous walls in Compound A (figs. 13, 14) which had been previously covered with a soil-cement coating, and heavy soil-cement sections in Compound B. At Tumacacori the entire granary was treated and an application was made on the patched upper surface of the barrel-vault roof on the sacristy.

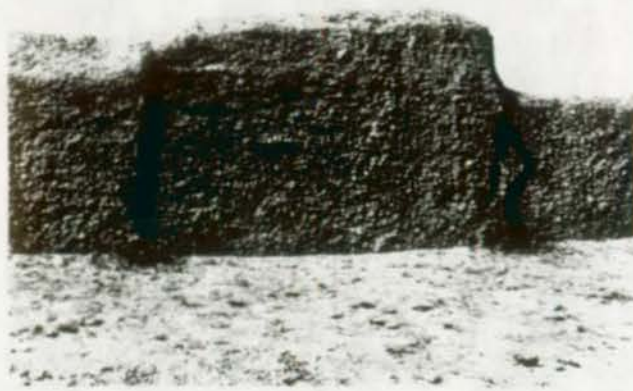
FIGURE 14. West wall of Compound A one year after the application of silicone waterproofing. Two hairline cracks were filled. The untreated smears of plaster have absorbed moisture, while the treated wall remains dry. (Casa Grande Ruins National Monument, Ariz.)

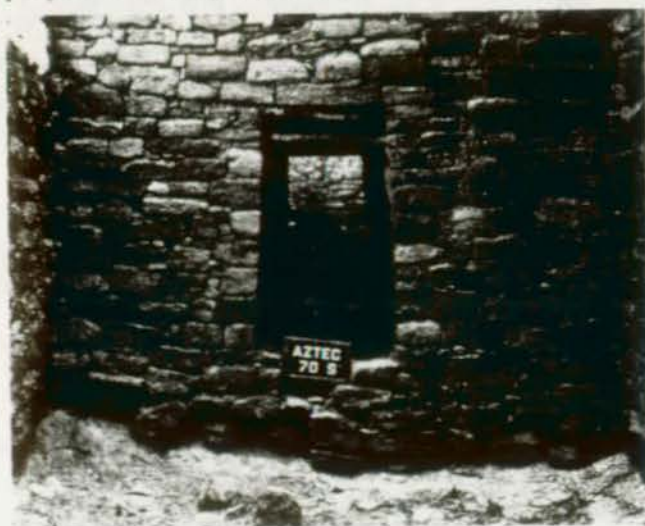
A similar evaluation was made of 19 walls (not retaining fill) constructed of and repaired with the same class of soft stone as in the 21 tested which retained fill. Fifteen remained in good condition. Four showed large wet areas where failure of drainage lines had impounded water (figs. 17 and 18).

FIGURE 17. Basal erosion from capillary moisture is particularly damaging in the interiors of excavated sites where drainage is poor. (West Ruin, Aztec Ruins National Monument, Ariz.)

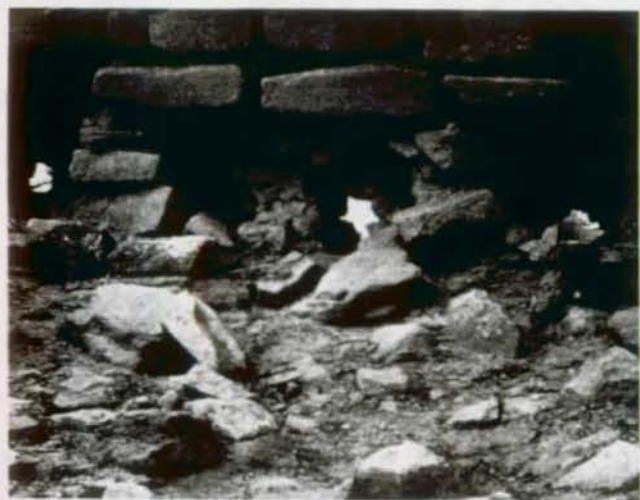
FIGURE 18. The severe undermining and basal erosion of a wall resulting from capillary moisture. If left untreated, such walls soon collapse. (West Ruin, Aztec Ruins National Monument, N. M.)

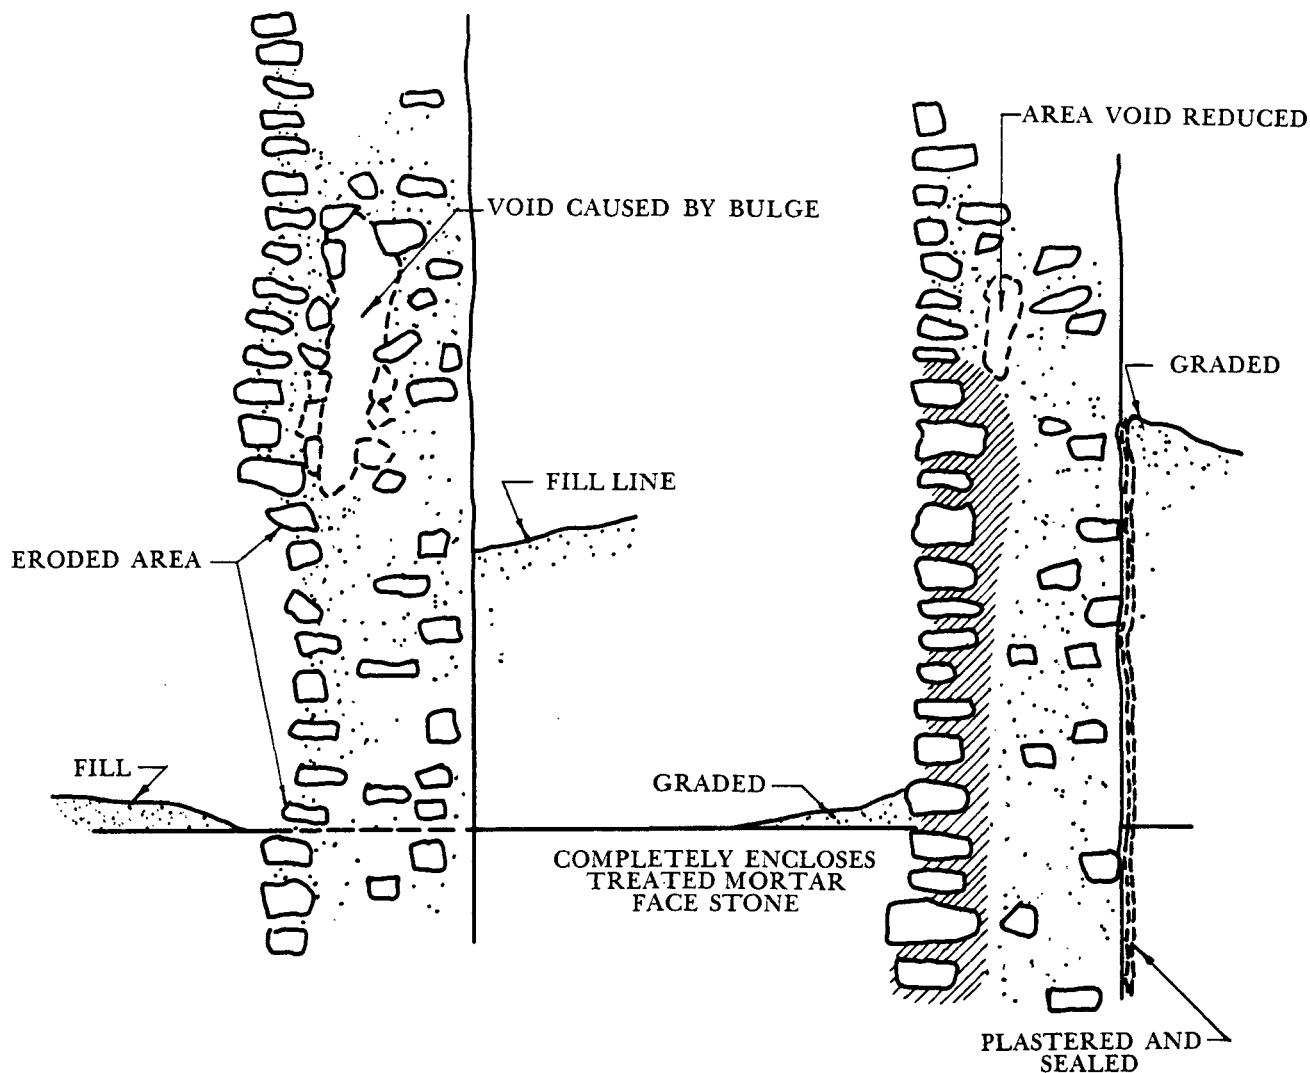
FIGURE 19. Field control of moisture erosion. Wall depicted in section at left before treatment; following stabilization at right.

In laying out stabilization for a wall deteriorating from moisture erosion, consideration must be given to any proposed changes in the fill level (fig. 19). Where the eroded wall also retains fill, the treated mortar should extend somewhat higher than the eroded area to insure against possible increases in the capillary rise. Thus, it is better to include too much rather than too little mortar in the area stabilized. While this might violate the precept of keeping the replacement of prehistoric or original material at a minimum, it is desirable that the replacement be made all at one time rather than over a period of years, as moisture works its way around too small a patch.

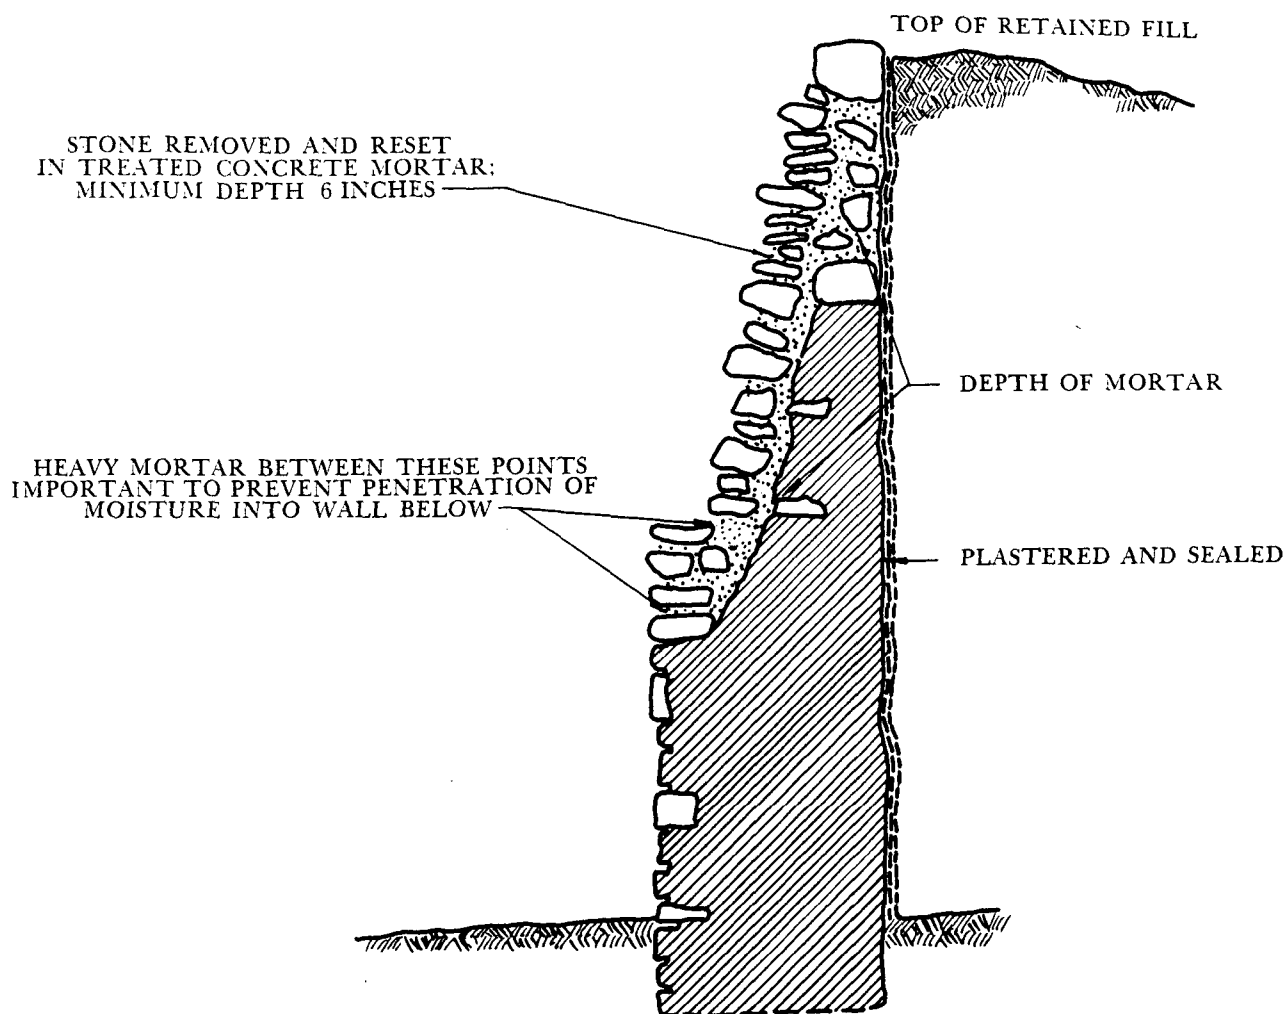
FIGURE 20. The application of waterproofed cement mortar to an oblique wall.

Relaying the oblique surface in a moisture-resistant cement mortar is more effective from the point of general appearance (fig. 20). The only drawback to this method is that large areas of the waterproofed mortar will be exposed. It is difficult, if not impossible, to color cement mortars containing emulsified asphalt. Special waterproof cements, however, can be colored.

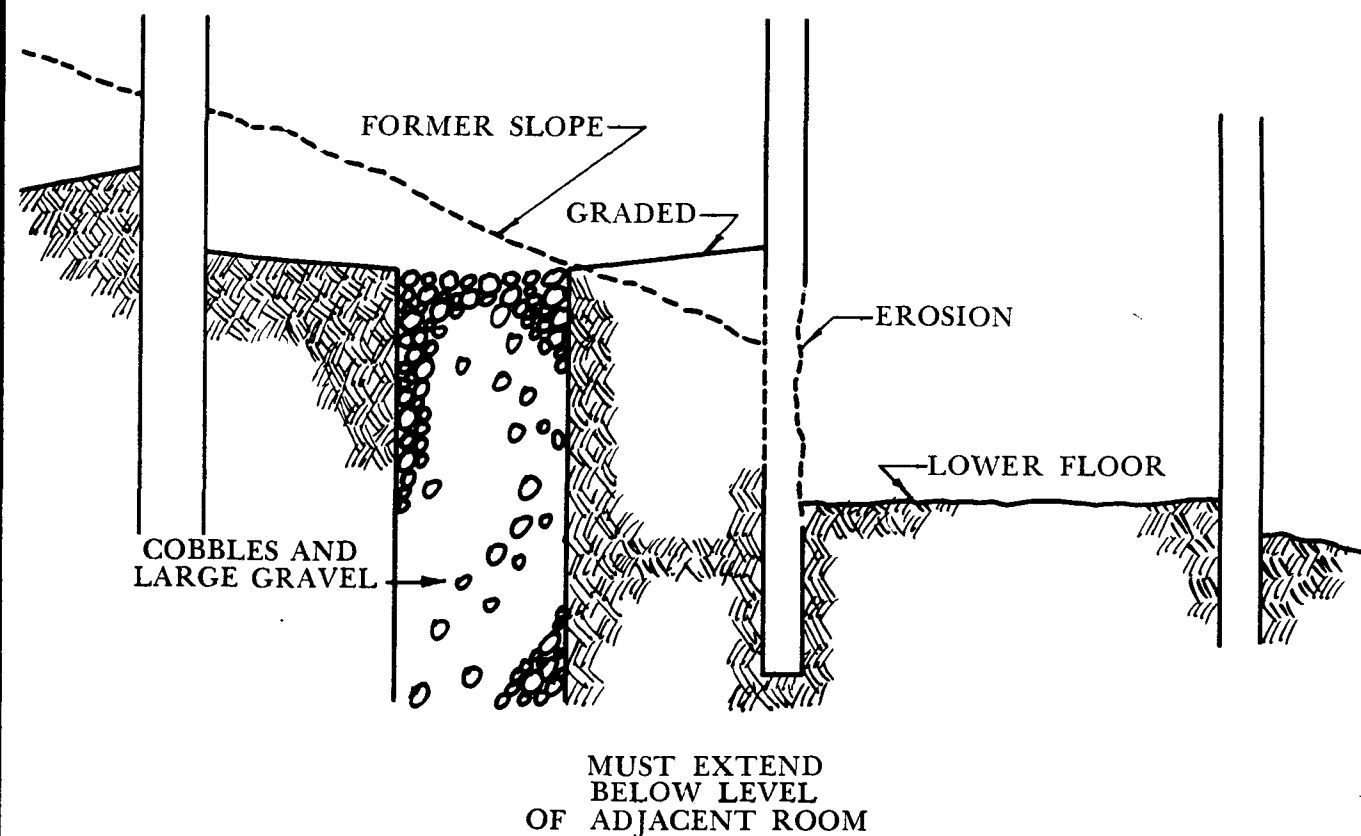
FIGURE 21. Construction of a dry-barrel (in section). Note that it has been carried well below the adjacent floor levels.

A dry-barrel is usually constructed at the center of a room or confined space (fig. 21). A circular hole 3 to 4 feet in diameter is dug to a depth which is at least 3 feet below the lowest level in adjoining rooms. The hole is then backfilled with random stone or gravel with fairly well graded material at the top to prevent the entrance of large amounts of silt or fine material. The surrounding surface is graded to the sides of the dry-barrel.

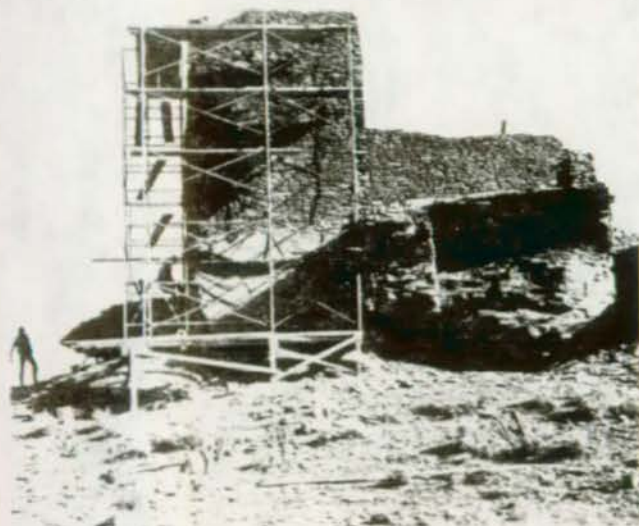
FIGURE 27 Scaffolding in place at completion of respalling and grouting large wall surfaces. (Wukoki Ruin, Wupatki National Monument, Ariz.)

Where masonry walls containing a large proportion of spalls or chinking on the surface are subject to extreme weathering in exposed locations, surface repair may become a time-consuming project. As the spalling is lost to weathering, the soil mortar between individual stones is then exposed. It weathers far more rapidly than did the spalling, and decay of the wall is accelerated. Loose and softened soil mortar must be scraped from between the individual stones, the space then partially filled with cement mortar and the spalls tapped into place in the mortar. Large walls require considerable equipment and an experienced crew (fig. 27).

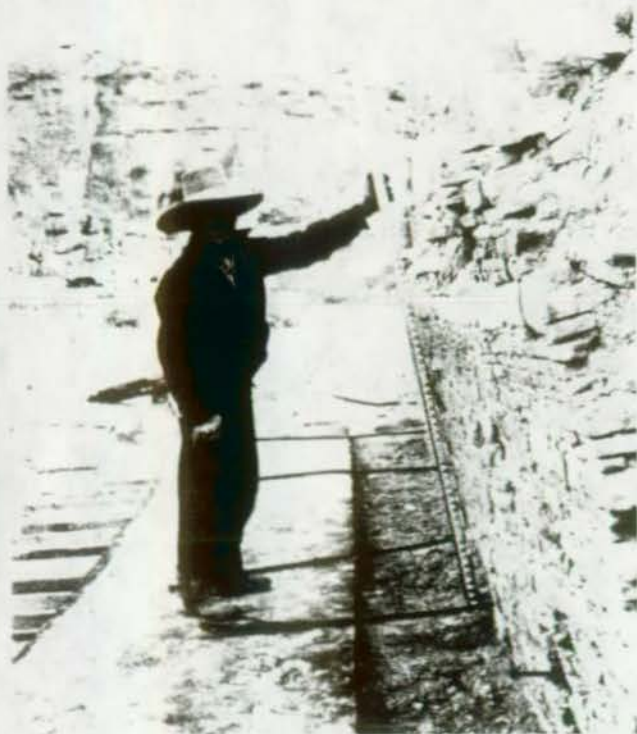
FIGURE 33. Beginning realignment. Cables have been placed through the base of the wall to be tied to the jacks. Note bolt, lower right, for holding frame against wall. (Pueblo Bonito, Chaco Canyon National Monument, N. M.)

Realignment of distorted, out-of-plumb walls is seldom practicable unless the wall is in otherwise good condition (figs. 33, 34, and 35). If the wall has to be realigned and is in poor condition, it must first be strongly repaired with a soil mortar. Do not repair the wall with cement or stabilized soil mortars. Considerable time, care, and equipment are required to realign a wall of any size. The general requirements are, first, that the wall must be completely formed on both sides and, secondly, that it be thoroughly damp if it is not to be cracked further or distorted in some other directions. The steps taken should include:

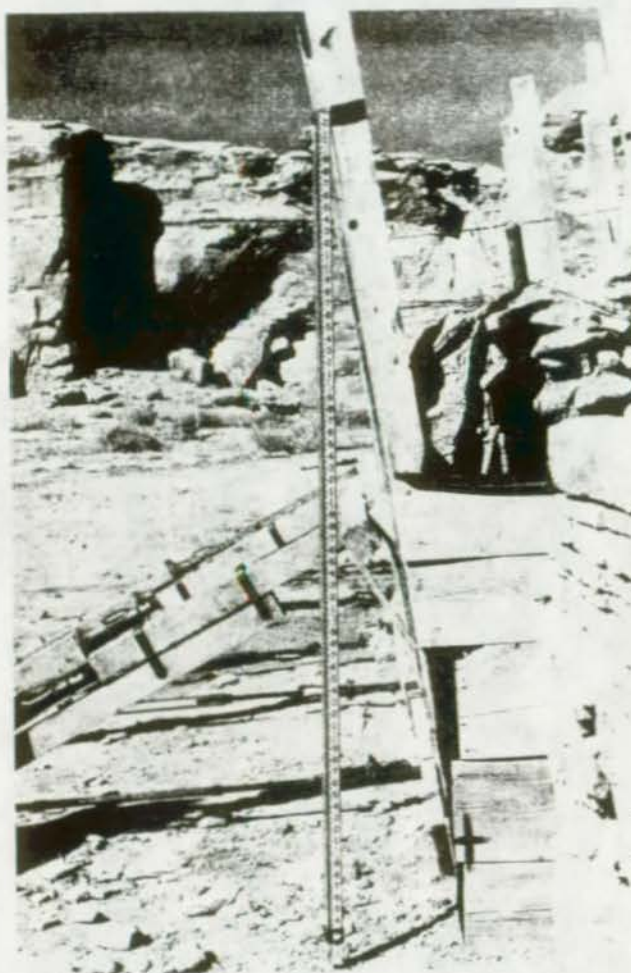
FIGURE 34. Realignment of wall depicted in figure 33. The framework is in place on both sides and is tied together. Frame lined with asphalt paper, space between frame and wall packed with sand. Note that the five screw jacks in sleeves bear against a 4 x 4 timber to distribute pressure.

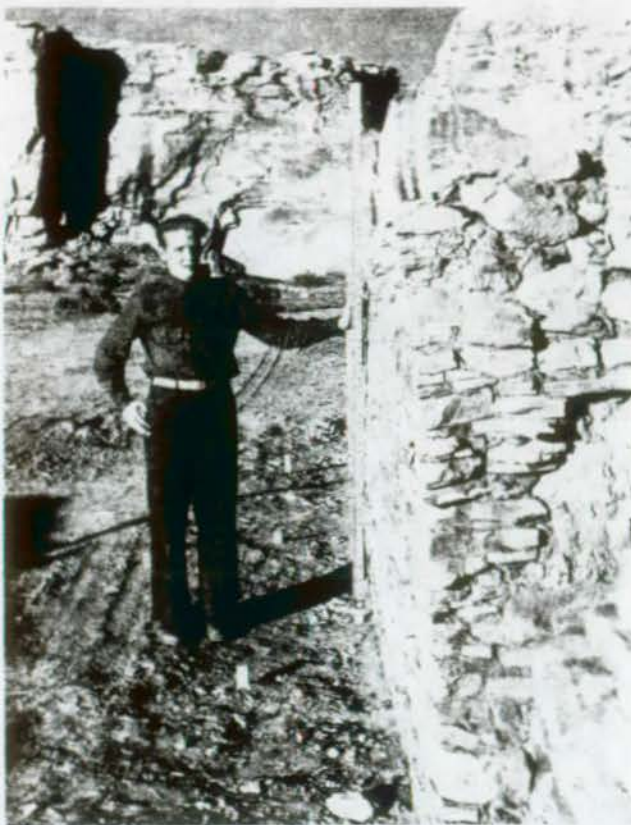
FIGURE 35. The wall depicted in figures 33 and 34 after pressure had been applied for three weeks by means of jacks in sleeves.

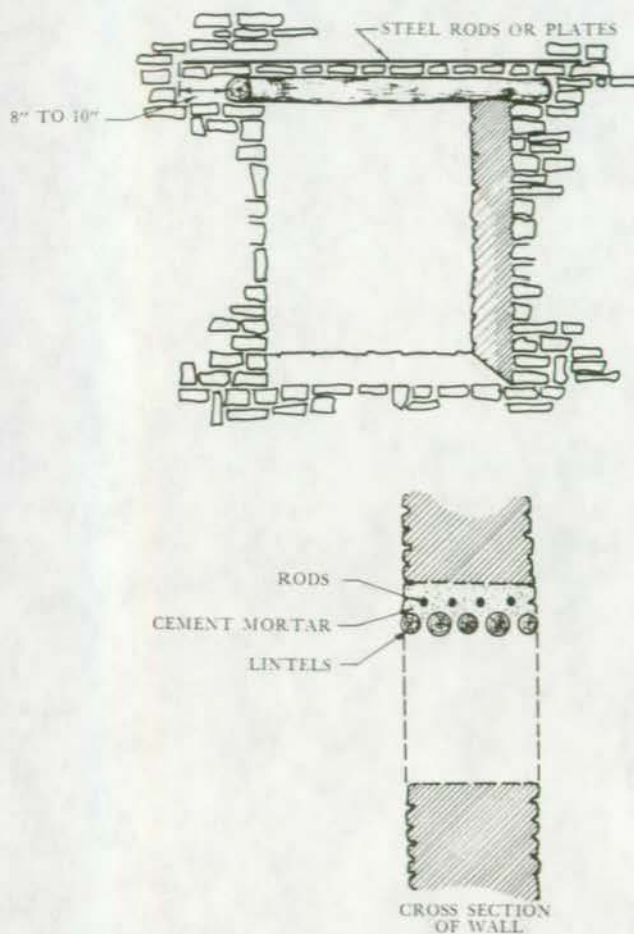
FIGURE 36. The placement of reinforcing in concrete mortar over pole lintels.

remove the timbers and replace them, either with wood or cast members. Rebuild the wall where necessary. Where wood is the replacing material, some reinforcing effort must be made. In short spans, steel plates may be set above the lintels. In longer spans the wall above the wood must be set in reinforced concrete mortar. In any case, the steps are the same (fig. 36):

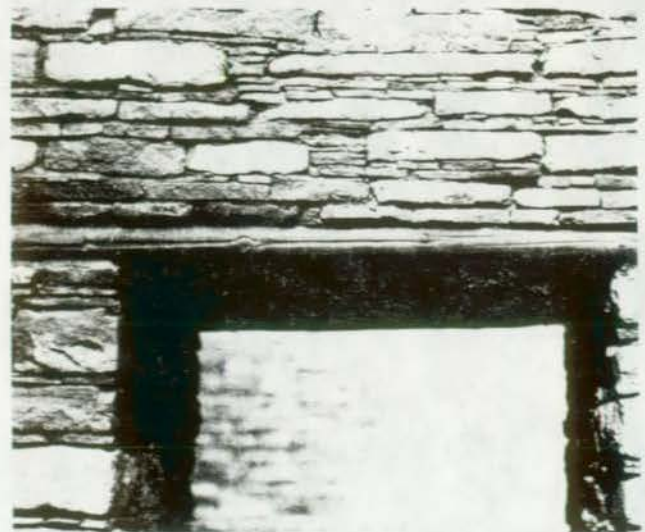
FIGURE 37. The cast concrete lintels have the same appearance as the originals from which they were cast. (Chetro Kettle Ruin, Chaco Canyon National Monument, N. M.)

masonry. The use of cast lintels and poles eliminates many of the above difficulties. They permit the replacement of wood with little disturbance; they provide a strong, rigid and very durable member. Cast lintels take the same surface and texture as the wood from which cast. With a little care they may be stained to faithfully reproduce the original (fig. 37).

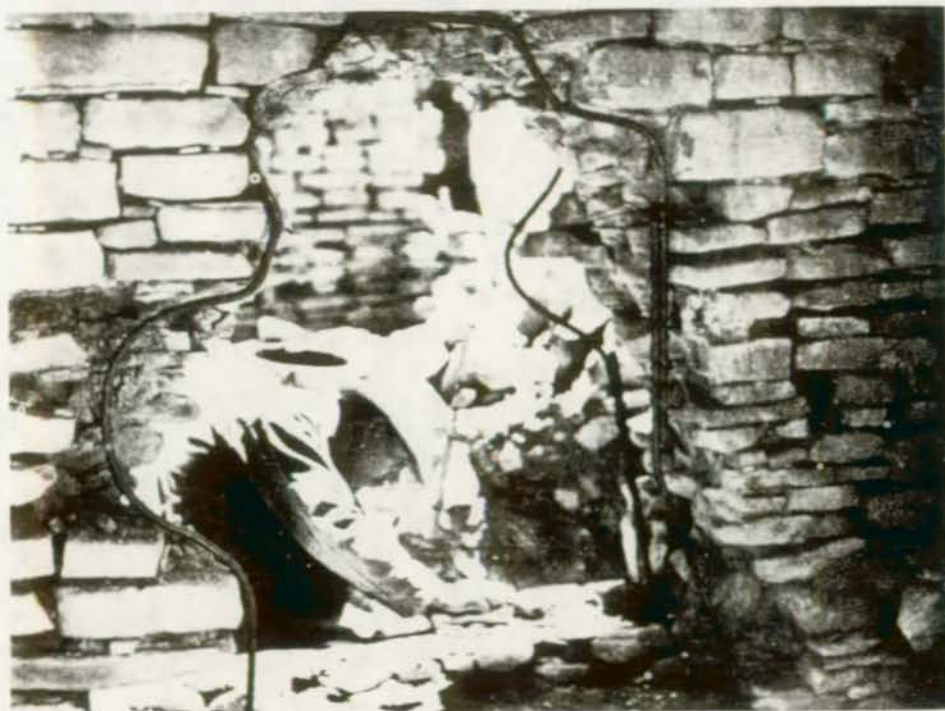
FIGURE 39. Integral members. Starting a reinforced arch section, rods have been bent to fit the contours of the break and are wired in place. The workman is laying the courses across the bottom of the break in concrete mortar to provide a solid base for the reinforced section. Above this level, masonry on the perimeter of the hole will be laid in concrete mortar which will also surround the steel rods. Masonry in the center of the hole will be laid dry or with a minimum of soil mortar; its only function will be to support masonry laid in cement until the latter has set. This dry masonry will then be removed. (Pueblo Alto, Chaco Canyon National Monument, N. M.)

outlines of the break. One piece goes on each side of the wall and just far enough inside the opening to allow a covering face of masonry. The two ends of each piece will rest on the masonry just laid across the bottom of the opening (fig. 39).

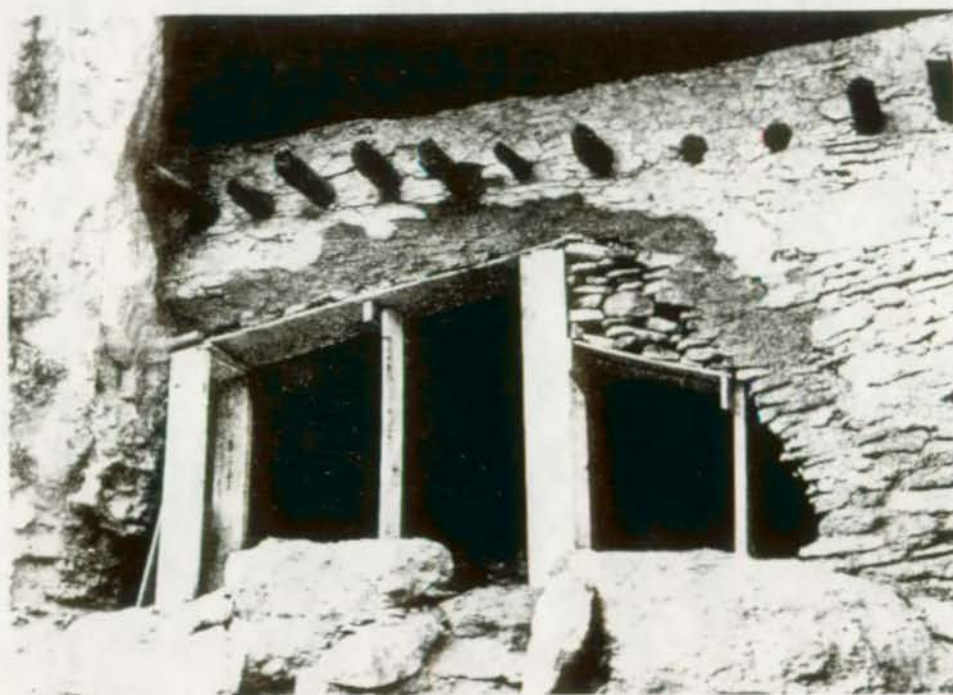
FIGURE 40. Integral member; a large reinforced arch section. The size of the break through the wall precluded filling the center with dry masonry as support, and the timber framework was substituted. The heavily reinforced band is socketed in the cliff wall at the left side, and based on bedrock at the right. The integral member has just been finished and the mortar has not yet dried. After the mortar has set the timber framework, the dry masonry at the right and that on top of the horizontal plank were removed. The large hole with its original outline remained. (Gila Cliff Dwellings National Monument, N. M.)

tected from further breakdown by the reinforced band (fig. 40).

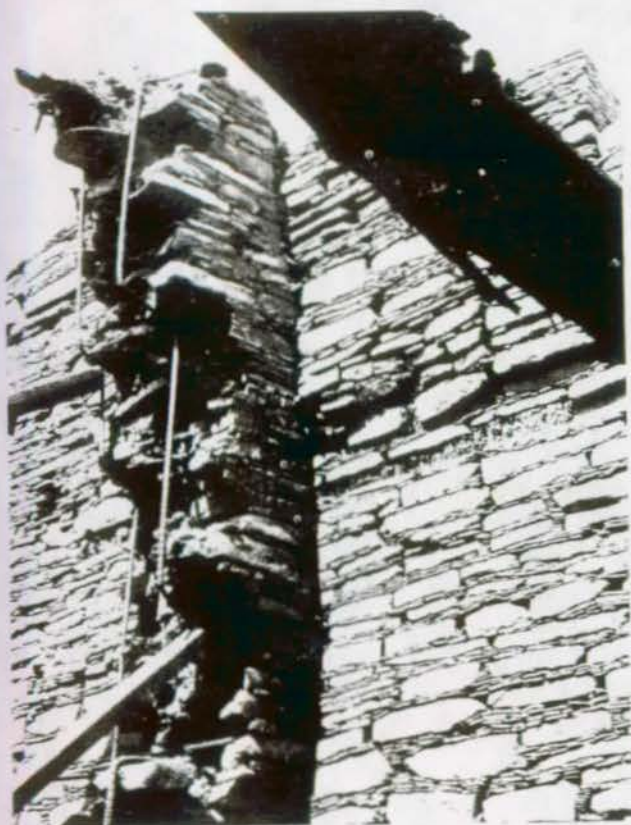
FIGURE 41. Integral members; steel in place for a narrow vertical section. The steel must be tied in securely to the cross wall at the top to provide support for the overhanging area. Some support will be required for the vertical strip of masonry as it is being laid, and until the concrete mortar has set. (Chetro Kettle Ruin, Chaco Canyon National Monument.)

The principal application of these members is to tie together sections of separated and out-of-plumb walls, to reinforce walls against which there is pressure of retained fill, to re-lay overhanging and precarious sections, and to provide support over horizontal logs (figs. 41, 42, and 43). Since conditions and structures vary so greatly, it is difficult to anticipate all possible applications. In general, the requirements are:

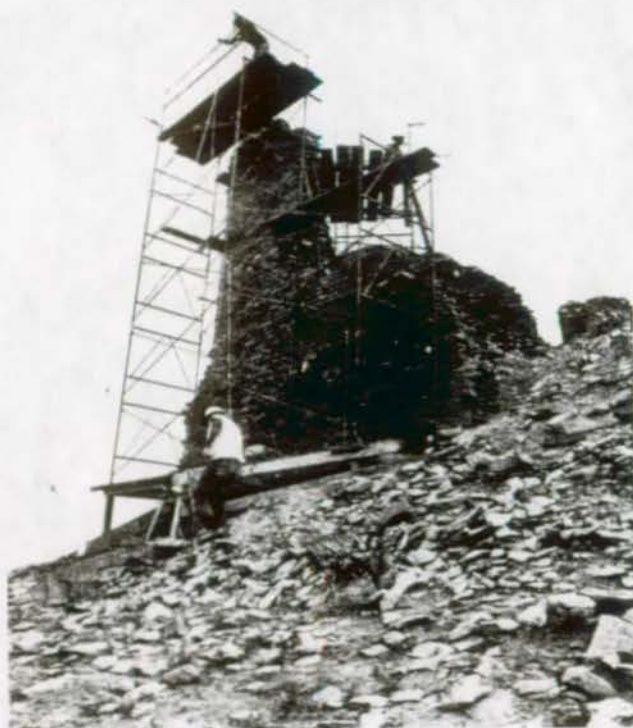
FIGURE 42. Reinforced integral members are important in the stabilization of spirelike structures such as this at the Tower Kiva, Kin Ya-a Ruin, Chaco Canyon National Monument, N. M. Considerable strength must be added without serious or objectionable alterations of the original profile.

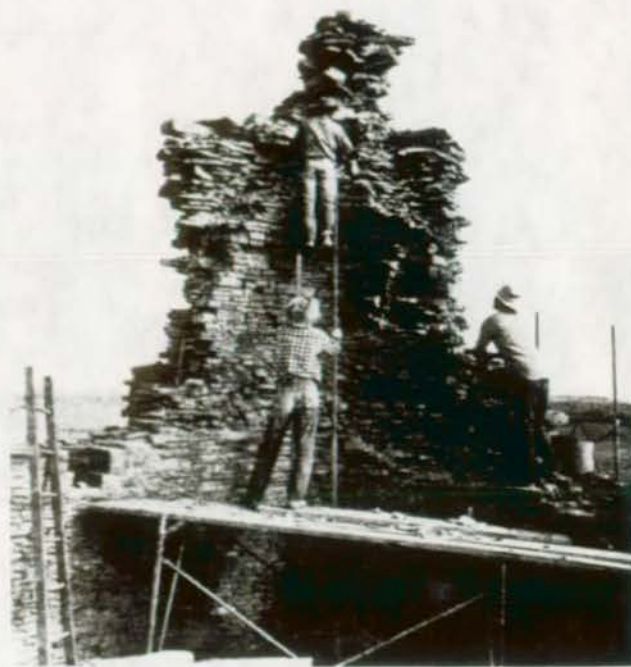
FIGURE 43. The placement of reinforcing in the third story portion of the structure shown in figure 42. The purpose is to reinforce heavily the vertical capping which will be placed up exposed ends of the wall to prevent further erosion, and to tie this part of the wall together.

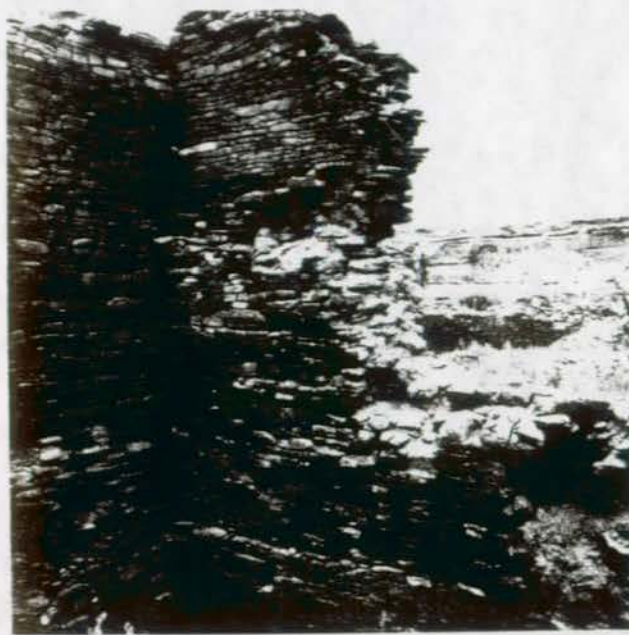
FIGURE 45. Patching of this hole at Pueblo del Arroyo will be combined with a short section of horizontal capping plus vertical capping for the exposed and weathered vertical rise of wall.

good bond with sound masonry (of stone, brick or adobe) below (figs. 44 and 45). Where regular units are employed in coursed walls, a sound, even surface must be reached or built up on which to place the flashing. In most cases, sufficient courses should be removed to provide the desired depth of capping without the addition of new units. Where the upper levels of a patch are to form a cap, new stone or other units must be employed (fig. 46).

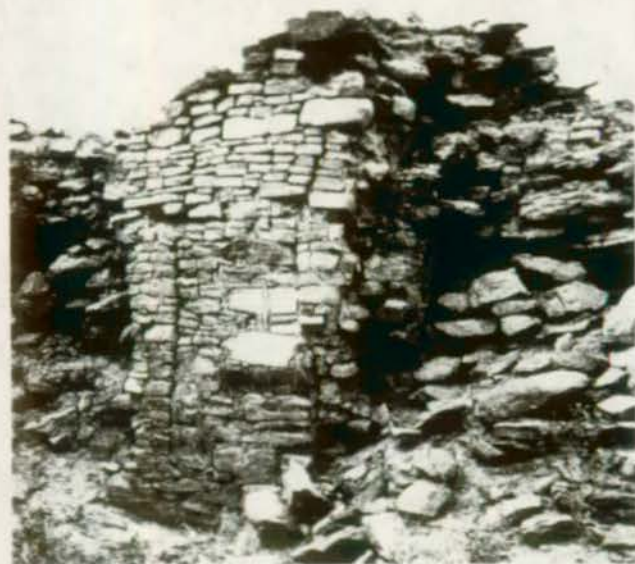
FIGURE 46. A good deal of repair masonry must be laid to fill breaks and support undercut areas in this wall at Pueblo del Arroyo. Some support must also be provided for the embedded timbers. Soil or masonry cement mortars may be used for the major part of this work. The upper courses however must be laid in concrete mortar as capping to halt further washing from the top. In this example, damage was started by surface water from adjacent, unexcavated fill and every effort should be made to prevent erosion.

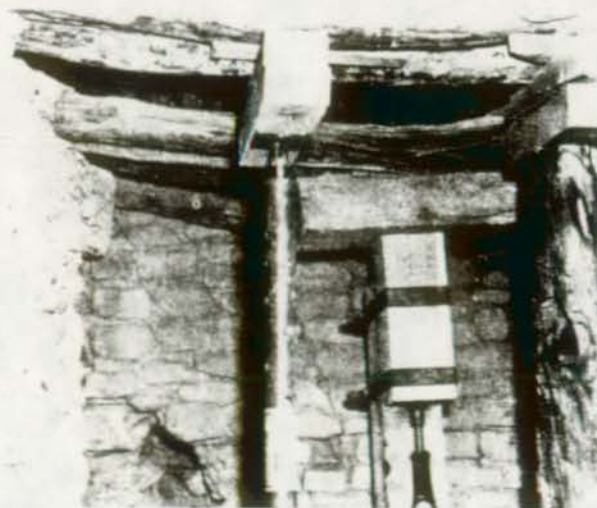
FIGURE 47. Temporary support of cracked and broken roof beams by means of jacks and timber props. Approximately 6 feet of overburden lay on this ceiling. The temporary supports were in place for several years before the overburden could be removed and a protective roofing constructed. (East Ruin, Aztec Ruins National Monument, N.M.)

From this and similar experience with difficult roofs evolved the coverings designed for and installed over 14 prehistoric ceilings in the East Ruin of Aztec during 1957 (figs. 47 and 48). These were in an unexcavated site where the only previous protective measure taken was the temporary bracing of cracked and broken timbers.
