# **RUINS STABILIZATION IN THE SOUTHWESTERN UNITED STATES**

Compiled by  
ROLAND VON S. RICHERT and  
R. GORDON VIVIAN

**National Park Service**

U. S. Department of the Interior  
Washington 1974

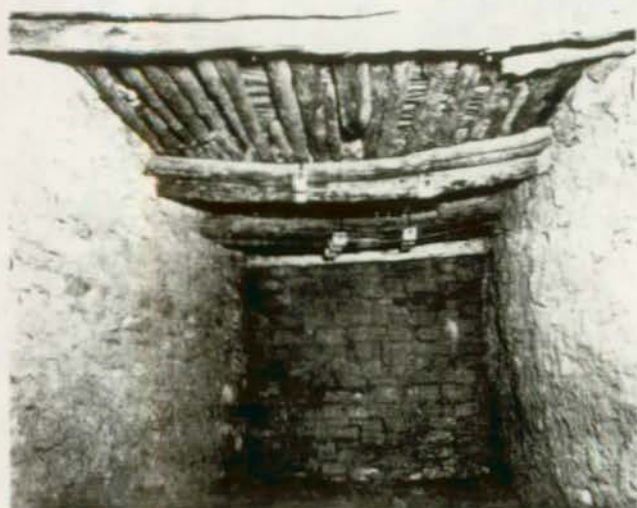
FIGURE 48. The ceiling shown in figure 47 after removal of the overburden and construction of a slab roof which protected the ceiling and permitted support of broken beams. The bolts are fastened in the slab above, and were taken up enough to transfer most of the weight from the old ceiling beams to the new roof.

From this and similar experience with difficult roofs evolved the coverings designed for and installed over 14 prehistoric ceilings in the East Ruin of Aztec during 1957 (figs. 47 and 48). These were in an unexcavated site where the only previous protective measure taken was the temporary bracing of cracked and broken timbers.

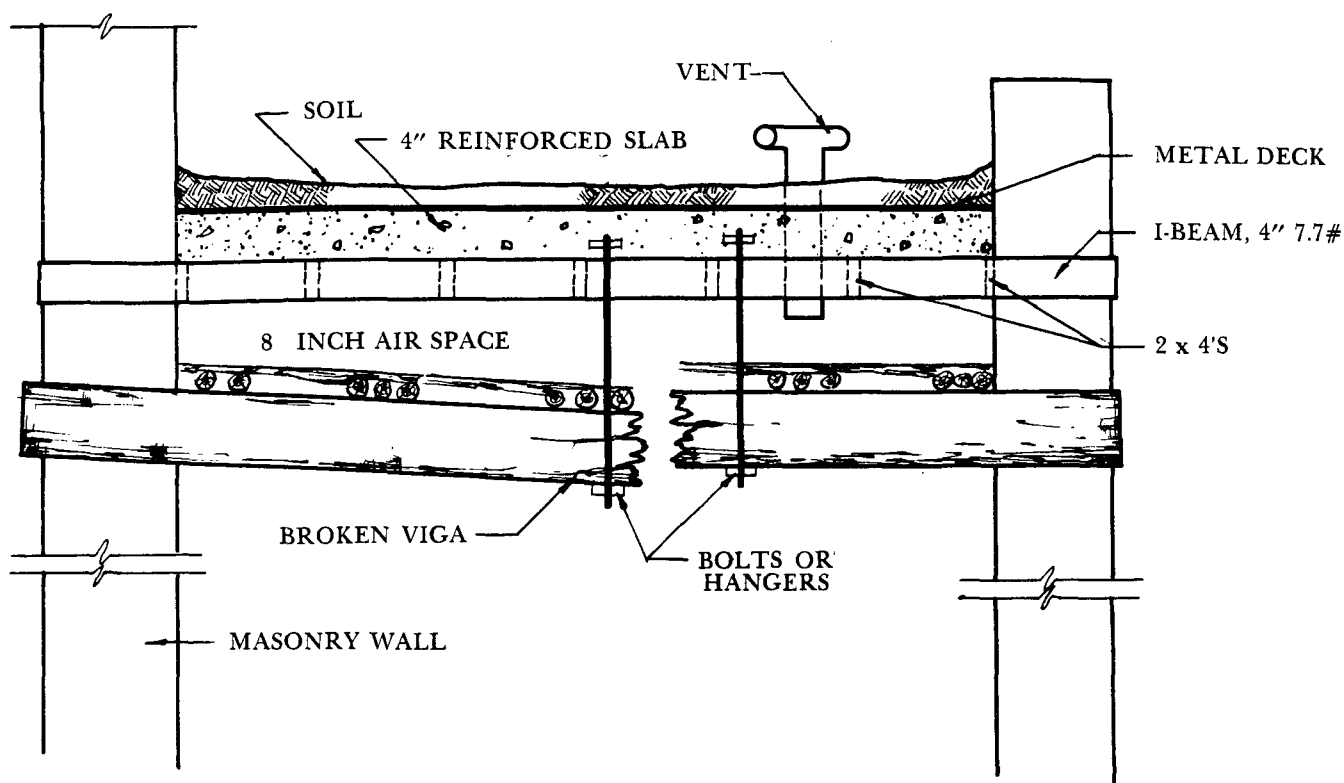
FIGURE 49. Typical roof covering and support employed at Aztec Ruins National Monument.

The general design of slab-type roofings are shown in figures 49, 50, and 51. No part of the new roofing may be supported by the aboriginal ceiling either during or after construction. This requires that the construction be self-supporting during the time that the concrete is being poured. Ordinarily, concrete forms for floors and decks are supported during pouring by vertical members from below, and the supports and forms are removed after the concrete has set. However, this is not possible in the placement of slabs over existing roofs where the space between the new slab and the old ceiling is usually less than a foot, and there is no means of access between the two.

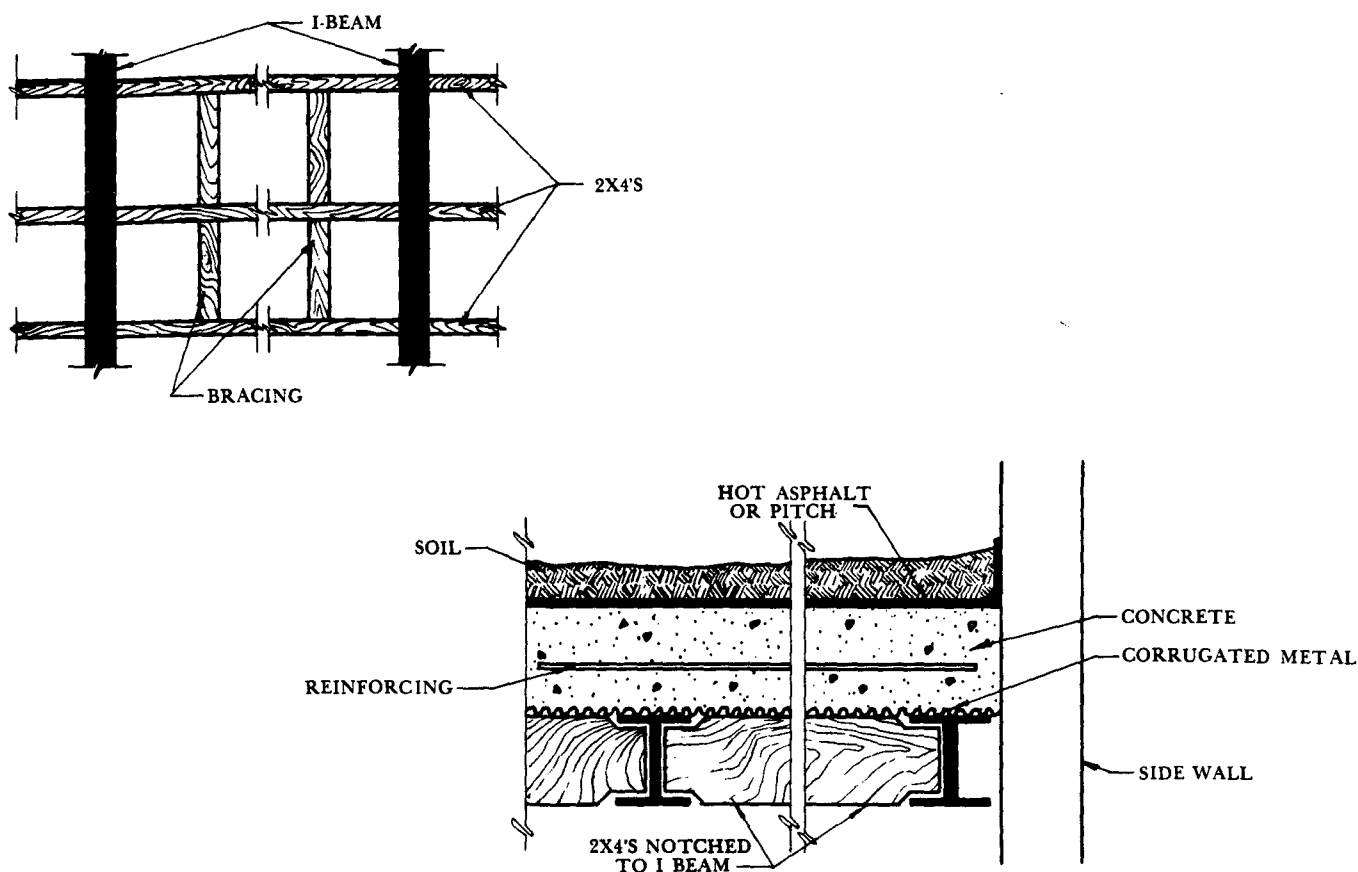
FIGURE 50. Details of roof supports (in section) at Aztec Ruins National Monument.

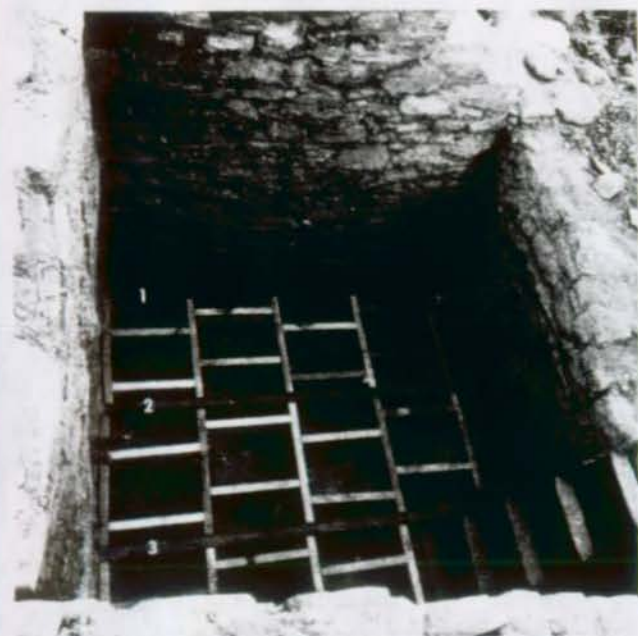
FIGURE 51. Construction of a slab covering. The numbered members are I-beams run through heavy masonry walls. The longitudinal members are 2 x 4's inset in the I-beams as purlins. Corrugated metal decking will be nailed to the wood as a base for a concrete slab. A covered vent will be provided through the concrete. Drainage will be provided by tile line through the wall at the right. (East Ruin, Aztec Ruins National Monument, N.M.)

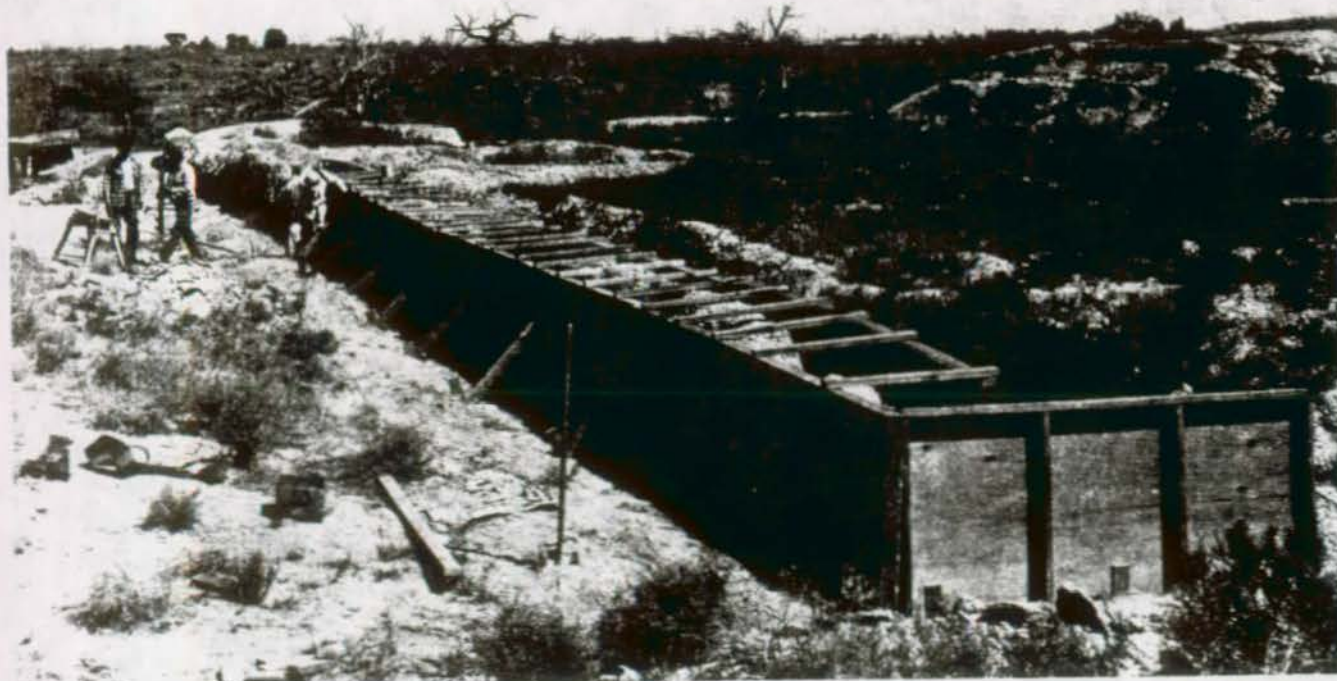
FIGURE 52. Placement of forms for stabilization of a wall with caliche-based soil cement. The forms are braced at the sides and tied at the top. (Compound B, Casa Grande Ruins National Monument, Ariz.)

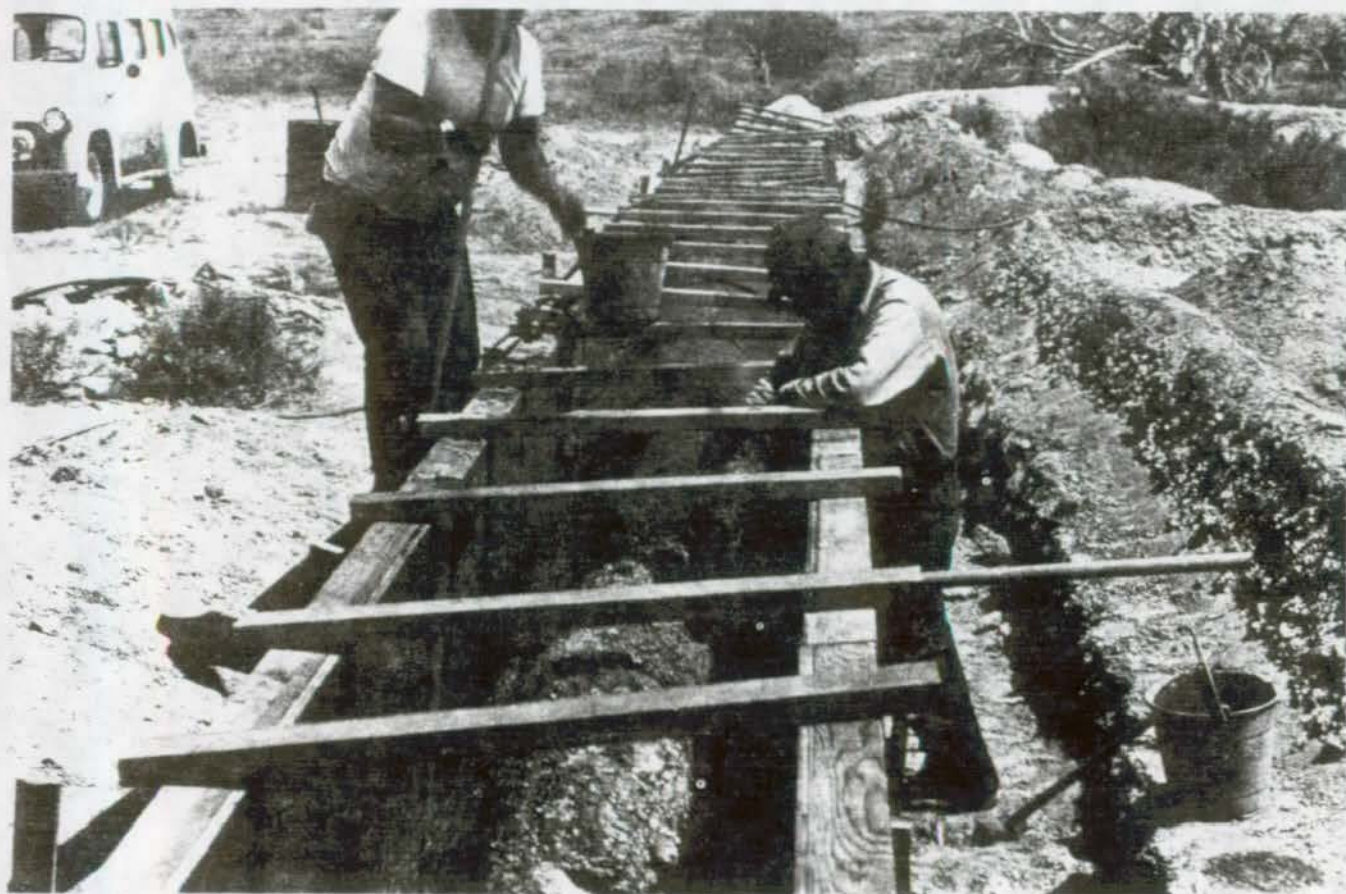
FIGURE 53. The start of placing caliche-cement mix over the wall depicted in figure 52. Note that the forms follow the irregular line of the wall.

The prehistoric wall was dampened and the mix placed between it and the form (fig. 53) well tamped in place to fill undercut spots. It was placed at a depth sufficient to cover the rise of the wall face and was then sloped to conform to the irregular, sloping surface of the wall top. After curing, the forms were removed and when completely dry the entire surface was treated with silicone water repellent (fig. 54). This use of heavier, self-supporting coverings of native materials parallels the already proven use of heavy sections of soil-cement in the repair of pit houses and for making facings in cuts in soft fill (figs. 9 and 10).

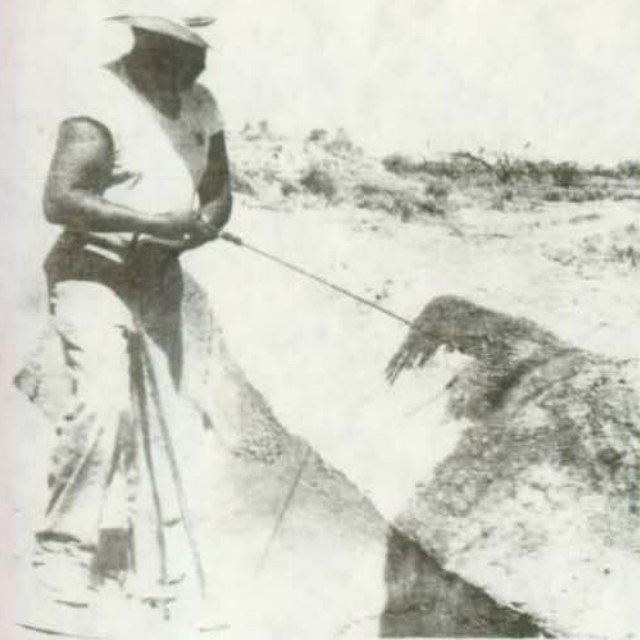
FIGURE 54. The application of a silicone water repellent. It is applied in a coarse stream, sufficient to produce a rundown of from 6 to 8 inches. (Casa Grande Ruins National Monument, Ariz.)

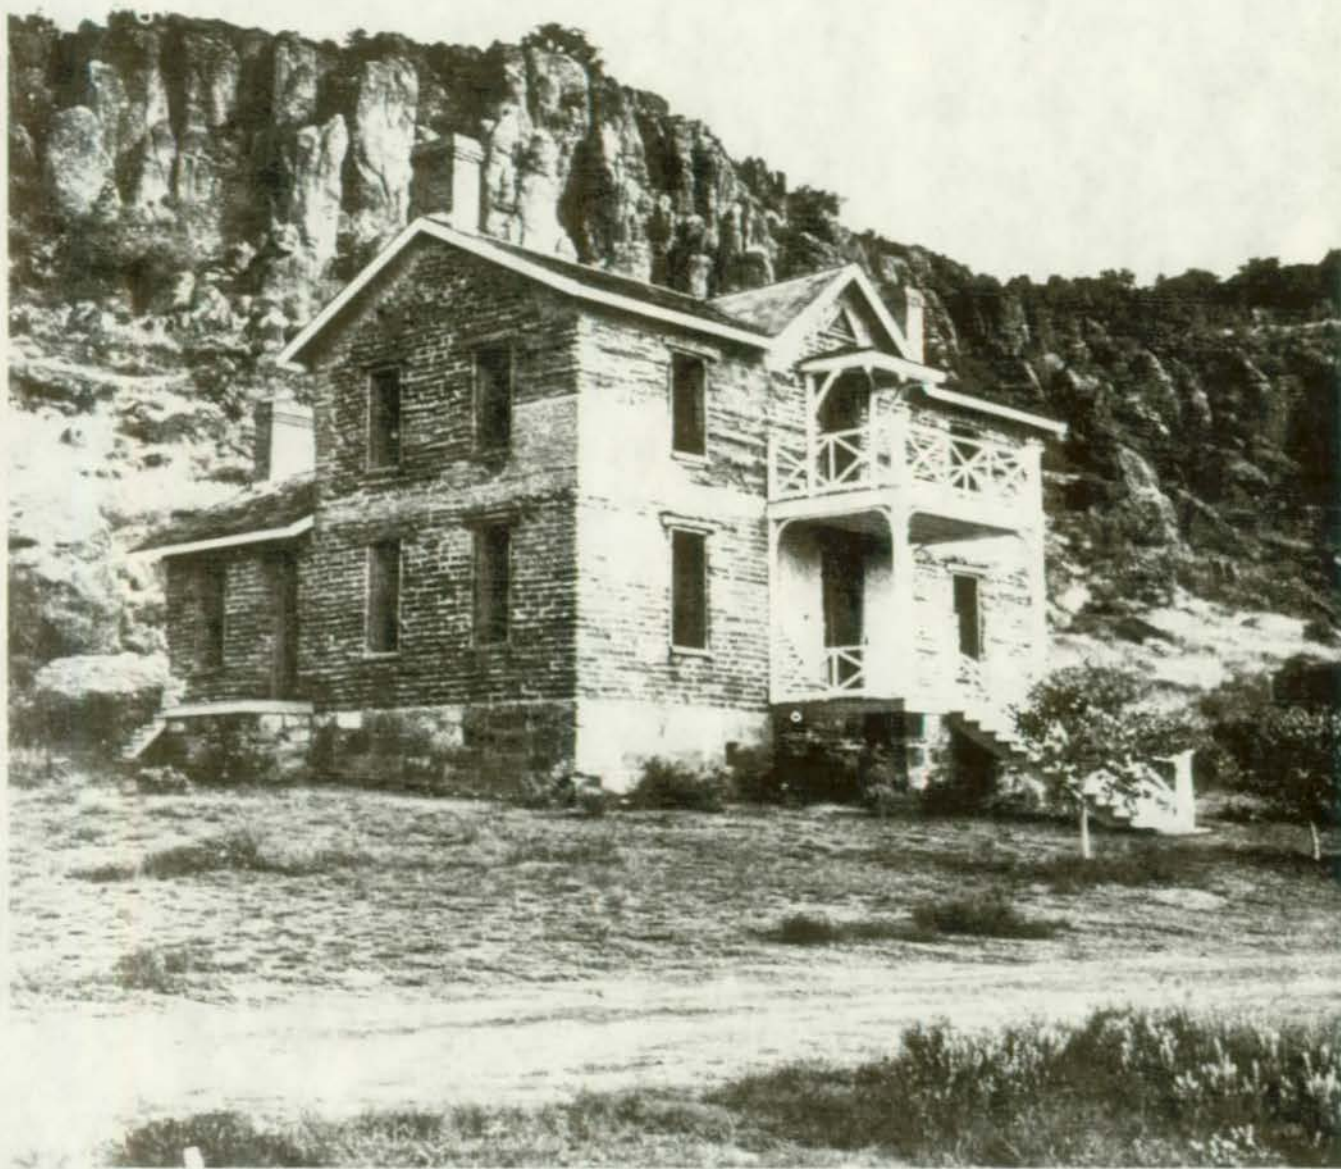
FIGURE 57. The completed stabilization and modified restoration of building HB-14, Fort Davis National Historic Site. Compare with figures 55 and 56.

This construction restored the exteriors of two 2-story buildings to their original appearance. The tops of the walls, weakened by erosion, were rebuilt and capped with reinforced concrete-bearing beams to support new roofs. Where exterior faces of adobe walls were severely weathered, a masonry veneer was added to rebuild the wall section to its original thickness using soil-cement units colored and textured to match the existing adobes. New wood porches were added to the exterior entrances, and doors and windows restored to the openings to secure the buildings. Thus the structures are interpreted as part of the historic scene. A self-guiding trail provides access and supplies necessary for interpretation.

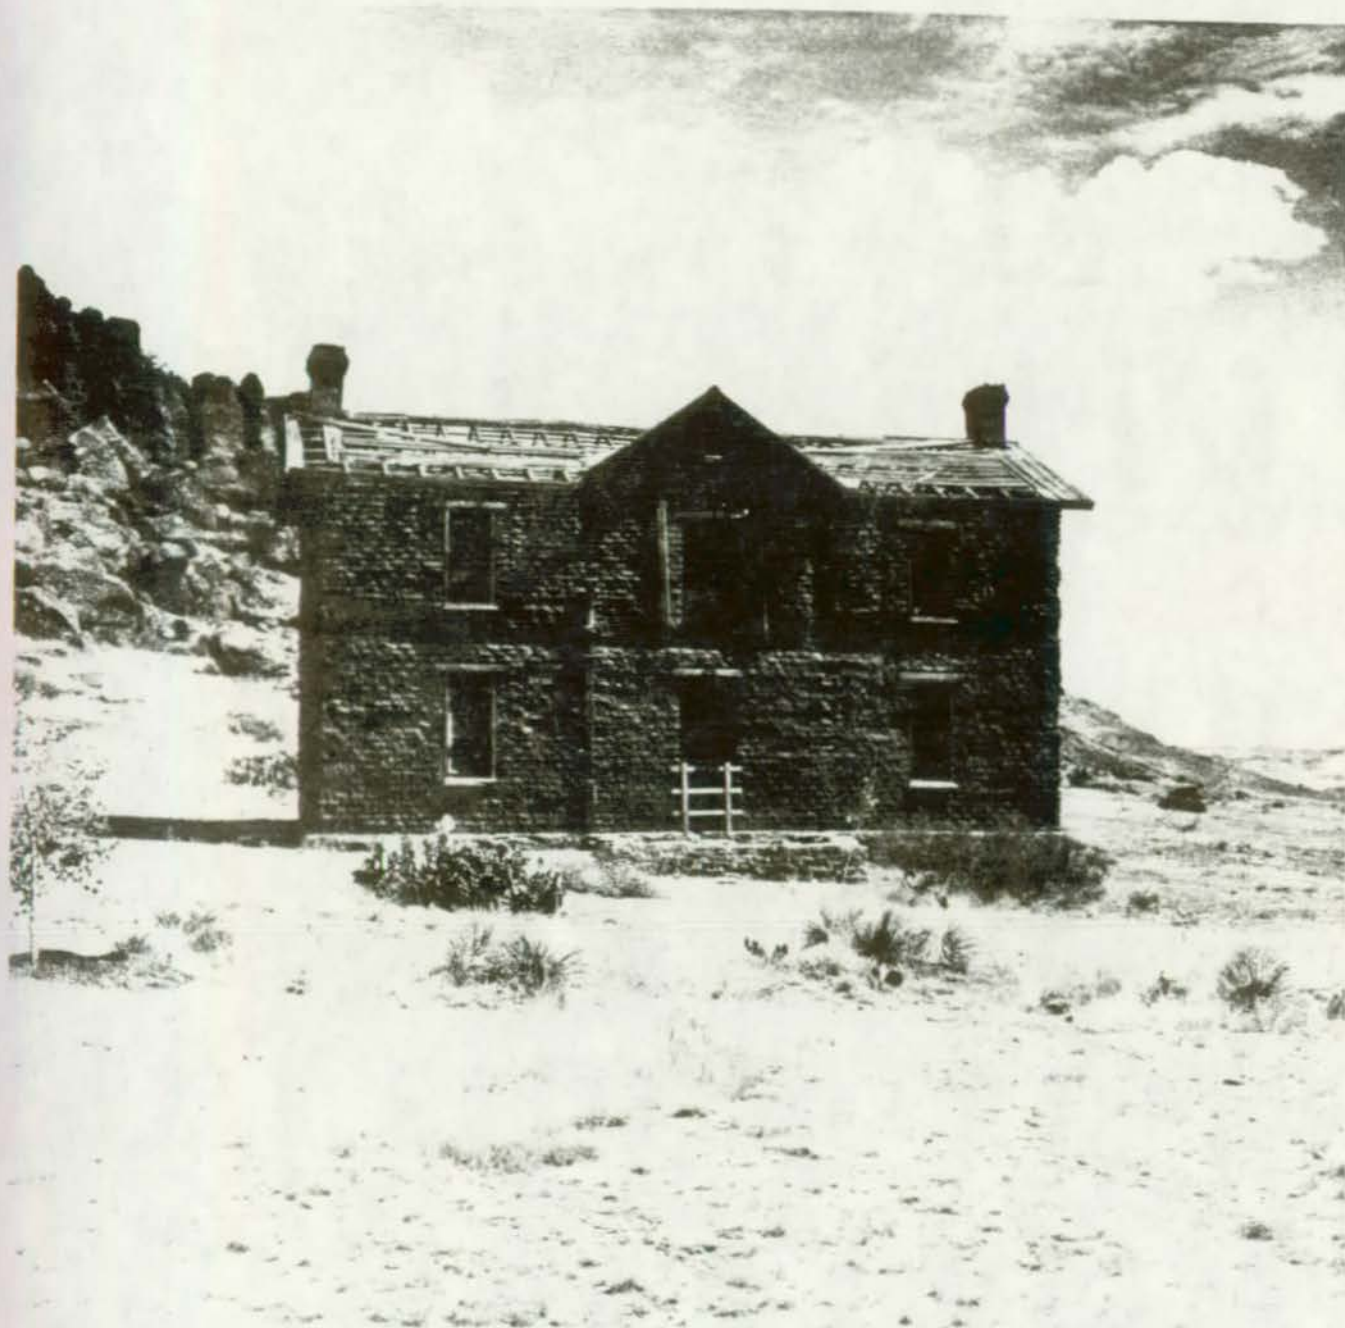
FIGURE 58. Building HB-15, a non-commissioned officers quarters at Fort Davis National Historic Site, before combined stabilization and modified restoration work was accomplished by the National Park Service.

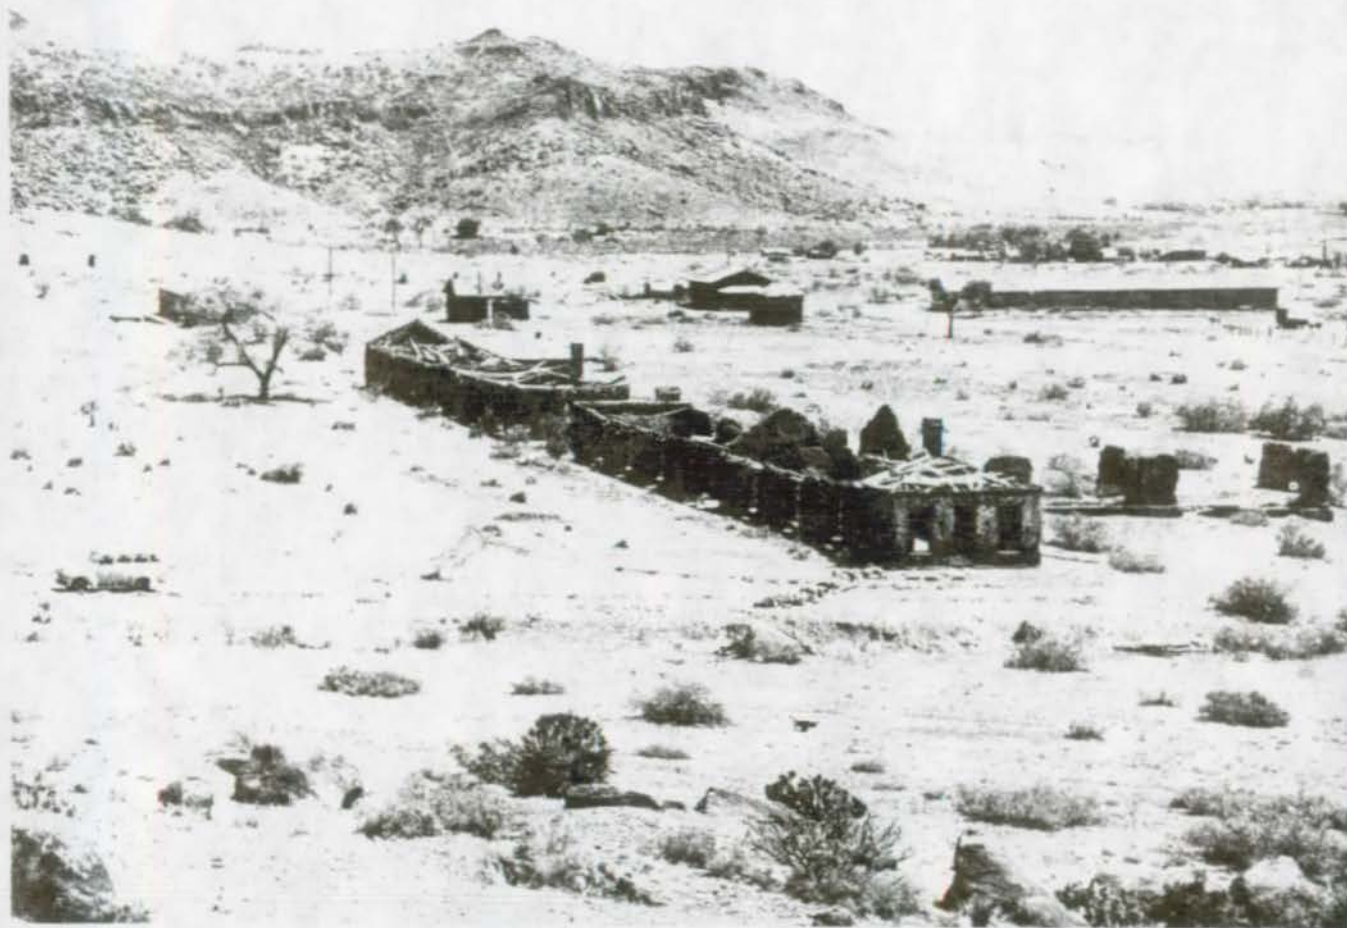
FIGURE 60. The 1870 enlisted men's barracks (in right foreground), Fort Davis National Historic Site. The photo was taken in 1960, before National Park Service status. Historic documents, drawings, and photographs provided ample evidence on which to base a restoration.

The visitor center at Fort Davis is an adaptive restoration. The 1870 enlisted men's barracks, which was a roofless, ruinous shell in 1964, was left virtually intact and a modern veneer of soil-cement bricks built around it. Some sections of original adobe walls were pared down so that the veneer would make up the original width. Bearing beams and integral support were provided for the modern though authentic roof. The restored portion of the exterior was faithfully preserved in both form and detail, while the interior was converted to modern, functional use (figs. 60 and 61). A small, glass-enclosed framework on the interior of the restored barracks shows an original portion of adobe wall for viewing by visitors.

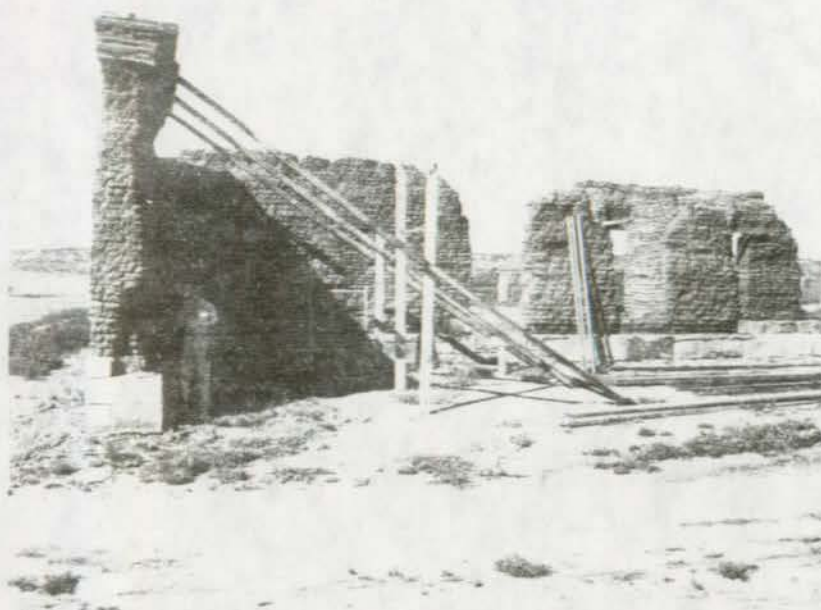
BUILDING 3-330,  
ROOM 331,  
WING WALL,  
BEFORE  
STABILIZATION

FIGURE 64. All ruins stabilization records should include before and after pictures attached to separate sheets such as the ones above for Fort Union National Monument.

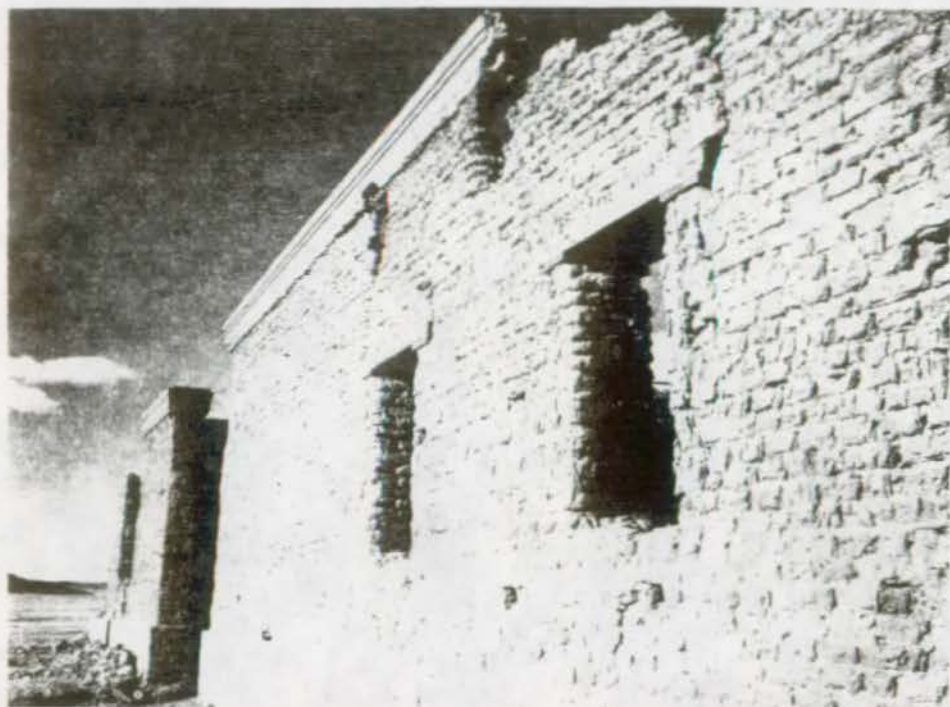
FIGURE 65. Building 3-450 (left) and building 3-440, west walls and coping, before stabilization. Fort Union National Monument.

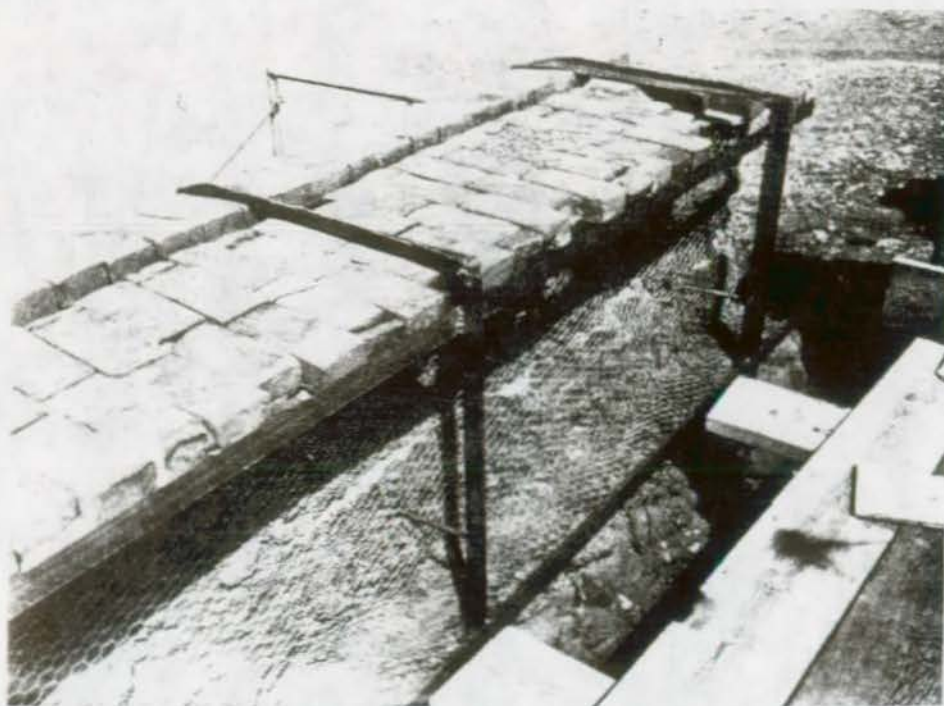
FIGURE 66. Building 3-440, coping on west wall, during stabilization, Fort Union National Monument.

*An angle-iron framework, whose components were welded together, was then erected in the channels of both walls. The supporting base plate of 1/8" x 2" strap iron was placed in the lowest horizontal channel of all walls, and rests directly on the rock wall foundations. The vertical members (of 1/8" x 2" angle-iron in the west wall, and 1/8" x 1 1/4" angle-iron in the abutting wall) are supported at their lower ends by the strap iron. All other horizontal members except those at the top of the walls are 1/8" x 3/4" angle-iron.*

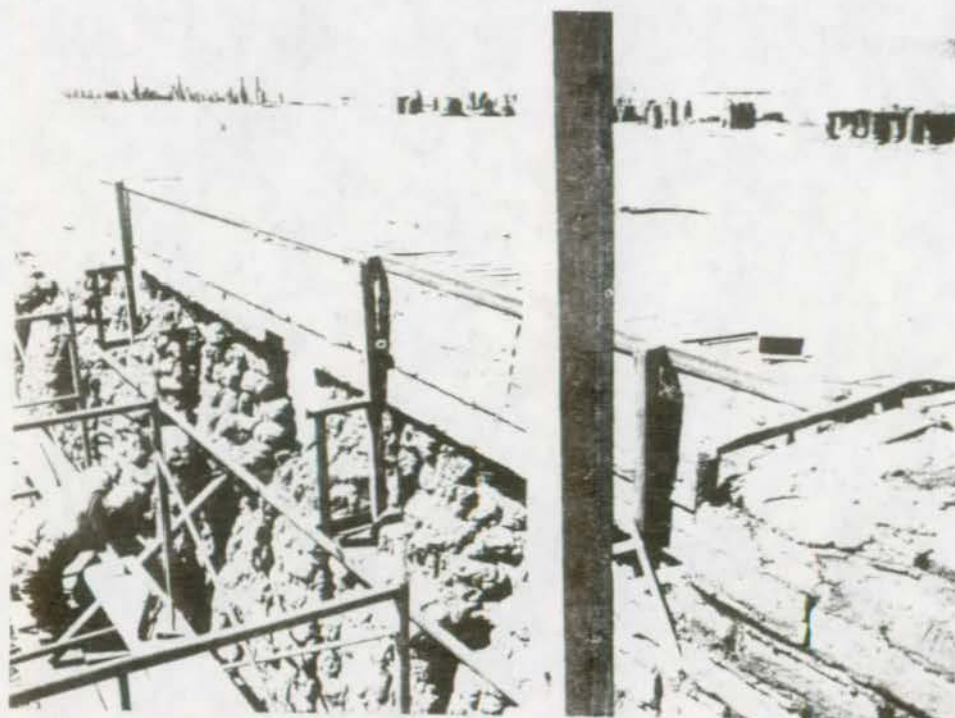
FIGURE 67. Building 3-440, coping on west wall, during stabilization. Fort Union National Monument.

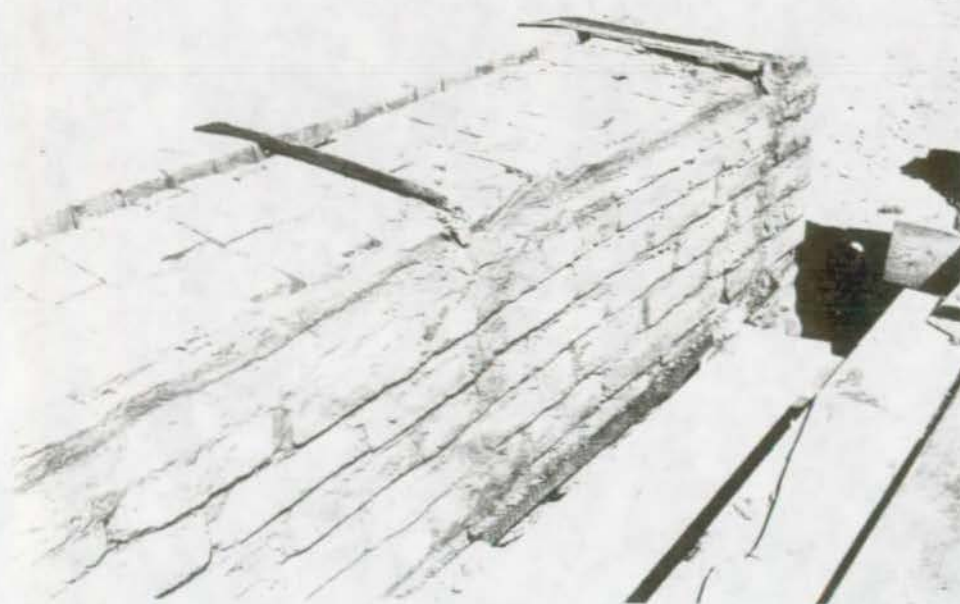
FIGURE 68. Building 3-440, coping on west wall, during stabilization. Fort Union National Monument.

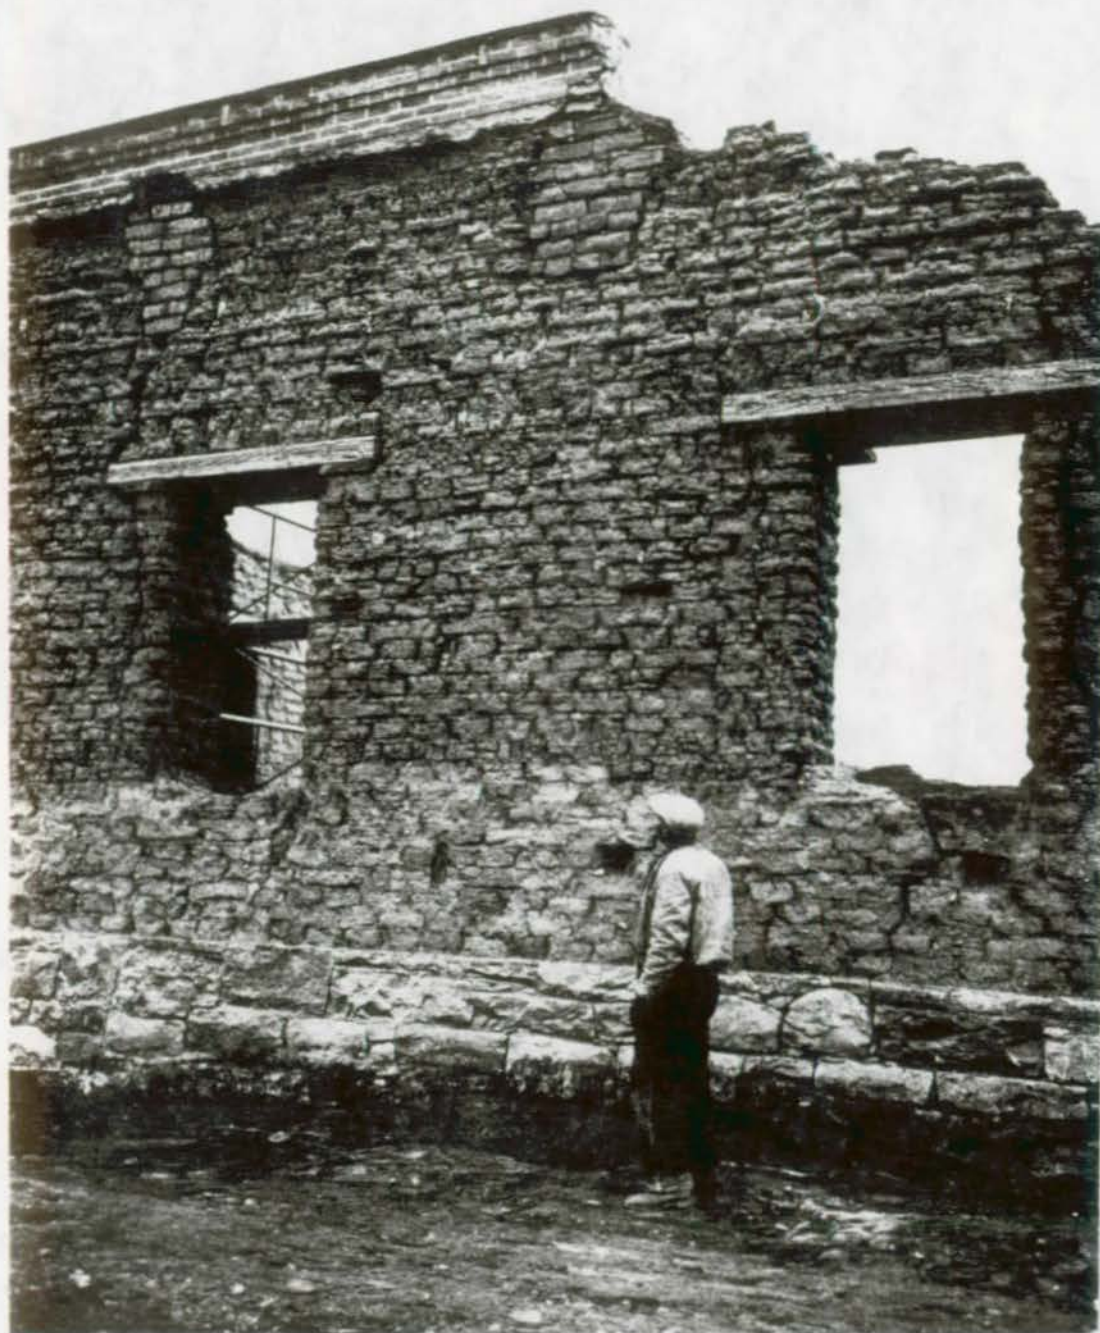
FIGURE 69. Building 3-440, west wall and coping, during stabilization, Fort Union National Monument.

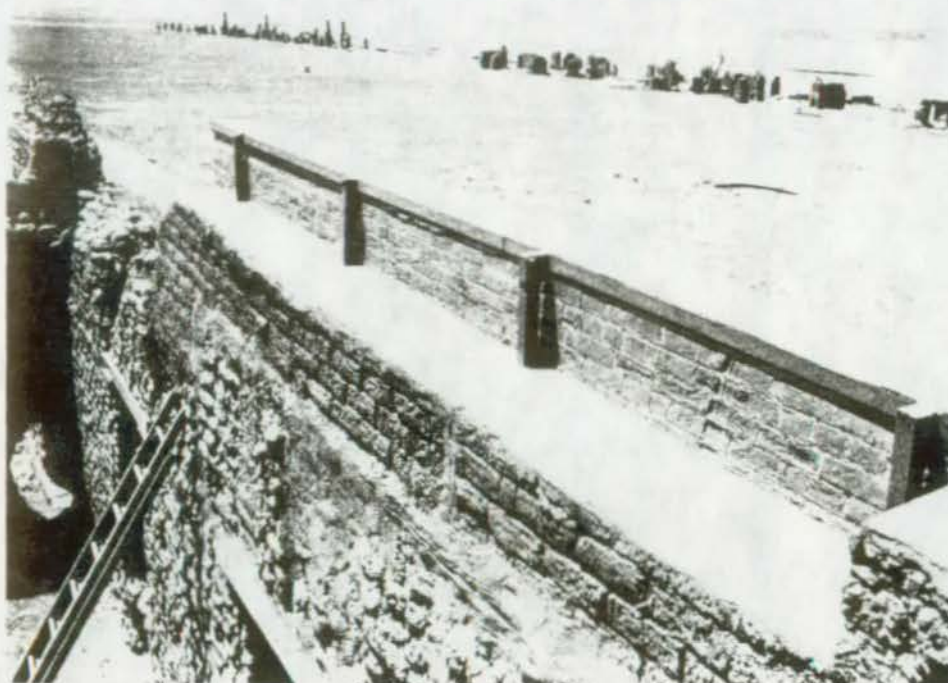
FIGURE 70. Building 3-440, south half of coping on west wall, during stabilization. Fort Union National Monument.

The south half of the coping is more massive in construction than the north half, and there is no veneer or brick over the inner (east) portion of the adobe wall. Although the method of securing the coping at the top of the angle-iron framework is similar to that used to support the north half of the coping, more rigid construction was necessary because the vertical supports are free-standing for the top 22", approximately. Also, these top sections are offset to the west a distance of 10" from the vertical axes of the lower portions in such a manner as to place the side of the upper portions against the coping.

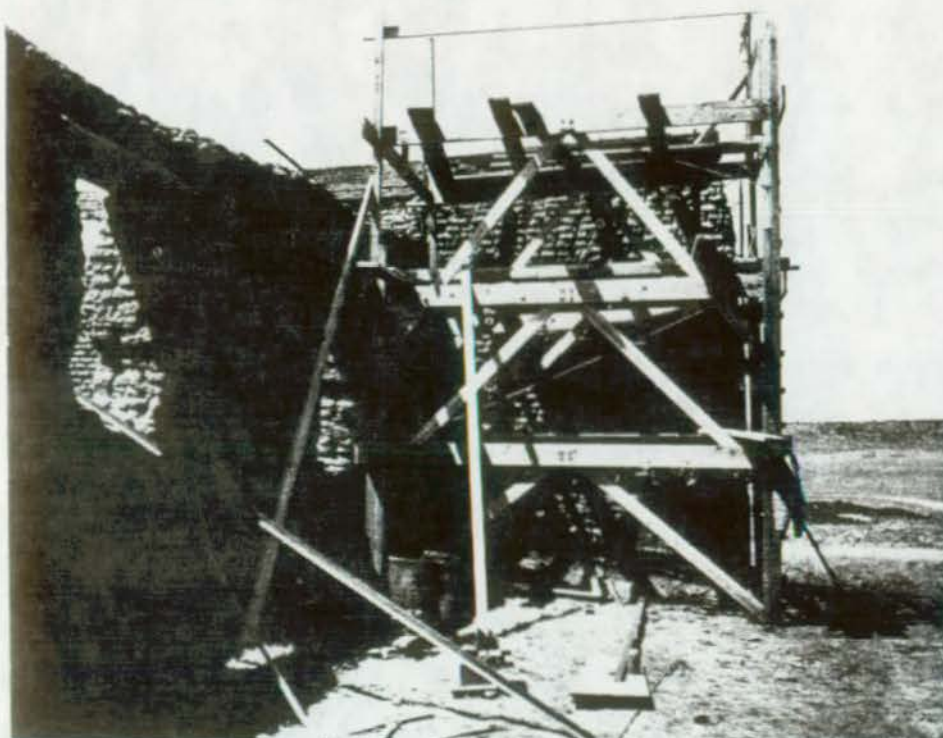
FIGURE 71. Building 3-440, northwest wing wall, during stabilization. Fort Union National Monument.

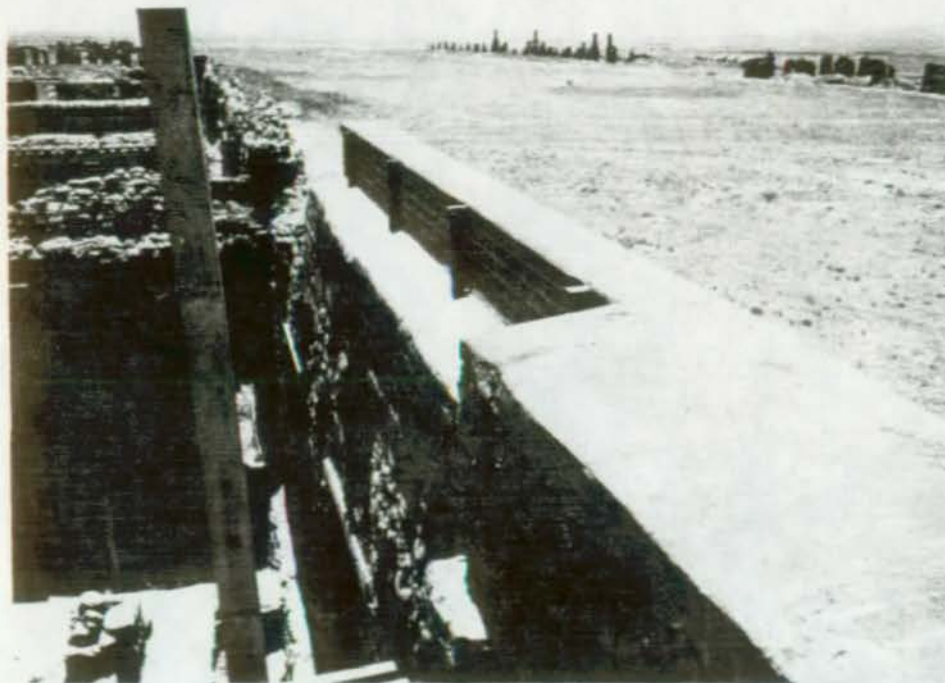
FIGURE 72. Building 3-440, coping on west wall, after stabilization. Fort Union National Monument.

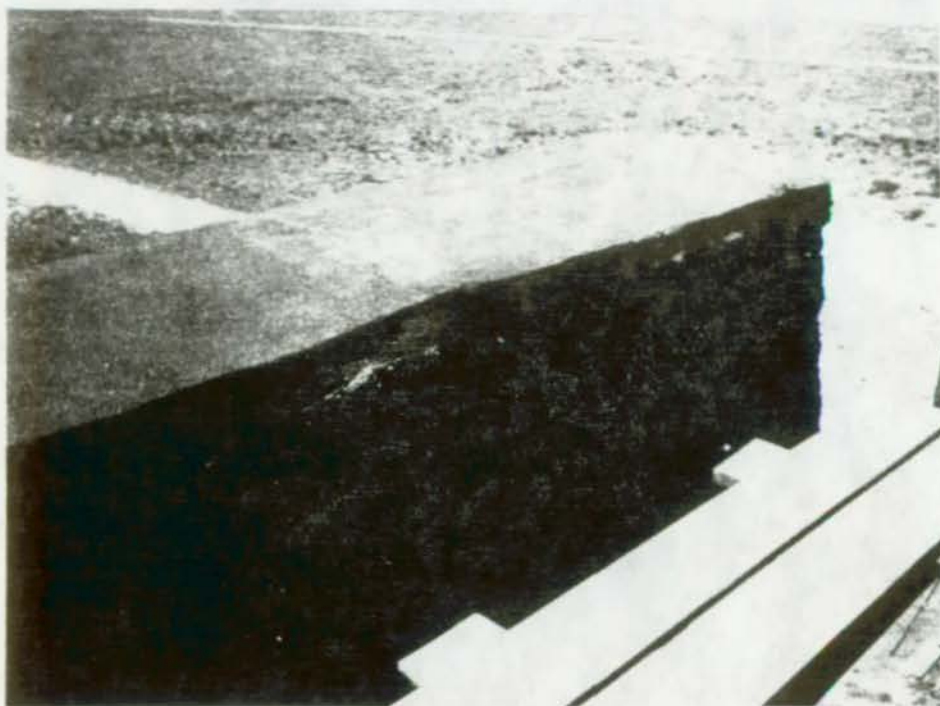
FIGURE 73. Building 3-440, coping on west wall, after stabilization. Fort Union National Monument.

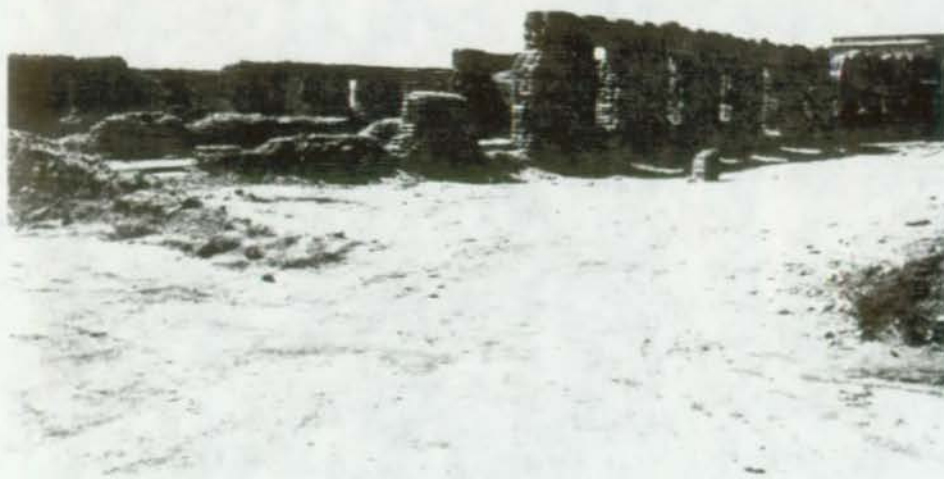
FIGURE 74. Building 3-440, from the northeast, after stabilization. Fort Union National Monument.

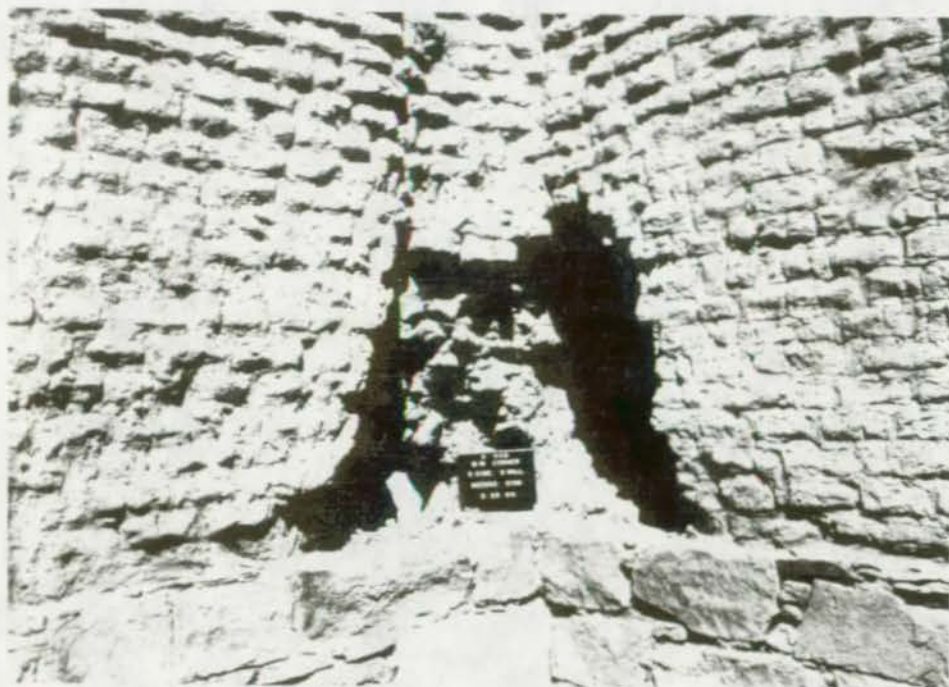
FIGURE 75. Building 3-440, southwest corner, before stabilization. Fort Union National Monument.

of 1/8" x 2" angle-iron. The rectangles formed were incorporated into the wall proper, by rebuilding this section with soil-cement brick up to and through the rectangles. (The upper sections of wall had eroded out, leaving the coping balanced on just a few inches of adobe.) Two large holes in the wall under the coping were also filled with soil-cement brick.

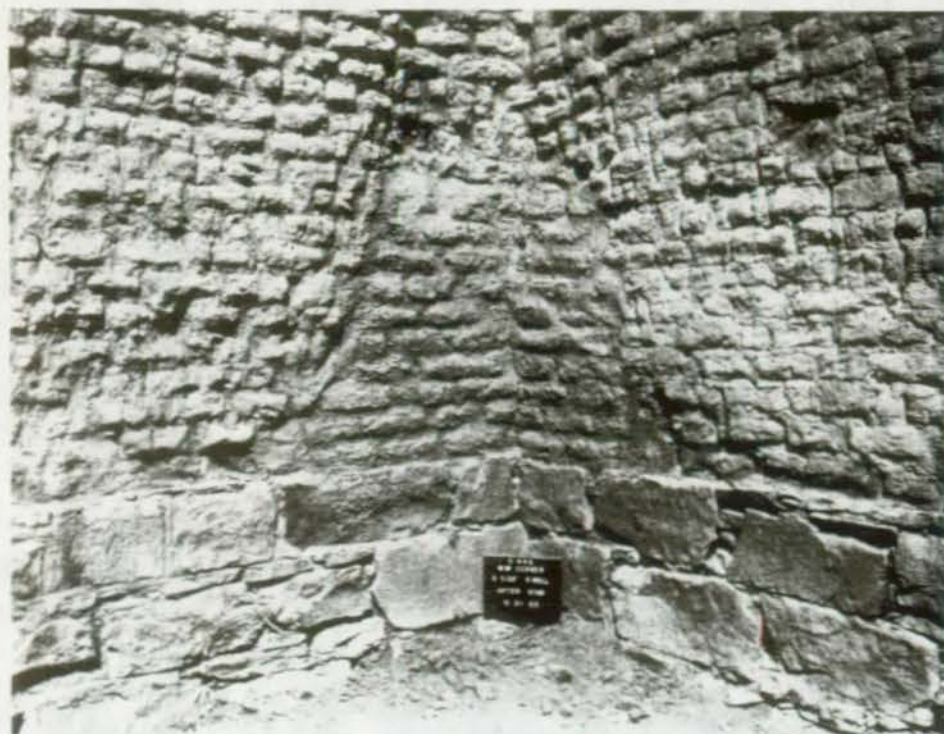
FIGURE 76. Building 3-440, southwest corner, after stabilization. Fort Union National Monument.
