# **RUINS STABILIZATION IN THE SOUTHWESTERN UNITED STATES**

Compiled by  
ROLAND VON S. RICHERT and  
R. GORDON VIVIAN

**National Park Service**

U. S. Department of the Interior  
Washington 1974

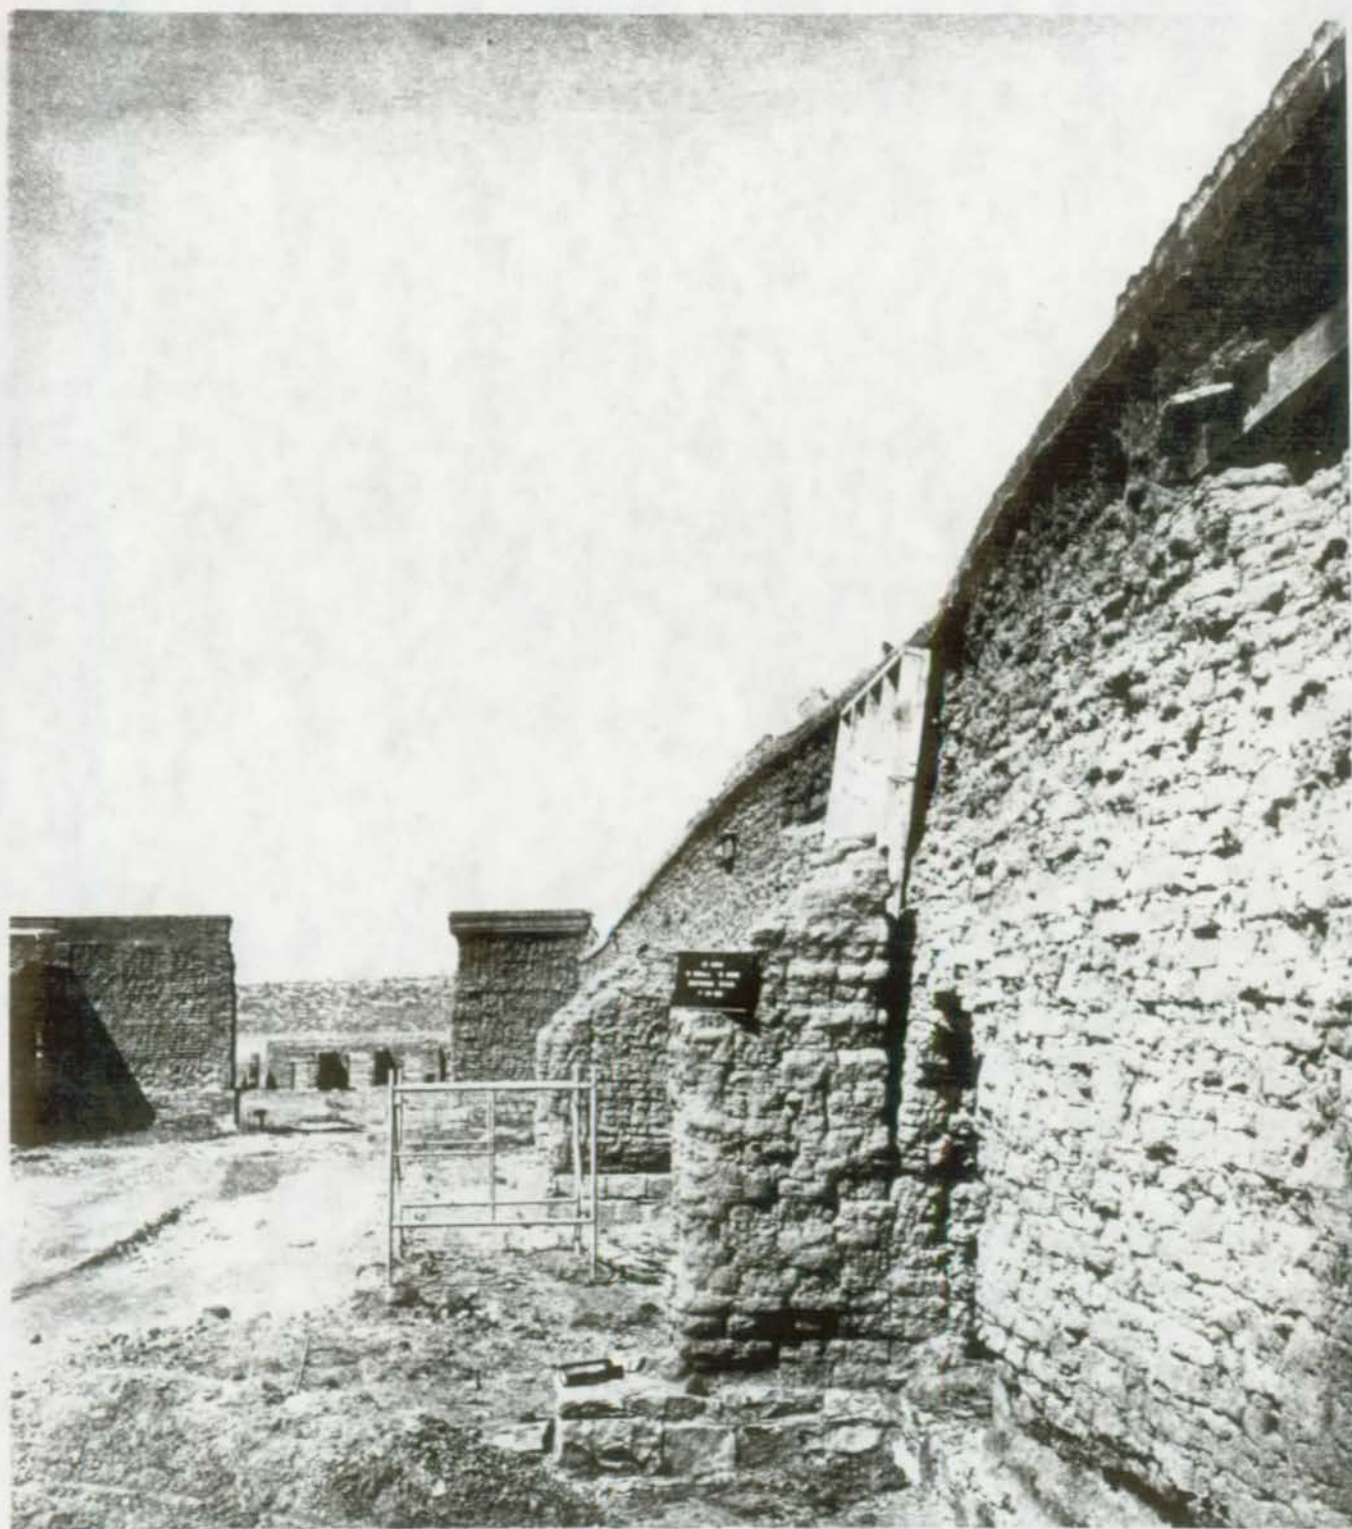
Condition on date work started. Masonry: *Massive south wall bulging northward. Only extreme west end of north wall standing. East and west walls in good condition but all walls needed capping to prevent further deterioration from penetration of moisture. Small north wall section leaning northward several inches out of plumb.*

FIGURE 77. Building 3-450, Room 451, south side of south wall, before stabilization. Fort Union National Monument.

Materials, construction, and technique in making repairs or accomplishing job: *South wall: A portion of the south wall was realigned in order to prevent collapse. The section, near the east end of the wall, bowed to the north about 12" at the top. Four wooden forms were completed and put in place on the bulge, two on either side of the wall. They were lined with asphalt roofing felt, wired together through the wall with No. 9 black wire, and then the space between form and wall was packed with damp sand. Two mine roof jacks and one heavy-duty jack were used to move the wall. The jacks push against the wall by means of long sections of 2" pipe (mine roof jacks) and 4" x 4" timber (truck jack). After pushing the wall into plumb the jacketing was removed from both sides of the wall and stabilization was begun by placing six upright steel members, and two horizontal members of the same material, with a steel strap along the bottom seated upon the stone foundation. The wall's brick coping is being held in place by seven steel rods looped about it and welded to the steel members on the wall's north side. The steel on the north side of the wall is secured by rods through the wall that are held in place by short steel straps. A hole in the wall was filled with regular adobes, cracks were grouted, steel was covered with adobe, the coping was secured, and adobes were laid along the top of the wall preliminary to capping.*

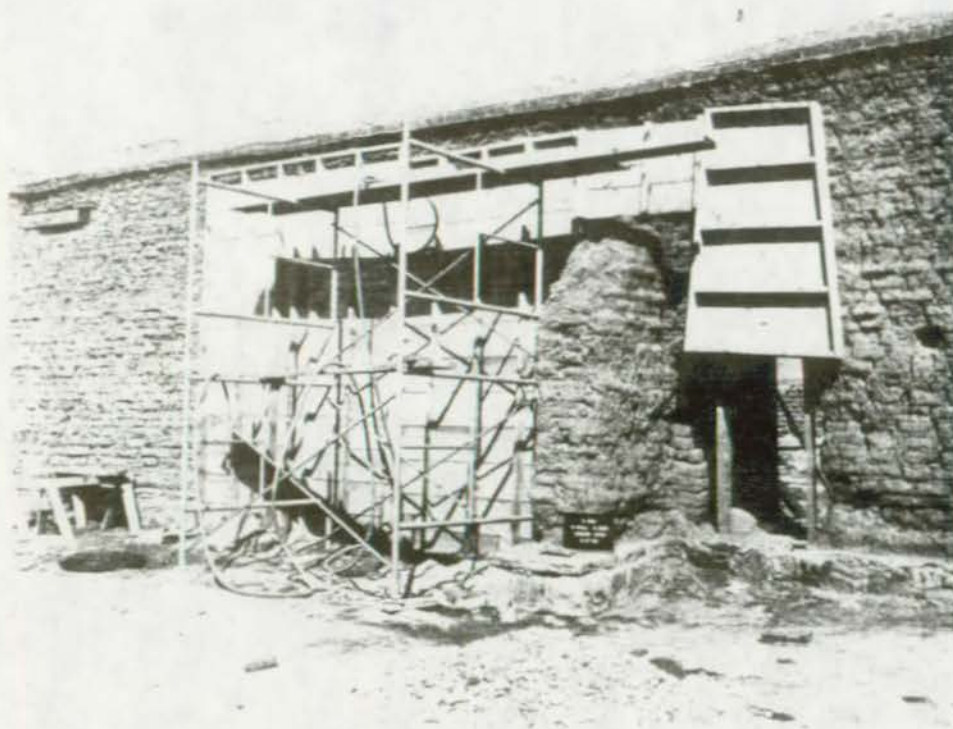
FIGURE 78. Building 3-450, Room 451, south side of south wall, during stabilization. Fort Union National Monument.

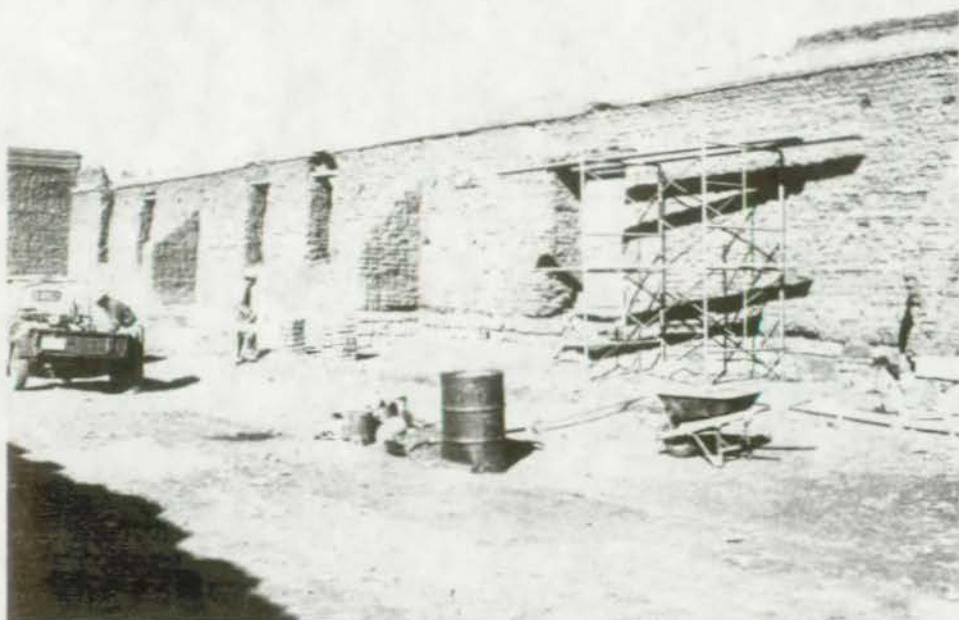
FIGURE 79. Building 3-450, Room 452, south side of south wall, before stabilization. Fort Union National Monument.

Condition on date work started. Masonry: South wall in good condition. Brick coping on

southwest wing wall needed reinforcing. Cracks needed grouting. Very low, short north wall remains. Only stub remains of west wall. All walls needed capping to prevent further deterioration due to penetration of moisture.

North and south walls: Capped (see introduction for detailed explanation of technique) and grouted with soil-cement. Missing adobes above windows were replaced and lintel timbers were replaced where missing. Sprayed with Dow Corning 772 diluted in water at a ratio of 1 to 9.

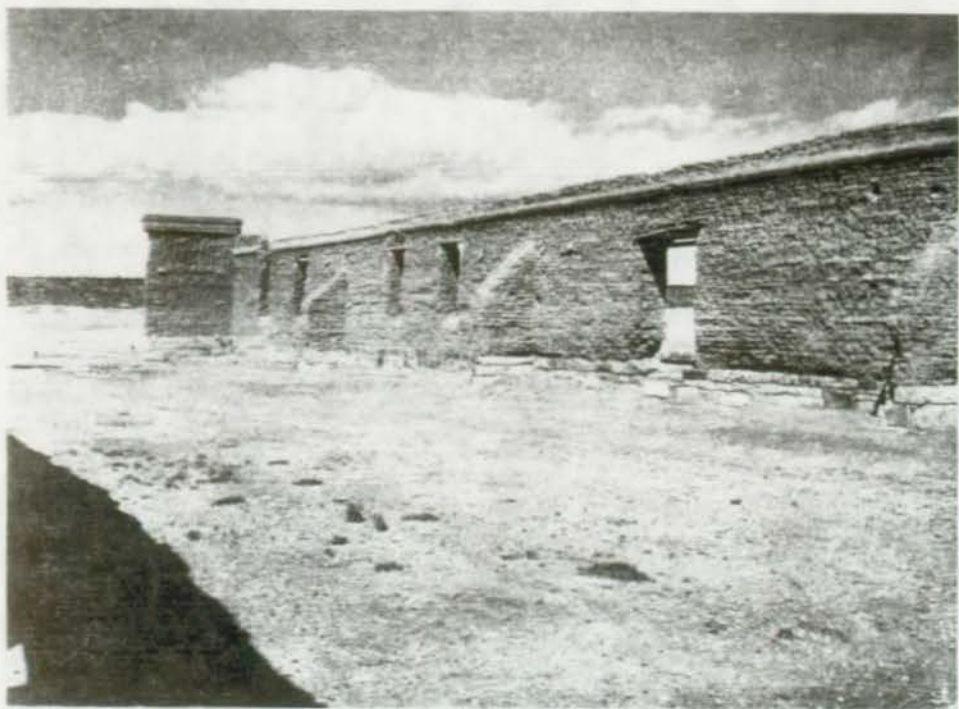
FIGURE 80. Building 3-450, Room 452, south side of south wall, after stabilization. Fort Union National Monument.

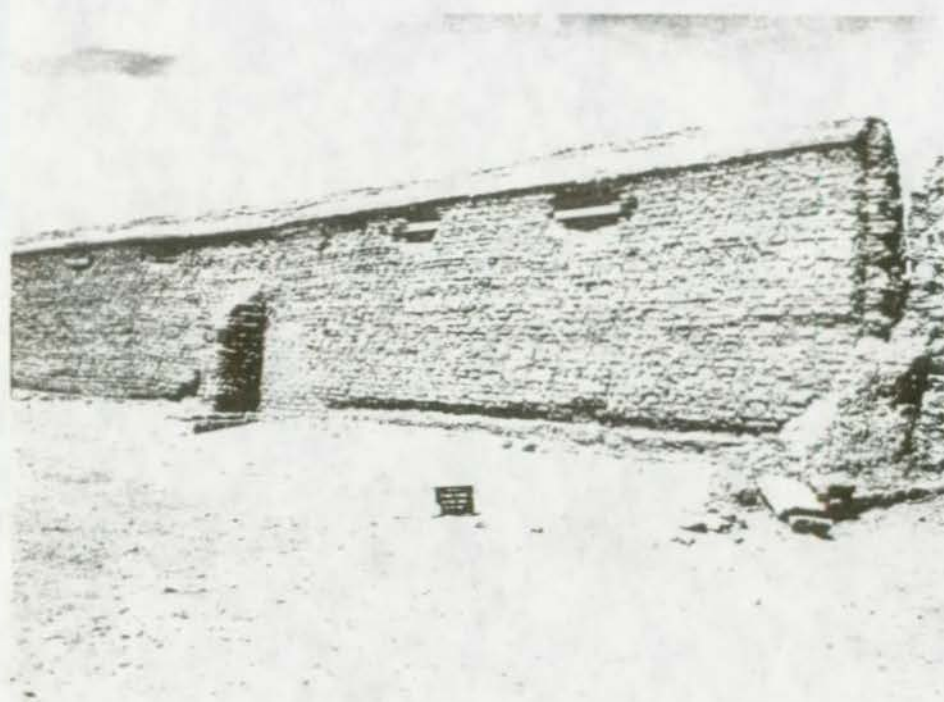
FIGURE 81. Building 3-450, Room 451, south side of south wall, after stabilization, Fort Union National Monument.

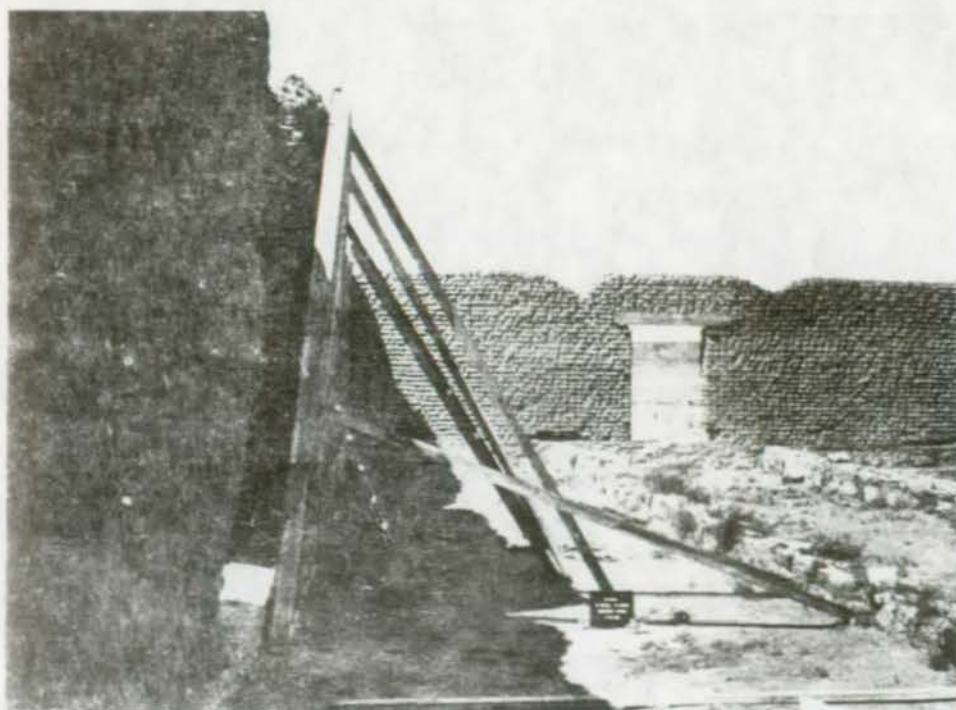
FIGURE 82. Building 3-450, Room 451, north side of south wall, before stabilization. Fort Union National Monument.

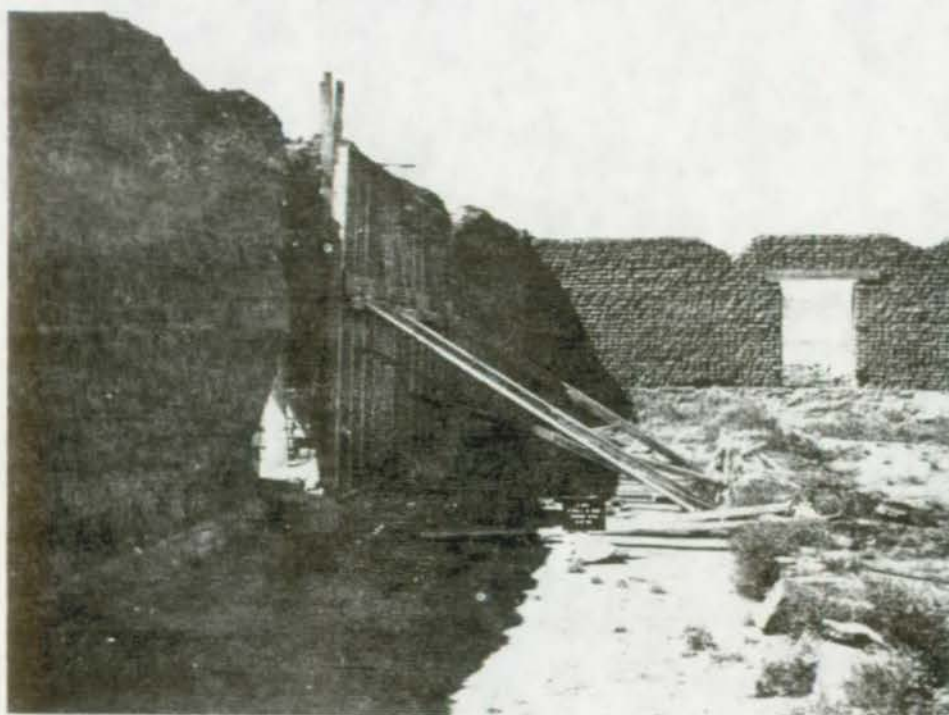
FIGURE 83. Building 3-450, Room 451, north side of south wall, during stabilization. Fort Union National Monument.

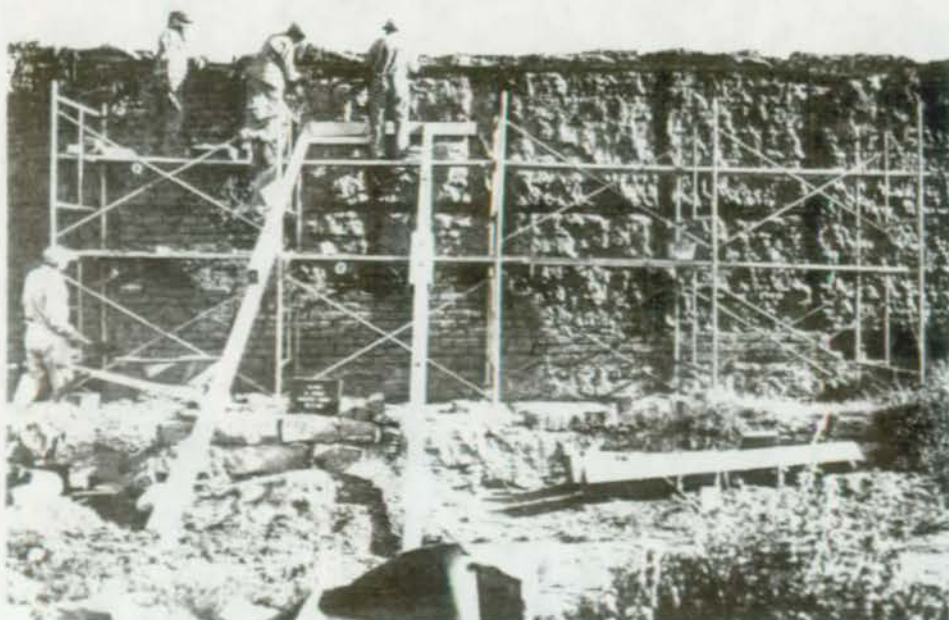
FIGURE 84. Building 3-450, Room 451, north side of south wall, during stabilization. Fort Union National Monument.

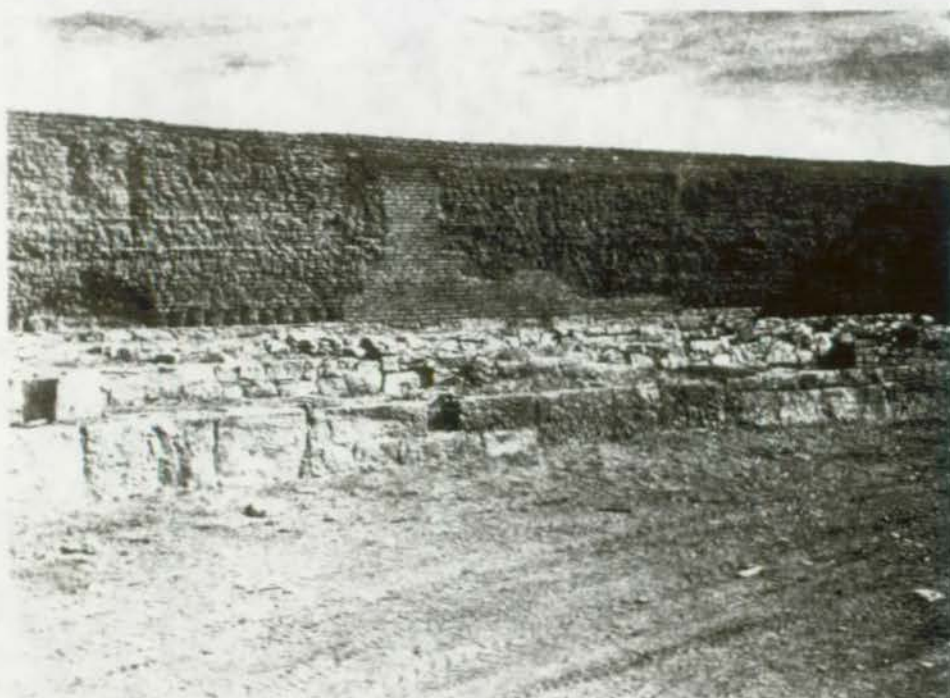
FIGURE 85. Building 3-450, Room 451, north side of south wall, after stabilization, Fort Union National Monument.

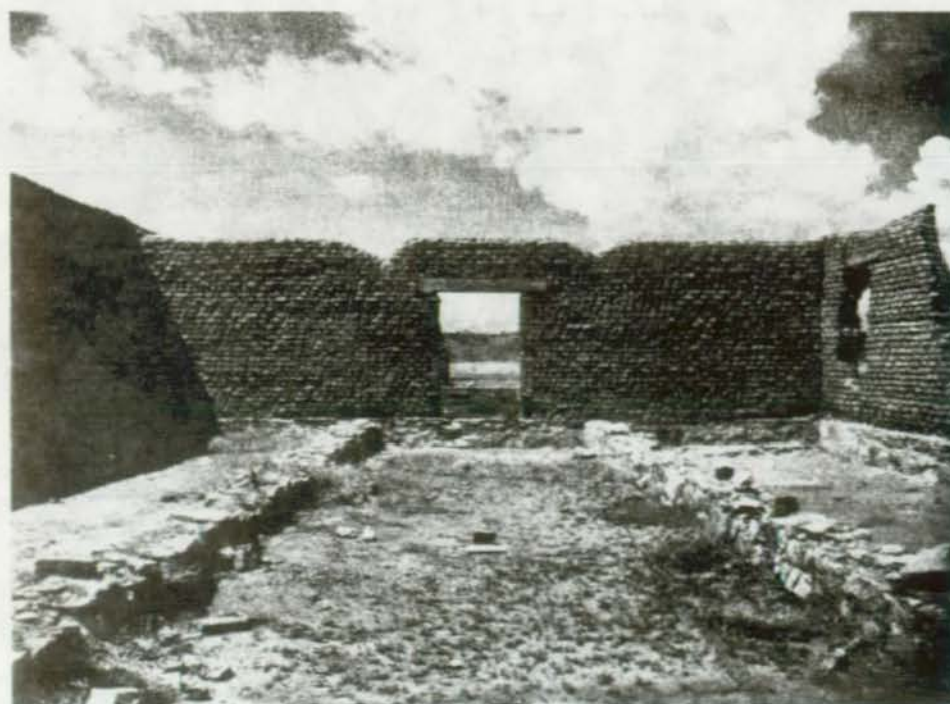
FIGURE 86. Building 3-450, Room 451, east side of west wall, before stabilization, Fort Union National Monument.

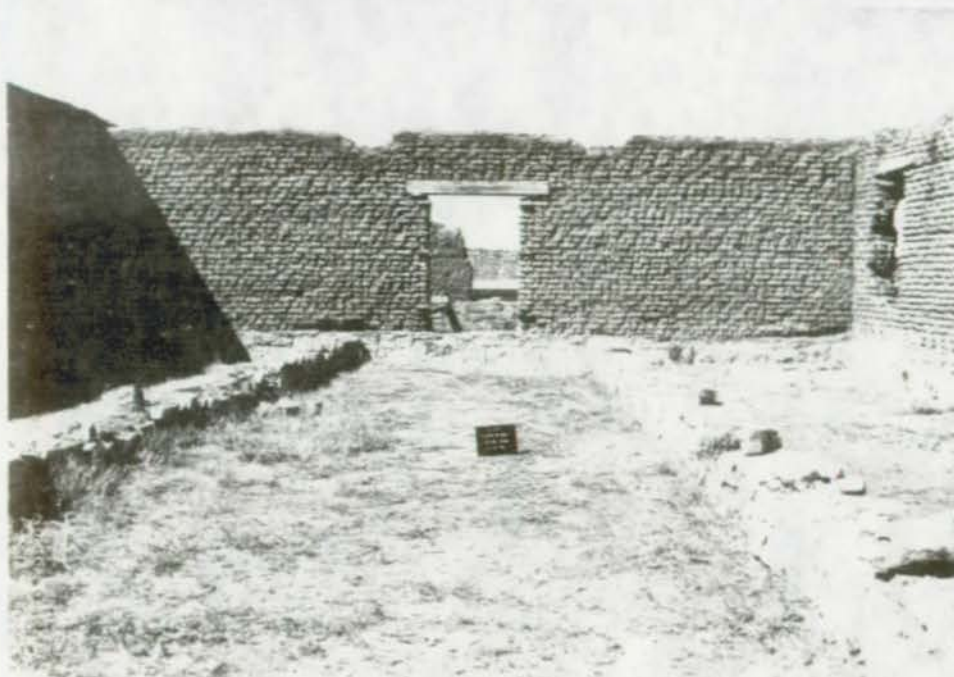
FIGURE 87. Building 3-450, Room 451, east side of west wall, after stabilization. Fort Union National Monument.

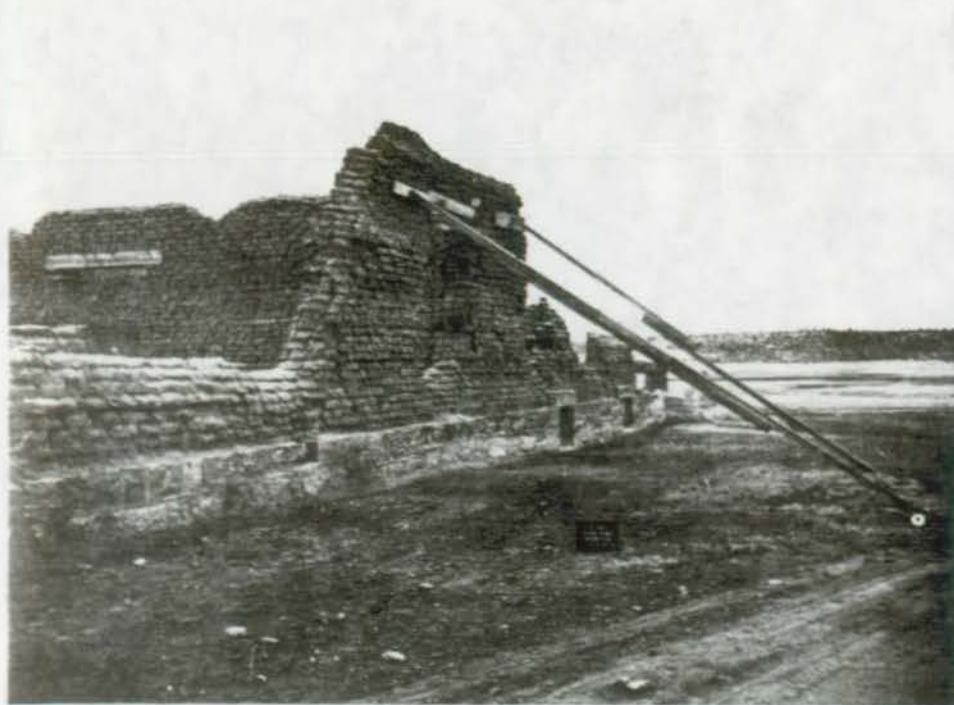
FIGURE 88. Building 3-450, Room 451, north side of north wall, before stabilization. Fort Union National Monument.

*North wall: Two deadmen holes, 2' x 4' x 22", were dug next to the joist footing wall inside the room. Two 44" lengths of 1/2" reinforcing rods*

were welded perpendicular to 2' lengths of 2" x 2" angle-iron, and looped at the other ends. These were placed in the holes which were then filled with concrete, reinforced with heavy wire. The wall was then jacked into plumb with mine jacks. A 15' length of 1 1/2" x 1 1/2" angle-iron was placed horizontally against the outside of the wall, near the top just above the lintel. The angle-iron was held in place by long bolts made by welding 5/8" carriage bolts on one end of 44" lengths of 1/2" reinforcing rod; these same rods were looped on the other ends to accommodate the 4" steel cable that was then attached to the deadmen. Turnbuckles on the two 16' cables allow for tightening.

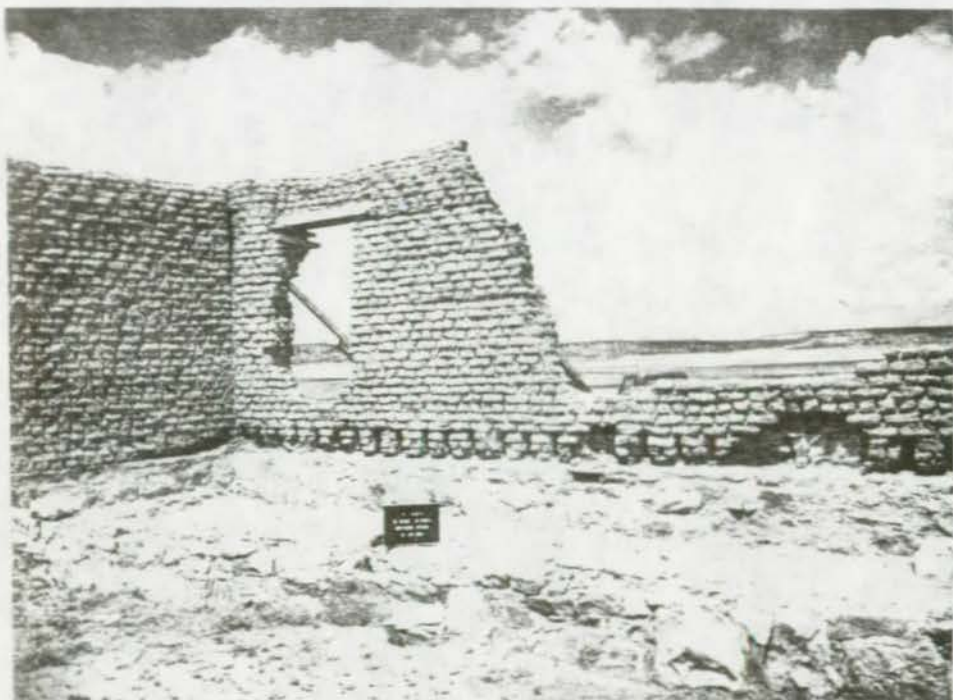
FIGURE 89. Building 3-450, Room 451, south side of north wall, before stabilization. Fort Union National Monument.

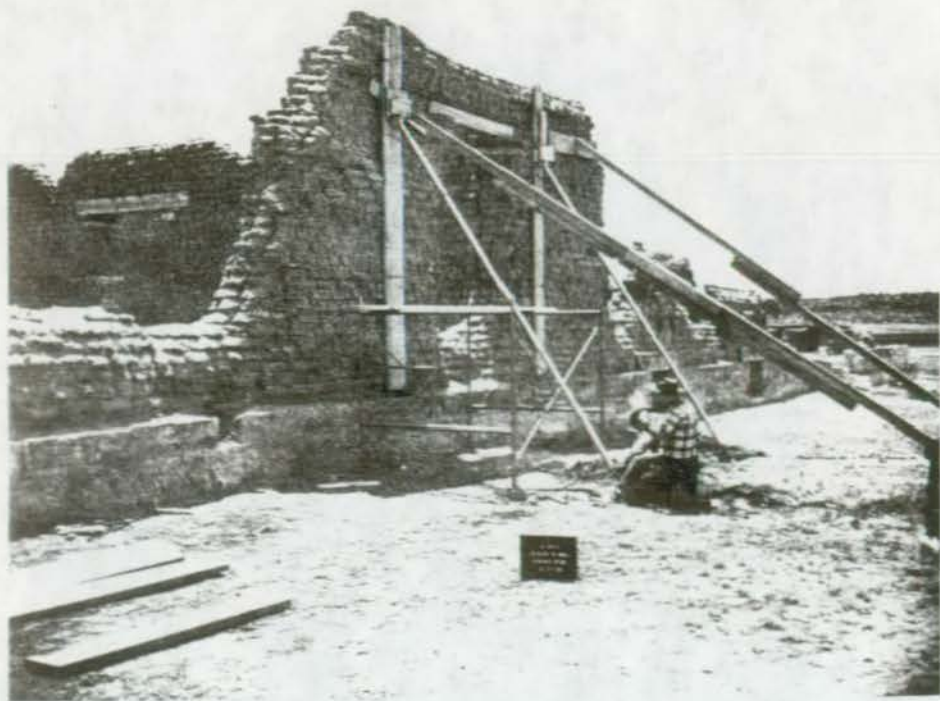
FIGURE 90. Building 3-450, Room 451, south side of north wall, during stabilization. Fort Union National Monument.

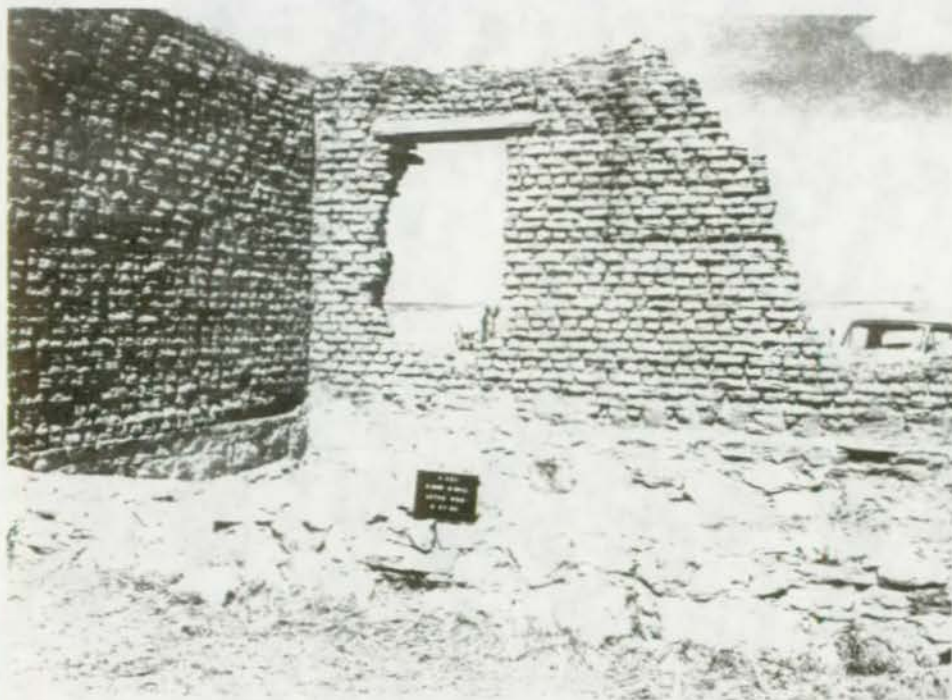
FIGURE 91. Building 3-450, Room 451, south side of north wall, after stabilization. Fort Union National Monument.

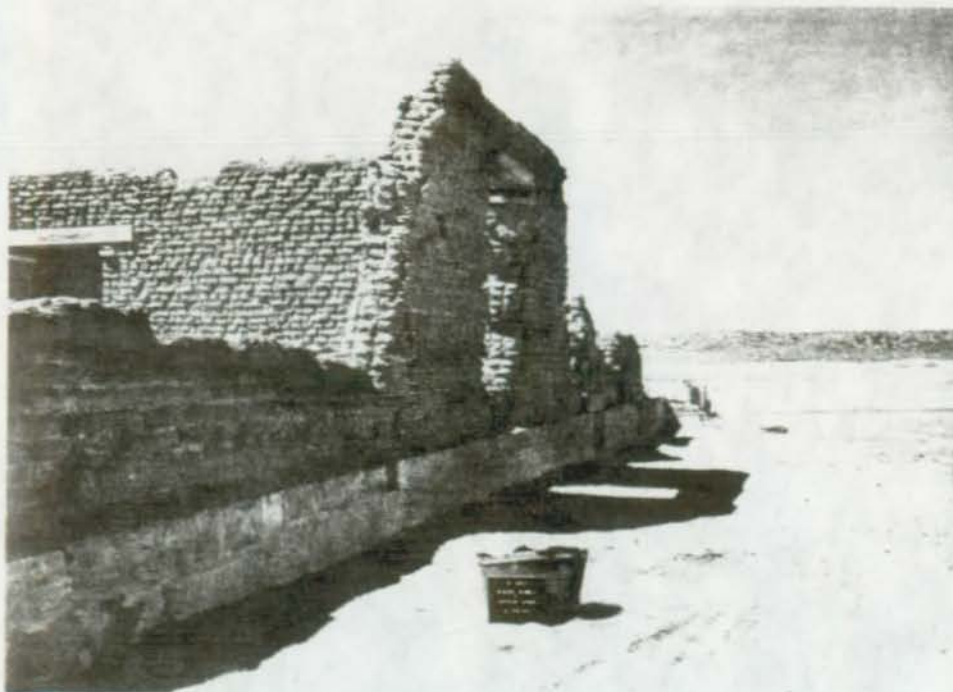
FIGURE 92. Building 3-450, Room 451, north side of north wall, after stabilization. Fort Union National Monument.

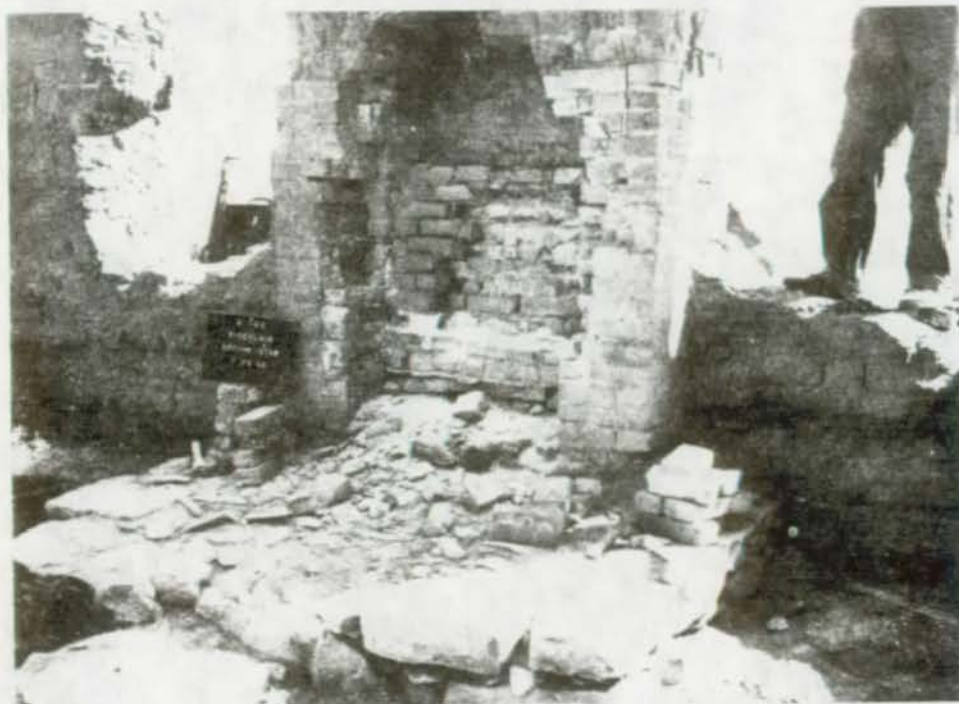
Details (notes on doorways, lintels, etc.): *Chimney and fire-place in east wall. North wall is south wall of rooms 161 and 162. Fireplace badly weakened by missing bricks. Loose bricks in chimney remnant. Brick hearth missing.*

FIGURE 93. Building 6-160, Room 163, fireplace in east wall, before stabilization. Fort Union National Monument.

Materials, construction, and technique in making repairs or accomplishing job: *East wall: Missing foundation stones replaced in fireplace, brick hearth rebuilt with historic brick, missing fireplace brick reset in soil-cement mortar. Missing adobes were replaced in the north, east, and south sides of the flue. The small chimney remnant stabilized by resetting loose bricks in soil-cement mortar and replacing several missing bricks.*

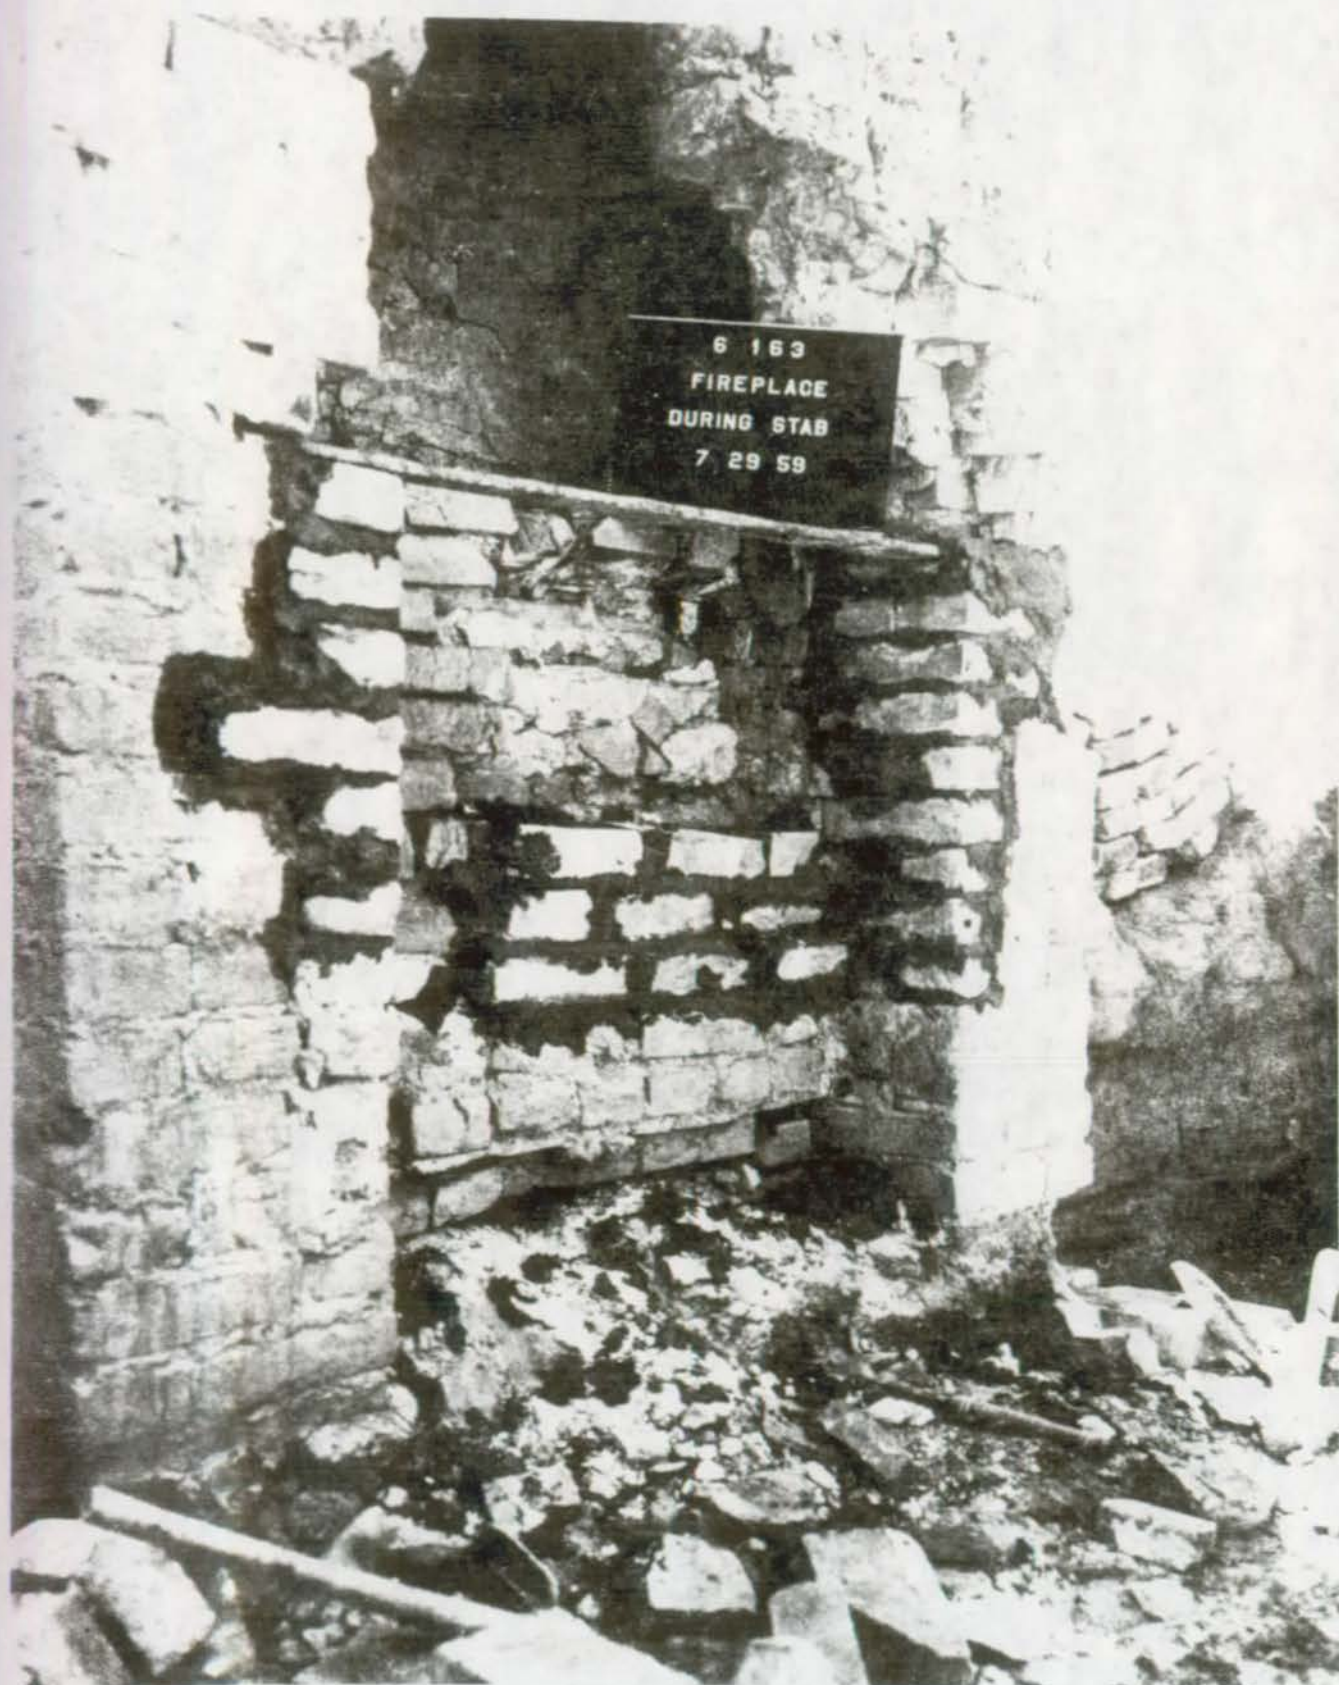
FIGURE 94. Building 6-160, Room 163, fireplace in east wall, during stabilization. Historic bricks are being reset in soil-cement mortar. Fort Union National Monument.

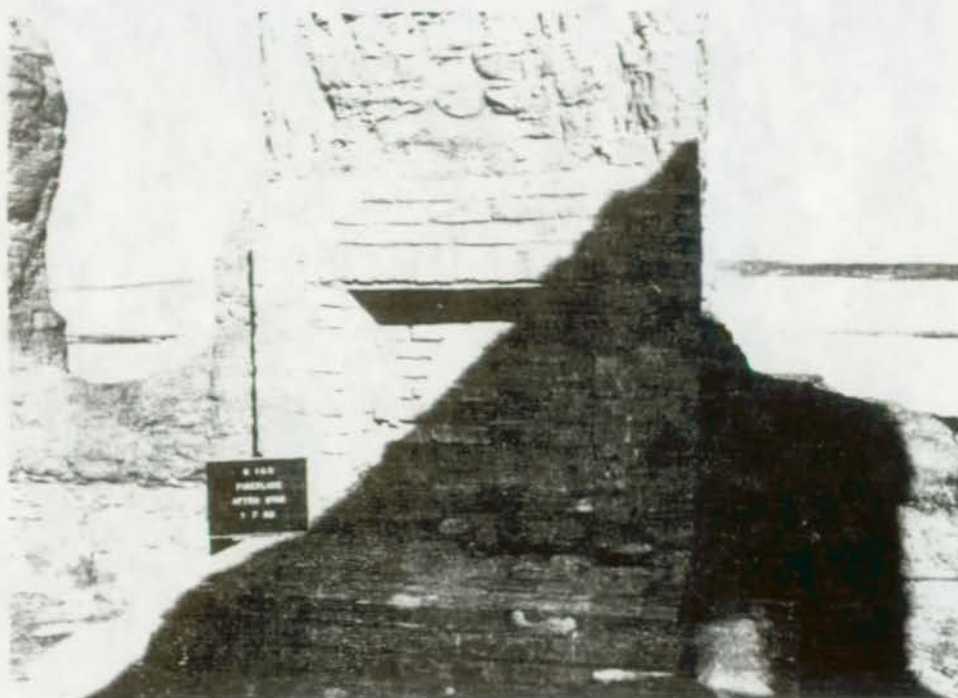
FIGURE 95. Building 6-160, Room 163, fireplace in east wall, after stabilization. Soil-cement mortar used to reset bricks was brushed to prevent shine. Fort Union National Monument.

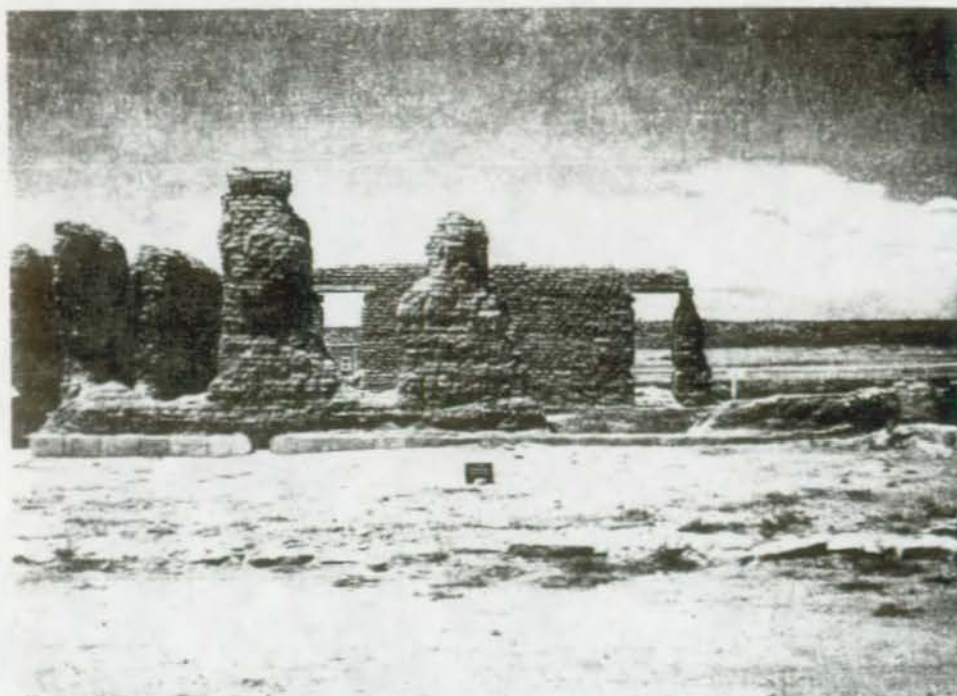
Condition on date work started. Masonry: *Nearly all of east wall missing except for flue. Many adobes missing from all sides of adobe flue. North wall in good condition. Lintels missing from window in south wall. West wall in good condition.*

FIGURE 96. Building 6-160, east side of east wall, before stabilization. Fort Union National Monument.

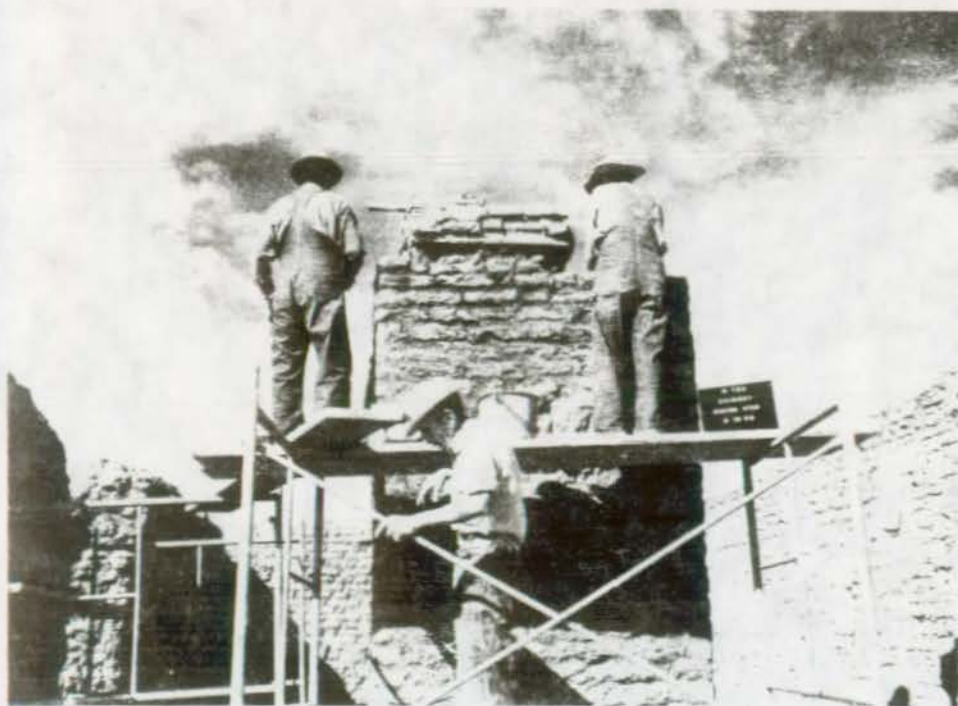
FIGURE 98. Building 6-160, Room 163, flue and chimney in east wall, during stabilization. Fort Union National Monument.

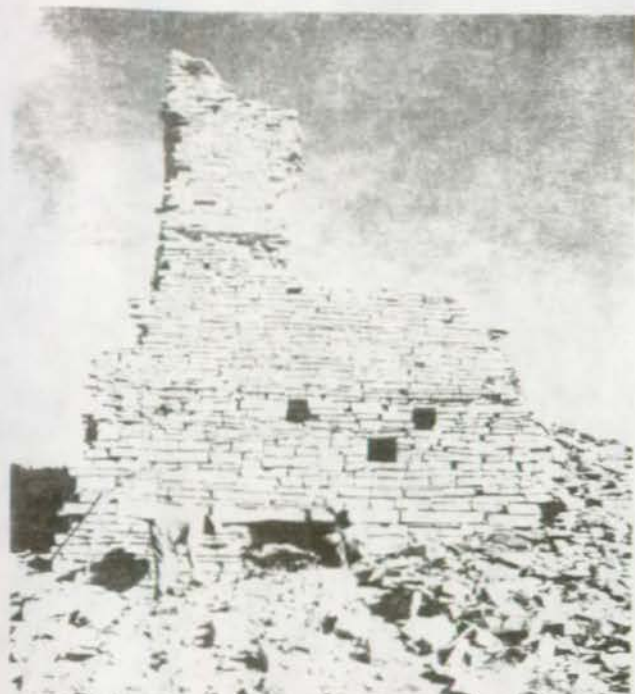
FIGURE 100. Close-up of north wall, Tower Kiva.

Condition, description: *The Tower Kiva, north wall exterior. In profile this is an L-shaped wall remnant, the vertical arm of the L forming a narrow section 8' wide, beginning at the second story and tapering at the top to an area only one stone wide. It is four stories high, measuring 32' 10" from the base at present surface level to the top stone. The exposed base of the wall at the*

Materials, construction, etc.: The Tower Kiva, north wall exterior. The high, sloping east and west wall stubs were capped, extending the east stub slightly eastward to provide a short but strong buttress section. Two integral members were placed in the west stub where it rises vertically, beginning at the second story level, the members extending to those rising from the east wall. The second and third story ledges or insets were repaired. The several openings including the two square beam holes, and the ventilator beneath them, and the beam holes at the east side were all repaired. The large hole at the base of the wall was filled with repair masonry in cement, the rough interior core being set in cement and the face stones laid in matching tinted cement. Following the above work, the entire wall face was grouted, pointed, and respalled. It was necessary to reset a few loose stones here and there in the facing.

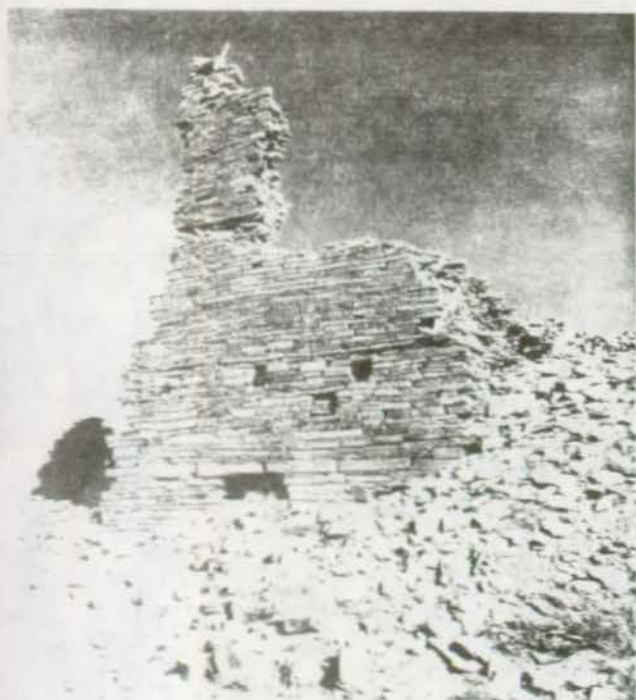
FIGURE 101. Tower Kiva, north wall exterior. Note large hole at base, and eroded insets (arrows) where second, third and fourth stories were slightly stepped back.

Considering its spectacular height, the wall is in good condition, but must be strengthened by repairing, reinforcing and capping to preserve its present condition.

The two eccentric, offset ledges along the north arc just above fill line were repaired. The lower half of a T-shaped ventilator in the center of the wall between the second and third story levels was repaired. East and west stubs were reinforced with paired integral members in connection with work on north wall exterior, already described. Within the upper kiva wall (includes the upper, spire-like fragment) considerable face stones were reset, and, where core was exposed, this was reset and pointed with soil-mortar. At the very top spire fragment itself, paired T-shaped integral members were installed.

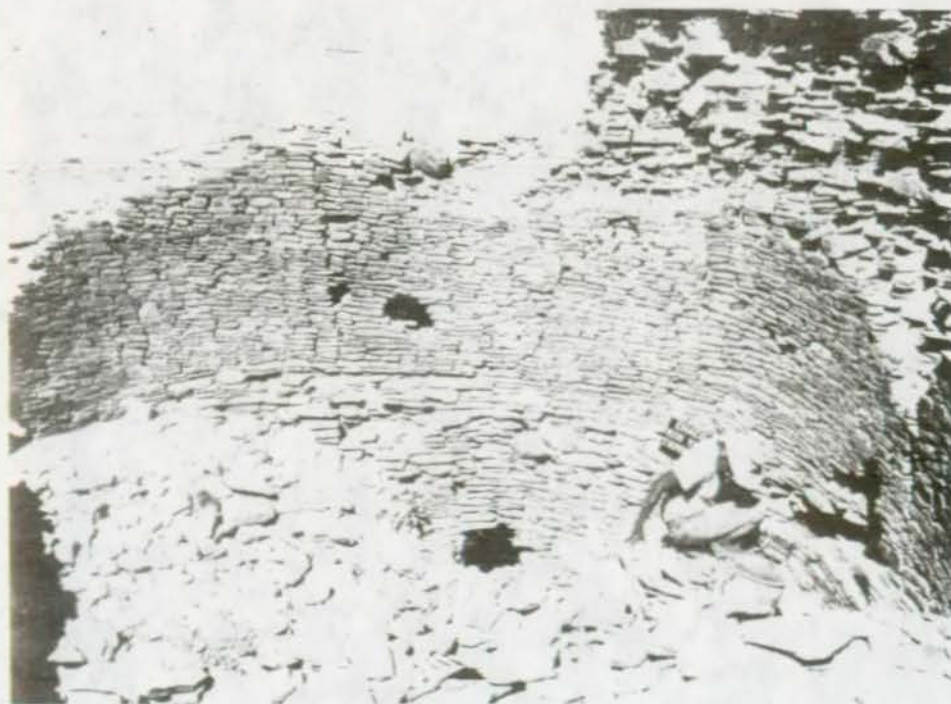
FIGURE 104. Another view showing general condition of lower part of interior.

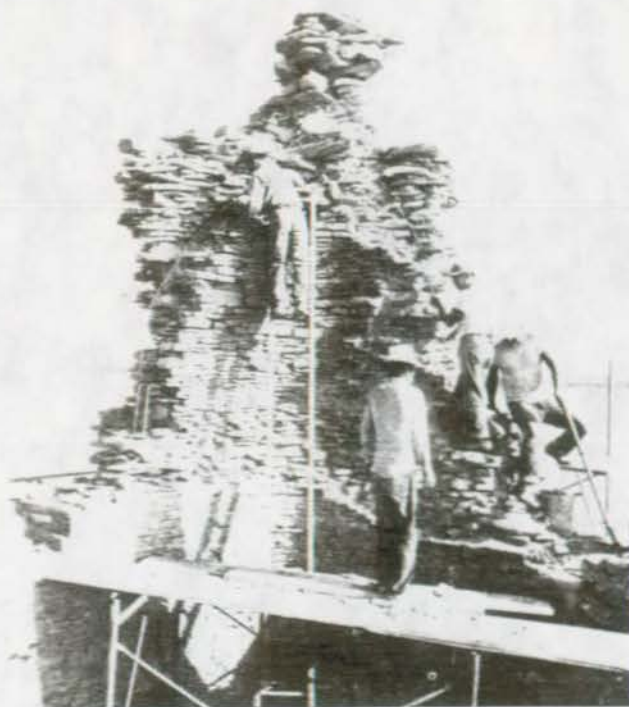
FIGURE 107. Tower Kiva, interior northeast corner, during installation of integral members to strengthen the highest wall section.

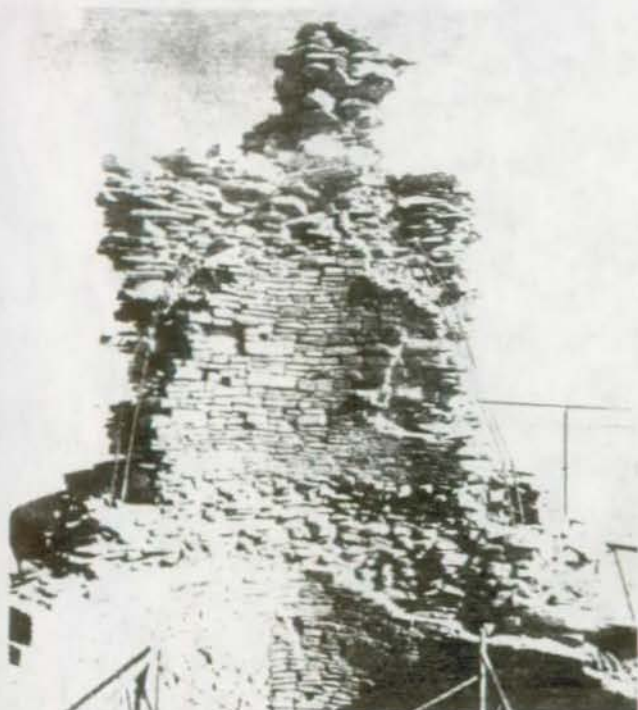
FIGURE 108. Upper portion of Tower Kiva, northeast corner interior, after the integral members were anchored in masonry.

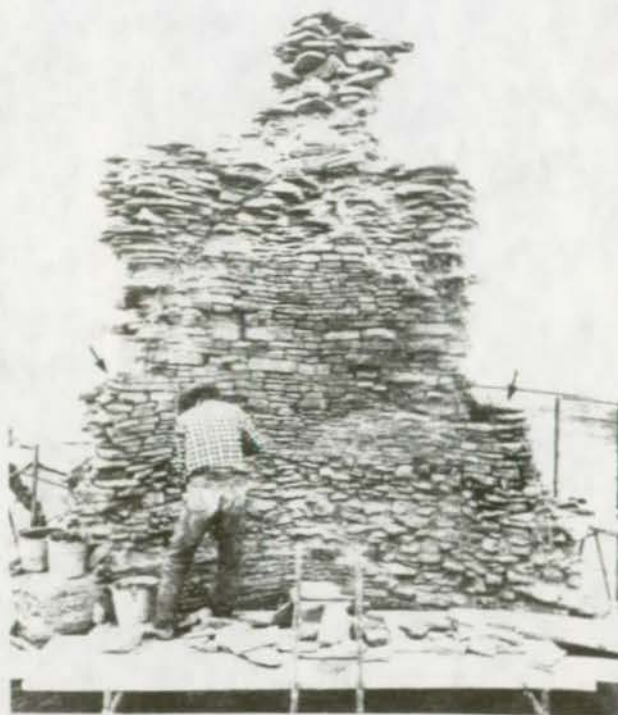
FIGURE 109. Beginning the vertical, reinforcement capping (arrows).
