# **RUINS STABILIZATION IN THE SOUTHWESTERN UNITED STATES**

Compiled by  
ROLAND VON S. RICHERT and  
R. GORDON VIVIAN

**National Park Service**

U. S. Department of the Interior  
Washington 1974

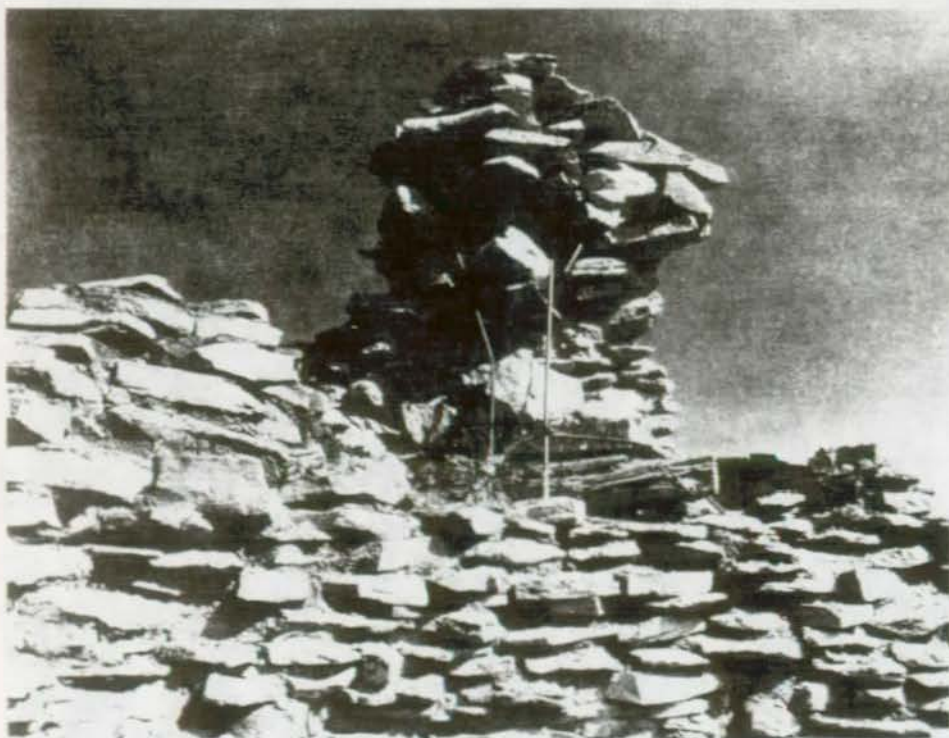
FIGURE 110. Integral members in the form of a T were installed in this top fragment of core masonry after the lower wall section had been strengthened to that point.

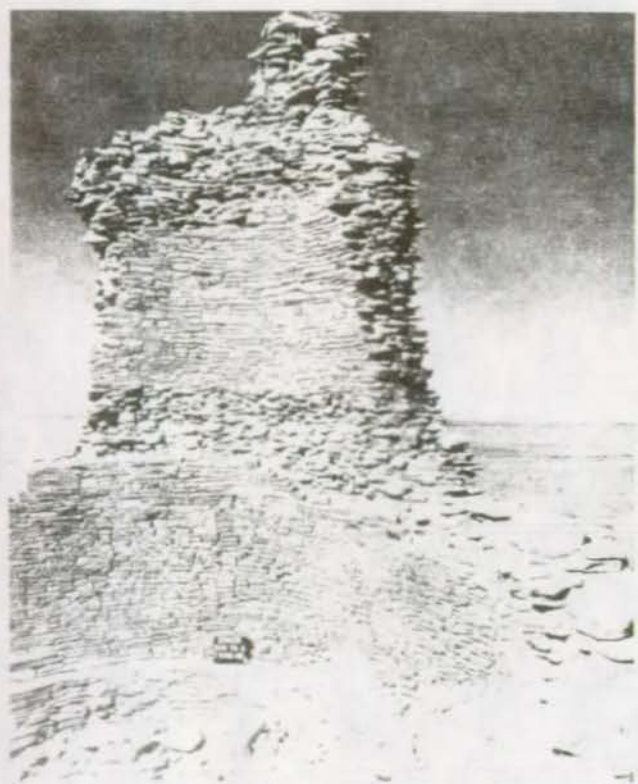
FIGURE 111 The wall at completion of stabilization. The wall is considerably strengthened and tightened without a serious or objectionable alteration of the original profile.

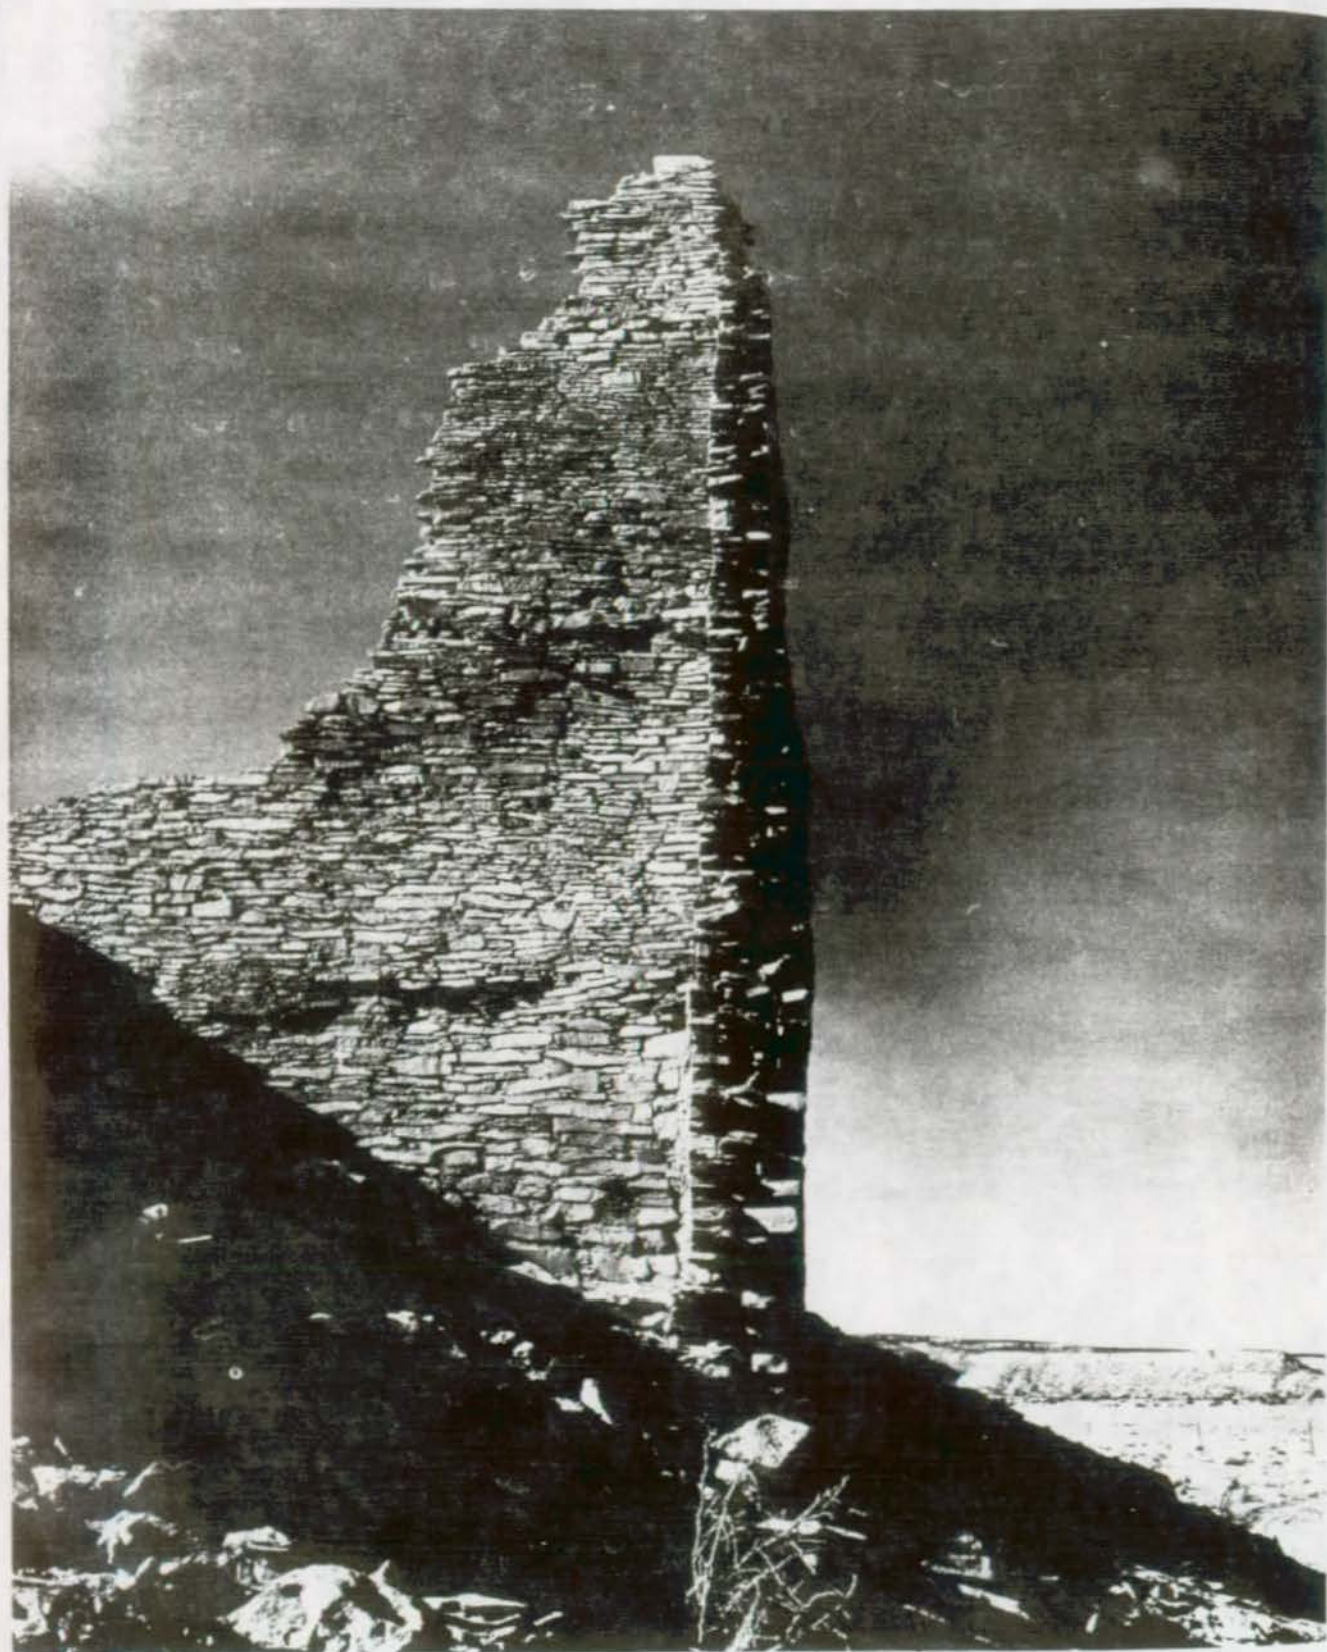
FIGURE 113. View of Tower Kiva showing vertical cap.

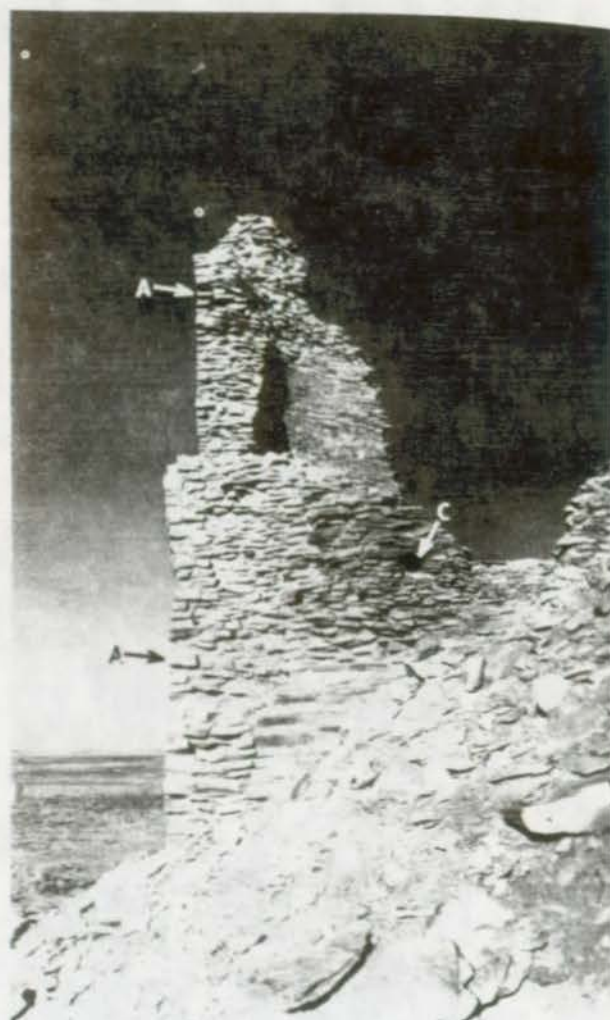
FIGURE 116. North wall stub capped (arrows A), lower portion of west wall facing reset (B), and exposed portion of thick core grouted (C).

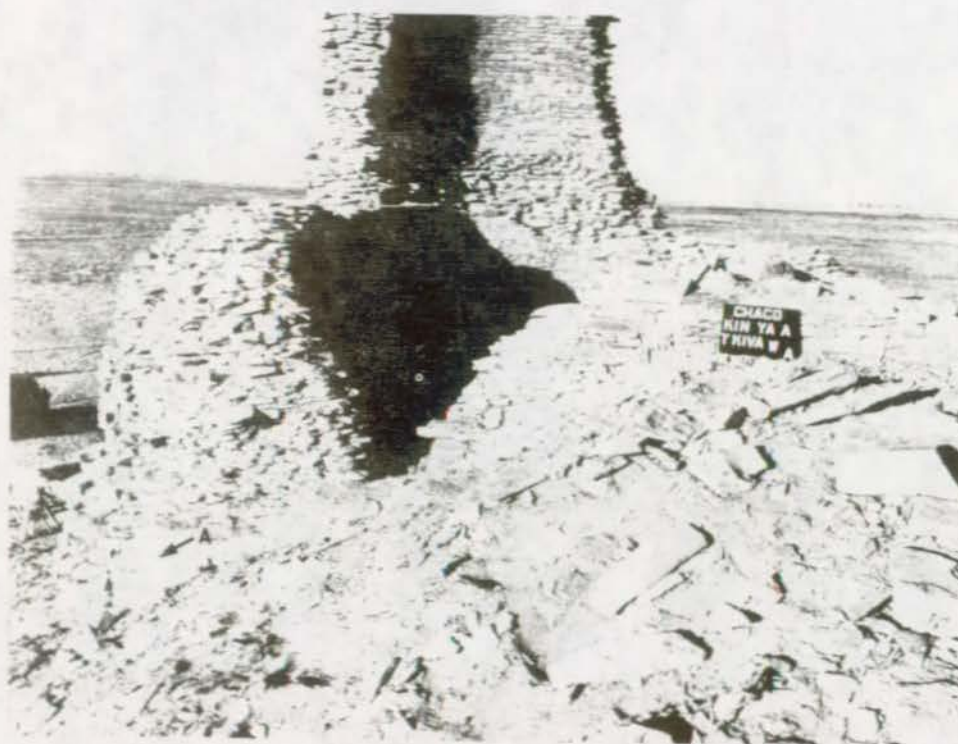
FIGURE 117. Tower Kiva, west wall. This fragmentary section of the square tower enclosing a round one was repaired by resetting the facing (arrow A), capping and grouting the thick core (B).

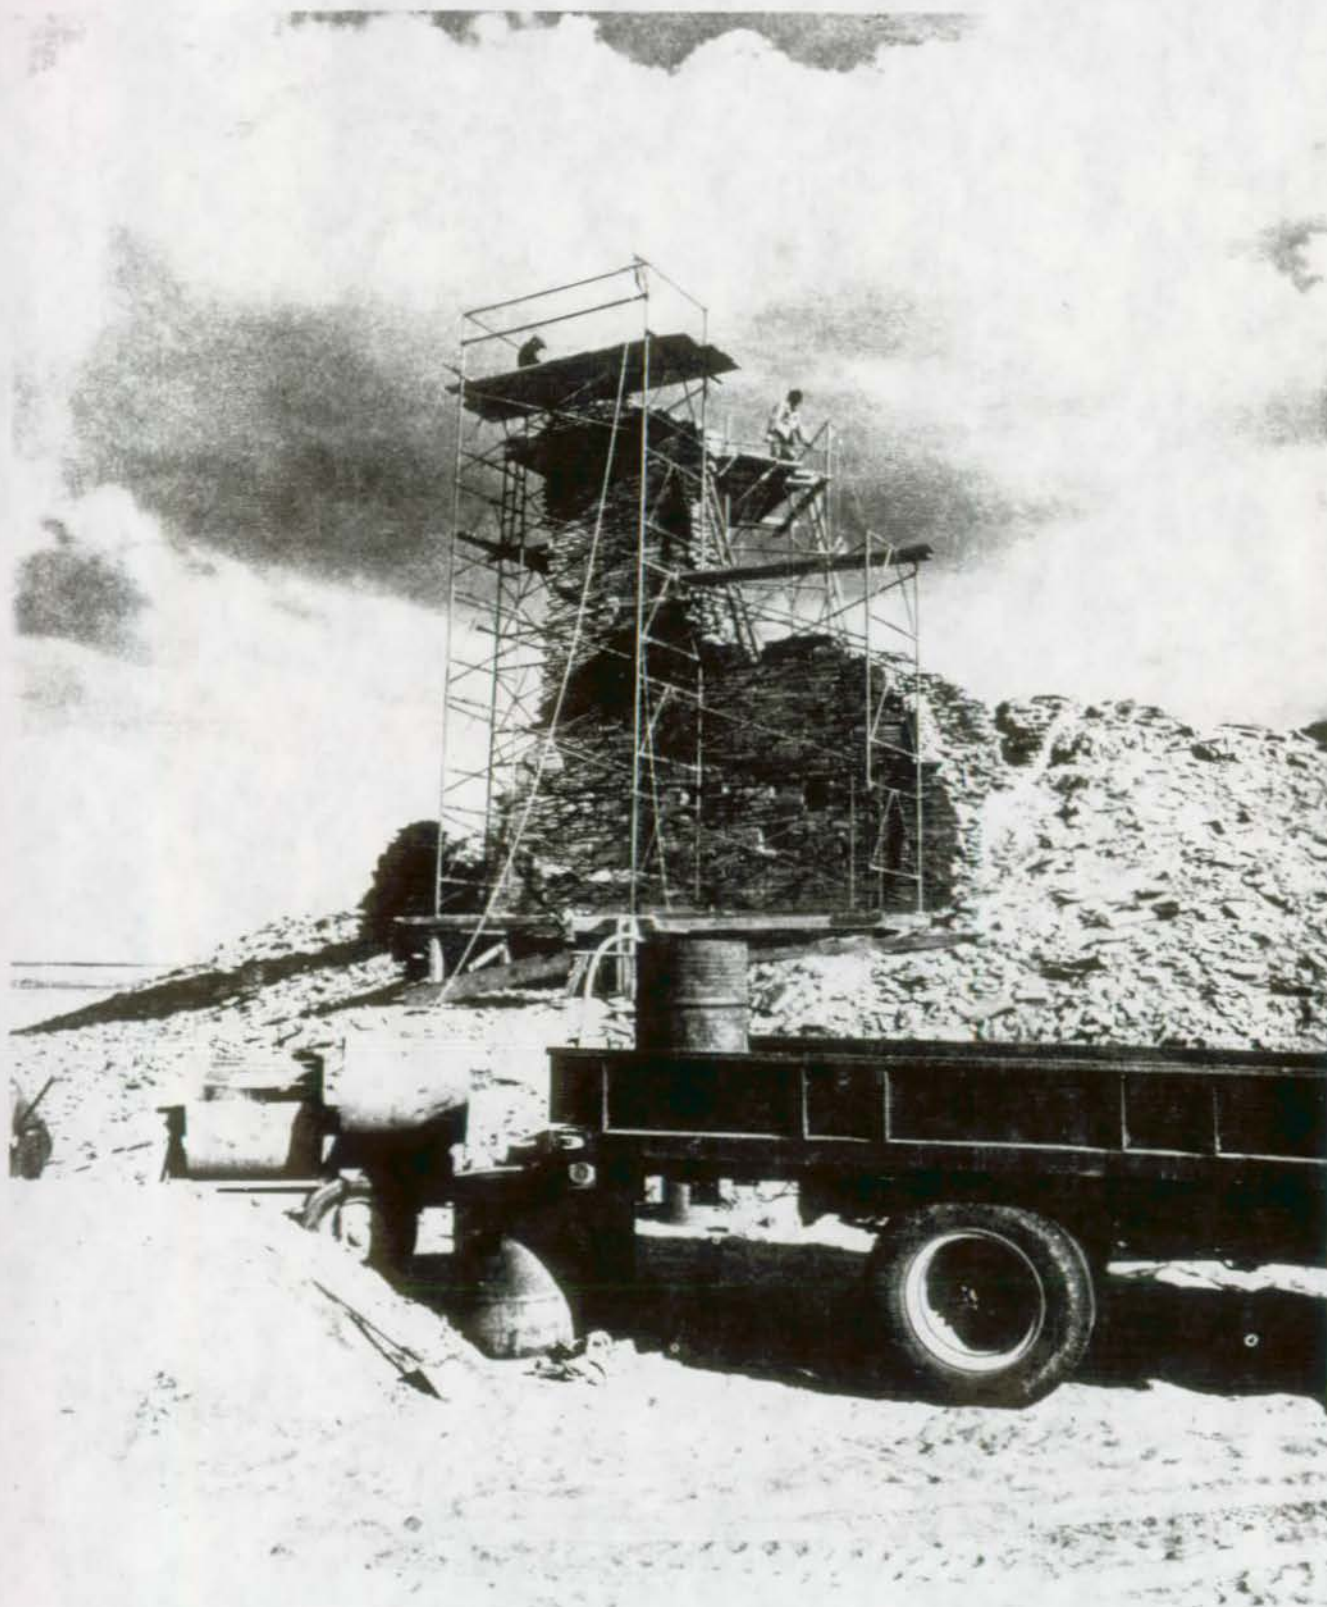
FIGURE 118. Work on the highest portion of the tower. The scaffolding completely surrounded the structure. To provide maximum safety for the workmen, the three sets of scaffolding were anchored at the bases and across the top and through midsections.

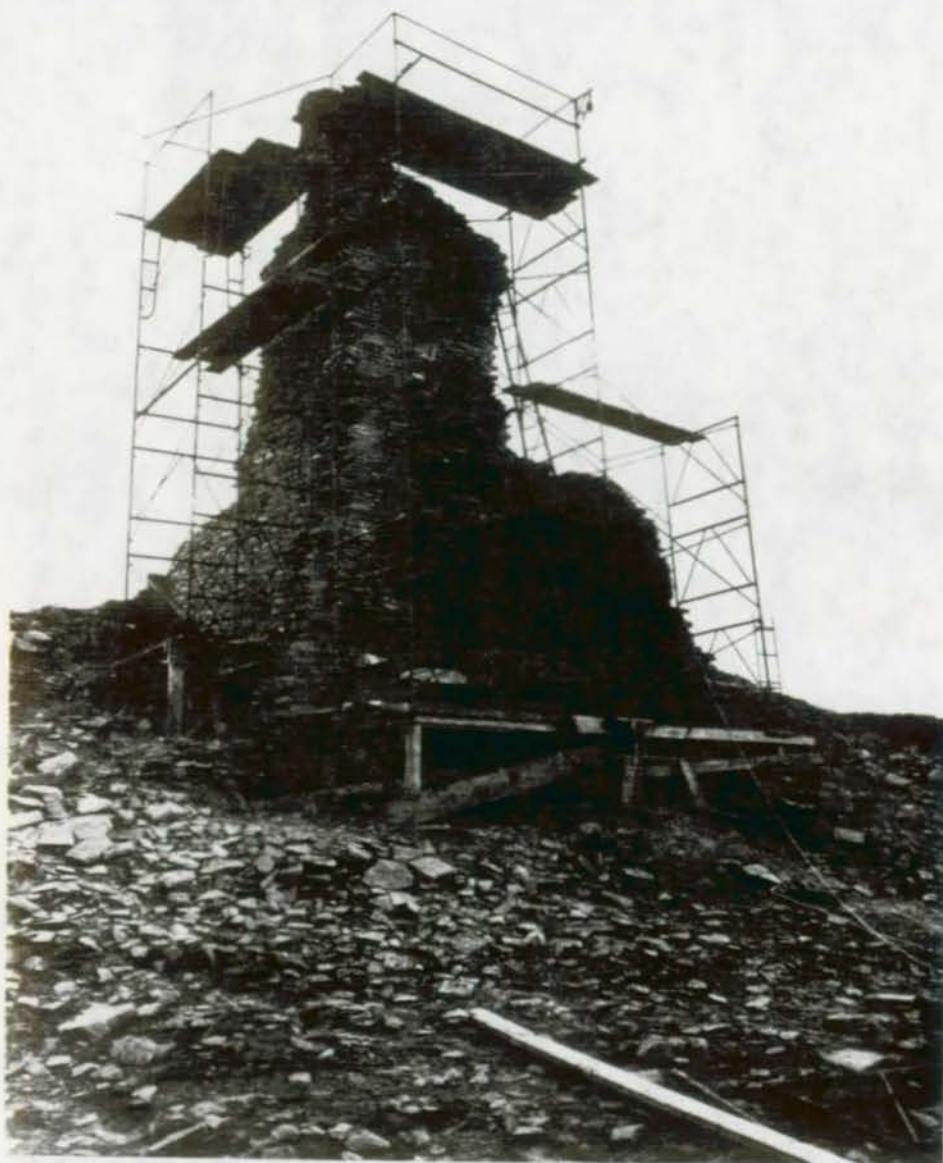
FIGURE 119. Tower Kiva. Scaffolding was anchored on firm and level bases built of heavy timbers.

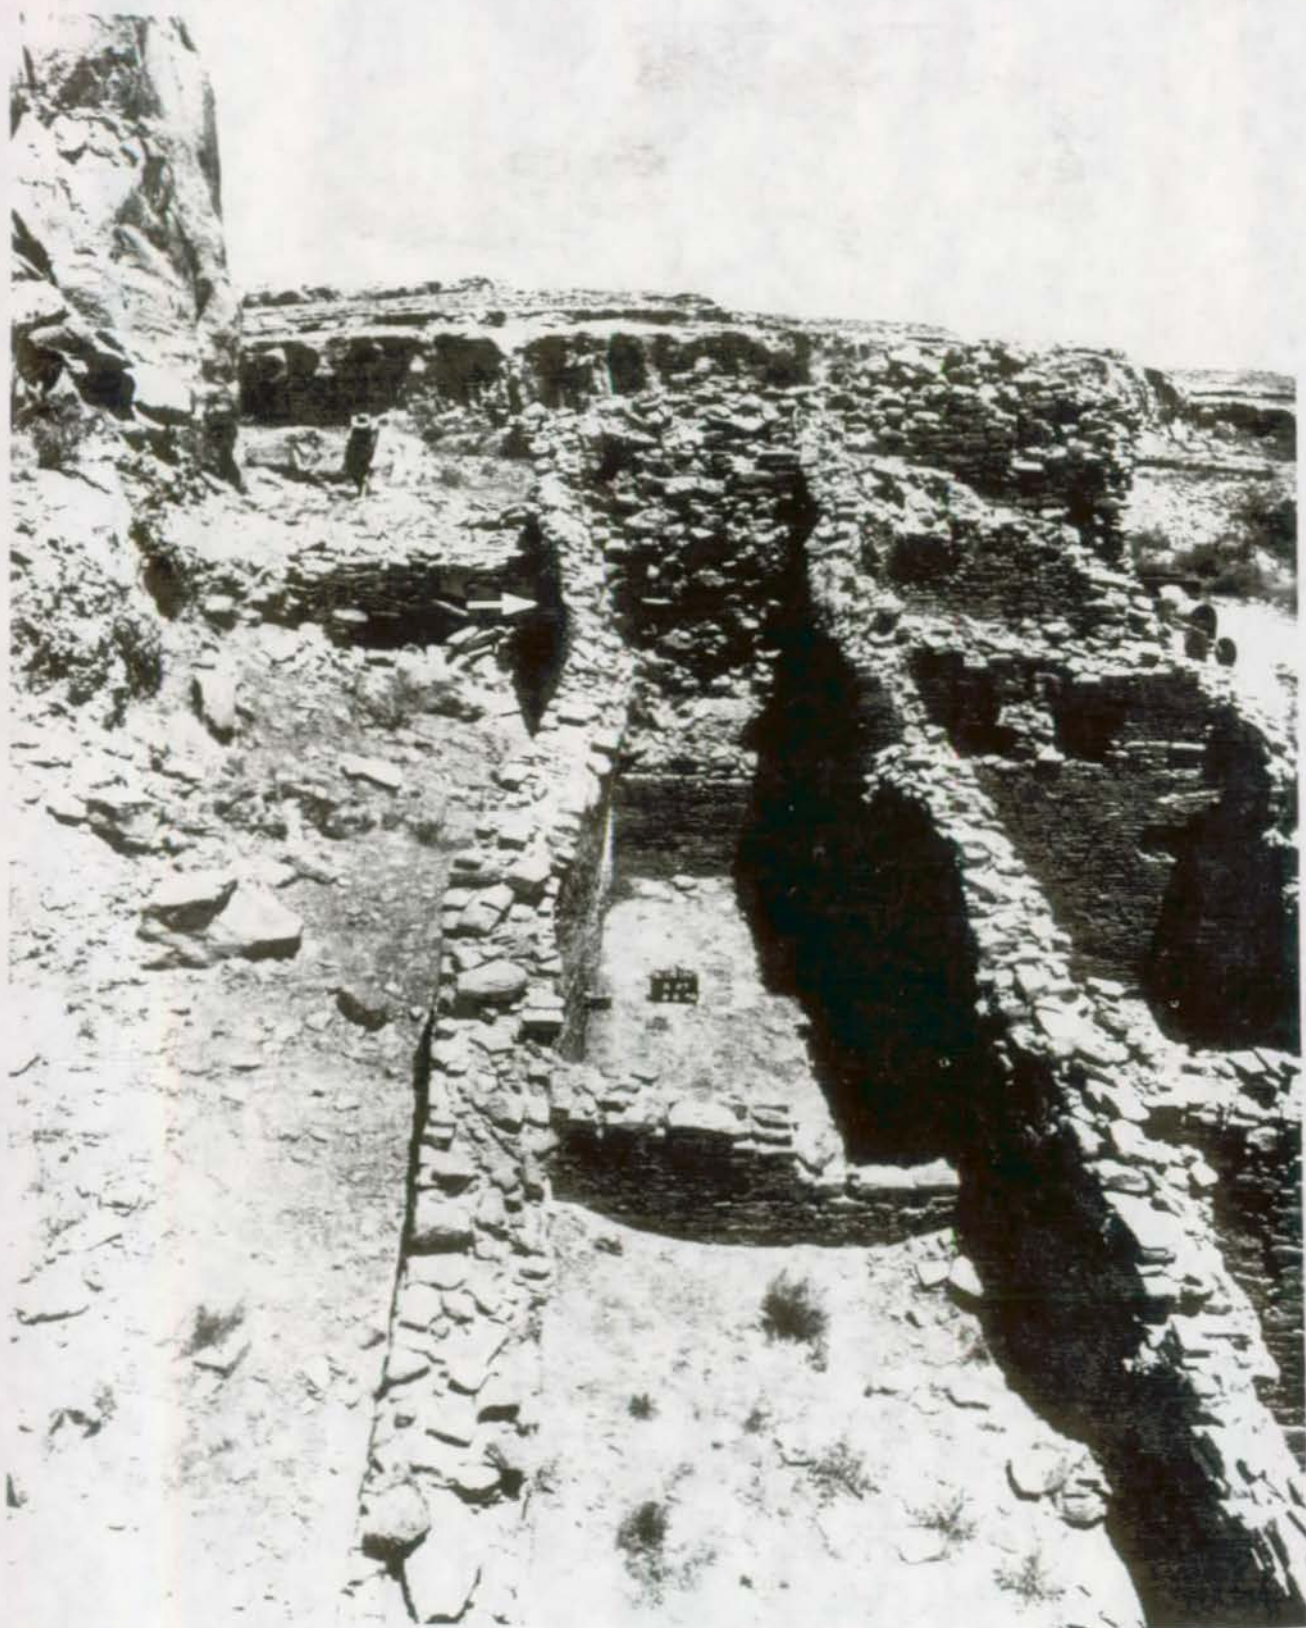
*Ancient masonry: North wall above the ledge leans precariously into the room. East and west walls have eroded and are loose at the top. Footings of all four walls are undercut by erosion. Beam holes are eroding where beams have decayed.*

FIGURE 120. The wall between Rooms 27 and 28, Talus Unit No. 1, was distorted and pushed out of line by pressure of fill, often damp, at left. Arrow shows direction of force. The purpose of the stabilization was to strengthen the wall against the pressure.

Materials, construction, and technique in making repairs or accomplishing job: *Part of the center section of the leaning wall was removed. A horizontal slab of steel-reinforced concrete was poured so as to abut against the junction on the partition walls. Steel rods were fastened through both wall and slab with turnbuckles between. Using the turnbuckles, the wall was pulled back to nearly vertical position. The stones removed were then replaced in tinted cement. East and west walls had already been patched and strongly capped to bear the load. New stones were set in cement around the wall footings. The beam holes were patched in tinted cement.*

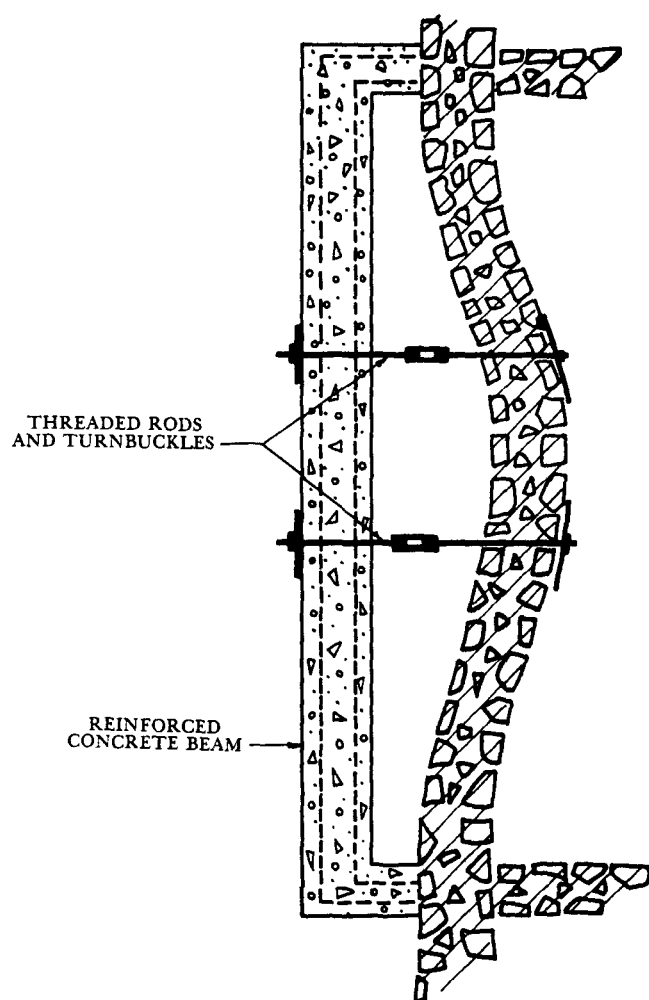
FIGURE 121. Plan of reinforced beam to realign and hold north wall, Room 27, Talus Unit No. 1 (not to scale).

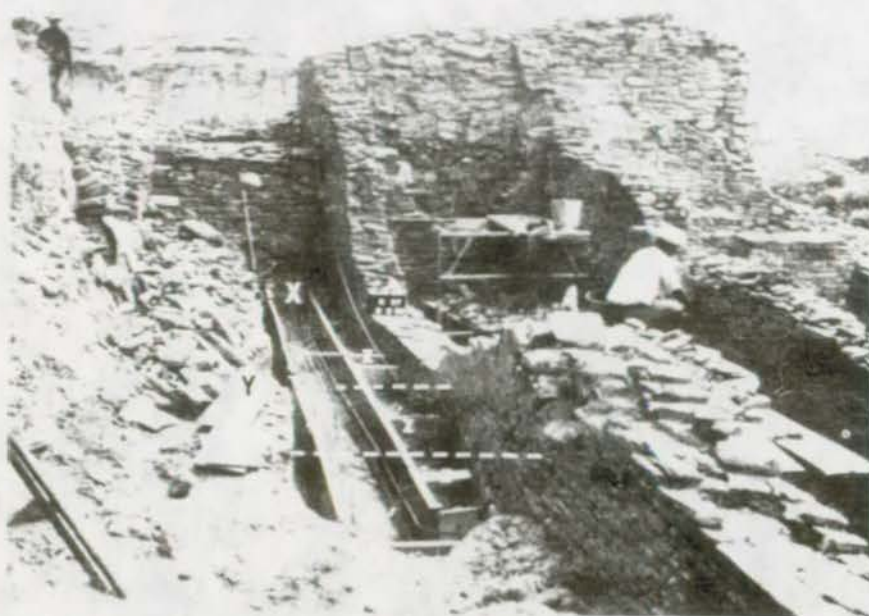
FIGURE 122. Construction of concrete beam shown in figure 121. The frame is complete and reinforcing rods are in place. X—X<sup>1</sup>—beam, Y—location of threaded rods and turnbuckles. Z—temporary braces. The ends of the beam bear against the wall at each side of the bulged area at points where the wall is braced against movement by partition walls. That at the east shown as A.

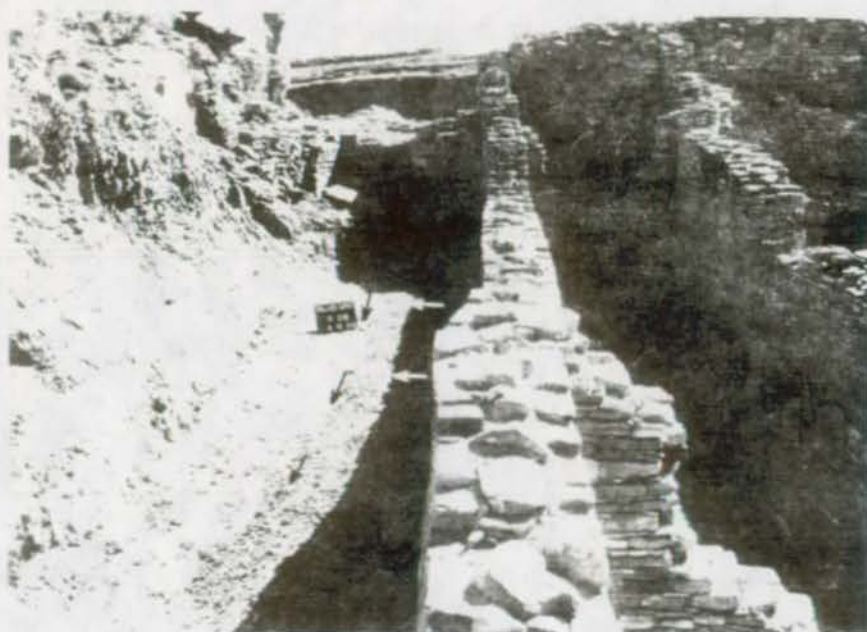
FIGURE 123. This wall in Talus Unit No. 1 has been pulled back into line; the capping is straightened up. The concrete beam dug into Room 28 is covered and the surface of this room (arrows) is graded to carry surface runoff away from the damaged wall.

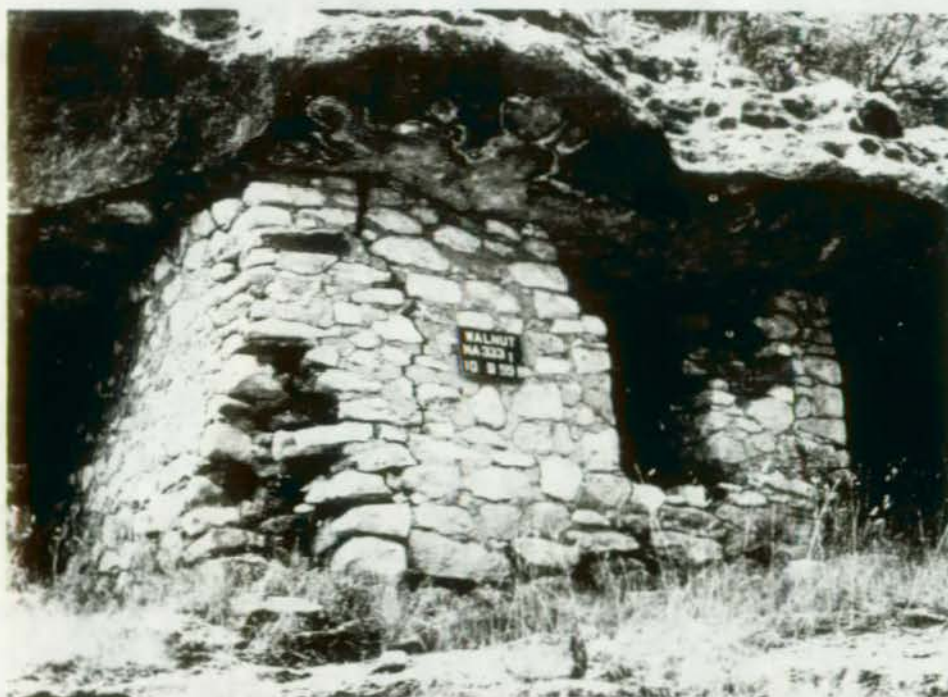
Condition on date when work started. *Ancient masonry: Fair. North Wall: In poorest condition. A large hole beginning at foundation and extending to midsection caused by pot hunters has made this wall extremely weak, and collapsed all of the eastern third except a fragile corner one stone wide. East Wall: Good except for eroded foundation, and the lower third of southeast corner which has collapsed. The V-shaped hole over doorway needs grouting on the north side.*

FIGURE 125. Room 1, east exposure, before replacement of fallen corner. (Walnut Canyon National Monument)

Materials, construction, and technique in making repairs or accomplishing job: *North Wall: The large hole measuring 3' x 4' was filled with repair masonry to save the upper section, and the northeast corner was buttressed also to preserve it. Repair work stained with black mortar color to match original.*

*East Wall: Entire foundation one stone high was grouted and pointed. The south wall also had a few small holes along the foundation row where original soil-mortar had eroded and these were filled. Sill and wall area below door grouted and pointed.*

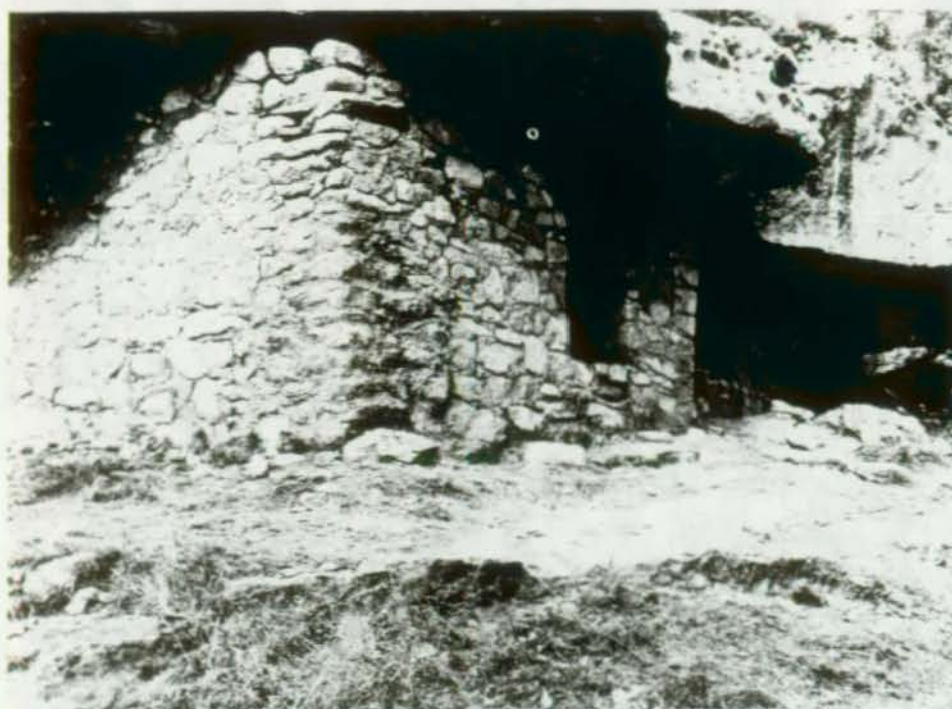
FIGURE 126. Room 1, east exposure, after replacement of fallen corner. The deeply eroded wall base was grouted, and the area above the doorway was partially reset. (Walnut Canyon National Monument)
