Cape Lookout National Seashore

Cape Lookout Lighthouse

**Historic Structure Report**

December 2008

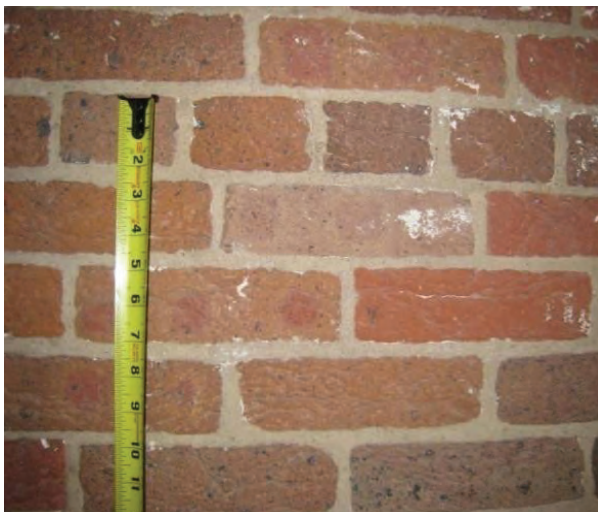
**Figure C-9** Brickwork of interior face of core wall.

The mortar joints of both the outside and inside walls have a width of about ½" and are struck flush. However, on the core wall interior face, it is clearly evident that portions of the brickwork have been re-pointed with a hard, Portland cement-rich mortar. The re-pointing mortar is also fairly impermeable as evidenced by the re-pointed joints sitting proud, hard and rigid, while the adjoining bricks have spalled well back from the face of the mortar. Similar spalling has not occurred on bricks adjoining the earlier mortar.

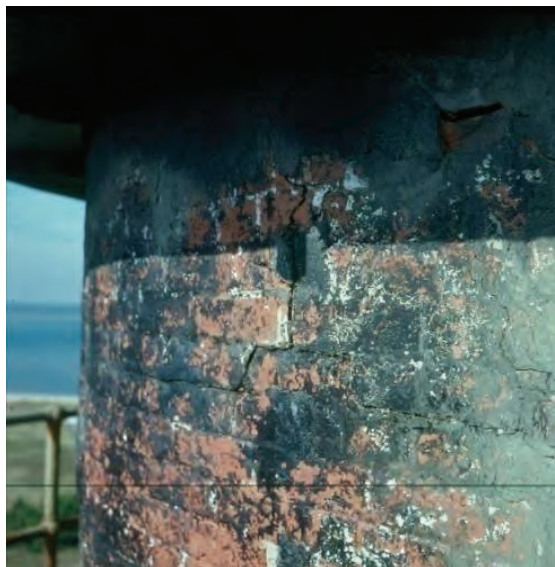
In addition, the condition of the bricks of the exterior wall is not known. These bricks have been water-blasted and subsequently covered with the current, thick, non-breathable coating. These actions are likely to have damaged the brick by removing portions of the fireskin and also trapping moisture, conditions that may affect their overall water absorption and possibly their compressive strength properties. Additional testing of the exterior brick is recommended to confirm actual performance characteristics. (See *Appendix D: Materials Analysis* for further discussion.)

**Figure C-12** A 1976-1981-era photograph of exterior masonry at Observaton Deck.

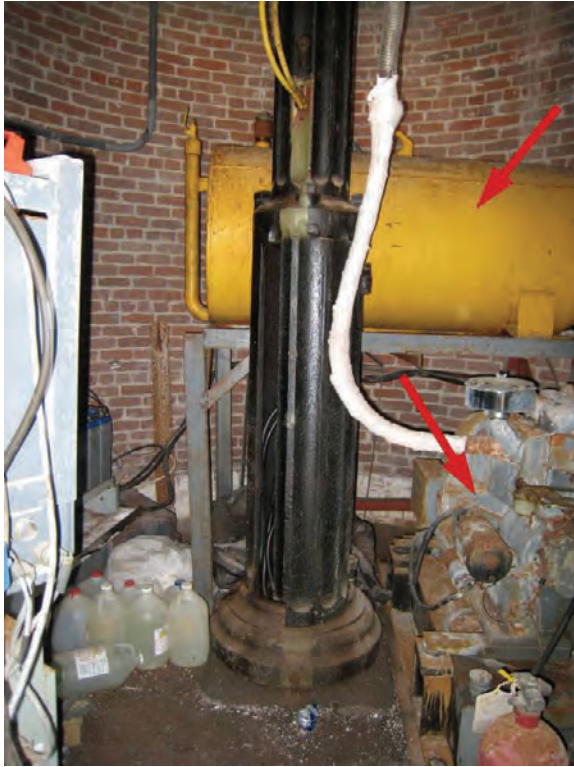
**Figure C-13** Center column on sandstone pedestal, abandoned emergency generator and fuel tank nearby.

together in sections and extends from the masonry floor of the First Floor to the Ninth Floor Lantern platform for the beacon. At all levels the column appears to be sound.

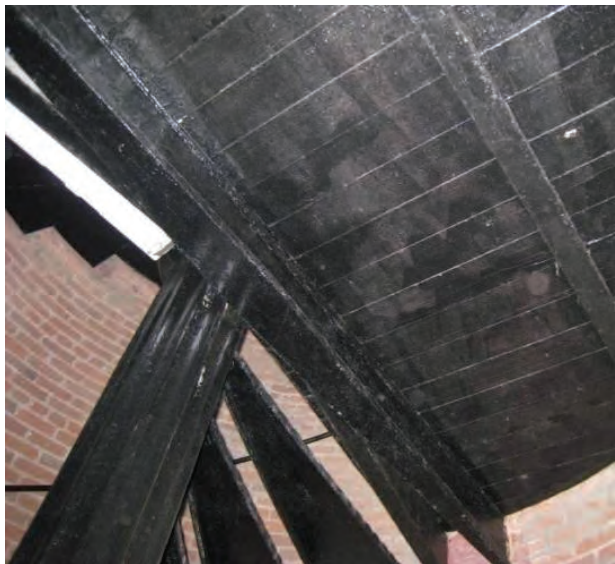
**Figure C-15** Wood deck and floor joists of rebuilt 1867 Third Floor landing.

At the Third Floor, a level damaged by the Confederate explosion, the landing was rebuilt in the 1867 repair effort and is comprised of wood plank flooring (3/4" x 5") atop two wooden joists (2 7/8" x 8") in addition to the original I-beam.

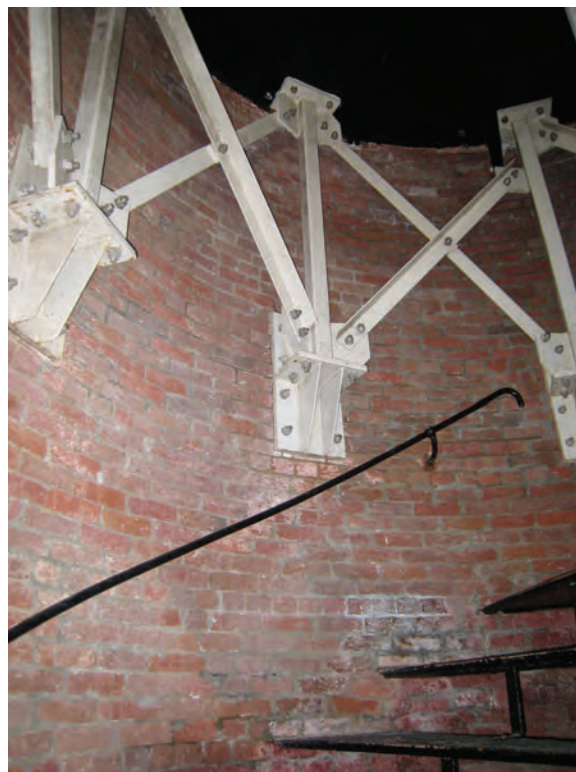
**Figure C-16** 1989 steel framing at Seventh Floor.

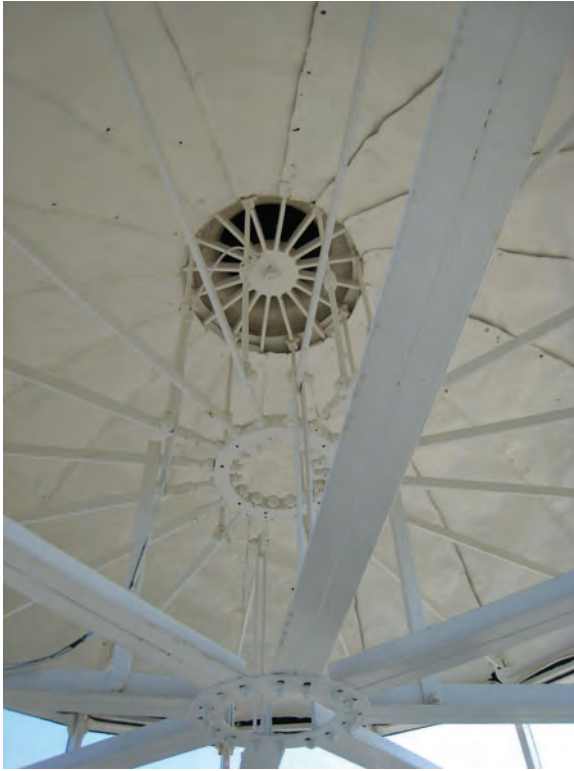
**Figure C-17** Structural supports and central ventilator of dome.

- *Roof Framing:* The sheet metal dome is supported with cast-iron ribs and interconnecting 7/8" diameter iron rods, and rests on a cast-iron wall plate. Seventeen vertical iron-framing members hold glass panels to create a sixteen-sided wall enclosure (Lantern) and to support the wall plate. This iron framing sits on an iron floor plate atop the masonry tower. The cross bracing is copper-based, probably brass. Corrosion is extensive among the supporting iron elements.

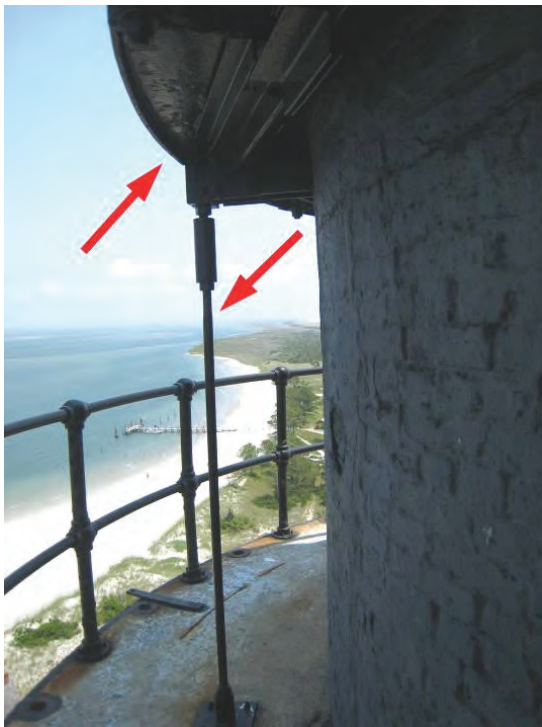
**Figure C-18** 1989 steel reinforcement of Gallery deck and connecting rod.

Outside, steel angles were added to the underside of the Lantern Gallery. Stainless steel, 1" diameter rods were added as connectors between the Lantern Gallery and Observation Deck. (See *Appendix B: Structural Assessment & Carrying Capacity Analysis.*)

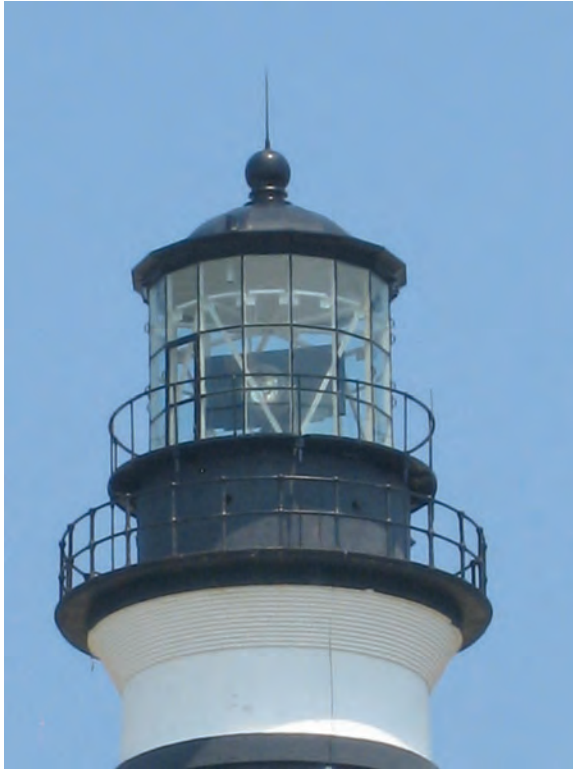
**Figure C-21** *Lantern, Lantern Gallery and Watch Level Observation Deck.*

cast-iron framing members and horizontal cross-bracing of a copper-based material, perhaps brass. An iron sill plate attaches the Lantern atop the masonry tower. There are extensive amounts of corrosion at the iron elements.

Four presumably original iron rods, each 7/8" in diameter, connect the sill plate of the Lantern to the floor at Watch Level. These rods have extensive corrosion with at least one severely compromised.

Along the outside perimeter of the Lantern is the narrow Lantern Balcony. This Balcony has sixteen cast-iron floor plates, probably the original. These plates are in very poor condition with extensive corrosion, numerous breaks and some loss of material. Stainless steel angles were added in 1989 for support beneath the floor plates. During those same repairs, the current stainless steel railing system was installed. This railing consists of 1½" round stanchions with a flat 1" x 2" handrail 38" above floor level.

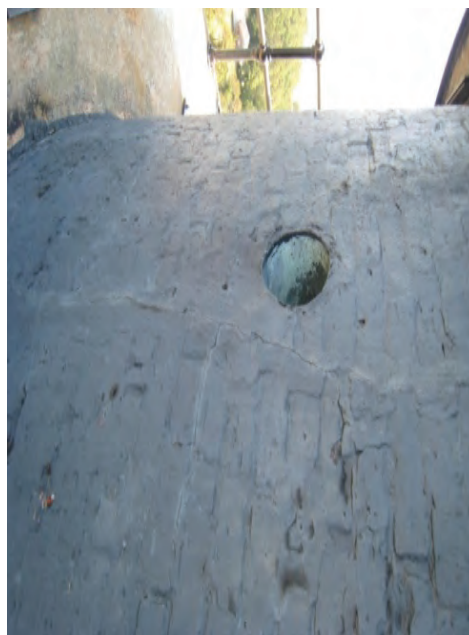
**Figure C-26** Exterior view of one of four Watch Room air vents.

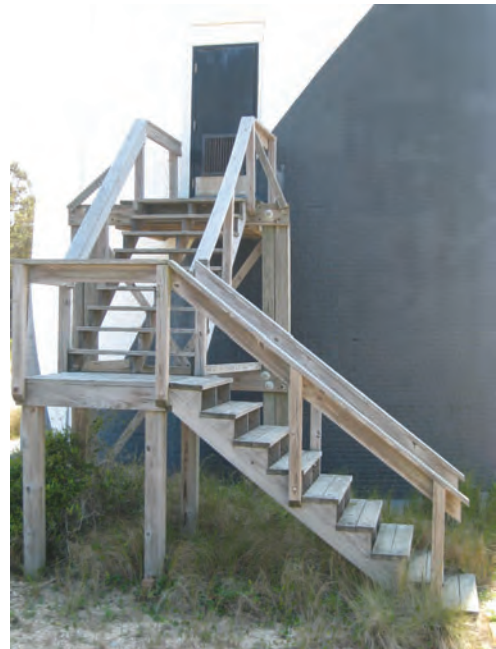
**Figure C-29** Modern entrance stair to Second Floor.

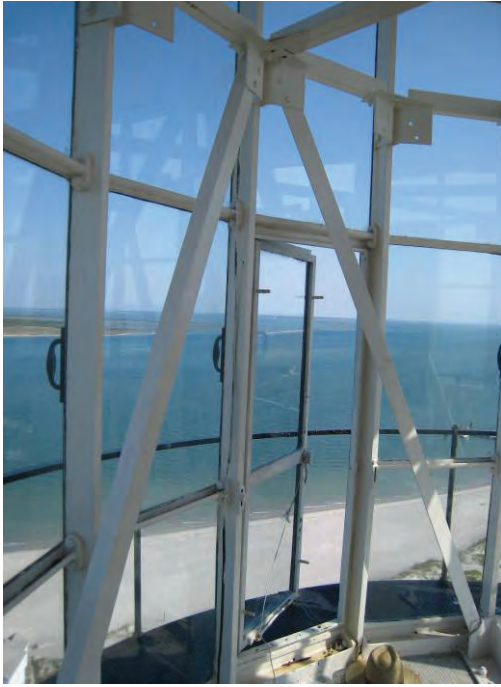
**Figure C-31** Doorway to Lantern Gallery.

A fourth doorway is at the Lantern. Apparently an original feature, it is made of brass framing with two, glass panels, designed to conform to the framing configuration of the Lantern. This door permits passage between the Lantern and the Lantern Gallery. The door metal is heavily encrusted with paint and difficult to operate.

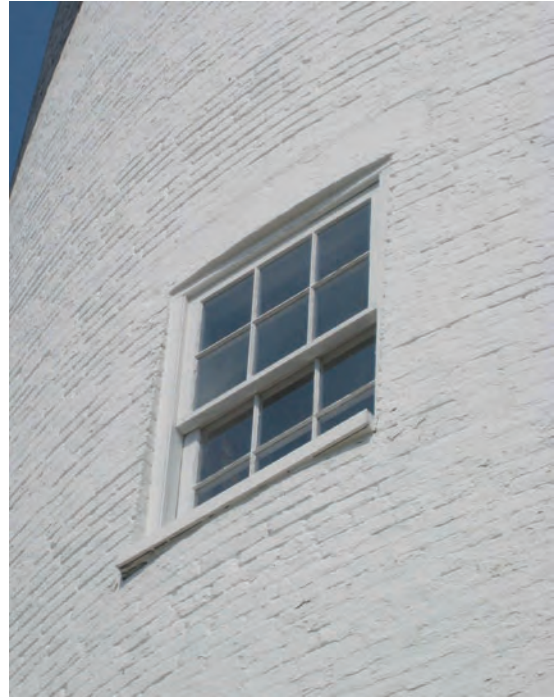
- **Windows:** Apart from the glass expanses of the Lantern, there are ten windows in the Tower. All ten of the current window units are replacements, fabricated and installed in 1999 by the NPS Historic Preservation Training Center of Shepardstown, West Virginia. Each window is an operable, double-hung, sash design made of wood.

**Figure C-32** Typical replacement window unit.

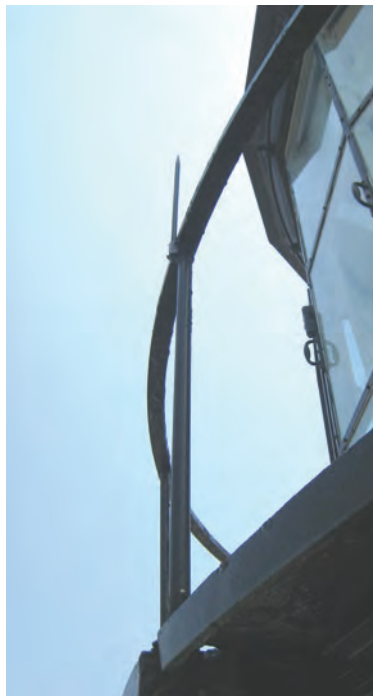
**Figure C-36** Modern lightning rod at Gallery railing.

- **Lightning Protection:** The prototype drawings indicate a lightning rod atop the roof finial. Today, a group of modern lightning rods include one atop the dome and four at the Lantern Balcony rail. Two grounding cables connect to this rail, one at the north side and one at the south, and then run down the face of the masonry to grade. The south ground cable is disconnected at the Eighth Floor.

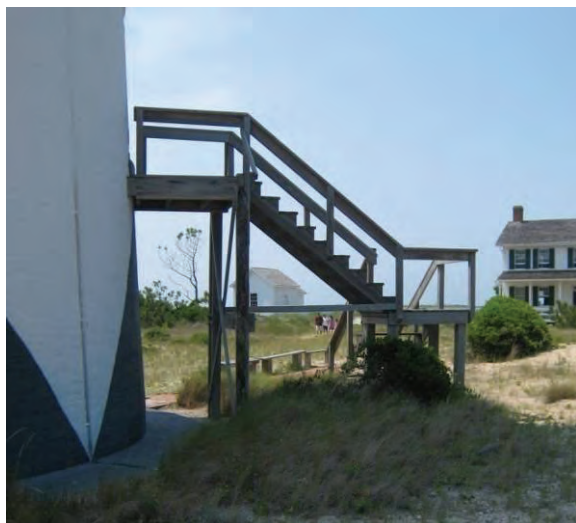
**Figure C-35** Stairs for Main Entrance.

- **Entrance Stairs:** According to park personnel, the current L-shaped configuration of stairs and landings was installed in the 1980s. The wood members are treated pine, unpainted, and cut to modern dimensions. They were constructed adjacent to and connected with remnants of a previous stairs.

The earlier elements include two 6" x 6" posts and their 2½" x 9¼" cross beam, all of which are attached to two modern 5 3/8" x 5

3/8" posts that support the entrance landing. These two early posts have extensive rot. The 1980s elements remain in good condition though the entrance landing posts would benefit from additional support as the earlier, now supplemental, posts continue to deteriorate.

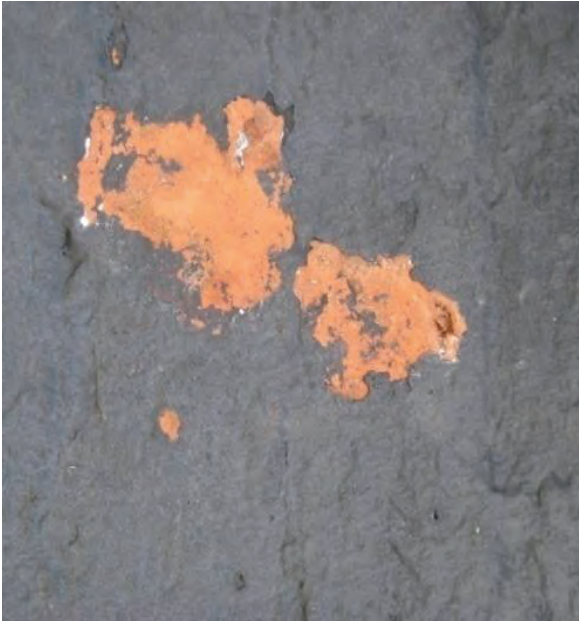
**Figure C-37** Physical evidence of red limewash on tower's exterior masonry.

- **Finishes:** According to the testing of exterior finishes prepared for this report, the brick masonry contains two campaigns of a red limewash followed by six campaigns of

black and white paint (in a harlequin pattern.) This finding apparently confirms the application of a coating as opposed to the simple exposure of the brickwork to give the red appearance noted in the 1859 *Notice to Mariners*.

The later black and white paints apparently post date the 1873 decision of the federal Light House Board to implement the current distinctive diamond pattern. The recent paints applied to the masonry are synthetic based, very rubbery and non-breathable. Probably applied for their waterproofing

capability and durability, they belong to a category of paint that has proven to be harmful to soft, handmade bricks, especially in combination with the use of hard, non-permeable repointing mortars as are found at this lighthouse.

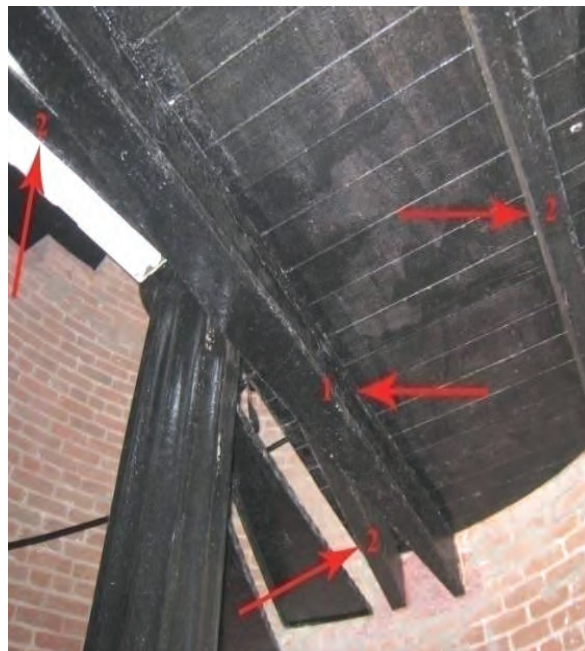
The third exception is also a mystery. Unlike all the landings above grade, the deck of the Third Floor landing is made of wood, not cast-iron. In the 1864 Union drawing of the temporary repairs, both the Second Floor and Third Floor original landing are absent, victims of the Confederate explosion. The makeshift runs of temporary wood stairs bypass the original locations of these two landings. In addition, the Union assessment calls for nine replacement floor plates, a number appropriate for the six needed at the full landing at the Second Floor and three for the intermediate half-landing of the Third Floor.

**Figure C-45** Third Floor Landing with reused 1859 cast-iron I-beam (1) and 1867 wood framing (2).

The Second Floor landing apparently was rebuilt with replacement iron floor plates, but the Third Floor landing is instead made of wood. The original cast-iron beam apparently was reused, but there are two

added wood joists to help support a wood board deck. No documentary explanation for this change in planning has been identified.

For whatever the reason, the Third Floor landing is different. Its construction seems certainly to date to the 1867 repair effort. And as tangible evidence of an important chapter in the lighthouse's history, it is exceedingly valuable.

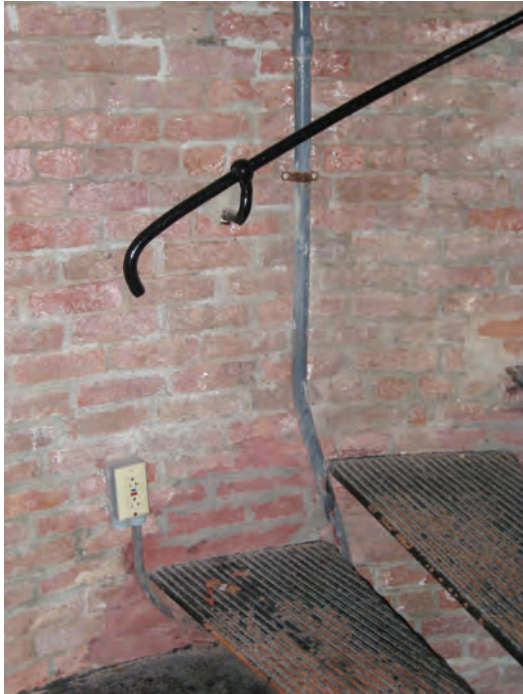
**Figure C-46** Original iron handrail of 1-inch diameter.

painted, round, iron handrail, 1" in diameter, apparently the original. The handrail is in good condition except for the masonry anchors, several of which are corroded and one has rusted through.

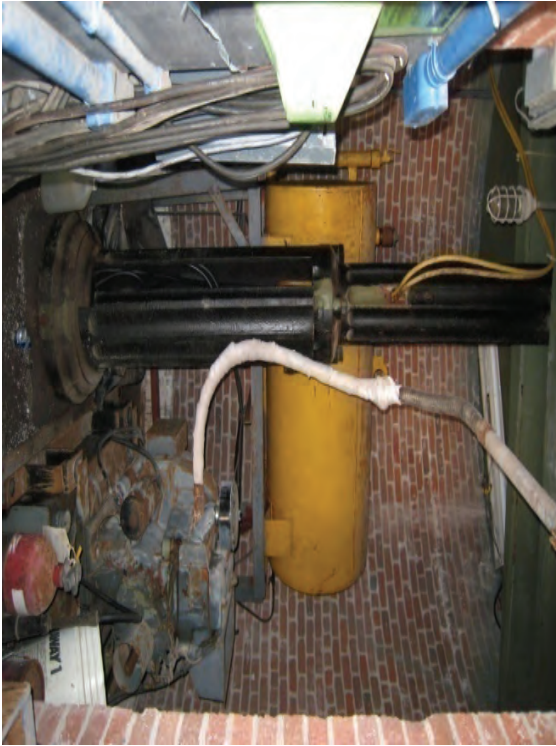
- **Walls:** The wall surface is constructed of handmade brick laid in a 1-to-5 common bond. In 1999 the brickwork was water blasted. The bricks' outer protective surfaces that faced the room were severely eroded in the process, exposing the softer interior of the bricks. This brickwork was then spot-repointed with a much too hard, impervious mortar. The combination of damaged brick and impervious mortar is causing the bricks to suffer further damage from moisture migration and spalling.

**Figure C-56** View of First Floor Room from Passageway.

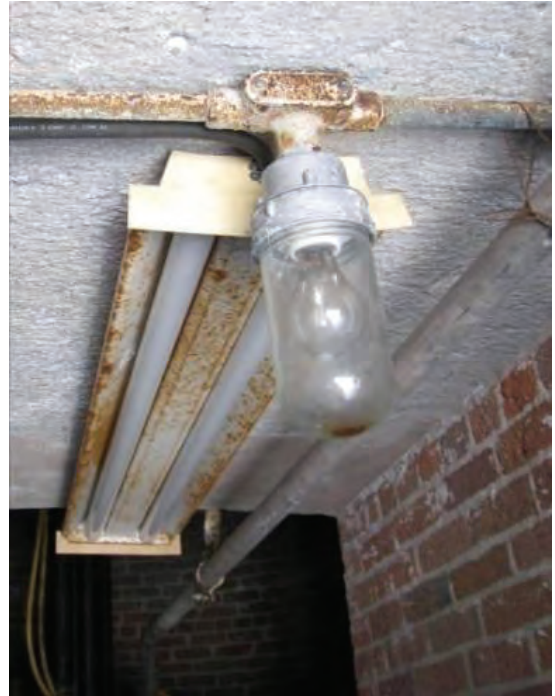
**Figure C-57** Metal electrical conduit with incandescent and fluorescent light fixtures.

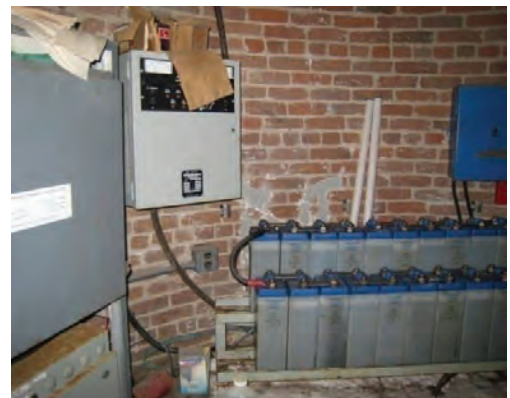
**Figure C-58** Abandoned power controller and fuel cells.

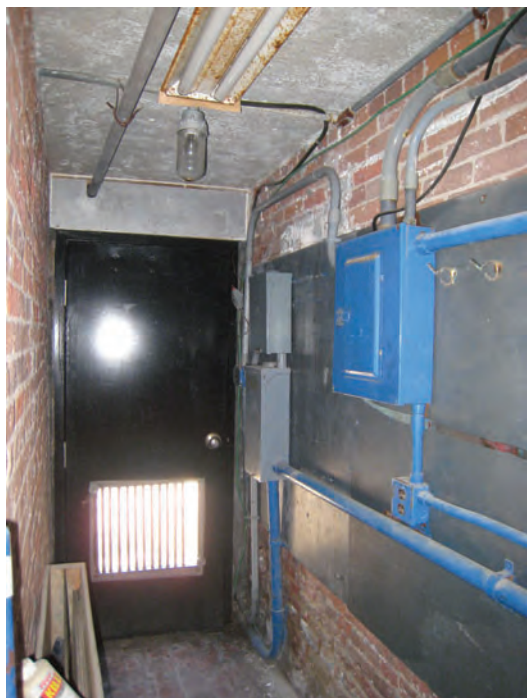
**Figure C-59** Currently operational electrical panels on west wall of entrance passage.

There are two electrical panel boxes on the west wall of the passageway. The circuit breaker is identified as 100 amp 600 v I Phase. The non-operational emergency generator is just east of the center column. Its fuel tank is just north of the column.

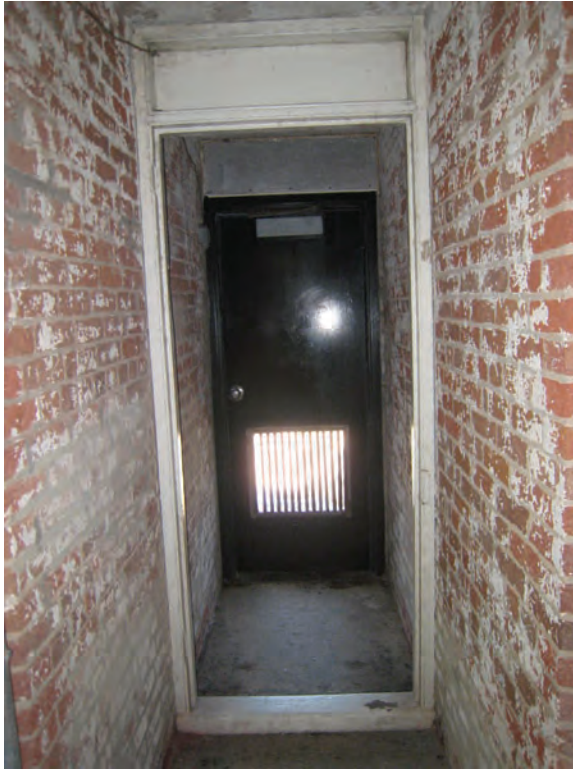
**Figure C-61** Modified original exterior doorway and c.1914 interior door/transom framing in foreground.

Partway down the passageway are the framing remnants of a wood doorway and transom framing. The door and transom sash are missing. Although associated documentary evidence has not been found, the construction is similar to the 1914 work at the Service Room and may be remnants of another air lock, part of the effort of that

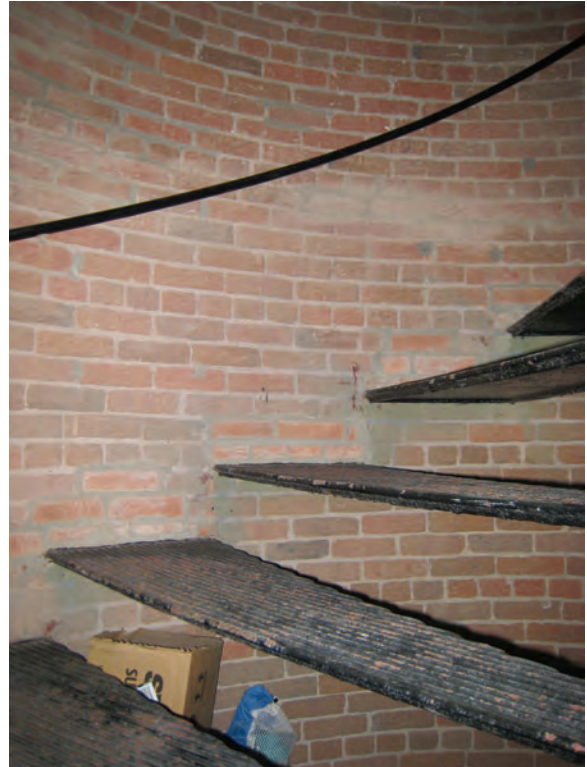
**Figure C-62** Typical cast-iron treads of Spiral Staircase.

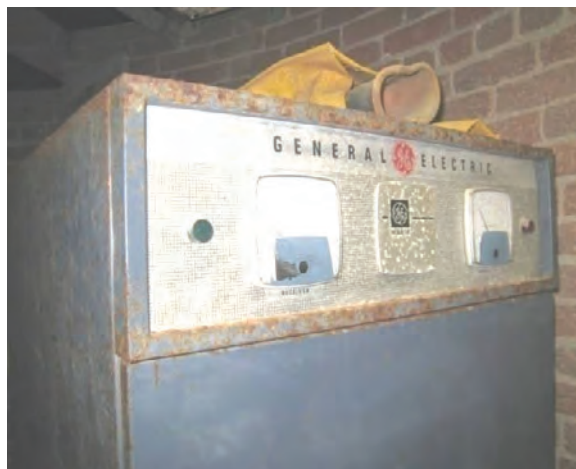
**Figure C-63** Abandoned GE transmitter/receiver.

Abandoned electronic equipment includes a General Electric Master Transmitter/Receiver.

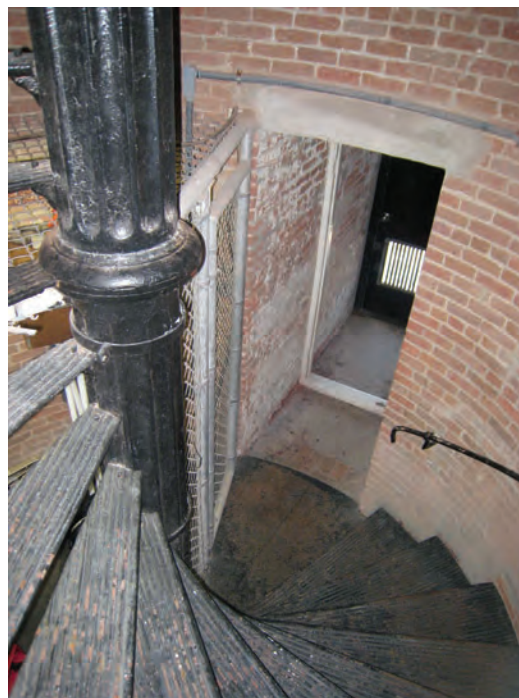
**Figure C-64** Second Floor entrance passageway, spiral stairs, and modern steel fence enclosure.

The masonry opening that connects the core with the window as discussed above is blocked at the interior core wall with two posts and a gate of metal cyclone-fence material. The gate is operable and in good condition.

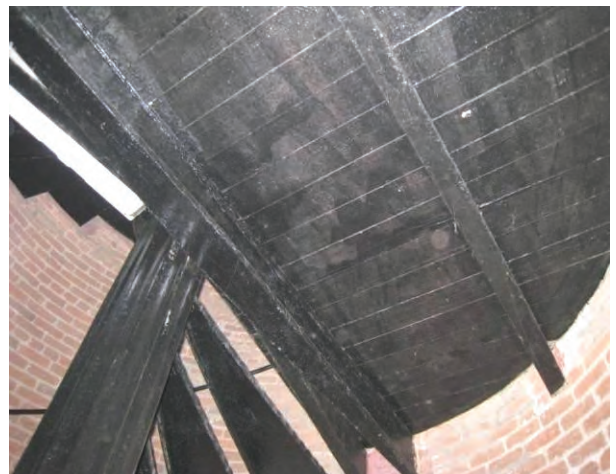
The original I-beam was apparently reused. However, two wood joists measuring 2 7/8" x 8" were added and a new flooring of boards measuring 1 3/4" x 5" was installed in place of iron floor plates.

Figure C-66 Third Floor wood Landing.

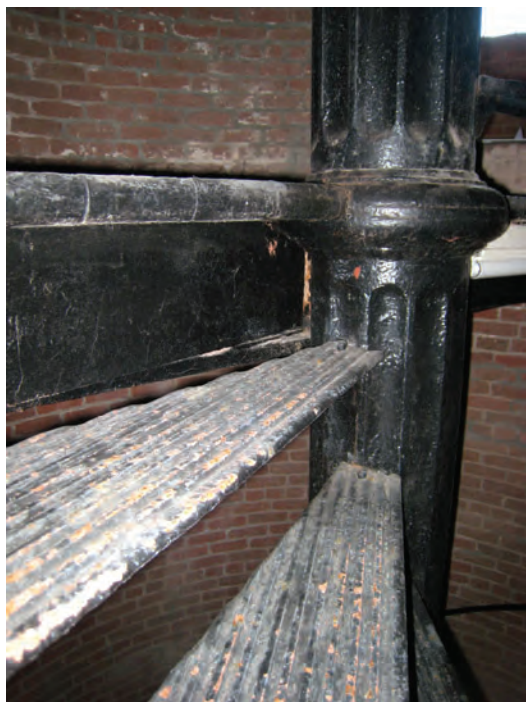
**Figure C-67** Detail of bull nose edging of Third Floor landing.

- **Flooring:** The landing was rebuilt in the same location and configuration as shown in the prototype design. However, the landing is made of wood instead of cast-iron. The plank floor boards, each measuring  $1\frac{3}{4}$ " x 5", are laid running northwest to southeast with a bull nose edge.

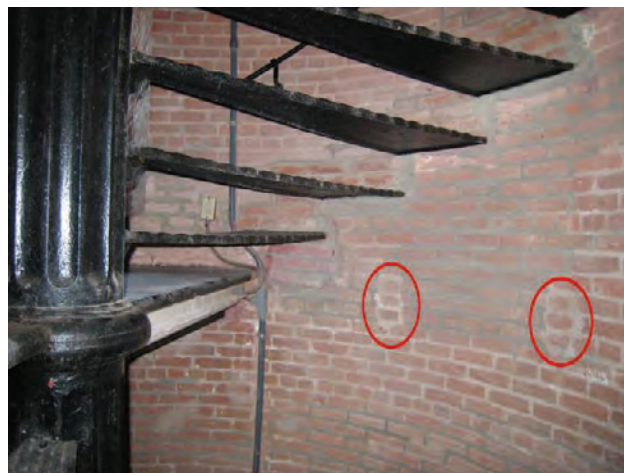
**Figure C-68** Two masonry patches presumably associated with the 1864 framing for temporary stairs.

The second set of evidence consists of five patches. All are at a height of 11'-9" above the top of the Third Floor landing. Two are on the north wall surface and three are opposite on the south wall surface. All five are similar to the other patches found lower at the level of the Third Floor landing and between the Second Floor and Third Floor landings.

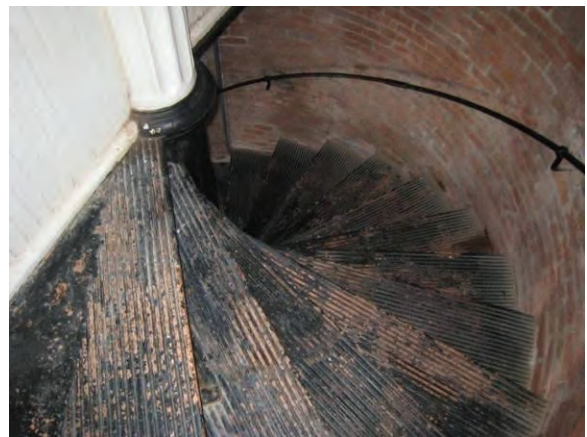
**Figure C-72** Original cast-iron steps leading down from Seventh Floor Landing.

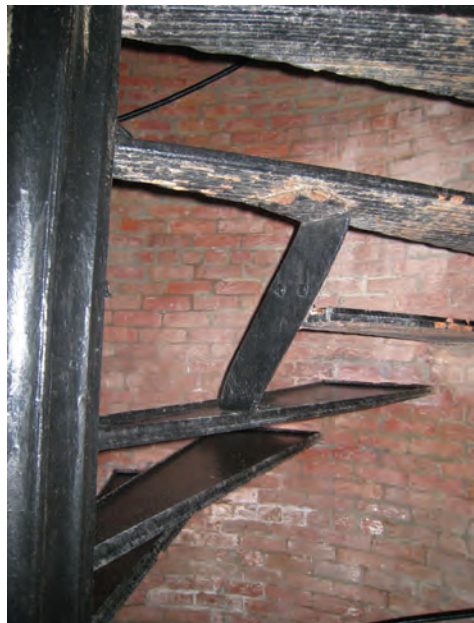
**Figure C-73** 1914 tread modification to accommodate the weight for occulting mechanism.

One step is missing half of its tread and is supported by an added vertical brace. This modification was made in 1914 to two treads in order to accommodate the chains for the new oscillating device.

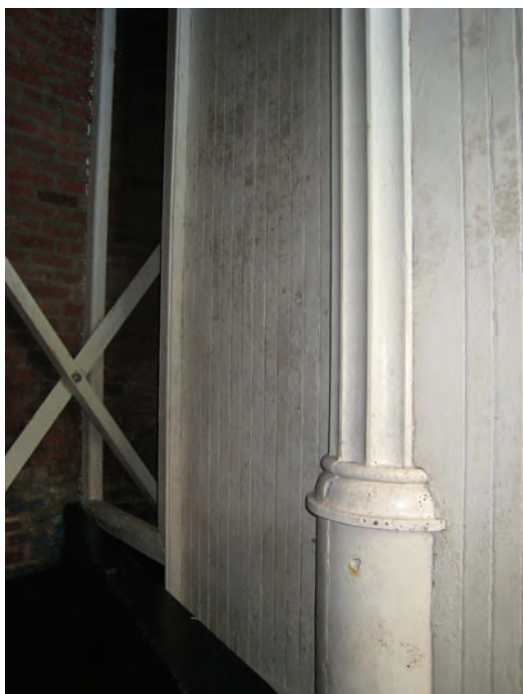
**Figure C-77** 1914 board wall and doorway at Seventh Floor landing. Note 1989 steel reinforcement added at masonry perimeter.

board wall at the lighthouse in types of material, methods of construction and paint finishes. The Museum's board wall and doorway appears to be part of the missing air lock. In addition, it appears that in situ wall was not repaired as called for on the 1913 plans but was rebuilt. Both the wall in situ and the air lock were constructed in 1914.

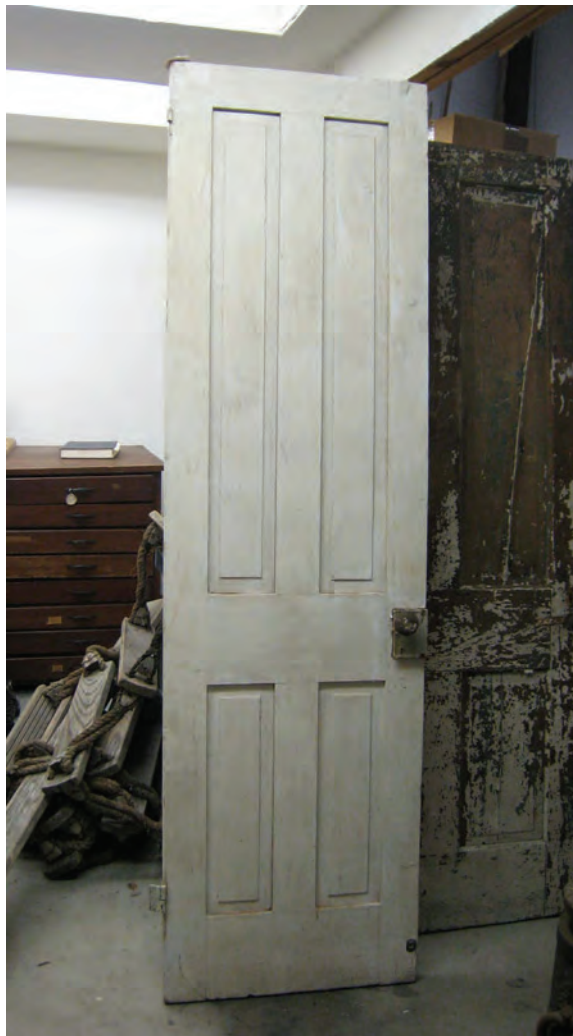
**Figure C-78** Salvaged four-panel door; detail images of rim lock with sheet metal doorknob and two-knuckle brass hinge. (North Carolina Maritime Museum Collection)

its hinges and rim lock. This door retains most of its original 1914 hardware. It has a sheet metal-clad, box lock measuring 3¼" wide x 4½" tall. The sheet metal doorknobs are probably replacements.

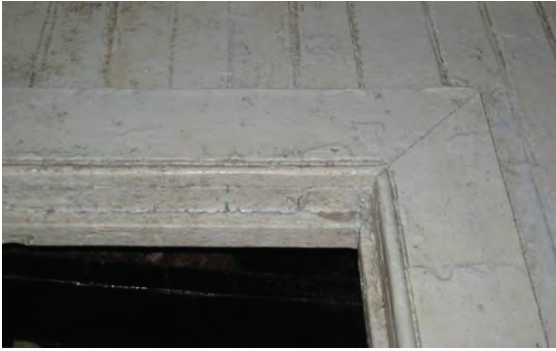
**Figure C-79** Seventh Floor door casing. Note miter cut of corner.

This door also retains its two, 2½" tall, two-knuckle, brass hinges. The keeper for the box lock remains on the doorway jamb still in place in the lighthouse. The door casing, appearing on both sides of the doorway, measures ¾" x 3½" with an edge bead of 3/8" and is mitered cut at the corners.

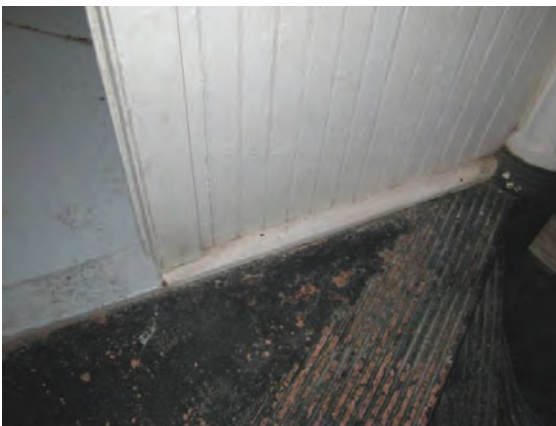
**Figure C-80** Door threshold and board wall at Seventh Floor, the top landing of the spiral stairs.

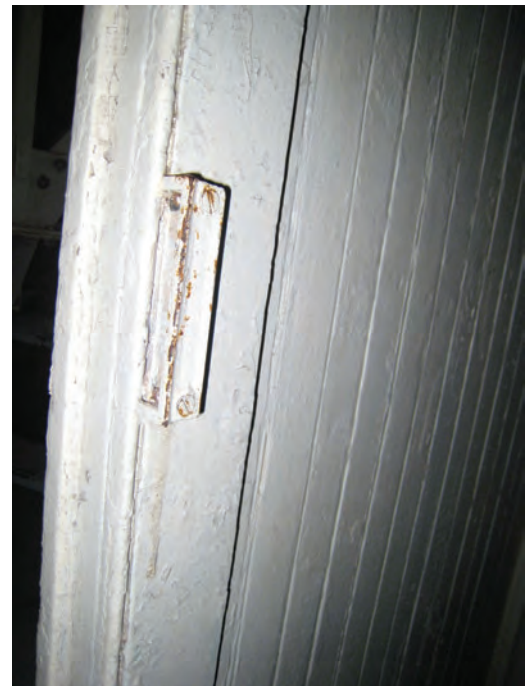
**Figure C-81** Door latch keeper matches rim lock of extra door in North Carolina Maritime Museum collection.

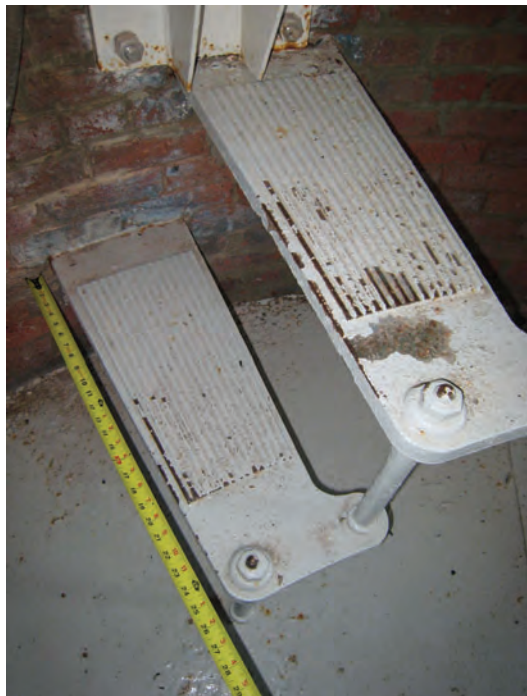
**Figure C-82** Original cast-iron ship's ladder stairs connecting Seventh Floor Service Room to Eighth Floor Watch Room.

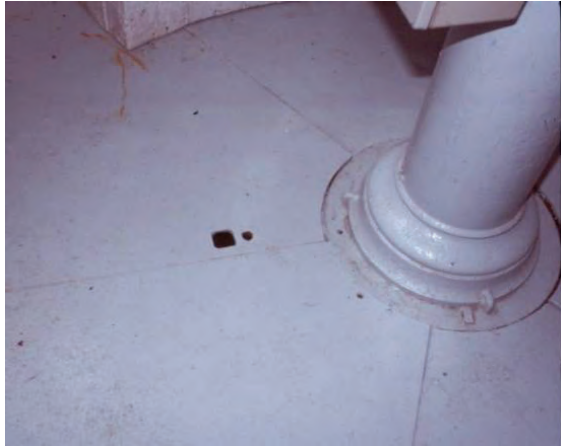
**Figure C-84** Floor cuts for 1914 drive chain for occulting mechanism.

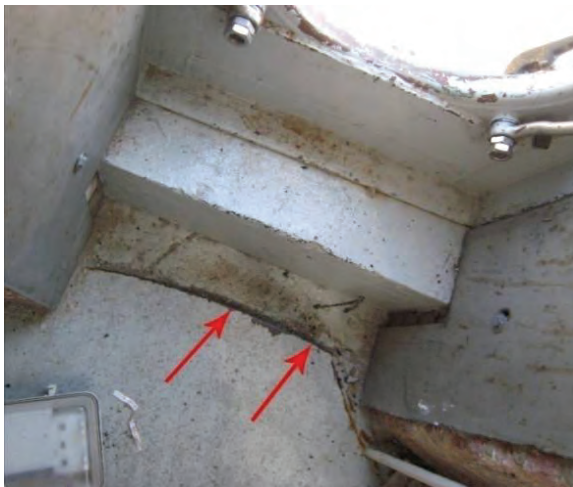
**Figure C-85** Jacking of iron floor plate at doorway to Observation Deck.

At the hatch to the Observation Deck, there is jacking of the iron floor plate with one section of broken plate sitting proud of the floor about 1¾".

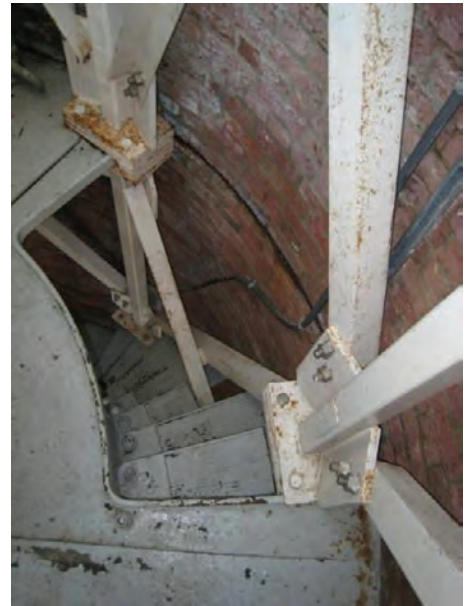
**Figure C-86** Cast-iron floor plates of Eighth Floor Watch Room looking to Seventh Floor Service Room.

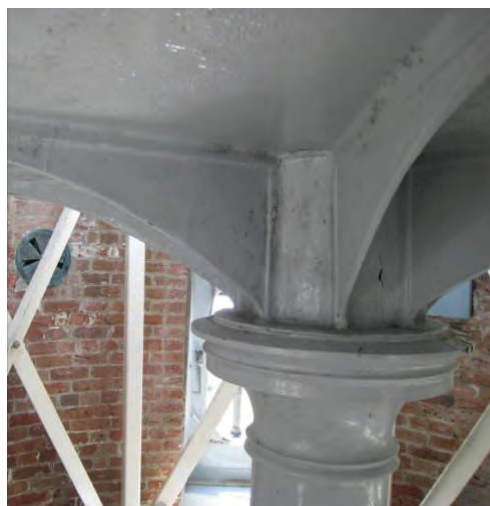
**Figure C-88** Column and underside of cast-iron platform for beacon.

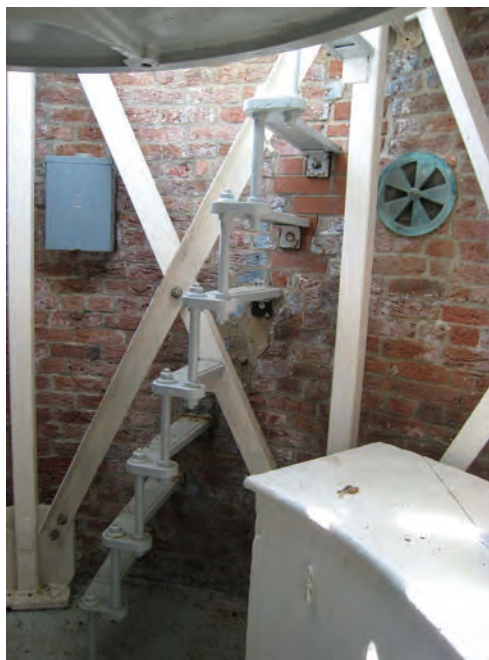
**Figure C-89** Original cast-iron ship's ladder to Lantern.

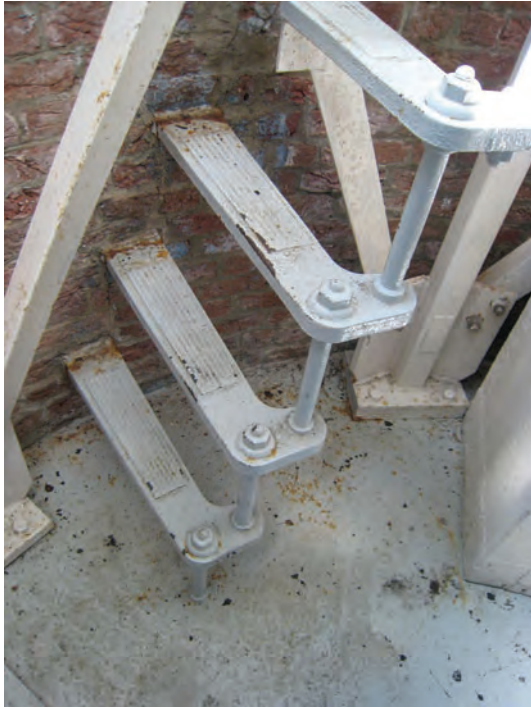
**Figure C-90** Close-up view of ship's ladder to Lantern.

- **Stairs:** The original cast-iron ladder stairs provide the access to the Lantern. These steps are also in the shape of a boot like those at the level below, but narrower and with a greater rise between treads. The steps begin along the southeast exterior wall (whereas the prototype plan has the steps beginning along the northeast wall.) Each tread measures 1'-9 ½" wide x 3½ to 4½" deep and 1" thick. The wider flange of each tread is connected to the masonry wall, while the narrow end is connected by two, separate 1" diameter rods with both the step above and the step below. The riser height is 9½". Portions of two of the eight treads have been removed to accommodate the steel reinforcement framing installed in 1989. Otherwise, this original ladder stair is intact and in good condition.

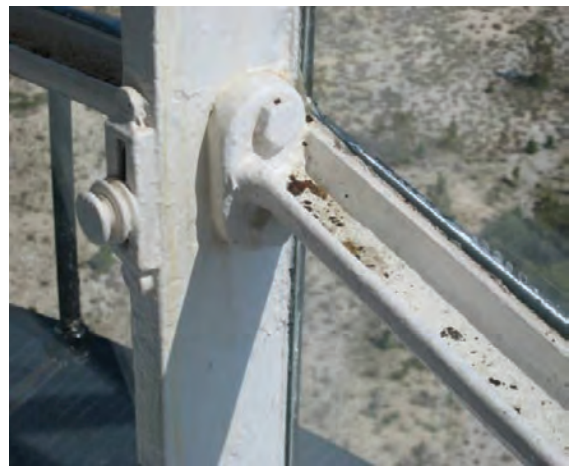
*Figure C-99 Close-up view of horizontal framing of a cast copper-based metal.*

refined details. There is much corrosion and surface loss of the cast iron, especially at the floor plate and at some connection points with the brass. A few of the glass panels are damaged.

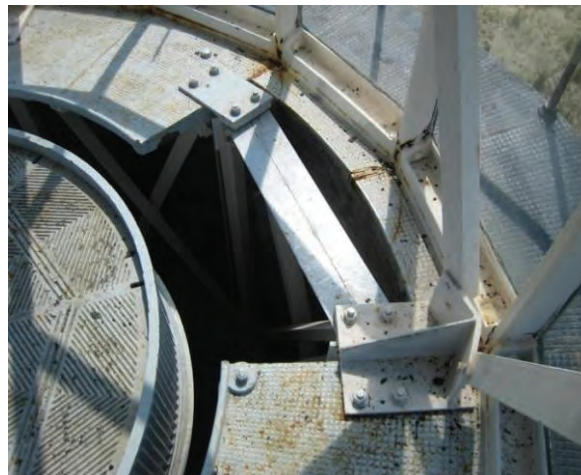
**Figure C-102** Access to stairs to Watch Level partially blocked by 1989 reinforcing steel.

The original cast iron ship ladder which allows passage of traffic from the storage to the watch level poses some challenges. The tread height is somewhat steep, the ladder consists of four partial treads due to the insertion of the 1988 adjacent bracing, and the maximum width of the stairs is narrow at 26". Passage is not ideal. Given its importance as an original character-defining element, other limitations of the path of travel, and the potential for full restoration of the lighthouse, it is recommended that if the ladder be retained in place and a temporary railing be added or other remedial action be taken to ensure safe passage.

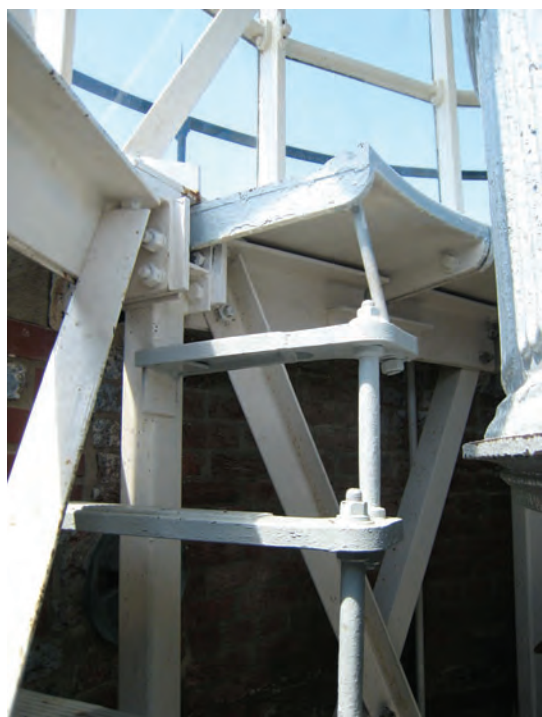
**Figure C-101** Original cast-iron ship's ladder connecting to Lantern floor plates.

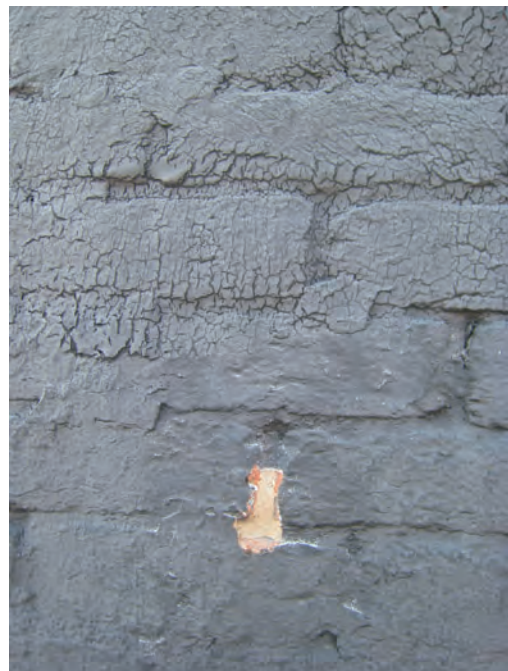
Unfortunately, both the interior surface of the core wall and the exterior surface of the exterior wall have been water blasted. The effect as seen on the interior of the lighthouse, is that the protective outer surfaces of the bricks have been damaged, exposing the less-durable interior material.

**Figure C-108** Non-breathable coating on exterior masonry.

brickwork, removal of incompatible mortars/reapplication of suitable mortar, and removal of the non-breathable exterior coating/replacement with a compatible coating.

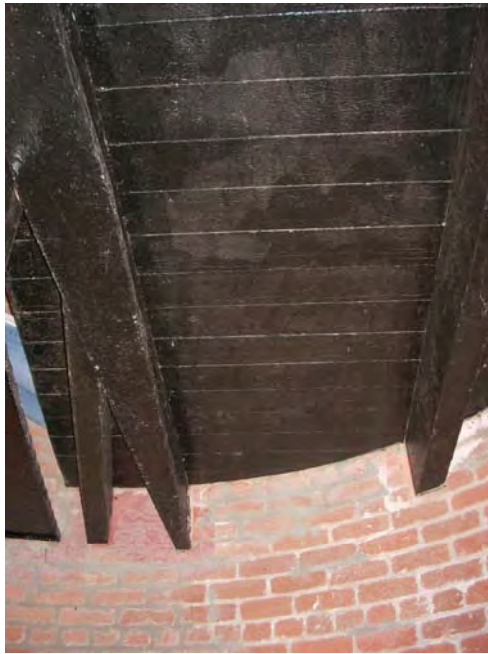
One landing differs in construction from the remainder of the other landings. The third floor landing is of wood construction with wood support beams (see Figure 4). Analyses were also performed on this landing to determine if it may provide adequate capacities to support the traffic which will occur. In addition, since this is the first landing that visitors will reach it is more likely that it will receive the most traffic and impact. Interest was expressed by both the park service staff, and the architect to preserve this landing during the May 2008 site visit. In an earlier report “Engineering Study of Cape Lookout Lighthouse” issued on May 12, 2005, issues concerning the fire resistivity of this landing were expressed. Recommendations for these concerns may be found in the recommendations section below. The flexural and shear capacities used in analysis were that of visually graded sawn Southern Pine No. 2. It is known that the lumber present during the construction of the lighthouse had a greater available capacity, but the decrease in allowable values ensure that the actual landing capacities are conservative.

Analysis has shown that the presence of the bracing ribs (at the steel landings) increases the allowable stress by 25 percent to 3.75 ksi for the landing plates. Using the minimum code recommended live load of 100 psf, the maximum stress of the landing plates as originally designed was calculated to be 5.4 ksi, giving a safety factor of 9.3 based on the additional 25 percent of allowable stress. Although that value is lower than the recommended safety factor for cast iron, it is still a comfortable safety factor since the landing plate showed no apparent signs of cracks. The maximum calculated deflection of 0.42 inch exceeds the allowable deflection of 0.23 inch. In its existing condition, an analysis of the steel plate landing produced stress and deflection results of 6.5 ksi and 0.56 inch. With the additional 25 percent allowable stress, the safety factor for the existing landing plate is 7.7, much lower than the recommended safety factor of 13.3 and exceeding the “comfort zone” for safety. Since analysis of the landing plate produces

results that exceed the safety “comfort zone,” there is a possibility of failure if the landing is fully loaded to the maximum code-mandated load of 100 psf; 16 people weighing 250 pounds per person would have to stand on the landing. It would be physically impossible for 16 people to stand on the landing simultaneously. A more realistic assumption would be 6 people on the landing at the same time (one person per 7 square feet), reducing the load to approximately 40 psf and the stress to 3.2 ksi. The resulting stress would be within the recommended range for cast iron.

**Figure 4 – Wood Landing**

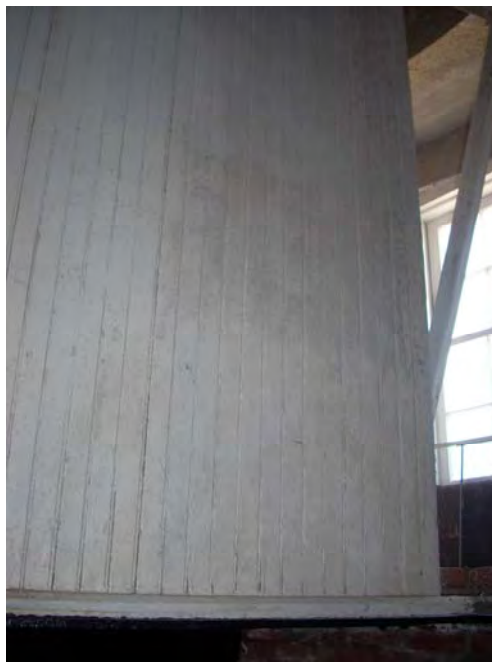
Bracing also occurs on the opposite wall face to the bracing described above. In order to insert this bracing element, the separation wall from the storage level to the main staircase opening had to be partially removed (see Figure 5). This opening and resulting instability of the wall could endanger tourists on this level. The bracing should be removed at this location and the wall should be restored so that it would fully block passage through this area. This separation wall must also be stiffened at mid-height with a horizontal brace supported off of the masonry wall and the center column in order to ensure that this wall provides enough rigidity in order to support a lateral force (visitors leaning against the wall) against this partition.

**Figure 5** – Bracing Interrupting Partition Wall at Storage Area
