Cape Lookout National Seashore

Cape Lookout Lighthouse

**Historic Structure Report**

December 2008

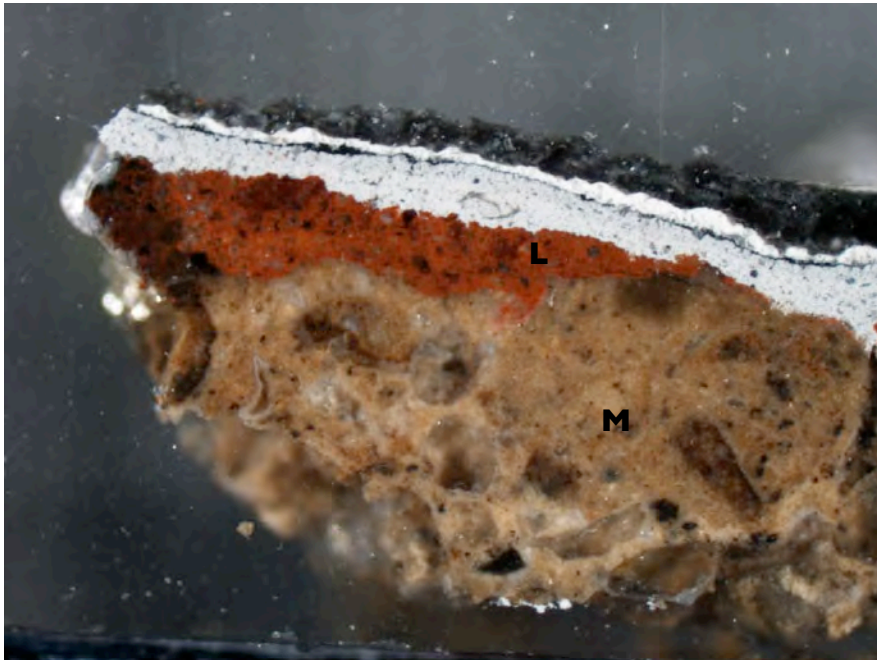
Analysis of paint samples indicates that the exterior brick masonry of the lighthouse contains two early campaigns of red limewash followed by four to six campaigns of black and white paint (always applied in a checkered pattern). The red limewash is also visible under the existing exterior paint coatings, on the surface of both the brick and mortar, in numerous locations. Archival research, performed by Joseph K. Oppermann Architect, P.A. as part of the HSR, revealed that the lighthouse was historically red in color. An 1859 *Notice to Mariners* states that: “The color of the tower is red.”<sup>6</sup> Until now, the source of the red color was unknown. The color could have been achieved through the application of an oil paint or the description could have simply referred to the color of the brick masonry construction. The current research, however, provides proof that the first finish applied to the lighthouse’s exterior masonry was in fact a pigmented red limewash. While it is possible that the exterior brickwork of the lighthouse was originally unpainted and that the red-colored limewash was applied subsequently in order to refresh its red brick appearance, the lack of a distinct dirt layer between the surface of the brick and the first pigmented limewash suggests that the first red limewash layer is original. (Figures 5 and 6)

**Figure 5.** Cape Lookout Lighthouse. Photomicrograph of Sample CALO.E.11, removed from the exterior of the lighthouse shows the original red limewash (L) applied over brick mortar (M), followed by layers of modern black and white paint coatings. Photograph by author, 40x magnification.

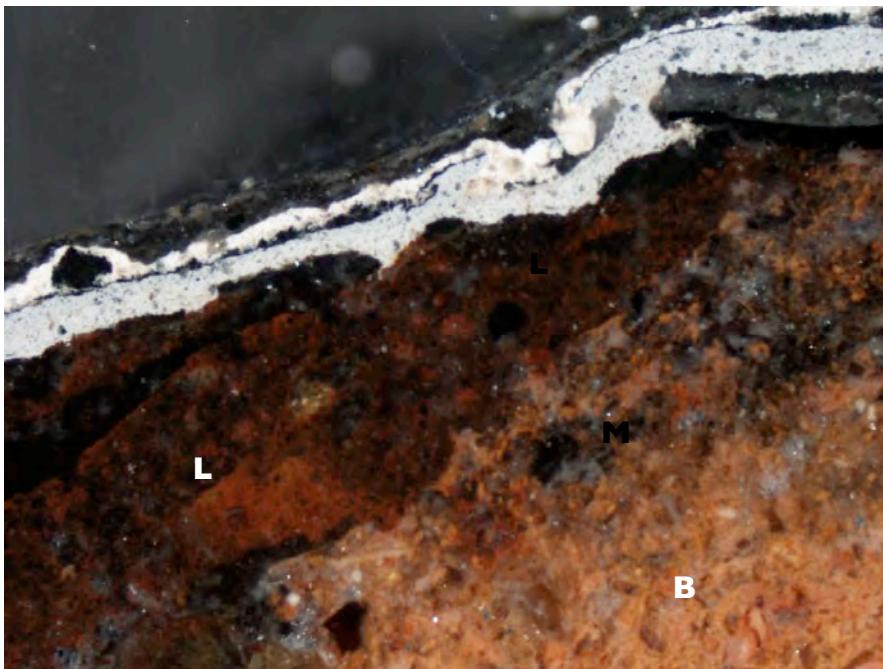
**Figure 6.** Cape Lookout Lighthouse. Photomicrograph of Sample CALO.E.10, removed from the exterior of the lighthouse shows the original red limewash (L) applied over brick substrate (B). Subsequent layers of black and white paint coatings are also visible. Photograph by author, 40x magnification.

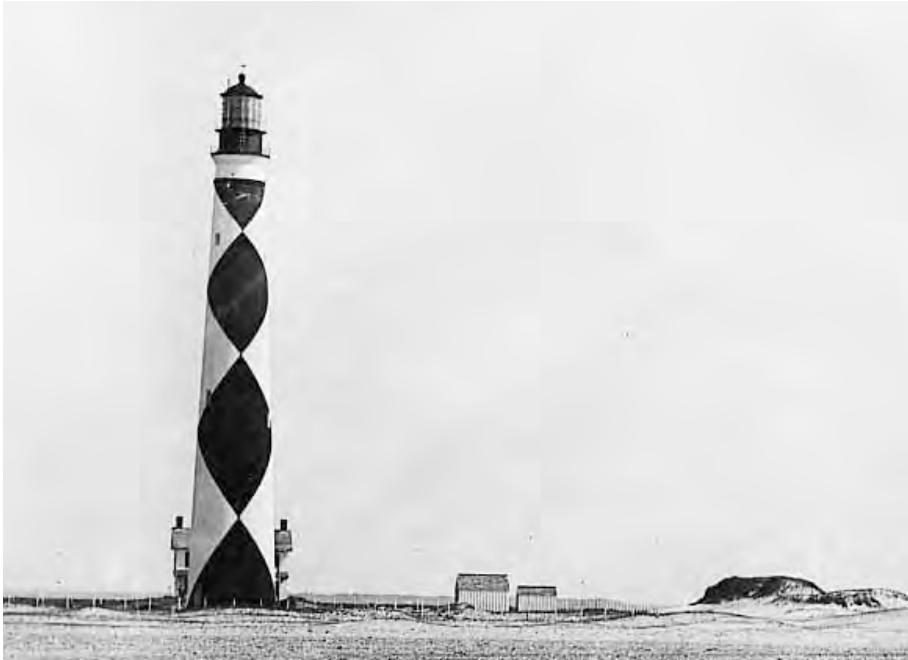
Historical documentation also provides information about the point in time when the masonry exterior of the lighthouse underwent this dramatic change. In 1873, the U.S. Light House Board directed that the lighthouse be painted in a new way in order to conform to new universal standards that gave each lighthouse along the Outer Banks a unique and discernible appearance. The new paint scheme called for the Cape Lookout Lighthouse to “be checkered, the checkers being alternatively black and white.”<sup>7</sup> It is this pattern, dating from 1873, that is depicted in the historic photographs from 1899 and 1910, and which still adorns the lighthouse today. Although the paint type has changed, from traditional oil paints to more modern coatings, the color palette and pattern has been maintained since 1873. The HSR includes five references to the exterior of the tower being painted since 1873 (in 1885, 1992, 1995, 2000 and 2004). In each of these repainting campaigns, the black and white diagonal checkered pattern was re-applied. (Figures 7 and 8)

**Figure 7.** Cape Lookout Lighthouse. A detail of an historic photograph of the lighthouse, dated 1899. This is the earliest known photograph of the lighthouse and shows its 1873 paint scheme. Photograph courtesy of Joseph K. Oppermann – Architect P.A.

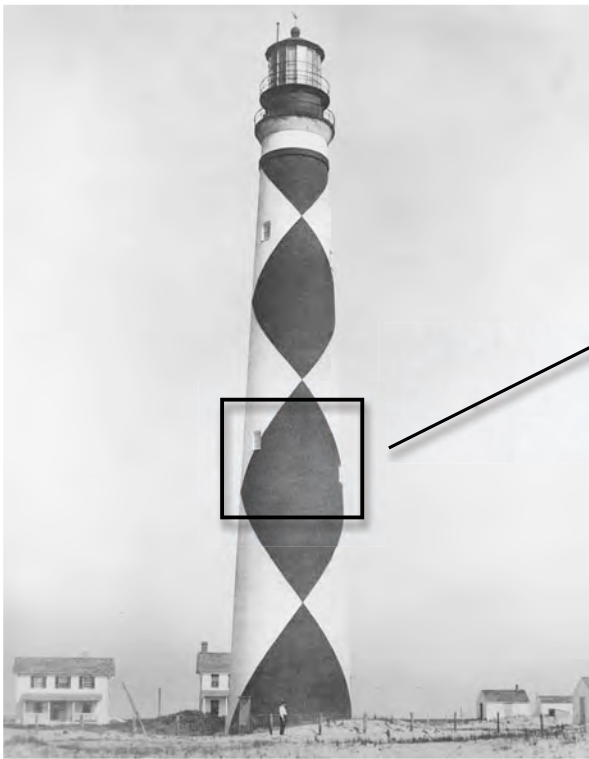
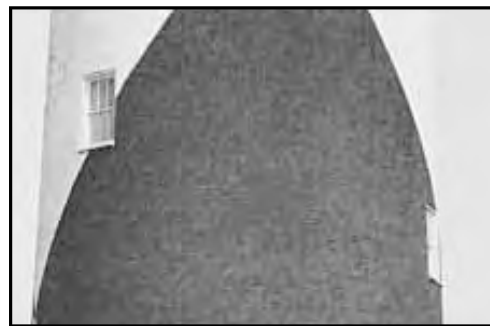
**Figure 8.** Cape Lookout Lighthouse. Another historic photograph, dated 1910. Note the light-colored window sash and frames, even in areas of black paint (inset). Photograph courtesy of Joseph K. Oppermann – Architect P.A.

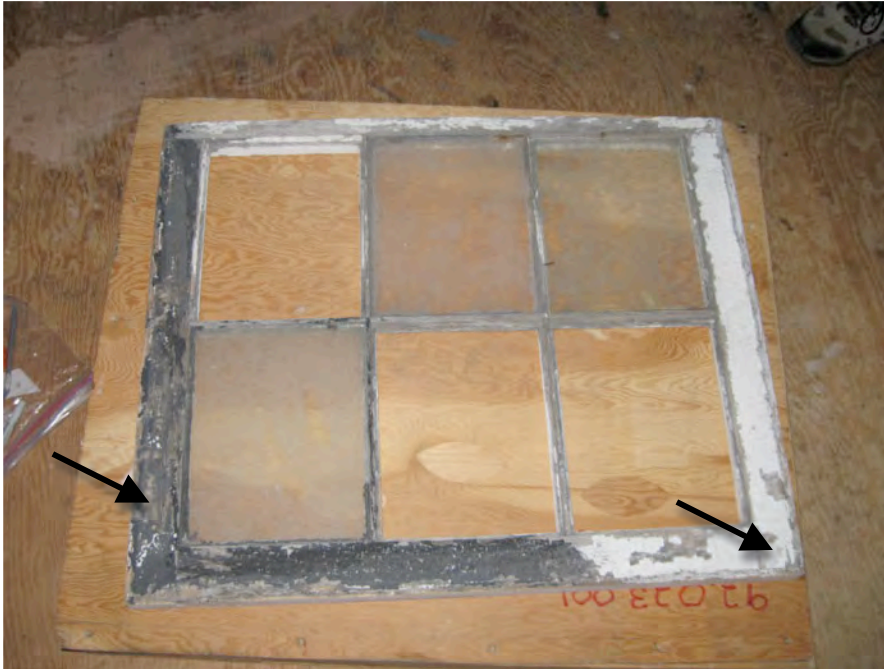
As previously mentioned, the majority of the exterior woodwork on the lighthouse was damaged by Hurricane Fran and replaced in 1996. However, the historic (presumably original) window sash were salvaged and are in storage at the North Carolina Maritime Museum in Beaufort, North Carolina. These sash were examined as part of this study and were found to retain much of their paint history. Unfortunately, the original exterior doors were not located. (*Figure 9*)

**Figure 9.** Cape Lookout Lighthouse, October 2008. A salvaged window sash currently located at the North Carolina Maritime Museum. Two samples were removed from the exterior face of the sash (arrows). Photograph by author.

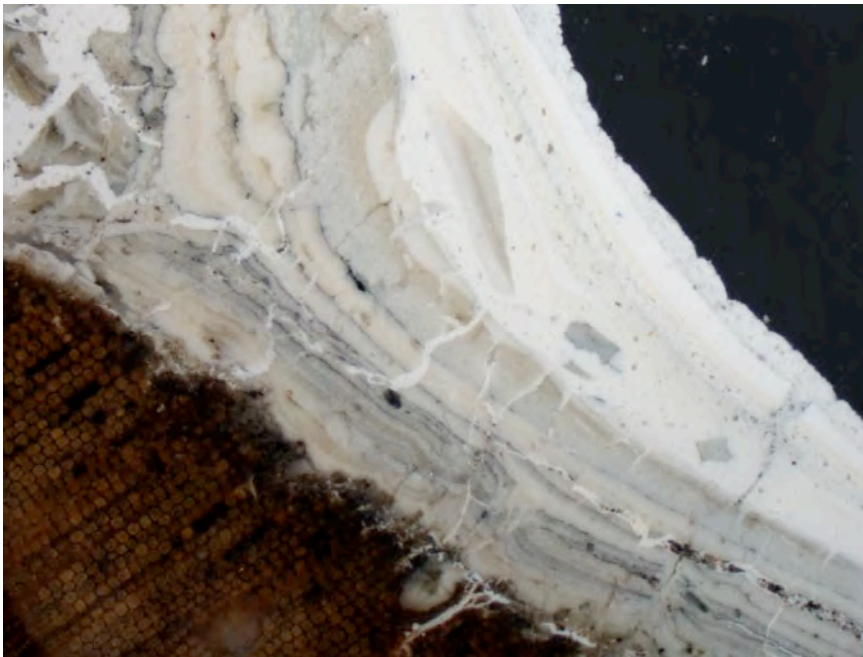
The current paint scheme of the salvaged window sash examined for this study, which must have been located at the diagonal seam between black and white sections of the lighthouse exterior, is half black and half white. A paint sample was removed from the black portion of the sash and revealed approximately 15-20 layers of paint, the majority of which were white or off-white. Therefore, it appears that the exterior face of the sash was historically painted solid off-white, even when the black and white checkered pattern was applied to the lighthouse masonry. In fact, the historic photograph from the early 20<sup>th</sup> century, visible in *Figure 8*, shows a light-colored sash in one of the window openings within the black-painted area. It seems that the bi-color paint scheme on the sash is not original and that it is a fairly recent treatment. (*Figure 10*)

**Figure 10.** Cape Lookout Lighthouse. Photomicrograph of Sample CALO. SALV.3, which was removed from the exterior face of the salvaged window sash. Between 12 and 18 paint layers were found on the exterior face of the sash and the majority of the layers were off-white, even in the area currently painted black. This evidence suggests that the sash were painted off-white for the majority of the lighthouse's history. Photograph by author, 40x magnification.

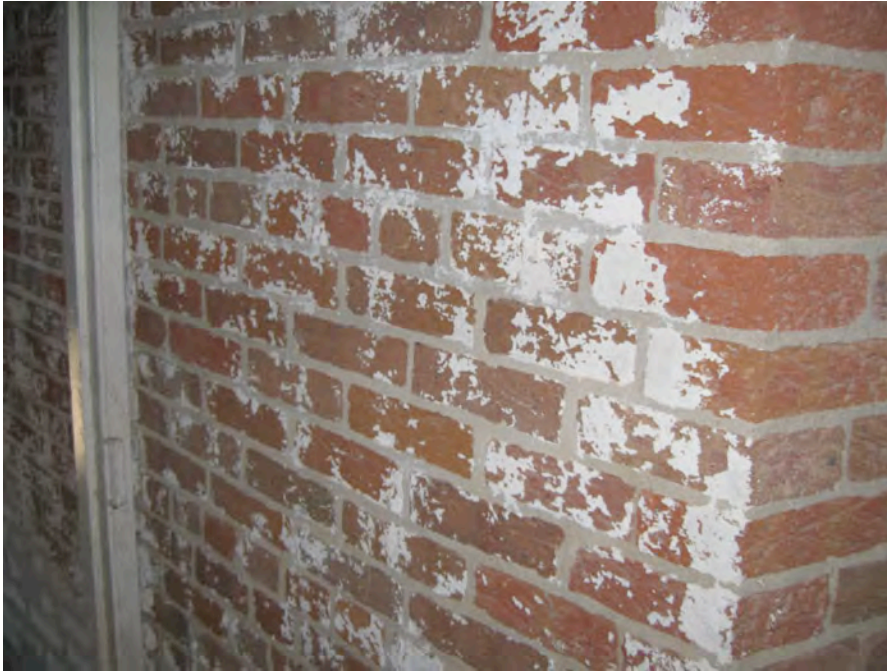
The interior brick walls, which were blasted in 1996, currently contain minimal evidence of paint finishes. The entry vestibule walls and the floors of window wells contain some evidence of limewashes, but all other walls throughout the lighthouse are exposed brick. Historical accounts of other lighthouse in the same region, namely the Bodie Island Lighthouse to the north, indicate that the interior was typically whitewashed on a regular basis.<sup>12</sup> This would certainly be in keeping with nineteenth century practices of maintenance and hygiene. White limewash was found on the entry vestibule walls and also on the bottom four courses of brick in the boiler room (in a location that would have been under a wood platform and therefore protected), suggesting that historically a white limewash treatment may have been applied to the interior of the lighthouse. Unfortunately, the lack of physical evidence prevents this from being documented with any degree of certainty. (*Figures 11 and 12*)

**Figure 11.** Cape Lookout Lighthouse, September 2008. Evidence of white limewash on the entry vestibule walls. All other finishes have been removed from the interior brick walls. Photograph by author.

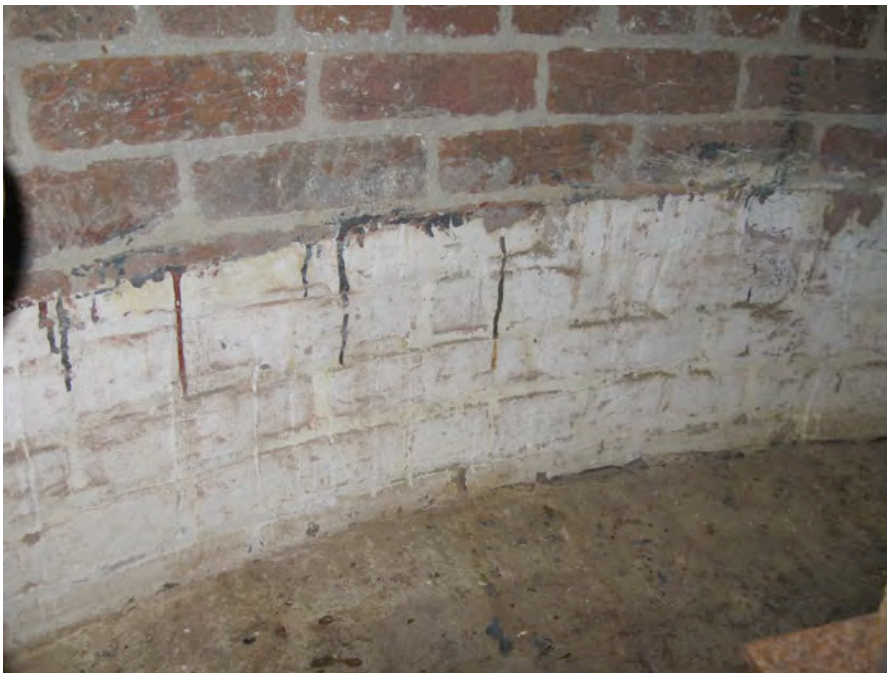
**Figure 12.** Cape Lookout Lighthouse, September 2008. Additional evidence of limewash was found in the boiler room, in an area previously covered by a wood platform. Photograph by author.

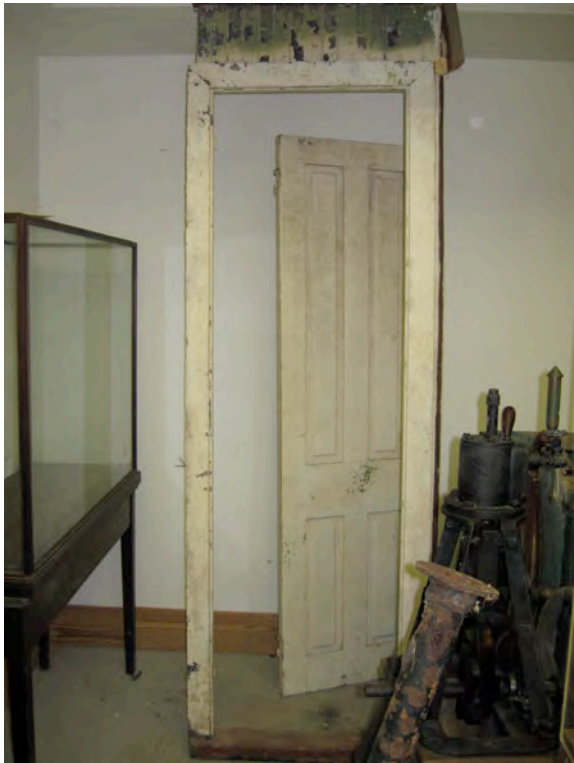
The interior woodwork of the Cape Lookout Lighthouse has a richer finishes history. In general, there is consistency between the paint evidence found on the salvaged woodwork and the pieces that remain in situ. On several pieces of interior woodwork, the earliest existing paint color is khaki. This color was found on a section of salvaged beadboard wall and associated interior door and frame, as well as on an in situ section of beadboard wall located on the service level of the lighthouse. These components of the lighthouse are believed to be contemporaneous, dating from a 1914 period of modification for the lighthouse.<sup>13</sup> On the salvaged interior door, the khaki color was documented on rails and stiles but the panels were picked out in a dark green. (*Figures 13 and 14*)

**Figure 13.** Cape Lookout Lighthouse, October 2008. An interior door salvaged from the lighthouse and now in storage at the North Carolina Maritime Museum. Photograph by author.

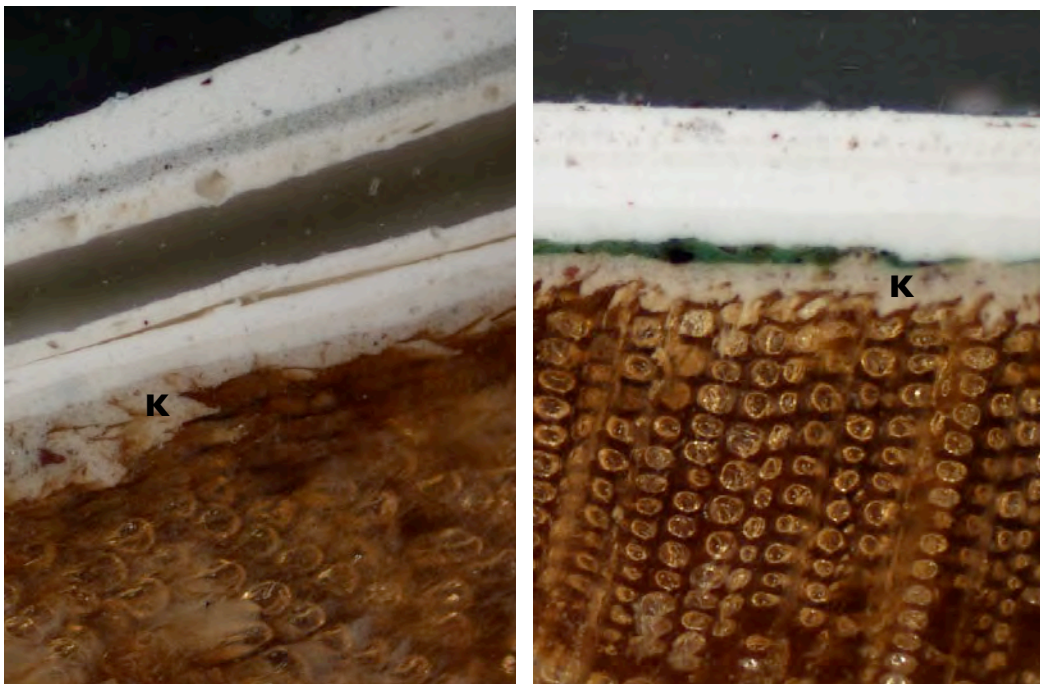
**Figure 14.** Cape Lookout Lighthouse. A comparison of two paint samples, CALO.SALV.4 (left) and CALO.SALV.5 (right), removed from the stile (left) and the recessed panel (right) of a salvaged interior door. Note the layer of dark green applied over the original khaki (K) paint only on the sample removed from the panel. This evidence suggests polychromy. Photograph by author, 100x magnification.

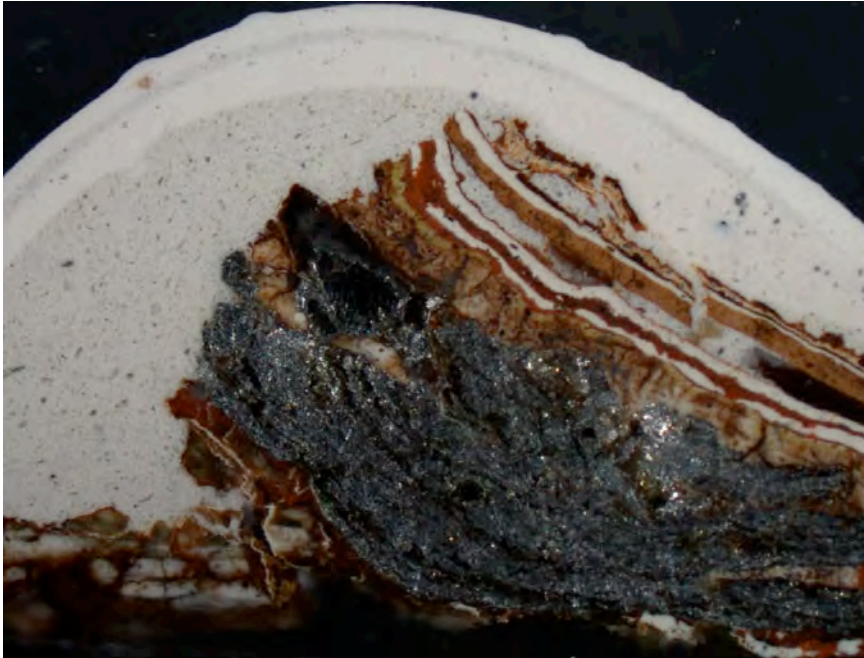
The one metal component of the interior that contains numerous layers of paint, the earliest of which may be original, is the glazed lantern frame. Although the frame is composed of two different types of metal (ferrous vertical pieces and copper alloy horizontal pieces), they both appear to have always been painted some version of white. One area of the copper alloy component was sampled and was found to contain twelve layers of cream or white paint, sometimes applied over a red primer. A similar stratigraphy was found on the iron-based component. This light color for the interior of the lantern would have been important for reflecting the light from the lens. (*Figures 15 and 16*)

**Figure 15.** Cape Lookout Lighthouse. Photomicrograph of Sample CALO. 1.22, removed from one of the copper alloy components of the glazed lantern frame. Numerous layers of off-white (as well as primer red) are visible. There is also a thick metallic paint layer that was applied to the lantern interior fairly early in its history but is not original. Photograph by author, 40x magnification.

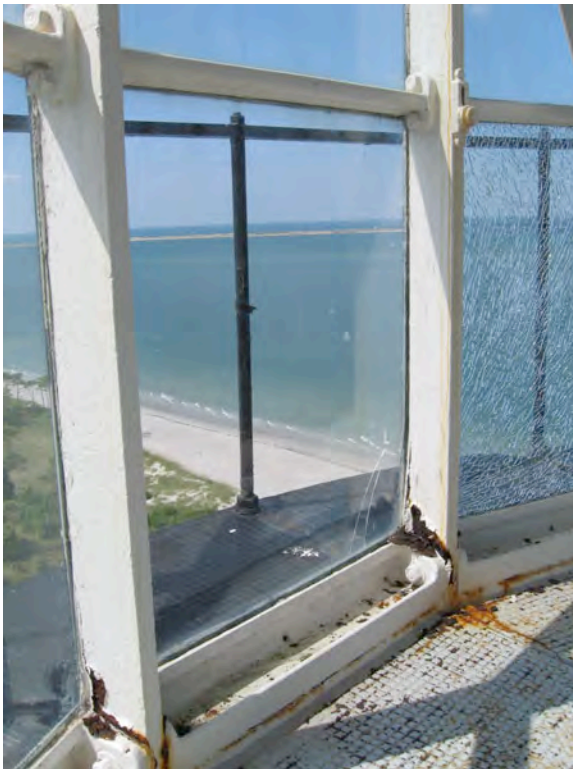
**Figure 16.** Cape Lookout Lighthouse, September 2008. Glazed lantern, interior face.

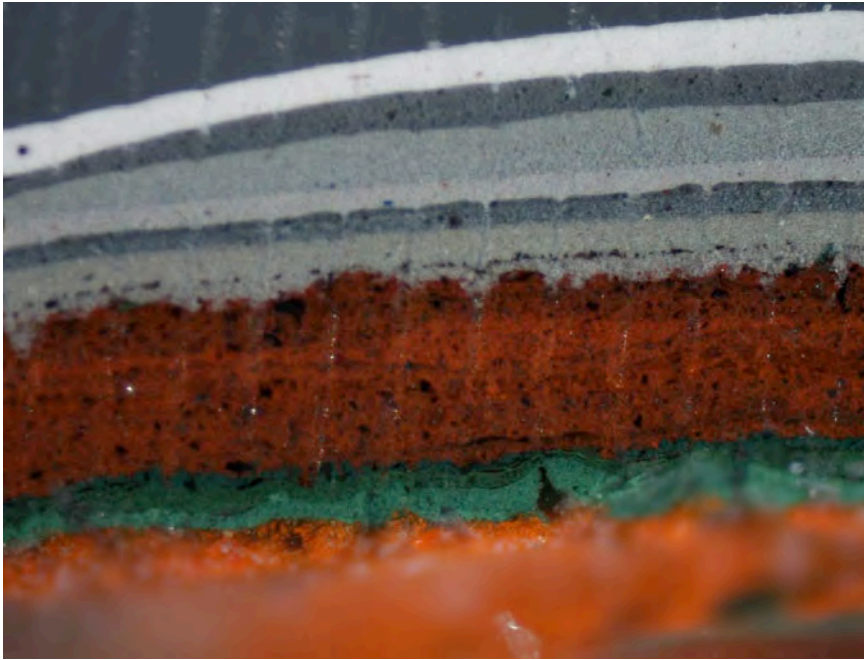
Other metal components of the interior were painted differently. The earliest paint color on the central cast iron column was dark green (two layers), followed by numerous red-browns and grays. The dark green was applied directly over a red primer on the metal, indicating it may have been original. In total, however, there were twelve layers of paint applied to the column. The earliest color on the cast iron stair treads was dark gray, followed by several red-browns and dark grays. This area also contained approximately twelve layers of paint. Although there are a fair number of paint layers on both of these interior elements, the lighthouse would have been well maintained and one would expect to find evidence of even more paint layers. There is unfortunately no way to determine whether or not the early dark green and gray paint colors on these metal components are original. (*Figures 17 and 18*)

**Figure 17.** Cape Lookout Lighthouse. Photomicrograph of Sample CALO. I.3, removed from the astragal of the center cast iron column (at the Watch Level). Note the early red-orange primer followed by a dark green paint finish at bottom of photograph. This campaign may be original. Photograph by author, 100x magnification.

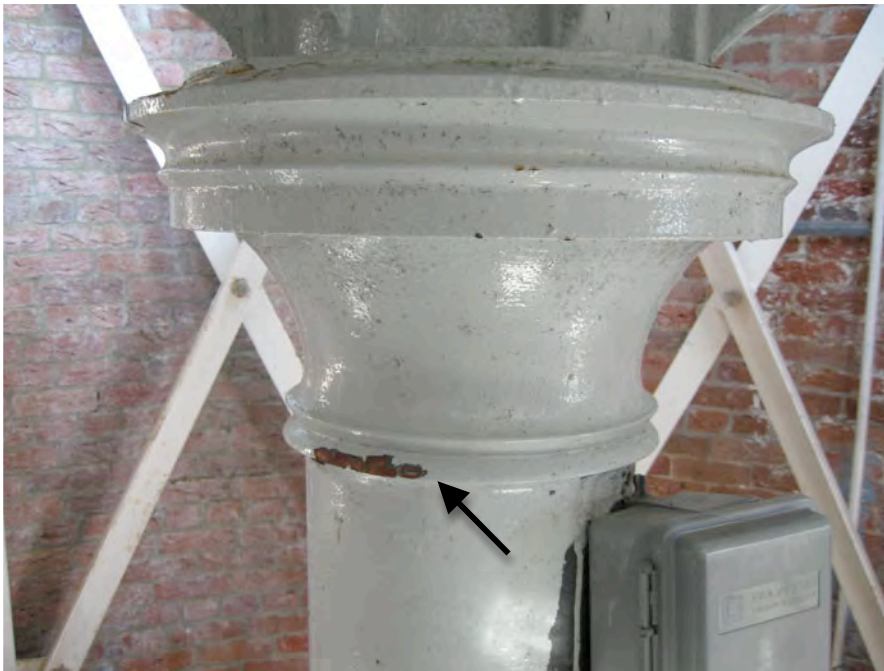
**Figure 18.** Cape Lookout Lighthouse, September 2008. Location of Sample CALO.I.3. Photograph by author.

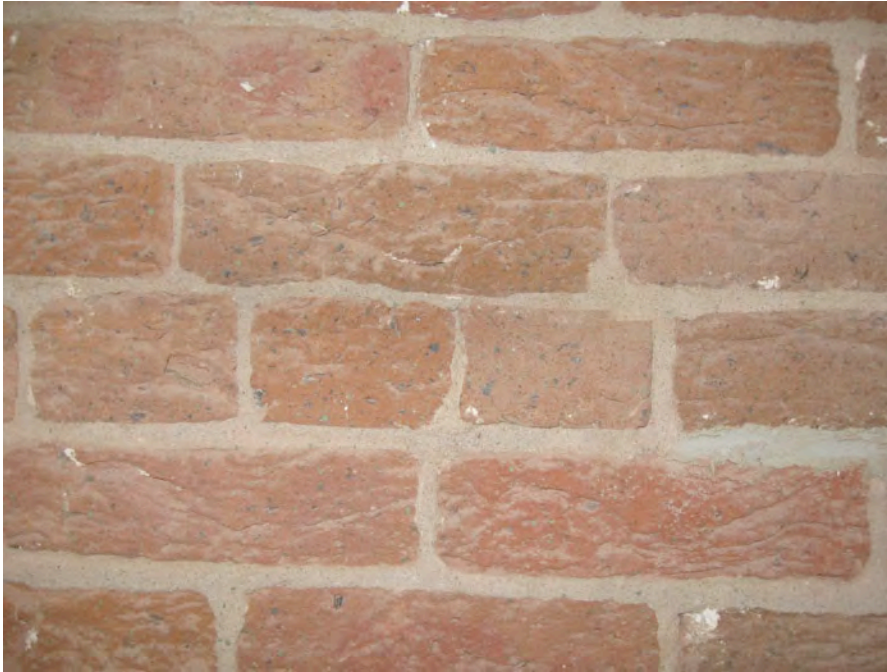
**Figure 19.** Cape Lookout Lighthouse, September 2008. Area of typical interior brickwork showing the brick's hand-pressed, low-fired quality and appearance. Photograph by author.

The bricks that the Cape Lookout Lighthouse is constructed of are low-fired and handmade, with subtle variations in color and texture due to the low temperature firing process. There are also numerous visible inclusions of aggregate and clay, as well as evidence micro-cracks from the forming process. Although much of the brickwork on the exterior of the building is obscured by paint, the interior brick is currently exposed. (*Figured 19 and 20*)

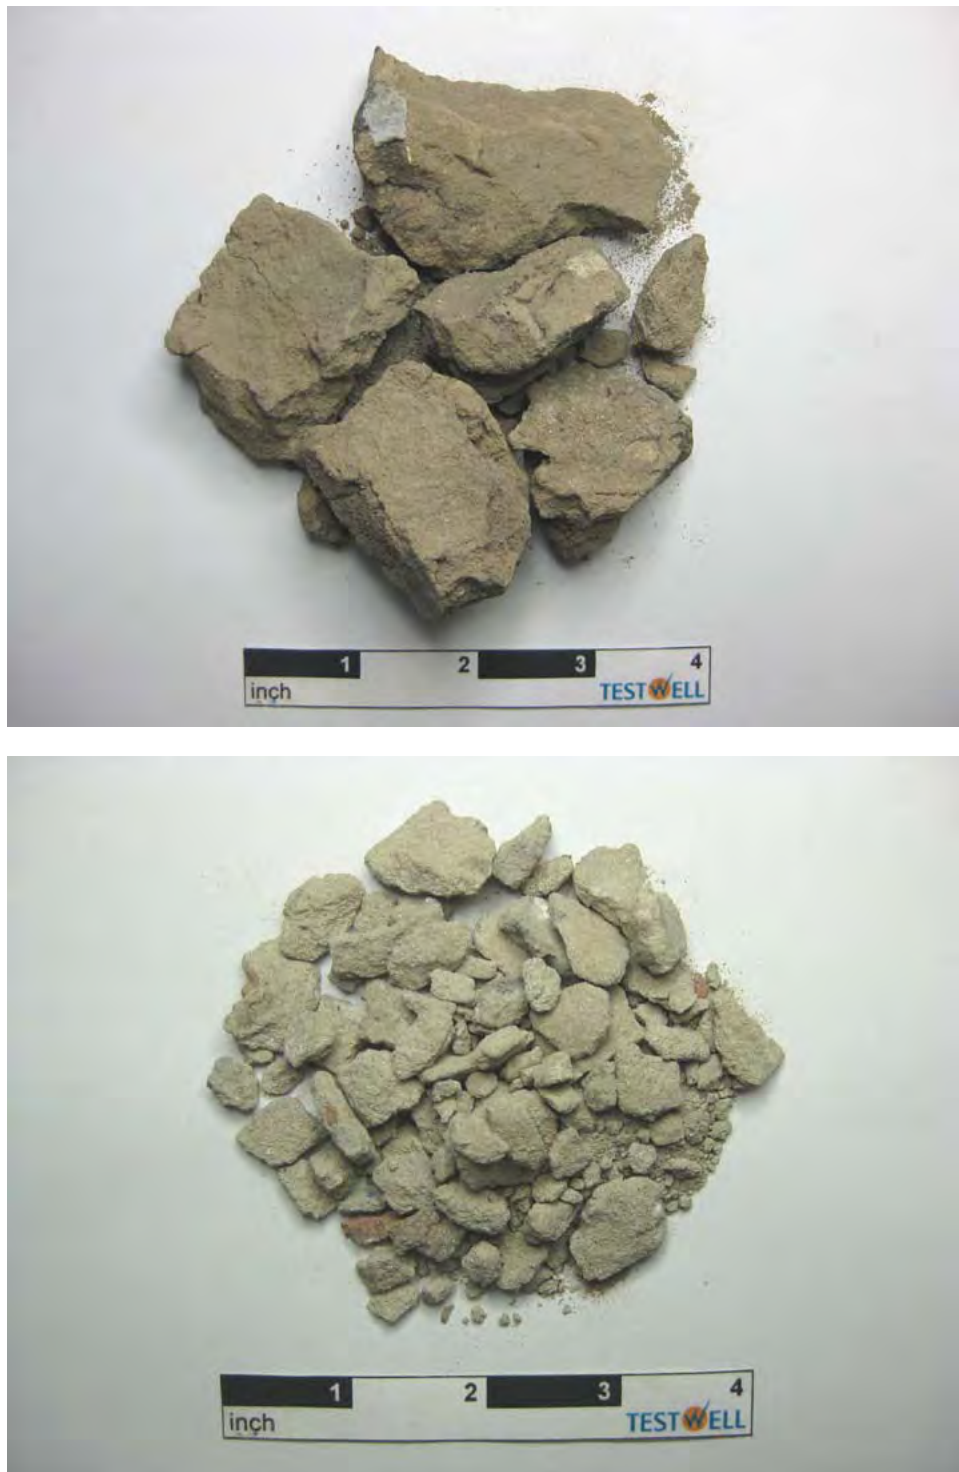
**Figure 1:** Mortar samples CALO.Mortar.1 (top) and CALO.Mortar.2 (bottom) received by Testwell for comprehensive analysis.

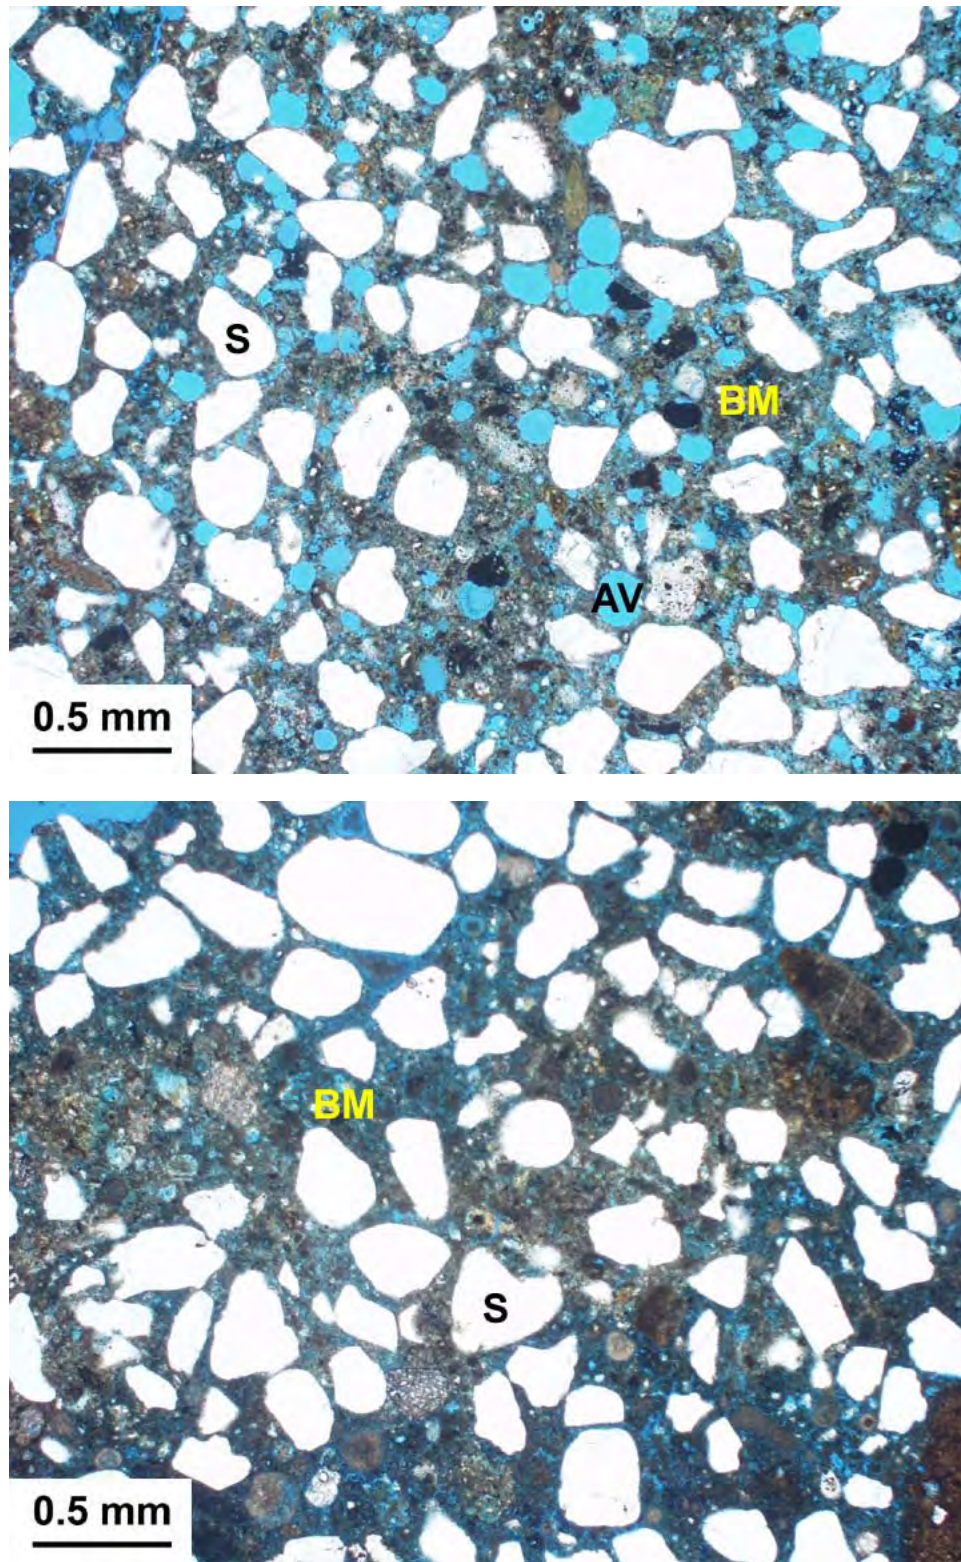
**Figure 2:** PPL photomicrographs illustrating the microtexture of mortar samples CALO.Mortar.1 (top) and CALO.Mortar.2 (bottom). Relatively rounded and narrowly graded sand grains (S) are well distributed throughout the binder matrix (BM). The cementitious matrix has a moderate capillary porosity as indicated by the blue-dyed epoxy used in the sample preparation. Air-voids (AV) are shown for sample CALO.Mortar.1 and these are abundant. Voids are nearly as abundant in sample CALO.Mortar.2 but are mostly filled with secondary calcium carbonate rendering them nearly invisible at this scale (see Figure 6).

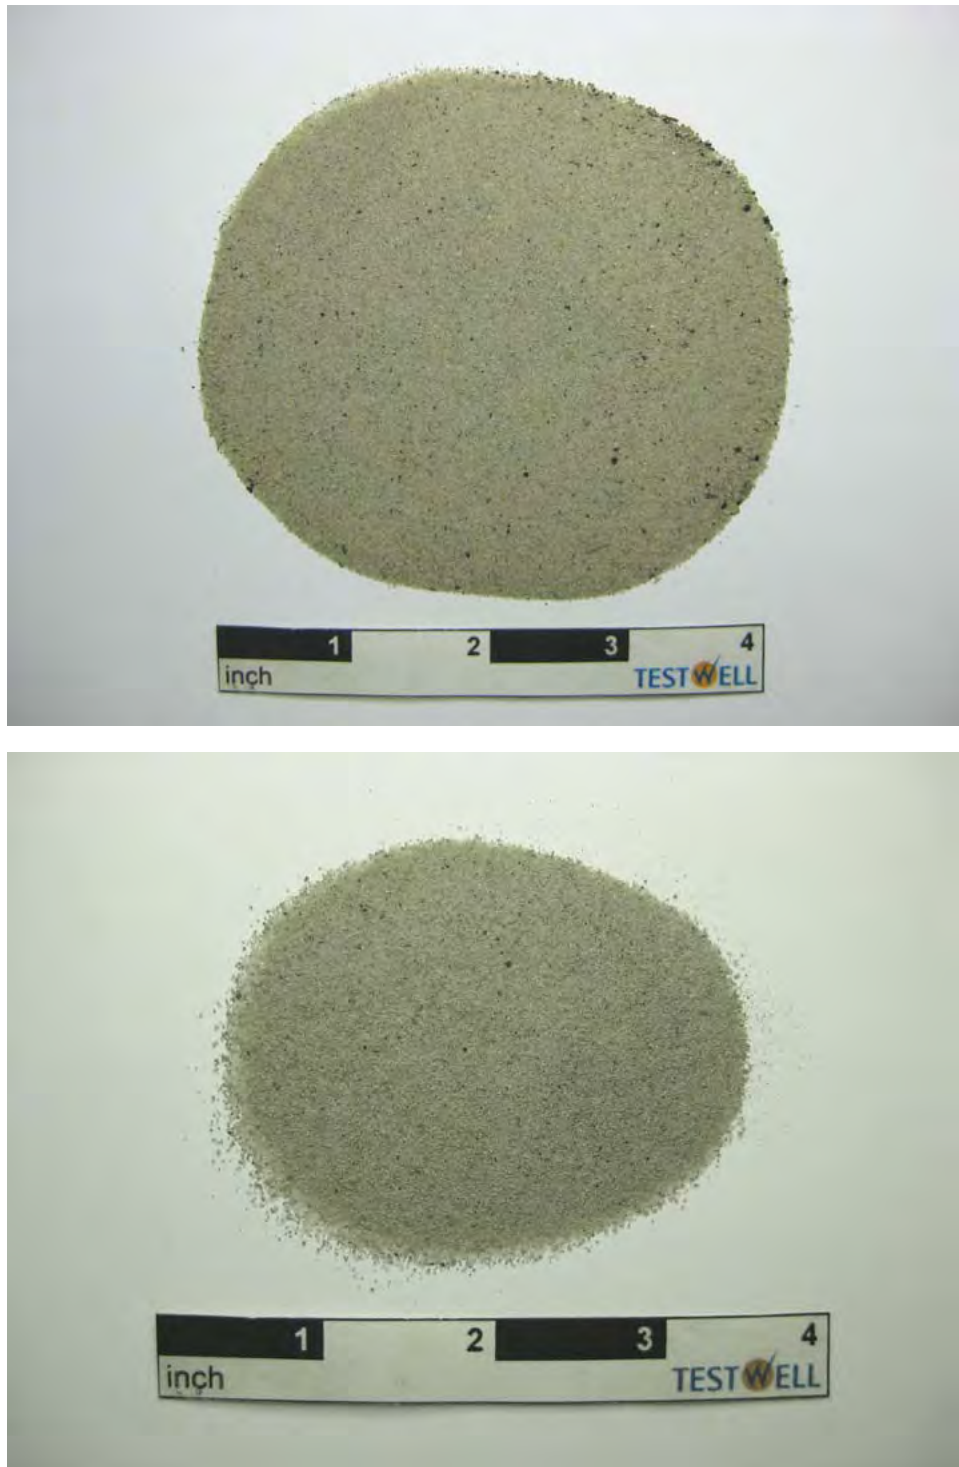
**Figure 3:** Photographs of sand separated from mortar samples CALO.Mortar.1 (top) and CALO.Mortar.2 (bottom). The sands are virtually identical appearing as uniform, fine-grained, and light-colored sands. The trace dark grains are identified as coal dust that likely represent a minor contaminant from the cement.

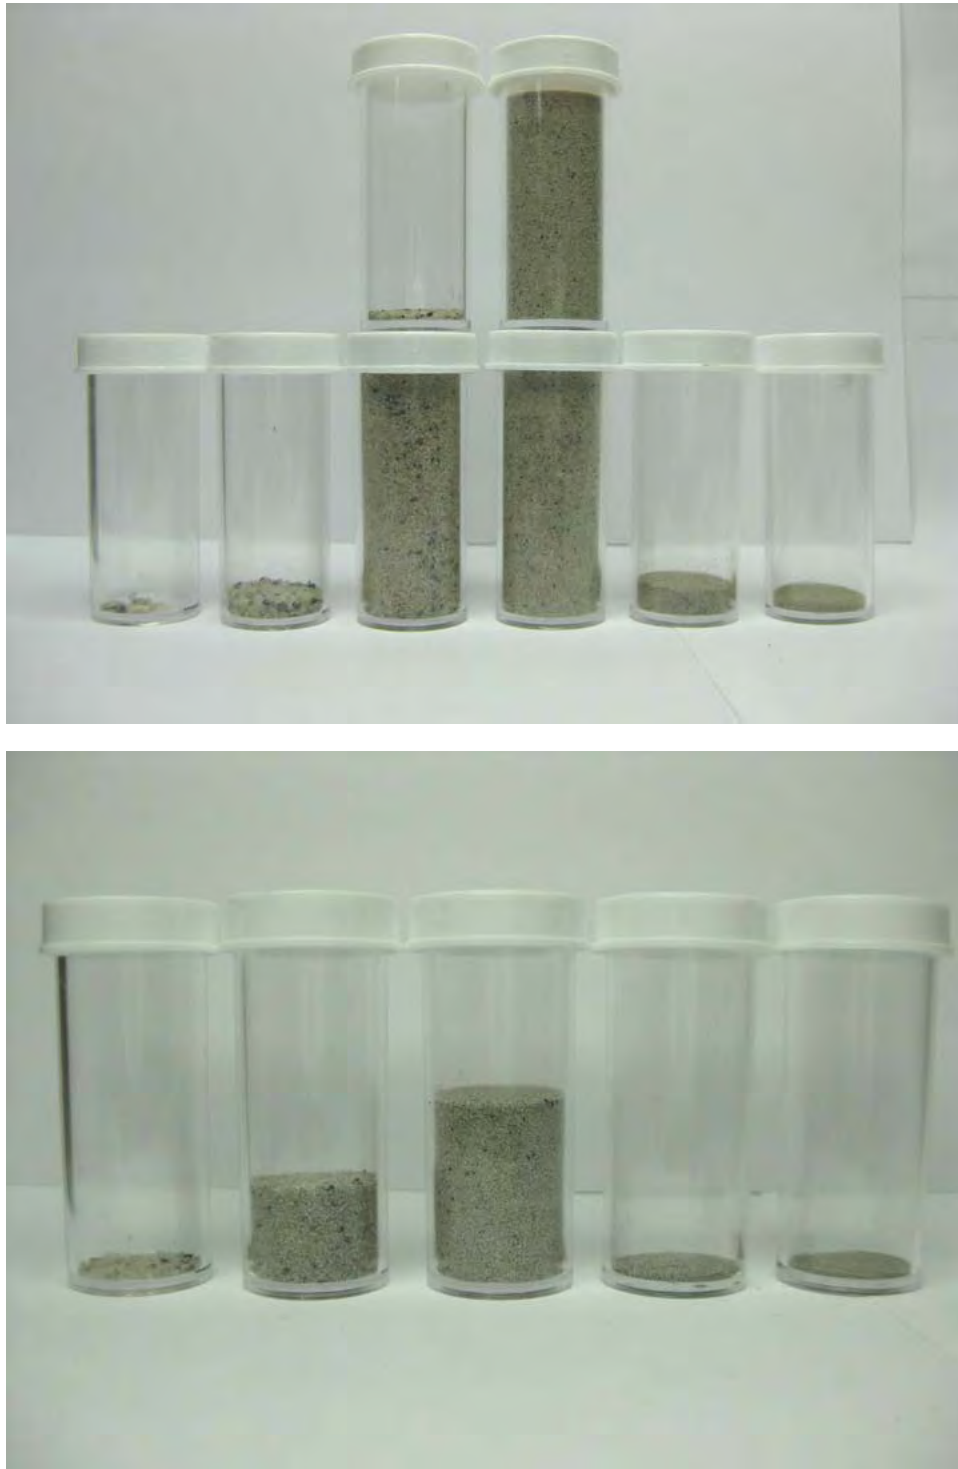
**Figure 4:** Photographs of the graded sand separated from mortar samples CALO.Mortar.1 (top) and CALO.Mortar.2 (bottom). The sands are both narrowly graded with a vast majority of material found between the No. 30 and No. 100 sieves.

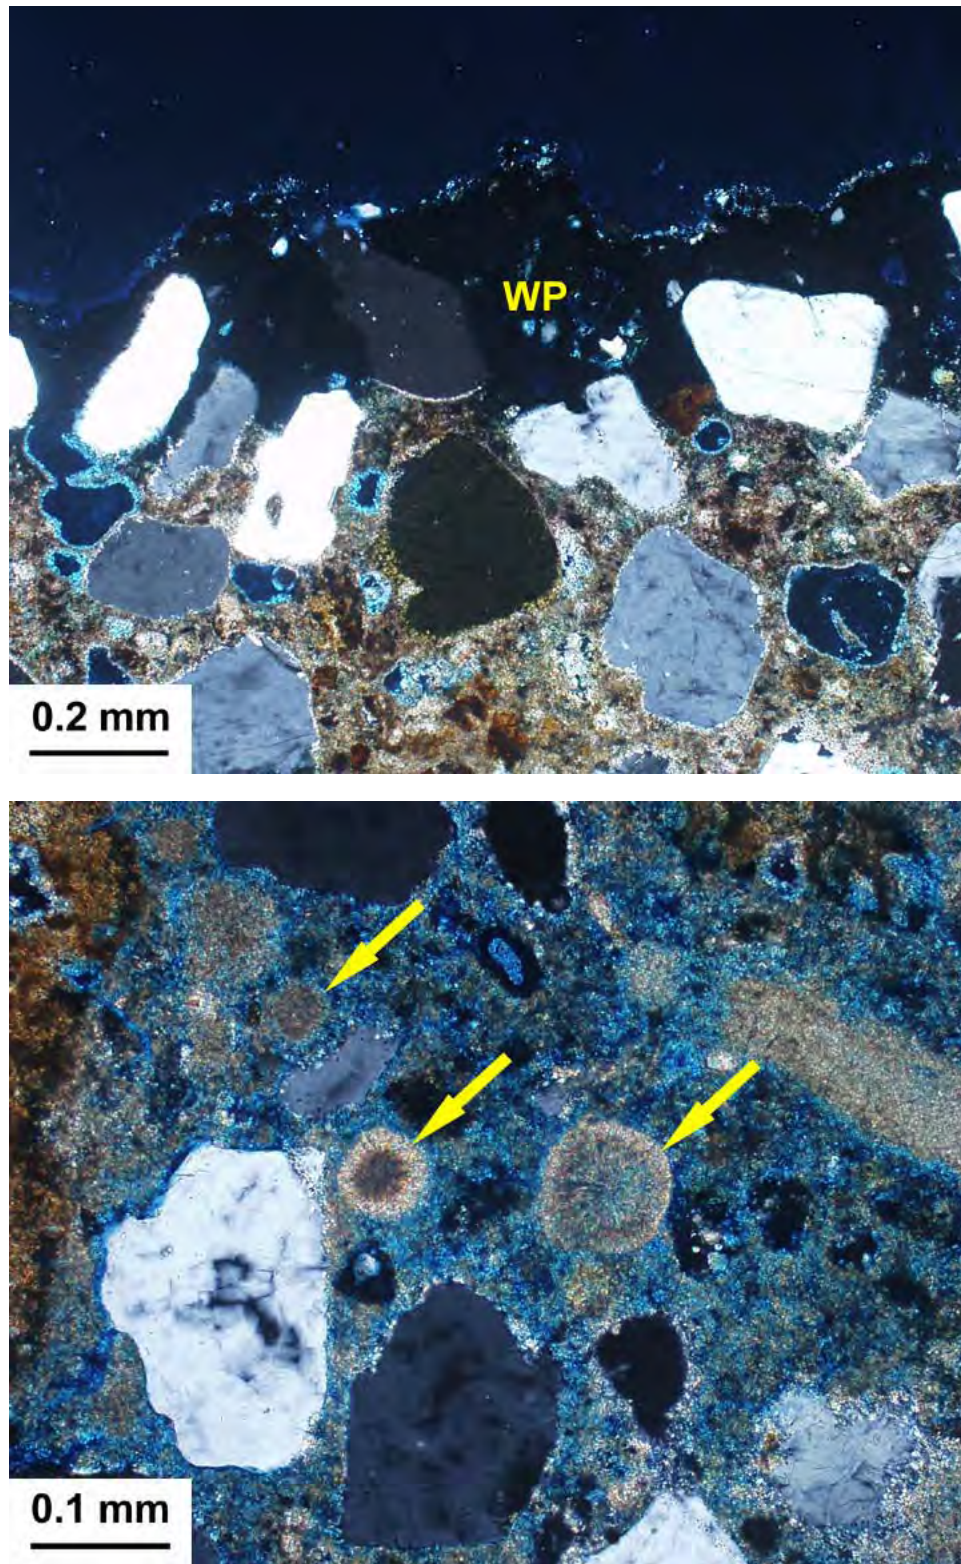
**Figure 6:** XPL photomicrographs illustrating minor secondary chemical reactions. (Top) Sample CALO.Mortar.1 exhibits a rind of weathered paste (WP). The golden color of the paste below is due to normal carbonation. The dark color within the rind indicates dissolution of this secondary carbonate along with other acid-soluble phases. The weathered paste is consistent in texture with that affected by acidic solution. (Bottom) The arrows indicate air-voids in Sample CALO.Mortar.2 that are filled with secondary calcium carbonate. These are visible in hand sample as fine white spots that should not be confused with lime inclusions.
