# NPS Structural/Seismic Evaluation: Cabrillo National Monument

San Diego, California

## Final Report

October 29, 2010

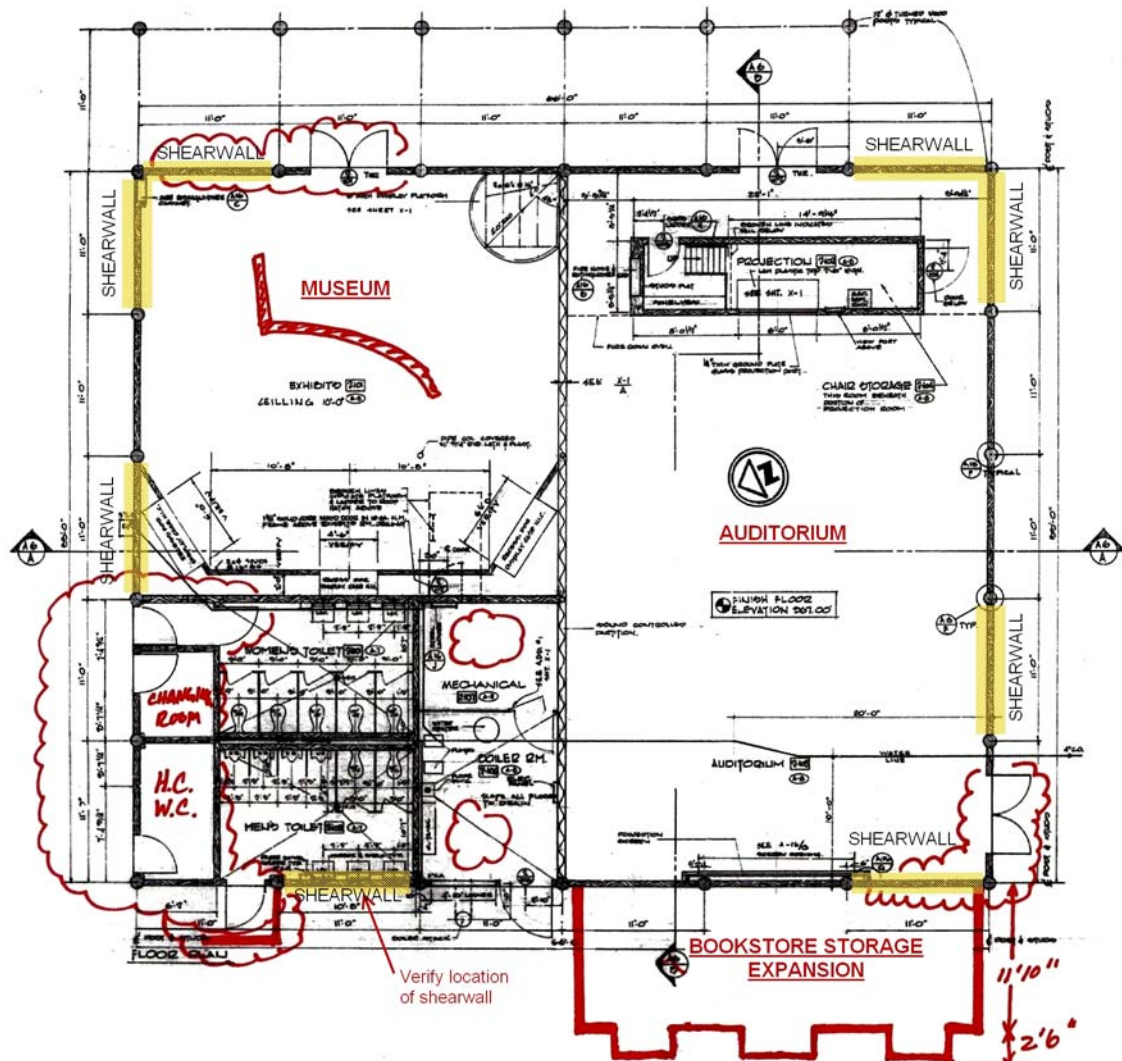
Figure 19: Auditorium/Museum Changes and Alterations Plan

These changes are shown graphically in Figure 19. Red clouds represent an area that has changed. Red lines also represent the curved partition and beginning of the walls for the expansion.

The lateral-force-resisting system in the main building consists of the plywood-sheathed roof diaphragm and wood shearwalls. We were unable to directly observe the locations of the shearwalls and noted discrepancies in the plans in that door openings exist where shearwalls are shown in the plans at 3 locations. In fact, the auditorium fire doors are shown in the architectural drawings where a shearwall is shown in the structural drawings. Since the plans were clearly engineered with the intent to provide 2 bays of shearwall on each side, we presume that the changes to the design accounted for this and simply swapped door and shear wall positions such that shear walls are located where hatched in yellow in Figure 19. The only area that was obviously renovated and not considered part of the original design intent is the restroom area. This area has been drastically altered after the building was constructed and the men's bathroom door may have effectively removed a shearwall depending on which bay it is located in. Finishes should be removed in this area to verify the presence of the shearwall.

Remove finishes by the men's restroom to verify the location of the shearwall by the bathroom as shown in Figure 19. Engineering recommendations and remediation will be necessary if the shearwall is not located in the bay.

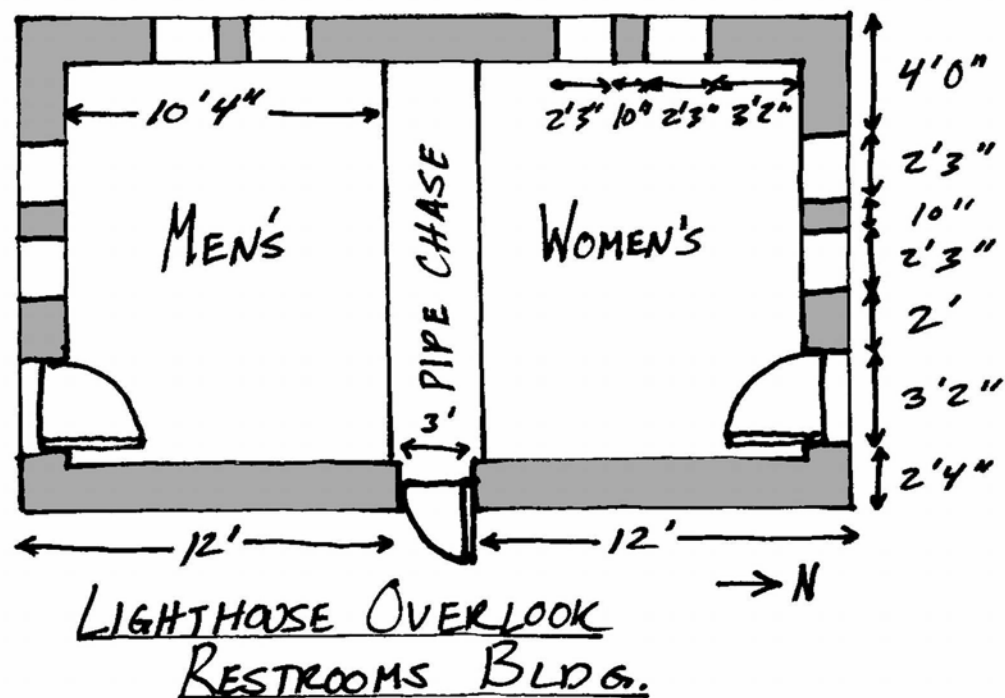
Figure 29: Lighthouse Overlook Restrooms Plan Sketch

Overall, the building appeared to be in good condition. The mortar between stones at the base of the east facade had occasionally disintegrated such that there were large, deep gaps around stones. A masonry wall that abuts the building on the north side is separated from it by a large crack in the mortar attaching it to the building, but this does not represent a hazard to the building itself. Otherwise, the structure appeared serviceable with no significant signs of damage or distress.

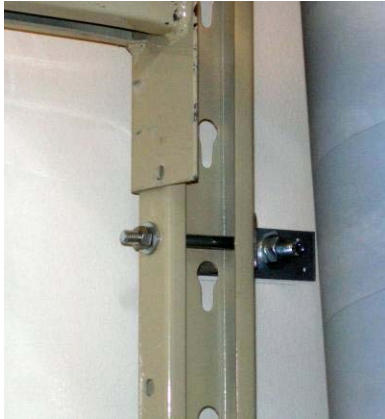
Figure 45: Shelf Anchor

Shelving has been anchored to the walls as shown in Figure 45, and archival storage shelves are locked into a track system anchored to the concrete floor. These present very little threat during a seismic event.

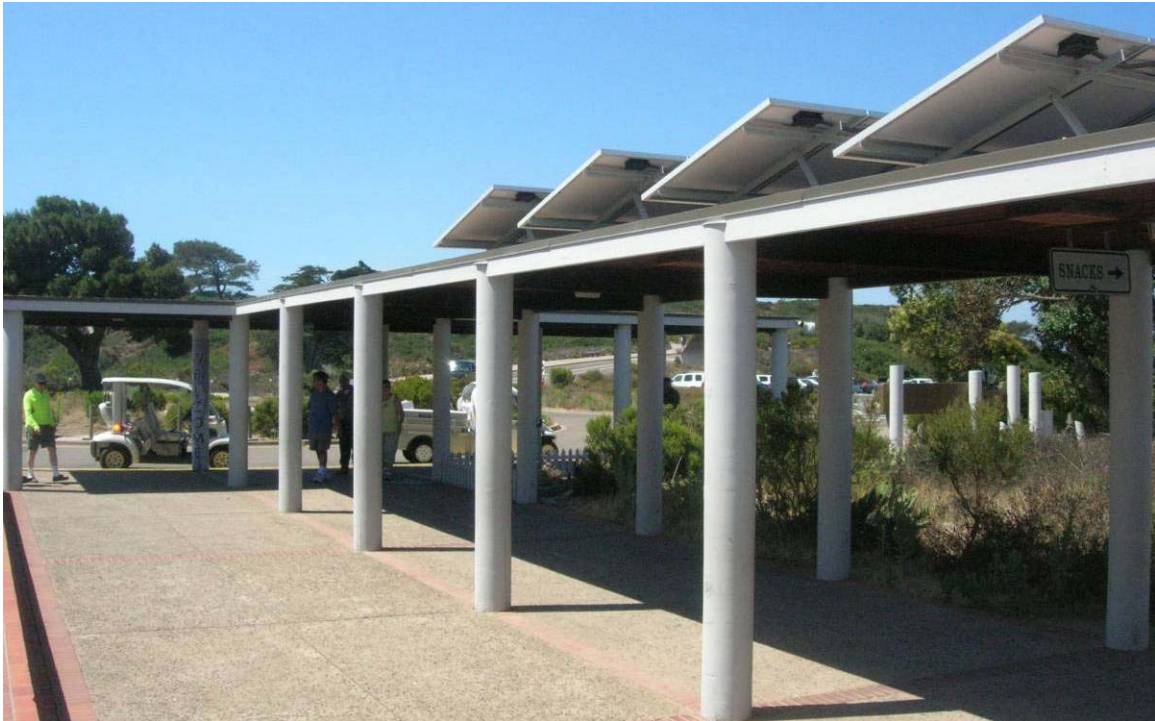
Figure 46: Pergola Entry

Overall, the pergola was observed to be in good condition. A few plugs that had once disguised countersunk bolts are missing, though this does not affect the integrity of the connection. Rim boards are connected to posts via toenails, some of which have come loose or have insufficient edge distance. Loose nails should be driven back in, and rim boards having nails with insufficient edge distance should be connected by nails with sufficient edge distance to prevent them from being a falling hazard in a seismic event. Otherwise, the structure appeared serviceable with no signs of significant damage or distress.

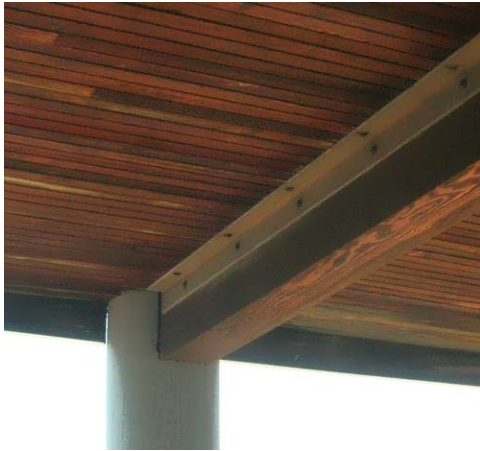
Figure 47: Expansion Joint

The roof consists of  $\frac{3}{8}$ -inch plywood sheathing over 2x3 lam decking on 6x8 beams. The decking and beams are exposed, probably weatherproofed, but not painted. Expansion joints, as shown in Figure 47, were provided for in the roof by way of 2½-inch by 2-inch steel angles fastened to the beams and the deck above via lag screws in slotted holes.

At other locations close to the Administration Building and the Visitor Center View Building, expansion joints allow for only a small amount of movement between the Pergola and the neighboring building. The current system is highly flexible, and these expansion joints may not allow for enough movement. Instead, the bolts will move to the end of their slotted holes and forces will be shared between the Pergola roof and the neighboring building roof or wall.

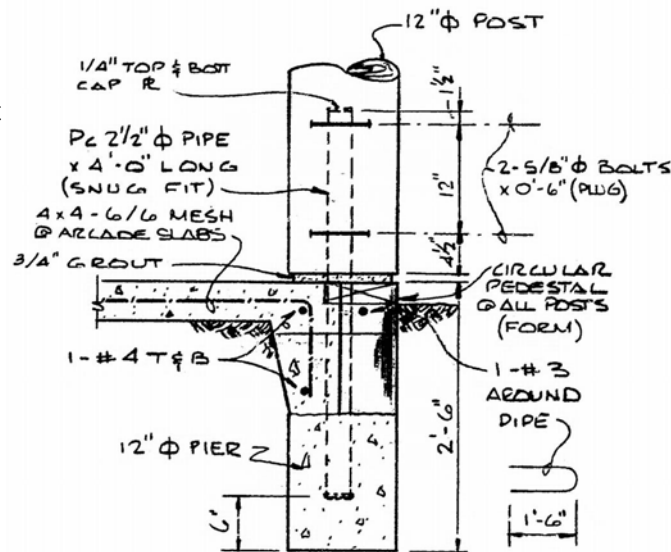
Figure 48: Post Connection

The posts are founded on 12-inch diameter reinforced concrete piers 2-feet 6-inches beneath the top of the neighboring 4-inch thick concrete paving. A 2½-inch diameter pipe, embedded within the pier, extends into the wood post and is fastened with two  $\frac{5}{8}$ -inch bolts per the detail on the original plans, shown here as Figure 48.

Columns are attached to piers via a pipe and bolts in an effort to provide a load path to the foundation. This pipe may not be sufficient to withstand the flexural stresses expected in an earthquake given the additional dead loads on the structure.

The piers themselves appear insufficient. They are quite shallow at 2 feet 6 inches below grade and are unlikely to be sufficient in resisting overturning or flexural moments in an earthquake. In fact, the 2005 Resource Management Office plans showing the Law Enforcement Building and Pergola expansion specify a minimum of 5 foot deep piers below new Pergola columns. This implies that by today's standards, piers shorter than 5 feet deep are probably inadequate in resisting seismic loads. Moreover, the first foot of soil around the pier cannot be relied upon to provide lateral resistance, and the paving slab is too thin to provide restraint; as such, these independent piers are at risk of failure in an earthquake. Being on independent piers, the columns are in danger of great amounts of differential movement in an earthquake causing higher stresses in the roof and greater damage to finishes and equipment. A foundation that ties several columns together would alleviate this tendency and provide greater rigidity.

Replace select columns with columns capable of resisting expected lateral loads such as a steel column with wood fascia or covering. Fasten the roof sheathing and beams to columns. Connect columns to foundation with anchor bolts and base plate capable of resisting expected seismic loads and moments.
